ADVANCED HYBRID PARTICULATE COLLECTOR

Quarterly Technical Progress Report
for the period July 1, 1999, through September 30, 1999

November 1999

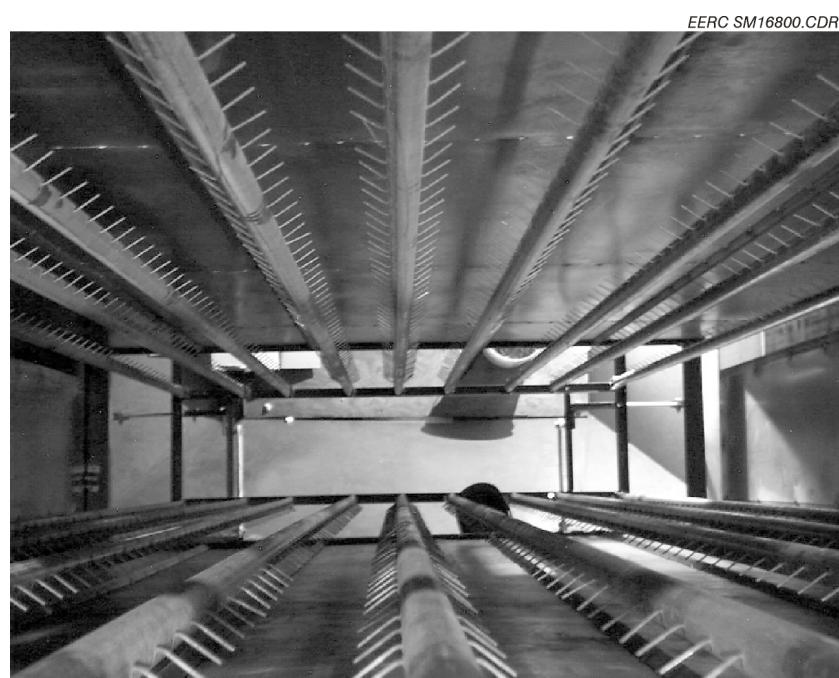
Figure 3. View from top of the AHPC with tube sheet and bags removed showing two rows of nine discharge electrodes.

Figure 1 (figures follow text) is a top view of the geometric arrangement of the AHPC showing how the rows of bags are centered between parallel collecting plates with rows of discharge electrodes on opposite sides of the bags between the bags and plates. Figures 2 and 3, which were taken during construction without bags and before installation of the tube sheet, show the arrangement of discharge electrodes and collecting plates. AHPC specifications are given in Table 1, and the bag pulsing specifications are shown in Table 2. Photos of the AHPC as installed at the ESP inlet duct at Big Stone plant are shown in Figures 4 and 5. Note the small, compact, high-voltage (HV) power supply at the top of the unit (Figure 5). This small housing, which contains the entire transformer rectifier (TR) set and controls, is mounted directly over one of the support insulators for the discharge electrodes. Figure 6 shows one of the Goyen pulse valves along with one of the sight ports. Figure 7, taken from the opposite side at the top of the AHPC, shows one of the pneumatic plate rappers along with another sight port. Figure 8 is a photo taken through the sight port during actual operation showing the first bag centered between the directional discharge electrodes and plates.

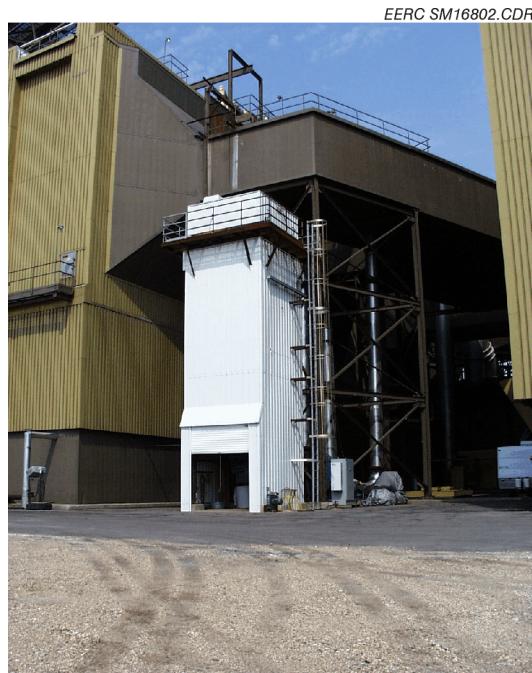
Figure 4. AHPC installed at the ESP inlet at the Big Stone plant.

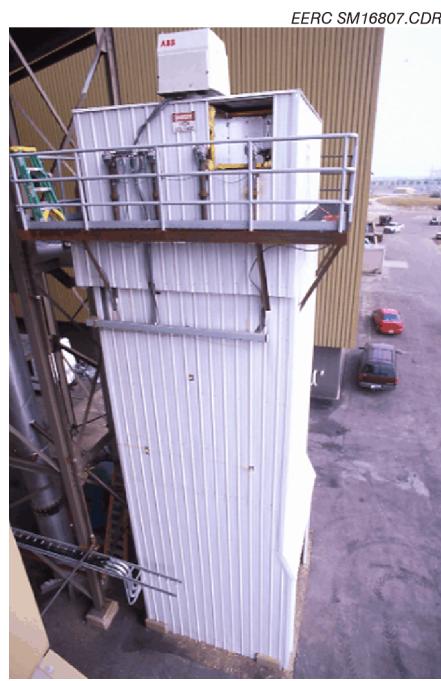
Figure 5. AHPC showing access platform and HV power supply.

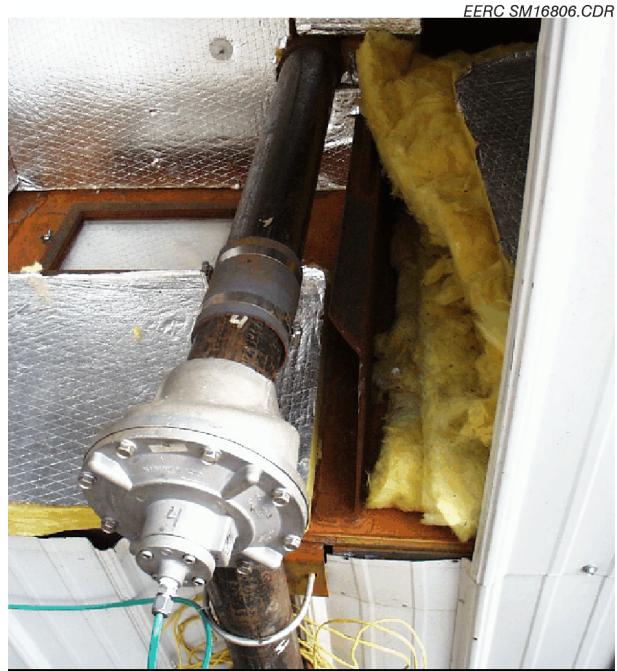
Figure 6. Goyen pulse valve and sight port at top of AHPC.
