Acid Pit Stabilization Project (Volume 1—Cold Testing)

**Idaho National Engineering and Environmental Laboratory
Environmental Restoration Technologies Department
Lockheed Martin Idaho Technologies Company
Idaho Falls, Idaho 83415**

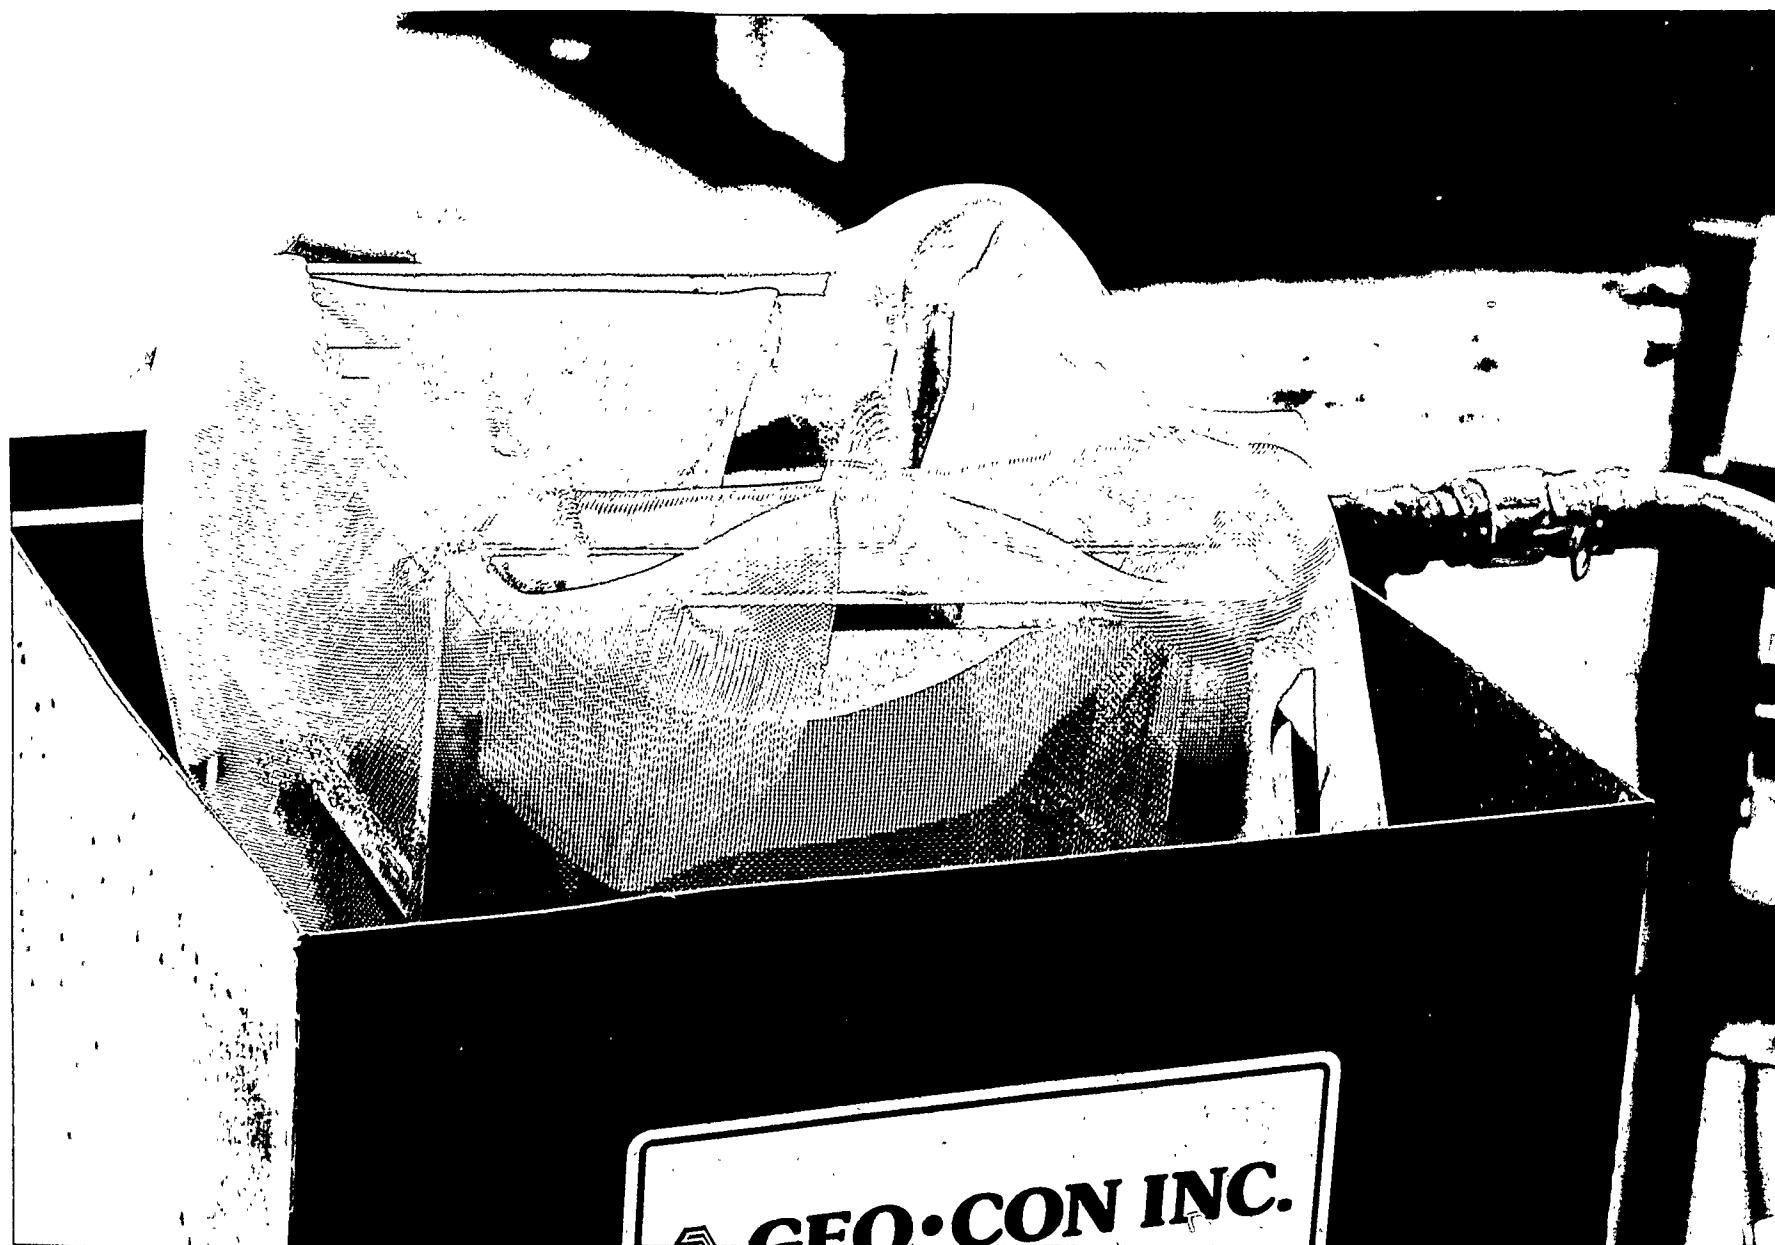
Figure 6. Filter screen for Moyno pump (Photo 97-481-3-11).

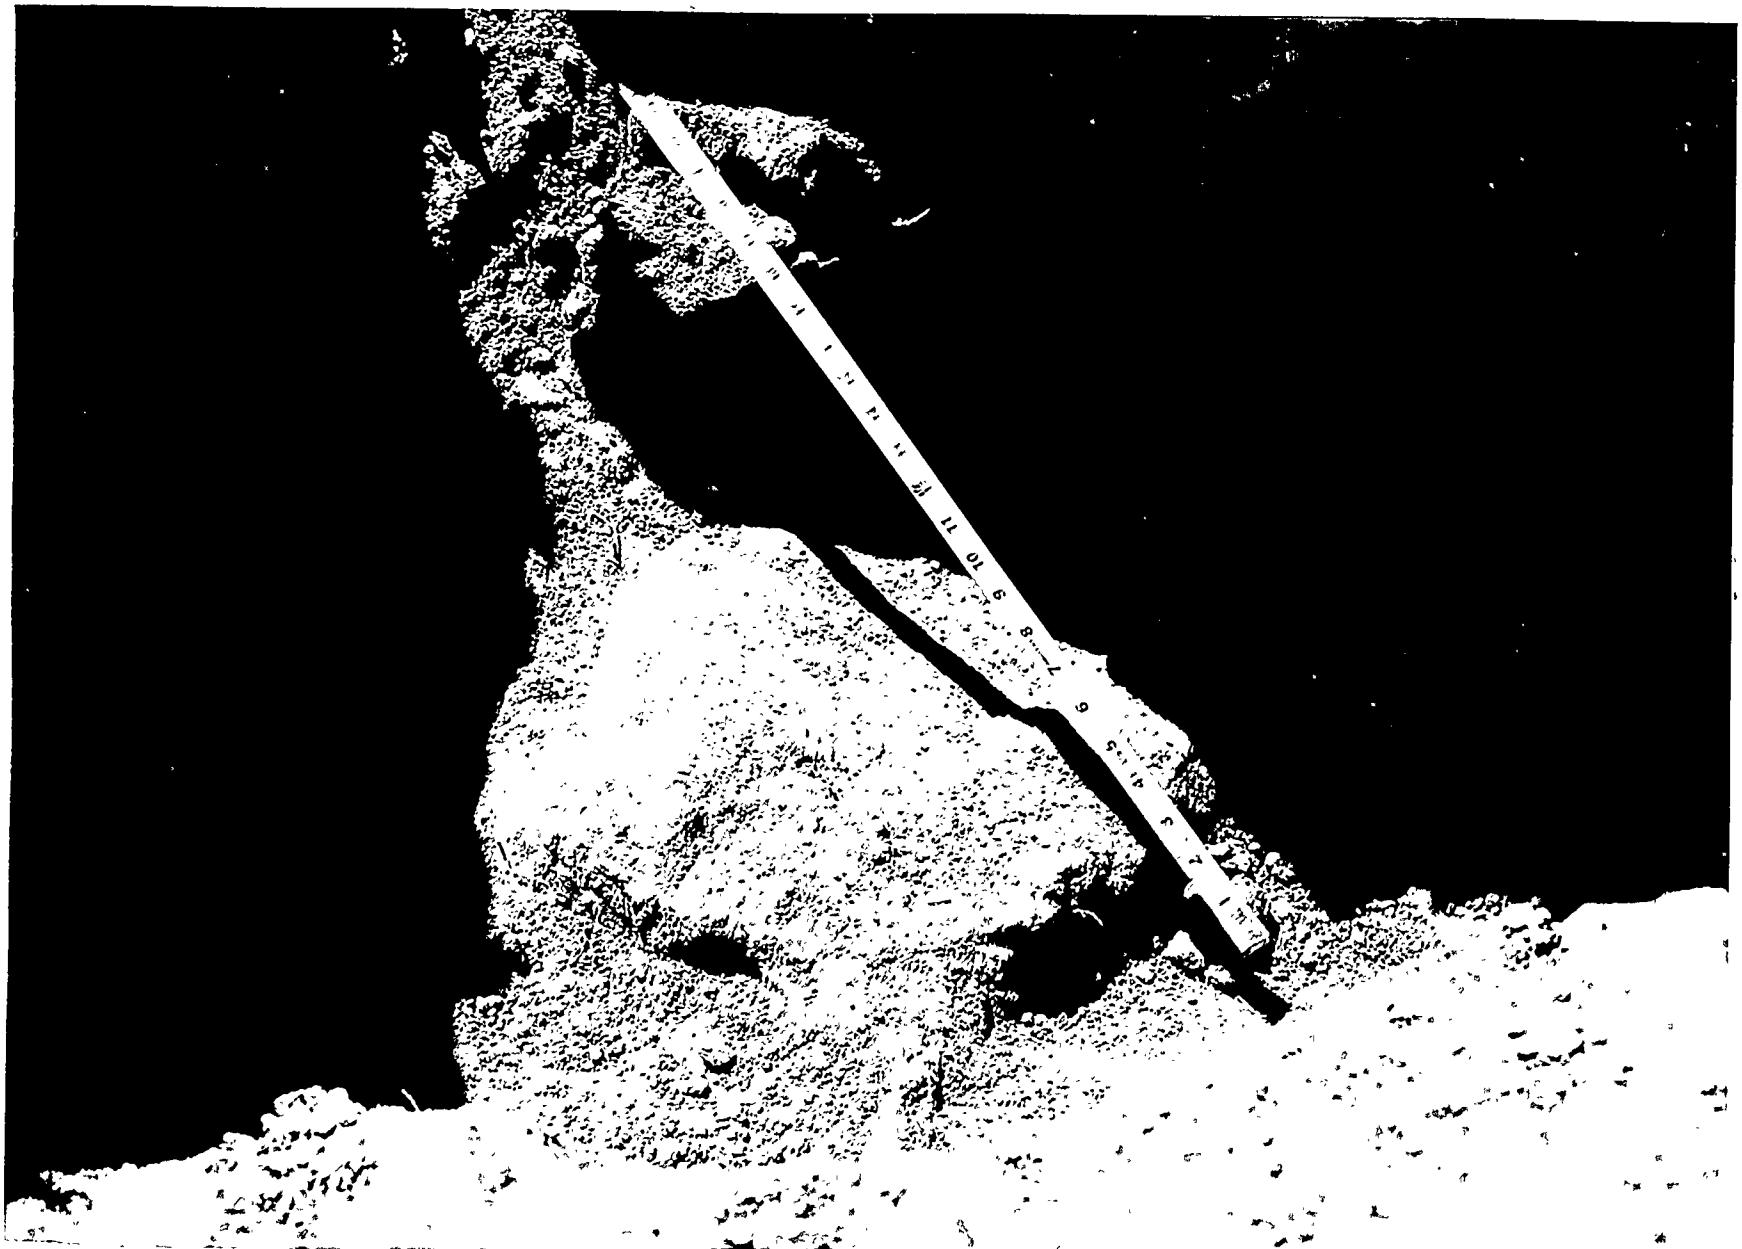
Figure 23. A solid core in the field trial hole (Photo 97-490-1-21A).

of grout returns for drilling all four holes within a single joist of a thrust block did not fill the joist under the holes being grouted nor was there an excessive amount of grout collected under other joists (presumably by drainage through leakage paths caused by the imperfect seal between the thrust block joists and the sublayer of pea gravel). An interesting excursion of grout approximately 1 gal of viscous soilcrete came to the surface approximately 2 ft to the north of hole 4 (see Figure 20) during the grouting of holes 1-4 in the debris pit with the DAVY KENT system. Field trial FT-5 was then grouted in the disturbed soil area to ensure that, at 4 s per step, the column size was still adequate. Excavation of the field trial hole showed a solid grout column with dimensions approximately 20-25 in. in diameter as shown in Figure 23.

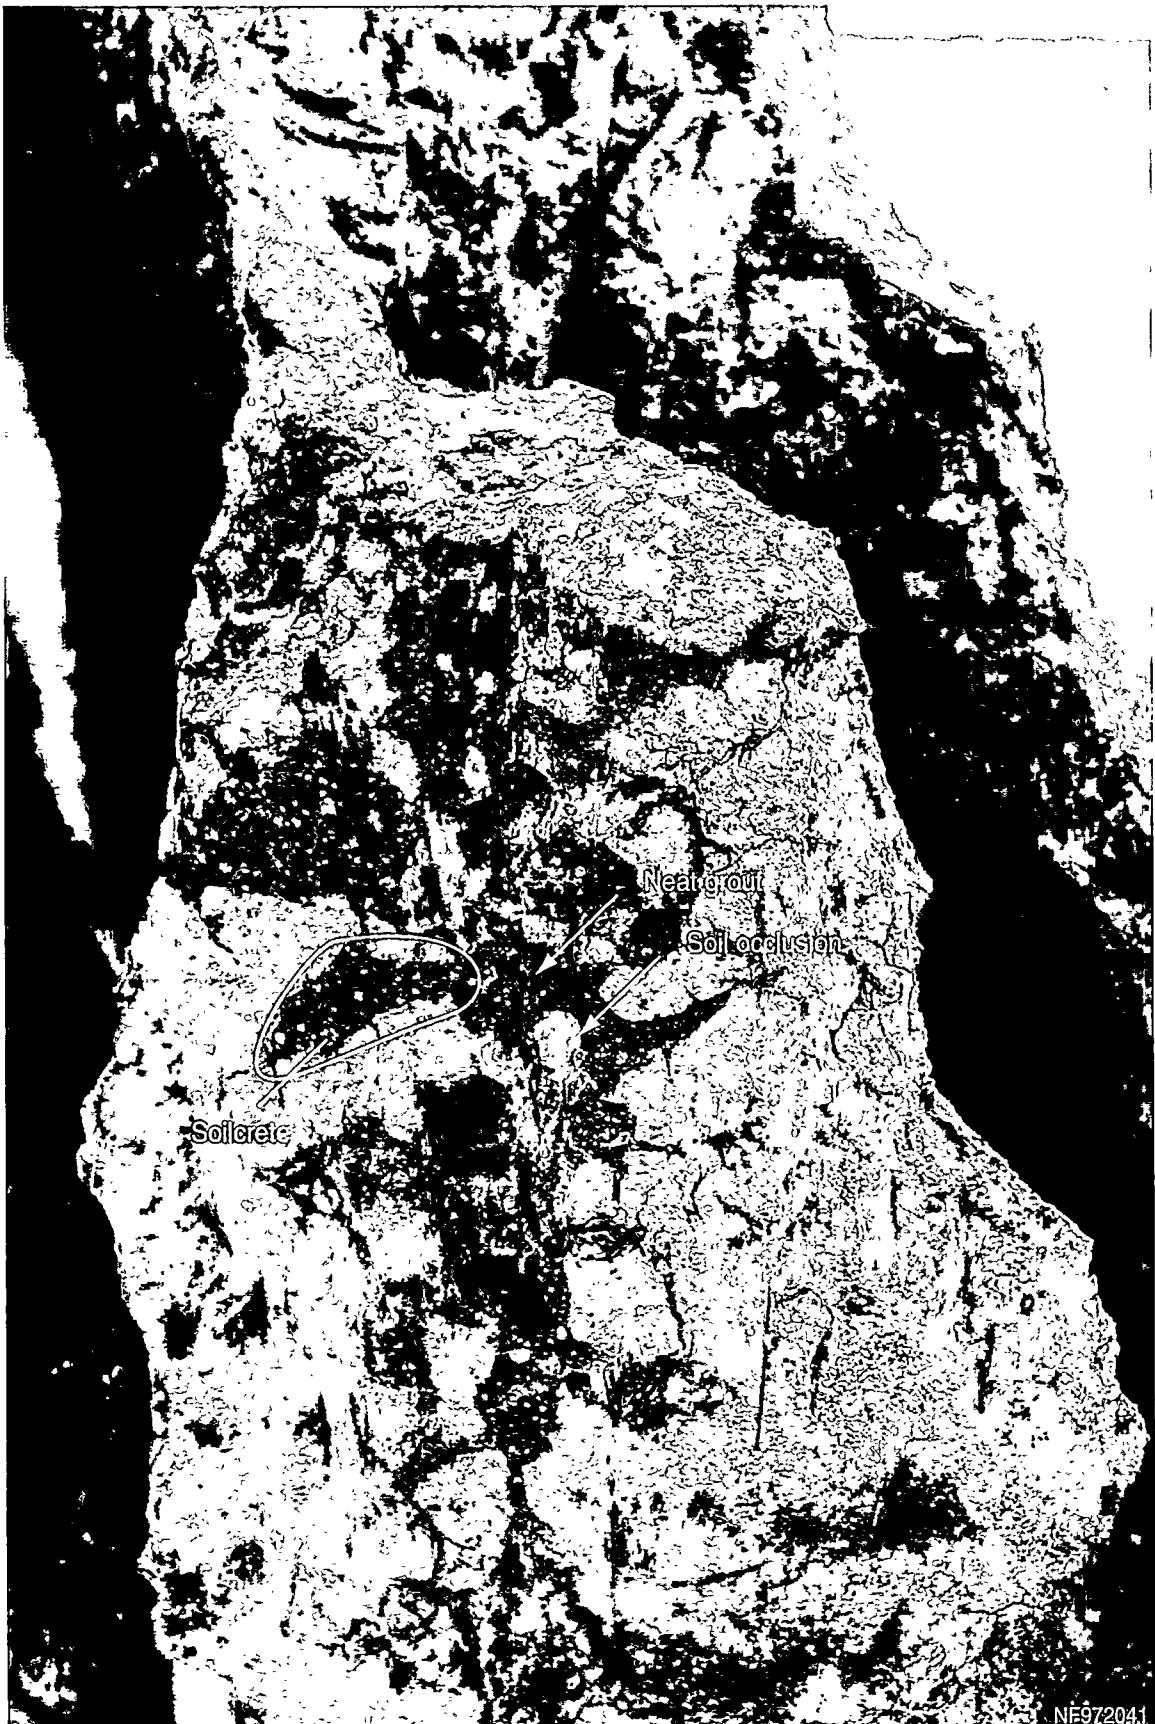
Figure 26. Detail of monolith typical (Graphic M98 0018).

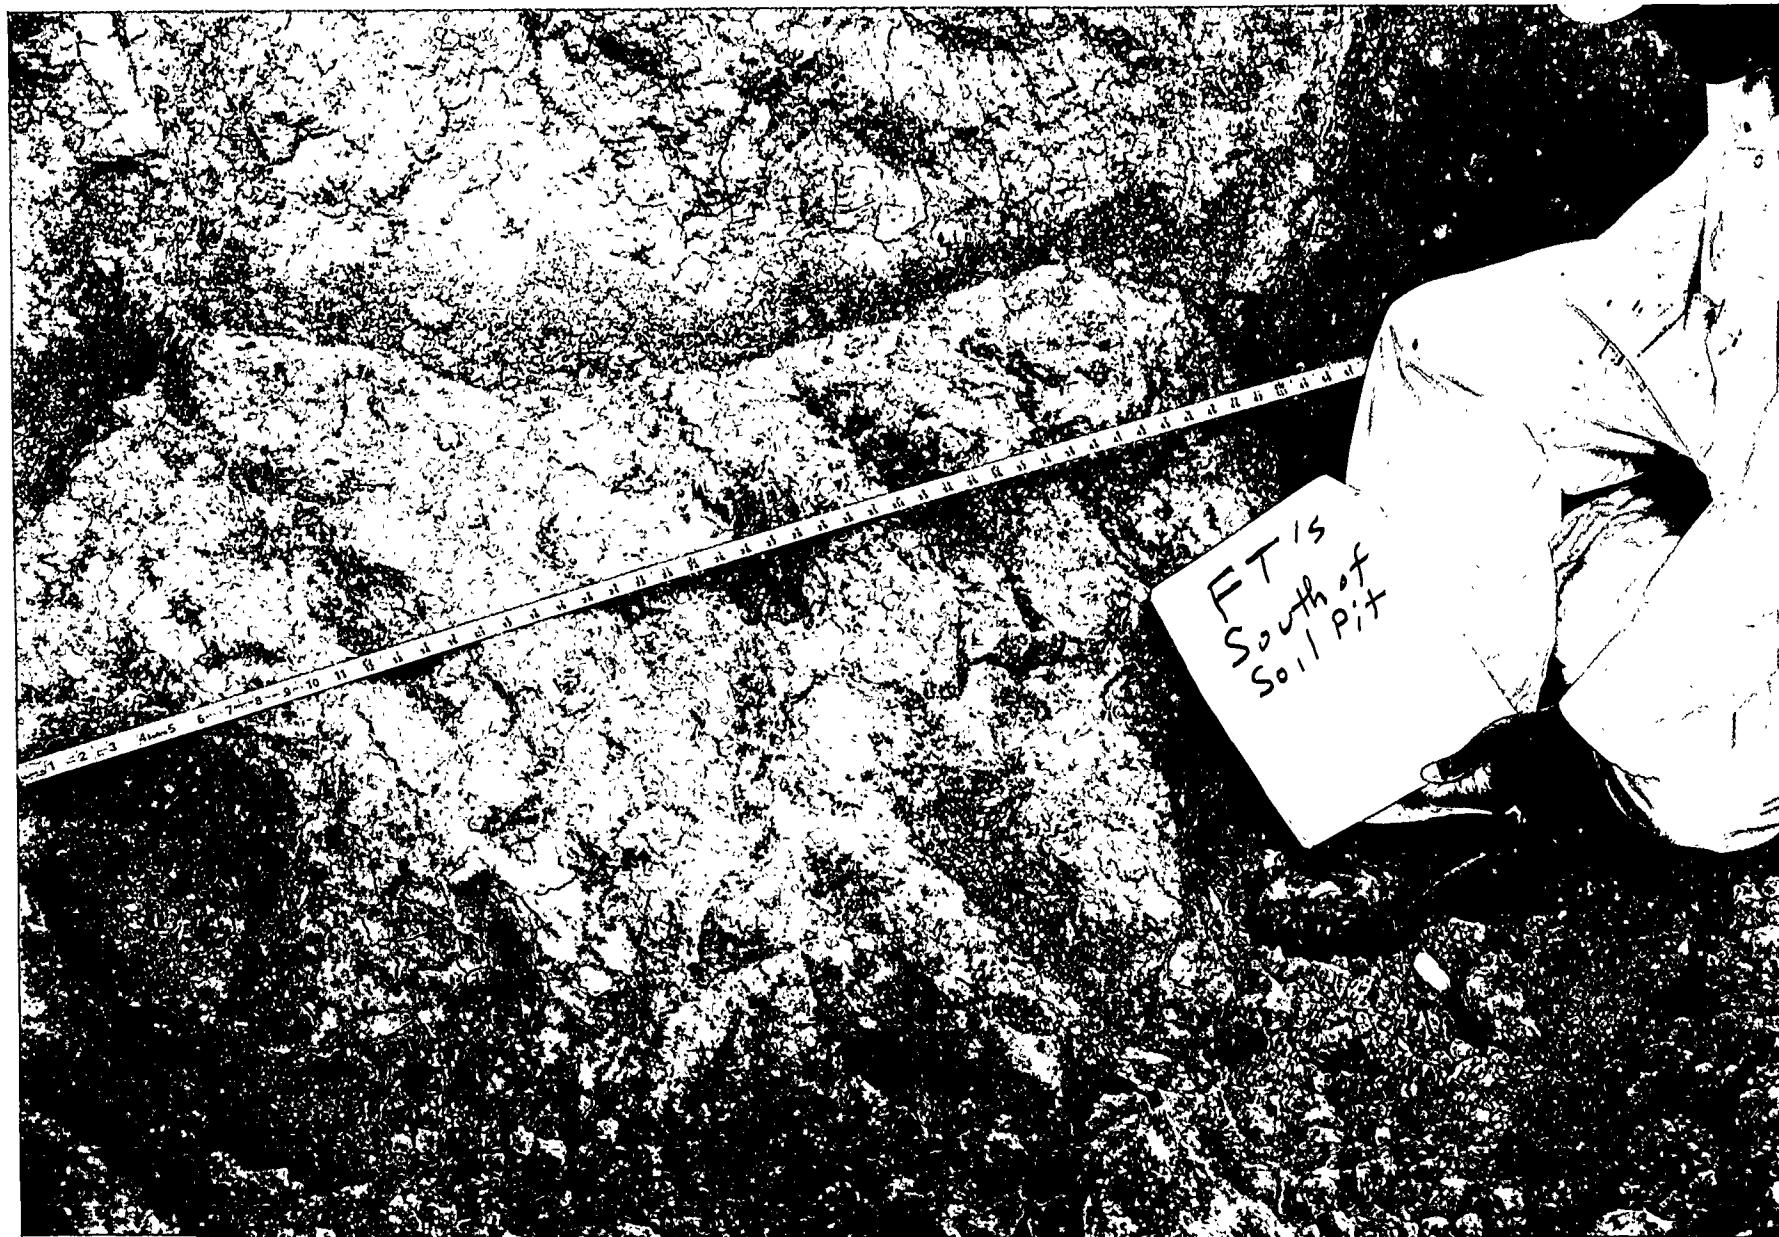
Figure 27. Three field trials south of the soil pit (approximately 50 in. across) (Photo 97-755-1-13).

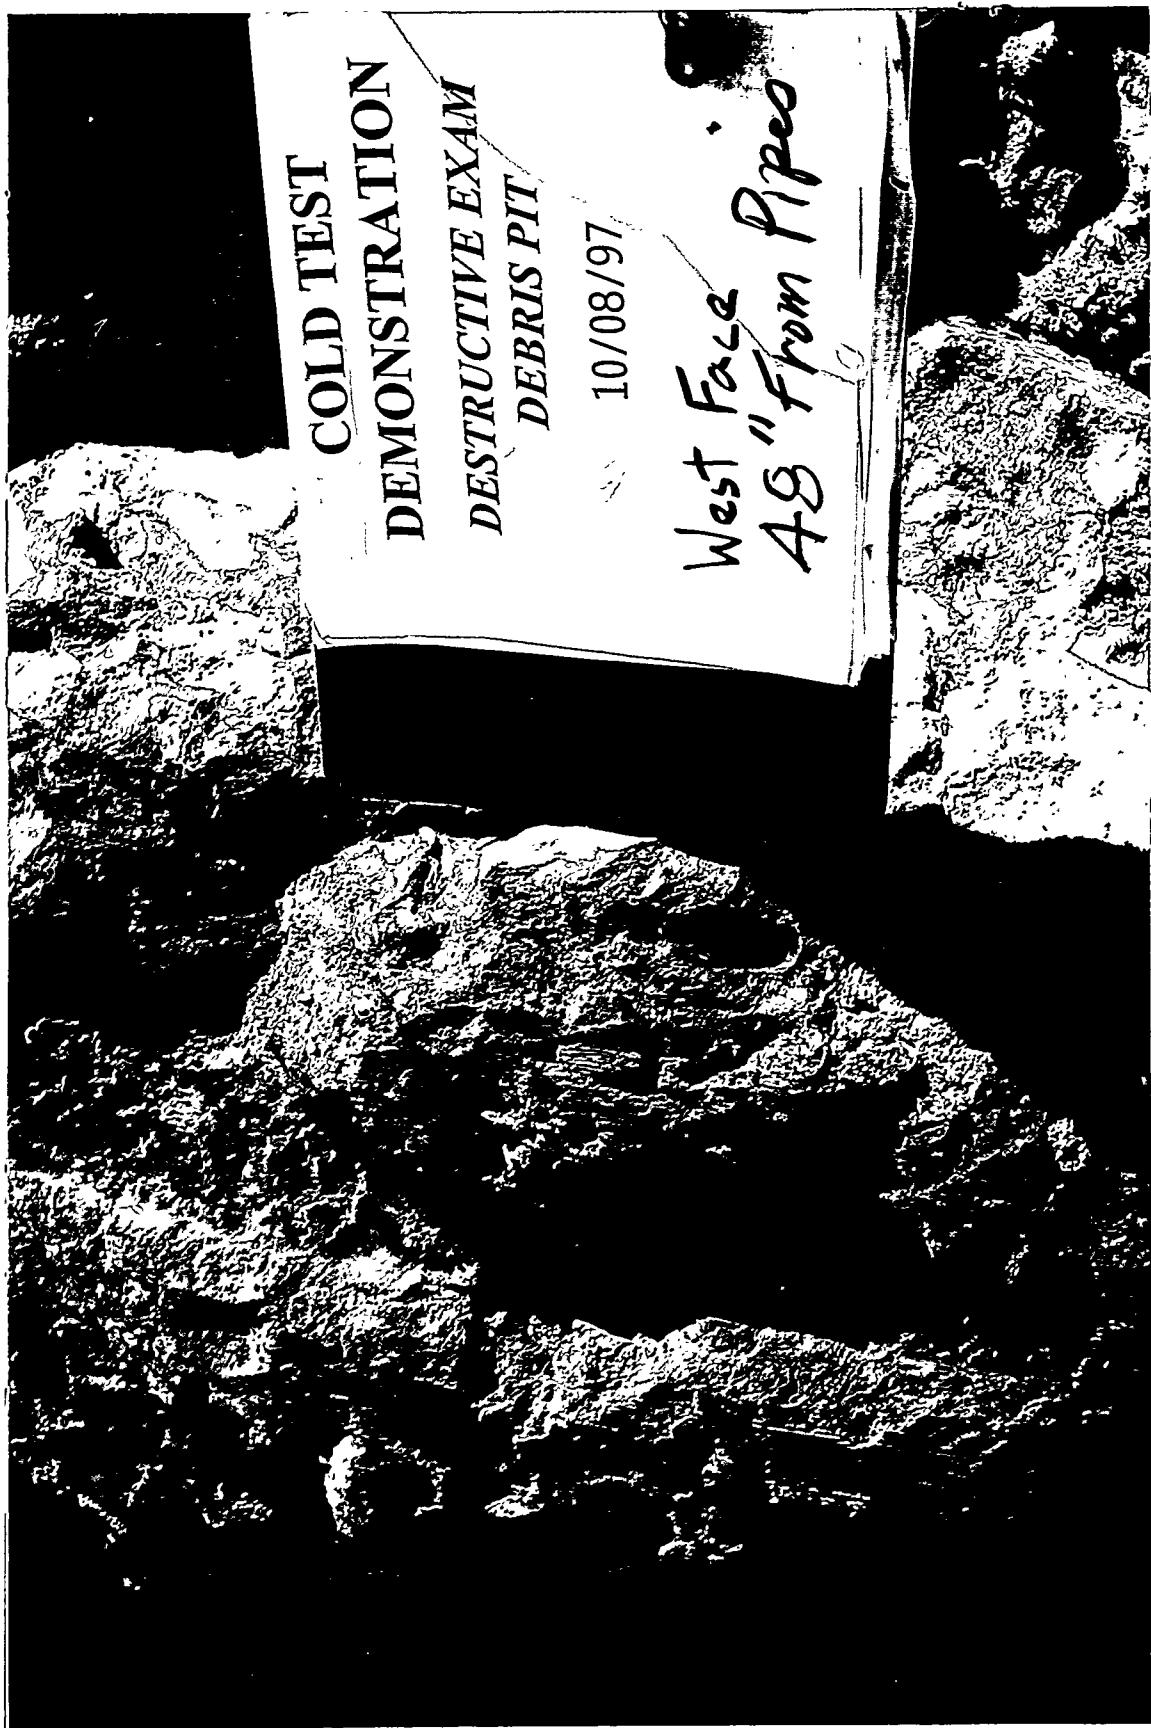
Figure 32. West face of debris pit (Photo NF971987).

In general, for the western face of the monolith only a few inches of the face could be broken off at a time using a standard backhoe. Figure 32 shows detail of the monolith 48 in. from the row containing hole 12. Figure 32 shows a dense cohesive monolith with almost no occlusions of soil. This dense layer of cured TECT/soil persisted for approximately 26 in. in from the west face, at which point the number and size of soil occlusions increased as shown in Figure 33. The farther into the debris pit the poorer the monolith appeared. In fact, at 36 in. into the face, evidence of a solid monolith was intermittent as shown in Figure 34. At this point, the front-end loader was used to topple the remaining monolith. Examination of the rubble showed virtually no loose soil; rather, the rubble was quite "glued" together with the TECT grout and the pieces ranged from 1 ft in average diameter to 3 ft as shown in Figure 35. Figure 35 also shows the instrumentation pipe imbedded into the debris pit into hole 12.

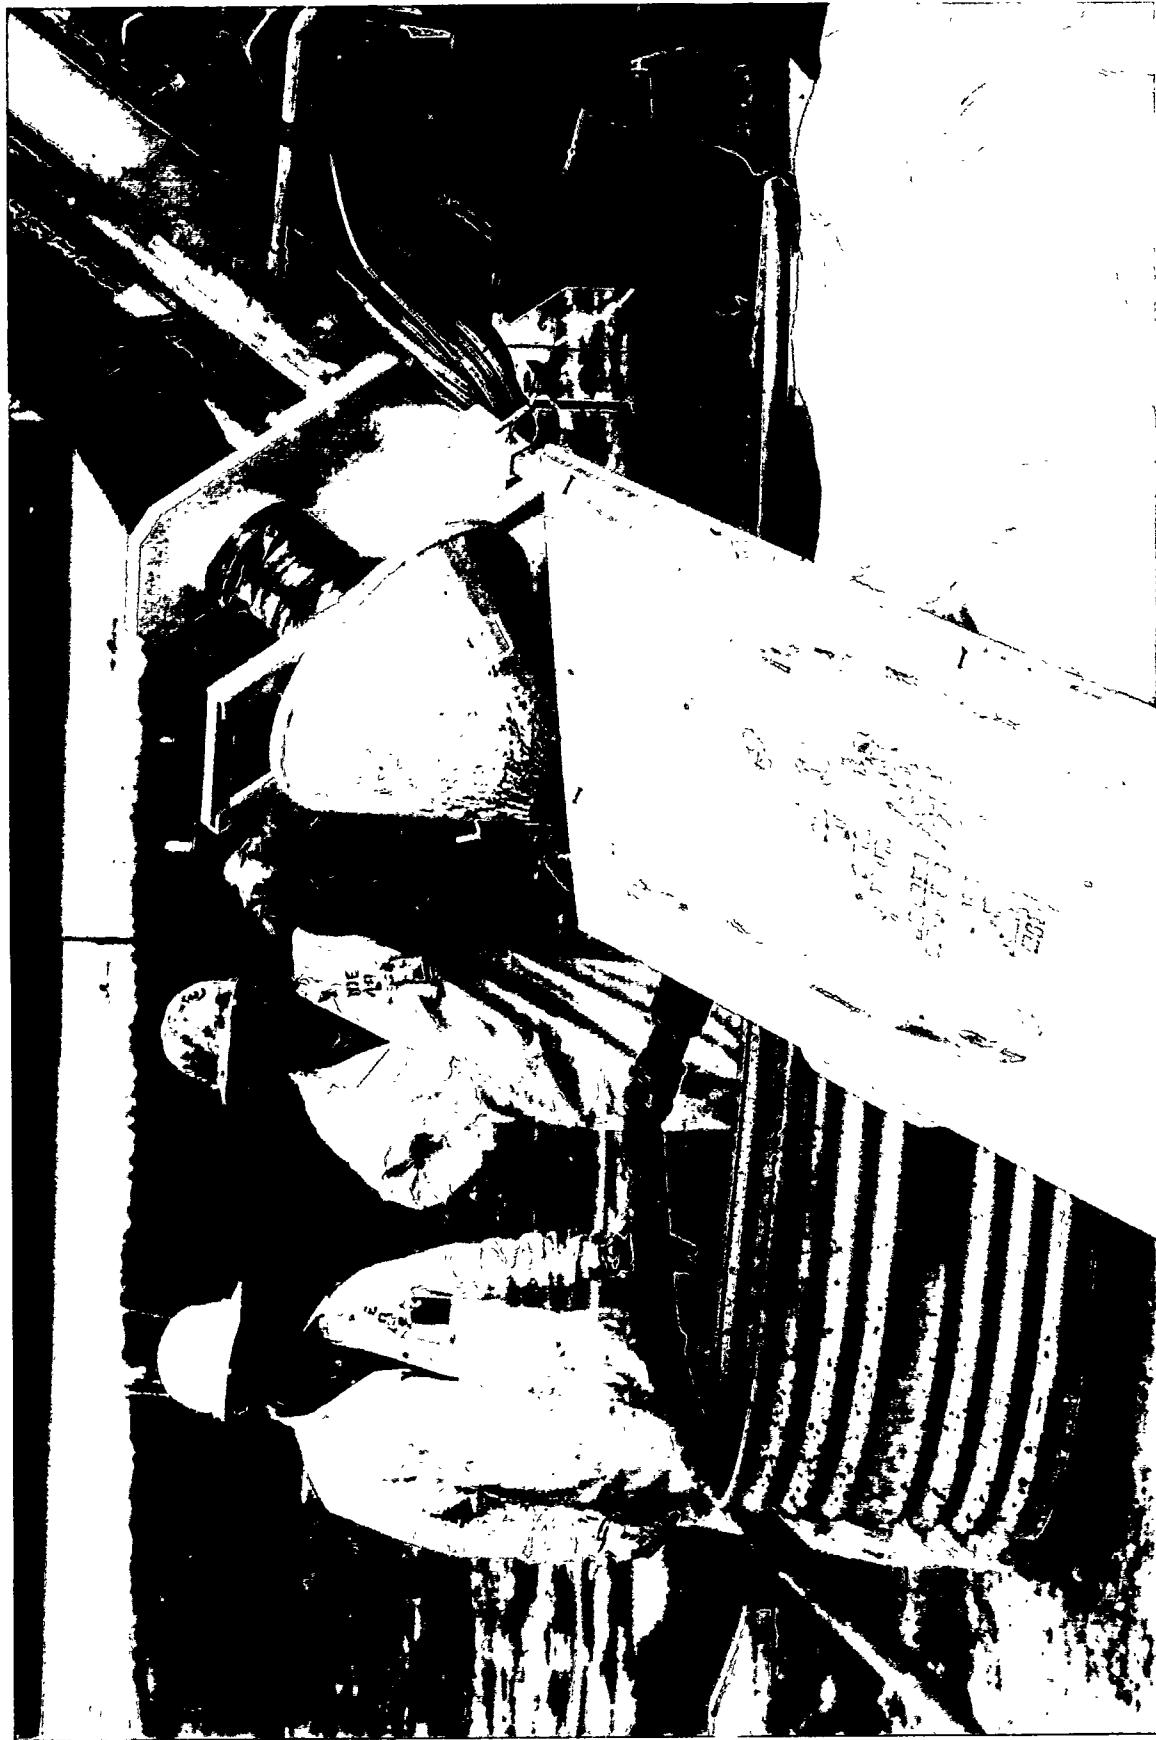
Figure 21. Cleanout sub attached to the bottom of the drill stem (Photo 97-791-1-27).

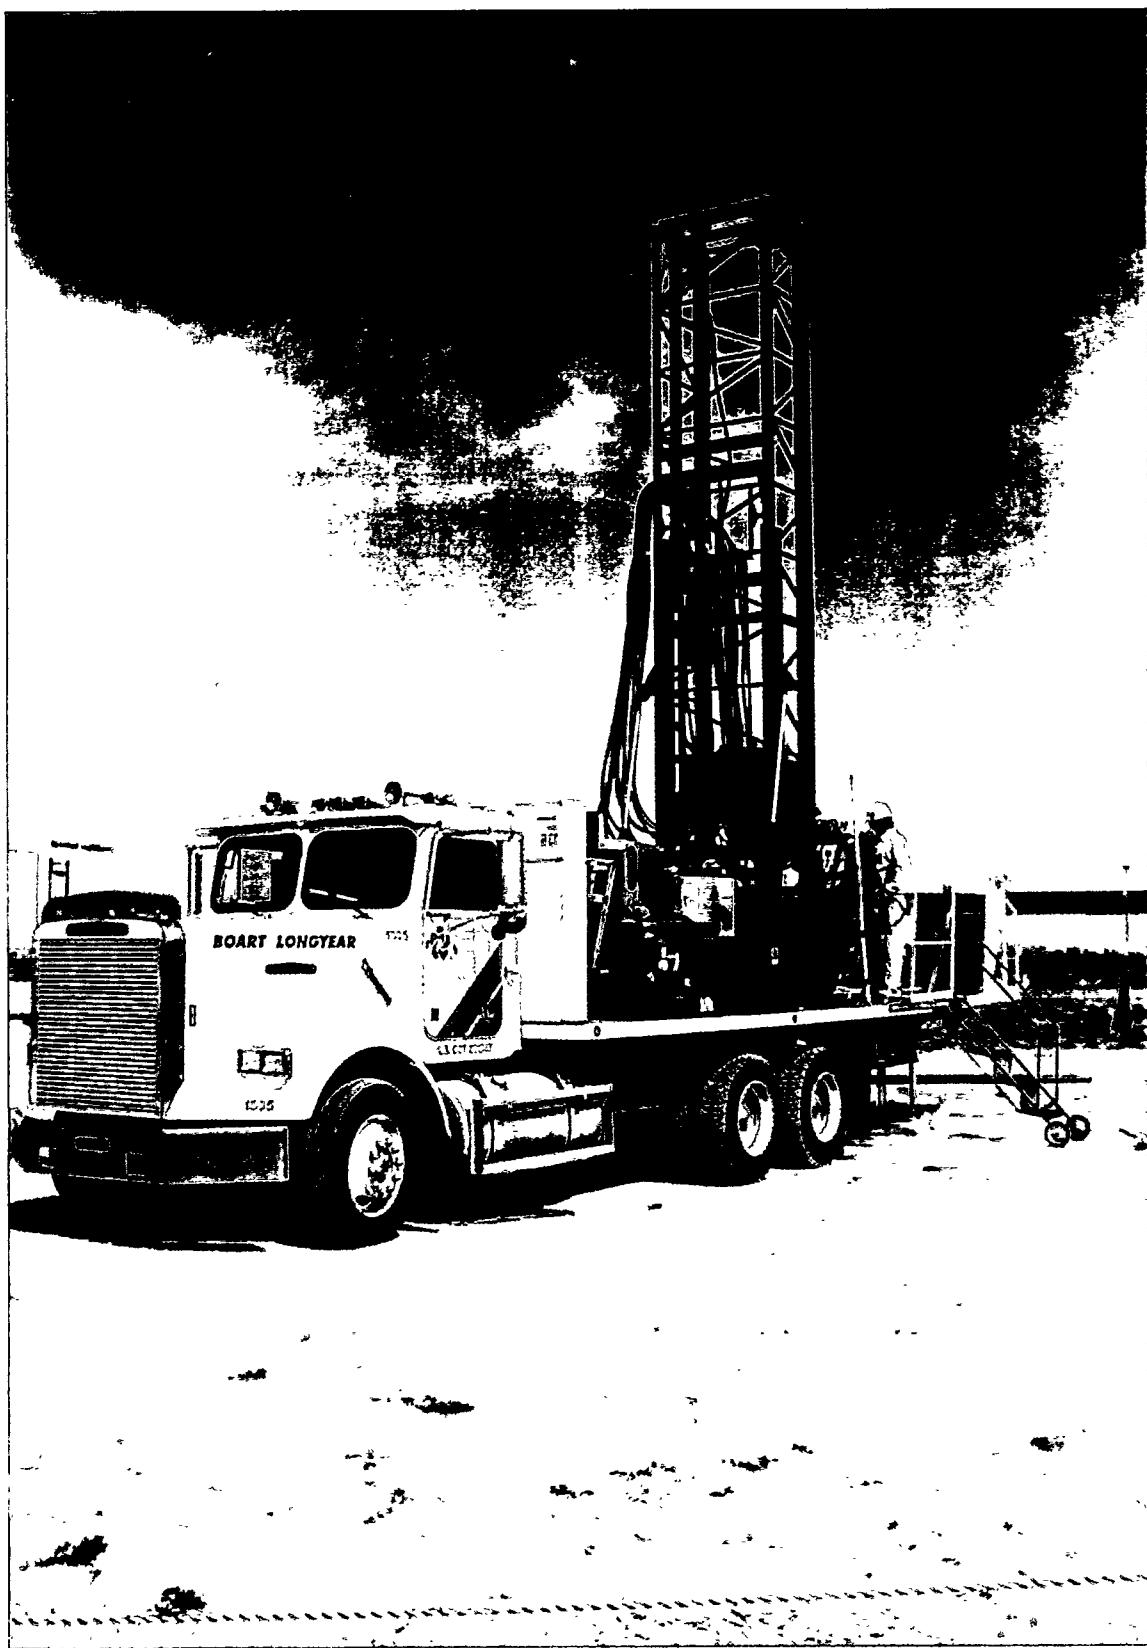
Figure 26. Sonic core drilling rig (Photo 98-216-1-11).

Sonic drilling was used to obtain the cores primarily to avoid the possibility of potential release of contaminants with conventional core drilling techniques (through drilling fluids and dust generation). Drilling services were provided by Boart Longyear (office location in Schofield, Wisconsin). A rotary-vibratory, also referred to as "sonic," drilling technique was used (Figures 26 and 27 show views of the sonic drilling rig in operation). The sonic drilling method employs high-frequency mechanical vibration to penetrate the subsurface and take continuous core samples. The sonic rig is similar to a conventional top-drive rotary rig, with the main difference being a specially designed hydraulically powered drill head or oscillator that generates adjustable high-frequency vibrational forces down the drill steel to the face of the drill bit.

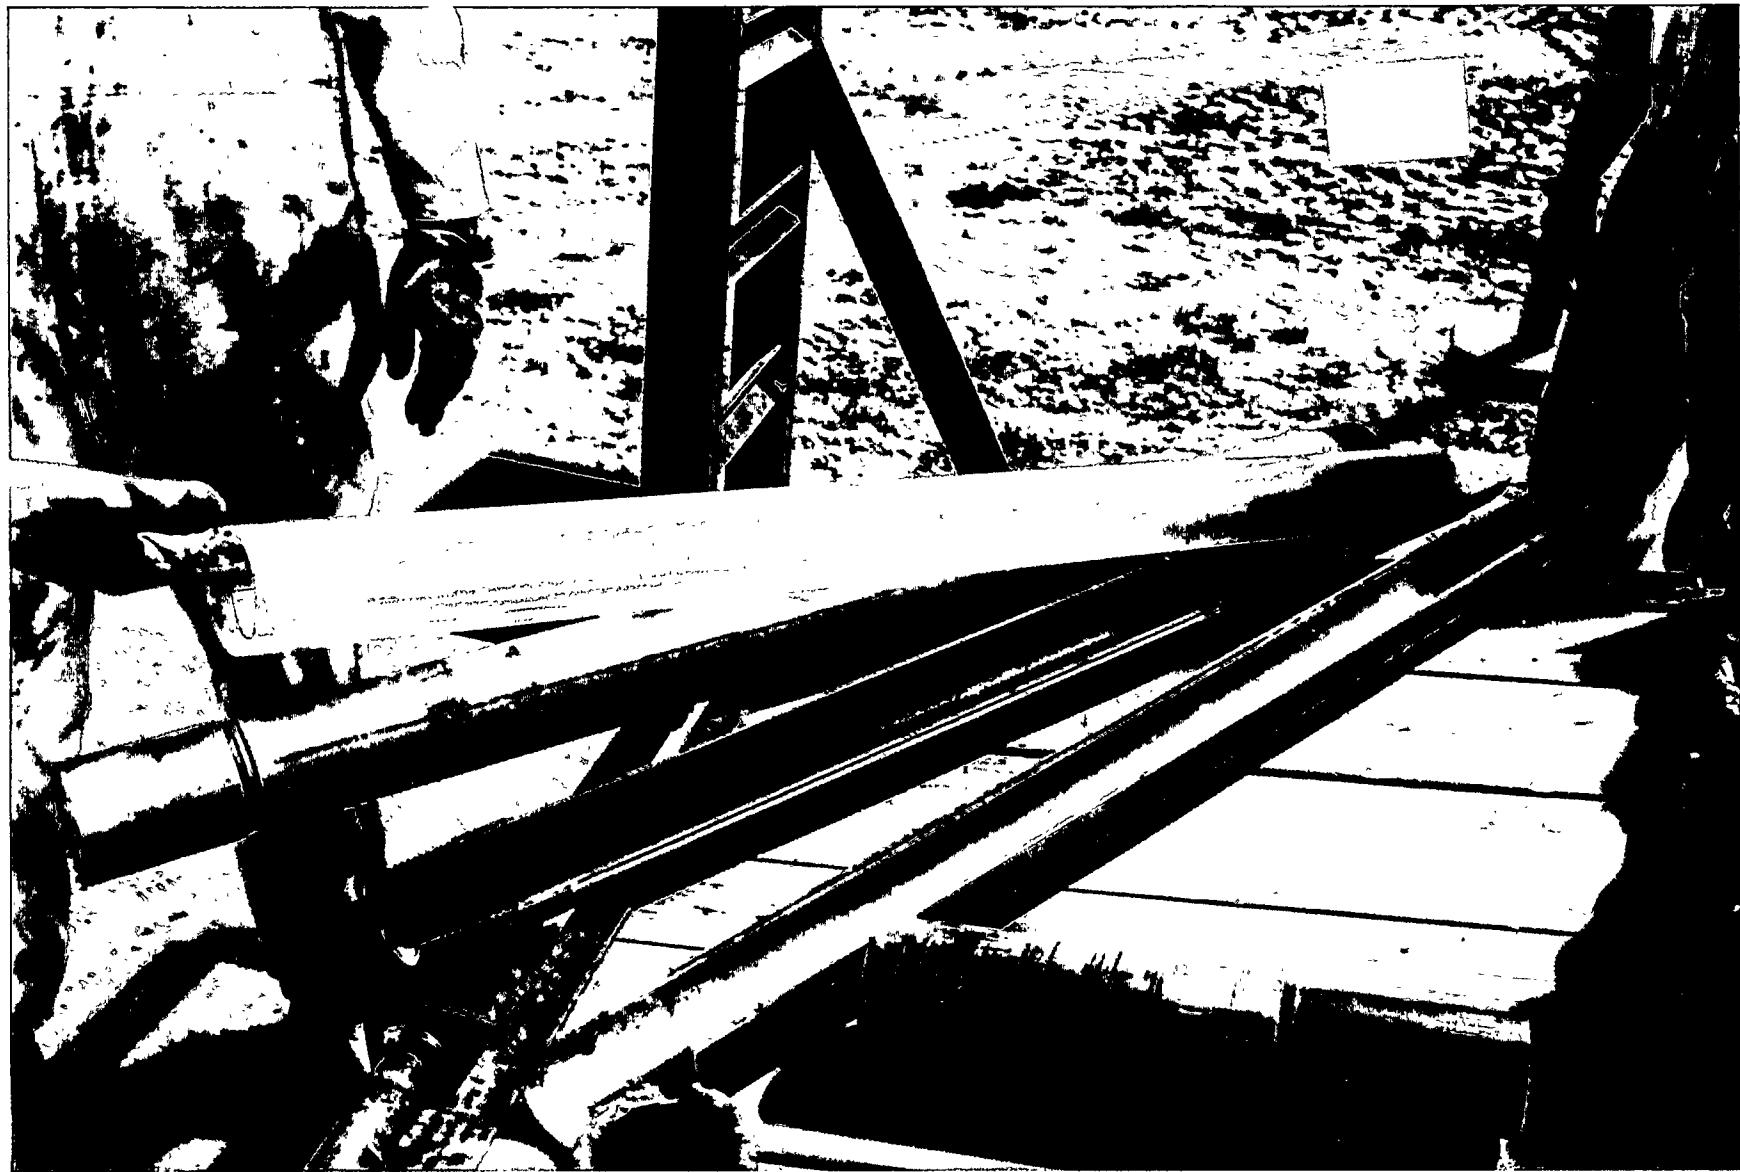
Figure 29. Lexan tubing used in the split spoon core system (Photo 98-216-1-23).

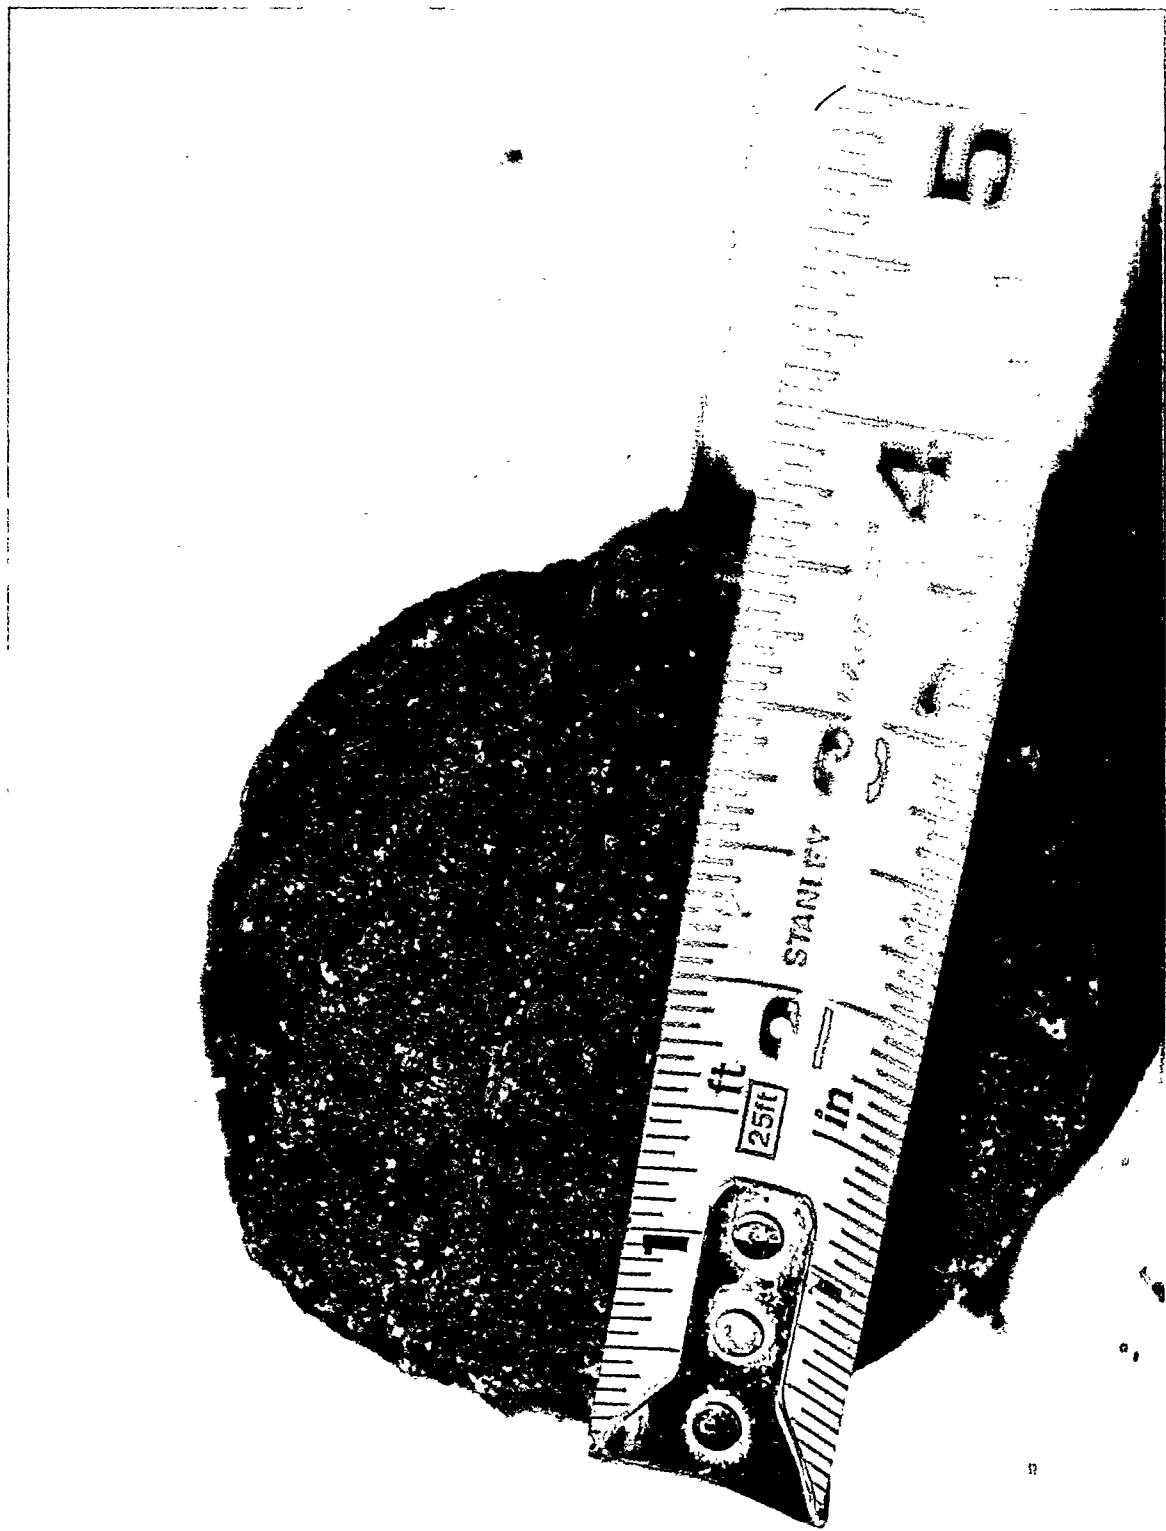
Figure 36. Detail of core fragment showing TECT stringer (neat grout) (Photo 98-386-2-9).
