INEEL/EXT-99-00116

# **Summary and Evaluation of NRC-Sponsored Stellite 6 Aging and Friction Tests**

**Published April 1999**

**Idaho National Engineering and Environmental Laboratory  
Nuclear Engineering Technologies Department  
Lockheed Martin Idaho Technologies Company  
Idaho Falls, Idaho 83415**

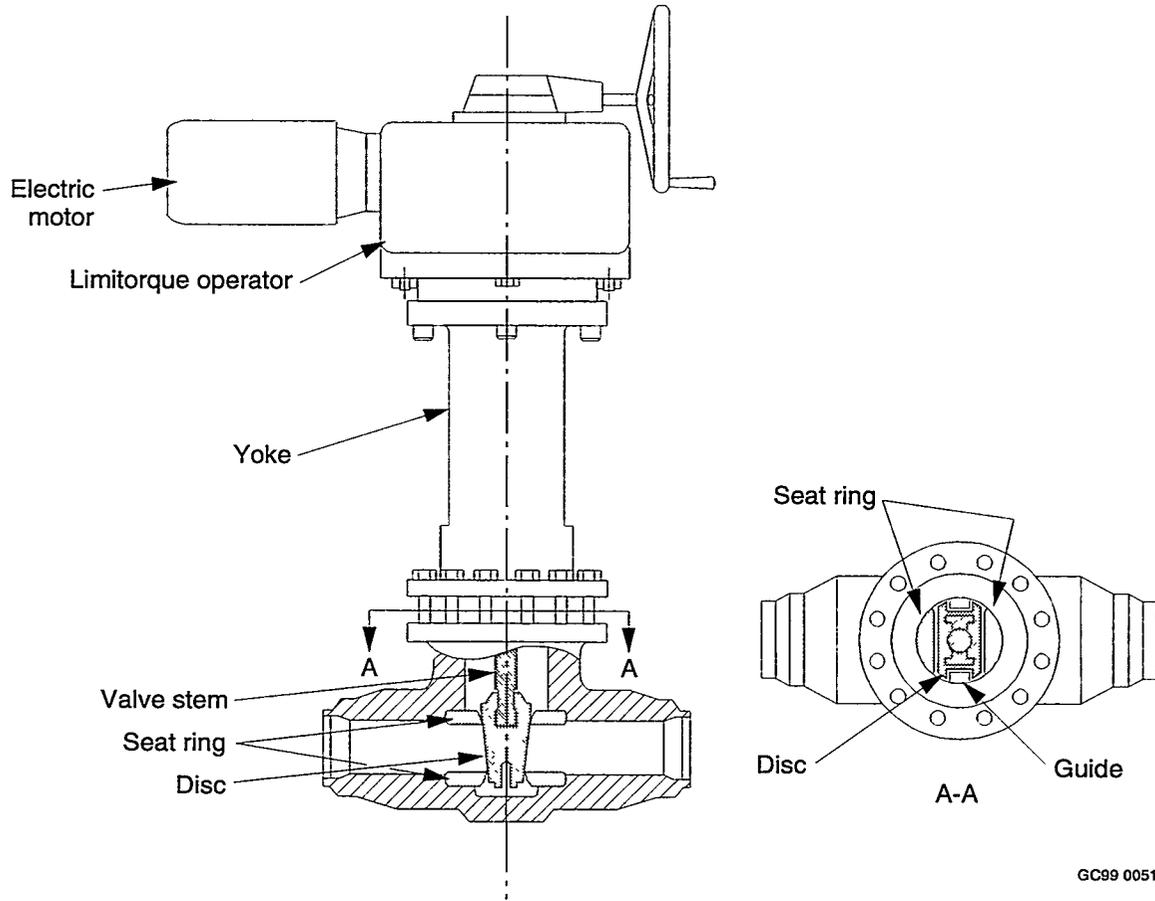
**Figure 1.** Diagram of a typical motor-operated gate valve, showing the main components.

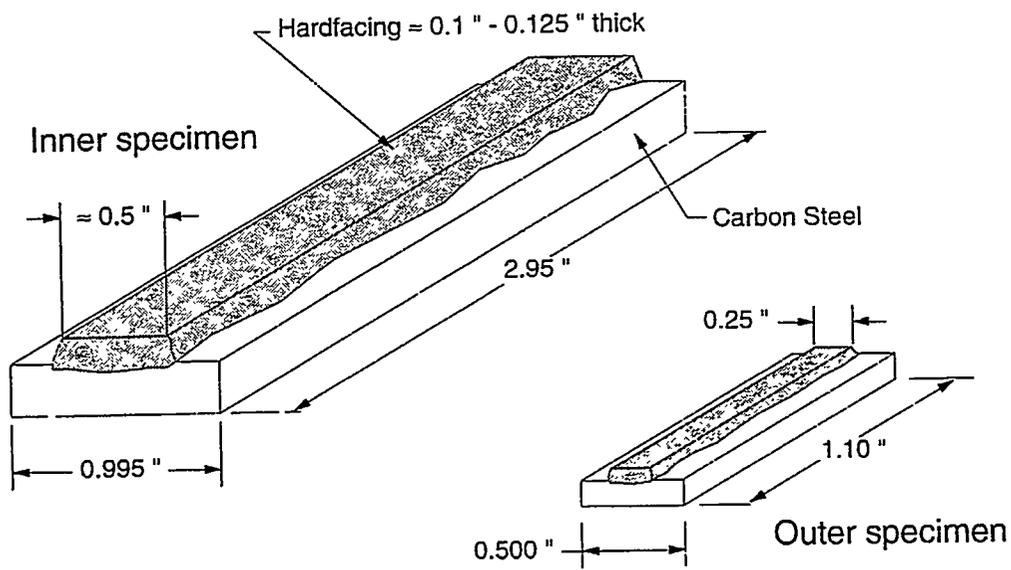
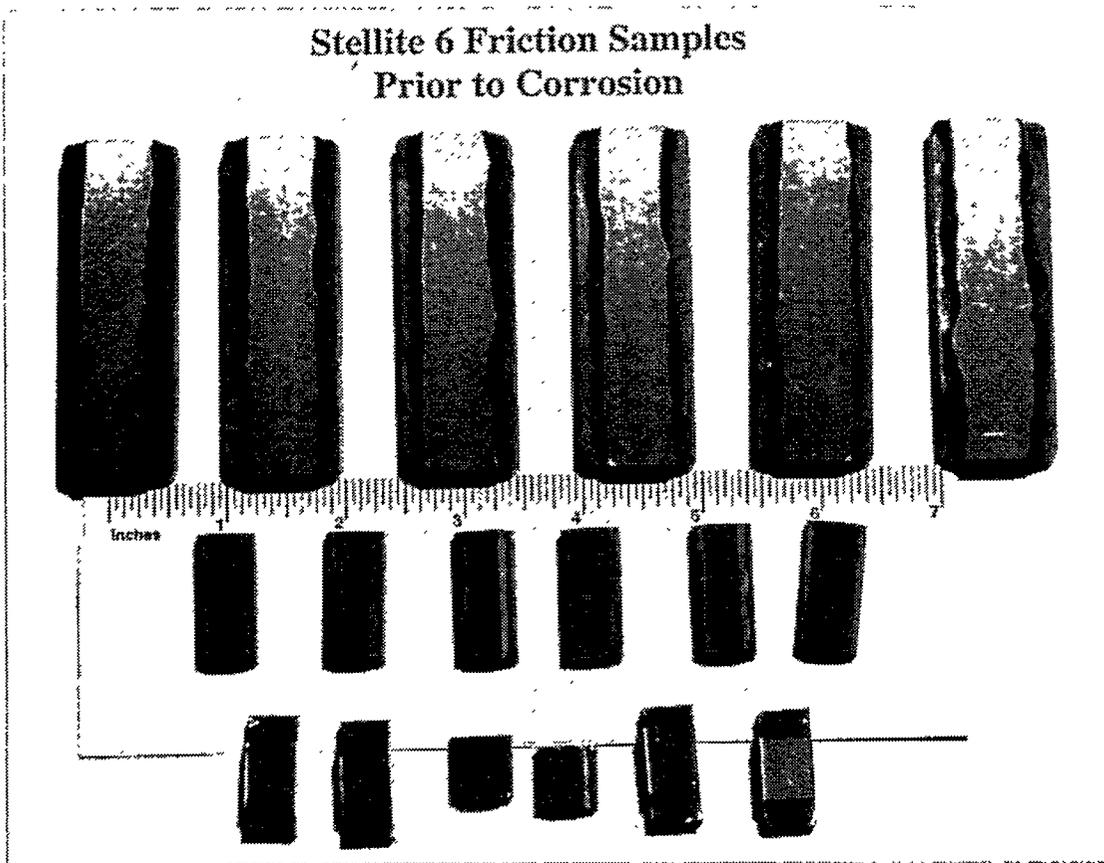
**Figure 2.** Photograph of Stellite 6 specimens before aging (top to bottom: inner, outer, and dummy specimens); the sketch at the top shows dimensions.

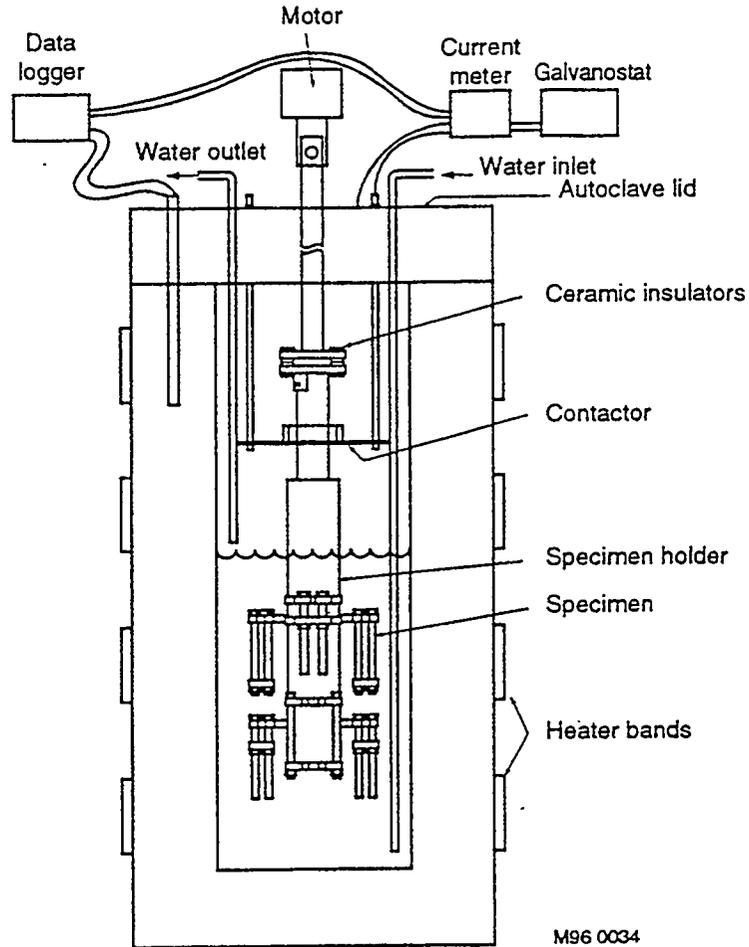
**Figure 3.** Diagram of the first corrosion autoclave.

The corrosion autoclave used in the first three tests was a five-gallon, flow-through, stainless steel “stirring” autoclave (Figure 3). The setup for the first test included a galvanostat and other provisions for supplying an anodic current to the specimens to accelerate the aging process. These provisions were excluded in the second and third tests. A different autoclave was used in the fourth test. A replacement autoclave was necessary because the original autoclave failed during the initial heatup of the fourth test. A number of cracks were discovered in the autoclave that could not be repaired. The replacement autoclave was made of Hastelloy and was smaller, approximately 1 gallon in size, but still large enough to accommodate all the specimens. The replacement autoclave retained all the functional capabilities of the original autoclave.

In the original autoclave, the specimens were attached to a rack fabricated from zirconium and heat-treated to provide a non-conductive zirconium dioxide ( $ZrO_2$ ) film. A stirring unit was used to ensure adequate mixing during the aging process and to simulate typical flow past a valve in a RWCU system. Except for the accelerated aging tests using high pH fluid conditions, the pH was maintained at 6.5 to 7.0. The autoclave pressure and temperature were continuously recorded and the solution conductivity and dissolved oxygen concentration were recorded twice each day. The smaller autoclave used for the fourth test contained a rack made from Type 316 Stainless Steel, with Teflon sheeting to avoid direct contact between the rack and the specimens.

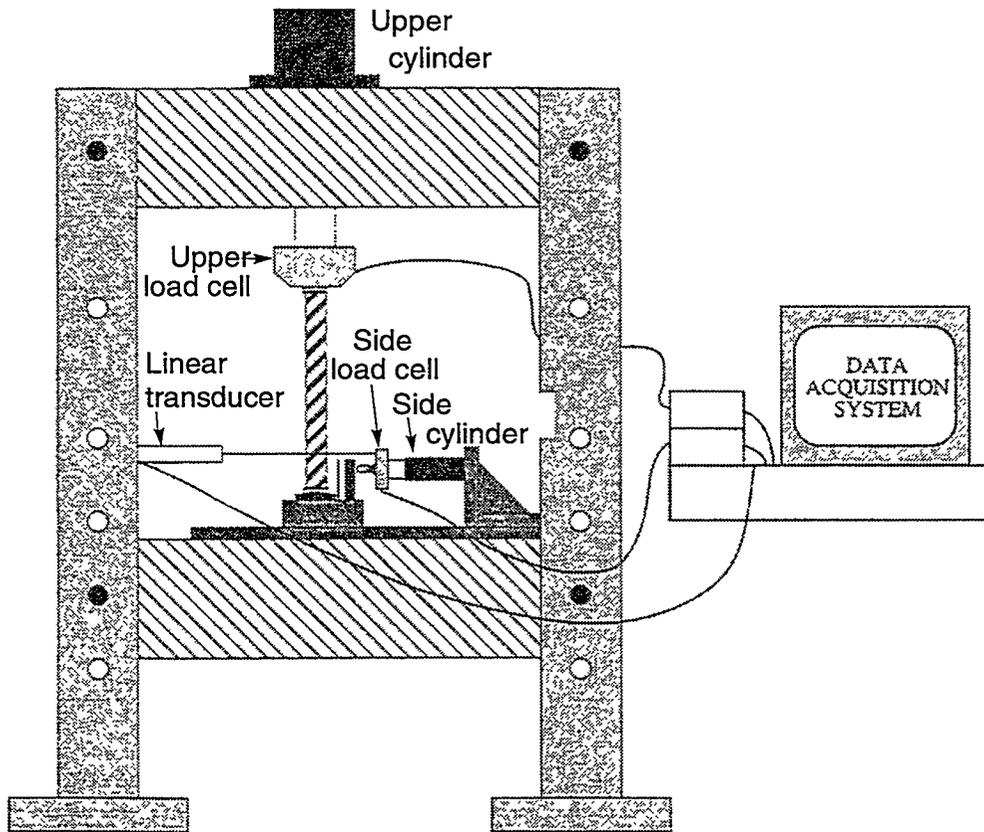
**Figure 4.** Diagram of the in-service testing simulation rig.

Selected 10-ksi friction specimens and oxide film characterization specimens underwent simulated valve wedging cycles representing typical in-service testing (IST) in the IST simulation rig (Figures 4 and 5). To subject the entire surface of each specimen to a simulated valve wedging, like-sized specimens were placed with their Stellite 6 surfaces face to face, a normal load of 20 ksi applied, and then the specimens moved 0.040 in. (1 mm) relative to each other. Unlike the corrosion autoclave (described in the previous subsection) and the friction autoclave (described in the next subsection), the IST simulation rig treated the specimens to a water bath at room temperature and atmospheric pressure rather than simulated BWR coolant conditions. (The high-temperature friction autoclave could not be used for the IST simulation, because it was not capable of generating high enough normal loads on the like-sized

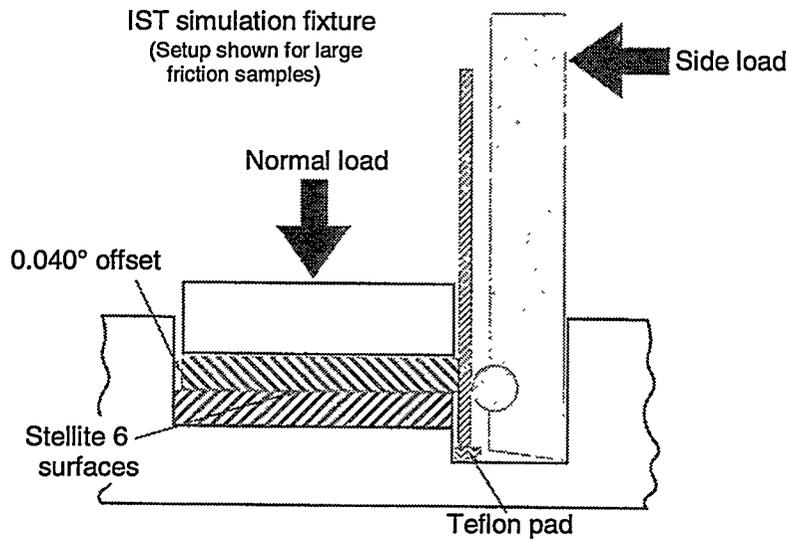
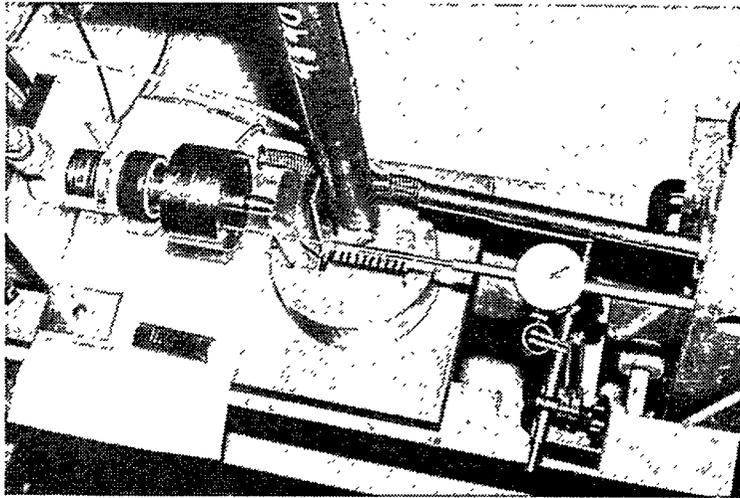
**Figure 5.** Details of the simulated valve wedging fixture and loading configuration (top), and a photo of the test fixture with dummy large specimens shown with stripes (bottom).

A stress level of 20 ksi was selected to approximate the stresses occurring during a valve wedging cycle of a typical RWCU system valve. Selected specimens were subjected to the simulated valve wedging after 25 days and again after 50 days of natural aging.

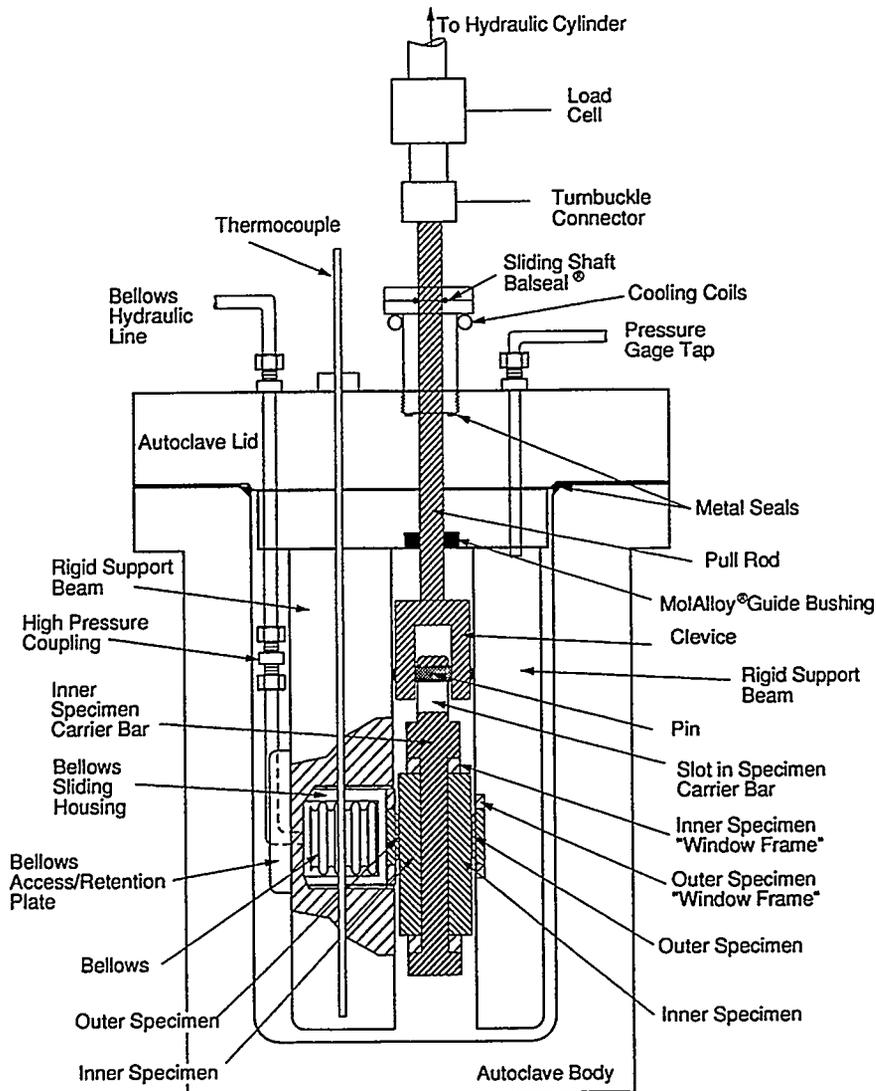
**Figure 6.** Diagram of the friction autoclave.

Friction testing at Battelle used the same friction autoclave in all four sets of tests. The friction autoclave (Figure 6), like the corrosion autoclave, was attached to a reservoir of water in which the oxygen was controlled in the range of 100 to 200 ppb. Testing was performed with the autoclave heated to 550°F and pressurized to about 1050 psi. During each test, a specimen assembly (friction set) consisting of two small outer specimens and two large inner specimens was tested. The small outer specimens were held in a stationary fixture, and the large inner specimens were attached to a carrier bar connected to a movable pull rod. Actuation of the pull rod caused the large inner specimens to slide between the small outer specimens at a relative velocity of 16 in./min, a rate within the range expected for typical gate valves.

The normal force ( $F_n$ ) was determined using a known calibration between the effective bellows pressure and the resulting force exerted by the bellows. (The effective bellows pressure is the difference between the pressure inside the bellows and the pressure in the autoclave.)

The sliding force was determined from a load cell attached between the pull rod and the hydraulic cylinder that actuated it. A high pressure, low-friction seal on the top of the autoclave lid allowed the pull rod to be moved through the lid with minimal friction. As the pull rod was withdrawn during a friction test cycle, the first inch of stroke took up the slack in the pin-to-clevis assembly, thus allowing a measurement of the "tare" force ( $f_{tare}$ ) resulting from the seal friction force ( $f_{seal}$ ) less the expulsion force ( $f_{expulsion}$ ) on the pull rod. In terms of forces on a valve, this represents the packing drag less the stem rejection load. After the pin reached the top of the clevis, the pull rod began pulling the large inner specimens between the small outer (stationary) specimens for a distance of approximately 1.5 to 2.0 inches. During this portion of the stroke, the load cell measurement less the previously determined "tare" force derived the force required to move the specimens. Dividing the sliding force ( $F_s$ ) by two is necessary because the sliding force is the result of friction at two interfaces, not just one. Thus, this formula gives the average friction value for the two sliding interfaces. Continuous measurements were taken during each friction test. The results are presented later in this report.

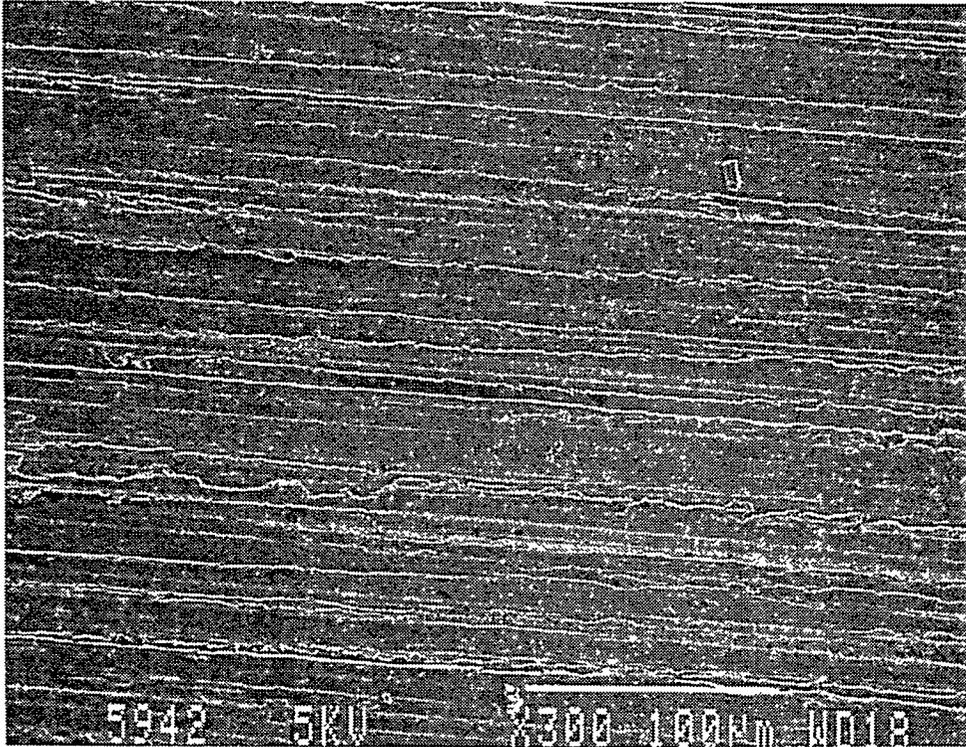
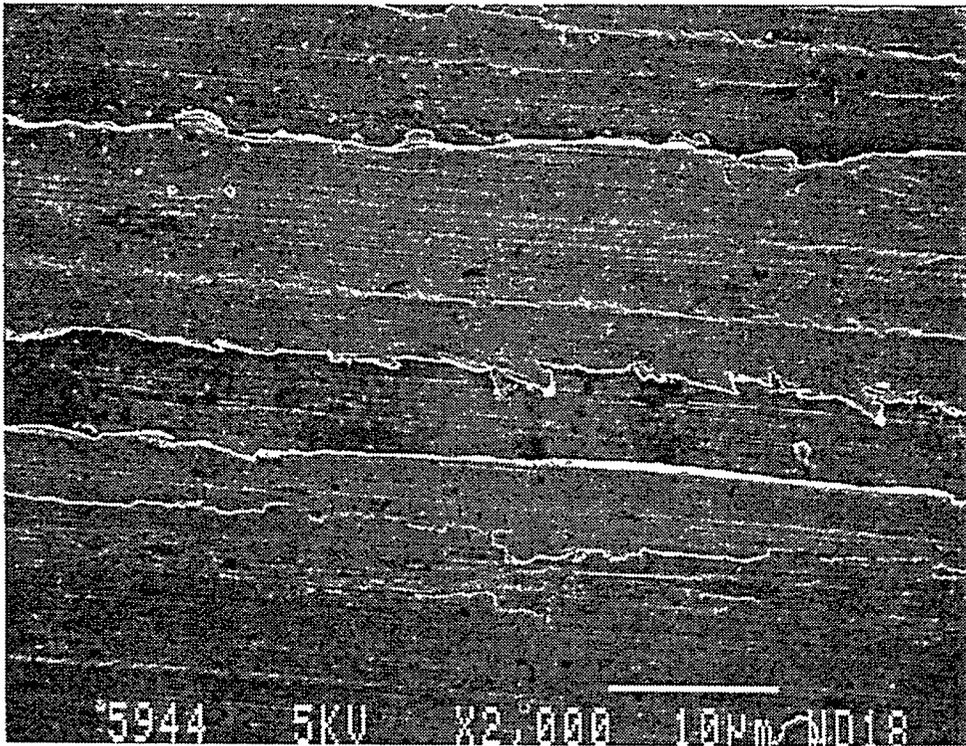
**Figure 7.** Electron micrographs of the surface of an as-ground Stellite 6 specimen, before exposure to aging; magnification at X300 and X2,000.

Figure 7 is an electron micrograph showing the surface of a Stellite 6 specimen from one of the natural aging tests before exposure to aging conditions. Note that the machining marks are visible on the surface, which is relatively smooth. Typical results of exposure of the Stellite 6 specimens to natural aging in the corrosion autoclave are shown in Figure 8 for a 78-day specimen. Note that the original machining marks are still visible on the surface. The growth of the oxide film was not sufficient to hide these surface imperfections.

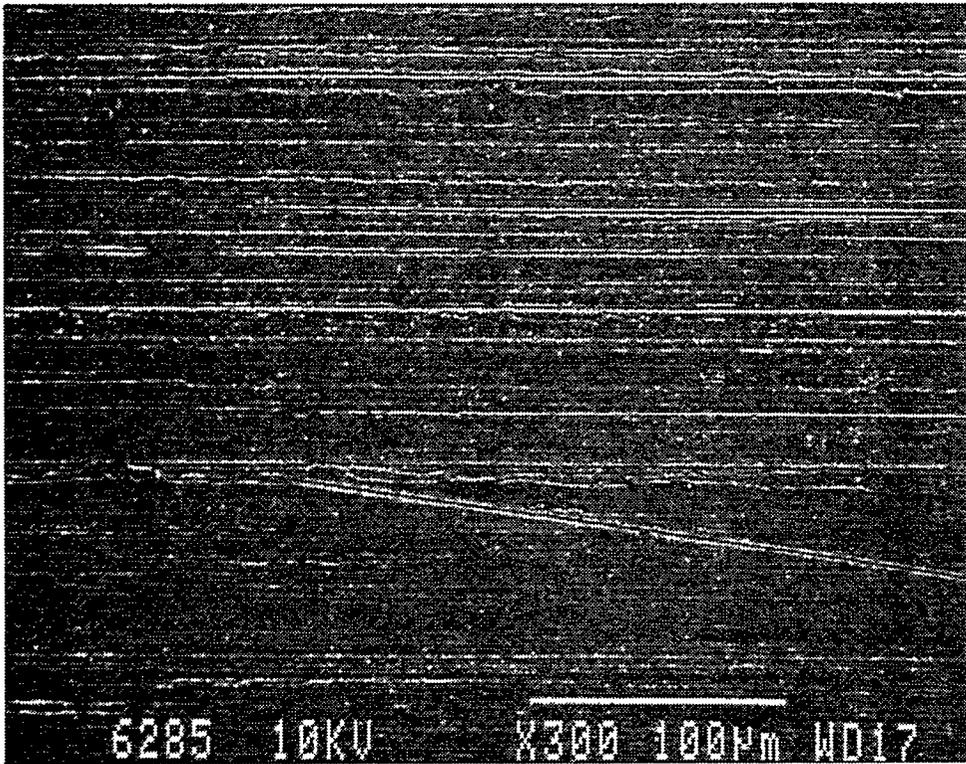
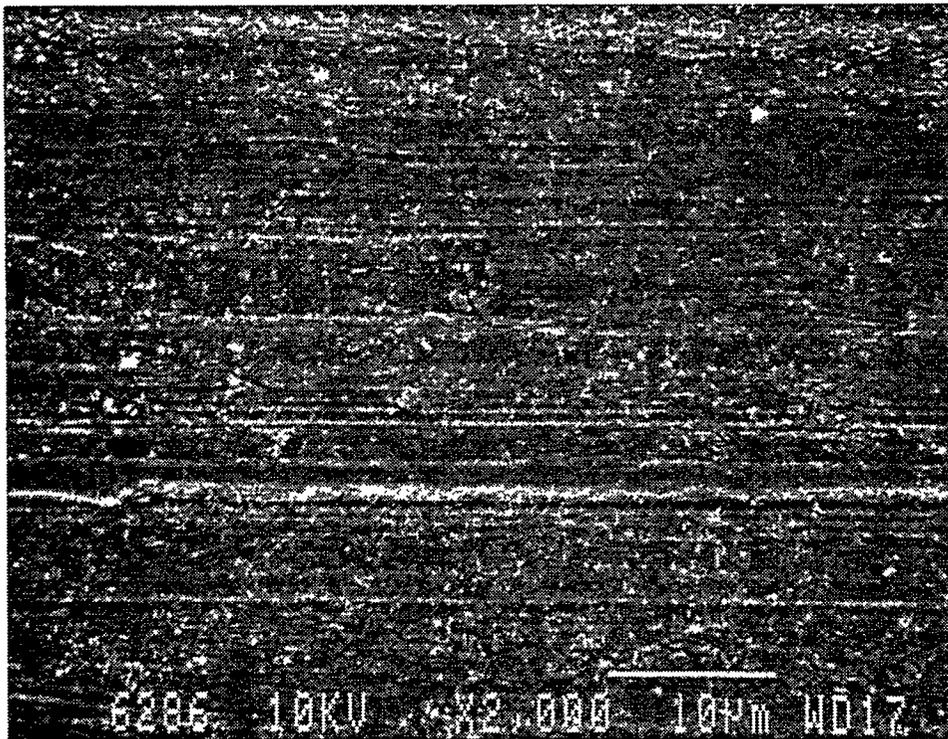
**Figure 8.** Electron micrographs of the surface of a Stellite 6 specimen after 78 days exposure to natural aging conditions.

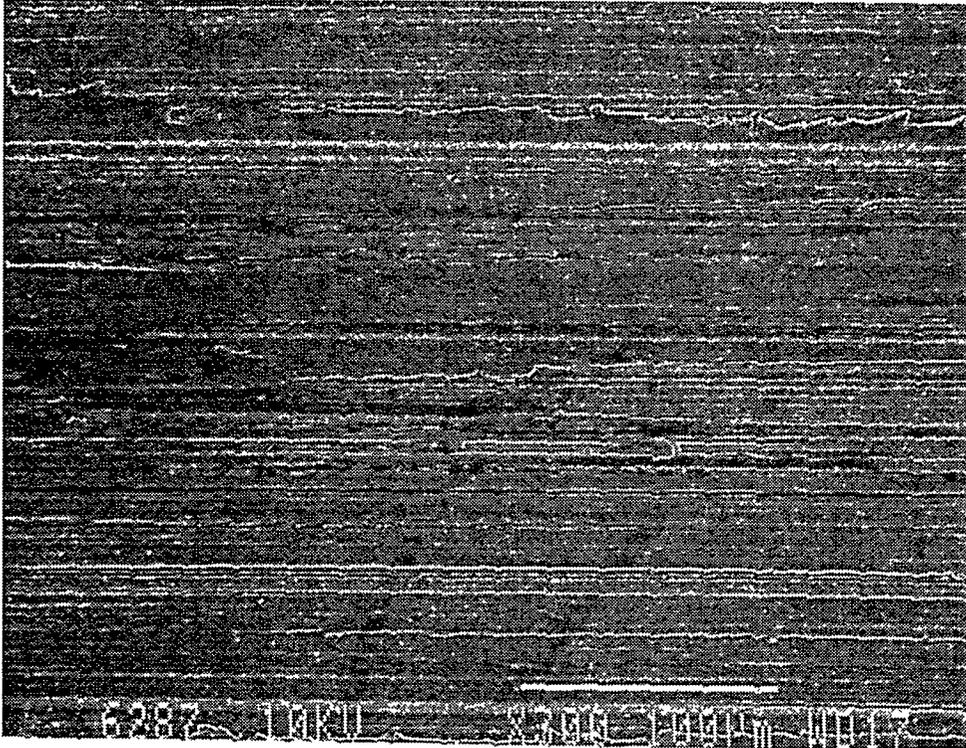
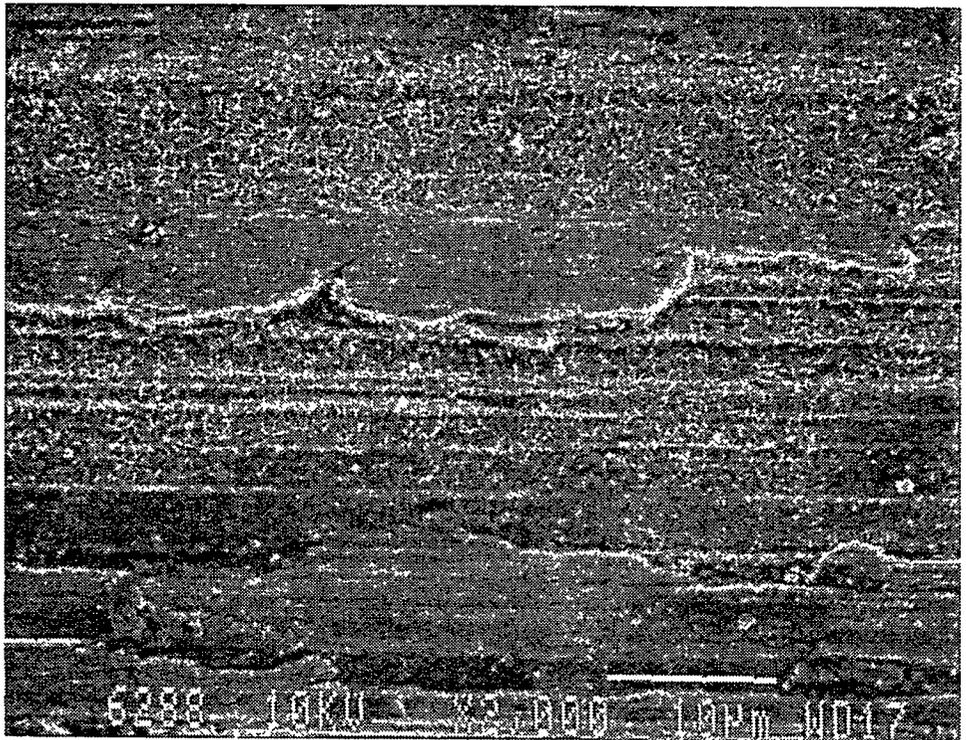
**Figure 9.** Electron micrographs of the surface of a Stellite 6 specimen after 78 days exposure to natural aging conditions, with simulated in-service testing at 25 days and again at 50 days.

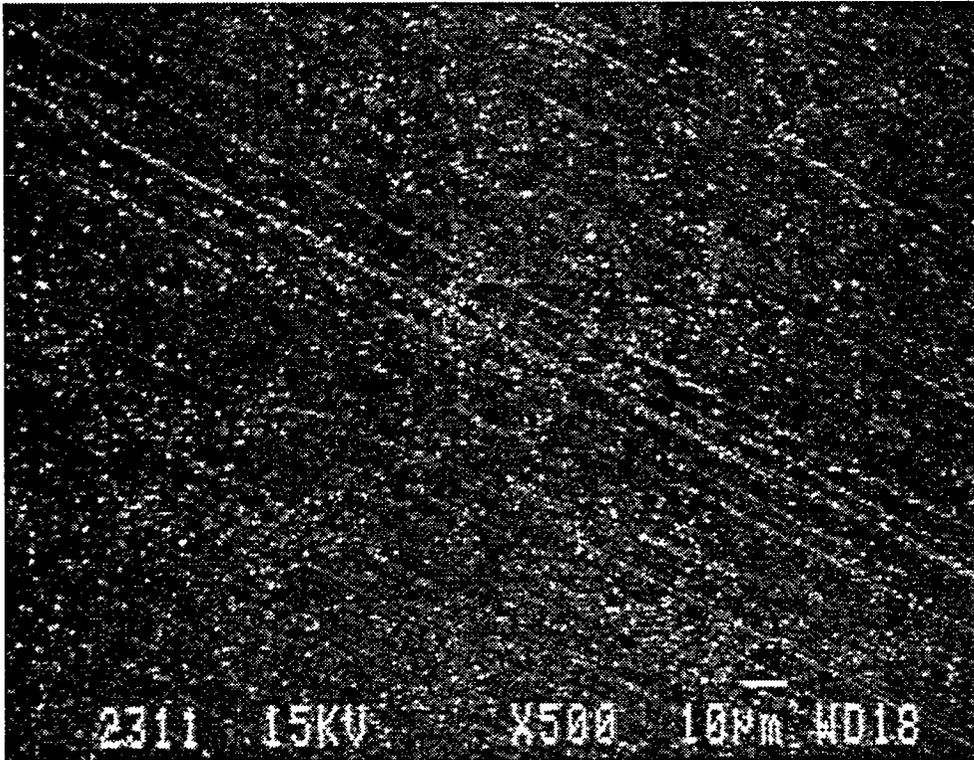
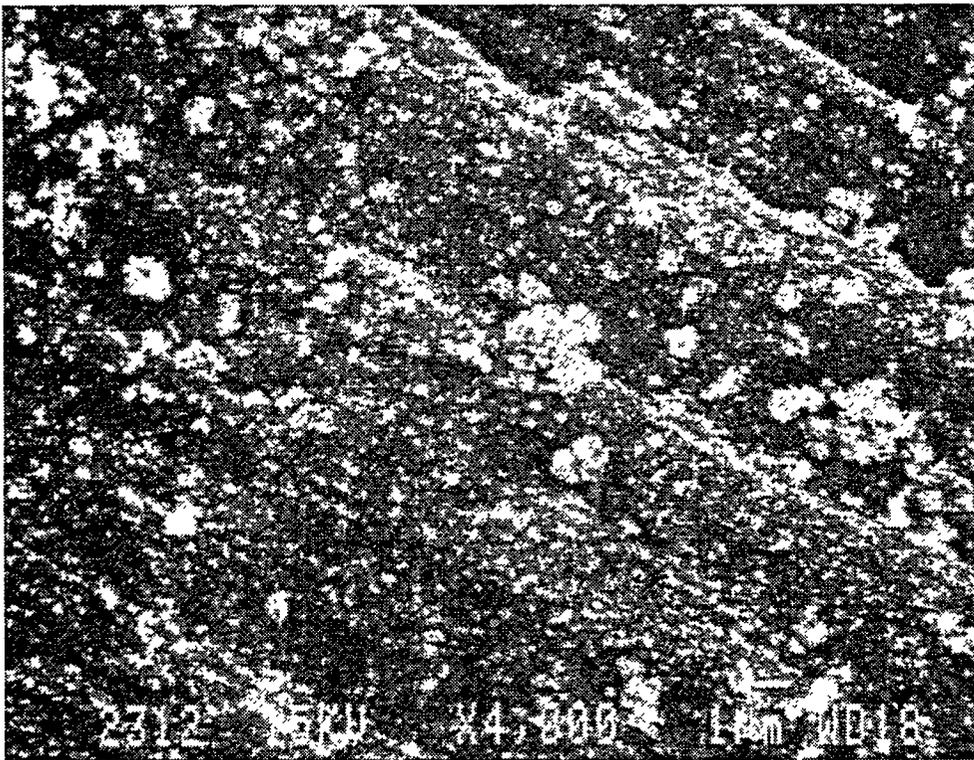
**Figure 10.** Electron micrographs of the surface of a Stellite 6 specimen after 11 days exposure to an anodic current density of  $0.15 \text{ mA/cm}^2$ .

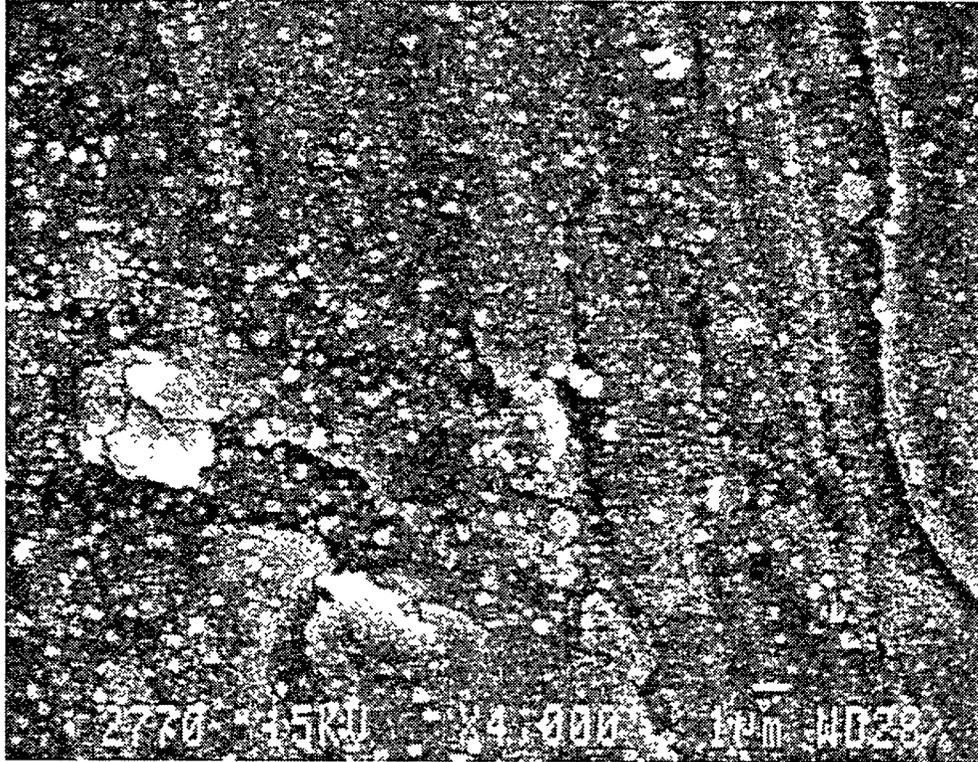
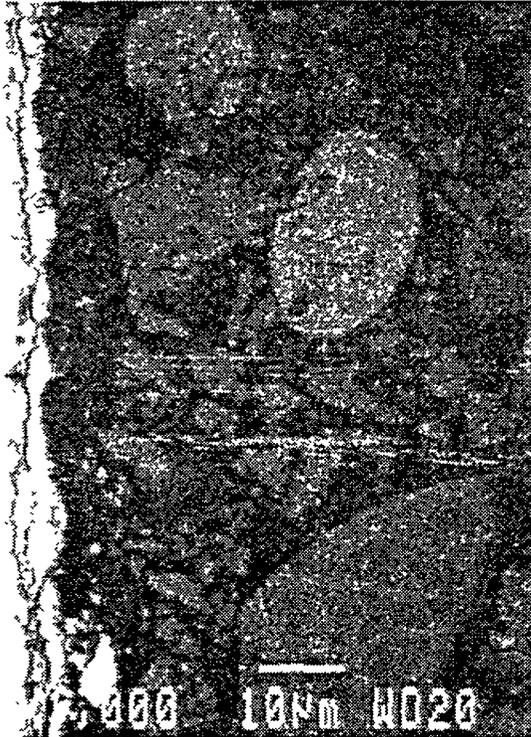
**Figure 11.** Electron micrographs of the surface and cross section of a Stellite 6 specimen after 14 days exposure to an anodic current density of  $0.35 \text{ mA/cm}^2$ .

Figure 11 presents images of the surface and the cross section of Stellite 6 after 14 days aging with an applied current density of  $0.35 \text{ mA/cm}^2$ . Here, too, the surface shows a large number of nodules; these nodules might be characteristic of surfaces grown under applied currents. The cross section shows the base metal on the left; the right side is a section of the plastic coating applied to the specimen during

sample preparation, and the oxide film is the thick line separating the two. The thickness of the oxide film is determined by measuring the apparent film thickness on this magnified image of the cross section. (Film thickness is discussed in more detail later in the report.) We also observed that this oxide film was cracked in several locations both parallel and perpendicular to the alloy surface.

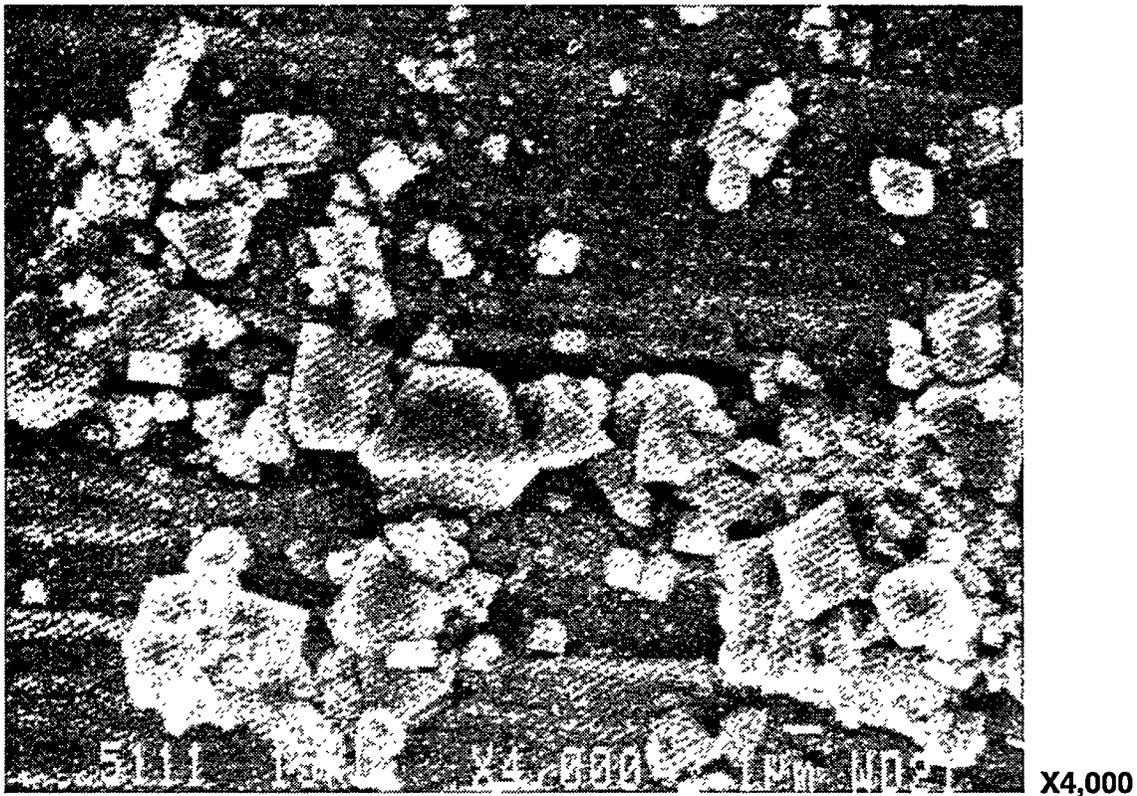
**Figure 12.** Electron micrograph of the surface of a Stellite 6 specimen after 19 days exposure to high-pH conditions; the large, zirconium-rich crystals are conspicuous.

The surface morphology from the accelerated high-pH aging test is shown in Figure 12. The large crystals apparent here were identified as zirconium dioxide ( $ZrO_2$ ). The apparent source of the  $ZrO_2$  was the specimen rack in the corrosion autoclave. We infer that the high pH (9.0) in this test either corroded the zirconium specimen rack or encouraged  $ZrO_2$  in the coating to dissolve in the water, and that the  $ZrO_2$  then precipitated on available surfaces when the water was cooled at the end of the test. These large crystals, which resided only at the surface of the film, were removed by cleaning the specimen with isopropyl alcohol. Smaller crystals remained. Figure 13 shows the specimen after cleaning, at two different magnifications. The appearance of the small crystals contrasts significantly with the morphology of a natural aging oxide film, where the surface is typified by a more uniform coating. Energy Dispersive Spectroscopy (EDS) analysis of the large particle in the center of the frame of the lower photograph indicates that the crystals appear to be iron-rich and are most likely oxides.

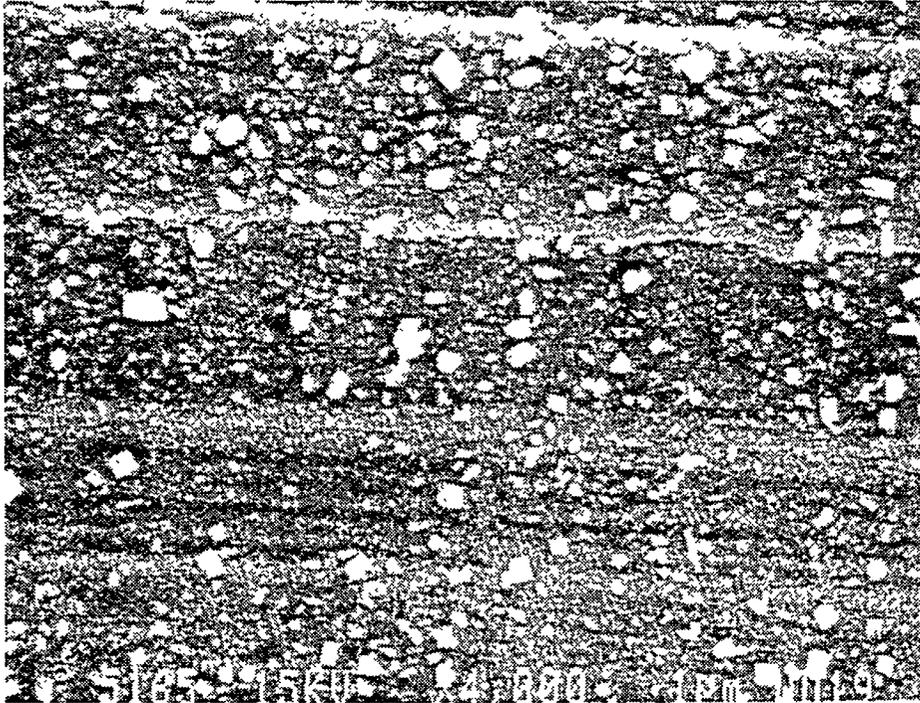
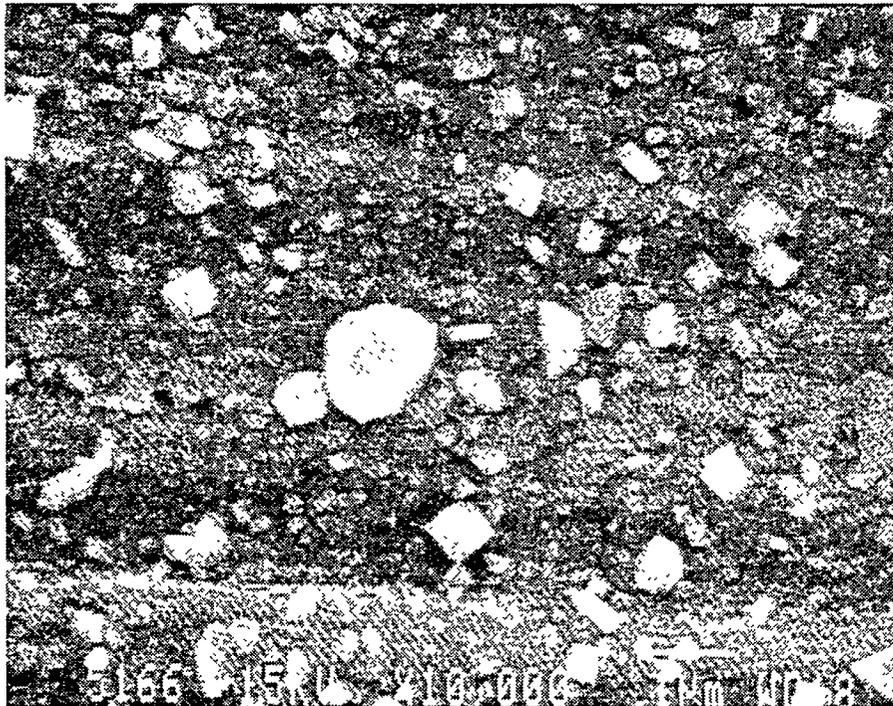
**Figure 13.** Electron micrographs of the surface of a Stellite 6 specimen after 19 days exposure to high-pH conditions; the zirconium-rich crystals have been removed, but iron-rich crystals remain.

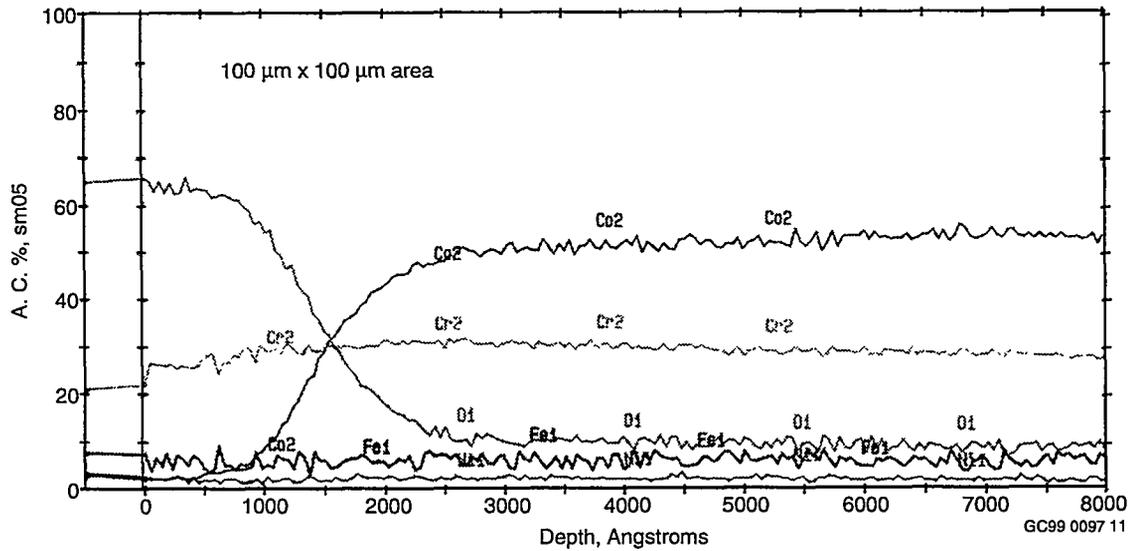
**Figure 14.** AES depth profile for Stellite 6 after 20 days exposure to natural aging conditions.

Figure 14 shows an AES depth profile of the oxide film after 20 days exposure to natural aging conditions. As shown in the figure, the chromium concentration is almost constant, whereas the cobalt concentration rapidly rises between 1000 and 2000 Å. [One Angstrom (Å) equals one ten-millionth ( $10^{-7}$ ) of a millimeter.]

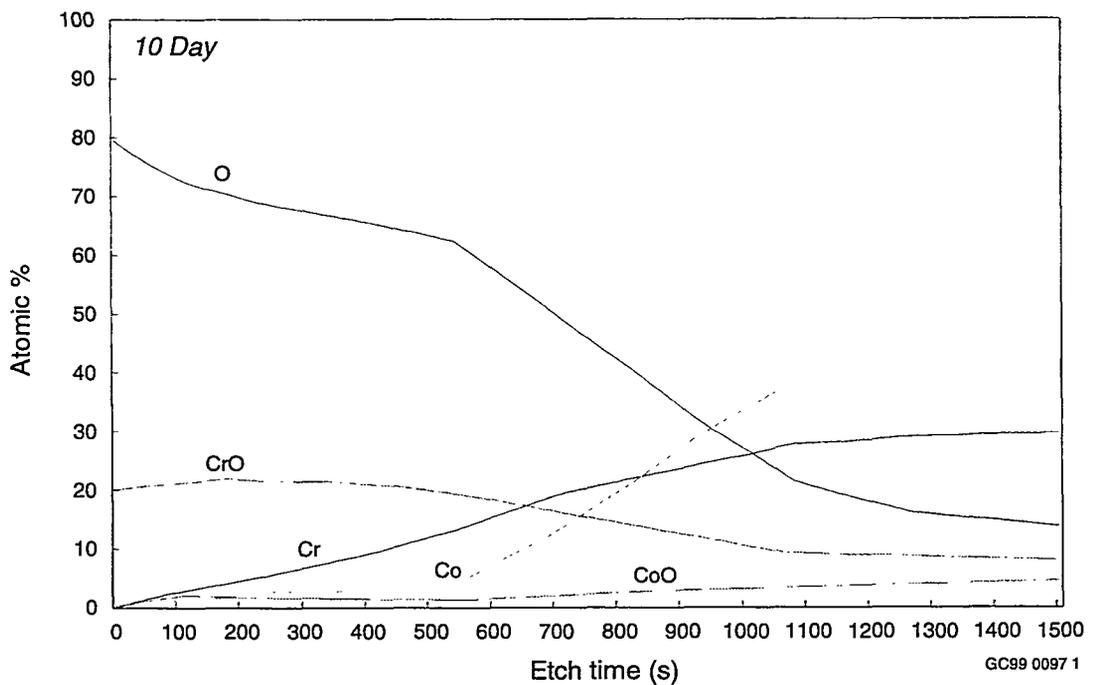
**Figure 15.** XPS depth profile for Stellite 6 after 10 days exposure to natural aging conditions.

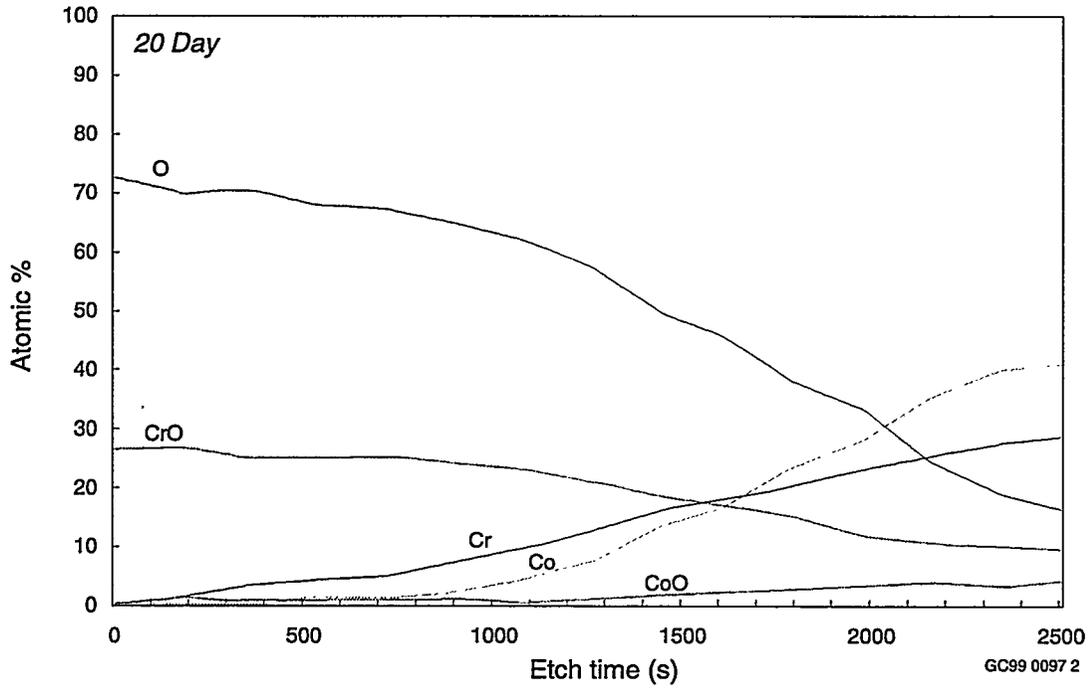
**Figure 16.** XPS depth profile for Stellite 6 after 20 days exposure to natural aging conditions.

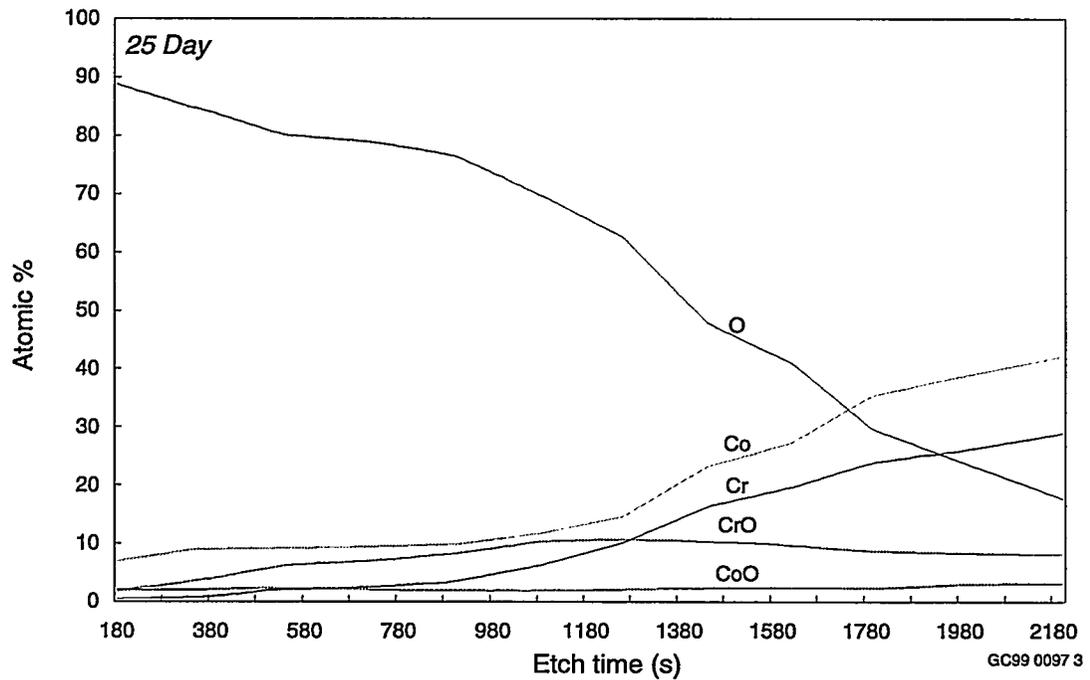
**Figure 17.** XPS depth profile for Stellite 6 after 25 days exposure to natural aging conditions.

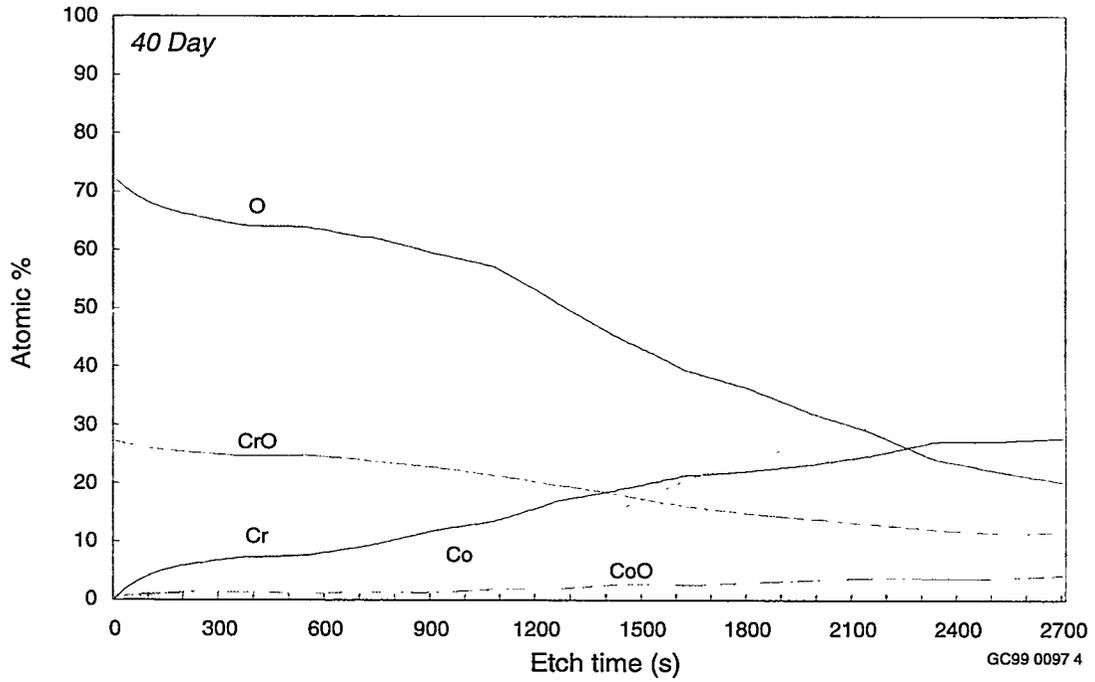
**Figure 18.** XPS depth profile for Stellite 6 after 40 days exposure to natural aging conditions.

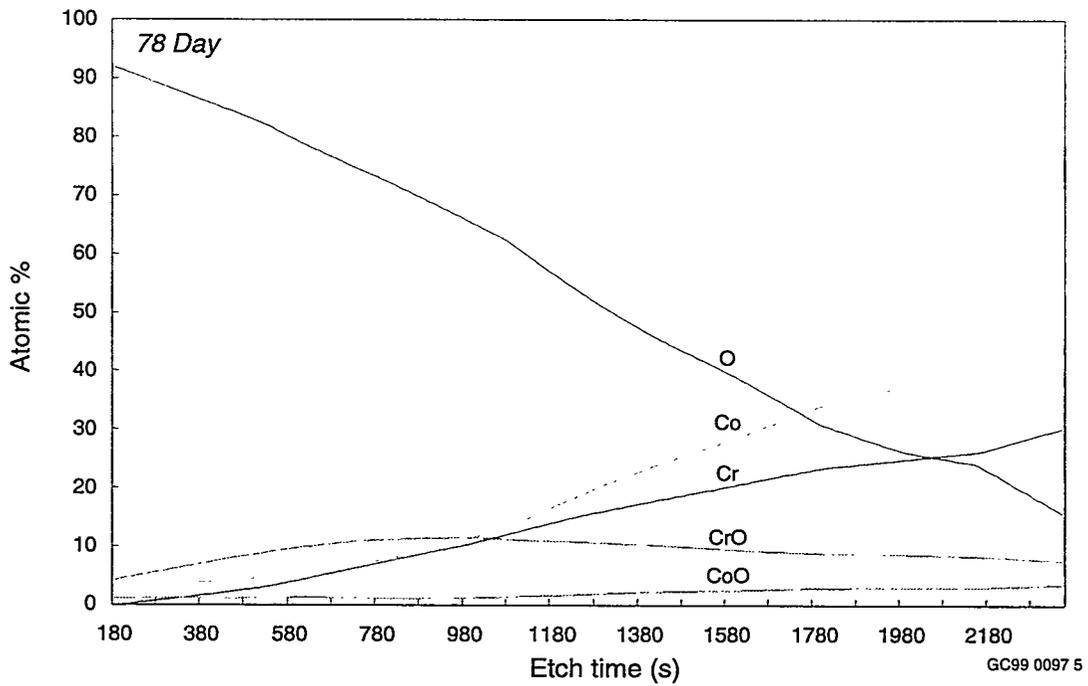
**Figure 19.** XPS depth profile for Stellite 6 after 78 days exposure to natural aging conditions.

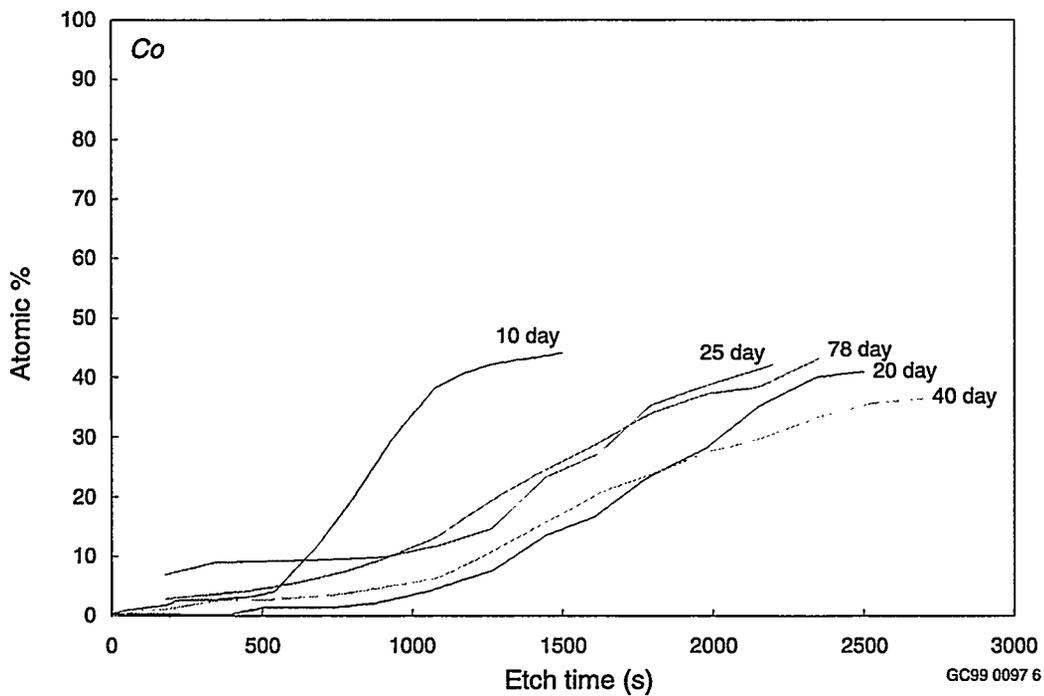
**Figure 20.** XPS depth profile of the cobalt in Stellite 6 specimens exposed to natural aging conditions.
