INEEL/EXT-99-00116

# **Summary and Evaluation of NRC-Sponsored Stellite 6 Aging and Friction Tests**

**Published April 1999**

**Idaho National Engineering and Environmental Laboratory  
Nuclear Engineering Technologies Department  
Lockheed Martin Idaho Technologies Company  
Idaho Falls, Idaho 83415**

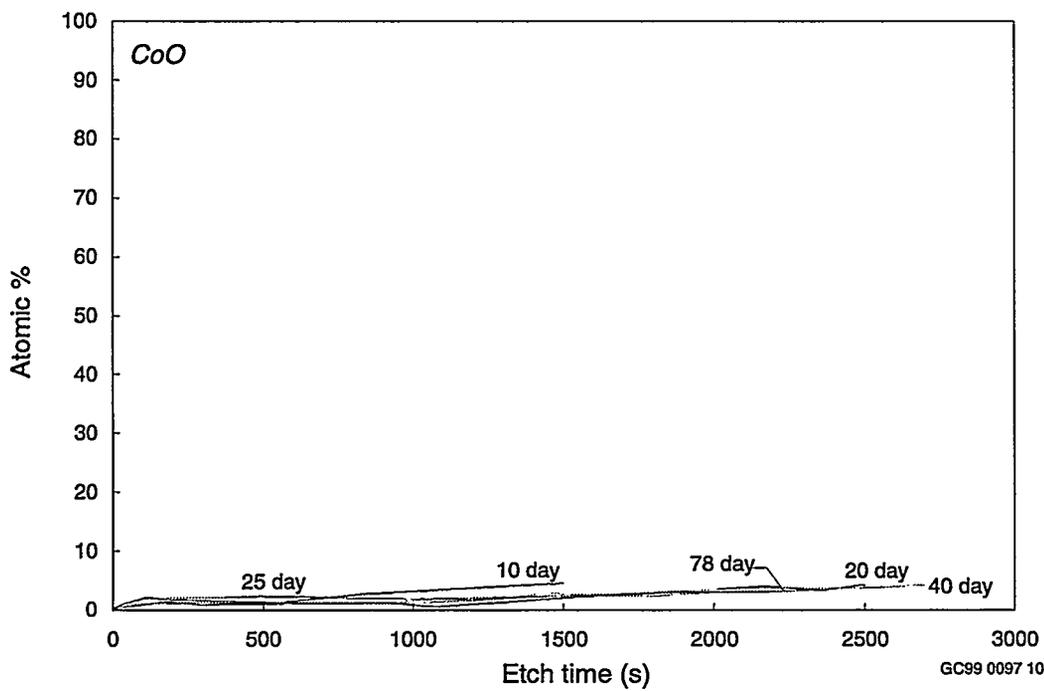
**Figure 21.** XPS depth profile of the cobalt oxide in Stellite 6 specimens exposed to natural aging conditions.

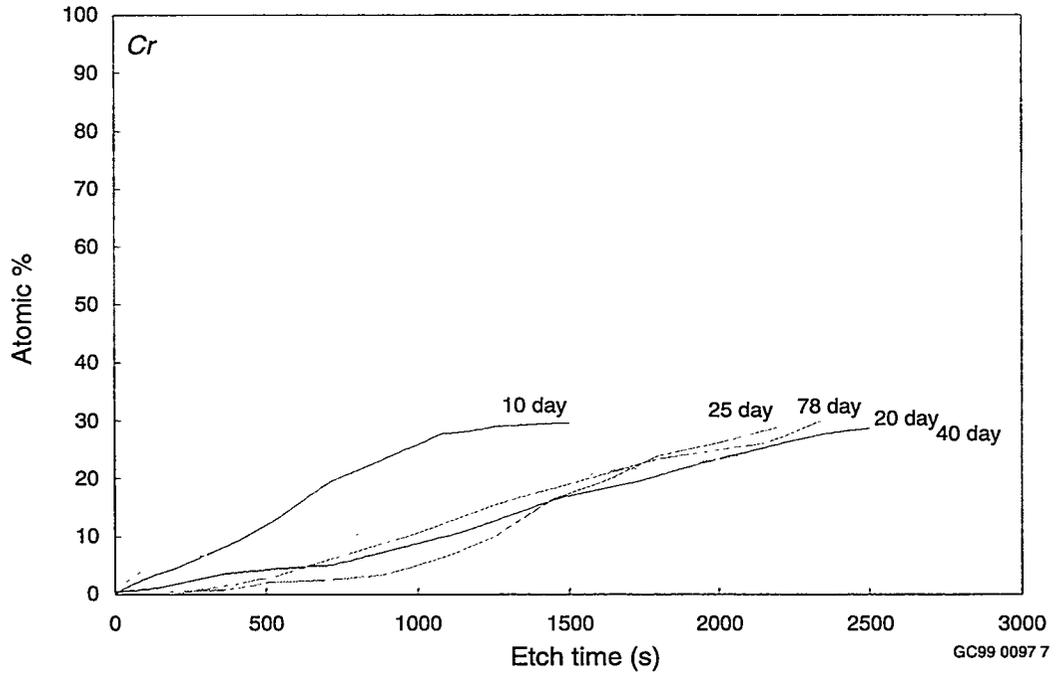
**Figure 22.** XPS depth profile of the chromium in Stellite 6 specimens exposed to natural aging conditions.

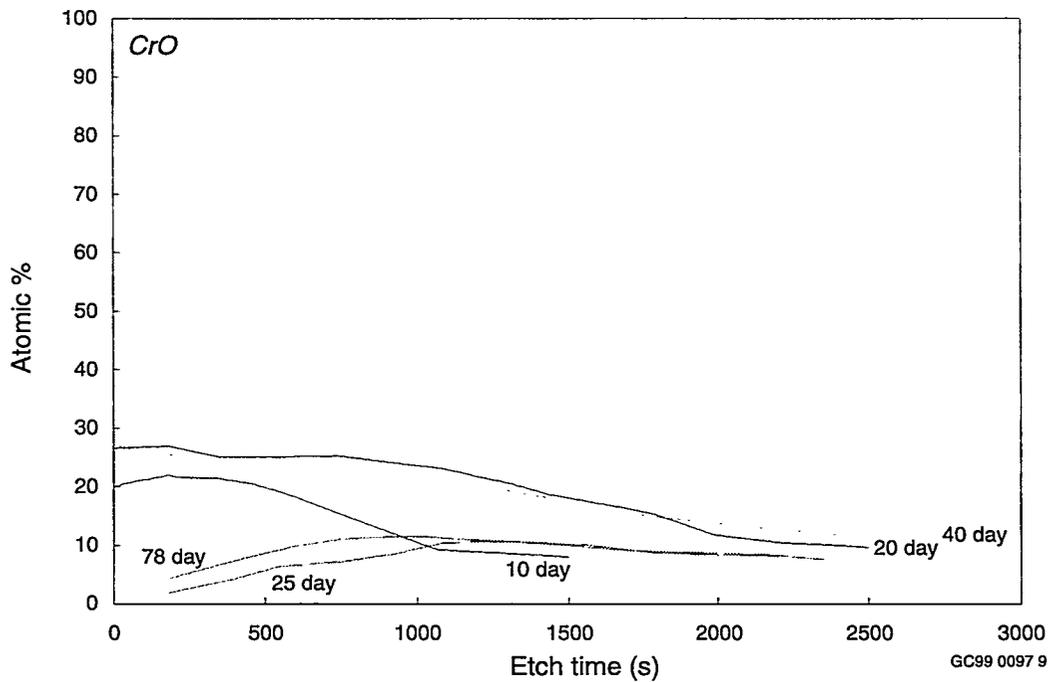
**Figure 23.** XPS depth profile of the chromium oxide in Stellite 6 specimens exposed to natural aging conditions.

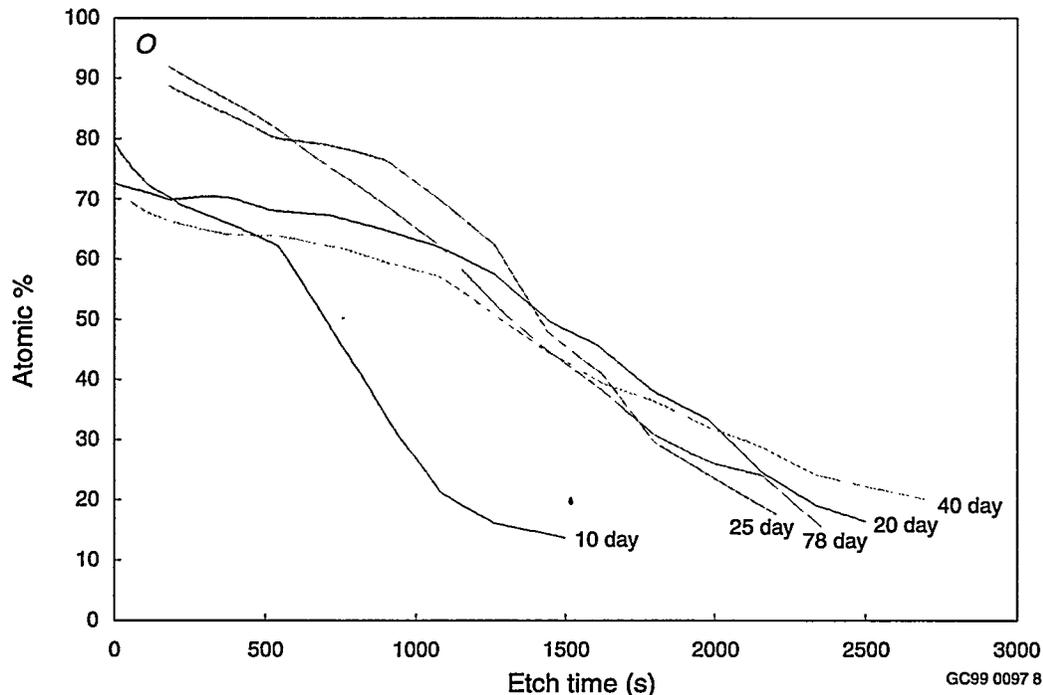
**Figure 24.** XPS depth profile of the oxygen in Stellite 6 specimens exposed to natural aging conditions.

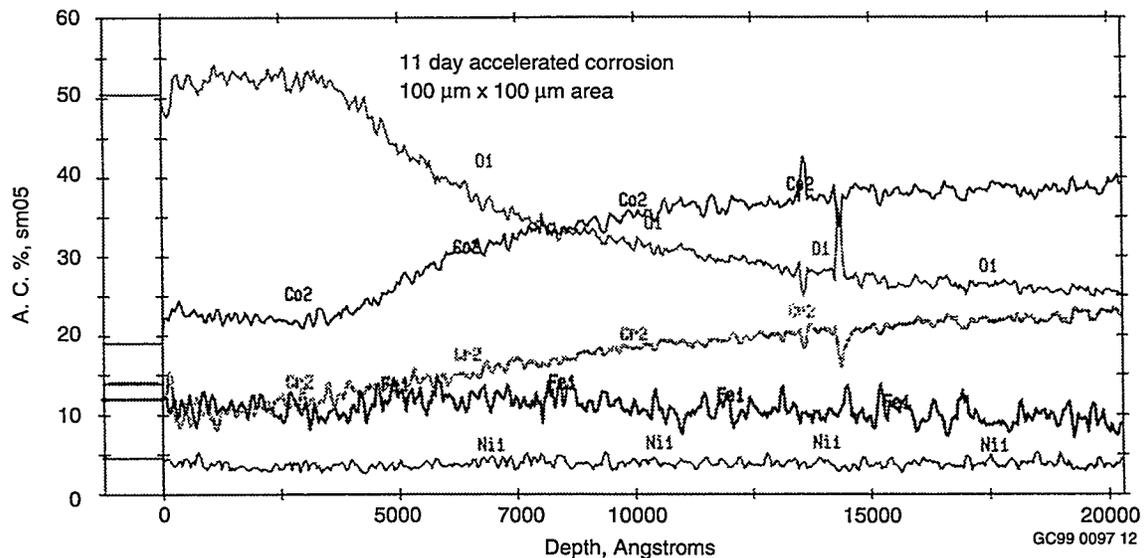
**Figure 25.** AES depth profile for Stellite 6 after 11 days exposure to an anodic current density of  $0.15 \text{ mA/cm}^2$ .

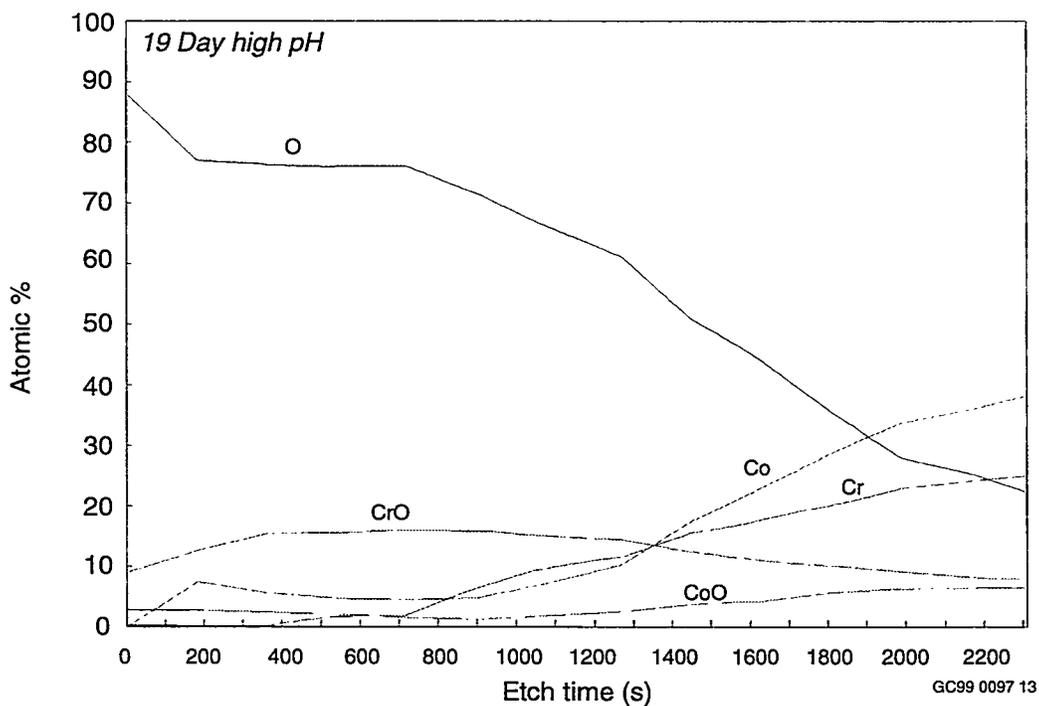
**Figure 26.** XPS depth profile for Stellite 6 after 19 days exposure to high-pH aging conditions.

Figure 26 shows the results of an XPS depth profile completed for a specimen subjected to accelerated aging with high pH. This profile was obtained after cleaning the surface with isopropyl alcohol to remove the zirconium dioxide ( $\text{ZrO}_2$ ) crystals. The presence of the  $\text{ZrO}_2$  crystals was confined to the surface, as no  $\text{ZrO}_2$  crystals were found in the XPS depth profile through the thickness of the film. The results show that the oxide film composition for the high-pH specimens is similar to the composition of the natural aging specimens. One difference in the results, a difference not shown in this figure, was the presence of iron and iron oxide in the film. The iron was fairly evenly distributed through the film thickness; the iron oxide content was higher near the surface of the film and lower at greater depth.

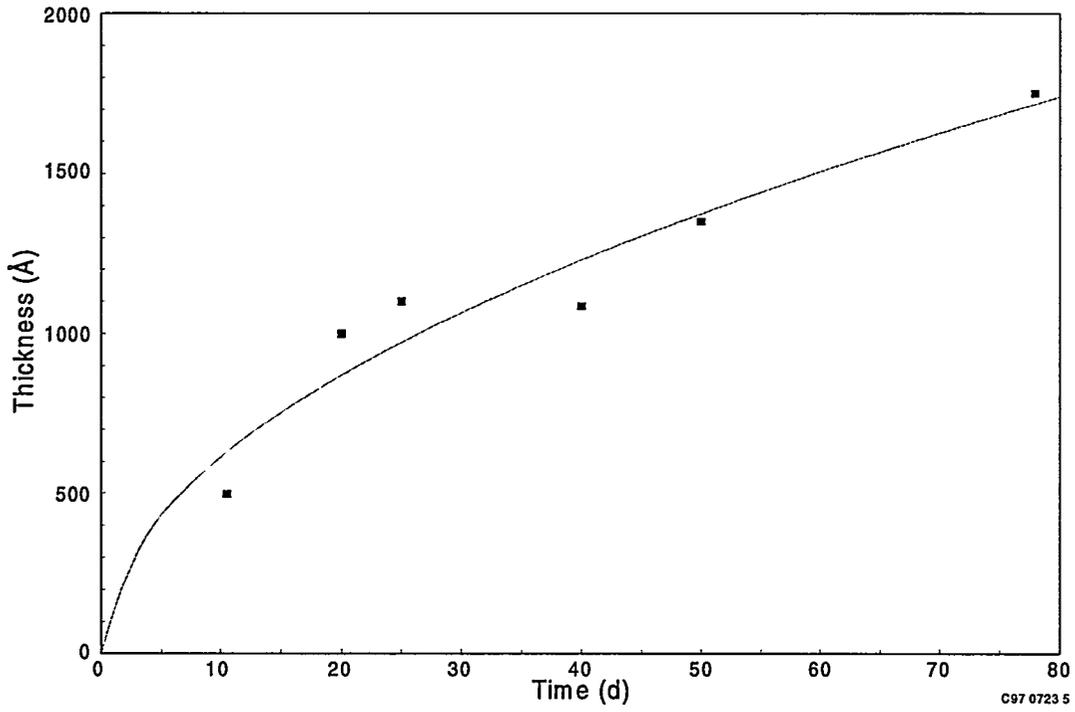
**Figure 27.** Oxide film thickness versus time for Stellite 6, showing the data from the natural aging tests and the parabolic data fit.

Based on the oxide film thickness data obtained, the oxide film thickness versus time is plotted in Figure 27, along with a best fit of the data. These results indicate that the oxide film growth rate appears to be parabolic. By comparison, the work of Honda et al. (1987) investigated the oxide film growth characteristics of Type 304 Stainless Steel and of carbon steel. Figure 28 shows that the oxide film growth rate of Stellite 6 is slower than that of the Type 304 Stainless Steel and much slower than the growth rate of carbon steel. Although the thickness of the oxide film is continuing to increase, the ability to safely operate a valve is not necessarily based on the thickness or thinness of the oxide film. Rather, safe operation of a valve is dependent on the mechanical properties of the oxide film as it ages, specifically the coefficient of friction.

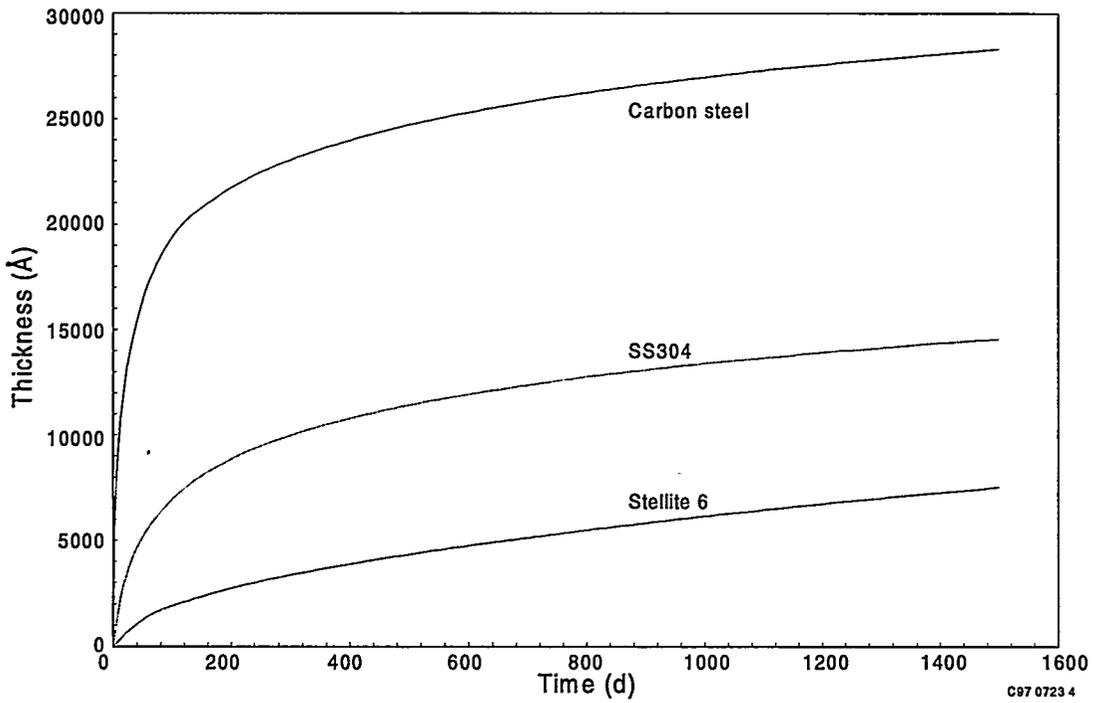
**Figure 28.** Oxide film thickness versus time for Stellite 6, Type 304 Stainless Steel, and a carbon steel.

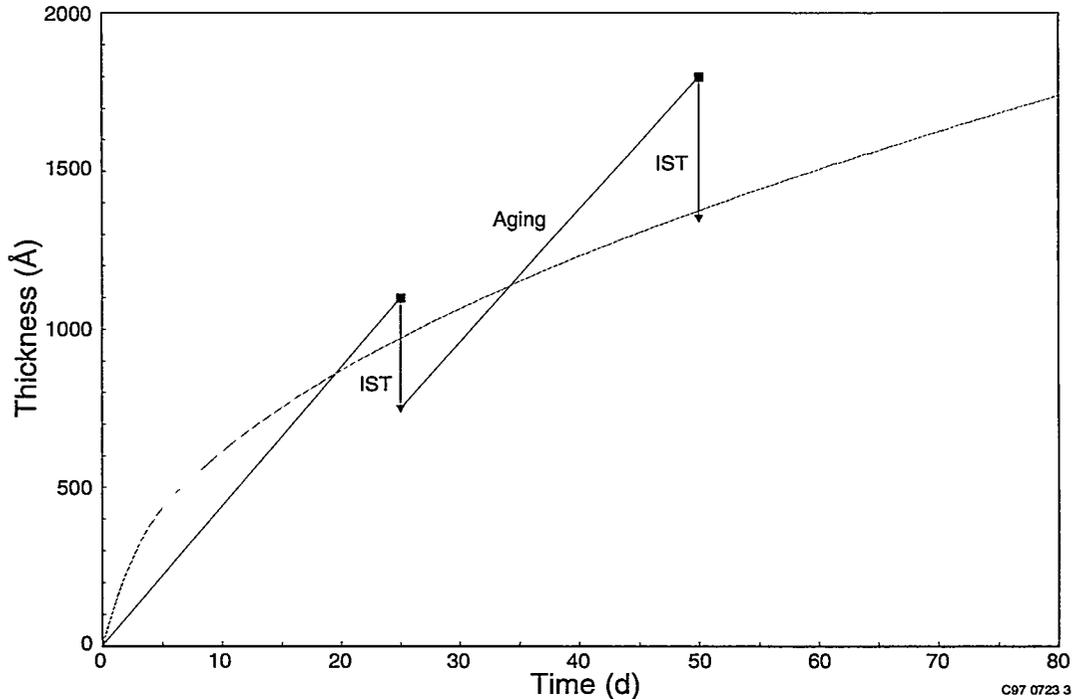
**Figure 29.** Oxide film thickness versus time for Stellite 6, showing the data from the simulated valve wedging tests and the parabolic data fit of the naturally aged tests.

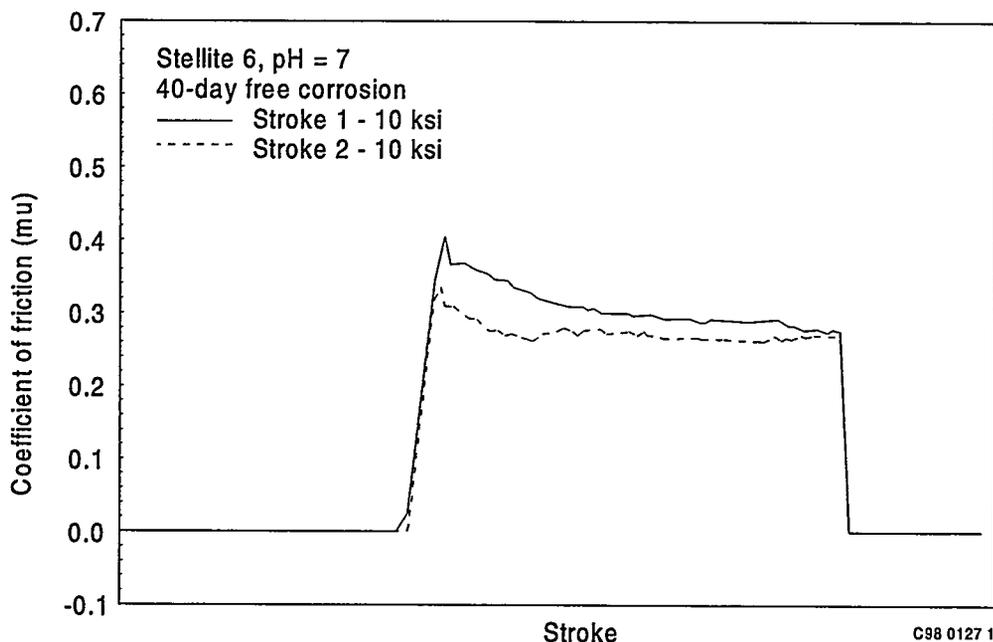
Figure 30. Typical friction traces from the friction testing of Stellite 6.

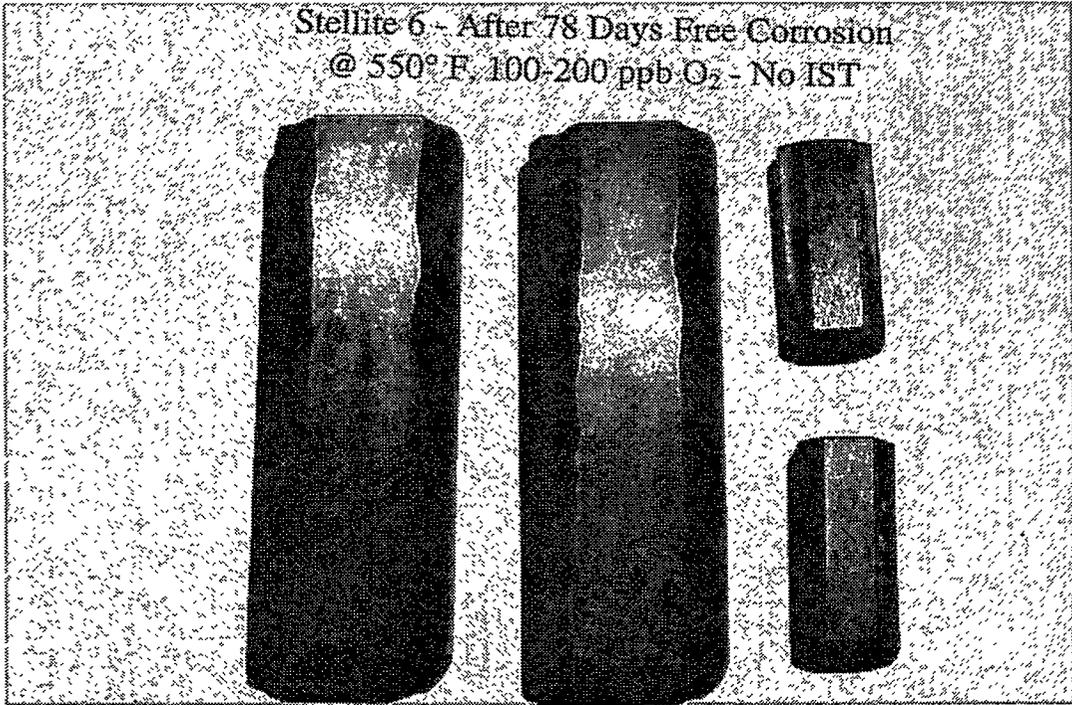
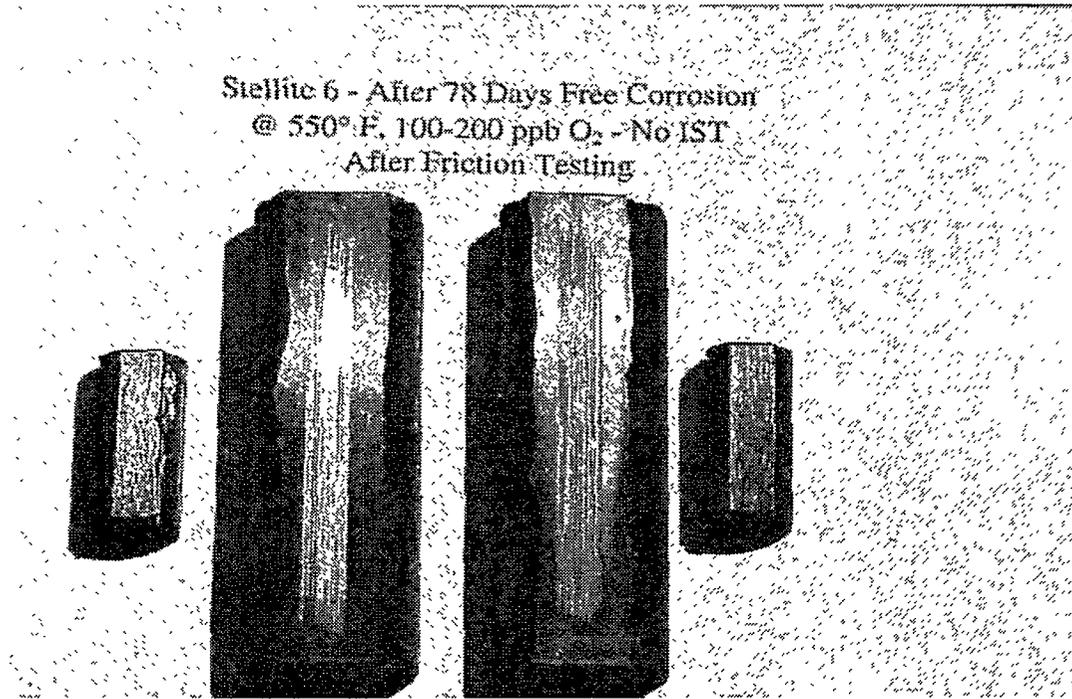
Figure 31. Photograph of 78-day natural aging Stellite 6 specimens before and after friction testing.

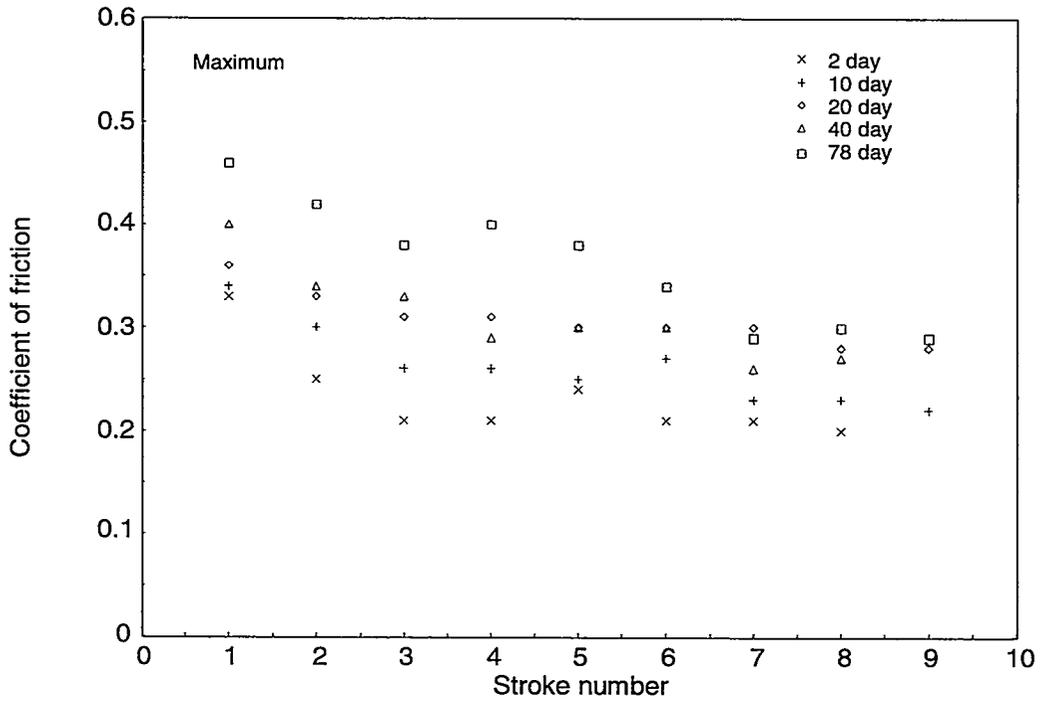
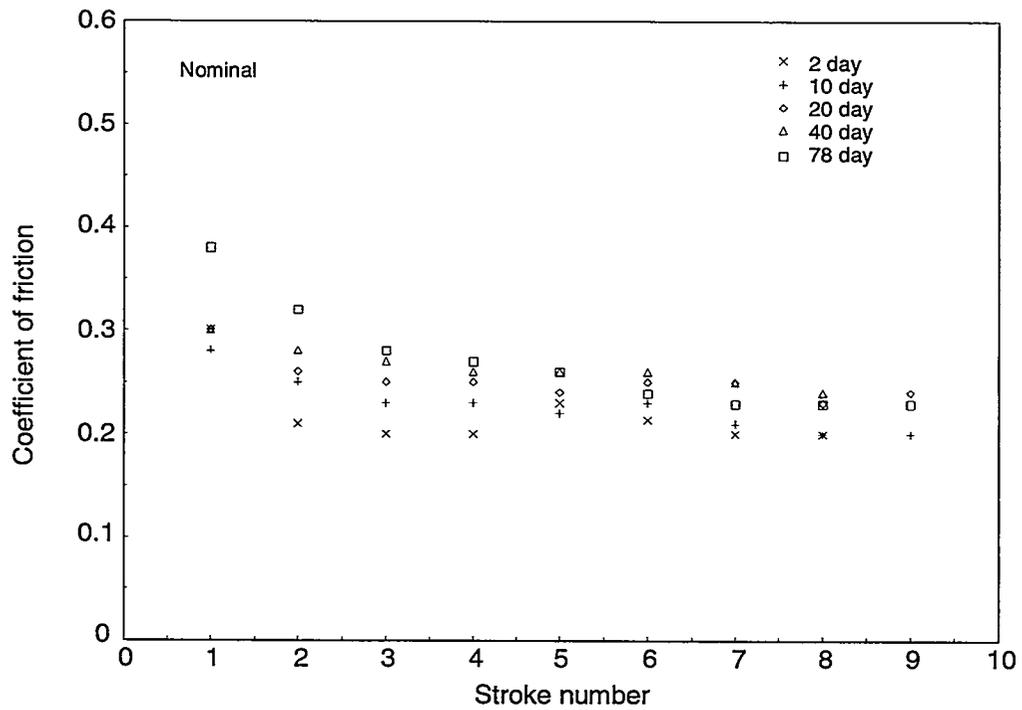
**Figure 32.** Coefficient of friction versus stroke for Stellite 6 specimens exposed to natural aging conditions; maximum values (top) and nominal values (bottom).

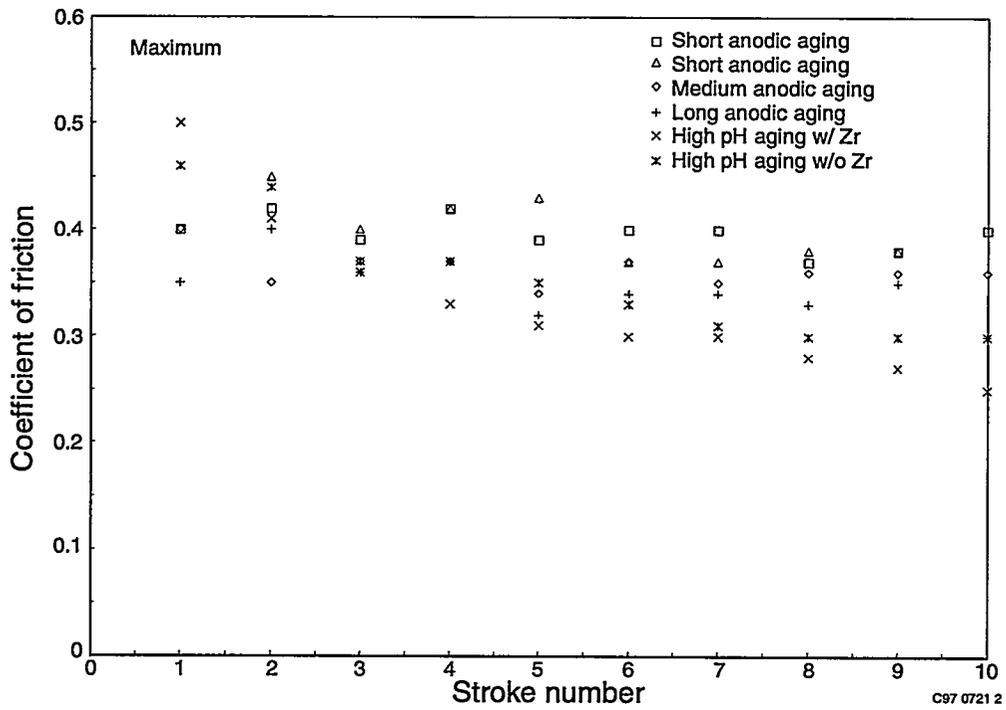
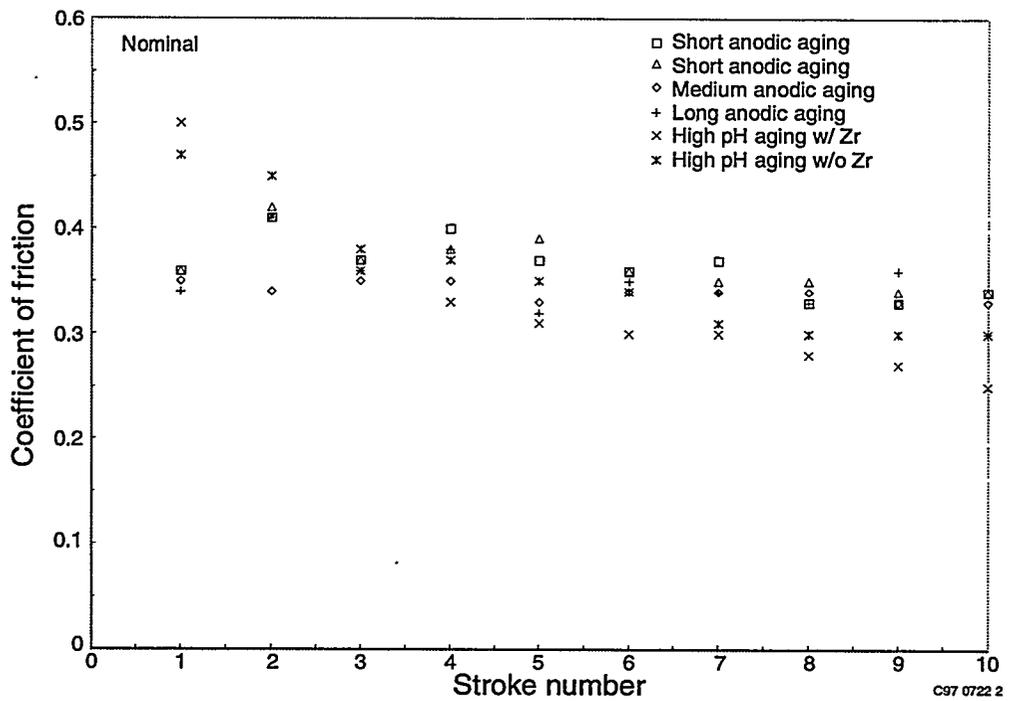
**Figure 33.** Coefficient of friction versus stroke for Stellite 6 specimens exposed to accelerated aging conditions; maximum values (top) and nominal values (bottom).

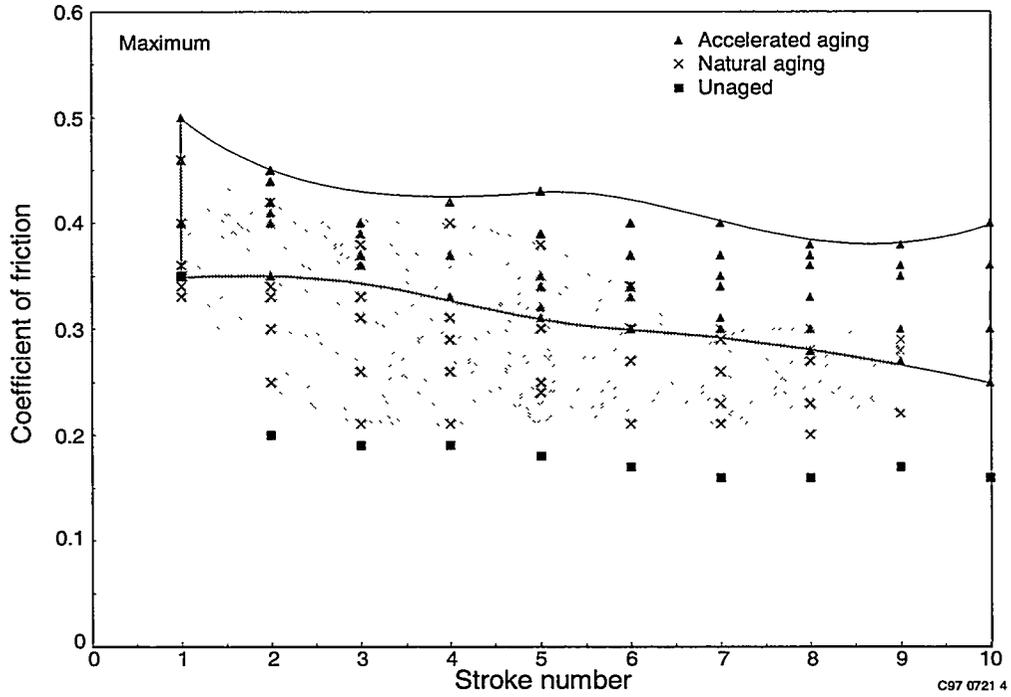
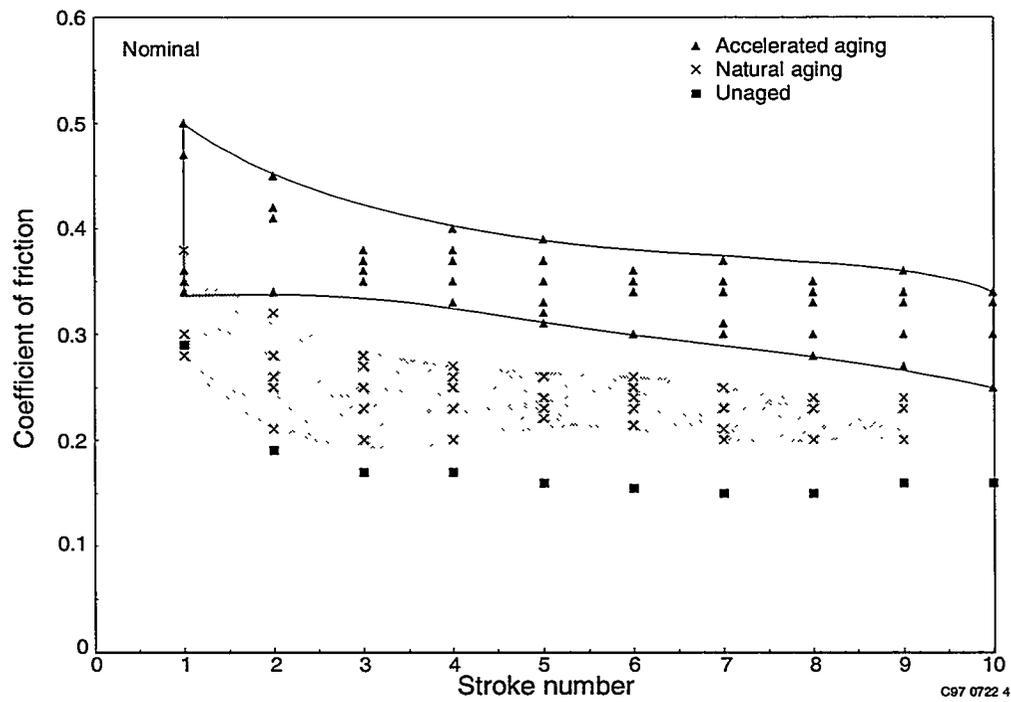
**Figure 34.** Coefficient of friction versus stroke for unaged and aged Stellite 6 specimens; maximum values (top) and nominal values (bottom).

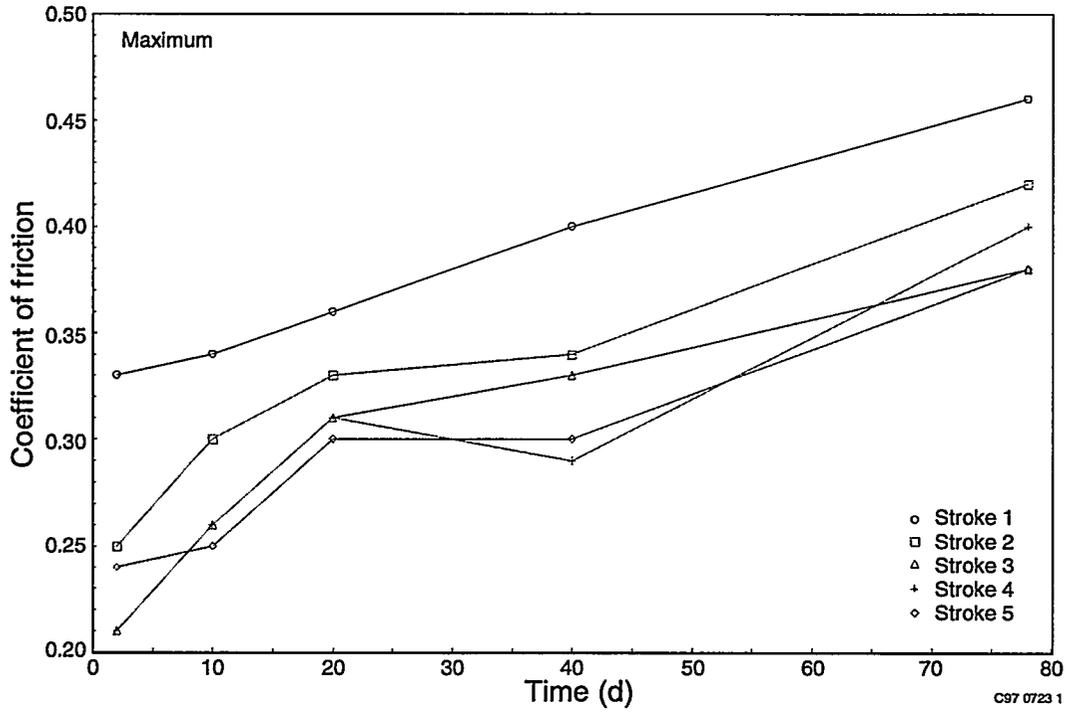
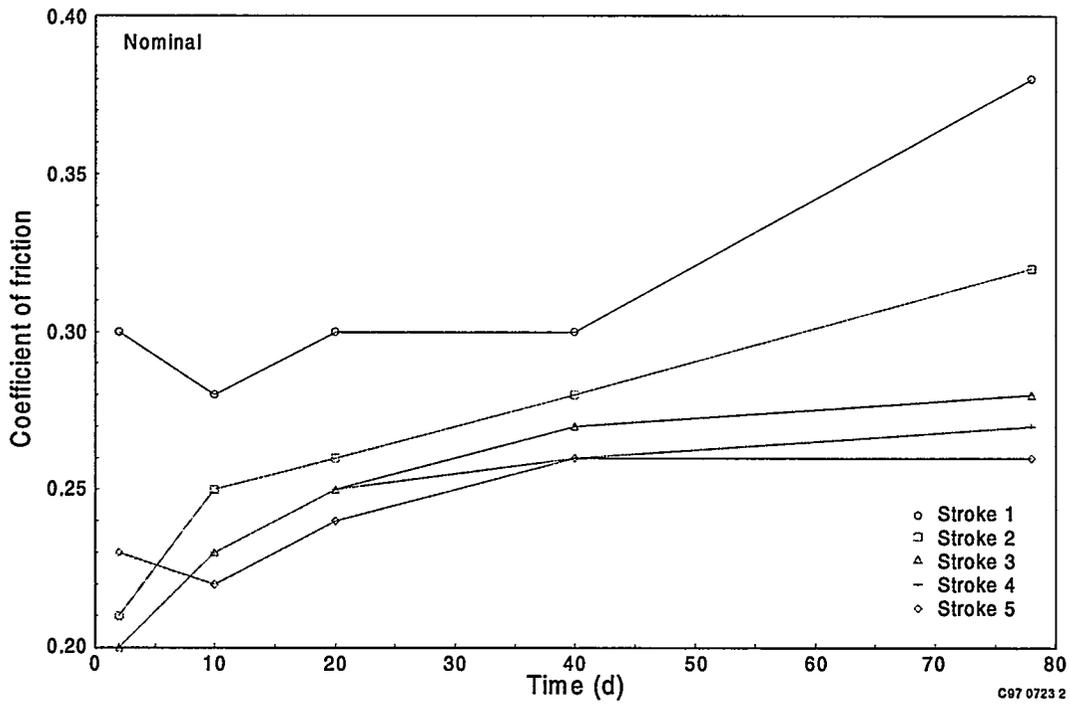
**Figure 35.** Coefficient of friction versus time for naturally aged Stellite 6 specimens; maximum values (top) and nominal values (bottom).

Results from friction testing of the naturally aged specimens at Battelle Columbus are plotted versus aging time in Figure 35. This figure indicates an increasing trend in both the maximum and the nominal coefficient of friction during the first and second stroke as the specimens age. For the third and subsequent strokes, the maximum friction shows a continuing increase with longer aging time, whereas the nominal friction begins to stabilize after 40 days. The maximum aging time (78 days) for these tests is short compared with the many years a nuclear power plant is expected to operate. The short aging times used in these tests do not provide enough information to determine whether the friction coefficient increases indefinitely with longer aging times or whether the friction coefficient eventually reaches a stable plateau, at some as-yet unknown aging time or film thickness.

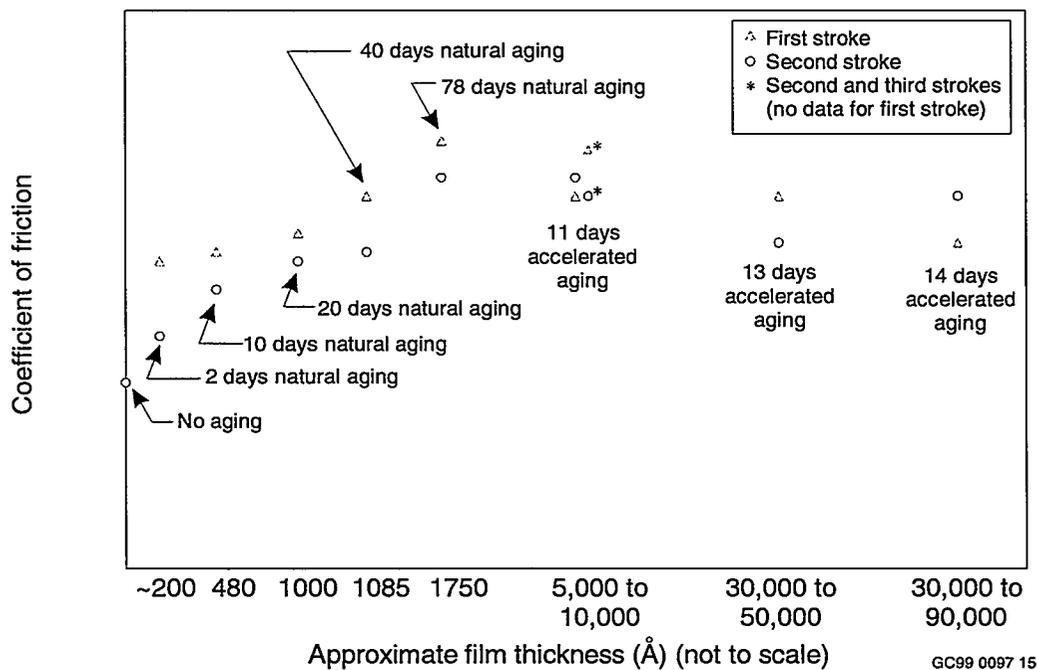
**Figure 36.** Coefficient of friction (maximum) versus approximate film thickness for naturally aged and accelerated aging (anodic current) Stellite 6 specimens.

Figure 36 shows the friction results from the accelerated aging (anodic current) specimens, plotted against film thickness, along with the data shown in Figure 35 for the naturally aged specimens. (Results from high-pH specimens are not included.) Because the structure and chemical composition of the oxide films produced by anodic acceleration are different from those produced by natural aging, these results are not specifically applicable to Stellite 6 surfaces aged under BWR conditions. However, the trend shown in these results is interesting, in that it shows an eventual plateau in the friction coefficient. Intuitively, we would expect the same kind of trend to eventually manifest with naturally aged Stellite 6, but again, available data are insufficient to confirm the existence of such a plateau or to identify the magnitude of the friction coefficient or the aging time at which it occurs. We have excluded numerical values from the vertical axis in Figure 36 as a reminder to the reader that numerical values of the friction coefficient in this comparison are not relevant to Stellite 6 surfaces in nuclear applications.

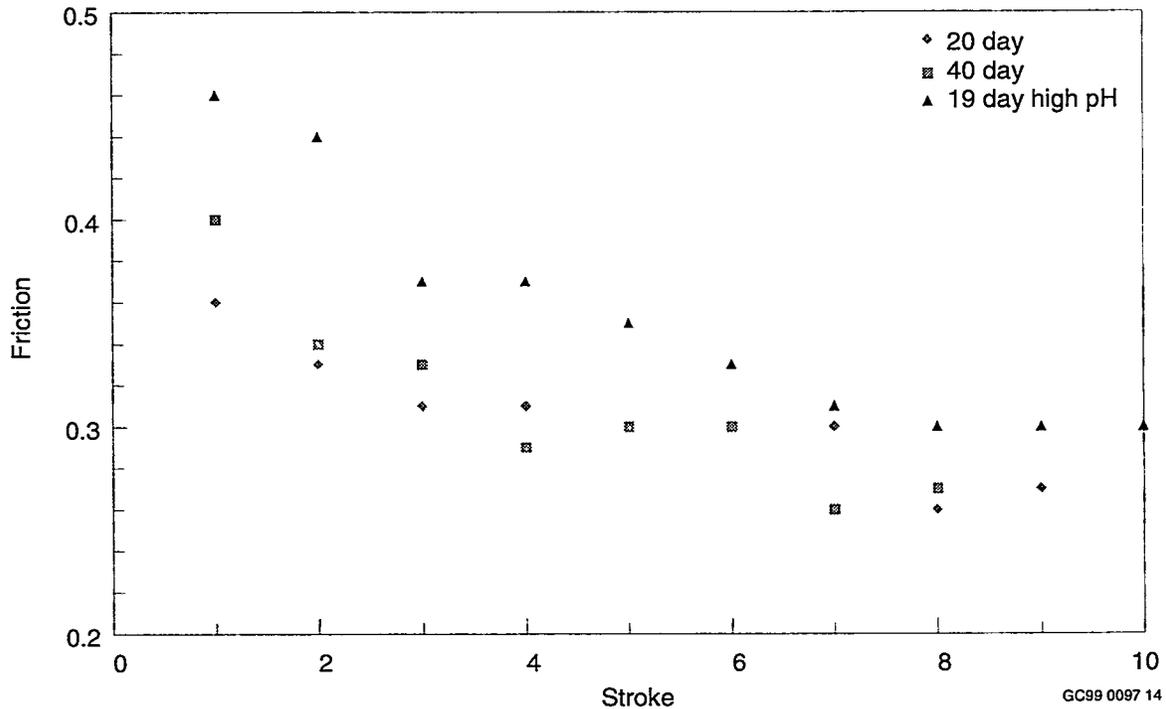
**Figure 37.** Coefficient of friction versus stroke for 20- and 40-day naturally aged and high-pH accelerated aging Stellite 6 specimens.

To investigate the effect the contact method has on the resulting friction between the valve disc and the valve body seat, NIST performed additional friction testing on 10-day and 50-day specimens. The testing used either a 0.5-in. steel ball or a 0.125-in. steel ball moving against the flat surface of a Stellite 6 specimen so that the oxide film would not be trapped between the surfaces, but rather could be pushed aside by the ball. This testing was performed at ambient temperature and pressure and yielded friction values in the range of 0.15 to 0.17. When the contact geometry was changed to a small 1.8 mm<sup>2</sup> flat surface against the flat surface of a Stellite 6 specimen, such that the oxide film would be trapped between

the surfaces, friction values in the range of 0.30 to 0.35 were observed. By comparison, the friction testing performed by Battelle at BWR coolant conditions produced maximum friction values in the range of 0.35 to 0.40.

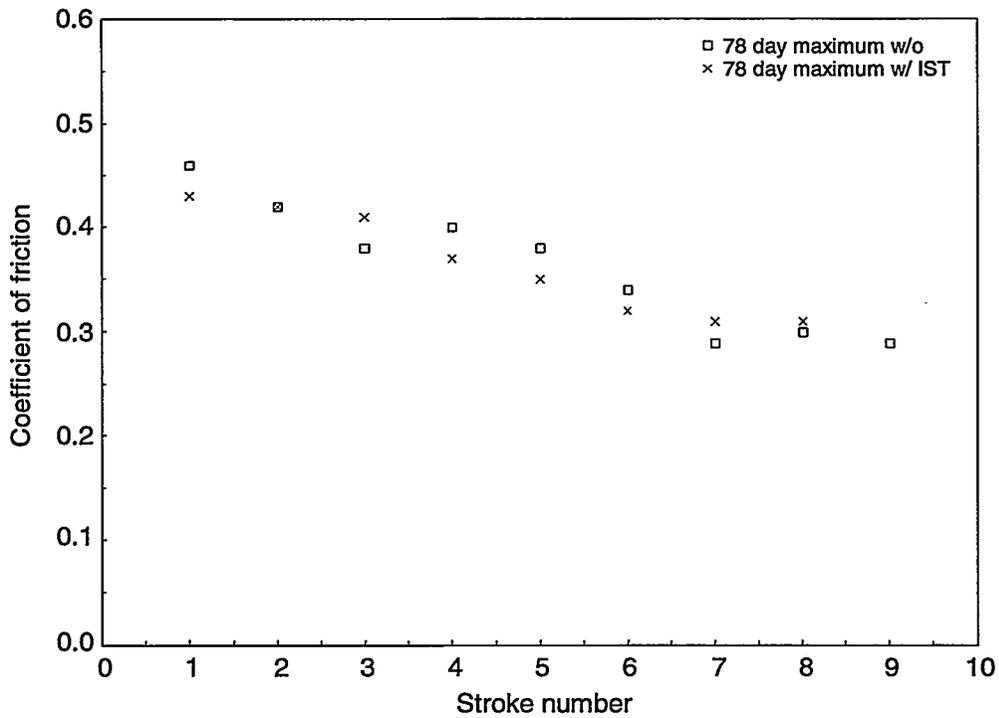
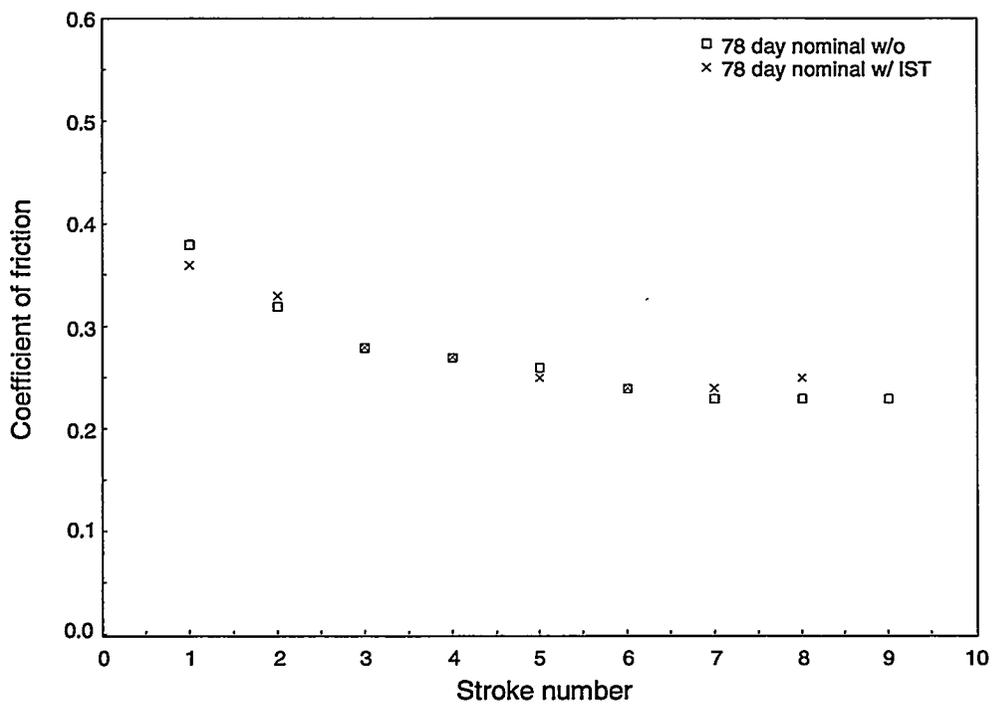
**Figure 38.** Coefficient of friction versus stroke for naturally aged Stellite 6 specimens and specimens subject to in-service testing; maximum values (top) and nominal values (bottom).

Figure 38 presents the maximum and nominal friction coefficients for specimens subjected to simulated valve wedging, compared to specimens not subjected to simulated valve wedging, both sets having undergone 78 days of natural aging. A slightly lower value in both the maximum and nominal friction was observed during the first stroke for specimens that had undergone the simulated valve wedging, with nominal friction coefficients of 0.36 versus 0.38 and maximums of 0.43 versus 0.46.

During subsequent strokes, the effect of the simulated valve wedging on the resulting friction coefficient was either negligible or varied from stroke to stroke.
