Second-Generation PFBC Systems R&D - Phase2 and 3

Annual Technical Report

PRESSURIZED FLUIDIZED BED COMBUSTION

TECHNICAL PROGRESS FOR PHASE 2
OCTOBER 1, 1997 THROUGH SEPTEMBER 1998

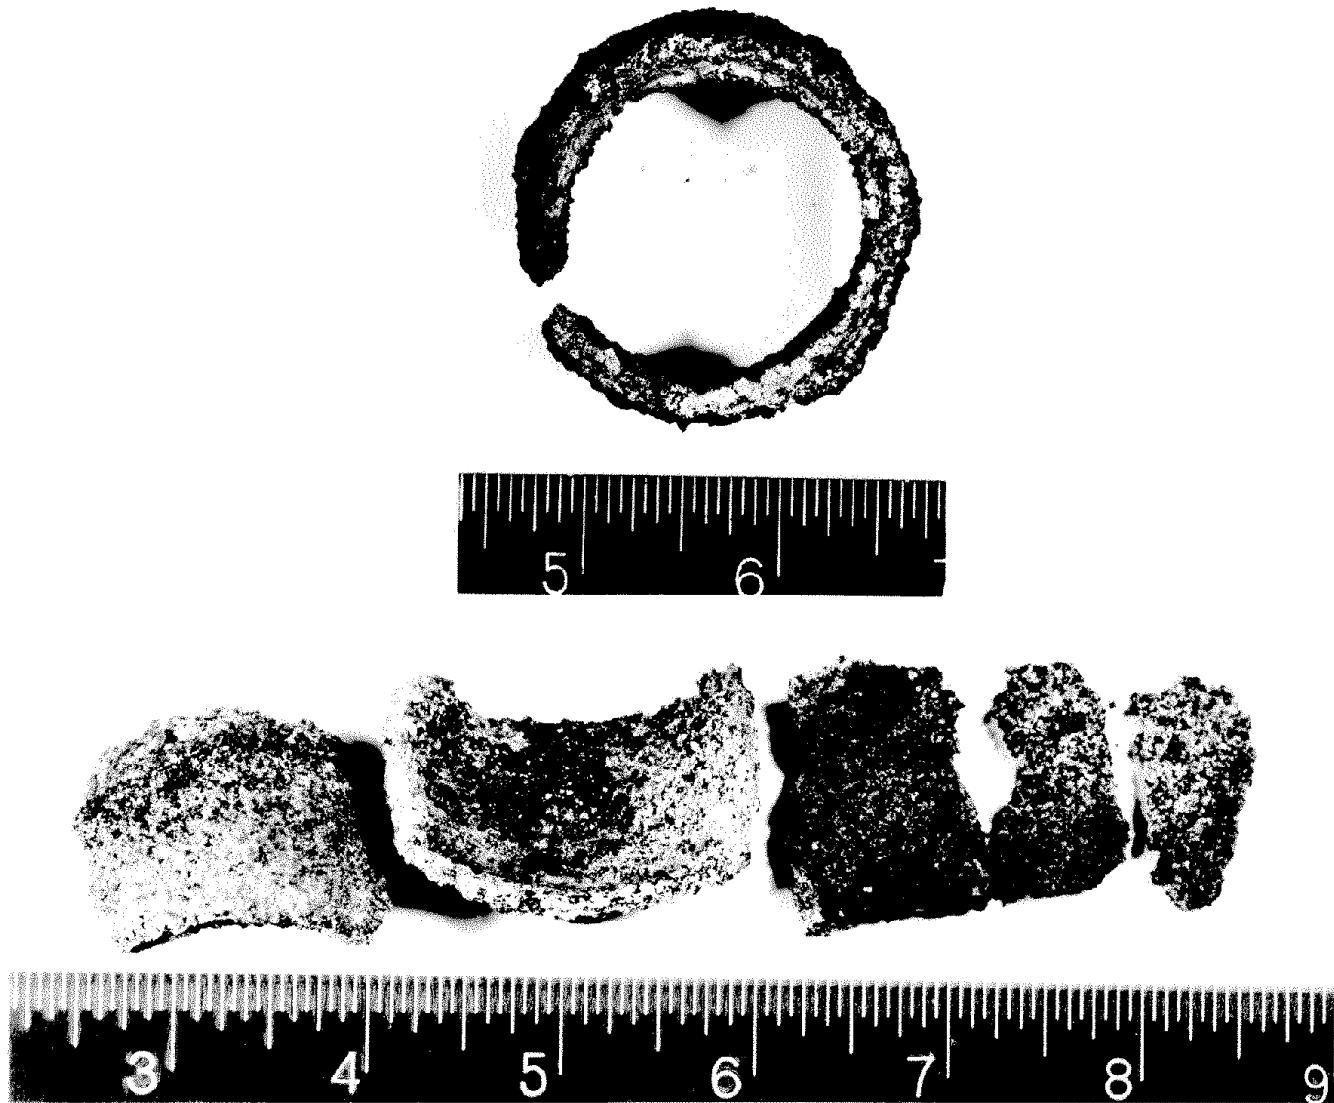
Figure 7 Doughnut Shaped Deposit Found in Carbonizer Test Run TR07

With agglomeration having caused the termination of the previous carbonizer run, each batch of material drained from the bottom of the carbonizer bed was screened for oversize material as soon as it was removed from the process. About 5 hours after transitioning to coal, pieces of a deposit were drained from the unit which, when assembled (see Figure 7), formed a doughnut shape. The inside diameter of the doughnut matched the feed pipe outside diameter, and this is the first time a deposit of this shape has been observed in the entire carbonizer development program. Figure 8 shows a sample of the balance of the oversize material found in the drains. Unlike the doughnut, they could be easily broken by hand and are considered acceptable. A total of 1.9 pounds of this oversize material was generated from the 2,500 pounds of high caking coal fed to the unit – again, a value that is deemed acceptable.
