DOE/RL-90-11
Revision 2

300 Area Waste Acid Treatment System Closure Plan

Date Published
May 1999

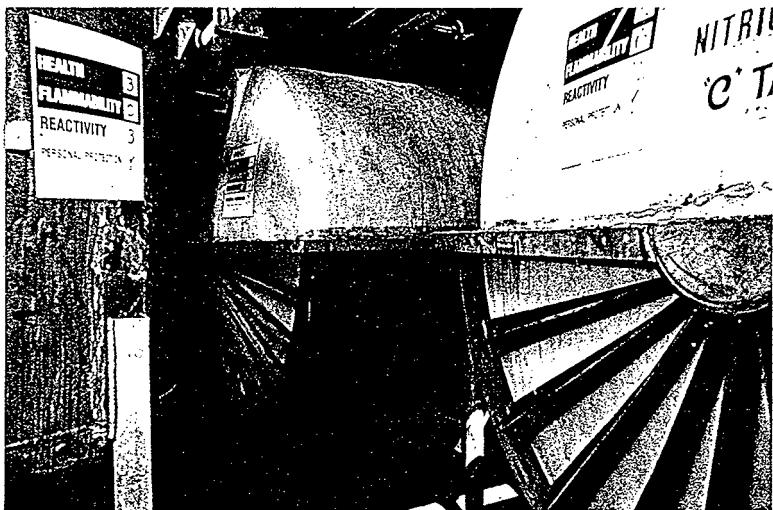
300 AREA WASTE ACID TREATMENT SYSTEM--334-A WASTE ACID STORAGE TANKS

TANKS A, B, AND C
(TANK A TAKEN OUT OF SERVICE IN 1988)

30 Tanks B and C, which have a capacity of 7,570 liters each, are horizontal cylindrical tanks of high-
31 density polyethylene construction supported belowgrade by stainless-steel saddles. These tanks are
32 3.54 meters long and 1.77 meters in diameter (outside dimensions) and sit approximately 51 centimeters
33 above the floor. Tank wall thicknesses are unknown, but are highly variable as a result of the molded
34 plastic construction. A maintenance hole with a stainless-steel cover is located on the top of each tank
35 above the normal acid levels. Electrode-type high-level alarms and float- and cable-level indicator
36 systems remain in the tanks. As dangerous waste tanks, inspections of each tank, adjacent piping, and
37 surrounding areas were performed weekly to check for damage, deterioration, or leakage. The completed
38 inspection forms are filed in the 333 Building.
39

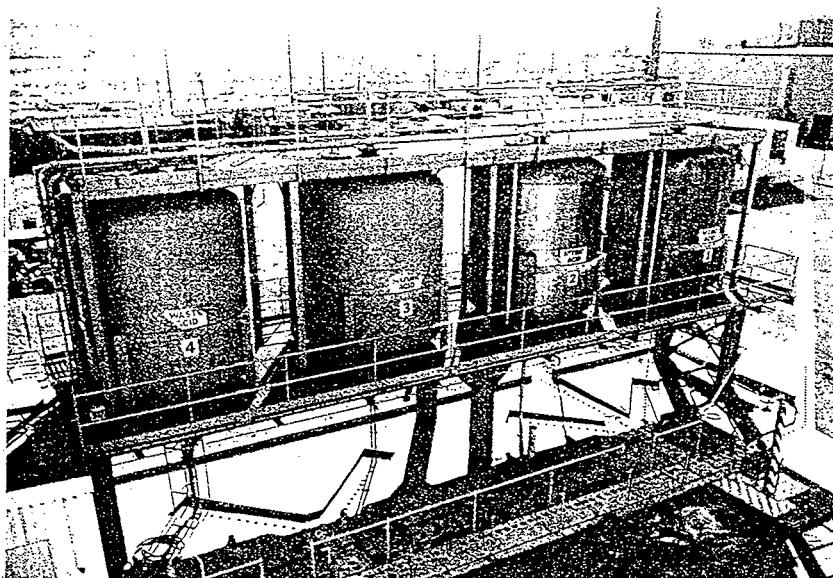
300 AREA WASTE ACID TREATMENT SYSTEM--334 TANK FARM

WASTE ACID TANK 4 (REMOVED, CLEANED, AND BURIED IN 1988)

18 The 300 Area WATS portions of the 334 Tank Farm are the uncoated concrete pad and drainage trench
19 (identified in Figure 2-6) and the tank support structure. The pad is located directly below where 300
20 Area WATS tank 4 and three other similar, non-300 Area WATS tanks were supported by a large steel
21 structure. No cracks exist in the concrete pad. Tank 4 was a lined carbon steel tank that usually was
22 empty but was kept available as an overflow tank for the tanks in the 334-A Building. In 1986, tank 4
23 failed near the top, above the liner. In 1988, tank 4 was removed, cleaned, and disposed in the LLBG.
24 The paint on the tank support structure predates this spill. Portions of the painted surface exhibit rust.
25 No 300 Area WATS piping remains at this location.
26

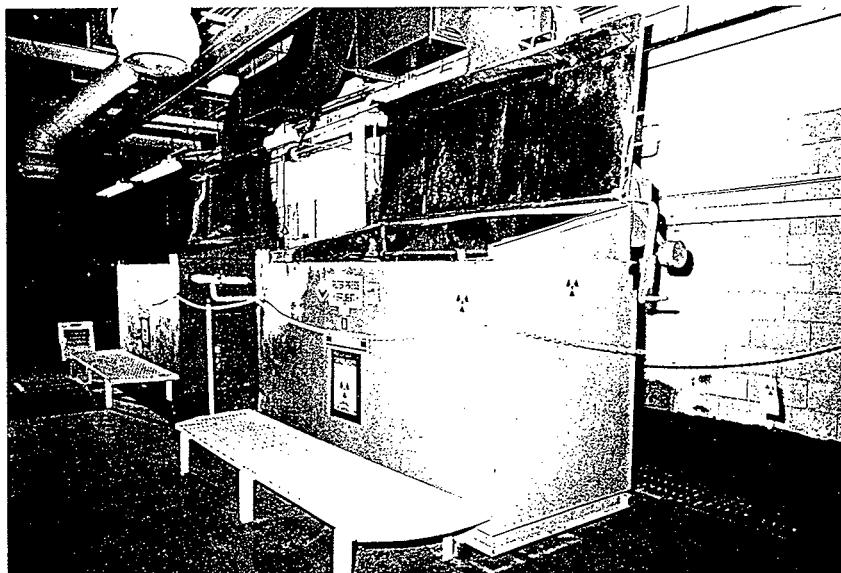
300 AREA WASTE ACID TREATMENT SYSTEM--313 BUILDING

TANKS 9 AND 10--EFFLUENT COLLECTION TANKS

9
10 The fourth bermed area was created in 1987 when berms were built around tanks 9 and 10 and an east-
11 west running trench. A contiguous area of the floor beneath tanks 9 and 10, and the drainage trench in
12 this area, were covered with acid split brick in 1953. This area was sandblasted before constructing the
13 berm and recoating the floor with Semstone. The trench contains a sump that was backfilled with
14 concrete in 1987, plugging the drain to the PS. As discussed in Chapter 3.0, soil beneath this portion of
15 the floor could be contaminated from defective drains. The trench was covered with removable cast-iron
16 alloy metal grates and lined with a stainless steel catch pan similar to the liner installed in the early
17 1970's in bermed area 1. The floor around the tanks was sloped to drain to the trench.
