PHASE 2 FINAL REPORT

CONTINUOUS FIBER CERAMIC COMPOSITES PROGRAM: GASEOUS NITRIDATION

**R. Suplinskas G. DiBona, W. Grant
Textron Systems Corporation
2 Industrial Avenue
Lowell, MA 01851**

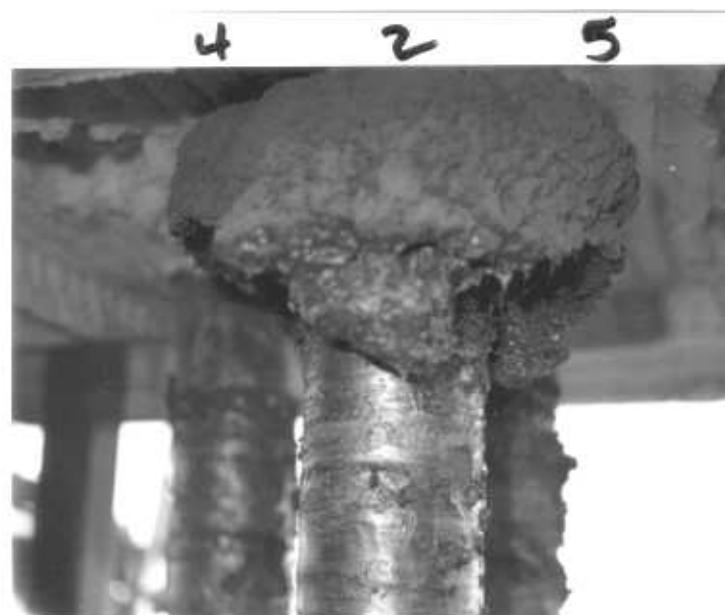
Figure 3.3-1 Burner locations in the test furnace

Figure 3.3-2 Burners 4 and 5 showed no significant corundum buildup, but contained surface cracks.

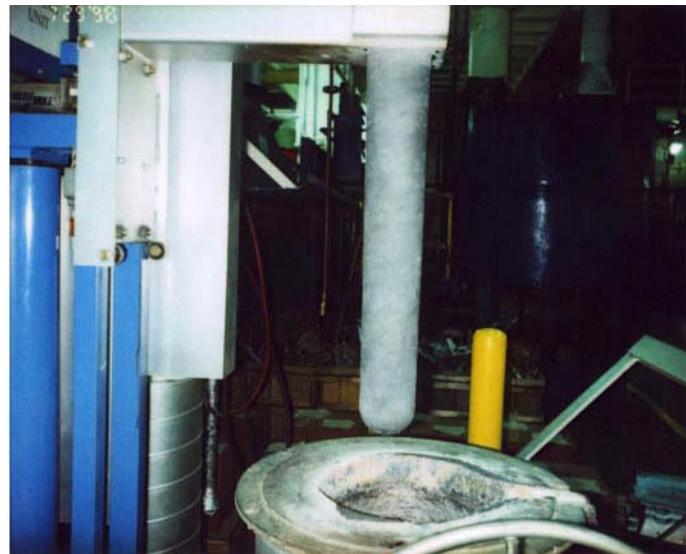
Figure 3.3-22 Textron CFCC Immersion Tube held over the melting crucible

Figure 3.3-22 shows the immersion tube just before it is lowered into the crucible.

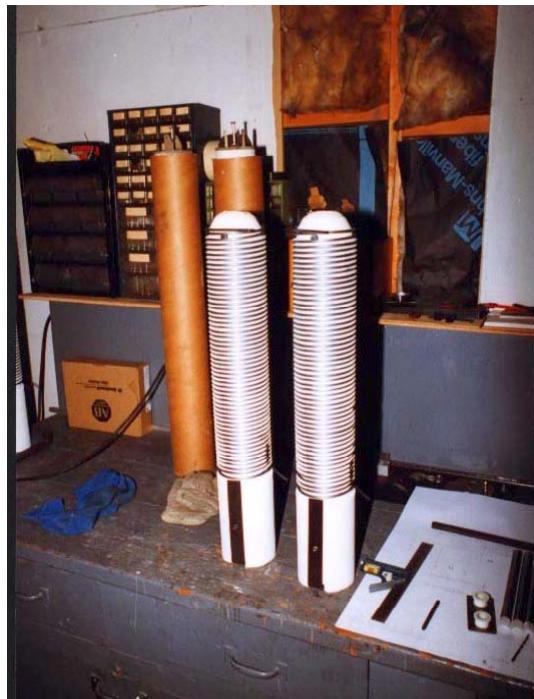
Figure 3.3-25 The electric heating element being used in immersion tube #6 at GM Advanced Development Center in Saginaw, MI

This immersion tube had performed extremely well in service at GM's facility. Early indications were that the tube is more energy efficient than the thicker unreinforced tubes previously used. Warm-up periods during a "cold start" were reduced by 1/3 and (non-transient) static hold heating conditions required a lower heater temperature to maintain the melted aluminum at temperature. Figure 3.3-25 shows the 12 kW Kanthal heating element assembly used inside the immersion tube.

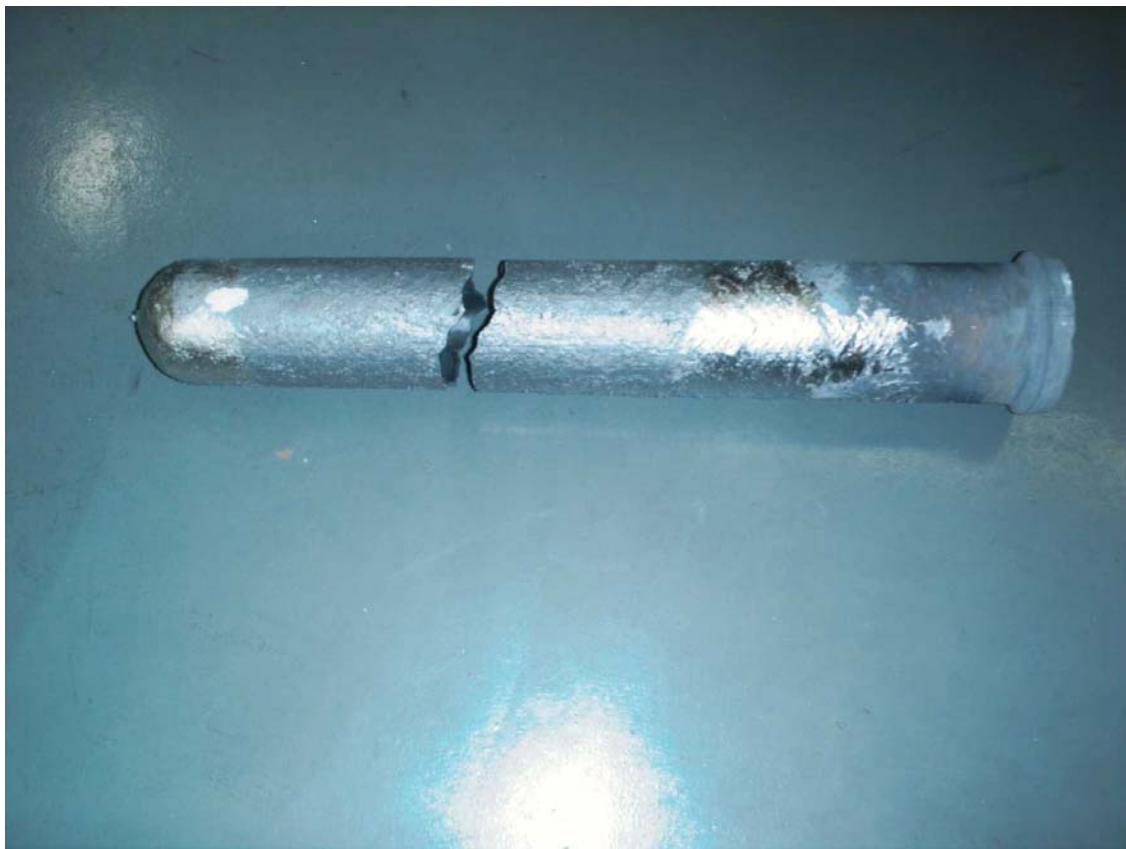
Figure 3.3-27 Immersion Tube No. 6 Fracture

Pictures of the failed tube No. 6 along with radiographic inspections are show in figures 3.3-27 thru 3.3-32. In general, it appears that the major fractures are consistent with the region of the immersion tube that is sometimes not fully immersed in molten aluminum, but is exposed to direct radiation from the heating element. A failure analysis effort has begun to look at fracture sites and regions along the axis of the tube in order to better understand the failure mechanisms.

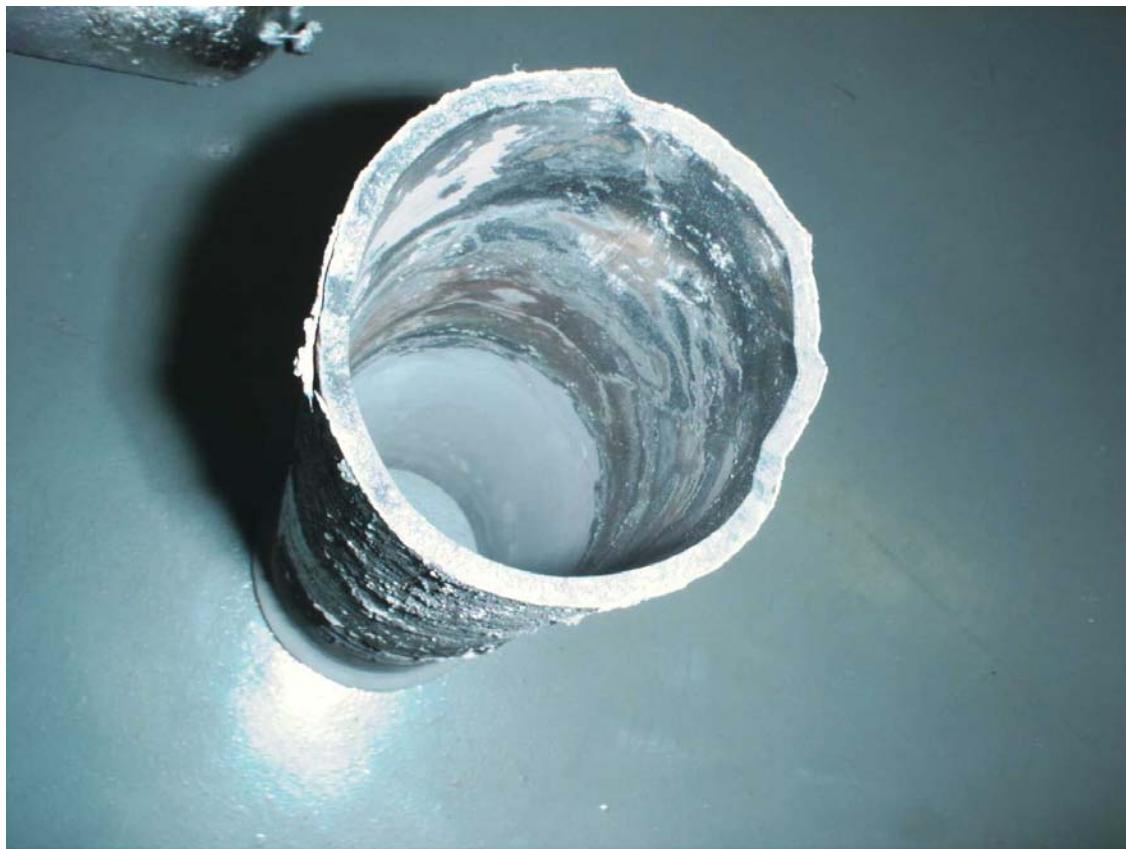
Figure 3.3-28 Upper region of fractured tube No. 6 toward flange end

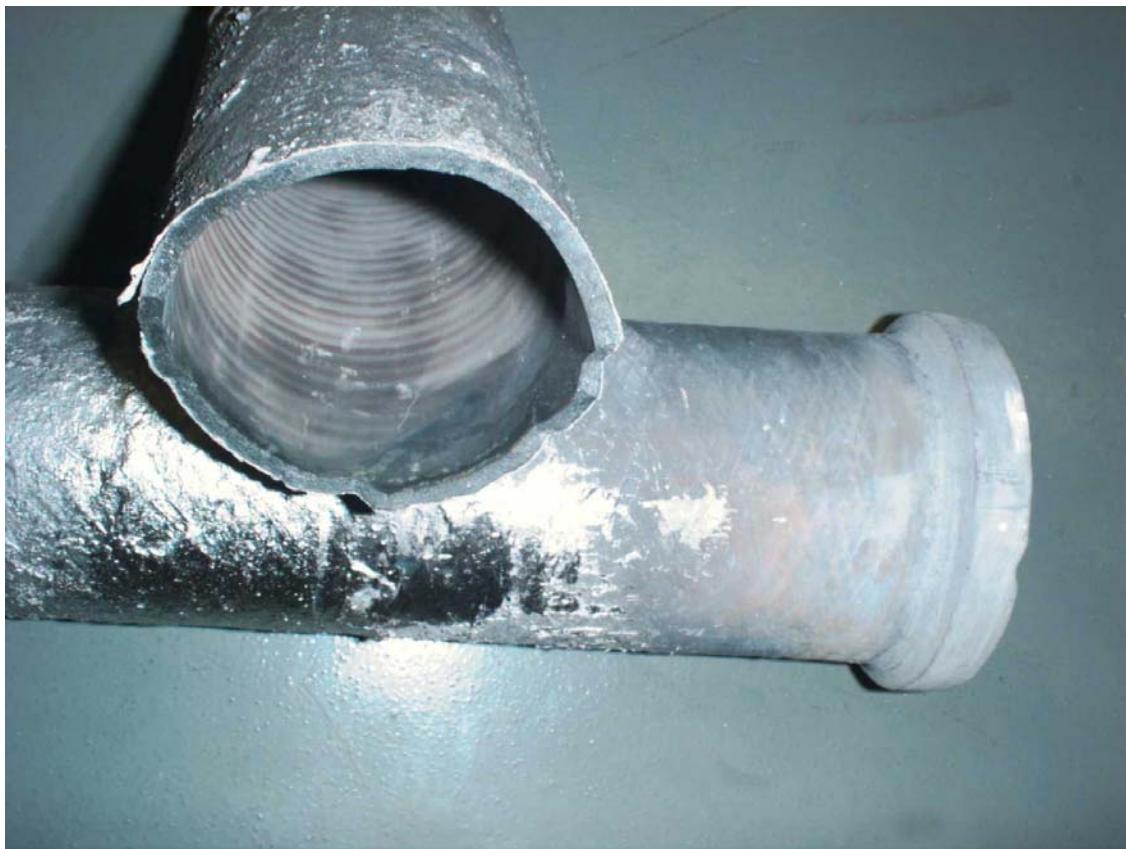
Figure 3.3-29 Lower Section of Tube No. 6

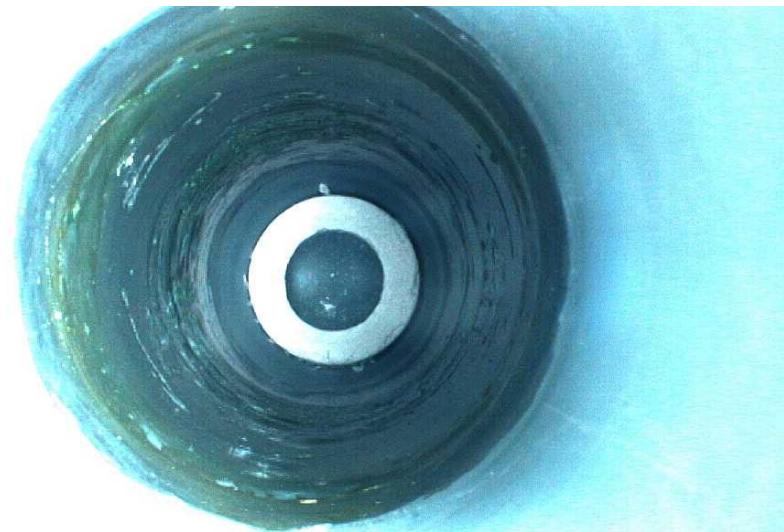
Figure 3.3-53 Photograph taken during the inspection of the inside of Tube No. 8
