OPTIMIZATION OF COMPOSITION AND HEAT TREATING OF DIE STEELS FOR EXTENDED LIFETIME

Case Western Reserve University

January 2002

Work Performed Under Contract DE-FC07-00ID13847

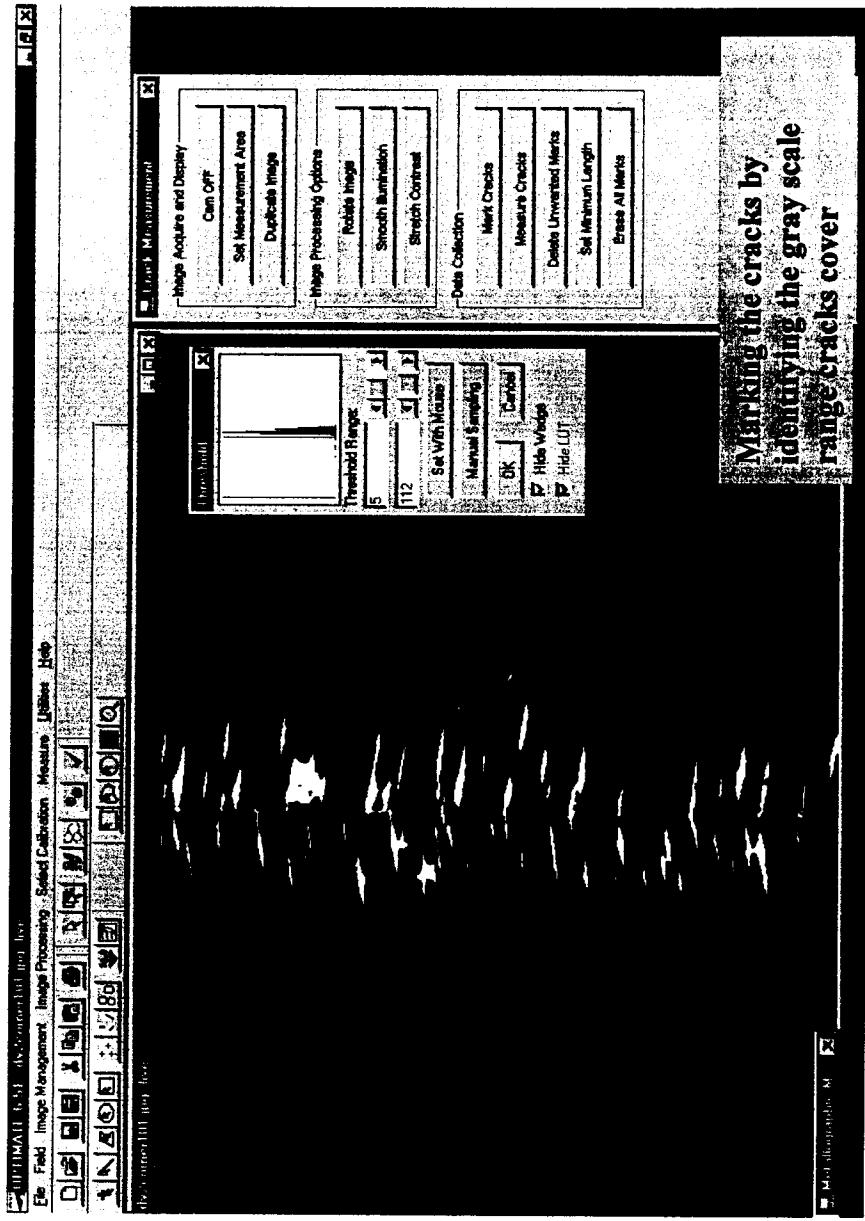
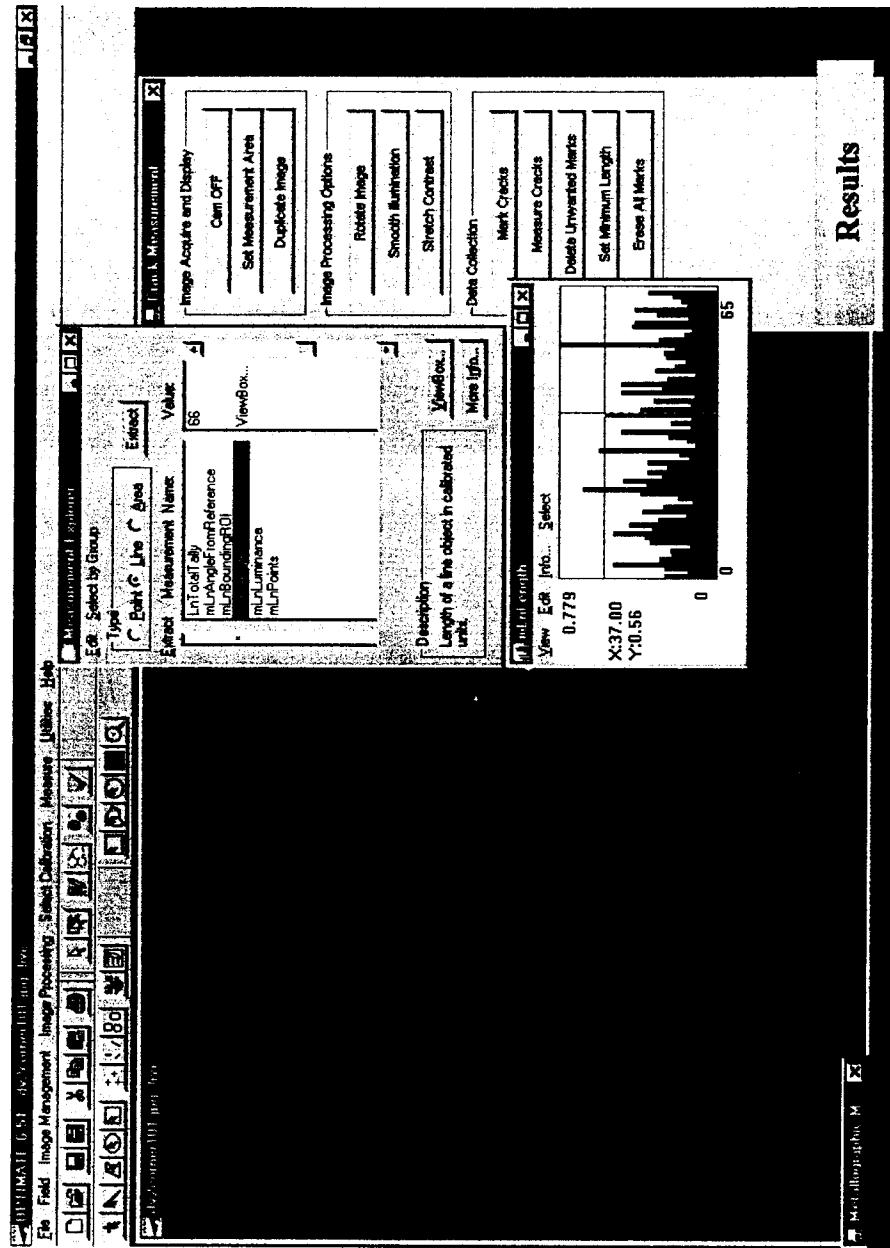
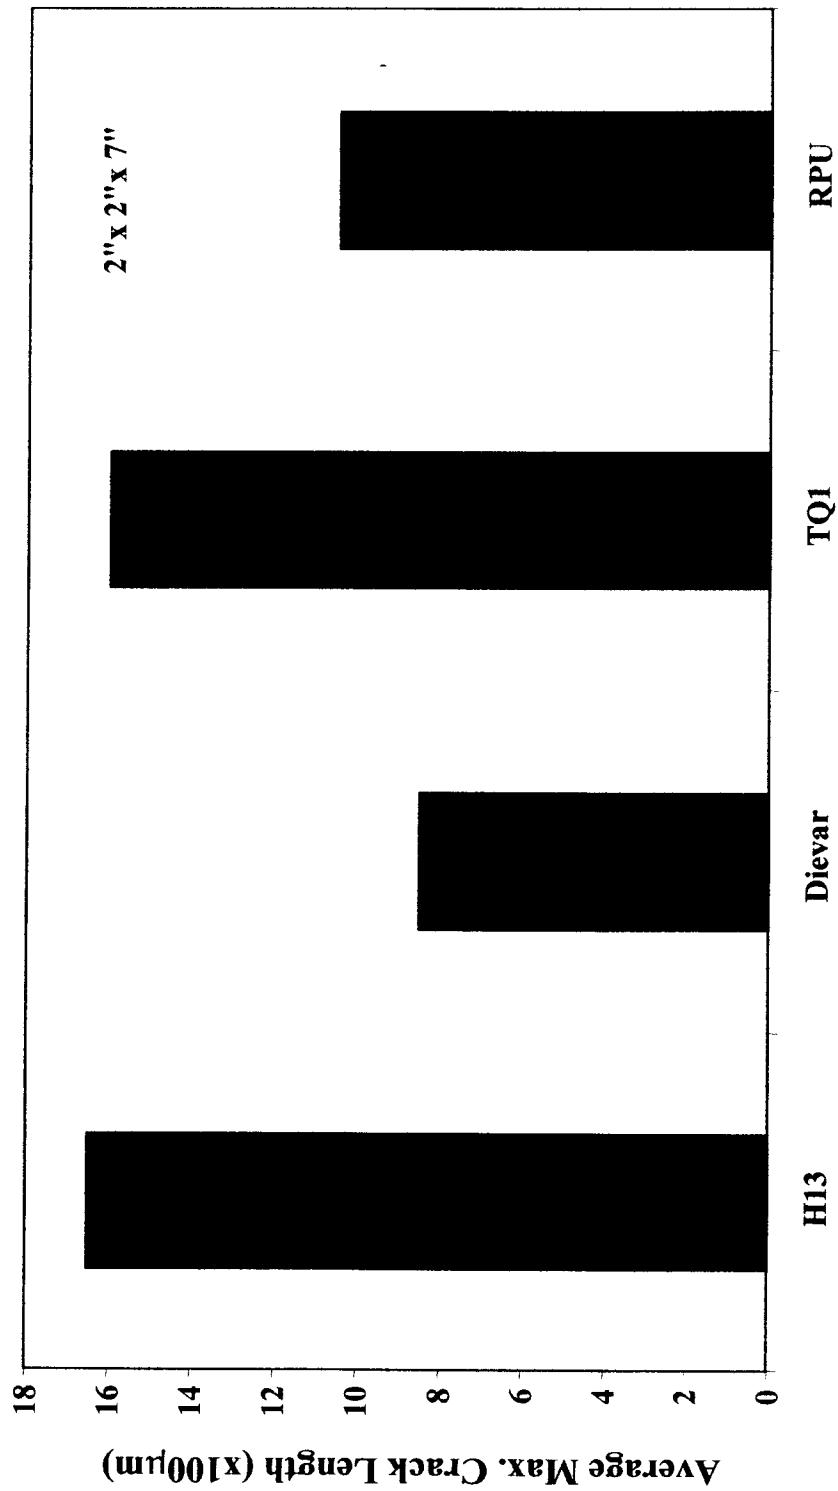
Fig.2.5(a) Process of cracks measurement by MSQ image analyzer
--Acquiring image

Fig.2.5(b) Process of cracks measurement by MSQ image analyzer
--Marking the cracks

Fig.2.5(c) Process of cracks measurement by MSQ image analyzer
--Measuring the cracks

Two concepts are used to evaluate the thermal fatigue resistance of the steels: average maximum crack length and total crack area. Average maximum crack length is the average length of the longest cracks on the four corners. The crack area of each crack is defined as the square of the crack length. The total crack area is the sum of the crack areas of all the cracks. The number and length of all cracks were measured under an optical microscope attached to a Leitz microhardness tester and a MSQ Image Analysis system. The process of crack measurement by the system is shown in Fig. 2.5.

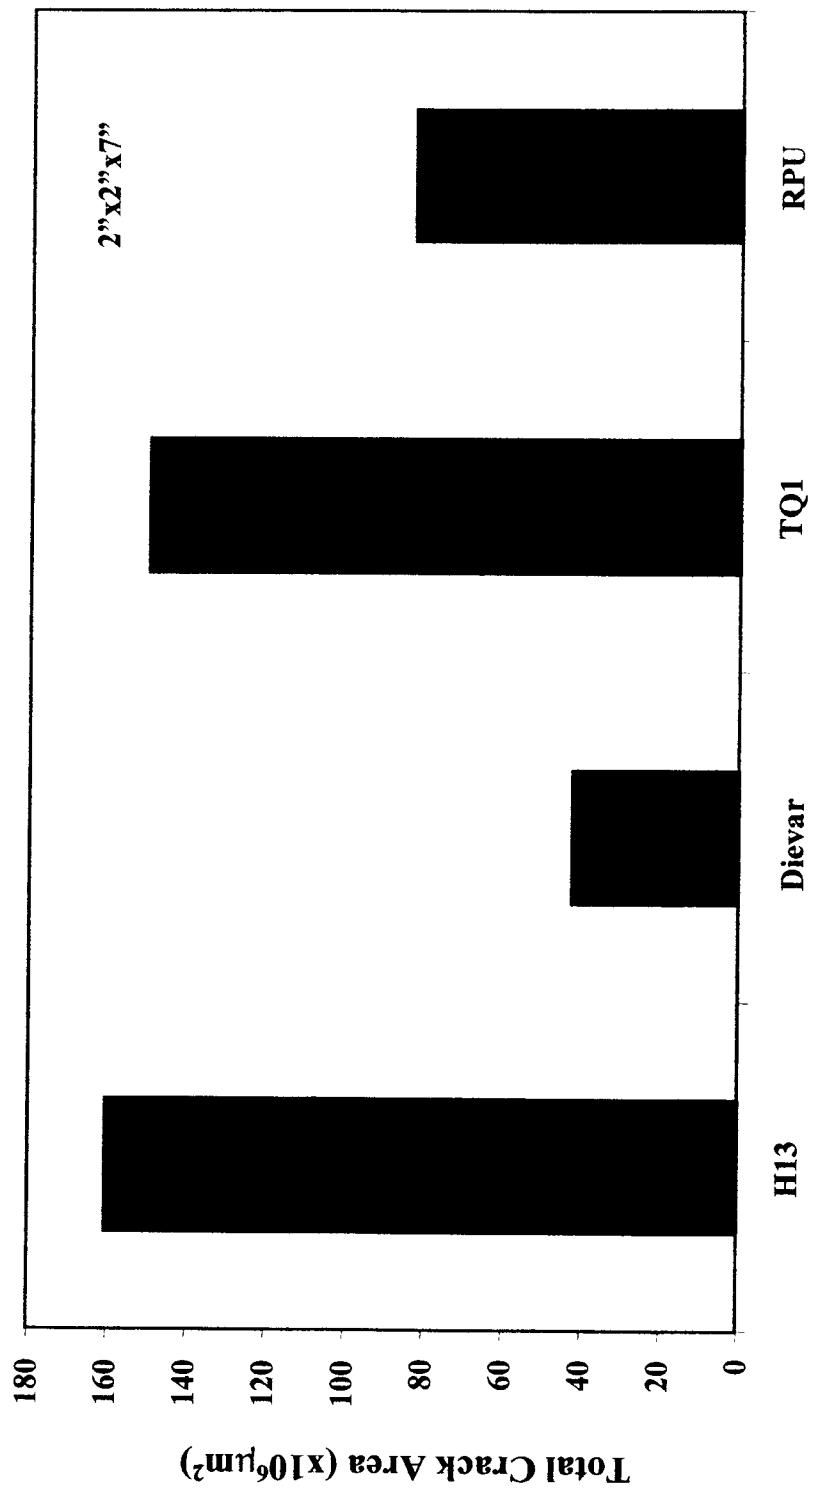
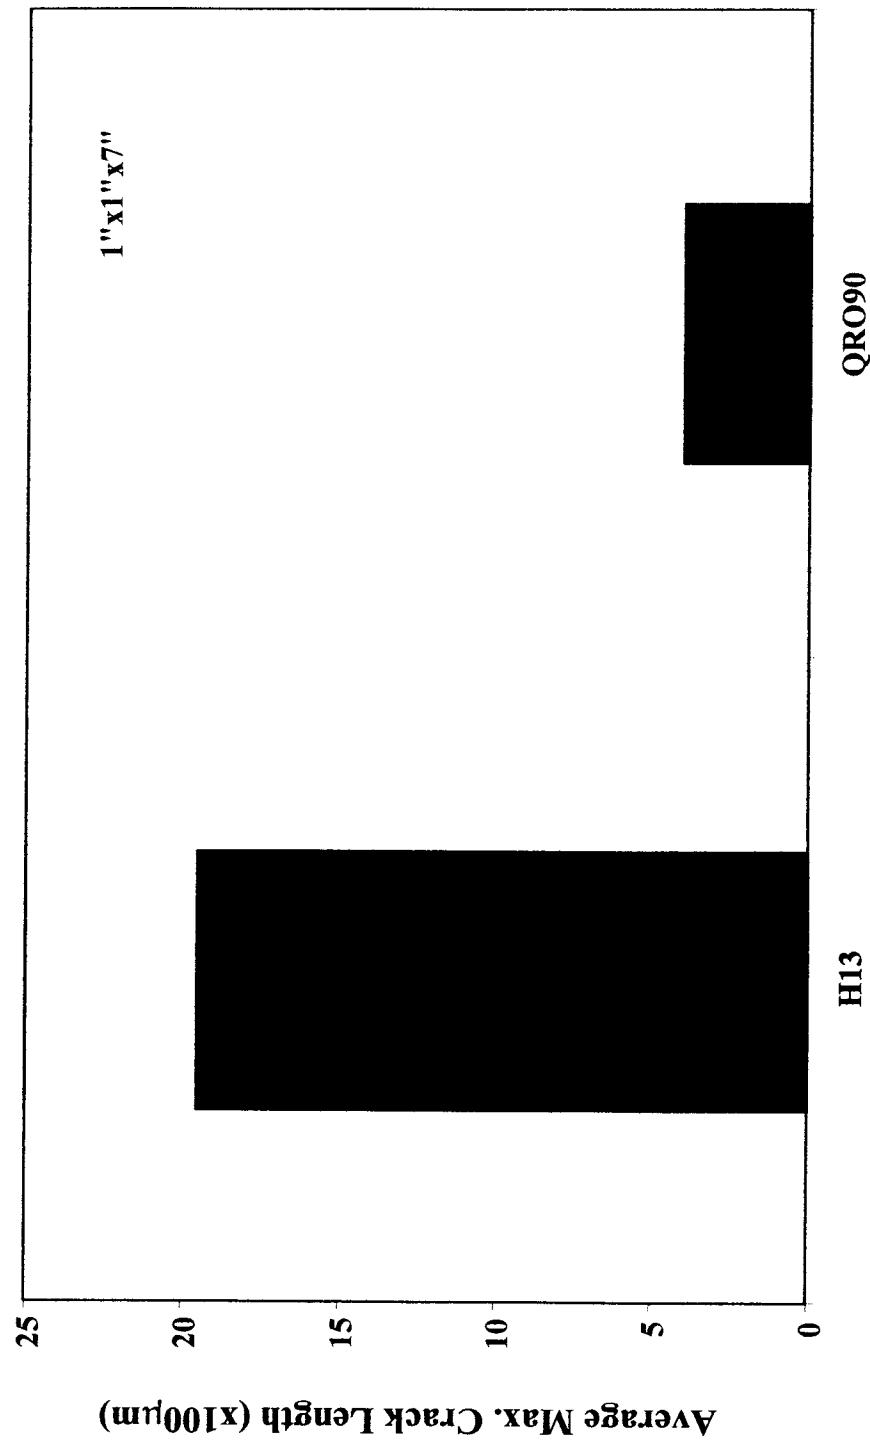
Fig.3.1(a) Average maximum crack length of Dievar,TQ1,RPU and H13 after 15,000 cycles for 2" x2" x7" specimens

Fig.3.1(b) Total crack area of Dievar, TQ1, RPU and H13 after 15,000 cycles for 2" x 2" x 7" specimens

average value of two specimens for each kind of steel. The average maximum crack length and total crack area of the five steels are shown in Fig. 3.1 and 3.2, respectively.

It is shown that Dievar, RPU and QRO90 have shorter average maximum crack length than H13. TQ1 has similar average maximum crack length to H13. They all have smaller total crack areas than H13, thus have better thermal fatigue resistance. Among the

Of the three steels, Dievar, TQ1, RPU, Dievar has the least maximum crack length, followed by RPU and TQ1. The maximum crack length of Dievar is ~55% shorter than that of H13, while that of RPU is ~45% shorter. Comparison of total crack areas of Dievar, TQ1, RPU and H13 shows the same trend. That is, Dievar has the smallest total crack area, followed by RPU, TQ1 and H13. The total crack areas of Dievar, RPU and TQ1 are ~70%, ~40% and ~8% smaller than that of H13.

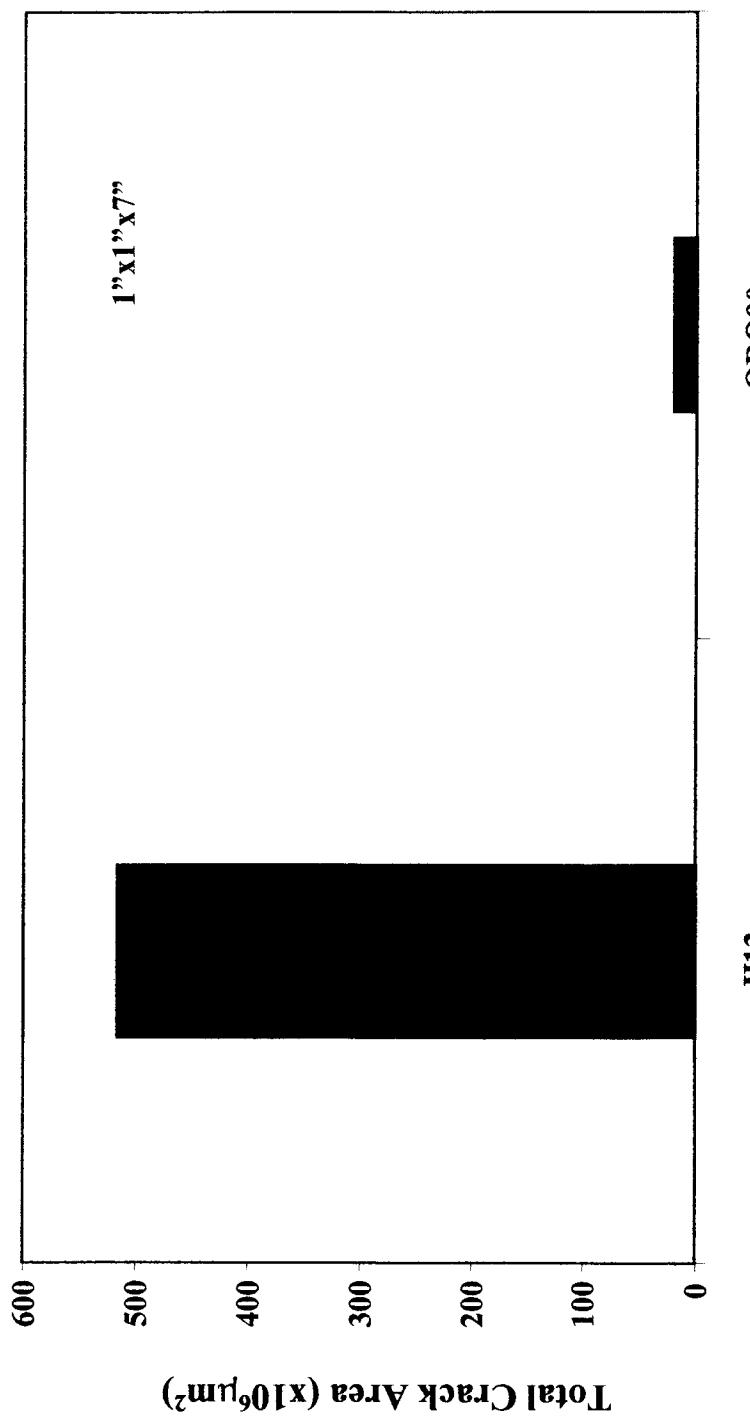
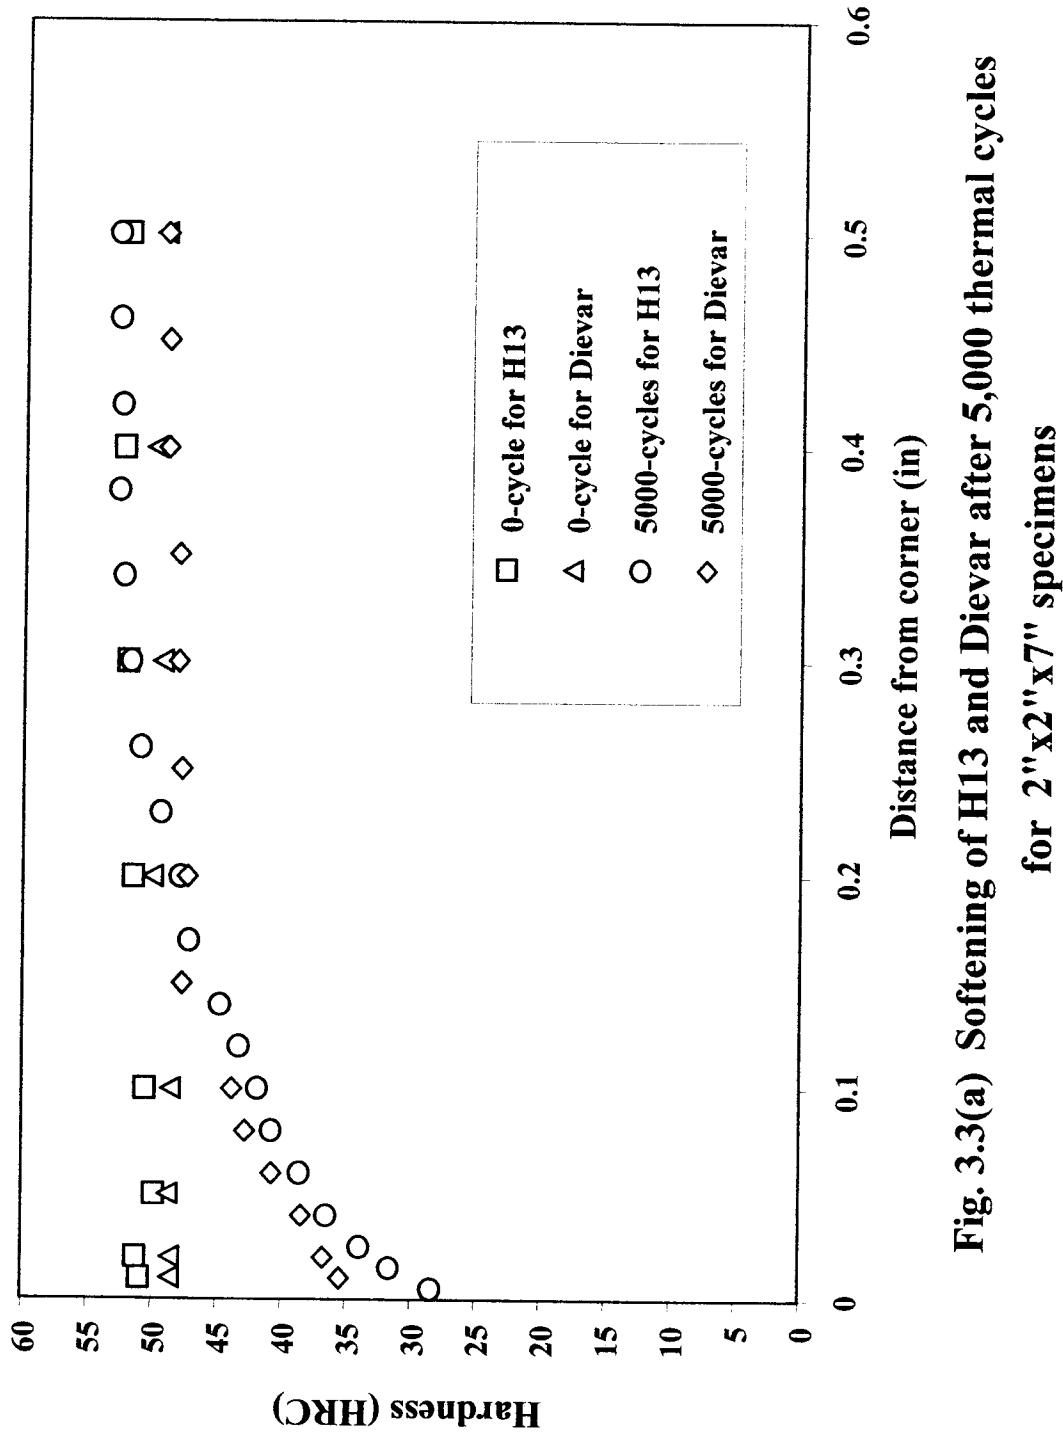
Fig.3.2(a) Average maximum crack length of QRO90 and H13 after 15,000 cycles for 1" x 1" x 7" specimens

Fig.3.2(b) Total crack area of QRO90 and H13 after 15,000 cycles for 1" x 1" x 7" specimens

The dimensions of the Dievar, TQ1 and RPU specimens are 2" x 2" x 7", while those of the QRO90 specimens are 1" x 1" x 7". H13 steel specimens are of both 1" x 1" x 7" and 2" x 2" x 7" dimensions. The average maximum crack length and total crack area of Dievar, TQ1 and RPU specimens are compared with 2" x 2" x 7" H13 steel and are shown in Fig. 3.1a and Fig. 3.1b, respectively. The properties of QRO90 are compared with those of 1" x 1" x 7" specimen of H13 and are shown in Fig. 3.2a and Fig. 3.2b, respectively.

Since the dimensions of QRO90 specimens are different from the Dievar, TQ1 and RPU, the thermal fatigue plots can not be compared directly. Fig.3.2a,b shows the total crack area and maximum crack length of QRO90 and H13. Both are much smaller for QRO90 than H13 when the same dimensions of the specimen are employed. QRO90 therefore has considerably better thermal fatigue resistance than H13.

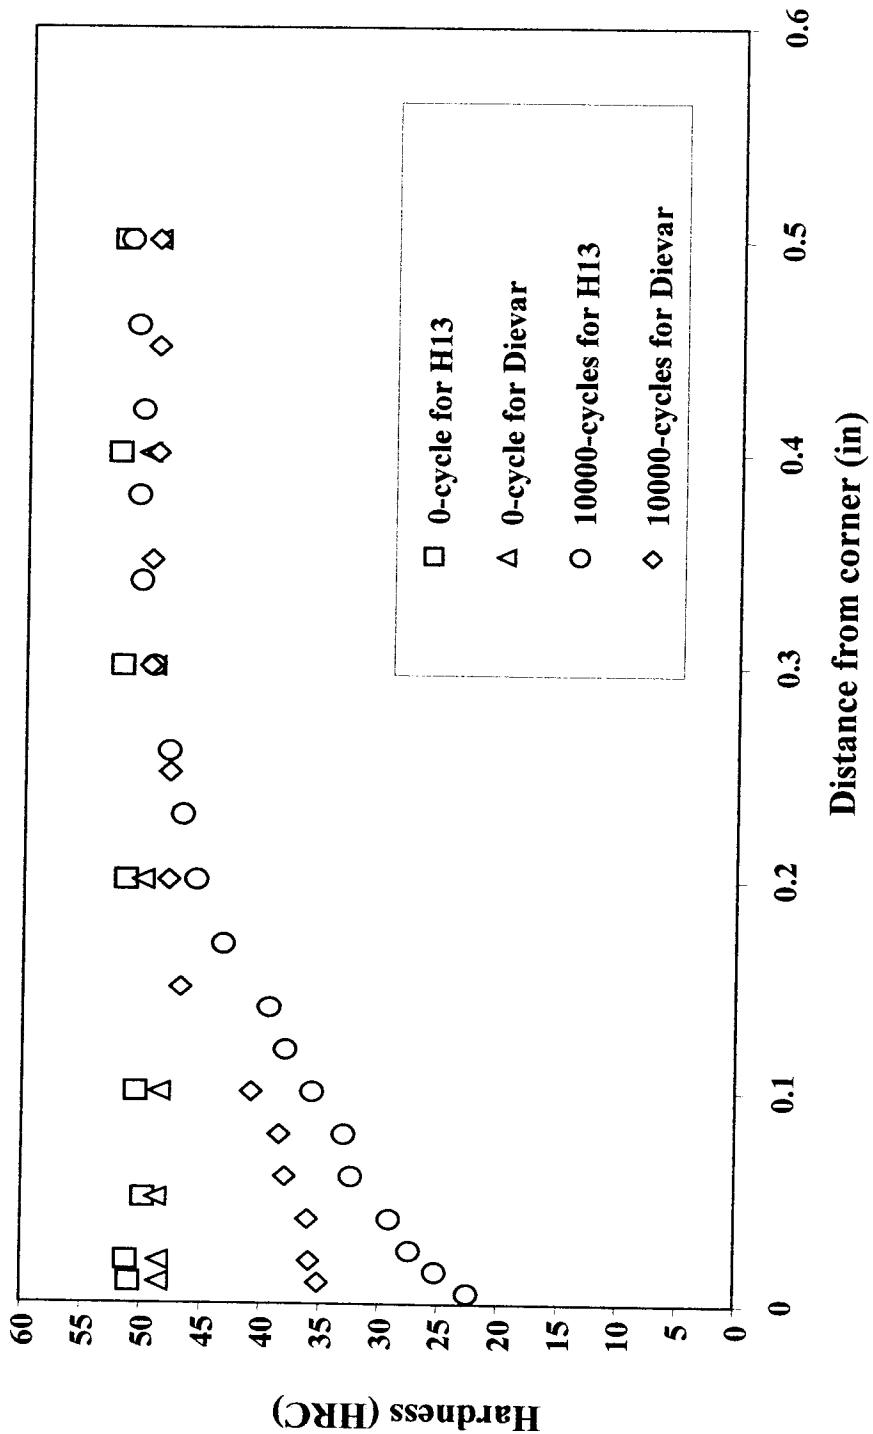
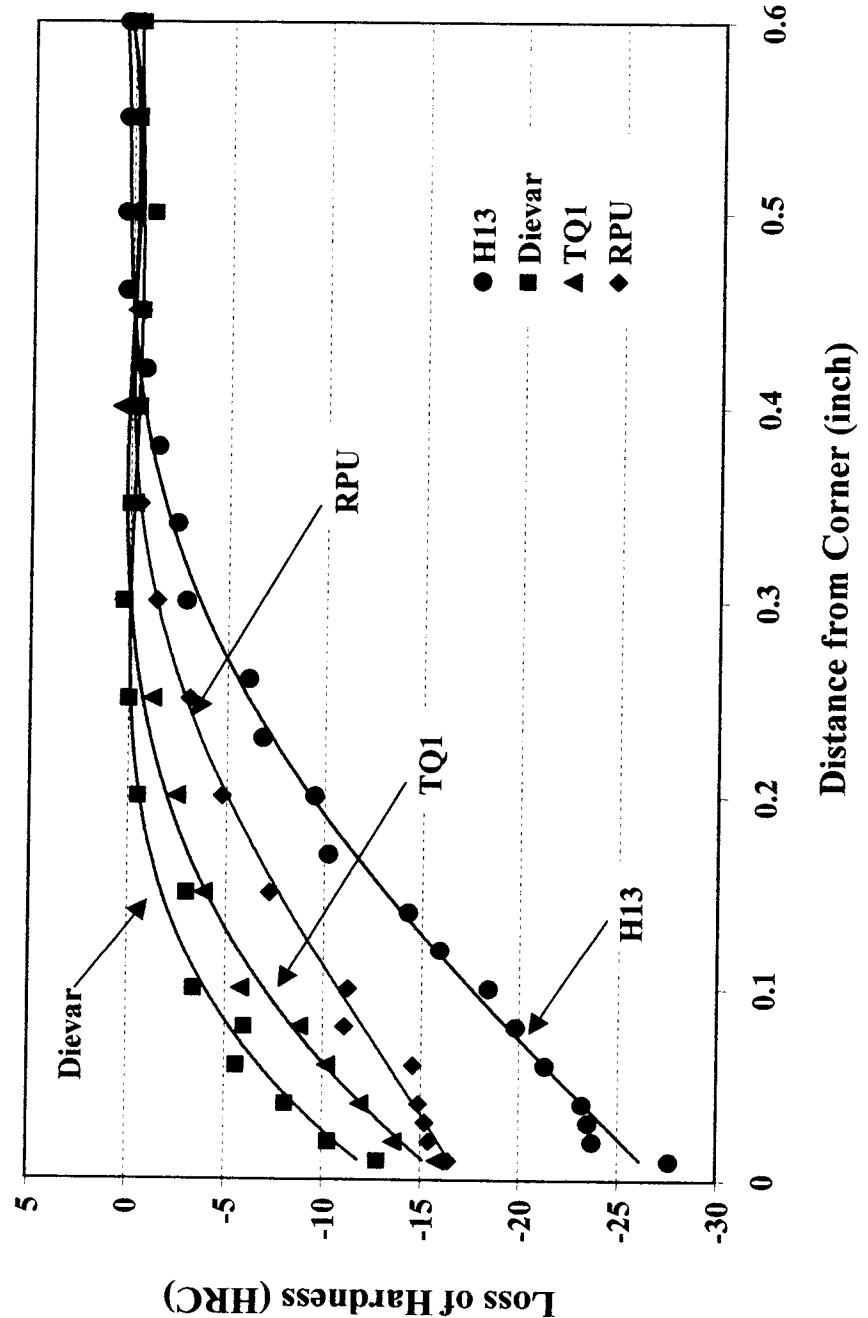
Fig. 3.3(a) Softening of H13 and Dievar after 5,000 thermal cycles for 2" x 2" x 7" specimens

Fig. 3.3(b) Softening of H13 and Dievar after 10,000 thermal cycles for 2" x 2" x 7" specimens

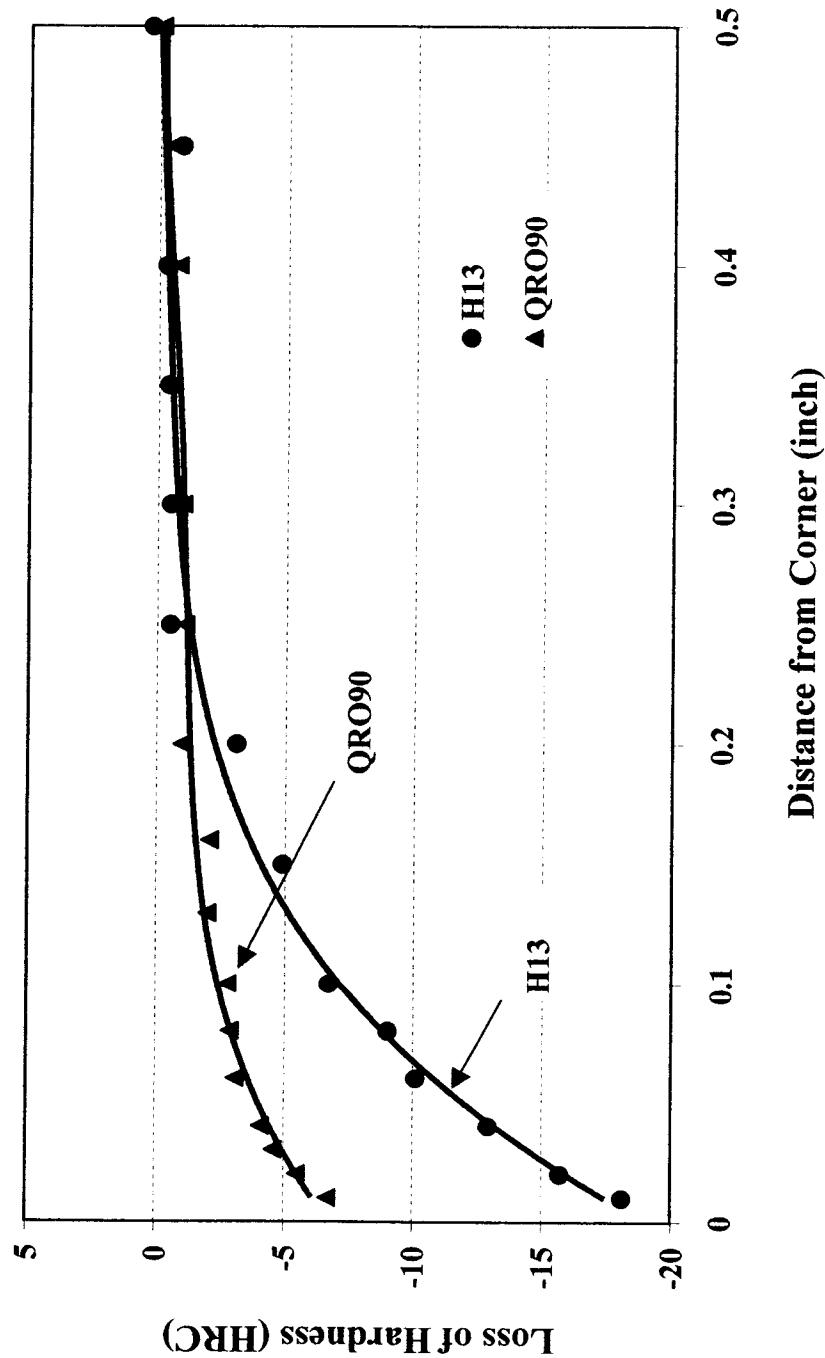
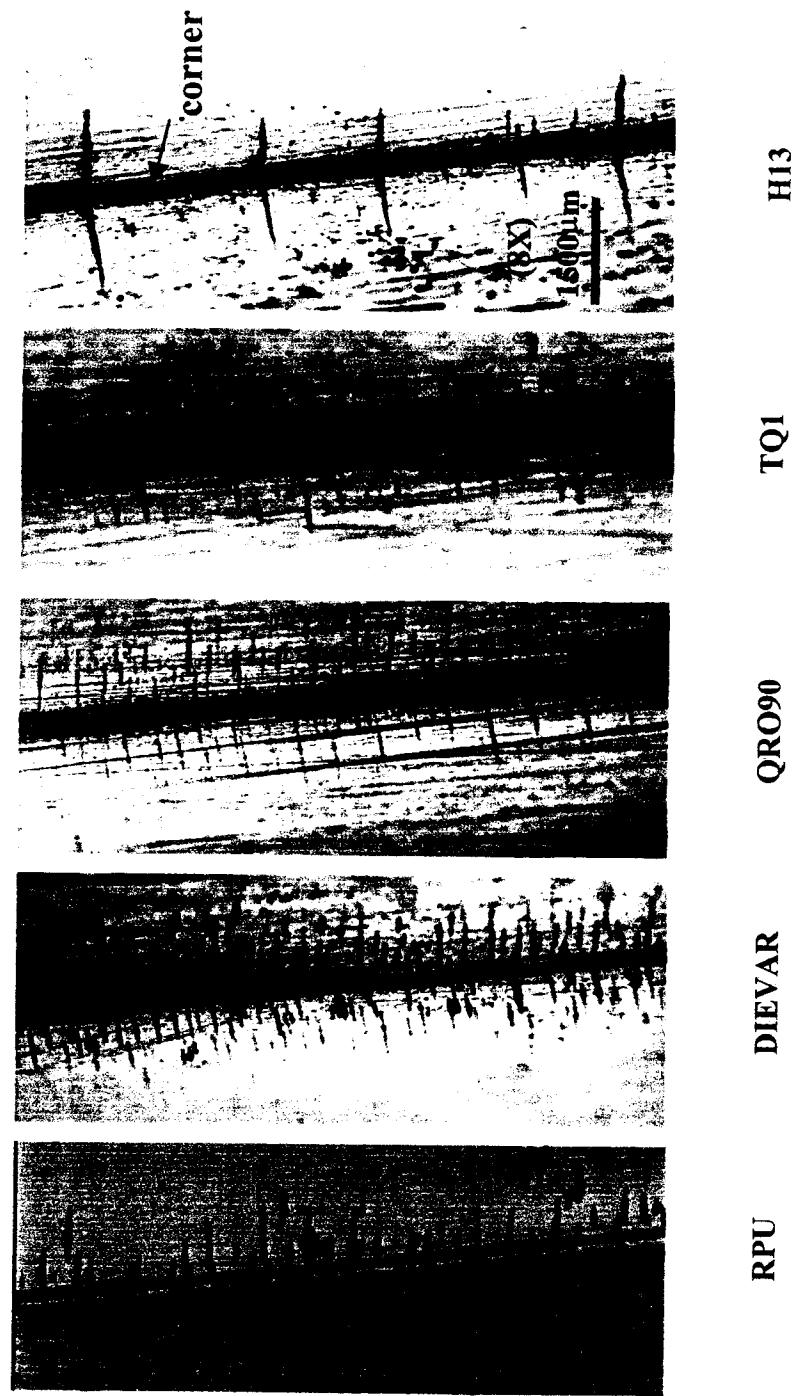
Fig. 3.4(a) Softening of Dievar, TQ1, RPU and H13 after 15,000 thermal cycles for 2" x 2" x 7" specimens

Fig.3.4(b) Softening of QRO90 and H13 after 15,000 thermal cycles for 1" x 1" x 7" specimens

Thus for 2" x 2" x 7" specimens, the tempering resistance of Dievar is the best, while that of H13 the worst, which is consistent with the thermal fatigue properties as measured by the immersion test. The tempering resistance and thermal fatigue properties for RPU and TQ1 are inconsistent, which is not unusual as crack initiation and propagation are complicated processes and microhardness is not the only parameter that controls the length and density of cracks in steels at elevated temperature.

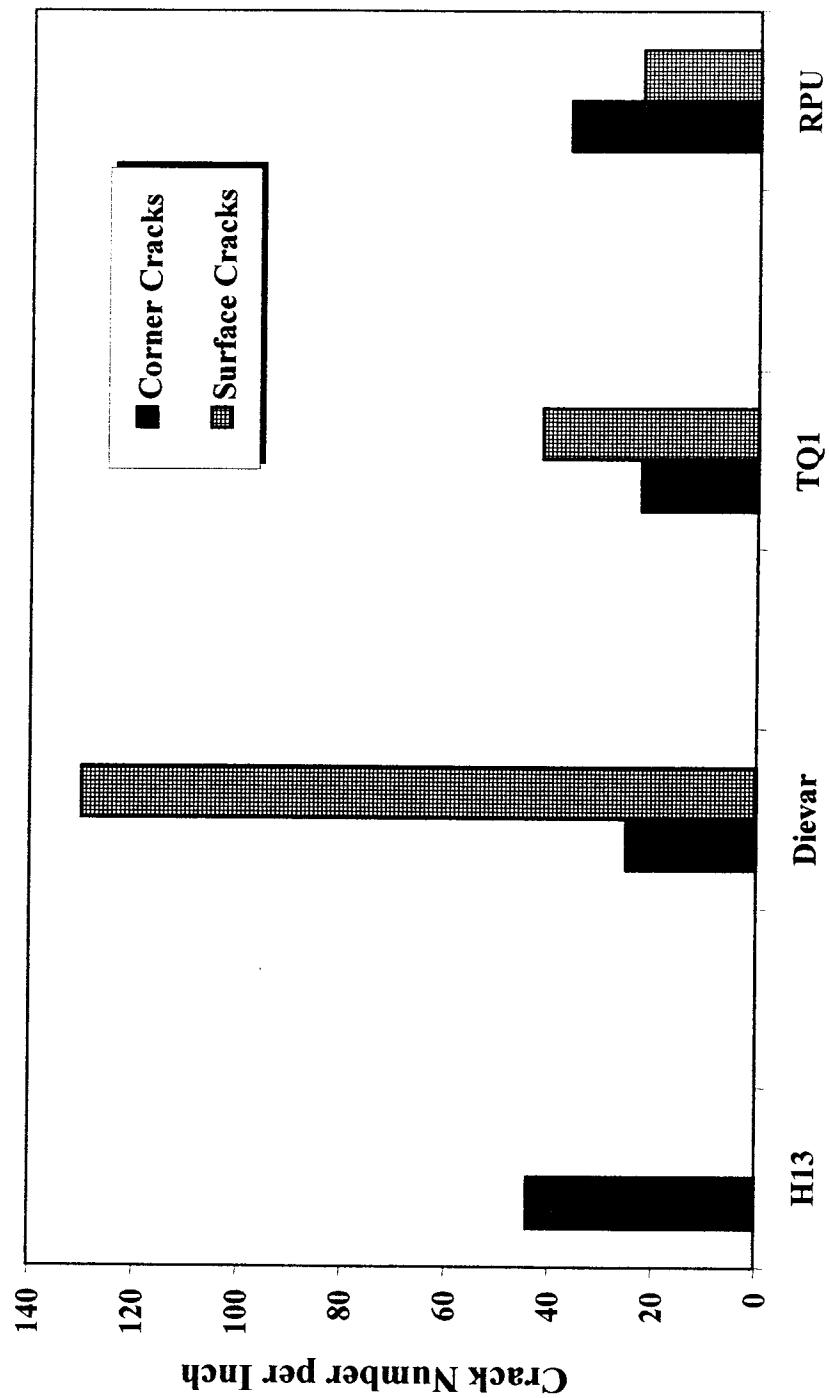
Fig.3.5 Thermal fatigue cracks in five die steels after 15,000 thermal cycles

Fig. 3.5 illustrates the appearance the thermal fatigue crack patterns of RPU, Dievar, QRO90, TQ1 and H13 after 15,000 cycles. The crack pattern for H13 is characterized by cracks that generally reach the corners of the specimen. Most of the cracks are cut-through-corner cracks (these cracks are called corner cracks). The crack patterns of the other four steels are different. Some corner cracks coexist with shallow

cracks distributed near the corner of the specimens at rather high density (such cracks are known as surface cracks). Surface cracks are numerous and shallow. Corner cracks of these four steels are shorter than those of H13.

As the corners of the specimens were under the highest stress condition, the corner cracks probably initiate from the corner and propagate towards the direction away from the specimen corner. The initiation source of surface cracks is not clear. It appears that their distribution is related to the location of corner cracks. The density of surface cracks is always low when the incidence that of corner cracks is high. For example, H13 has very little surface cracks, but a lot of corner cracks. Dievar steel has extensive surface cracks, but only a few corner cracks.

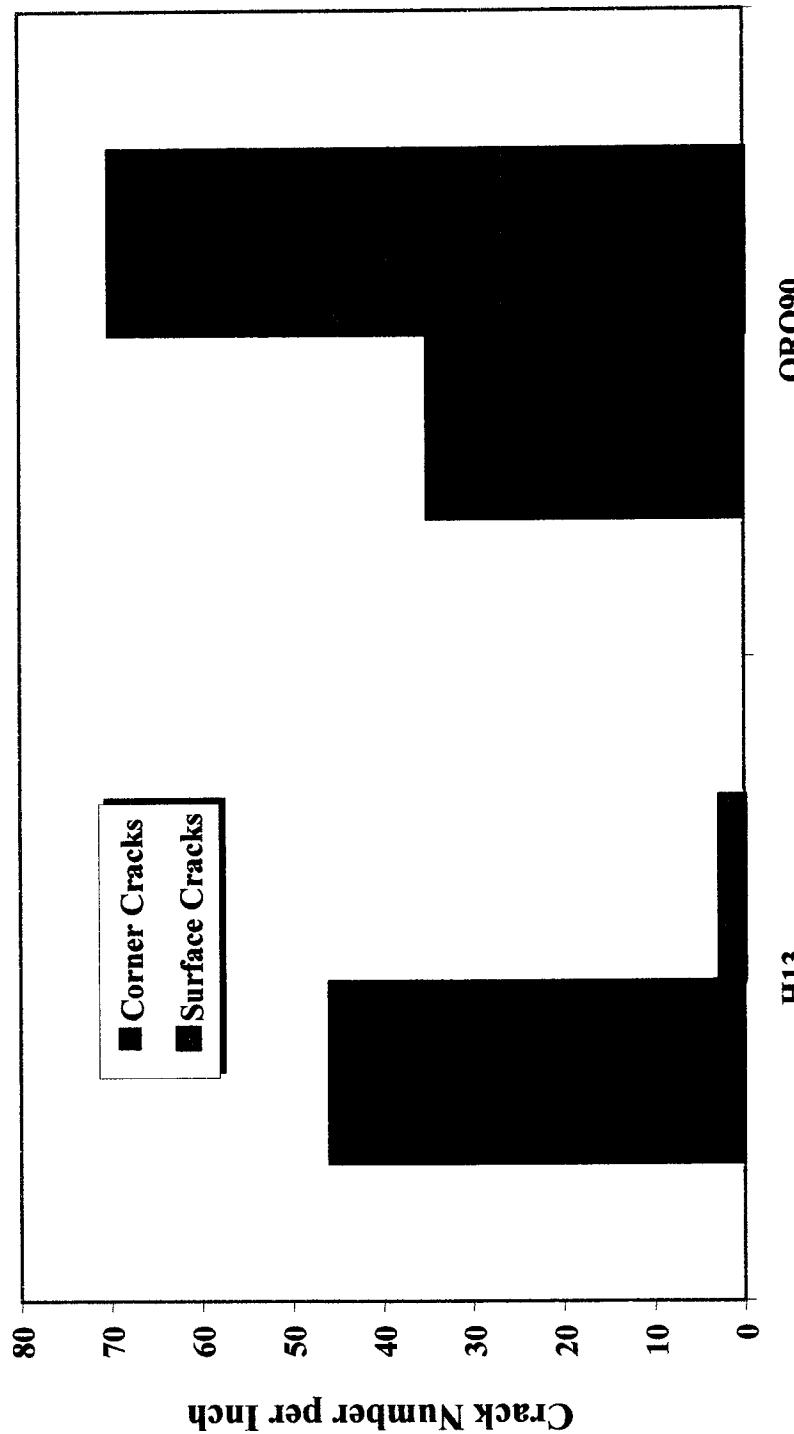
Fig. 3.6(a) Crack number of Dievar, TQ1, RPU and H13 after 15,000 thermal cycles for 2" x 2" x 7" specimens

Fig. 3.6(b) Crack number of QR090 and H13 after 15,000 thermal cycles for 2" x 2" x 7" specimens

The distribution of corner cracks and surface cracks in the five steels is expressed as crack number per inch in Fig. 3.6. The results from RPU, Dievar, and TQ1 are compared with the 2"x2"x7" H13 steel specimen and are shown in Fig. 3.6a; that of QRO90 is compared with a 1"x1"x7" specimen of H13 and shown in Fig. 3.6b. Among RPU, Dievar, TQ1 and H13, the density of surface crack of Dievar is the highest, followed by TQ1, RPU and lastly H13. The density of corner cracks is in decreasing order: RPU (~80% of that for H13), Dievar (~60% of that for H13) and TQ1 (~55% of that for H13). In QRO90 the corner crack density is 74% less than in a 1"x1"x7" H13 specimen and a considerably higher surface crack density than that of H13.

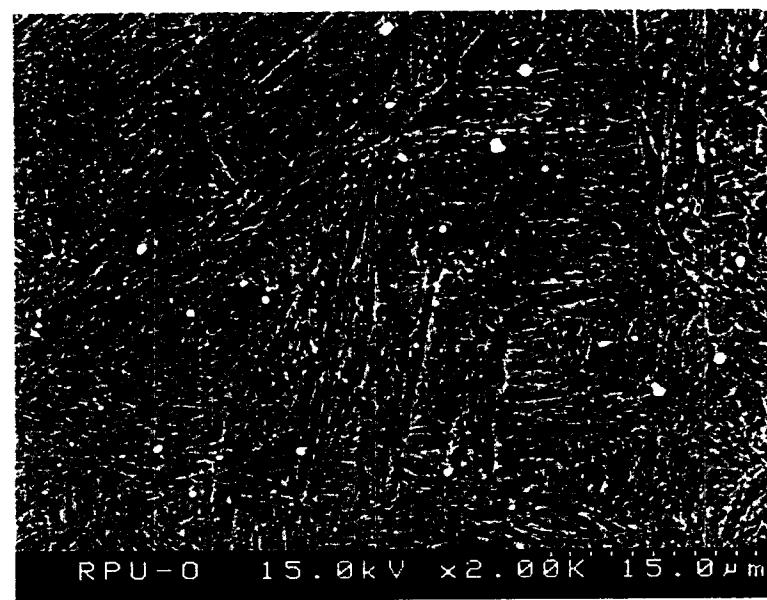
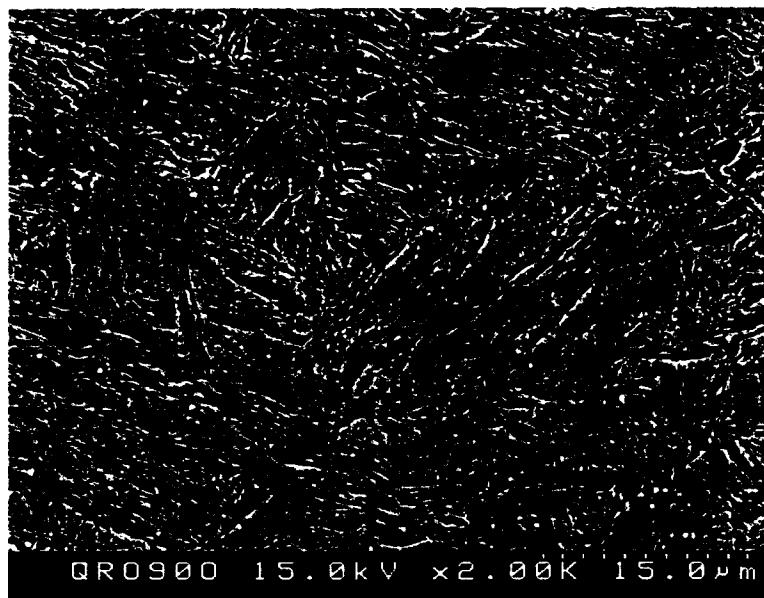
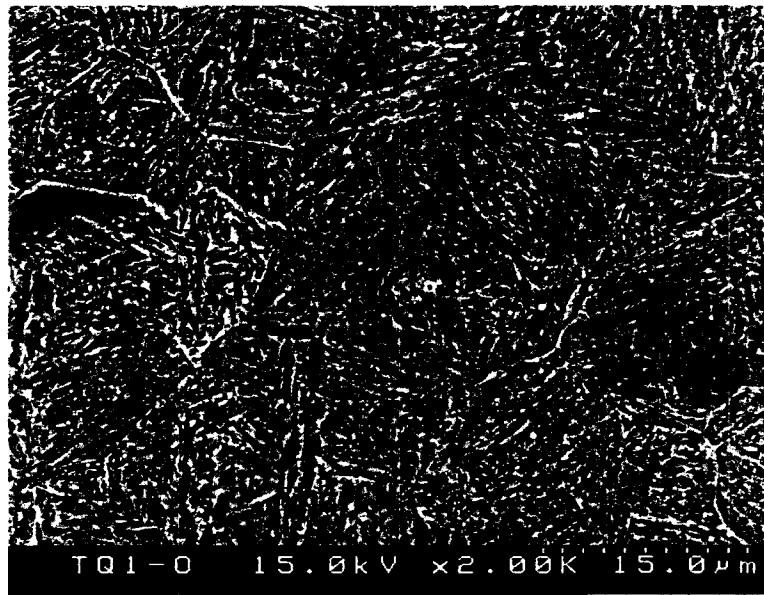
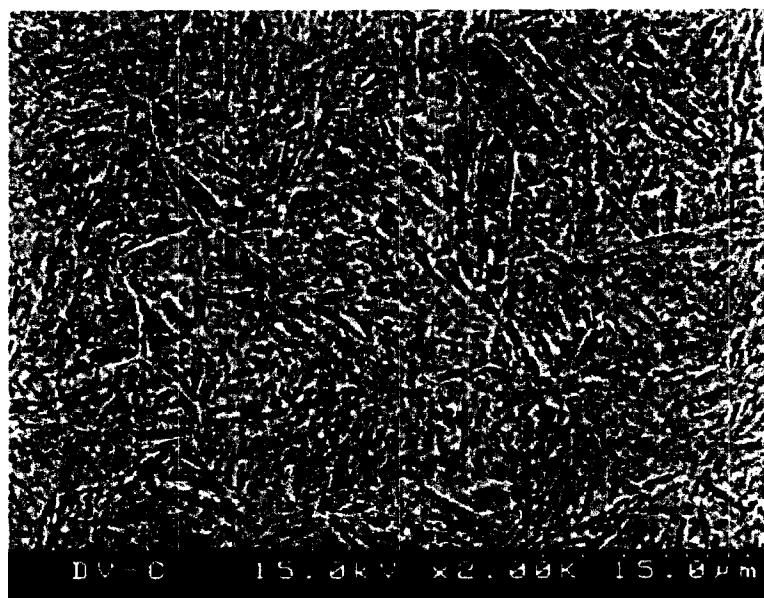
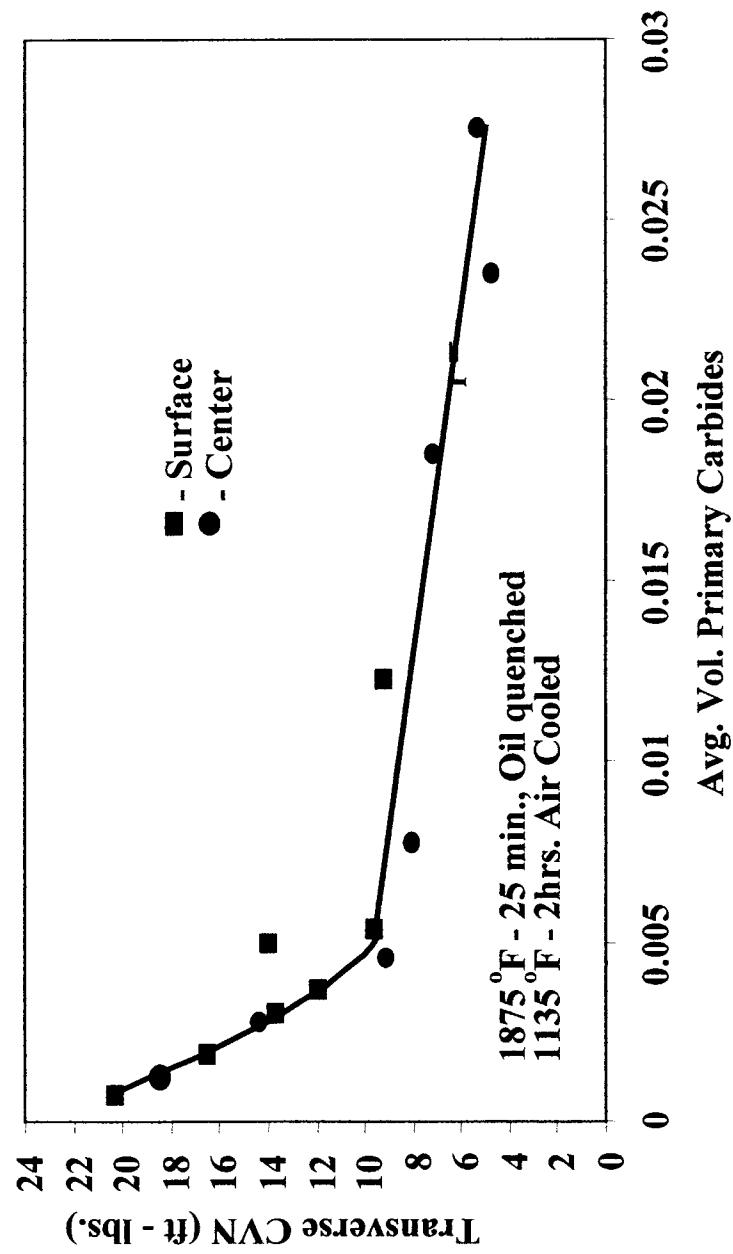
Fig. 3.8(a) Micrograph of the microstructure of H13, as quenched

Fig.3.8(b) Micrograph of the microstructure of RPU, as quenched

Fig. 3.8(c) Micrograph of microstructure of QRO90, as quenched

Fig.3.8(d) Micrograph of microstructure of TQ1, as quenched

**Fig.3.8(e) Micrograph of the microstructure of Dievar,
as quenched**

The mechanical properties of materials are affected by their microstructure [30-33]. To understand the contribution of the microstructures of the five steels to their thermal fatigue resistance, the microstructures of these five steels in as quenched condition were examined under scanning electron microscope. The results are shown in Figure 3.8.

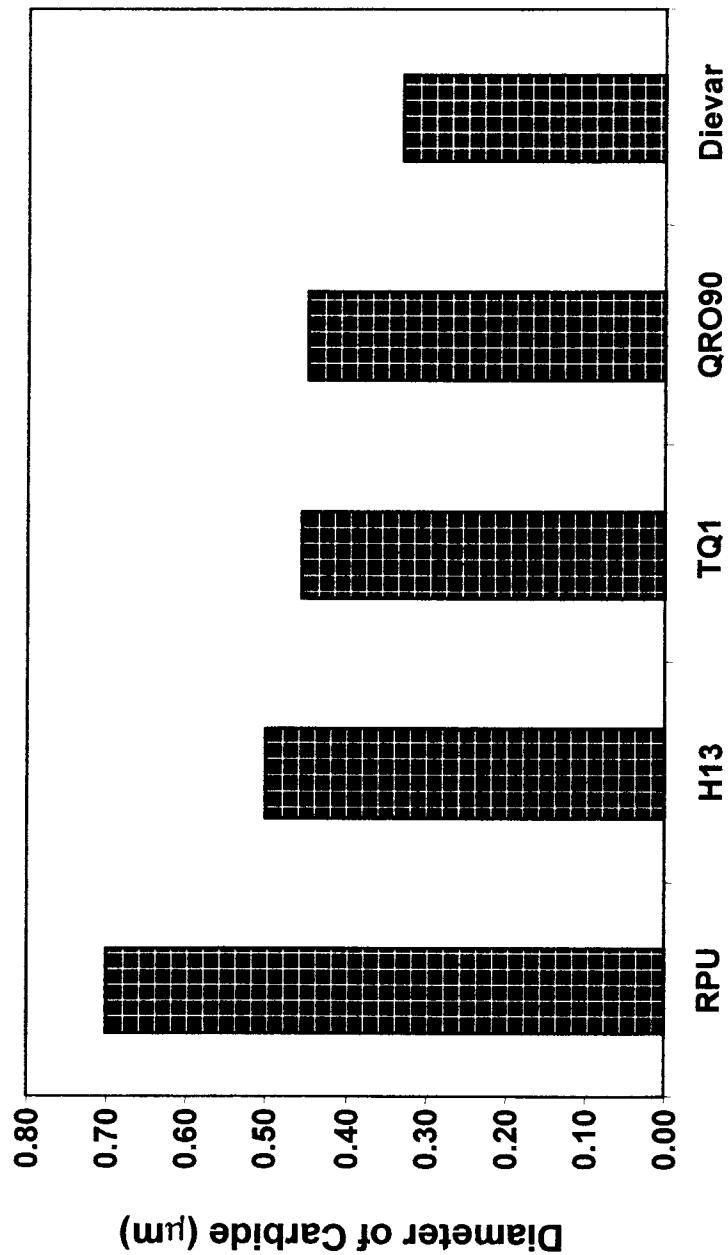
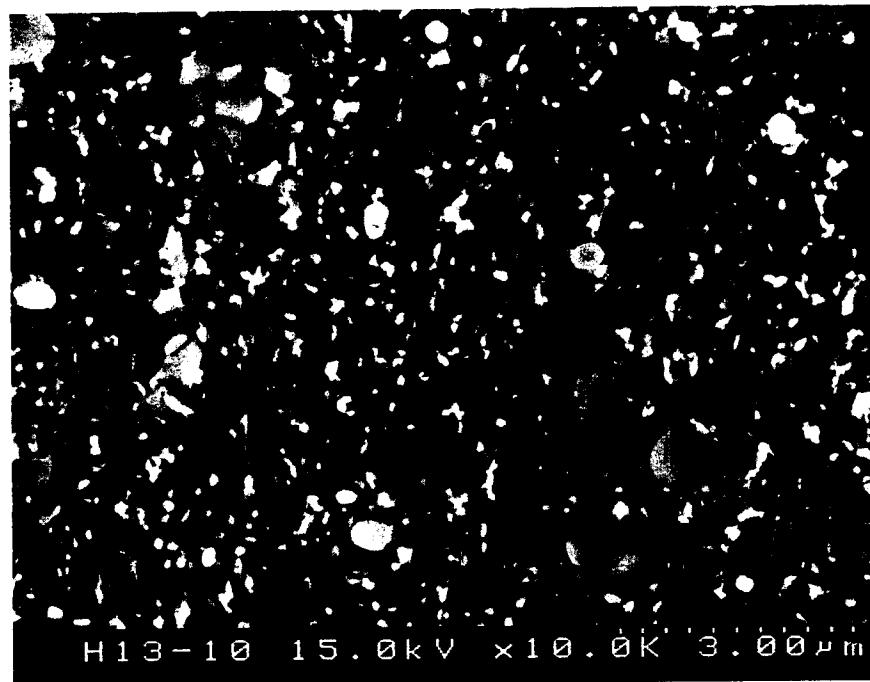
Fig.3.10 Carbide number in five steels as quenched conditions

Fig. 3.11 Carbide size in five steels as quenched conditions

Quantitative information on the carbides in the as quenched condition is shown in Fig. 3.10 and 3.11.

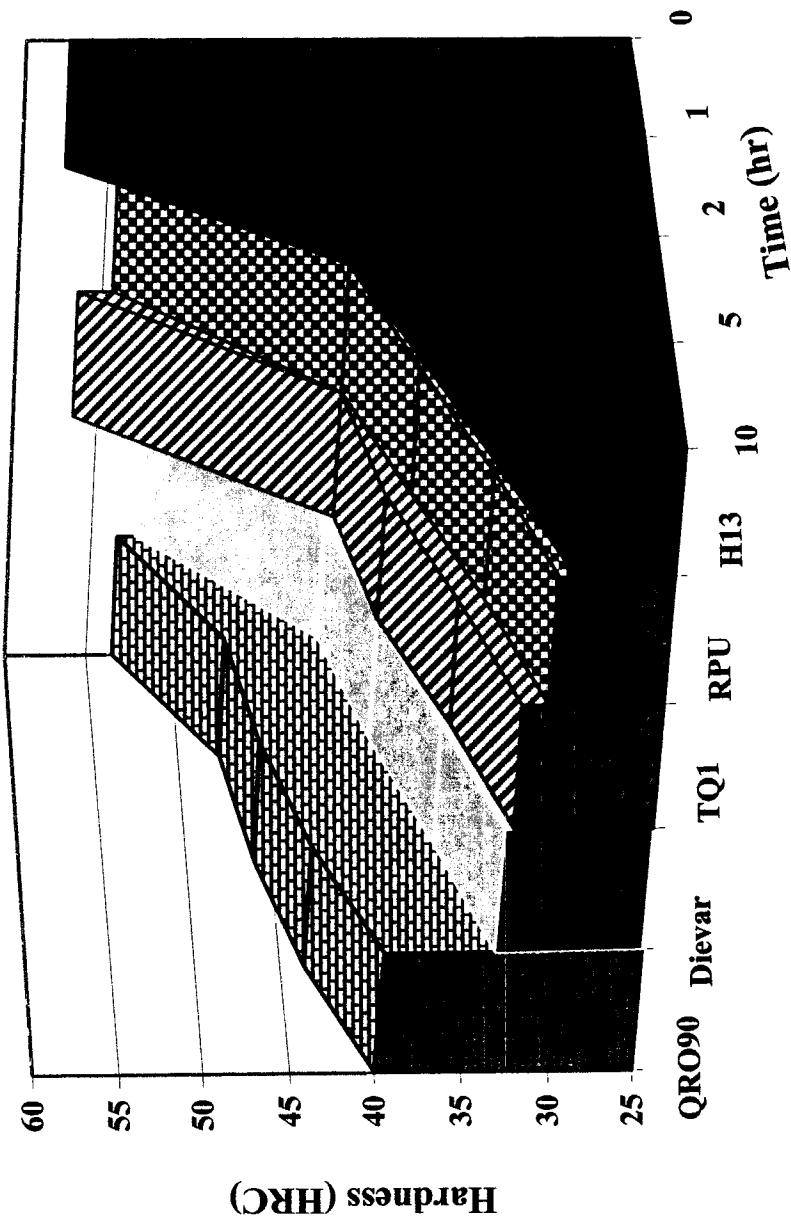
Fig .3 . 13 Effect of tempering time on the hardness of five steels
