OPTIMIZATION OF COMPOSITION AND HEAT TREATING OF DIE STEELS FOR EXTENDED LIFETIME

Case Western Reserve University

January 2002

Work Performed Under Contract DE-FC07-00ID13847

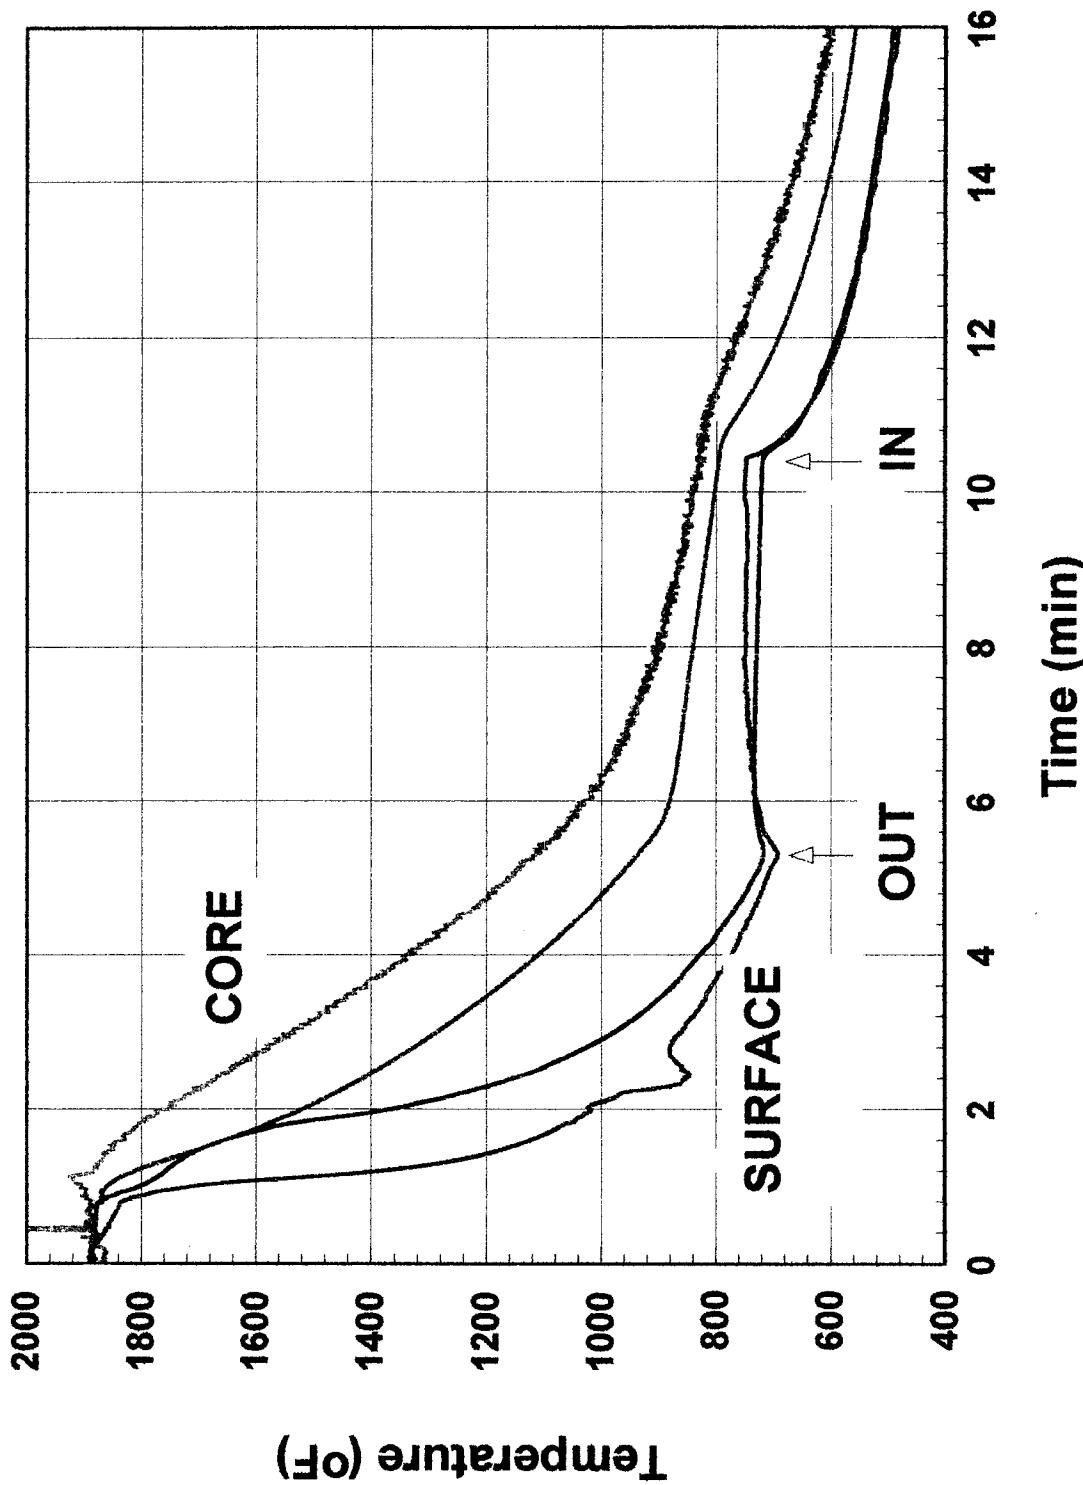
Figure 6.1

Die 4 on Quenching Fixture at Euclid H.T.

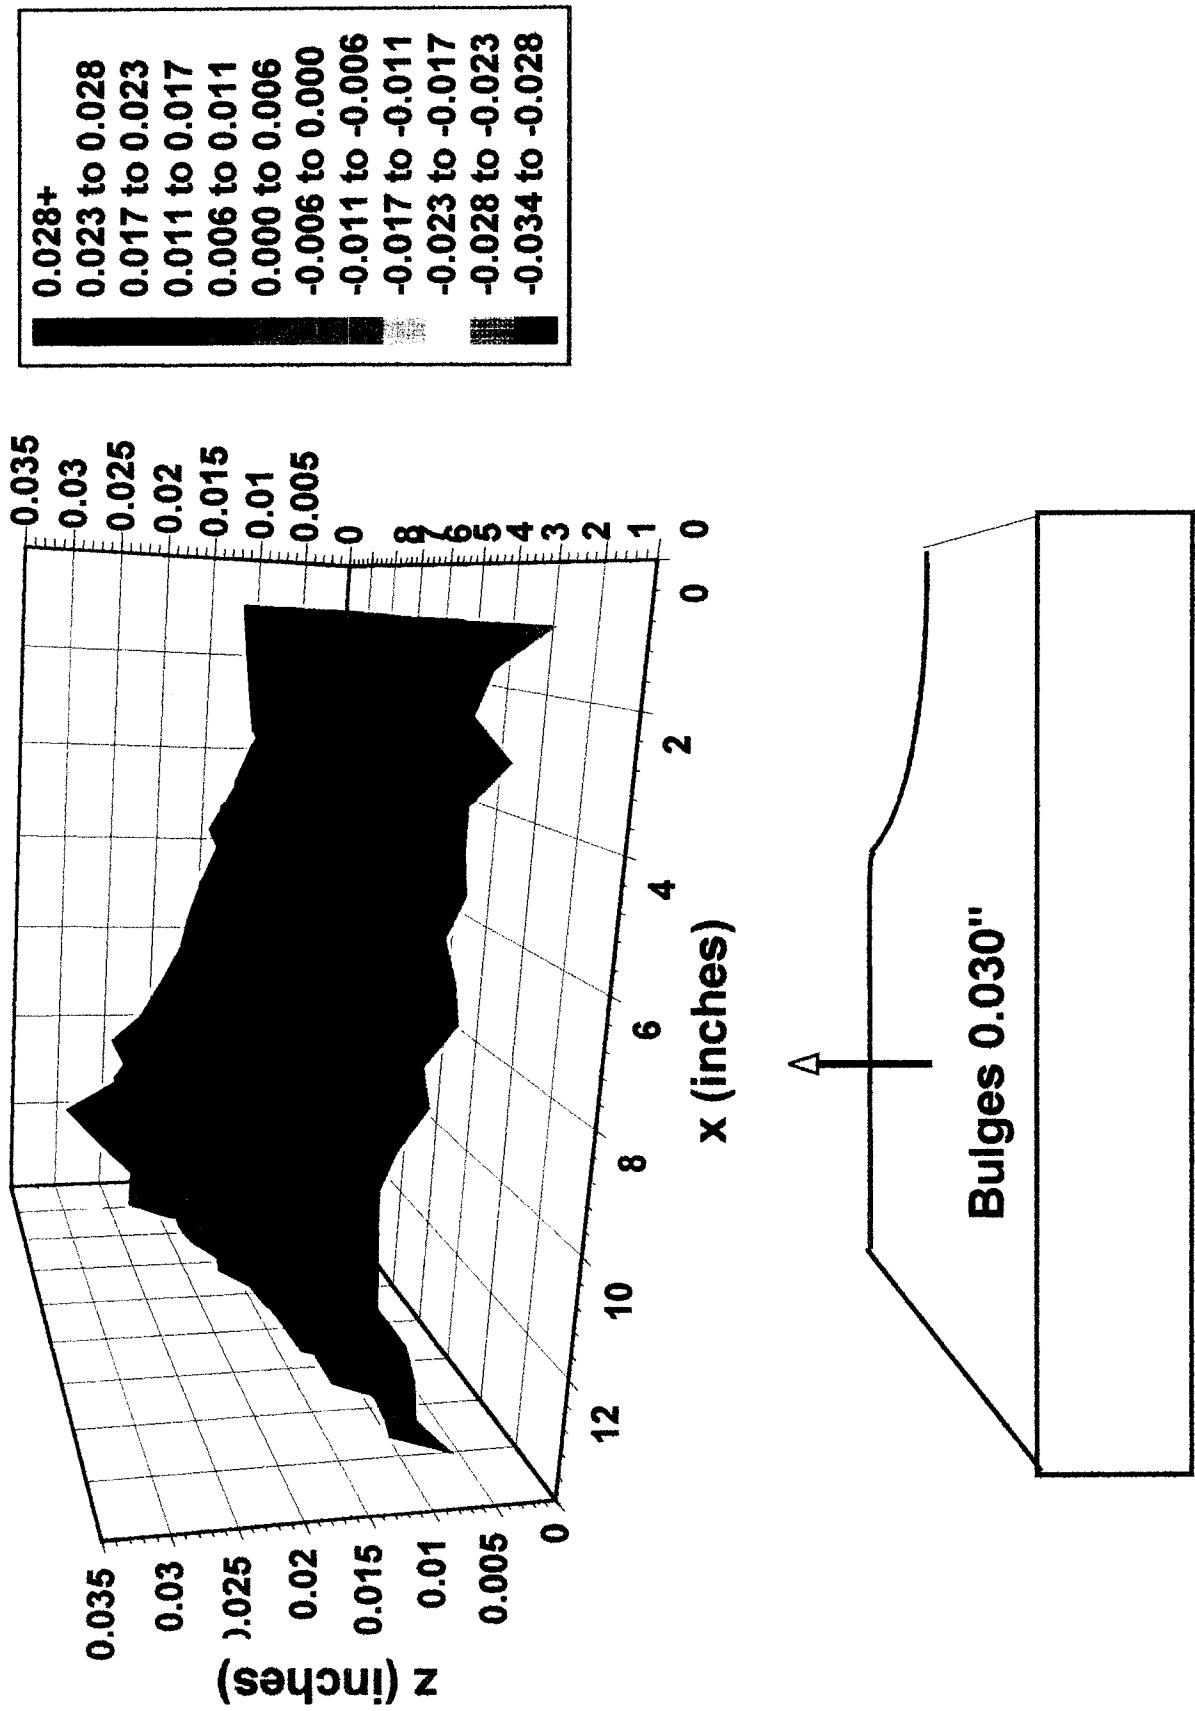
Figure 6.2:

INTERRUPTED OIL QUENCH OF DIE #4 AT EUCLID HEAT TREATING

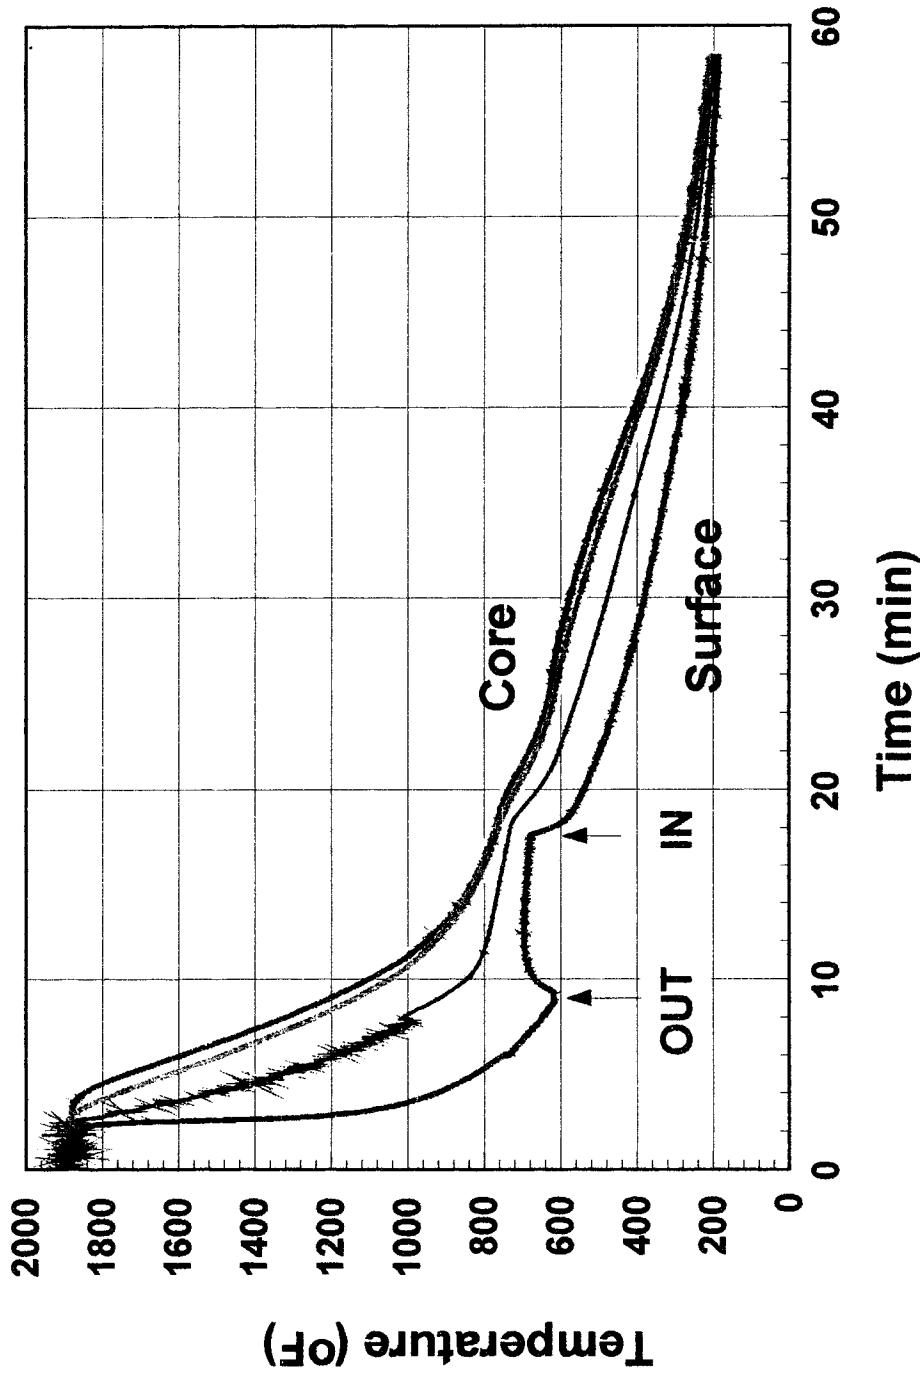
Figure 6.13:

Die 7 (14.6"x7.9"x7.75") - Interrupted Oil Quench @ EHT

Cooling rate measured by the surface (1/8") thermocouple at the center of the largest face between 1750°F to 615°F is 1770F/min.

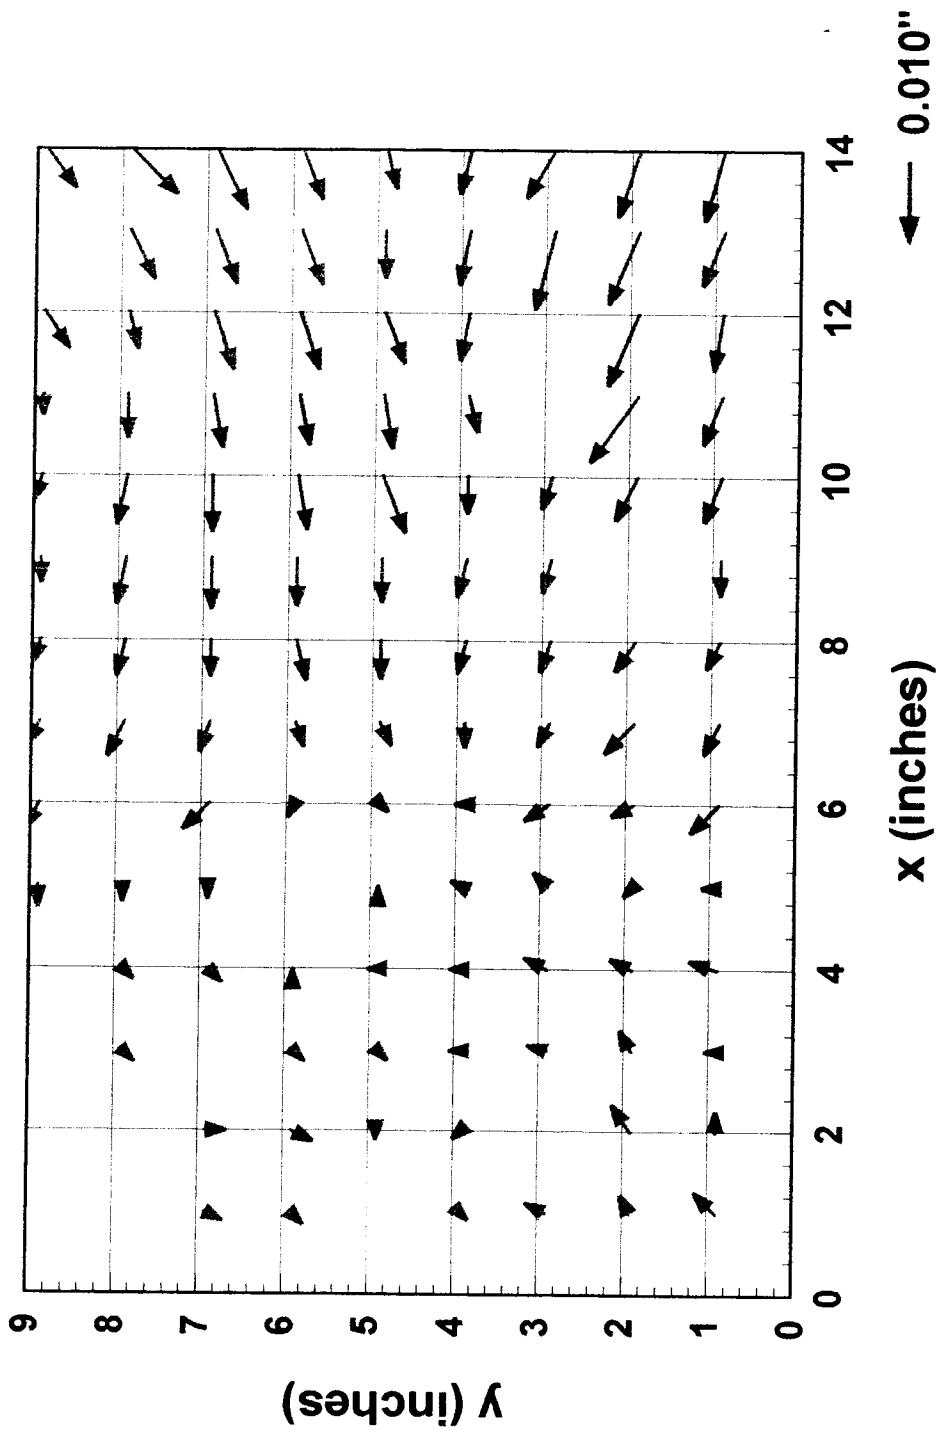
Figure 6.15: **Vector Plot of Side 1 - Die 7
Interrupted Oil Quench at EHT**

Shows the direction and magnitude of the X-Y move for every point on side 1 of the die as a result of the quench. This face of the die became 0.013" shorter (0.1%) than before the quench.

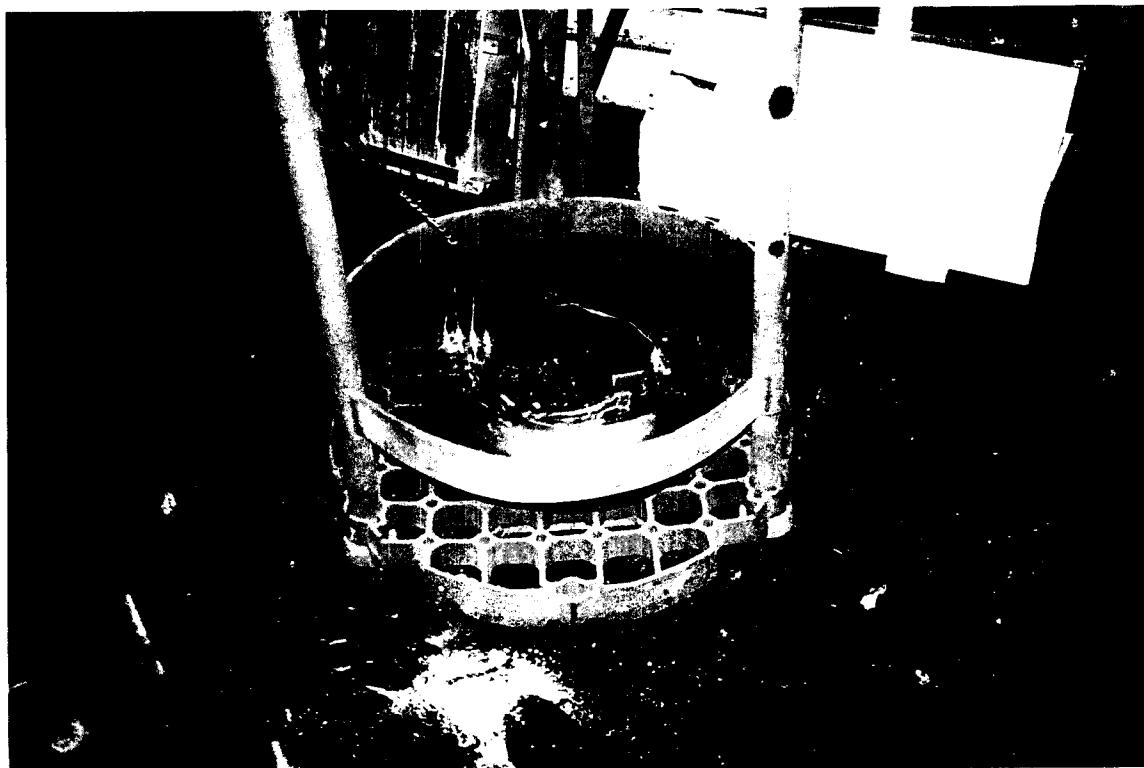
Figure 6.17:

Oil Quench of Die 8 @ EHT

This insert as shown in Figure 6.16 has the shape of a doughnut. It is about 20 inches in diameter and 8 inches thick. It was milled before heat treatment to remove a gross crack thus creating a one inch wide slot. All the other welded areas and details were left in place. The insert also had multiple water lines, through holes and threaded blind holes. A radial grid of 1/8" diameter, 1/8" deep holes was drilled for distortion measurements before heat treatment. The die was positioned on the flat bottom side in the quenching basket. The cooling curves during quenching are shown in Figure 6.17. This die cracked during the quench. No further analysis was conducted.

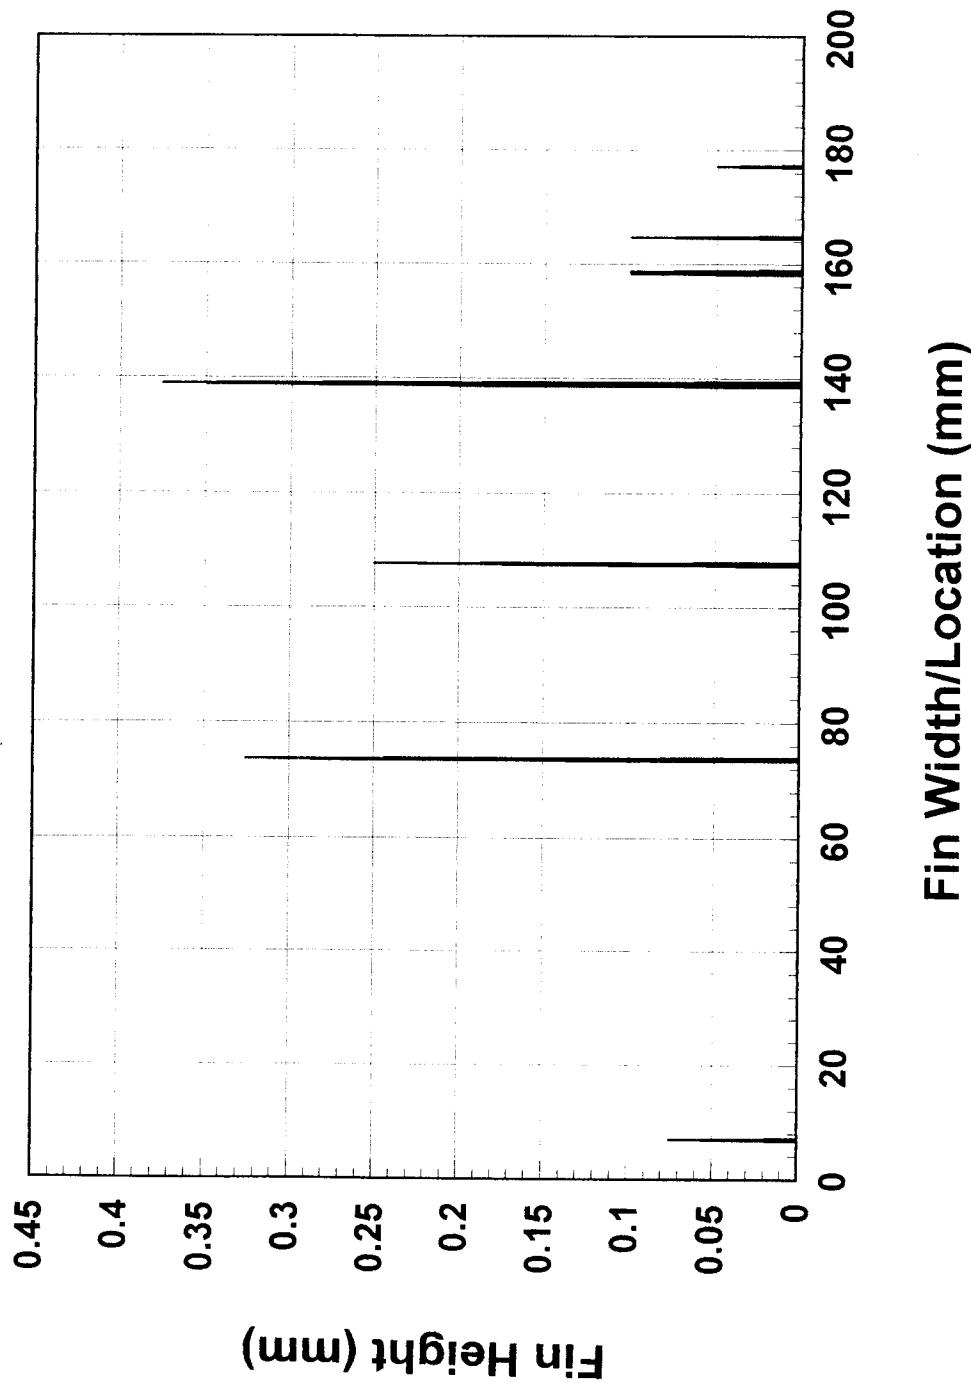
Figure 7.8:

#29 AFTER 59,000 SHOTS - FIN SIZE/LOCATION

Total fin area in ROI = 0.485 sq.mm

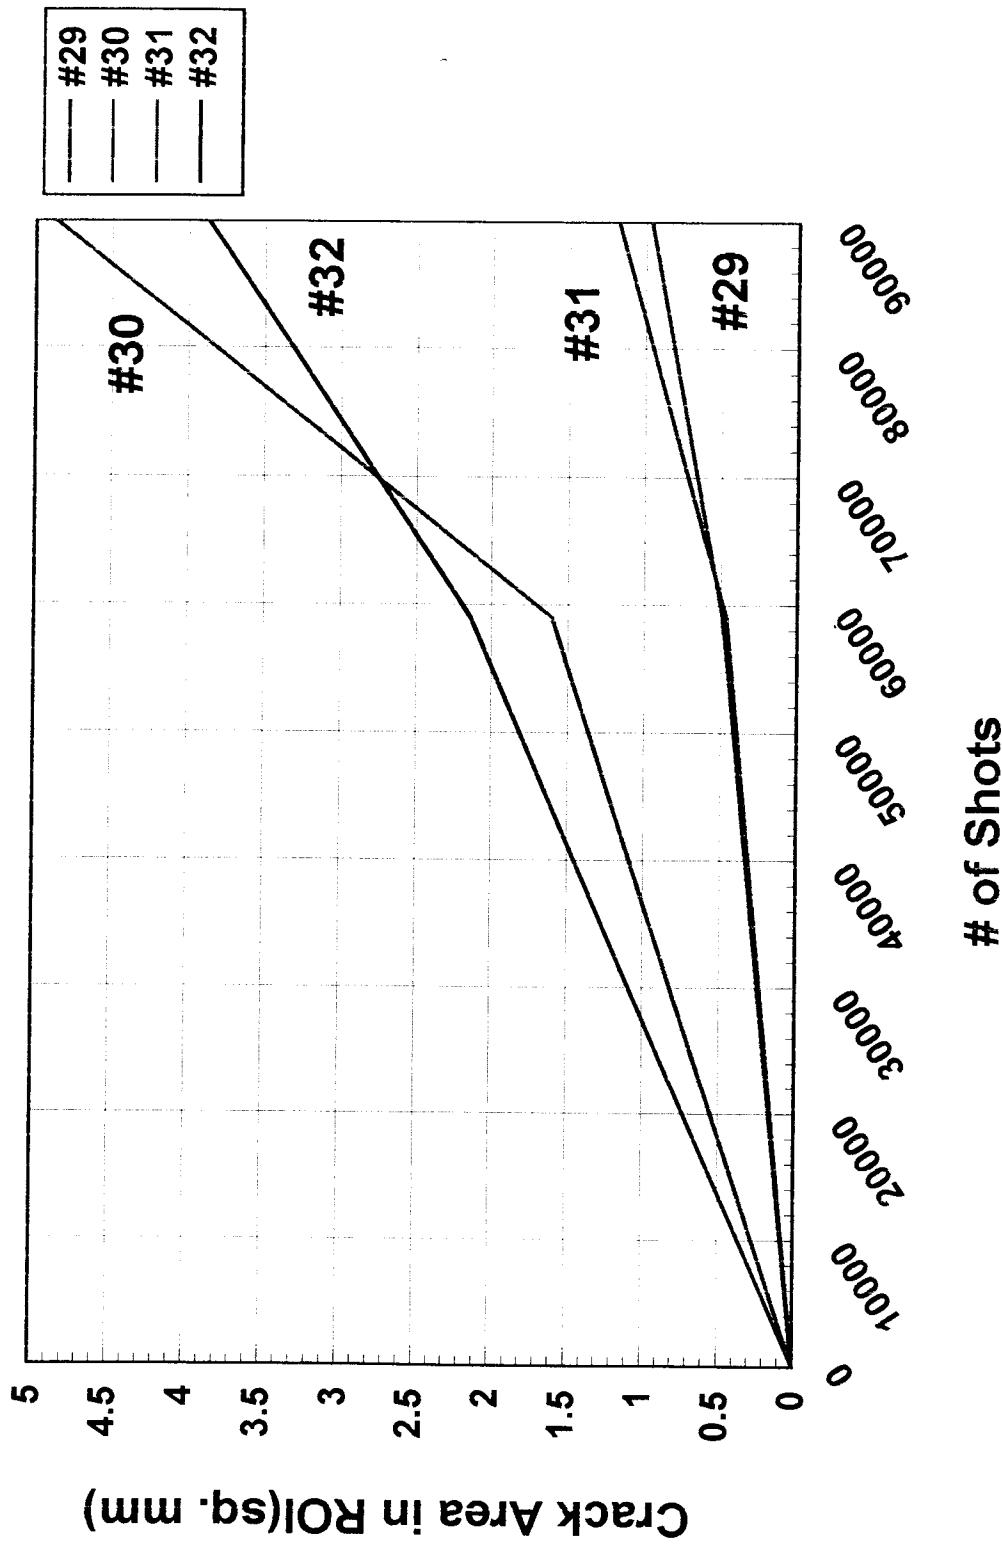
Figure 7.9:

Crack Area in the Region of Interest of a Four Cavity Die: #29, #30, #31, #32

Note: Crack area was measured by profilometry on castings sampled randomly after 59,000 and 90,000 shots
