Nevada
Environmental
Restoration
Project

DOE/NV--745

Streamlined Approach for
Environmental Restoration Plan
for Corrective Action Unit 330:
Areas 6, 22, and 23 Tanks and
Spill Sites, Nevada Test Site,
Nevada

August 2001

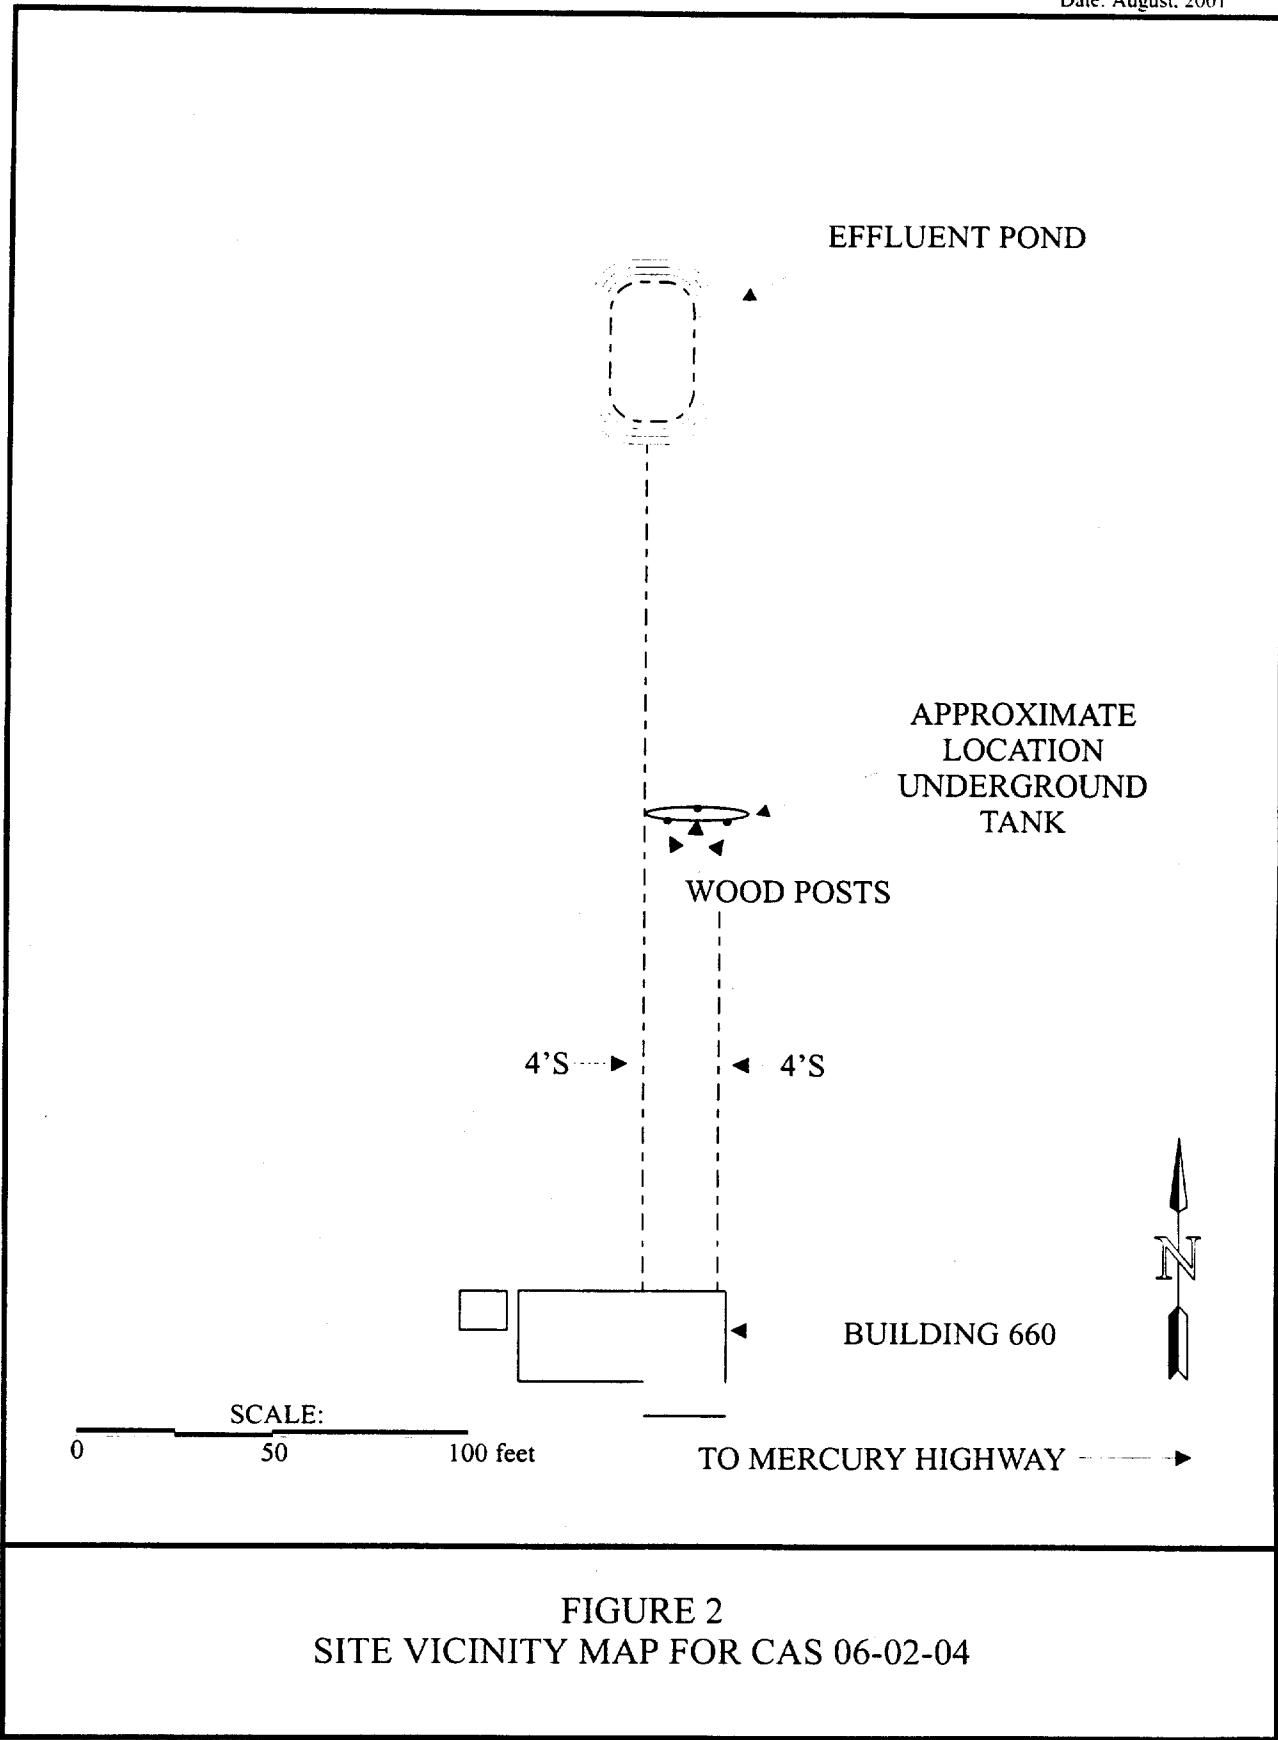
FIGURE 2
SITE VICINITY MAP FOR CAS 06-02-04

CAU 330 is located on the NTS. CAS 06-02-04 is located approximately 140 ft north of Building 600 in the Area 6 Well 3 Yard (Figure 2). CAS 22-99-06 is located approximately 150 ft north-northwest of the barricade on Camp Desert Rock Road, on the west side of the Building T-1001 concrete foundation in Area 22 (Figure 3). CAS 23-01-02 is located in Area 23, west of the intersection of the Mercury Bypass and Jackass Flats Roads on the south side of Jackass Flats Road (Figure 4). CAS 23-25-05 is located north of Building 160 in Area 23 (Figure 5).

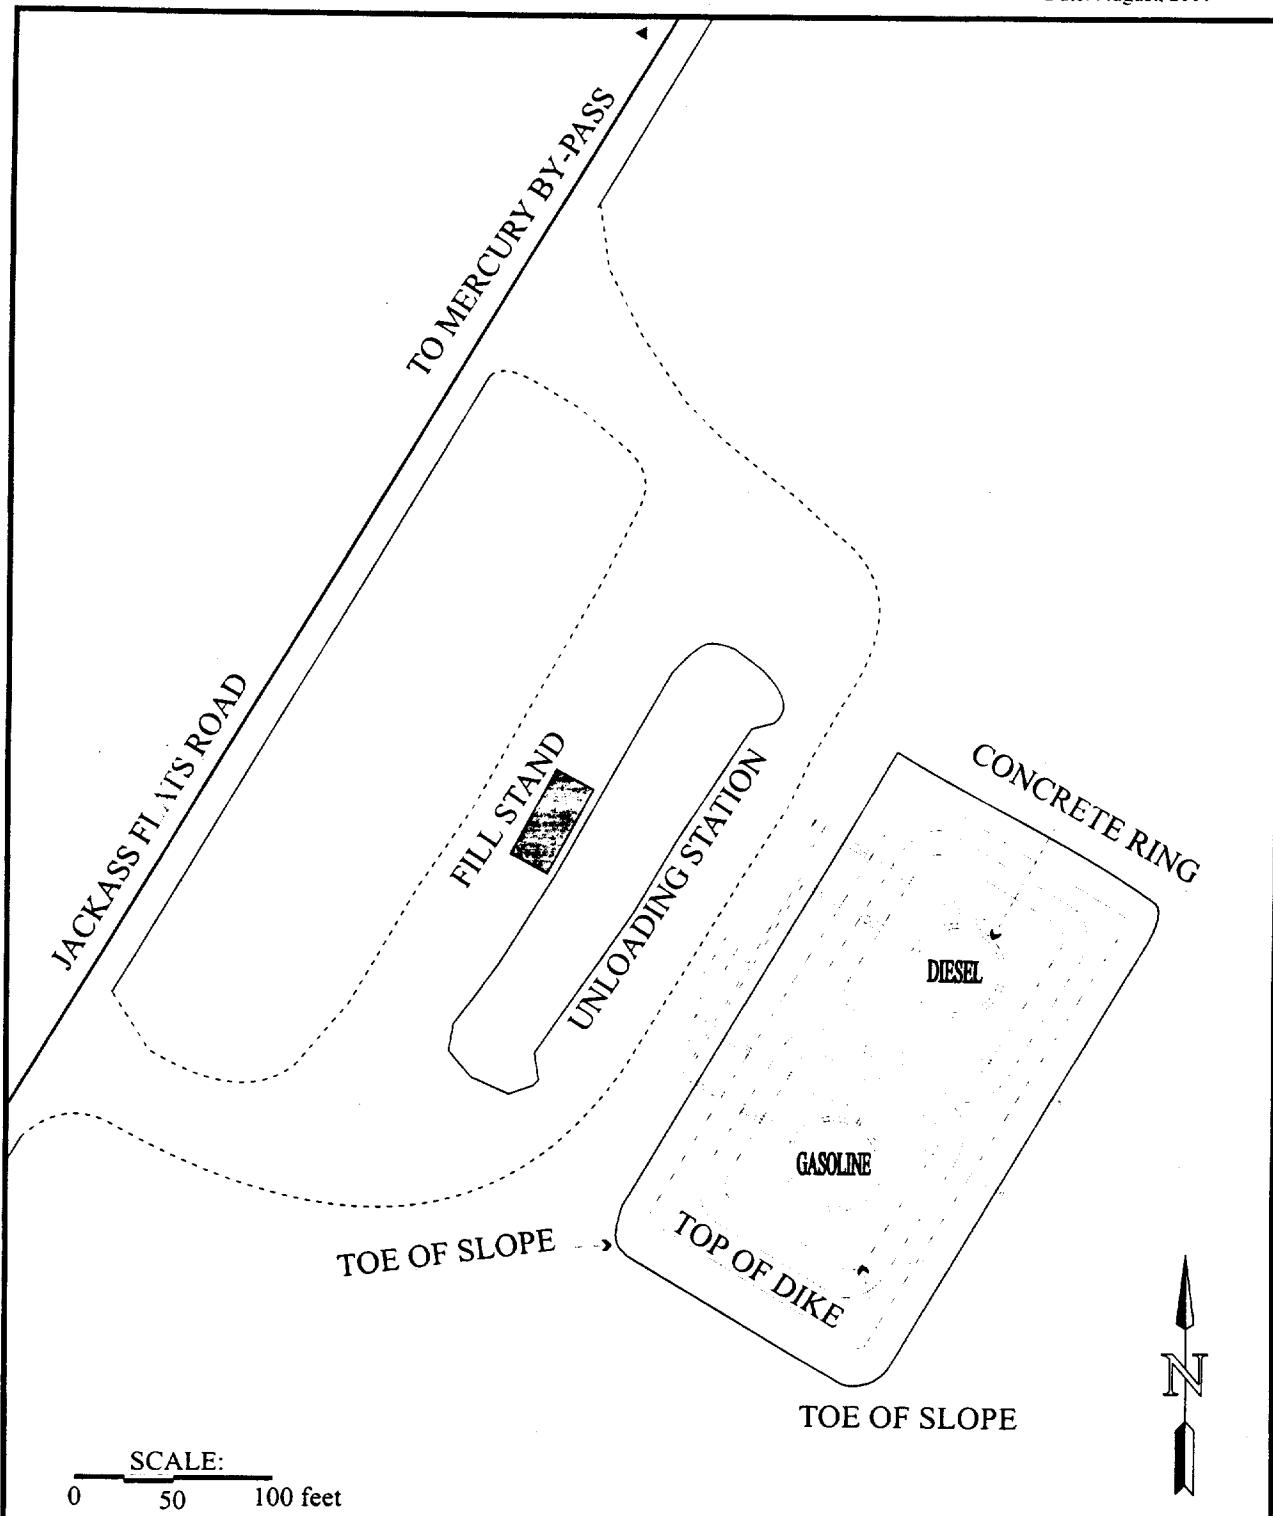
FIGURE 4
SITE VICINITY MAP FOR CAS 23-01-02

This CAS is located west of the intersection of the Mercury Bypass and Jackass Flats Roads. It is on the south side of Jackass Flats Road in Area 23 of the NTS. This site is also known as the Area 23 Tank Farm or Mercury Bulk Fuel Station. The ASTs are each 55 ft in diameter, 24 ft tall and 1,590 cubic meters (420,000 gal) capacity for each. The ASTs sit on a concrete foundation and are surrounded by an earthen berm with dimensions of 43 by 80 m (140 by 264 ft). The total amount of associated piping is approximately 365 m (1,200 ft), consisting of four different diameters of pipe; 15.2, 10.2, 5.1, and 2.5 cm (6, 4, 2, and 1 in). Three pipes extend from each of the ASTs to unloading stations that are connected to a delivery pump station. The NTS Grid Coordinates is U08-07.

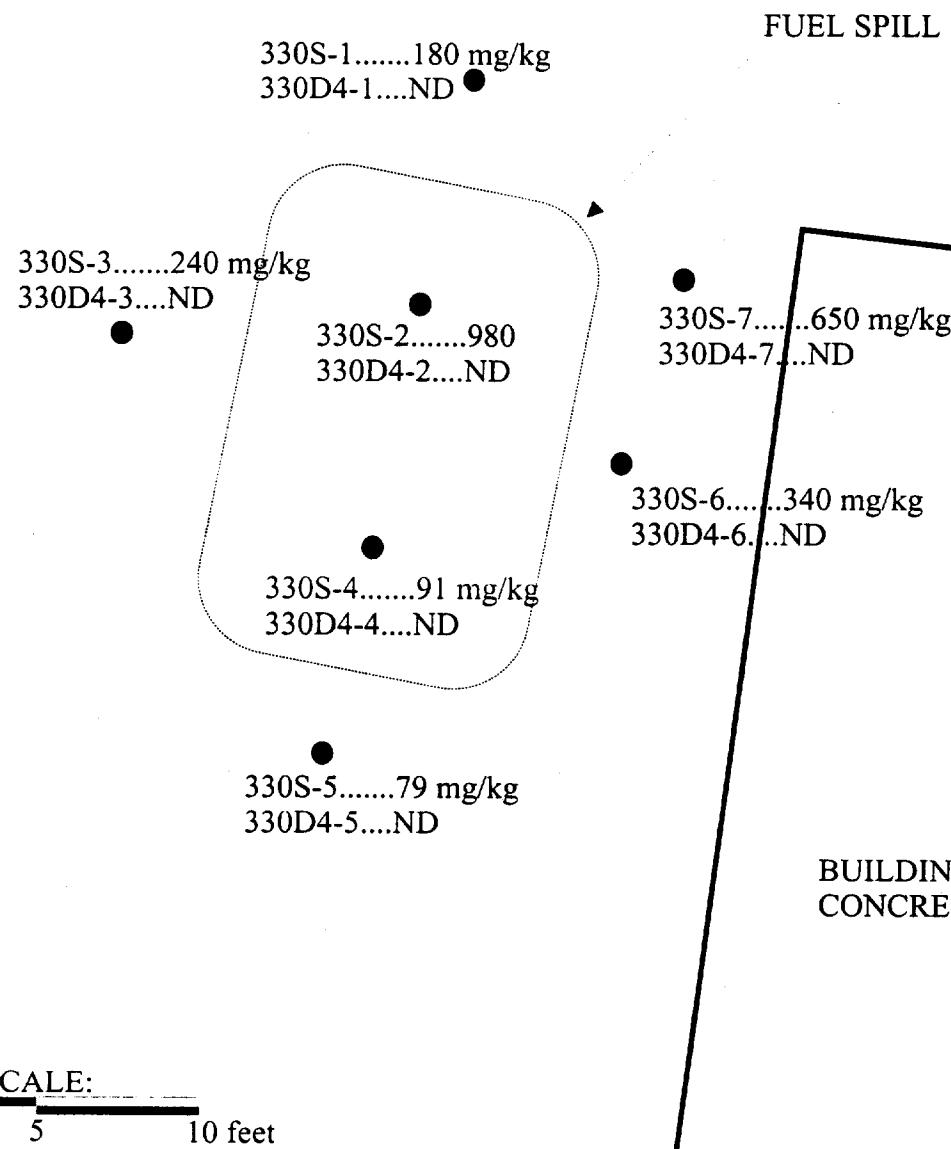
FIGURE 6
TPH SAMPLING RESULTS AT CAS 22-99-06

330S-1 = Sample ID for Surface samples

330D4-1 = Sample ID for samples taken 4 ft below ground surface

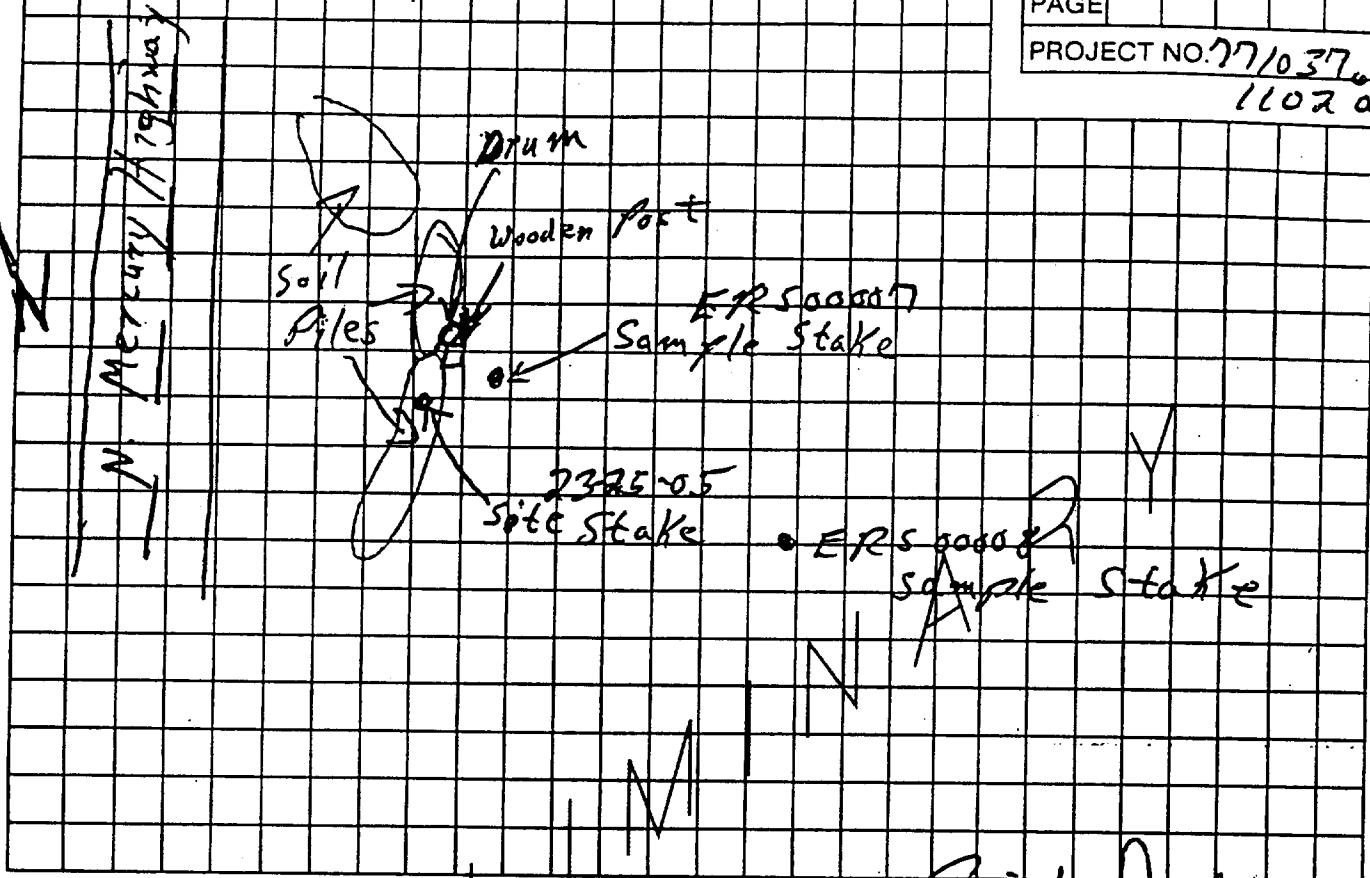
Site located 562 ft, 34.5 ft
from 23-25-05 site stake
to sample location stake.

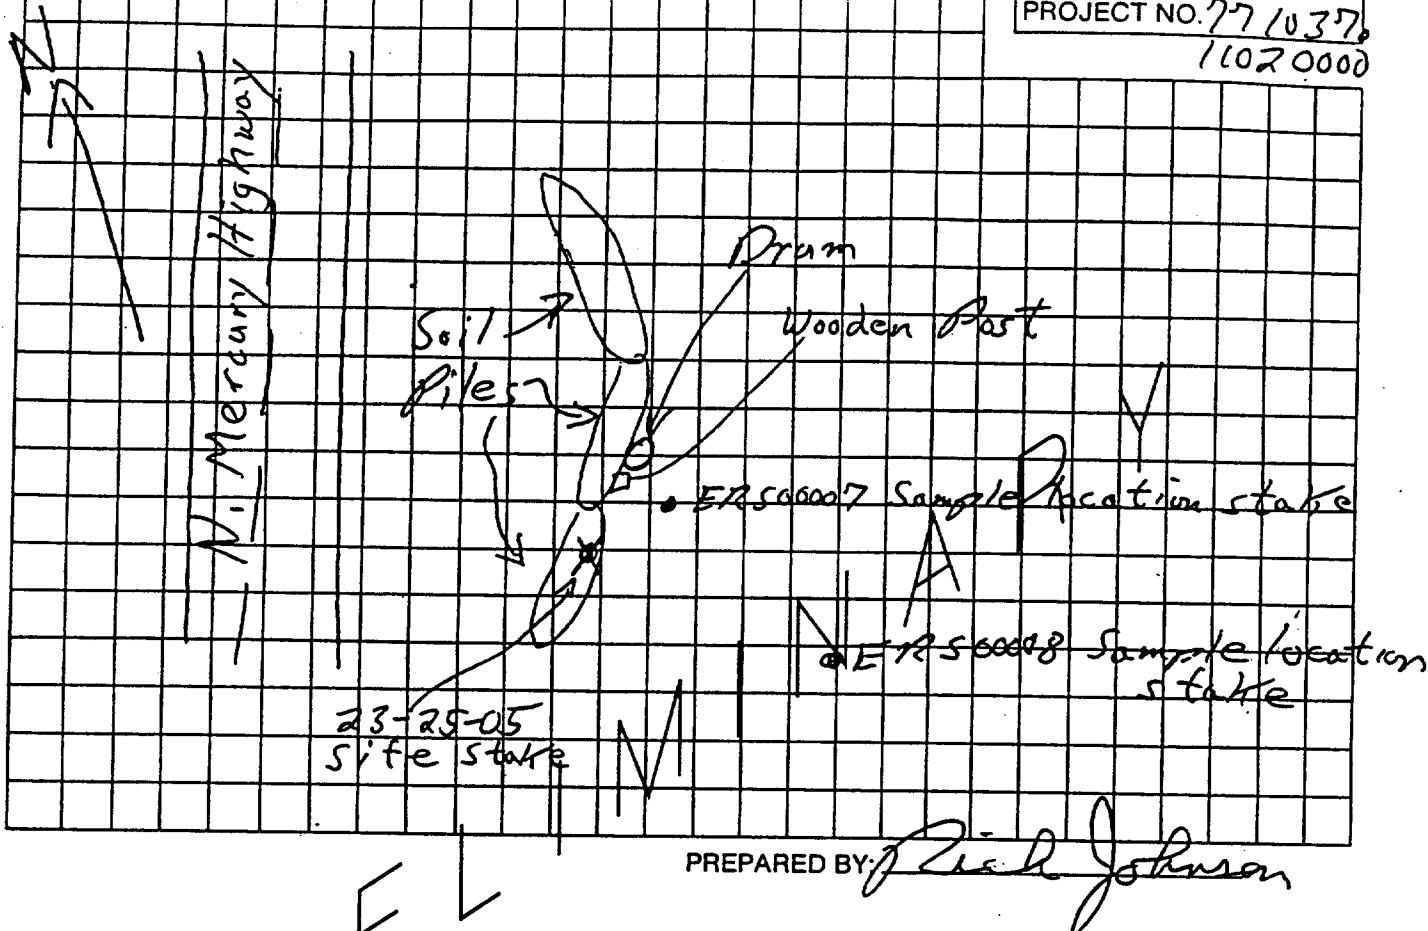
Sample site located ~~525~~
128 ft. from 23-25-05
site stakes. See map below.
