Nevada
Environmental
Restoration
Project

DOE/NV-743

Closure Report for
Corrective Action Unit 417:
Central Nevada Test Area
Surface, Nevada

November 2001

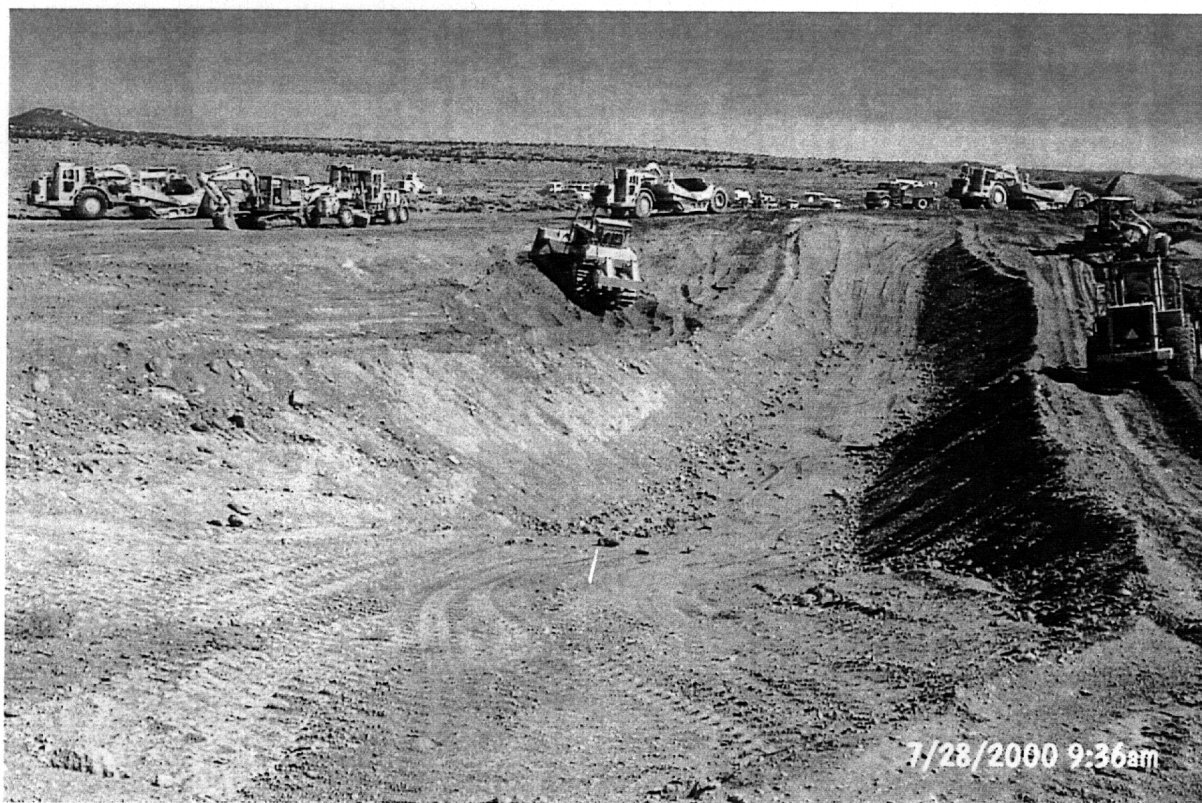
PHOTOGRAPH 6 - Excavation of the CMP Mud Relocation Trench

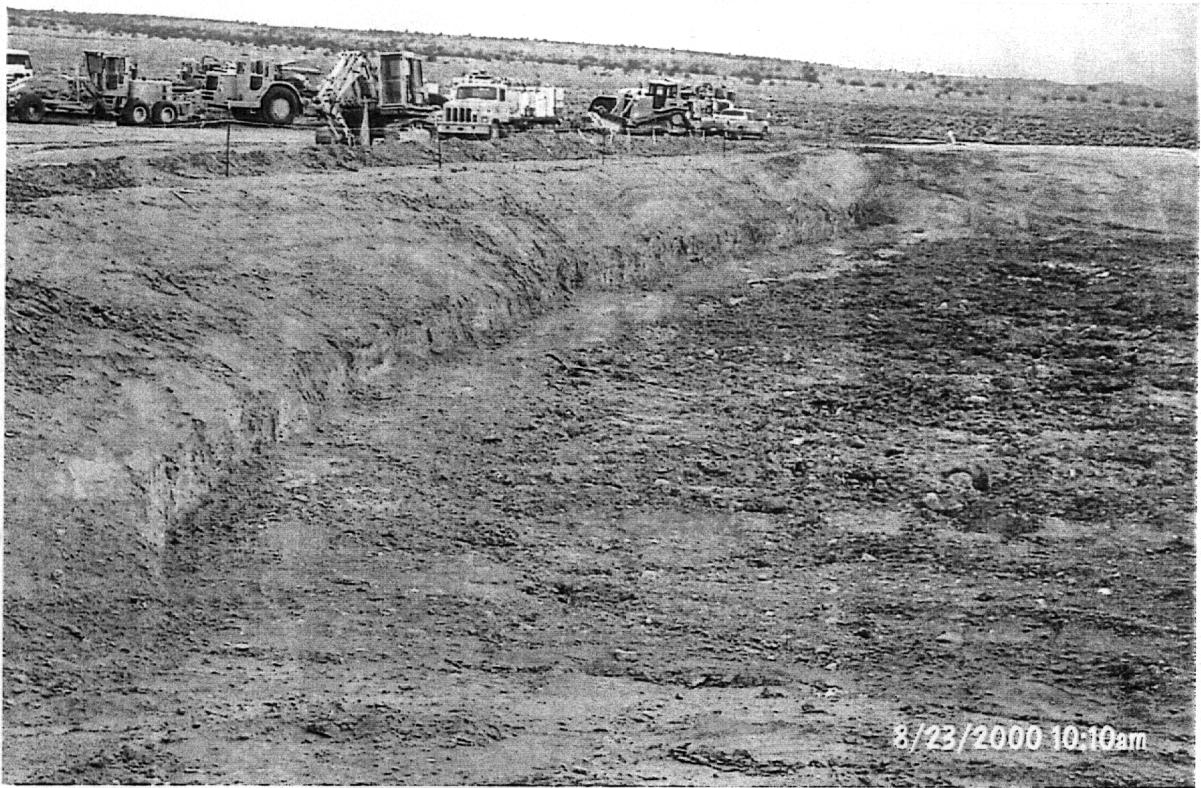
PHOTOGRAPH 12 - Geogrid anchor bench, west side of Mud Relocation Trench

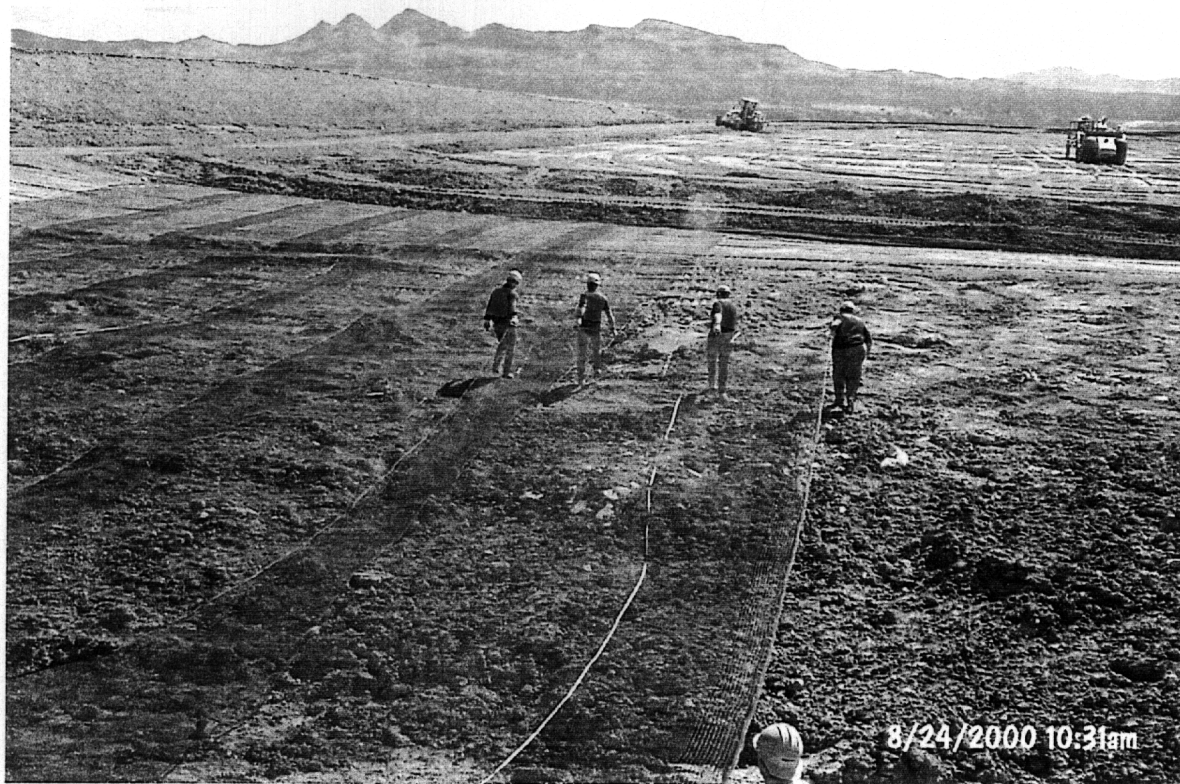
PHOTOGRAPH 13 - Placing geogrid over CMP Mud Relocation Trench

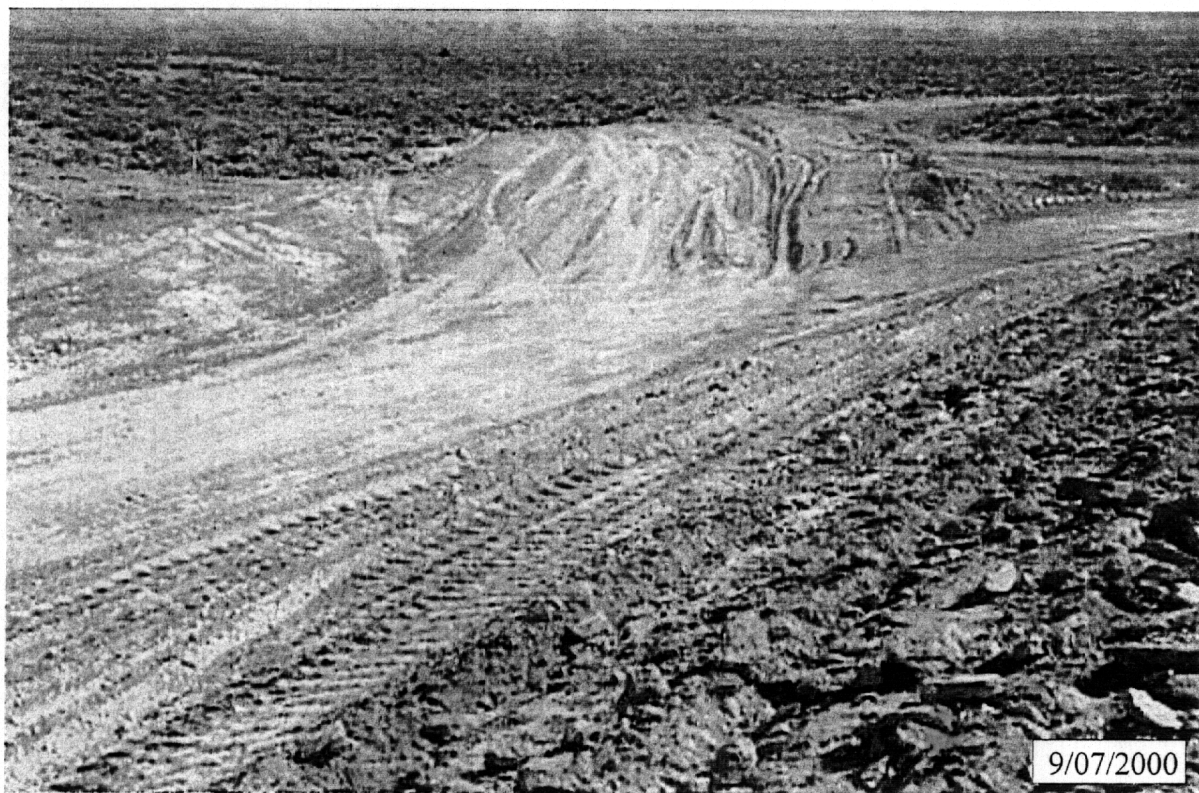
PHOTOGRAPH 16 - Completed East Diversion Channel

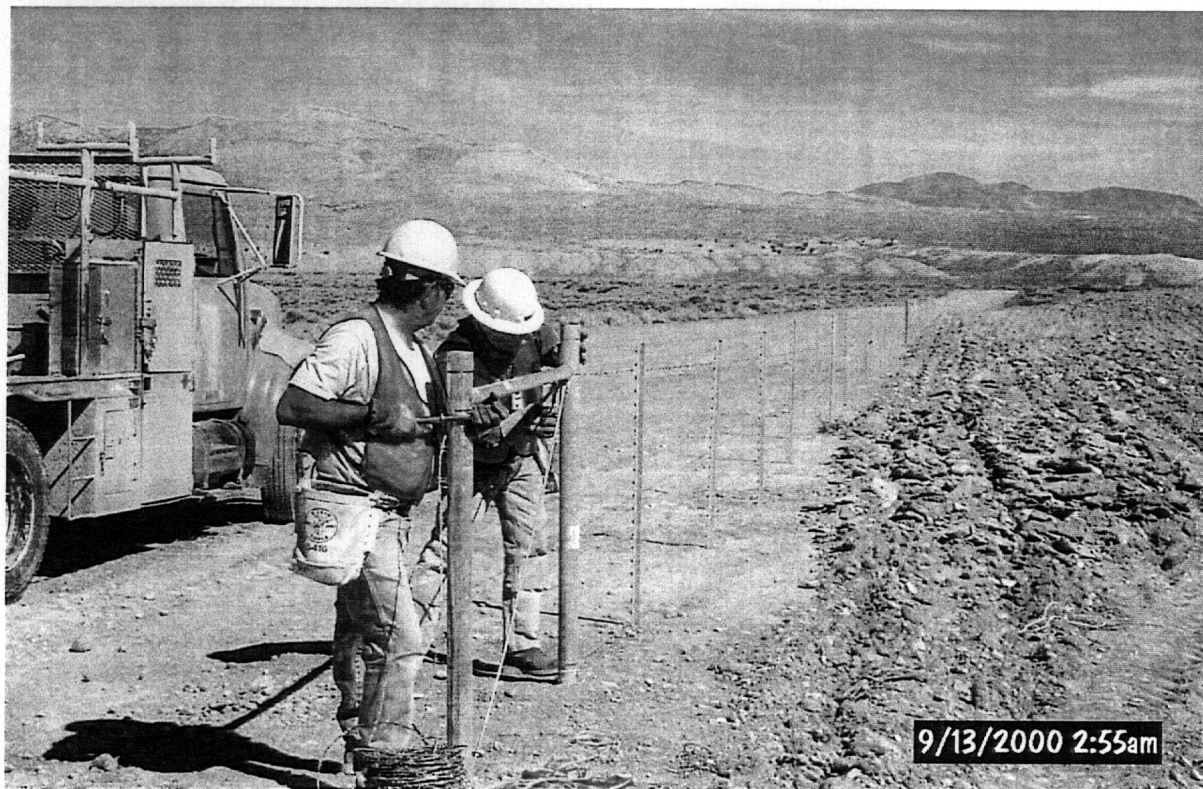
PHOTOGRAPH 17 - Erecting the CMP cover fence

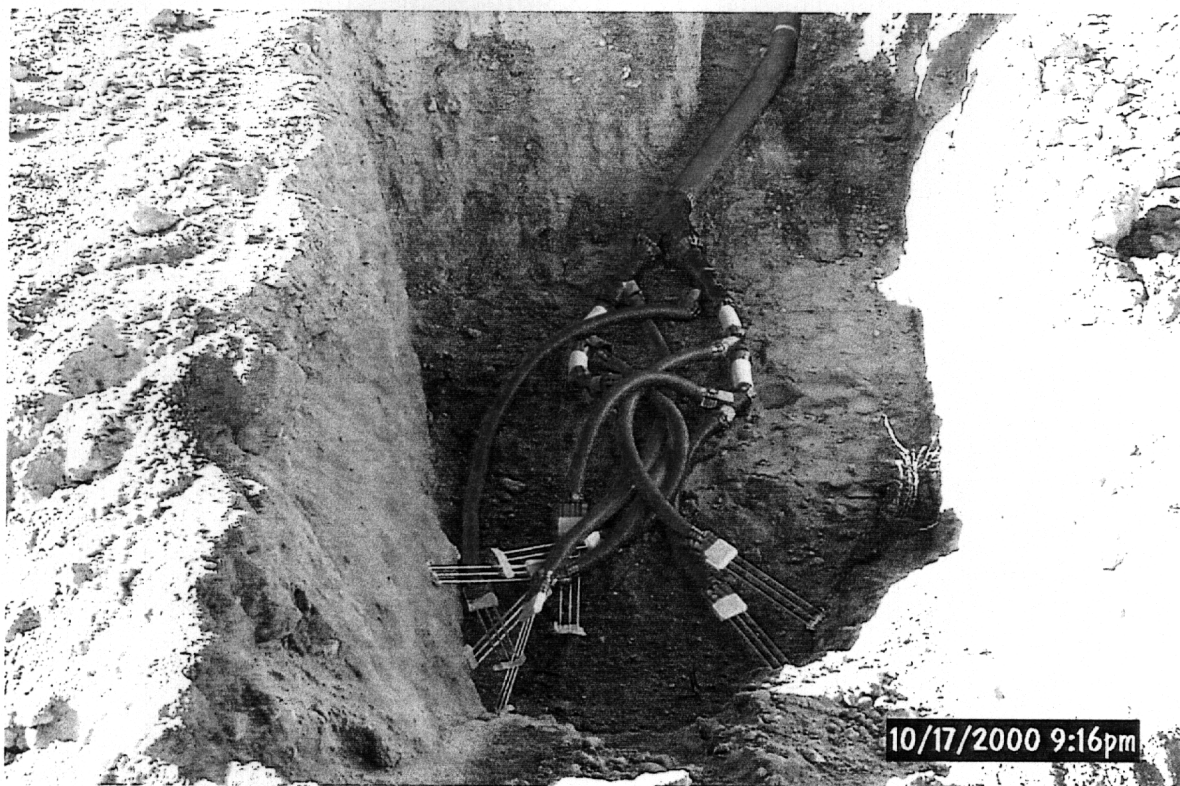
PHOTOGRAPH 21 - Installing TDR sensors in CMP cover

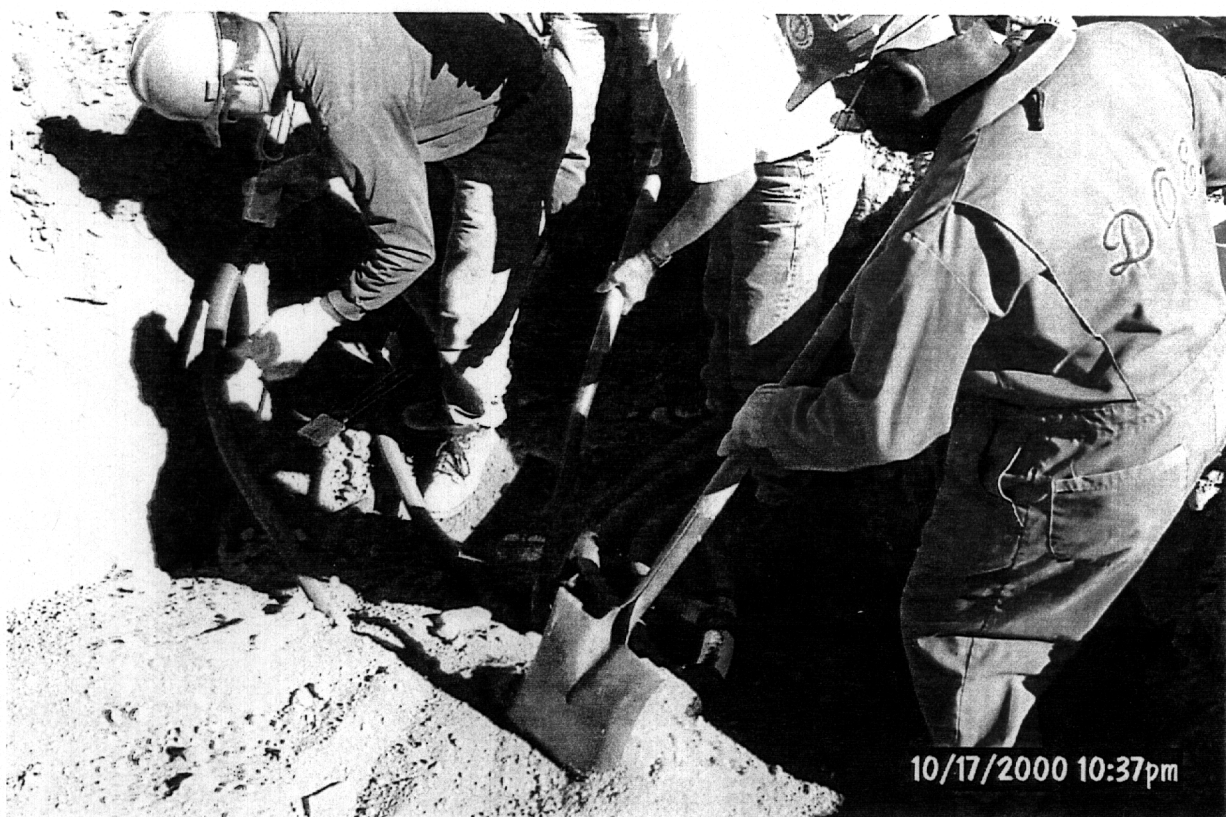
PHOTOGRAPH 22 - Placing and burying TDR sensors in CMP cover

After completion of construction and prior to seeding of the CMP cover, a TDR system was installed to monitor soil moisture in the cover. The system consists of 16 TDR sensors, cabling connecting each sensor to a datalogger which collects the data, a battery and solar panel to power the equipment, and a transceiver for remote retrieval of data and access to the datalogger programing. The TDR sensors were placed in two pits excavated with a backhoe on the cover. The pits measured approximately 0.9 by 1.8 m (3 by 6 ft), and were dug to a depth of approximately 1.4 m (4.5 ft) below the cover surface, down to the level of the geogrid. In each pit, two TDR sensors were placed at 0.15, 0.5 0.76, and 1.1 m (0.5, 1.5, 2.5, and 3.5 ft) bgs, one on each side of the pit. The cables from each sensor were combined and placed into 10-cm

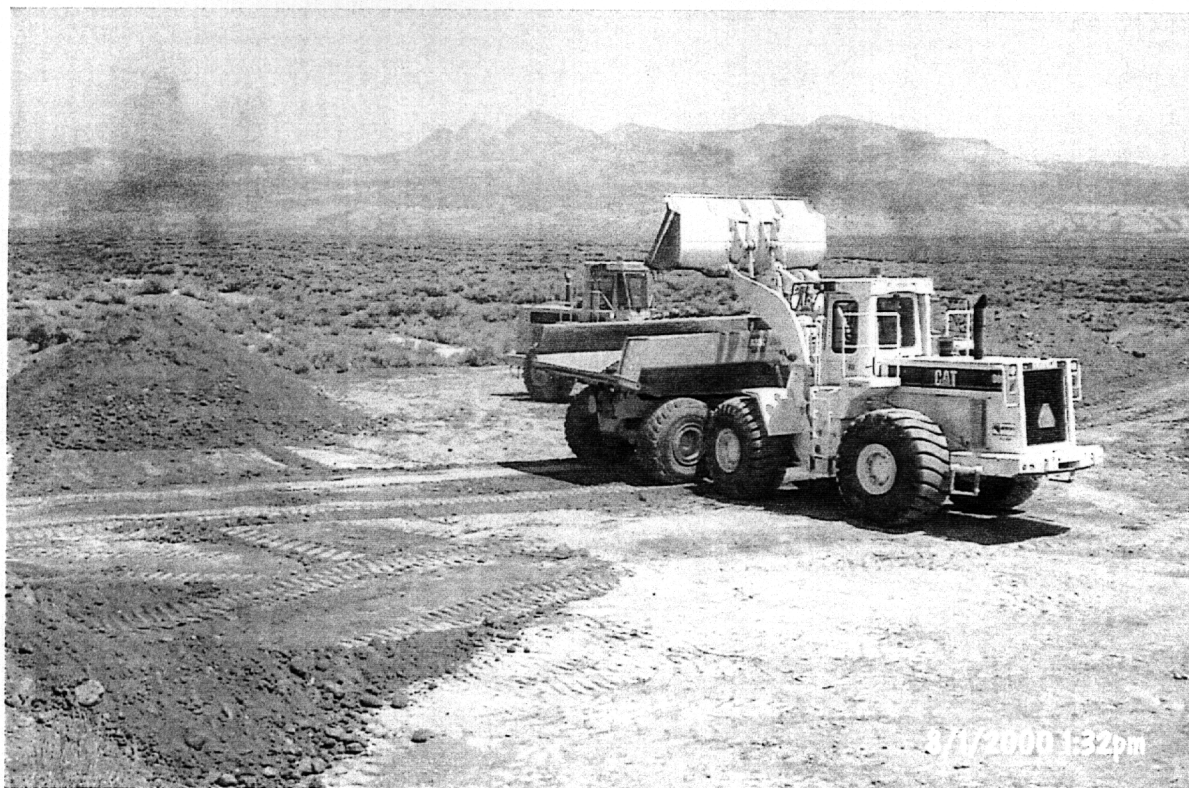
PHOTOGRAPH 25 - Clean closure by excavation of UC-1 Area S, CAS 58-10-03

the excavation on August 1, 2000 (Figure 5) and submitted for TPH analysis to an off-site contract laboratory. Four of the samples had TPH levels below the NDEP action level for petroleum hydrocarbons (100 mg/kg). Sample UC1SV1 had a TPH value of 170 mg/kg, which was greater than the NDEP action level (100 mg/kg). As a result, on August 7, 2000, an additional 76.5 m³ (100 yd³) of soil was excavated from an area centered on the location of sample UC1SV1, measuring approximately 12.5 by 12.5 m (41 by 41 ft) to a depth of 0.46 m (1.5 ft) bgs. The excavated soil was used in the construction of the CMP cover. A sixth soil verification sample, UC1SV6, was collected on August 8, 2000, from the bottom of this over-excavated area and submitted for TPH analysis. TPH results for sample UC1SV6 were less than the NDEP action level for petroleum hydrocarbons (100 mg/kg). Analytical results for the verification samples are provided in Table 3 and discussed in Section 4.1.1. Based upon the results of sample UC1SV6, it was determined that additional removal of material from UC-1 Area S was not required (see Drawing C25, Appendix C).

Following excavation, five verification samples were collected at UC-1 Area S on August 1, 2000 (Figure 5). One sample, UC1SV1, exceeded the NDEP TPH action level of 100 mg/kg. Additional material was excavated from the immediate area around this sample location, approximately 6 by 6 by 0.3 m (20 by 20 by 1 ft) volume of material was removed. A sixth verification sample (UC1SV6) was collected from the bottom of the second excavation and submitted for TPH analysis. This sample did not exceed the TPH action level. After excavating approximately 1,177 m³ (1,540 yd³) of hydrocarbon-impacted material, and moving it to the CMP cover, UC-1 Area S is considered clean closed. Sample analytical results are found in Table 3 and in Appendix A.

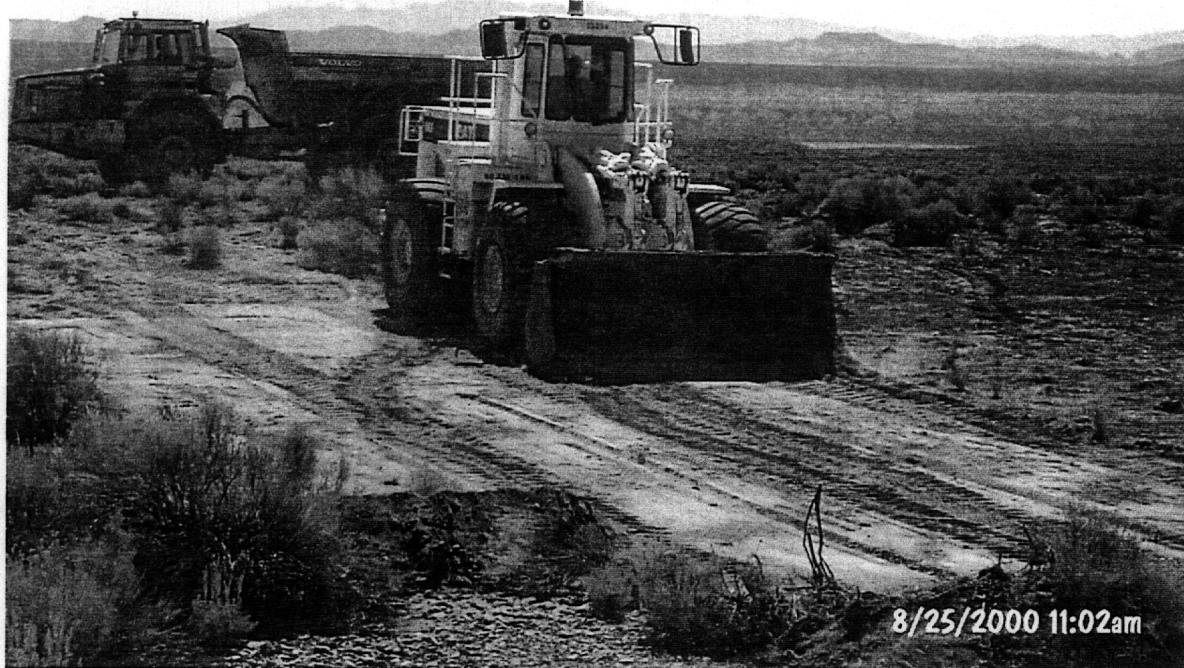
PHOTOGRAPH 26 - Clean closure by excavation of UC-1 Area Y, CAS 58-44-06

A total of approximately 84 m³ (110 yd³) of petroleum hydrocarbon-impacted soil was excavated from UC-1 Area Y, CAS 58-44-06, and transported to the UC-1 CMP. On August 25, 2000, approximately 38 m³ (50 yd³) of material was excavated from a 9 by 9 m (30 by 30 ft) area, to a depth of 0.5 m (1.6 ft) bgs. Two soil verification samples were collected from the bottom of the excavation (Figure 6), and submitted for TPH analysis to a contract laboratory. Sample UC1YV2 had a TPH value of 107 mg/kg, slightly greater than the NDEP action level for petroleum hydrocarbons (100 mg/kg). As a result, on August 31, 2000, an additional 46 m³ (60 yd³) of soil was excavated from an area centered on the location of sample UC1YV2, and measuring approximately 12 by 12 m (40 by 40 ft) to a depth of 0.3 m (1 ft) bgs. A third soil verification sample, UC1YV3, was collected from the bottom of this over-excavated area and submitted for TPH analysis. Results for UC1YV3 were less than the NDEP action level for petroleum hydrocarbons. Analytical results for these samples are discussed in Section 4.1.1 (Table 3). Based upon the results of sample UC1YV3, it was determined that additional removal of material from UC-1 Area Y was not required (see Drawing C37, Appendix C).

Following excavation, two verification samples were collected at UC-1 Area Y (Figure 6). One sample (UC1YV2) exceeded the NDEP TPH action level of 100 mg/kg. Additional material was excavated from the immediate area of this sample location; approximately 4.6 by 4.6 by 0.5 m (15 by 15 by 1.5 ft) volume of material was removed. A third verification sample (UC1YV3) was collected from the bottom of this over-excavated area and submitted for TPH analysis. This deeper sample did not exceed the TPH action level. Therefore, after excavating approximately 84 m³ (110 yd³) of hydrocarbon-impacted material, and moving it to the CMP cover, UC-1 Area Y is considered clean closed. Sample analytical results are found in Table 3 and in Appendix A.

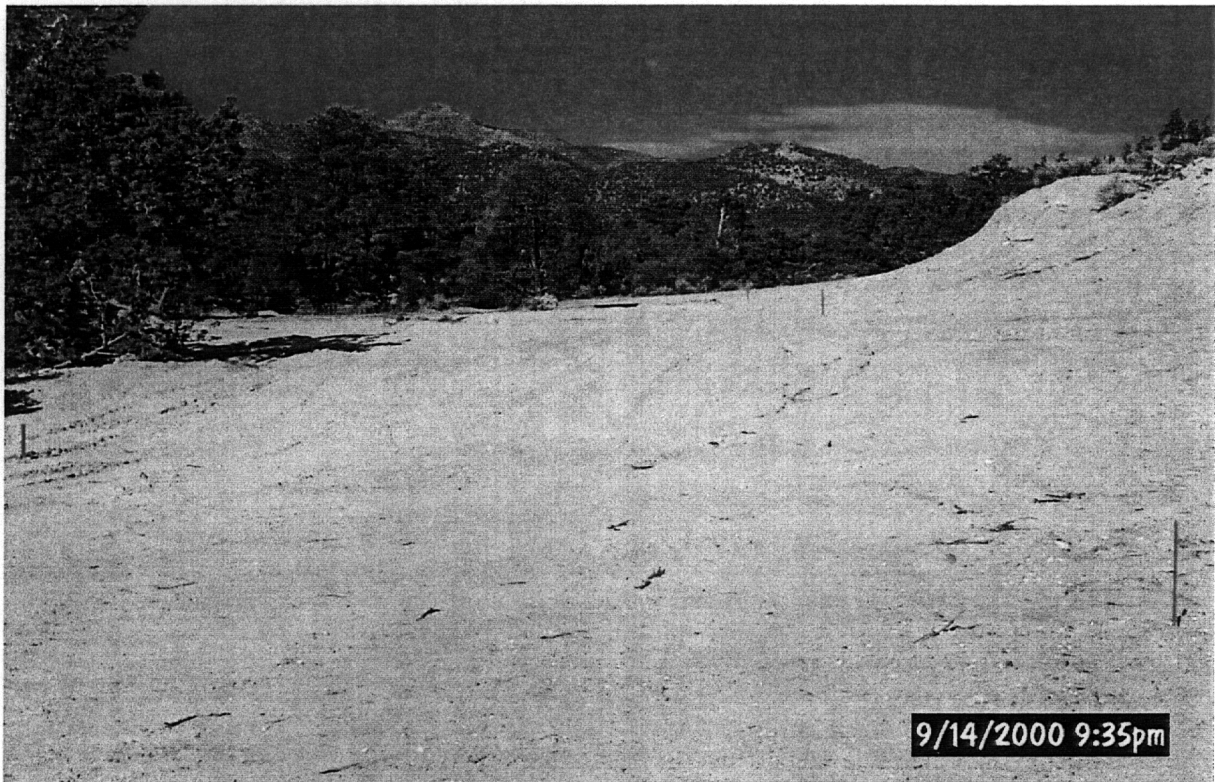
PHOTOGRAPH 32 - Clean closure of UC-4 Area W, CAS 58-10-04

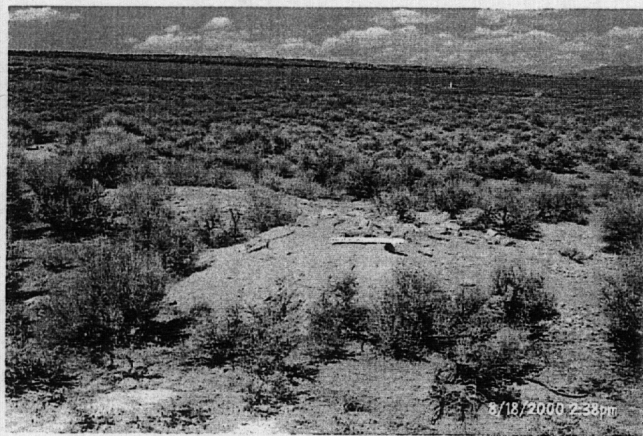
Waste Item(s) Originally at Site	Apparent Waste Type*
Grout pile (north pile)	Ordinary

Housekeeping Site Prior to Clean Up
(taken 08/18/2000)

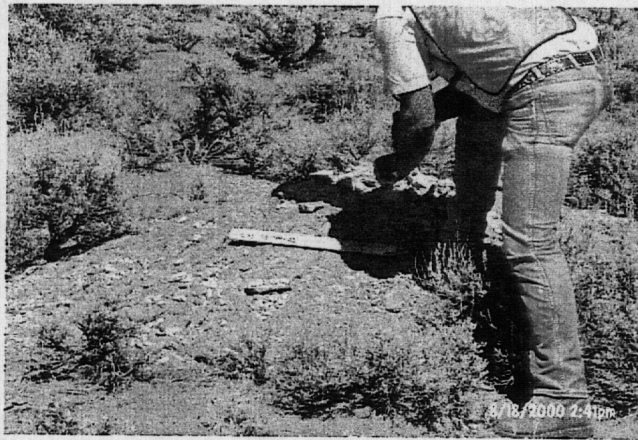
Waste Item(s) Originally at Site	Apparent Waste Type*
Grout pile	Ordinary

Housekeeping Site Prior to Clean Up
(taken 08/18/2000)

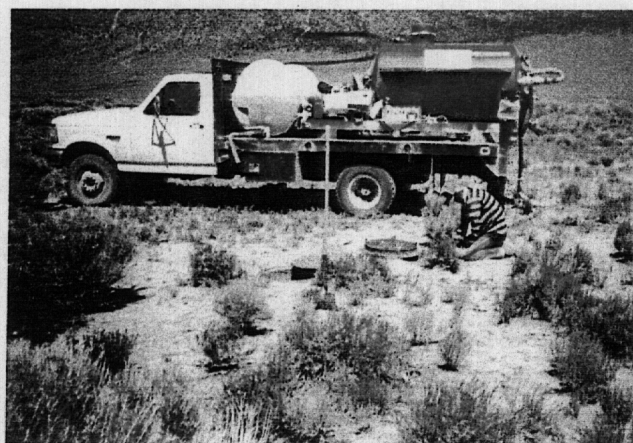
Waste Item(s) Originally at Site	Apparent Waste Type*
Septic tank	Ordinary

Housekeeping Site During Closure
(taken 06/23/1998)

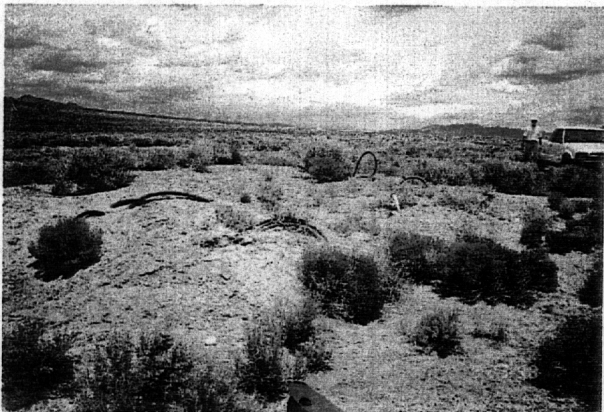
Waste Item(s) Originally at Site	Apparent Waste Type*
Trash and metal debris	Ordinary / scrap metal

Housekeeping Site Prior to Clean Up (taken 06/23/1998)	Housekeeping Site During Clean Up (taken 06/07/2001)

Current Site Description/Observations: This CAS was first identified by the IT Off-sites group in a site survey performed on February 13, 1996. The waste was removed on June 23, 1998. Scrap metal was sent to NTS salvage and the remainder disposed of at the NTS U10c Landfill. The current condition CAS 58-98-02 is clean of all waste material.

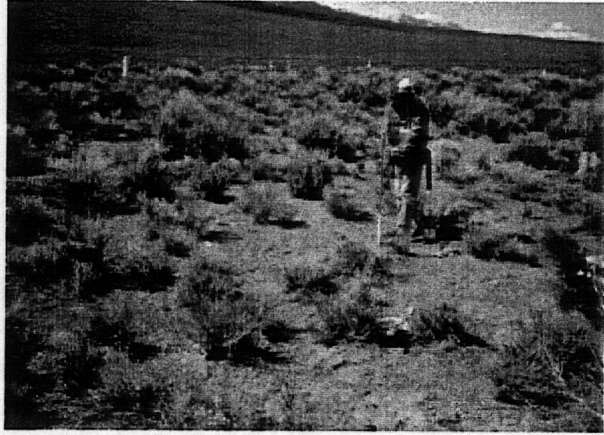
Waste Item(s) Originally at Site	Apparent Waste Type*
Trash and metal debris	Ordinary / scrap metal

No Before Photograph of Housekeeping Site Available	Housekeeping Site After Closure (taken 04/10/2001)

Current Site Description/Observations: This CAS was first identified by the IT Off-sites group in a site survey performed on February 13, 1996. The waste was removed on June 23, 1998. Scrap metal was sent to NTS salvage, remainder disposed of at the NTS U10c Landfill. The current condition of CAS 58-98-04 is clean of all waste material.

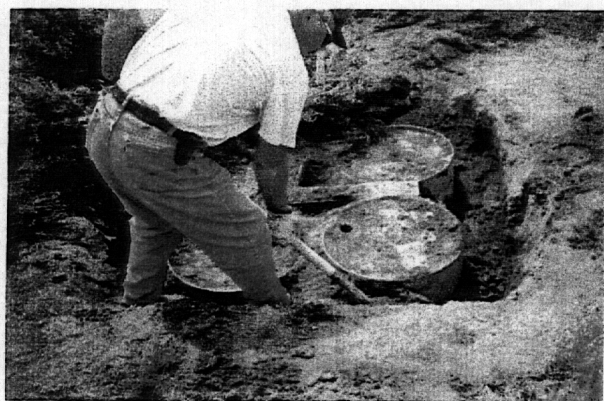
Waste Item(s) Originally at Site	Apparent Waste Type*
Underground storage tank - 55 gallon drums	Ordinary / scrap metal

Housekeeping Site During Closure
(taken 06/16/1998)
