Nevada
Environmental
Restoration
Project

Post-Closure Inspection Report for
Corrective Action Unit 427: Area 3
Septic Waste Systems 2 and 6
Tonopah Test Range, Nevada
Calendar Year 2001

January 2002

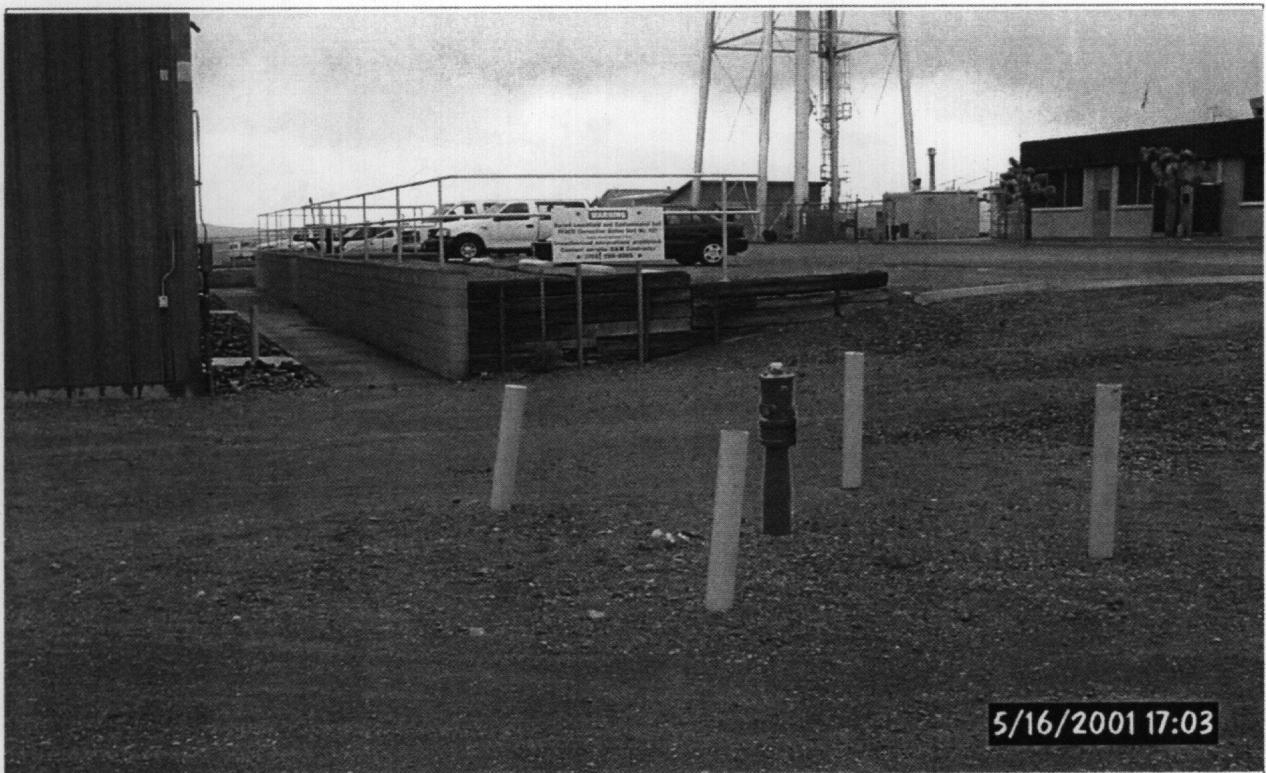
PHOTO NUMBER	DATE	DESCRIPTION
1	05/16/2001	View north over Septic Tank 33-5 (central area of photograph). Warning sign on south side of septic tank is visible in center of the photograph.
2	05/16/2001	View to southwest across Pre-1965 Leachfield, and of the southeast ends of Leachfield A, Leachfield B, and Abandoned Leachfield.
3	05/16/2001	View of the two warning sign on the west and south sides of Building 0367.
4	05/16/2001	View to east of Leachfield B and Abandoned Leachfield. Note the presence of a slight erosion feature/depression trending along the axis of Leachfield B and the Abandoned Leachfield.
5	11/06/2001	View to east of Abandoned Leachfield and Leachfield B. Note that the erosion feature/depression present in photograph 4 is no longer present; the area has been regraded.
6	11/06/2001	View to southeast of Leachfield B and Abandoned Leachfield.
7	11/06/2001	View of warning sign posted on the west side of Building 0367.

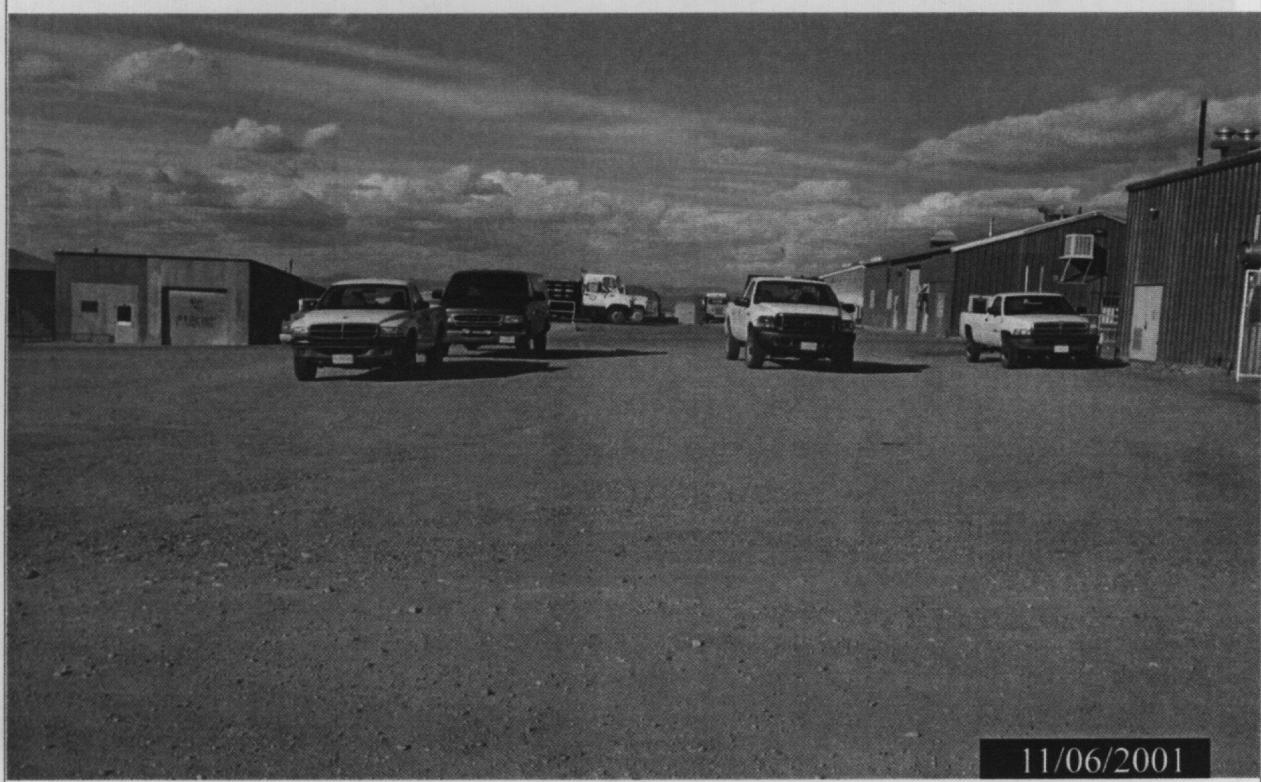
8	11/06/2001	View north of Pre-1965 Leachfield.
