DOE/NV--694-rev 1

**Closure Report
for Corrective Action Unit 407:
Roller Coaster RADSAFE Area,
Tonopah Test Range, Nevada**

December 2001

Environmental Restoration
Division

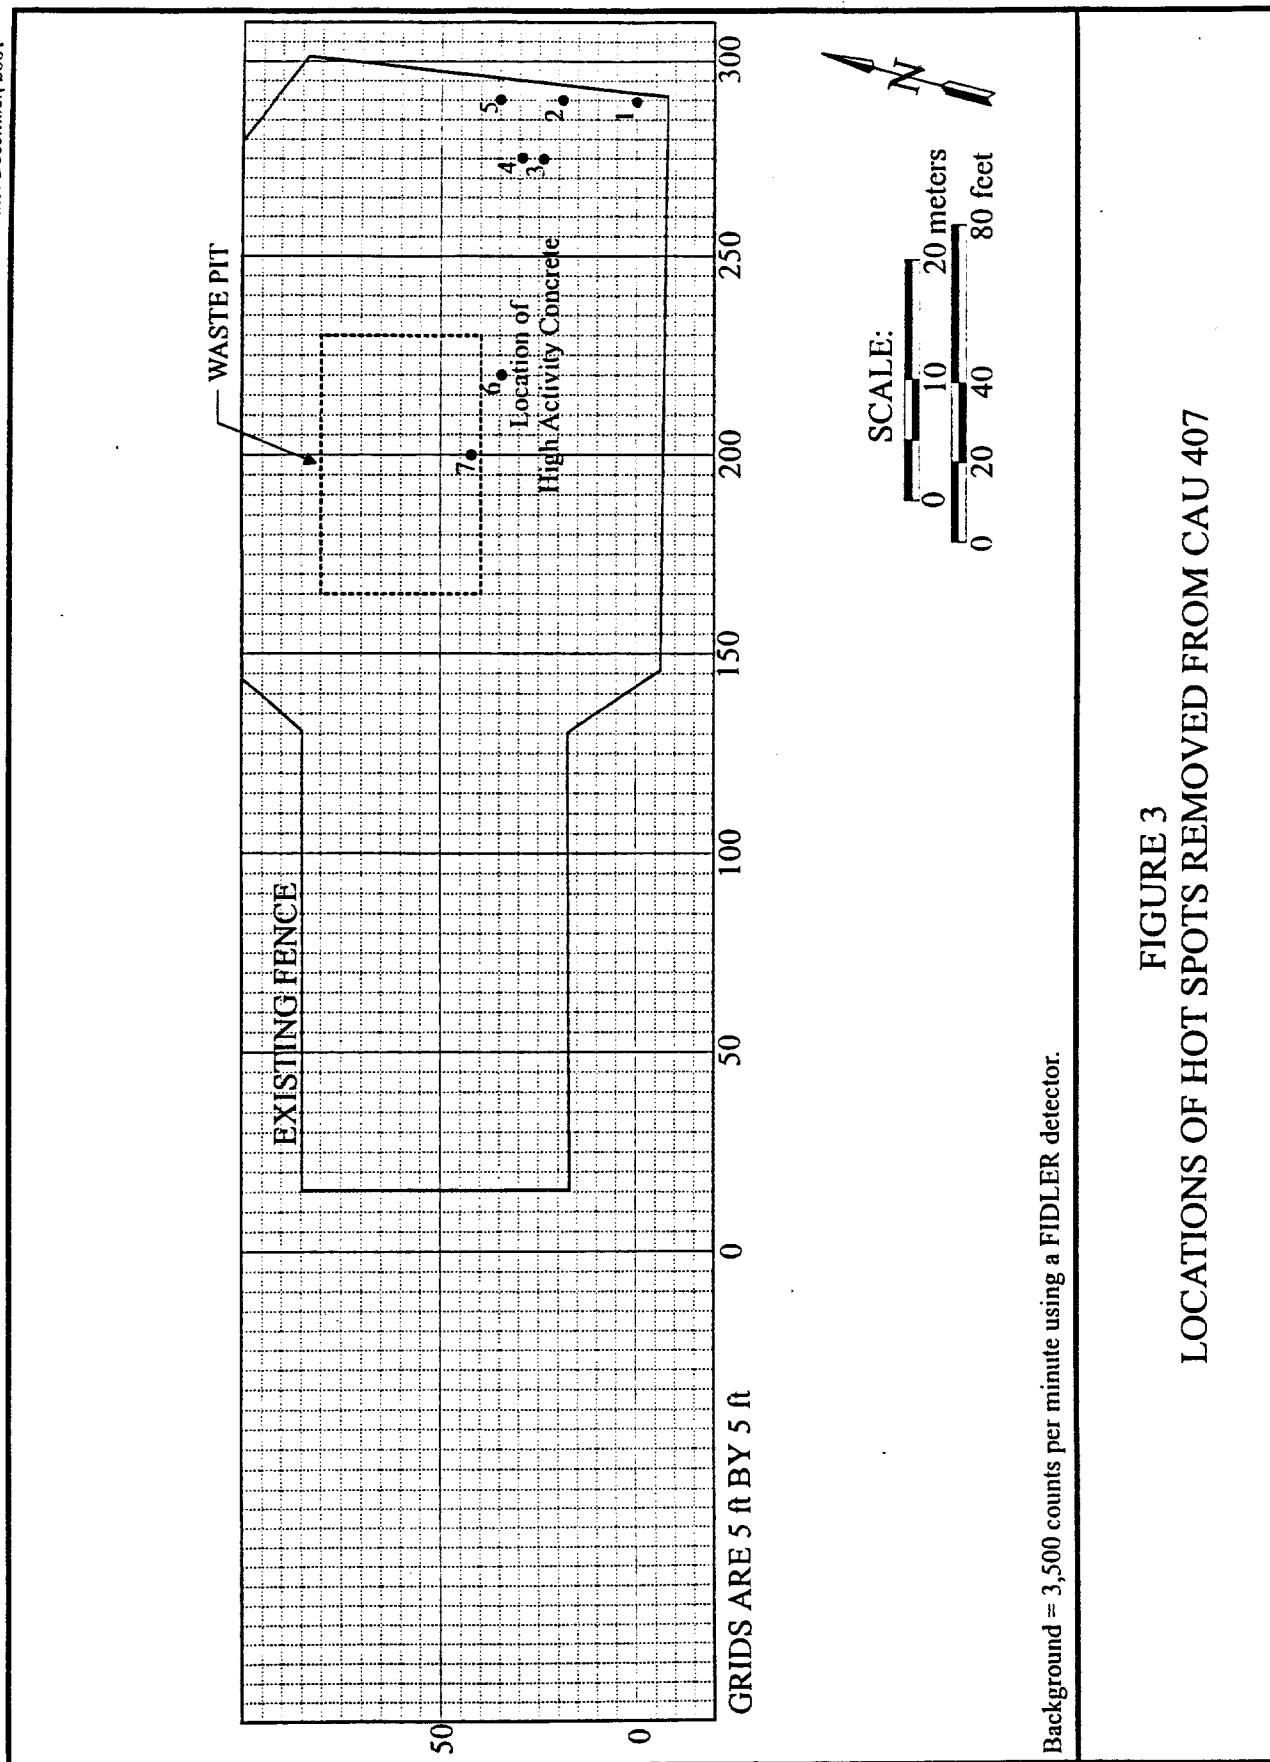
Soil was removed from the "hot spot" locations until the criterion of less than three times background was met. The locations of the soil removals are shown in Figure 3. FIDLER readings taken after "hot spot" removal confirmed that no surface soil activity remained that was greater than the three times background criterion. Excavated soil was managed as LLW. Impacted soil was placed into a 55-gallon (gal) drum following Bechtel Nevada (BN) Procedure OP-2151.304, "Radioactive Waste Tracking, Handling, and Management at the NTS," (BN, 1999) and stored temporarily in a waste management area prior to disposal at the Area 5 RWMS on the NTS. Excavations were backfilled with clean fill from a borrow source near the site.

During removal of impacted soils, 4 pieces of impacted concrete were discovered which had a high level of surface activity. These pieces of concrete were isolated for sampling and analysis (see Section 3.0 for analytical results). Sample results indicated that one of the concrete pieces had an activity which qualified it as transuranic (TRU) waste. This was previously identified as one of several "hot spots" located during the walkover radiological surveys of CAU 407. The impacted surface soils and debris have been removed and the area re-surveyed to confirm compliance with the CAP.

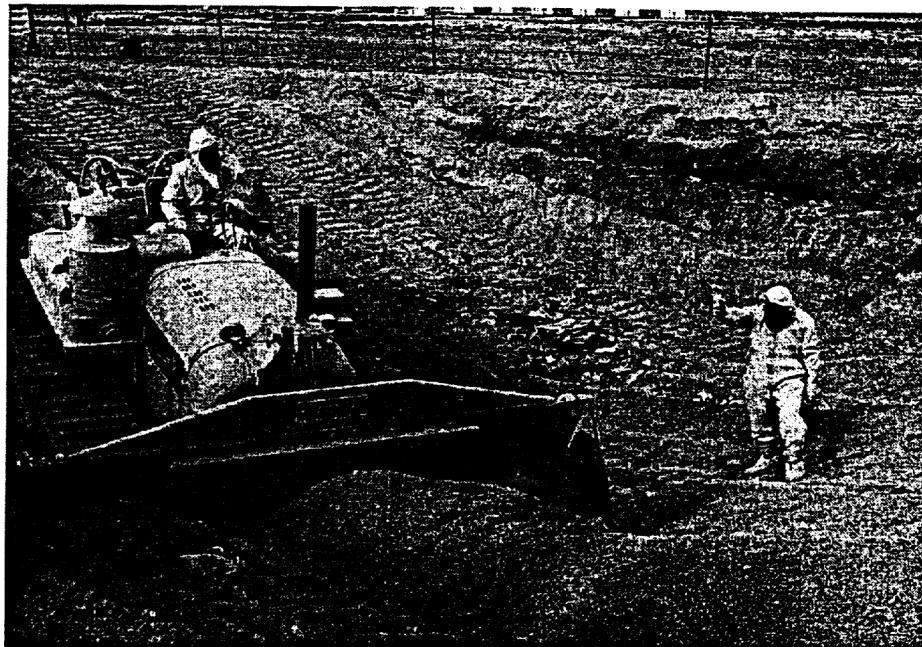
Photo 175-03-TTR-63 shows Radiological Control Technicians during the Roller Coaster Followup Operation directing a bulldozer operator during digging for buried debris at the Rad Safe Waste Pit at Tonopah

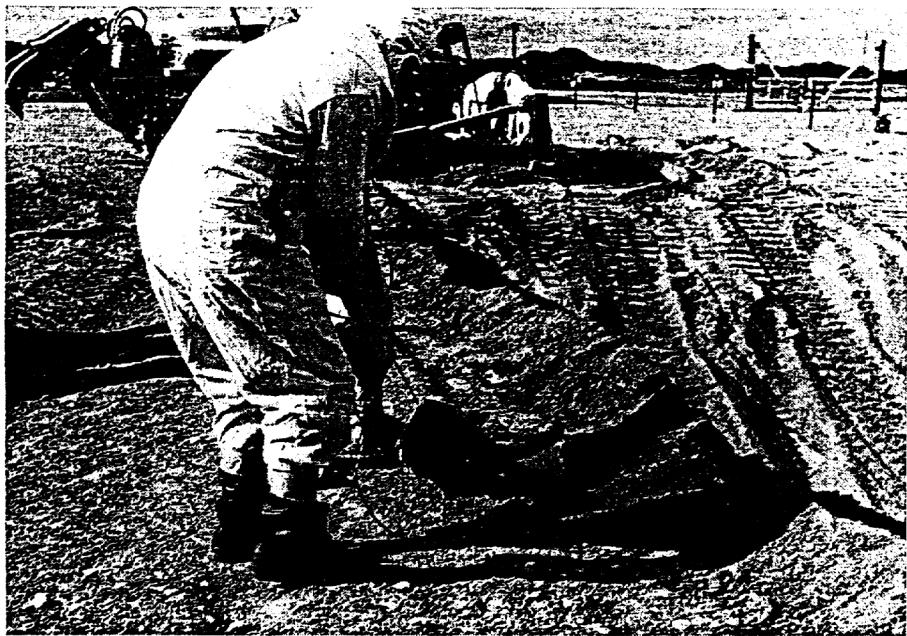
Photo 175-04-TTR-63 shows a Radiological Control Technician during the Roller Coaster Followup Operation using rope to handle contaminated debris at the Rad Safe Waste Pit at Tonopah

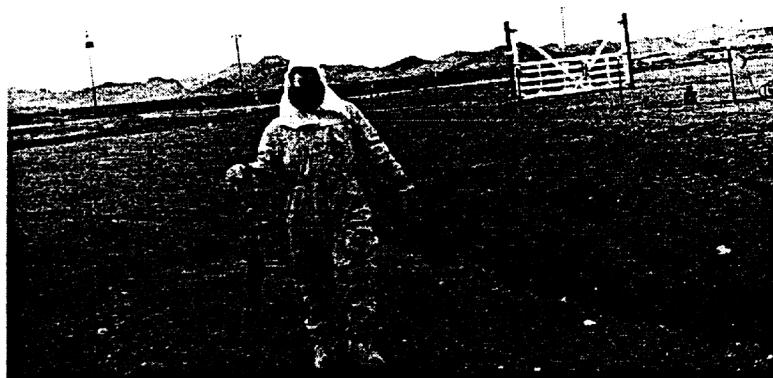
Photo 175-05-TTR-63 shows a Radiological Control Technician carrying debris from the Rad Safe Waste Pit at Tonopah

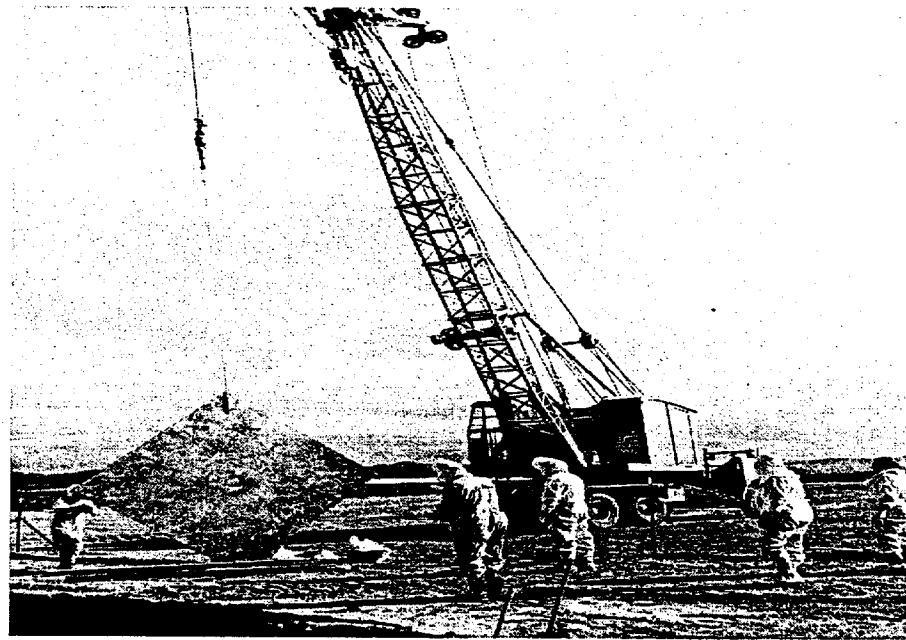
Photo 175-12-TTR-63 shows the crane lifting the 8 x 8 ft Double Tracks Steel Base Plate from the Rad Safe Waste Pit at Tonopah during the Roller Coaster Followup Operation

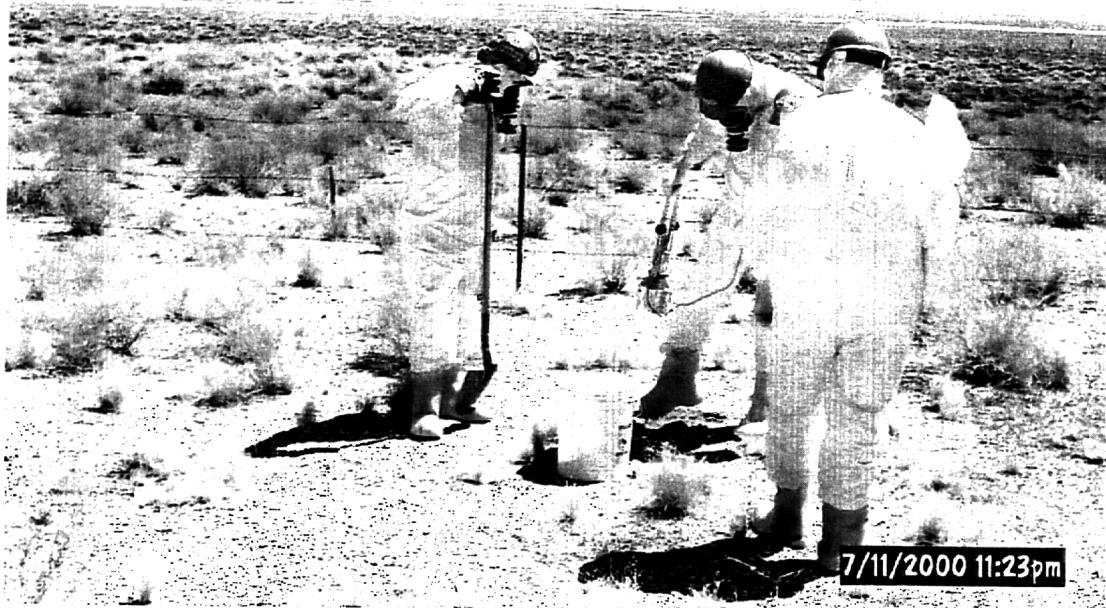
PLACING COVER FILL MATERIAL

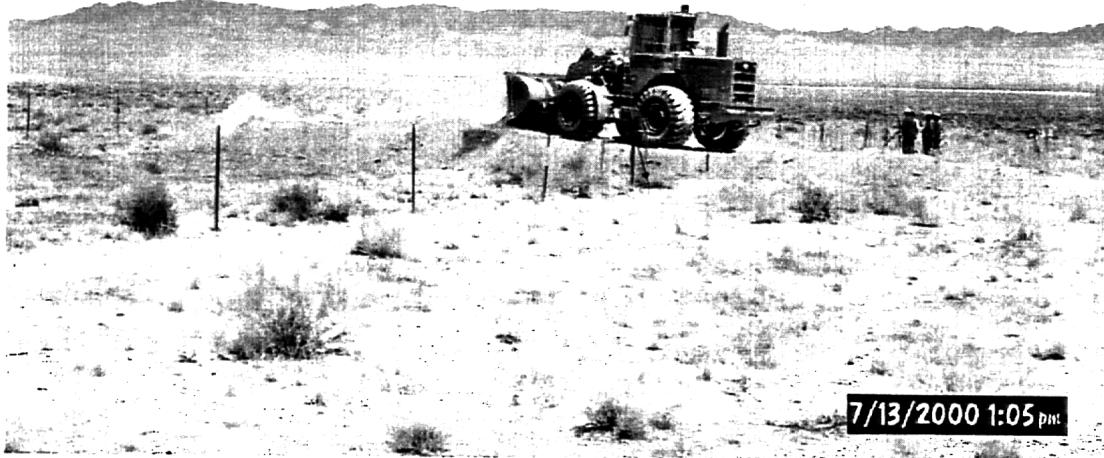
DISCING THE COVER SURFACE
