**EFFECT OF MICROSTRUCTURE ON LOW TEMPERATURE CRACKING BEHAVIOR OF EN82H
WELDS**

W. J. Mills, C. M. Brown and M. G. Burke

May 2001

BETTIS ATOMIC POWER LABORATORY

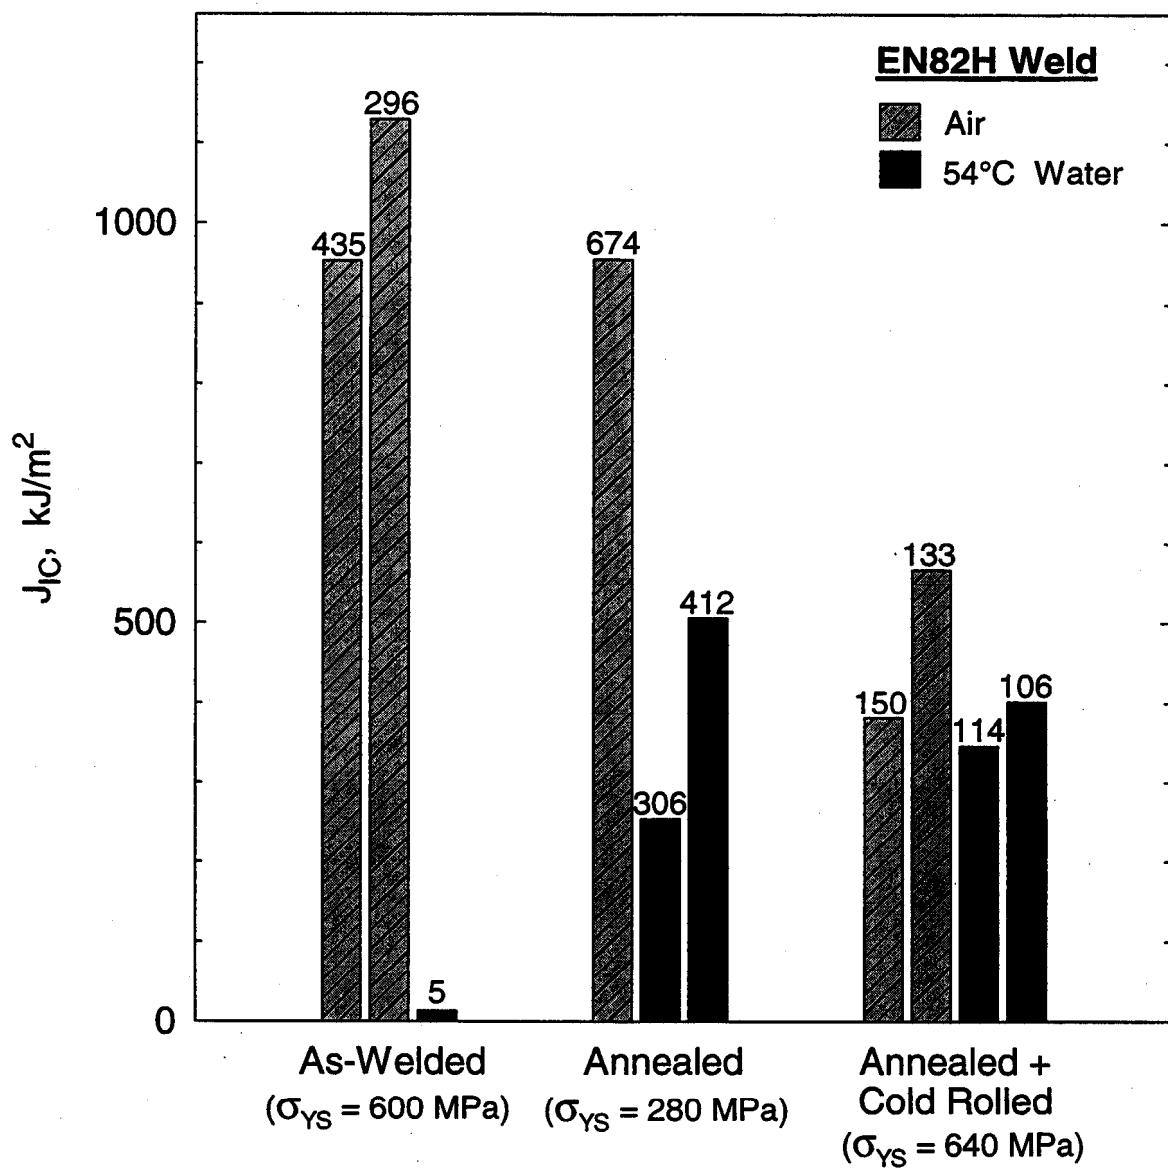
Figure 1. Effect of low temperature water on the fracture toughness of EN82H weld in the as-welded, 1093°C annealed, and 1093°C annealed + cold rolled conditions. Values of T are given above each bar.

The fracture toughness response for the EN82H weld tested in air and water is provided in Figure 1. The as-fabricated weld exhibits very high fracture toughness in air, with J_{IC} values of 953 and 1129 kJ/m^2 and tearing moduli of 296 and 435. In 54°C water the fracture

resistance is severely degraded as J_{IC} and T are reduced by 99% ($J_{IC} = 13 \text{ kJ/m}^2$, $T = 5$). The loss in toughness is associated with a fracture mechanism transition from ductile dimple rupture to intergranular cracking (Figure 2a). This behavior is consistent with that reported in References (4) and (5).

The 1093°C annealed weld also exhibits exceptionally high toughness in air. Its J_{IC} of 955 kJ/m^2 is comparable to that for the as-welded condition, while its tearing modulus of 674 exceeds its as-welded counterpart. Although the toughness of the annealed weld is reduced in 54°C water ($J_{IC} = 254-506 \text{ kJ/m}^2$ and $T = 306-412$), the degree of degradation is far less than that for the as-fabricated weld. In fact, the annealed weld retains sufficient toughness in low temperature water to eliminate fracture as a concern.

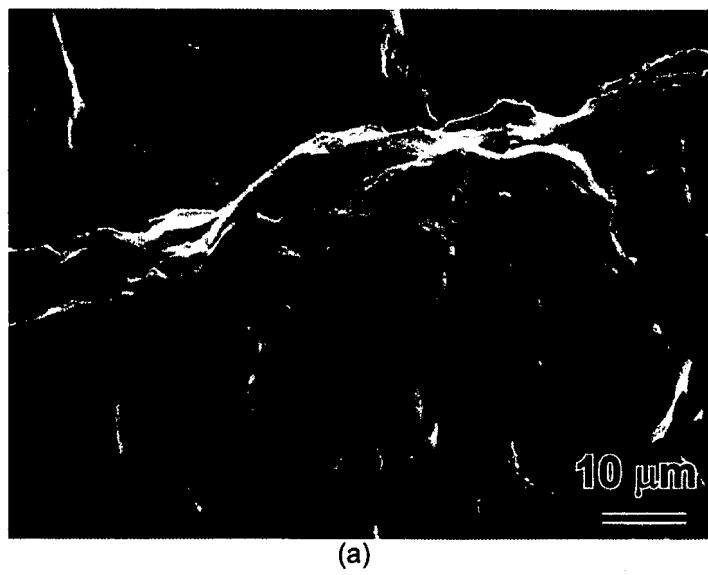
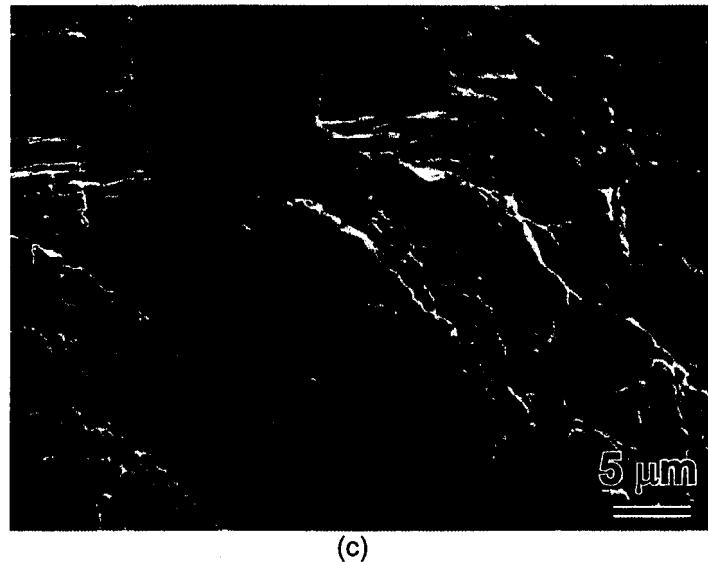
Figure 2. SEM fractographs showing (a) intergranular fracture in as-fabricated weld tested in 54°C water, (b) crystallographic facets and poorly defined dimples in annealed weld tested in 54°C water, and (c) high magnification of crystallographic facets in (b) .

The fracture surface morphology for the annealed weld tested in 54°C water is markedly different than those for the as-fabricated weld tested in air or water. The fracture surface takes on a faceted appearance with no evidence of intergranular cracking, as shown in Figures 2b and 2c. Most of the facets are small, but a few are large and steeply inclined to the loading direction. The steep angle indicates that the faceting mechanism is dominated by shear stresses, which are maximized in this orientation. Some evidence of dimple rupture is observed, but the dimples are poorly defined. The faceted morphology is essentially the same as that observed in hydrogen-precharged Alloy 600 and within transgranular islands in hydrogen-precharged EN82H welds.⁽⁵⁾ In the latter, transgranular faceting was found to occur in localized ligaments that resist intergranular cracking. After the primary intergranular crack extends well beyond these ligaments, local stress intensities become large enough to nucleate separation along planar slip bands, thereby resulting in the crystallographic facets. Reference (5) concluded that hydrogen in the matrix promotes heterogeneous deformation and separation along planar slip bands, except when preempted by hydrogen-induced intergranular cracking.

Unlike the polygonal-shaped boundaries present in wrought metals, grain boundaries in the weld have a wavy or curved shape, as shown in Figures 4 and 5a. This undulating appearance, which is typical of an as-welded structure, results from impingement of dendritic colonies and inclusions pinning grain boundaries along interdendritic regions. The wavy morphology gives rise to the undulating nature of intergranular fracture in as-fabricated welds, as shown in Figure 2a.

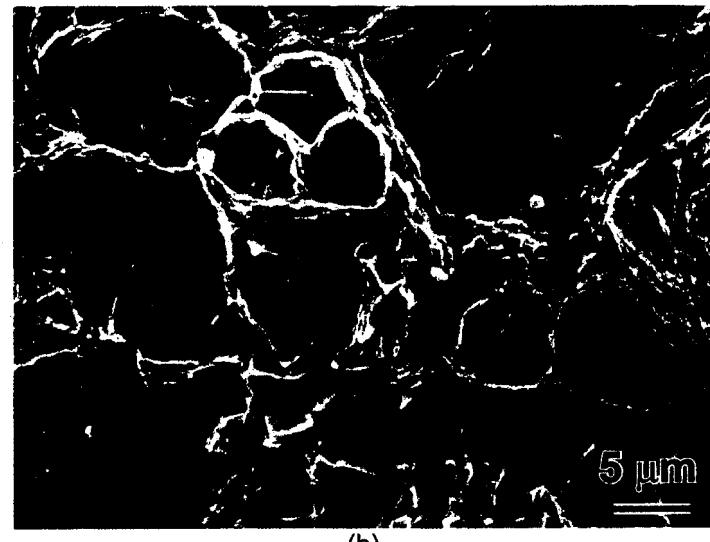
Figure 3. SEM fractographs of annealed and cold-rolled weld tested in 54°C water showing: (a) well-defined dimples and a few crystallographic facets steeply inclined to loading axis, and (b) high magnification of dimples.

It is noted that annealing at 1093°C alters the microstructure,⁽⁸⁾ as discussed later, and reduces the yield strength from 620 to 280 MPa. Because strength level affects local hydrogen concentrations and stresses ahead of crack tips, it is possible that the absence of intergranular cracking in the annealed weld may be due to reduced strength levels (rather than differences in grain boundary structure). To evaluate this possibility, fracture toughness tests were performed on a section of weld that was annealed and then cold-rolled so its yield strength (640 MPa) was comparable to that for the as-fabricated weld. Figure 1 shows that cold rolling causes a modest reduction in fracture toughness in air as J_{IC} is reduced from 955 kJ/m² after annealing to 381-567 kJ/m² after annealing and cold rolling. In a similar fashion, cold working reduces T from 674 to 133-150. This response is expected because increased strength levels restrict plastic deformation capabilities. Low temperature water is seen to have relatively little effect on the toughness of the annealed and cold-rolled weld, as both J_{IC} and T in 54°C water are reduced by only 20%. The fracture surface for the annealed and cold-rolled weld tested in water is predominantly dimple rupture with limited evidence of large, steeply inclined facets (Figure 3).

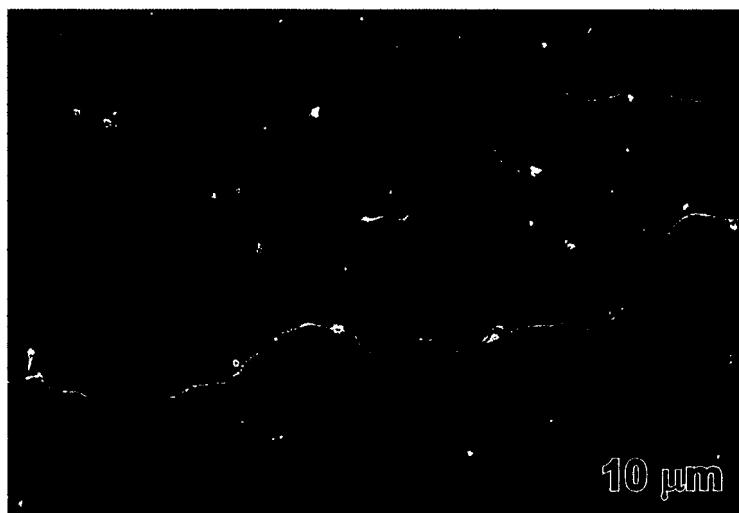
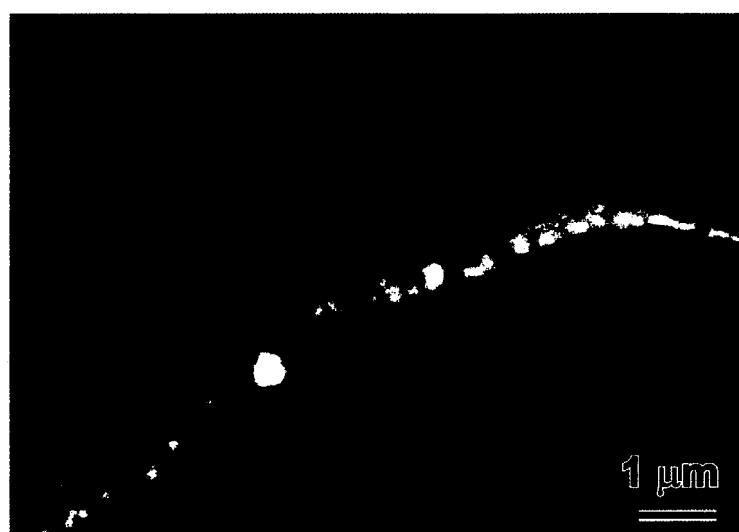
Figure 5. SEM micrographs of as-fabricated weld (etched). (a) Undulating nature of grain boundaries. TiN inclusions within interdendritic regions sometimes pin grain boundaries. (b) Clusters of fine Nb₃Ti(C,N) precipitates along shallow section of grain boundary.

As-fabricated weld – Figure 4 reveals that the as-fabricated weld exhibits well-defined grain boundaries separating colonies of similarly oriented dendrites. The grain structure is anisotropic, particularly in the weld root region where columnar grains are aligned normal to the welding direction. Numerous inclusions are observed in the interdendritic regions throughout the weld fusion zone (Figure 4b and 5a).

The SEM micrograph in Figure 5b also shows evidence of small, brightly-imaging precipitates decorating essentially all grain boundaries. These features appear to be agglomerated in this etched specimen.

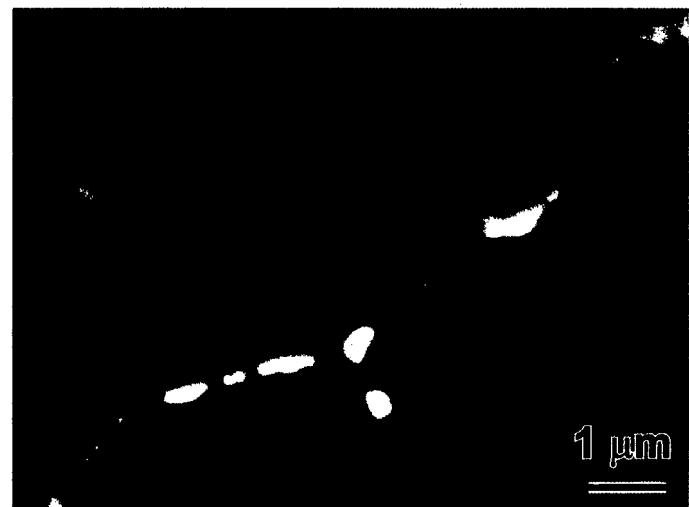
Figure 7. SEM micrographs of annealed weld. (a) Unrecrystallized region with undulating grain boundaries (right) and recrystallized region with annealing twins (left). (b) Coarsened precipitates decorate grain boundaries in unrecrystallized region.

Some regions of the annealed weld show what appears to be original grain boundaries (Figure 6b and 7a). In these regions, a columnar grain structure with wavy grain boundaries remains. Unrecrystallized grain boundaries in the annealed weld continue to exhibit coarsened intergranular precipitates, whereas no evidence of these precipitates is observed along recrystallized boundaries. Inclusions that formed in interdendritic regions are not dissolved during annealing as they are present in both the recrystallized and unrecrystallized regions.

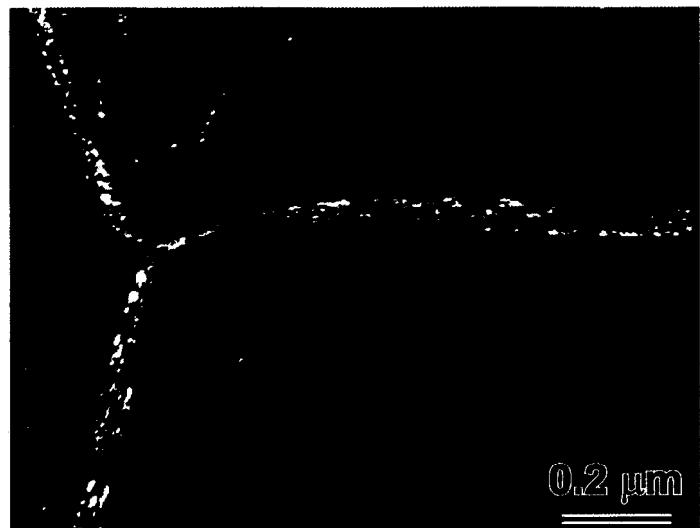
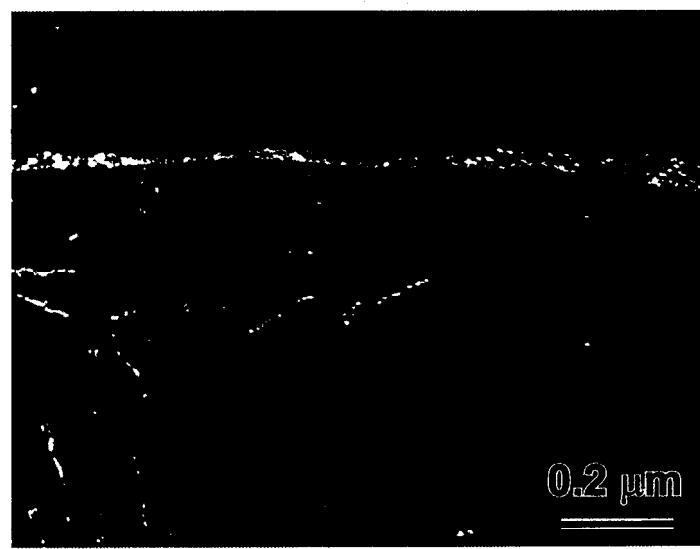
Figure 9. Dark-field transmission electron micrographs of as-fabricated weld showing (a) fine (3-16 nm) Nb,Ti(C,N) precipitates decorating grain boundaries, and (b) fine intergranular Nb,Ti(C,N) precipitates and discrete intragranular carbonitrides at pre-existing dislocations.

Detailed characterization of the grain boundaries revealed that most boundaries in the as-fabricated weld were decorated with fine face-centered cubic (fcc) MC-type carbonitrides ranging from 3 to 16 nm in size. STEM-EDS microanalysis confirmed that these precipitates were enriched in Nb and Ti. Figure 9 contains typical examples of the discrete intergranular M(C,N) precipitates, which are incoherent with the fcc matrix. In addition to the intergranular precipitates, a nonuniform distribution of fine M(C,N) precipitates was observed throughout the matrix. The size and distribution of these precipitates indicated that they had nucleated on pre-existing dislocations, as shown in Figure 9b. The AEM analysis also provided evidence of coarse ($\sim 1 \mu\text{m}$) TiN inclusions with AlMgSi-rich oxide inclusions. No Cr-rich M_{23}C_6 carbides or intergranular Cr depletion was detected in the weldment.

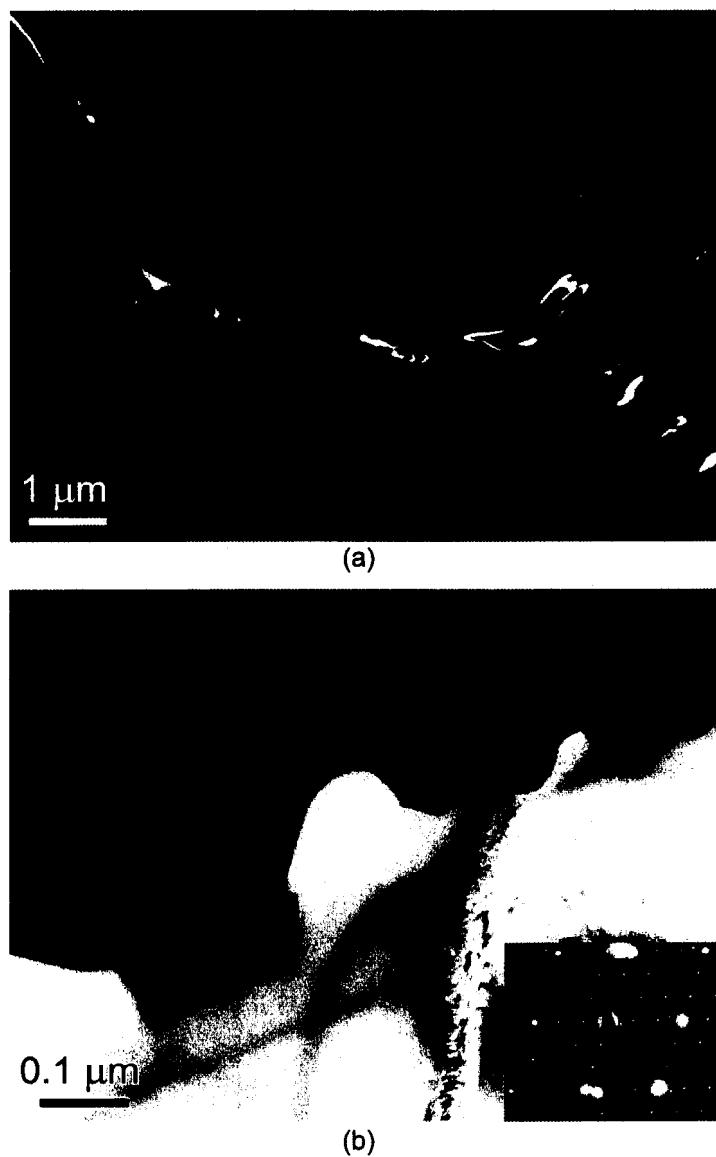
Figure 11. Intergranular carbide morphology for 1093°C annealed weld. (a) Secondary electron micrographs showing extensive M_7C_3 coverage of grain boundaries. (b) Transmission electron micrograph showing intergranular $M_{23}C_6$ carbides. Inset: [110] selected area electron diffraction pattern showing cube-on-cube orientation relationship between semicoherent $M_{23}C_6$ and fcc matrix.

Annealed weld – The 1093°C anneal resulted in a dramatic reduction in dislocation content, consistent with a fully recrystallized microstructure. Some planar arrays of dislocations were occasionally observed in the vicinity of coarse inclusions, as expected for an as-cooled structure. Figure 10 shows the typical recrystallized microstructure associated with the annealed weld. AEM characterization confirmed that the 1093°C anneal dissolved the vast majority of the fine inter- and intragranular carbonitrides that were present in the as-fabricated weld. This high-temperature anneal promoted the intergranular precipitation of Cr-rich M_7C_3 (Figure 11a), and $M_{23}C_6$ on some boundaries (Figure 11b). The fcc $M_{23}C_6$ carbides exhibited the well-known cube-cube orientation relationship with the fcc weld matrix, and were semicoherent with the matrix.

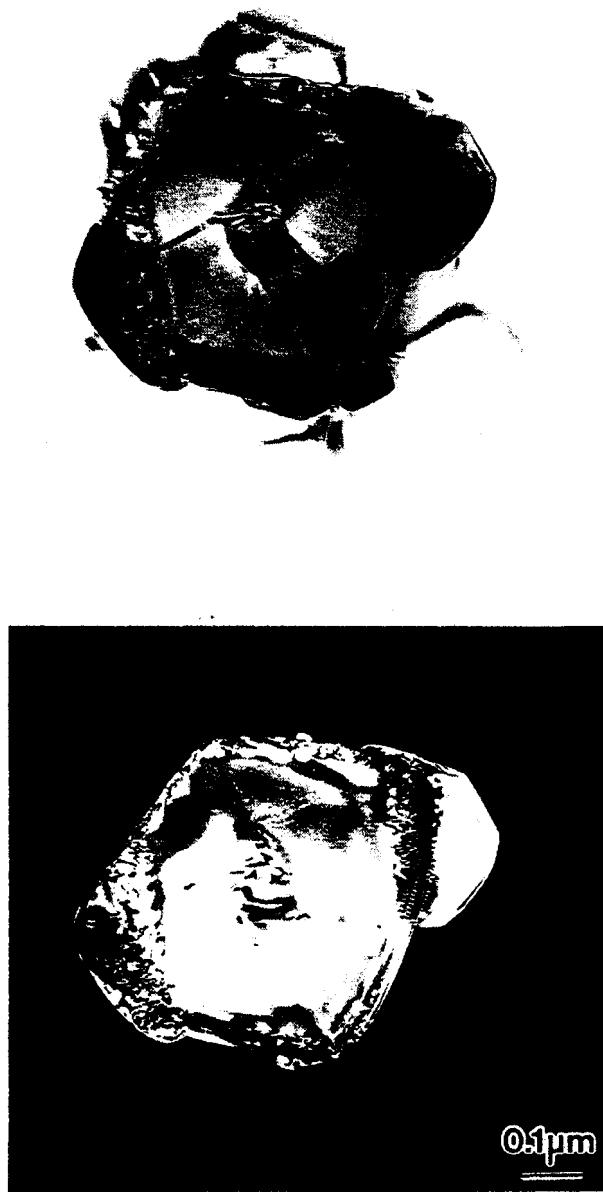
Figure 12. Transmission electron micrographs of multi-phase inclusion in annealed weld. (a) Bright-field and (b) dark-field images showing the AlMgSi-rich oxide inclusion core surrounded by a TiN inclusion that served as nucleation site for NbC precipitation.

AEM analysis showed that the pre-existing TiN and AlMgSi-rich oxide inclusions serve as heterogeneous nucleation sites for preferential precipitation of NbC during the 1093°C anneal and slow cool. Specifically, the AlMgSi-rich spheroidal oxide inclusions were observed to act as nucleation sites for the primary TiN inclusions, and appeared as a “core” within the TiN inclusions. During the 1093°C anneal and slow-cool, the Nb and Ti in solution formed the MC (predominantly NbC) carbides at the TiN/matrix interface. This resulted in the formation of the complex multi-phase inclusions shown in Figure 12. These inclusions were occasionally observed at grain boundaries, as they apparently pinned the migrating boundaries.

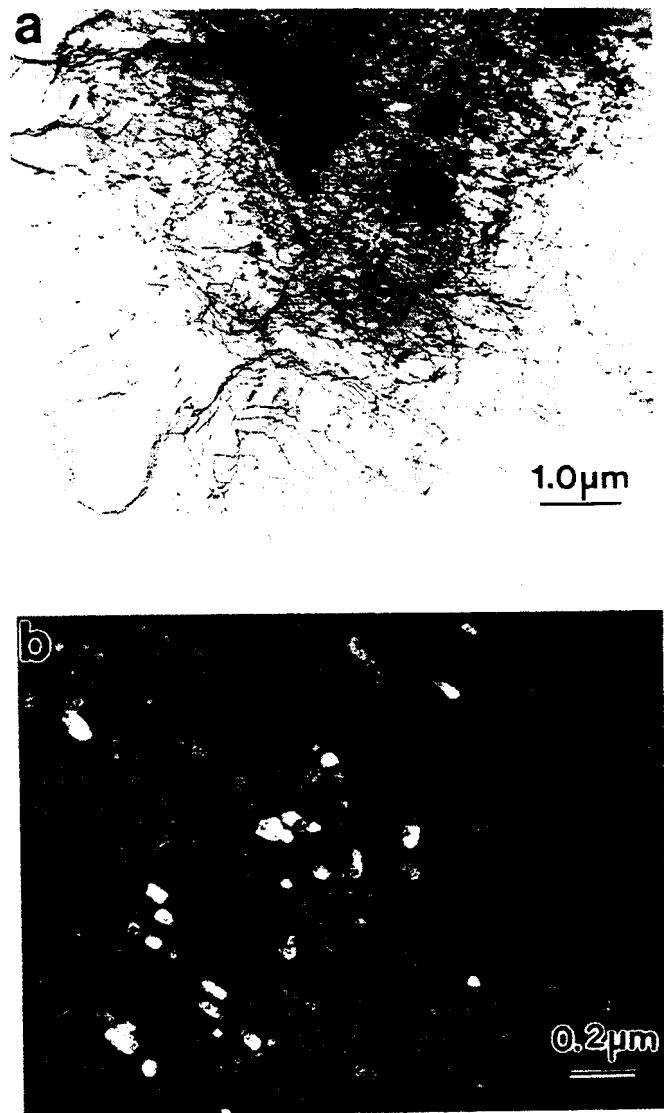
Figure 13. Transmission electron micrographs of an unrecrystallized region within annealed weld. (a) Bright-field image showing dislocation substructure in region with coarsened Nb-rich carbonitrides that inhibited recrystallization. (b) Dark-field image of the coarsened carbonitrides.

Some isolated regions were observed within the weld that had not recrystallized during the high-temperature anneal, as shown in Figure 13. These areas were characterized by an increased dislocation content and the presence of discrete Nb-rich carbonitrides that were notably coarser (up to 200 nm) than the ultra-fine carbonitrides present in the as-fabricated weld. The microstructure within these regions appeared to have experienced some degree of recovery of the heavily dislocated structure present in the as-welded condition, as evidenced by the presence of some subgrains.

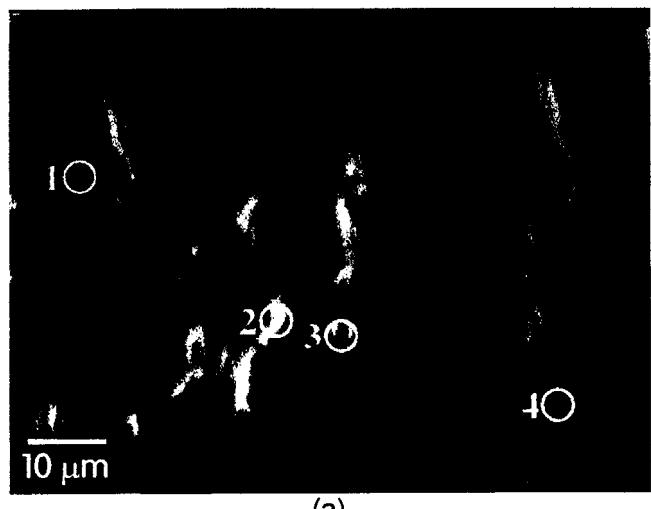
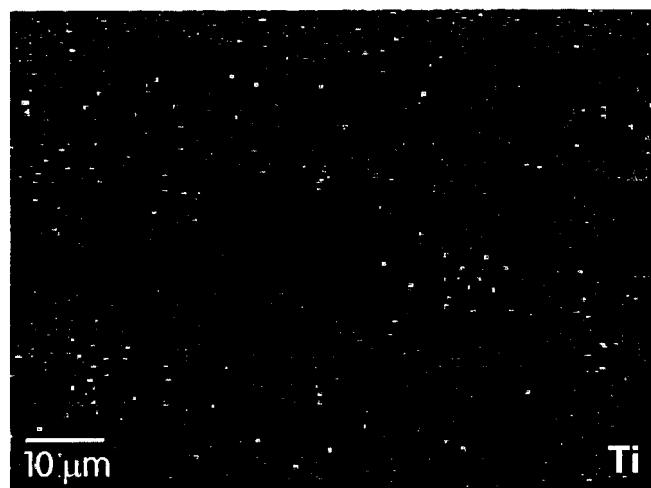
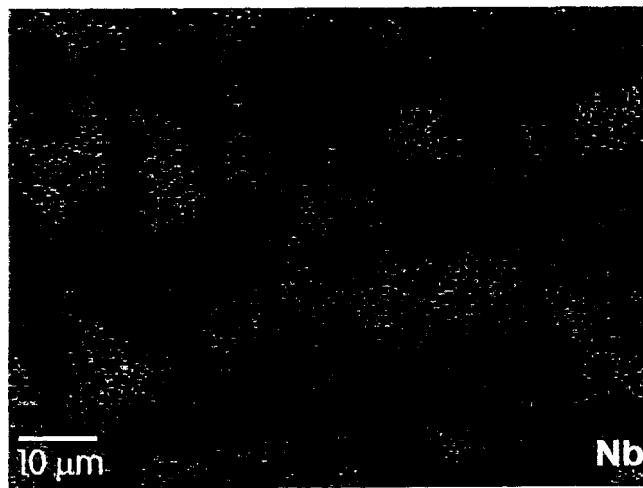
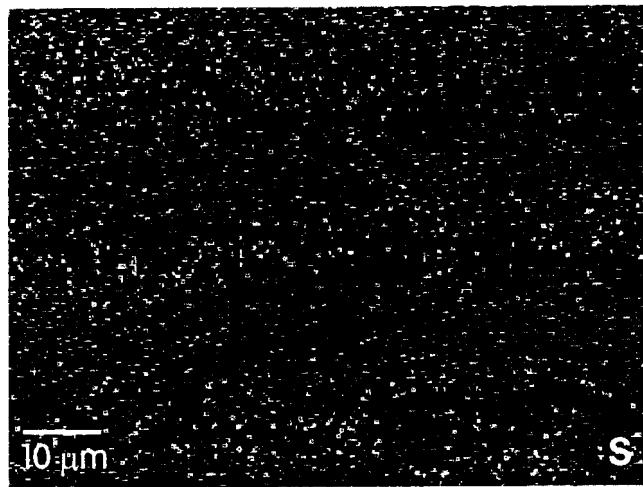
Figure 14. AES elemental distribution maps of as-fabricated weld. (a) Secondary electron fractograph showing intergranular fracture surface interrogated by AES. (b)-(f) Elemental distribution maps for carbon, titanium, niobium, chromium and sulfur.

AES spectra results in Table 2 together with the elemental distribution maps in Figure 14 show that grain boundaries in the as-fabricated weld are enriched in Nb, C and N (not mapped), consistent with AEM analysis showing the presence of fine intergranular niobium-rich carbonitrides. Table 2 reveals that there are two populations of grain boundaries, with some showing modest Nb and N enrichment (7.6 ± 2.4 a/o Nb, 1.5 ± 0.5 a/o N) and others showing greater enrichment (19.2 ± 2.0 a/o Nb, 2.5 ± 0.4 a/o N). The elemental maps indicate that grain boundaries with higher Nb enrichment also exhibit increased C enrichment. This boundary-to-boundary variability is consistent with grain boundaries being located in both interdendritic and intradendritic regions and varying densities of niobium-rich carbonitrides. In addition to Nb enrichment, Ti and Cr enrichments were also detected on some boundaries, suggesting that

The Ti-rich spots in Figure 14c correspond to TiN inclusions that form in the interdendritic regions and often pin grain boundaries. These intermediate-sized ($\sim 1 \mu\text{m}$ diameter) inclusions are not dissolved during annealing, but their morphology was changed. Specifically, Nb and C, as well as Ti and N, are present after annealing. This is consistent with the AEM analysis that clearly identified complex multi-phase inclusions in which the AlMgSi-rich oxide core serves as the nucleation site for TiN inclusions, which, in turn, serve as preferential nucleation sites for the NbC during the high-temperature anneal.

The S-rich regions found on grain boundaries correspond to MgS inclusions. Most grain boundaries contained a very limited number of sulfides (e.g., the map in Figure 14f shows a few sulfide particles), while a few boundaries exhibited a slightly higher density. Although annealing at 1093°C did not dissolve the MgS inclusions, relatively few were observed at grain boundaries due to boundary migration.
