**Title and Subtitle:** Cold Work Embrittlement of Interstitial Free Steel

**Authors:** Pierre Martin and John T. Bowker

Materials Technology Laboratories (MTL)  
Canada Centre for Mineral and Energy Technology (CANMET)  
568 Booth Street  
Ottawa, Ontario K1A 0G1  
Canada

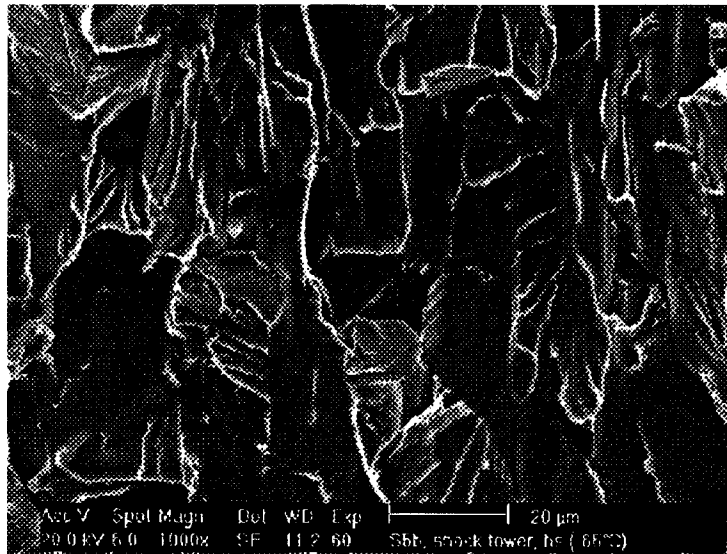
Figure 62. Fracture surface of shock tower parts after localized testing of steel S5b.

a) Fracture surface in an area with 50-60% strain, specimen fractured at -80°C

b) Fracture surface in an area with 70-80% strain, specimen fractured at -65°C
