ELIMINATING A MAJOR CAUSE OF WIRE DRAWING BREAKAGE
IN A-15 HIGH-FIELD SUPERCONDUCTORS

Final Report

A. R. Austen

**Innovare, Inc.
Bath, PA, 18014**

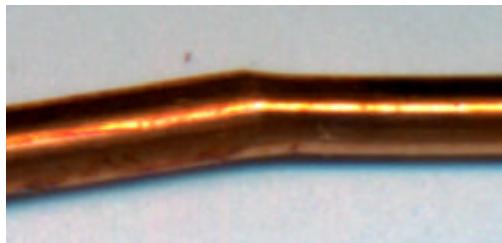
Figure 1(a). Magnification: 6X

In Figure 1(a)&(b).., to the left, the 0.072" diameter wire was entering the die from the left so the product [which broke about 0.5" from the die] was being pulled in alignment with the die axis and the unguided wire entered the die at an angle to the die axis. The wire drawing was done at Outokumpu.

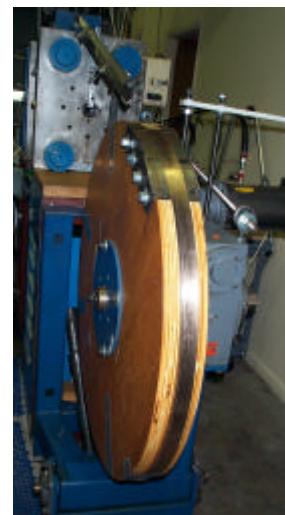
Figure 9.

In Figure 9., the steel cylinder with block end closures holds the drawing die and guide dies while the brass cylinder in the wire inlet side houses the lubricant application system. When high pressure stiffening is used, pressurized lubricant enters through the fitting at the top of the wire guidance unit.

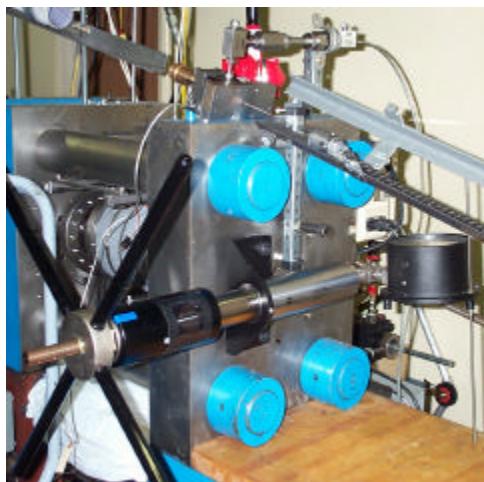
The pressure for the high pressure straightening guide was generated by a hand operated pressure generator mounted on the press platen as shown in the photograph, Figure 10. The schematic drawing, Figure 11., shows the basic components of the system. The system worked well in the 24 trials that were made with high pressure straightening.

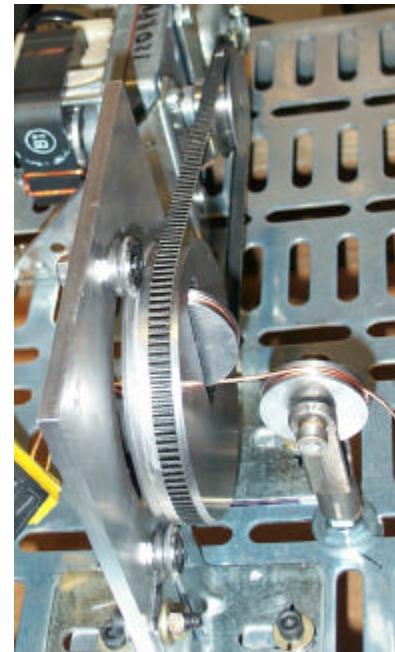
Figure 13.

Various methods were evaluated for managing the residual stress pattern including torsional flexing of the wire using an apparatus [shown in Figure 13] that twisted and untwisted the wire as it passes through the apparatus. While this operation did reduce the residual stresses significantly, it had to be applied frequently since the residual stress pattern built up again during drawing. While it was effective in extending the drawing reductions before the onset of the defect formation, it wasn't sufficiently
