Nevada
Environmental
Restoration
Project

DOE/NV--919

Closure Report for Corrective
Action Unit 346: Areas 8, 10
Housekeeping Sites, Nevada Test
Site, Nevada

August 2003

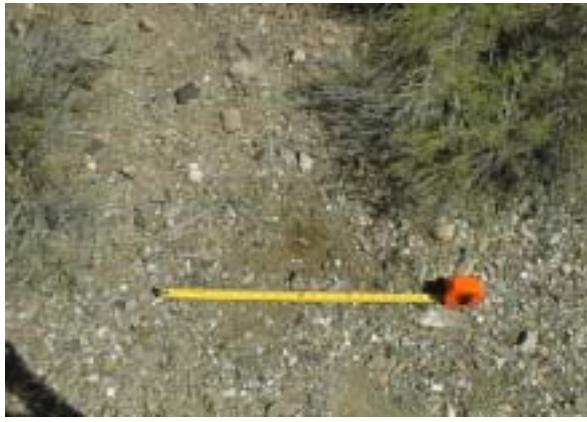
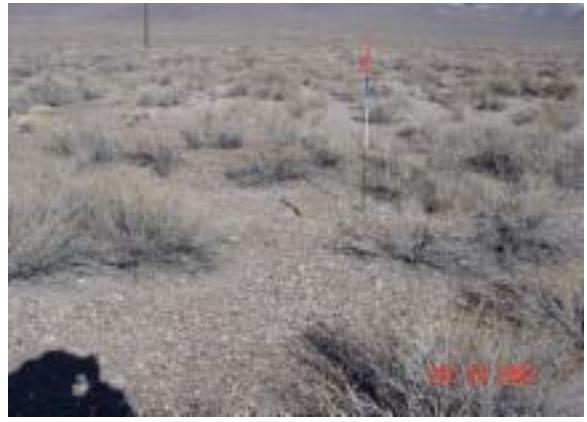
Waste Item(s) Originally at Site	Apparent Waste Type*
Two drums	None - waste previously removed.

Housekeeping Site As Identified (taken 8/20/2002)	Housekeeping Site During BN Site Visit (taken 12/23/2002)

Current Site Description/Observations: The waste had been previously removed from the site.

The drums originally identified in the FFACO were not present at the time of the Preliminary Assessment (PA) or during the subsequent BN ER site visit (IT, 2002). The original waste site was located near a mud pit associated with the four craters remaining from the U8d crater area and outlying post-shot holes from the 1970 "Baneberry" test (U.S. Department of Energy, Nevada Operations Office [DOE/NV], 2000). Site closure was documented with photographs and field notes. No further action is required at this site.

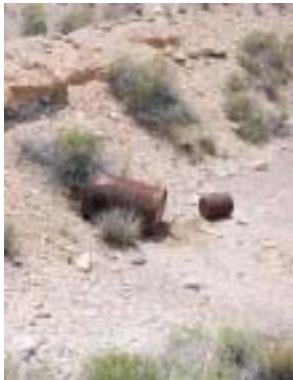
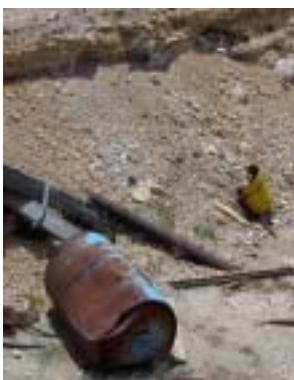
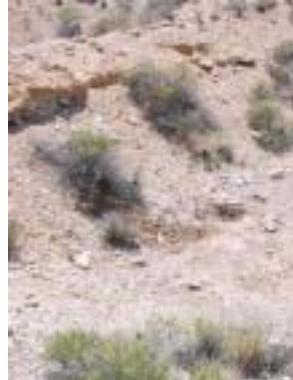
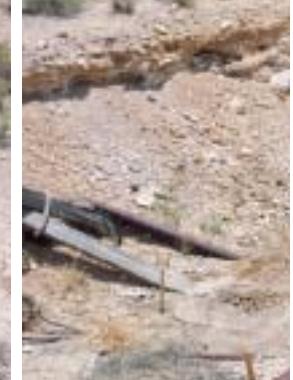
Waste Item(s) Originally at Site	Apparent Waste Type*
Drums, buckets	Ordinary
* Ordinary, Scrap Metal, Asbestos, PCB, Salvageable, Hazardous, Radioactive, Mixed, Unknown, Other

Housekeeping Before Closure (taken 5/30/2003)	Housekeeping Site After Closure (taken 5/30/2003)

Current Site Description/Observations: The empty drums and buckets were disposed of at the Area 9 U10c Landfill.

Three empty buckets and two empty drums were located in two mud pits associated with the U8d crater area and outlying post-shot holes from the 1970 "Baneberry" test (DOE/NV, 2000). Previous soil sampling results from the PA indicated the presence of diesel range petroleum hydrocarbons above the Nevada State Action Level (Nevada Administrative Code [NAC], 2003) in the northern mud pit known as Mud Pit B (IT, 2002). Mud Pit B is part of CAS 08-09-03 which is currently included in CAU 357 and scheduled for remediation later in 2003. The housekeeping waste was removed from the mud pits. However, soil samples were not collected, as the diesel range TPH in the soil will be addressed as part of CAU 357 closure activities. All CAU 346 closure activities were documented with photographs and field notes. Clean closure of the housekeeping portion of this site was verified by visual inspection. Verification samples were not required or collected. No further actions relating to CAU 346 are required at this site.

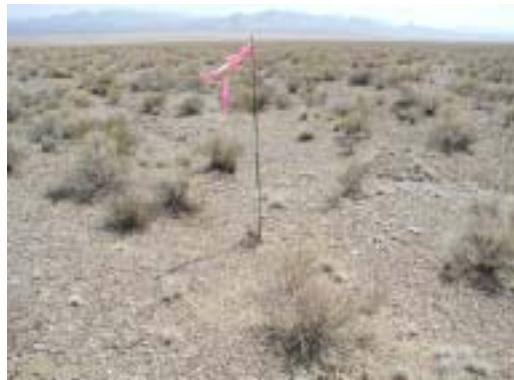
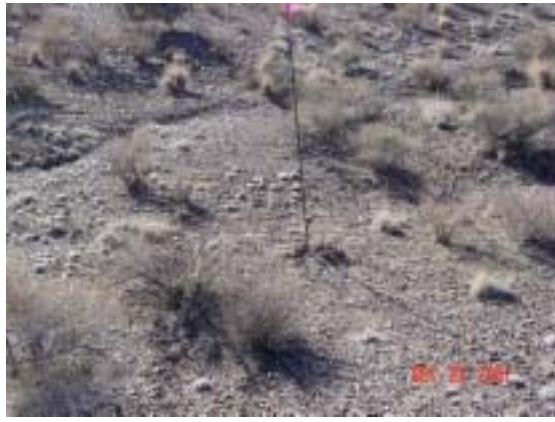
Waste Item(s) Originally at Site	Apparent Waste Type*
Battery	None - waste previously removed.

Housekeeping Site As Identified (taken 8/20/2002)	Housekeeping Site During BN Site Visit (taken 12/23/2002)

Current Site Description/Observations: The waste had been previously removed from the site.

The battery originally identified in the FFACO was not present at the time of the PA or during the subsequent BN ER site visit (IT, 2002). The original waste site was located north of the four craters (U10am1 through U10am4) remaining from the 1969 "Tun-A" through "Tun-D" detonations (DOE/NV, 2000). Site closure was documented with photographs and field notes. No further action is required at this site.

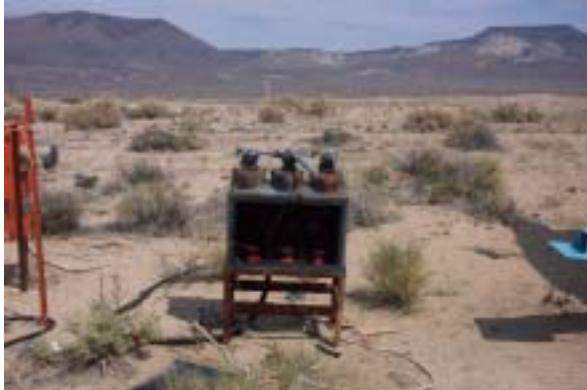
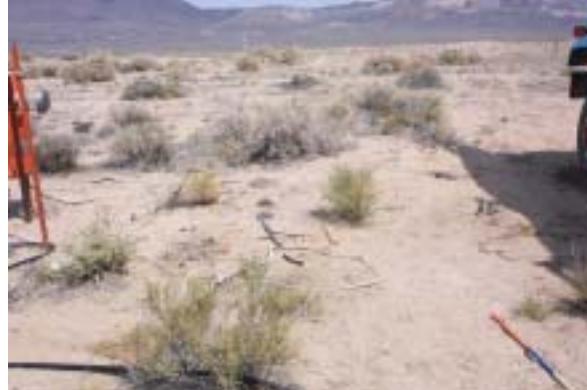
Waste Item(s) Originally at Site	Apparent Waste Type*
Oil-Filled Circuit Breaker	Salvageable

Housekeeping Before Closure (taken 7/16/2003)	Housekeeping Site After Closure (taken 7/16/2003)

Current Site Description/Observations: The circuit breaker was salvaged by Site Utilities.

An oil-filled circuit breaker was located directly south of the U10cb crater from the 1984 “Normanna test (DOE/NV, 2000). The circuit breaker contained three oil reservoirs that were sampled and showed to contain a maximum of 1.9 parts per million PCBs. This classified the circuit breaker as non-PCB electrical equipment as defined by Title 40, Code of Federal Regulation (CFR) Part 761 (CFR, 2002). The circuit breaker was sprayed and cleaned to address Hanta virus concerns and was removed from the site for recycling/disposal. All closure activities were documented with photographs and field notes. Clean closure of this site was verified by visual inspection. Verification samples were not required or collected. No further action is required at this site.

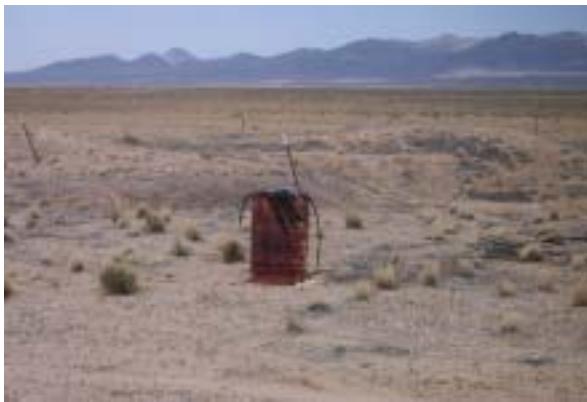
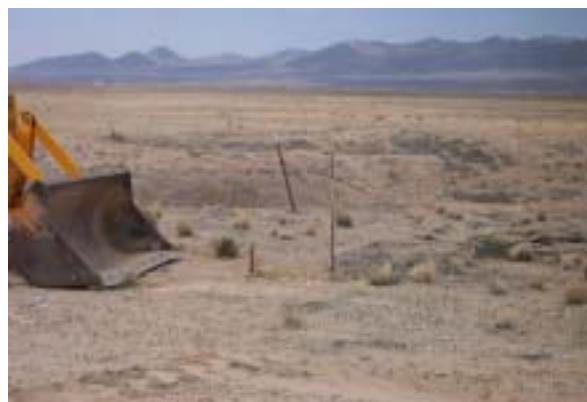
Waste Item(s) Originally at Site	Apparent Waste Type*
55-Gallon Drum Gas Block	Ordinary

Housekeeping Before Closure (taken 5/30/2003)	Housekeeping Site After Closure (taken 5/30/2003)

Current Site Description/Observations: The drum gas block was disposed of in the Area 9 U10c Landfill.

One gas block drum was located at the site near the crater from the 1966 “Vigil and “Rovenna tests (DOE/NV, 2000). During the PA a surface soil sample was collected adjacent to the west side of the drum and analytical results showed no COC were present in the soil (IT, 2002). The drum was filled with solidified grout and 27 cables of various sizes were protruding from it. Each of the cables was cut and screened for radioactivity. After the drum was released it was disposed of at the Area 9 U10c Landfill. All closure activities were documented with photographs and field notes. Clean closure of this site was verified by visual inspection. Verification samples were not required or collected. No further actions are required at this site.

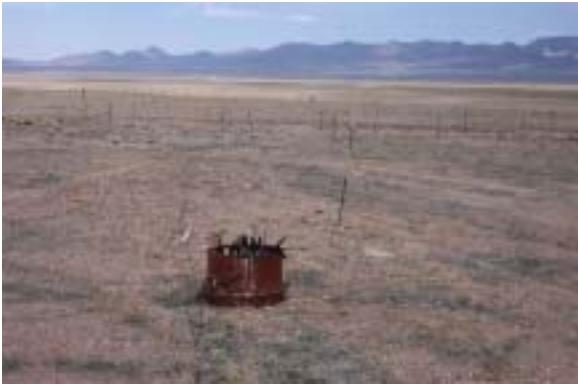
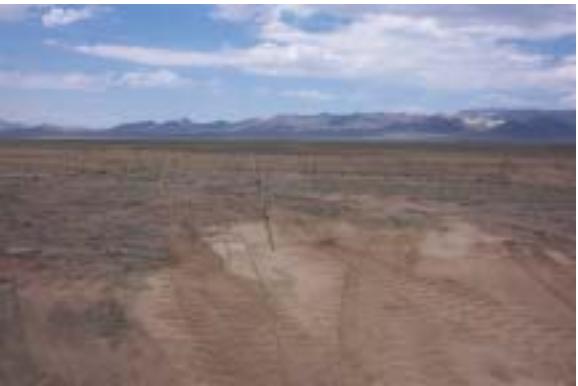
Waste Item(s) Originally at Site	Apparent Waste Type*
55-Gallon Drum Gas Block	Ordinary

Housekeeping Before Closure (taken 5/30/2003)	Housekeeping Site After Closure (taken 5/30/2003)

Current Site Description/Observations: The drum gas block was disposed of in the Area 9 U10c Landfill.

One partially buried gas block drum was located at the site southwest of the crater from the 1968 “Tub-A and “Tub-F detonations (DOE/NV, 2000). During the PA a surface soil sample was collected adjacent to the south side of the buried drum and analytical results showed no COC were present in the soil (IT, 2002). The drum was filled with solidified grout and 26 cables of various sizes were protruding from it. Each of the cables was cut and screened for radioactivity. After the drum was released it was disposed of at the Area 9 U10c Landfill. All closure activities were documented with photographs and field notes. Clean closure of this site was verified by visual inspection; no verification samples were required or collected. No further actions are required at this site.

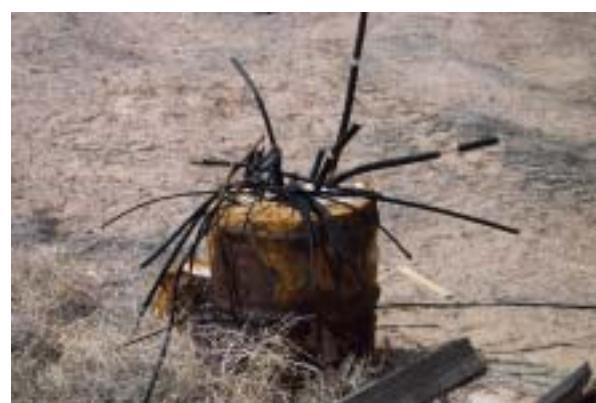
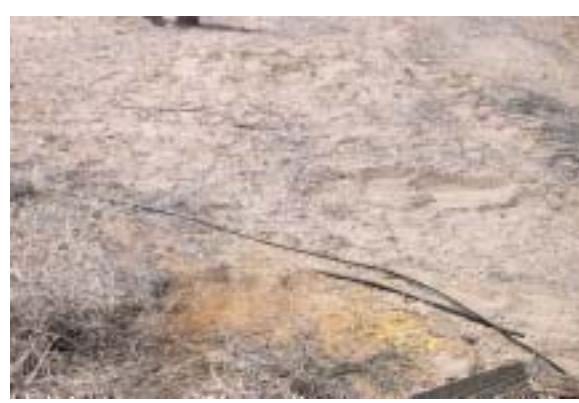
Waste Item(s) Originally at Site	Apparent Waste Type*
55-Gallon Drum Gas Block	Ordinary

Housekeeping Before Closure (taken 5/30/2003)	Housekeeping Site After Closure (taken 5/30/2003)
--	--

Current Site Description/Observations: The drum gas block was disposed of in the Area 9 U10c Landfill.

One gas block drum was located at the site near the a post-shot hole associated with the 1968 “Tub-C detonation (DOE/NV, 2000). During the PA a surface soil sample was collected immediately south of the drum and analytical results showed no COC were present in the soil (IT, 2002). The drum was filled with solidified grout and 21 cables of various sizes were protruding from it. Each of the cables was cut and screened for radioactivity. After the drum was released it was disposed of at the Area 9 U10c Landfill. All closure activities were documented with photographs and field notes. Clean closure of this site was verified by visual inspection. Verification samples were not required or collected. No further actions are required at this site.

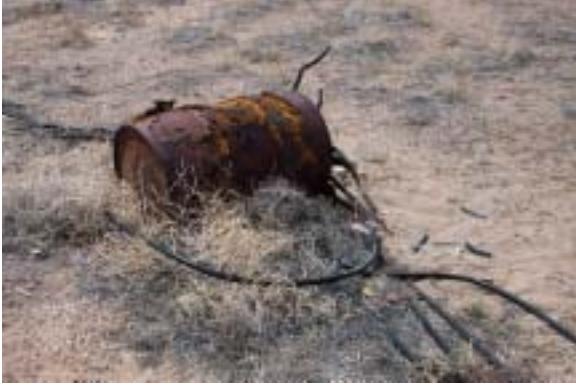
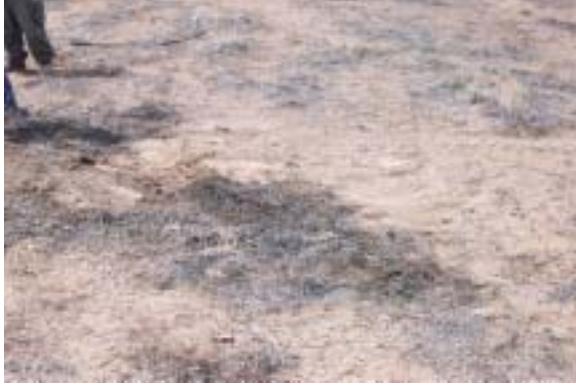
Waste Item(s) Originally at Site	Apparent Waste Type*
55-Gallon Drum Gas Block	Ordinary

Housekeeping Before Closure (taken 5/30/2003)	Housekeeping Site After Closure (taken 5/30/2003)

Current Site Description/Observations: The drum gas block was disposed of in the Area 9 U10c Landfill.

One gas block drum was located at the site near the a post-shot hole associated with the 1968 “Tub-C detonation (DOE/NV, 2000). During the PA a surface soil sample was collected adjacent to the south side of the drum and analytical results showed no COC were present in the soil (IT, 2002). The drum was filled with solidified grout and 23 cables of various sizes were protruding from it. Each of the cables was cut and screened for radioactivity. After the drum was released it was disposed of at the Area 9 U10c Landfill. All closure activities were documented with photographs and field notes. Clean closure of this site was verified by visual inspection. Verification samples were not required or collected. No further actions are required at this site.

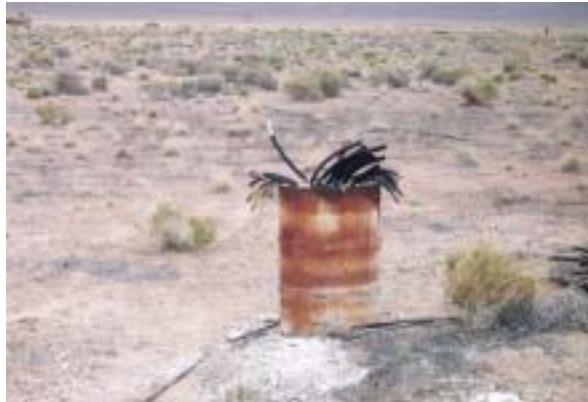
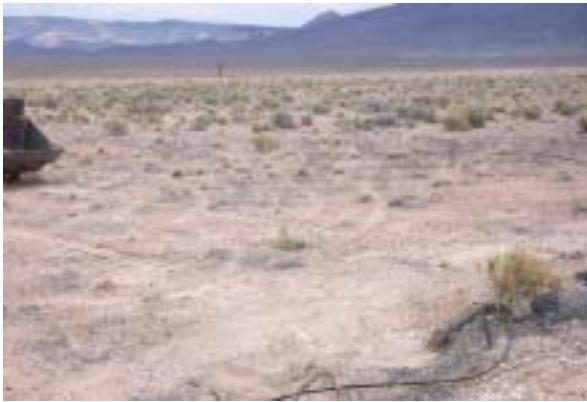
Waste Item(s) Originally at Site	Apparent Waste Type*
55-Gallon Drum Gas Block	Ordinary

Housekeeping Before Closure (taken 5/30/2003)	Housekeeping Site After Closure (taken 5/30/2003)

Current Site Description/Observations: The drum gas block was disposed of in the Area 9 U10c Landfill.

One gas block drum was located at the site directly north of the crater associated with the 1966 “Reo test (DOE/NV, 2000). The drum was filled with solidified grout and 52 cables of various sizes were protruding from it. Each of the cables was cut and screened for radioactivity. After the drum was released it was disposed of at the Area 9 U10c Landfill. All closure activities were documented with photographs and field notes. Clean closure of this site was verified by visual inspection. Verification samples were not required or collected. No further actions are required at this site.

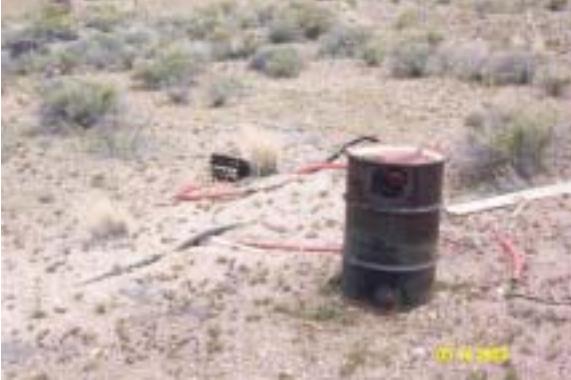
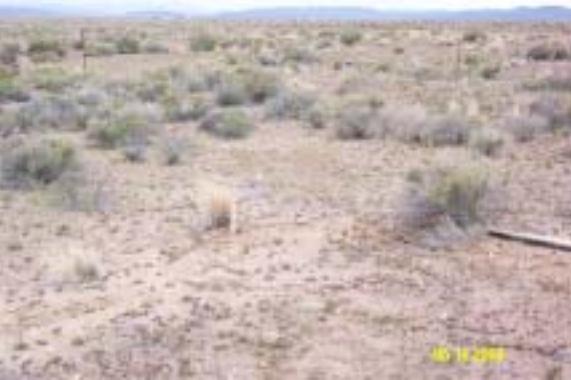
Waste Item(s) Originally at Site	Apparent Waste Type*
40-Gallon Drum	Ordinary

Housekeeping Before Closure (taken 8/20/2002)	Housekeeping Site After Closure (taken 5/30/2003)

Current Site Description/Observations: The drum was disposed of in the Area 9 U10c Landfill.

One 151-L (40-gal) drum filled with dehumidifying crystals was located between the two craters (U10am3 and U10am4) associated with the 1969 “Tun-C and “Tun-D detonations (DOE/NV, 2000). During the PA a surface soil sample was collected beneath the drum and analytical results showed no COC were present in the soil (IT, 2002). The drum was screened for radioactivity. After the drum was released it was disposed of at the Area 9 U10c Landfill. All closure activities were documented with photographs and field notes. Clean closure of this site was verified by visual inspection. Verification samples were not required or collected. No further actions are required at this site.

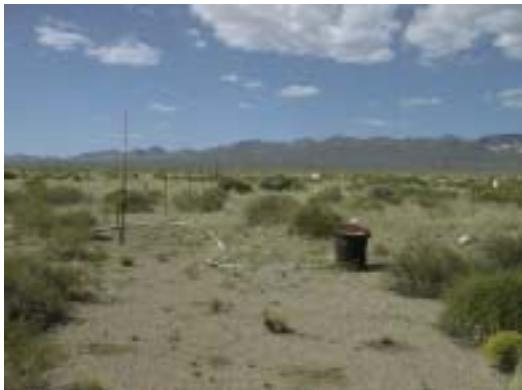
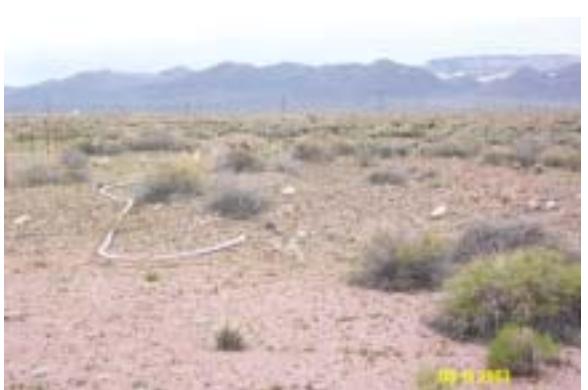
Waste Item(s) Originally at Site	Apparent Waste Type*
40-Gallon Drum	Ordinary

Housekeeping As Identified (taken 8/20/2002)	Housekeeping Site After Closure (taken 5/30/2003)

Current Site Description/Observations: The drum was disposed of in the Area 9 U10c Landfill.

One 151-L (40-gal) drum filled with dehumidifying crystals was located between the two craters (U10am1 and U10am2) associated with the 1969 “Tun-A and “Tun-B detonations (DOE/NV, 2000). During the PA a surface soil sample was collected beneath the drum and analytical results showed no COC were present in the soil (IT, 2002). The drum was screened for radioactivity. After the drum was released it was disposed of at the Area 9 U10c Landfill. All closure activities were documented with photographs and field notes. Clean closure of this site was verified by visual inspection. Verification samples were not required or collected. No further actions are required at this site.

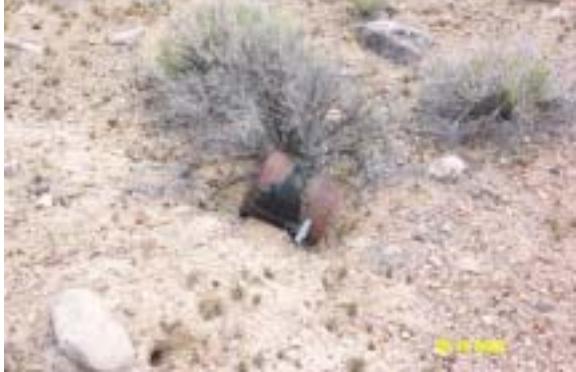
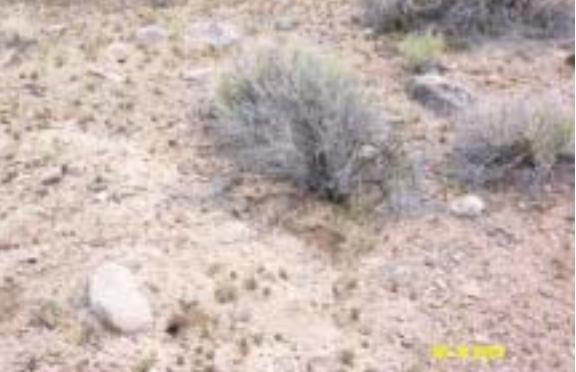
Waste Item(s) Originally at Site	Apparent Waste Type*
Empty one-gallon Paint Can	Ordinary
* Ordinary, Scrap Metal, Asbestos, PCB, Salvageable, Hazardous, Radioactive, Mixed, Unknown, Other

Housekeeping Before Closure (taken 5/30/2003)	Housekeeping Site After Closure (taken 5/30/2003)

Current Site Description/Observations: The can was disposed of in the Area 9 U10c Landfill.

One empty paint can was located at the site to the south of the crater area from the 1969 “Tun-A through “Tun-D detonations (DOE/NV, 2000). During the PA a surface soil sample was collected beneath the paint can and analytical results showed no COC were present in the soil (IT, 2002). The empty can was removed from the site and disposed of at the Area 9 U10c Landfill. All closure activities were documented with photographs and field notes. Clean closure of this site was verified by visual inspection. Verification samples were not required or collected. No further actions are required at this site.

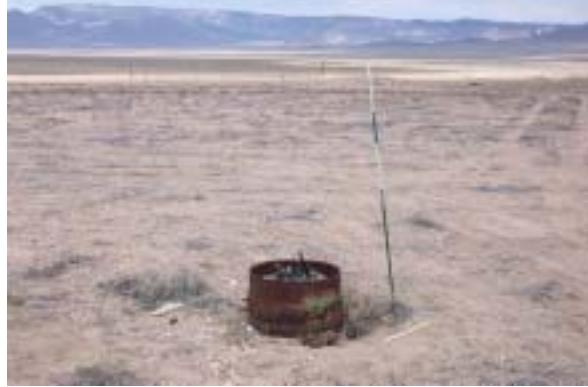
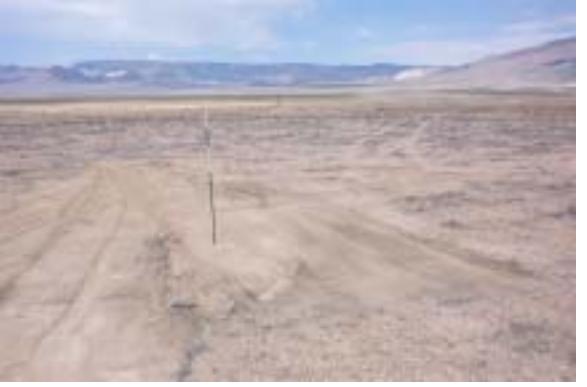
Waste Item(s) Originally at Site	Apparent Waste Type*
55-Gallon Drum Gas Block	Ordinary
* Ordinary, Scrap Metal, Asbestos, PCB, Salvageable, Hazardous, Radioactive, Mixed, Unknown, Other

Housekeeping Before Closure (taken 5/30/2003)	Housekeeping Site After Closure (taken 5/30/2003)

Current Site Description/Observations: The drum gas block was disposed of in the Area 9 U10c Landfill.

One partially buried gas block drum was located to the north of the U10ajf crater associated with the 1968 “Tub-C detonation (DOE/NV, 2000). During the PA a surface soil sample was collected adjacent to the east side of the drum and analytical results showed no COC were present in the soil (IT, 2002). The drum was filled with solidified grout and 14 cables of various sizes were protruding from it. Each of the cables was cut and screened for radioactivity. After the drum was released it was disposed of at the Area 9 U10c Landfill. All closure activities were documented with photographs and field notes. Clean closure of this site was verified by visual inspection. Verification samples were not required or collected. No further actions are required at this site.
