## Laboratory Evaluation of an Electrochemical Noise System for Detection of Localized and General Corrosion of Natural Gas Transmission Pipelines

Sophie J. Bullard, Bernard S. Covino, Jr., James H. Russell, Gordon R. Holcomb,  
Stephen D. Cramer, and Margaret Ziomek-Moroz  
Albany Research Center  
U.S. Department of Energy  
Albany, OR

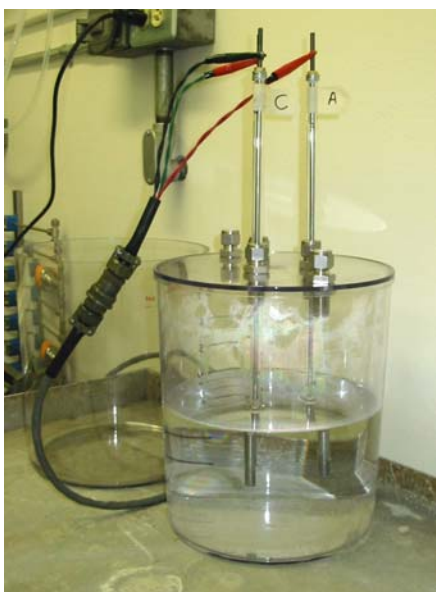
Figure 1- Test cell for aqueous solutions with three electrodes.

The electrochemical tests for measuring the corrosion of gas transmission pipeline metal in aqueous solutions typical of those found within gas pipelines were performed in the corrosion cell shown in Figure 1. Two lexan containers sealed with silicone were used; one for the corrosion cell (Figure 1) and one for a trap to minimize carry-over of liquid in the off-gas stream. In a previous study<sup>6</sup>, where the internal corrosion behavior of gas transmission pipeline material was measured in solutions representative of those found in the field, analyses showed that these solutions contained chloride in the form of calcium, potassium, magnesium and sodium chlorides. The  $\text{Cl}^-$  concentration ranged from approximately 0.006 wt % to 0.13 wt %. For the aqueous electrochemical tests, the solution used was 3.5 wt %  $\text{NaCl}$  solution (a standard laboratory solution) with 1000 mL/min  $\text{N}_2$ , 0-2 mL/min  $\text{O}_2$  and 0-10 mL/min  $\text{CO}_2$ . The test was performed at room temperature.

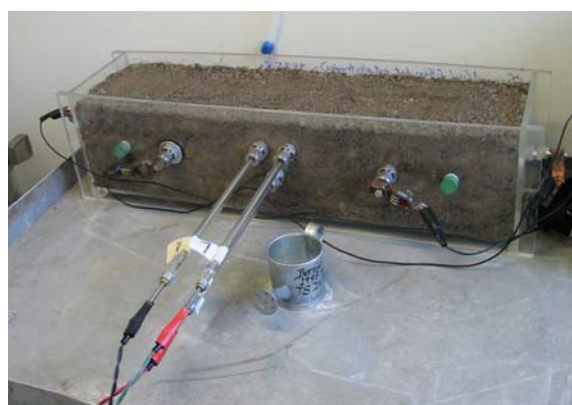
Figure 2- Soil test cell with three electrochemical electrodes and four electrodes for soil resistivity.

For measuring the external corrosion of gas transmission pipelines, electrochemical noise tests were performed in soil. The test cell (Figure 2) was a typical soil box as specified in ASTM G57, "Field Measurement of Soil Resistivity Using the Wenner Four-Electrode Method." Three cylindrical electrodes of X42 gas transmission pipeline steel were inserted into the soil box as the corrosion sensors

and four stainless steel electrodes were inserted for measuring soil resistivity. The soil resistivity was measured on a daily basis and the pH measured before and after each test.

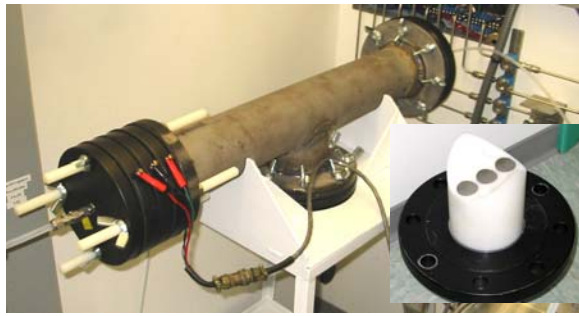
Figure 3 – Pipeline test cell with three flange electrodes and three disc electrodes (inset) in the side arm.

For measuring the internal corrosion of gas transmission pipelines in simulated internal gas/liquid pipeline environments, electrochemical measurements were performed in a pipeline cell. The apparatus for this phase of the research consisted of a section of X42 gas transmission pipe that contained two different sensor configurations (Figure 3). The first sensor configuration consisted of three insulated carbon steel flanges in series with the pipe. The chemical composition of the flange electrodes is shown in Table 1. The flange electrodes were cleaned and degreased and the surface area left as received. The total exposed area was  $60.76 \text{ cm}^2$ . The second sensor configuration consisted of three solid disc electrodes (Figure 3 inset) inserted at the bottom of the pipe in a tee adapter. The material used to make these electrodes was No. 12, Grade A615 rebar. The exposed area was  $6.48 \text{ cm}^2$ . The disc electrodes were finished to 600 grit with SiC paper. Prior to the test the disc electrodes were cleaned and degreased in methanol. The electrochemical noise experiment was performed in an environment that consisted of water saturated 1000 mL/min  $\text{N}_2/0$ , 5, and 10 mL/min  $\text{CO}_2/0$ , 2, and 4 mL/min  $\text{O}_2$  gas phase and 800 mL of 3.5 wt % NaCl added over time.

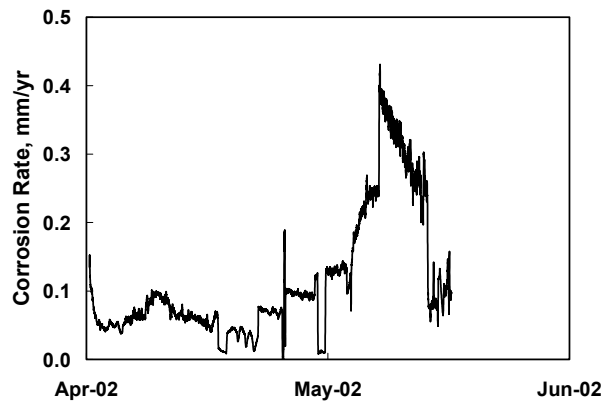
Figure 5- EN Corrosion rate of X42 transmission pipeline electrode in 3.5 wt % NaCl aqueous solution.

The X42 gas transmission pipe cylindrical electrodes were exposed to a 3.5 wt % NaCl solution for 6 weeks. Figure 5 shows the EN corrosion rate as a function of time. The EN corrosion rate stayed at 0.1 mmpy for a month, rose briefly to 0.4 mmpy, then dropped back to 0.1 mmpy. During this 6 weeks period,  $\text{O}_2$  and  $\text{CO}_2$  levels were varied and responsible for these changes in corrosion rate. Figure 6

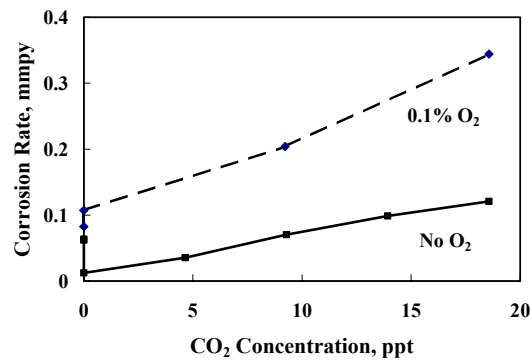
Figure 6 – The effect of O<sub>2</sub> and CO<sub>2</sub> on the corrosion rate of X42 transmission pipeline electrode in 3.5 wt % NaCl aqueous solution.

shows the same EN corrosion rates plotted as a function of O<sub>2</sub> and CO<sub>2</sub> concentration. The results showed that O<sub>2</sub> concentrations increased the corrosion rates as did increasing the CO<sub>2</sub> concentration.

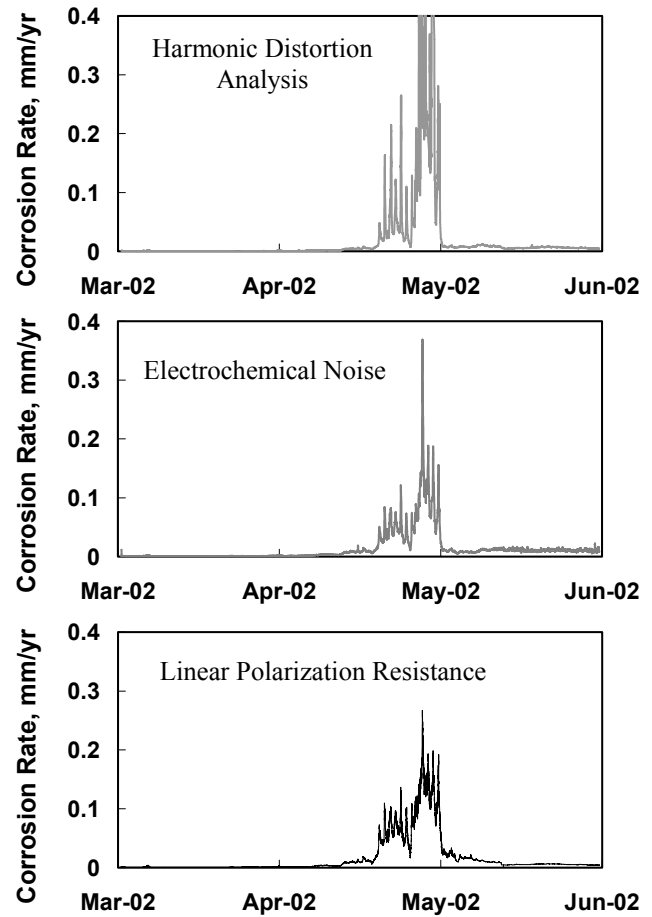
Figure 4 – Comparison of corrosion rates from harmonic distortion analysis, electrochemical noise, and linear polarization resistance measurements.

The instrument used in this research has multi-technique capabilities for combined electrochemical monitoring. The comparison of the corrosion rates determined from harmonic distortion analysis, electrochemical noise, and linear polarization measurements of the cylindrical electrodes in soil is shown in Figure 4. There was good agreement between the three techniques.

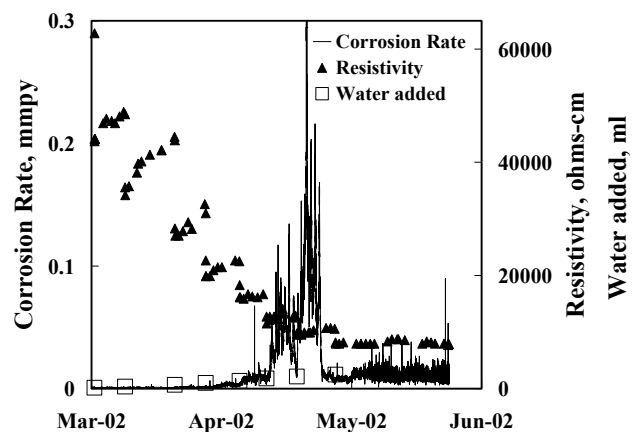
Figure 7 – Effect of resistivity and water on the corrosion rate of X42 transmission pipeline electrodes in “as received” soil. The squares represent mL of water added. The triangles represent the resistivity of the soil.

The corrosion rate of the X42 gas transmission pipeline steel cylindrical electrodes in “as received” soil, mL of water added, and the resistivity of the soil as a function of time is shown in Figure 7. For soil to be corrosive there must be: oxygen, moisture, and soluble salts<sup>6</sup>. Table 2 shows the moisture and salt contents before and after the tests. In the “as received” soil experiment, as 2488 mL (16 wt %) of additional water was added to the soil over a period of 2.5 months, the resistivity decreased from relatively less corrosive<sup>6</sup> (> 60,000 ohms-cm) to moderately corrosive<sup>6</sup> (8000 ohms-cm). Figure 7 shows that beginning at 1028 mL (8 wt %) added water and a resistivity of 10,000 ohms-cm, the corrosion rate increased to 0.15 mmpy. At 2488 mL (16 wt %) additional water and a resistivity of 8000 ohm-cm, the corrosion rate decreased to <0.01 mmpy, possibly due to the lack of availability of oxygen in the water-saturated soil.

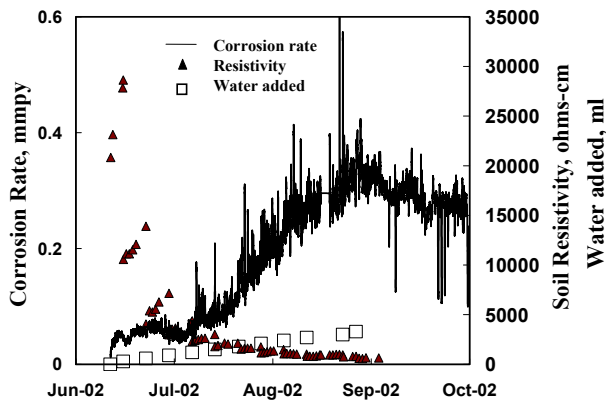
Figure 8 – Effect of resistivity and water on the corrosion rate of X42 transmission pipeline electrodes in soil + 1 wt % NaCl. The squares represent the mL of water added. The triangles represent the resistivity of the soil.

Figure 8 shows the corrosion rate of the X42 gas transmission pipe cylindrical electrodes in soil +1 wt % NaCl, and the mL of water added, and the resistivity of the soil as a function of time. In this environment, after the addition of only 300 mL (2 wt %) additional water, the resistivity dropped from 35,000 to 10,000 ohms-cm and the corrosion rates began increasing. At approximately 2400 mL (~16 wt %) of added water, the resistivity dropped to 1000 ohms-cm and the corrosion rates became constant possibly due to the lack of availability of oxygen in the water-saturated soil.

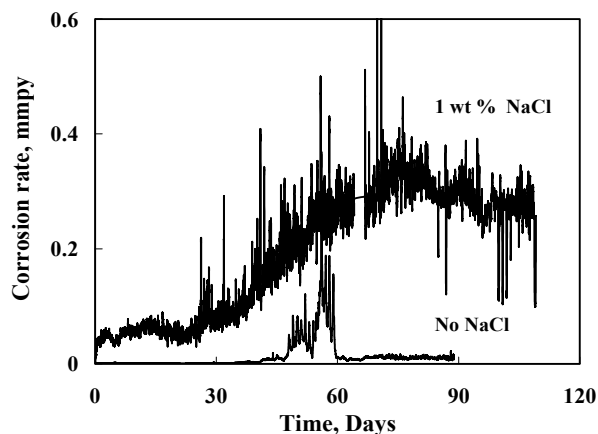
Figure 9 – Effect of NaCl on the corrosion rate of X42 transmission pipe cylindrical electrodes in soil.

The effect of NaCl on the corrosion rate of the X42 gas transmission pipe cylindrical electrodes in soil is shown in Figure 9. It showed that NaCl increased the corrosion rate 35 fold in soil. The response of these soil corrosion rates to increased room temperature and moisture is shown in Figure 10. In the soil experiments, when the water and air temperatures increased, the corrosion rates increased.

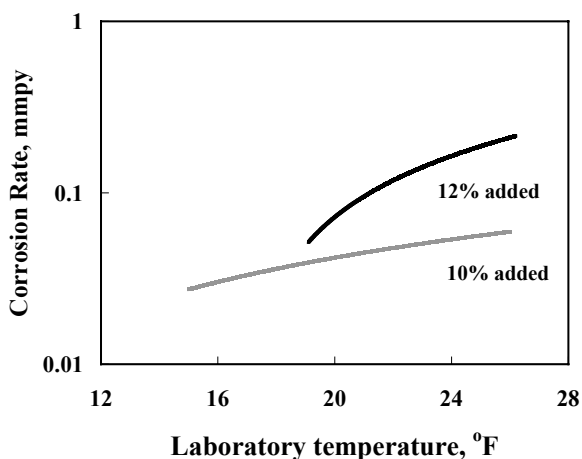
Figure 10 – Effect of water and temperature on the corrosion rate of X42 transmission pipeline electrodes in soil.

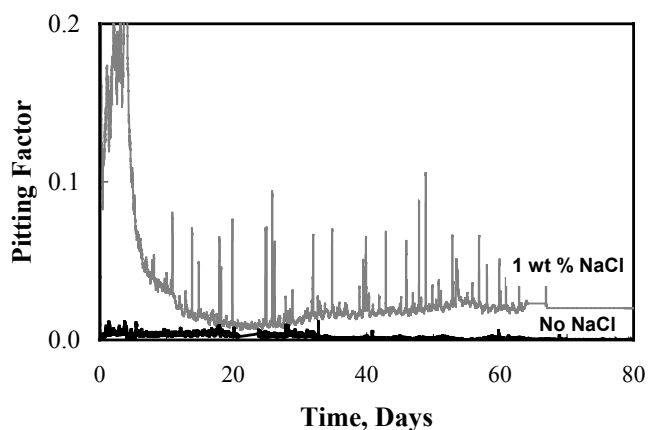
Figure 11 – Effect of NaCl on the Pitting Factor of X42 transmission pipe electrodes in soil.

Figure 11 shows the effect of NaCl on the pitting factor of the X42 transmission pipe electrodes in soil. The electrodes in the as received soil showed pitting factors between 0.0001 and 0.0008 indicating that there was no pitting. The electrodes in the soil with 1 wt % NaCl showed an initial spike between 0.1 and 0.2 indicating that pitting may have initiated on the metal surface, then decreased, possibly due to pit repassivation or to a transition to general corrosion. After 20 days the pitting factor remained at approximately 0.02 until the end of the experiment. Examination of these electrodes after removal from the soil showed a rough general corrosion of the majority of the surface and some pitting of the ends.

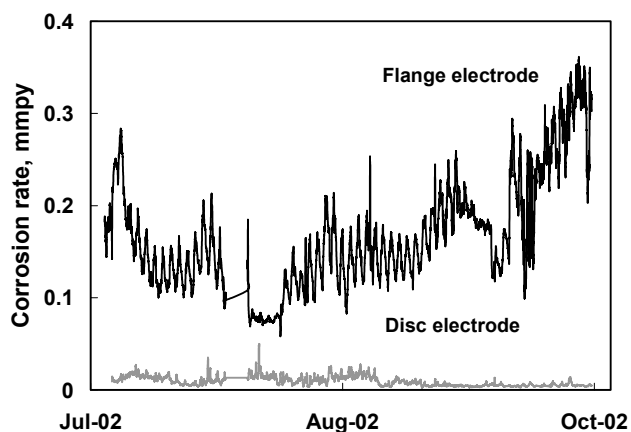
Figure 12 – Comparison of the corrosion rates of flange electrodes to the disc electrodes.

For the corrosion tests in simulated internal gas/liquid pipeline environments, one sensor configuration consisted of three insulated steel flanges in series with the pipe. The flange electrodes were exposed to both the liquid and gas phases. To evaluate the corrosion rates and pitting factors for the flange electrode, the test exposure area was taken to be only that area that was submerged in the liquid phase. The second sensor configuration that consisted of three solid disc electrodes inserted at the bottom of the pipe remained submerged in the liquid phase throughout the experiment. Figure 12 shows the corrosion rates of the flange and disc electrodes as a function of time. The corrosion rates of the disc electrodes were approximately 0.01 mmpy throughout the test. The corrosion rates of the flange electrodes increased from 0.005 to 0.08 after three weeks and increased to 0.35 after two months. The

higher corrosion rate of the flange electrodes compared to the disc electrode could be due to the different surface finish, commercial finish (usually 120 to 180 grit) for the flange electrodes and 600 grit for the disc electrodes and possibly corrosion at the interface between the liquid and gas phases for the flange electrodes as opposed to corrosion in the liquid phase only for the disc electrodes. The flange and disc electrodes were also made from different materials (Table 2). Figure 13 shows the pitting factors of the flange and disc electrodes as function of time. Initially the Pitting Factor for the flange electrode was in above 0.2 (in the pitting regime). The Pitting Factor for the flange electrode dropped to 0.001 possibly due to pitting repassivation and remained at 0.001 throughout the remainder of the test. The Pitting Factor for the disc electrodes remained below 0.1 throughout the test, indicating no pitting. Visual examination of the flange and disc electrodes showed no pits.

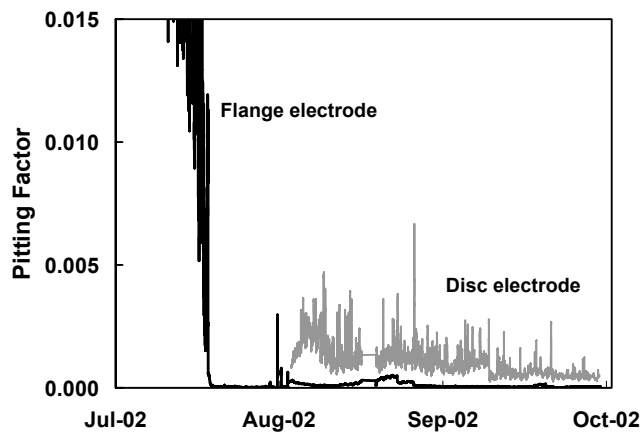
Figure 13 – Comparison of the Pitting Factors of flange electrodes to the disc electrodes
