# **Stress Corrosion Crack Growth Rate Testing and Analytical Electron Microscopy of Alloy 600 as a Function of Pourbaix Space and Microstructure**

N. Lewis, S.A. Attanasio, D.S. Morton, G.A. Young

### Abstract

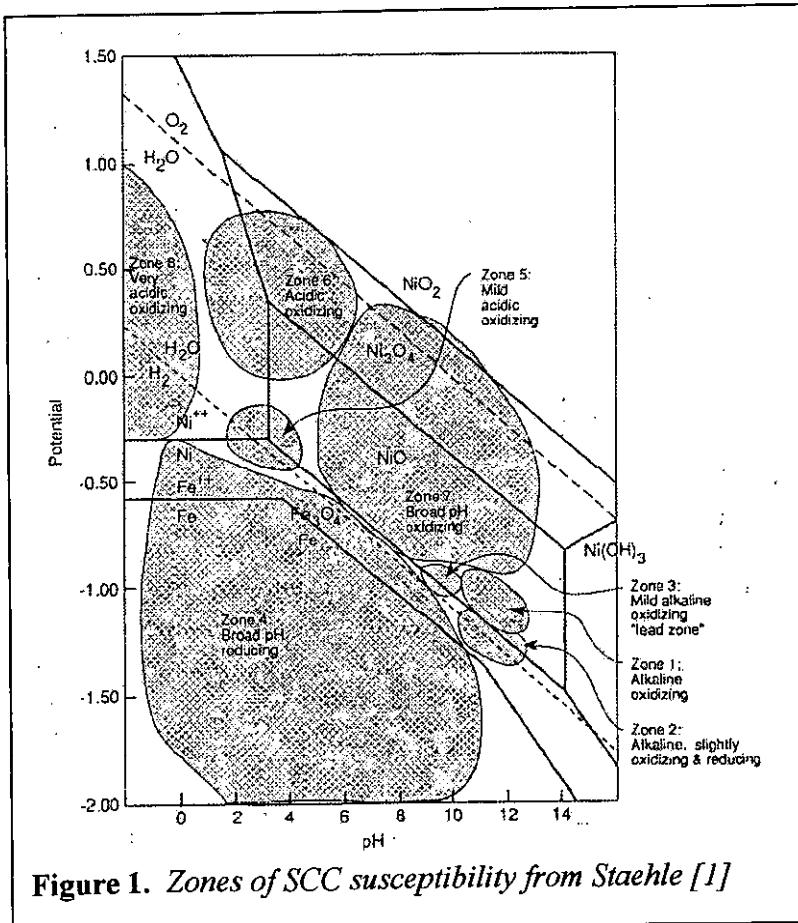
Figure 1. Zones of SCC susceptibility from Staehle [1]

Stress corrosion cracking (SCC) of Alloy 600 occurs under a variety of environmental conditions at elevated temperatures (e.g., 260 to 399°C). An excellent review of these SCC-susceptible environments has been provided by Staehle [1]. As part of this review, Staehle has organized Alloy 600 SCC in the context of the Pourbaix diagram for nickel, and has identified eight zones of SCC susceptibility, as shown in Figure 1. The present paper reports data from SCC tests conducted within three of these eight zones: (i) mild acidic-oxidizing, (ii) alkaline-slightly oxidizing and reducing, and (iii) broad pH-reducing (also referred to as low potential stress corrosion cracking, LPSCC). Although some comparison will be made in this paper as to the SCC propensity between these zones, the primary focus of this effort is to contrast Analytical Electron Microscopy (AEM) morphologies between the zones. Breummer *et al.* [2] have pointed out the importance of characterizing the AEM morphologies of crack growth rate specimens from tests with controlled environmental conditions. Development of a 'library' of AEM morphologies formed by SCC in different environments is important for interpreting the results of AEM studies performed on cracks in components exposed to time-varying environments, such as the steam generator tubing evaluation performed in [2]. A comparison between the AEM morphology of a cracked component and the 'library' of AEM morphologies from controlled environmental conditions may assist in determining the SCC-inducing environment(s).

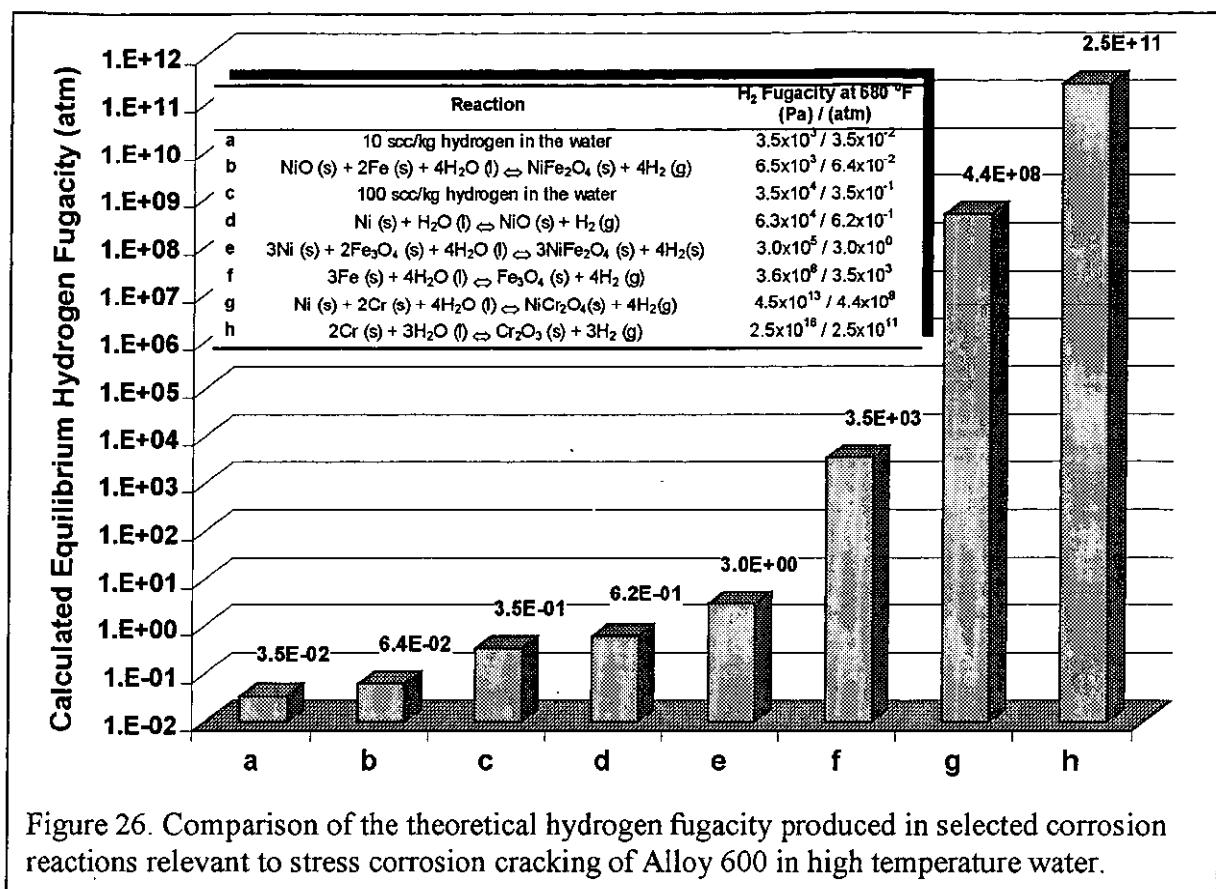
Figure 26. Comparison of the theoretical hydrogen fugacity produced in selected corrosion reactions relevant to stress corrosion cracking of Alloy 600 in high temperature water.

Using the thermodynamic data compiled by Ziemniak [25] and taking the activity of water equal to 1, the equilibrium fugacity of hydrogen produced by corrosion reactions of the major elements in Alloy 600 is summarized in Figure 26. Additionally, the equivalent fugacities for 10 and 100 scc/kg H<sub>2</sub> are included in Figure 26 for comparison. The fugacities of hydrogen gas additions to the water were calculated from Henry's law using a coefficient of 0.35 kPa/(scc/kg H<sub>2</sub>) [7].

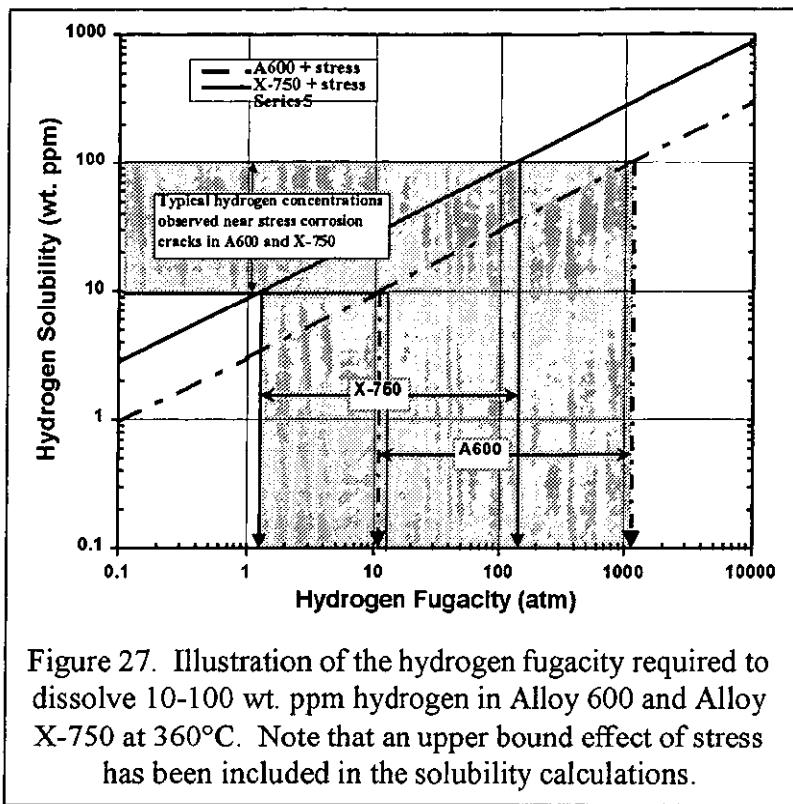
Figure 27. Illustration of the hydrogen fugacity required to dissolve 10-100 wt. ppm hydrogen in Alloy 600 and Alloy X-750 at 360°C. Note that an upper bound effect of stress has been included in the solubility calculations.

As shown in Figure 27, the oxidation of Fe and Cr to produce  $\text{Fe}_3\text{O}_4$ ,  $\text{NiCr}_2\text{O}_4$ , and  $\text{Cr}_2\text{O}_3$  (reactions f, g, and h in Figure 26) can result in high ( $>>100$  atm) fugacities of hydrogen and can account for the 10 to 100 wt. ppm of hydrogen observed near stress corrosion cracks [22-24]. Of the oxidation reactions that can produce high hydrogen fugacities, the Cr-rich spinel is more commonly observed in near-neutral hydrogenated water (Table IV) than  $\text{Fe}_3\text{O}_4$  or  $\text{Cr}_2\text{O}_3$ , and is therefore more likely to influence SCC. It is also possible that oxidation to form a mixed  $(\text{Ni},\text{Cr},\text{Fe})\text{O}$  oxide results in a significantly higher hydrogen fugacity than pure  $\text{NiO}$  formation. The possible influence of an  $\text{NiO}$ -structure oxide containing Cr and Fe on SCC is consistent with the findings of Yonezawa *et al.* [23] and Morton *et al.* [6] who observed maximum hydrogen concentrations and SCCGRs, respectively, near the  $\text{Ni}/\text{NiO}$  phase transition in Alloy X-750.

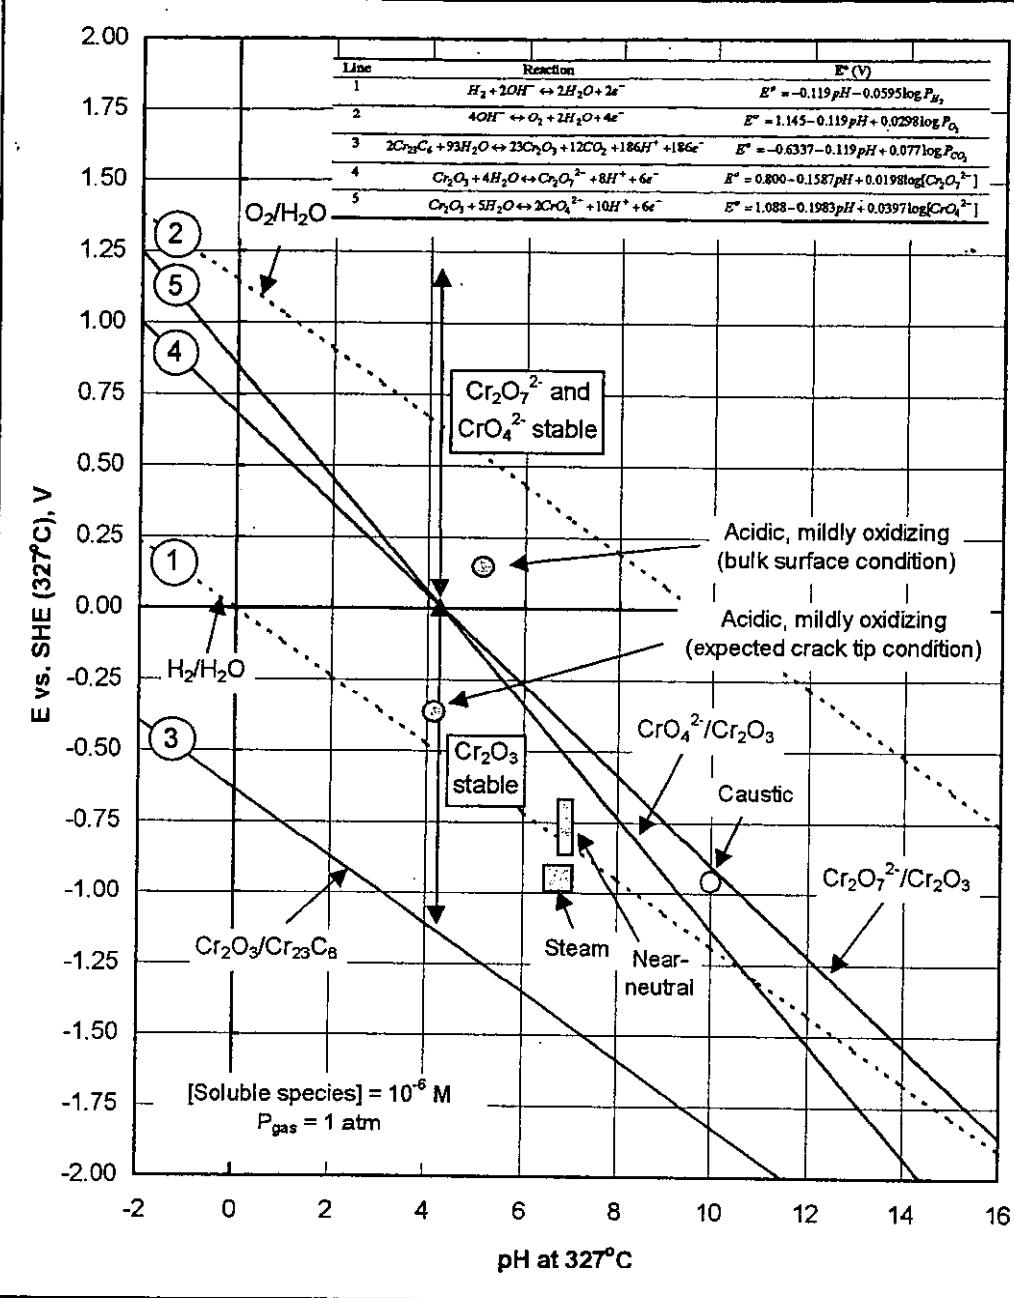
Figure 28. Pourbaix diagram for chromium carbide stability [Staehle].

One practical use of AEM is to establish the environmental conditions under which SCC occurred. As an example, it was suggested by Staehle [19] that the recent occurrence of Alloy 600 secondary-side SCC at the Oconee plant [34] may have been caused by high oxygen conditions at startups. This suggestion can be evaluated to some degree by comparing the oxidizing, mildly acidic test specimen evaluated in the present work to the Oconee AEM work of Thomas and Bruemmer [17]. In that study, the presence of fully oxidized carbides in the crack wake was very evident. From the present work, it appears that this morphology is more consistent with caustic exposure, or perhaps with the steam exposure, than with the aerated, mildly acidic environment exposure. However, this comparison is not definitive, since it cannot be ruled out that cracking could have occurred in an aerated environment at startup, with oxidation of the crack wake carbides occurring during subsequent superheated conditions (*i.e.*, steam environment) during steady-state operation. An additional caveat is that oxidation kinetics could be playing a role. In other words, since the oxidation of carbides appears thermodynamically favorable but kinetically slow in many environments, it is possible that carbides in the Oconee tubing, which was in service for ~17 effective full power years [34], could have been oxidized by long time exposure to any number of possible environments. Most cracks which have been examined by AEM in the present work, and in prior work [4, 8-13] were

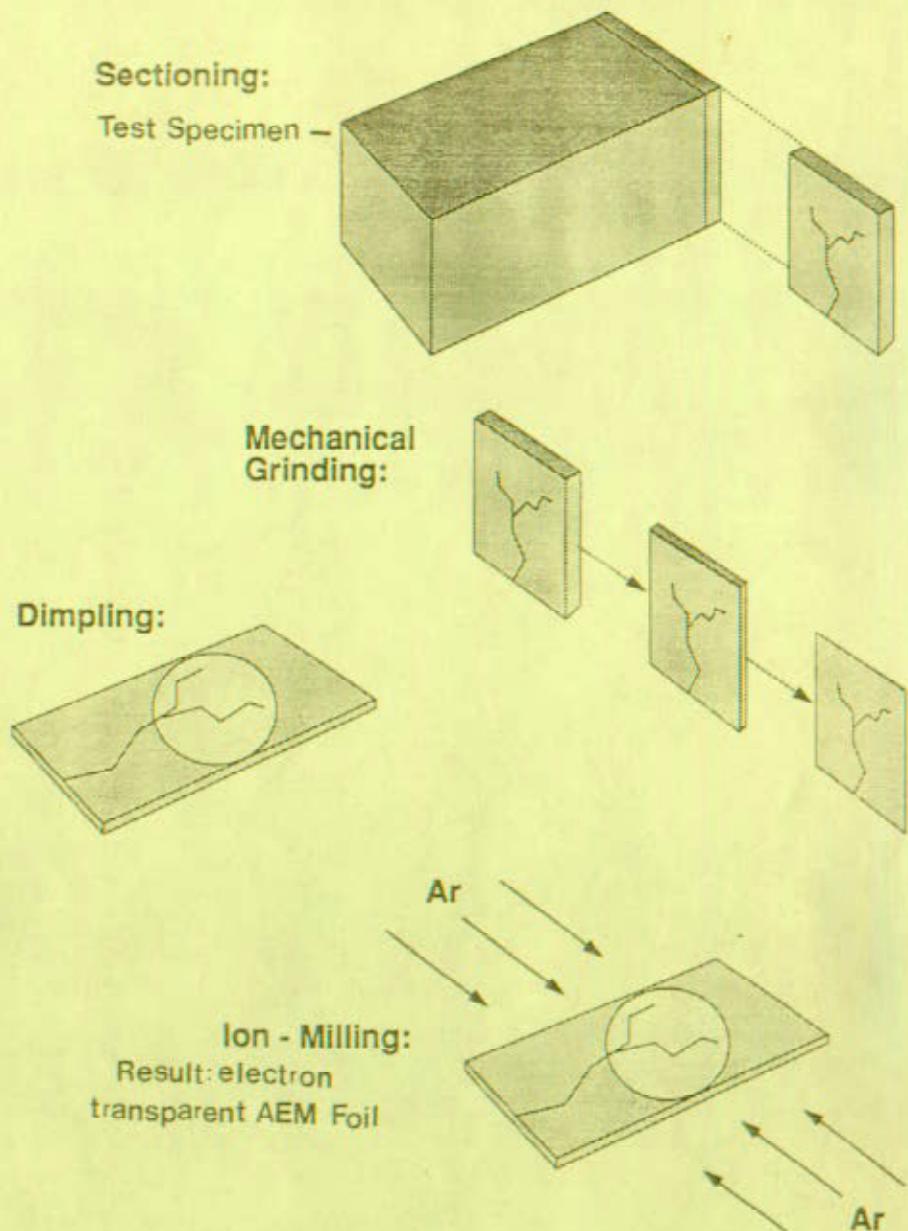
Figure 2.

SCHEMATIC ILLUSTRATION  
OF CROSS-SECTIONAL AEM SAMPLE  
PREPARATION.

**AEM Examinations.** The AEM specimen preparation process for the cross-sectional examination of cracks has been described previously [8], and has been used in several other investigations [4, 8-13]. As shown in Figure 2, sectioning is performed to obtain a piece of the test specimen containing the SCC crack. After sectioning, mechanical grinding is conducted, followed by dimpling and ion milling (with argon ions) to form an electron transparent foil. The surface oxide preparation was performed by grinding an oxide-covered specimen from the substrate side to reach a depth of 75 to 125  $\mu$ m. The oxide is then covered with electroplater's stop-off lacquer and electropolishing is conducted to remove the remainder of the substrate. Once the oxide is perforated by the electropolishing, the stop-off lacquer is removed using acetone; the surface oxide is then examined by AEM and x-ray diffraction. The AEM examinations were performed using a Philips CM 300 instrument with a LaB<sub>6</sub> filament, operated at 300 keV.

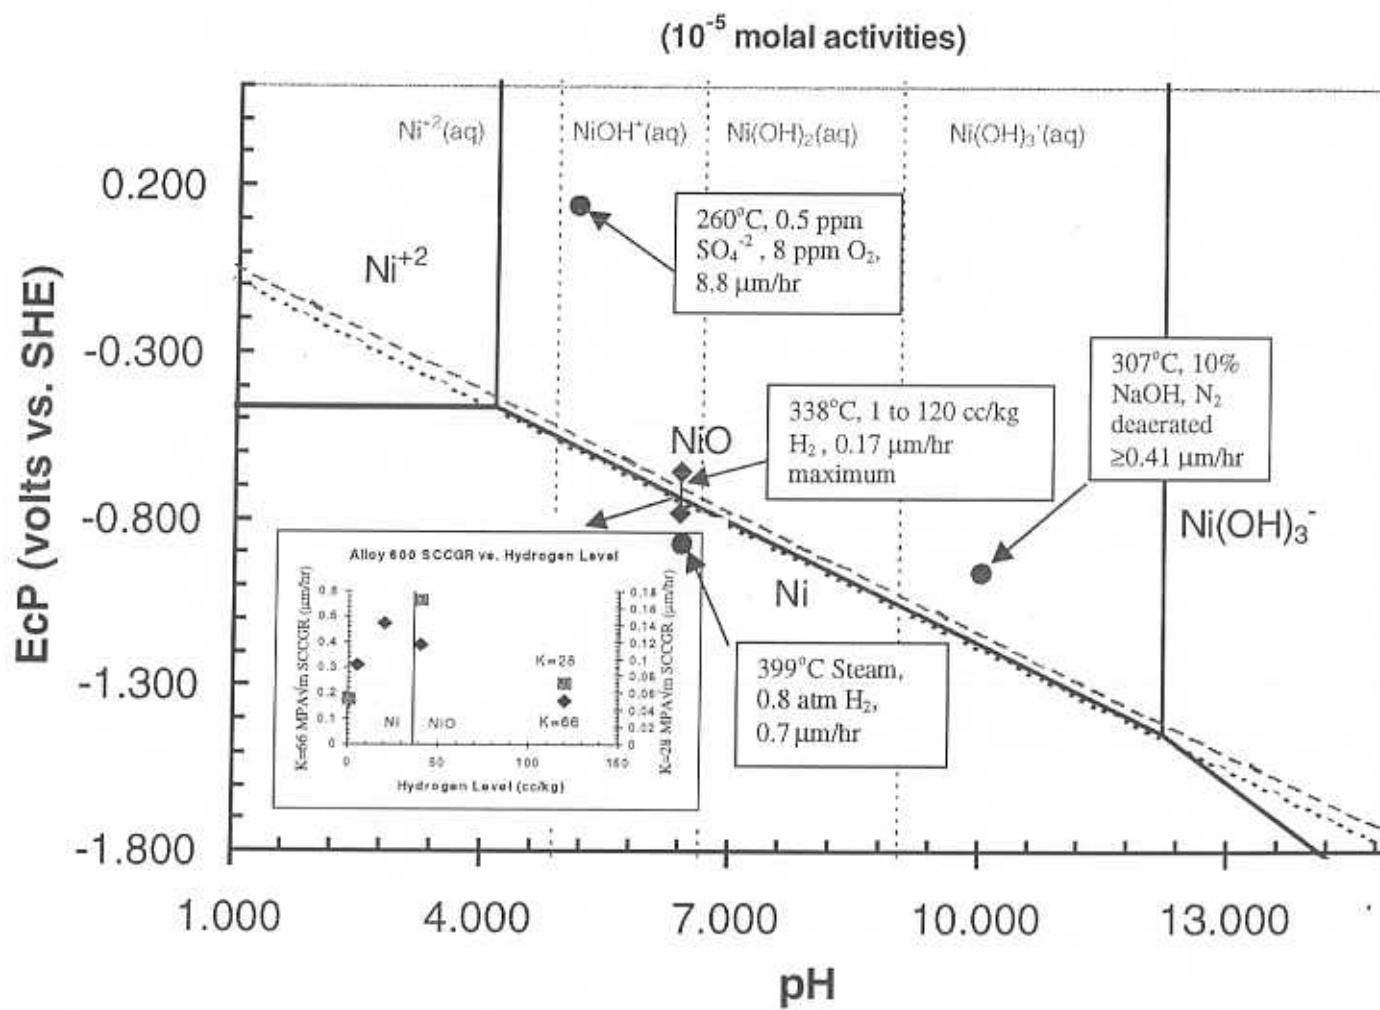
Figure 3: Alloy 600 Crack Growth Rate Imposed upon the 338°C Nickel Pourbaix Diagram (Stress Intensity Factor of 27 MPa $\sqrt{m}$ )

The Alloy 600 crack growth rates observed in this study in each of the environments investigated are shown in Figure 3 and are summarized in Table III.

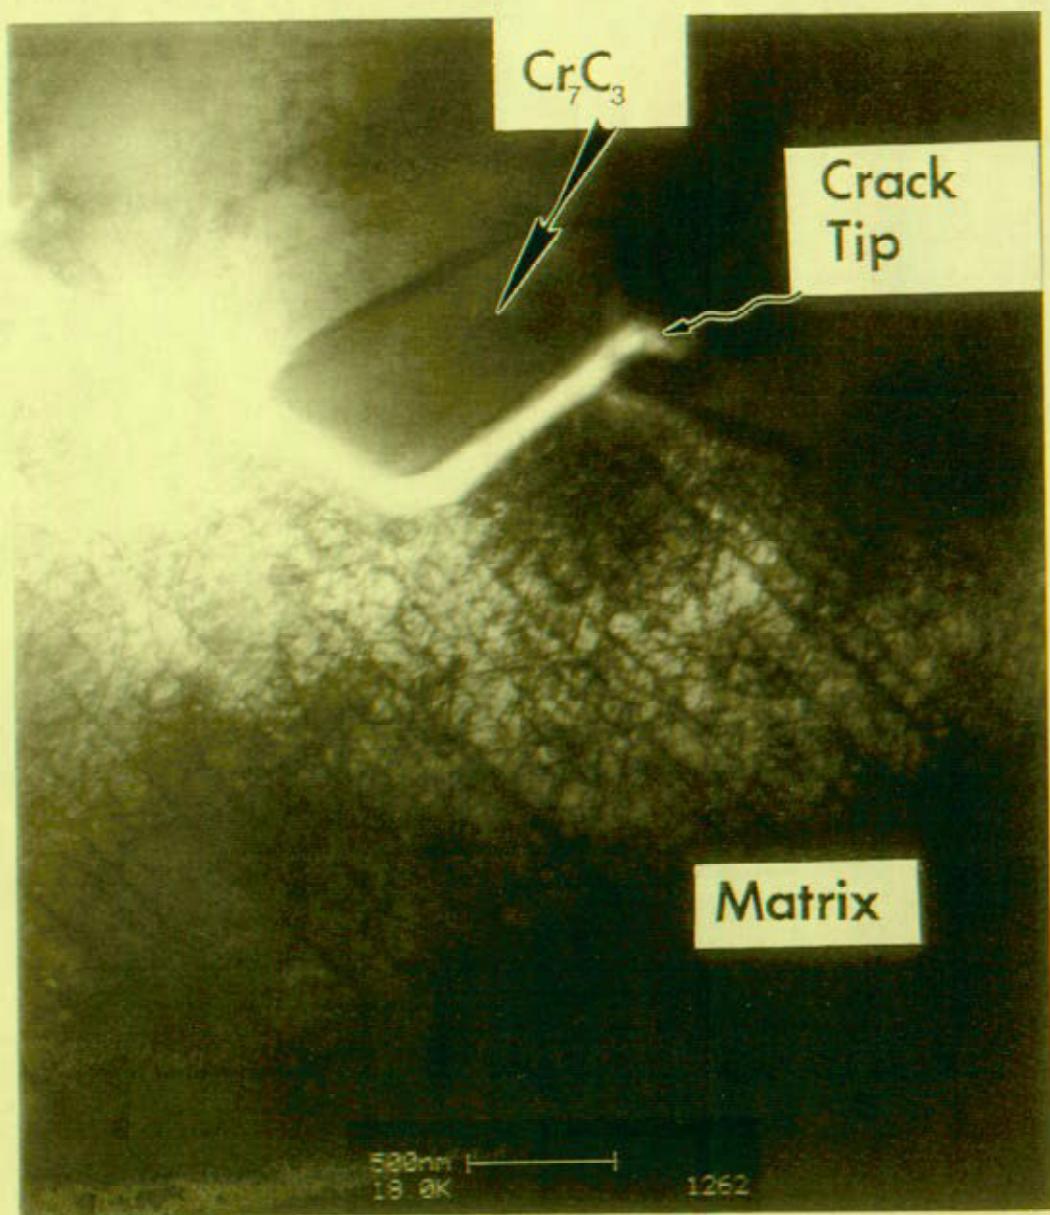
Figure 4. AEM bright field image showing cross-section of Intergranular stress corrosion crack (IGSCC) crack-tip region. SCC crack propagates around  $\text{Cr}_7\text{C}_3$  carbide which remain unoxidized but still in contact with one grain. Dislocations in matrix visible in image. (Acid mildly oxidizing, 260°C, sensitized)

Mildly Acidic, Oxidizing Condition. As shown in Figures 4 through 7, the crack was found to preferentially propagate intergranularly along the carbide-matrix interfaces. This finding is consistent with expectations, since the Cr-depleted zone adjacent to the carbides should be the preferred crack path in a reduced pH environment<sup>7</sup>. The carbides were intact, with no significant carbide oxidation, as shown in Figures 5, 6, and 7. Evidence that the carbides have not been oxidized is given by the parallel markings in the carbide particles, which are planar faults commonly observed in Cr<sub>7</sub>C<sub>3</sub>. The presence of non-oxidized carbides is consistent with prior work under acid sulfate conditions [8]. The oxide in the crack typically exhibited a fine-grained structure which resulted in a 'speckled' appearance (Figures 5 and 6), but certain regions also exhibited an acicular structure as shown in Figures 6 and 8. Electron diffraction patterns from the oxide index to NiO-type and to an unidentified textured phase are shown in the inset of Figure 8.

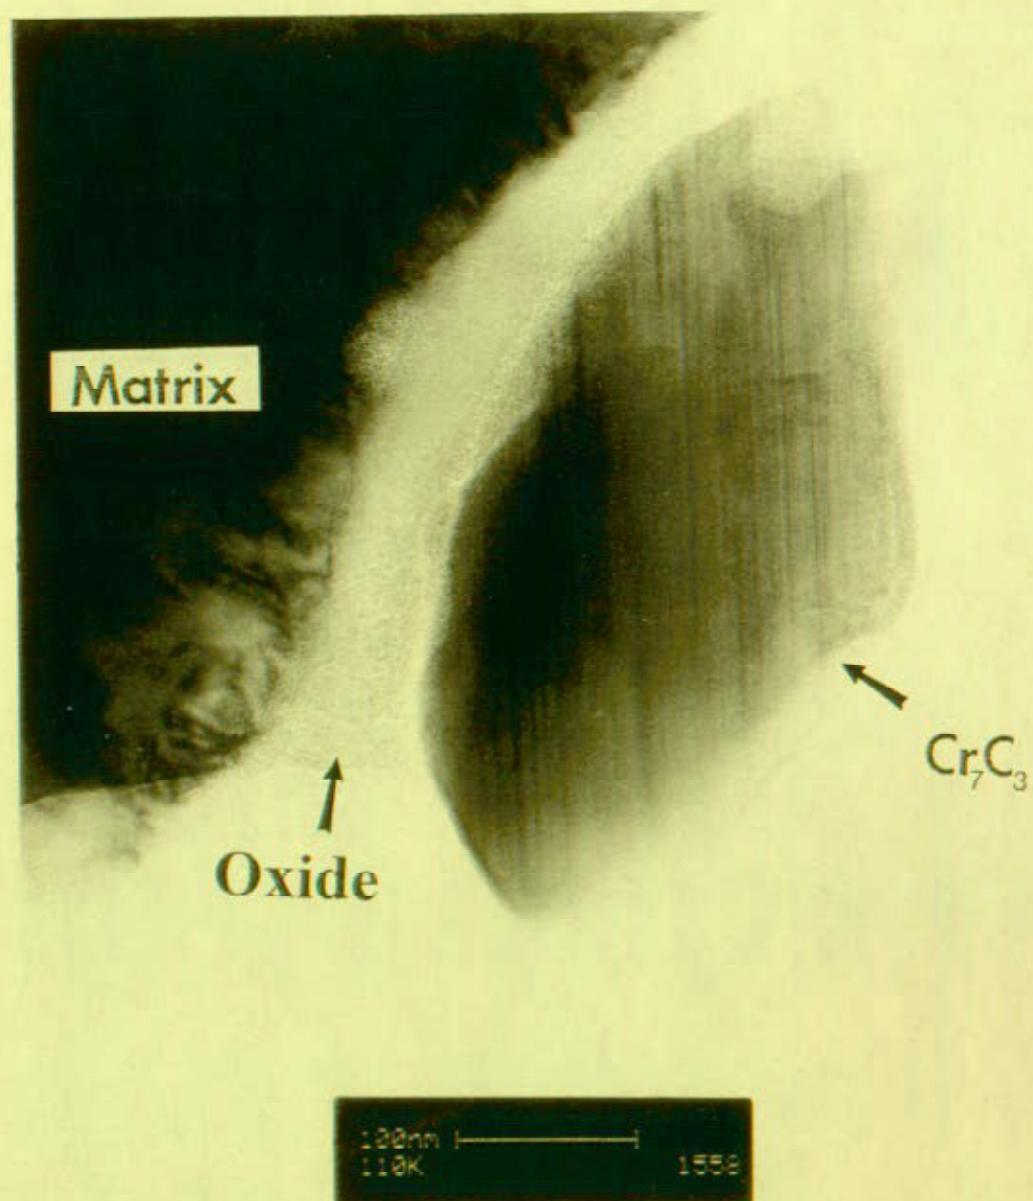
Figure 5. AEM bright field image showing cross-section of IGSCC crack region. SCC crack propagates around carbide which remains unoxidized. Oxide is visible between carbide and matrix. (Acid mildly oxidizing, 260°C, sensitized)

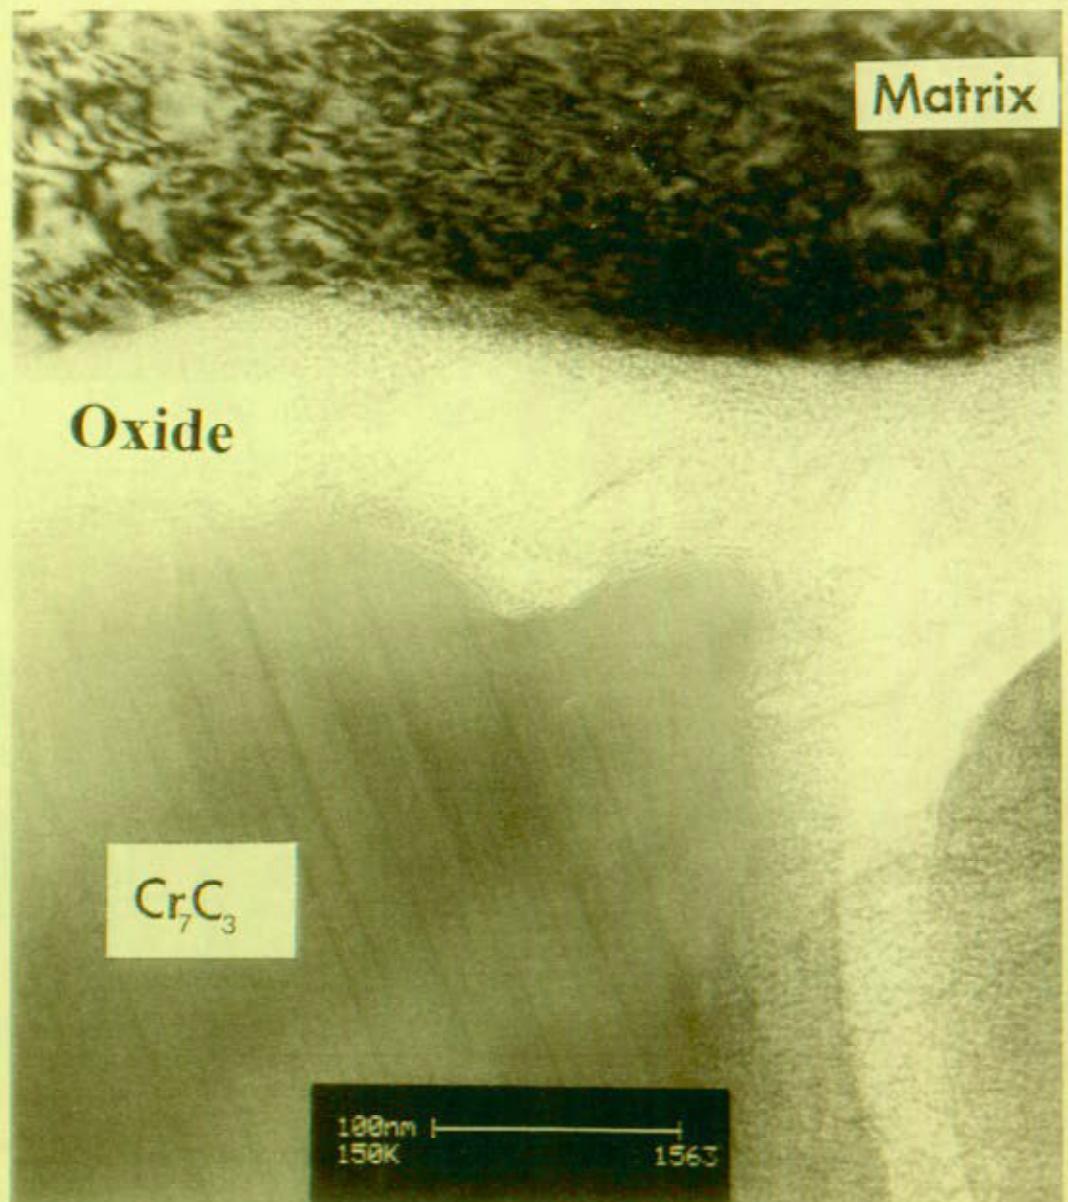
Figure 6. AEM bright field image showing cross-section of IGSCC crack. SCC crack propagates around carbide which remains unoxidized. Oxide is visible between carbide and matrix. (Acid mildly oxidizing, 260°C, sensitized)

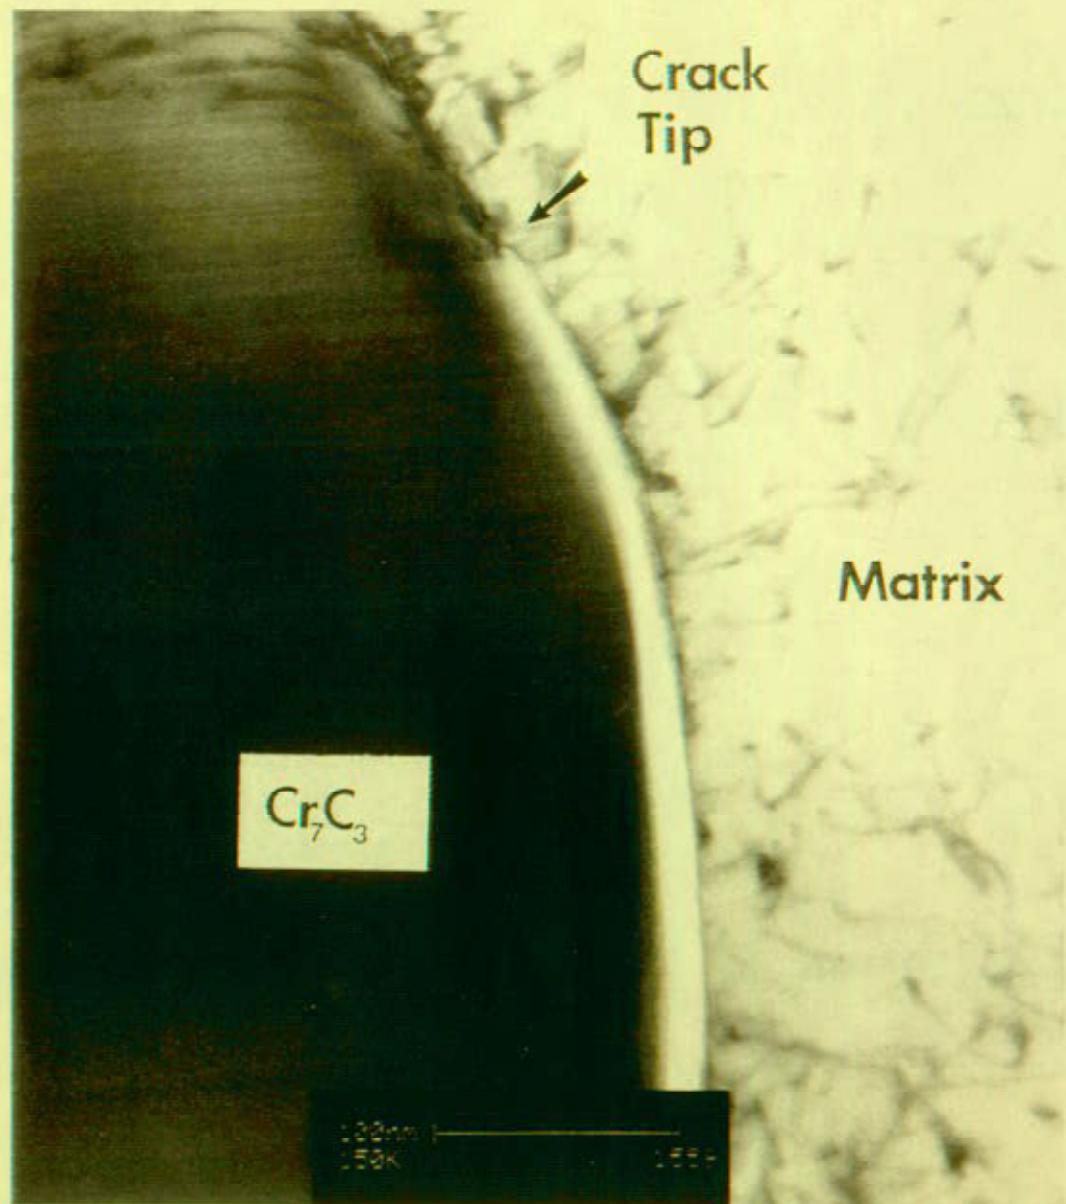
Figure 7. AEM bright field image showing cross-section of IGSCC crack-tip region. SCC crack propagates around carbide which remains unoxidized (Acid mildly oxidizing, 260°C, sensitized)

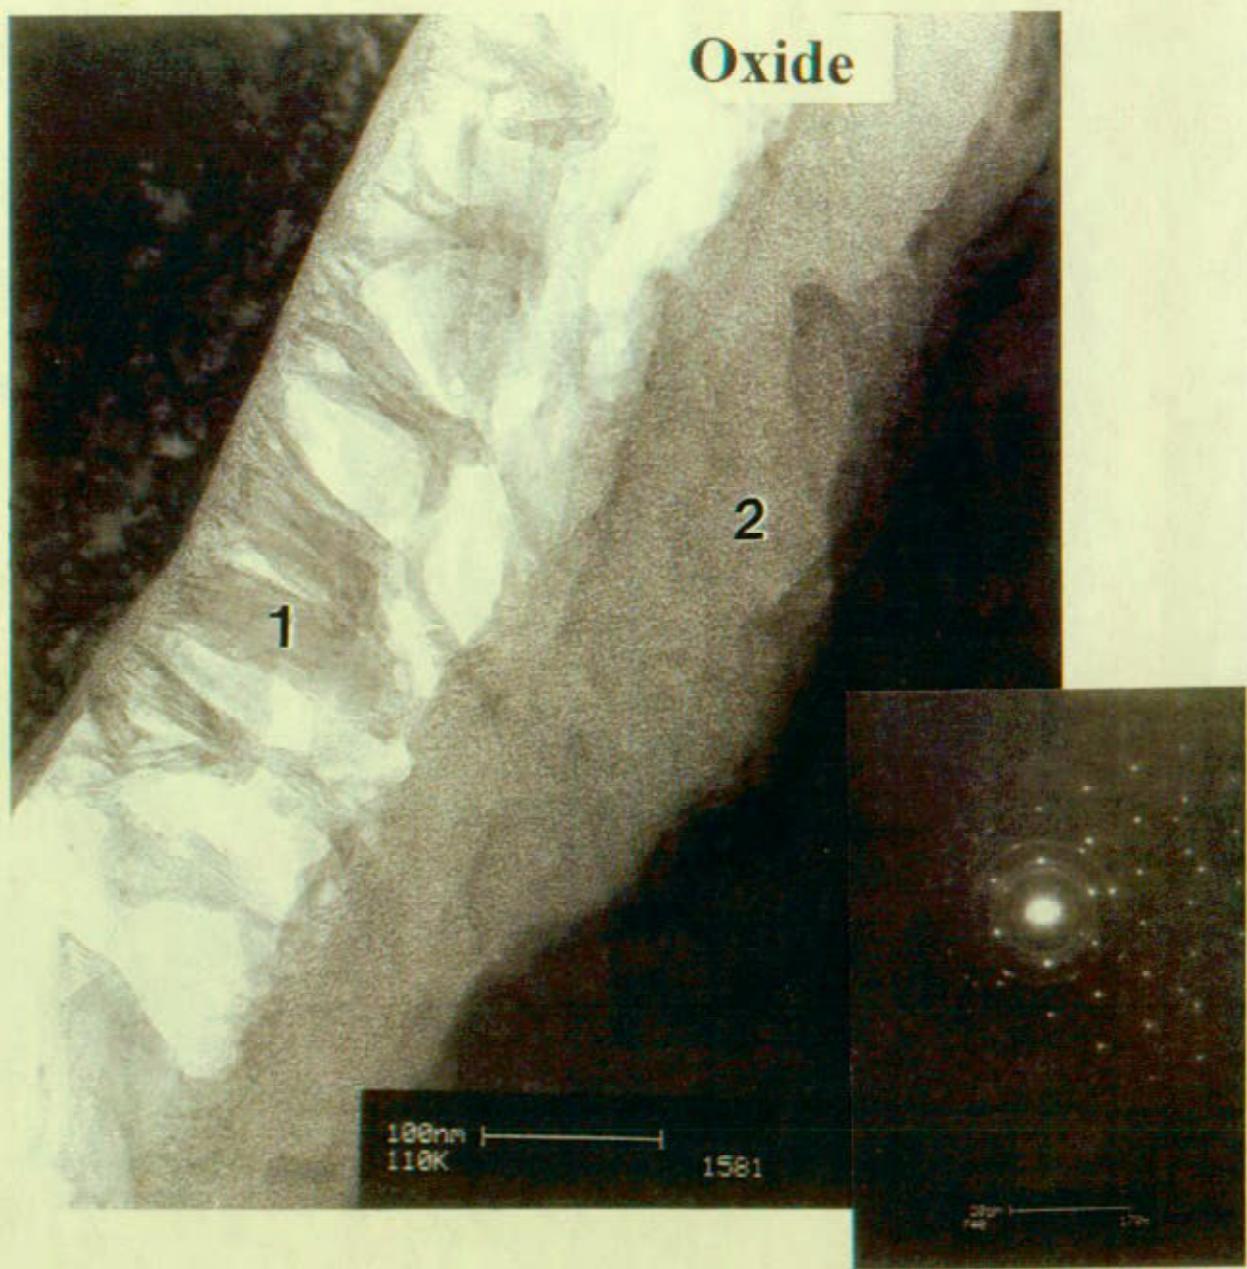
Figure 8. AEM bright field image showing cross-section of wide IGSCC crack away from carbides. Oxide corrosion product exhibits speckled and acicular morphologies. Electron diffraction pattern contains some NiO and unidentified textured phase. (Acid mildly oxidizing, 260°C, sensitized)

In this specimen, the oxide in the crack was relatively thick (e.g., Figure 8) compared to specimens tested in near neutral hydrogenated water or steam, for example. The oxide completely filled wide portions of the crack. The thick oxide is believed to be further evidence of appreciable corrosion within the crack. Sulfur was frequently found to be associated with the oxides within the crack, as shown by the energy dispersive spectroscopy (EDS) spectrum in Figure 9. However, sulfur was not detected in the oxides on the bulk surface as shown in Figure 10 (note that the electron diffraction pattern from this area indexes to CrOOH, as shown in Figure 10). This observation is consistent with work by Andresen and Young [16], which showed that in an oxidizing environment, anions will concentrate in the crack due to a gradient in EcP<sup>8</sup>.

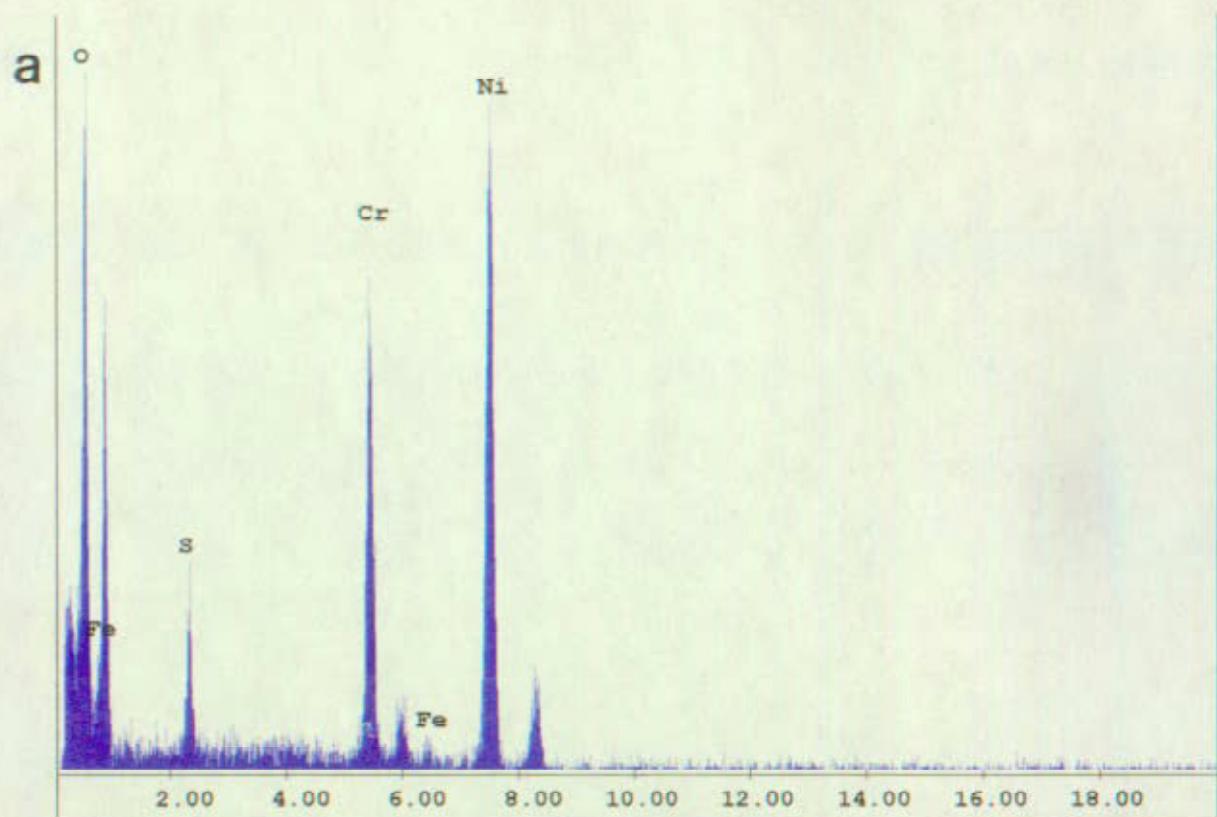
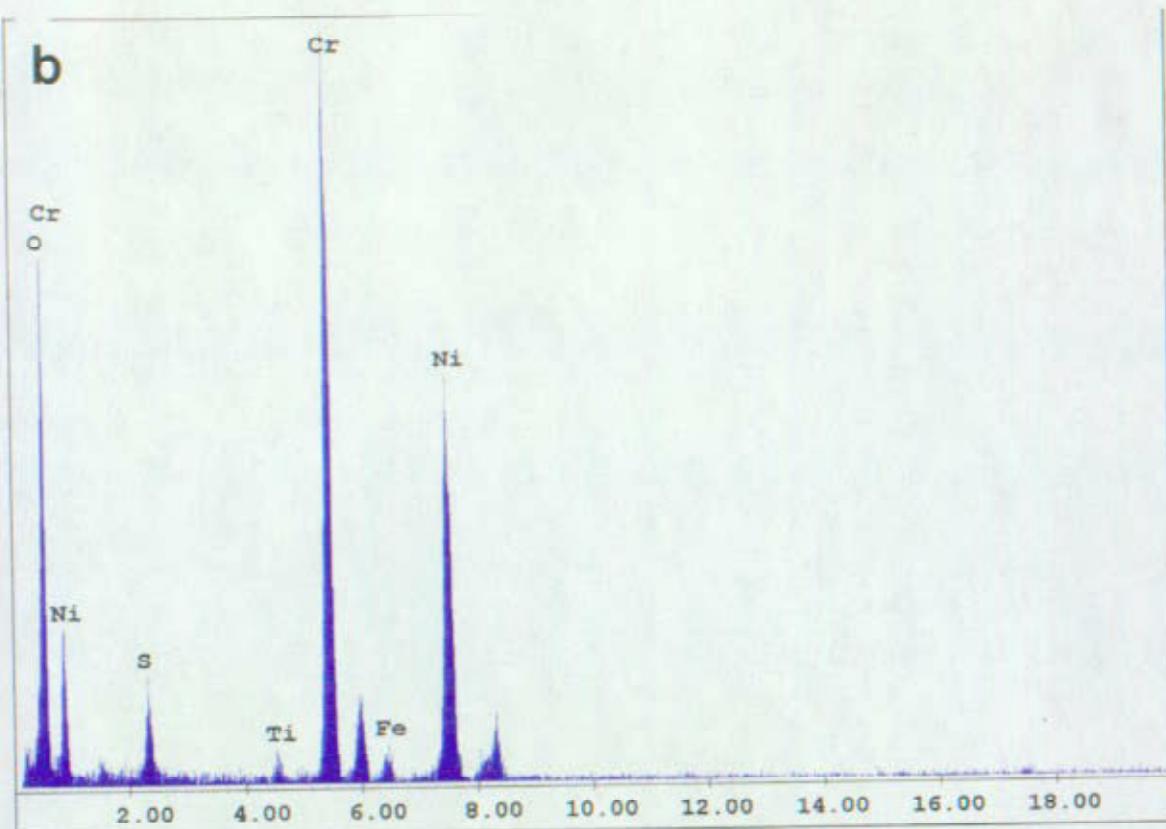
Figure 9. a ) X-ray spectrum from area 1 in Figure 8 showing high Ni,Cr and S. b) X-ray spectrum from area 2 in Figure 8 showing higher Cr than Ni and some Ti. (Acid mildly oxidizing, 260°C, sensitized).

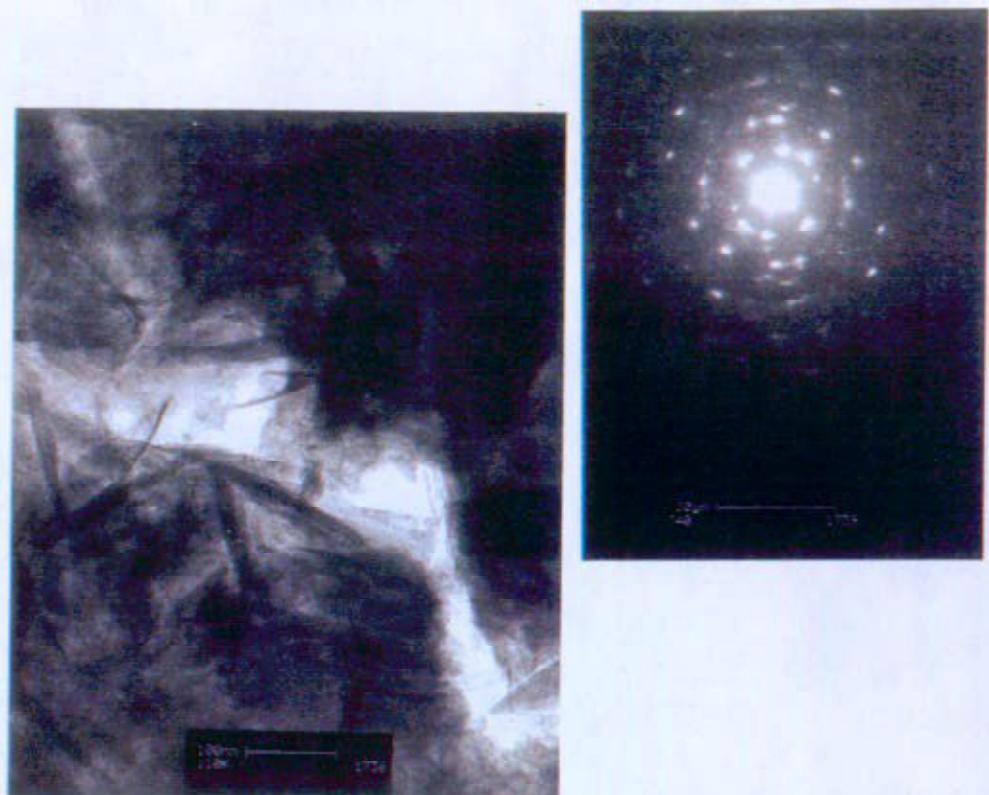
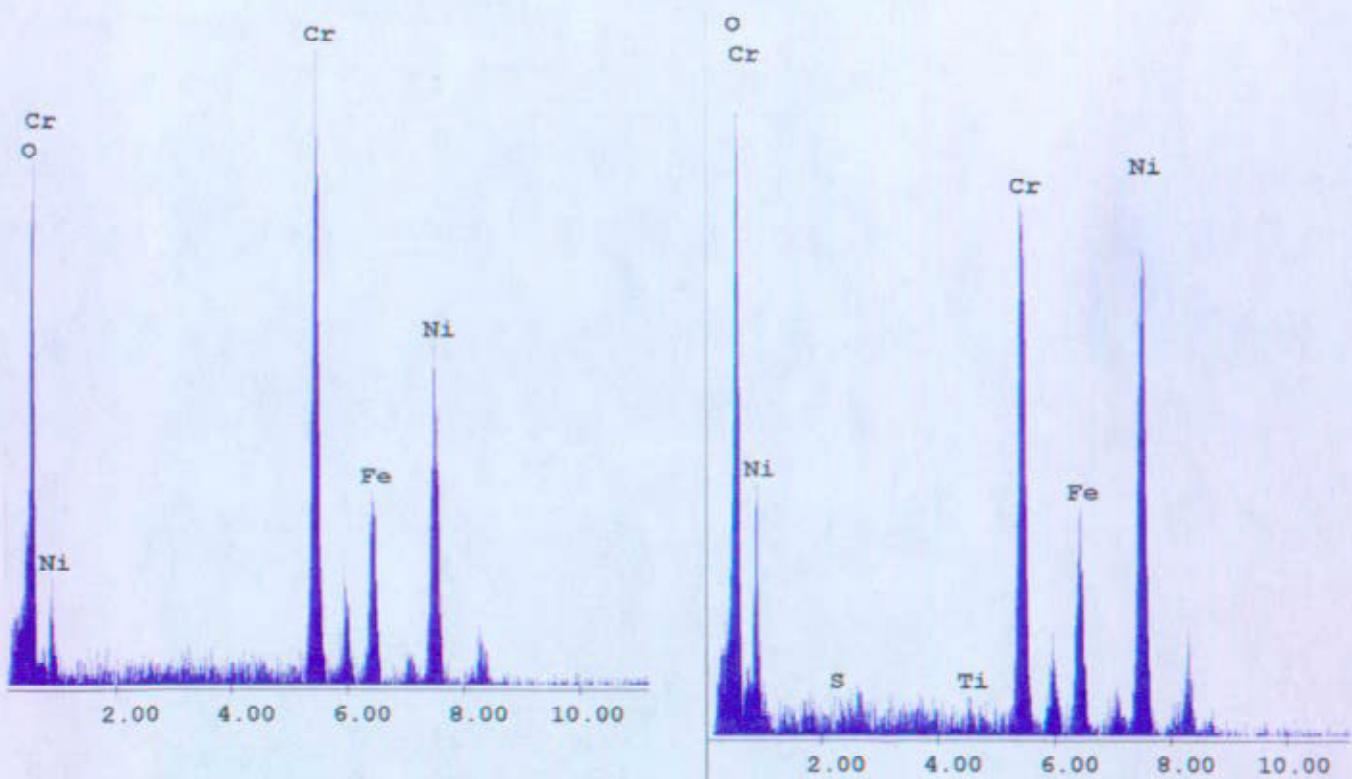
Figure 10. AEM bright field image and corresponding x-ray spectrum showing acicular structure in planar section of bulk oxide. Oxide is enriched in Cr but contains significant Ni Fe and Cr. Electron diffraction pattern indexes to CrOOH (Acid mildly oxidizing, 260°C, sensitized).

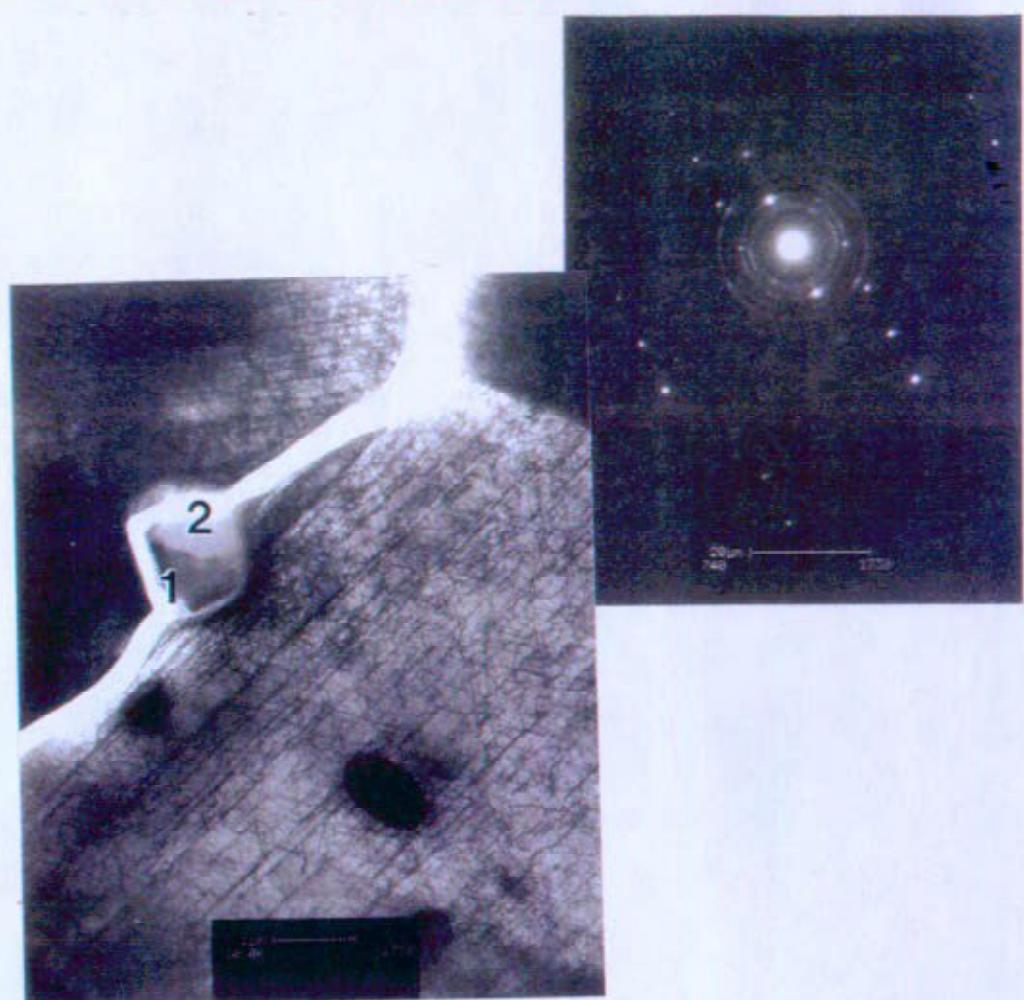
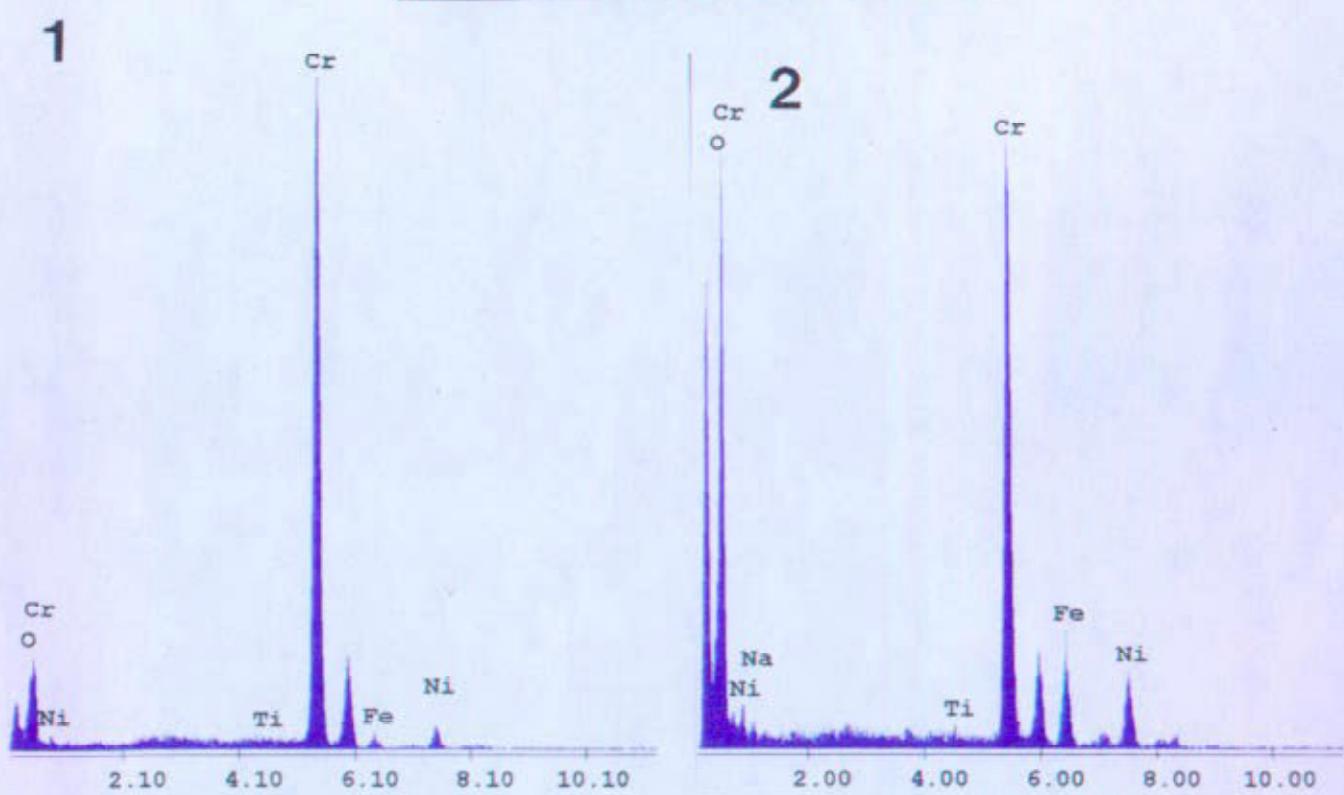
Figure 11. AEM bright field image and corresponding x-ray spectrum showing IGSCC crack propagating around partially oxidized carbide. Dislocation structure visible in matrix. Spectrum 1 is from carbide, spectrum 2 is from oxidized portion of carbide. Oxide is enriched in Fe and Ni relative to carbide. Some Na observed in this region. Electron diffraction pattern indexes to  $\text{Cr}_2\text{O}_3$  (caustic, 307°C, healed).

10% Caustic Condition. Figure 11 shows a portion of the IG crack formed in this environment. This region of the crack propagated around a carbide and a triple point near the upper right of the photo. The darker portion on the left is  $\text{Cr}_7\text{C}_3$ , while the lighter portion on the right has been oxidized to form  $\text{Cr}_2\text{O}_3$ . The oxidized portion of the carbide is enriched in Fe and Ni relative to the non-oxidized portion of the carbide and shows trace levels of Na. Figure 12 shows a somewhat similar observation for a different carbide. In this case, the fine-grained, 'speckled' region on the left is Cr-rich oxide, while the lighter area with some evidence of parallel planar faults running right to left is  $\text{Cr}_7\text{C}_3$  as seen in the electron diffraction pattern to the right of Figure 12a. Figure 12b shows the EDS signal from the oxidized portion of the carbide showing a high level of chromium, oxygen and increased Fe relative to a non-oxidized carbide. Note that there is no Na observed at this location. In this case, the oxidized portion of the carbide exhibits a spinel structure<sup>9</sup>, as shown by the diffraction pattern to the left of Figure 12a (note that the diffraction rings are quite diffuse, however). The oxide in the crack away from the carbides is shown in Figure 13. An array of Cr-rich crystallites containing Ni, Fe, Ti and a small Na signal are seen. The electron diffraction pattern obtained from the region can be indexed to a spinel structure. However, the rings are quite diffuse for crystallites 50-100 nm in size.
