# **Stress Corrosion Crack Growth Rate Testing and Analytical Electron Microscopy of Alloy 600 as a Function of Pourbaix Space and Microstructure**

N. Lewis, S.A. Attanasio, D.S. Morton, G.A. Young

### Abstract

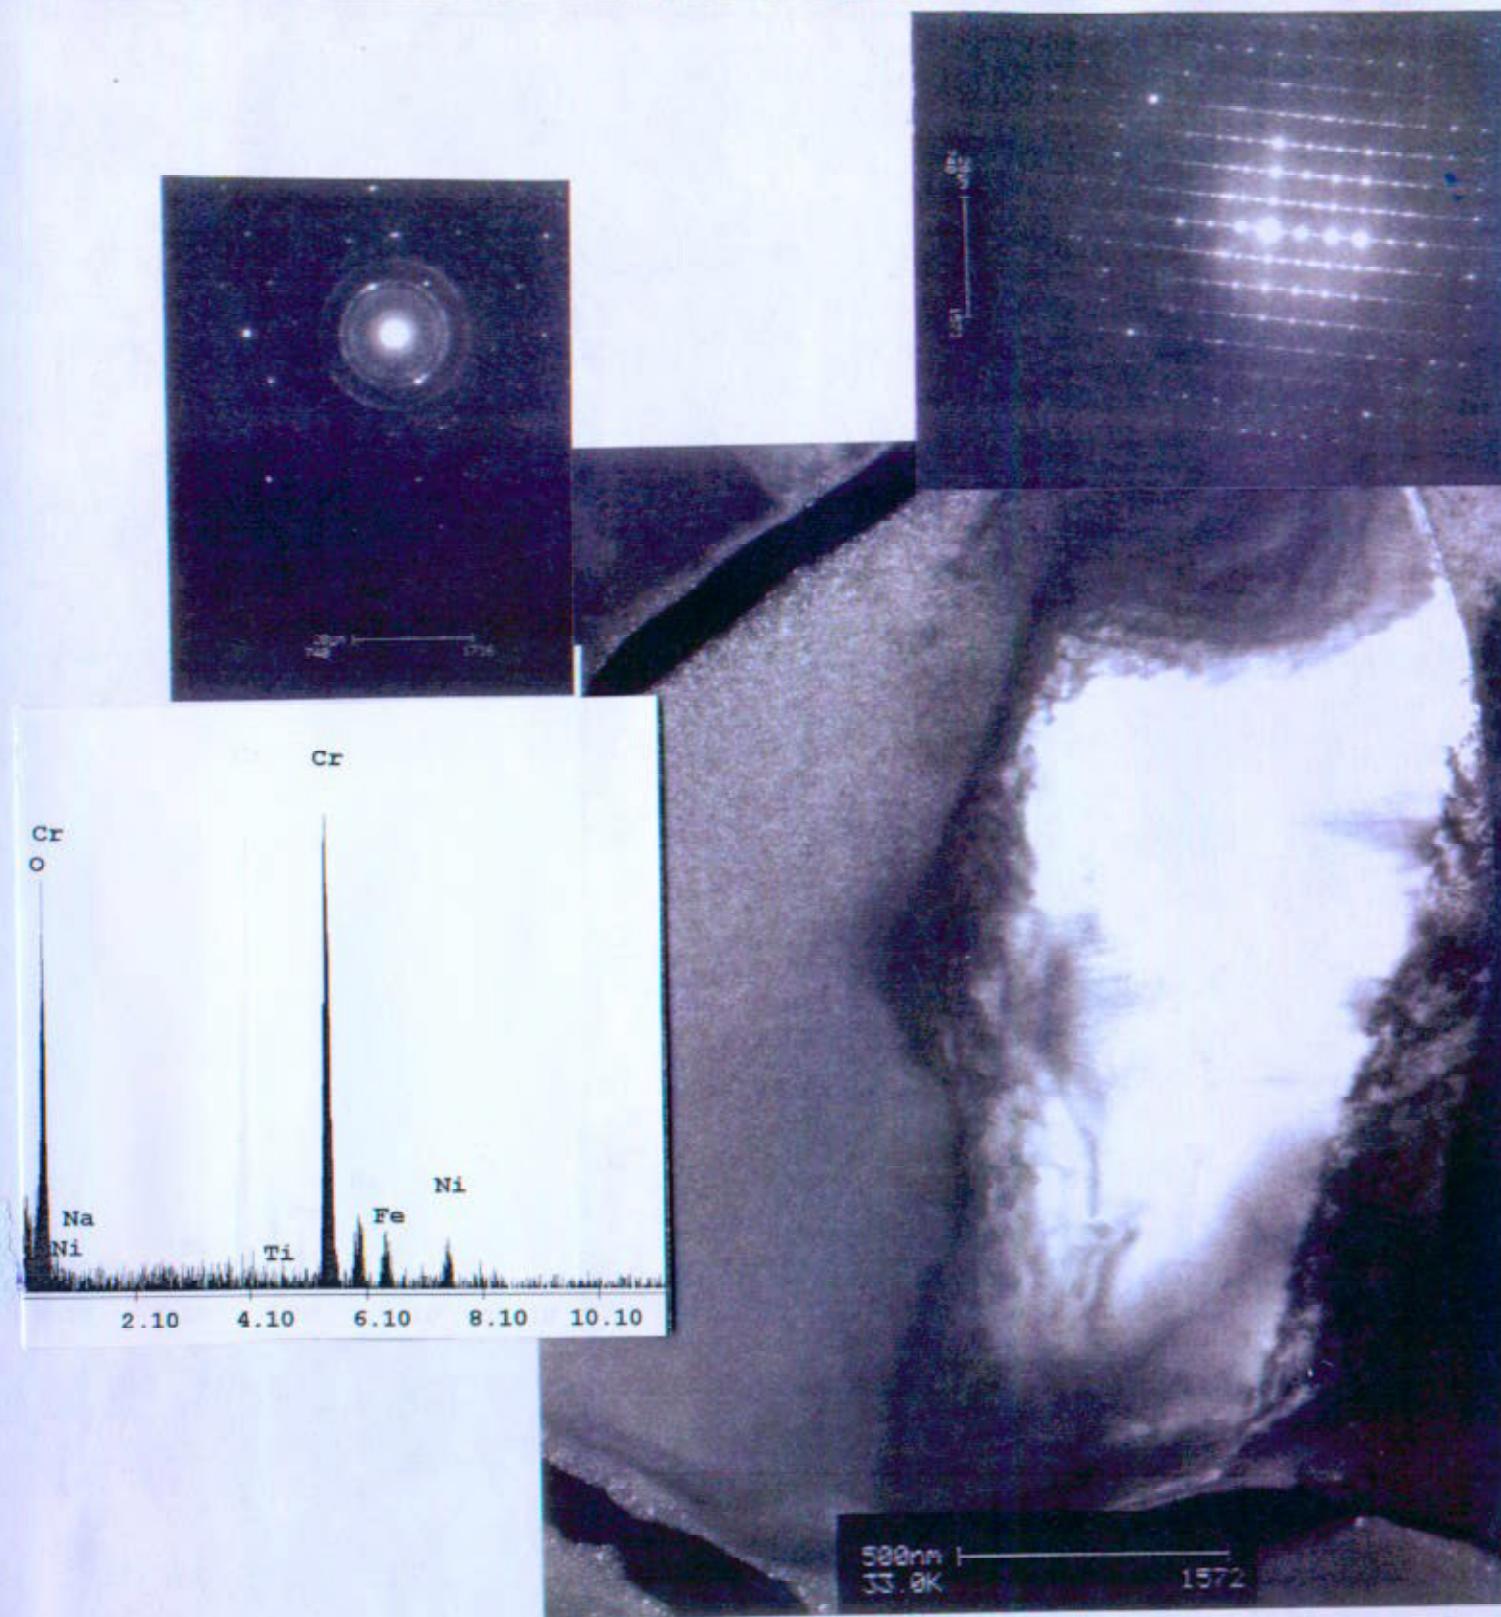
Figure 12. AEM dark field image (carbide reflection) showing IGSCC crack propagating around partially oxidized carbide. Bright area is single crystal Cr<sub>7</sub>C<sub>3</sub>, speckled area is Cr rich polycrystalline structure consistent with spinel but diffraction rings are weak and diffuse (caustic, 307°C, healed).

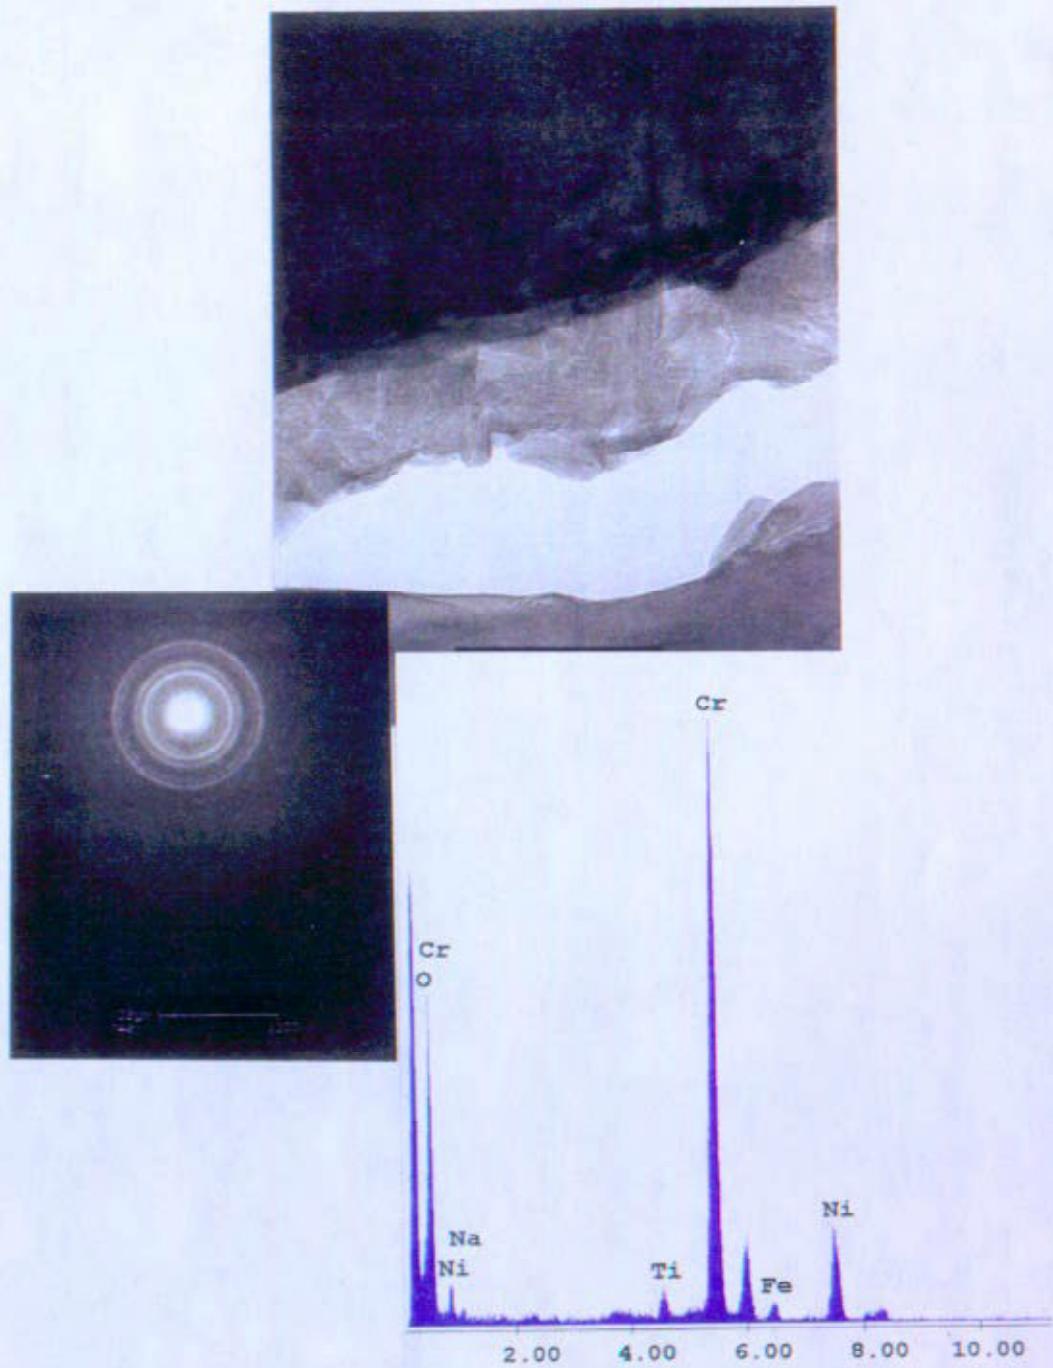
Figure 13. AEM bright field image showing cross-section of wide IGSCC crack away from carbides. Oxide corrosion product exhibits array of Cr rich crystallites with some Ni, low Ti and trace Na. Diffraction pattern is consistent with spinel structure but the lines are diffuse (caustic, 307°C, healed).

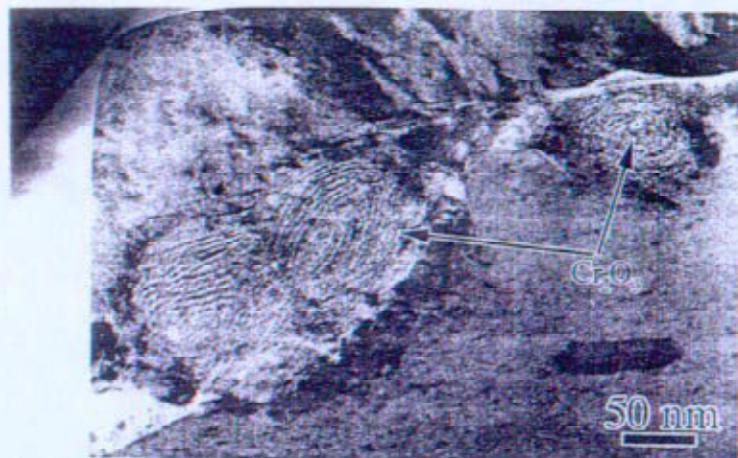
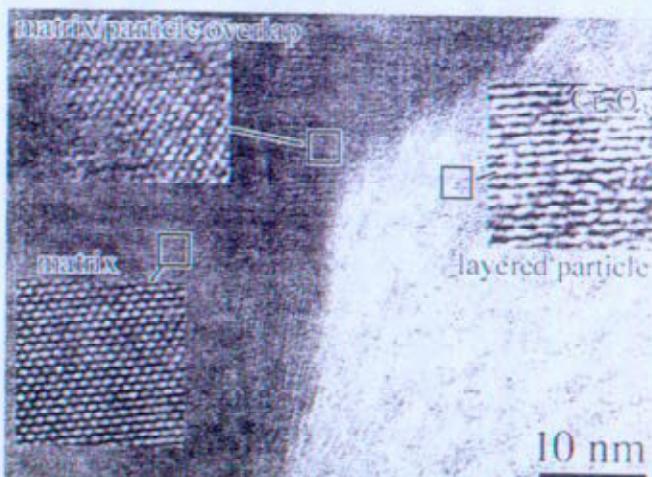
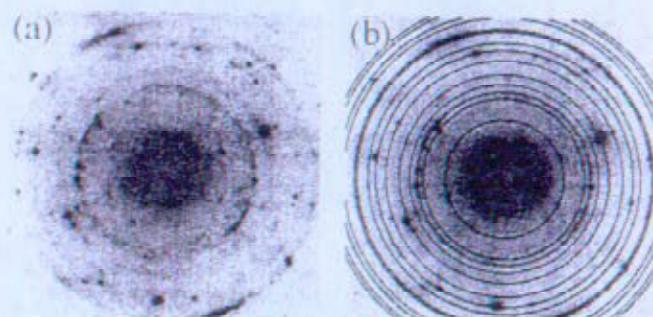
Altered carbide particles along open IG penetration near primary crack in OTSG tube.

Figure 10. Layered particle and adjacent metal matrix in preceding figure. Insets show crystal lattice images of selected areas.

Figure 11. Diffraction analysis of layered particle in Fig. 9. (a) diffraction pattern from particle area. (b) matching rings for Cr<sub>2</sub>O<sub>3</sub>.

Figure 14. AEM bright field image showing oxidized carbide from tubing from Oconee #3 plant. Oxide reported as Cr rich polycrystalline Cr<sub>2</sub>O<sub>3</sub> (Thomas and Breummer, Reference (17)).

Carbide oxidation is believed to be caused by contact with the water in the cracks. The extensive oxidation of carbides in the crack wake is generally consistent with the AEM work performed by Thomas and Bruemmer [17] on cracked Alloy 600 tubing taken from the Oconee #3 plant. However, one apparent difference is that the present work in a caustic environment revealed no evidence of a layered, "onion-skin" morphology that was often present in the oxidized carbides in the Oconee cracks (Figure 14). This observation implies that perhaps the layered morphology observed by Thomas and Bruemmer [17] may result from repetitive carbide oxidation during multiple plant cycles, which are not present in the laboratory testing.

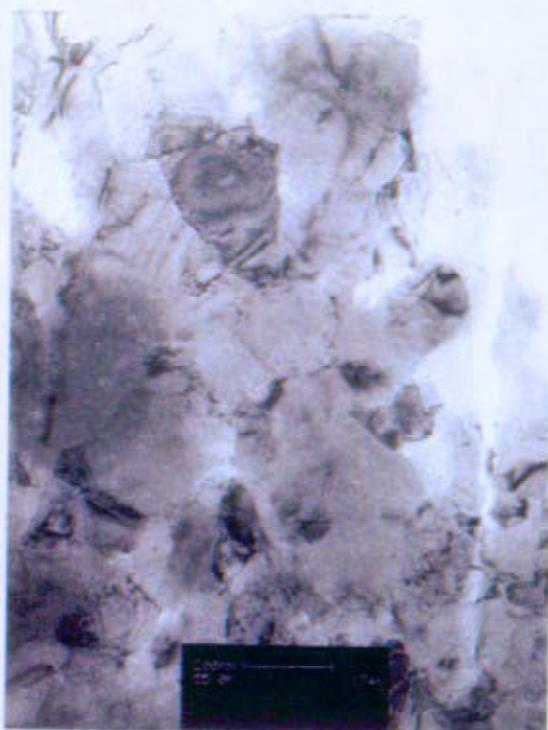
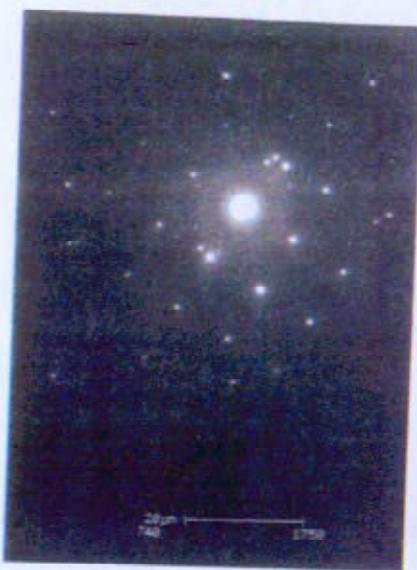
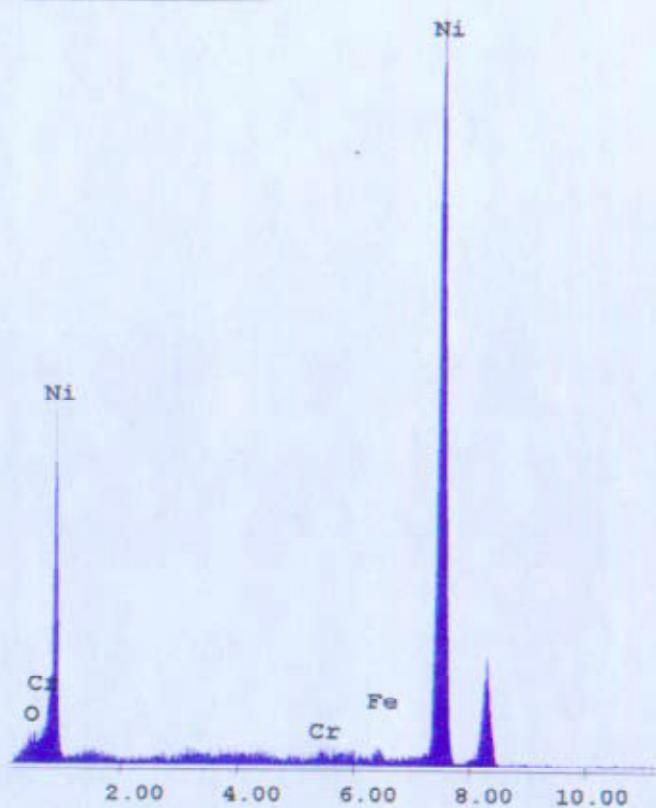
Figure 15. AEM bright field image showing planar section of bulk surface film consisting of polycrystalline grains approximately 200 nm in size. X-ray spectrum shows pure Ni and diffraction pattern indexes to Ni. (caustic, 307°C, healed)

An additional finding in this test is that the specimen surface contains Ni nodules in the metallic (*i.e.*, non-oxidized) form, as shown in Figure 15. All of the testing in this study was conducted in stainless steel autoclaves, with the exception of the caustic testing, which was conducted in a nickel autoclave. Given this difference in vessel materials, it is expected that the environment is saturated with respect to nickel ions in the caustic testing, but not in the other aqueous test environments. This fact helps explain the extensive presence of Ni-rich deposits on the surface of the caustic specimen, but does not explain why the Ni was present in the reduced (*i.e.*, metallic) form. This result is unexpected since the test environment was nitrogen-deaerated, which should produce an EcP slightly electropositive to the Ni/NiO phase transition. This result is not understood at present; however, it is possible that hydrogen buildup occurred during the test since the caustic testing was conducted in a static nickel autoclave. It is noted that the crack itself contained oxide, but did not contain the metallic nickel observed on the surface. The reason for different findings on the surface and within the crack is not understood at present.

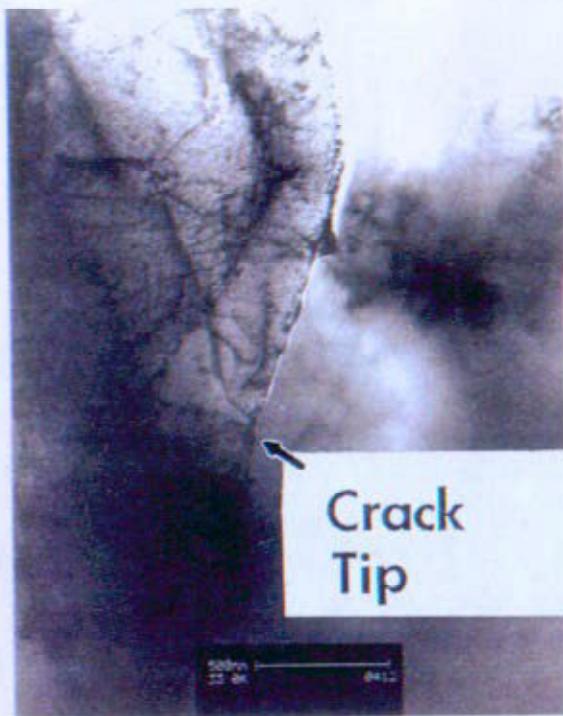
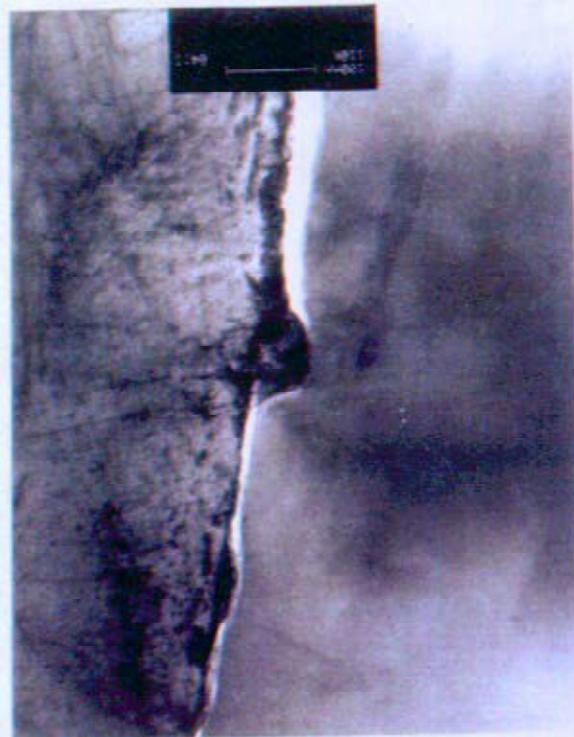
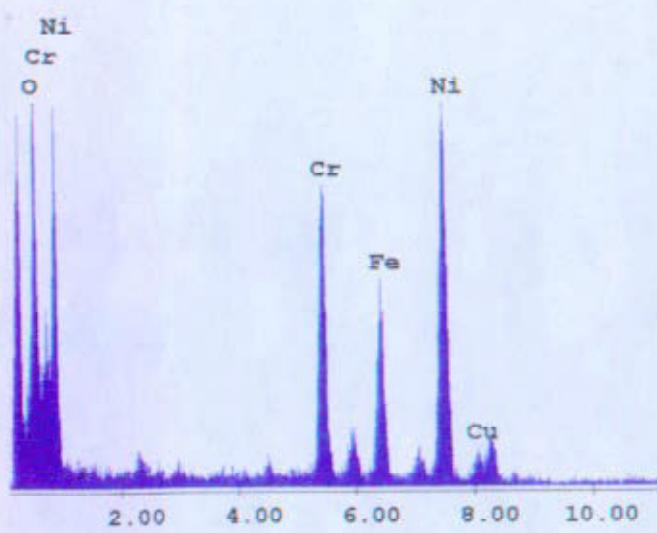
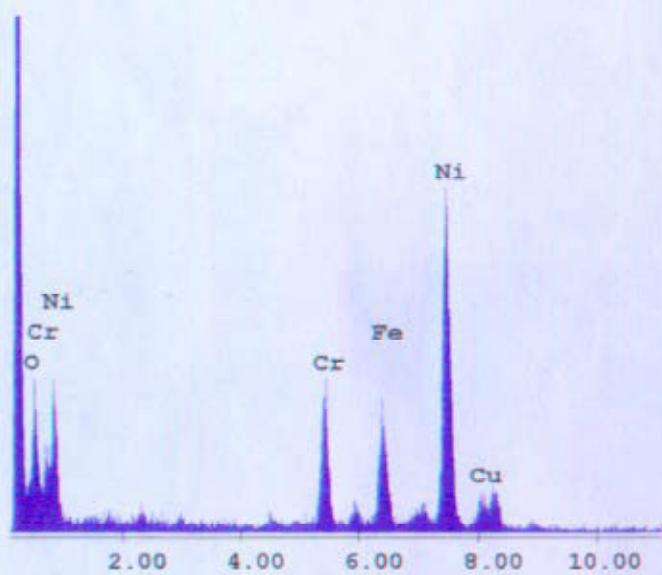
Figure 16. AEM bright field images showing IGSCC crack tip. Note sharpness of crack-tip. X-ray spectrum from oxide in crack varies from Ni rich to Ni and Cr rich. (near- neutral hydrogenated water, 338°C, MA<sup>980</sup>)

The near-neutral hydrogenated water specimens exhibited sharp crack tips with crack tip radii  $\sim$  2-3 nm and good registry between matching halves of the fracture surface indicating that very little general corrosion had occurred (Figure 16). The crack path was truly intergranular with no evidence of cracking along slip planes or off the grain boundary and proceeded around Cr<sub>7</sub>C<sub>3</sub>-type carbides. In the crack wake, a thin layer of oxide on the carbide was commonly observed, both on the surface adjacent to the crack and between the carbide and the substrate (Figure 17), consistent with prior AEM work [2,4] in near-neutral hydrogenated water. As shown in Figure 17, the oxide layer on the carbides exhibits a thickness up to  $\sim$  20 nm. This thin oxide layer is Cr-rich, but efforts to obtain a valid diffraction pattern from this phase have been unsuccessful to date. Note that the thin layer observed between the substrate and the carbide is often associated with small secondary cracks on the substrate side of the carbide. No oxidation of carbides ahead of the crack tips was apparent.

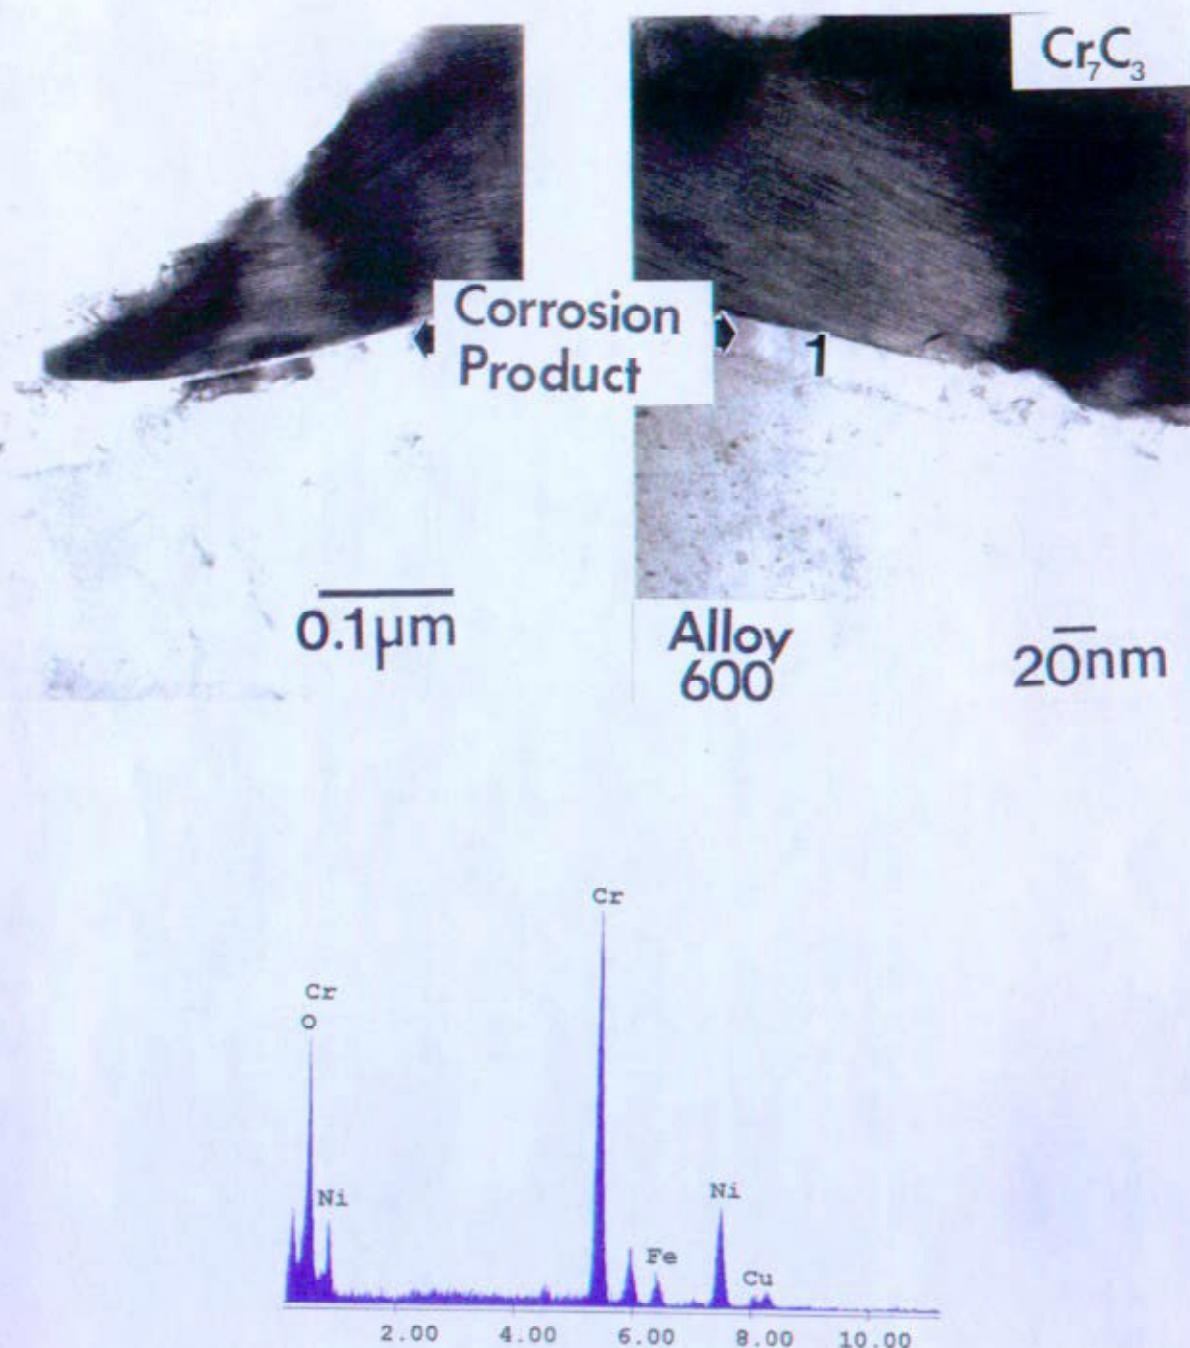
Figure 17. AEM bright field image showing  $\text{Cr}_7\text{C}_3$  carbide along IGSCC crack. Top of image is main crack. Bottom of image is oxide layer between carbide and substrate. X-ray spectrum from area 1 indicates a Cr rich oxide. (near- neutral hydrogenated water,  $338^\circ\text{C}$ , MA<sup>980</sup>)

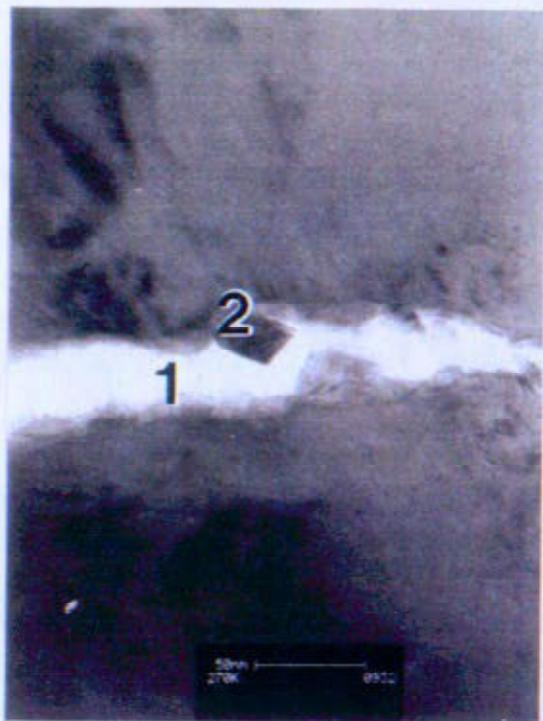
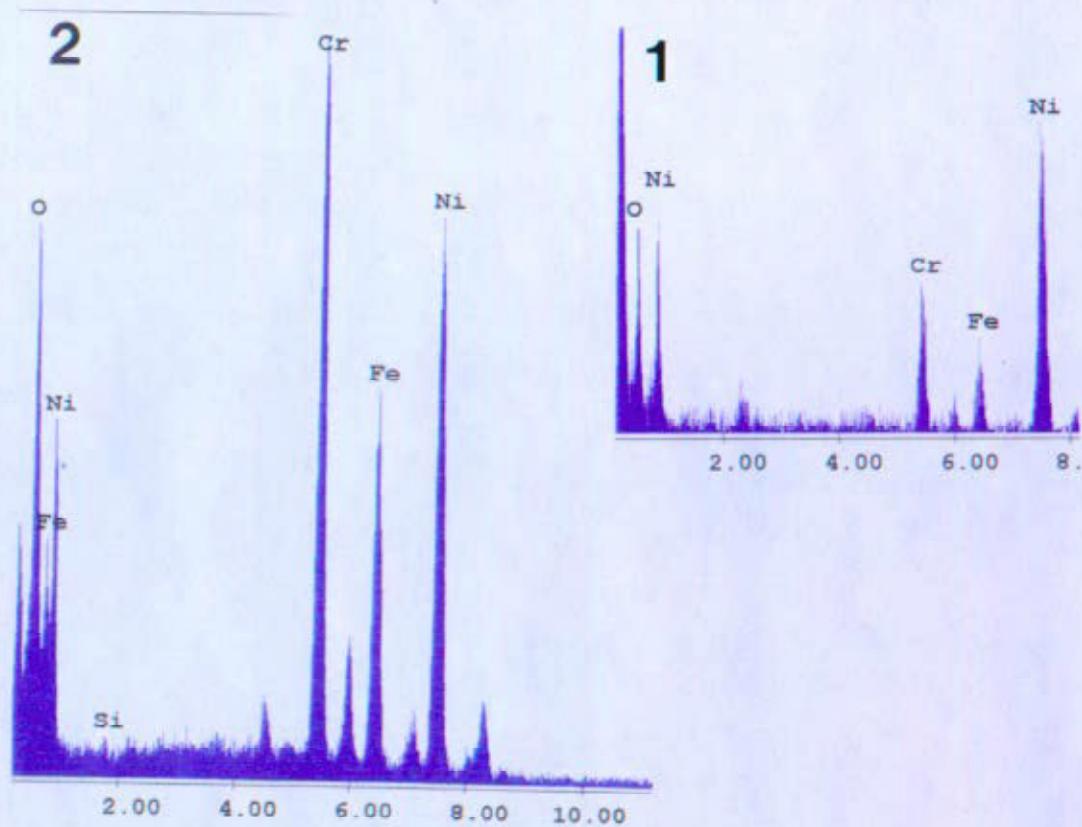
Figure 18. AEM high magnification image near IGSCC crack -tip showing very fine grain oxide area 1 and larger oxide crystal area 2. X-ray spectrum 1 and 2 from area 1 and 2 show Ni rich oxide with elemental ratios similar to the base metal and larger oxide with roughly equal Fe, Cr and Ni. (near- neutral hydrogenated water, 338°C, MA<sup>980</sup>)

The crack tip and crack wake oxides consisted of NiO-structure and spinel-structure oxides. It is important to note that, consistent with prior AEM findings [4], both iron and chromium were observed in the NiO-structure oxide (*i.e.* (Ni, Cr, Fe)O). Both iron-rich spinels (*e.g.*, NiFe<sub>2</sub>O<sub>4</sub>) and chromium-rich spinels (*e.g.*, NiCr<sub>2</sub>O<sub>4</sub>) were observed, with the Cr-rich spinel being the most common spinel form observed. The high resolution AEM image in Figure 18 shows a chromium-rich, spinel-structure oxide embedded in the NiO-structure oxide near the crack tip of the specimen tested in 120 scc/kg hydrogen.

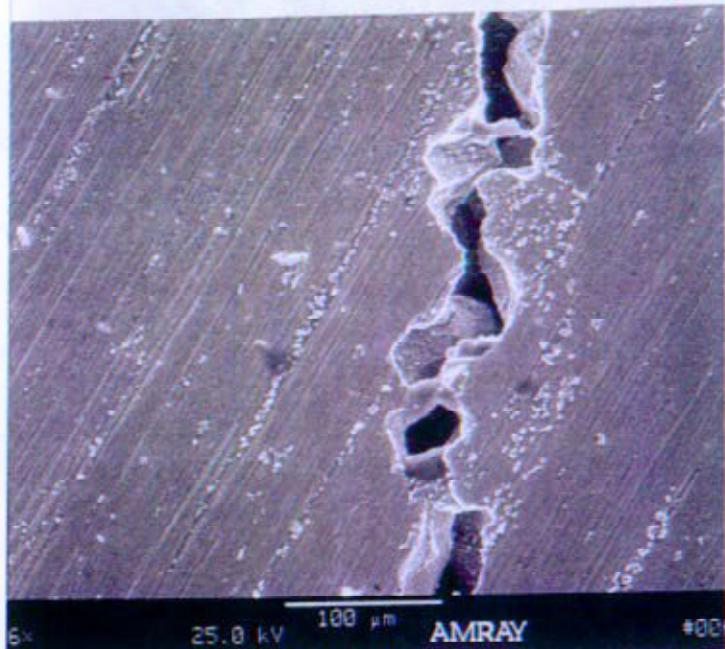
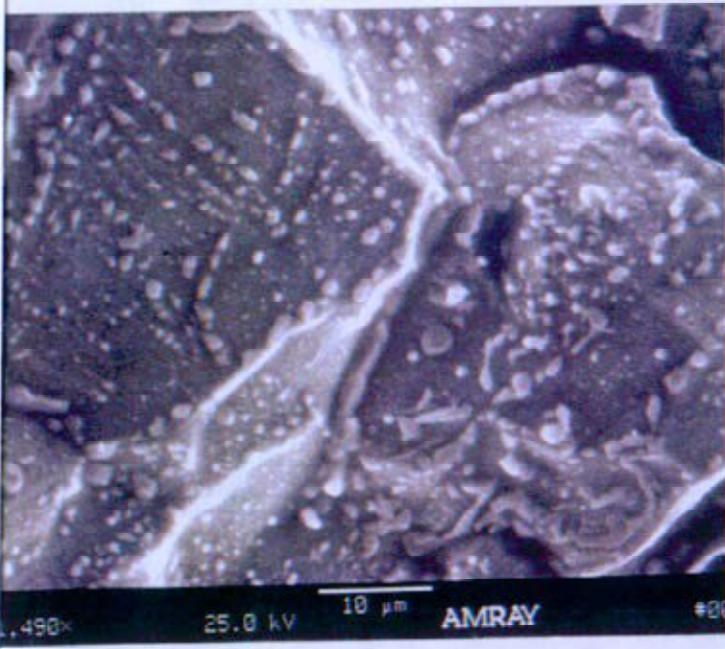
Figure 19. Secondary electron image showing outside surface of IGSCC specimen. Note Ni rich precipitates appearing white on outside surface decorating grain faces in crack. (hydrogenated steam, 399°C, MA<sup>1010</sup>)

Figure 20. Secondary electron image showing IGSCC grain facet. Note Ni rich precipitates on the surface of the grain. (hydrogenated steam, 399°C, MA<sup>1010</sup>)

399°C Hydrogenated Steam Condition. A noteworthy aspect of this specimen, as shown via scanning electron microscopy (SEM) photographs, is the presence of metallic Ni nodules on the specimen surface (Figure 19), and along most of the crack wake (Figure 20). The nodules were verified to consist essentially of Ni via EDS, and the phase identification was performed by micro-diffraction, as shown in Figure 21. The Ni nodules have not been typically observed on specimens examined by AEM [4,8-13]. Their presence in this specimen may be due to the reducing nature of the environment (*i.e.*,  $P_{\text{hydrogen}}$  of 83 kPa). Also, the precipitation kinetics may be affected by the steam and/or aqueous environment. The environment may be saturated with respect to nickel ions in this case (similar to the caustic case described above), since the nickel ions cannot diffuse away into the bulk water as they can in an aqueous test environment. Interestingly, as one moves along the crack wake in the direction of the crack tip, the Ni nodules are no longer present (Figure 22). The reason for the absence of the Ni nodules in the near crack tip region is not known. It is possible that the conditions are less reducing near the crack tip. It is also conceivable that this observation may be related to formation kinetics (*i.e.*, the time available for precipitation is lower near the crack tip since this is the most recently created surface), or perhaps to the access of steam and/or condensed water to the crack tip region. Additionally, it is possible that capillary action affects the condensation of steam, which might affect the Ni nodule formation within the crack.

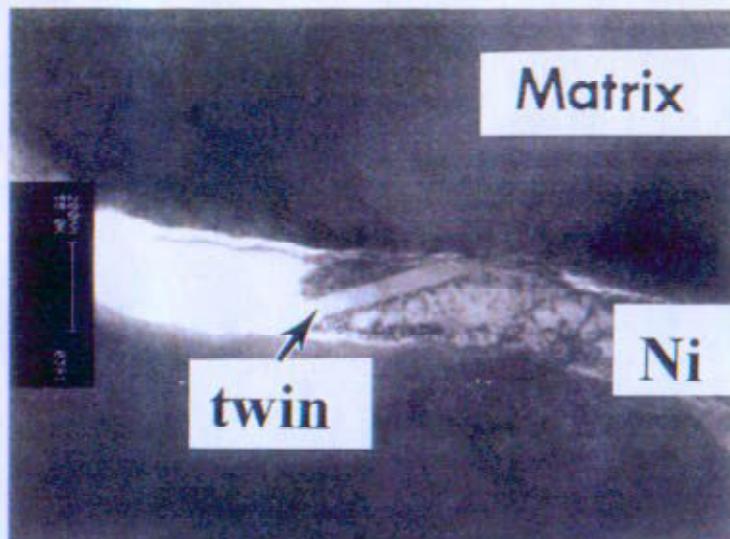
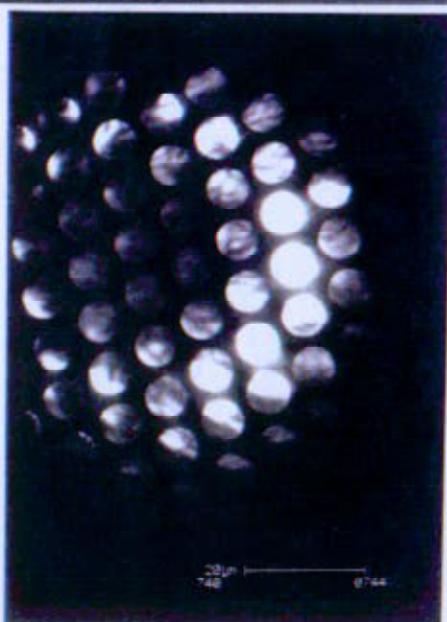
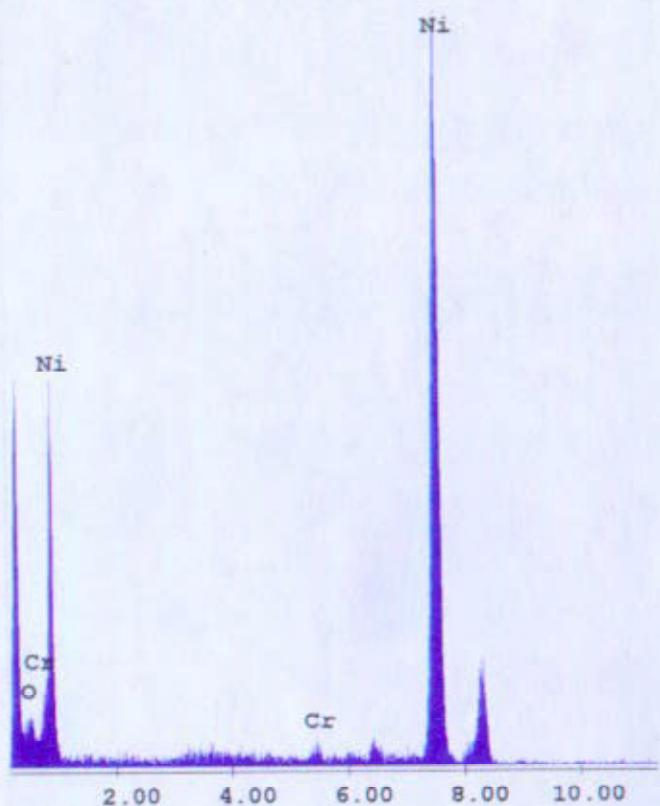
Figure 21. AEM bright field image showing cross-section of IGSCC crack. X-ray spectrum and electron diffraction pattern confirm that pure Ni metal is filling the crack. Note the twin within the Ni metal precipitate which does not match mating grains. (hydrogenated steam, 399°C, MA<sup>1010</sup>)

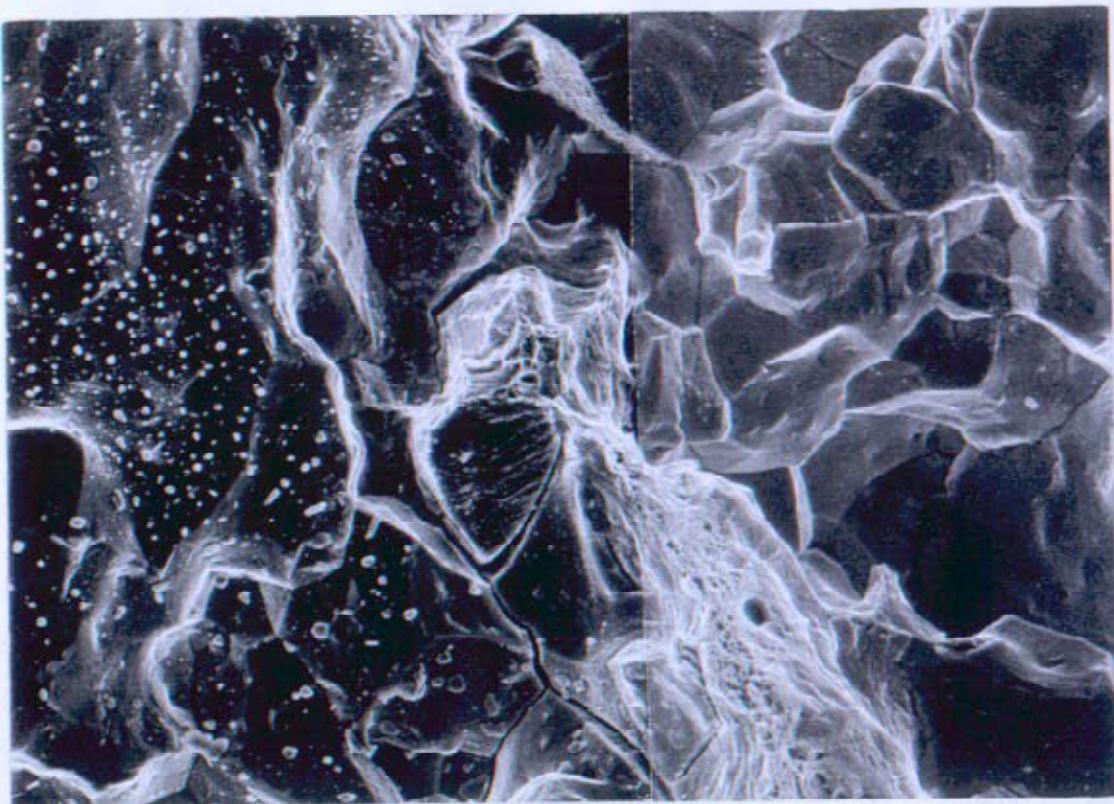
Figure 22. Secondary electron image showing IGSCC fracture surface near crack-tip. Note that Ni rich precipitates do not extend all the way to the crack-tip. (hydrogenated steam, 399°C, MA<sup>1010</sup>)

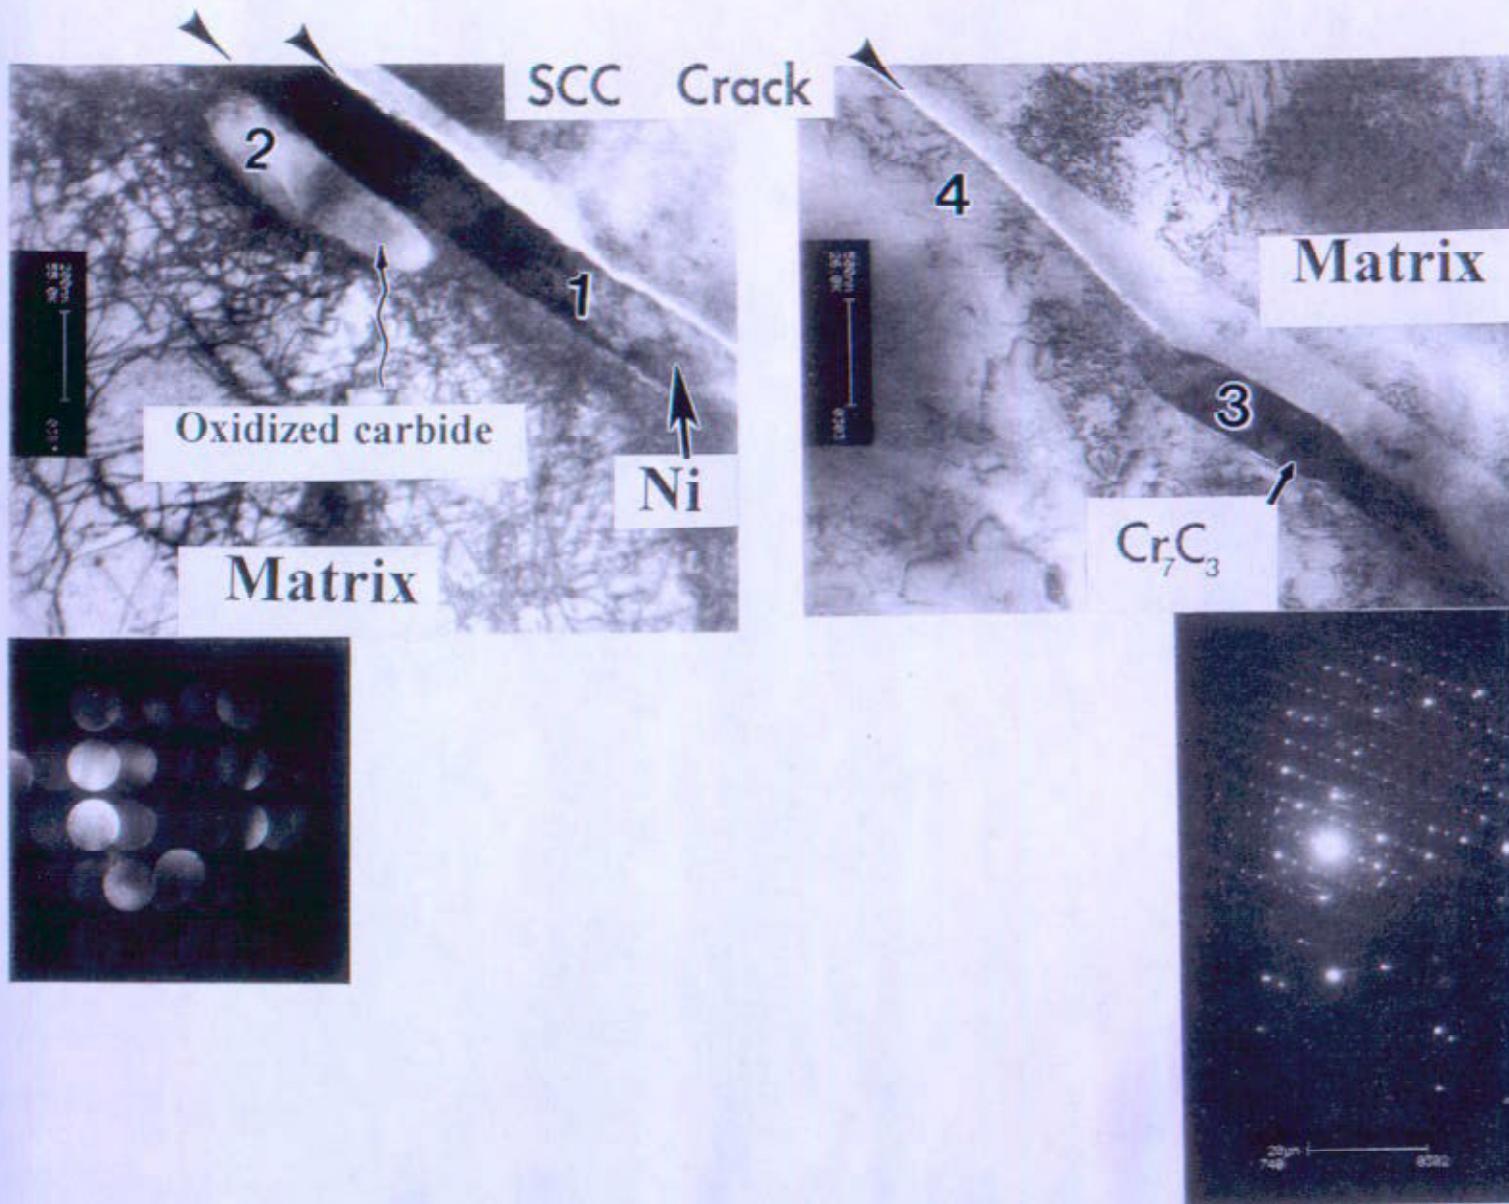
Figure 23 AEM bright field images and electron diffraction patterns showing IGSCC crack. a) wider crack with Ni rich precipitate area 1 and single crystal oxide spinel area 2. b) narrow crack near crack-tip intersecting unoxidized area 3 and adjacent to twin area 4. Arrows denote crack width. (hydrogenated steam, 399°C, MA<sup>1010</sup>)

Another unusual aspect of this specimen is the presence of single crystal oxide particles found along the crack wake, as shown in Figure 23a. These single crystal oxide particles exhibit a spinel structure. It is believed that these particles represent oxidized carbides, but the evidence is not definitive. Key evidence supporting this view is that the general size and shape of the oxide particles is similar to the size and shape of the microstructural carbides (Figure 23b). However, as shown in Figure 24a, these particles contain appreciable Fe and Ni which is not present in the microstructural chromium carbides, as shown in Figure 24b (note that the EDS spectra for the Ni metal precipitate and the alloy matrix are included for comparison in Figures 24c and 24d, respectively).

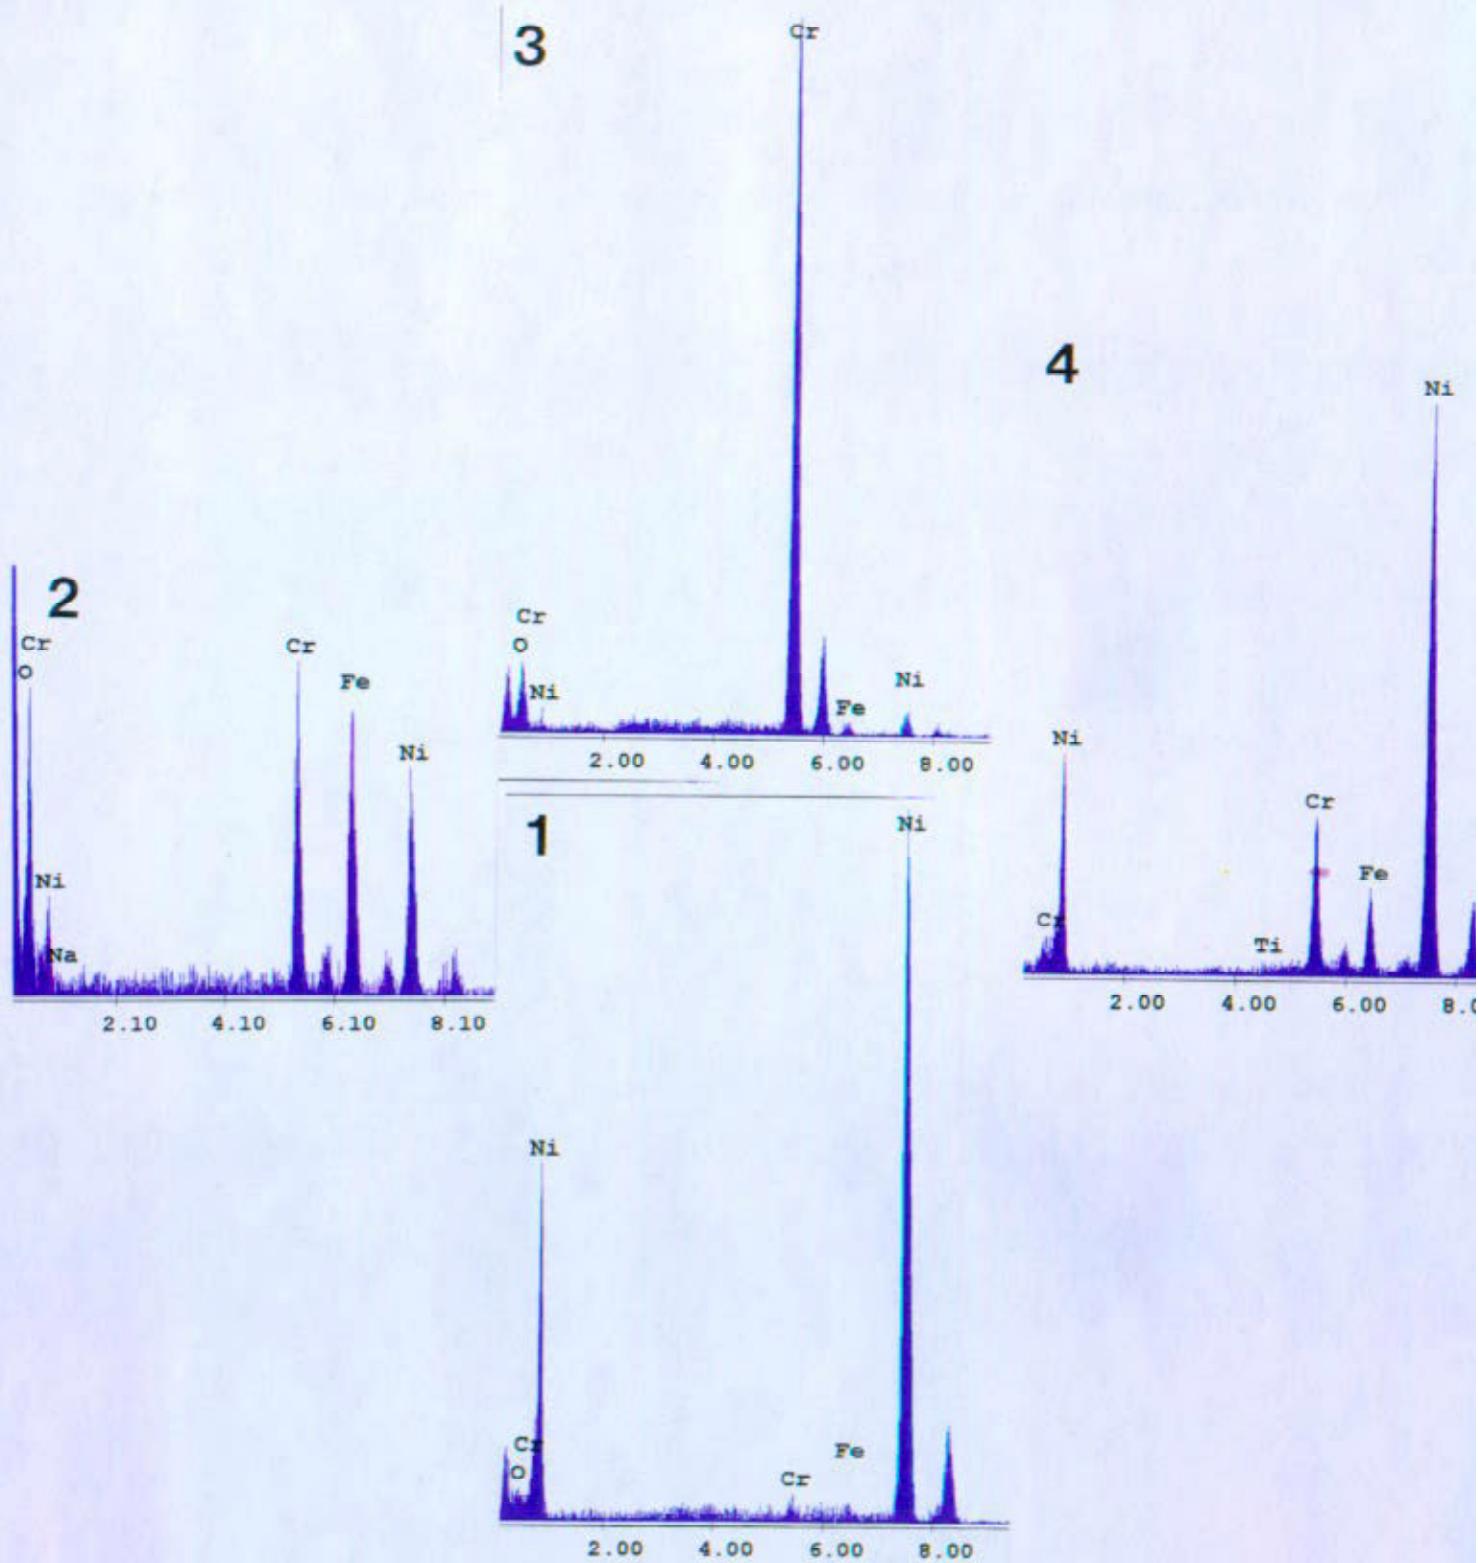
Figure 24. X-ray spectrum 1-4 from areas 1-4 in Figure 23. Area 1 is Ni metal, area 2 is single crystal oxide spinel, area 3 is  $\text{Cr}_7\text{C}_3$  carbide and area 4 is alloy 600 matrix. (hydrogenated steam,  $399^\circ\text{C}$ ,  $\text{MA}^{1010}$ )

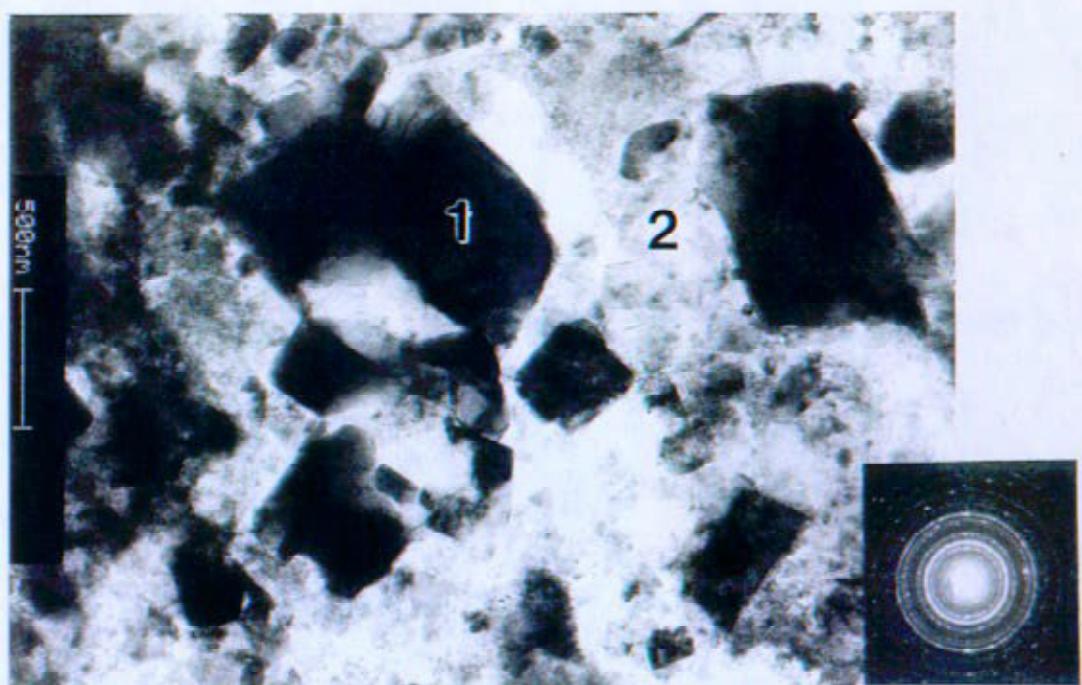
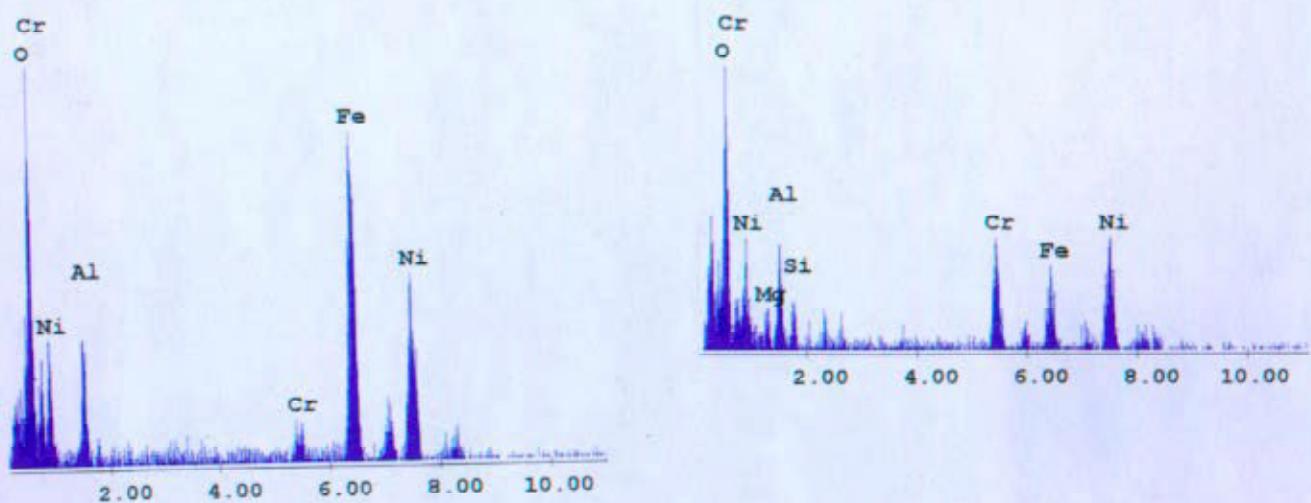
Figure 25. AEM bright field images showing plan view of bulk surface oxide. Electron diffraction pattern (inset) indexes to oxide spinel. X-ray spectrum 1 and 2 from area 1 and 2 is  $\text{NiFe}_2\text{O}_4$  and  $\text{Ni}_x\text{Fe}_{(1-x)}\text{Cr}_2\text{O}_4$  respectively. (hydrogenated steam, 399°C, MA<sup>1010</sup>)

The bulk surface oxide (Figure 25) exhibits a spinel structure with faceted crystallites. The large crystals are  $\text{NiFe}_2\text{O}_4$  and the smaller crystals are  $\text{Ni}_x\text{Fe}_{(1-x)}\text{Cr}_2\text{O}_4$  (with Ni metal precipitates also occasionally observed). These structures are similar to that observed for the bulk oxides in near-neutral hydrogenated water, though Ni metal was not found on the surface of those samples.
