Project/Job Name Corrective Action Decision Document for CAU 005: Areas 5, 6, 12, 20, and 23 Landfills

This Corrective Action Decision Document (CADD) has been prepared for Corrective Action Unit (CAU) 5, Landfills. The purpose of the CADD is to identify and provide a rationale for the recommendation of a corrective action alternative for each corrective action site (CAS) within CAU 5. The corrective action investigation was conducted in accordance with the *Corrective Action Investigation Plan for Corrective Action Unit 5: Landfills, Nevada Test Site, Nevada* (NNSA/NV, 2002a), as developed under the *Federal Facility Agreement and Consent Order* (FFACO, 1996). Corrective Action Unit 5 is located in Areas 5, 6, 12, 20, and 23 of the Nevada Test Site, Nevada, and includes the following CASs:

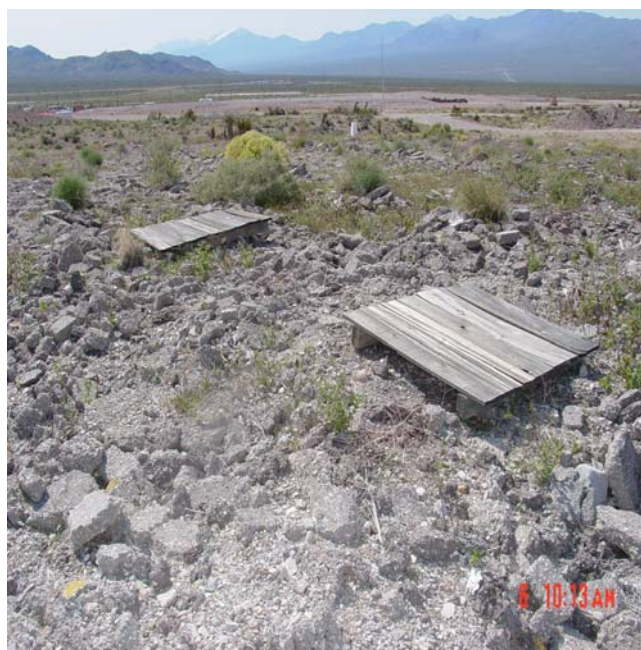
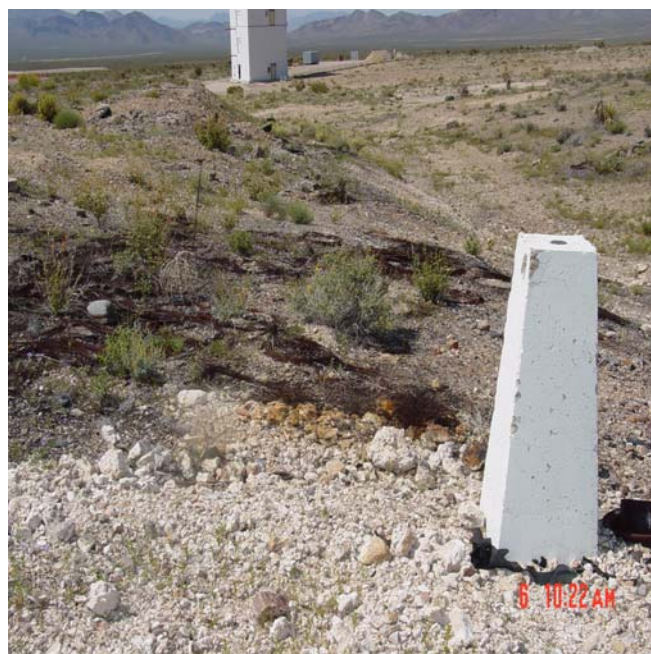
**Figure A.10-4**  
**Asphalt Debris Field at CAS 23-15-03, Disposal Site (Disposal Area)**

Material here consists mostly of asphalt, with some areas of burned material and many coiled rolls of thin wire. The field, extending over approximately 31,375 ft<sup>2</sup>, is located at the north end of the CAS and is bordered by the north/south-trending access road to the east and the bottom of the steep wash to the west. Most of the debris field is on a flat area between the road and the wash and is visible as a layer of waste at the top of the hill. In some places the wastes drapes over the side of the hill toward and into the adjacent wash. Lesser amounts of waste are visible as scattered occurrences along the slope of the hill and in the bottom of the wash. Thin stringers and layers of caliche are present in the hill sidewall, showing that the hill is natural material and not waste.

Asphalt was found only on the surface to an average thickness of about 1 ft (1,160 yd<sup>3</sup>), based on excavation, borings, and a sidewall view of the debris from the wash. [Figure A.10-4](#) shows the surface asphalt debris and burned wire.

**Asphalt Debris on Surface, View to South**  
(Photograph Taken 05/06/2003)

**Asphalt and Wire on Surface, View to Southwest**  
(Photograph Taken 05/06/2003)

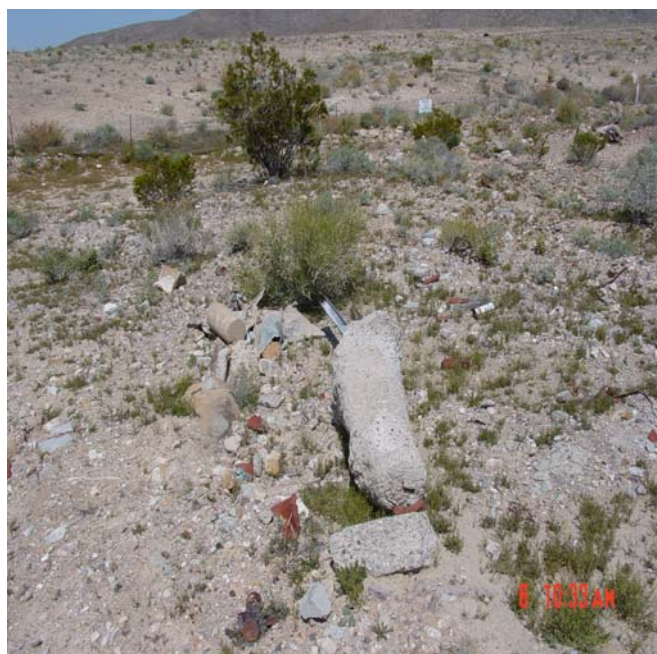
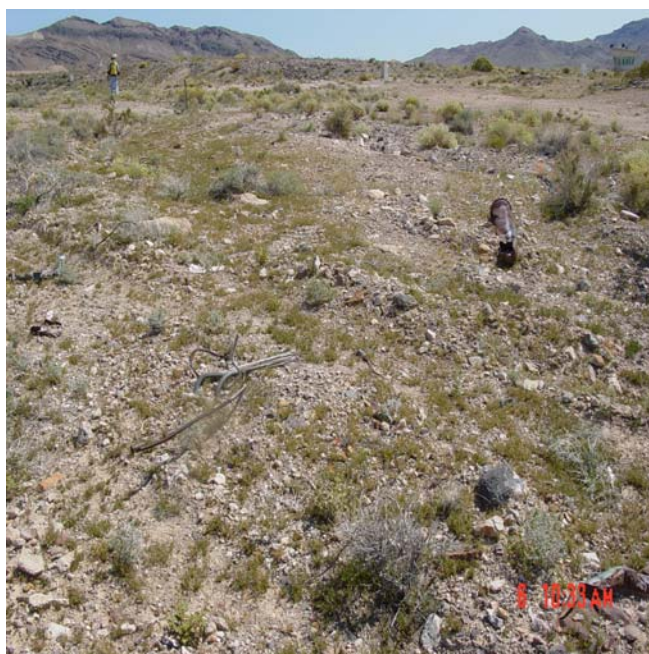
**Figure A.10-5**  
**Construction Debris Field at CAS 23-15-03, Disposal Site (Disposal Area)**

This field consists of surface debris containing the “green ooze” around CWA2. In places, the debris is covered with about 1 in. of dirt and reaches a maximum thickness of 3 ft. The surface area of the

field is estimated at approximately 18,900 ft<sup>2</sup>, based on excavation, borings, and visual examination. The volume of waste in this field is estimated at 2,100 yd<sup>3</sup>, based on the above dimensions. This debris field is the source of the material excavated during the investigation, as described below.

**Concrete Debris on Surface, View to Northwest**  
(Photograph Taken 05/06/2003)

**Irregular Piles of Surface Debris, View to Northwest**  
(Photograph Taken 05/06/2003)

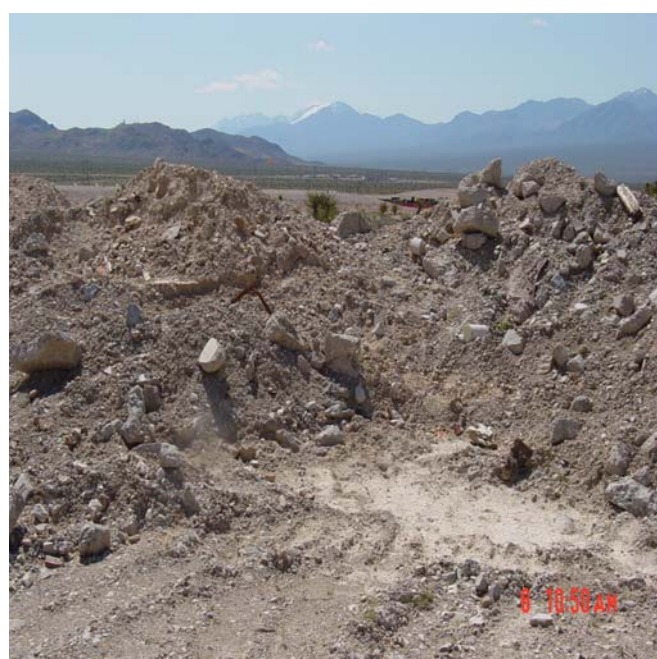
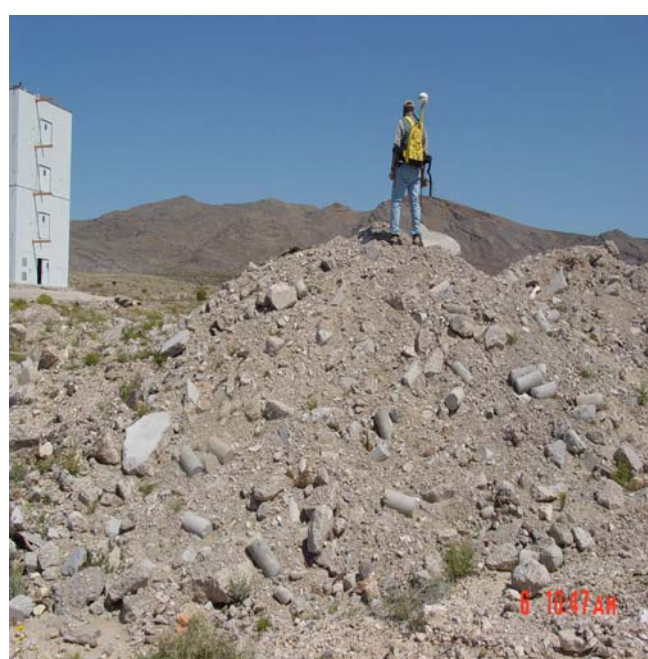
**Figure A.10-6**  
**Soil/Concrete Piles at CAS 23-15-03, Disposal Site (Disposal Area)**

The piles consist mostly of soil containing asphalt and debris. One of the piles is around MWA3 and is estimated to be 375 yd<sup>3</sup> of material. The other pile is around CWA2 and is estimated to contain 485 yd<sup>3</sup> of material. These volumes were estimated based on a GPS perimeter survey, a visual estimate of height (7-ft tall), and a “cone volume” calculation. [Figure A.10-6](#) shows the two debris piles.

Debris Pile Around MWA3, View to Southeast  
(Photograph Taken 05/06/2003)

Debris Pile Around CWA2, View to Northeast  
(Photograph Taken 05/06/2003)

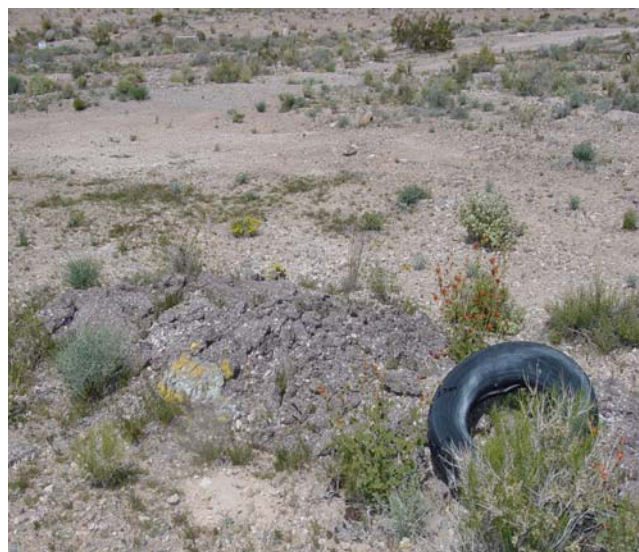
**Figure A.10-7  
Asphalt Debris Pile at CAS 23-15-03, Disposal Site (Disposal Area)**

There are several circular and linear debris piles around the southern portion of CWA1 and north of CWA2. The piles contain mostly asphalt with lesser amounts of concrete, metallic scrap, and soil. The combined volume of this material is estimated to be about 65 yd<sup>3</sup>. [Figure A.10-7](#) is a photograph of one of the asphalt debris piles at this area.

**Close-up of Asphalt Debris Pile  
(Photograph Taken 05/06/2003)**

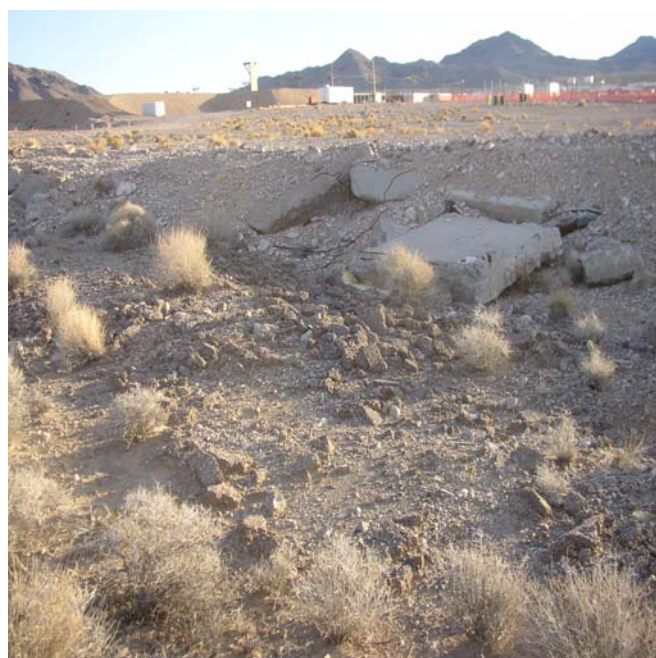
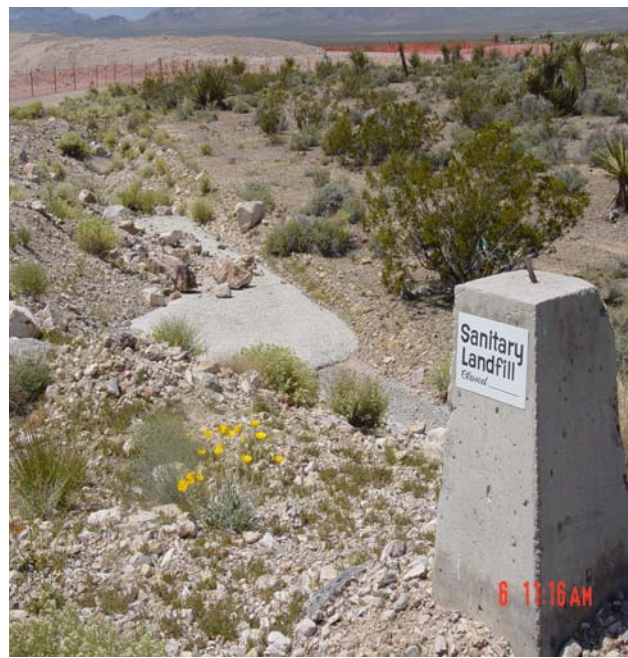
**Figure A.10-9**  
**Surface Debris West of Trench 1 at CAS 23-15-03, Disposal Site (Landfill)**

Approximately 50 ft west of T1, there is a north/south-trending linear pile of surface debris, consisting mostly of soil with concrete and miscellaneous metallic scrap, as shown in [Figure A.10-2](#). The material is estimated to cover approximately 3,900 ft<sup>2</sup>. This debris pile is adjacent to a natural wash, which meanders through a generally undisturbed area to the west. Based on observations made in excavation H09 that was extended to the west as well as scattered debris on the surface, it appears debris was dumped in the wash and on the surface between T1 and the wash. This debris is currently covered with a few inches of soil, except the linear debris pile described above. There are also several piles of miscellaneous construction waste in the wash, with a combined estimated volume of 15 yd<sup>3</sup>. [Figure A.10-9](#) shows the debris pile and its relation to the wash.

Concrete Surface Debris, View to Northeast  
(Photograph Taken 01/26/2003)

Surface Debris and Landfill Monument, View to South  
(Photograph Taken 05/06/2003)
