# **Internal Repair of Pipelines**

## **Semi-Annual Technical Progress Report**

**Reporting Period:**  
September 30, 2002 through March 31, 2003

**DOE Award No.: DE-FC26-02NT41633**

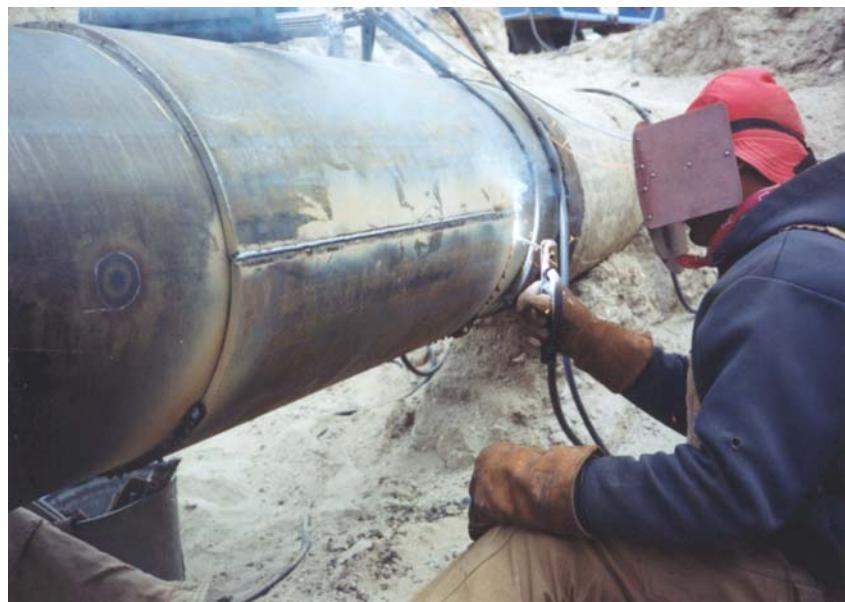
**Figure 1 - Installation of a Full-Encirclement Repair Sleeve**

The Task 2.0 - Technology Status Assessment indicates that the most commonly used method for repair of gas transmission pipelines is the full-encirclement steel repair sleeve (Figure 1). This and other repair methods commonly applied from the outside of the pipeline are typically done so while the pipeline remains in-service. While this would be desirable for internal repair, many of the repair methods that are applicable to the inside of the pipeline would require that the pipeline be taken out-of-service. Most of the repair methods that are commonly applied to the inside of other types of pipelines, which typically operate at low pressure, are done so to restore leak tightness. These repair methods would require further development in order for them to restore the strength of a gas transmission pipeline.

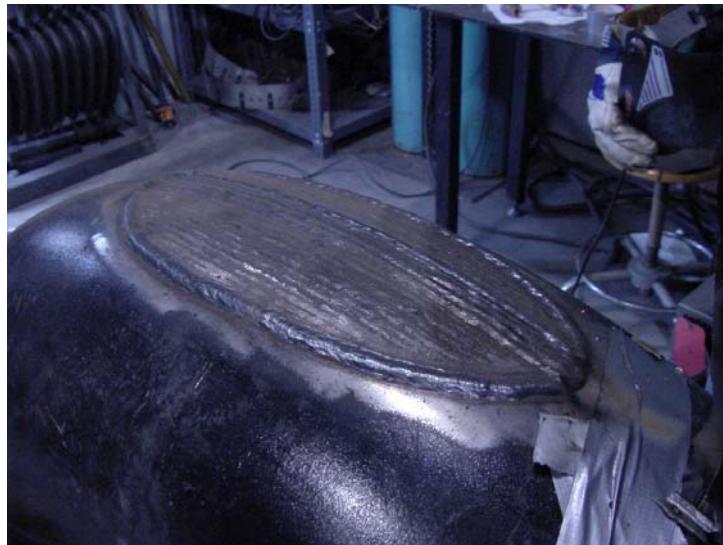
Gas transmission pipeline repair by direct deposition of weld metal, or weld deposition repair, is a proven technology that can be applied directly to the area of wall loss (e.g., external repair of external wall loss - Figure 1) or to the side opposite the wall loss (e.g., external repair of internal wall loss – Figure 2).

**Figure 2 - External Weld Deposition Repair of Internal Wall Loss in 90 Degree Elbow**

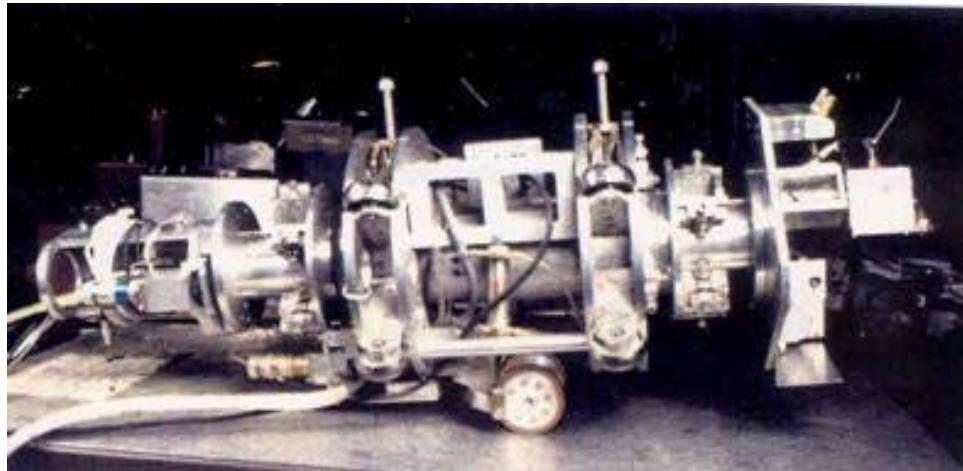
There are no apparent technical limitations to applying this repair method to the inside of an out-of-service pipeline. It is direct, relatively inexpensive to apply, and requires no additional materials beyond welding consumables. However, application of this repair method to the inside of an in-service pipeline would require that welding be performed in a hyperbaric environment. Deposited weld metal repairs are also used to repair circumferentially oriented planar defects (e.g., intergranular stress corrosion cracks adjacent to girth welds) in the nuclear power industry. Remote welding has been developed primarily by needs in the nuclear power industry, though working devices have been built for other applications, including repair of gas transmission pipelines. An example is shown in Figure 3.

**Figure 3 - Osaka Gas System for Remote Robotic Internal Repair of Root Weld Defects in Gas Transmission Pipelines**

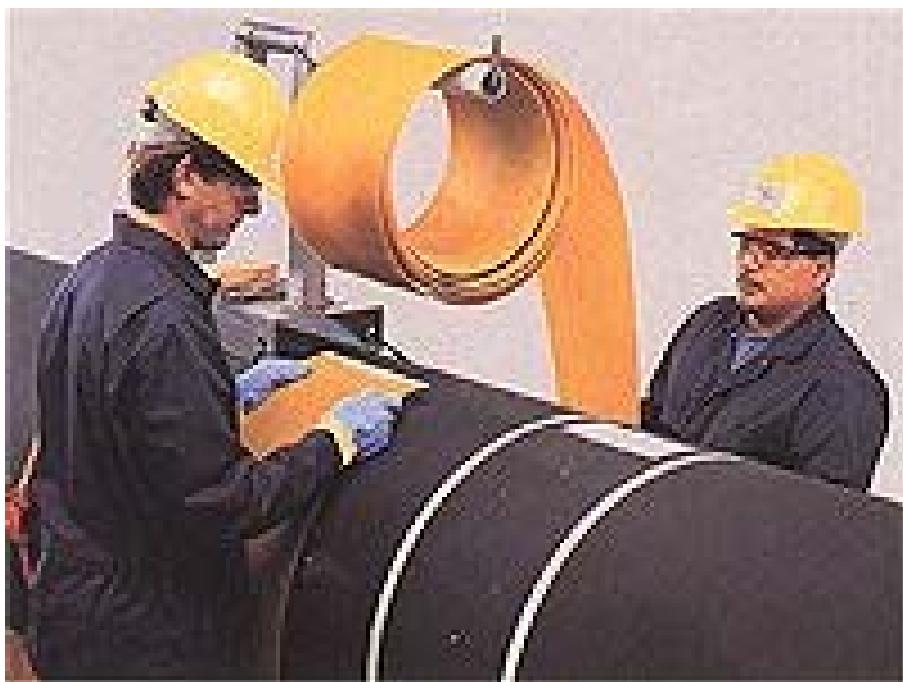
Fiber-reinforced composite repairs are becoming widely used as an alternative to the installation of welded, full-encirclement sleeves for repair of gas transmission pipelines. These repairs typically consist of glass fibers in a polymer matrix material bonded to the pipe using an adhesive. Adhesive filler is applied to the defect prior to installation to allow load transfer to the composite material. The primary advantage of these repair products over welded, full-encirclement sleeves is the fact that welding is precluded. An illustration of the most commonly-used of the fiber-reinforced composite devices, Clock Spring®, is shown in Figure 4.

**Figure 4 - Clock Spring® Fiber-Reinforced Composite Device for Pipeline Repair**

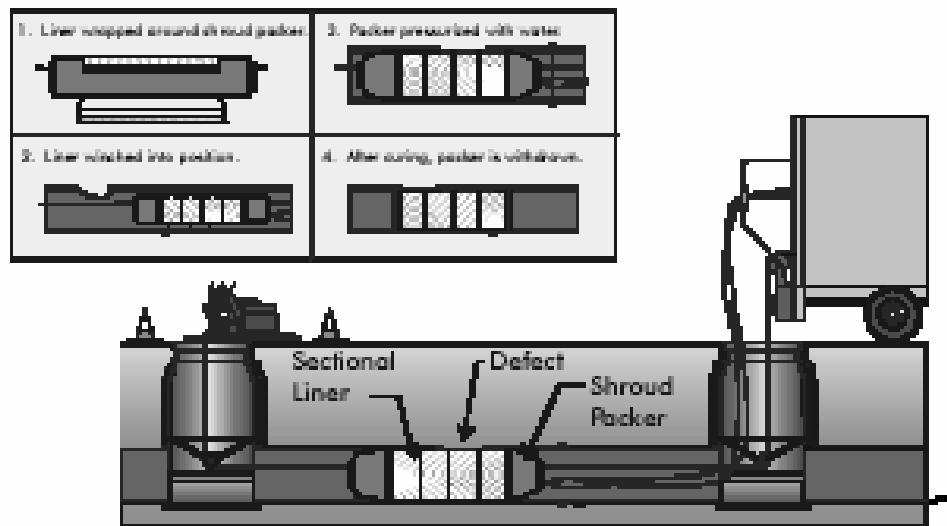
A variety of liners are commonly used for repair of other types of pipelines (gas distribution lines, sewers, water mains, etc.). Of these, the three that are potentially applicable to internal repair of gas transmission pipelines are sectional liners, cured-in-place liners, and fold-and-formed liners. Sectional liners are typically 3 to 15 feet in length and are installed only in areas that require repairs. Cured-in-place liners and fold-and-formed liners are typically applied to an entire pipeline segment. Cured-in-place liners are installed using the inversion process, while fold-and-formed liners are pulled into place and then inverted so that they fit tightly against the inside of the pipe. The installation of a sectional liner is illustrated in Figure 5.

**Figure 5 - Installation of a Sectional Liner in Low-Pressure Pipeline**

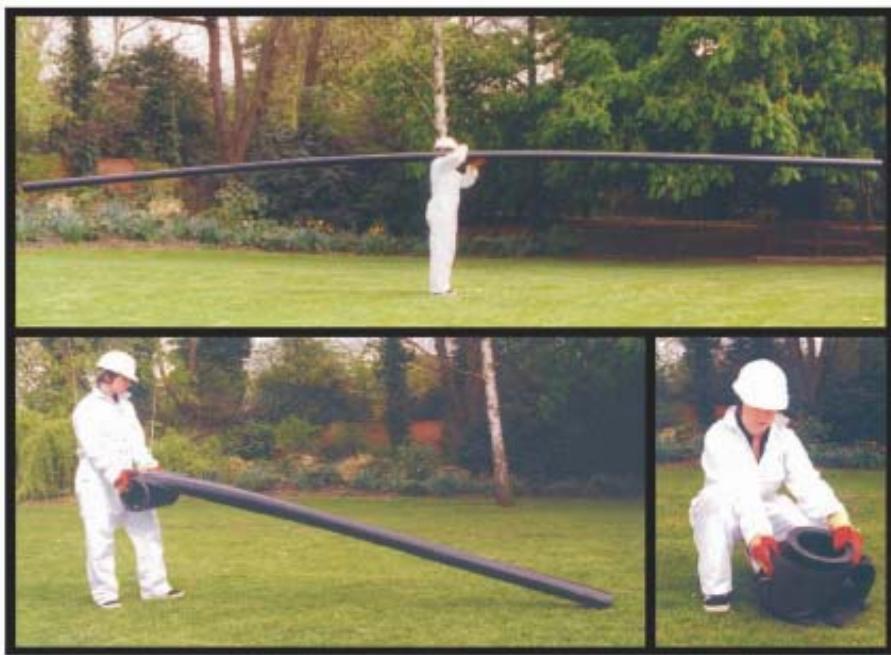
Task 2.0 research activities resulted in the discovery of several potentially useful commercial fiber-reinforced composite products that are directly applicable to internal repair. The initial test program is focusing on a modified Wellstream-Haliburton/RolaTube product, which is a bi-stable reeled composite material used to make strong, lightweight, composite pipes and pipe linings (Figure 6). When unreeled, it changes shape from a flat strip to an overlapping circular pipe liner that can be pulled into position. Following deployment, the longitudinal seam is welded with an adhesive that is activated and cured by induction heating. One example of this product is 100 mm (4 in.) diameter by 2.5 mm (0.10 in.) thick and is said to have a 60 bar (870 psi) short-term burst pressure.

**Figure 6- RolaTube Bi-Stable Reeled Composite Material**

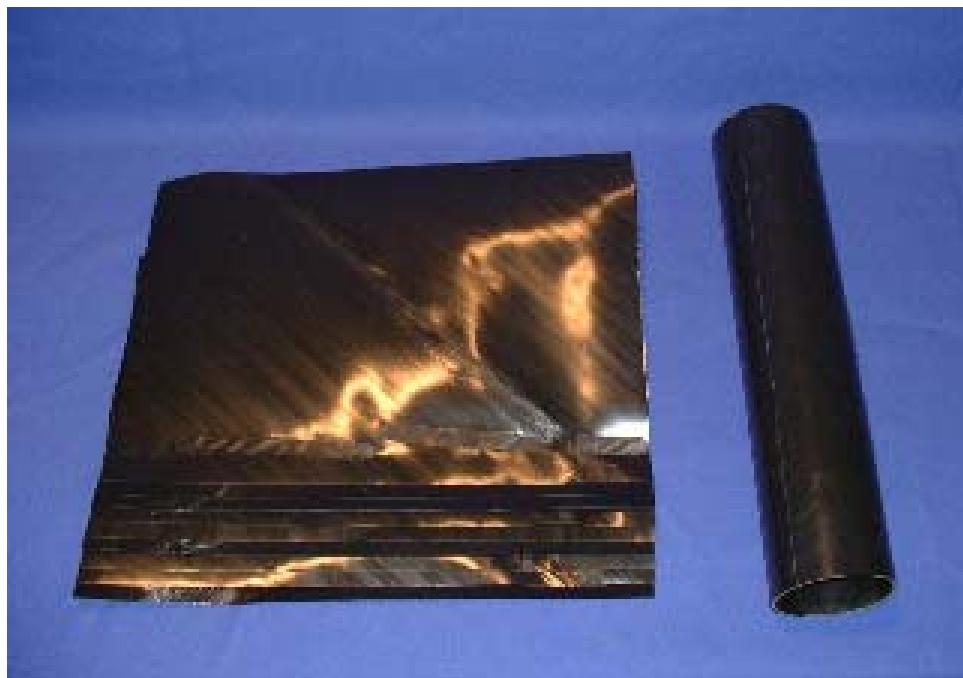
overlapping, pre-pregnated tapes of unidirectional glass and polymer. Glass-high density polyethylene (HDPE) material was also considered. The glass-polypropylene material was selected after problems bonding the glass-HDPE material to steel were encountered. Heat and pressure were used to consolidate the plies glass-polypropylene material into a liner (Figure 7). The resulting wall thickness of the liner is 2.85 mm (0.11 in.).

**Figure 7 - Lay-Up and Forming of Fiber-Reinforced Composite Liner**

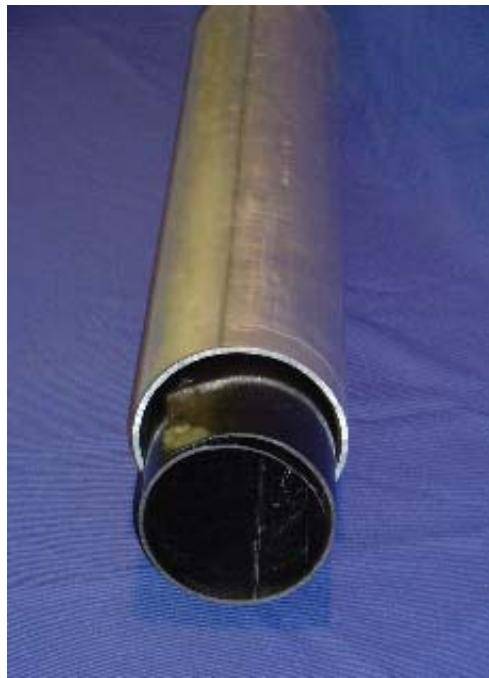
A supply of 114.3 mm outside diameter (OD) x 4 mm wall thickness (4.5 in. OD x 0.156 in.) API 5L Grade B pipe material was procured and cut into four sections approximately 1.2 m (4 ft.) long. After the inside surface was degreased, lengths of lining were installed into two of the pipe sections (Figure 8). The installation process consisted of inserting a silicon rubber bag inside the liner (Figure 9) and locating the liner inside the pipe. The silicon bag was then inflated to press the liner against the pipe wall. For these experiments, the entire pipe sections were then heated to 200°C (392°F) in an oven (Figure 10) to fuse the liner to the pipe wall. Possible choices for liner installation in the field include infra-red (IR) heaters on an expansion pig or a silicon bag inflated using hot air. An installed liner is shown in Figure 11.

**Figure 8 - Insertion of Liner into 114.3 mm (4.5 in.) Diameter Pipe**

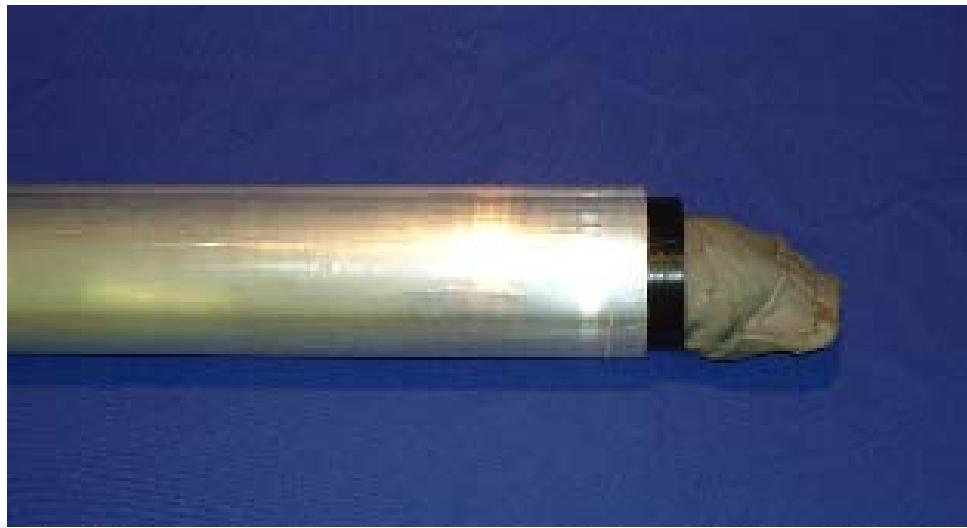
**Figure 9 - Silicon Rubber Bag Inserted into Liner**

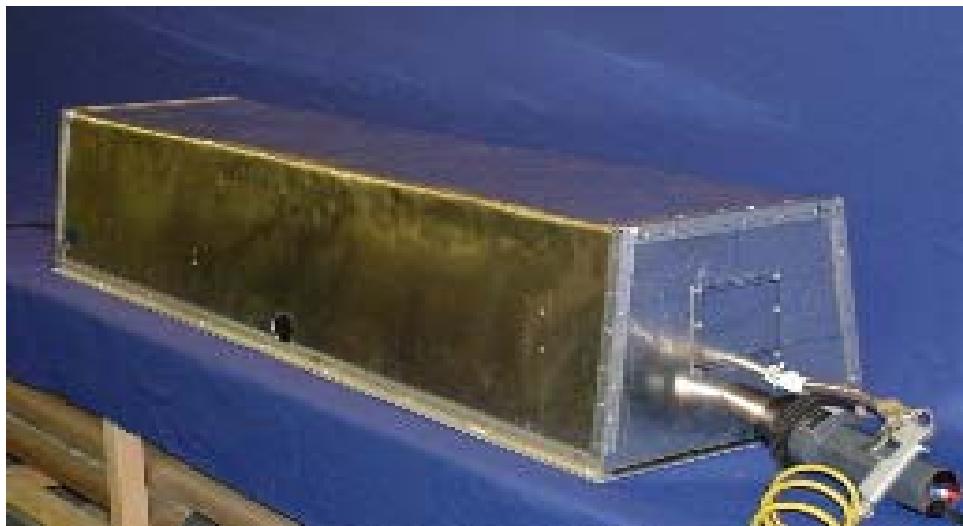
**Figure 10 - Oven Used to Heat Pipe and Liner to 200°C (392°F)**

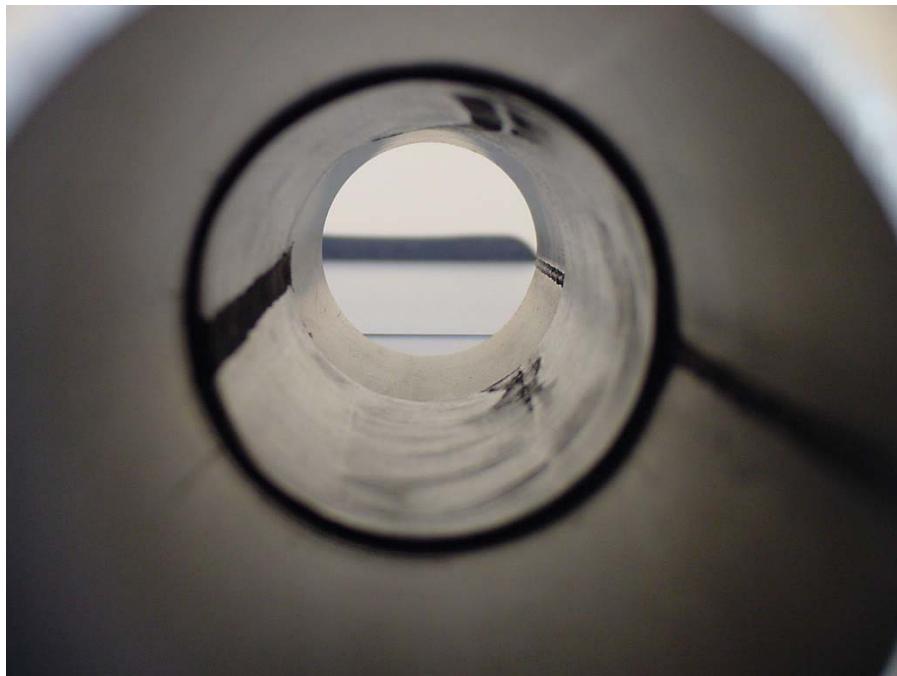
**Figure 11 - Liner Inserted into Center of 114.3 mm (4.5 in.) Diameter Pipe**

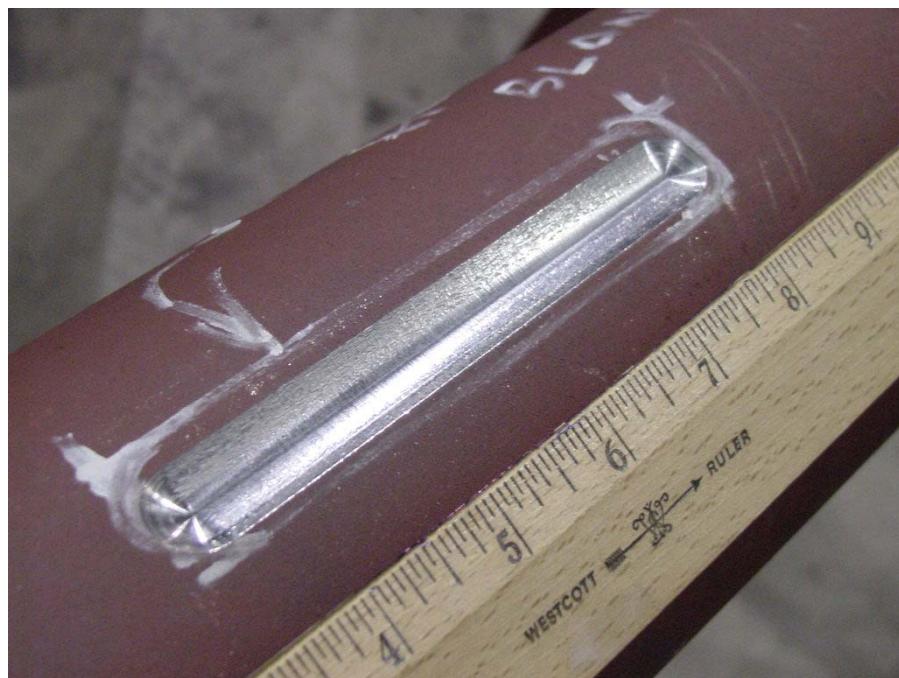
Using the RSTRENG software,<sup>(1)</sup> dimensions of simulated general corrosion and a deep, isolated corrosion pit both with a 30% reduction in burst pressure were calculated then introduced into pipe sections with a milling machine. Using a ball end mill, long shallow damage representative of general corrosion (Figure 12) was introduced into one pipe section lined with fiber-reinforced composite pipe (FRCP) and one without. Using an end mill with rounded corners, short, deep damage representative of a deep isolated

**Figure 12 - Long, Shallow Simulated Corrosion Damage**

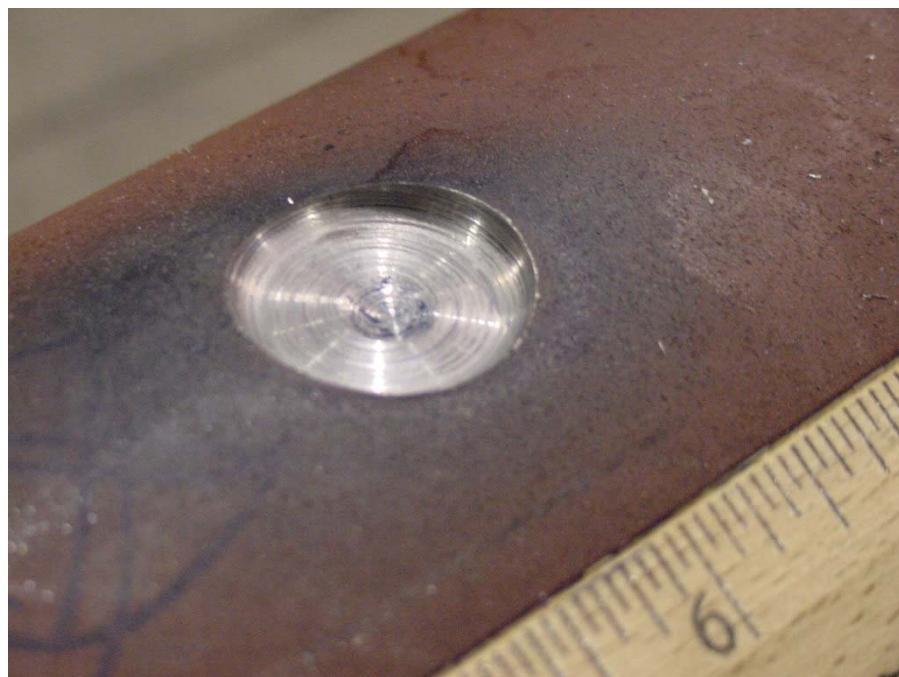
corrosion pit (Figure 13) was introduced into the second pair of pipe sections; one lined, one not lined. End caps were then welded to all four of the pipe sections (Figure 14).

**Figure 13 - Short, Deep Simulated Corrosion Damage**

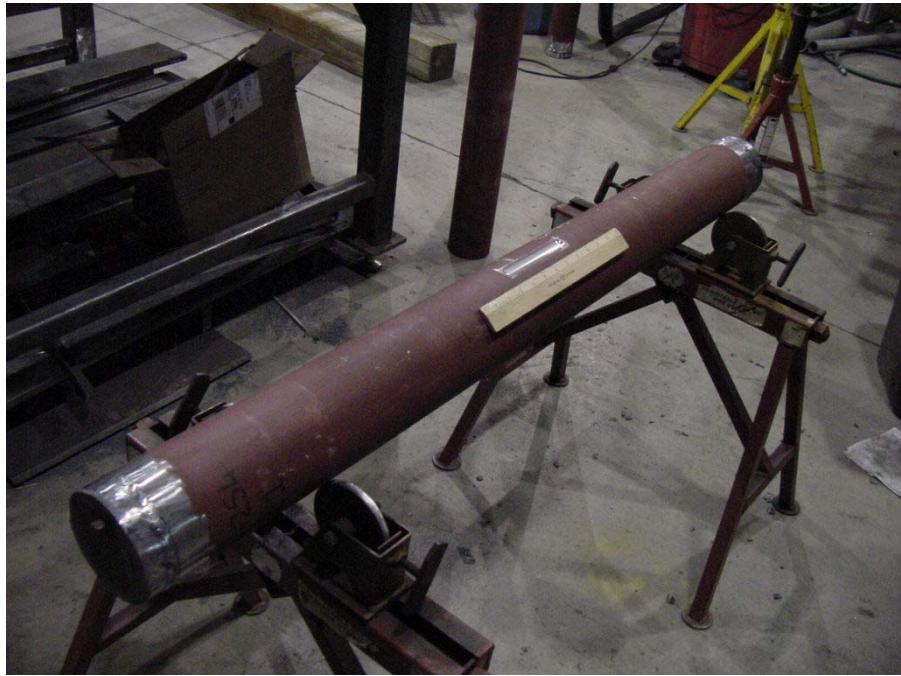
**Figure 14 - 114.3 mm (4.5 in.) Diameter Pipe with End Caps Welded and Simulated Corrosion Damage Introduced**

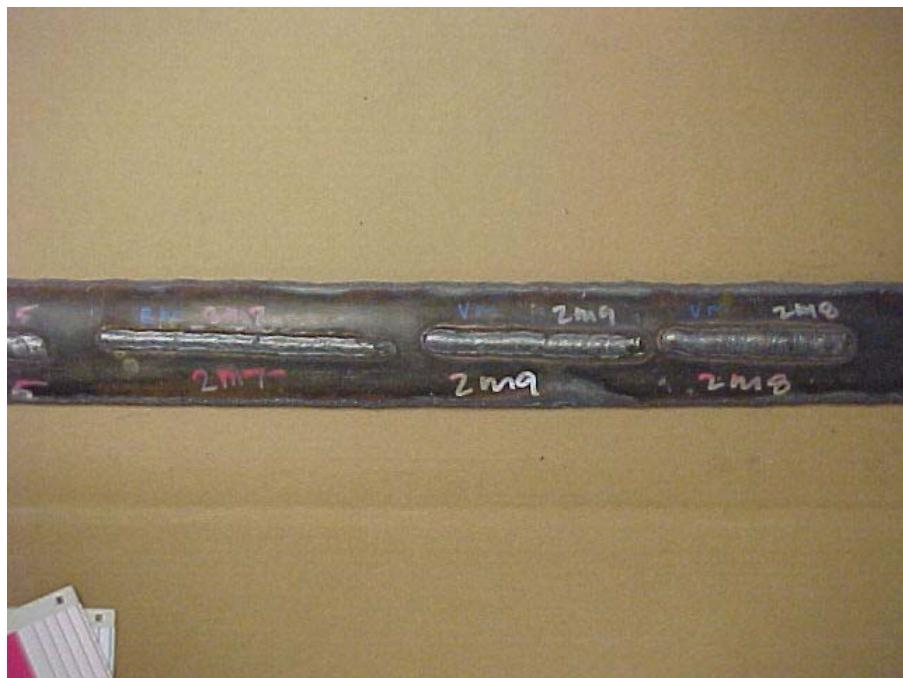
**Figure 16 - External Appearance of Welds Made on 3.2 mm (0.125 in.) Thick Pipe with Methane Gas at 4.5 mPa (650 psi) and 6.1 m/sec (19.9 ft/sec) Flow Rate**

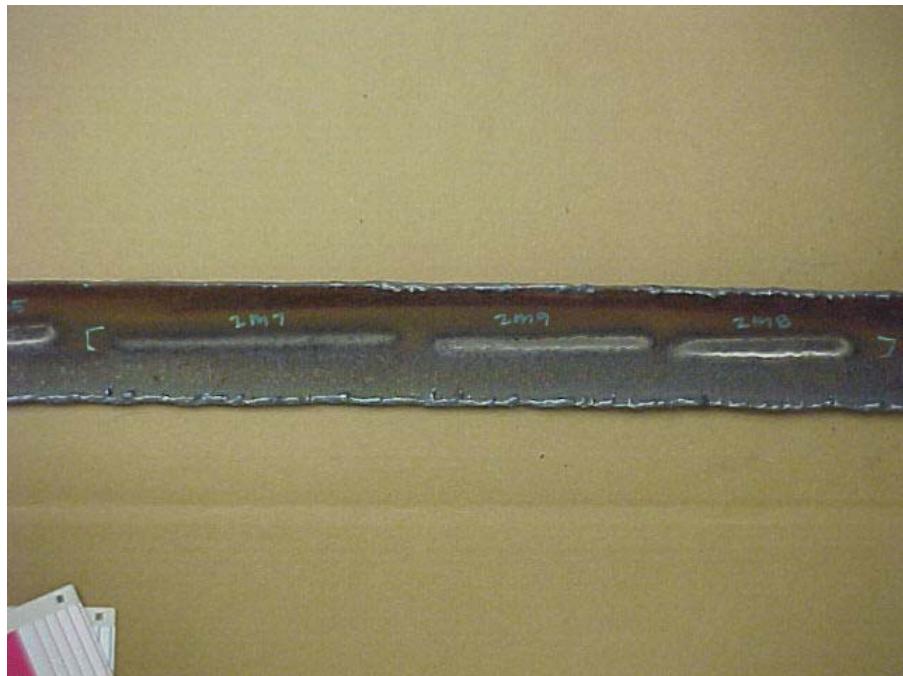
**Figure 17 - Internal Appearance of Welds Shown in Figure 16**

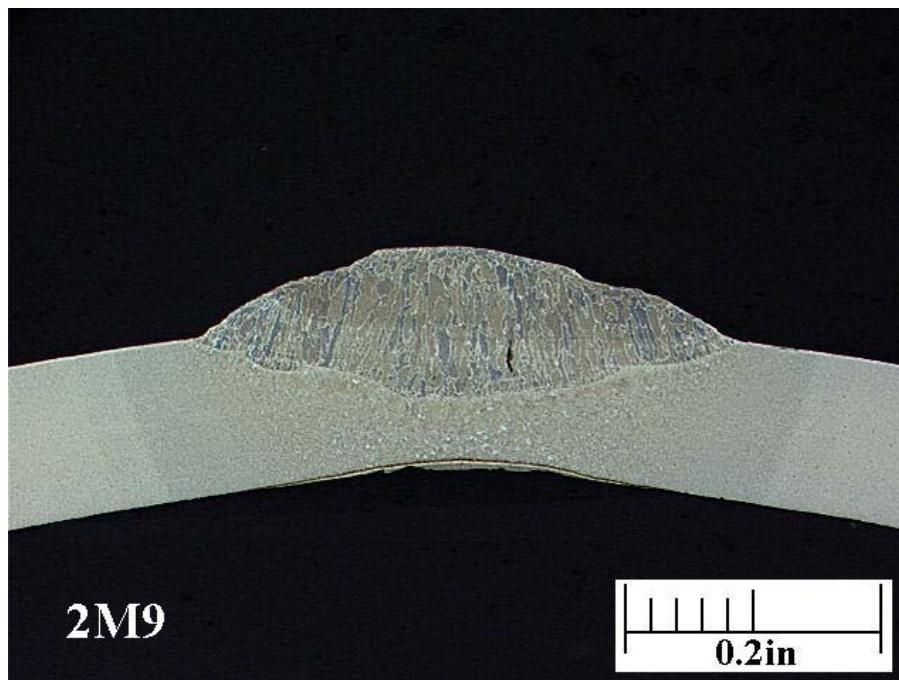
**Figure 18 - Metallographic Section through Weld 2M9 (middle weld shown in Figure 16 and Figure 17)**

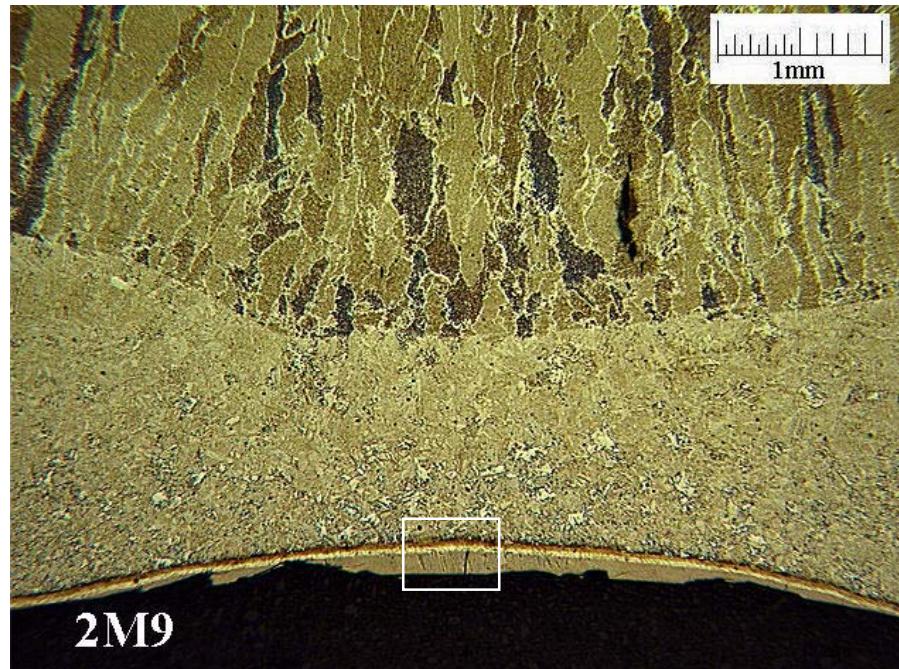
During any arc welding operation, the material being welded is exposed to temperatures that range from ambient to well above the melting temperature 1,536°C (2,736°F). When steel at high temperature is exposed to a hydrocarbon gas (such as methane), carburization can occur. When steel at temperatures above 1,130°C (2,066°F) is exposed to methane, eutectic iron can form as the result of diffusion of carbon from the methane into the steel. In previous work at EWI,<sup>(4)</sup> in which welds were made on the outside of thin-wall pipe containing pressurized methane gas (Figure 15, Figure 16, and Figure 17), carburization and the formation of thin layer of eutectic iron occurred (Figure 18 and Figure 19). This phenomenon was previously reported by Battelle during experiments with liquid propane.<sup>(5)</sup> There were also small cracks associated with the eutectic iron layer (Figure 20), which were attributed to the limited ductility of eutectic iron.

**Figure 19 - Eutectic Iron Layer at Inside Surface of Metallographic Section through Weld 2M9**

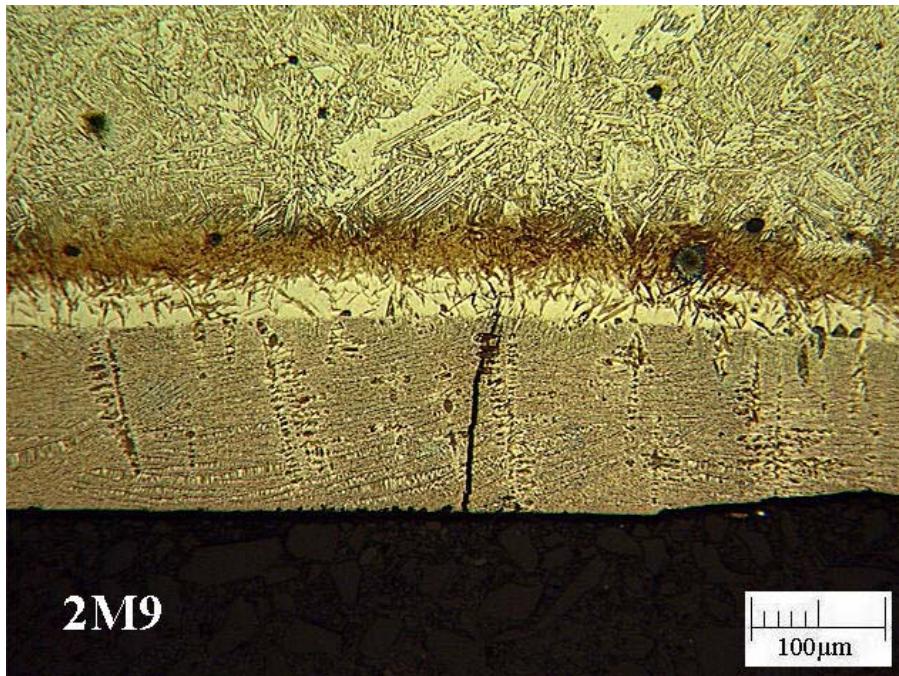
**Figure 20 - Cracks in Eutectic Iron Layer of Metallographic Section Shown in Figure 19**

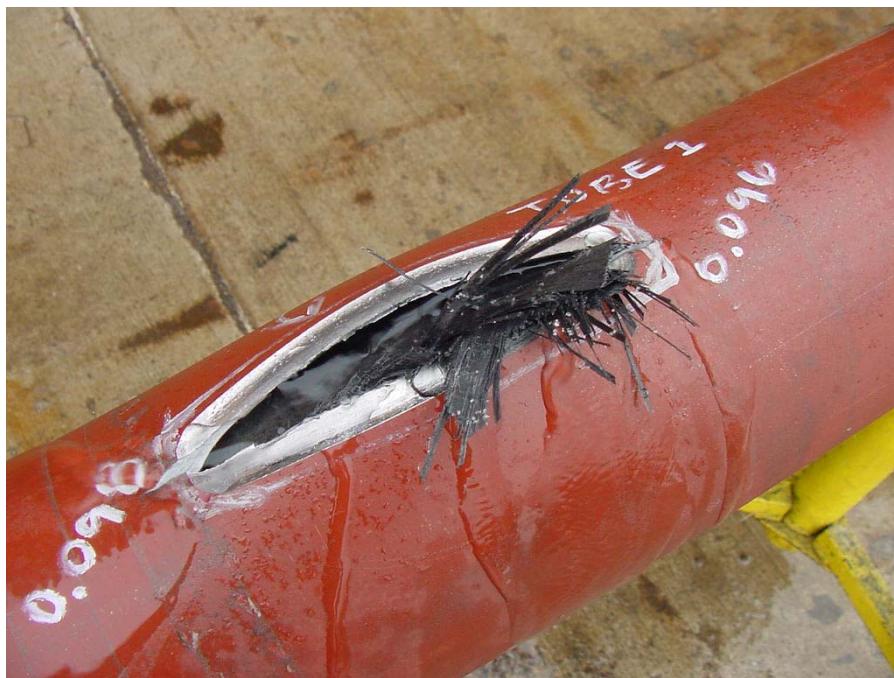
Ruptures were produced in the pipe sections containing long, shallow simulated corrosion damage (Figure 21). Leaks were produced in the pipe sections containing short, deep simulated corrosion damage (Figure 22).

**Figure 21 - Hydrostatic Test Rupture of Long, Shallow Simulated Corrosion Damage in Pipe Section Containing Fiber-Reinforced Composite Liner**

In both cases (long, shallow and short, deep simulated corrosion damage), the failure pressure for the pipe with the liner was only marginally greater than the pipe without the liner. Postmortem analysis of the pipe section with the long, shallow damage revealed that the liner did rupture, indicating that disbonding was not an issue (Figure 23 and Figure 24). Analysis of the results indicates that the difference in modulus of elasticity between the steel and the liner material prevents the liner from carrying its share of the load. The liner is currently being redesigned by RolaTube using a carbon/polypropylene material instead of glass/polypropylene so that the modulus of elasticity is approximately 95% less than that of steel.

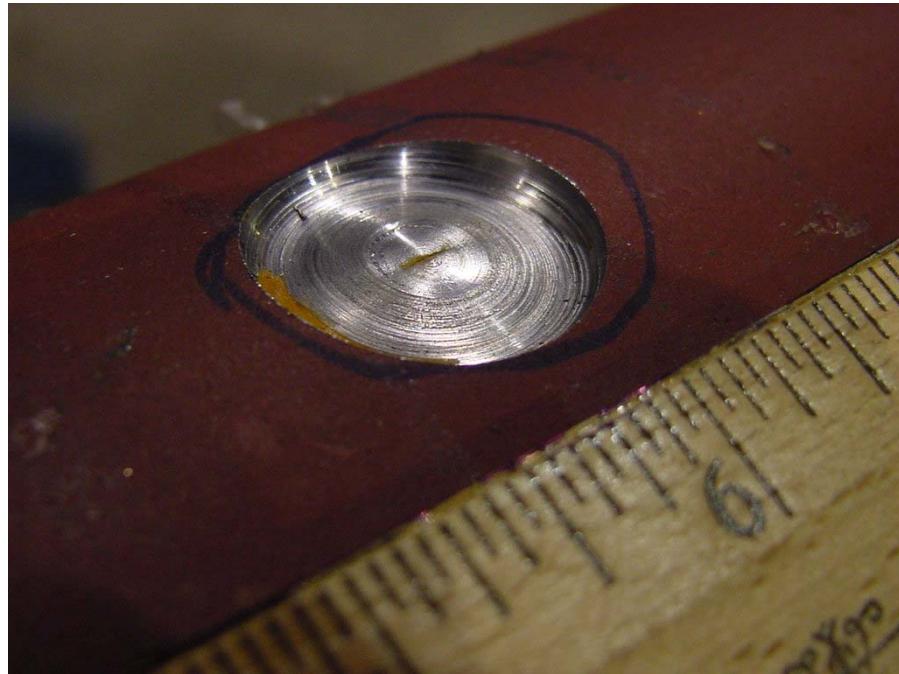
**Figure 22 - Hydrostatic Test Leak of Short, Deep Simulated Corrosion Damage in Pipe Section Containing Fiber-Reinforced Composite Liner**

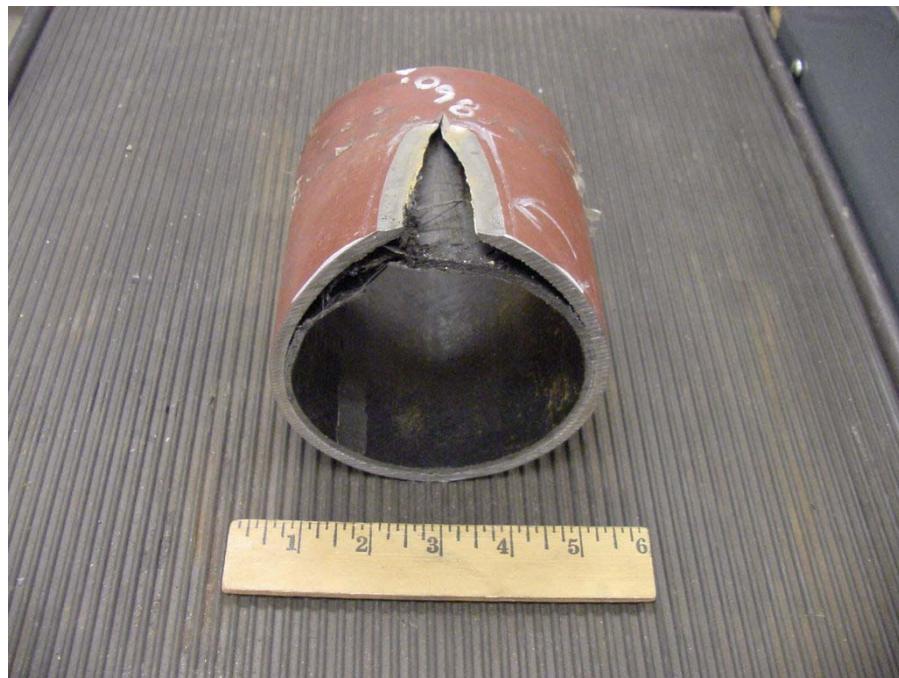
**Figure 23 - Section Taken Hydrostatic Test Rupture of Long, Shallow Simulated Corrosion Damage in Pipe Section Containing Fiber-Reinforced Composite Liner**

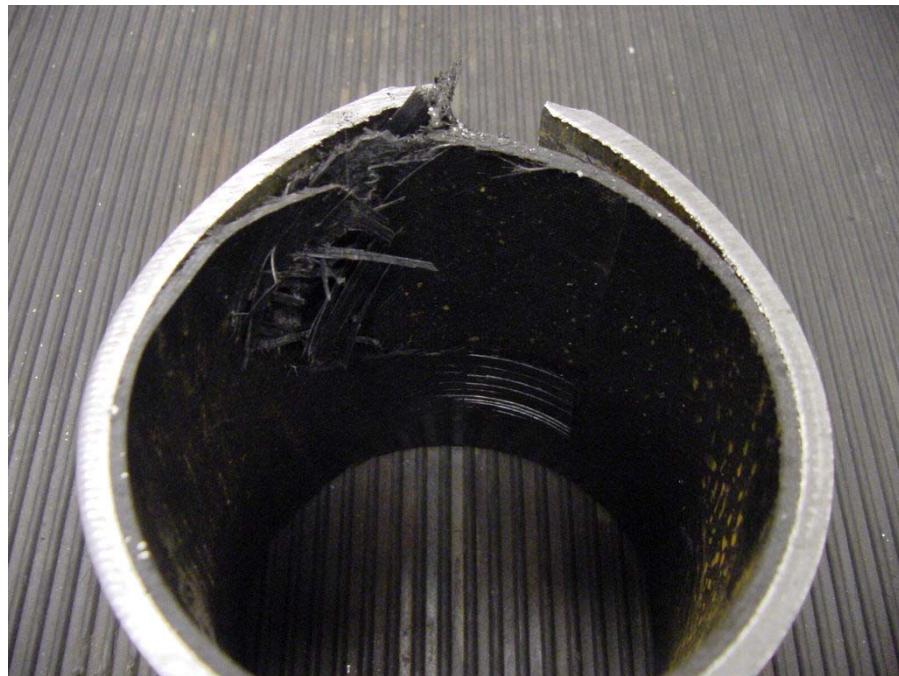
**Figure 24 - Fiber-Reinforced Composite Liner in Ruptured Pipe Section Containing Long, Shallow Simulated Corrosion Damage Fiber-Reinforced Composite Repairs**
