Advanced Hot Gas Filter Development

Final Report
September 29, 1994 to September 30, 2000

E. S. Connolly
G. D. Forsythe
September 30, 2000

Honeywell Advanced Composites Inc.
(formerly AlliedSignal Composites Inc.)
(formerly DuPont Lanxide Composites Inc.)
400 Bellevue Road
Newark, DE 19713

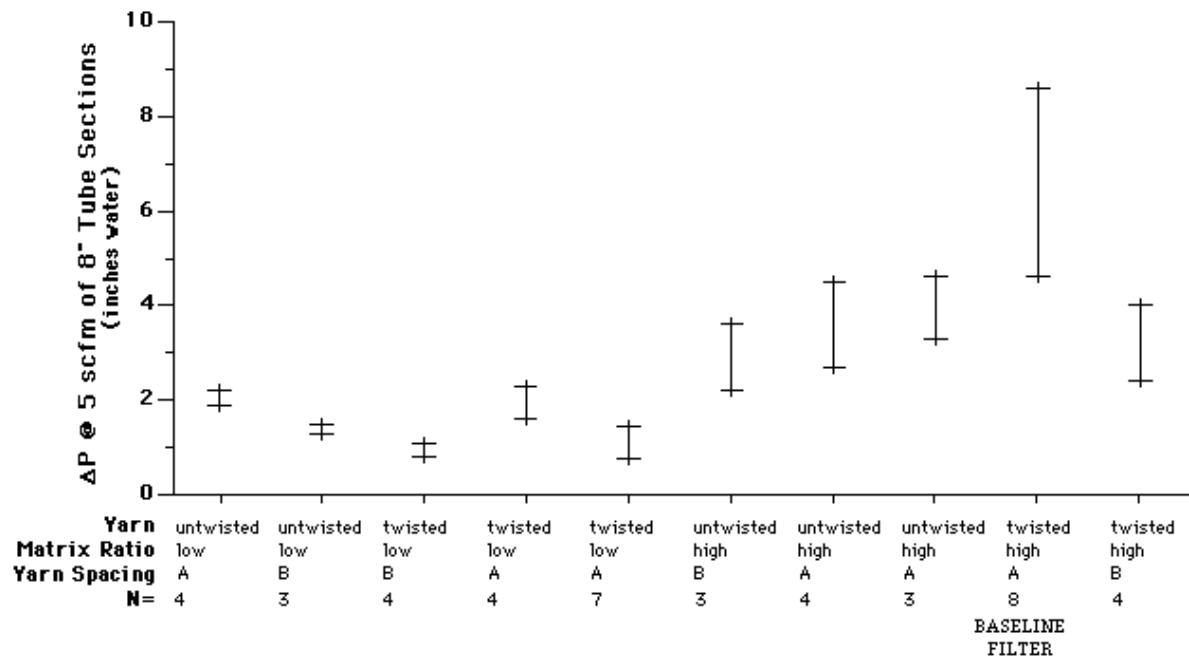
Figure 4 - Impact of three PRD-66 variables on backpressure (DP), where “N” is the number of samples.

As seen in Figure 4, every combination of yarn twist, matrix ratio, and yarn spacing examined in these experiments resulted in a reduction in backpressure when compared to the baseline filter. In these experiments, the new combinations were also less variable than the baseline filter. It should be noted that the backpressure measurements were made on 8" long samples taken from full size filters; the backpressure values presented in Figure 4 ARE NOT EQUAL TO values found on full filters, but they are proportional to them, so comparisons are meaningful.

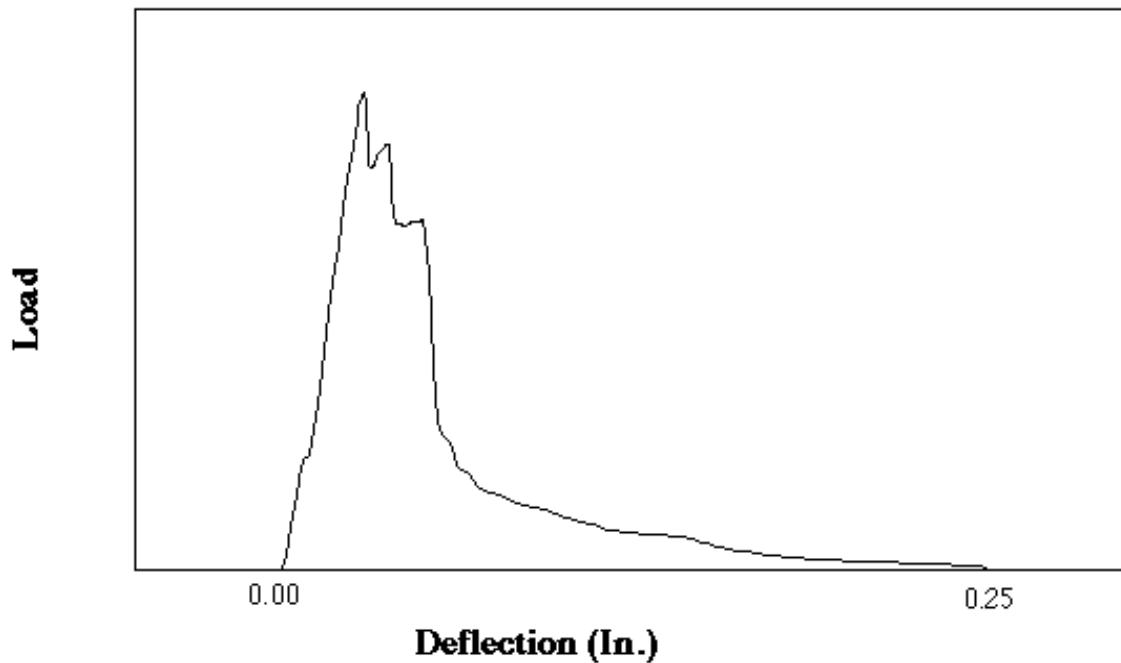
Figure 6 - Typical Load Displacement Curve for PRD-66 filter segment.

This displacement curve reveals a great deal of reloading and strain tolerance after peak load is achieved. Tests that were carried out until essentially no load resistance was encountered often had deflections as high as 0.25 inches, or roughly the same as the wall thickness of the sample. As shown in Figure 7, the samples were intact, though macroscopic cracks were readily visible. In the 100 or so mechanical tests conducted in developing this o-ring diametrical compression test, no sample fractured instantly into two or more pieces.

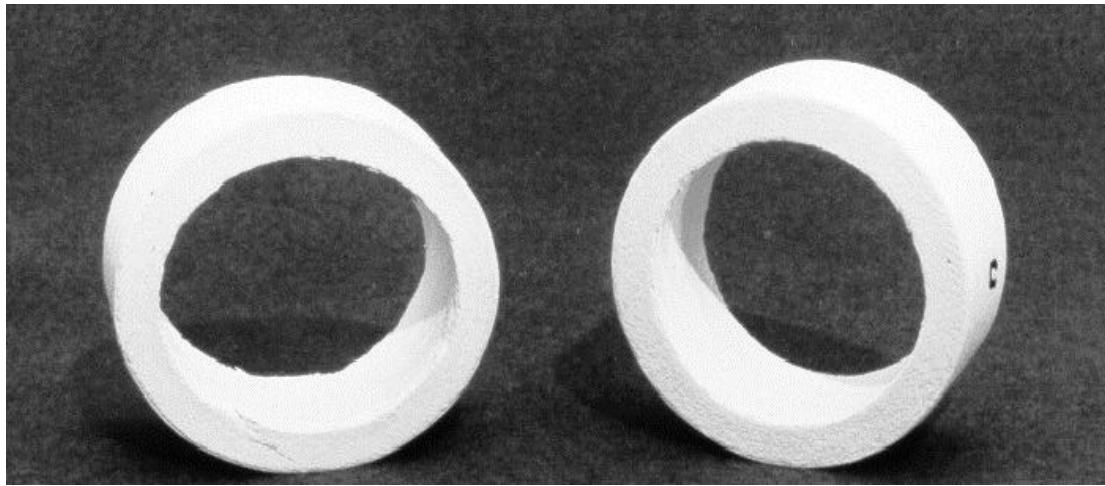
Figure 7 - O-rings AFTER (left) and BEFORE (right) diametrical compression testing.

The diametrical compressive strength was determined by the maximum peak at which the first crack occurred. To characterize PRD-66, forty-one 1-inch wide samples, from three different production filters were tested. The average crushing strength on the samples was 410 psi (std.dev. = 38 psi). This is significantly lower than the results of Westinghouse Science and Technology Center's tests, which reported strengths of 1050 psi on $\frac{3}{4}$ " wide o-rings. Unfortunately, the DLC records, which detailed the exact calculations used, were not available, however, a more accurate equation was adopted approximately a year after the original data was generated. In the later equation, developed by O.M. Jadaan, et al.10, stress is defined as follows:

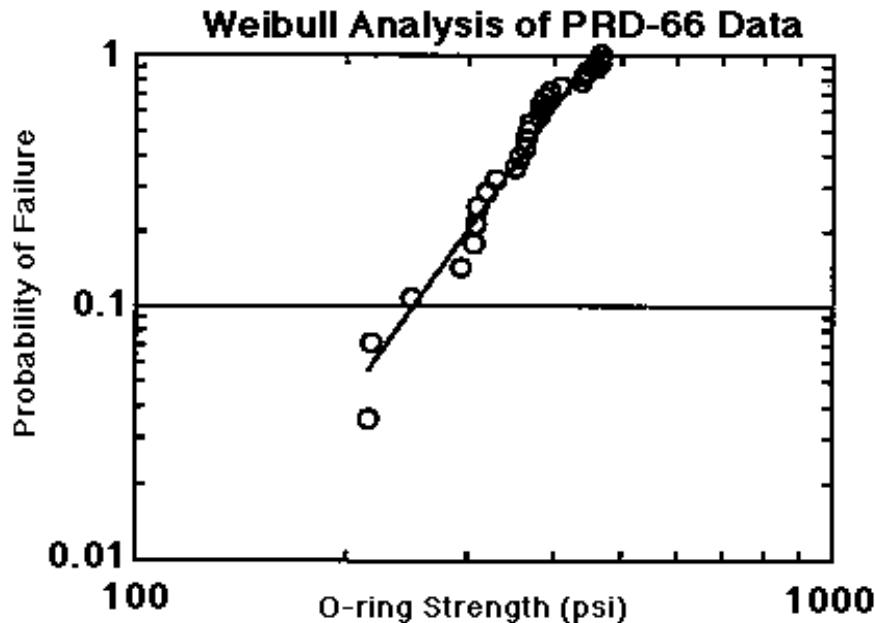
A Weibull analysis, shown in Figure 8, was conducted on the original data after calculating the failure strengths of each of the o-rings at the point of maximum stress on the load/deflection curve (Figure 6). The resulting failure stresses were then used to obtain parameter estimates associated with the underlying population distribution.¹¹ PRD-66 behaved as expected for a porous ceramic material, with a Weibull modulus around “4”. Significantly more data would be necessary to correct for statistical bias errors and calculate confidence bounds.

Figure 8 - Weibull Analysis of PRD-66 candle filter segment.

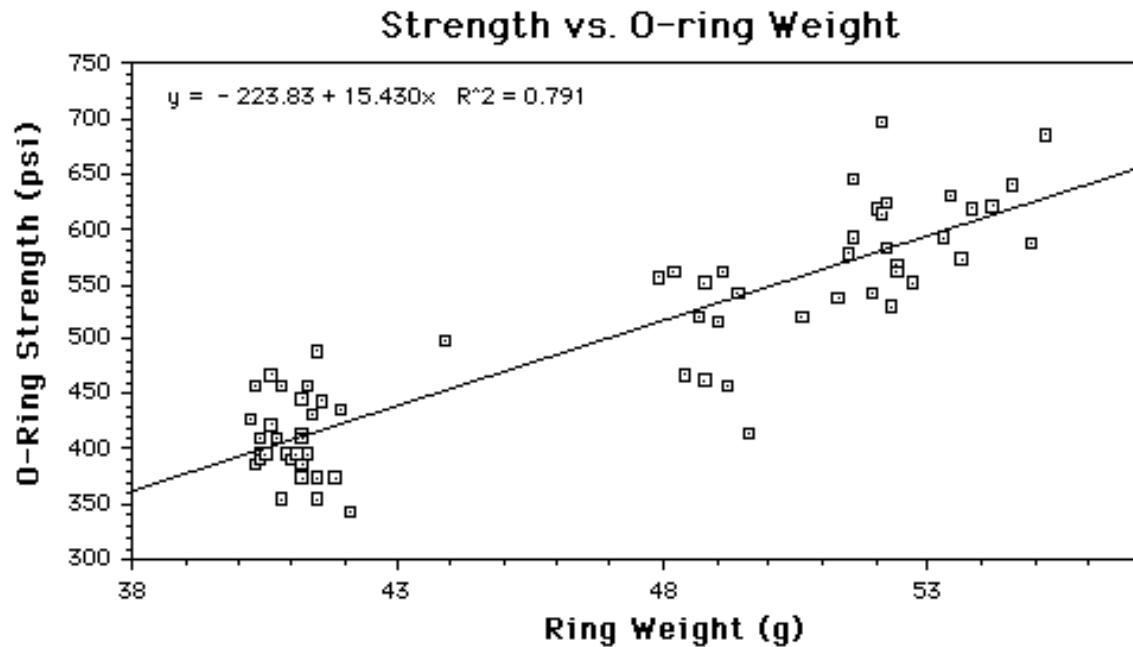
As seen in Figure 10 and Figure 11, there is a strong positive correlation between both the “weight gain” and “volume of added slurry” with o-ring crushing strength of 1-inch segments of the filter. Overall, strength increased from about 400 psi for uninfiltrated sections to about 600 psi for fully infiltrated samples, about a 50% increase in strength.

Figure 10 - O-ring diametrical compressive strength versus ring weight.

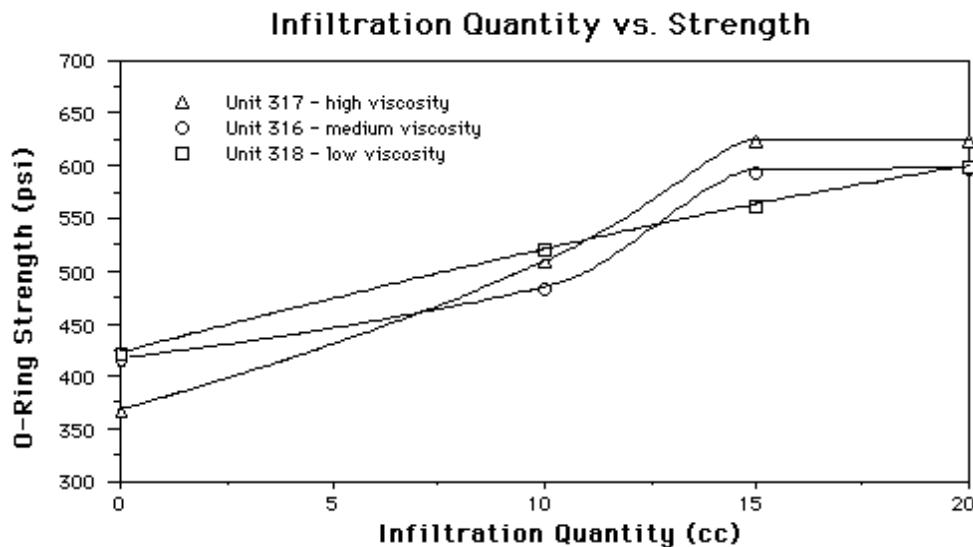
Higher viscosity slurries (Figure 11) achieved higher strengths with less slurry addition, and lower viscosities took more slurry to attain the same strength. This is probably due to migration of the slurry out of the test segment into the regions adjacent to it, which would result in less effective reinforcement.

Figure 11 - O-ring diametrical compressive strength vs. amount & viscosity of infiltrate

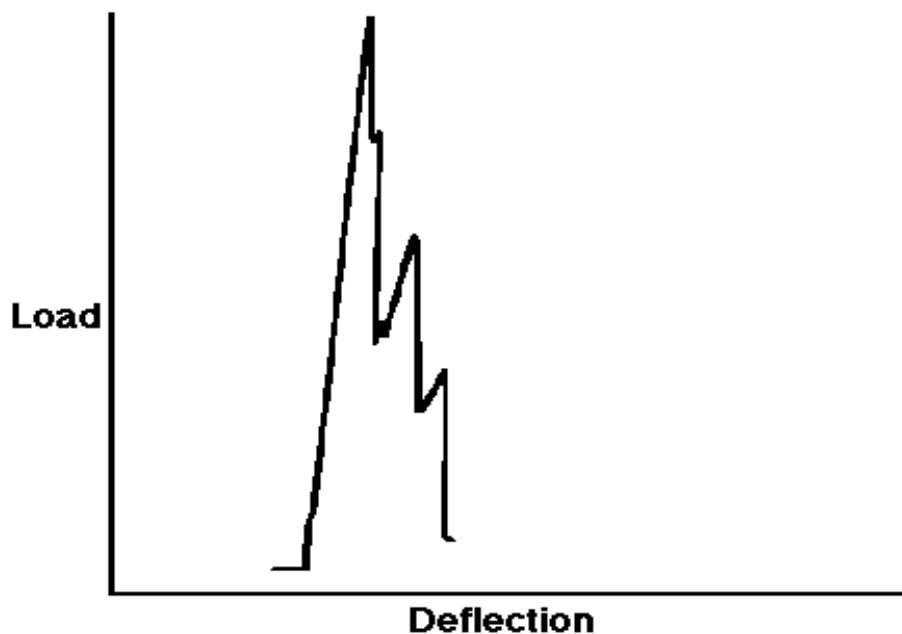
There appears to be a greater tendency toward brittle failure with the infiltrated material, but, as shown in the load displacement curve of Figure 12, there is still quite graceful failure. We interpret the more triangular shape plot after maximum load (compared to Figure 6) as an indication of more brittle failure, but the fact that there is significant reloading after "peak load" still suggests graceful failure. As with the uninfiltrated material, these samples never broke into two pieces, even with deflections as large as $\frac{1}{4}$ inch and as many as four independent cracks per specimen.

Figure 12 - Load Displacement Curve for infiltrated PRD-66 filter segment.

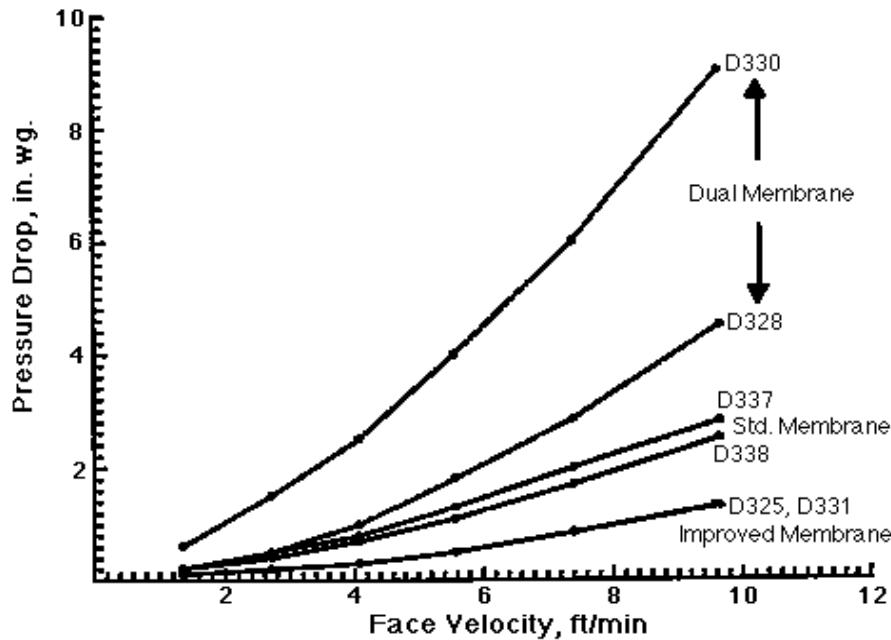
As mentioned earlier, DLC fabricated the following 1.5-meter candles for testing: two with improved (low pressure) outside membrane only, two dual membrane candles, and two “baseline” candles, ALL with strengthened flanges. Westinghouse performed room temperature gas flow resistance measurements on all six candles; results are show in Figure 13. These results parallel measurements conducted at DLC.

Figure 13 - W-STC Room Temperature Gas Flow Resistance measurements of 1.5-meter PRD-66 filter elements with various membranes.¹²

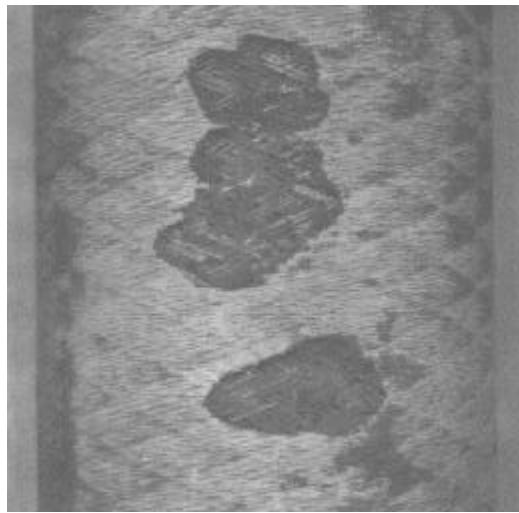
Concurrent with the development of the low-pressure and dual-membrane filter elements under this program, twenty-two “baseline” PRD-66 candle filters (identical to those used in Test Segment 4) were placed in service in Tidd Test Segment 5. After the test, it was discovered that all of the PRD-66 candle filters had experienced significant damage. Two types of failure were observed. The first was a classic flange failure, with filters broken in the holder area where the flange transitions to the filter body. The second failure mode was observed mid-body, with approximately half the filter body remaining intact. In this failure mode, “divots” were taken out of the filter body, appearing as lenticular avulsions greater than a millimeter deep, as shown in Figure 14. In filters with mid-body failures, fracture occurred at these thinned spots in the body wall, often where a “divot-in-a-divot” had removed most of the wall thickness.^{2,8}

Figure 14 - “Divots” in PRD-66 filter tested in Tidd Test Segment 5.

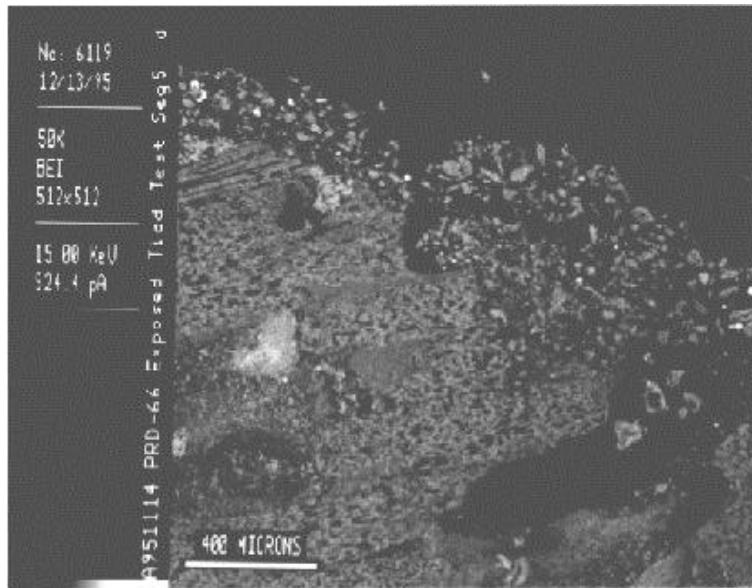
Based on this evidence, a hypothesis of the failure mechanism of PRD-66 candle filters in Test Segment 5 was formulated. Despite earlier results of room temperature and high temperature tests to the contrary, ash that contained adsorbent penetrated the surface membrane of the PRD-66 filters. This ash then became trapped in the bulk filtering body of the candle. Once trapped there, it was subjected to long term exposure of hot SO₂ gas, causing in situ sulfation of the ash to calcium and/or magnesium sulfates in the pores and microcracks of the filters.

Figure 15 - White deposit (middle left) in vicinity of “divot” (upper right).

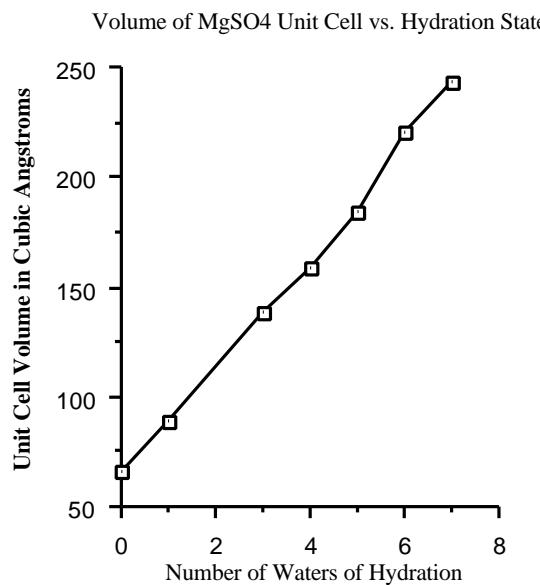
Once lodged in a microcrack at high temperature, these deposits could change in size by several mechanisms. One possible damage mechanism is by thermal expansion and contraction of the sulfate deposit during process interruptions, of which there were several in Test Segment 5. A second possible mechanism is by crystal growth from the hydration of sulfates during cooling in a moisture-containing atmosphere, which also would occur on process interruptions. Figure 16 shows how the unit-cell volume of anhydrous magnesium sulfate increases as it picks up waters of hydration.

Figure 16 - Unit-cell size of magnesium sulfate versus state of hydration.

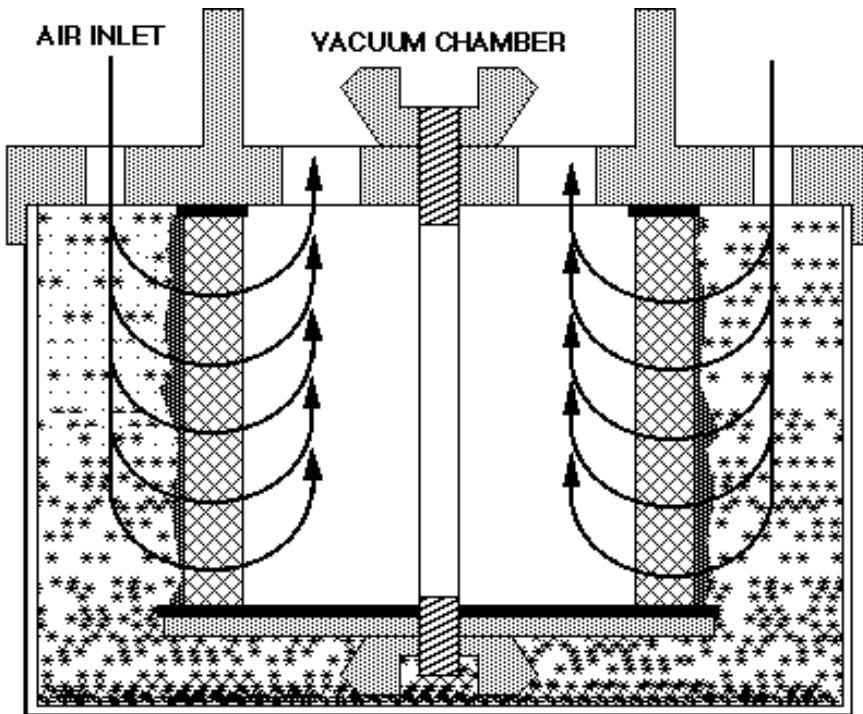
Figure 17 - Particle Infiltration Test (PIT) Device

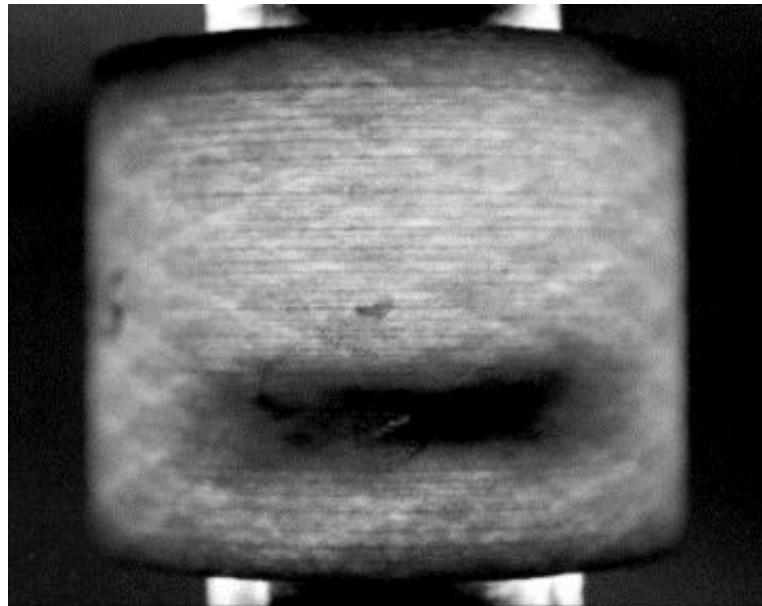
filled pinholes showed signs of leakage. No additional defects developed during the final ceramic conversion firing. Figure 26 shows the result of testing a defective segment where a pinhole, detected prior to firing, was allowed to remain.

Figure 26 - Hole in membrane after 25 PIT cycles, viewed in transmitted light.

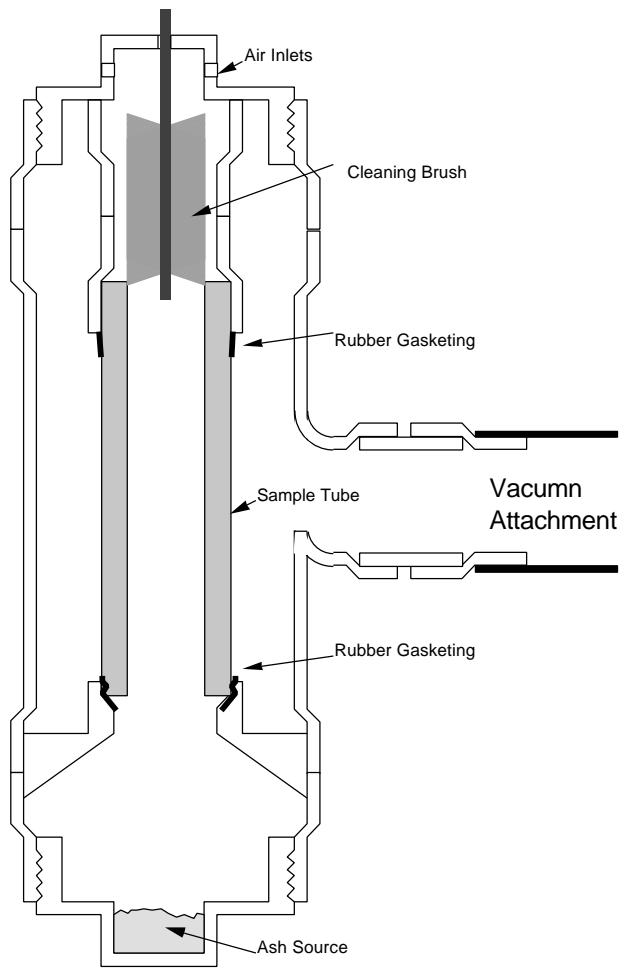
A schematic of the device is shown in Figure 31. To conduct the test, a 4.5" long candle filter sample is mounted in the tester. Approximately 100 cc of ash is placed into the screw-on cap at the base of the unit. The vacuum is turned on and the device is manually inverted to disperse the ash. After 5 seconds, the device is set up-right and the vacuum turned off. The cleaning brush is then pushed down, and pulled back, through the center of the filter specimen. Another ash exposure is then conducted and the specimen ID cleaned. After 25 exposure cycles, the specimen is evaluated using transmitted light.

Figure 31 - Particle Infiltration Test device for ID membranes

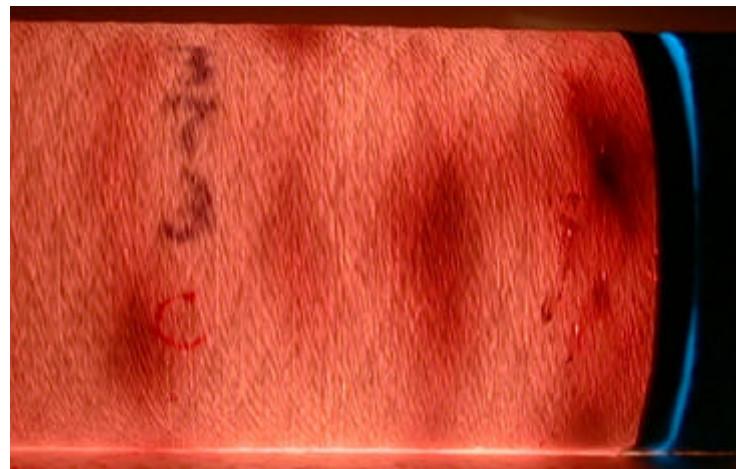
To demonstrate the functionality of this device, a old candle filter with both an ID and OD membrane (Section 3.2.2) was tested, then examined using transmitted light. The areas of ash penetration can be seen as dark blotches within the filter wall, as shown in Figure 32.

Figure 32 - ID P.I.T. evaluation of original “hoop-only dual membrane” filter (1995)

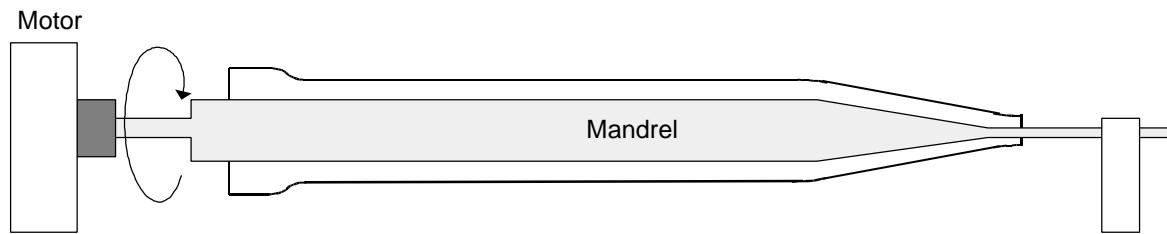
The standard method for applying the alumina particulate to the outside surface is to slide the low-fired candle filter onto a mandrel, as shown in Figure 33. As with the original mandrel, the support-pin at the tip protrudes through the hole in the tip of the candle filter. This mandrel is then supported at both ends and rotated, while the membrane filler is rubbed into the surface. The most common problem is that, when the mandrel is removed from the low-fired filter, the support-pin at the tip snags several strands of yarn from the inside diameter and pulls them out.

Figure 33 - Standard filter support scheme during membrane-filler application.

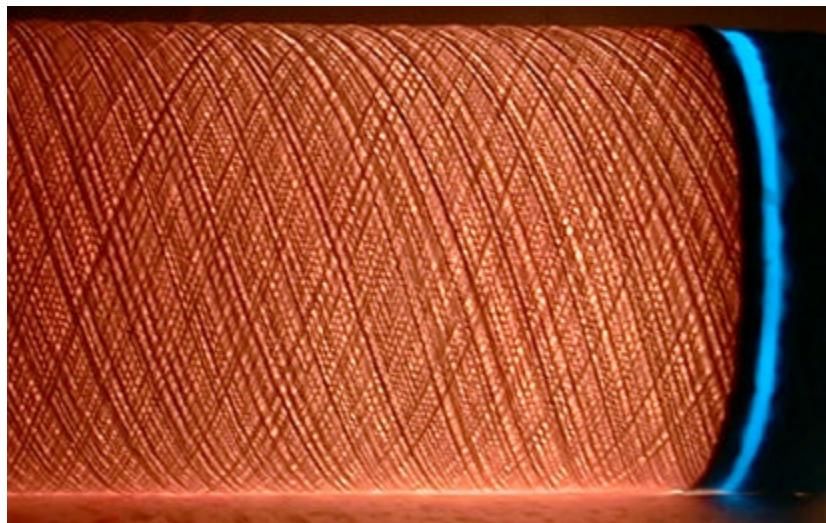
The general appearance of the membrane was very good, but apparent pinholes were noticed when the surface was visually examined. The most promising candidate was tested in the “Inside Diameter, Particle Infiltration Tester” (ID P.I.T.) and examined with transmitted light as shown in Figure 35. No indication of ash penetration could be found.. After performing the ID P.I.T., the sample was cut up and the sites of the pinholes were reexamined. The “apparent” pinholes were actually bubbles, which were only open on the ID side of the membrane. Based on these findings, later work focused on the feasibility of de-airing the suspension to reduce bubbles.

Figure 35 - ID P.I.T. evaluation of “slip-cast ID membrane” filter (no membrane on OD)

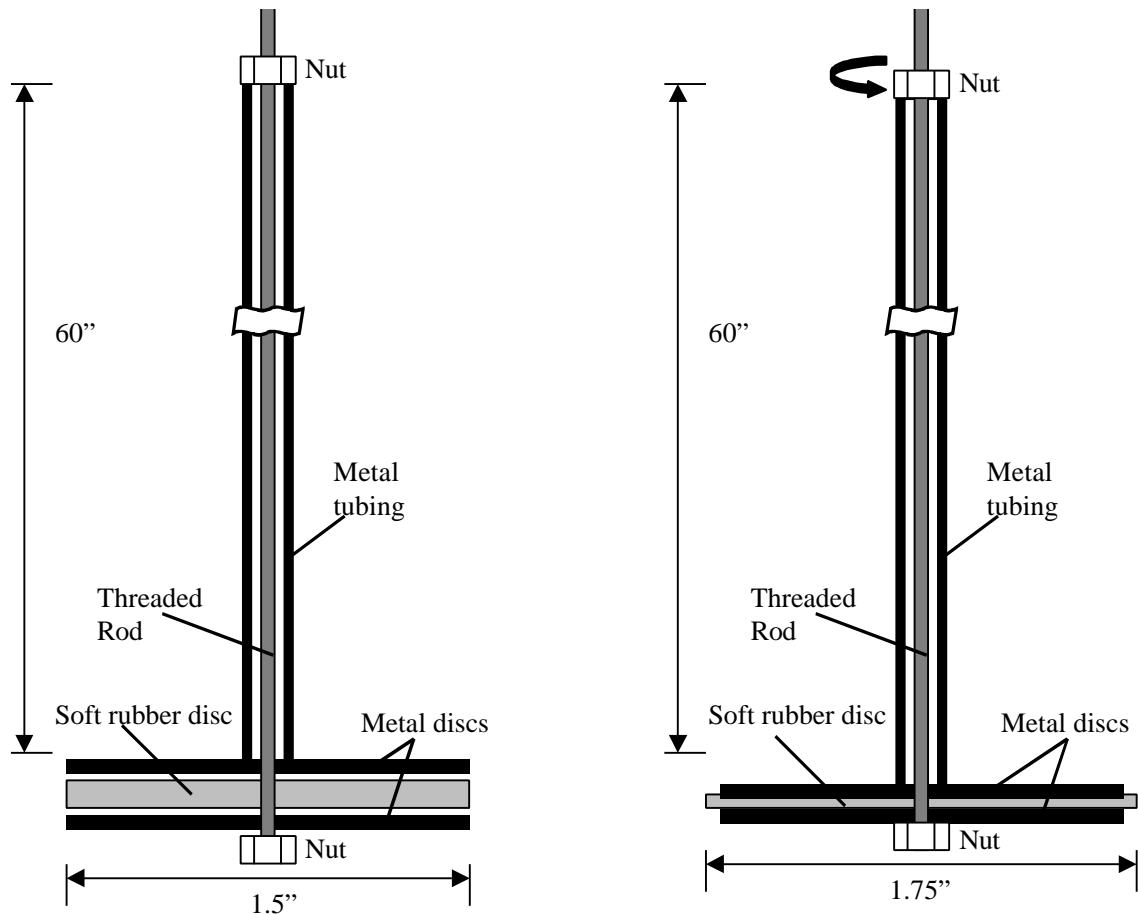
The most feasible design to accomplish this task is shown in Figure 36. It is meant to be used by first inserting it into the filter. The alumina particulate suspension is then added and poured out two minutes later. By twisting the nut at the end of device, the rubber disc near the tip is compressed. As the disc expands, makes contact with the inside diameter of the filter. The entire assembly would then be pulled out.

Figure 36 Device for removing excess membrane from the inside surface of a filter.

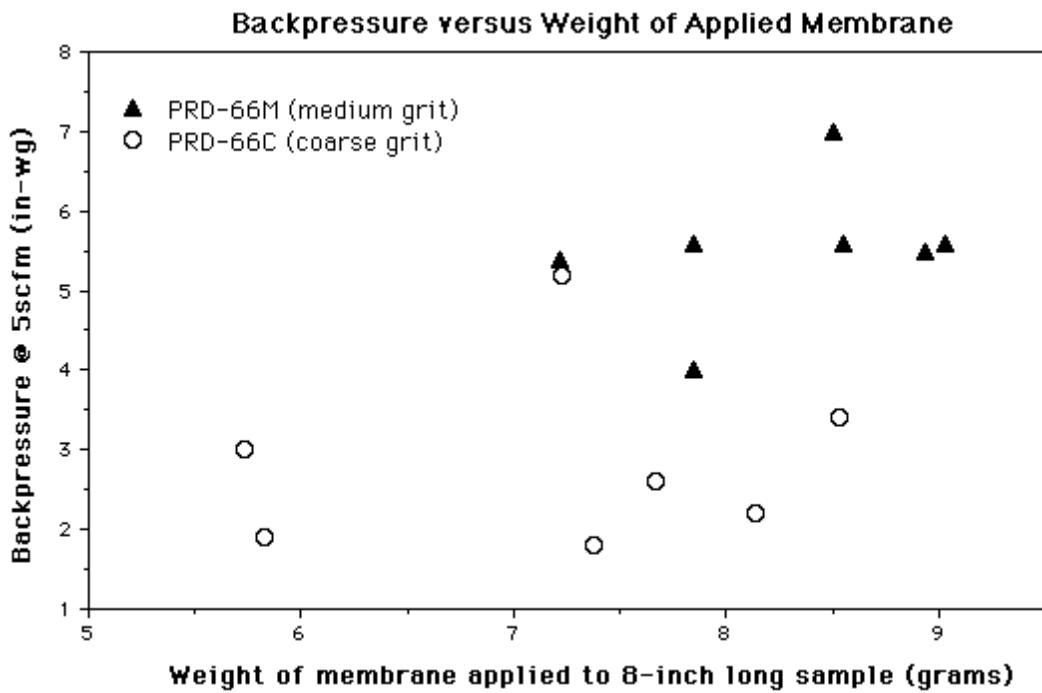
The data shown in Table 7 was also used to evaluate the impact of applying reproducible amounts of the particulate membrane. A correlation of the weight of the membrane filler and the backpressure was plotted in Figure 37. In general, the exact amount of the added membrane filler did not directly effect backpressure, at the quantities being used; in severe cases, however, excess material has been observed to crack during the high-fire step.

Figure 37 - Impact of membrane weight and type on backpressure.

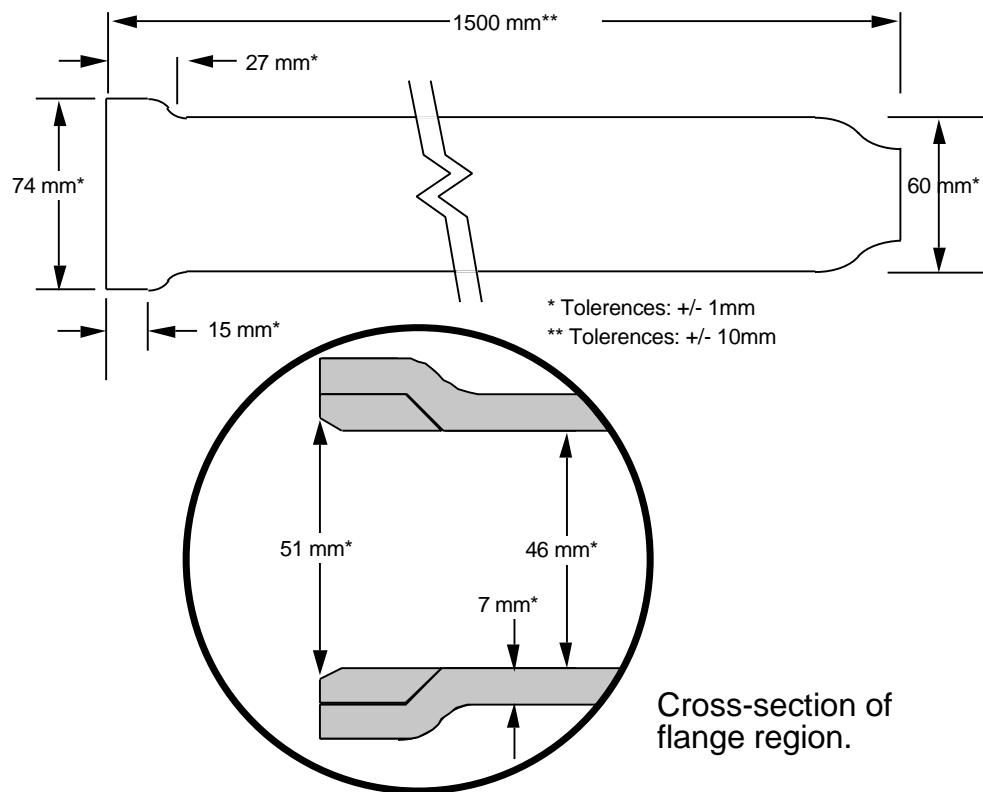
Figure 38 - PRD-66 Candle Filter dimensions

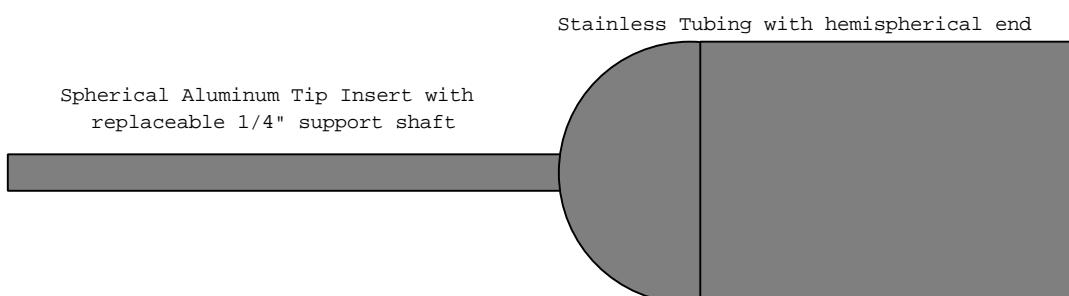
During this investigation, however, another reason for yarn breaks was observed. The yarn would most frequently break during the first 20 minutes of winding, when the guide changed direction at the tip-end of the mandrel. The mandrel on which the PRD-66 filter element was wound had a hemispherical shape at the tip end, going from 45 mm down to 6 mm in diameter in approximately 1” of length, as shown in Figure 39.

Figure 39 - Tip of original steel mandrel

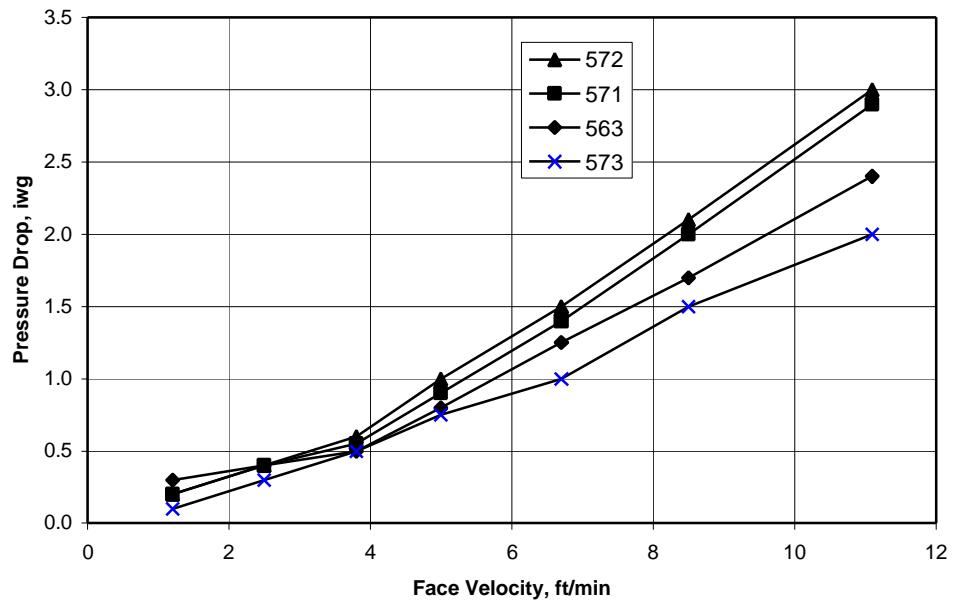
Figure 42 - PRD-66C - Room temperature gas flow resistance¹²

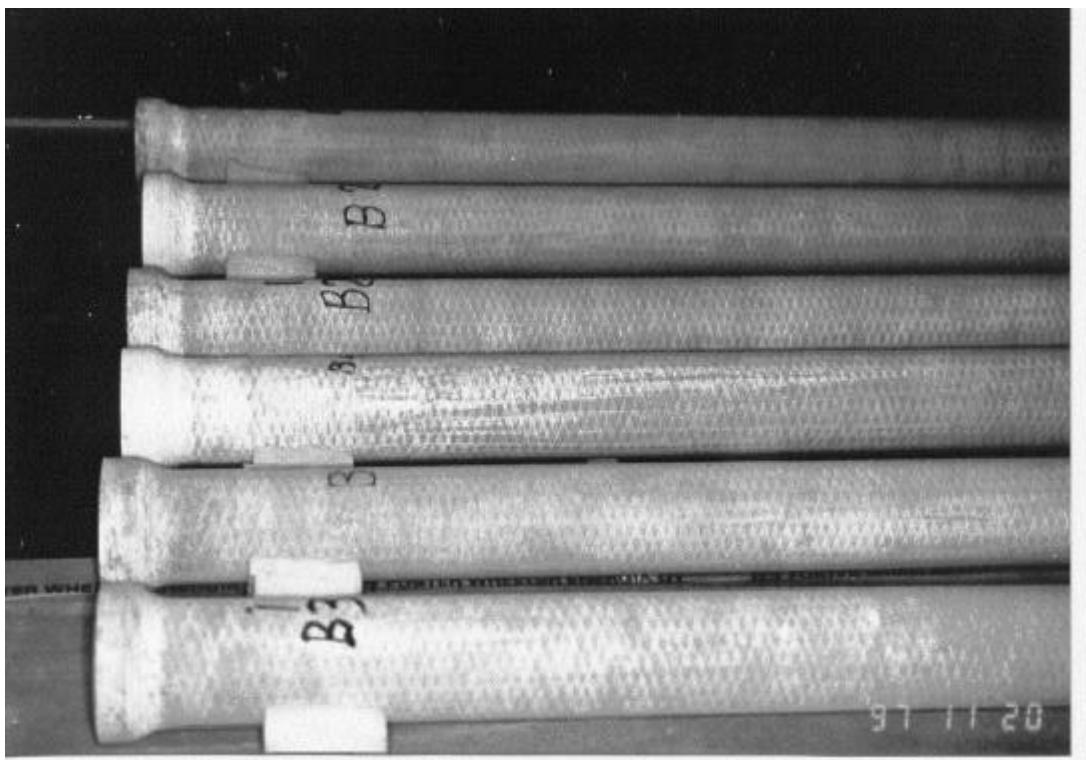
At the conclusion of the run, the six PRD-66C elements that were exposed for the entire 581 hours, and the one candle that was exposed for a total of 342 hours, all looked good. All but one of the elements had been cleaned by brushing and vacuuming prior to inspection, see photograph in Figure 46. There was no sign of any material deterioration in the possible forms of "divots", abrasion, poor membrane adhesion, or cracking. A significant amount of ash, however, was observed in the wall of the inside diameter, though it was much less for the element that was only exposed for 342 hours.

Figure 46 - Karhula-exposed PRD-66C filters

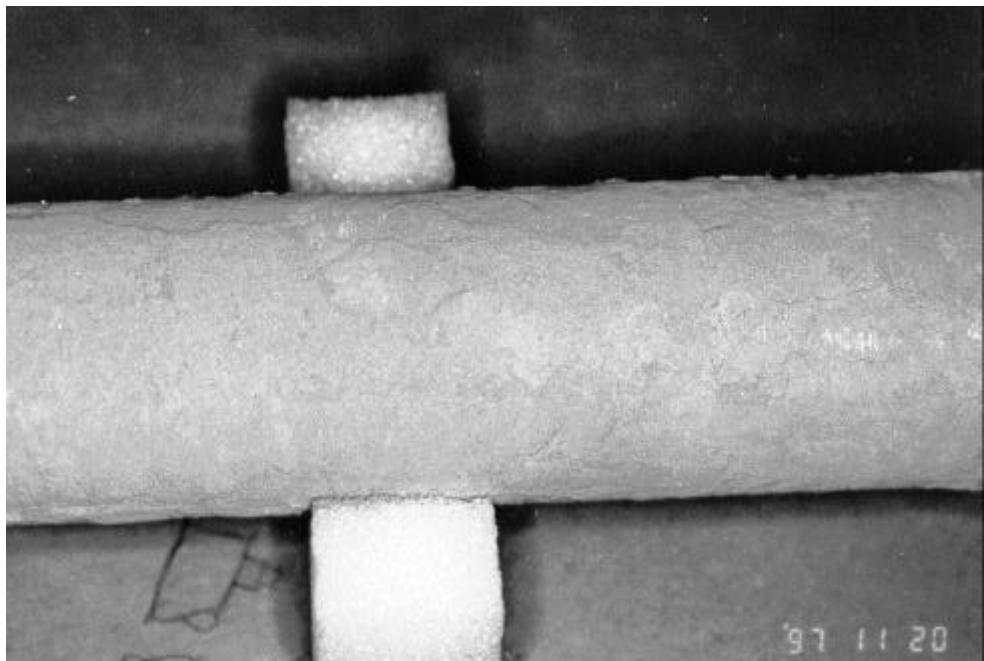
Figure 47 - Outside diameter of Karhula-exposed element before ash removal

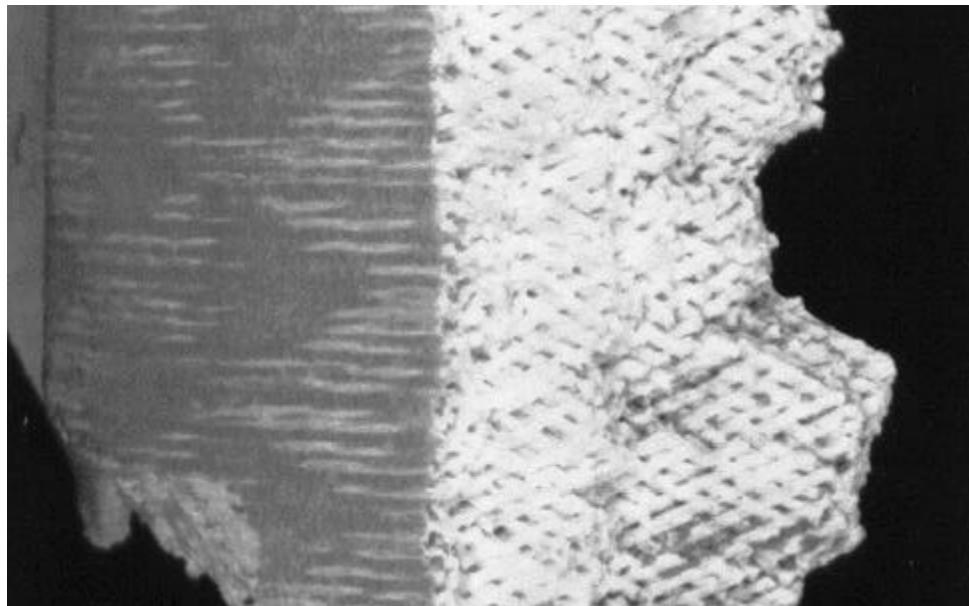
Figure 50 - Wall interior of Karhula-exposed candle #577

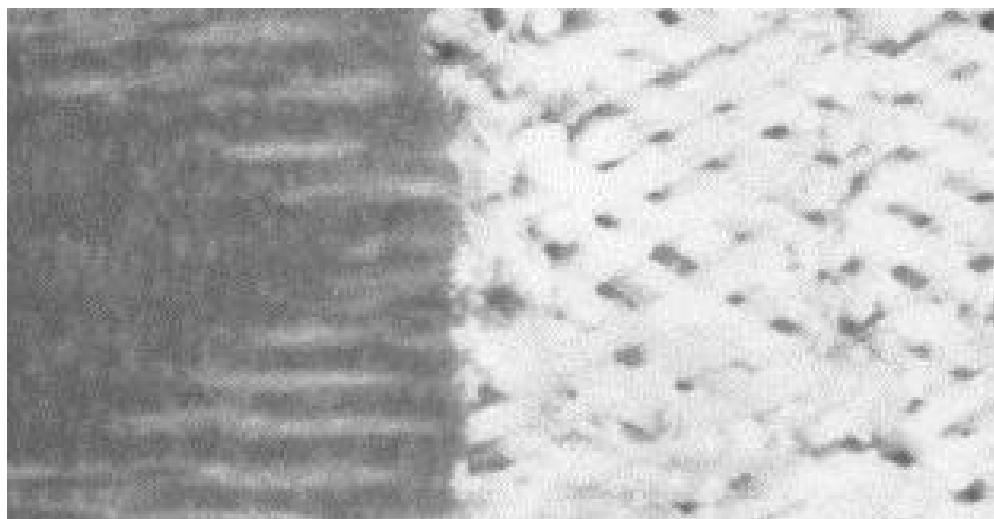
Figure 51 - Close-up of #577 - OD surface and 1-2mm below

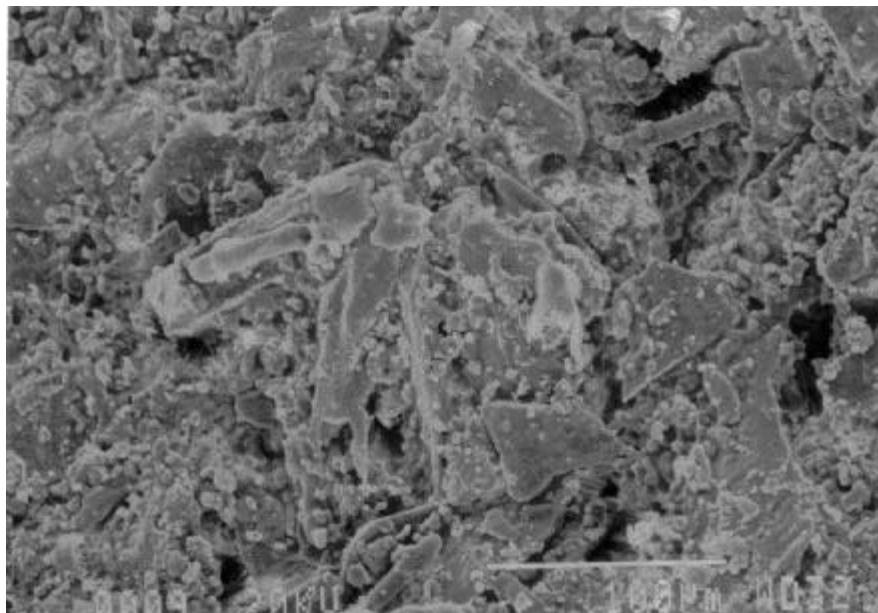
Figure 52 - 300X - UNEXPOSED candle surface

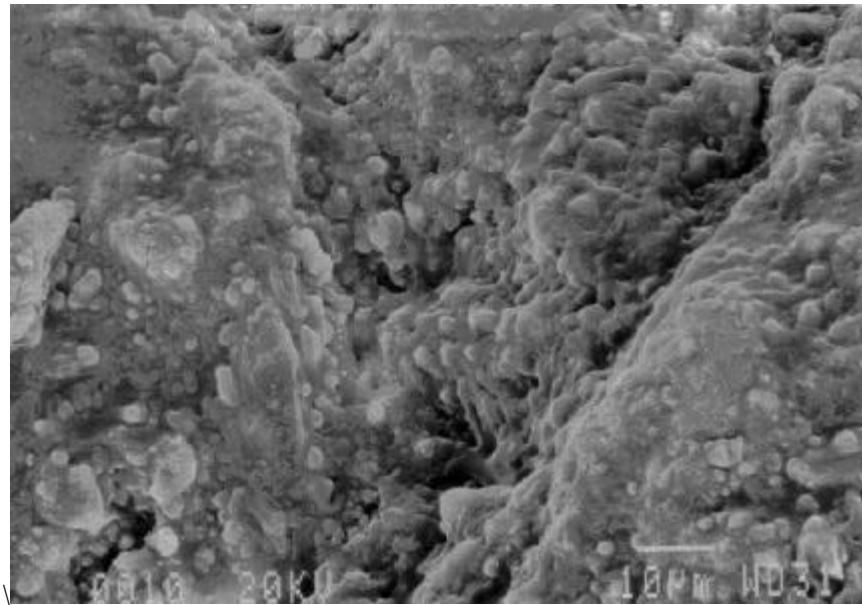
Figure 54 - 1,000X - EXPOSED candle surface

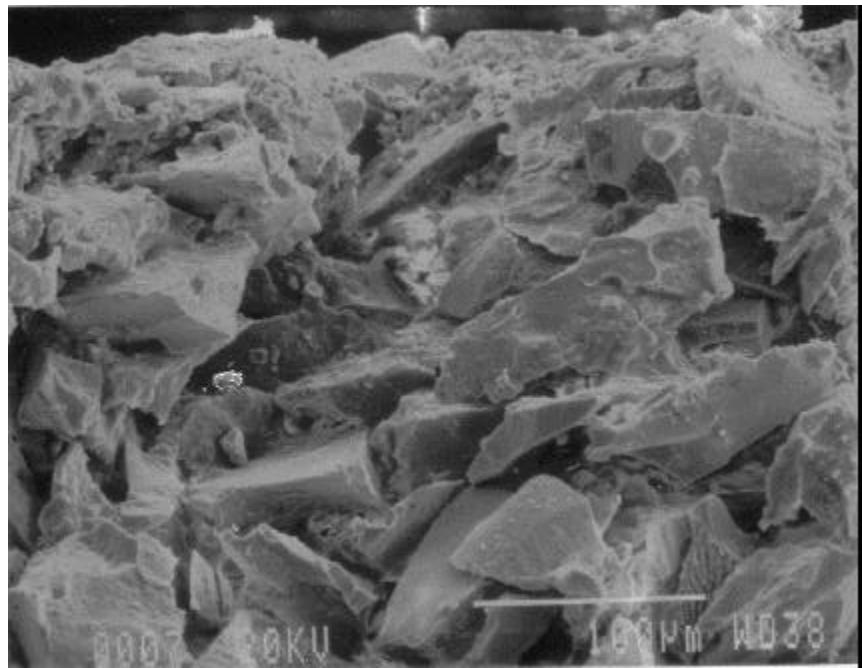
Figure 55 - UNEXPOSED CANDLE, cross-section of membrane filler (300X)

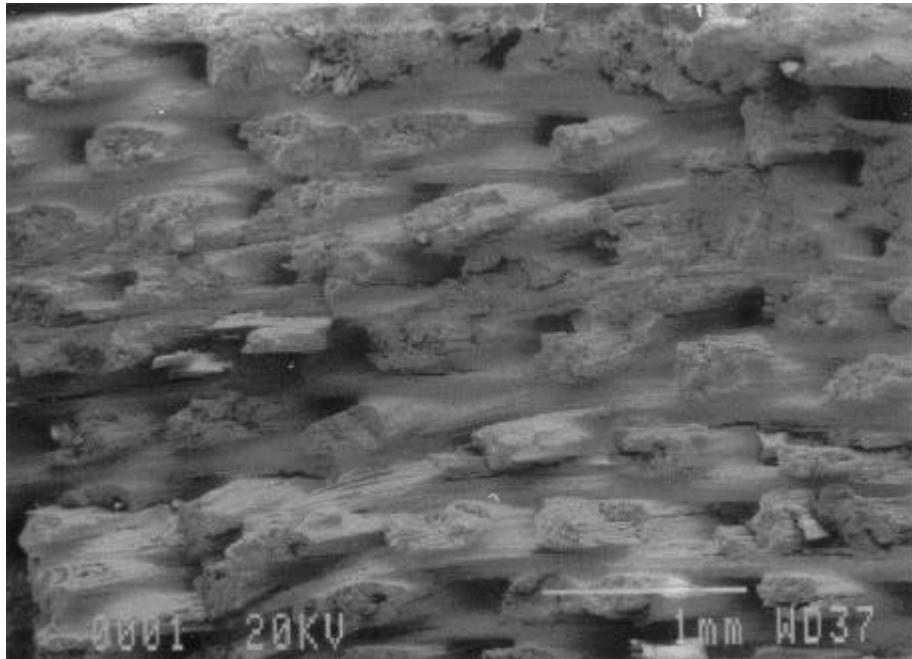
Figure 57 - 25X, fast-fracture - UNEXPOSED CANDLE, interior of support wall

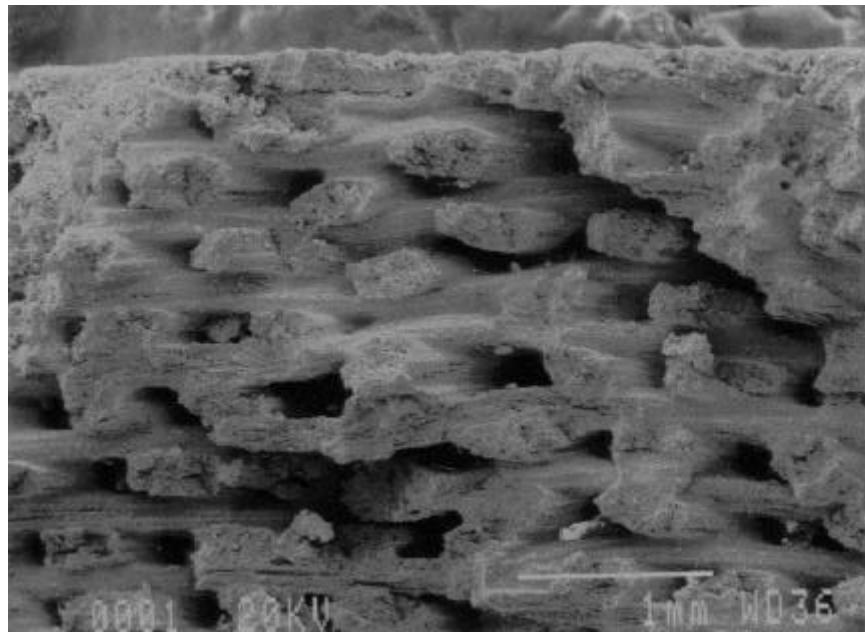
Figure 58 - 25X, fresh-fracture - EXPOSED CANDLE, interior of support wall

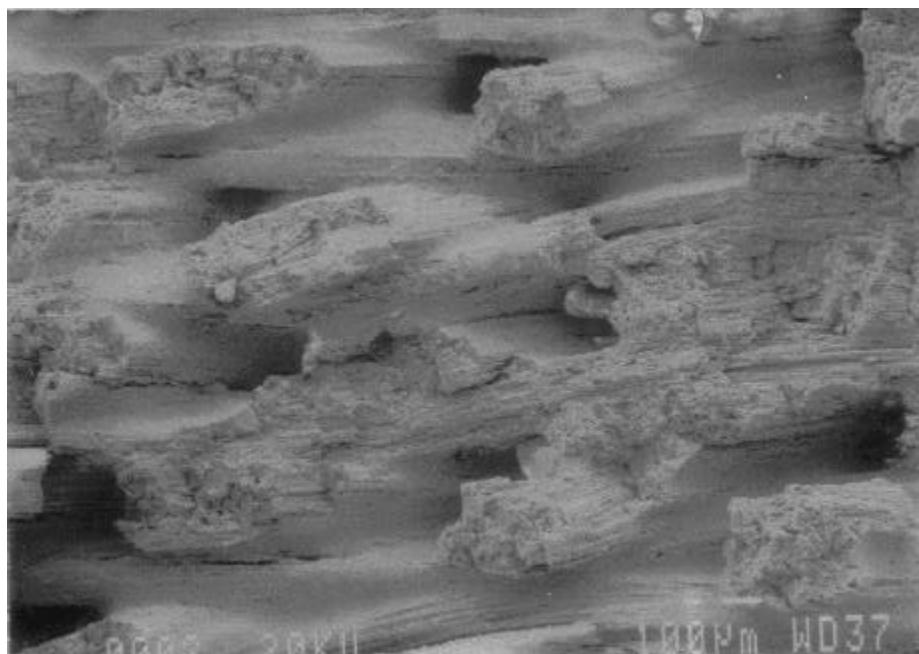
Figure 59 - 50X, fast-fracture - UNEXPOSED CANDLE, interior of support wall

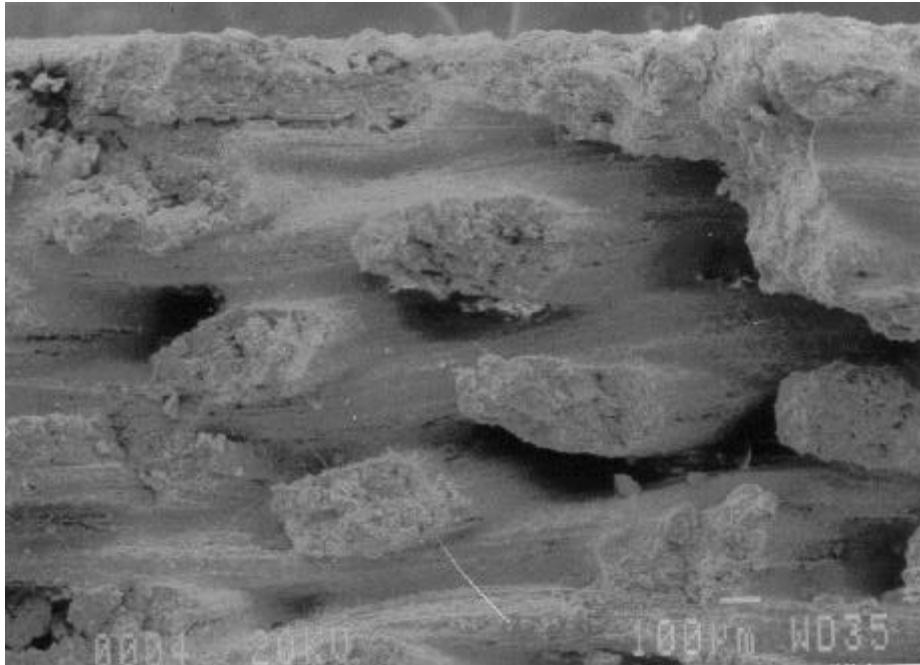
Figure 60 - 50X, fast-fracture - EXPOSED CANDLE, interior of wall support
