Advanced Hot Gas Filter Development

Final Report
September 29, 1994 to September 30, 2000

E. S. Connolly
G. D. Forsythe
September 30, 2000

Honeywell Advanced Composites Inc.
(formerly AlliedSignal Composites Inc.)
(formerly DuPont Lanxide Composites Inc.)
400 Bellevue Road
Newark, DE 19713

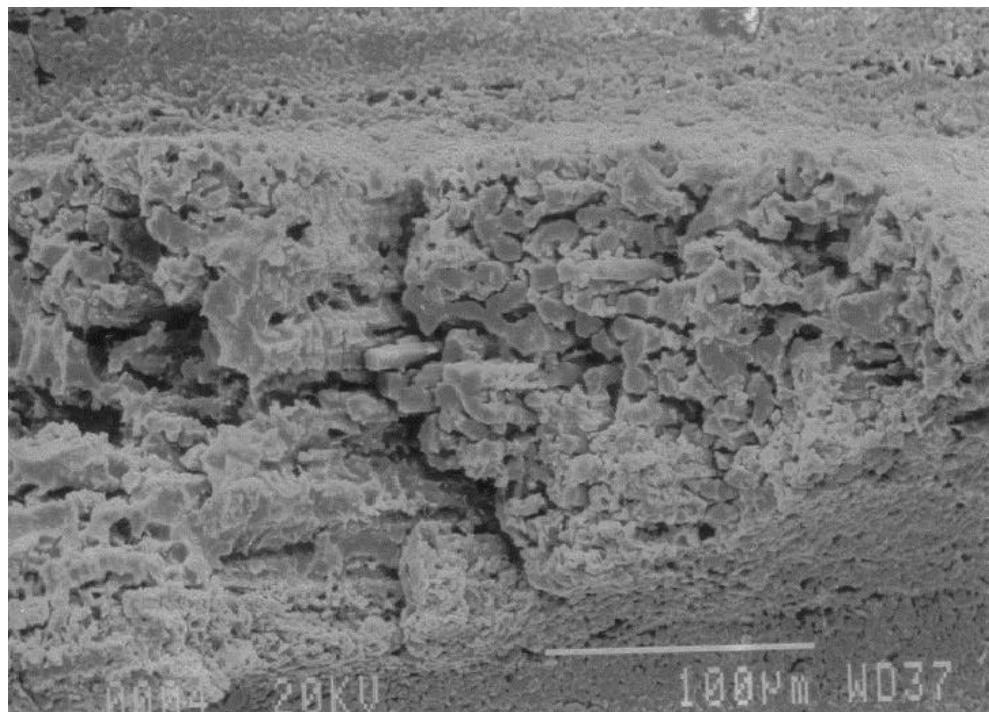
Figure 61 - UNEXPOSED CANDLE, individual “yarn bundle” (300X)

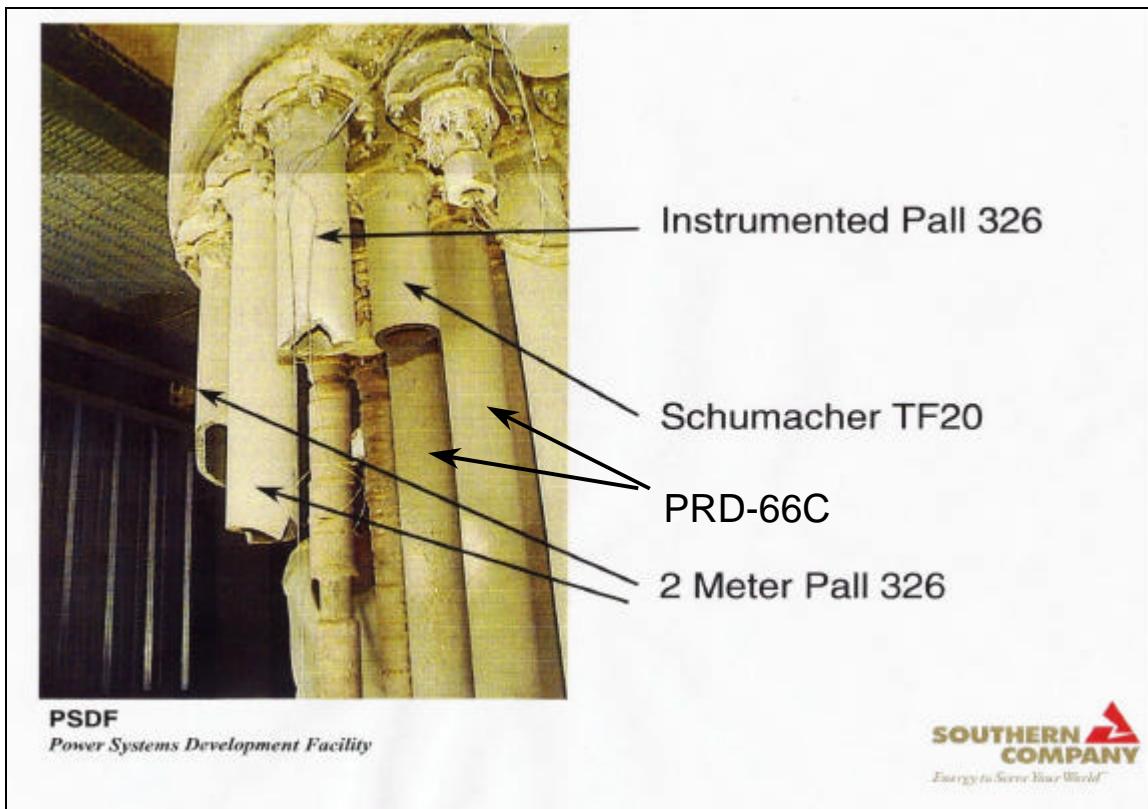
Figure 65 - Aftermath of Oct'98 thermal event in the lower plenum at the PSDF.¹³

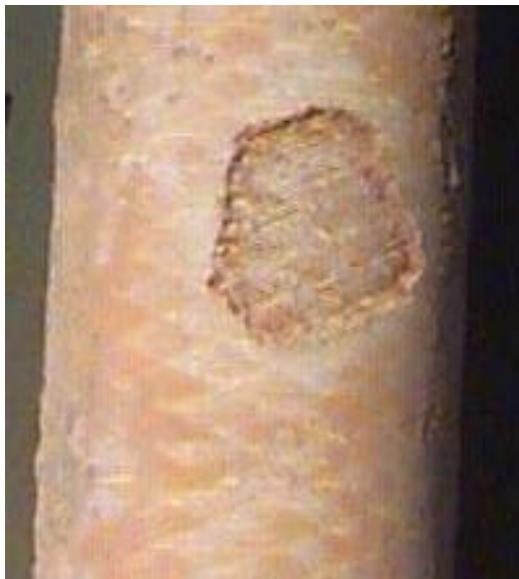
Figure 66 - C740 (T12), 18-19" from open end

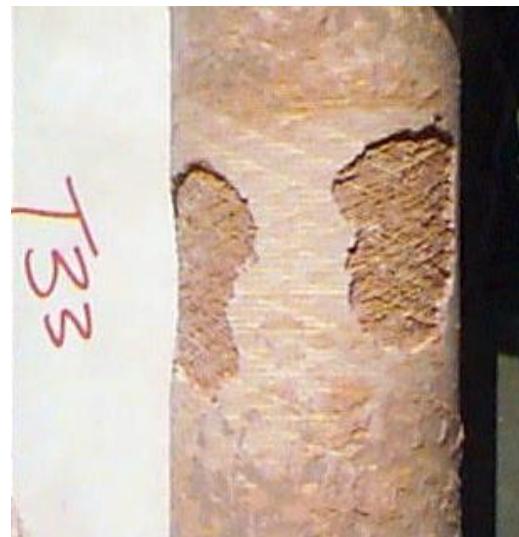
Figure 67 - C749 (T33), 12" from open end

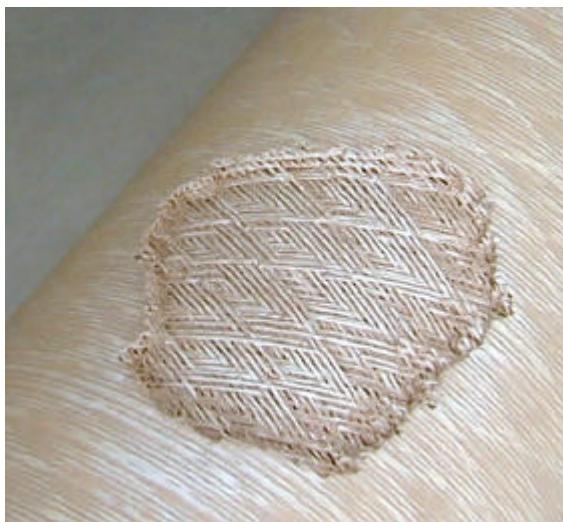
Figure 68 - Spalled area of Filter #C740, 18" from open end, no other similar damage

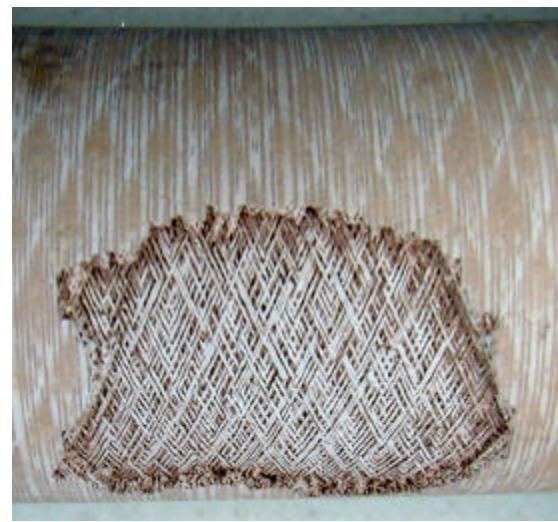
Figure 69 - Spalled area of Filter #C749, 12" from open end, similar damage 90° away.

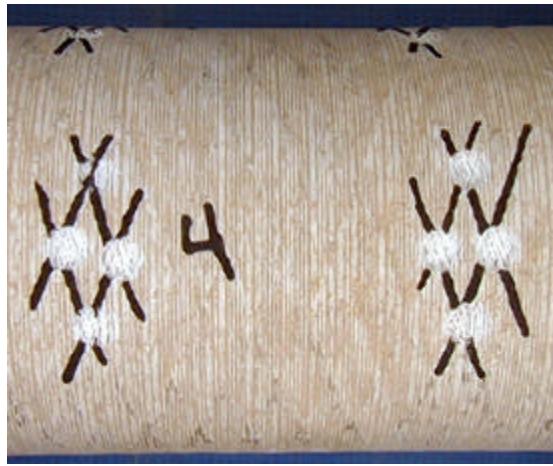
Figure 70 - Damage resulting from impact testing of Filter C633, Alumina Lot#1, 1360 exposure hours

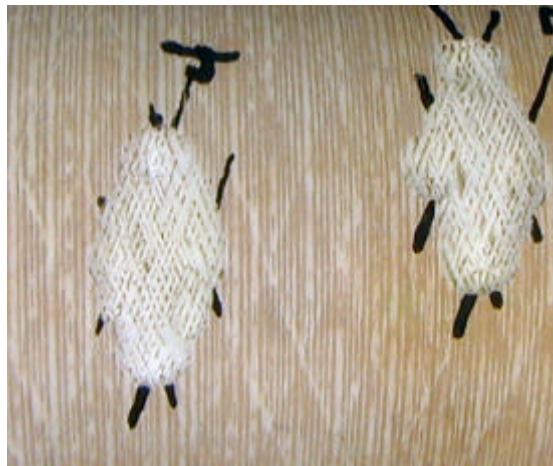
Figure 71 - Damage resulting from impact testing of Filter C740, Alumina Lot#2, 636 exposure hours

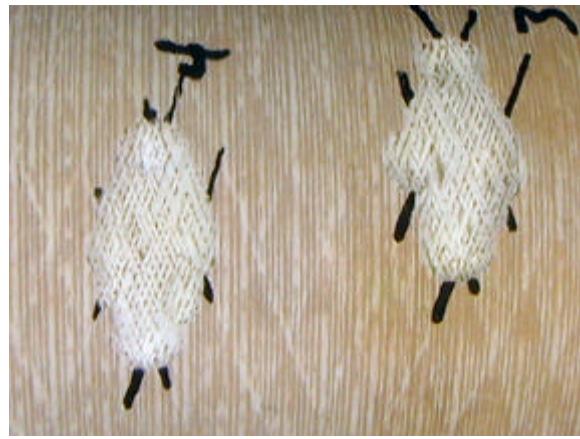
Figure 73 - Surface Damage Rating = 4

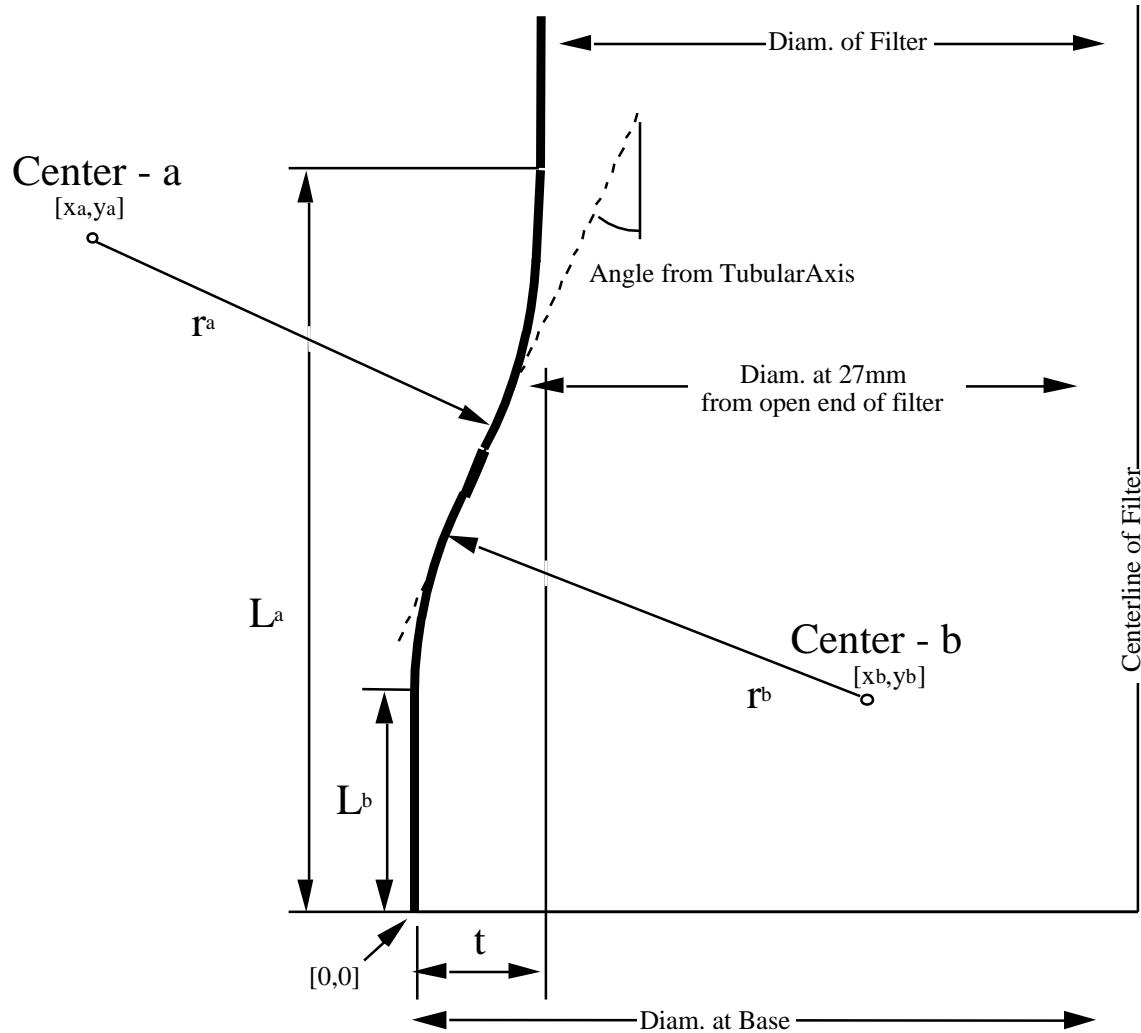
Figure 76 - Description of flange contours as determined by Optical Comparator

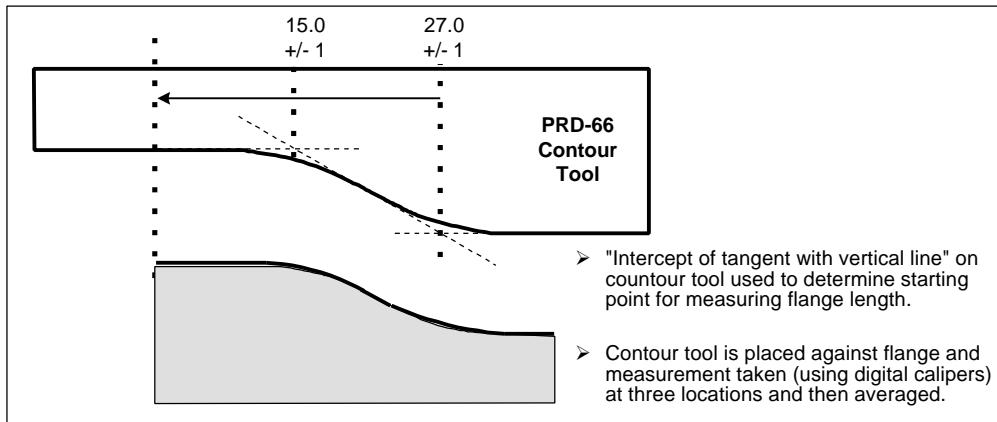
Figure 77 - PRD-66 Flange Measurement Technique

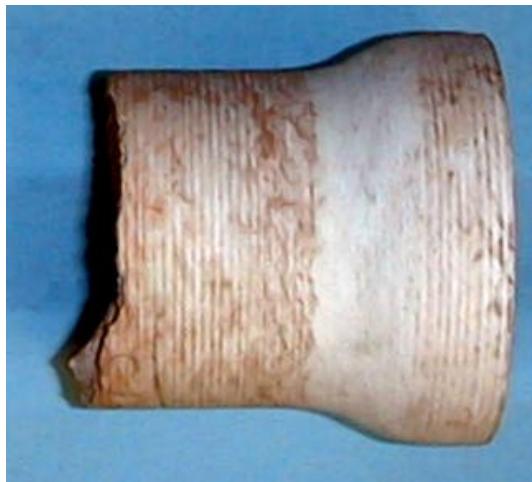
Figure 80 - C750, similar to C731 and C752

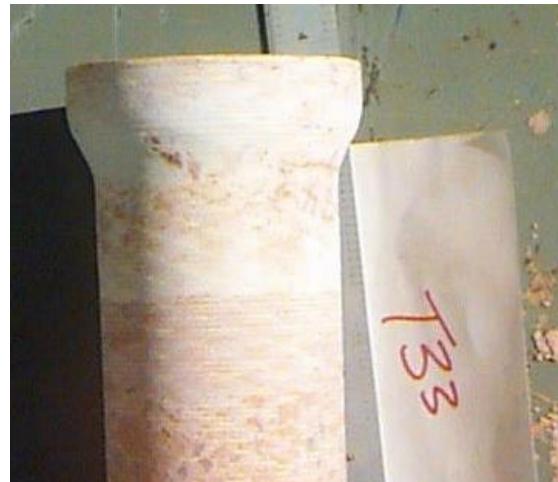
Figure 81 - C749 (T33), flange end

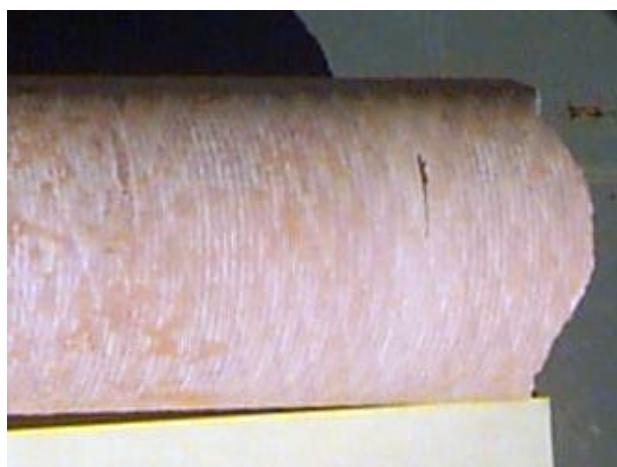
Figure 82 - Broken end of Filter C752, with deep chip 1¼" below the break

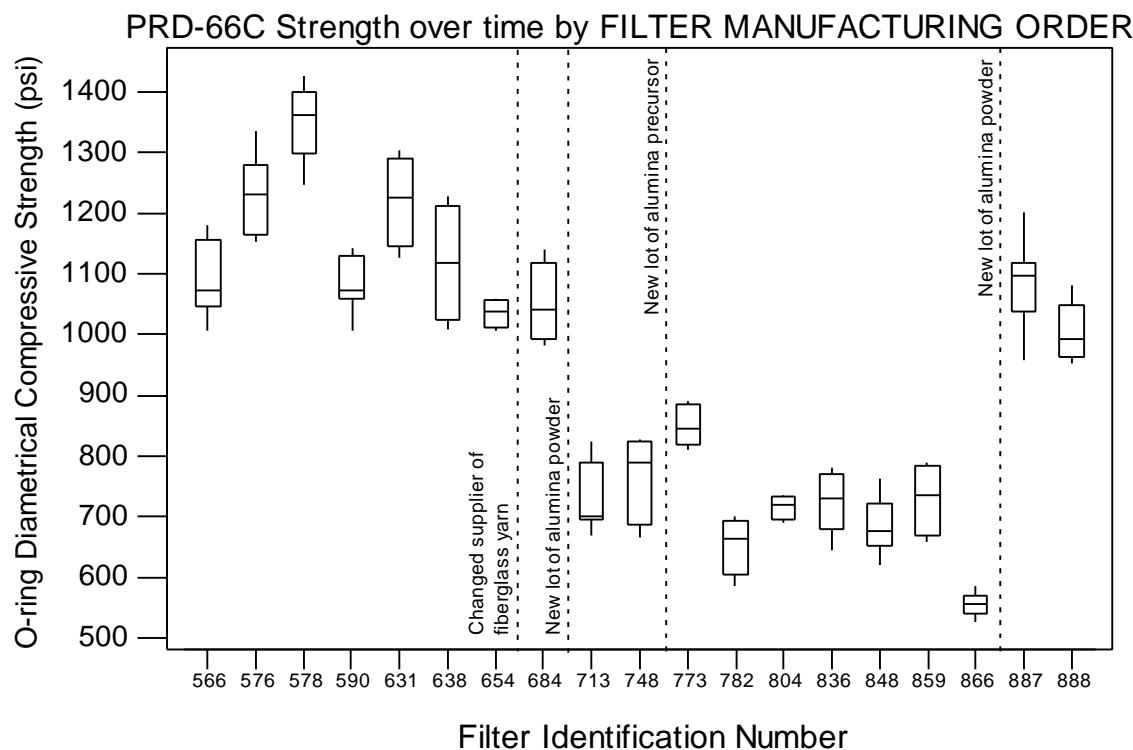
Figure 85 - Box Plot of o-ring compressive strength for as-manufactured filters.
(each box represents all o-rings from a particular filter)

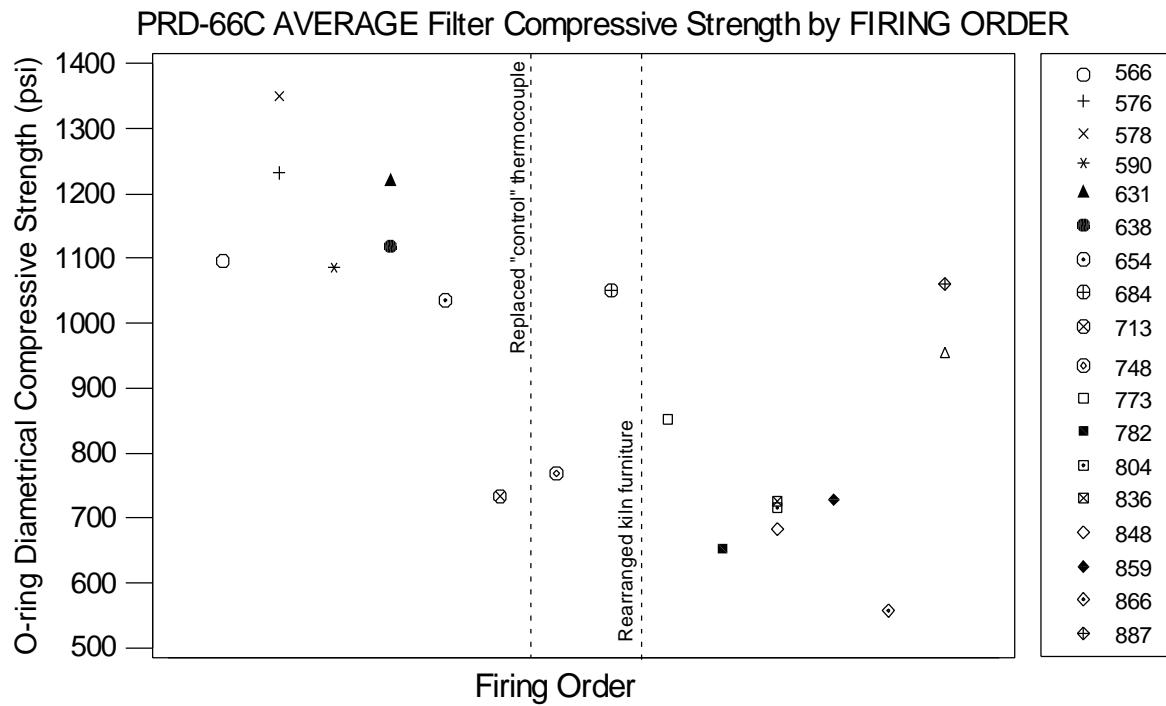
Figure 86 - Average o-ring compressive strength for as-manufactured filters, plotted in the order in which they were fired.

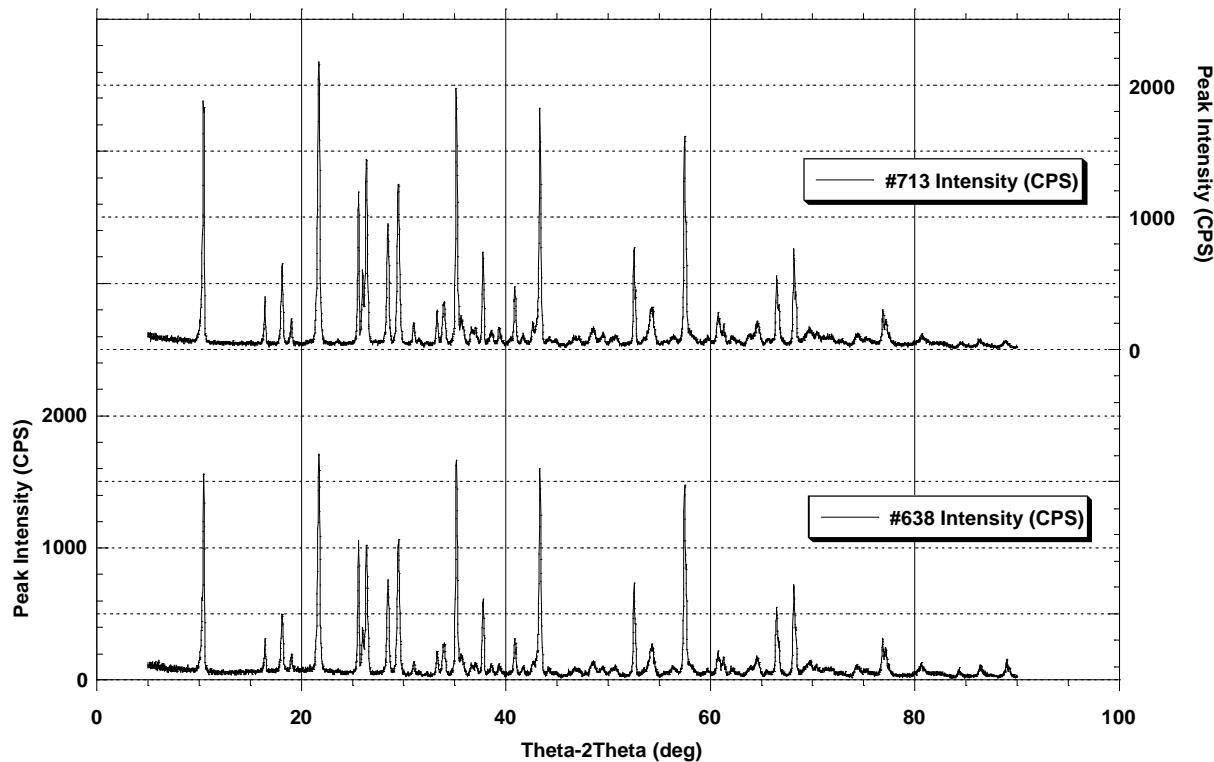
Cordierite (Indialite)	Corundum (Alumina)	Mullite	Cristobalite	Amorphous
35%	30%	20%	5%	10%

Figure 88 - X-ray Diffraction Comparison of Filter #638 (Alumina Lot #1) and Filter #713 (Alumina Lot #2) shows no differences in crystalline phases.

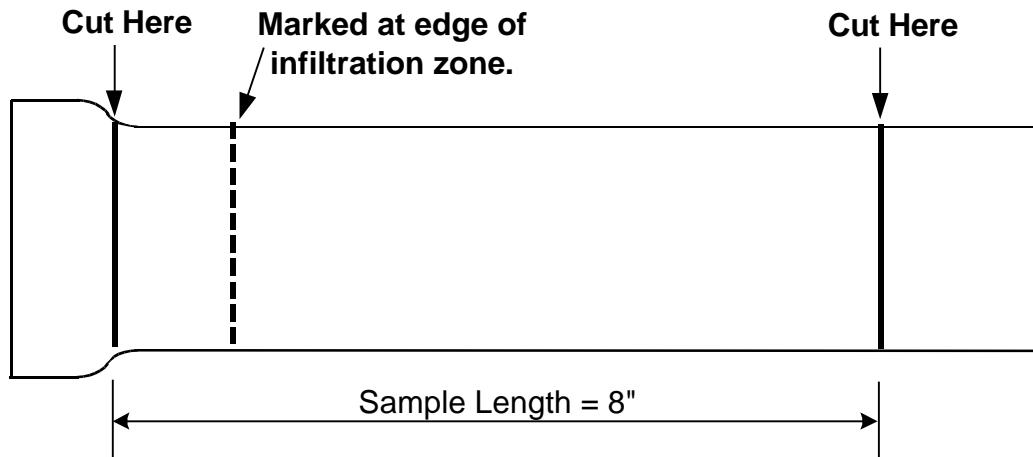
Figure 89 - Cutting plan for tensile coupons from PRD-66C "as-manufactured filters".

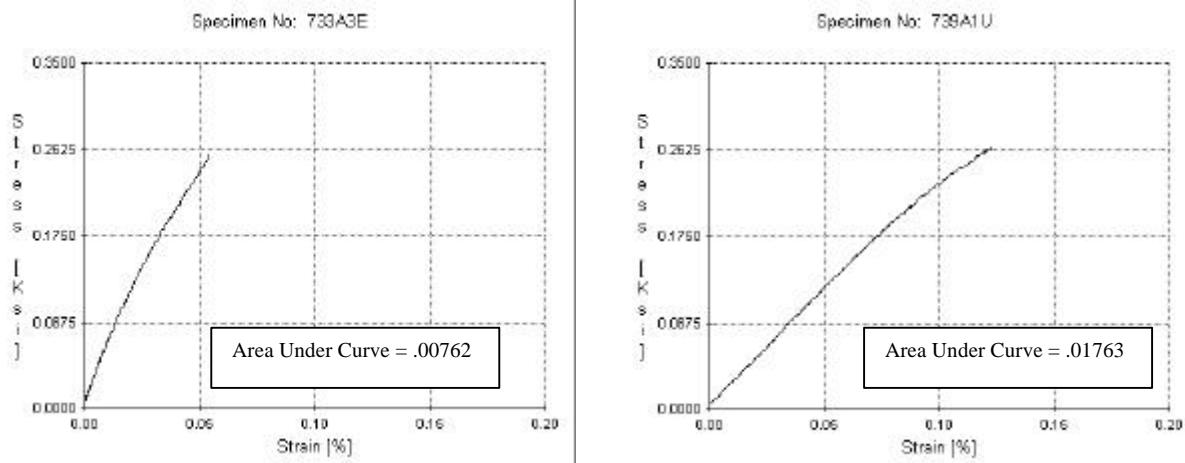
Figure 92 - Axial Tension stress/strain curves for unexposed filters made with Alumina Lot#2

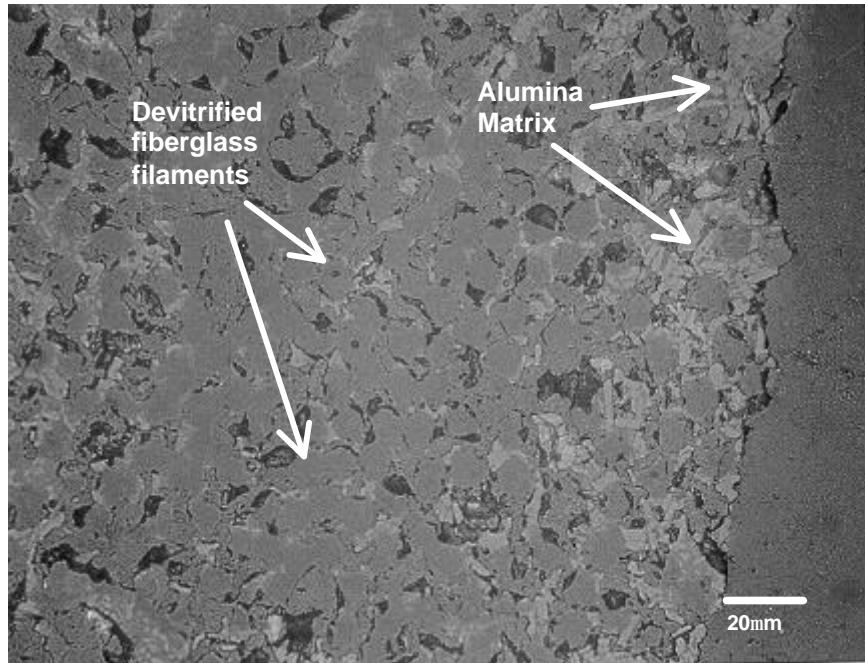
Figure 93 - Microstructure of PRD-66C Filter #C567, 500X

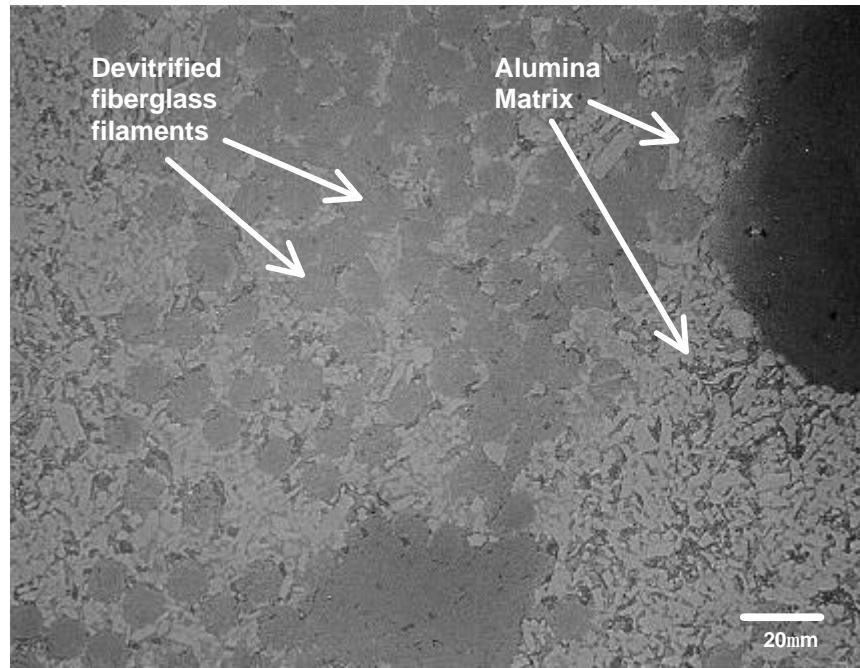
Figure 94 - Microstructure of PRD-66C Filter #713, 500X

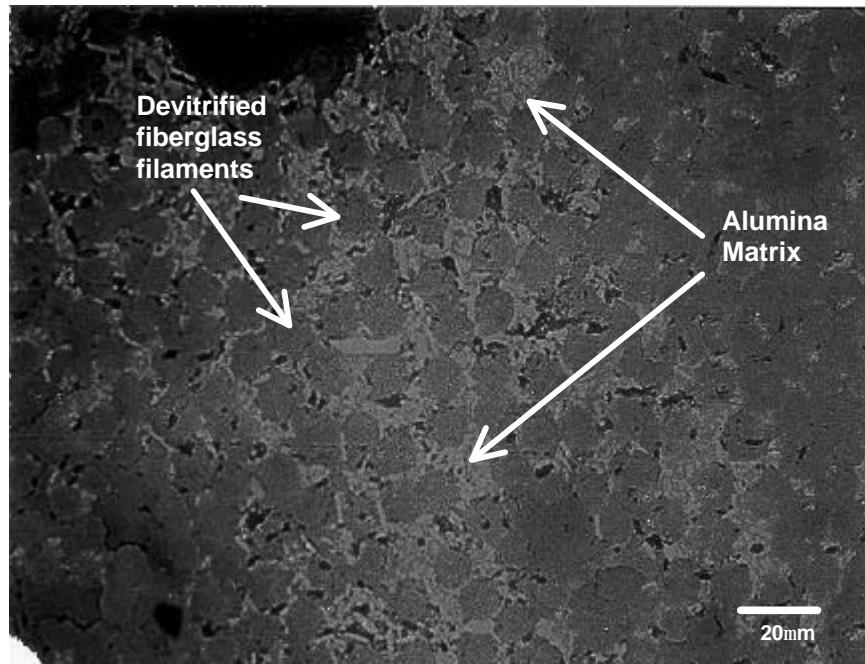
Figure 95 - Microstructure of PRD-66C Filter #C752, 500X

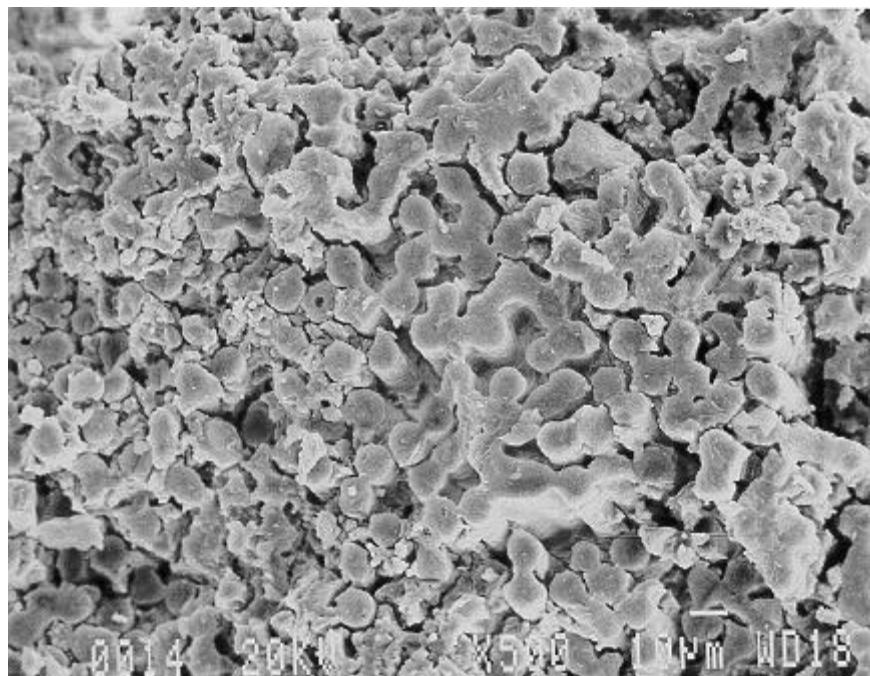
Figure 96 - Fresh-fracture SEM of PRD-66C Filter #C567 (high strength) at 500X

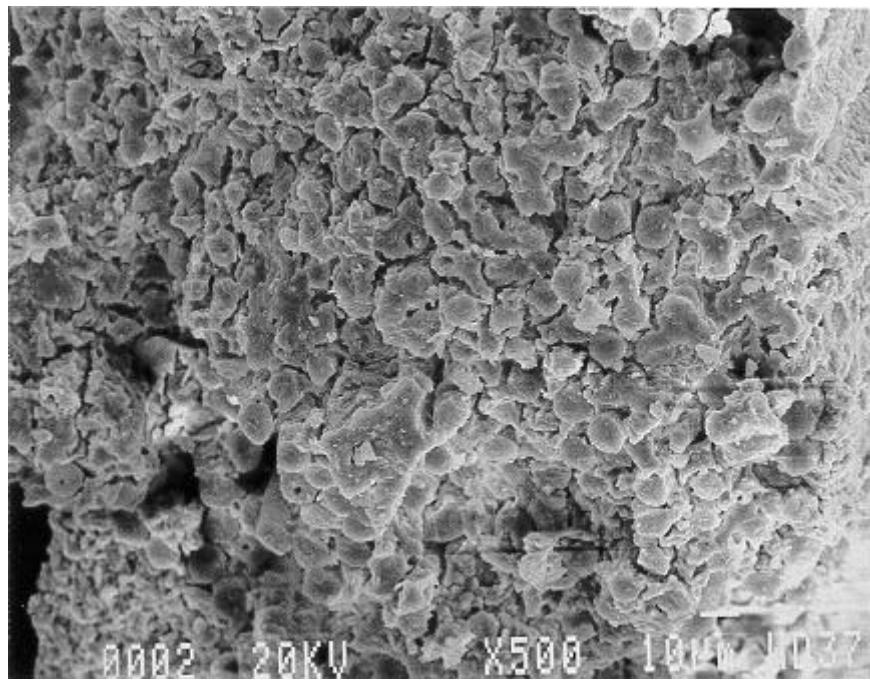
Figure 97 - Fresh-fracture SEM of PRD-66C Filter #C713 (low strength) at 500X

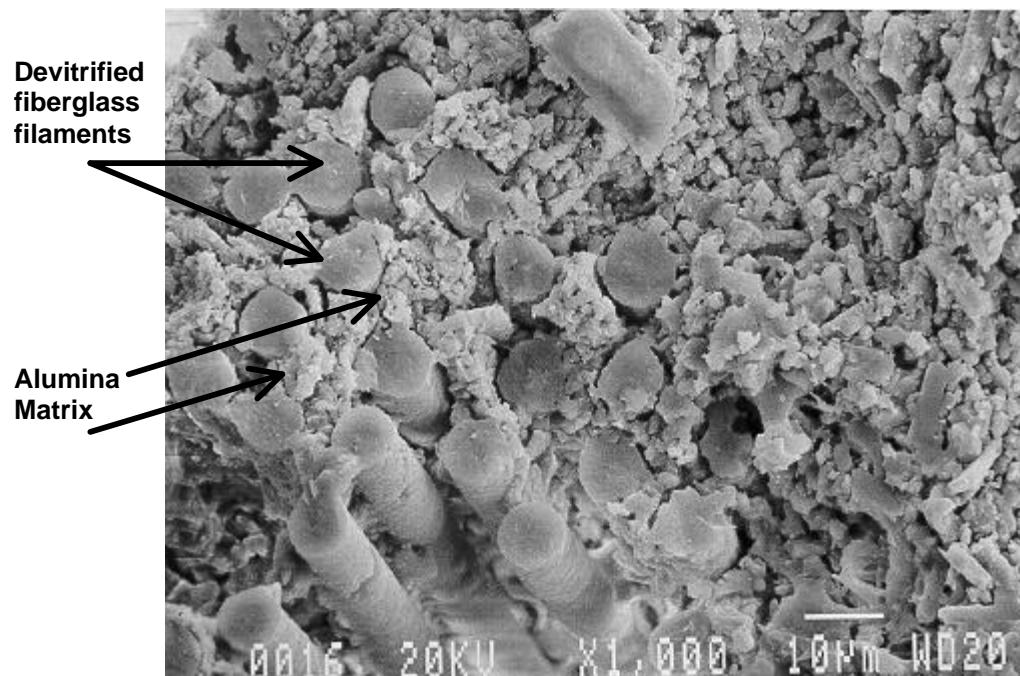
Figure 98 - Fresh-fracture SEM of #C567 in high-alumina region at 1,000X

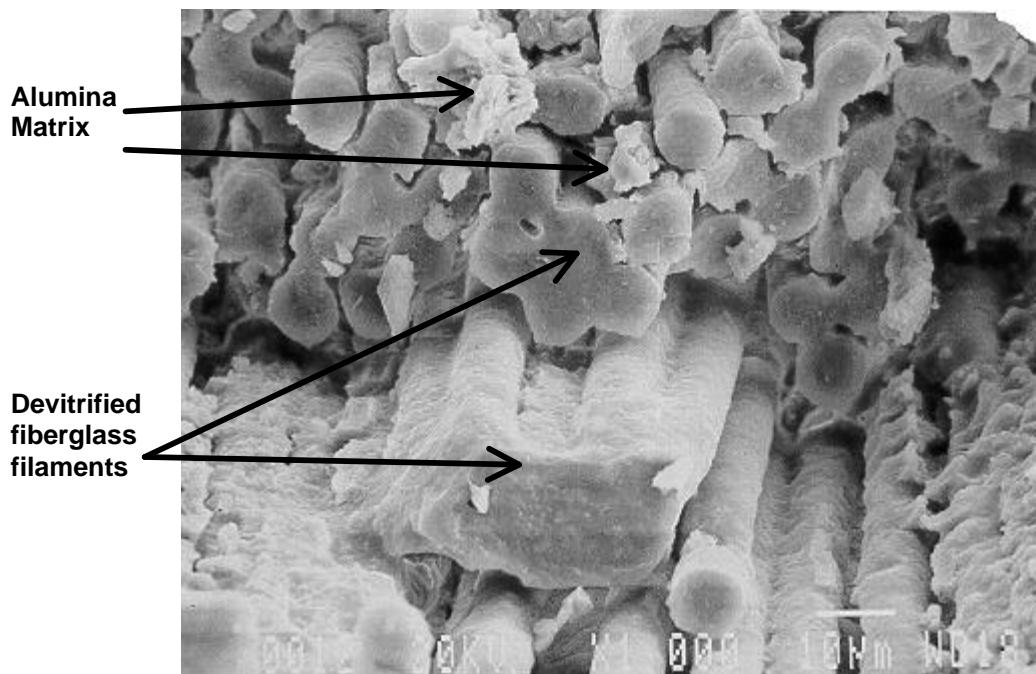
Figure 99 - Fresh-fracture SEM of #C567 in low-alumina region at 1,000X

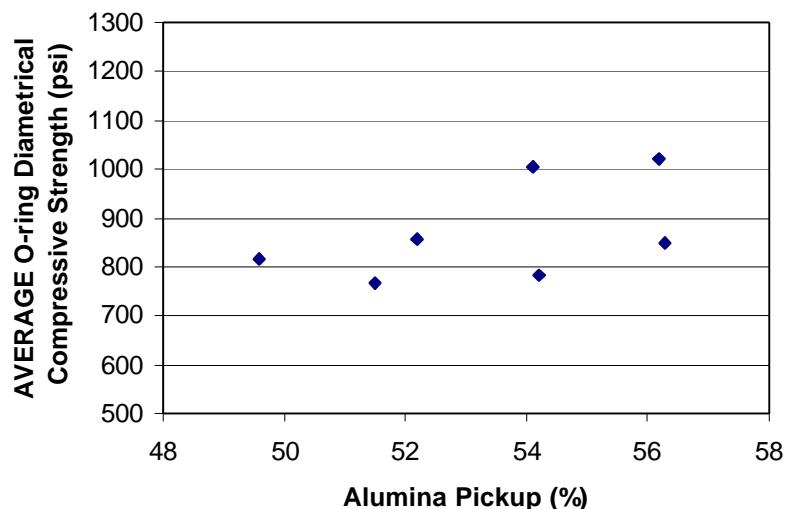
Figure 100 - Alumina content versus average o-ring diametrical compressive strength for as-manufactured PRD-66 filters made with Alumina Lot #2

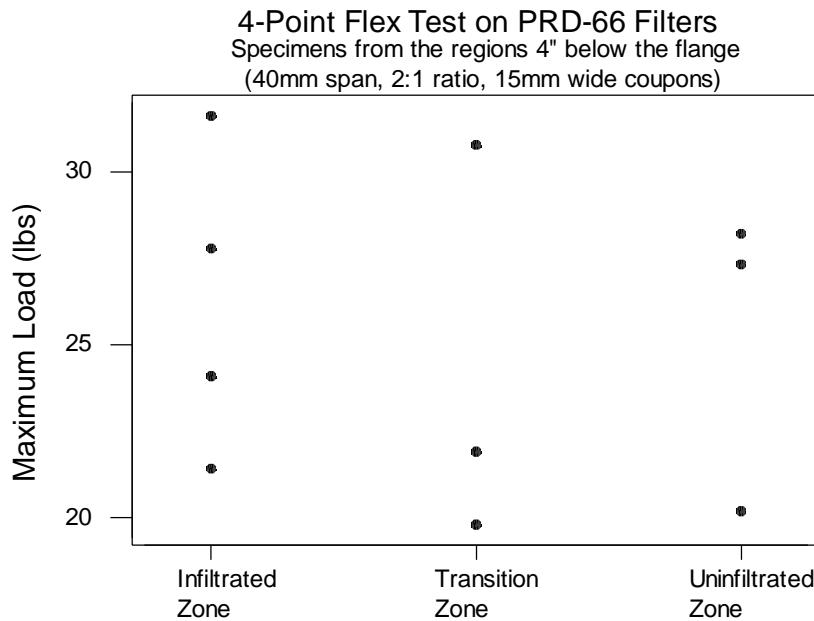
Figure 104 - Maximum 4-Point Load for the Flex Testing of PRD-66 filters in three different regions: infiltrated zone, transition zone, and uninfiltrated zone

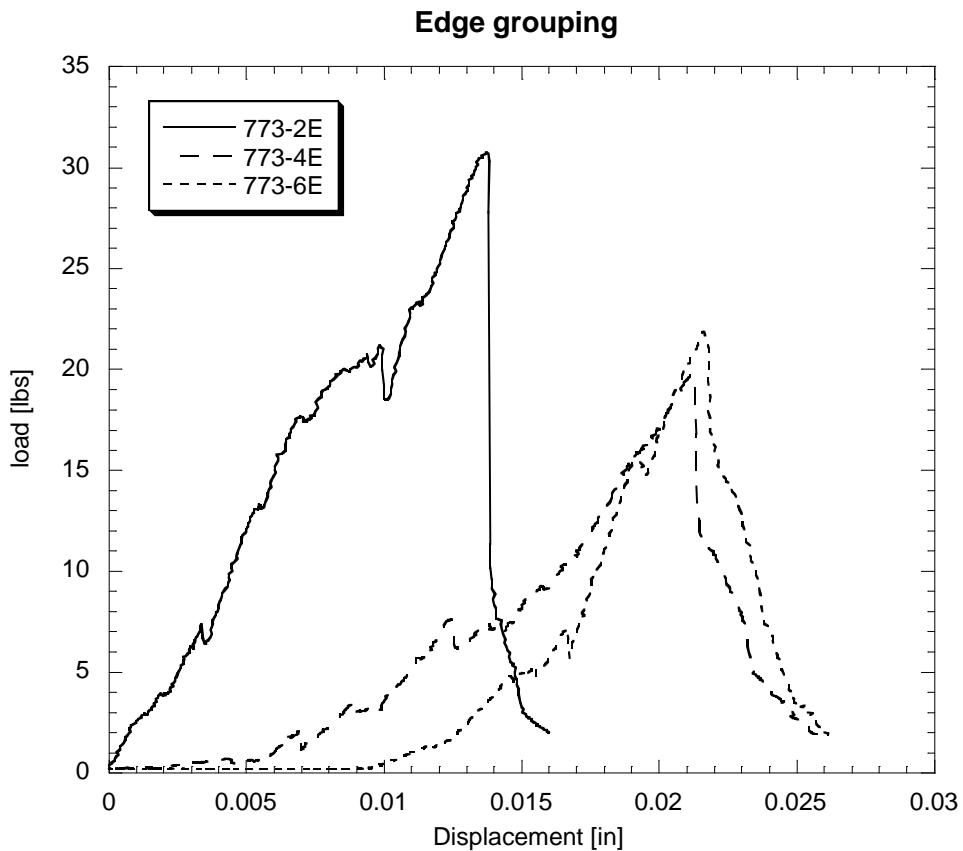
Figure 105 - Load-Displacement Curves for 4-point flex tests in the “transition (edge) zones”.

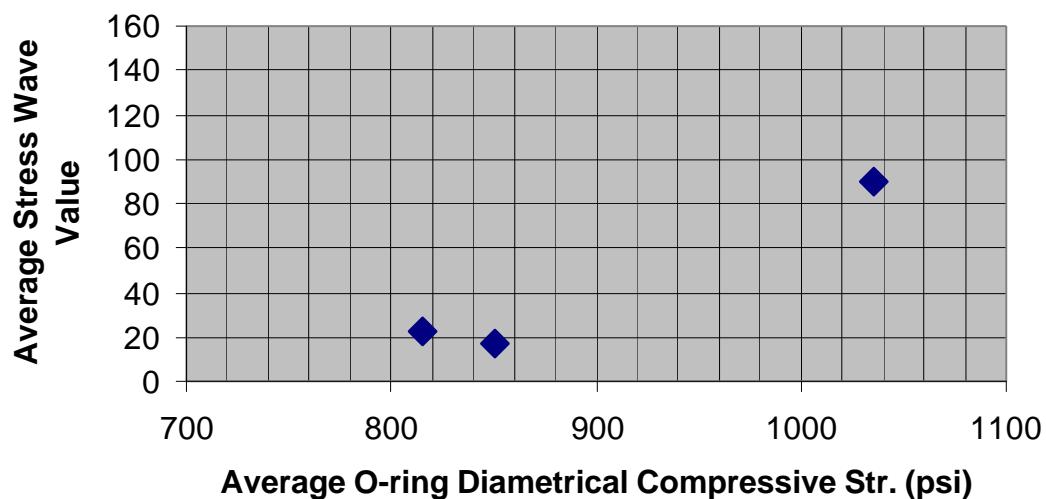
Figure 106 - Preliminary NDE results on PRD-66 hot gas filters, comparing ANL’s Stress Wave Value to the o-ring diametrical compressive strength of the same filter.

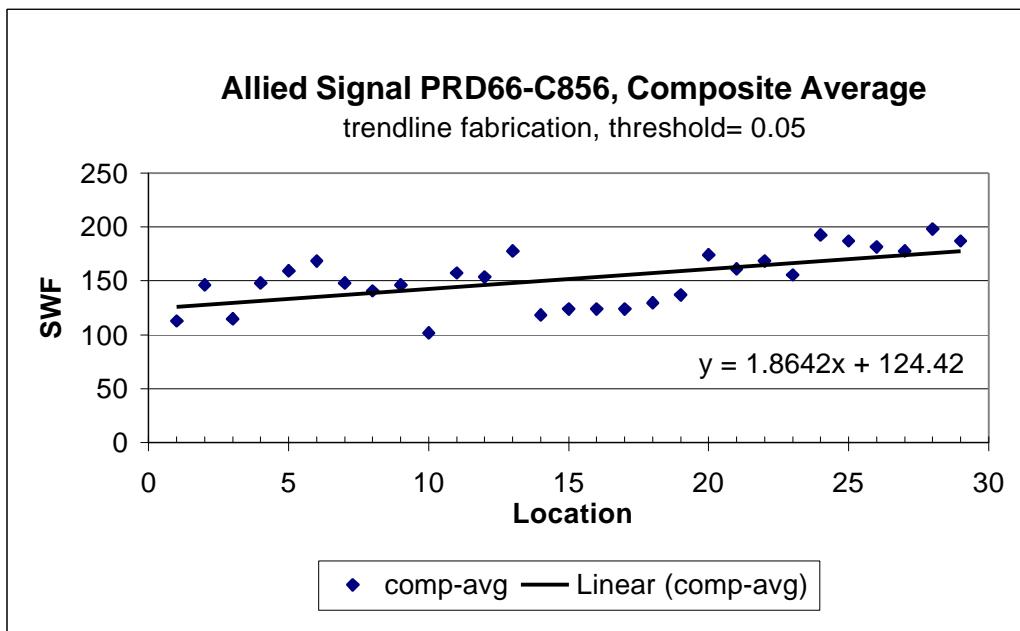
Figure 107 - Stress Wave Factor (SWF) trend along the length of PRD-66 filter C856

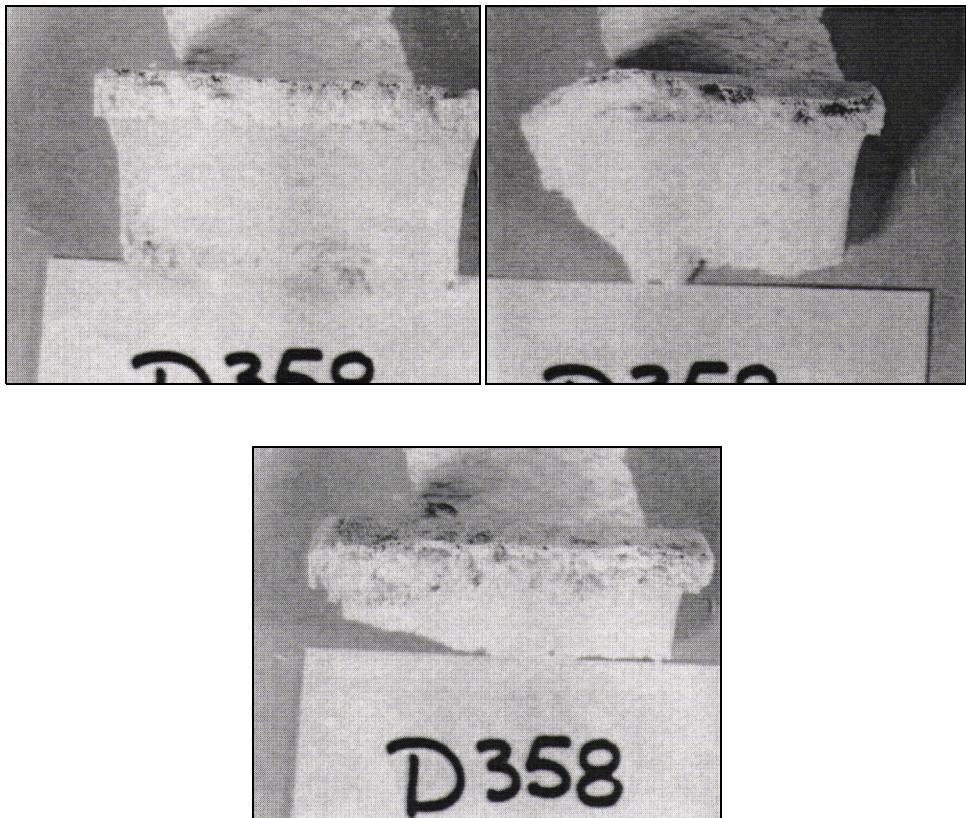
Figure 3a – Fresh fractured surface of the particle challenged D-358 filter matrix.

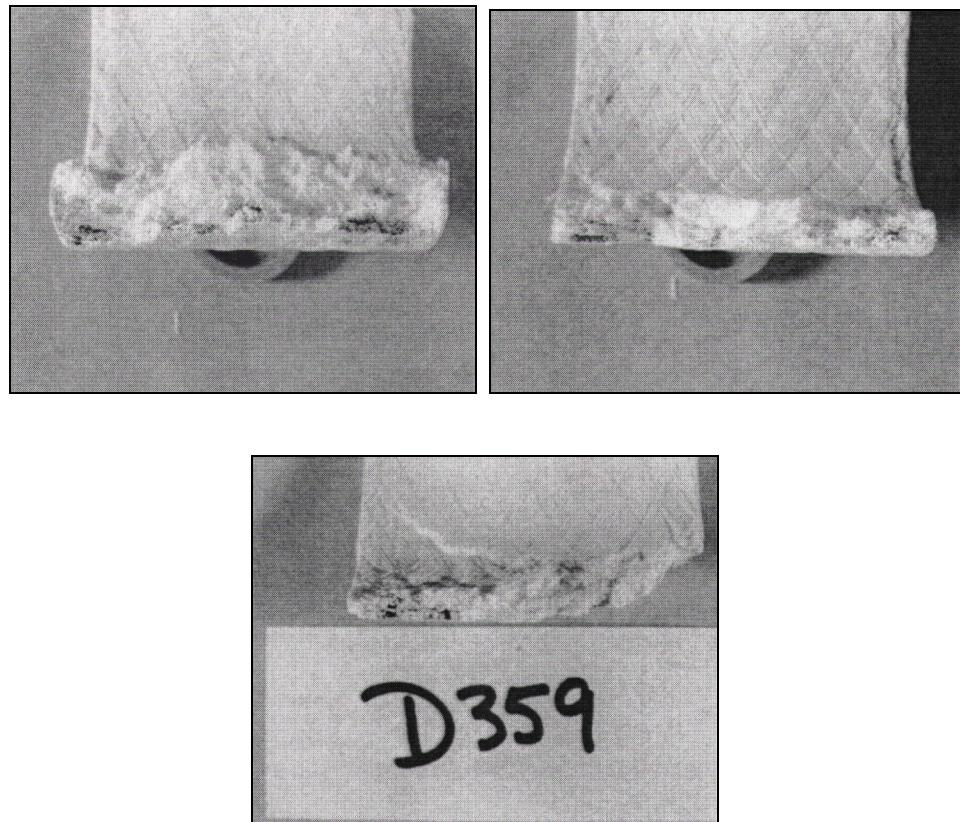
Figure 3b -- Fresh fractured surface of the particle challenged D-359 filter matrix.

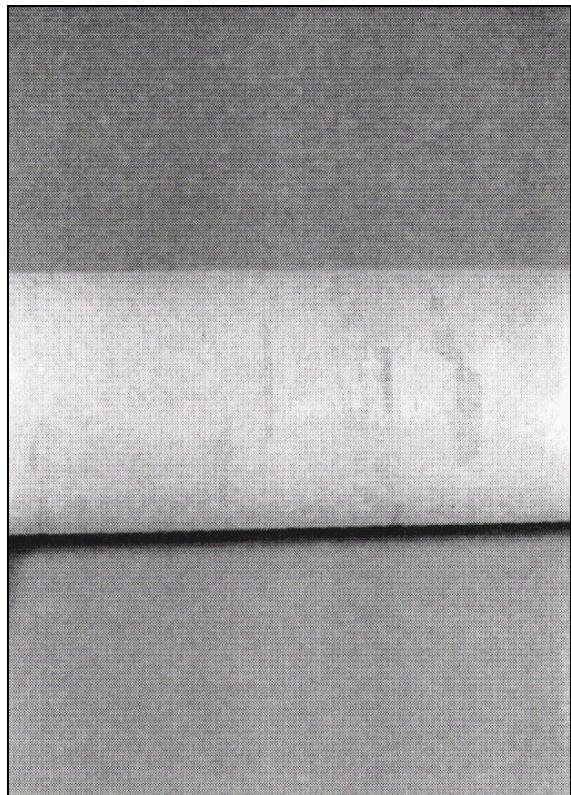
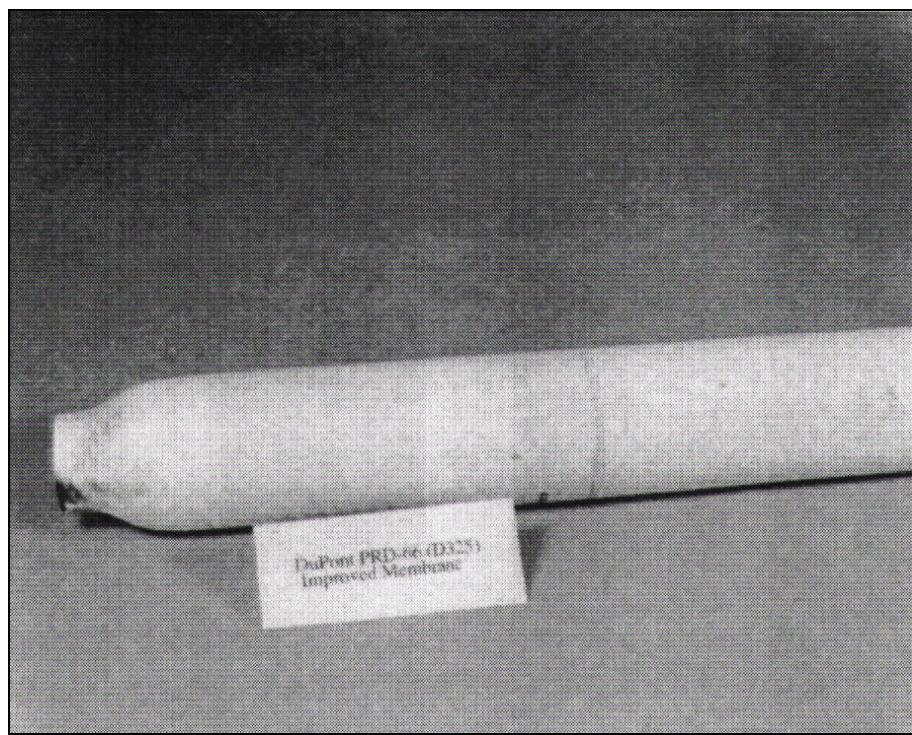
Figure 4a – HTHP-tested DuPont PRD-66 candle filter (Improved o.d. membrane; Strengthened flange).

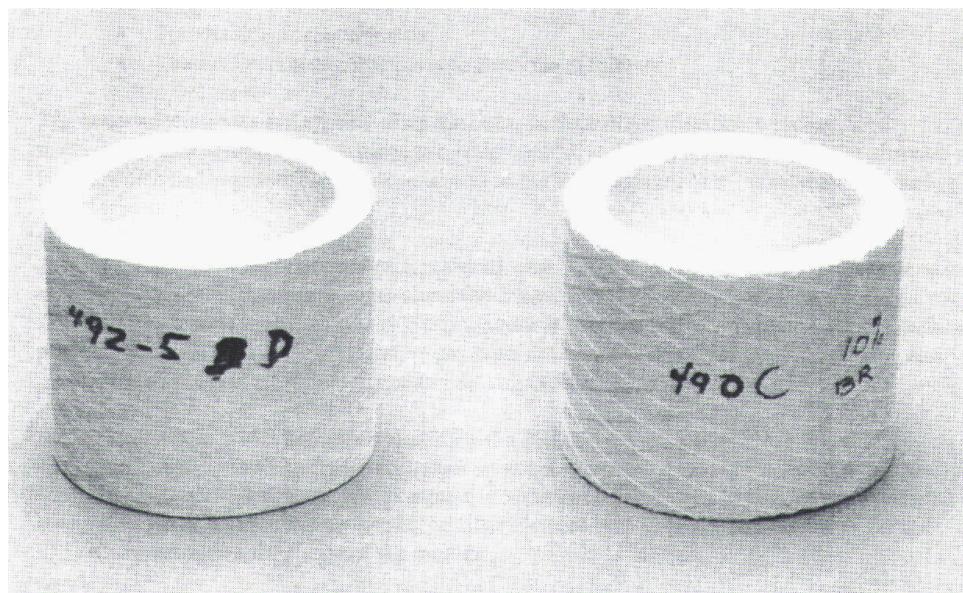
Figure 5 – PRD-66 combination membrane and particulate membrane filter concepts.

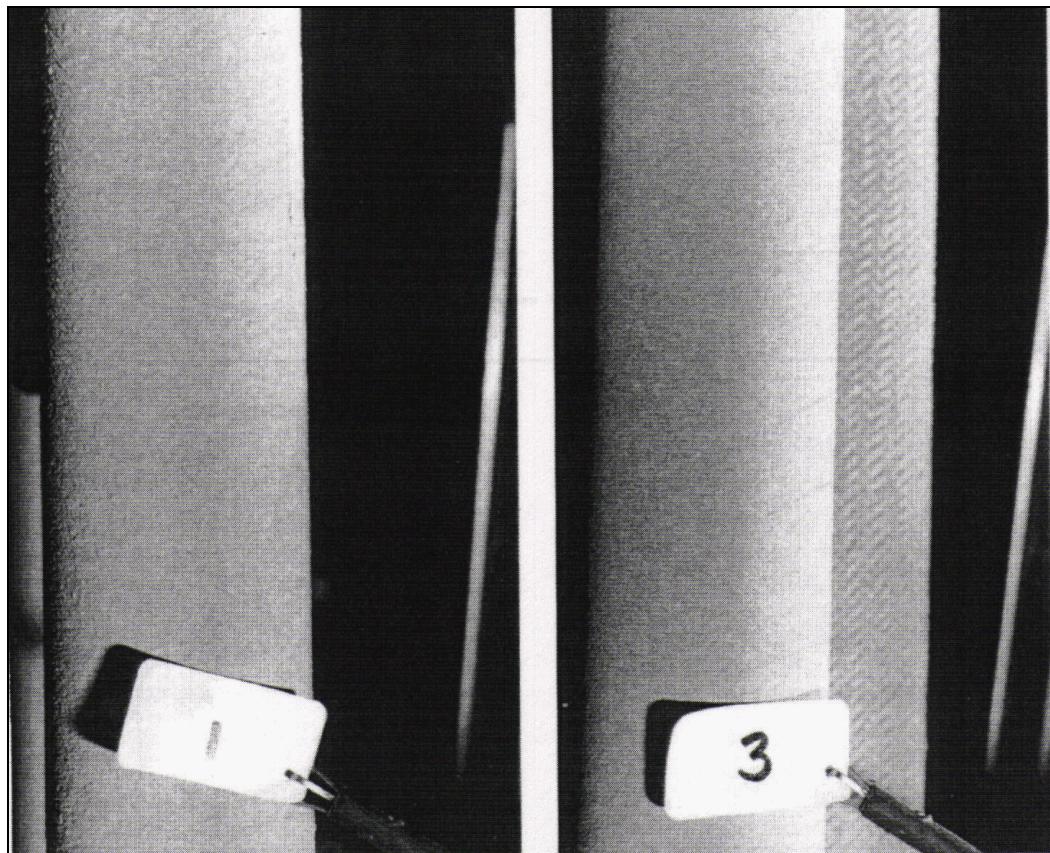
Figure 8 – Photograph illustrating the residual ash cake layer that remained along the outer surface of the PRD-66 candle filters after qualification testing that was conducted under simulated PFBC conditions.
