SANDIA REPORT

SAND95-1236 • UC-802

Hanford Coring Bit Temperature Monitor Development Testing Results Report

Instrumentation which directly monitors the temperature of a coring bit used to retrieve core samples of high level nuclear waste stored in tanks at Hanford was developed at Sandia National Laboratories. Monitoring the temperature of the coring bit is desired to enhance the safety of the coring operations. A unique application of mature technologies was used to accomplish the measurement. This report documents the results of development testing performed at Sandia to assure the instrumentation will withstand the severe environments present in the waste tanks.

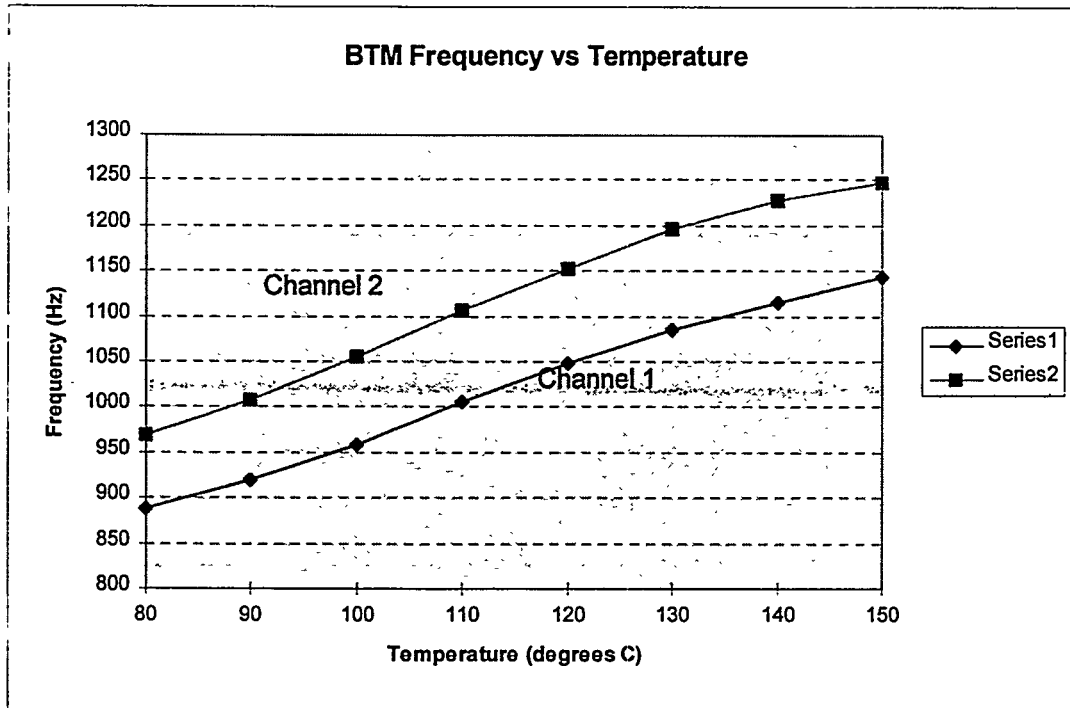
These tests demonstrate that an infrared signal can be reliably transmitted and received over 60 feet of drill string even when the pipe has a severe bend. In the initial tests, the drill bit was inserted into a small temperature chamber with thermistors bonded to the surface of the bit. A thermocouple was also bonded to observe the temperature in the chamber. The signal amplitude was observed with no intentional bends in the drill string. Figure 2 plots the frequencies measured on both channels as a function of temperature.

Figure 2. Channels 1 and 2 Frequency vs Temperature

For the development unit, unscreened thermistors were used and channel frequencies were not calibrated. This explains why the two curves shown in Figure 2 are not identical. The final unit will be calibrated by using thermistors that are interchangeable
