EWI Project No. 46211GTH
Electronic File Name: 41633R42.pdf

Internal Repair of Pipelines 18-Month Technical Progress Report

Reporting Period:
September 30, 2003 through March 31, 2004

DOE Award No.: DE-FC26-02NT41633

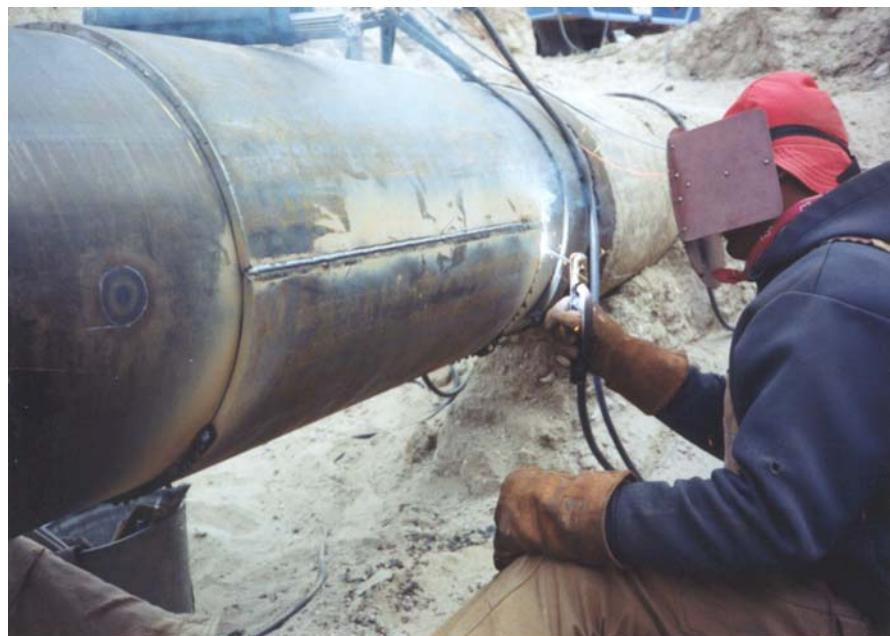
Figure 1 - Installation of a Full-Encirclement Repair Sleeve

Gas transmission pipeline repair by direct deposition of weld metal, or weld deposition repair, is a proven technology that can be applied directly to the area of wall loss (e.g., external repair of external wall loss - Figure 1) or to the side opposite to the wall loss (e.g., external repair of internal wall loss - Figure 2).

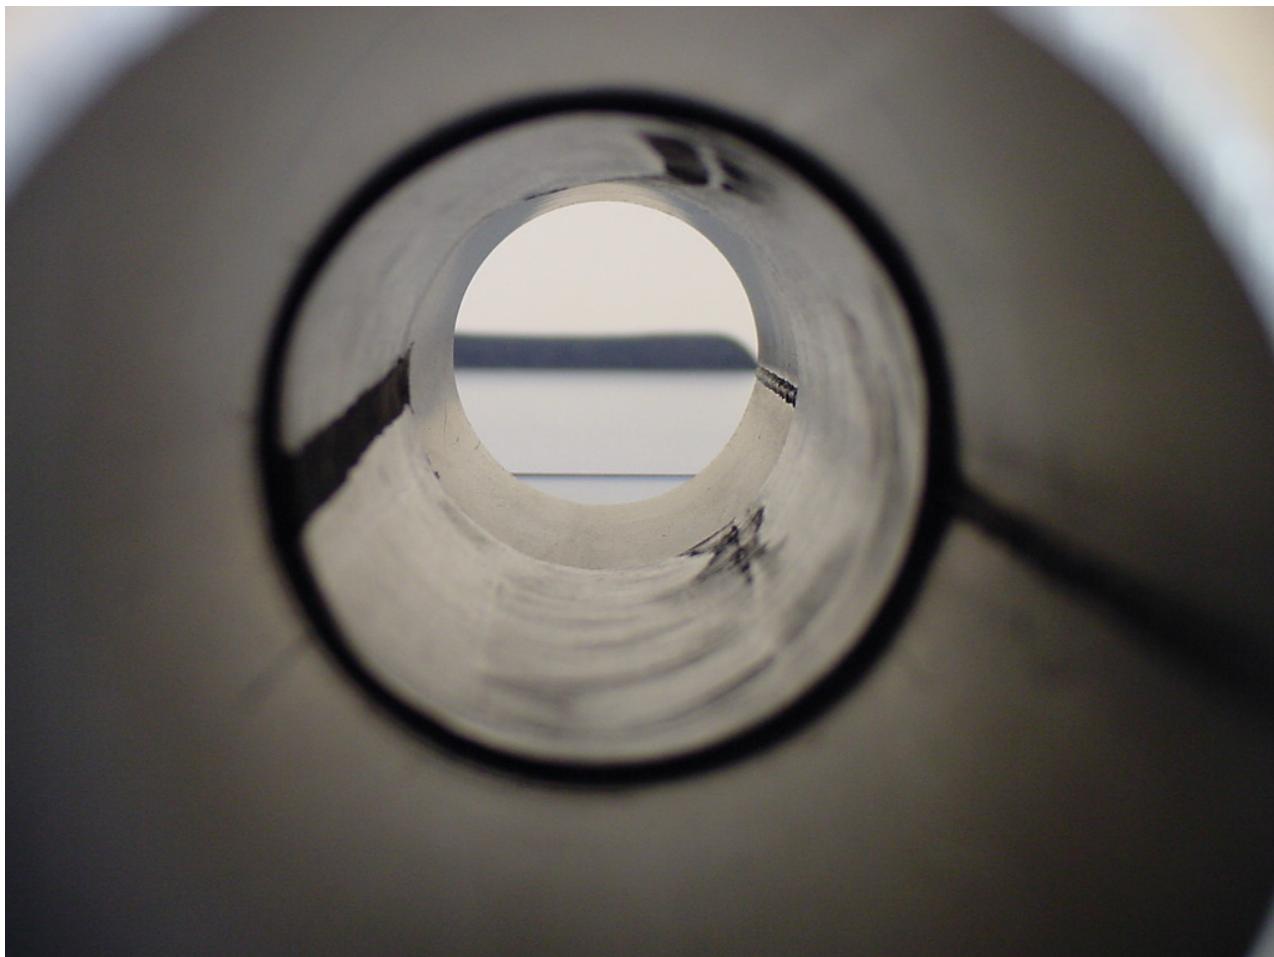
Figure 11 - Liner Inserted into Center of 114.3 mm (4.5 in.) Diameter Pipe

Possible choices for liner installation in the field include infra-red (IR) heaters on an expansion pig or a silicon bag inflated using hot air. An installed liner is shown in Figure 11.

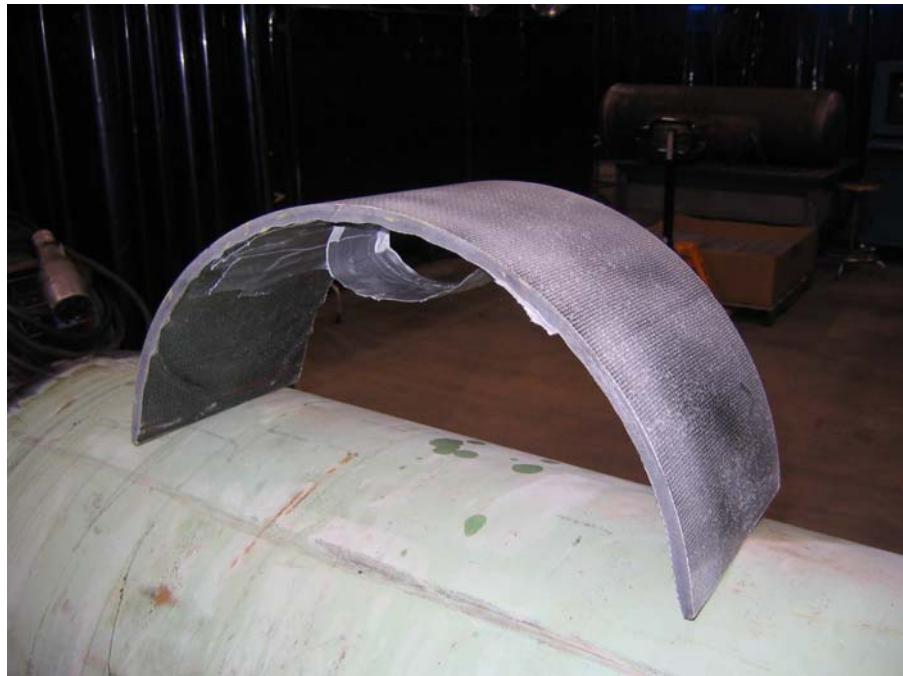
Figure 22 - Completed Repair Patch with Grit-Blasted Outer Diameter

To facilitate patch installation, the outer surface of the patch was grit-blasted using 50 - 80 grit Alumina to remove surface resin (Figure 22). Similarly, the installation area inside the pipe was grit-blasted to a near-white blast with 50 - 80 grit Alumina (Figure 23). After cleaning, a liberal coating of 3M DP460 epoxy adhesive was applied to the internal faying surface and a thin coating was applied to the patch faying surface (Figure 24).

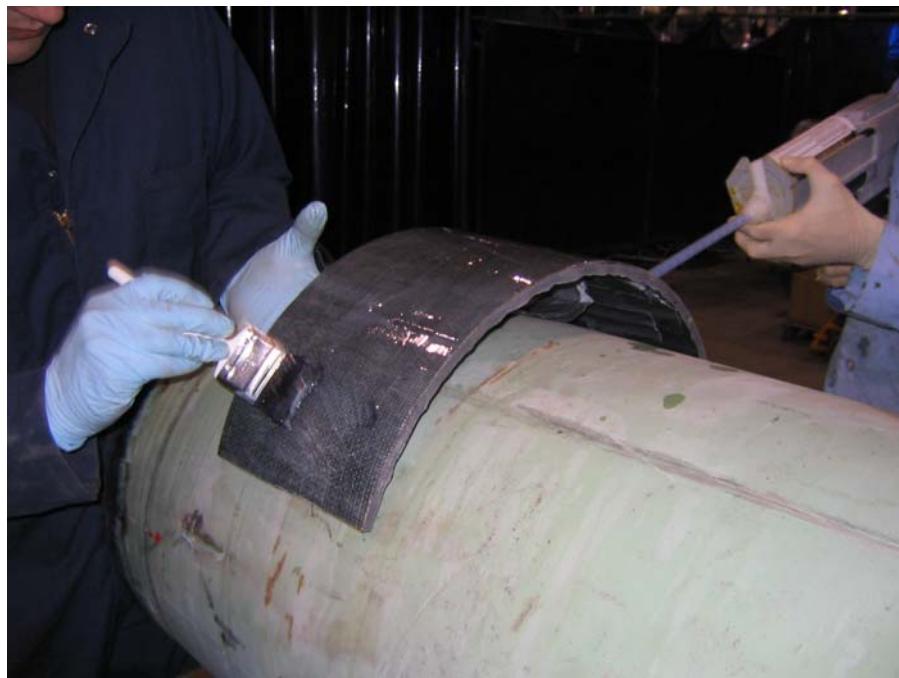
Figure 24 - Application of Adhesive to Repair Patch

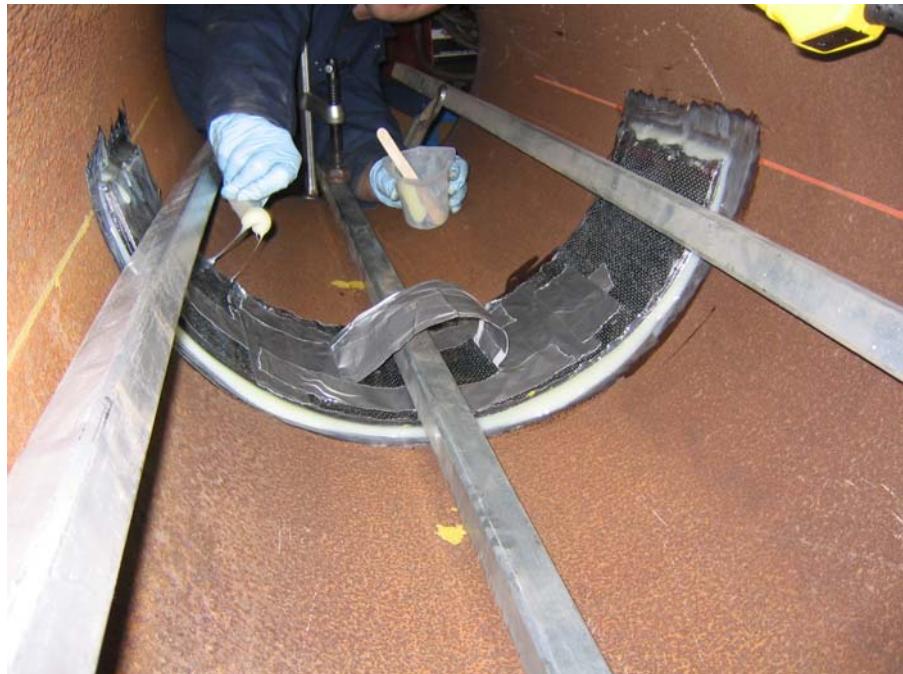
Figure 26 - Clamping Bars Used to Hold Repair Patch in Place

Bar clamps were used along the axis of the pipe to hold the patch in place for cure. Figure 26 shows the adhesive squeeze-out being removed prior to forming a fillet as shown in Figure 27

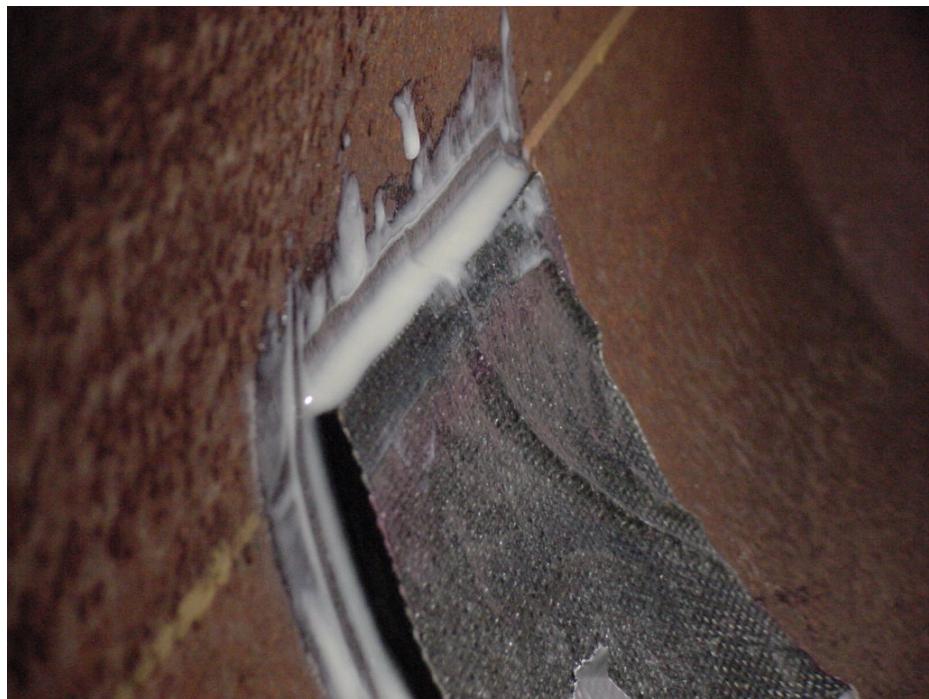
Figure 27 - Adhesive Fillet Around Repair Patch

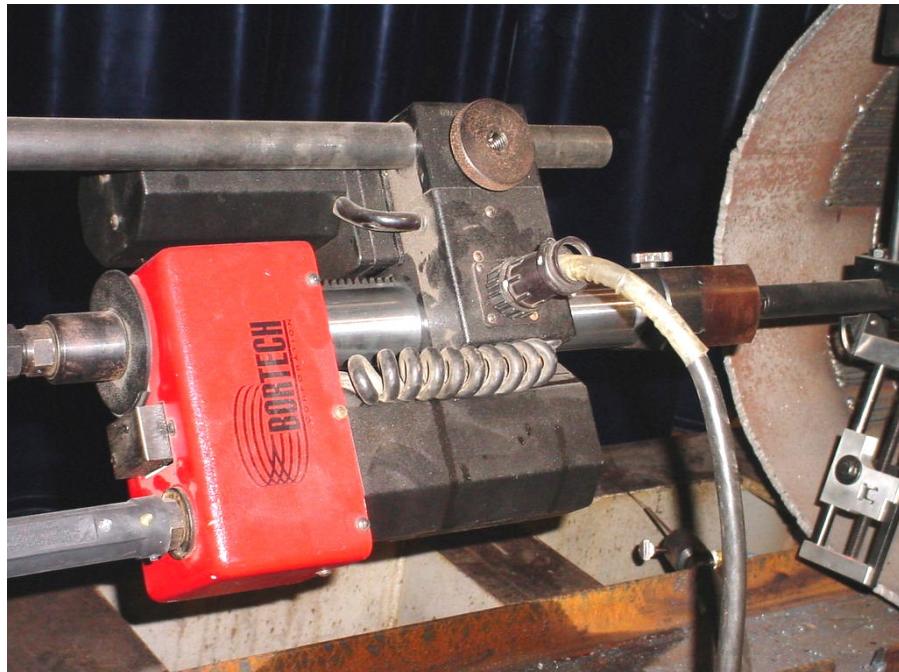
Figure 29 - Bortech Motion Mechanism for Continuous Spiral Deposition

Each system had motion control limitations and individually would not be appropriate candidates for an internal repair welding system. The internal bore cladding system manufactured by Bortech (Figure 29 and Figure 30) was designed for spiral cladding the inside of pipe that is preferably in the vertical position.

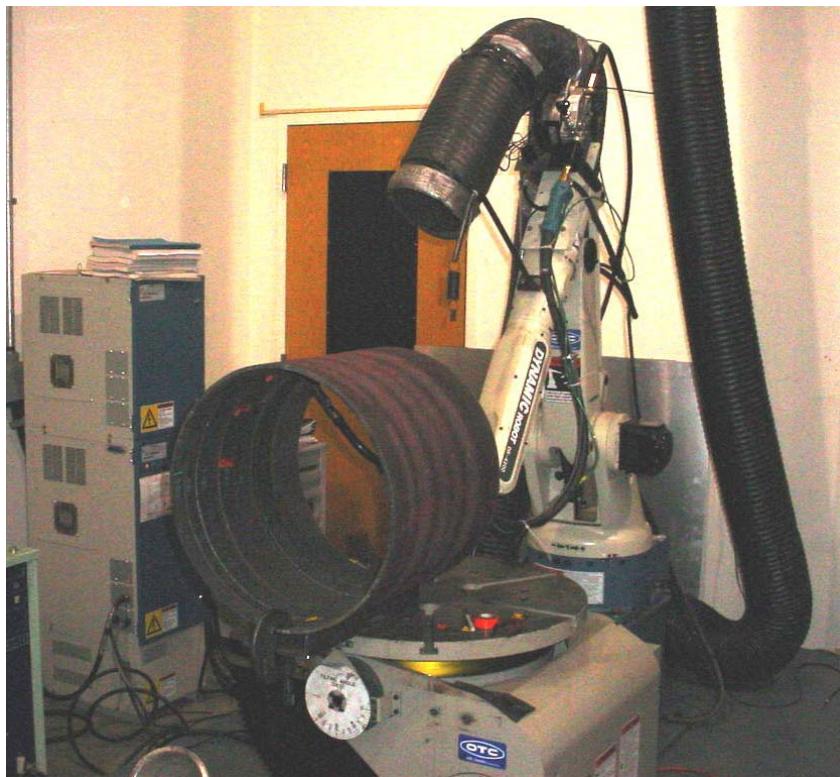
Figure 32 - OTC Robot Set-Up for Internal Welding

Based on the results experienced with the Bortech system, it was decided to develop preliminary welding procedures using a robotic GMAW system. A 6-axis coordinated motion robot (Figure 32) permitted the application of weave beads for spiral cladding or stringer beads in either direction. An observed limitation was the fact that the system did not have a welding torch current commutator to permit continuous spiral welding.

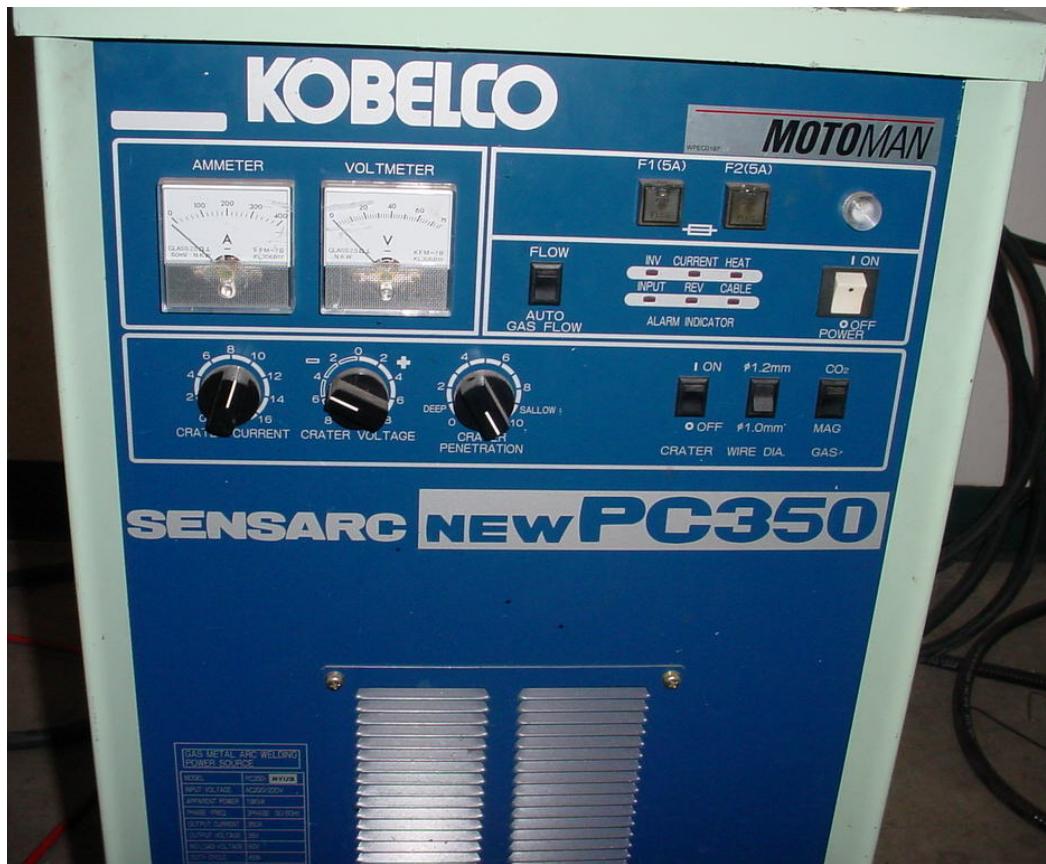
Figure 34 - Kobelco PC-350 Variable Polarity Fuzzy Logic Power Supply

0.8 mm (0.035 in.) or 1.2 mm (0.045 in) diameter electrodes. The waveform was simply modified by changing the electrode negative ratio on the pendant. Arc length and heat input is changed by an arc length knob on the pendant, which varies the pre-programmed pulse frequency.

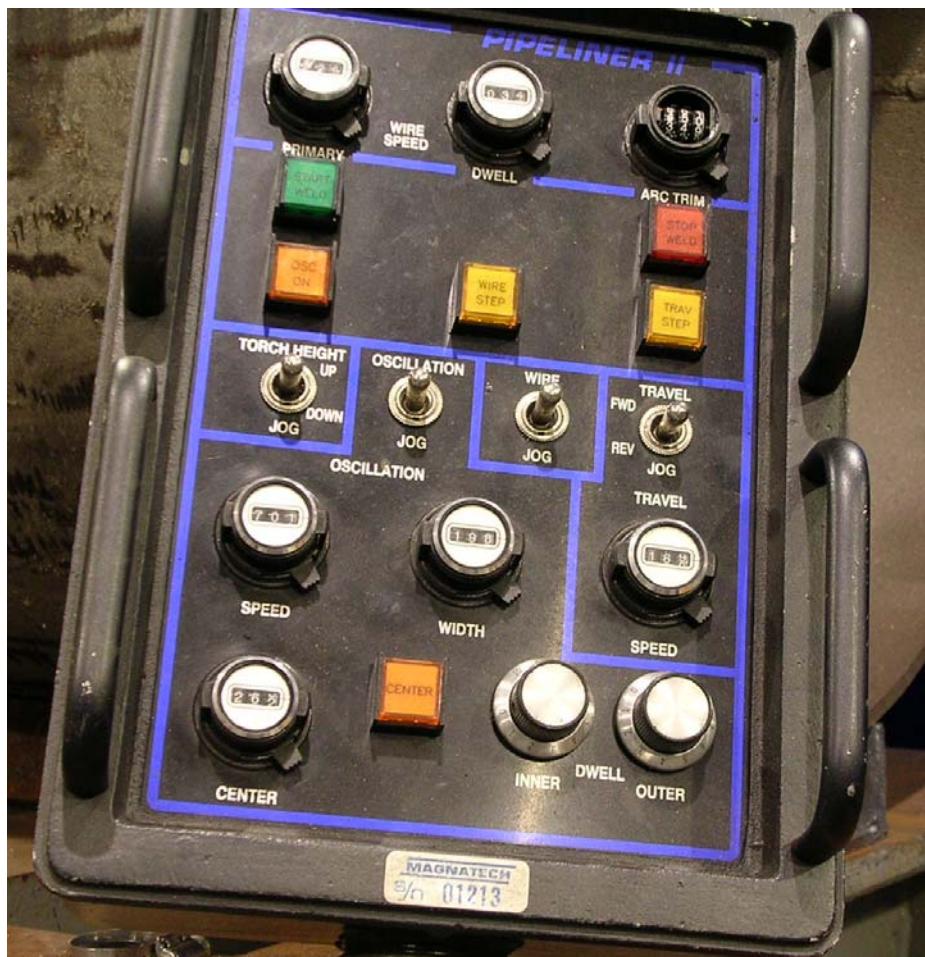
Figure 36 - Magnatech Control Pendant Showing Control Parameters

The Magnatech welding tractor has orbital motion with controls (Figure 36) for torch oscillation. The system is limited to a finite number of revolutions that can be made before cables need to be unwound. The controls are analog and do not have high accuracy, however, they are sufficient for preliminary parameter development and demonstration welding. Programmable controls would be required for an internal repair welding system using a Magnatech tractor. In addition, numerous mechanical changes would be required to accommodate a range of pipeline diameter sizes.

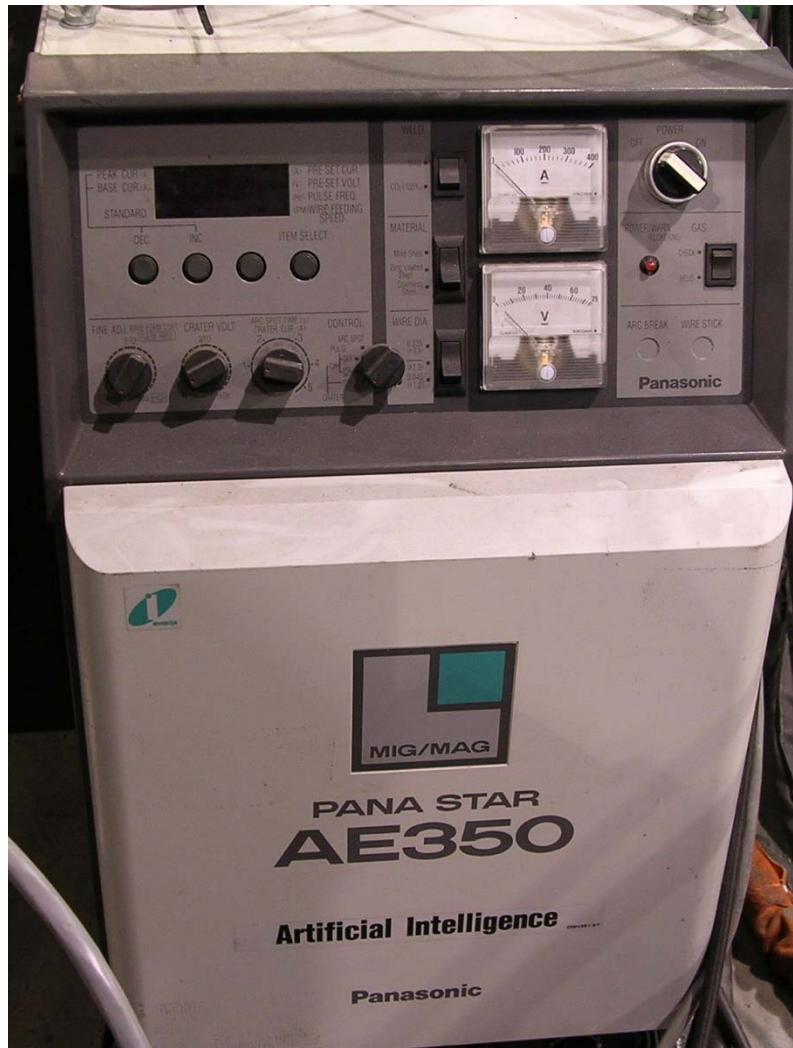
Figure 37 - Panasonic AE 350 Power Supply with Pulse Short-Circuit Metal Transfer Control

The Magnatech tractor was interfaced to a Panasonic AE 350 power supply (Figure 37). This power supply provides pulse waveforms and can be operated in a short-circuit mode where artificial intelligence is used to minimize spatter. The current pulsing and short circuiting helps lower heat input and improve deposition rate in out-of-position welds. Pre-programmed current waveforms are provided by algorithms for steel electrodes, and many other materials.

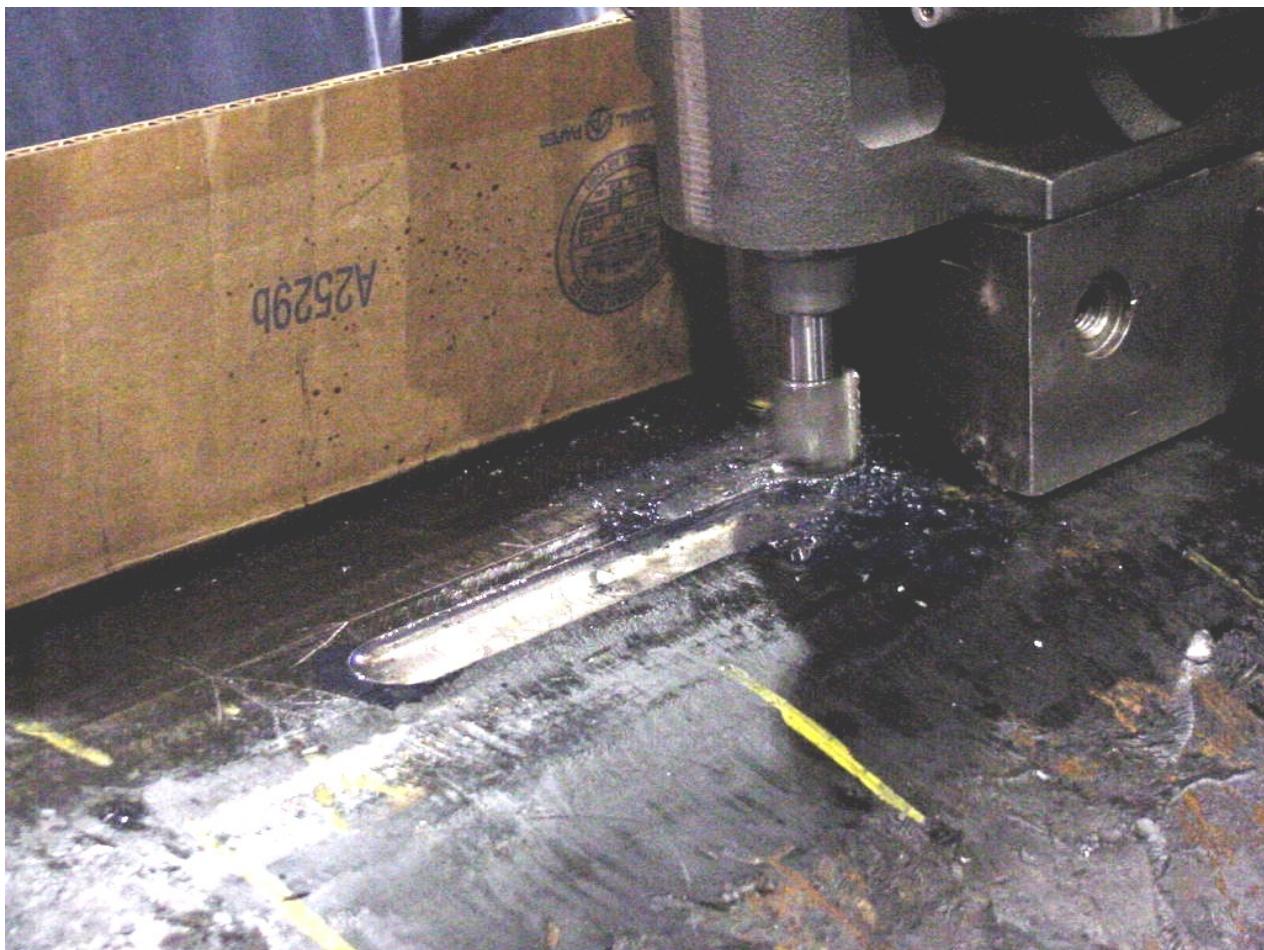
Figure 38 - Milling Machine Set-Up Used to Simulate Corrosion on Pipe Sections

The simulated corrosion in the pipe was introduced by milling a slot into a 559 mm (22 in.) OD pipe with a wall thickness of 7.9 mm (0.312 in.) using the set-up as shown in Figure 38. The dimensions of the corrosion damage are shown in Figure 39; finished simulated damage is found in Figure 40; and a magnified view of the damage is located in Figure 41.

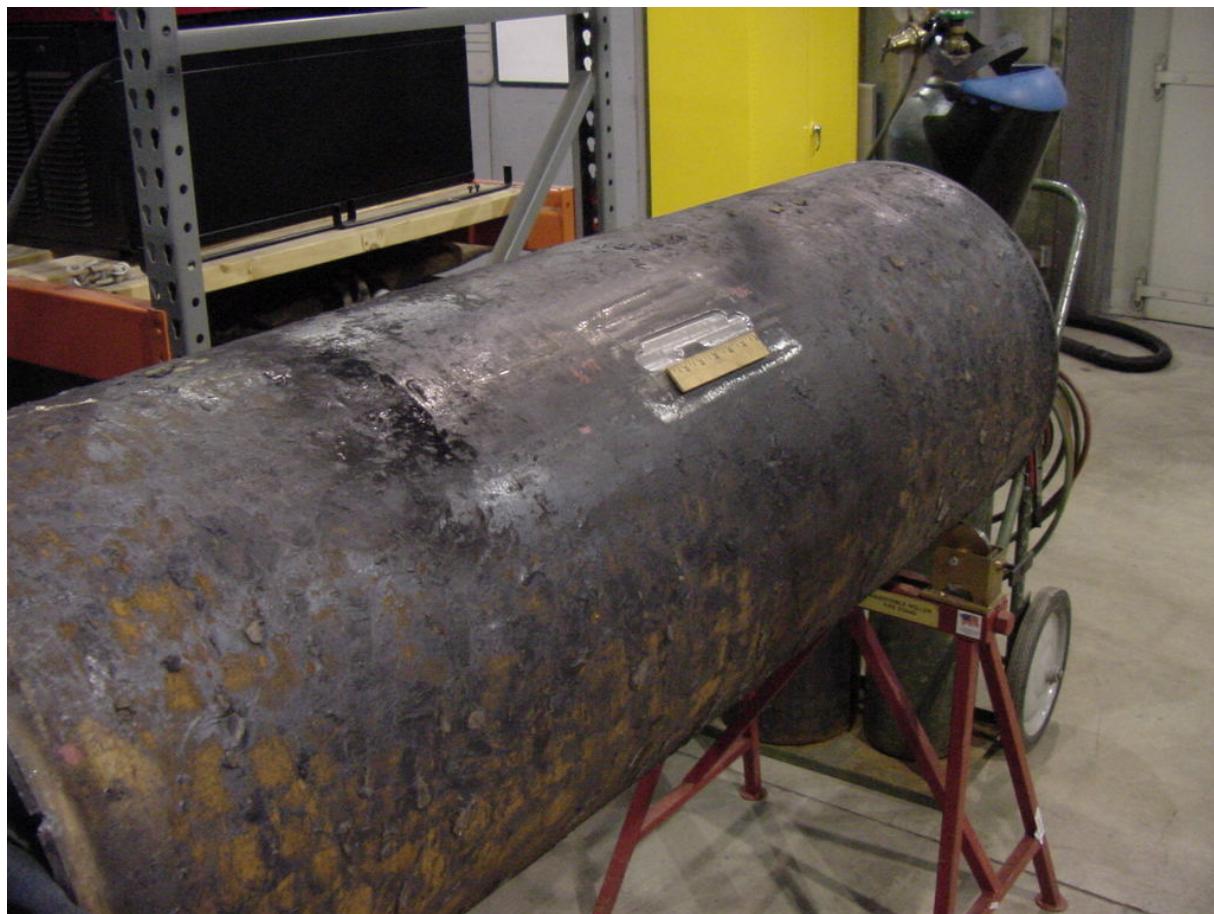
Figure 40 - Simulated Corrosion on 558.80 mm (22 in.) Pipe

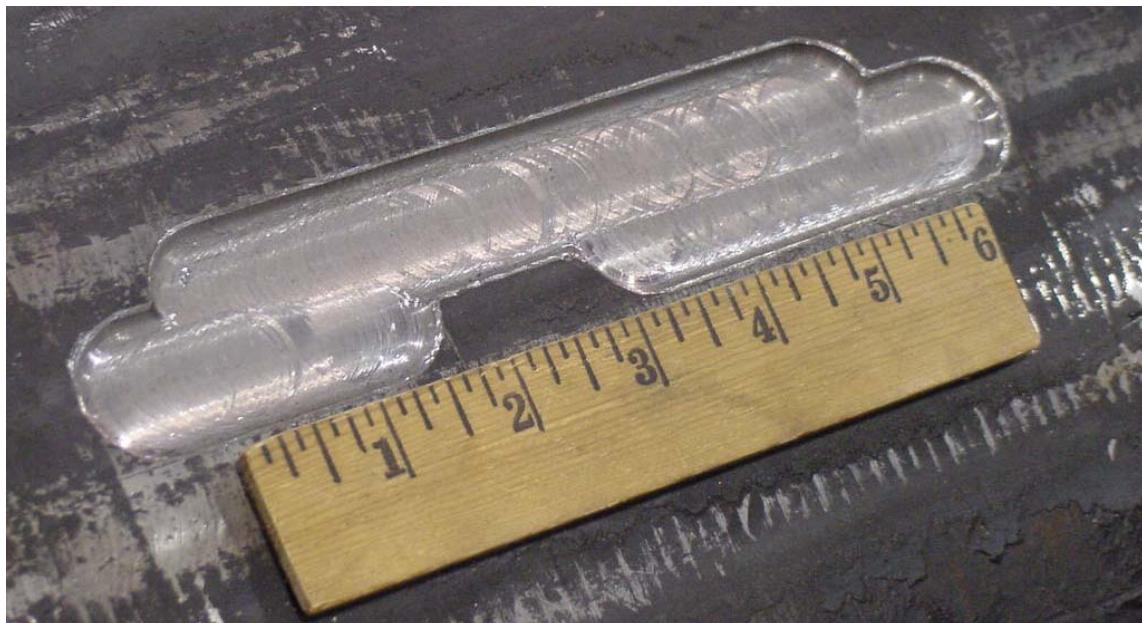
Figure 41 - Magnified View of Simulated Corrosion on 558.80 mm (22 in.) Pipe

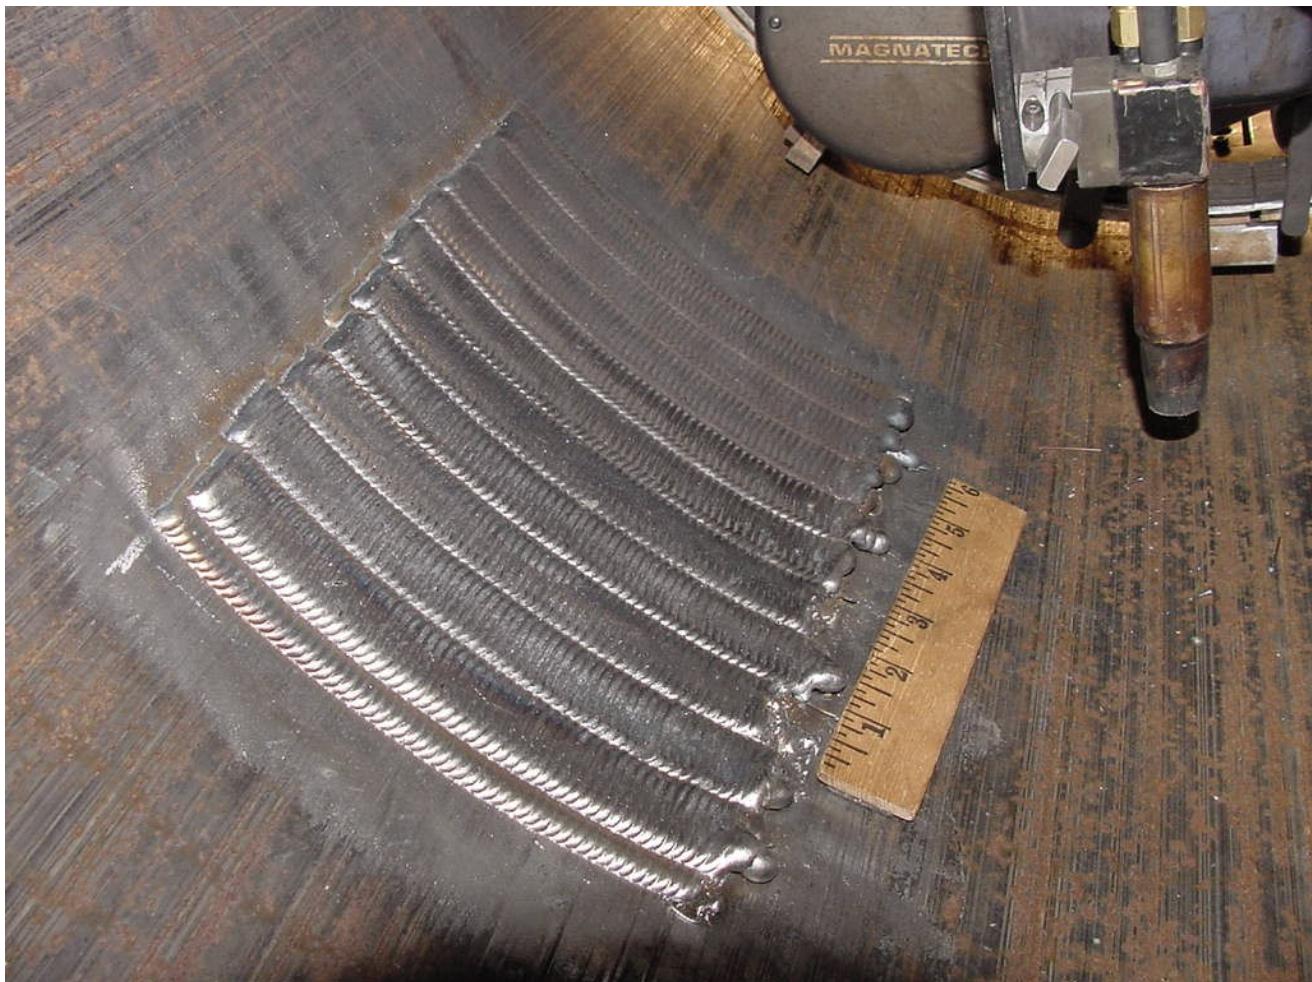
Figure 50 - Finished Second Layer of Deposited Weld Metal on Inside Pipe Diameter

Completed second layer is shown in Figure 50.

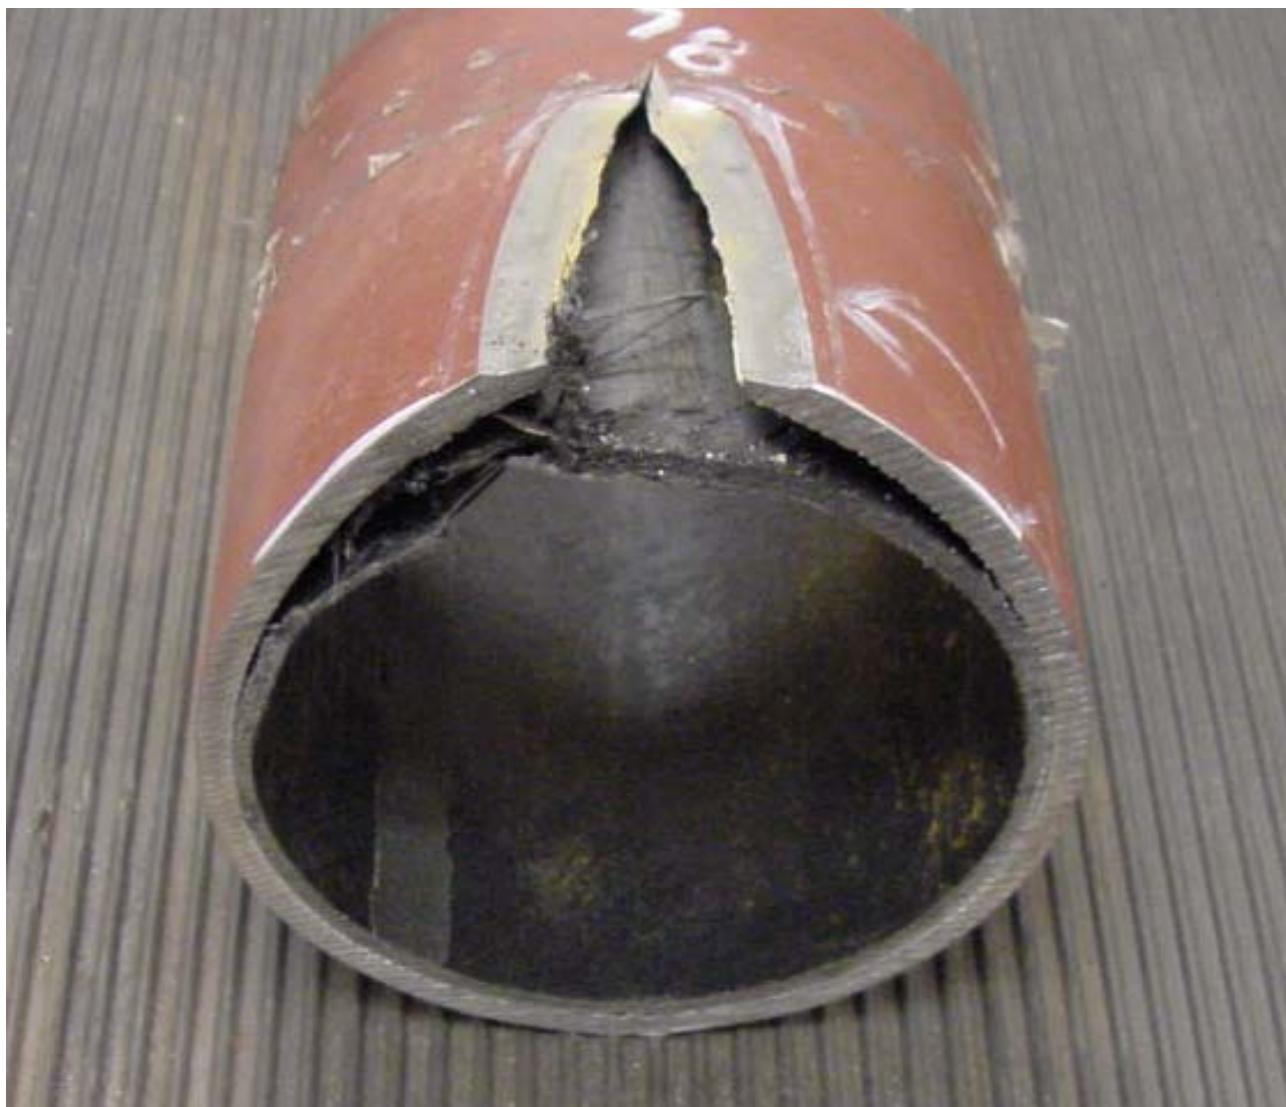
Figure 77 - Water-Jet Cut Section through Pipe Sample Containing Round-Bottom Longitudinal Slot with Liner Installed

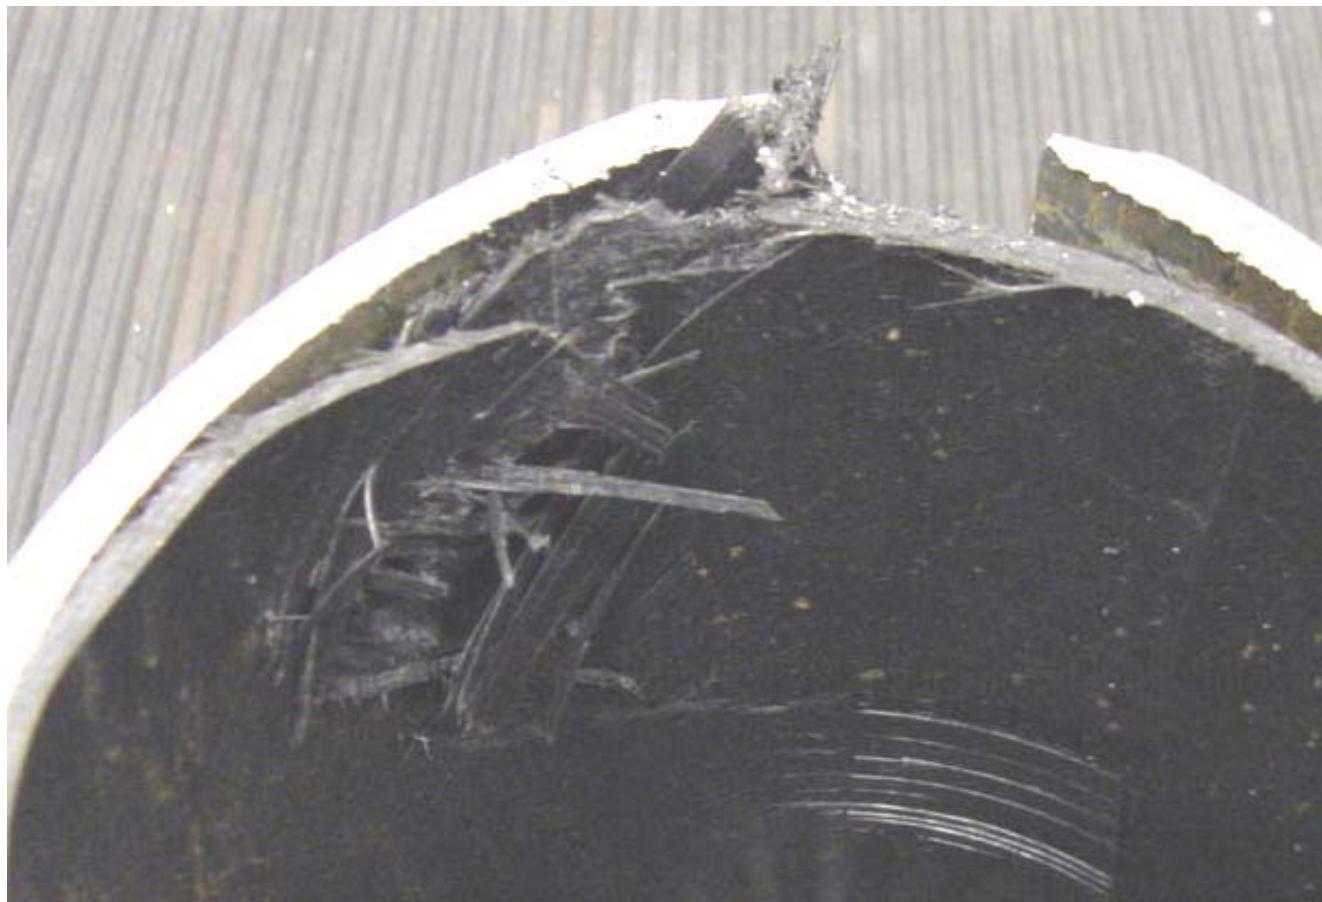
Figure 78 - Pipe Sample Containing Round-Bottom Longitudinal Slot Showing Rupture of Liner Material

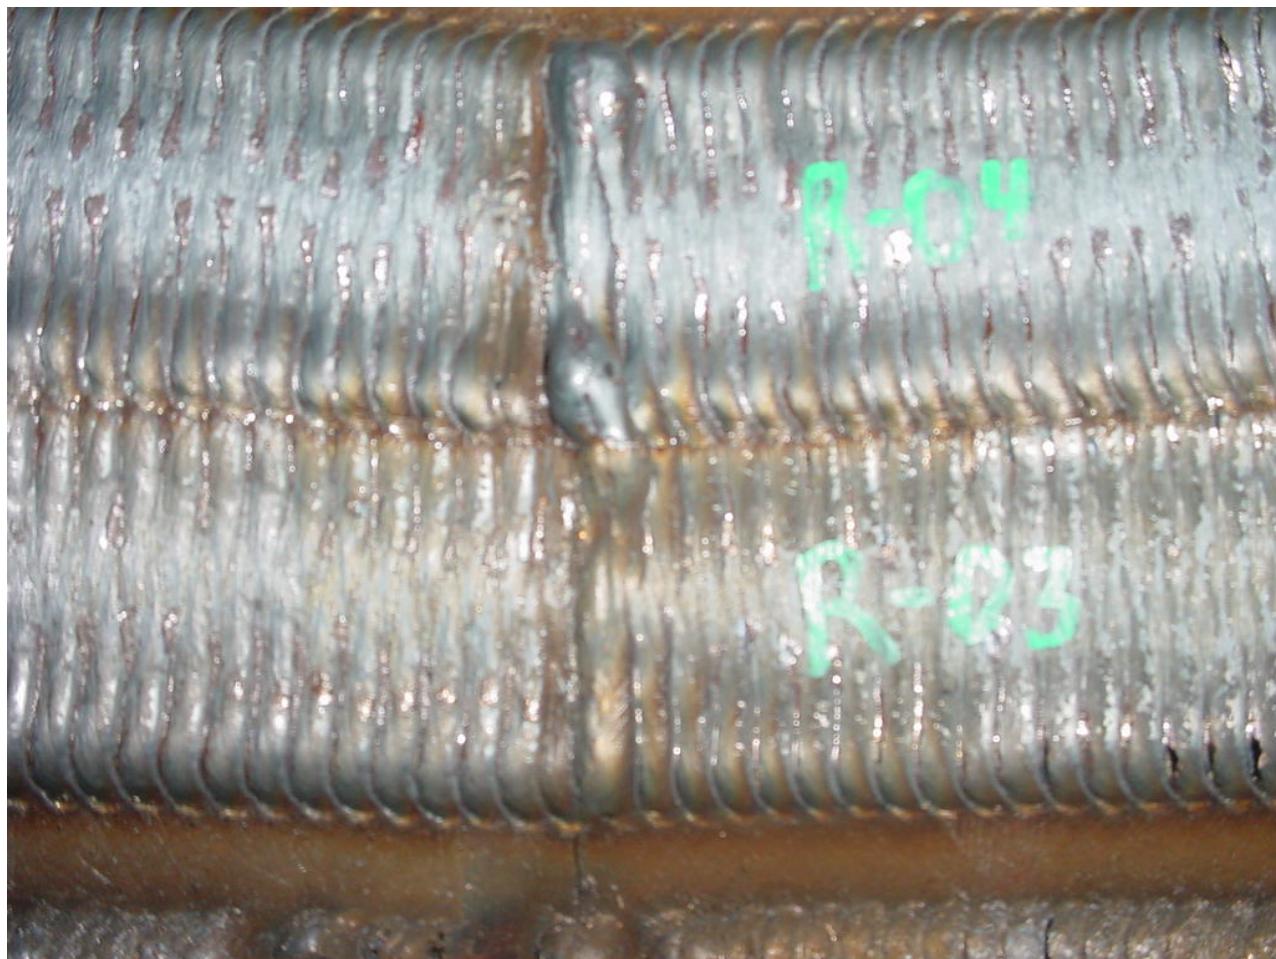
Figure 83 - Tests R-03 and R-04 at 12:00 Showing Better Stop-Start Overlap.

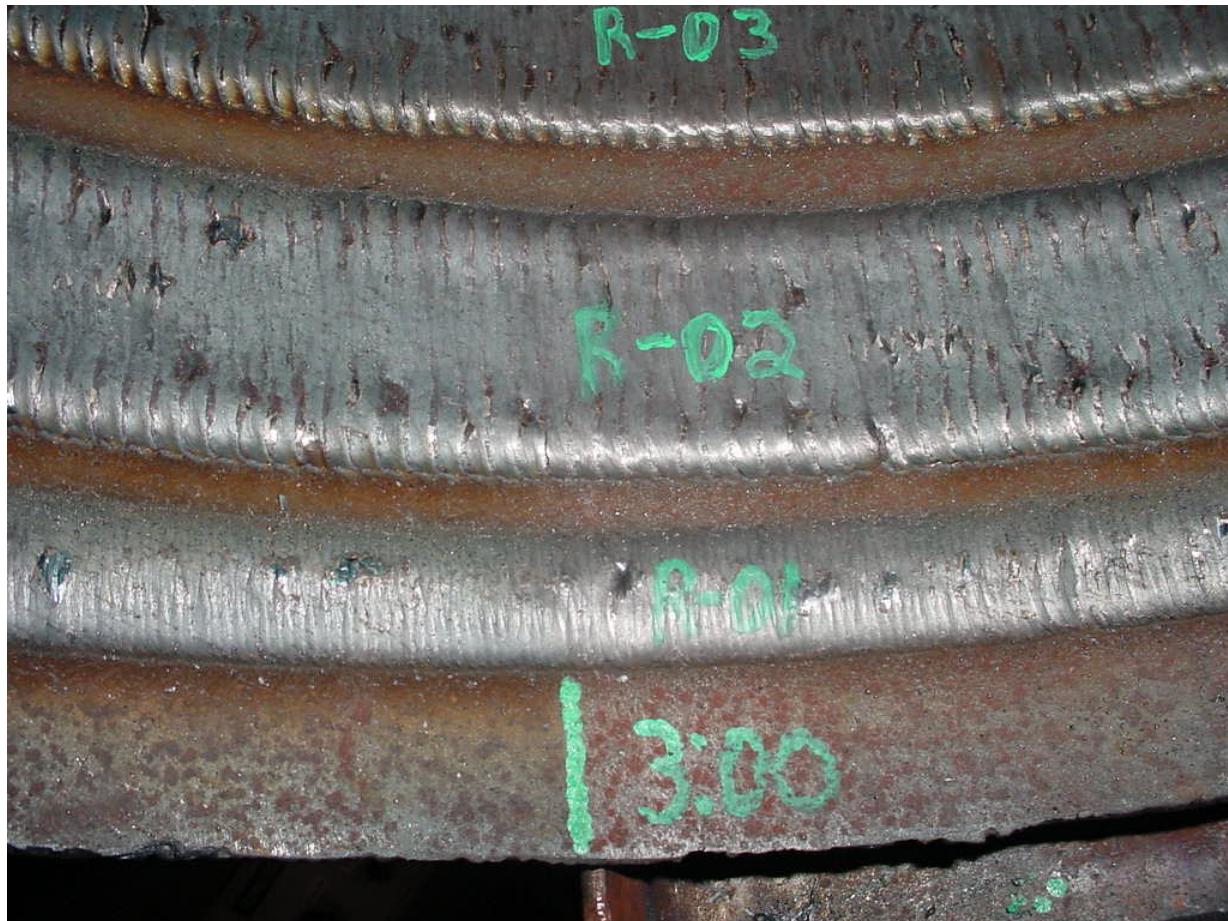
Figure 84 - Tests R-01 and R-02 at 3:00 Showing Steady-State Bead Shape

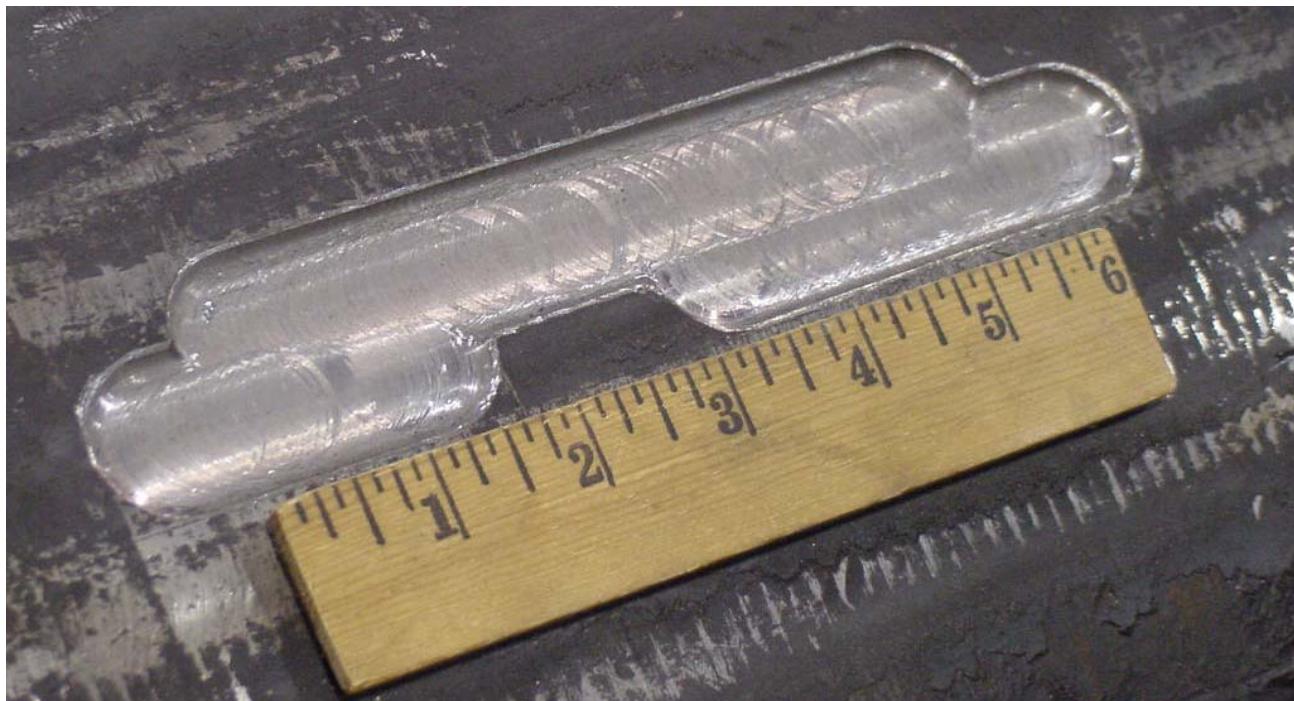
Figure 86 - Selected Configuration of Simulated Damage for 558.80 mm (22 in.) Diameter Pipe Sections

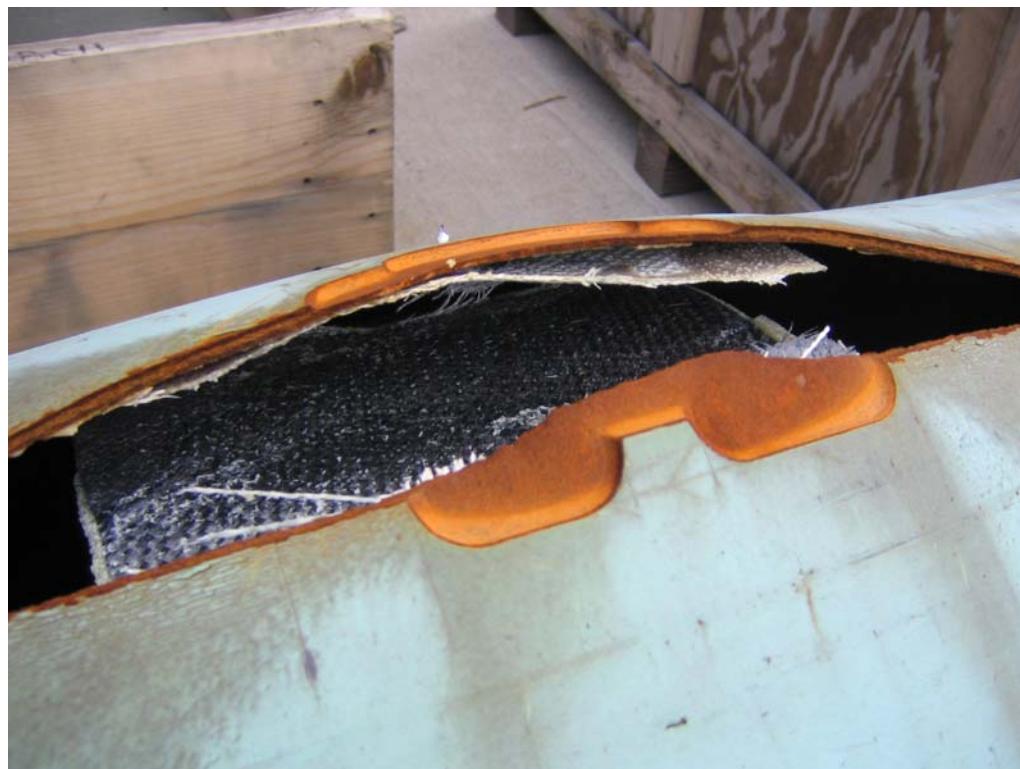
Figure 91 - Failure Initiation Site For Burst Tested Pipe With Carbon Fiber-Reinforced Liner Repair

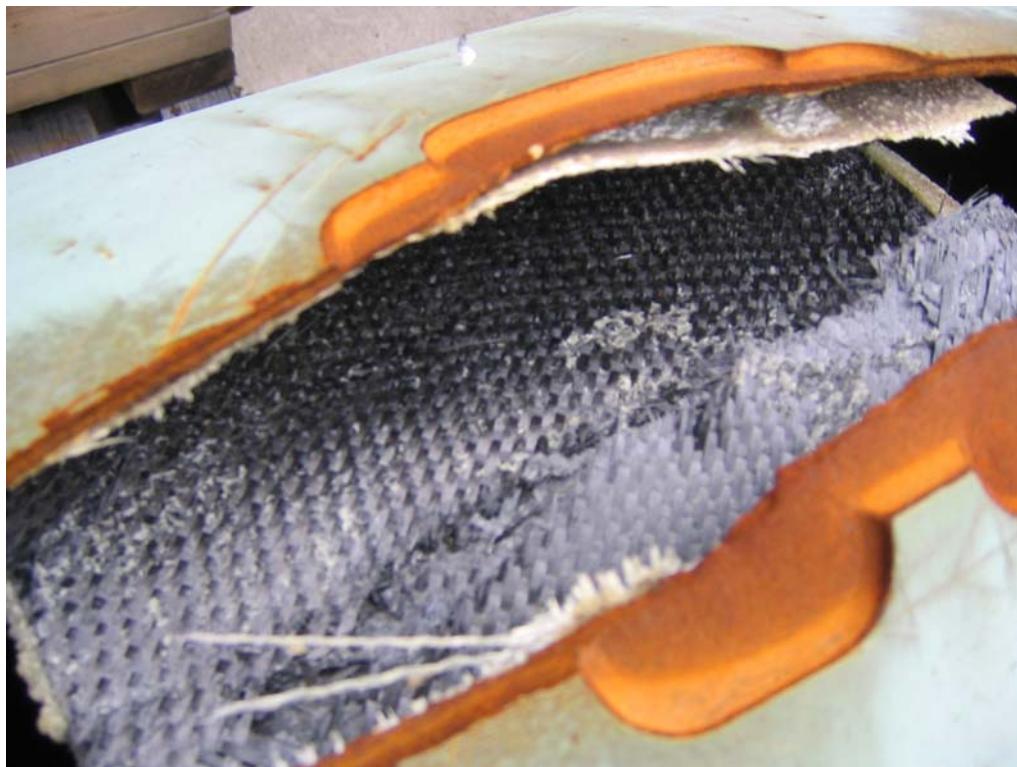
Figure 92 - Magnification of Carbon Fiber-Reinforced Patch After Burst Test

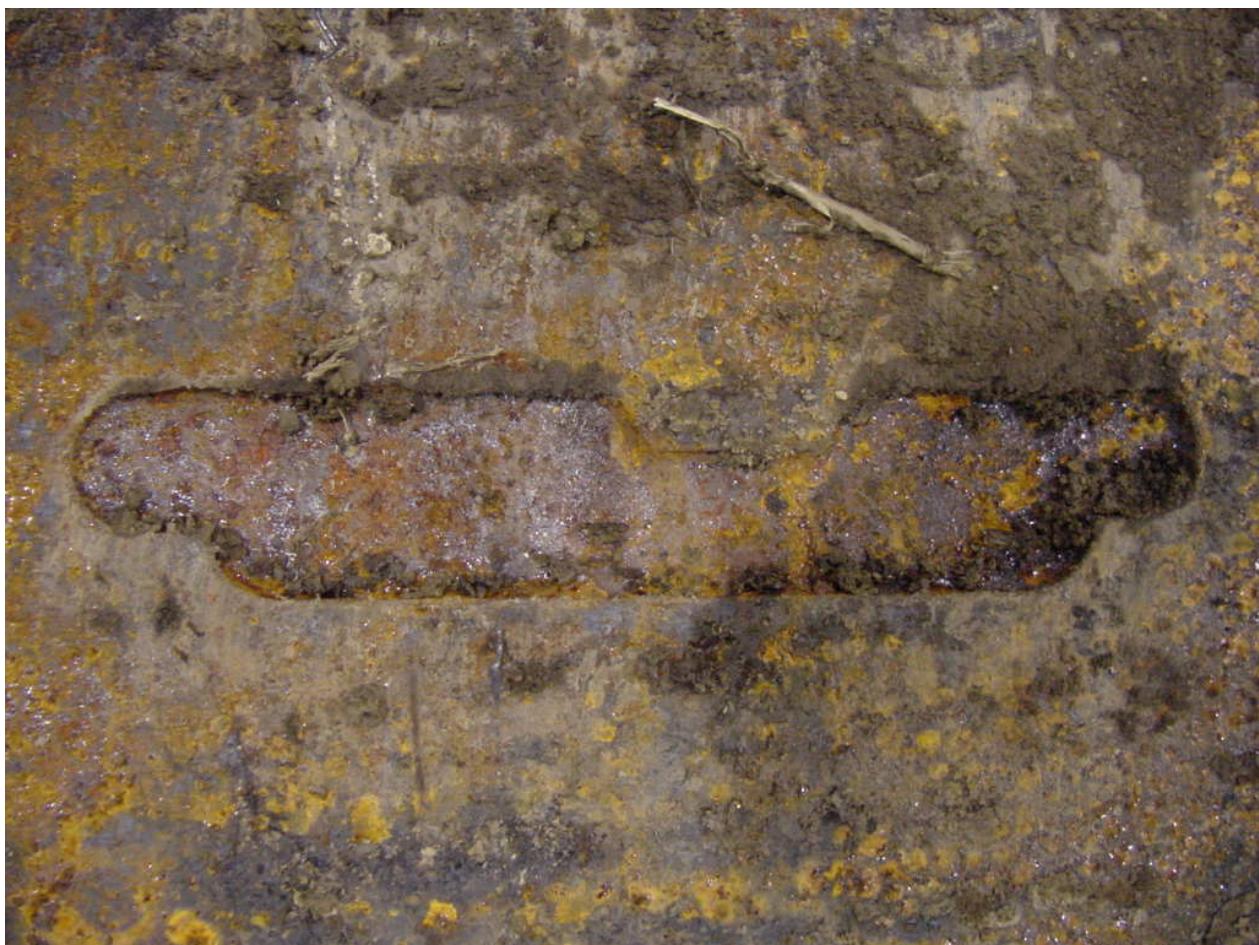
Figure 94 - Simulated Corrosion on Outside of Pipe After Internal Weld Deposition Repair
