EWI Project No. 46211GTH
Electronic File Name: 41633R42.pdf

Internal Repair of Pipelines 18-Month Technical Progress Report

Reporting Period:
September 30, 2003 through March 31, 2004

DOE Award No.: DE-FC26-02NT41633

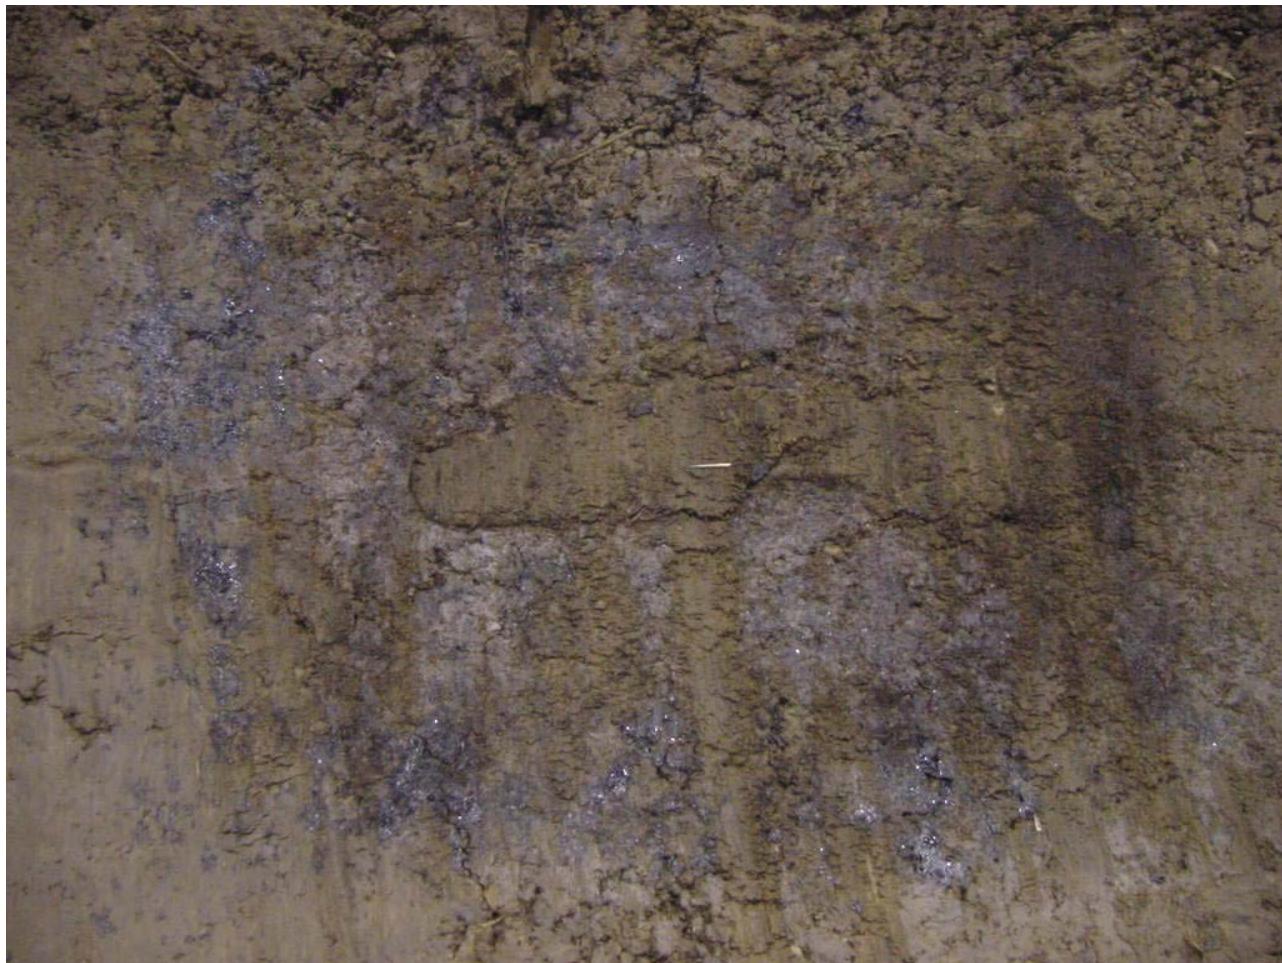
Figure 95 - Dirt That Was In Contact With Pipe During Internal Weld Deposition Repair

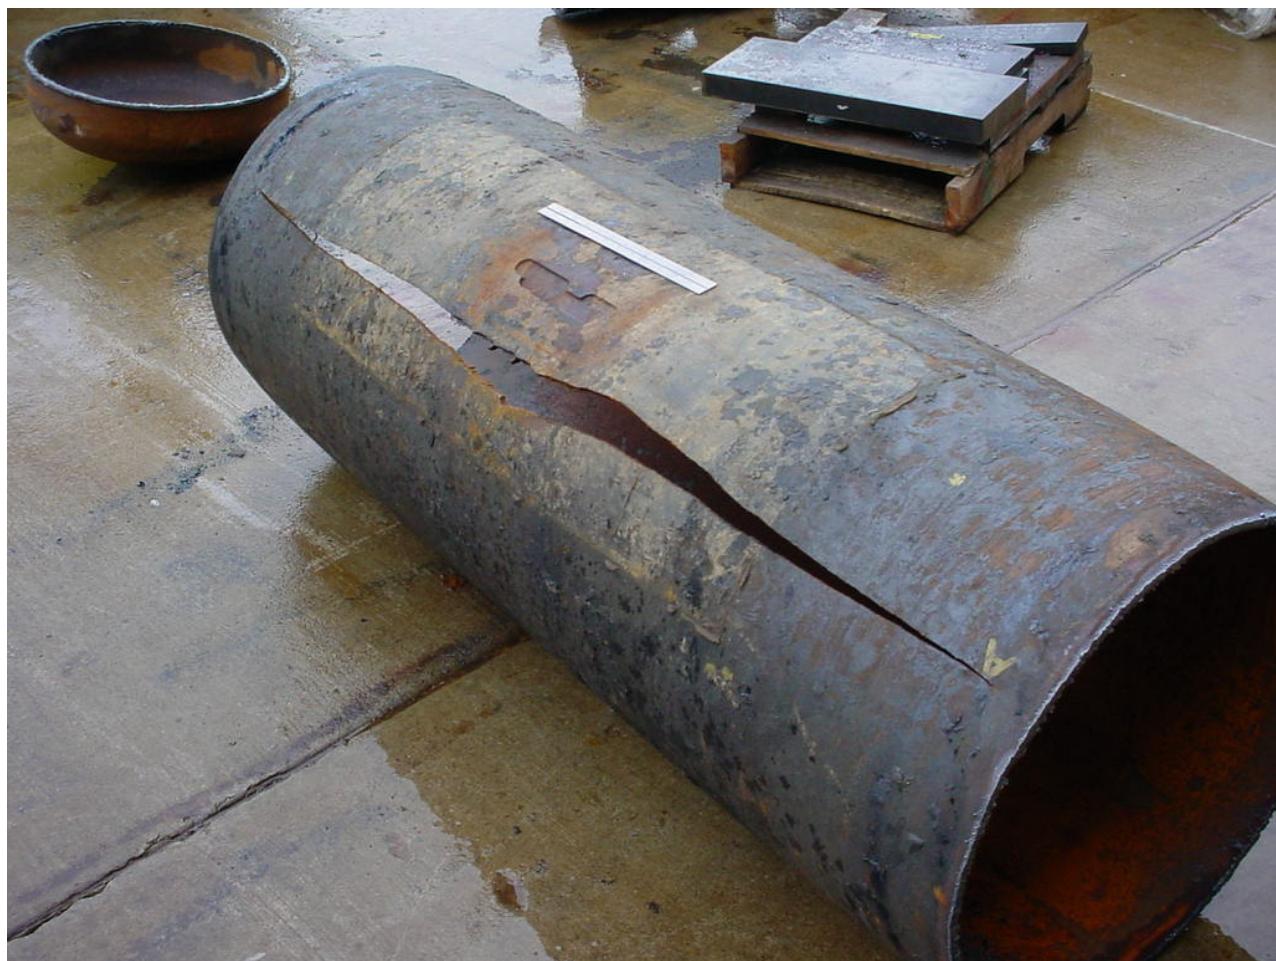
Figure 98 - Pipe Section with Internal Weld Deposition Repair After Hydrostatic Burst Test

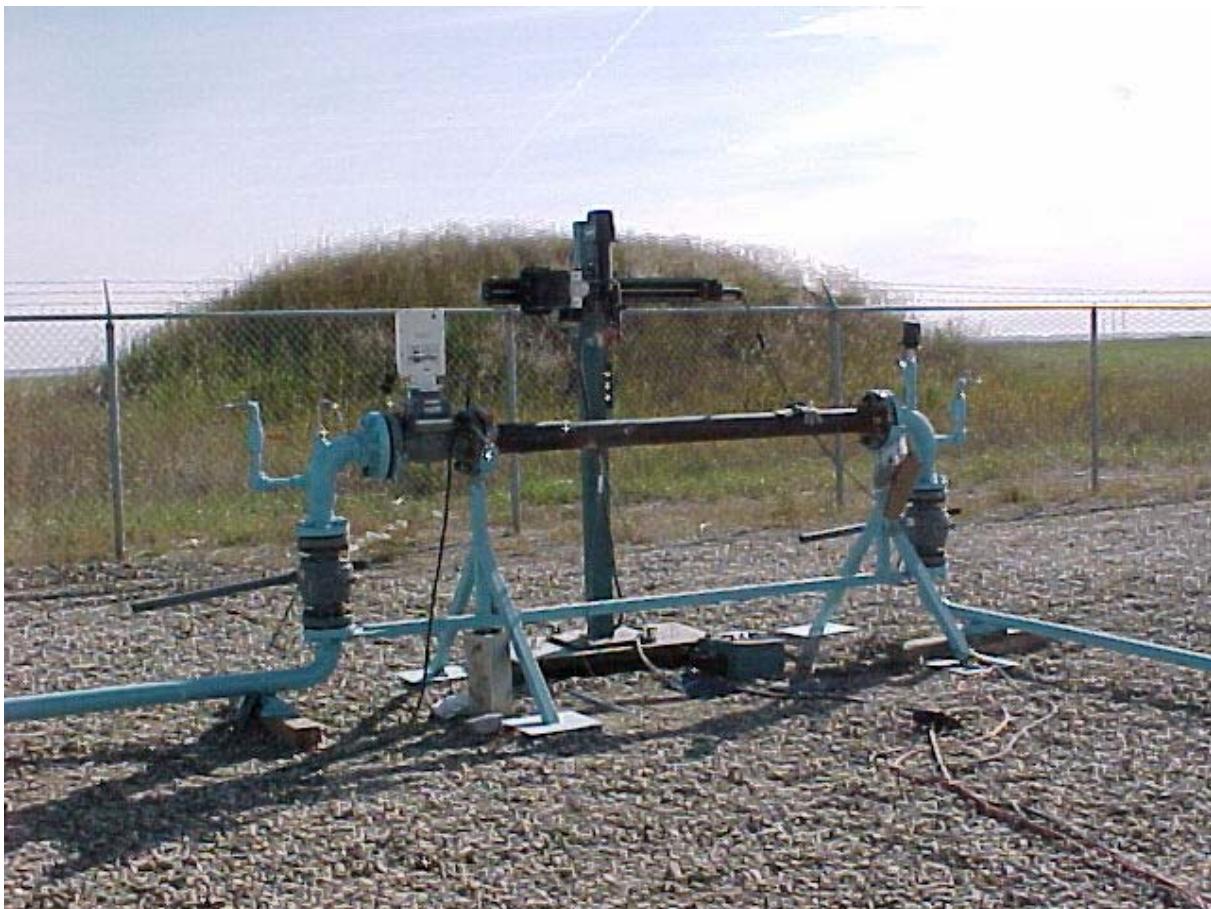
Figure 99 - Experimental Set-Up for Welding onto Thin-Wall Pipe containing Pressurized Methane Gas

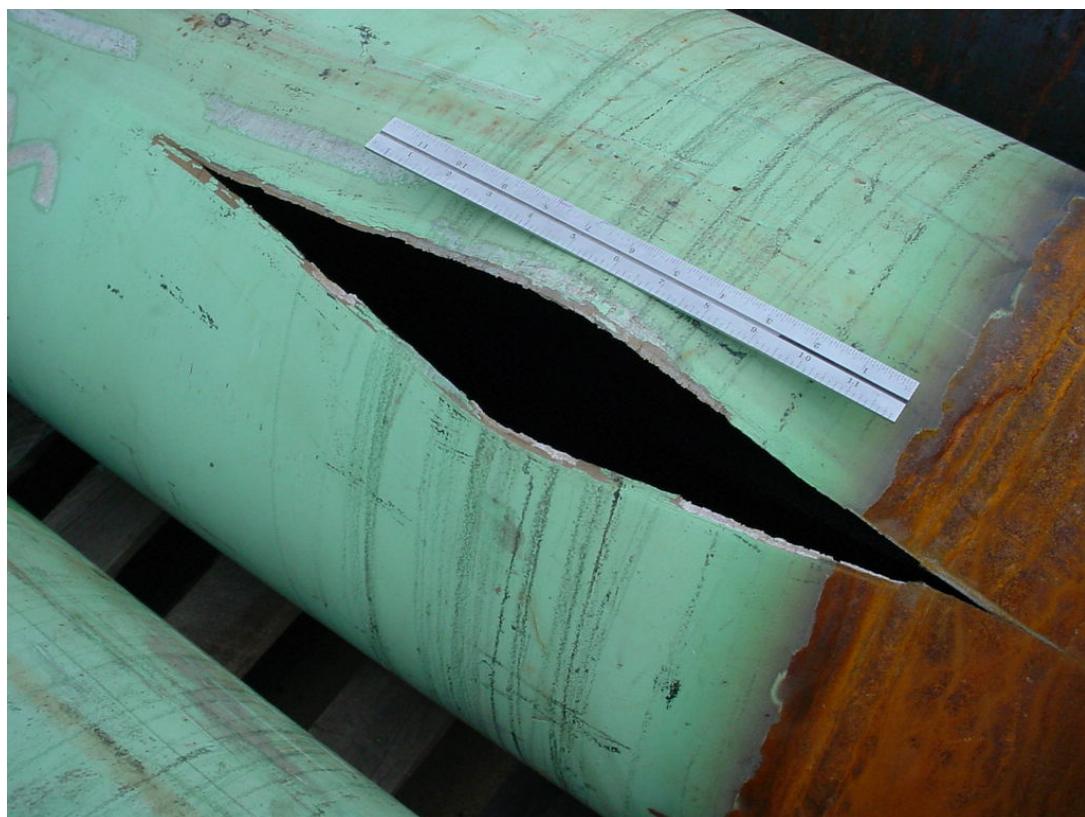
Figure 113 - Hydrostatic Burst Specimen of 508.0 mm (20 in.) in Virgin Pipe

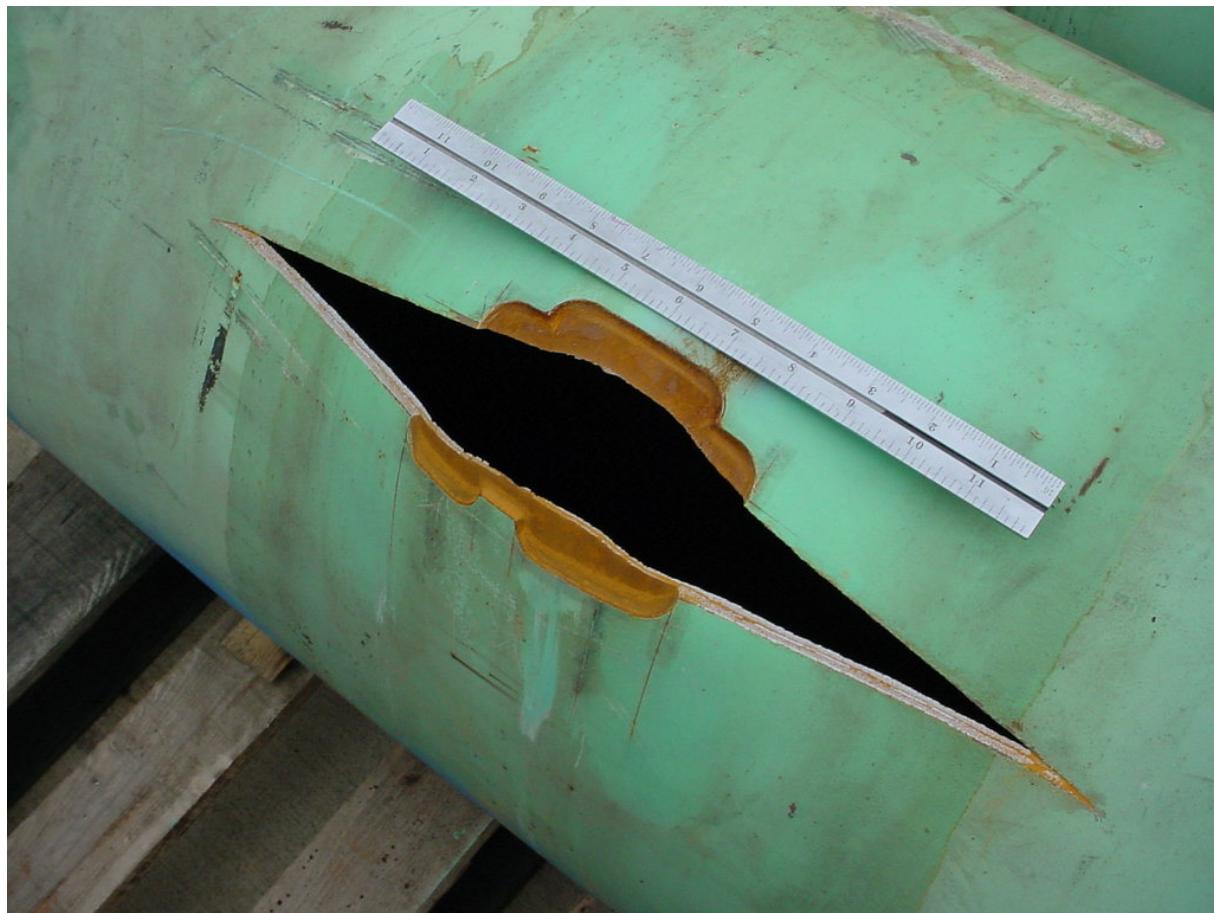
Figure 114 - Hydrostatic Burst Specimen of 508.0 mm (20 in.) with Un-Repaired Damage

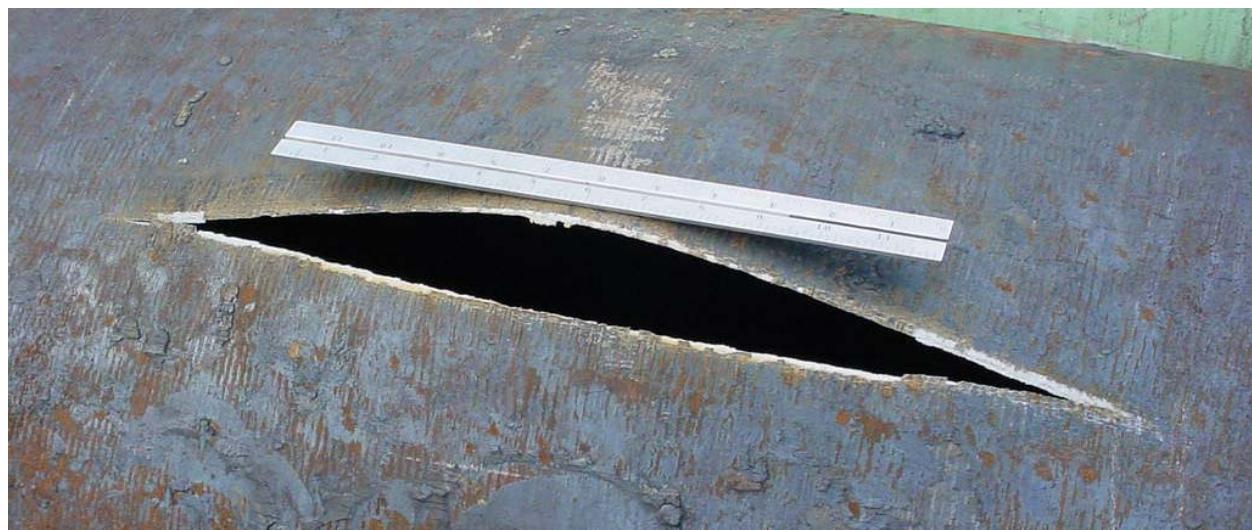
Figure 115 - Hydrostatic Burst Specimen of 558.8 mm (22 in.) Pipe in Virgin Pipe

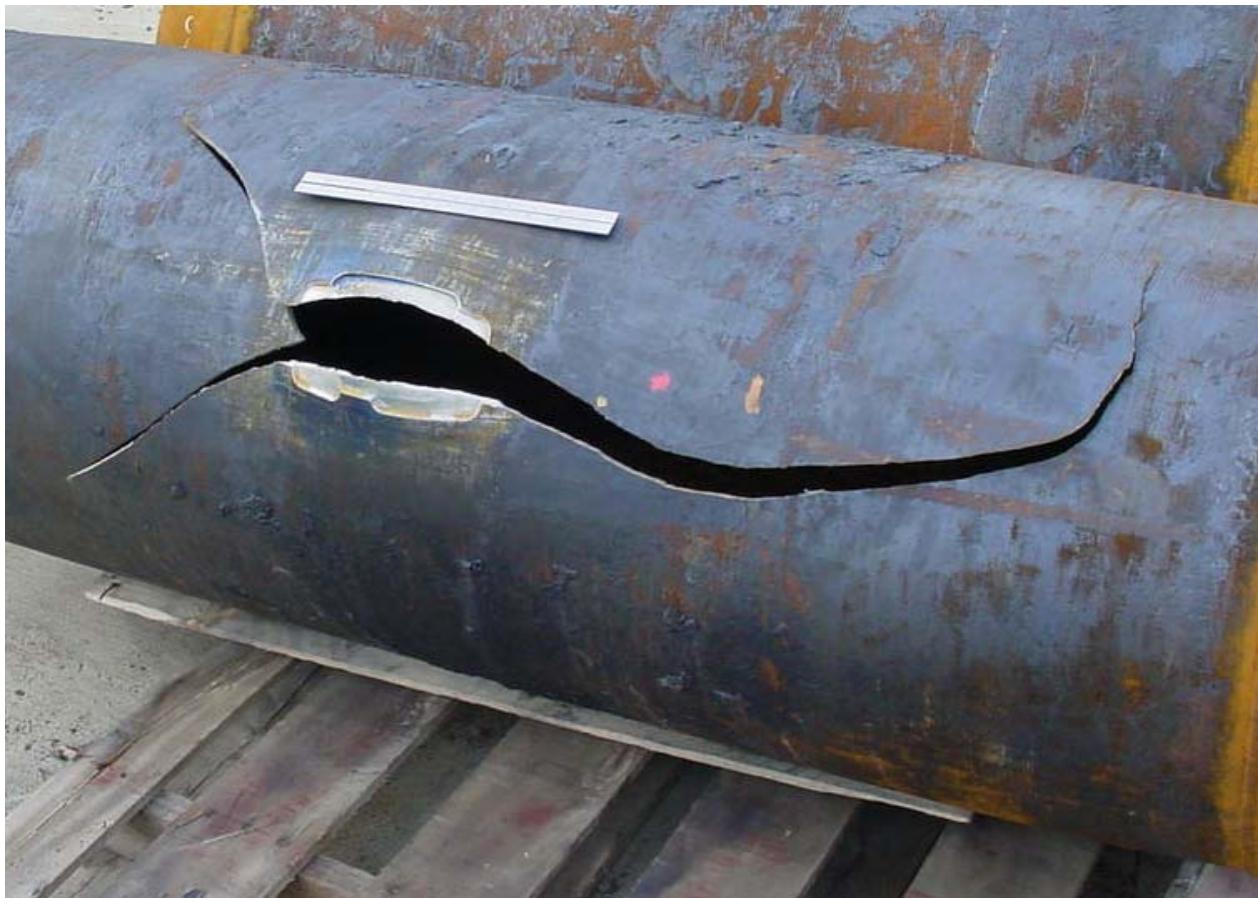
Figure 116 - Hydrostatic Burst Specimen of 558.8 mm (22 in.) With Un-Repaired Damage
