### **RESEARCH & DEVELOPMENT OF MATERIALS/PROCESSING METHODS FOR CONTINUOUS FIBER CERAMIC COMPOSITES**

#### **CFCC Phase 2 Final Report**

**Dow Corning Corporation**

**January, 2001**

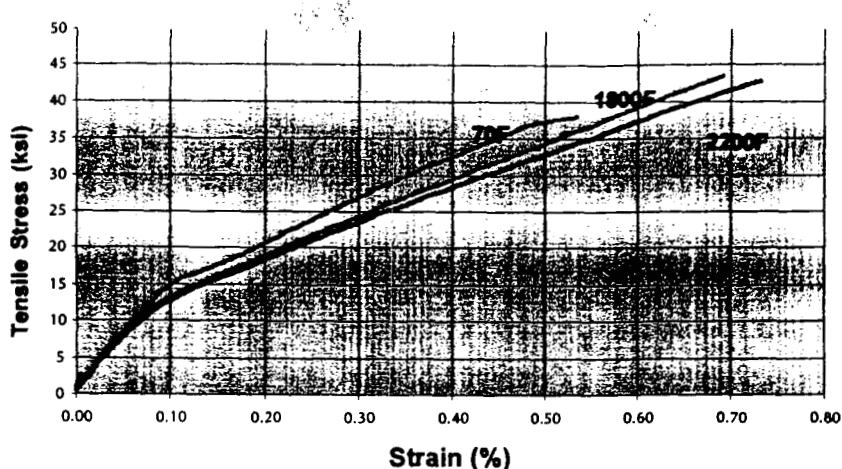
Figure 8. Stress/Strain Curves for S200 at Various Temperatures

Composites fabricated by the PIP process have been evaluated by a variety of potential end users. The data generated has shown that these ceramic composites demonstrate both high tensile strength and tough composite behavior at both room and elevated temperatures (Figure 8). Unlike most materials, the strength of these composites is higher at 1200°C than at room temperature.

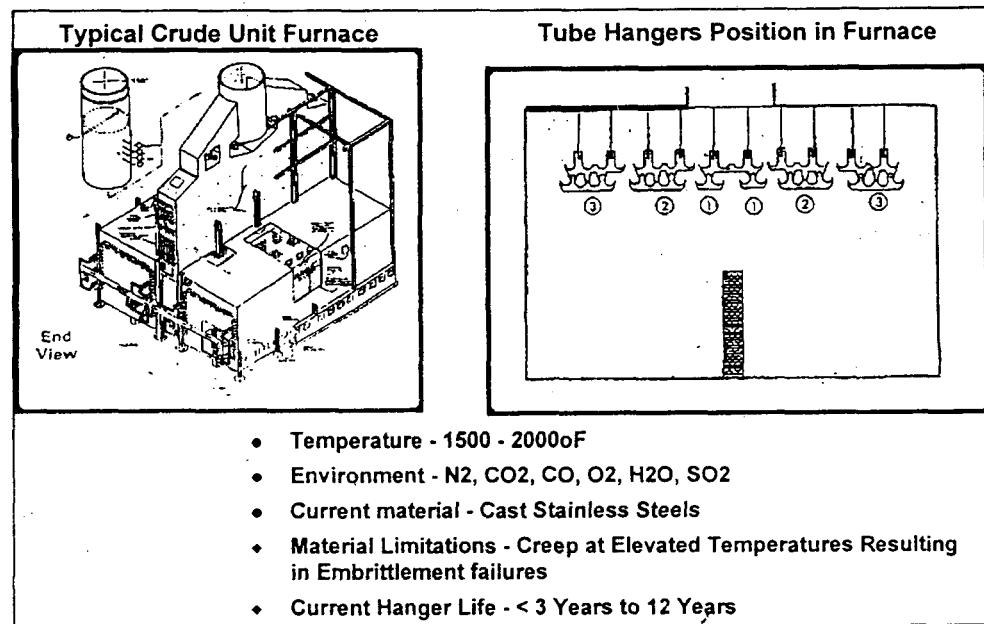
Figure 1-5. Configuration of Pipe Hangers in a Crude Unit Furnace

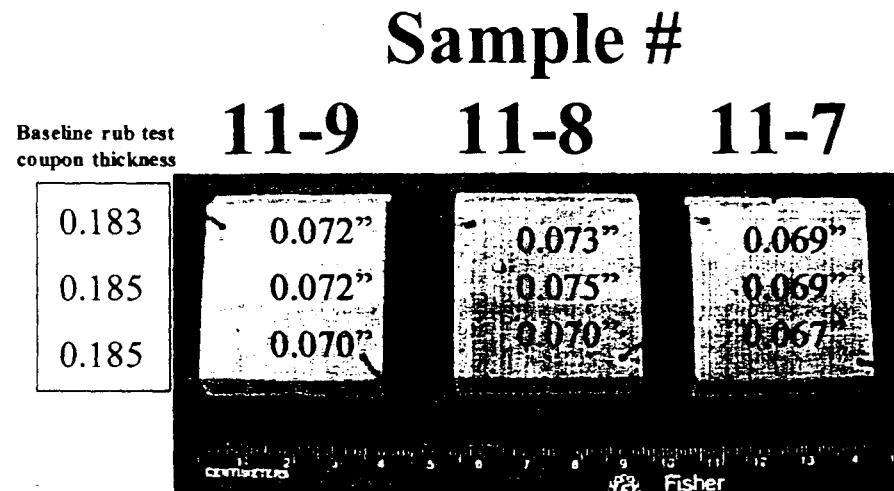
**Figure 3.1-8. Environmental Barrier Coating Thickness on the S200 Rub Test Coupons**

These coatings were the same as the environmental barrier coatings that were applied to S200 CFCC coupons for evaluation in combustion environments. It was considered that these coatings could provide both environmental protection and also be abradable. These barium strontium aluminosilicate (BSAS) coatings were applied to the top surface only by proprietary plasma spray process. The initial requested coating thickness for the rub test coupons was 0.030", but the actual coating thickness was 0.070". Figure 3.1-8 shows the coated rub test coupons and their corresponding coating thickness.

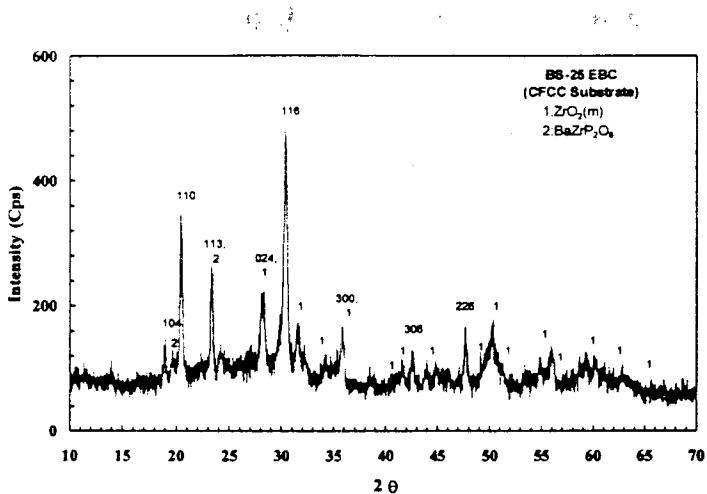
Figure 3.1-14. XRD Trace of Plasma Sprayed BS-25 Coating on CFCC Substrate

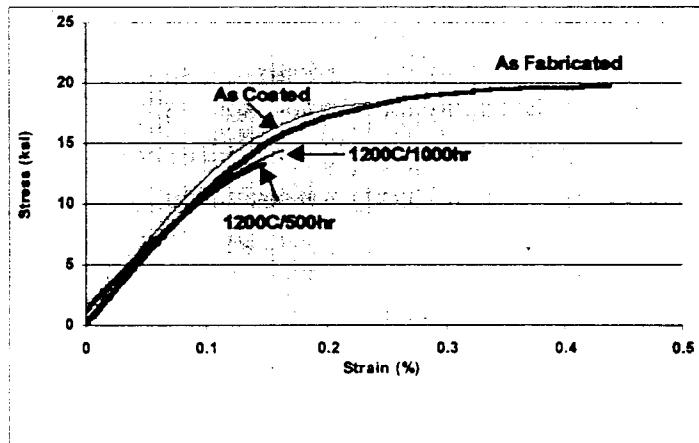
**Figure 3.1-21. Comparison of Tensile Properties of EBC/ S200 CFCC Before and After Oxidation Exposure at 1200°C**

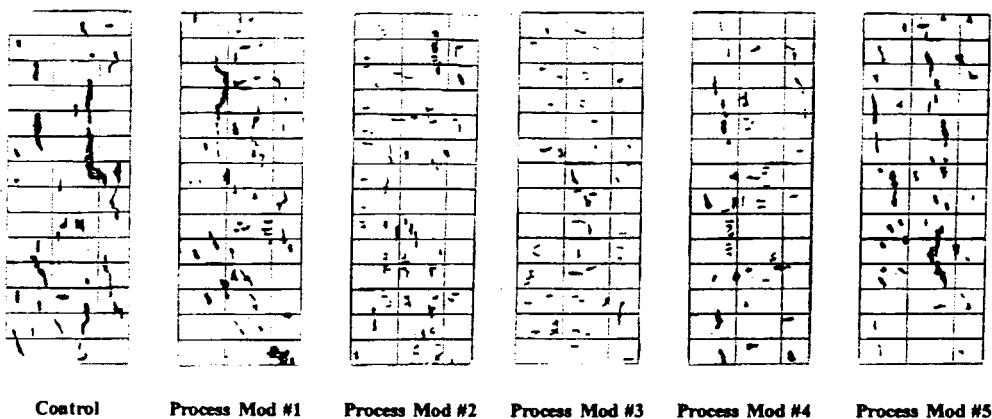
**Figure 3.2-2. Semi-Quantitative Analysis of Microstructures of Samples from the Debulk/Cure Optimization Study**

each panel after 5 PIP cycles was examined. The semi-quantitative analysis of the microstructures is shown in **Figure 3.2-2**. These figures were created by examining 42 microscope frames at 100x for each sample and drawing the locations of the large voids. They indicate that the various proprietary processing steps that have been changed have a real effect on reducing the presence of large voids.

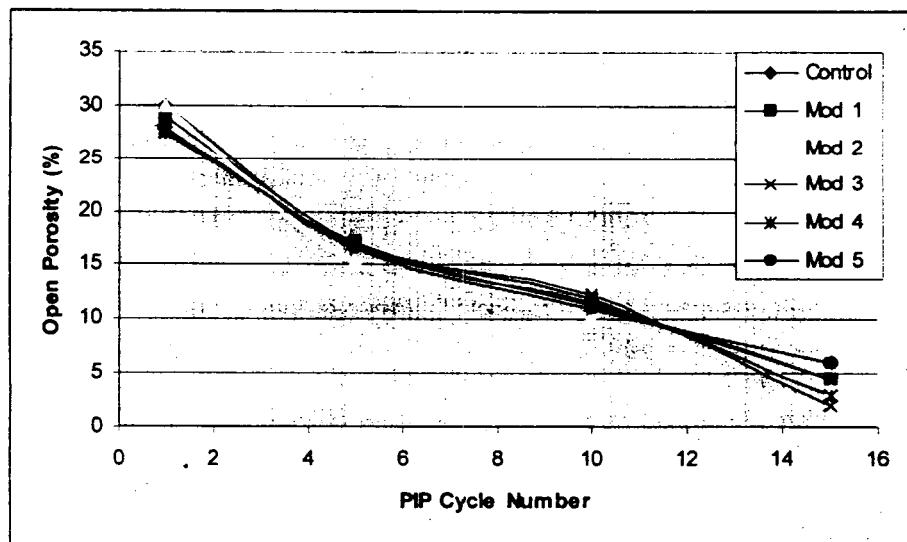
**Figure 3.2-3. Open Porosity vs. PIP Cycle for Samples from the Processing Modification Study**

Open porosity measurements indicate typical behavior for all of the variants (**Figure 3.2-3**). The as-made mechanical properties are shown in **Table 3.2-2**. Other evaluations of coupons cut from these panels include 1000 hour oxidation of tensile bars at 800°C, evaluation of shear strength after fatigue and after fatigue/thermal cycling, and the effect of a water soak treatment on shear strength.

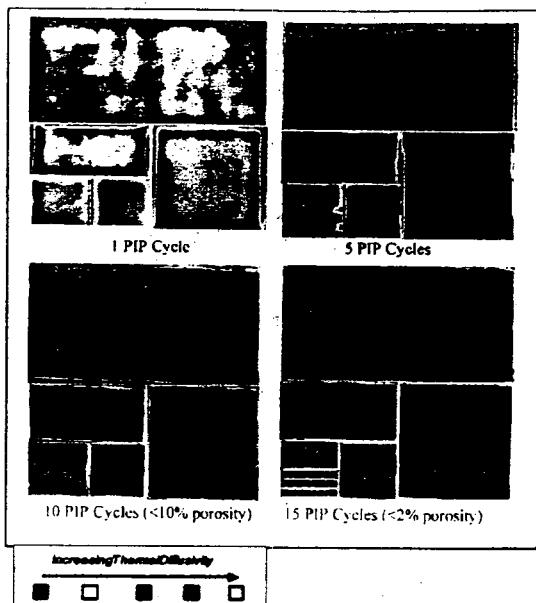
Figure 3.2-9. Thermal Diffusivity Images of the 16-Ply Samples as a Function of PIP Cycle

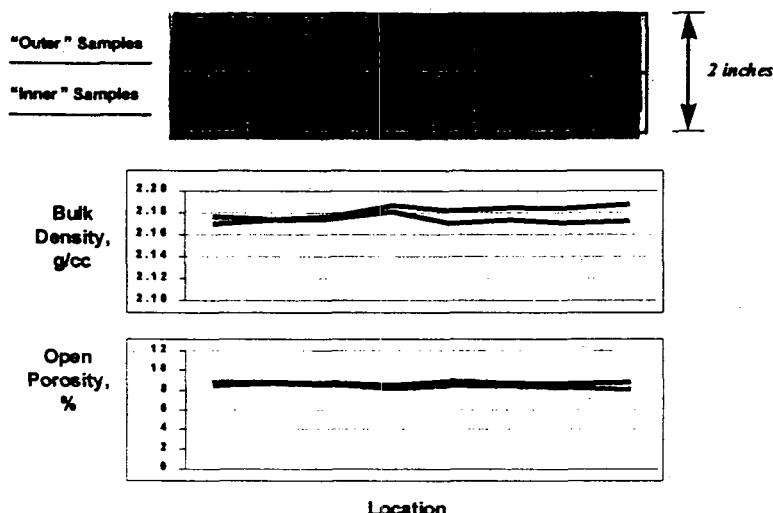
Figure 3.2-12. Bulk Density and Open Porosity Maps for a Portion of the 16-Ply Panel

both density and porosity. The variability in both properties is very low, only about 0.01 g/cc for the density and less than 0.5% for the porosity. The combination of the NDE and physical property results allows the conclusion that the PIP process is capable of producing CFCCs with a uniform macrostructure for 8" x 8" panels with 16 plies.

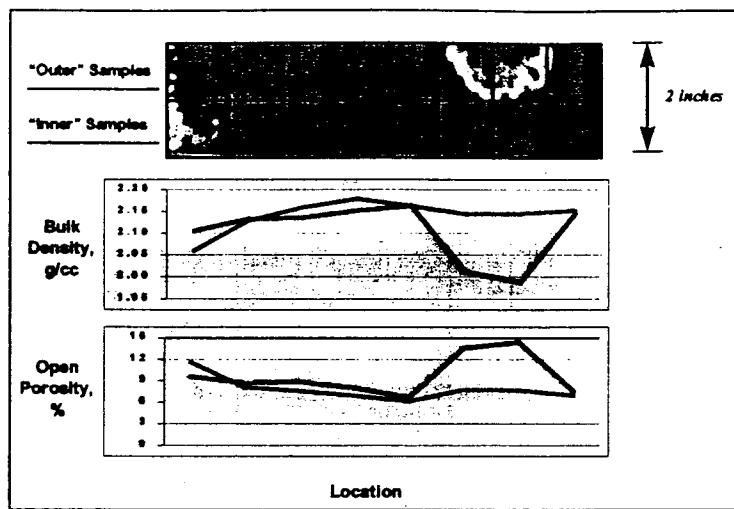
Figure 3.2-13. Bulk Density and Open Porosity Maps for a Portion of the 8-Ply Panel

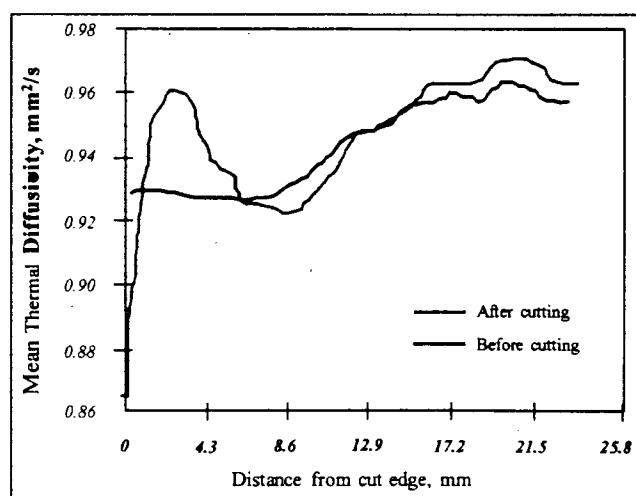
Figure 3.2-15. Thermal Diffusivity Profiles for the Top Half of the 4" x 8" Piece of the 16-Ply Panel Comparing As-Processed and Freshly-Cut Edges

Another phenomenon that was investigated was the possible existence of "edge-effects" which are an artifact of the NDE technique. This phenomenon could be caused by wrap-around of the thermal or acoustic signal that would artificially increase the strength of the signal at the sample edges. Stronger signals were especially apparent at the edges of the samples after the first pyrolysis cycle. In order to study this potential problem, the remaining 2" x 8" piece of the 16-ply panel was re-imaged using the thermal diffusivity method. This panel has three "as-processed" edges, and one freshly-cut edge. If there is not an edge-effect, the image should show the cut edge to be the same color as the interior of the panel before this sample was cut. The results are shown in **Figure 3.2-15**.

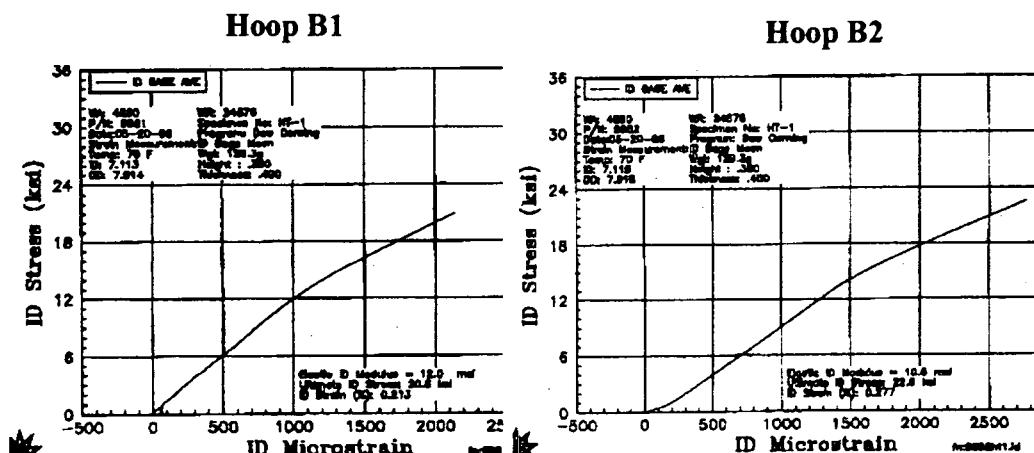
Figure 3.2-27. Hoop Stress/Strain Curves for Thick S200 Rings

was obtained with ultimate strains exceeding 0.2%. There appears to be a microcrack yield point at about 12 - 15 ksi. Figure 3.2-28 shows the fracture surface of shows a picture of the post-tested ring B1, indicating that there was one primary fracture in this case that appears to transgress across the thickness of the ring in a tough-looking manner. Also, the fracture surfaces can be seen to have opened up the ring, indicating some residual stress. It is also worth noting that this fracture crack does not follow the involute ply stacking sequence. Closer examination of the rest of the ring, however, shows that there are a number of delaminations that have occurred that follows this stacking sequence (Figure 3.2-28). The fact that the primary fracture occurred at one location suggests that the delaminations may have occurred after the initial failure of the ring. This may be as a result of the ring opening after failure causing high interlaminar stresses and delamination, or as a result of energy release on failure. Figure 3.2-29 shows the failure of the second ring tested, B2. In this case there was a primary failure similar to B1, but also a secondary failure that occurred that was interlaminar in nature and follows the involute ply stacking sequence. There was no other evidence of delaminations in this ring.

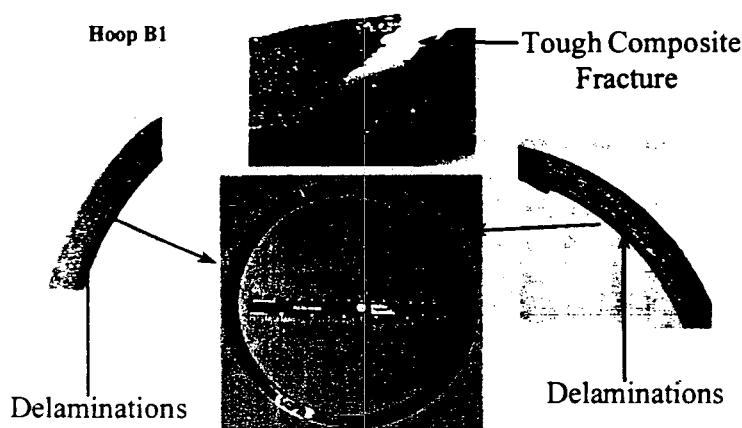
Figure 3.2-28. Fracture Surface of S200 Ring B1

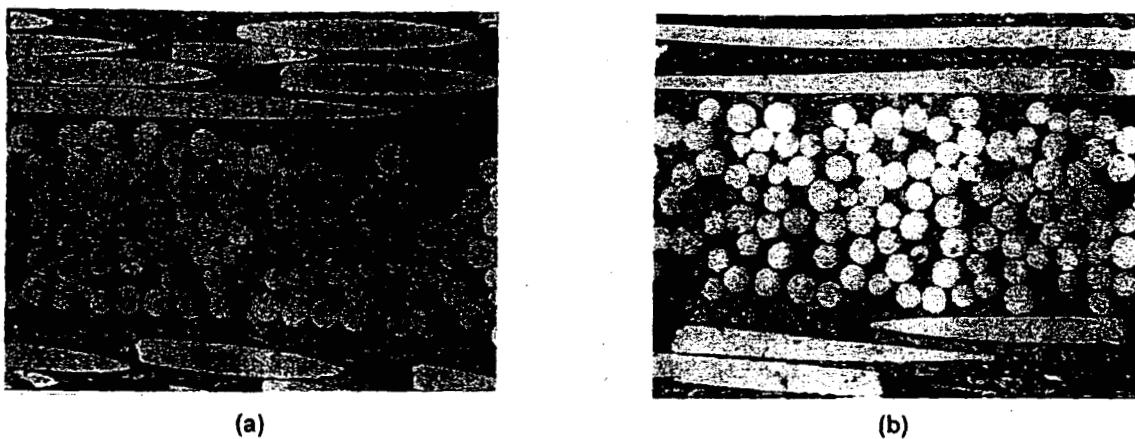
**Figure 3.2-31. Microstructures of (a) Resin B -Matrix Composite and (b) Resin E -Matrix Composite (400x)**

Sylramic S100 composites were fabricated with Resin B and resin E for evaluation of oxidation behavior. The microstructure of the as-fabricated CFCCs are shown in **Figure 3.2-31**. The oxidation behavior of these two composites at 550°F and 850°F are given in **Table 3.2-14**. Clearly the resin E matrix results in much less weight loss and strength degradation than the resin B matrix.

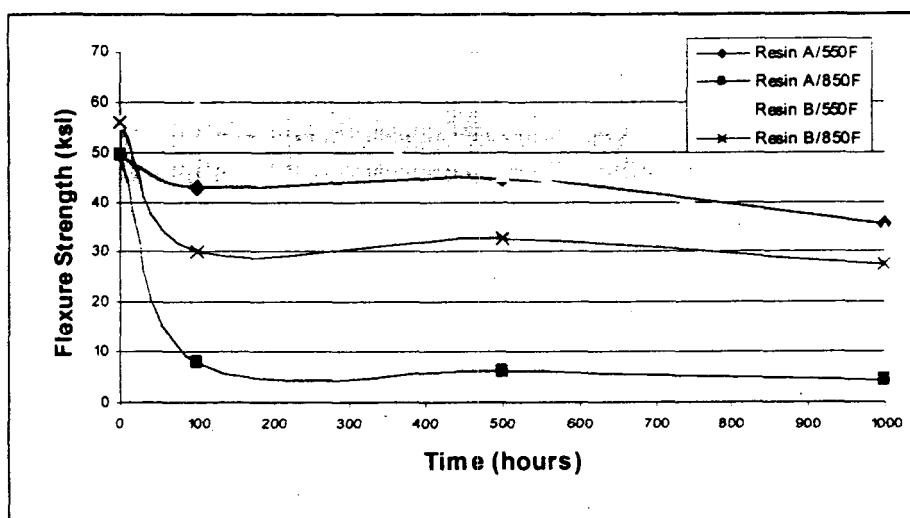
**Figure 3.2-32. Flexure Strength of CFCC Fabricated with Matrix Resin A and Resin B After Oxidation**

The effects of oxidation is shown in **Figure 3.2-32**. It is clear that the Resin B matrix composite is subject to significant strength deterioration at 850°F. After only 100 hours of oxidation the strength has dropped to about 10% of its original value. The Resin E matrix composite, on the other hand, exhibits a decrease in strength to about 50% of its original value after 100 hours of oxidation, but the strength appears to stabilize after the initial drop and remains at nearly the same value even after 1000 hours of oxidation. At the lower 550°F oxidation temperature, both materials have retained about 65-70% of their initial strengths after 1000 hours of exposure. It appears that the strength may continue to slowly degrade at longer exposure times, likely in parallel with the kinetics of oxidation of the matrix and interface. Photographs of the unexposed samples and the samples oxidized at 850°F for 1000 hours, shown in **Figure 3.2-33**, clearly show the extent of oxidation of the Resin B composite (**Figure 3.2-33 a**) for which the matrix has changed from black to white. The matrix of the Resin E composite, on the other hand, has not changed significantly in color (**Figure 3.2-33 b**).

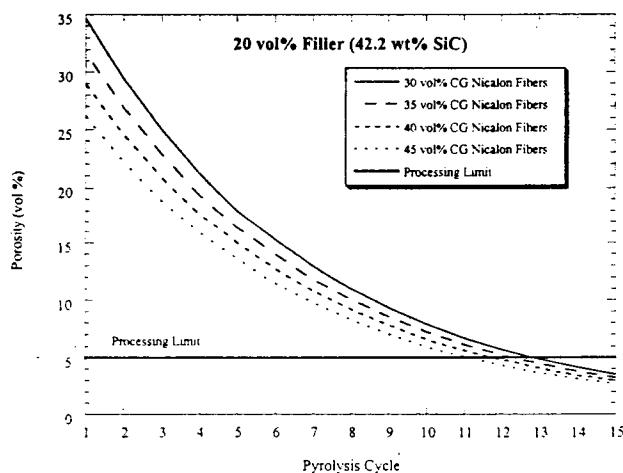
**Figure 3.2-36. Composite Porosity vs Pyrolysis Cycles for Different Fiber Volume Fractions**

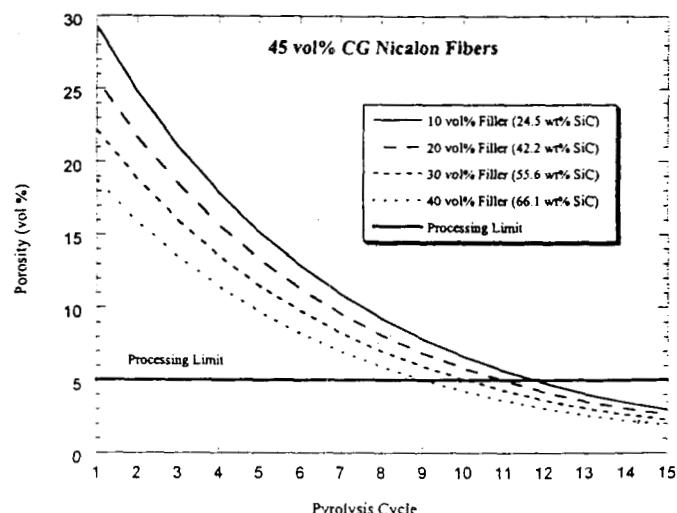
Figure 3.2-37. Composite Porosity vs Pyrolysis Cycle for Different Filler Levels

Obviously different fillers with different surface characteristics may alter this value. For a system with 45 vol% fibers and 25 vol% filler the minimum number of reimpregnation cycles required to achieve less than 5 vol% porosity is 11 pyrolysis cycles which corresponds to 10 reimpregnation cycles. In practice typically 14 reimpregnation cycles are required due to inefficiencies in the infiltration procedure.

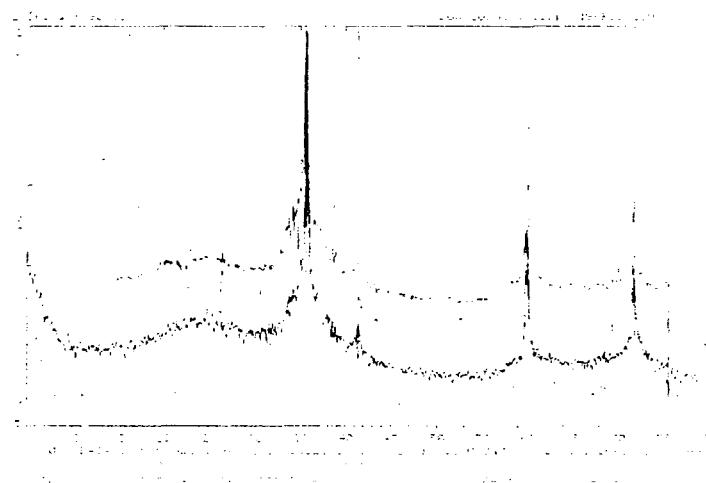
**Figure 3.2-58. X-Ray Diffraction Patterns for S300 CFCC Processed to Increasing Temperatures**

Densification of the CFCCs proceeded to reach a porosity of less than 5 % by using the PIP method and pyrolyzing to 1200°C followed by the selected temperature 1500°C, 1600°C or 1700°C. As many as 26 pyrolysis cycles were required to finish the processing.

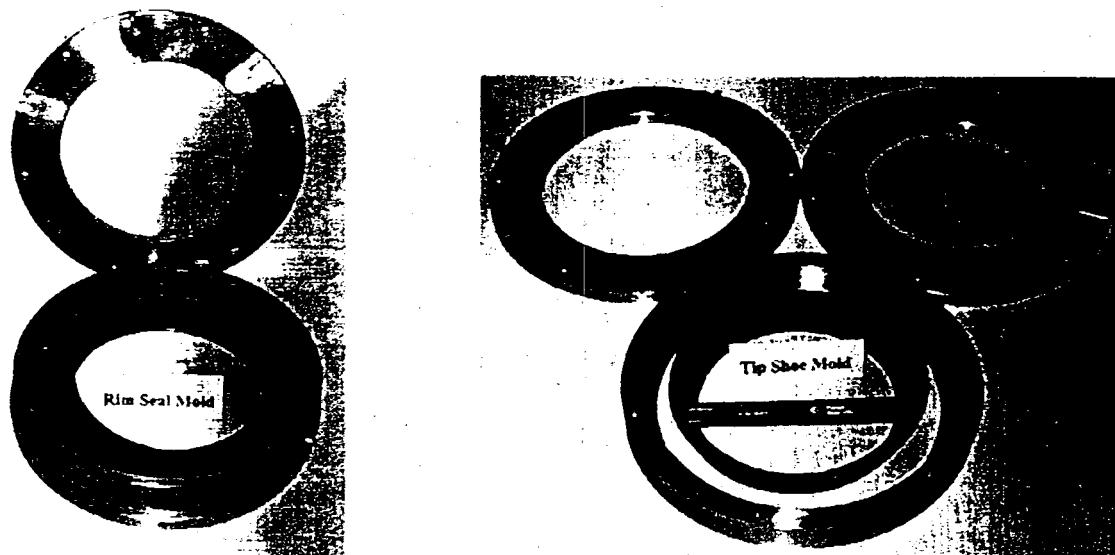
**Figure 3.3-15. Simple Tooling Concept Identified to Prototype Turbine Components**

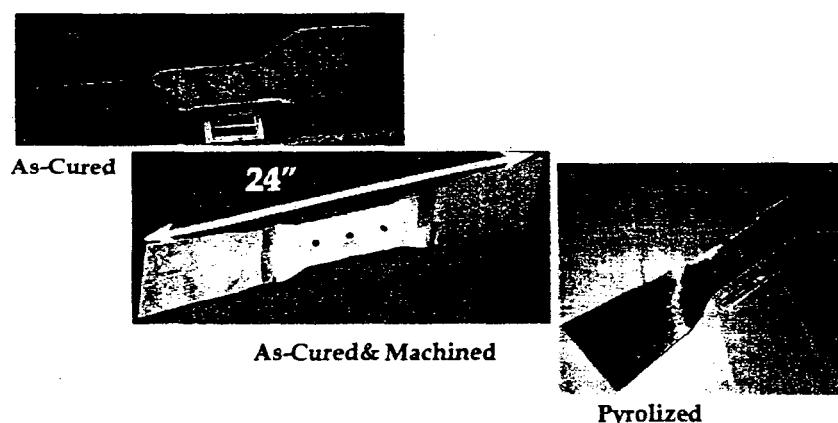
Figure 3.3-25. Machined Deliverable S200 CFCC Fan Blade

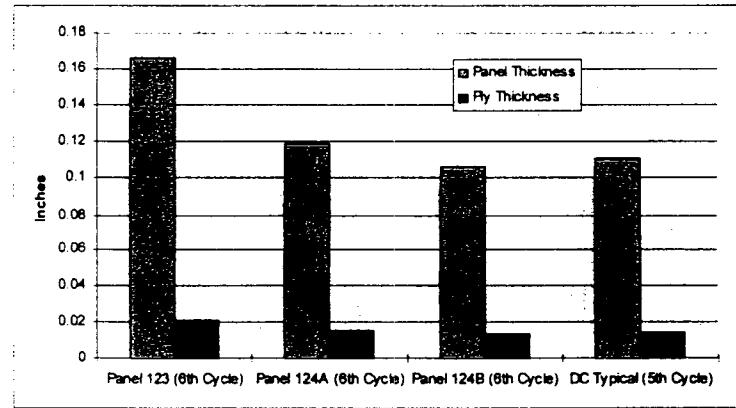
Figure 3.3-30. Panel and Ply Thickness for C-CAT Produced Panels at 6<sup>th</sup> Cycle

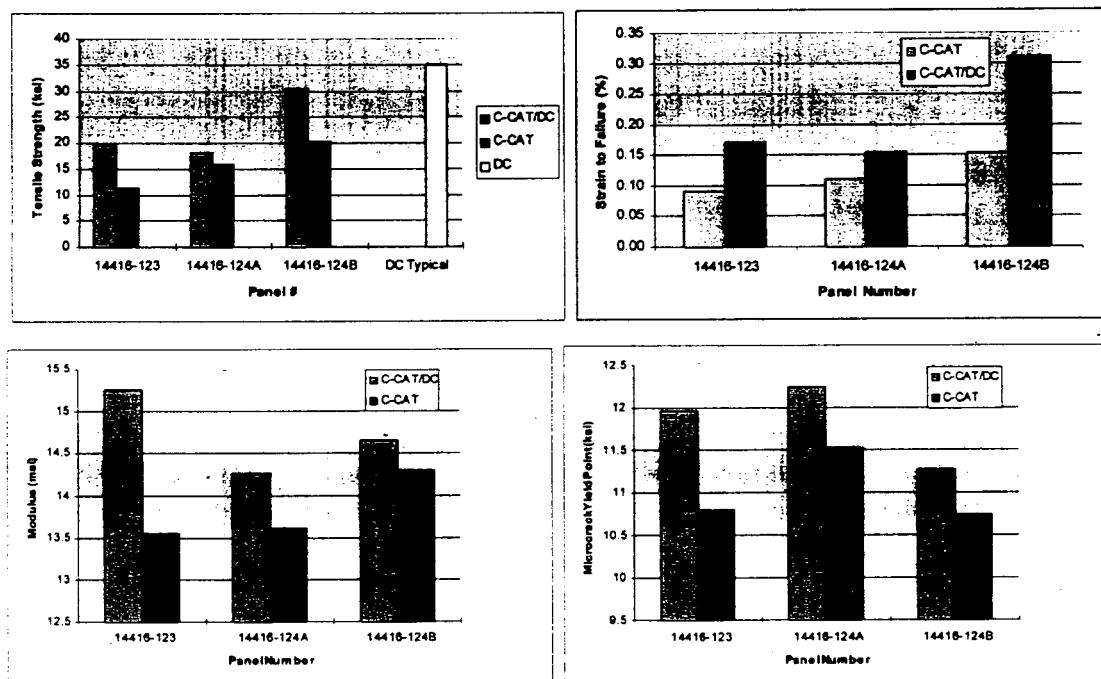
**Figure 3.3-31. Comparison of Mechanical Properties of S200 CFCC Processed at C-CAT and Dow Corning**

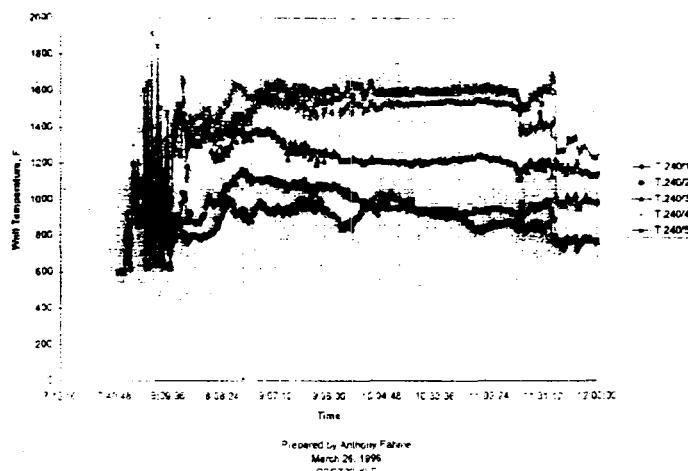
**Figure 3.3-34. Thermal Profile for the S200 Combustor Liner During the 10-Hour Rig Test**

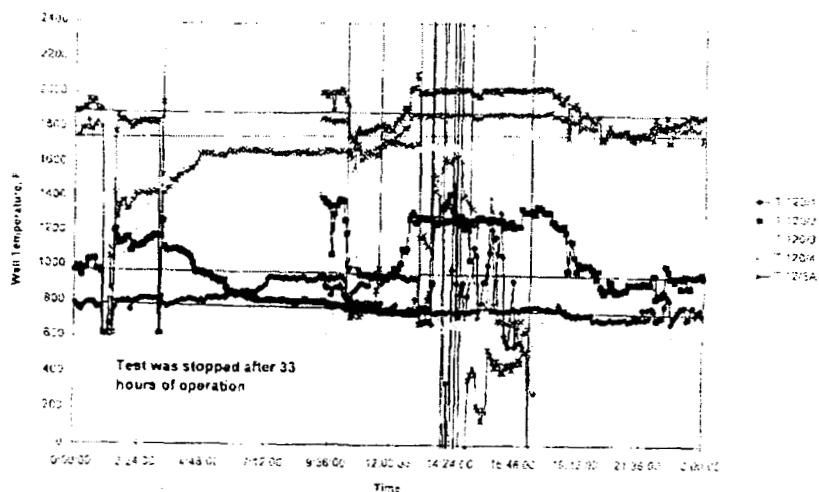
**Figure 3.3-35. Thermal Profile for the S200 Sub-Scale Combustor Liner During the First 33 Hours of Rig Testing**

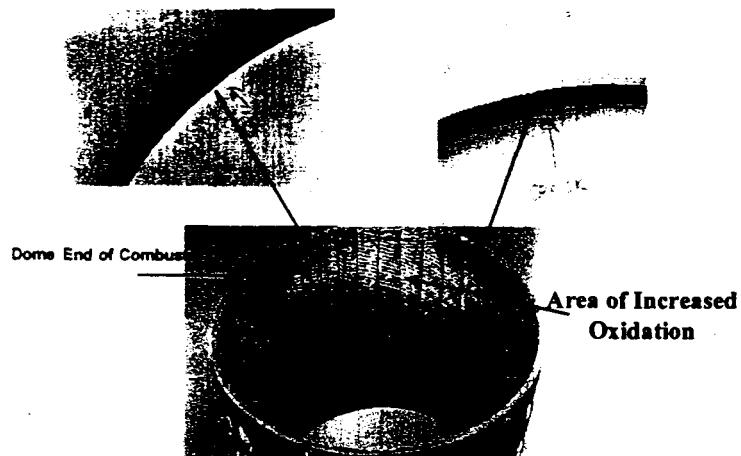
Figure 3.3-38. Location of Cracks Found on Machining of the Post 100-Hour Rig Test

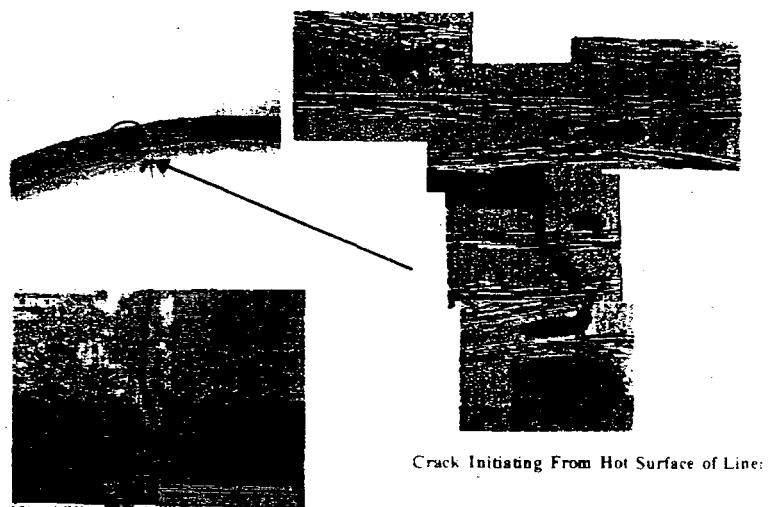
Figure 3.3-39. Microstructural Examination of One of the Cracks in the Liner

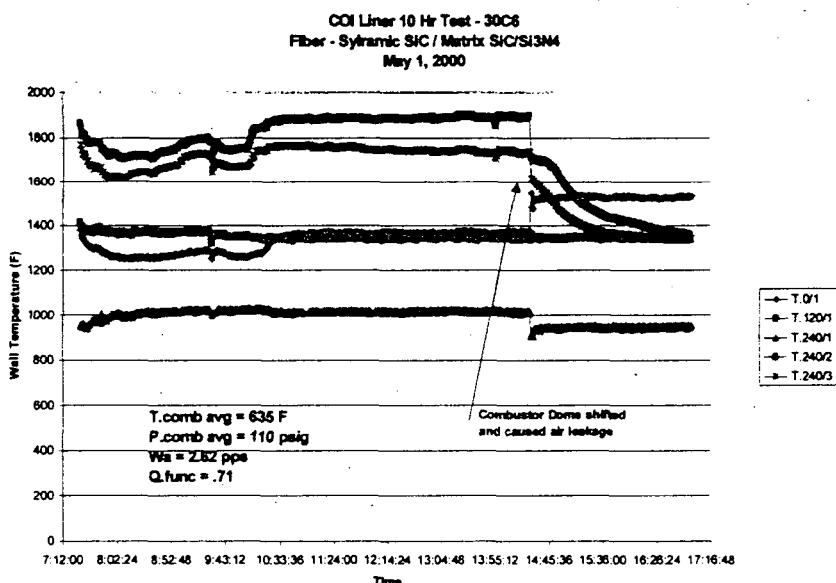
**Figure 3.3-40. Temperature Profiles for the S300 Sub-Scale Liner Measured During the 10-Hour Rig Test**

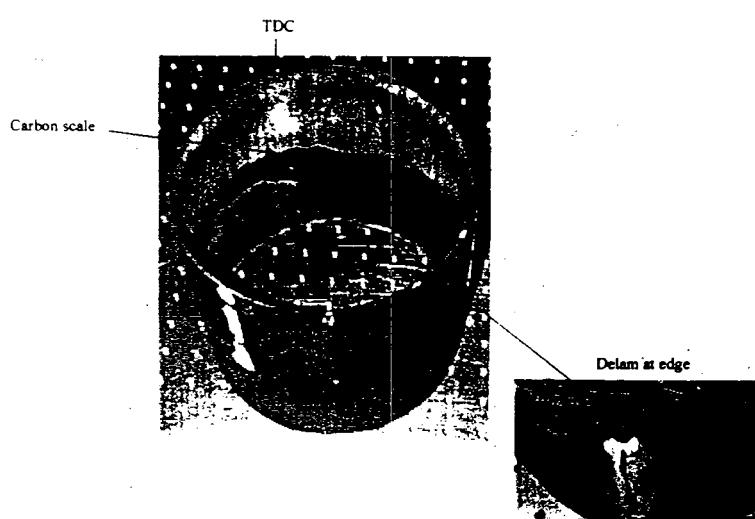
Figure 3.3-43. S300 CFCC Liner After 10-Hour Rig Test Showing Delaminated Area

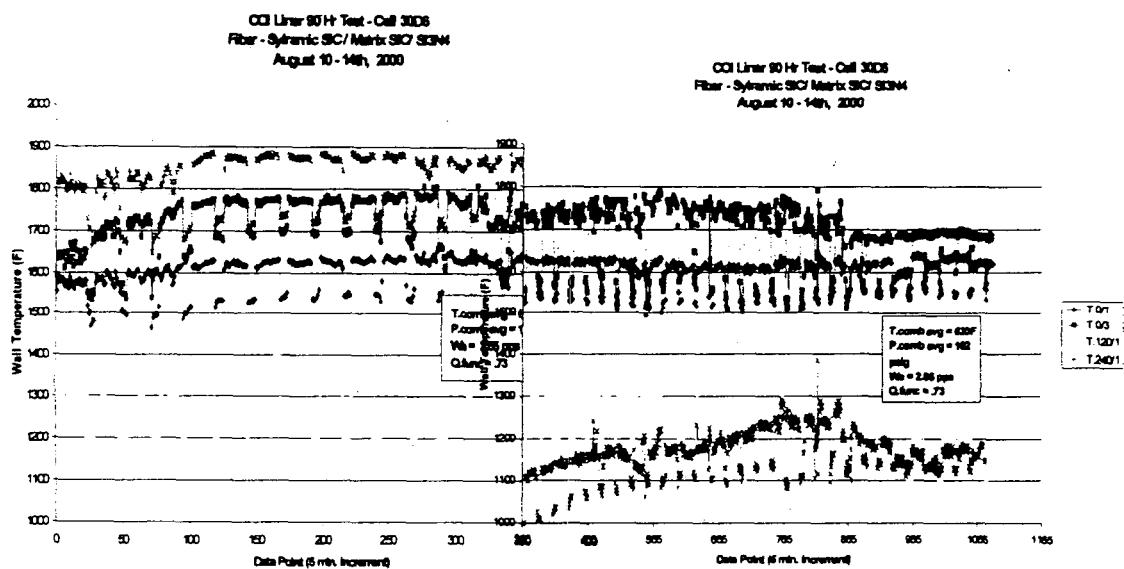
Figure 3.3-45. Temperature as a Function of Time for S300 Liner Sub-Scale Rig Test

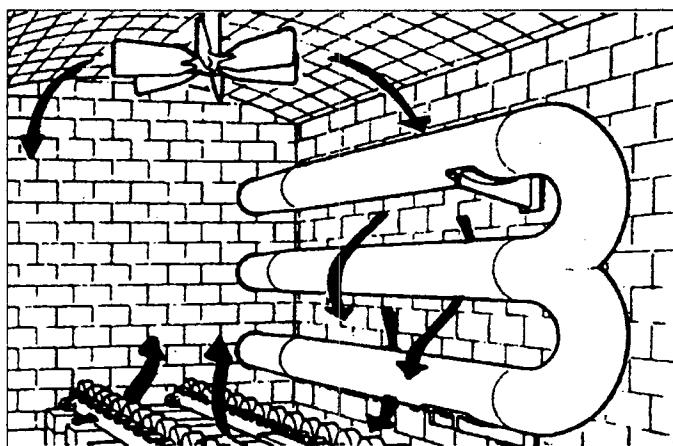
**Figure 3.3-48. Schematic of Surface Combustion ALLCASE Internals**

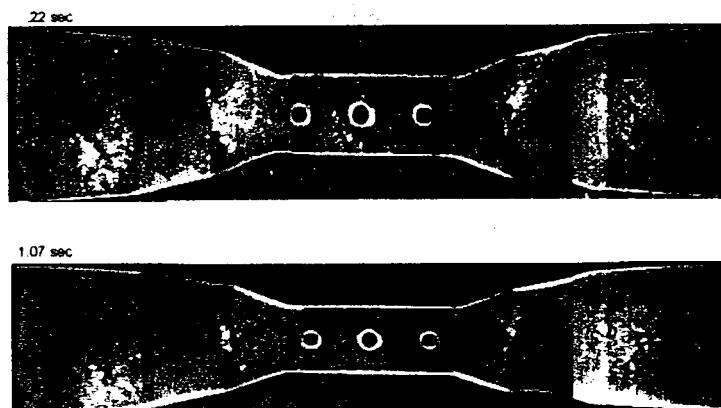
**Figure 3.3-50. Pulsed IR NDE of CFCC Furnace Fan Blade (-13A)**

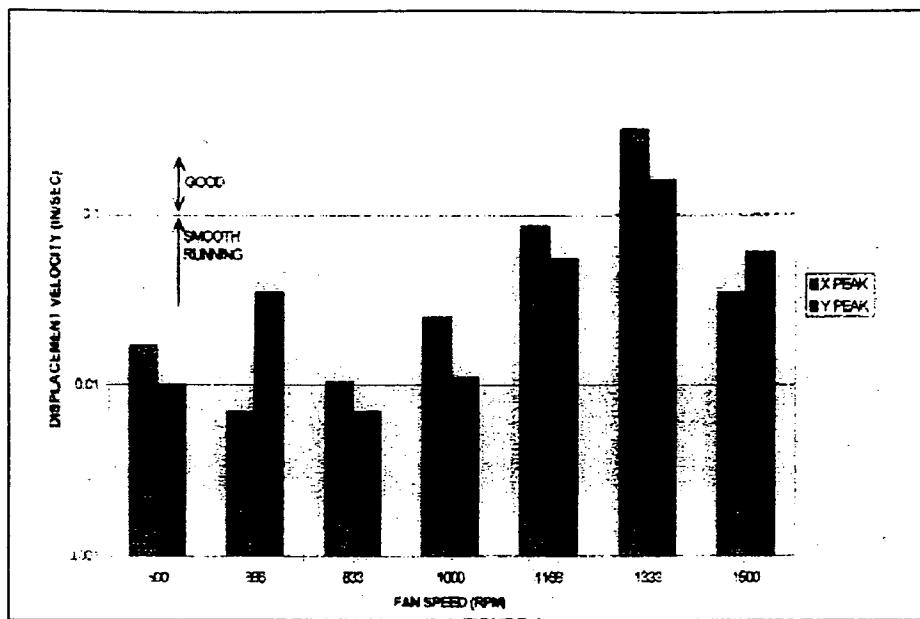
Figure 3.3-56. Vibration Profile for S200 CFCC Fan Assembly

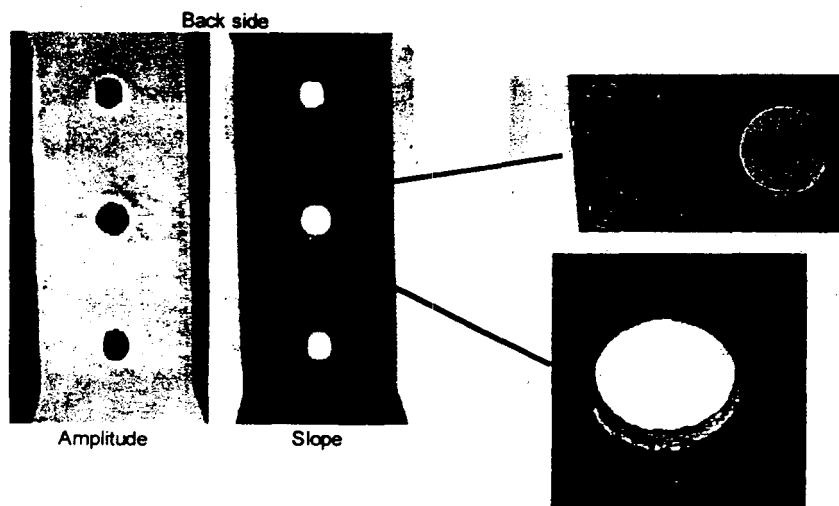
Figure 3.3-60. NDE of Blade #12 Center Section Showing Wear Around Location Holes and Edge Chip

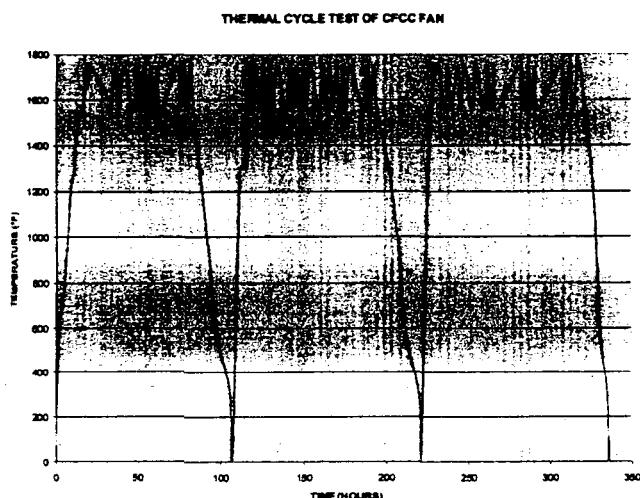
**Figure 3.3-63. The Approximate Furnace Fan Temperature Over the Duration of the Test Versus Time**

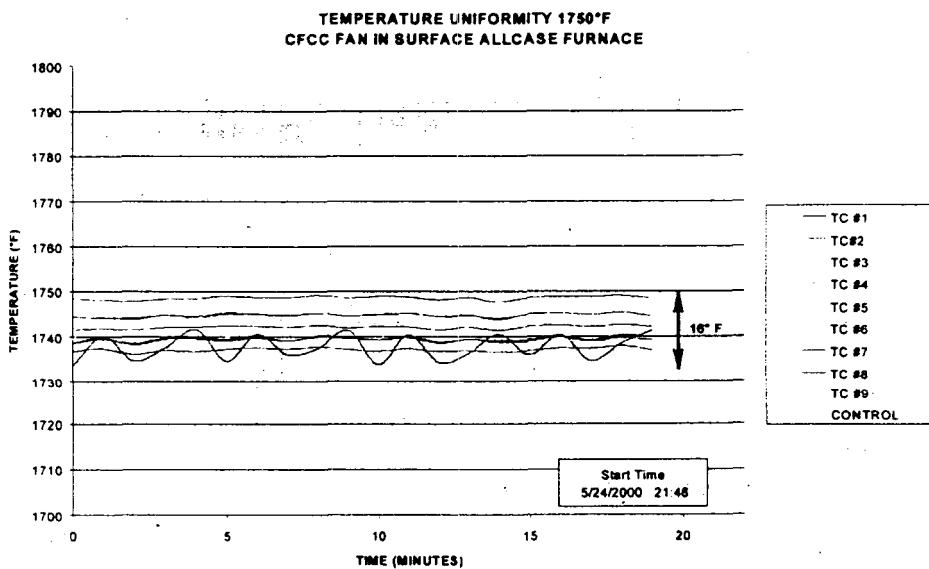
Figure 3.3-65. Temperature Uniformity Achieved Using the CFCC Fan at 1550°F

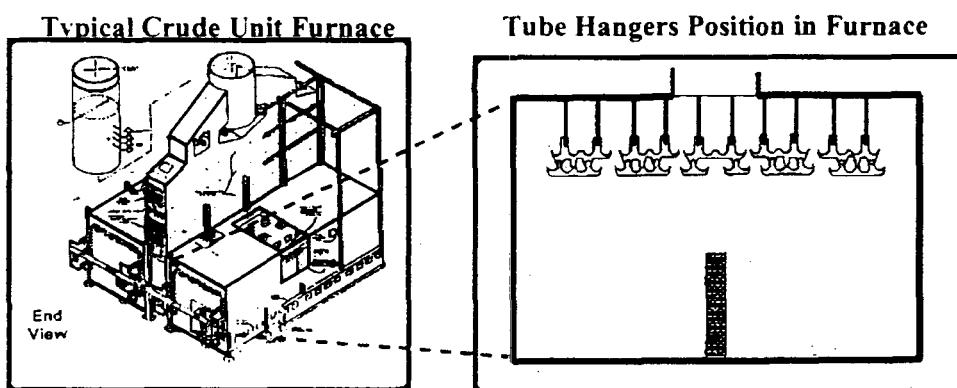
**Figure 3.3-73. Schematic Showing Chevron Crude Unit Furnace**

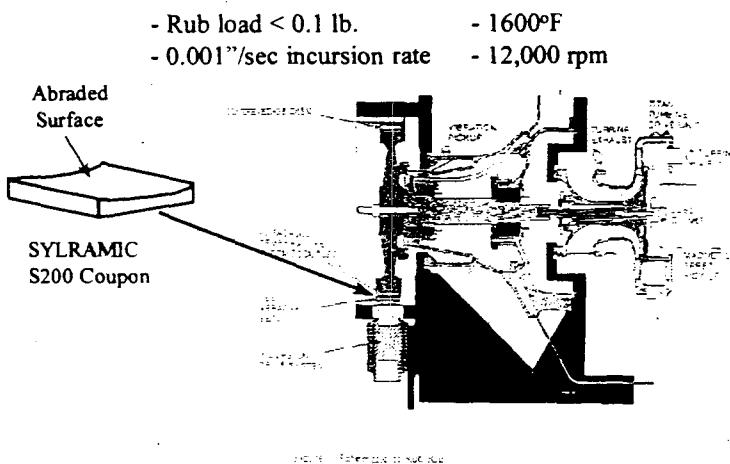
**Figure 3.3-75. Schematic of the Rub Test Rig**

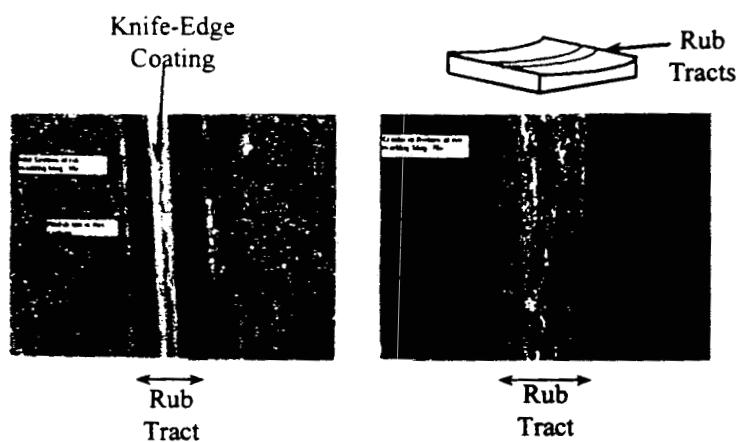
Figure 3.3-78. Rub Tracts in S200 CFCC Test Coupon After Rub Testing

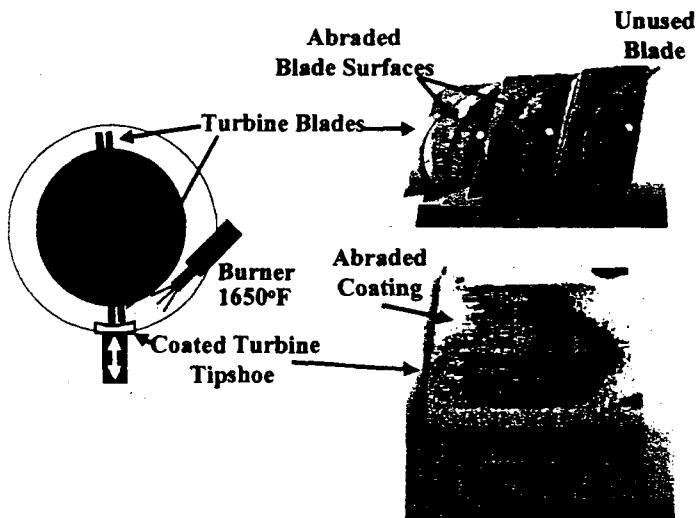
Figure 3.3-81. Results of Rub Rig Testing of EBC/S200

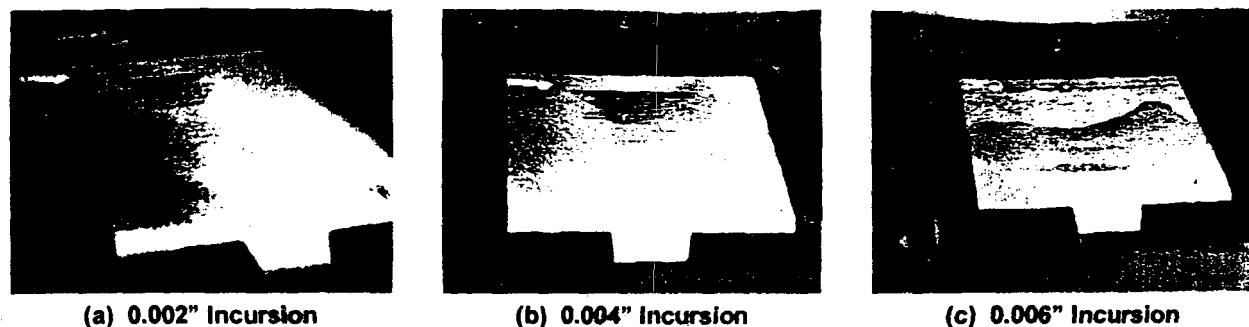
**Figure 3.3-83. EBC/S200 CFCC Coupon During Rub Testing**

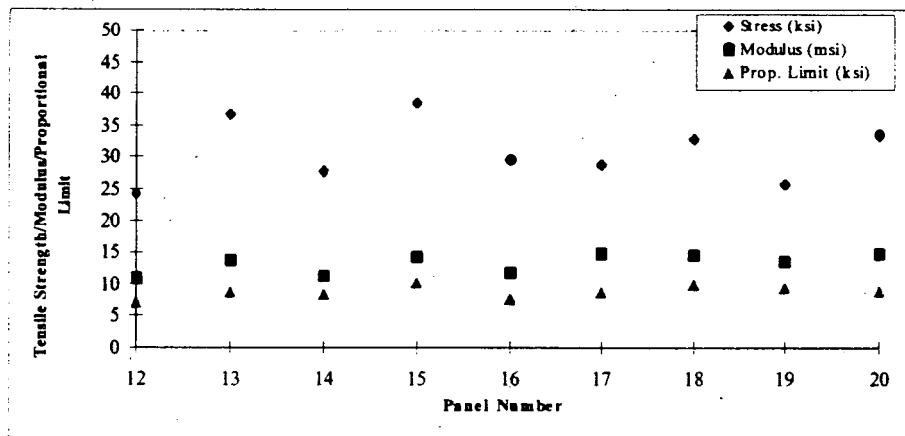
**Figure 3.3-92. Variation in Average Properties for QA Test Bars Cut from the Panels Fabricated for ASTM Study**

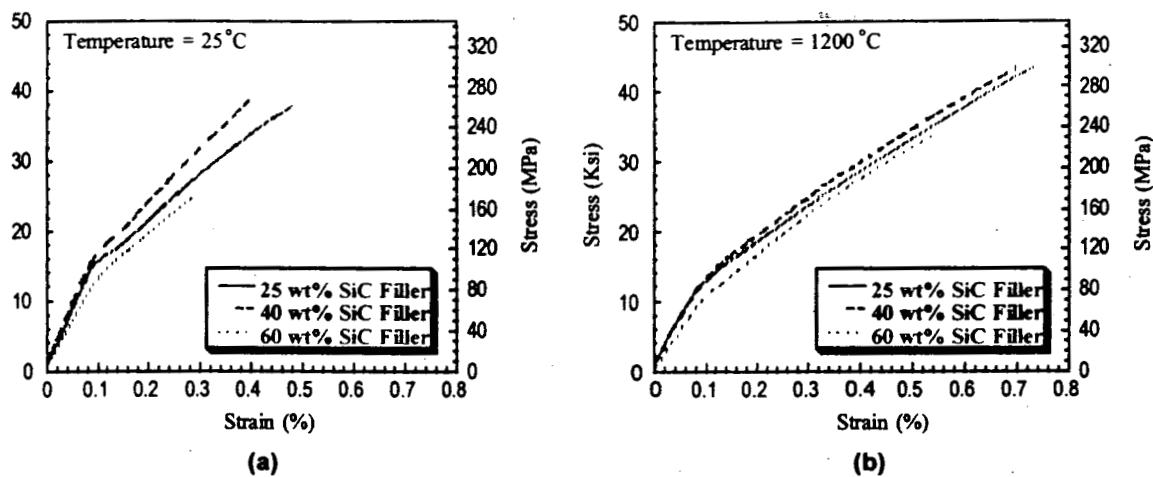
**Figure 3.4-15. Effect of Filler Content on the Stress/Strain Response of S200 at Room Temperature and 1200°C**

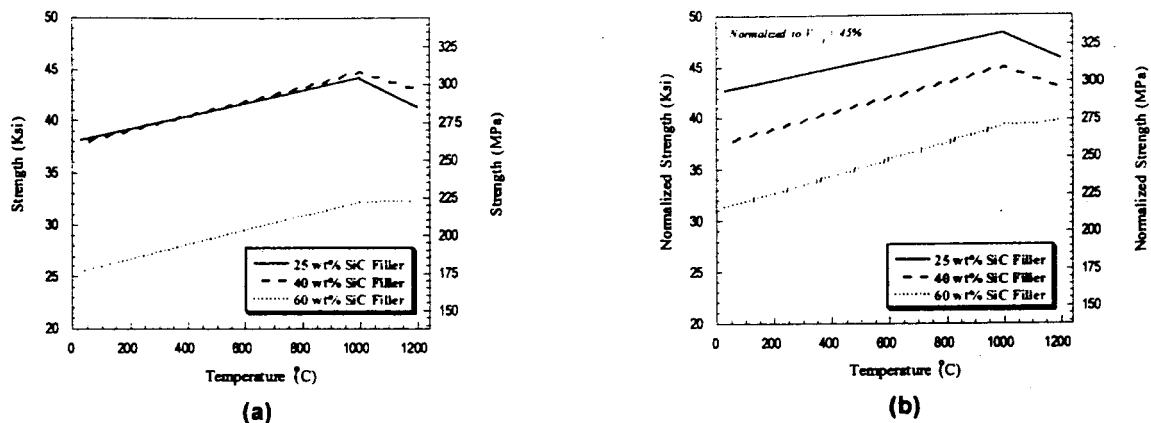
Figure 3.4-17. Strength as a Function of Test Temperature for S200 with Various Filler Loadings

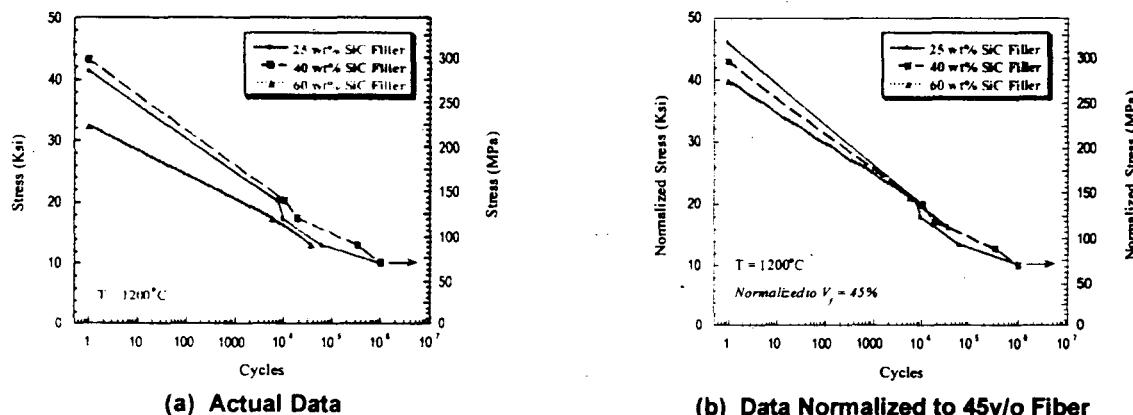
**Figure 3.4-20. Fatigue Curves for S200 CFCC with Various Filler Loadings**

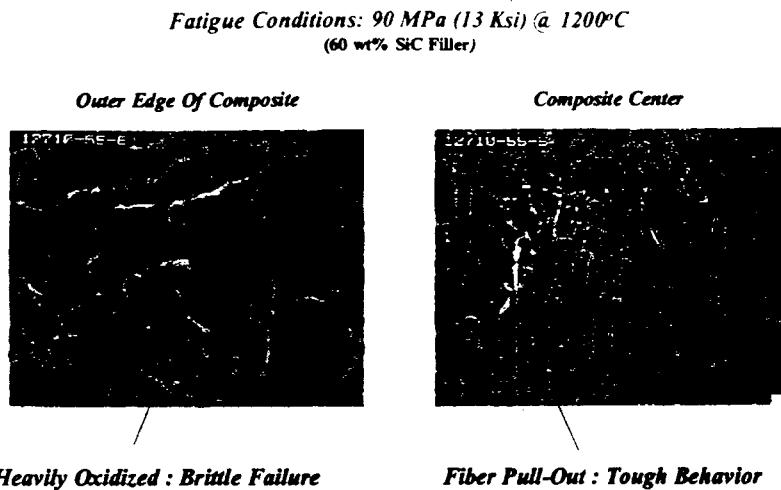
**Figure 3.4-21. Fracture Morphology of 60% Filled S200 CFCC After Fatigue Testing**

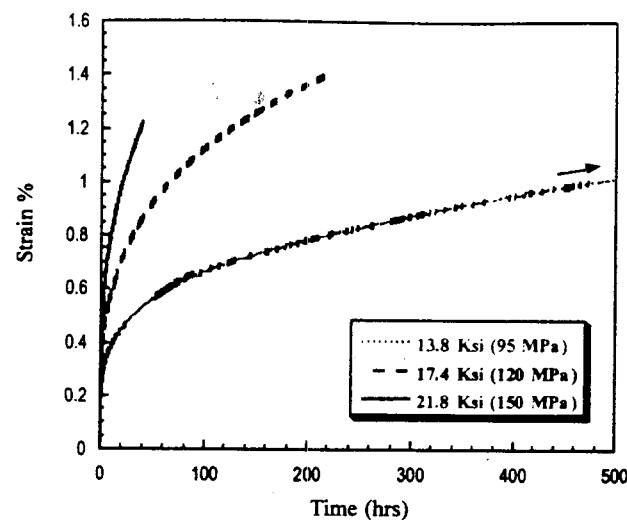
Figure 3.4-27. Impact of Stress on Creep Strain at 1200°C for CG Nicalon Reinforced S200 CFCC

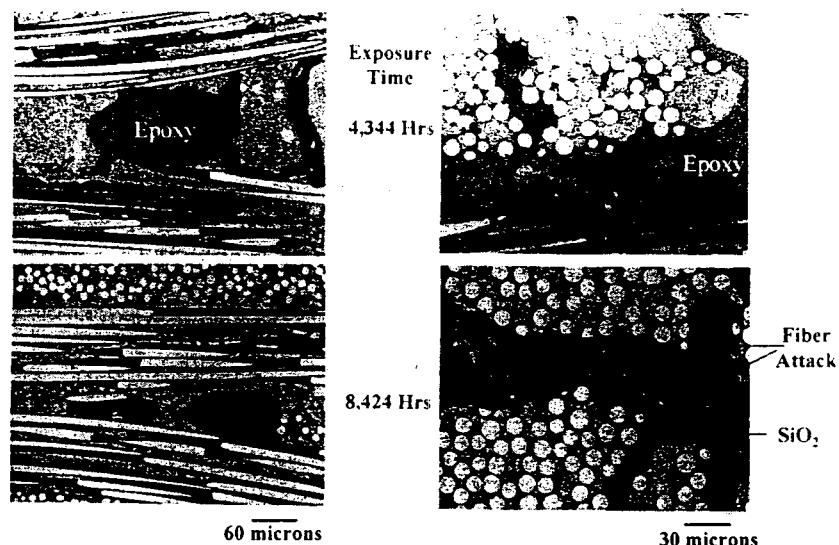
Figure 3.4-40. Static Exposure of Sylramic S200 Composite to Chevron Furnace Environment

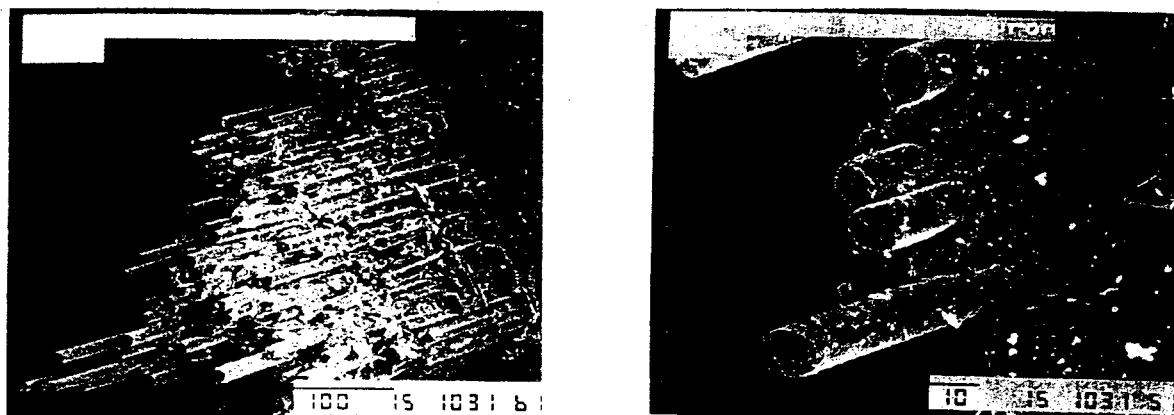
Figure 3.4-41. Fracture Surface of S200 CFCC Exposed for 4,344 Hours in Chevron Furnace Environment Showing Tough Composite Behavior
