### **RESEARCH & DEVELOPMENT OF MATERIALS/PROCESSING METHODS FOR CONTINUOUS FIBER CERAMIC COMPOSITES**

#### **CFCC Phase 2 Final Report**

**Dow Corning Corporation**

**January, 2001**

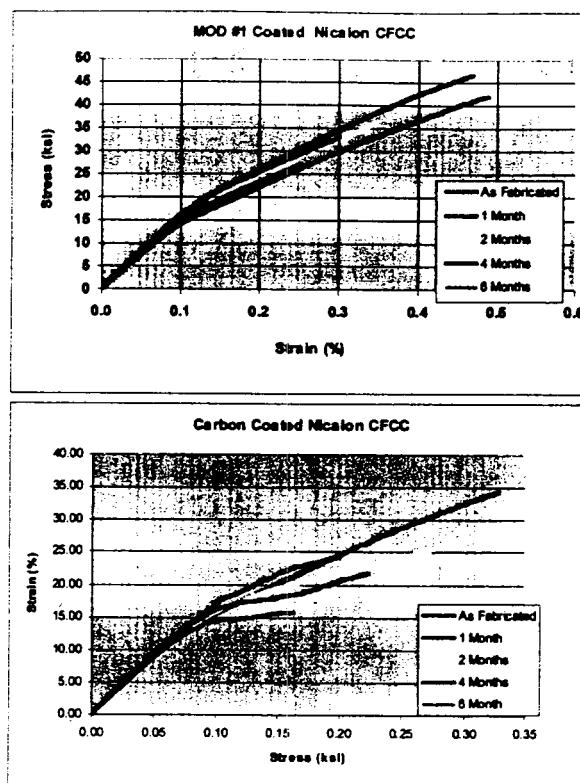
Figure 3.4-47. Stress/Strain Curves for S200 CFCC Coupons Subjected to Long-Term Exposure in a Carburizing Environment

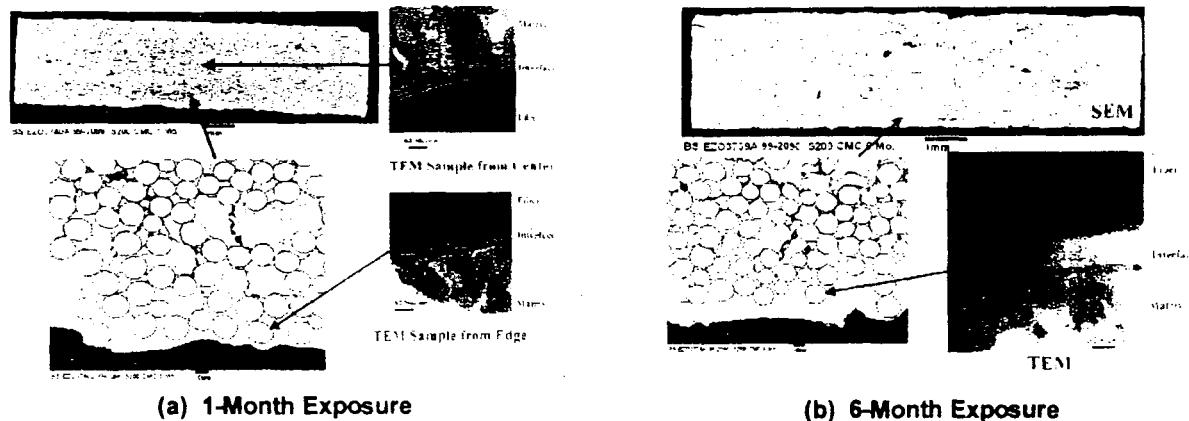
**Figure 3.4-50. Microstructural Examination of MOD#1 Interface Coated S200 After Carburizing Exposure**

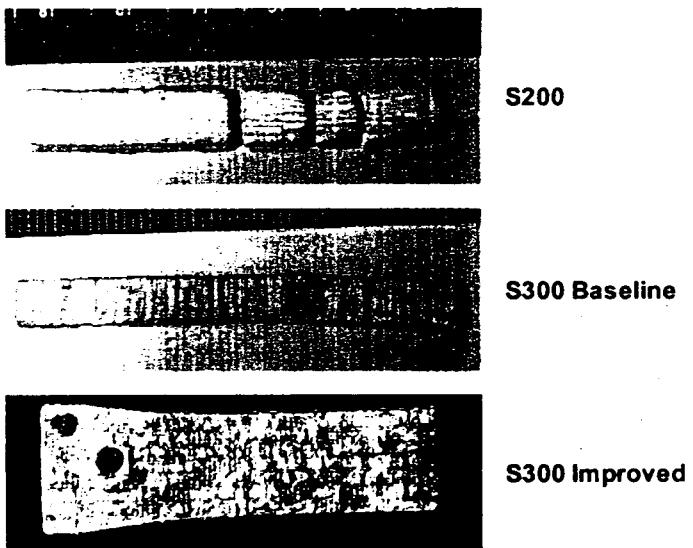
**Figure 3.4-53. Results of 500-Hour Exposure of S200 and S300 CFCC in ORNL Keiser Rig**

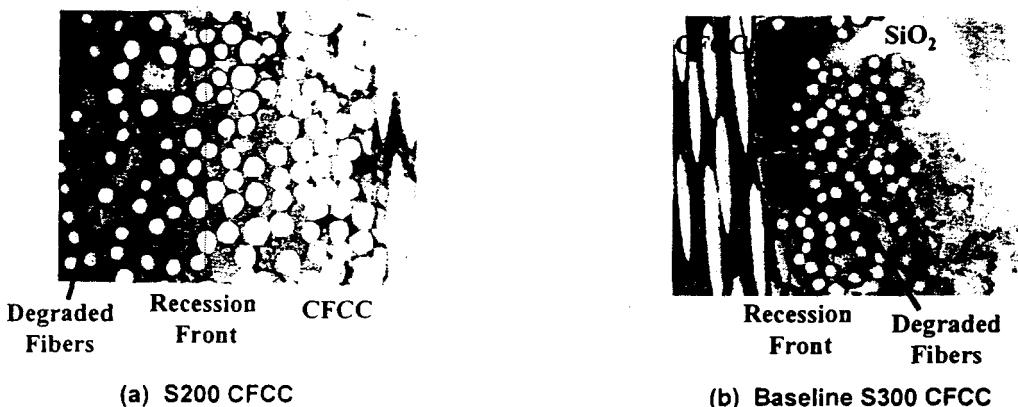
**Figure 3.4-54. Internal Structure of S200 and Baseline S300 After 500-Hour Exposure in Keiser Rig**

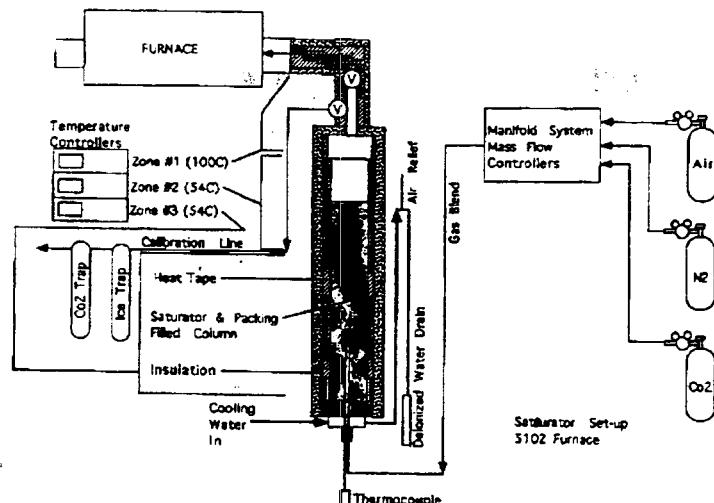
Figure 3.4-65. Schematic of Equipment Used for Simulated Combustion Experiments
