Field Study Final Report

A Field Study Comparison of the Energy and
Moisture Performance Characteristics of Ventilated
Versus Sealed Crawl Spaces in the South

Instrument # DE-FC26-00NT40995

June 22, 2005

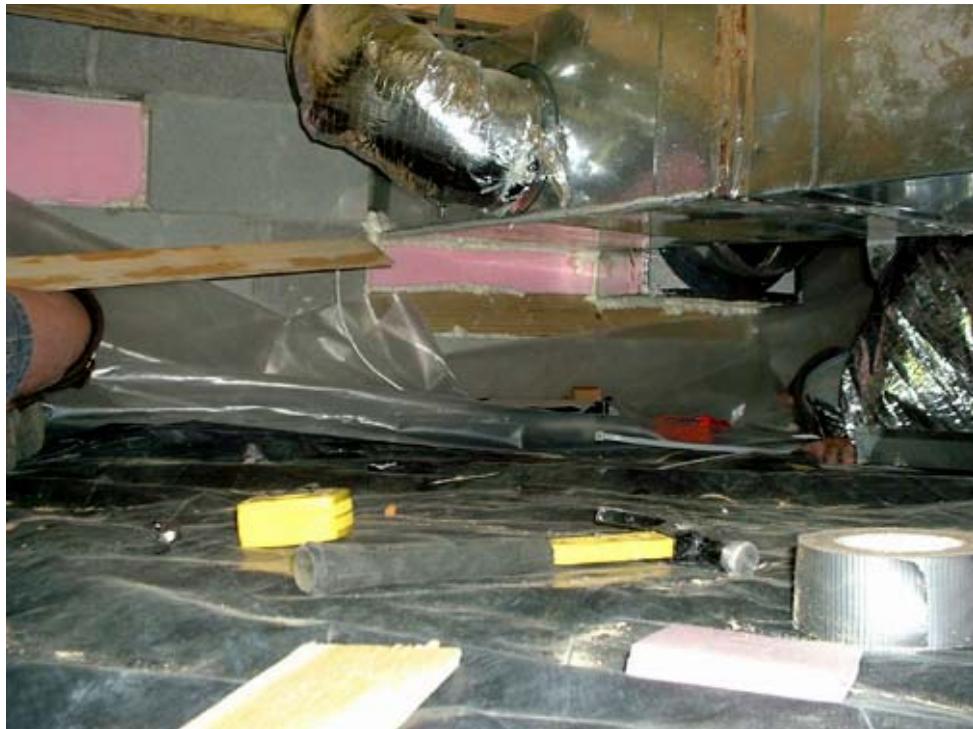
House address 106: Foundation vent and heat pump duct
wall penetration sealing

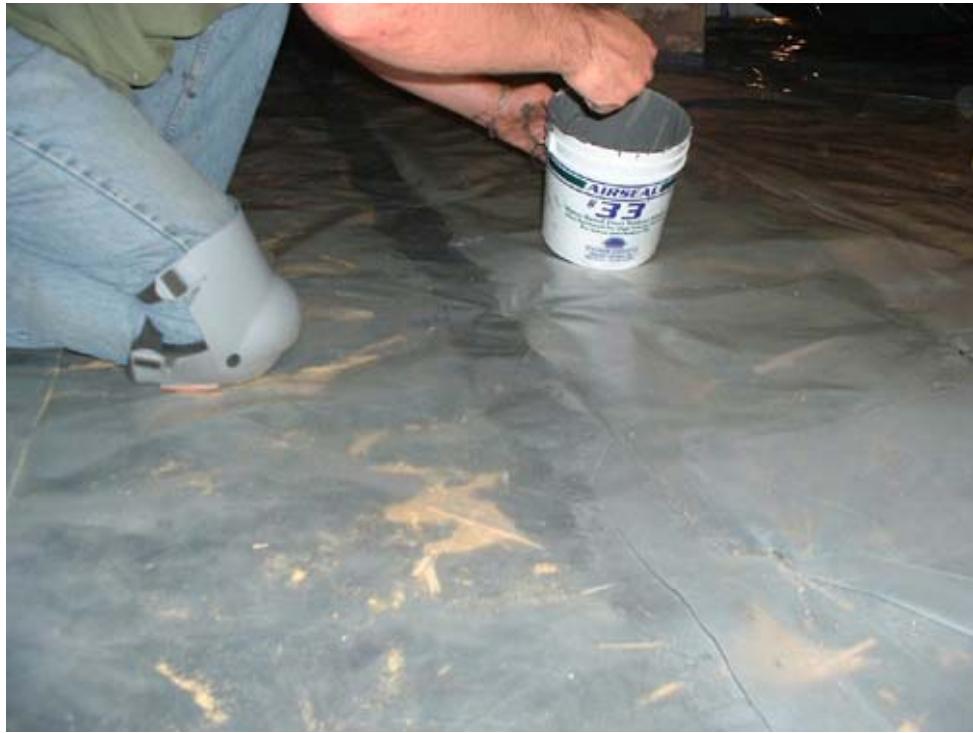
House address 106: Seal floor poly seams

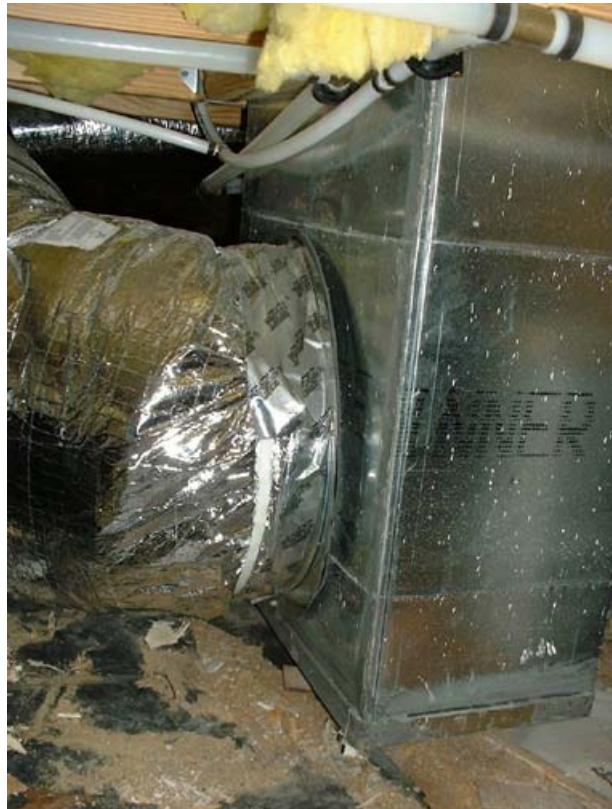
House address 106: Return duct air leakage

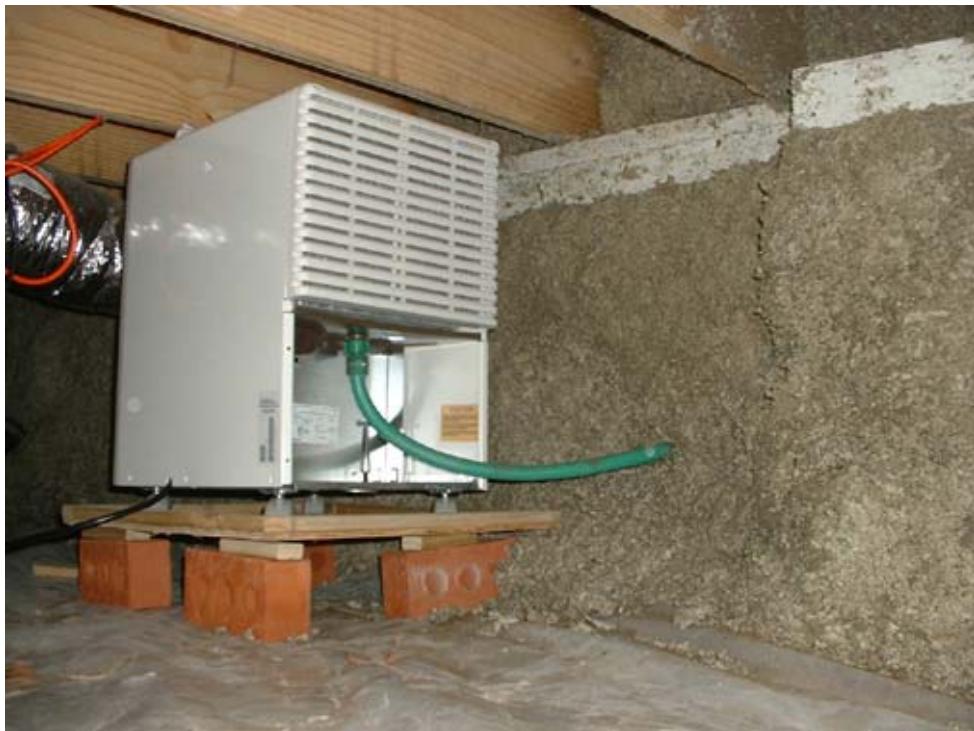
House address 109: Dehumidifier and wall insulation

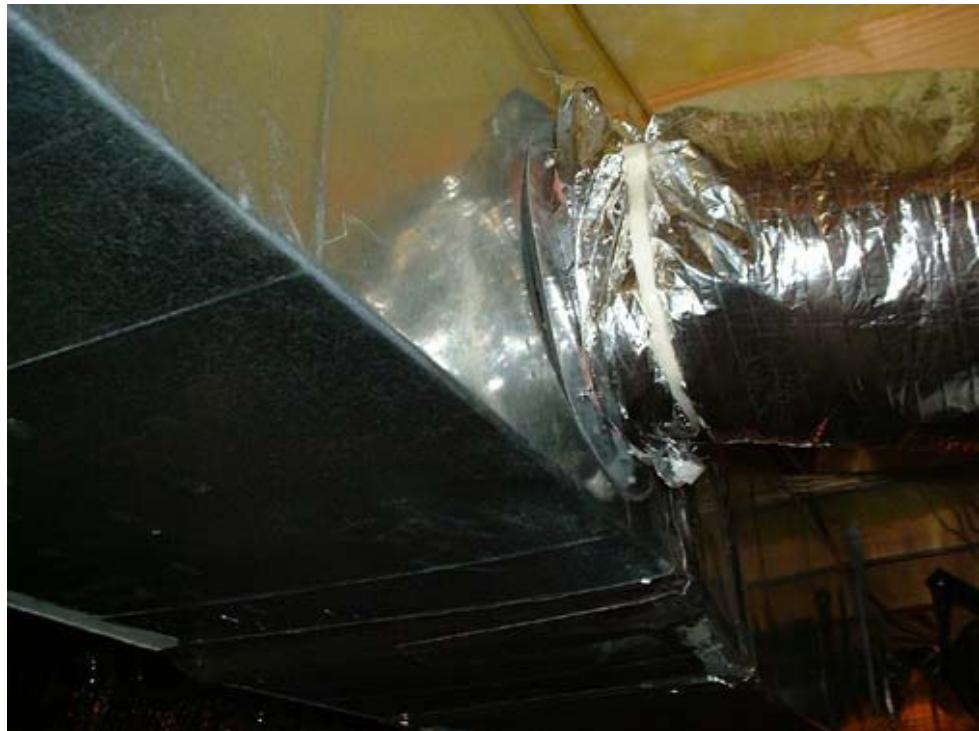
House address 110: Poor supply seal

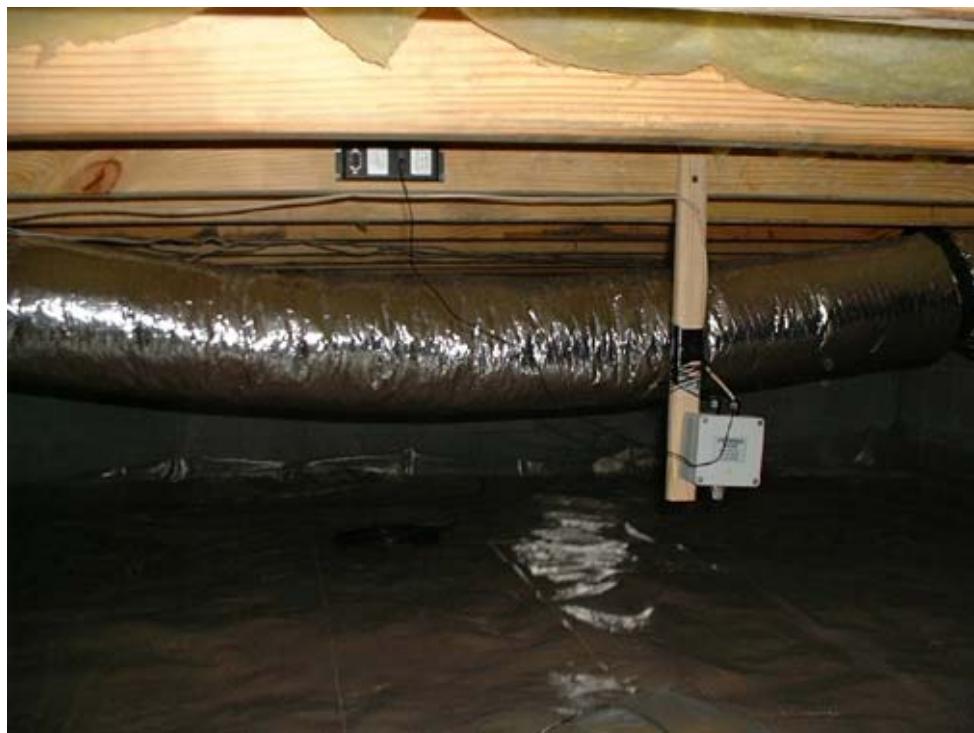
House address 110: Data logger sensors - hygrothermal
