**Development of Improved Materials for Continuous Steel
Hot-Dipping Processes**

Final Technical Report

DE-FC36-01ID14042

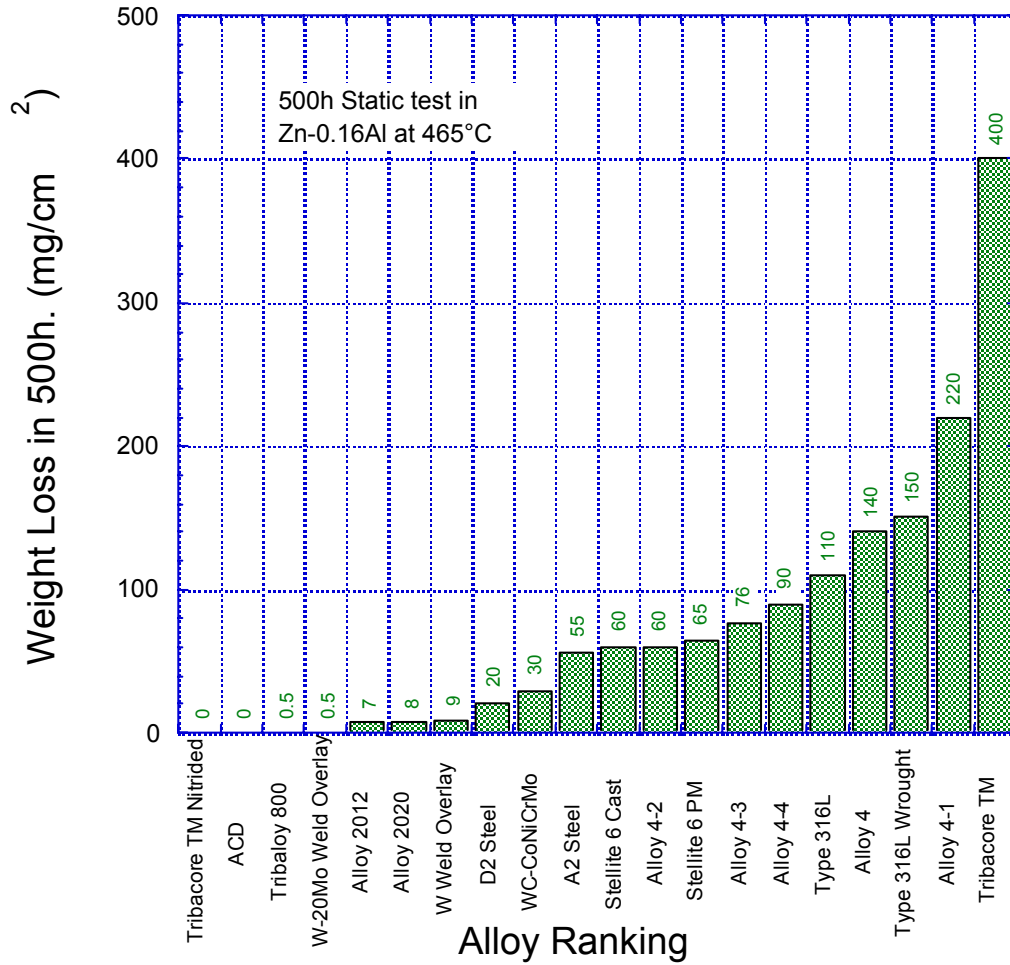
Figure 16: Materials ranking in machined conditions.

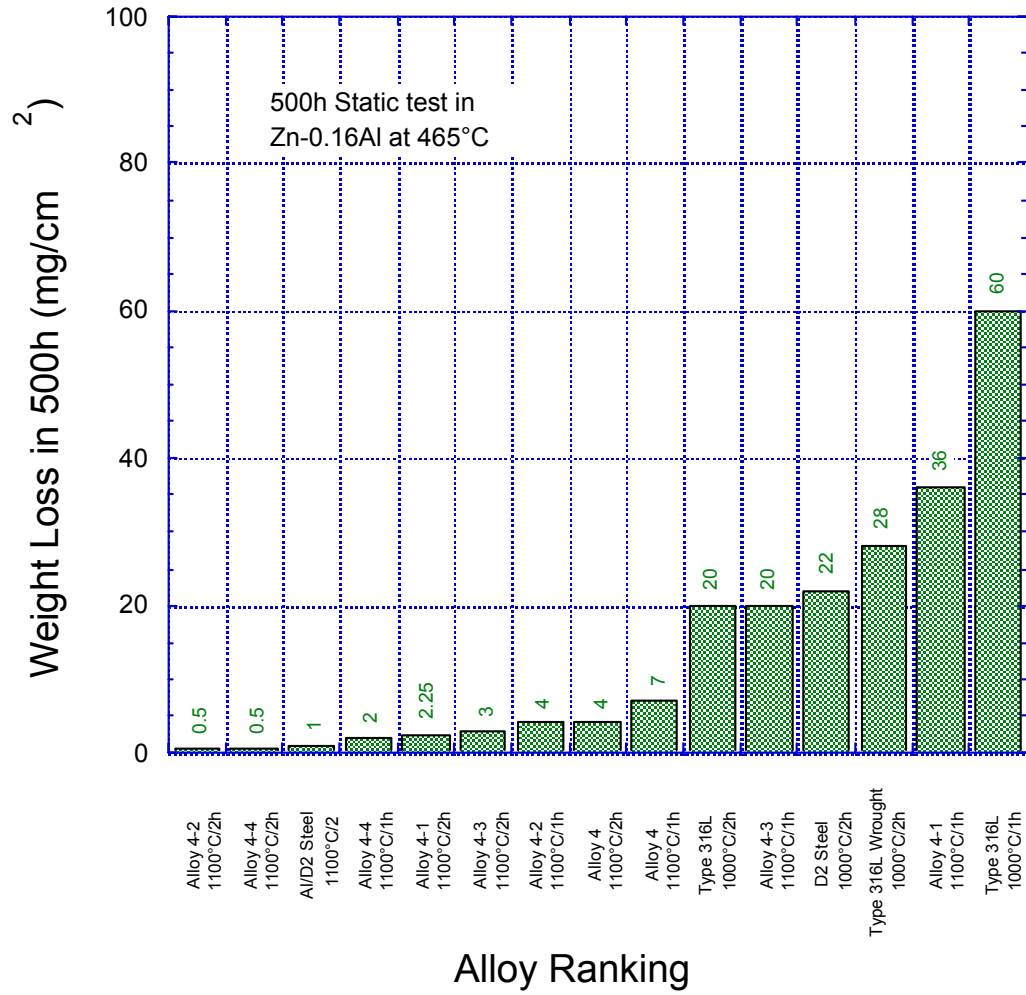
Figure 17: Materials ranking with preoxidation treatment.

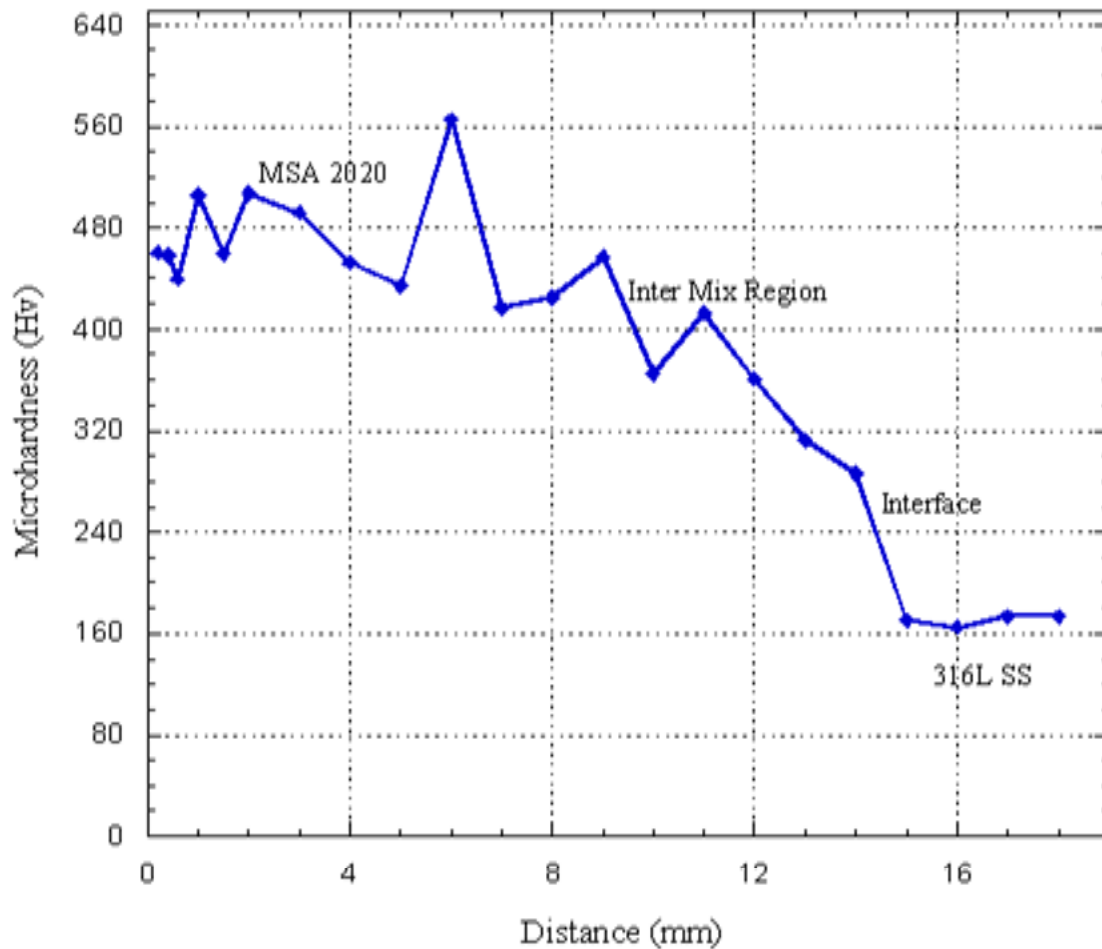
Figure 26: Hardness traverse from surface to core on weld overlay of a single pass weld of 2020 on stainless steel type 316L using MIG process.

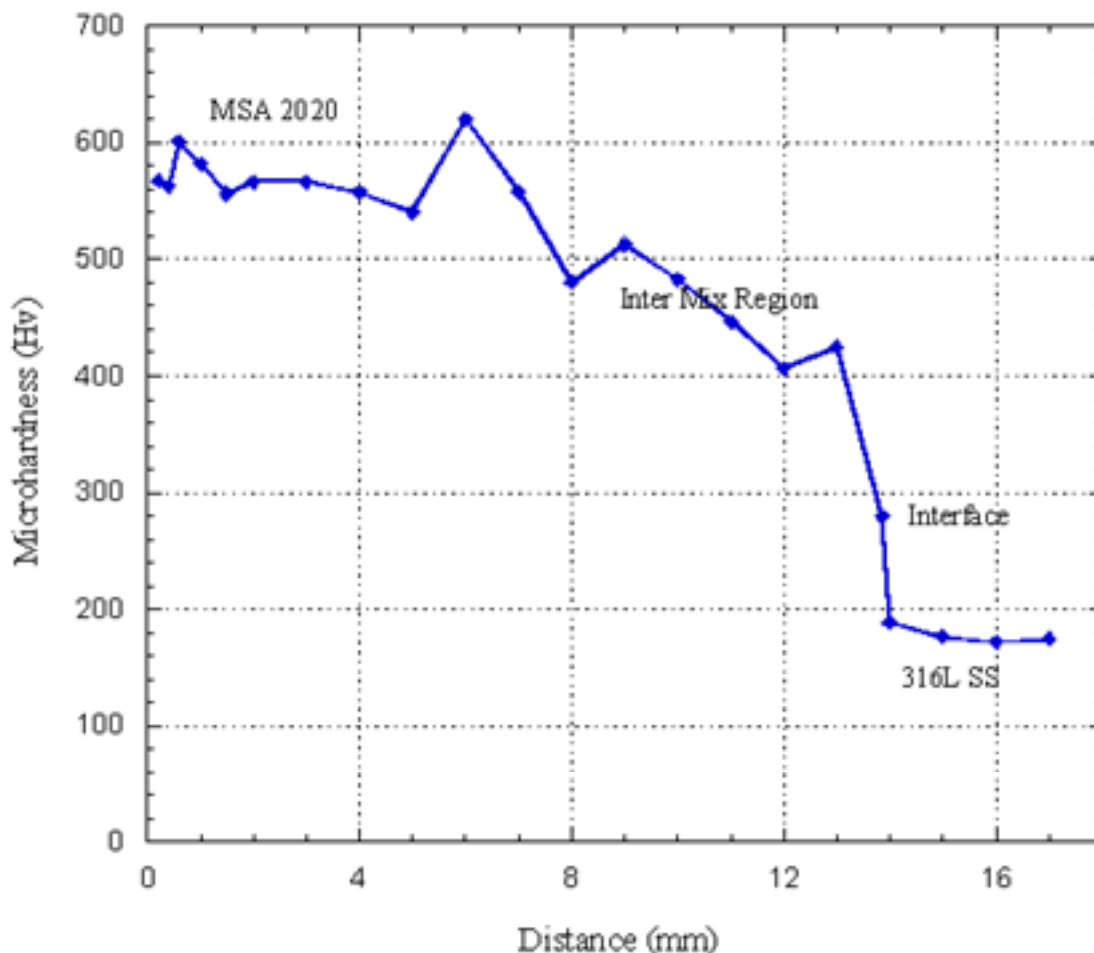
Figure 27: Hardness traverse from surface to core on multiple pass weld overlay of 2020 on stainless steel type 316L.

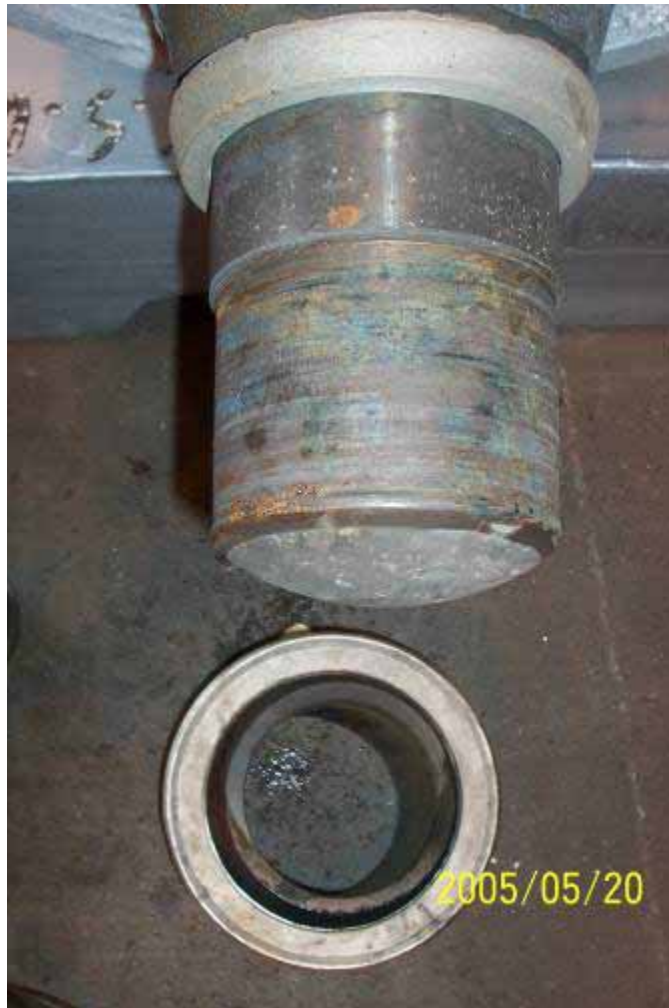
Figure 119: Shaft/bearing assembly after trial at steel partner A

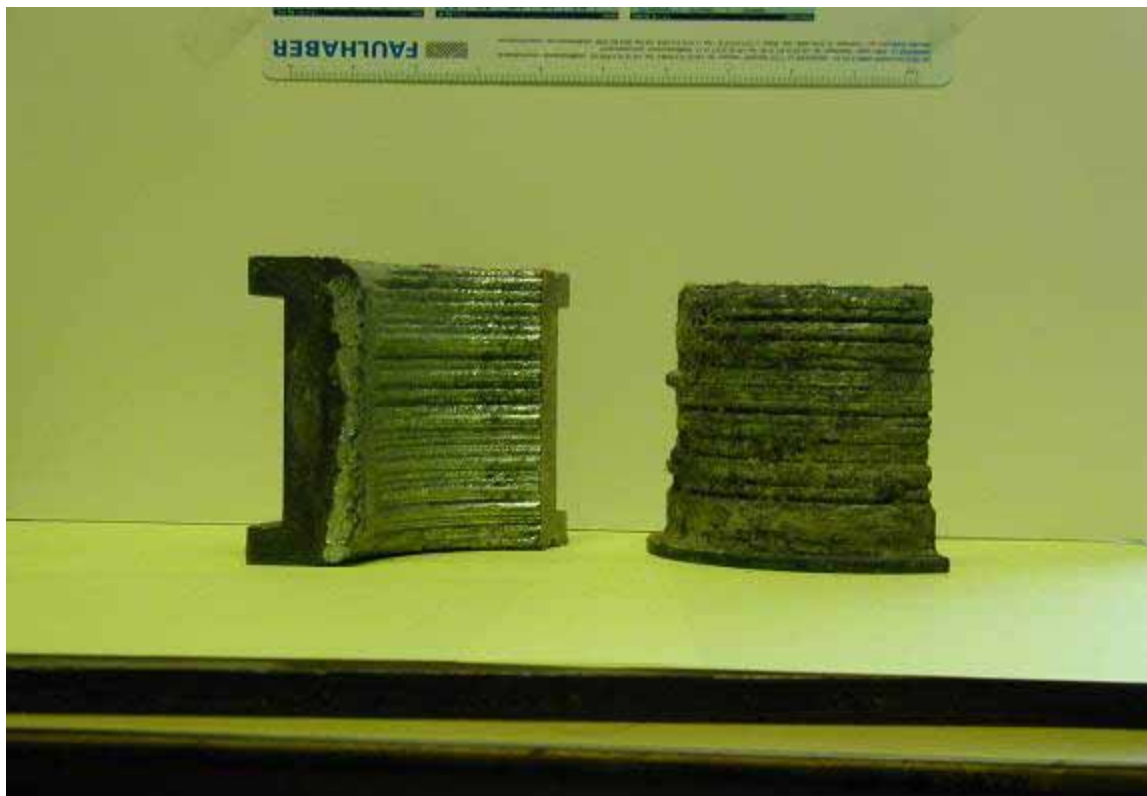
Figure 121: Stellite 6 bearings after service.
