## **Design and Performance Characteristics of the ORNL Advanced Microscopy Laboratory and JEOL 2200FS-AC Aberration-Corrected STEM/TEM**

L.F. Allard,\* D.A. Blom,\* M.A. O'Keefe,\*\* and S. Mishina\*\*\*

\*Metals and Ceramics Division, Oak Ridge National Laboratory, Oak Ridge, TN 37831-6064, USA

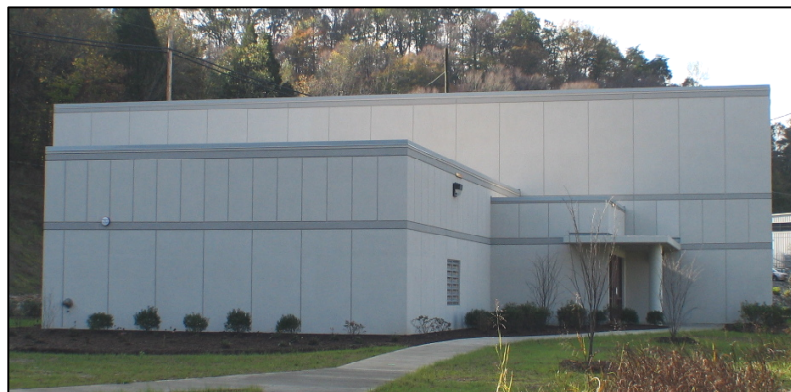
FIG. 1. View of Advanced Microscopy Laboratory at ORNL. The low building in front houses HVAC units, electrical distribution, and instrument water chillers, while the high building houses microscope and associated control rooms. Power to the instruments is supplied by a motor-generator set, housed in the adjacent High Temperature Materials Laboratory (HTML).
