DOE/NV--1075

**Post-Closure Inspection and
Monitoring Report for Corrective
Action Unit 110: Area 3 WMD
U-3ax/bl Crater, Nevada Test Site,
Nevada For the Period July 2004 -
June 2005**

August 2005

Environmental Restoration
Division

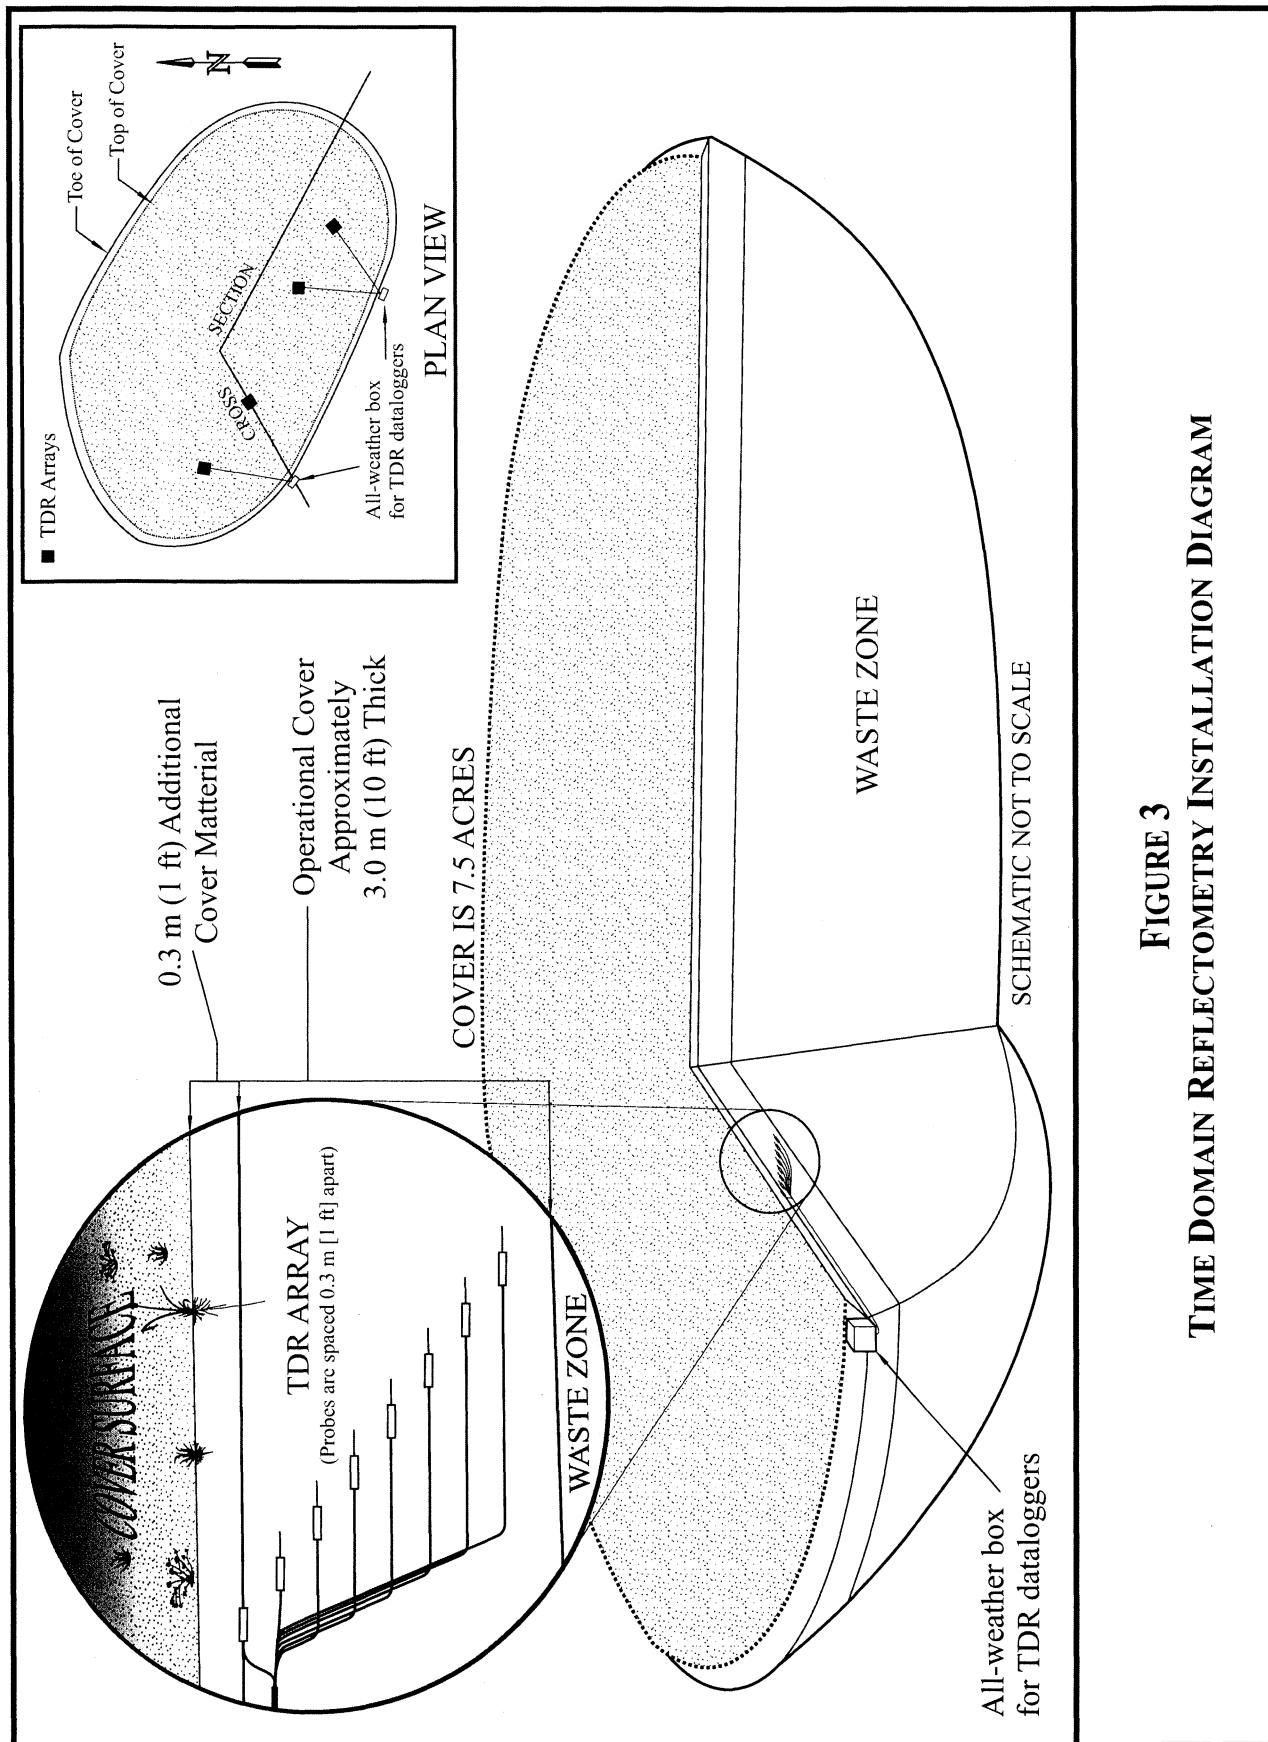
FIGURE 3
TIME DOMAIN REFLECTOMETRY INSTALLATION DIAGRAM

The CAU 110 cover is designed to limit infiltration of precipitation into the disposal unit by evapotranspiration of vegetation on the cover. The cover performance is monitored using Time Domain Reflectometry (TDR) soil water content sensors that are buried at 0.3 m (1 ft) depth intervals up to 2.4 m (8 ft) within the waste cover to provide water content profile data. TDR probes are installed at a distance of 50.3 m (165 ft) from the southern edge of the cover. A profile of eight probes (a stack) is repeated at four locations across the cover (Figures 2 and 3). The soil water content profile data are used to determine whether the cover is functioning as designed. Soil moisture content data from the TDR moisture probes are recorded daily and stored on a datalogger. The data are downloaded remotely over a radio/telephone link.

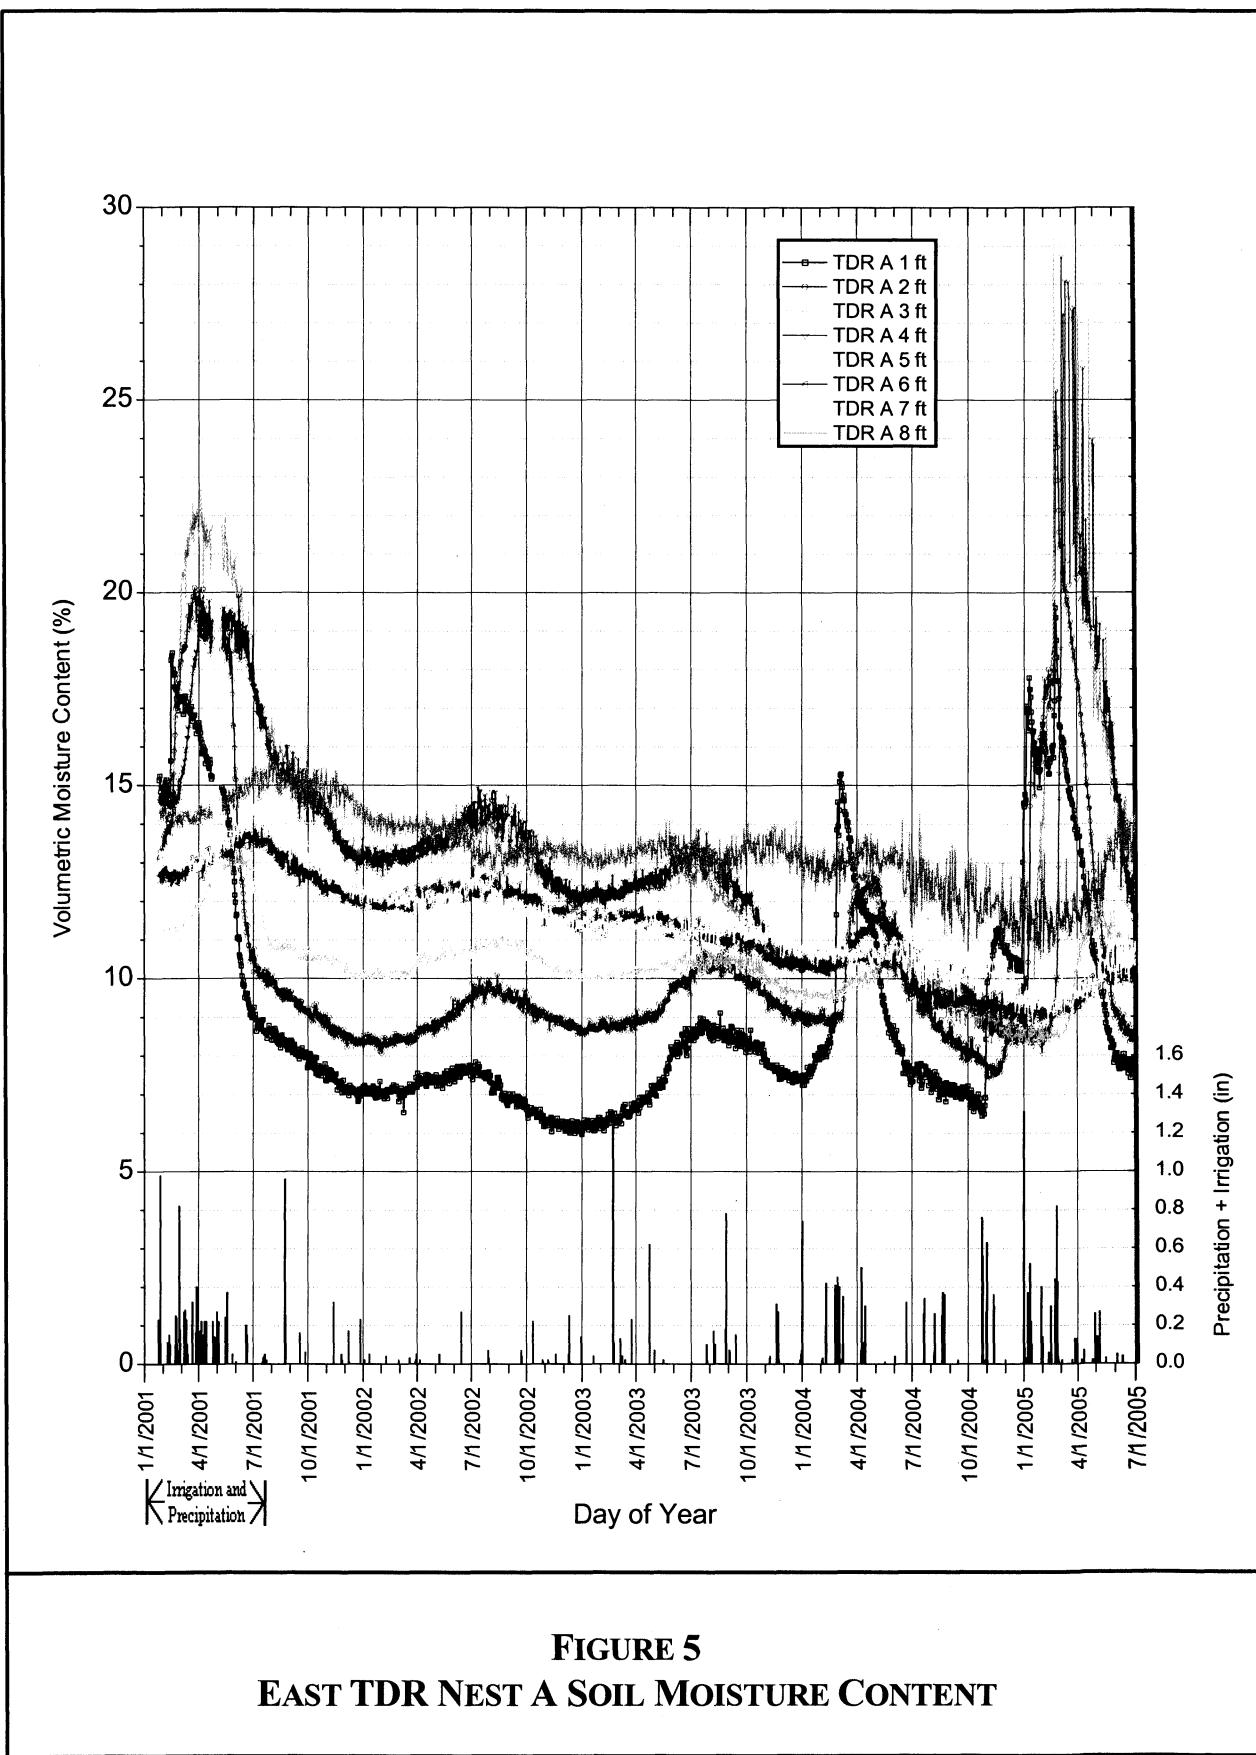
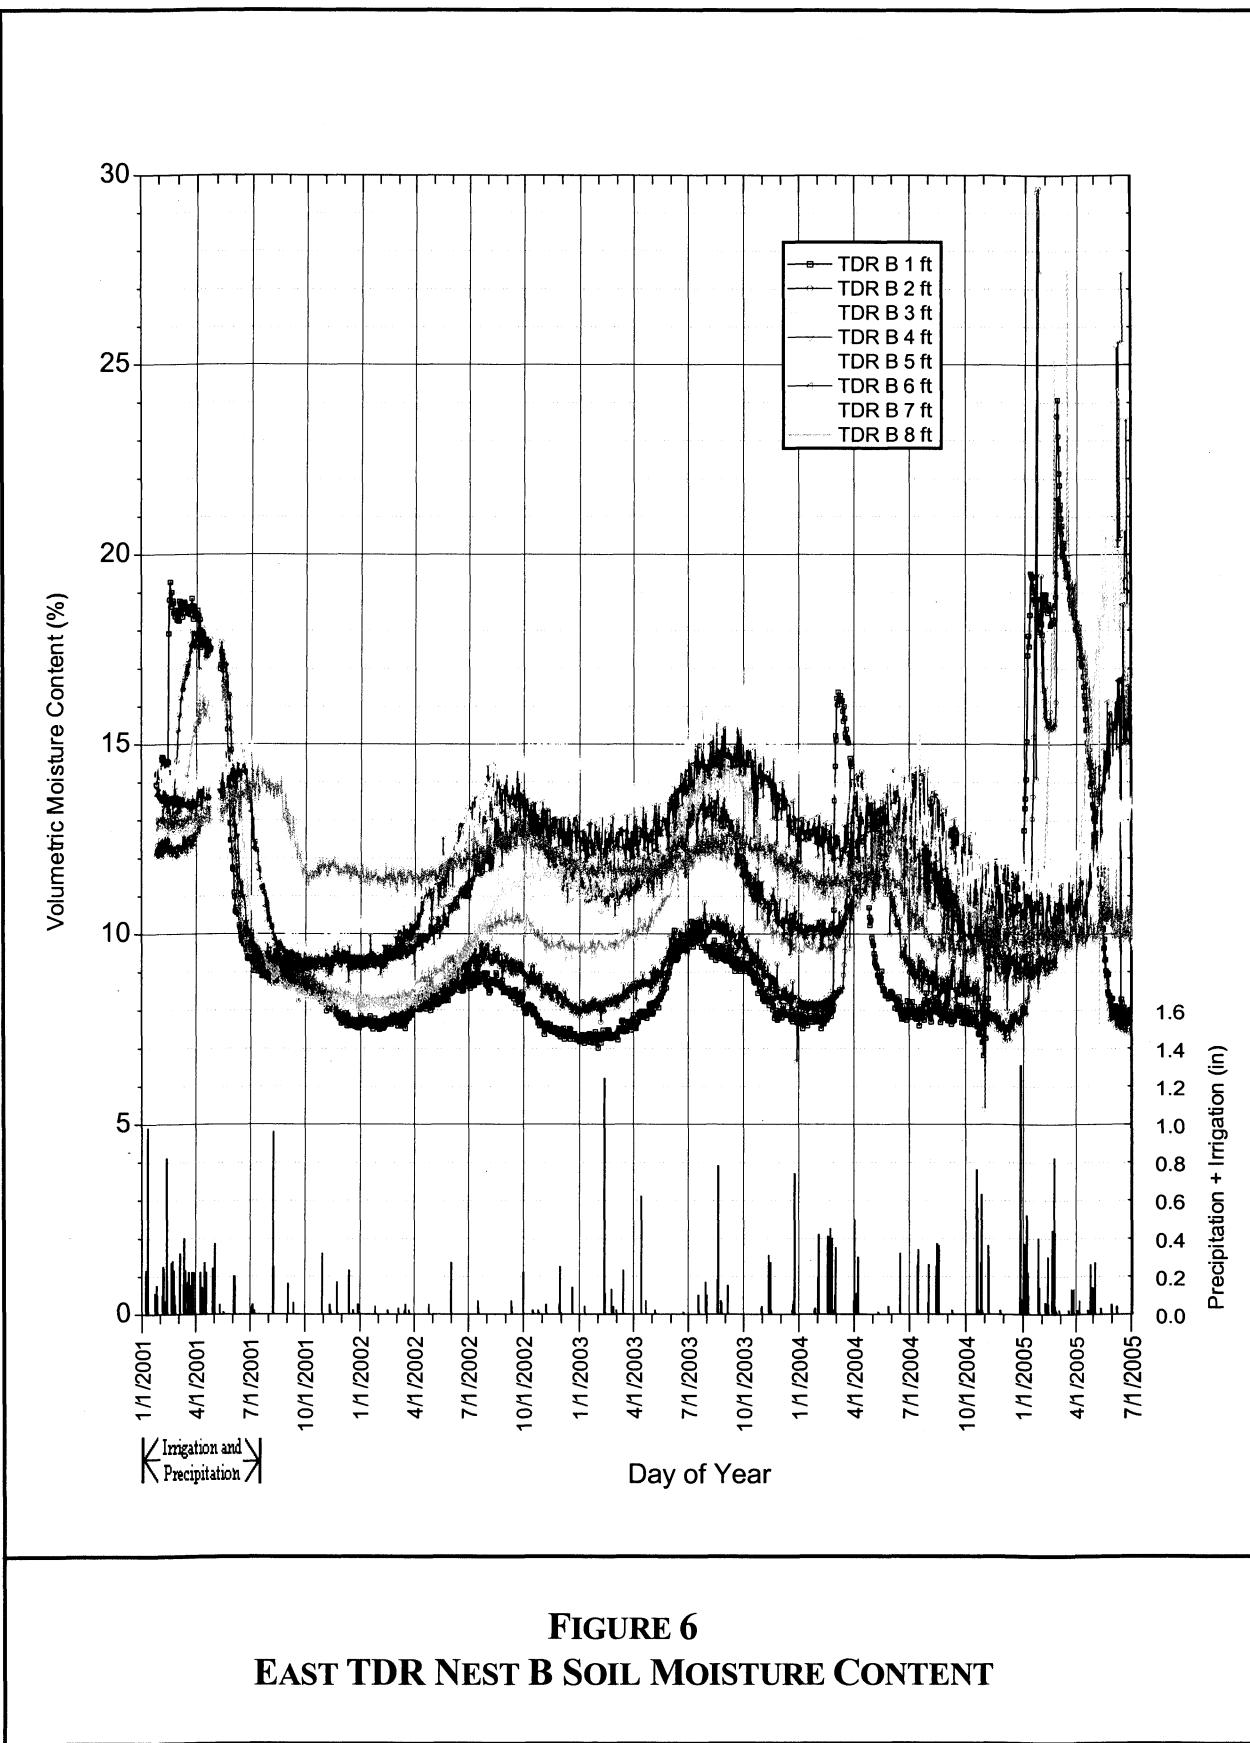
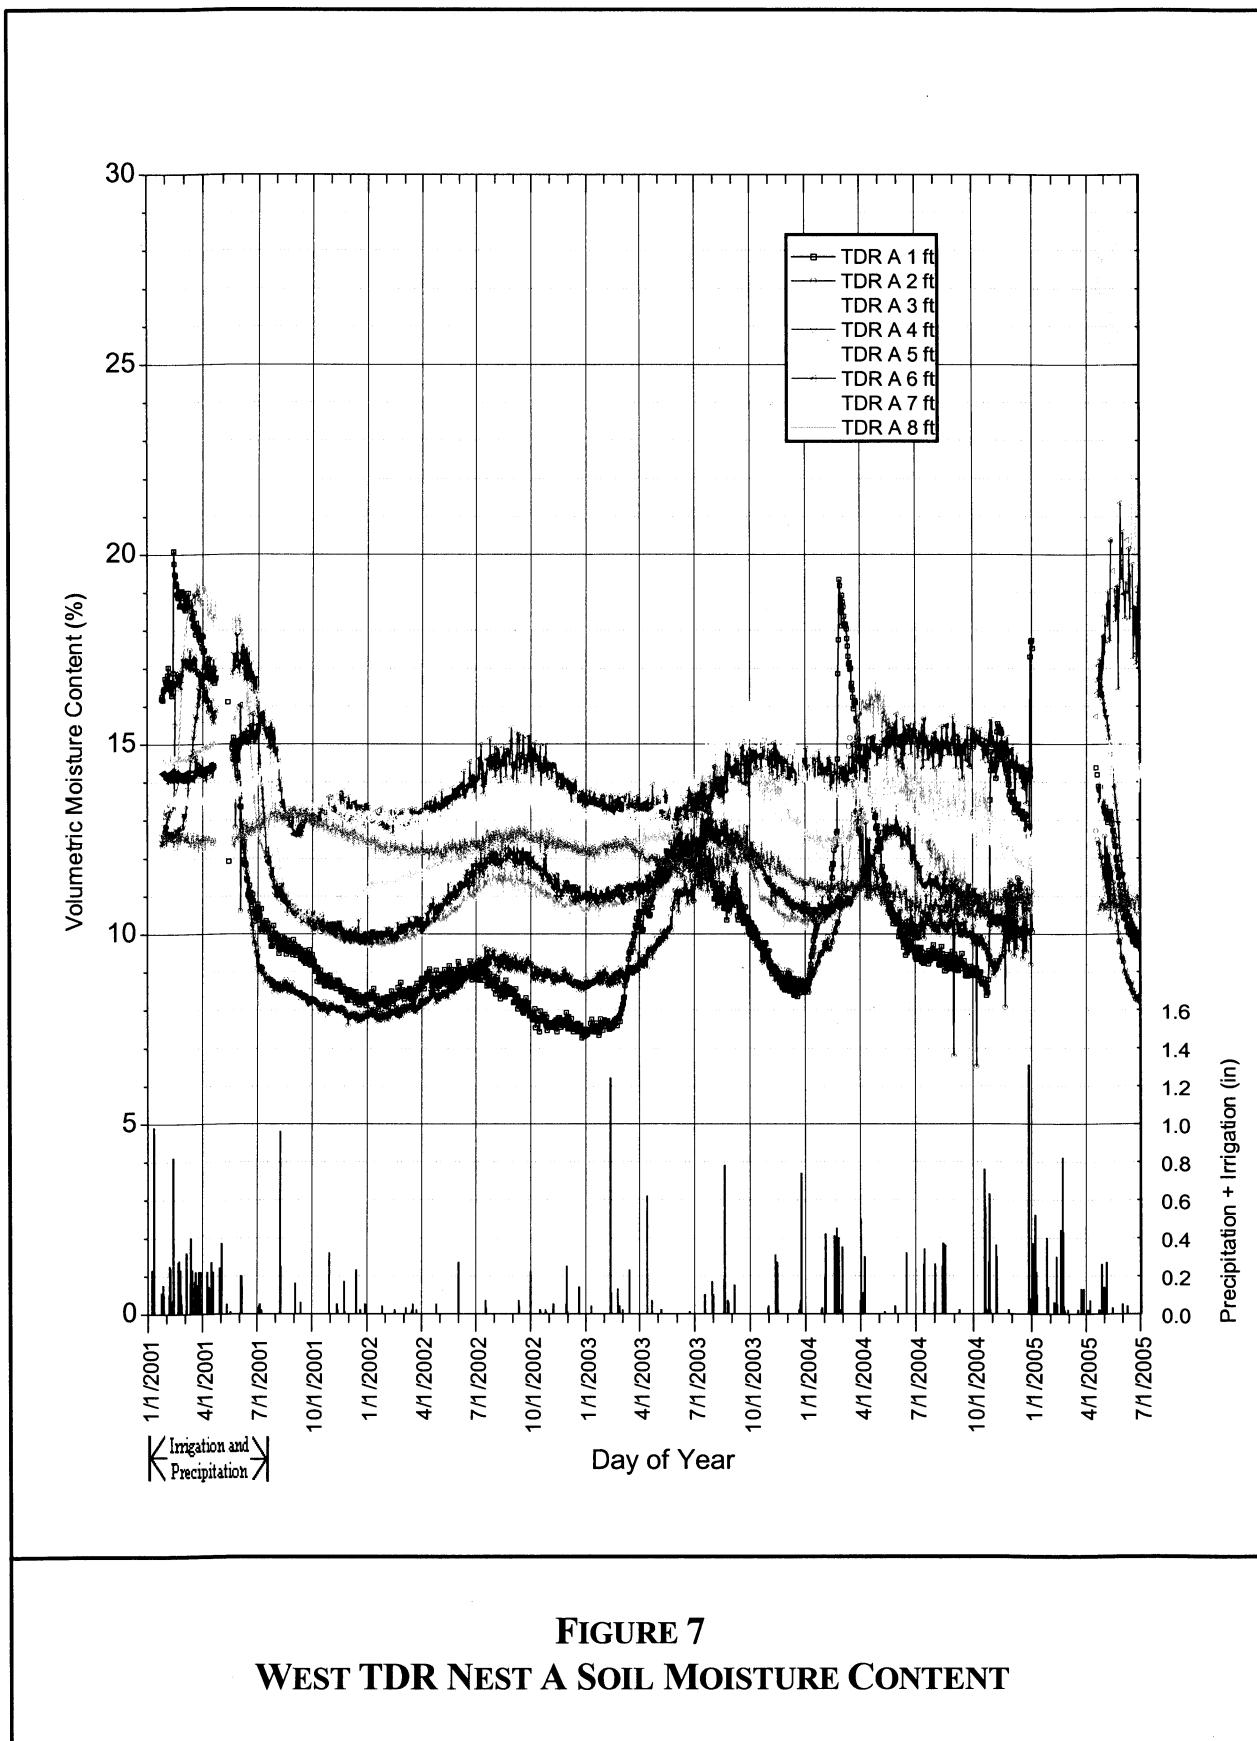
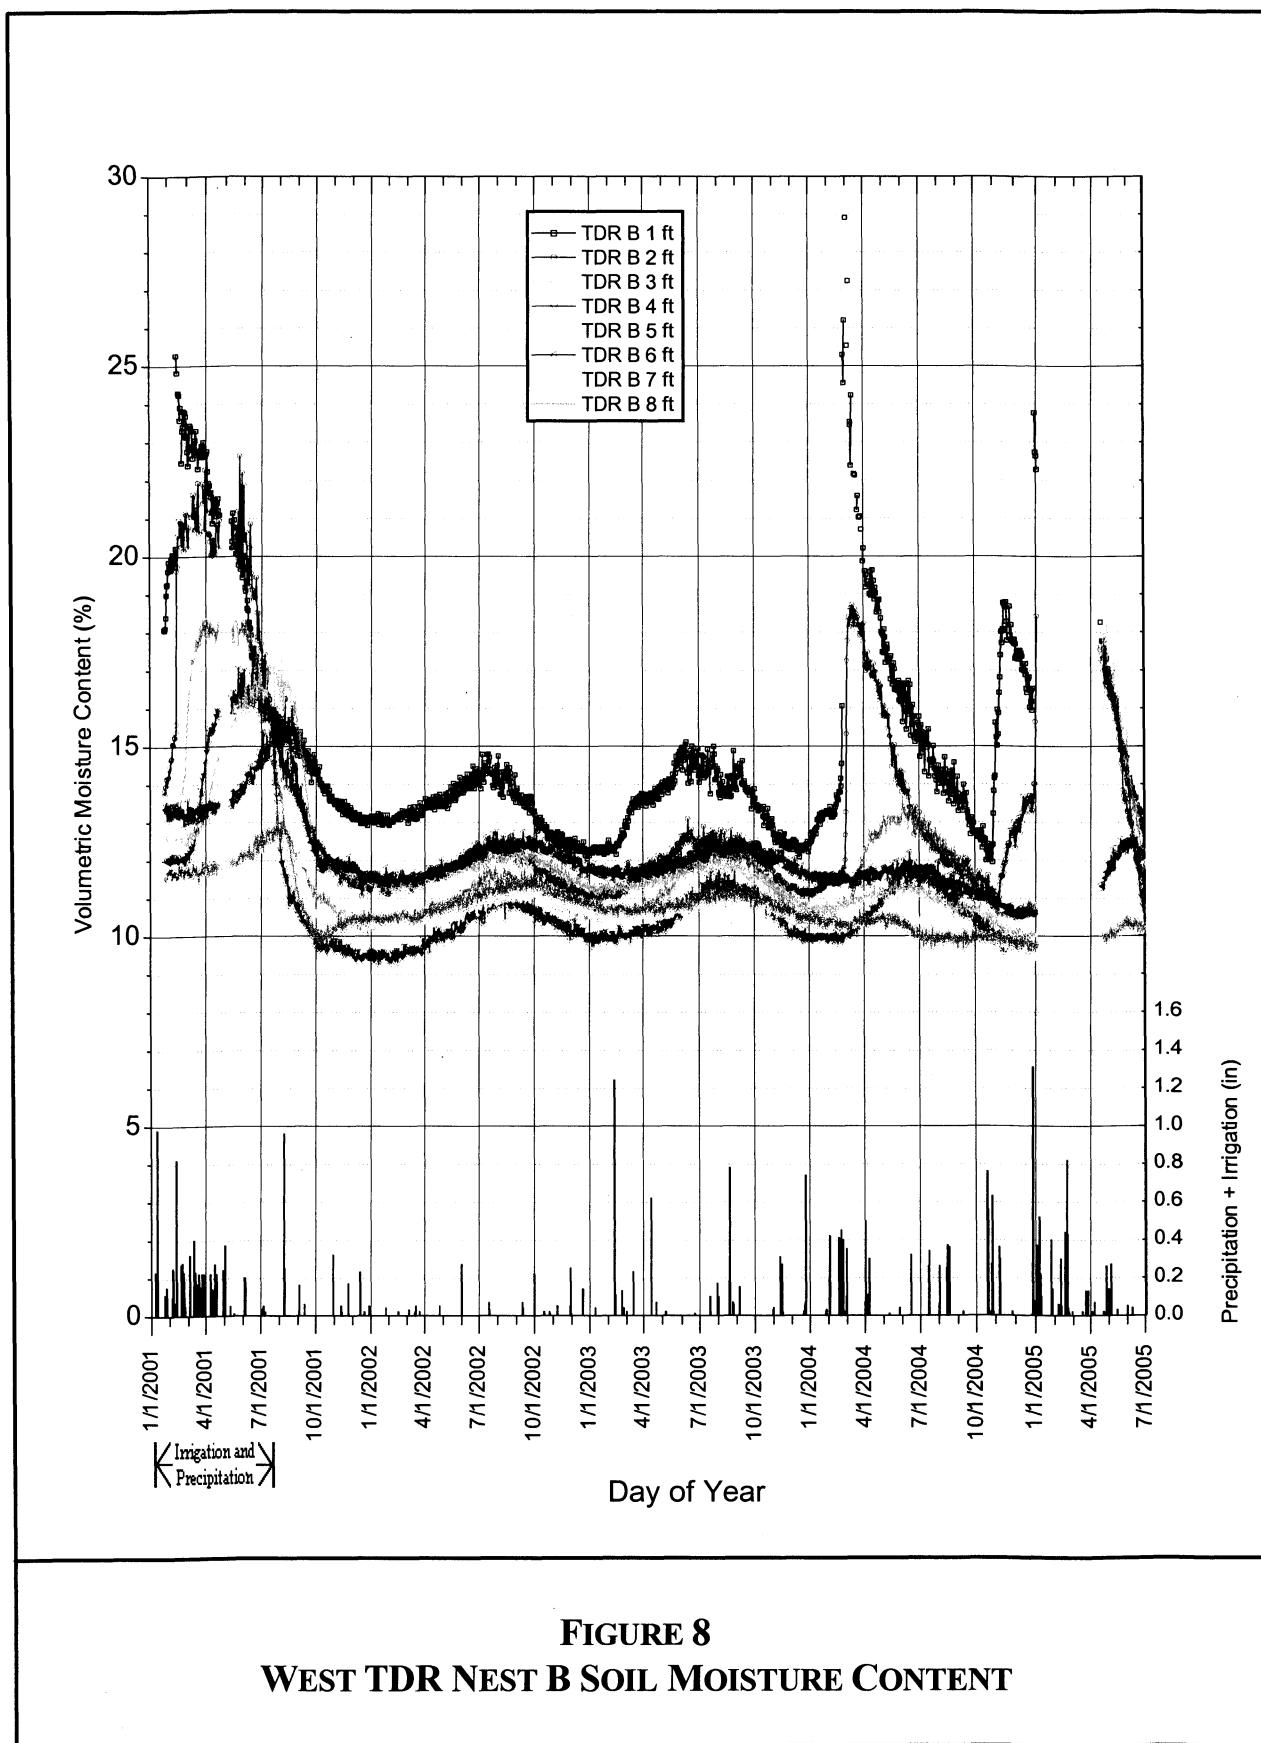
The soil moisture graphs, Figures 5 through 8, show several responses: the initial conditions, the irrigation wetting event, infiltration, and the trend to steady-state conditions. The initial conditions at the beginning of the data collection reflect the disturbed soil's intrinsic moisture conditions. The installation of the TDR probes is described in detail in the CAU 110 Closure Report (NNSA/NV, 2001). Health and safety considerations required that hazards caused by dust be minimized during the TDR probe installation; the trenching and compaction of each of the soil lifts required some water to be added to the soils prior to handling. The amount of water added to the soil, while kept to a minimum, was variable and resulted in a vertical moisture content profile that is not necessarily monotonic with depth as would be expected with a natural profile. Consequently, some depths appear wetter than others and will remain so until the system fully equilibrates.

Summer temperatures and germination of the seeds, along with the increase in evapotranspiration have produced the long-term trends, which can be seen in the data from about October 2001 to the present. An annual cycle of increasing soil moisture content at all depths can be observed peaking in August and decreasing to a minimum in January. This seasonal cyclic behavior lags behind the temperature and is most likely a combination of effects caused by the increased thermal gradient, water vapor transport from depth, and the lack of transpiration of plants during the hot summer months.

The TDR data indicate that the soil moisture content in the CAU 110 cover had been approaching steady-state under the prior drought conditions. A small amount of infiltration from the January through March 2005 precipitation events has reached down to 2.1 m (7 ft) in the cover at some of the TDR nests, and can be seen as a 2 percent increase in soil moisture content at 2.4 m (8 ft) in the East TDR Nest A data. Soil moisture content values on the TDR nests at depth are generally between 10 and 15 percent VMC, while moisture content on near surface probes increased significantly due to the heavy precipitation received between January and March 2005. Moisture content values between 25 and 30 percent VMC extended to 1.5 m (5 ft) on all the TDR nests and then showed progressive drying in the near surface to less than 10 percent VMC by the end of June. The wetting front on the West TDR Nest A has caused a loss of signal due to the high moisture content (greater than 30 percent VMC) at the 1.5-m (5-ft) depth in conductive soil. It is expected that data for this probe will recover as evapotranspiration lowers the soil moisture content and the VMC returns to the normal operating range.

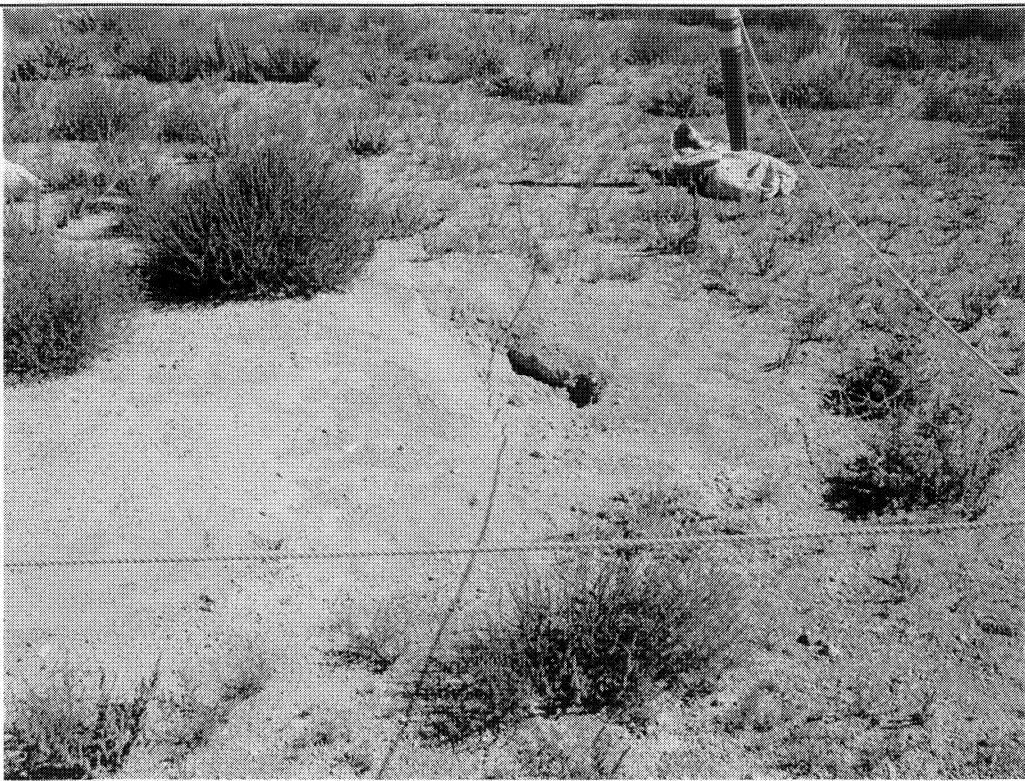
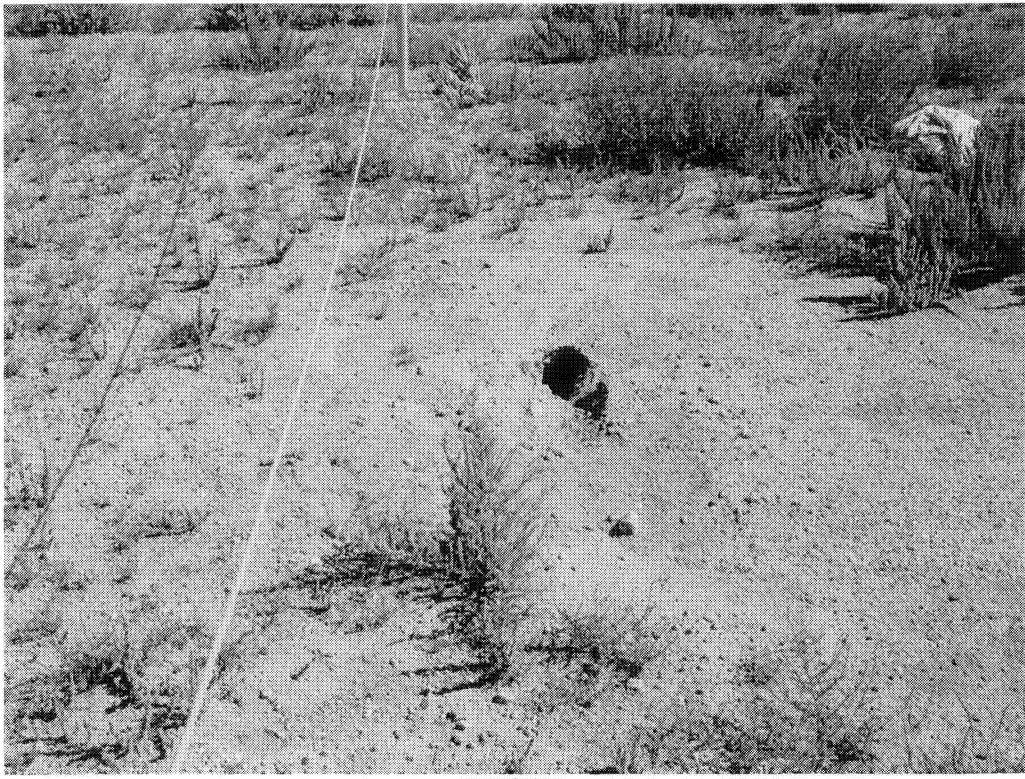
- Two areas of cracking and settling (one along the east side of the cover and one along the southeast side of the cover) were at actionable levels. The area along the east side of the cover had been repaired on three previous occasions.
- Animal burrows were noted on the cover.
- The condition of warning signs, fencing, subsidence monuments (SMs), and cover vegetation was good.

9. Subsidence area along east side of cover.

10. Subsidence area along east side of cover.

- Continue inspections as scheduled.
- Repair the two areas of cracking and settling.

During the September 14, 2004, inspection, two areas of settling (one along the east side of the cover and one along the southeast side of the cover) exceeded the settling compliance criterion. The area along the east side of the cover had been repaired on three previous occasions. The two areas were repaired on October 25, 2004. A portable, gas-powered tamper was used to collapse the cracks and open up the void spaces to the surface. The areas were then backfilled with clean soil using wheelbarrows and shovels, and compacted using the tamper. During the repair, a third system of cracks was noticed near the area along the southeast side of the cover. This area was also repaired during this time. Field notes for this repair are included in Appendix A.

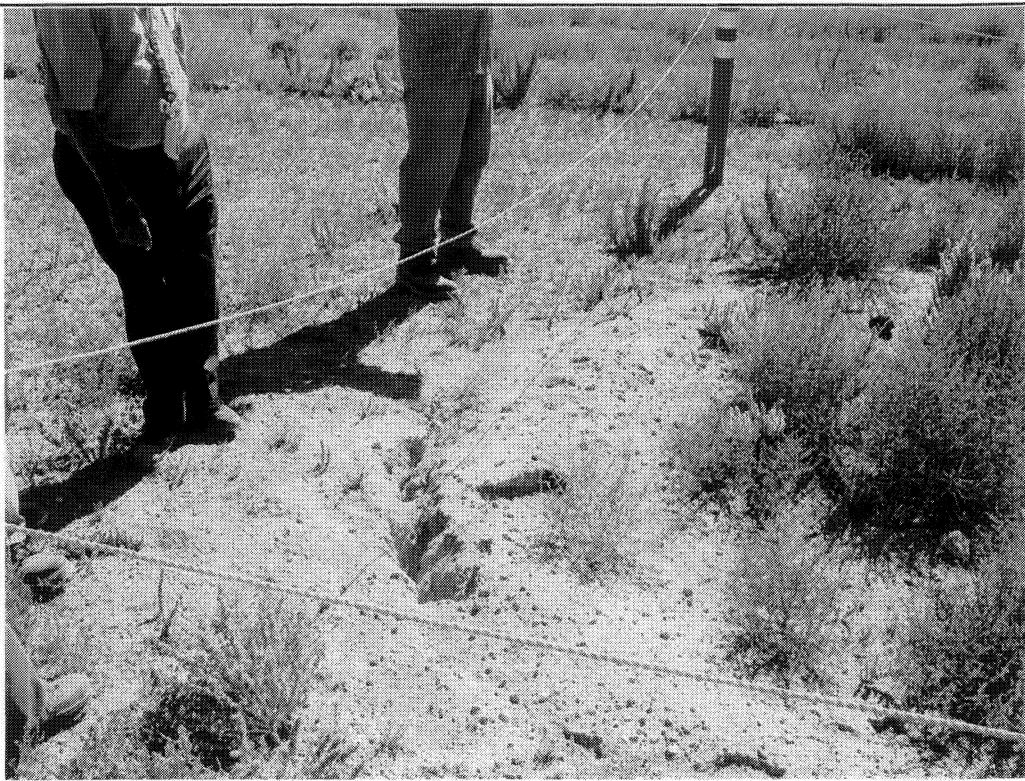
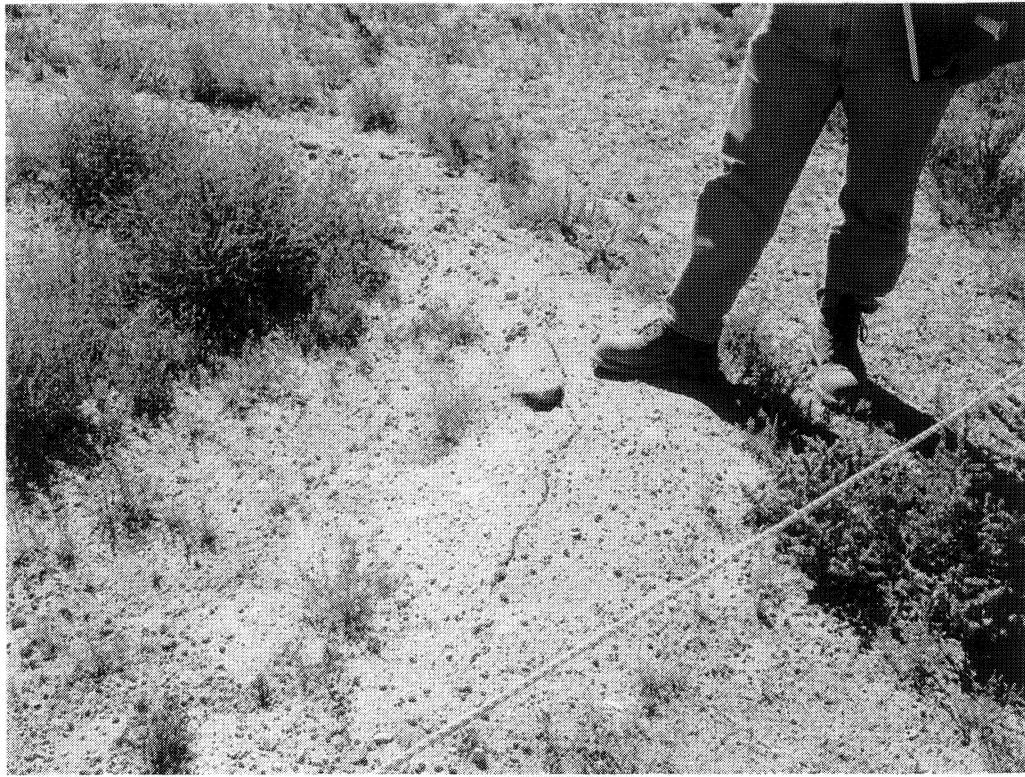
9/14/2004
11. Subsidence area along southeast side of cover.

9/14/2004
12. Subsidence area along southeast side of cover.

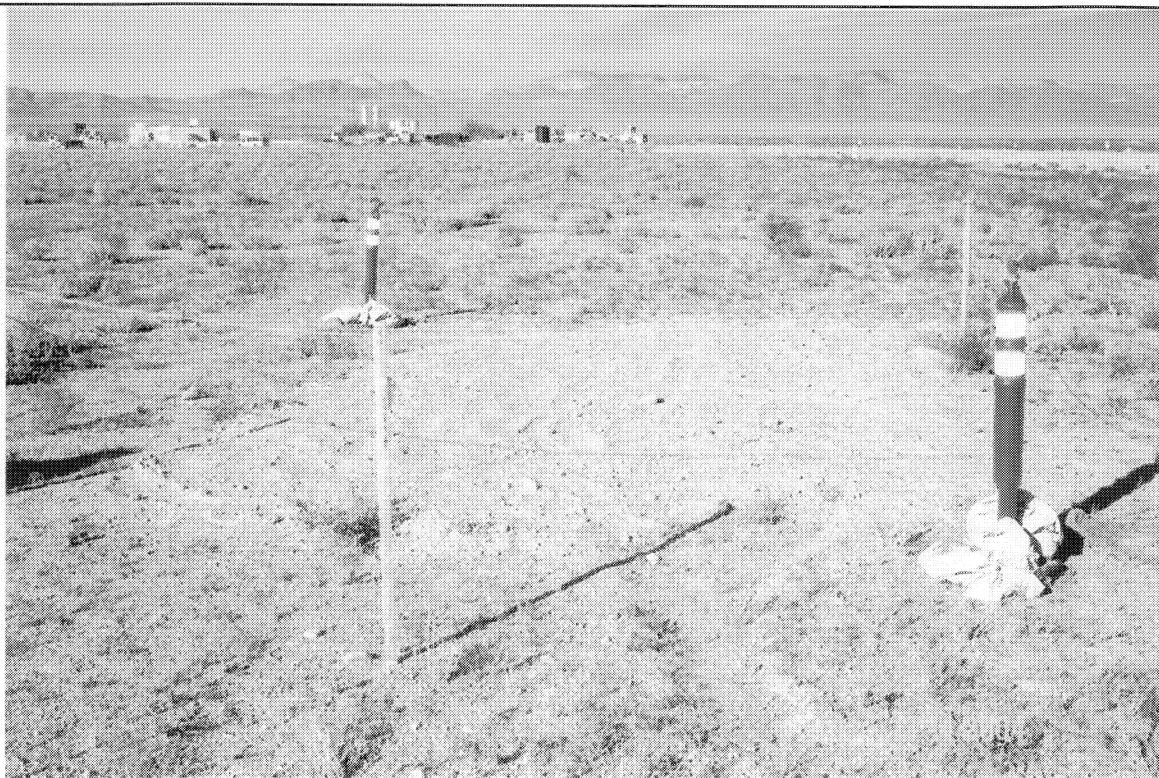
- The two areas of cracking and settling were repaired on October 25, 2004, and were in good condition during this inspection, with no indication of further cracking or settling.
- Animal burrows were noted on the cover.
- The condition of warning signs, fencing, SMs, and cover vegetation was good.

9. Repaired area along east side of cover.

- Continue inspections as scheduled.
- Monitor repaired areas for evidence of further settling.

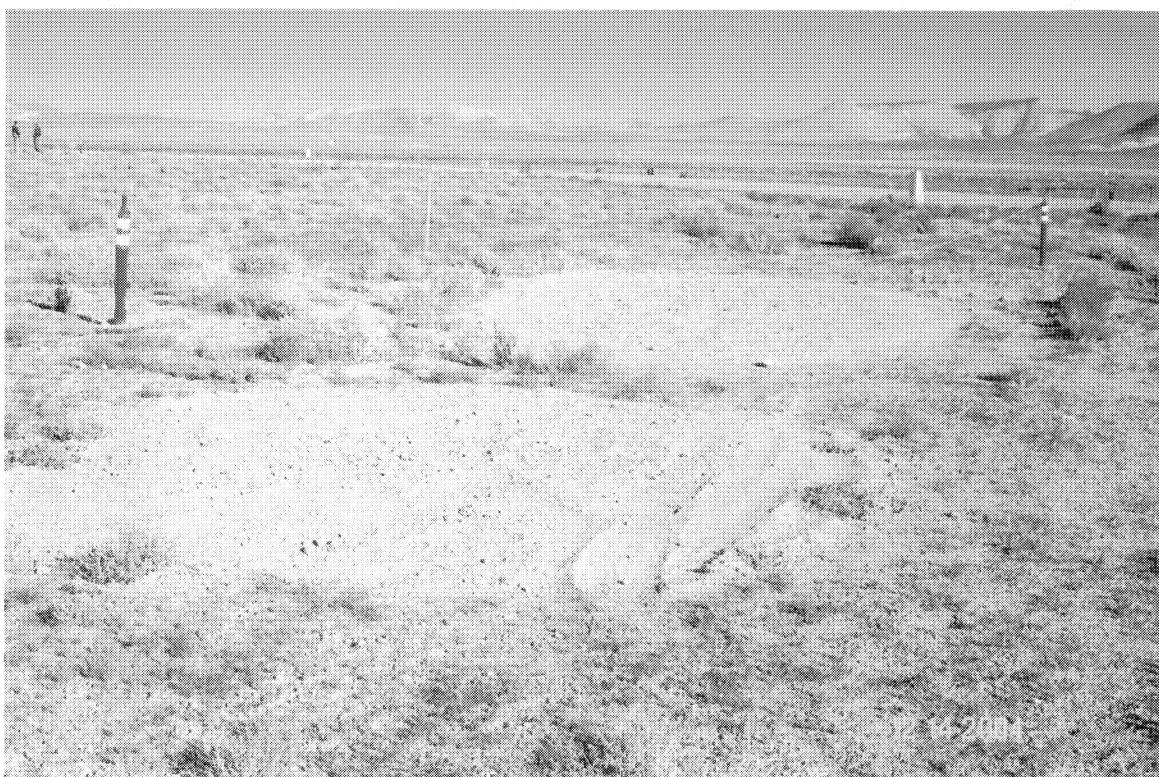
10. Two repaired areas along southeast side of cover.

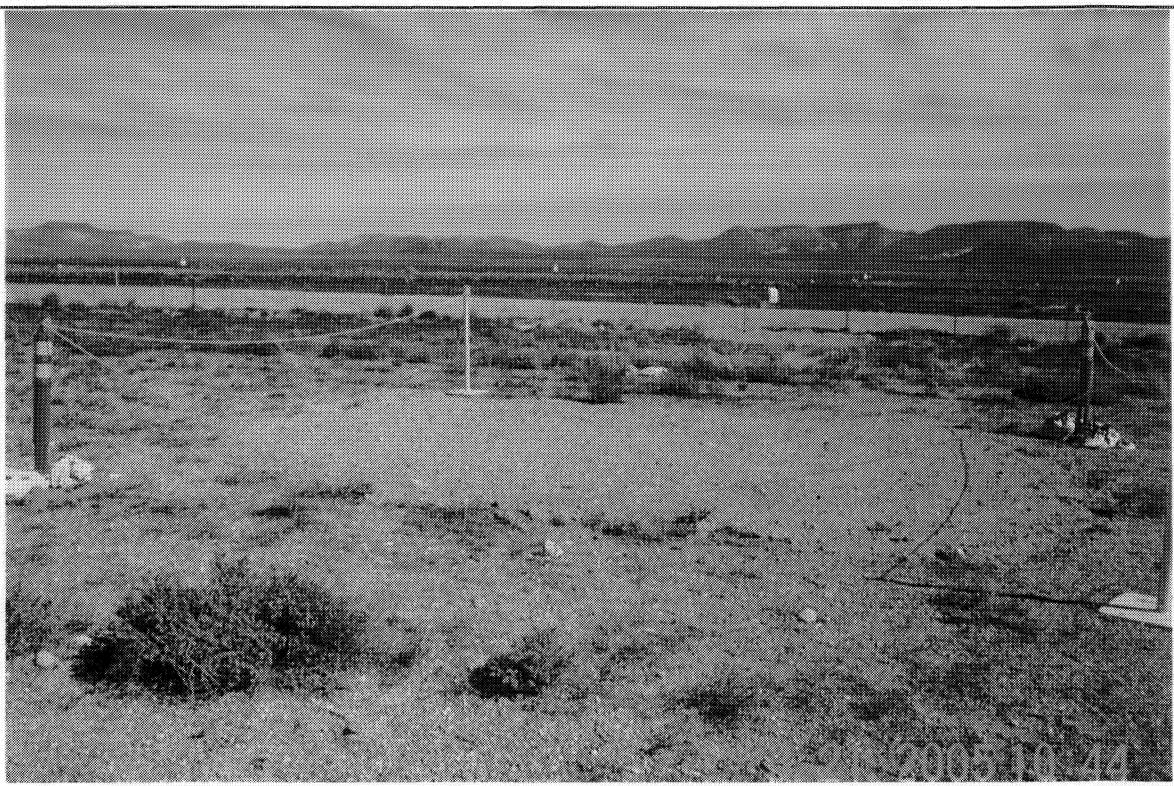
- The previously repaired areas were in good condition with no indication of cracking or settling.
- Animal burrows were noted on the cover.
- The condition of warning signs, fencing, SMs, and cover vegetation was good.

9. Repaired area along east side of cover.

- Continue inspections as scheduled.
- Trap and relocate small mammals in approximately April, June, and September of 2005.
- Monitor repaired areas for evidence of further settling.

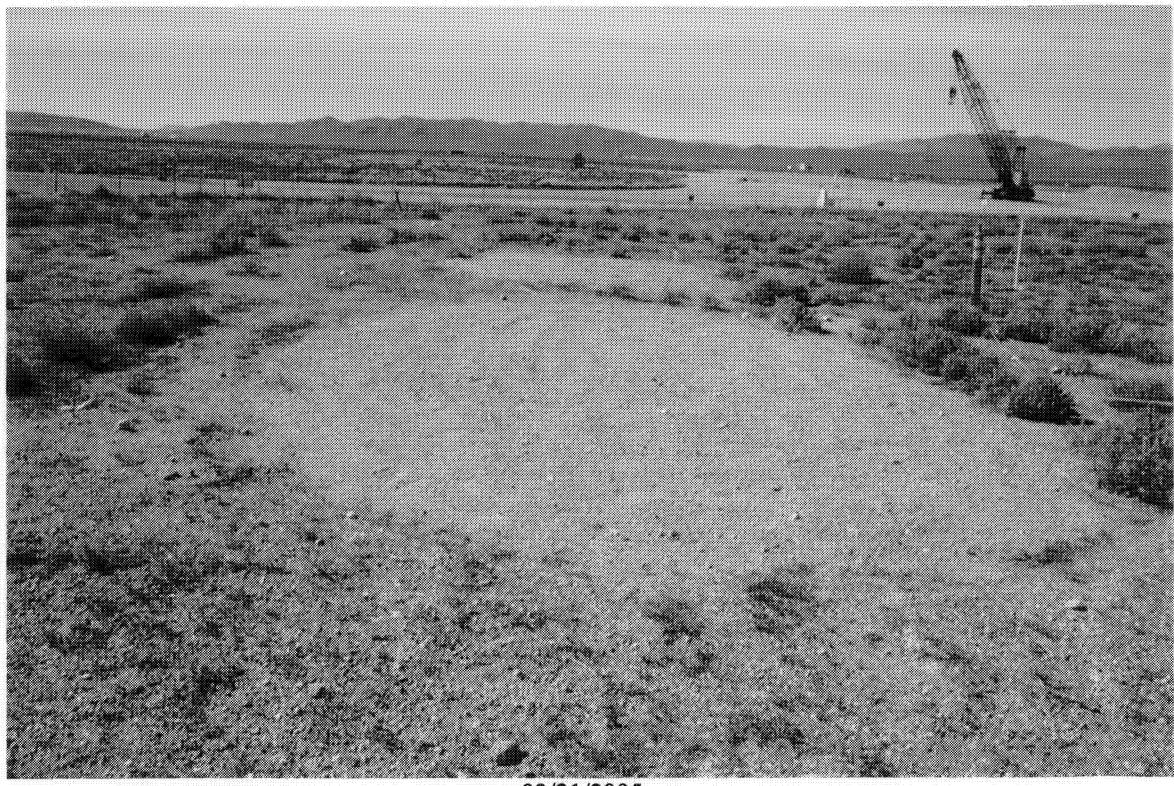
10. Two repaired areas along southeast side of cover.

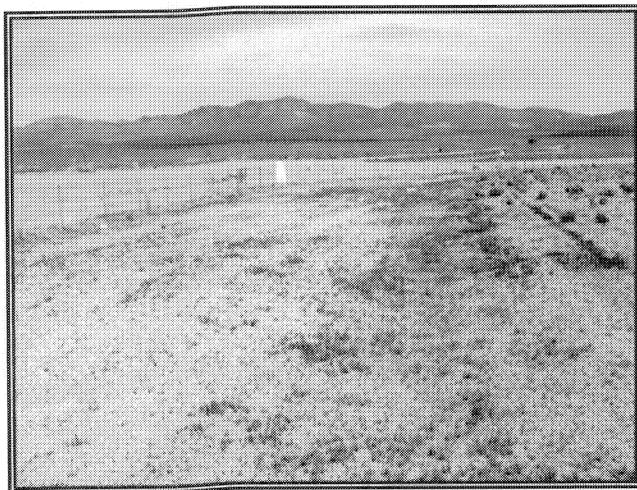
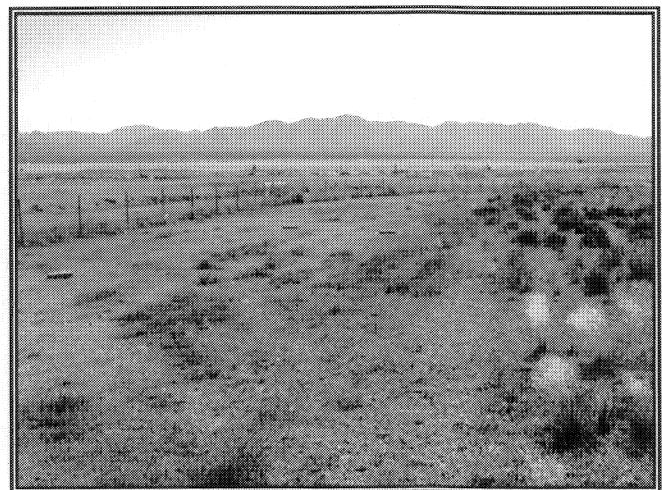
Figure 3. Invasion of weedy annual plants on the periphery of the closure cover. Photograph on left is from 2004 and shows beginning of invasion of Russian thistle and halogeton. The photograph on right was taken in 2005 and shows larger annual plants but no perennial plants.

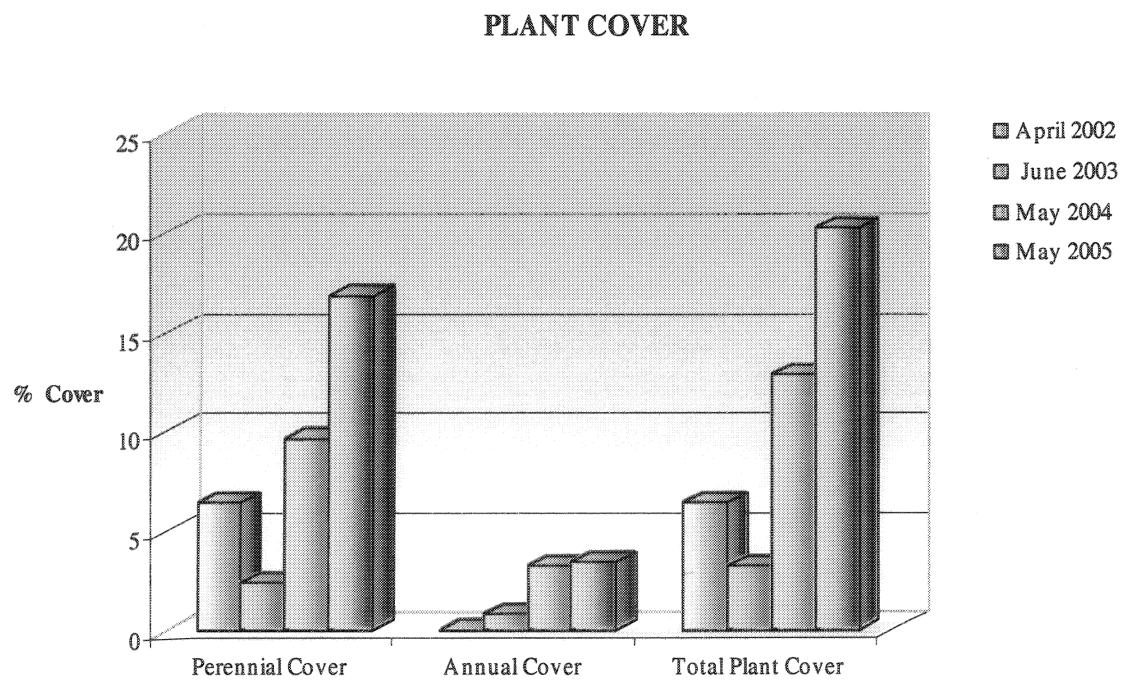
The trend in total plant cover over the last 4 years is as would be expected. After an initial flush of growth the second year after reseeding, due primarily to supplemental irrigation, plant cover declined in 2003 (Figure 5). Natural precipitation was below normal in 2003, as it had been in 2001 and 2002. Without supplemental irrigation, germination would have been less successful, and total plant cover would probably have been even lower than what was experienced the first three years after reseeding. It is due to the 17 percent plant cover this year that the native plant community on the closure cover is viable and able to endure the fluctuations in precipitation that is more typical than atypical for this region (Figures 8-12). The species of plants used in the revegetation process

Figure 5. Summary of total plant cover on the U-3ax/bl closure cover from April 2002 to May 2005.

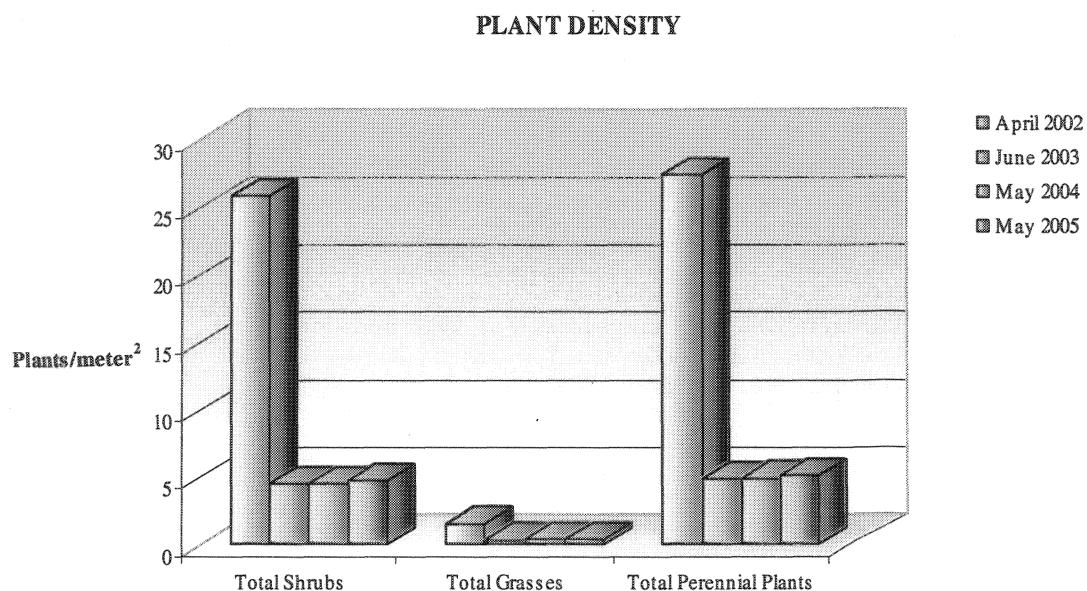
Figure 6. Summary of perennial plant density on the U-3ax/bl closure cover from April 2002 to May 2005.
