# Walla Walla River Basin Fish Habitat Enhancement Project

Annual Report 2002 - 2003

DOE/BP-00006414-3

Jed Volkman, Fish Habitat Biologist

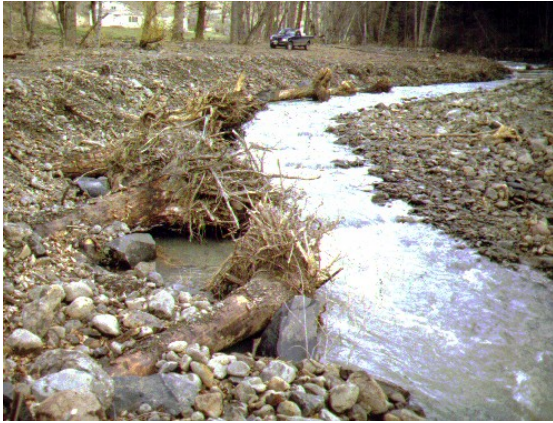
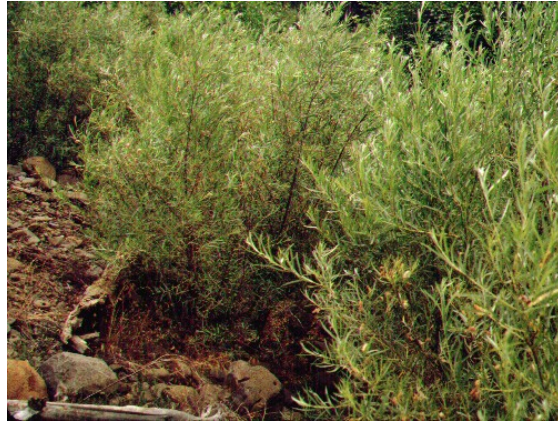
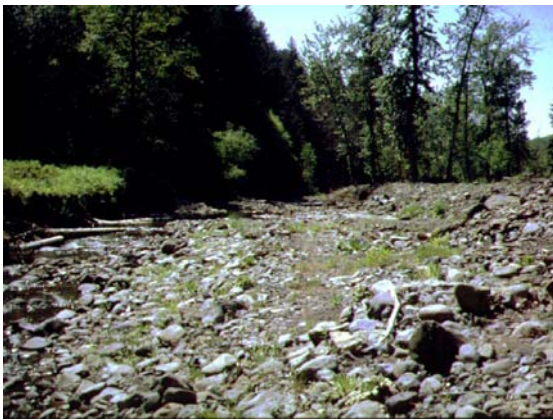
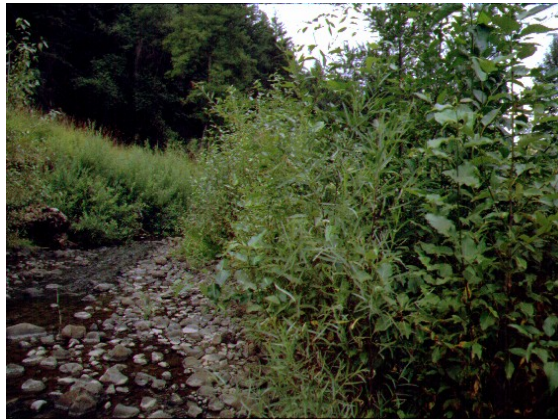
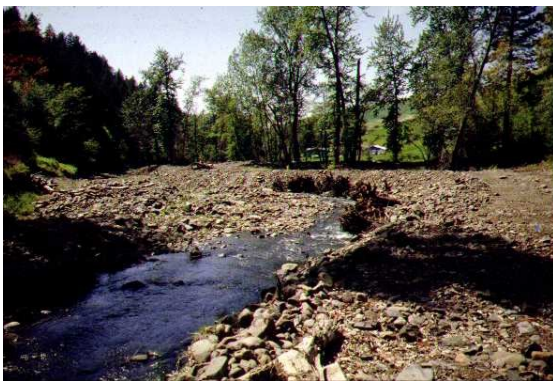
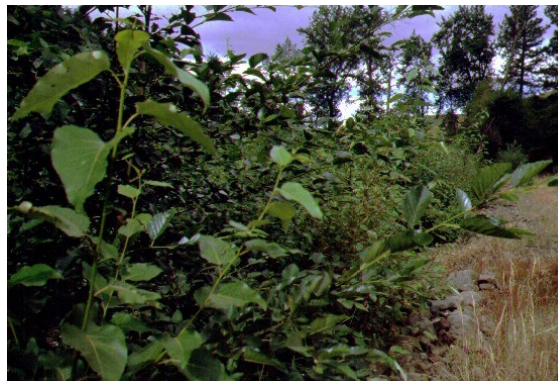
The following photo points portray the significant floodplain and channel form recovery that has occurred at this project site.

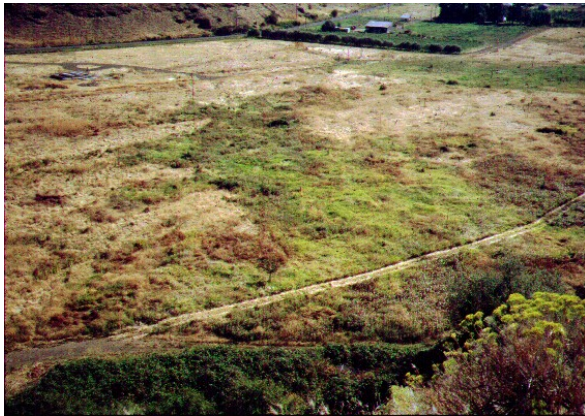
**August 1998**

In March of 2003, Wild West Riparian of Walla Walla was hired to install an additional 3,000 (tarps are 15 feet wide) feet of weed barrier tarp. The tarps were installed in sections of the field lacking natural tree and shrub recruitment. Several thousand tubling plants were then placed into the tarps by CTUIR habitat staff. The new tubling plants were watered several times during the drought months of July through September.

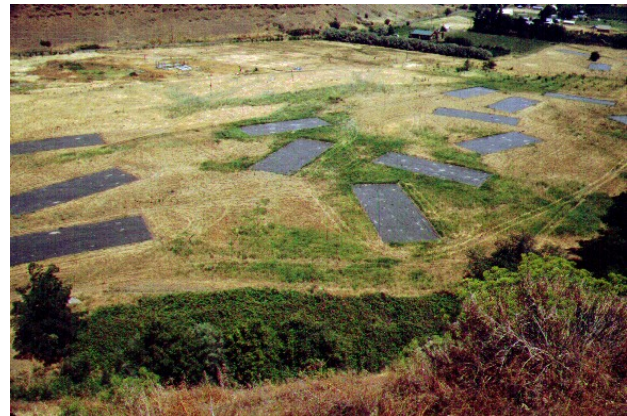
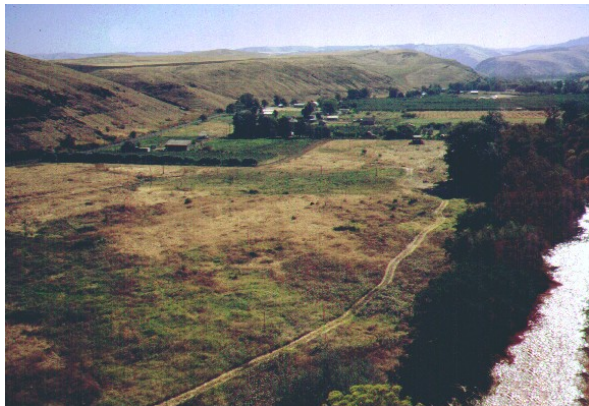
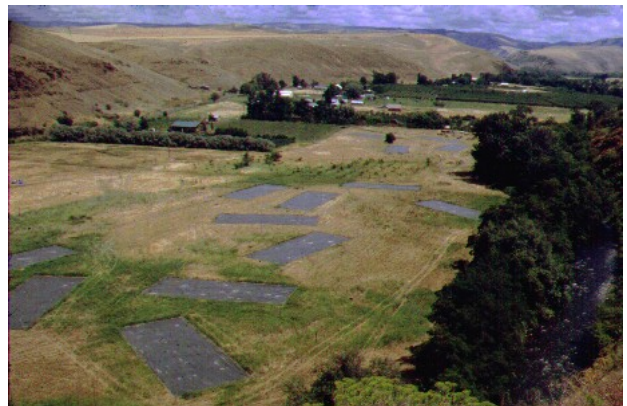
**July 2001**

Monitoring data for this project site was presented in the 2001 Annual Report of Progress and will be repeated in 2005.

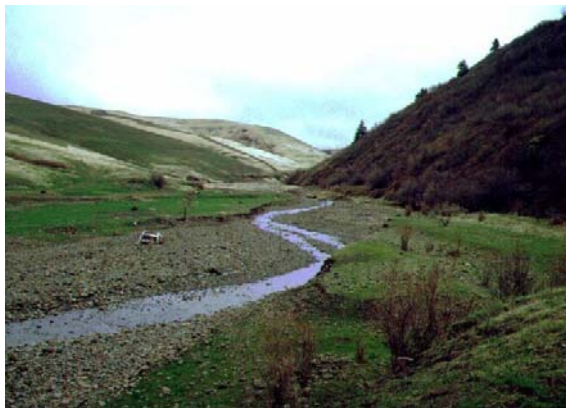
**December 1999**

A 15 year riparian easement was signed with the landowner in December of 1999 and in February of the following year a livestock exclusion fence was constructed. It was decided to forego the use of any bare-root stock plants at this site because of the poor soil conditions, and the harsh summer environment. Instead the project chose to hasten recovery through the installation of willow cuttings which when placed below the water line are self-watering. Several thousand native willow cuttings were collected nearby on the North Fork of the Walla Walla River and placed with an excavator during the fall of the 2000 reporting period. Survival of the cuttings was higher than 80% the following spring but as summer progressed and stream flows eventually stopped many of the plants began to die. By the summer of 2003 approximately 40% of the willows were growing and dozens of young cottonwood trees, hawthorne, rose, and various other species are beginning to grow also. We expect that with continued livestock exclusion and time, perhaps decades, the entire riparian corridor will again support a healthy riparian plant community and proper functioning stream channel.

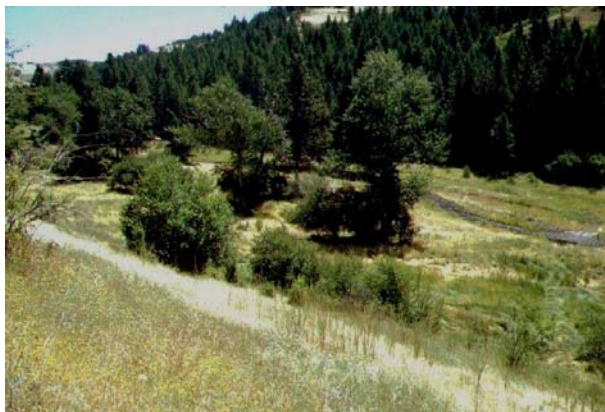
**July 2000**

Today the channel is functioning as we had designed and the willow cuttings placed during implementation are thriving. Some additional floodplain planting of ponderosa pine, willow, and cottonwood have provided mixed results. We will report on the success of these efforts and all other monitoring parameters in 2005.
