TDR-MGR-EV-000019 REV 00
April 2002

Site Release Report for C-Well Pipeline, UE-25 Large Rocks Test Site, and 29 GSF Test Pits

Prepared for:
U.S. Department of Energy
Yucca Mountain Site Characterization Office
P.O. Box 30307
North Las Vegas, Nevada 89036-0307

Prepared by:
Bechtel SAIC Company, LLC
1180 Town Center Drive
Las Vegas, Nevada 89144

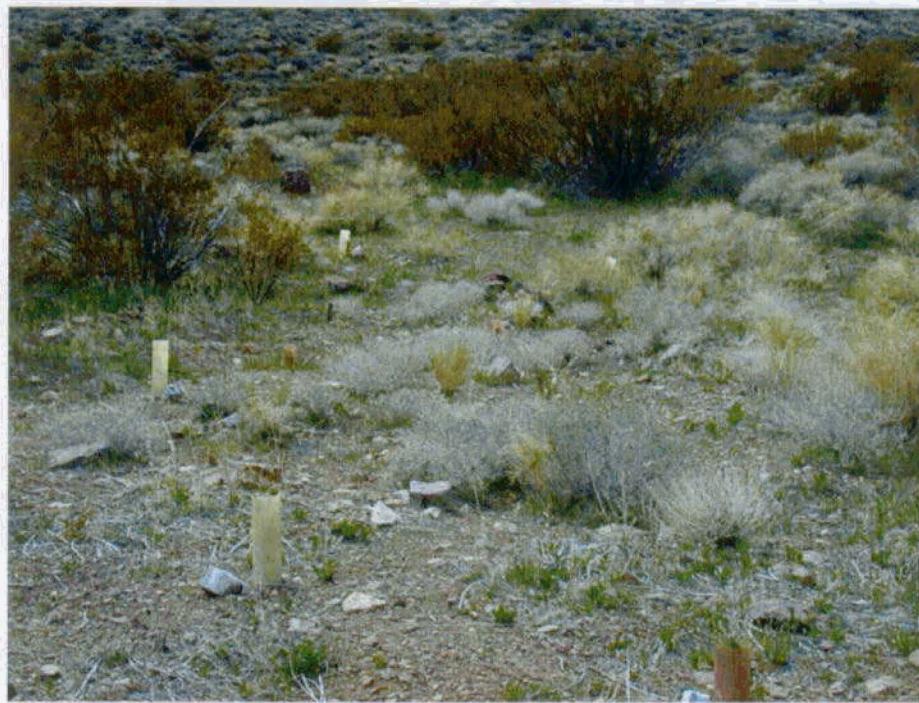
Figure 6. UE-25 GSF TP #24 in the Summer of 2000, Six Growing Seasons after Reclamation

NOTES: The reclaimed pit is visible in the foreground. The site was recommended for release from further monitoring.

Cover was below the criterion for eight of the 29 pits. However, density was above the criterion for five of those pits (11, 13, 23, 34, and 37) and no erosion was observed, suggesting soil stabilization and adequate conditions for establishment. Given time, those existing plants are likely to increase in cover. Additionally, three to eight species were flowering on these pits indicating potential for plant recruitment. Therefore, these five pits and the 21 pits that met the success criteria should be released from further monitoring (see Figure 6 for representative photograph of successfully reclaimed test pits).

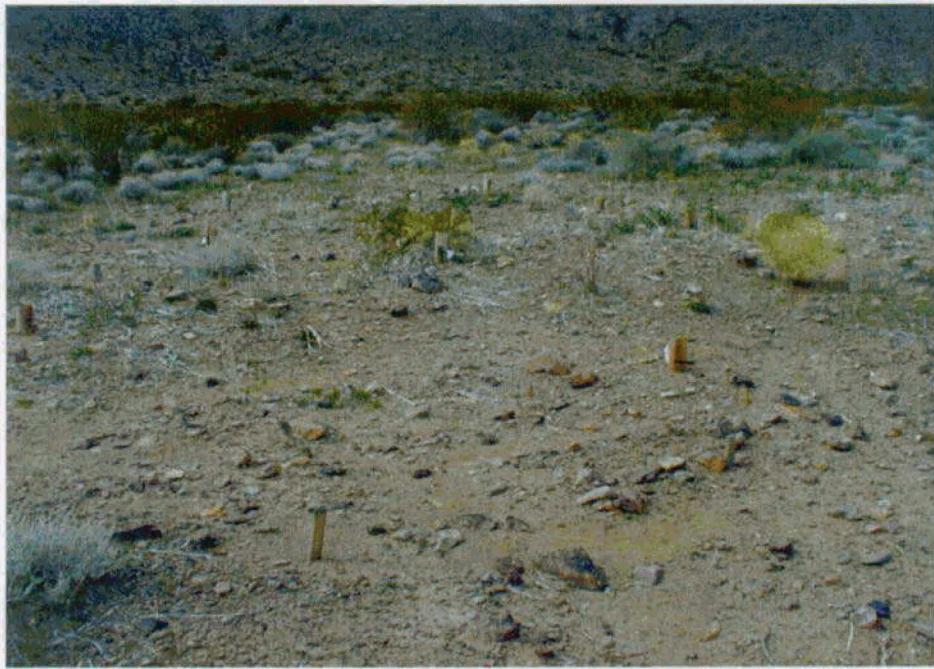
Figure 7. UE-25 GSF TP #20 in the Summer of 2000, Six Growing Seasons after Reclamation

NOTE: Because of low plant density and cover on the pit, the site was not recommended for release from further monitoring.

Cover and density were also below the criteria on pits 19 and 20 (Figure 10). Cover was estimated at 1 percent for both sites, while density was estimated at 0.21 and 0.14 plants/m² for pits 19 and 20, respectively. These values are exceedingly low compared to the criteria (see Figure 7 for representative photograph). Seven perennial species were observed at both sites (Appendix A); however, they were listed as rare or widely scattered. At pit 19 *B. rubens* was common, suggesting the possibility of an exotic weed problem. At pit 20 the presence of two exotic weed species was noted (*B. rubens* and *Salsola kali* [Russian thistle]) but these were rare to widely scattered. Based on the success parameter values and attributes for these two sites, remediation was performed in 2001 and another year of monitoring is recommended.

Twenty nine of the 31 sites that were six growing seasons old in 2000 exhibited characteristics that suggested an acceptable level of recovery had been reached and are recommended for release from further monitoring. GSF Test Pits 19 and 20 had low plant cover, low density, and key attributes that were of concern. These sites are not recommended for release and were remediated with addition of transplants in 2001.
