DOE/NV--1170

Amchitka Mud Pit Sites 2006 Post-Closure Monitoring and Inspection Report Amchitka Island, Alaska

September 2006

Prepared by Stoller-Navarro Joint Venture

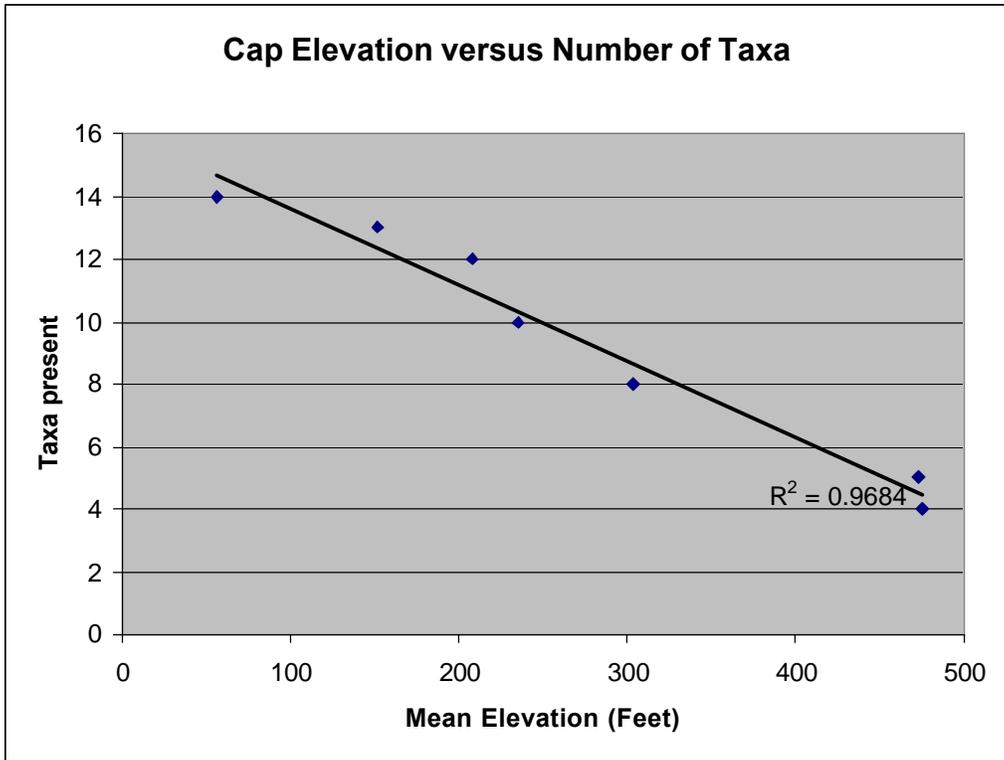
Figure 2.4

Species diversity showed inverse correlation with cap elevation (Figure 2.4). Cap E, the highest cap, had a total of only four observed taxa (moss, *F. rubra*, *D. behringensis*, and *Lupinus nootkatensis*) while Cap RR, the lowest cap, had a total of 14 taxa observed (including all four taxa observed at Cap E along with *Achillea borealis*, *Agrostis borealis*, *Anaphalis margaritacea*, *Carex macrochaeta*, *Cerastium beeringianum*, *Conioselinum chinense*, *Epilobium latifolium*, *Equisetum arvense*, *Poa stenantha*, and *Rhinanthus minor*). The higher diversity of taxa on the lower caps suggests that invading species are more readily established under the relatively hospitable conditions of the Crowberry Meadow Community of Amundsen (1972).

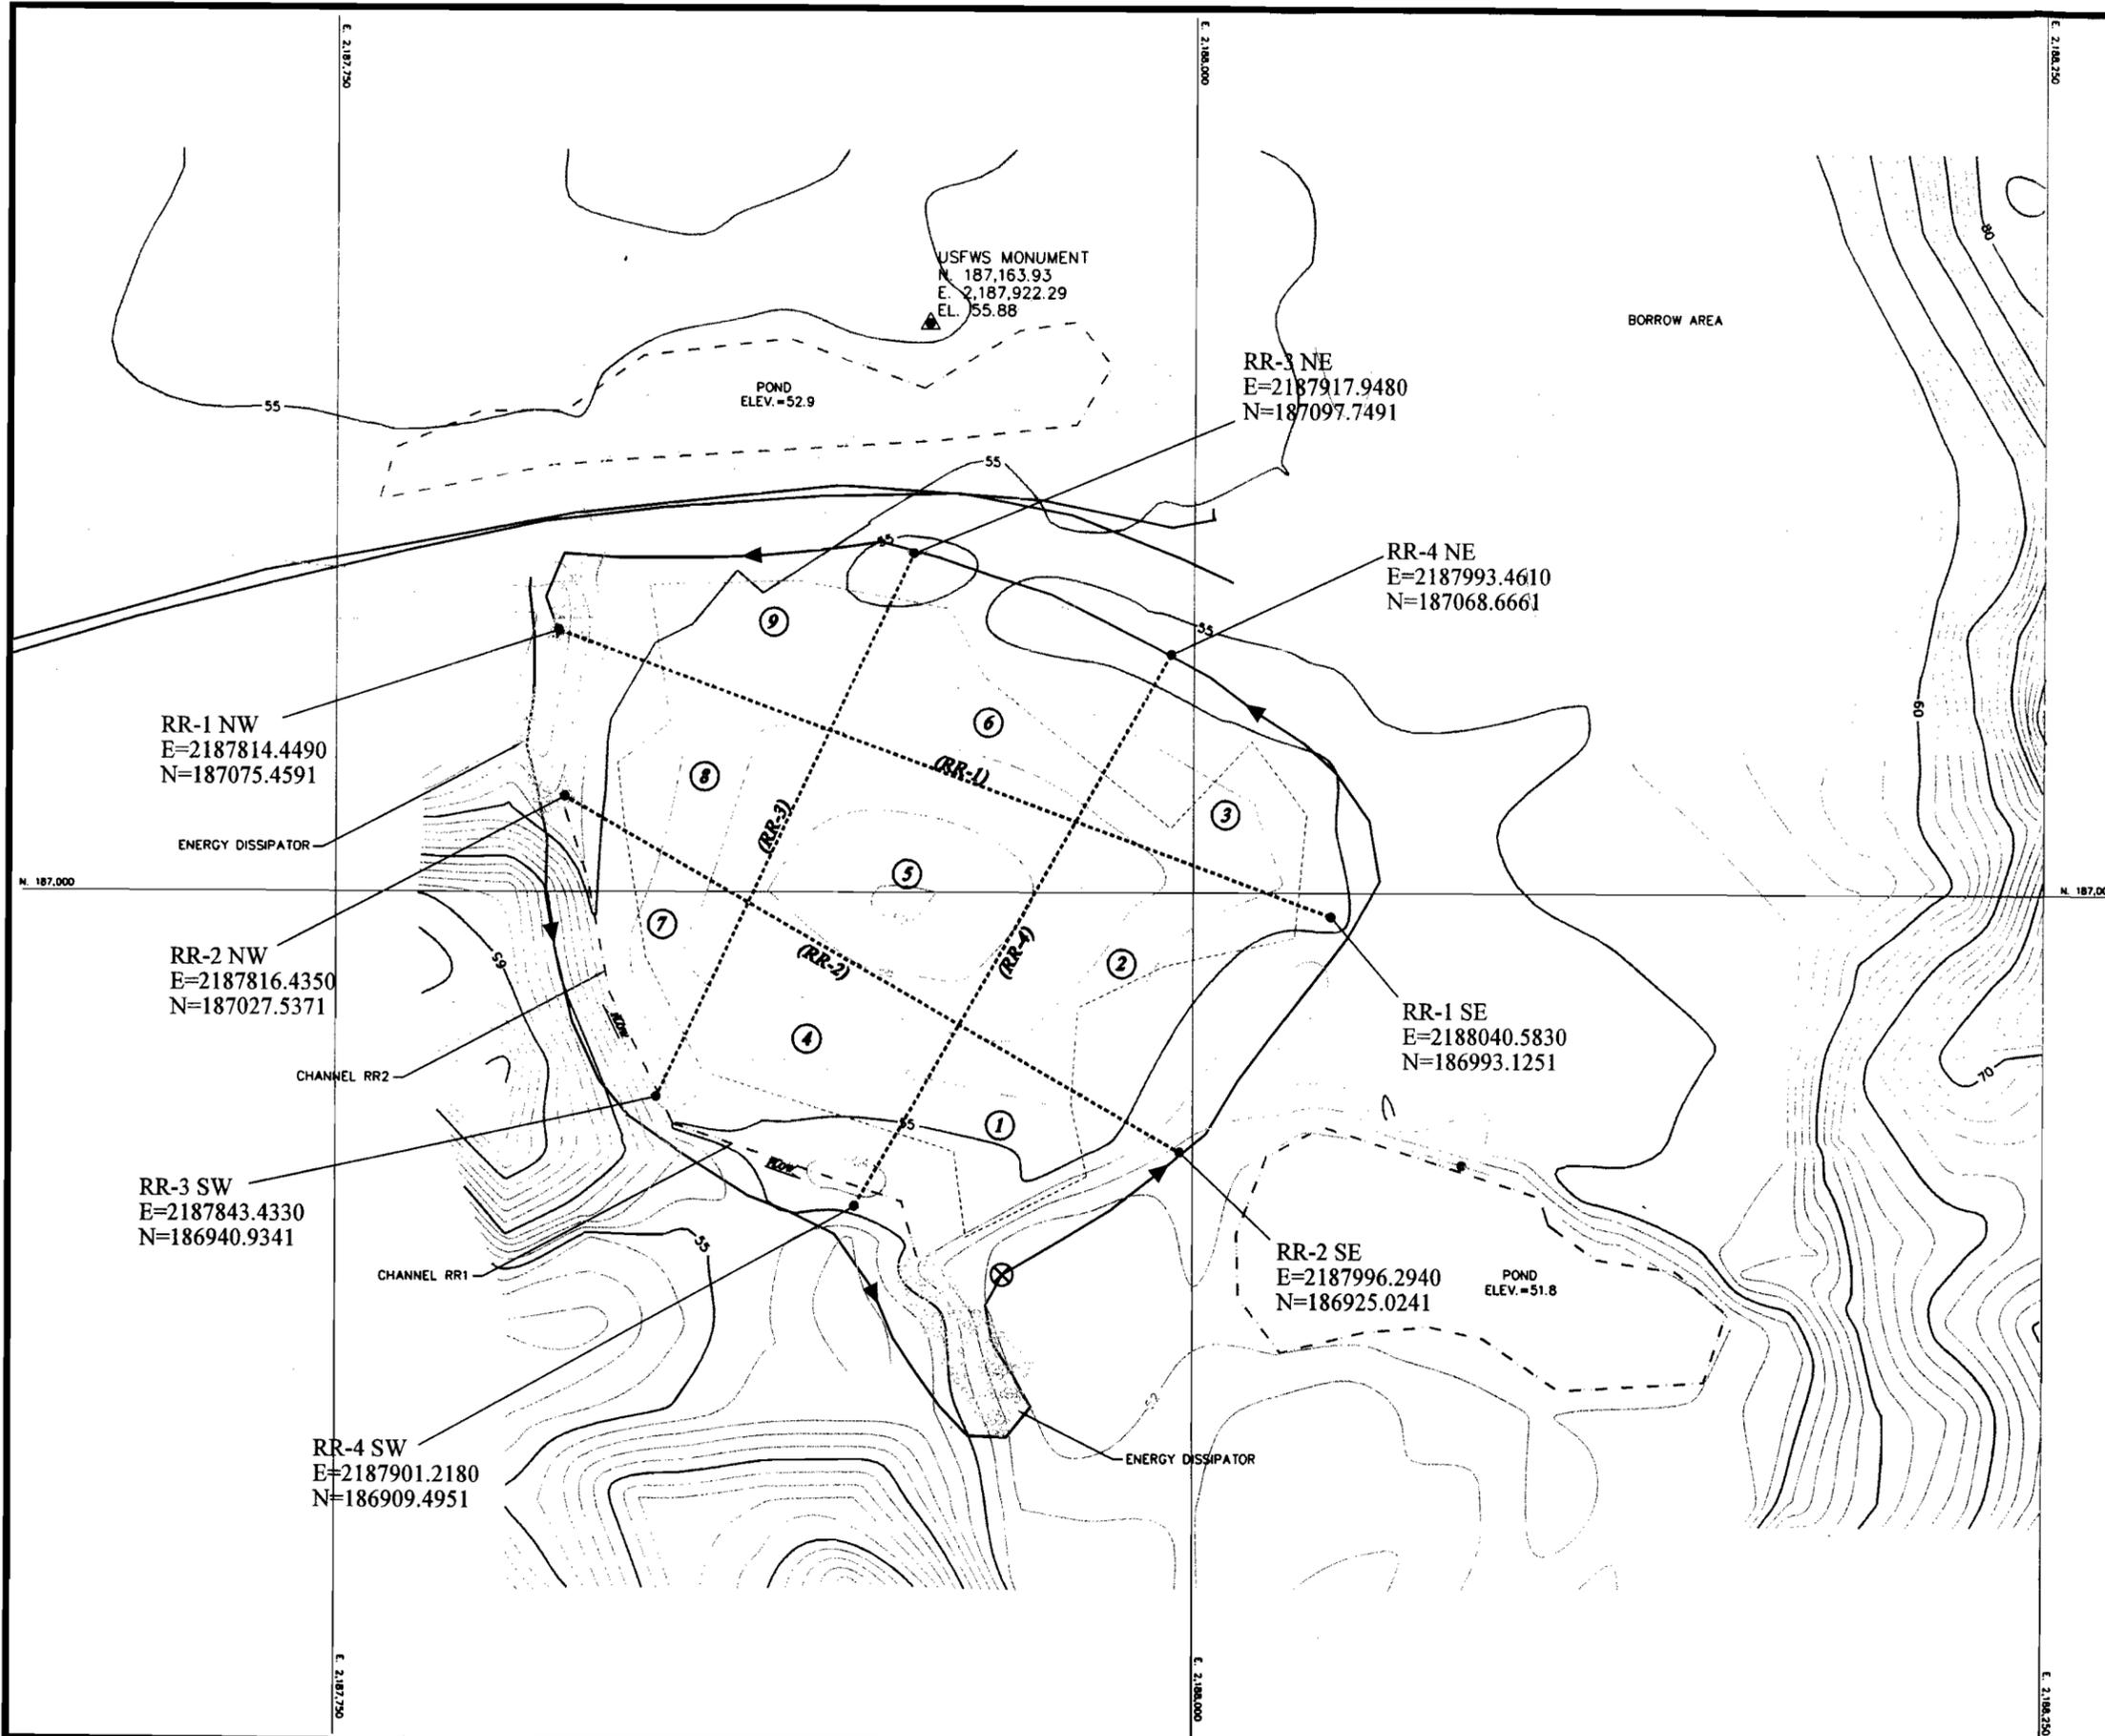
1.0 Rifle Range

- ① Vegetative Cover Grid Area
- Transect/Photopoint
- ⊗ Starting Point
- ➔ Visual Inspection Route

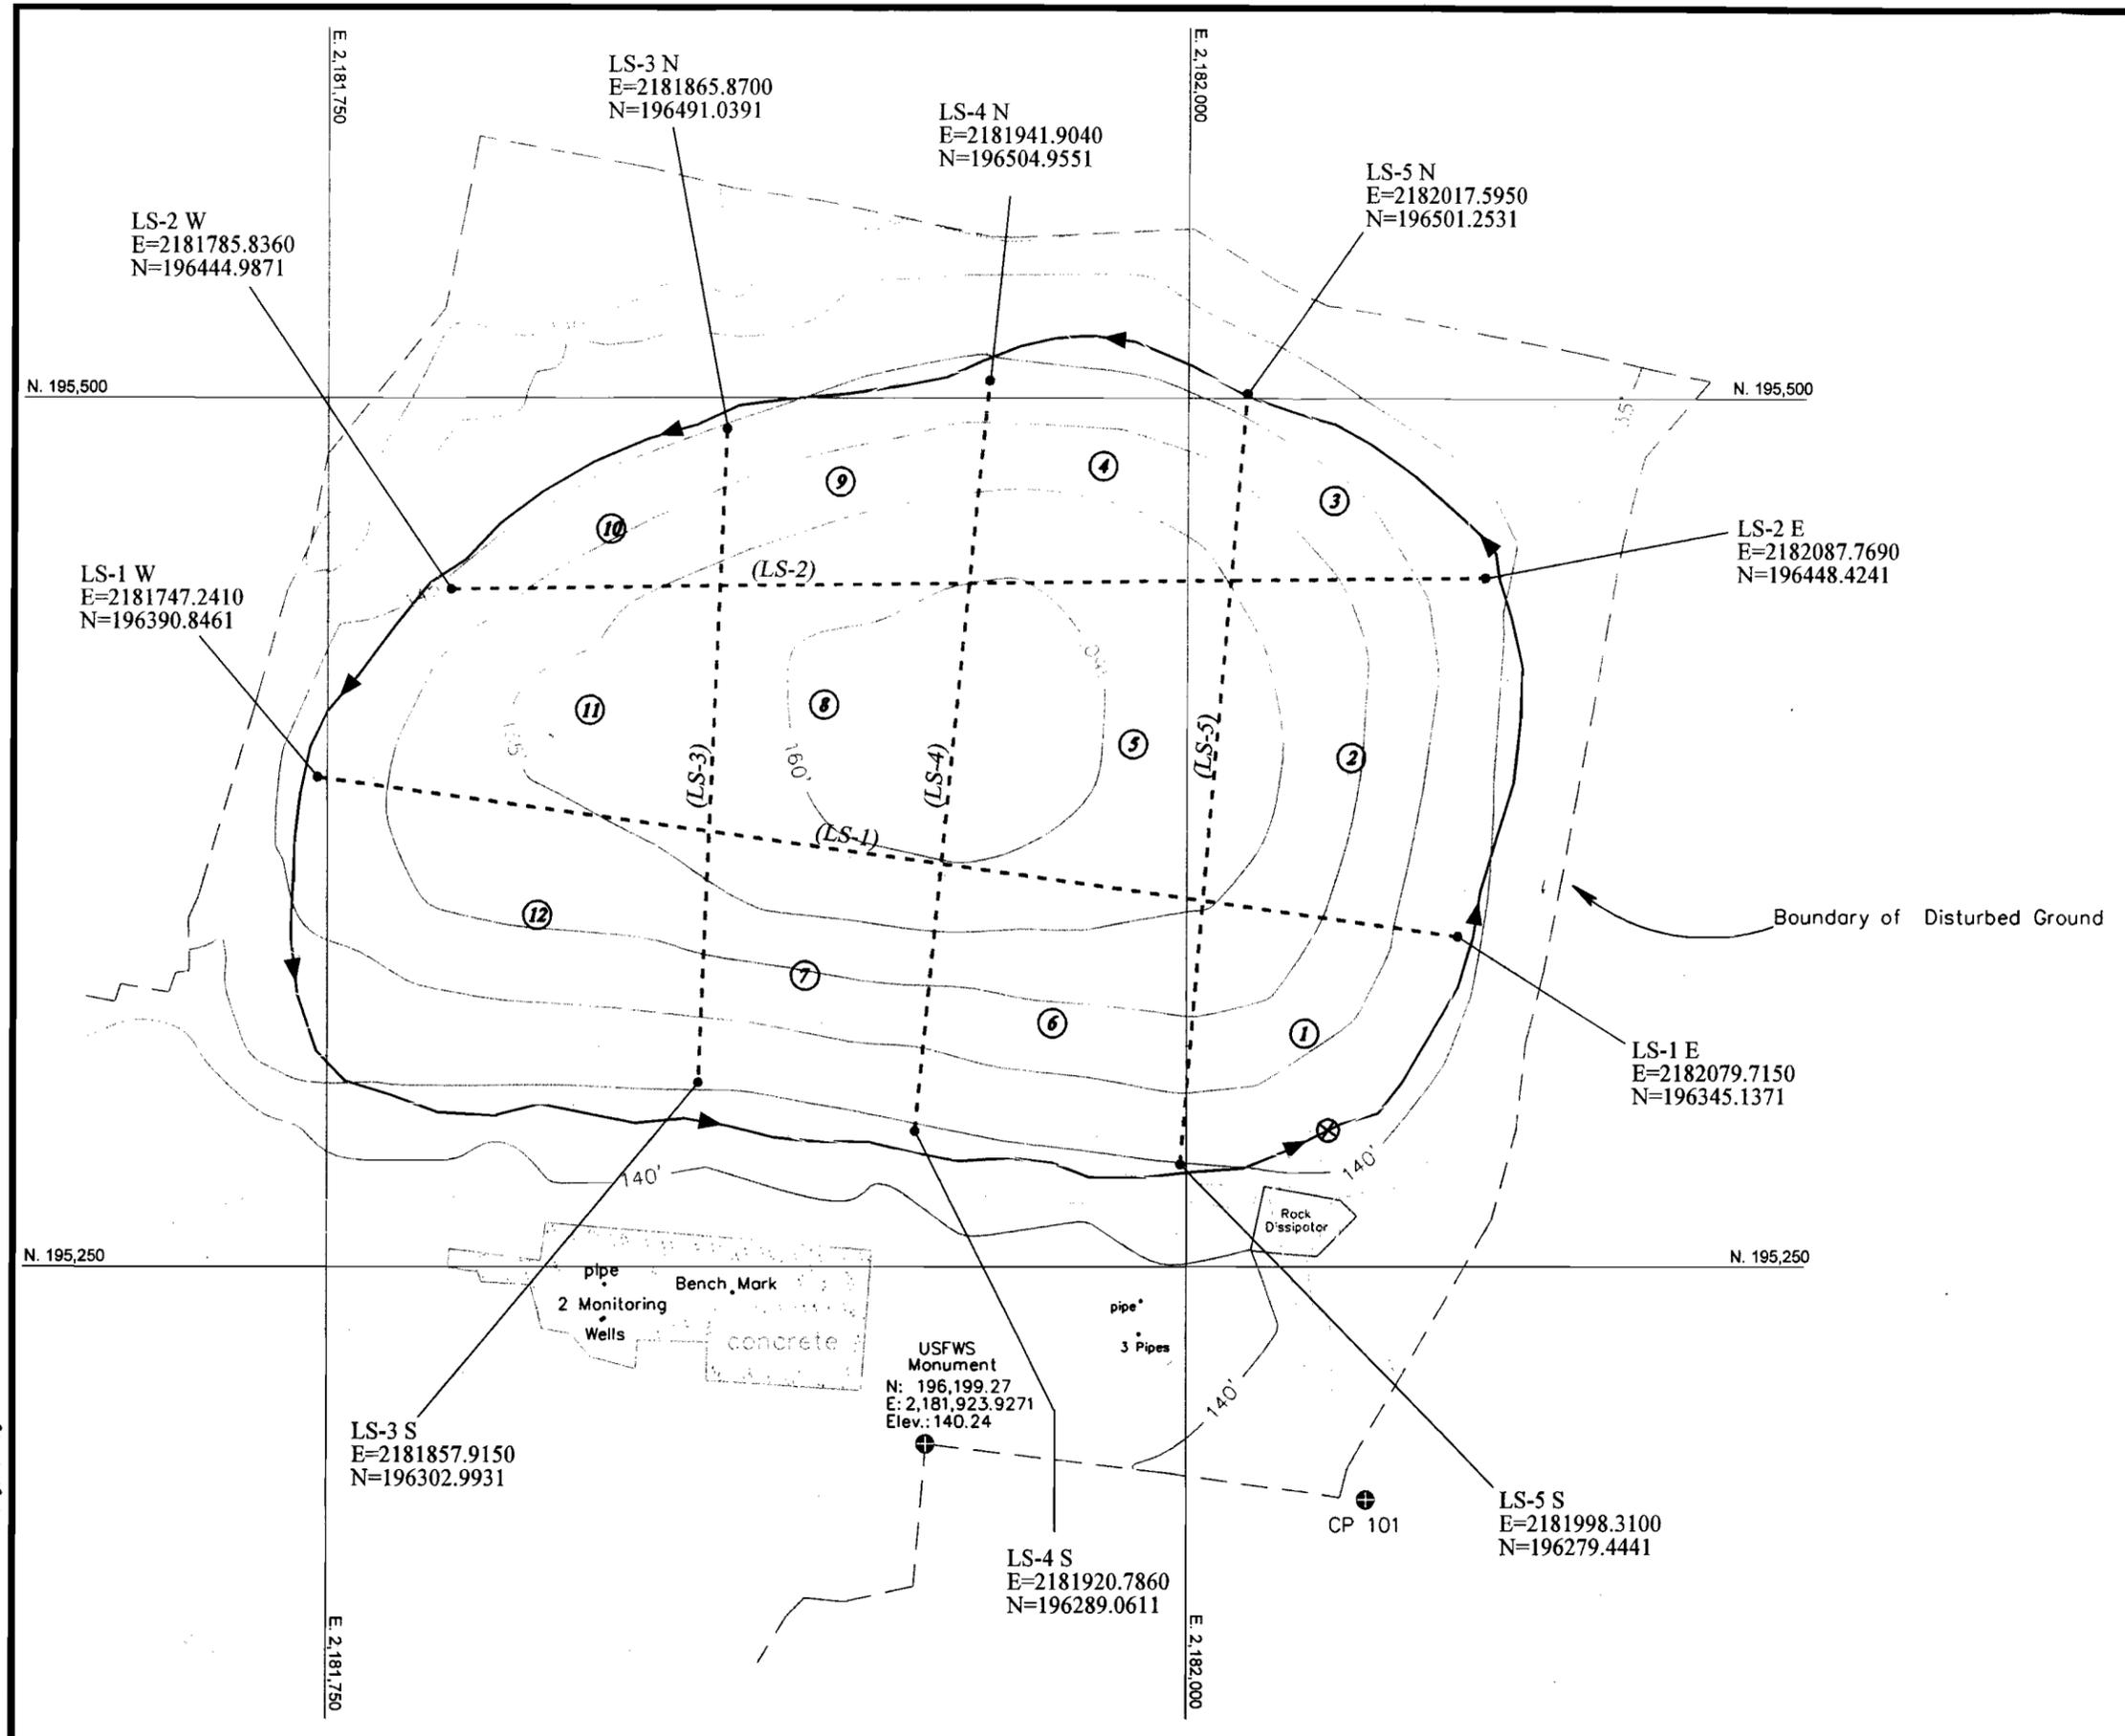
2.0 Longshot

- Explanation**
- (1) Vegetative Cover Grid Area
 - Transect/Photopoint
 - ⊗ Starting Point
 - ➔ Visual Inspection Route

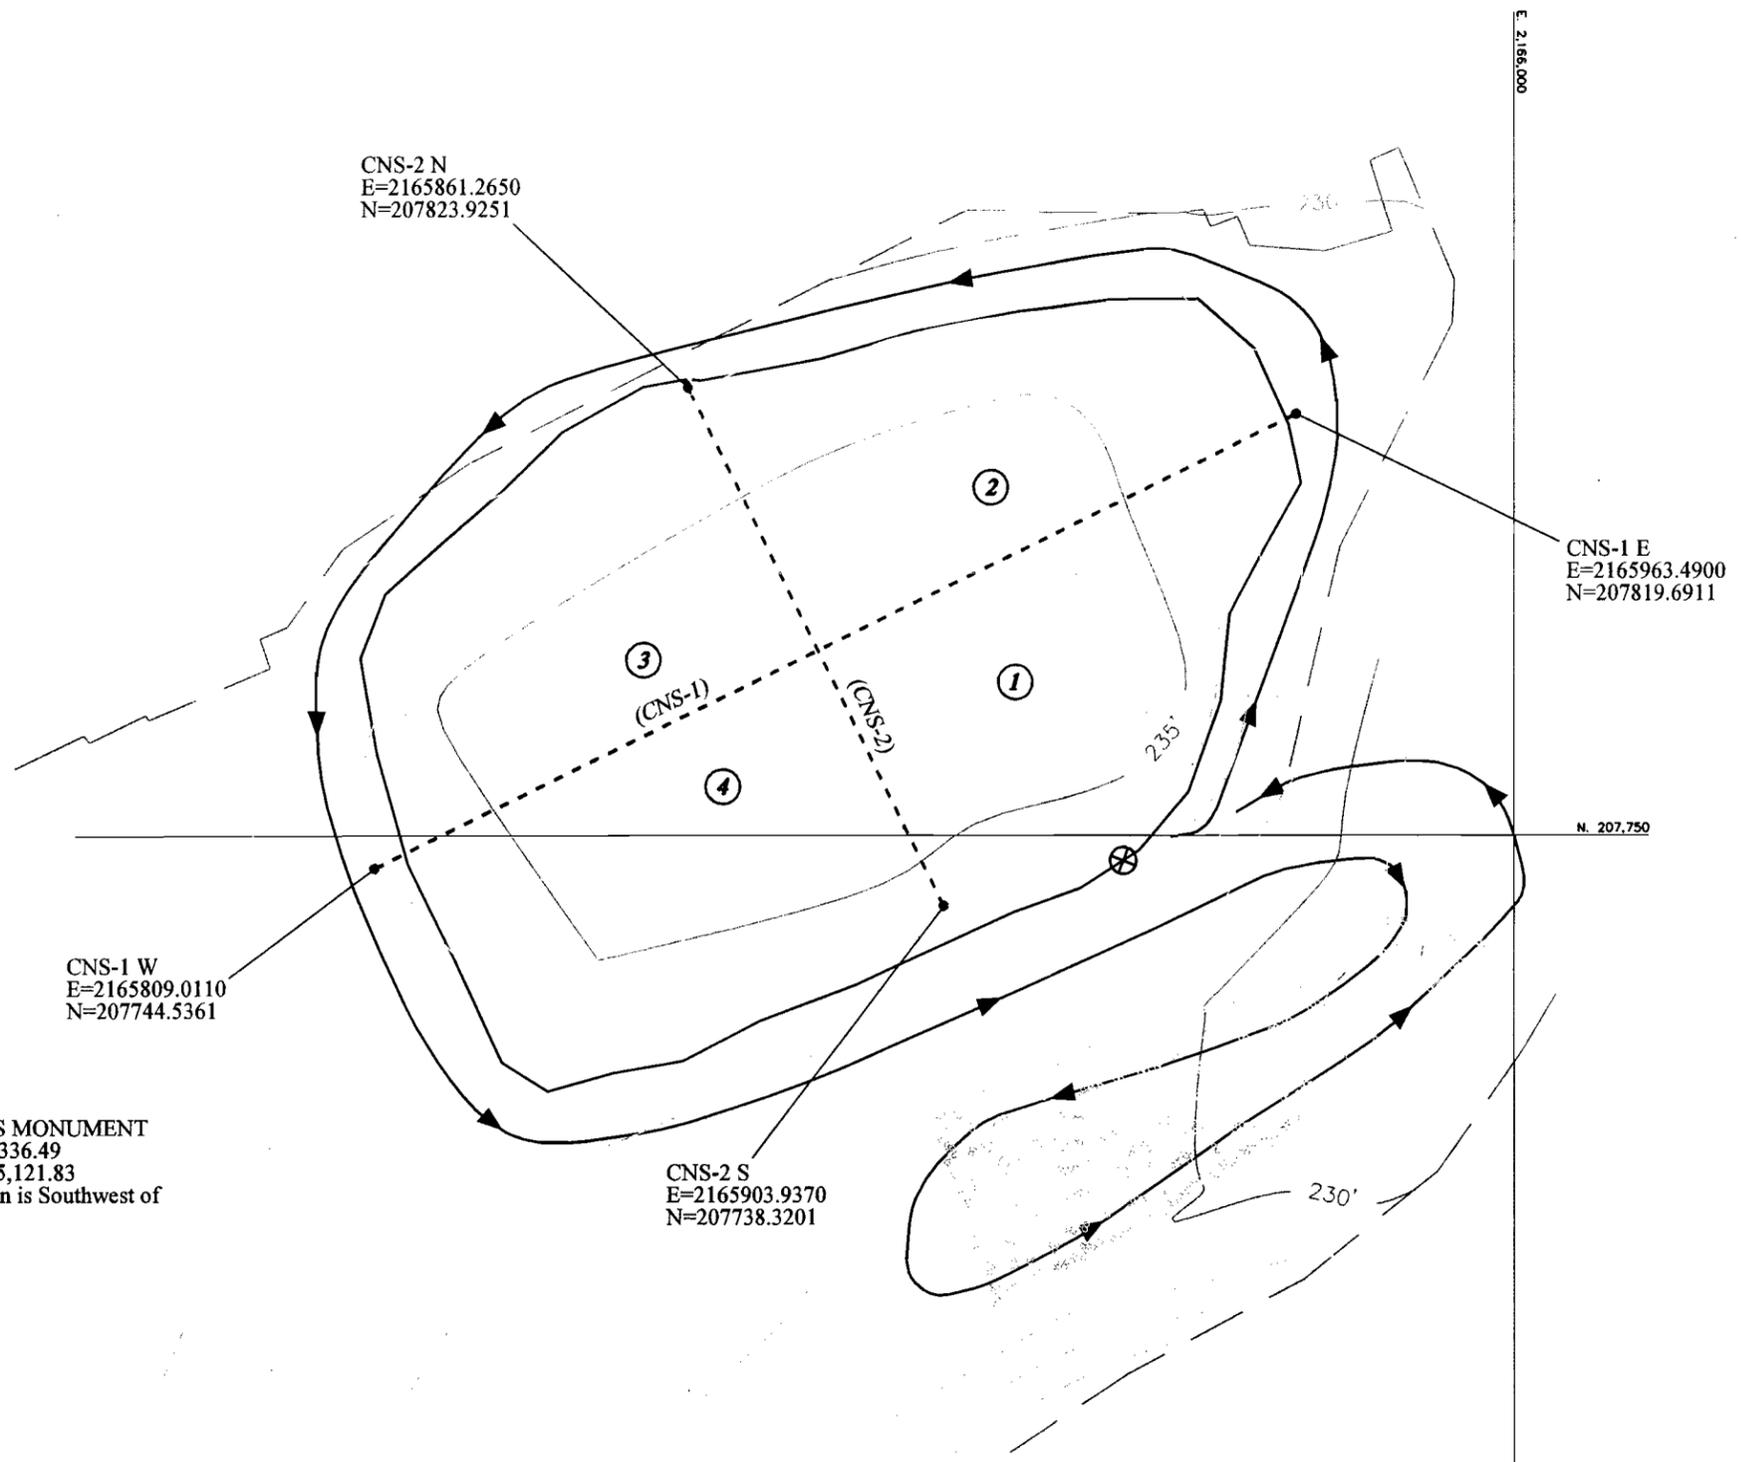
3.0 Cannikin North/South

- Explanation**
- ① Vegetative Cover Grid Area
 - Transect/Photopoint
 - ⊗ Starting Point
 - Visual Inspection Route

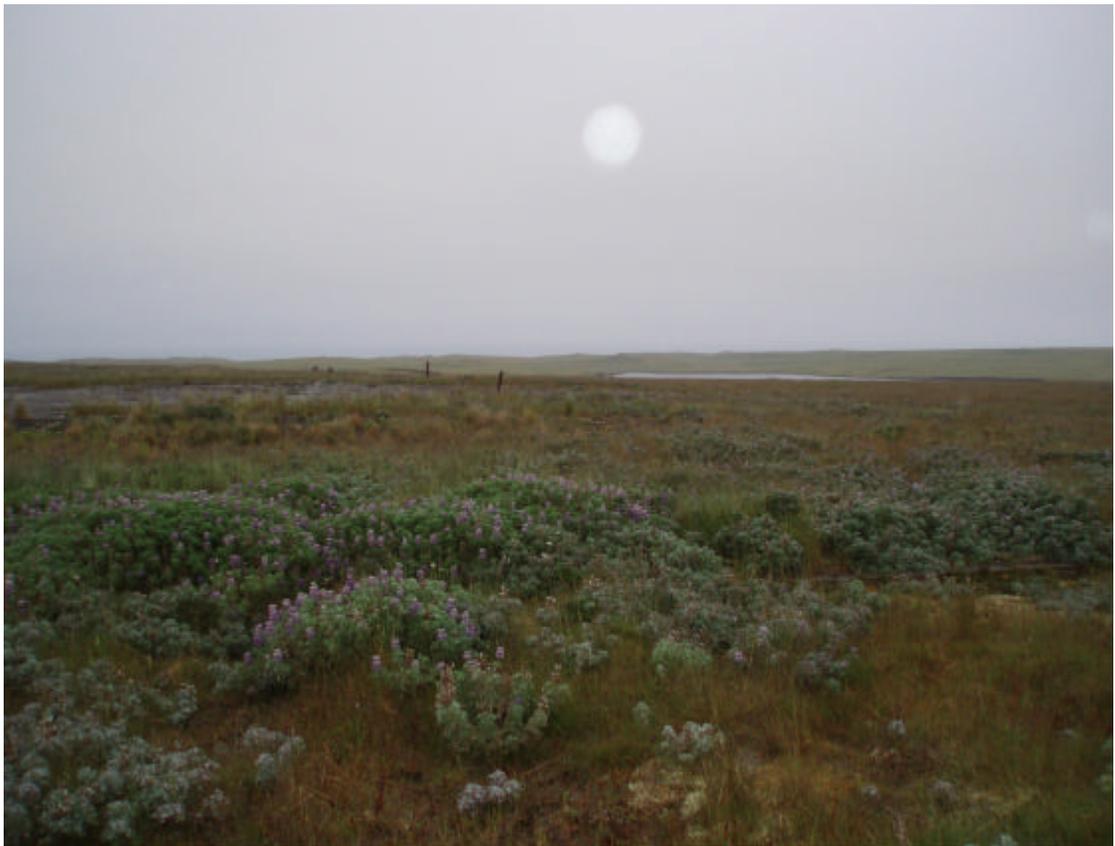
P8040003 CGZ aux pipes from USFWS Monument Facing N 57 E

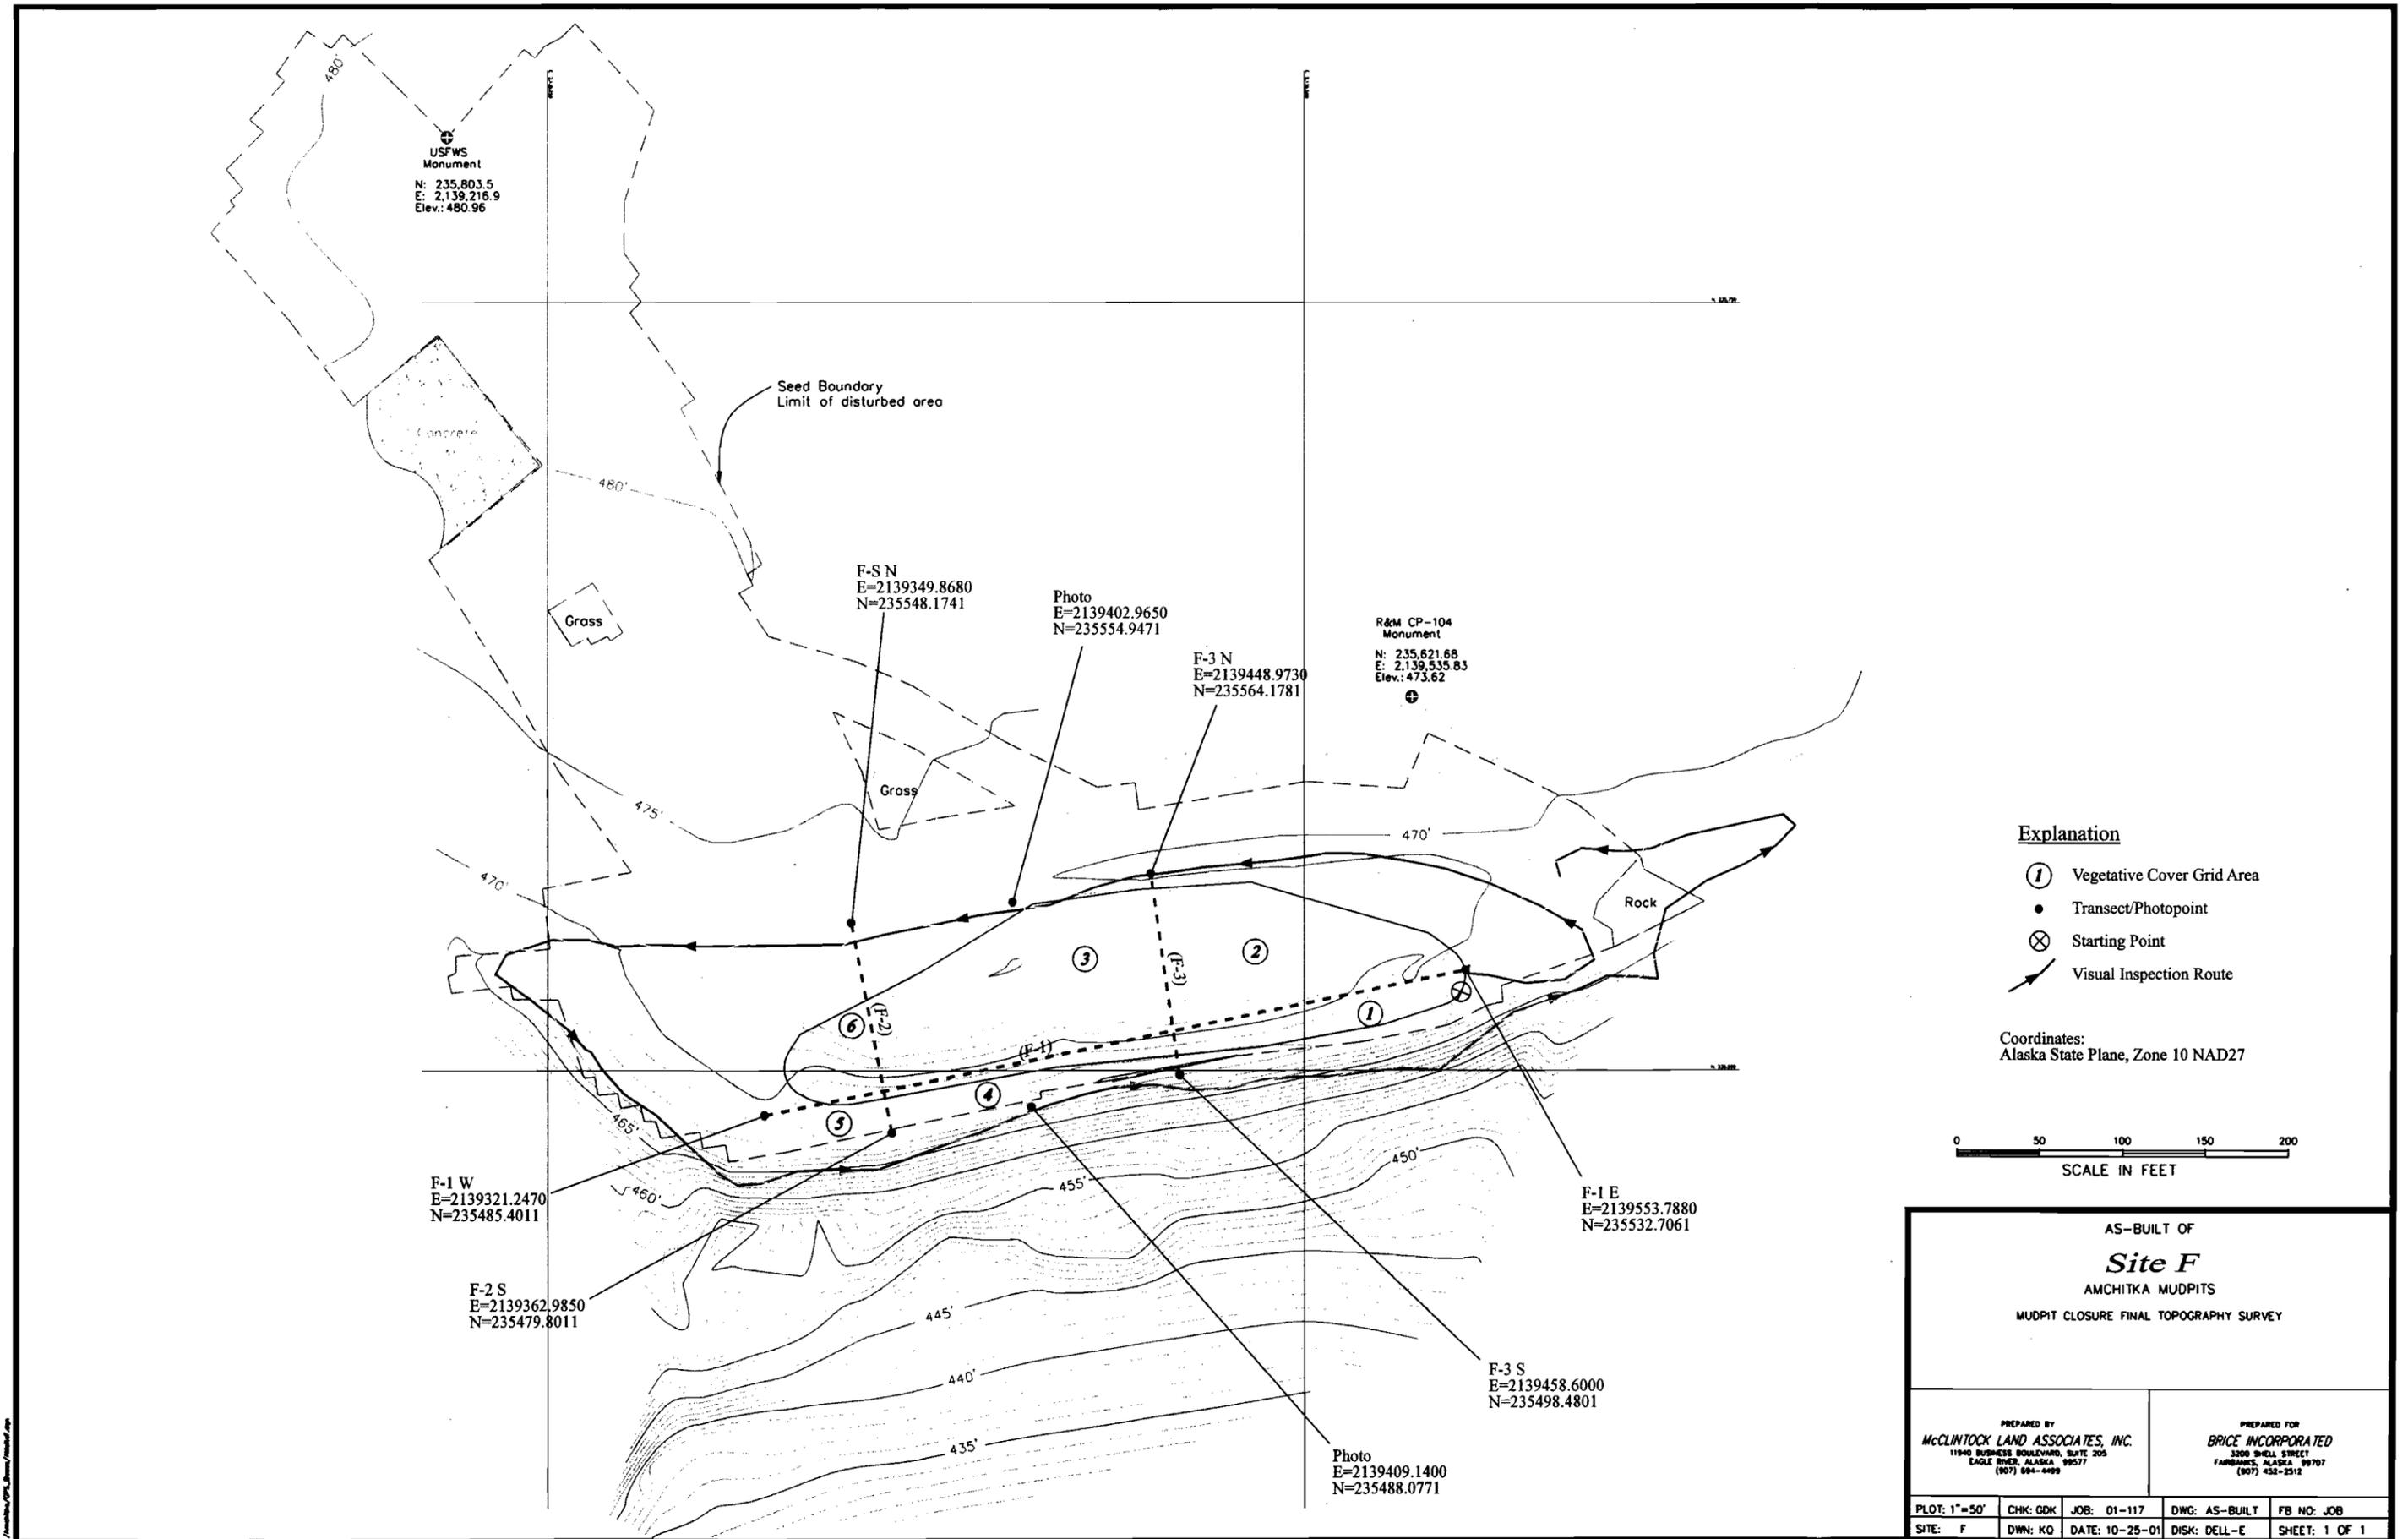
6.0 Drill Site F

- Explanation**
- ① Vegetative Cover Grid Area
 - Transect/Photopoint
 - ⊗ Starting Point
 - ↗ Visual Inspection Route

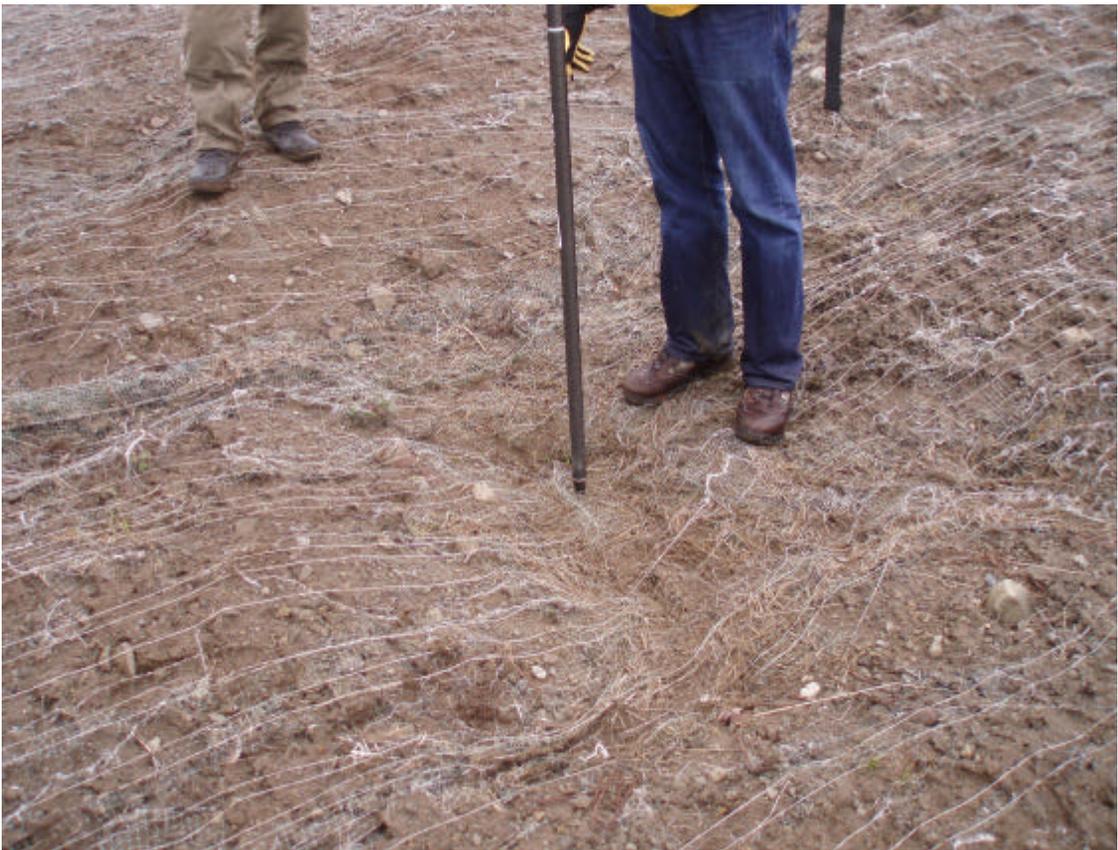
P8020012 Minor Subsidence Transect Area 5

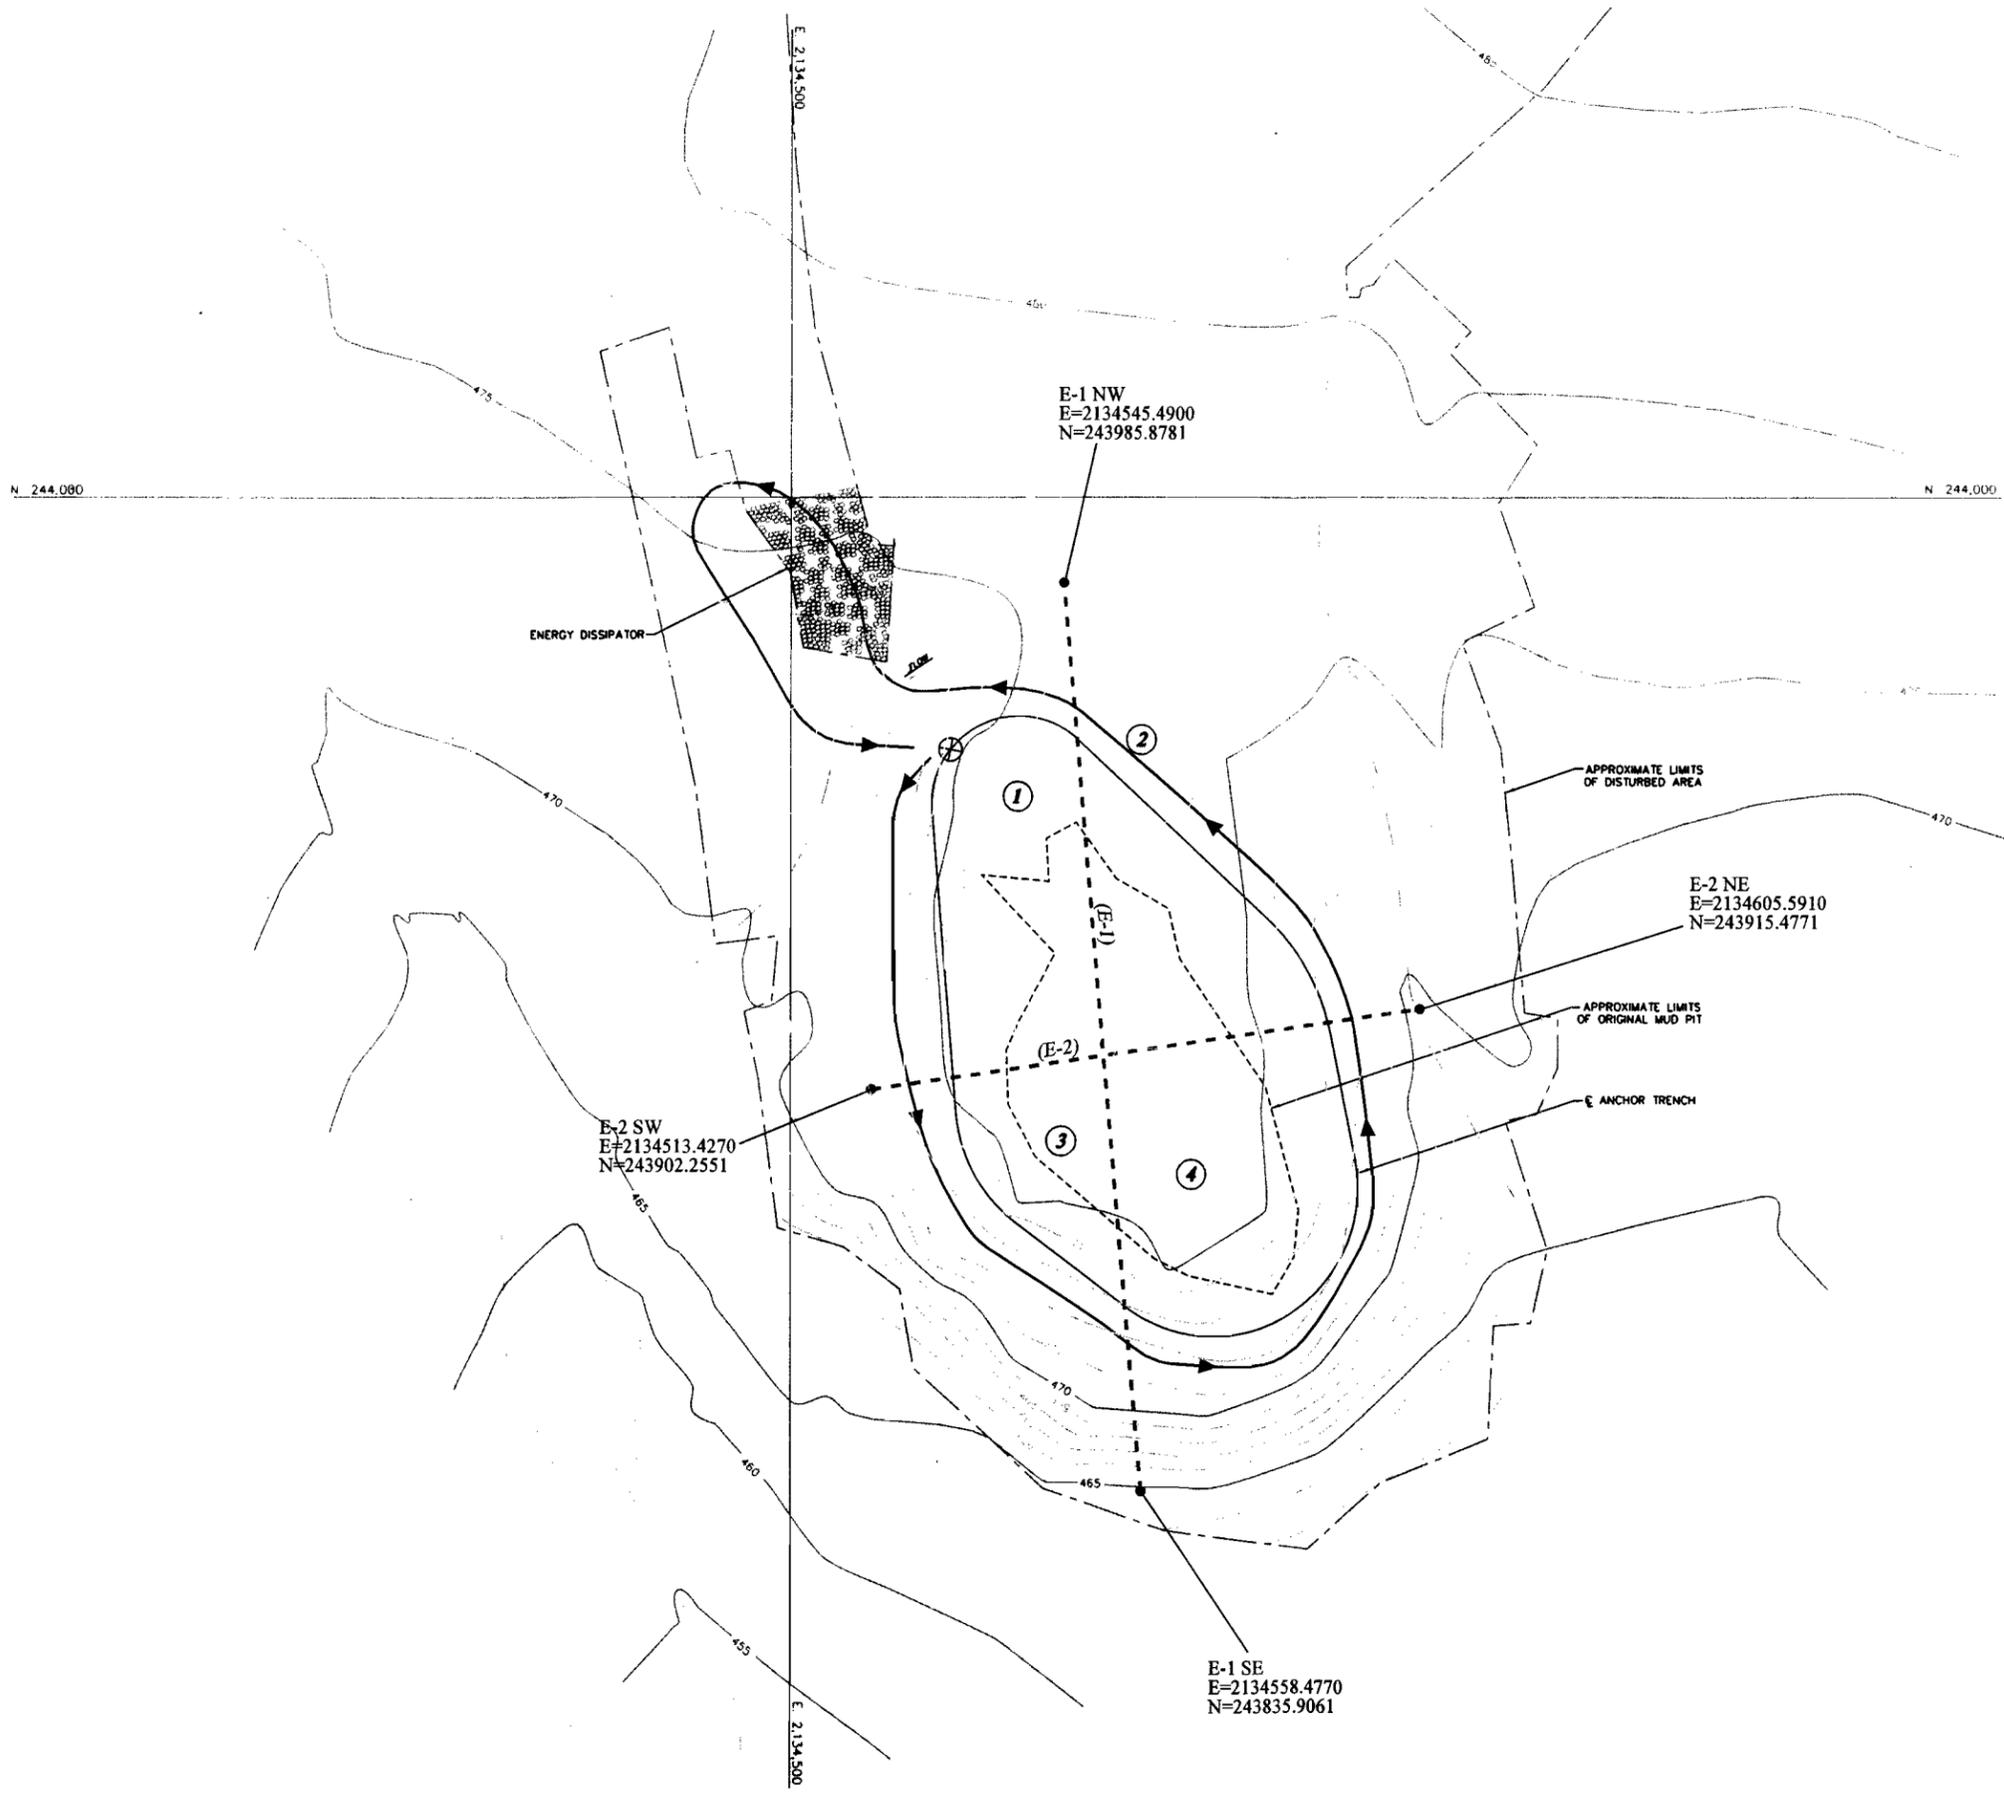
7.0 Drill Site E

- ① Vegetative Cover Grid Area
- Transect/Photopoint
- ⊗ Starting Point
- ➔ Visual Inspection Route
