# Preliminary Results from Field Testing an Improved Refractory Material for Slagging Coal Gasifiers

James Bennett

U.S. Department of Energy Albany Research Center, 1450 Queen Ave., SW, Albany, OR 97321  
E-mail: [jbennett@alrc.doe.gov](mailto:jbennett@alrc.doe.gov); Telephone: (541) 967-5983; Fax: (541) 967-5845

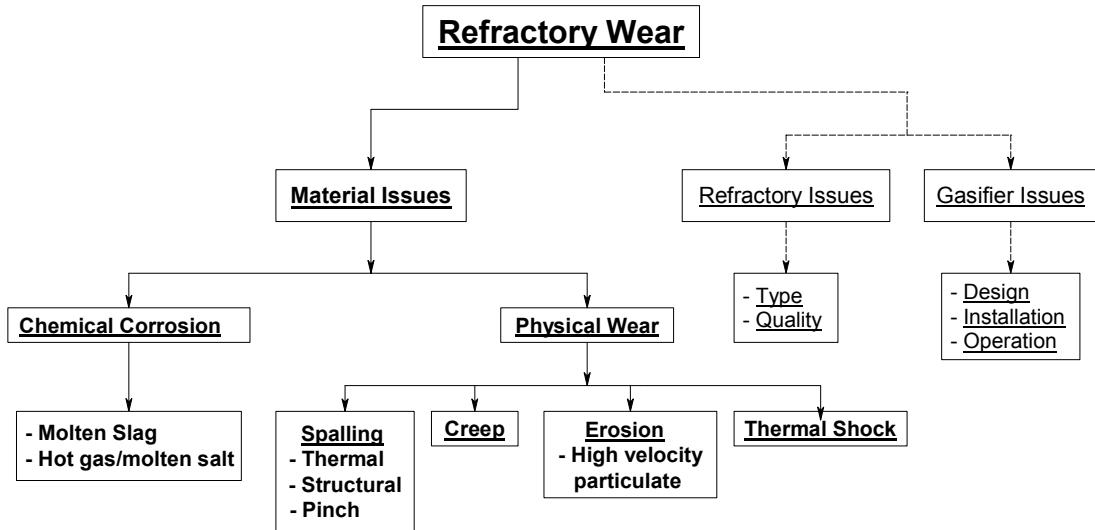
Figure 1 – Causes of refractory wear in a slagging gasifier.

A strategy was adopted by the Albany Research Center to develop new or improved high chrome-oxide refractory liner materials for the hot face of slagging gasifiers based on limiting refractory corrosion and based on limiting slag penetration into a refractory material. This strategy was developed after examining spent refractory materials removed from slagging gasifier environments and determining their failure mechanisms. From the forensic analyses of refractory brick removed from commercial gasifiers, it was noted that two primary causes of refractory failure occur, dissolution of the refractory in the molten slag and spalling. These and other causes of refractory failure are shown in figure 1. Other refractory and gasifier issues that impact refractory wear; such as the refractory type and quality, and the gasifier design, how it is operated, and factors involved in refractory installation; were not evaluated in this study. These other areas are indicated by dashed lines in figure 1.

Chemical corrosion as a refractory wear mechanism is caused by molten slag dissolution of the refractory as it flows down the refractory sidewall. As a slag dissolves a refractory material, it can also remove grains from the surface of the refractory material, producing a gradual and predictable wear. Spalling is caused by slag penetration and attack of the refractory, causing large “chunks” of the refractory hot face to be removed in layers. The removal of large surface portions from a refractory surface leads to unpredictable and incremental refractory wear. Spalling starts with slag that has penetrated the refractory’s surface, and is initiated by cracks that form parallel to the hot face near the slag-penetrated/virgin refractory interface. These cracks link-up, a processes accelerated by sudden or large changes in gasifier operating temperature. Thermal cycling of the gasifier, stresses within the refractory and within the gasifier, and other factors can also contribute to spalling. Slag corrosion and spalling of a gasifier sidewall are shown in figure 2. The circled area is spalled material sliding down the inside of a gasifier. Over time, the spalling cycle repeats, with renewed slag corrosion, penetration and attack of the freshly exposed refractory surface. Analysis of the spent refractory lining failure mechanisms was used to develop/re-design a high chrome oxide refractory material that is better able to withstand the causes of failure, as reported earlier<sup>14</sup>.

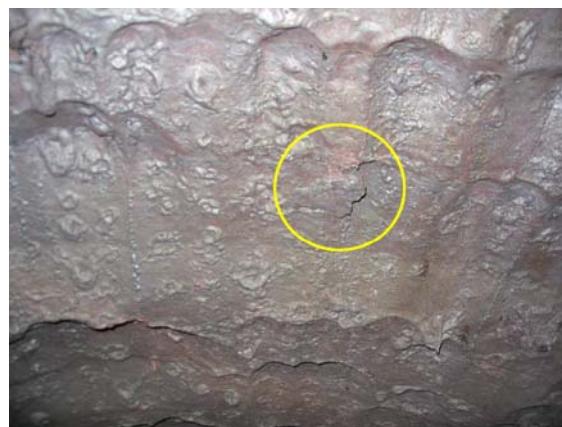
Figure 2. Slagging gasifier refractory sidewall showing corrosive wear and with spalled material (circled).

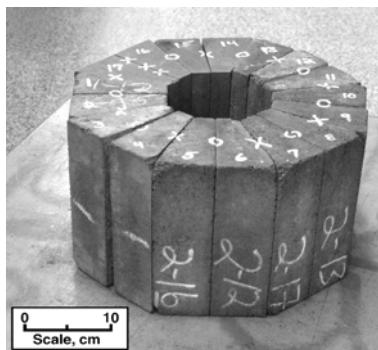
a.

Figure 3 - Refractory samples tested for molten slag resistance in the rotary slag test,  
a) samples prepared for mounting in test drum, and b) samples during rotary slag testing.

The rotary slag apparatus was heated to a target temperature range of 1650-1675°C in 2 ½ hrs, held in this temperature range for 1 hour, than slag fed at a rate of 400 grams every 10 minutes for the first hour and 200 grams every 10 minutes for the next 4 hours. The oxygen-propane flame used in rotary slag testing was burnt under reducing conditions to simulate the gasifier environment. During the test, excess slag flowed from the rotating test unit as slag was added to the test drum. When slag feed was discontinued, the drum was emptied of slag and cooled to room temperature naturally. Drum rotational speed during heat-up, testing and cooling was 2 ½ rpm. The effects of molten slag on the refractory during the rotary slag testing was measured by evaluating the change in surface area dimension of the brick and by evaluating the depth of slag penetration into the hot face of the refractory. Samples prepared for testing and being evaluated in the rotary slag drum are shown in figure 3. The results of these tests are noted in table 2.

Wear data of samples evaluated by the rotary slag test shown in figure 3 is listed in table 2. Data from table 2 indicated that no measurable wear occurred with any of the samples during the 5 hours of rotary slag testing at 1657°C. Given the high levels of chrome oxide in all samples, this result is not surprising. Slightly positive changes in slag wear measurements were observed with all samples and indicated an area increase, which may be due to slag adherence on the surface of samples or to reheat expansion that occurred in compositions A and C (see reheat expansion data shown in table 2).

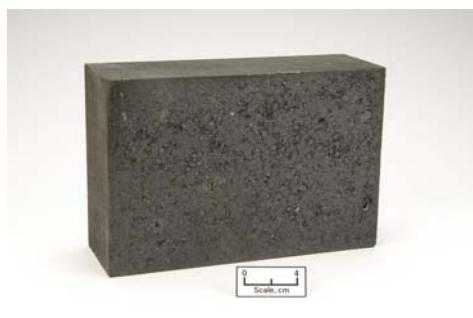
a.

Figure 4. Phosphate containing high chrome oxide refractory materials for gasifier testing:  
a) as manufactured, and b) after 17 days of trial service.

Samples of the high chrome oxide refractory material that contained phosphates (composition C) and whose chemical and physical properties are indicated in tables 1 and 2 was produced commercially by a refractory company for field testing in a commercial gasifier. An example of the test refractory material is shown in figure 4a. Unfortunately, the gasifier containing the test refractories was shut down after 17 days of service due to problems unrelated to this refractory composition. During the shutdown, the gasifier had a complete rebuild and the phosphate containing test samples were removed. Because preliminary evaluation of the test samples indicated good service results, additional testing of these materials in a future gasifier run is scheduled. Photographs of the test material after 17 days of service but before removal from the gasifier are shown in figure 4b.
