**Title: Improved Tubulars for Better Economics in Deep Gas Well Drilling using Microwave Technology**

**Annual Technical Progress Report**

**DOE Award No.** DE-FC26-02NT41662

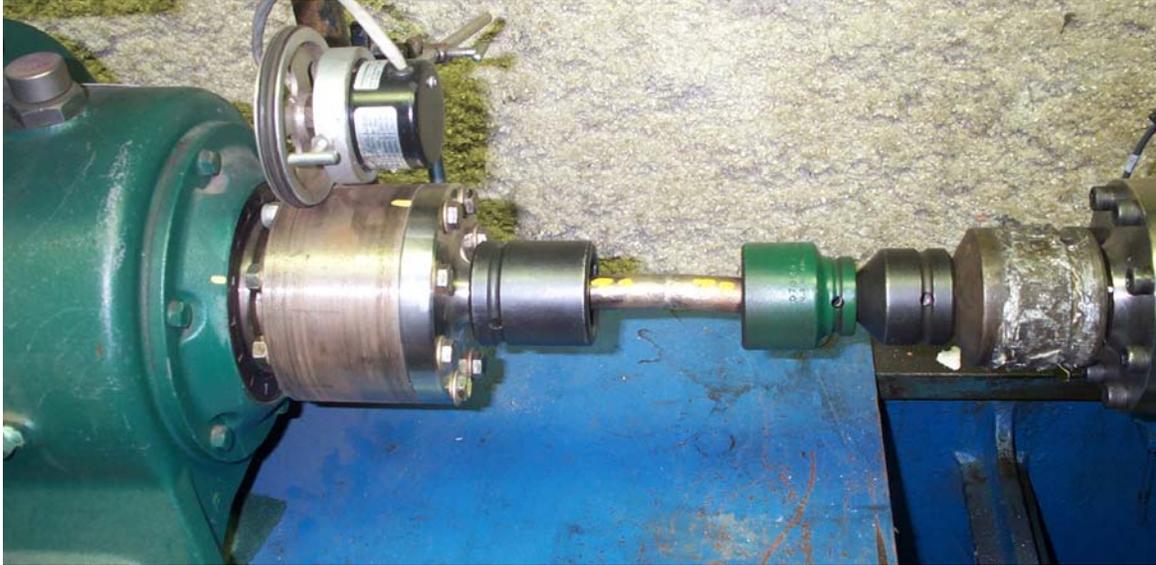
**Figure 3.1:** Torque test performed on the sample: Samples in torque machine: A. without safety shield, and B. with safety shield.

**A. Sample In Torque Machine (without safety shield)**

**B. Sample In Torque Machine (with safety shield)**

**Torsion Test:** Two brazed tubing assemblies (sintered stainless steel) were be loaded in torsion to failure. The tests were performed in a machine that includes an encoder to monitor the rotation and a torsion load cell to monitor the torque. Figure 3.1 shows a sample in the machines both with and without the safety shield. The machine is normally used to compare the friction characteristics of thread lubricants, but it is well suited for the torsion failure tests. Both samples were loaded to failure. The torque and rotation was recorded by a high speed data acquisition system. The yield and failure torques were used to calculate the yield and failure shear stresses based on the nominal pipe OD and ID. Since the torque machine is set up to use standard sockets, the shanks of  $\frac{3}{4}$ " bolts were turned down to slid

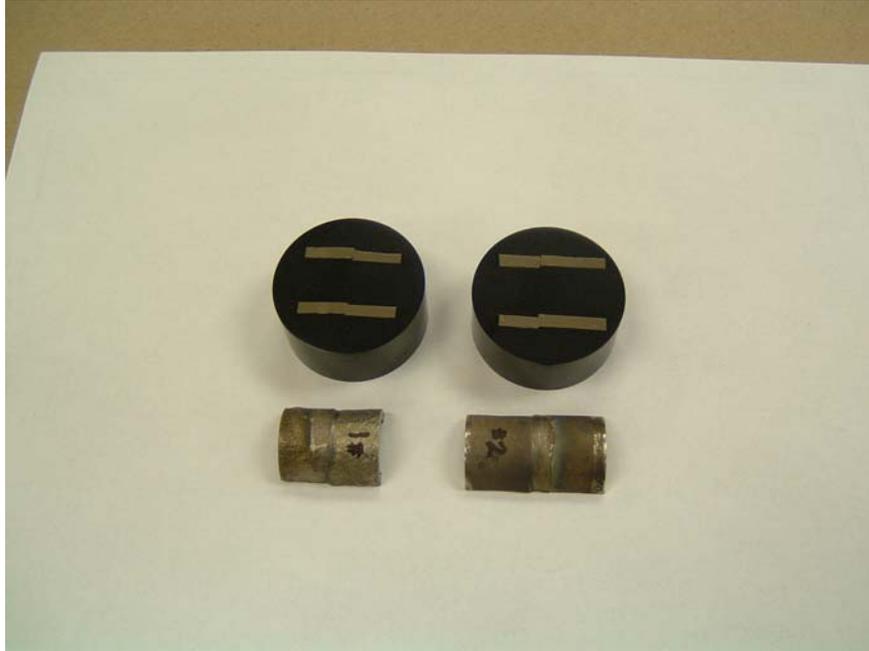
**Figure 3.3:** Microhardness photographs

A. A view of the samples containing the brazed joints (taken following sectioning and mounting).

B. A back-scattered electron image of a cross-section through the joint in sample 1. Locations where hardness measurements were made are identified.

**Micro hardness Test:** Two tubing samples containing brazed joints were supplied for micro-hardness evaluation of the brazed joints. A view of the two brazed joints (following sectioning) is presented in Figure 3.3. As can be seen, both tubing samples were sectioned along their longitudinal axes. Half of each brazed sample was subsequently mounted in plastic for examination of the structure and hardness of the brazed joint. The mounted portions of the tubing samples are shown toward the top of the field of view in Figure 3.3A.

Following polishing and etching, micro-hardness measurements were made on the brazed joints in the mounted samples. The original Vickers micro-hardness measurements were converted to equivalent Rockwell B values. For both samples, hardness reading # 1 was taken in the braze alloy, near the surface of the sample, outside of the thin braze zone. Reading # 2, on the other hand, was taken near mid wall in the center of the thin braze alloy layer. Reading # 3 for each sample was taken in the wall of the tube, remote from the braze zone. The approximate locations of the hardness measurements are shown by the arrows Figure 3.3 B and Figure 4.10 A.

The structures of the braze joints can be seen in Figure 3.3 B and Figure 4.10A. The lighter areas in these photographs thus represent regions of higher average atomic weight and the dark areas are from regions of relatively low average atomic weight. The braze alloy can thus be seen to have a somewhat higher average atomic weight than the wall of the adjacent tubes. The tubes, on the other hand, can be seen to contain a relatively high concentration of low average atomic weight particles or precipitates. A high magnification view (originally taken at 500 X) of the braze joint in sample # 1 is

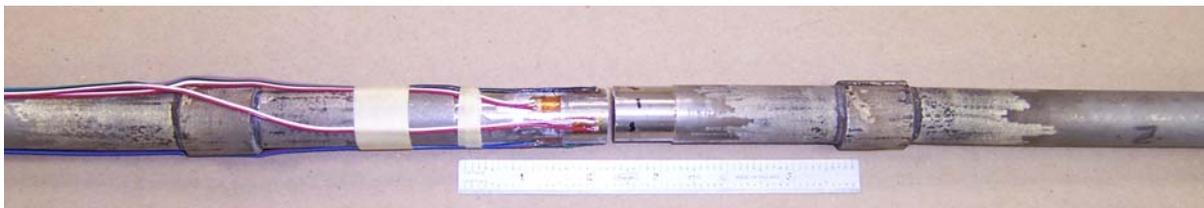
**Figure 3.5:** Sample in the fatigue machine after testing at different magnifications.

**Center Section with Typical Brazed Sleeves Connecting Sections of Sample**

**Strain Gages in Center of Turned Section**

In order to get a sample long enough to test in the resonant test machine five short (about 9” long) sections of tube were joined with stainless steel sleeves and brazed together, as shown in Figure 3.5. The center of the middle section was turned down so the failure would occur in the middle of the sample. A total of eight axial strain gages were installed to monitor the test, four at 90° intervals around the circumference on either side of center of the turned section in the center of the sample. The sets of four gages were offset by 45° so that there was a gage every 45° around the circumference of the sample as shown in Figure 3.5. The ID and OD at the strain gages were not concentric. The OD at the gages was 0.799” and the ID was 0.595”. After the sample broke, the diameters were measured along with the wall thickness at each strain gage. The thicknesses at the gages are given below.

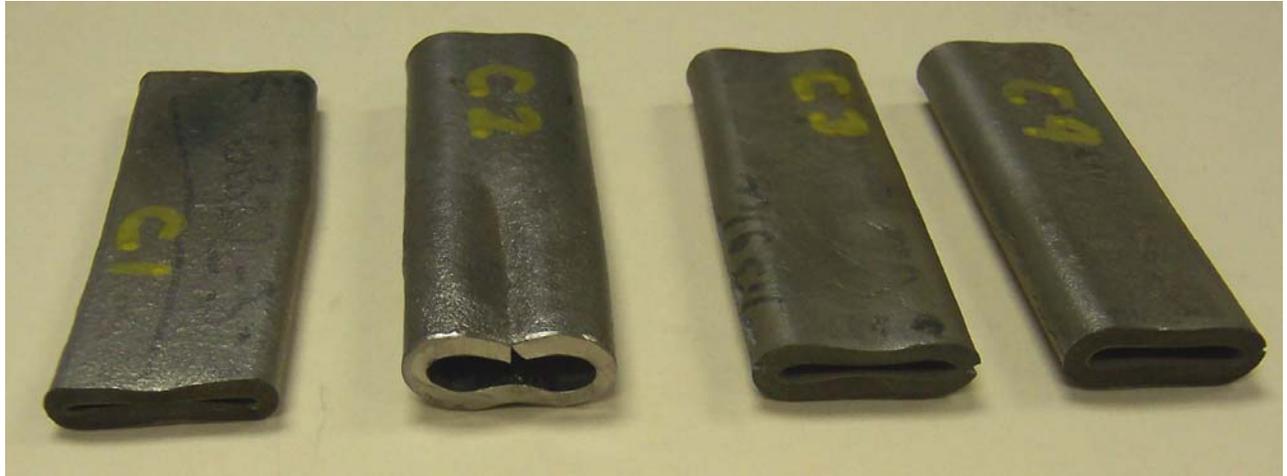
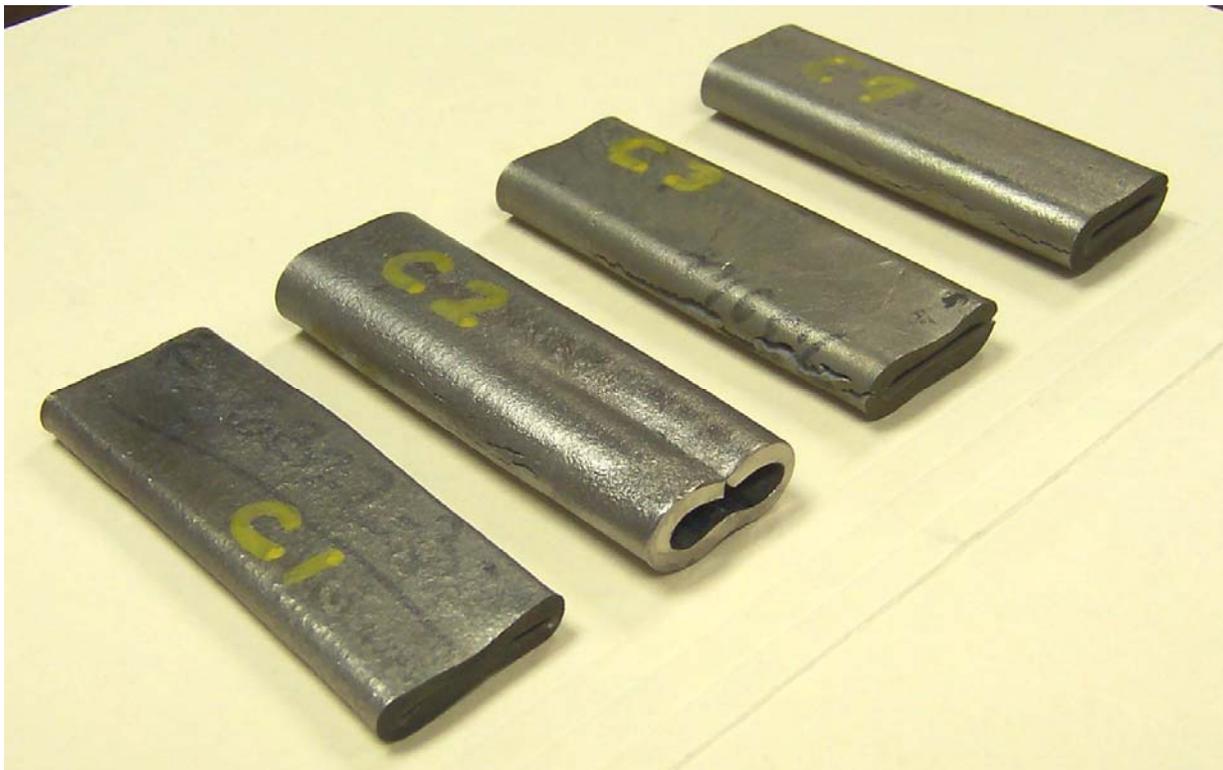
**Figure 4.8:** Crush test samples after the test, Sample C1 (left) did not crack. Samples C2, C3, and C4 (right) cracked.

**Figure 4.9:** Crush test samples after the test, Sample C1 (left) did not crack. Samples C2, C3, and C4 (right) cracked.

The supplied microwave samples for the crush tests were not the best we have seen (23.6-61.1 kips). In crush tests performed several times at Dennis Tool Company, it was noted that the sintered density of the sample plays a critical role in its resistance to cracking during the test. With good density, we have seen consistent results that are similar to the "C1" crush test sample above. These results compare very well against previous microwave samples tested in the QT report from 2004, and performed quite satisfactorily. Some crushed samples became totally flat without showing any cracks as shown in Figures 4.8 and 4.9.
