SOIL CORROSION MONITORING NEAR A PIPELINE UNDER CP

Albany Research Center, U.S. Department of Energy

ABSTRACT

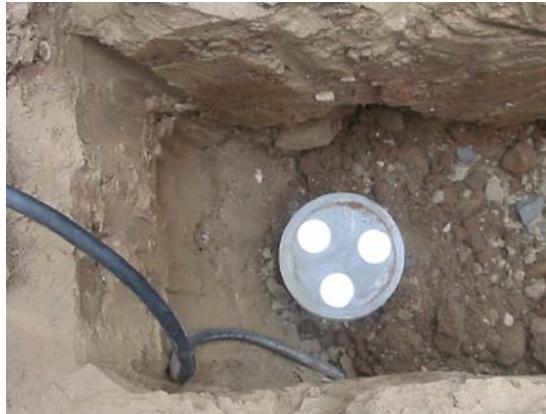
Figure 1 – Three electrode corrosion probe.

All of the electrochemical corrosion tests were performed using three-electrode electrochemical probes with electrodes made of the same material and surface area. The first electrode was used as the working electrode, the second as the counter electrode, and the third as the reference electrode.

For the tests, cylindrical electrodes were made from No. 12, Grade A615 rebar. The chemical composition of the cylindrical electrodes is shown in Table 1. The electrodes were 1.5 in. (3.8 cm) in diameter. The exposed area was 1.77 in.² (11.4 cm²). To construct the corrosion probe, three electrodes were placed in a triangle with 1.375 in. (3.5 cm) between adjacent

electrodes and cast in epoxy. Wires were attached to each electrode and all soldered connections were enclosed with epoxy prevent corrosion of the wire from the moisture in the soil and the wires were routed to the surface, Figure 1. The surfaces of the electrodes in the corrosion probes were finished to 600 grit with SiC paper. Prior to the test the surface of the electrodes were cleaned and degreased in methanol.

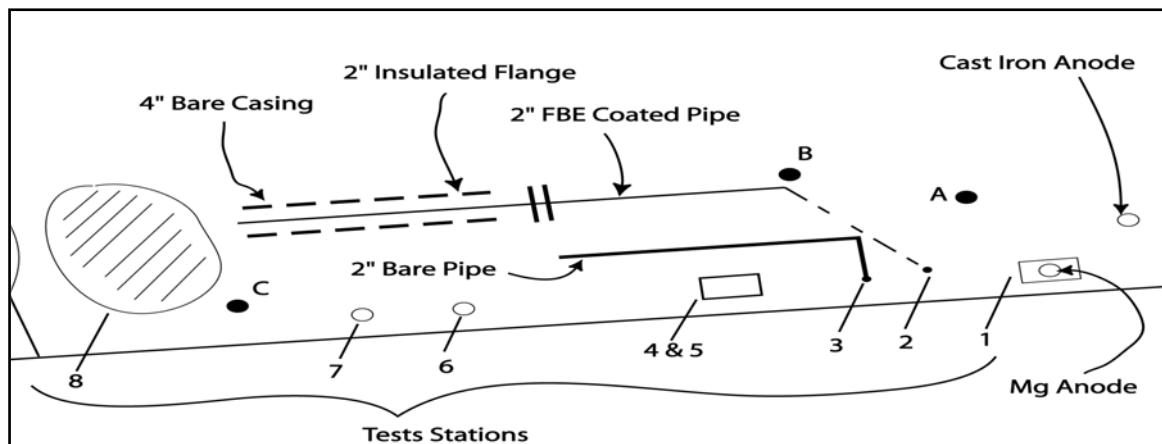
Figure 3 – Test site showing the locations of the equipment used in the field test: the buried corrosion probes at locations A, B, and C; the 2" Bare Pipe; and the Cast Iron Anode. Also shown:Mg anode, other pipes described in the text, and test station locations 1-8.

The site selected for the field test was one located in western Oregon and operated by a natural gas distribution company Figure 2. The test site consists of (Figure 3): 1) a 2 in. (5.1 cm) diameter bare steel pipe (Pipeline 1); 2) a 2 in. (5.1 cm) diameter fusion bonded epoxy (FBE) coated steel pipe (Pipeline 2); 3) a 4 in. (10.2 cm) diameter bare steel casing surrounding a second 2 in. diameter FBE coated steel pipe; 4) an insulated isolation flange connecting the 2 in. (5.1 cm) diameter FBE coated steel pipe inside the 4 in. (10.2 cm) diameter bare steel casing with the second 2 in. (5.1 cm) diameter FBE coated steel pipe, 5) a protected coupon which is a test coupon that can be connected to the 2 in. (5.1 cm) diameter pipe when CP is applied, and 6) a native coupon which is a test coupon that remains unpolarized. Pipeline 2 and the “protected” and “native” test coupons were used in this research.

Corrosion probes 1, 2, and 3 were buried in the soil at locations, A, B, and C, respectively. The probe locations with respect to the pipelines are shown in Figure 3. Locations A and B were within the CP zone with A directly in the path of current flow between anode and FBE pipeline and B very close to the FBE pipeline. Location C was well outside the zone that could be influenced by CP. All three probes were buried with the top of the probe at 24 in. (61 cm) below the surface of the soil, Figure 1. 10 to 15 gallons (37.9 to 56.8 L) of water were added at each location after the soil had been backfilled. This was done to settle the fill dirt and to provide a means for corrosion of the probes to start. The tests were run from August to October 2003 and February to April 2004.

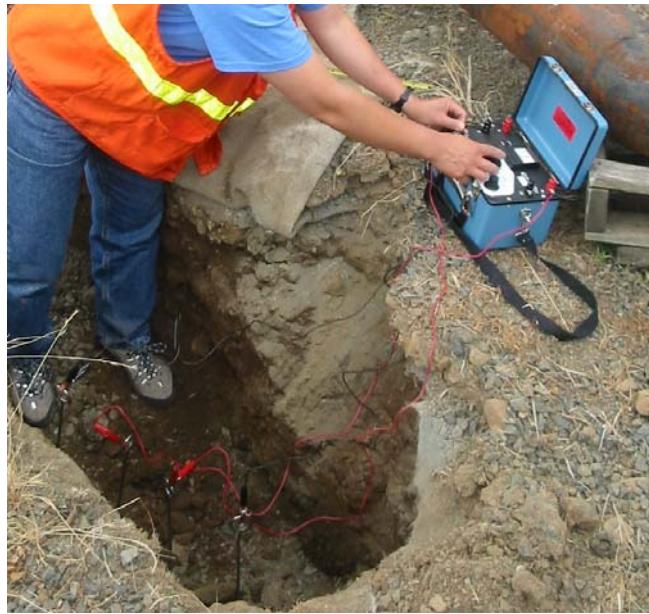
Figure 4 - Soil resistivity measurements.

The soil at the test locations can be characterized as a rocky heavy clay type of soil. Soil from the bottom of each hole was sampled and tested for pH and chemical composition. The analyses of the soil from these three locations showed ranges of pH = 4.8 to 5.4, wt pct moisture = 15.8 to 17.3, [Fe] = 250 to 550 mg/kg soil (ppm), and [Cl] = 2 to 31 mg/kg soil (ppm), Table 2. Four point resistance measurements, using a soil resistance meter and four stainless steel probes, were made in situ at the bottom of the holes (Figure 4) before the probes were installed. These calculated initial soil resistivities were 12,500, 9,100, and 12,900 $\Omega\text{-cm}$ for locations A, B, and C, respectively, Table 3. Using a published soil corrosiveness guideline based on soil resistivity,⁷ the soils at locations A and C can be classified as “slightly corrosive” (10,000 to 25,000 $\Omega\text{-cm}$) and the soil at Location B classified as the slightly more corrosive “moderately corrosive” (3,000 to 10,000 $\Omega\text{-cm}$) at location B. The soil at all three of the test sites was on the acidic end of the range of most soils.⁷ At the end of the tests, the soil resistance was again

measured in situ. For locations A, B, and C, the calculated soil resistivities were 12,450, 7,600, and 5,800 $\Omega\text{-cm}$ respectively, Table 3. The corrosiveness of locations A and B remained relatively the same but location C became more corrosive.

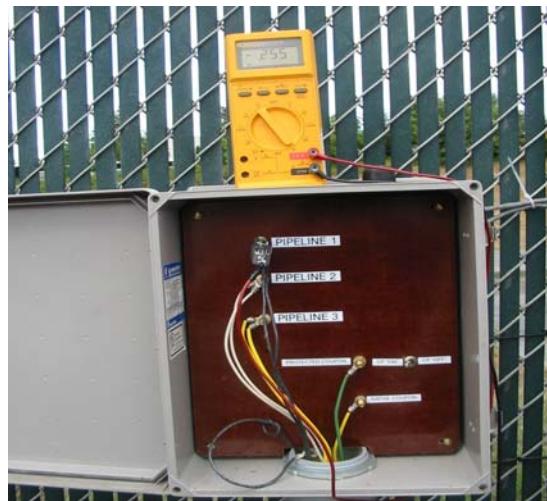
Figure 5- Junction box for measuring potentials of the pipe and coupons.

- 1) Potential measurements were made on the FBE coated pipeline, a protected (polarized) coupon, and a native coupon to establish base conditions of the unprotected pipeline (Figure 5).

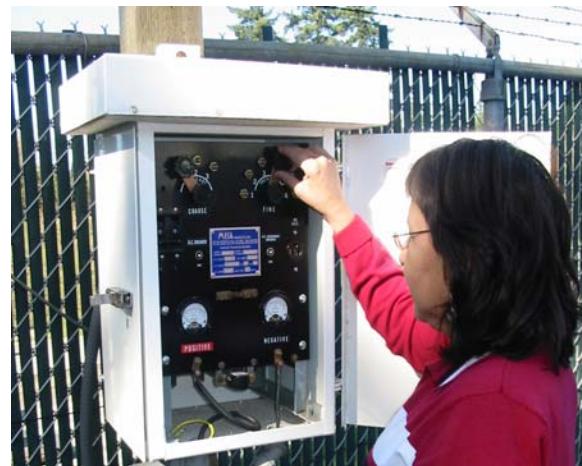
Figure 6 – Rectifier box for applying CP.

- 2) Corrosion rate and pitting factors were measured for two to four weeks to establish the baseline corrosion at the three probe locations.
- 3) Impressed current, CP, was applied to the pipeline (Figure 6) until the desired pipeline potential was reached.
- 4) The corrosion rate and pitting factors of the three electrochemical probes were measured under the influence of CP for a fixed period of time.
- 5) Polarized potential measurements were made on the pipeline, the protected coupon and the native coupon at the end of the period.
- 6) A 15-minute depolarization measurement was then taken on the pipeline.
- 7) Steps 3 to 6 were repeated for several levels of CP.

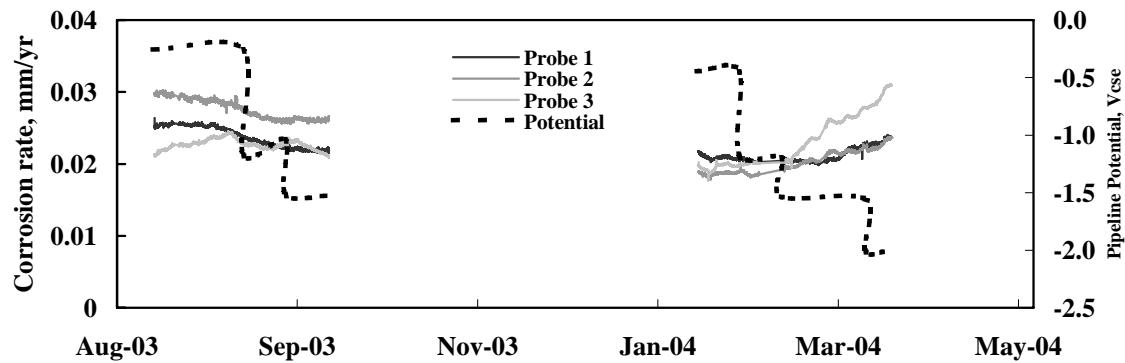
Figure 7 – Corrosion rates of the three probes and the pipeline potentials over time.

The corrosion rate measurements for the three corrosion probes and the applied potentials are shown in Figure 7 as a function of time for both tests. Figure 7 shows low corrosion rates of 0.02 to 0.03 mm/yr for probes 1, 2, and 3. The low corrosion rates for all three probes in general seem consistent with the categorization of the corrosivity of the soil by soil resistivity.⁶ The slight increase in the corrosion rate of probe 3 at the end of the second test can be attributed to the change in soil corrosivity from "slightly corrosive" to "moderately corrosive." There were no events in the corrosion rate-time data that could be correlated to the application of CP current, the increase in CP current, or any other cause. The conclusion is that applying CP near a corrosion probe that is being tested using EN, LPR, or HDA techniques is not a problem. The CP current will not interfere with those electrochemical measurements. The Stern-Geary constant as measured by HDA was 0.026 V for all tests and probes.

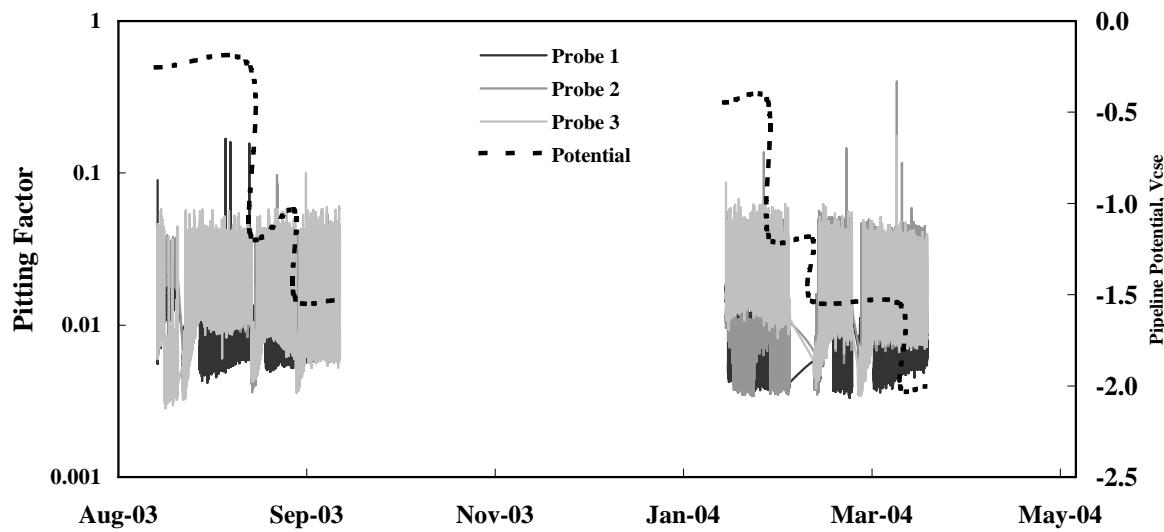
Figure 8 – Pitting factors of the three probes and the pipeline potentials over time.

The pitting factor measurements and the applied potentials are shown in Figure 8 for probes 1, 2, and 3. The results show that the pitting factors are on the order of 0.01, which indicates that there would be no pitting corrosion. There was no effect of applying the CP currents densities on the PF-time data. There were no other trends observed that could be correlated to any other factors.
