Umatilla River Subbasin Fish Habitat Improvement Program

Summary Report 1996 - 2003

FINAL 2003 ANNUAL REPORT (Project Completion/Summary Report for 2003 Habitat Improvement Projects and Historical Projects: 1996 to 2002)

Oregon Department of Fish and Wildlife
John Day Watershed District Office
73471 Mytinger Lane
Pendleton, OR 97801

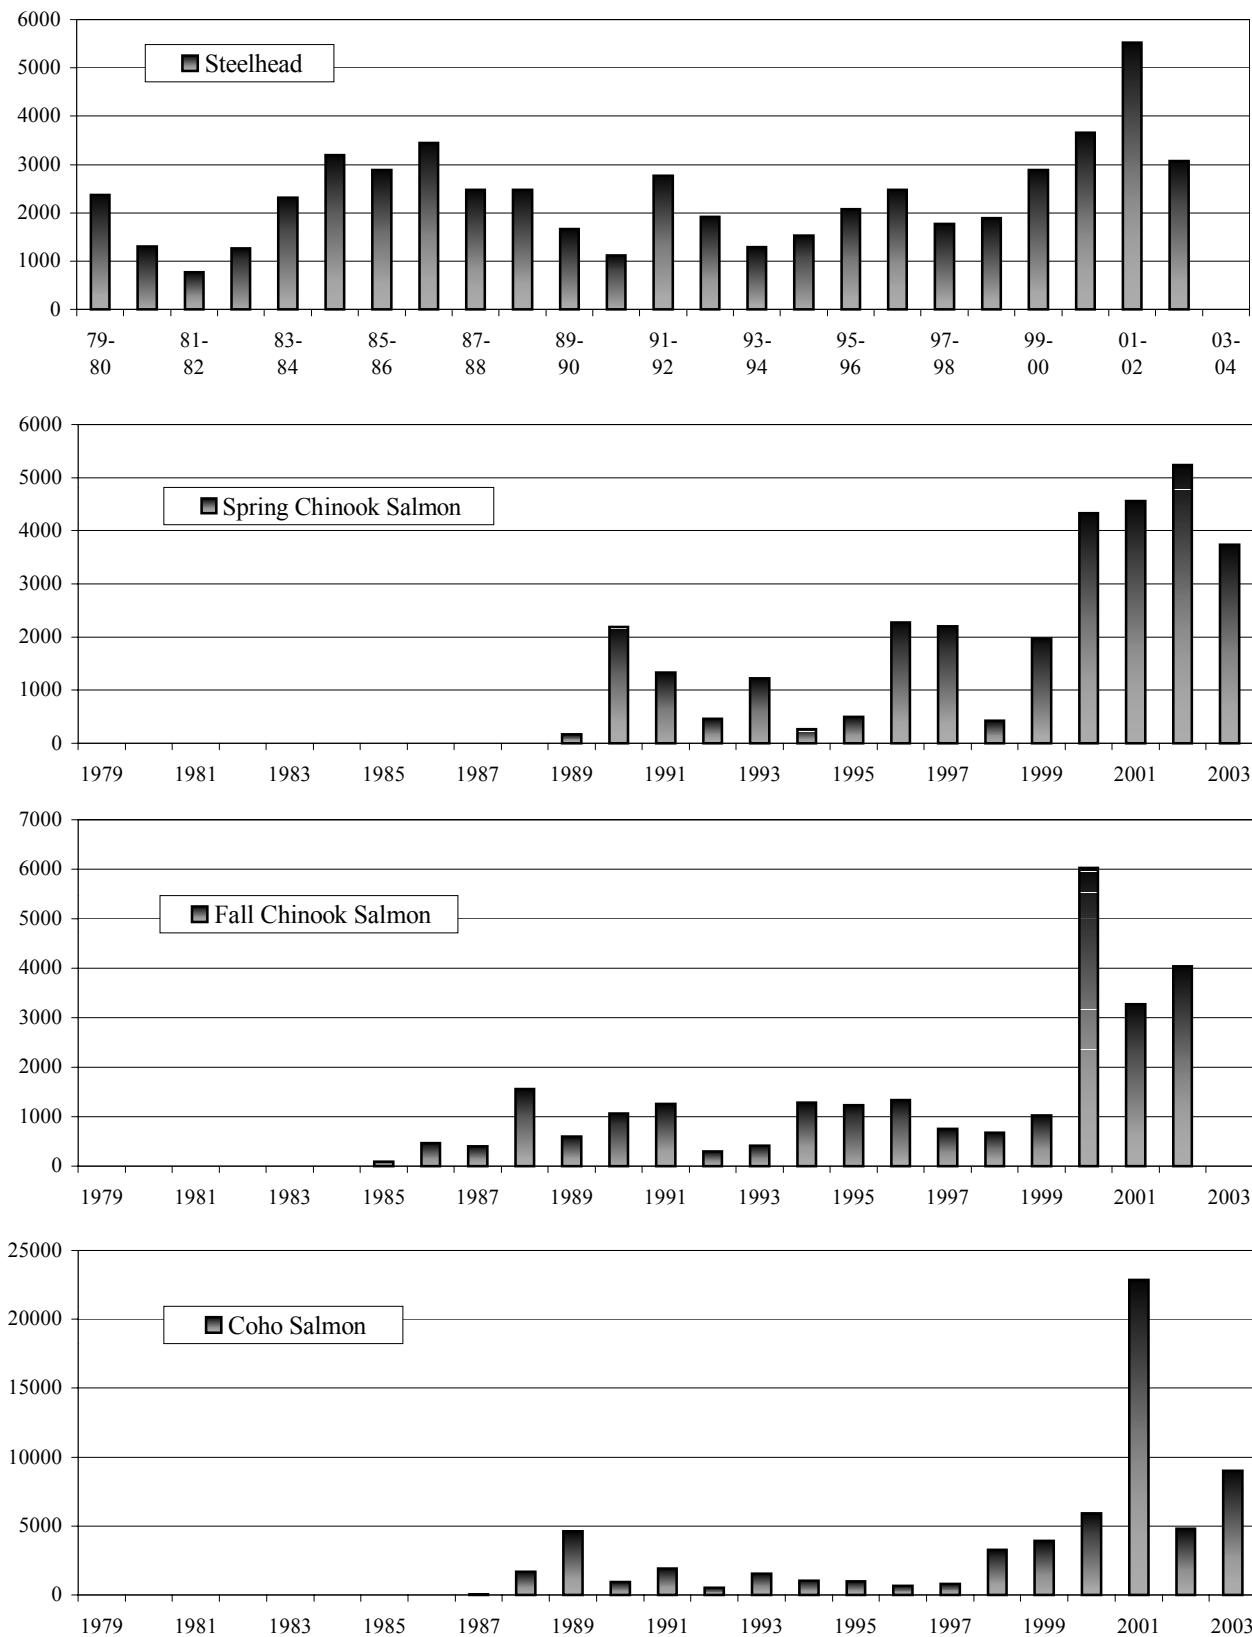
Historically, the Umatilla River Subbasin supported large runs of spring and fall chinook and coho salmon. Native salmon populations had become extinct by the mid 1900's (OGC 1963, Thompson and Haas 1960), while populations of native steelhead, redband trout and bull trout (*Salvelinus confluentus*) continue to persist, albeit at depressed levels. The actual historic run size of steelhead in the basin is not known, but based on the amount of habitat lost to steelhead production (both McKay and Butter Creek drainages are no longer accessible to anadromous fish) and the degradation of the existing habitat, current runs are thought to be a fraction of their historical size (CTUIR and ODFW 1990). In recent years, runs have ranged from a low of 768 during the 1981-82 run year to a high of 5518 in 2001-02 (Figure 2).

Figure 2. Steelhead and Salmon Returns to Three Mile Falls Dam

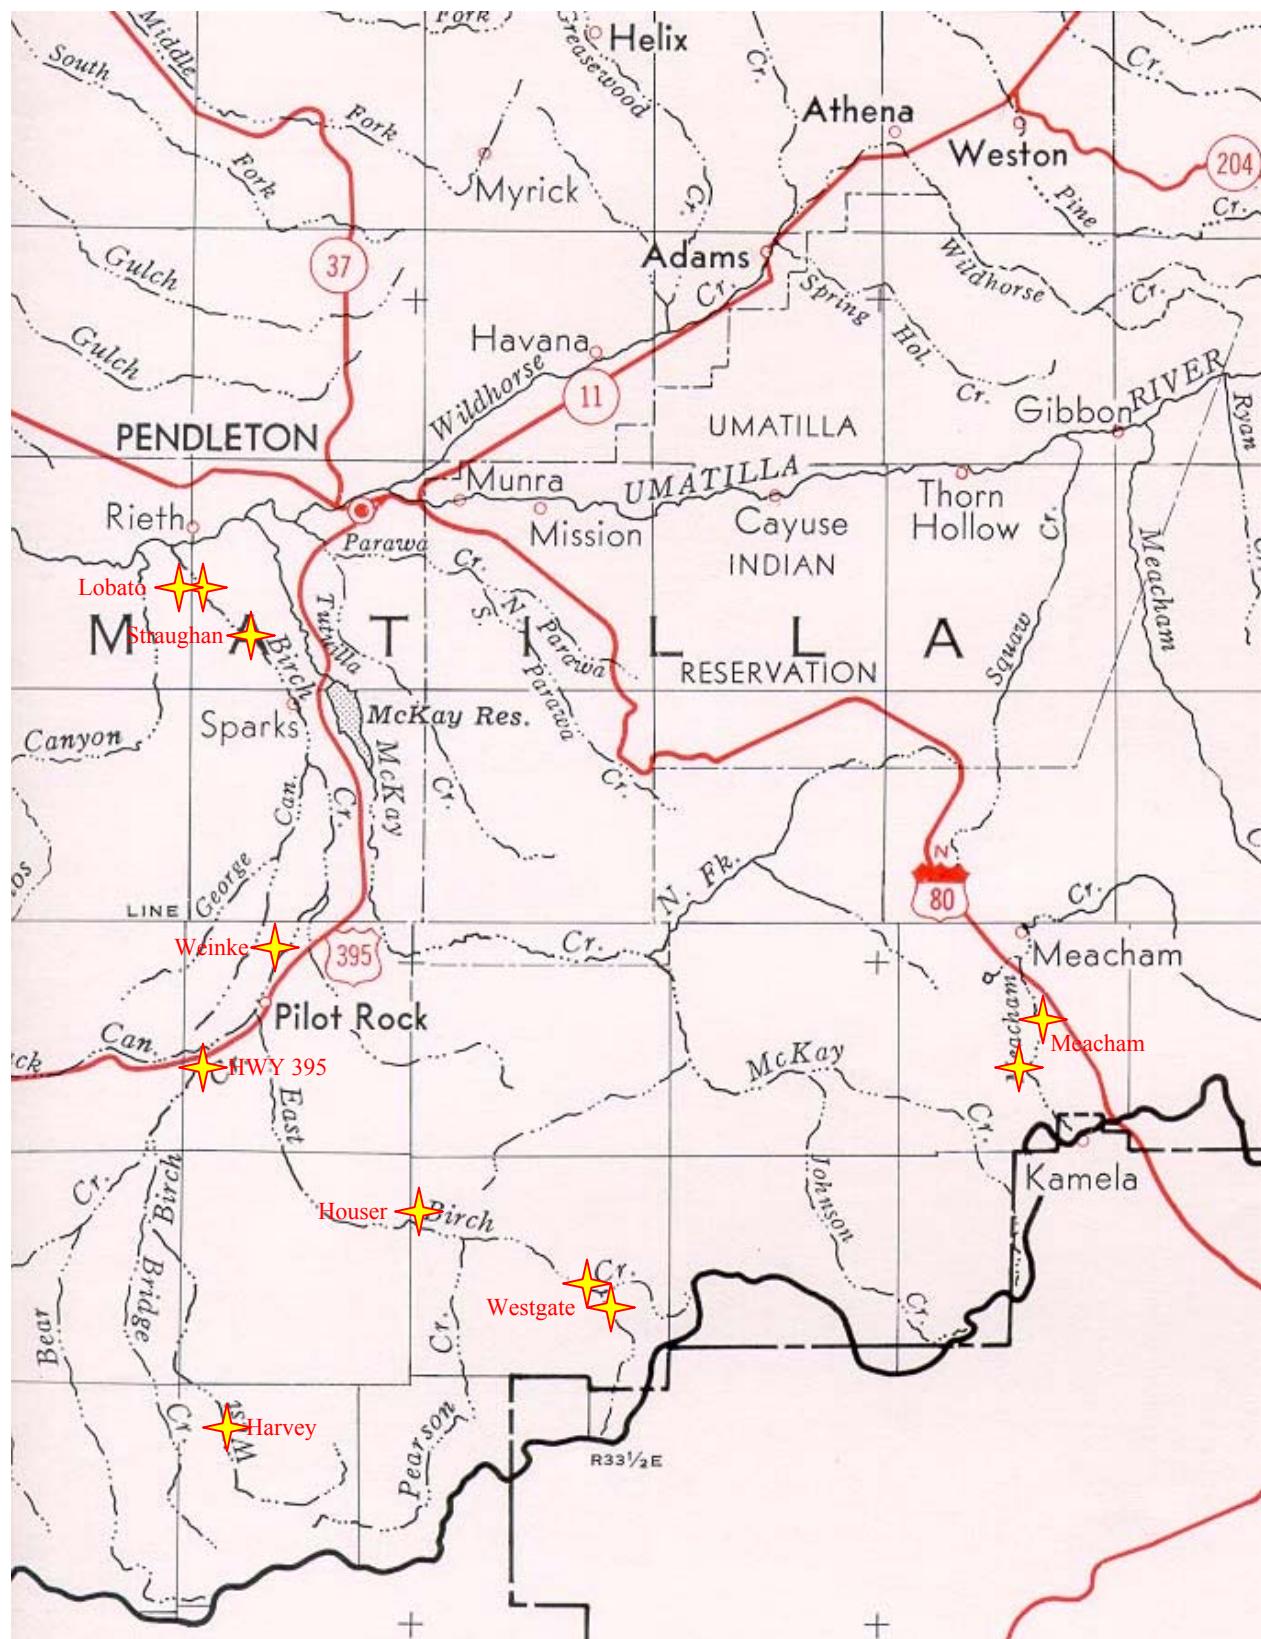
Thermograph data were collected at 11 permanently established stream temperature, gauging stations (Figure 3). Temperature data were recorded during the summer months (May through November) using *Onset* brand, HOBO model and STOWAWAY model, thermographs. Thermograph sites have been selected based on their location relative to (upstream and downstream of) existing Habitat Improvement Projects, and/or at locations that will allow the collection of control or pre-treatment data for future projects.

Figure 3. Umatilla Subbasin Fish Habitat Improvement Program Temperature Monitoring Sites

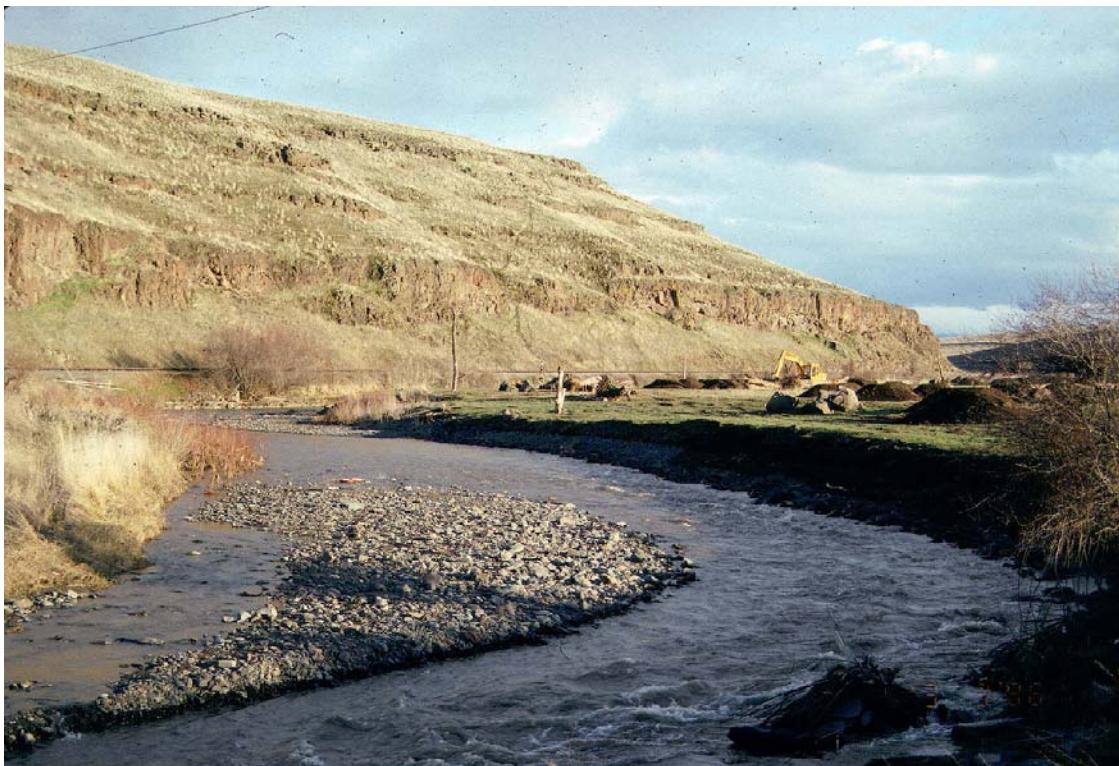
Photo 1. Upstream view of the Lobato channel re-construction/bioengineering project, (March 1996).

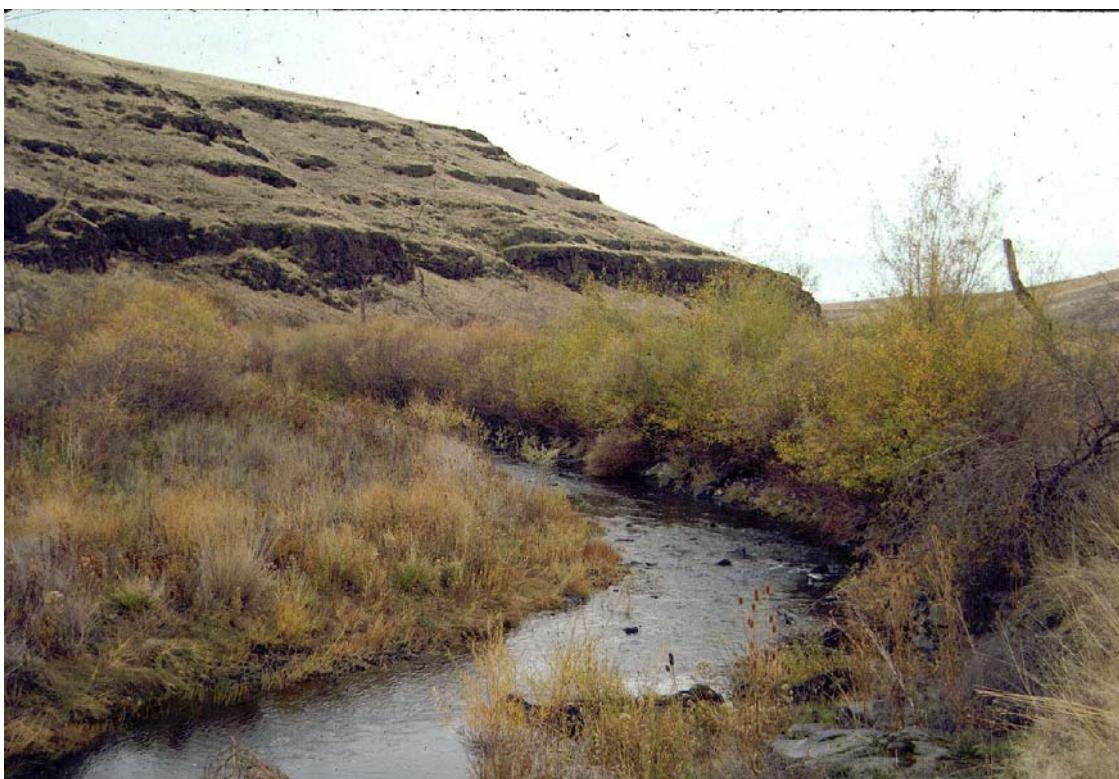
Photo 2. Upstream view of the Lobato channel re-construction/bioengineering project, (October 2000, same vantage point).

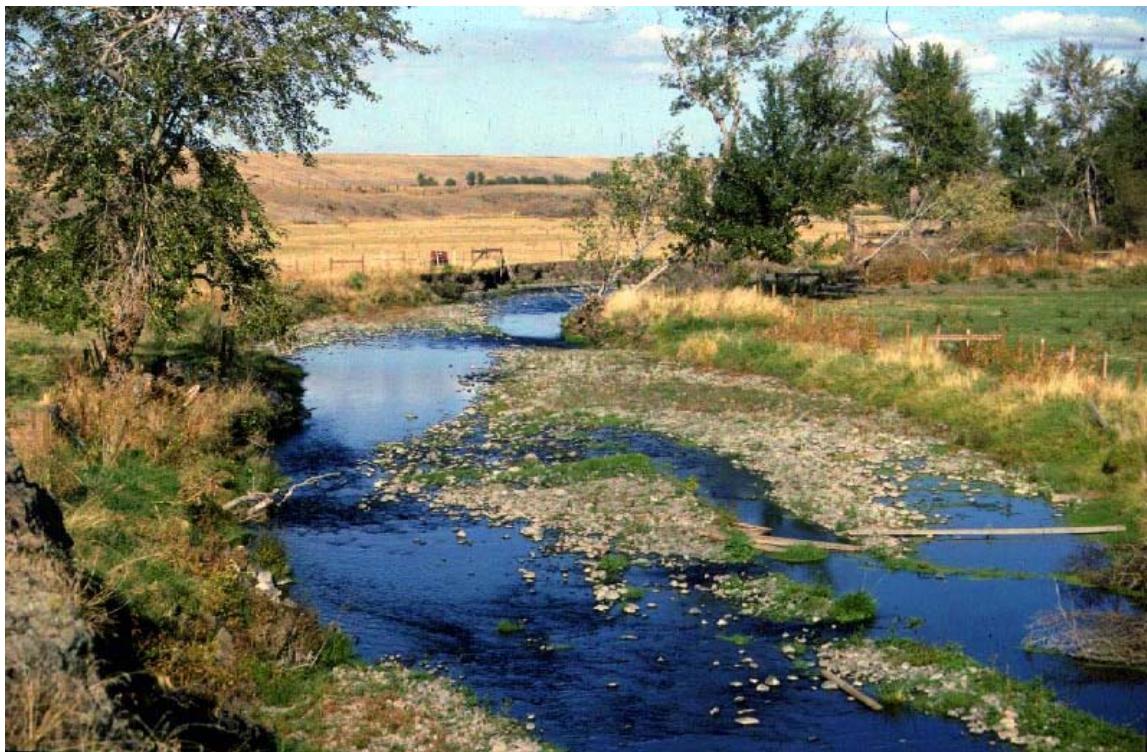
Photo 3. Upstream view of riparian fencing and re-vegetation efforts on the Gambill property.

ATEC design included a combination meander re-configuration and root wad revetment treatment (root wads and logs keyed into channel banks and cabled to boulders). Program staff implemented the ATEC design in 1998 within a 0.75 mile section of channel. The 1998 treatment also included willow stake plantings amongst the bank stabilization structures, and grass seeding within areas disturbed during project implementation. In 1999, a riparian fence was constructed to exclude livestock from within the lease areas. The same year, additional willow planting and rooted stock planting was conducted, as part of project O&M activities. Irrigation of planting projects began in 1999. Weed control activities have been conducted annually on the properties, within the fenced riparian areas (Photos 3 and 4).

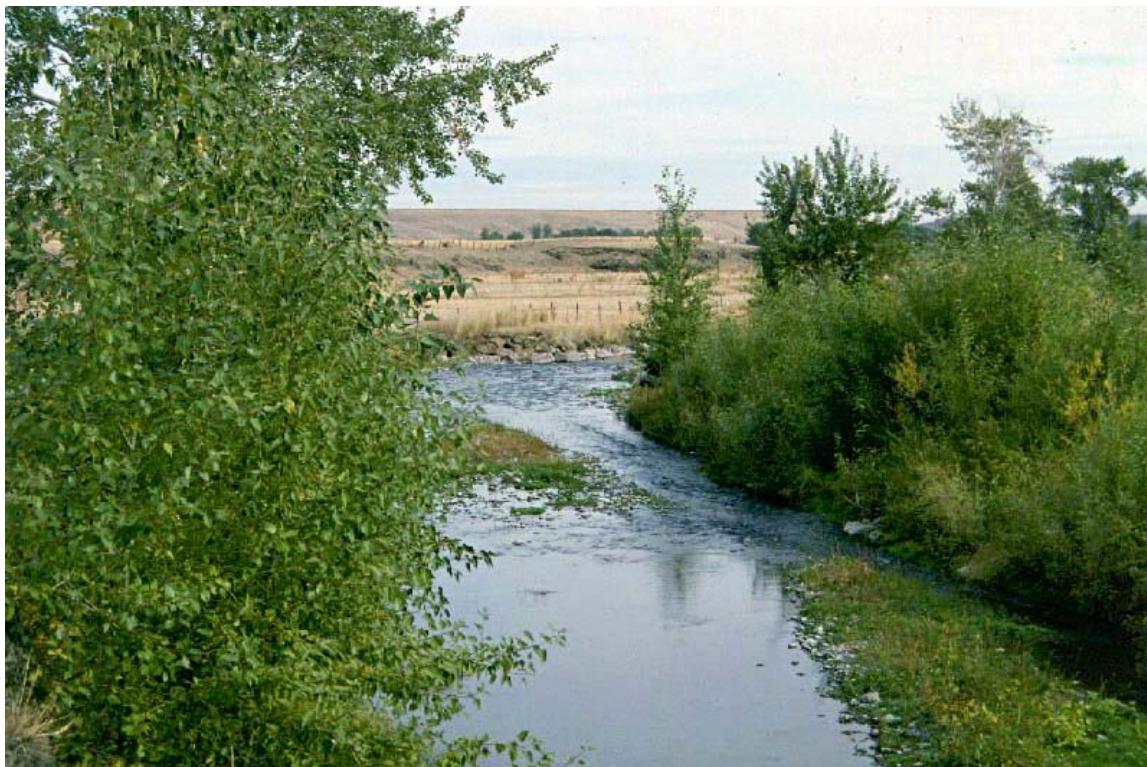
Photo 4. Upstream view of riparian fencing and re-vegetation efforts on the Gambill property (same vantage point), following 5 years of recovery.

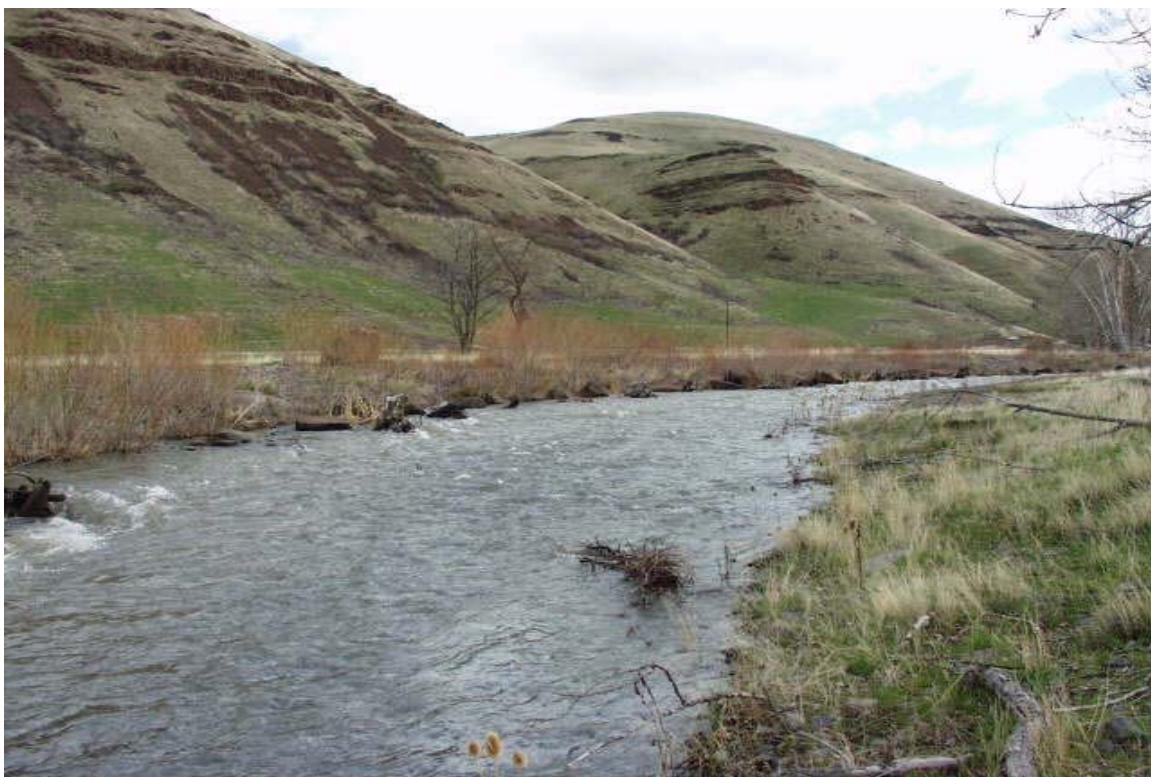
Photo 5. Upstream view (2002) of ATEC designed root wad revetments and willow plantings implemented on the lower Houser property in 1998.

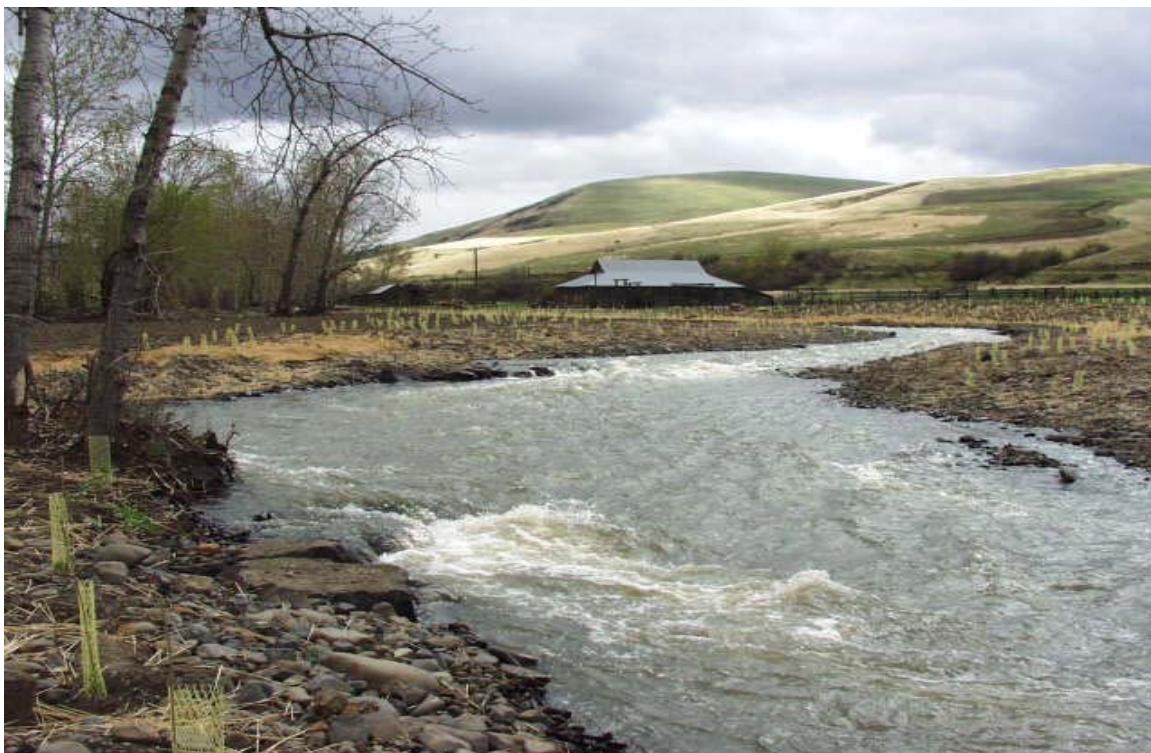
Photo 6. Upstream view (2002) of J-Hooks, reconstructed point bars and rooted stock plantings, implemented on the middle Houser property in 2001.

(Photo 6). J-Hook and Cross Vane structures are designed to reduce sheer stress along vulnerable banks, focus flow within the channel thalweg, and create scour pool habitat. Project objectives included the restoration of stable channel function and re-establishment of a naturally functioning floodplain.

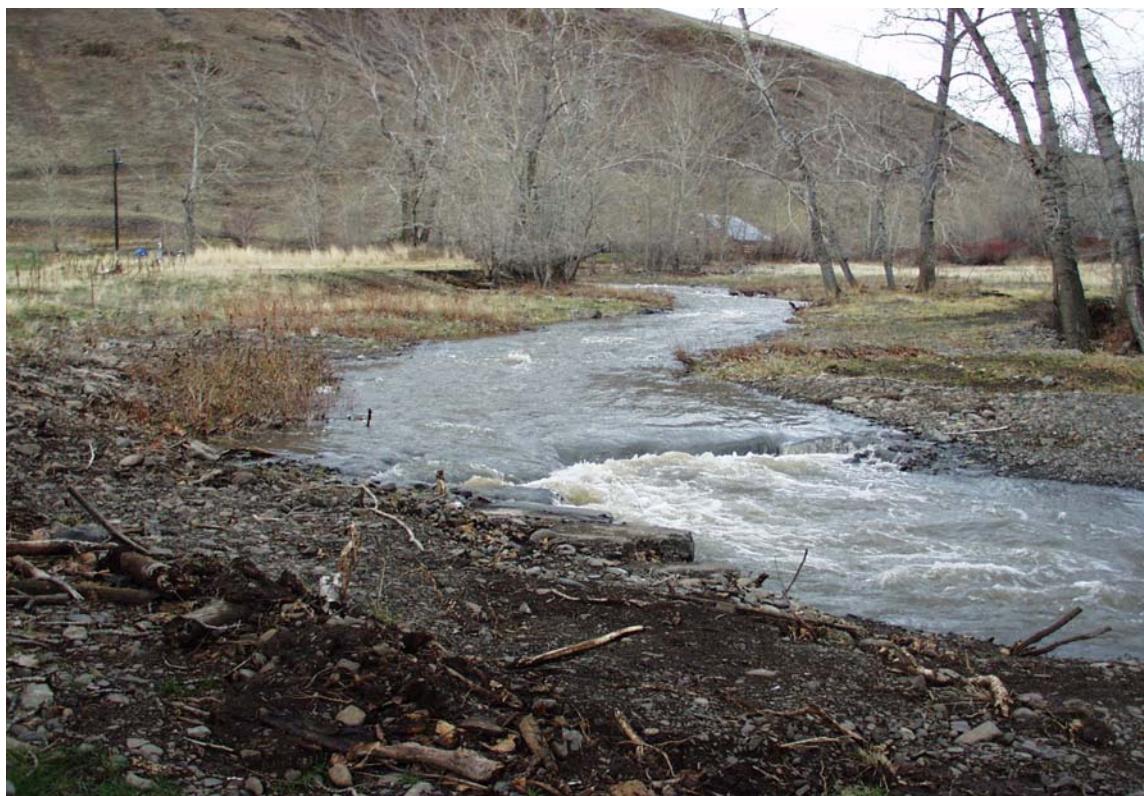
Photo 7. Upstream view (2003) of Cross Vane and reconstructed point bar, implemented on the Brogoitti property in 2001.

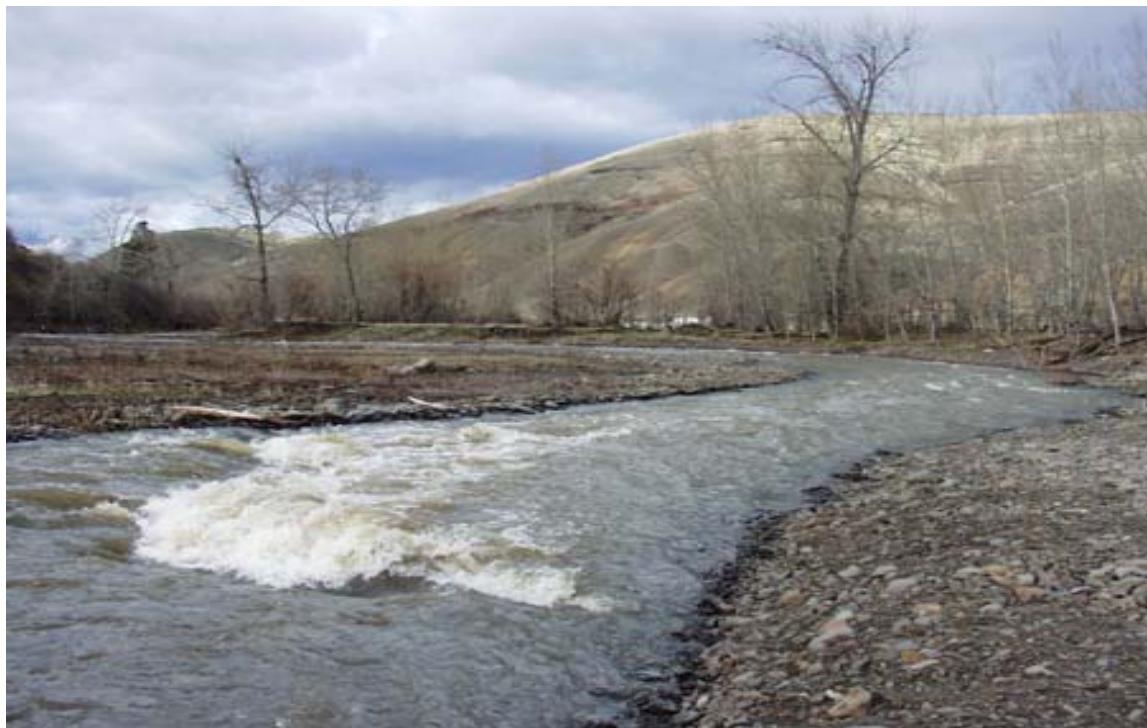
Photo 8. Downstream view (2002) of J-Hook structure and reconstructed point bar, implemented on the Brogoitti property in 2001.

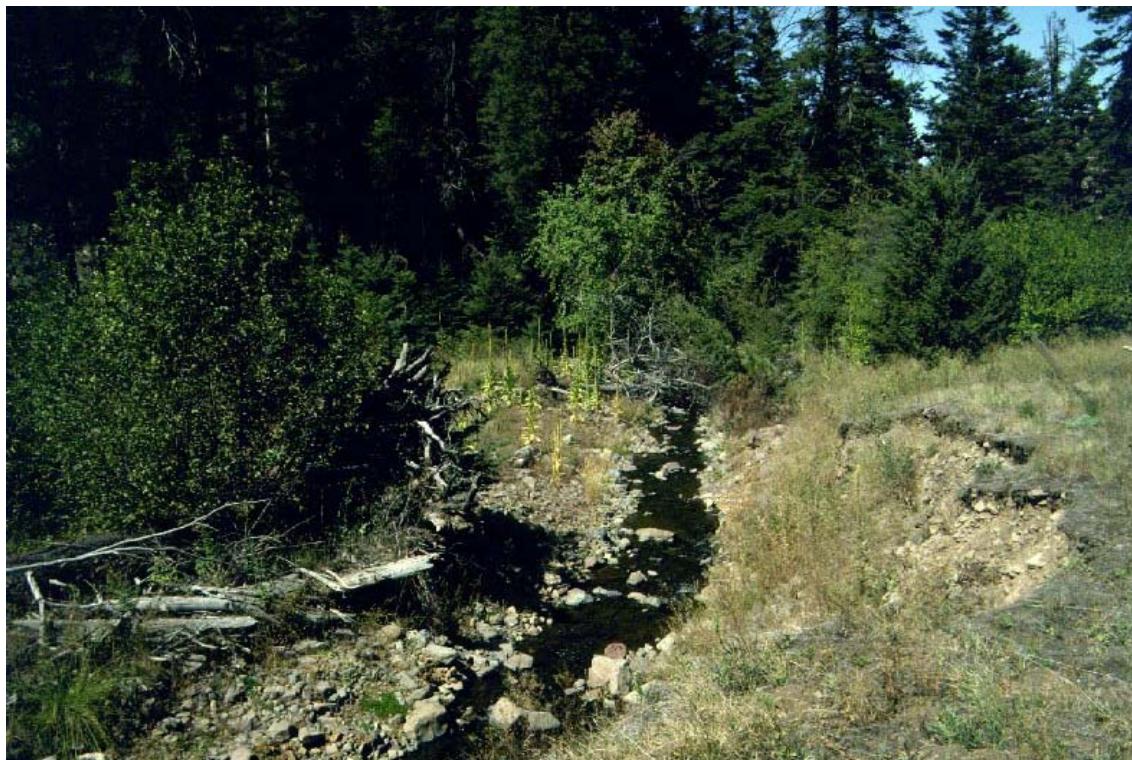
Photo 9. Downstream view (1992) of the Baker property, Westgate Creek.

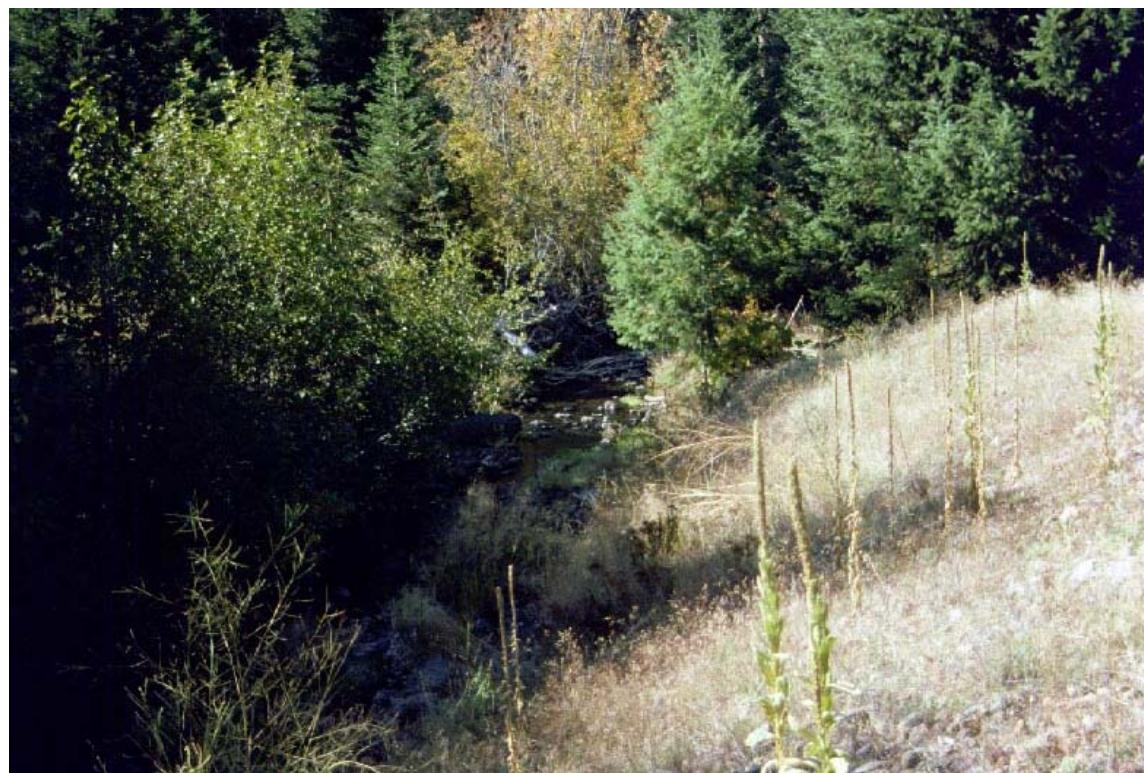
Photo 10. Downstream view (2000) of the Baker property, Westgate Creek (same vantage point).

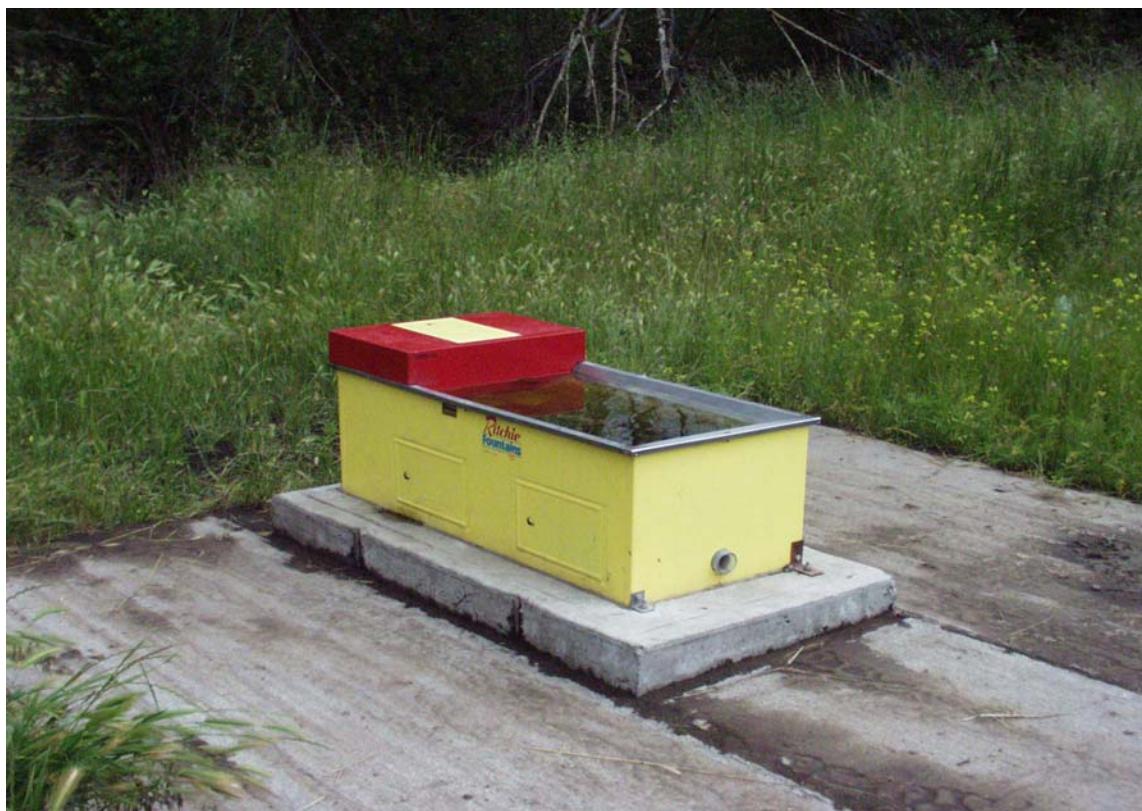
Photo 11. View of the heated water trough completed on the Brogoitti property in 2003.

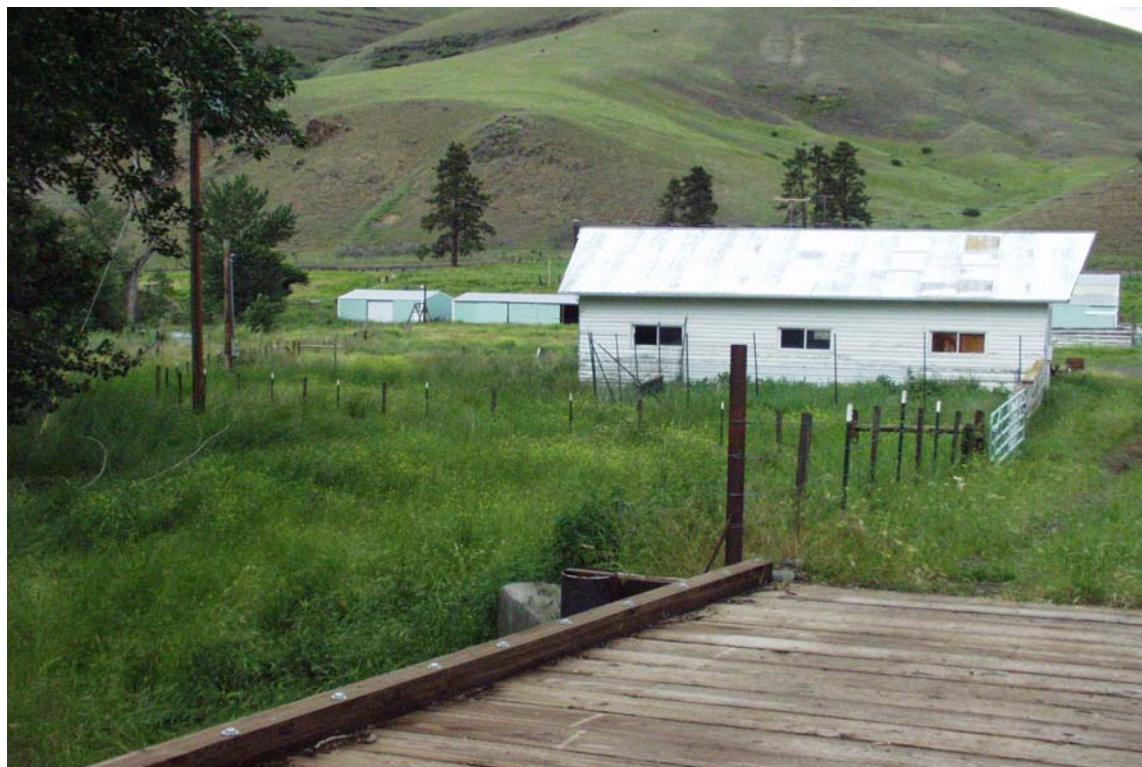
Photo 12. View of the riparian fence, including section tying in to the bridge, completed on the Brogoitti property in 2003.

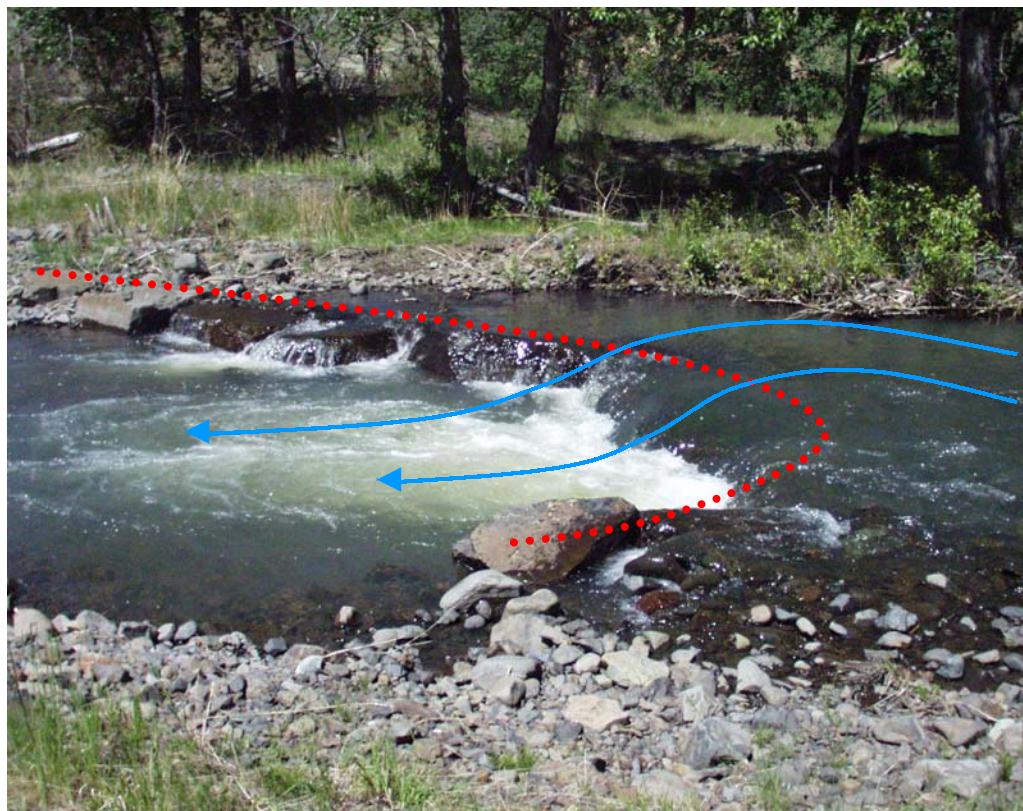
Cross stream view of typical “J-Hook Vane” installed on the Brogoitti property (East Birch Creek), using Rosgen design principals and techniques.

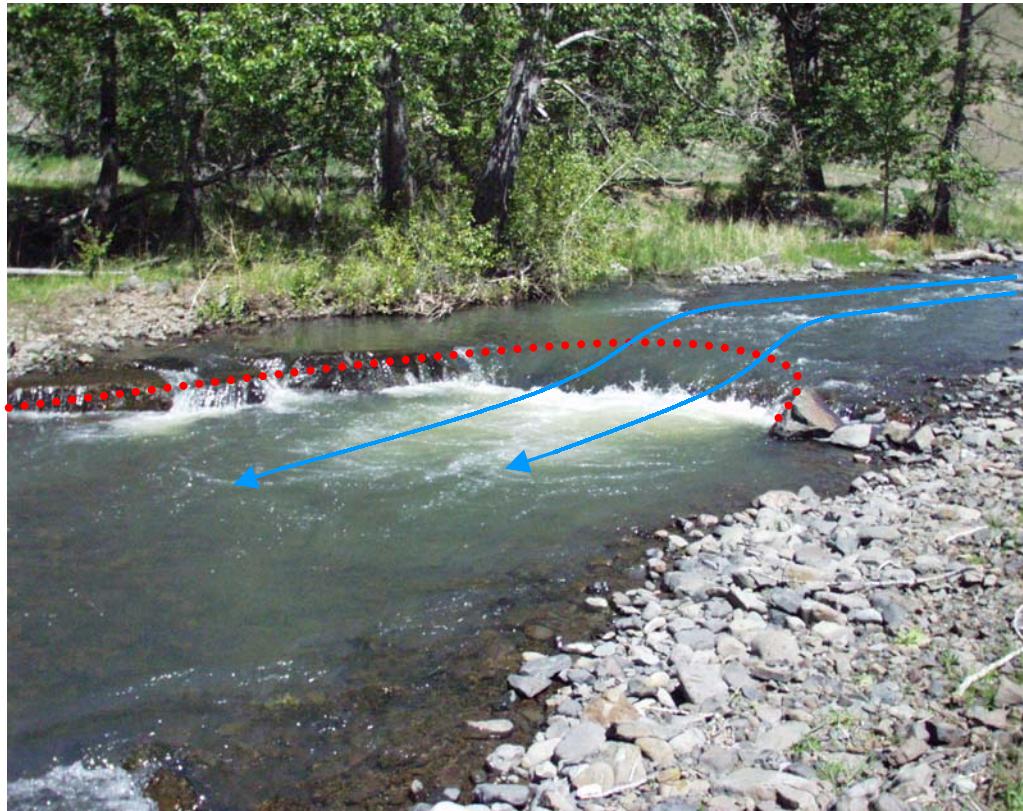
Upstream view of typical “J-Hook Vane” installed on the Brogoitti property (East Birch Creek), using Rosgen design principals and techniques.

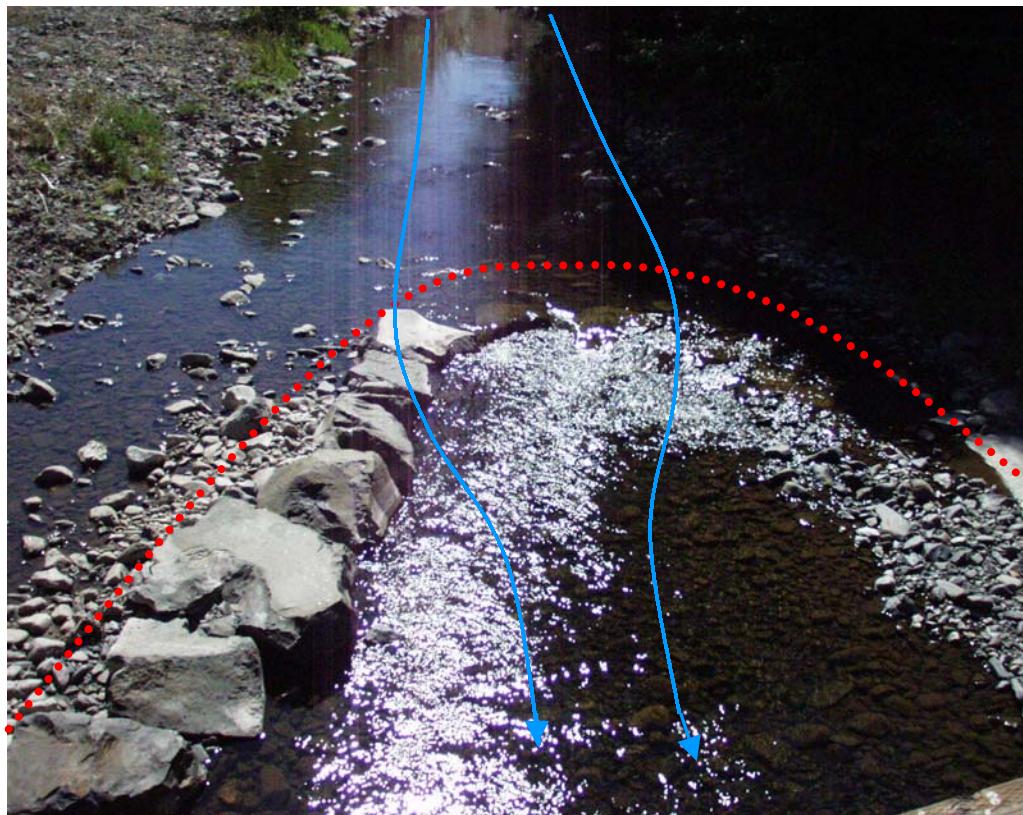
Upstream view of typical “Cross Vane” installed on the Brogoitti property (East Birch Creek), using Rosgen design principals and techniques.

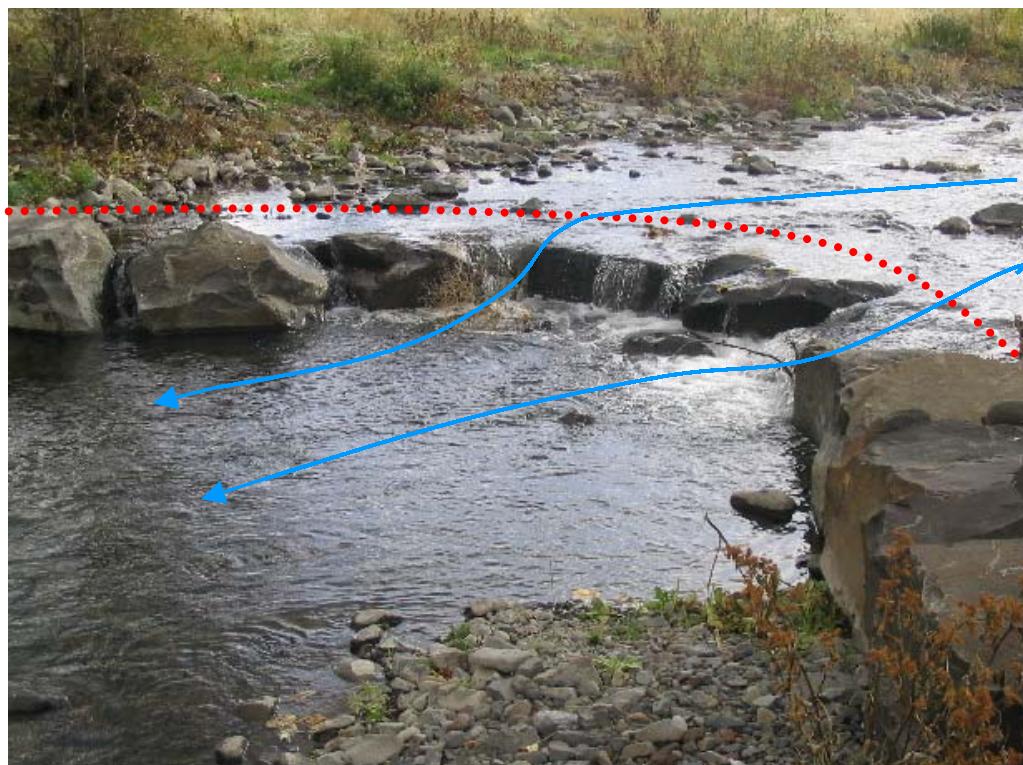
Upstream view of typical “Cross Vane” installed on the Brogoitti property (East Birch Creek), using Rosgen design principals and techniques.

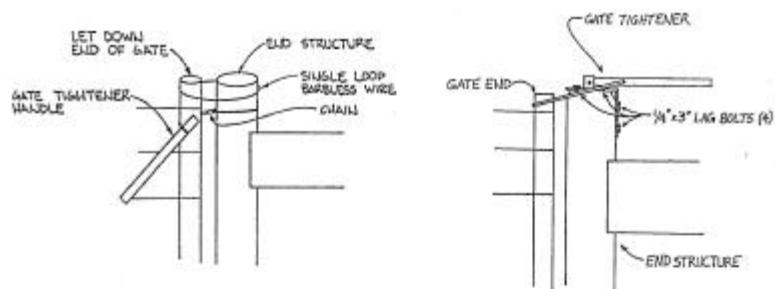
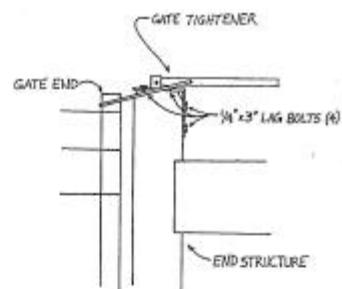
CABLE DETAILS

Typical Fence Construction Specifications

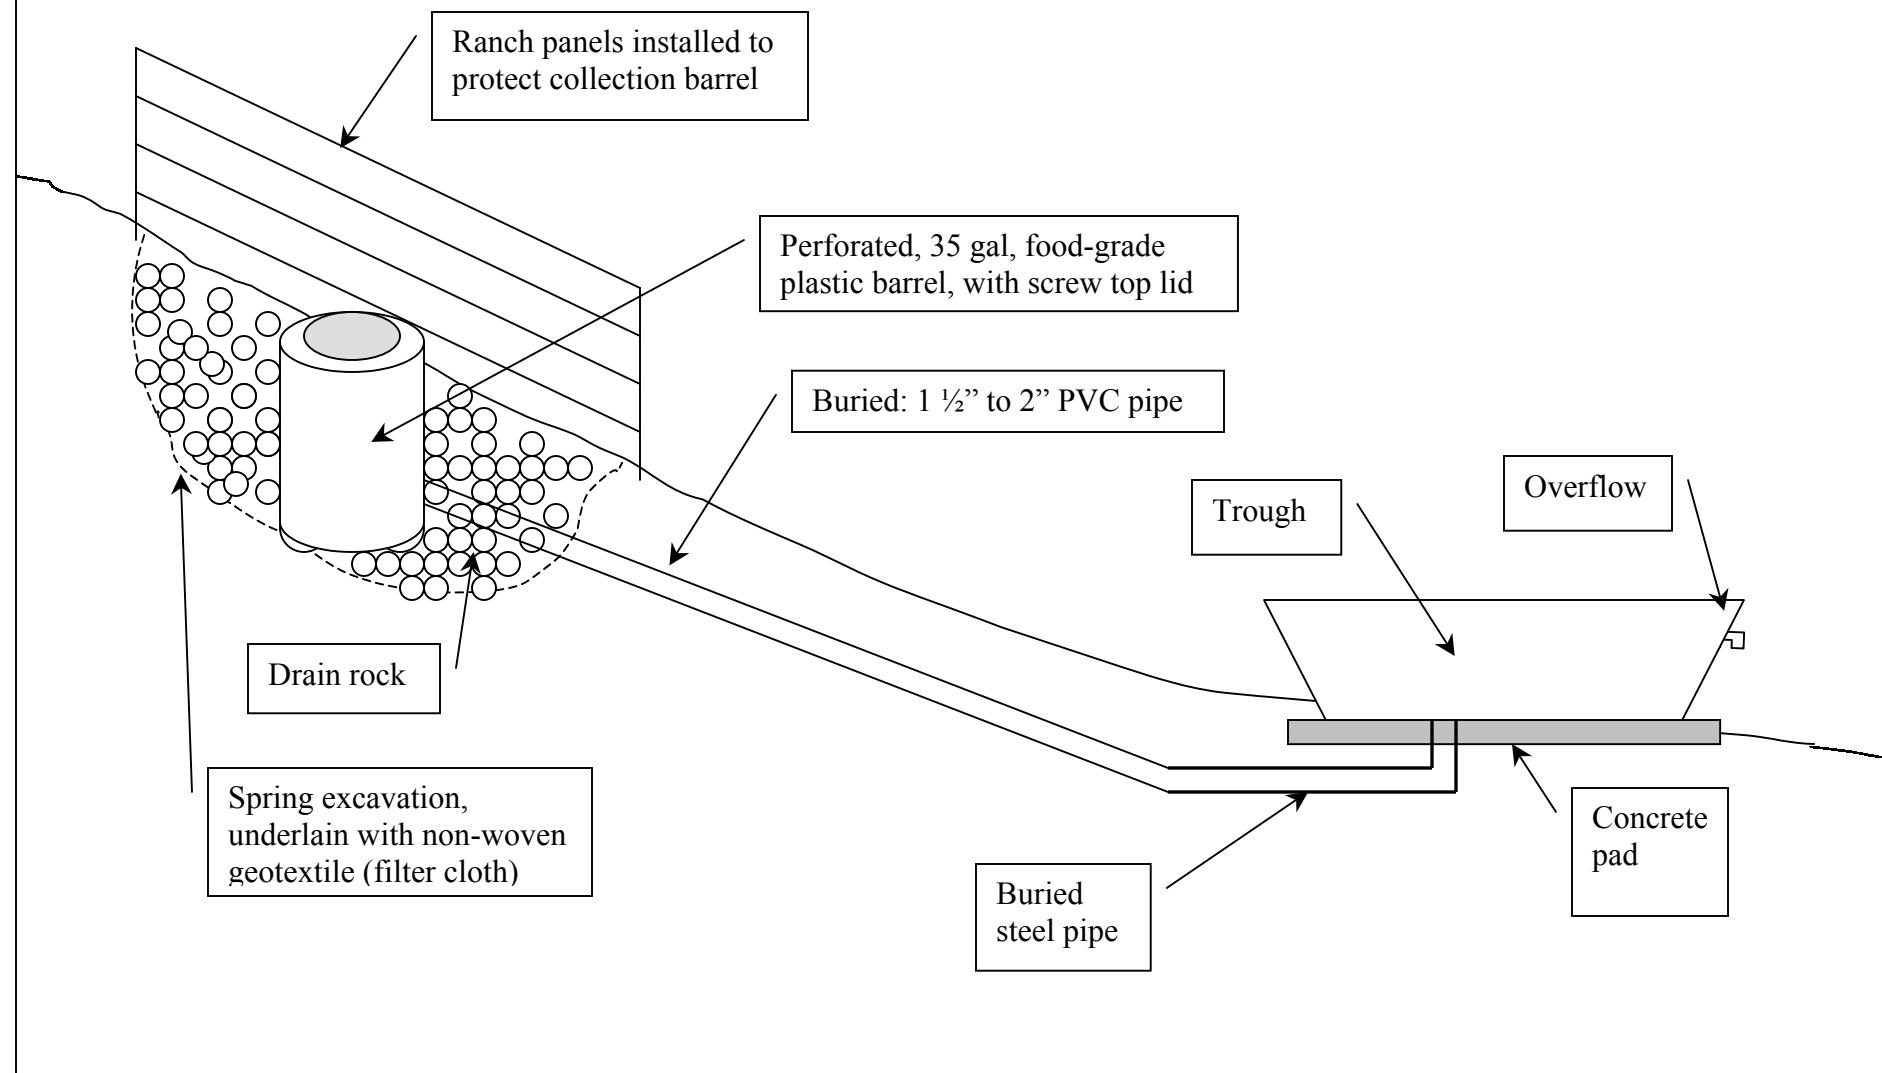
**Schematic Diagram of a Typical, Off-Site Livestock Watering Development
(Gravity Feed, Spring Improvement)**
