Umatilla River Subbasin Fish Habitat Improvement Program

Annual Report 2004 - 2005

2004 ANNUAL REPORT Project Completion/Summary Report January through December 2004

BPA Project No. 1987-100-02
Contract No.: 00005101

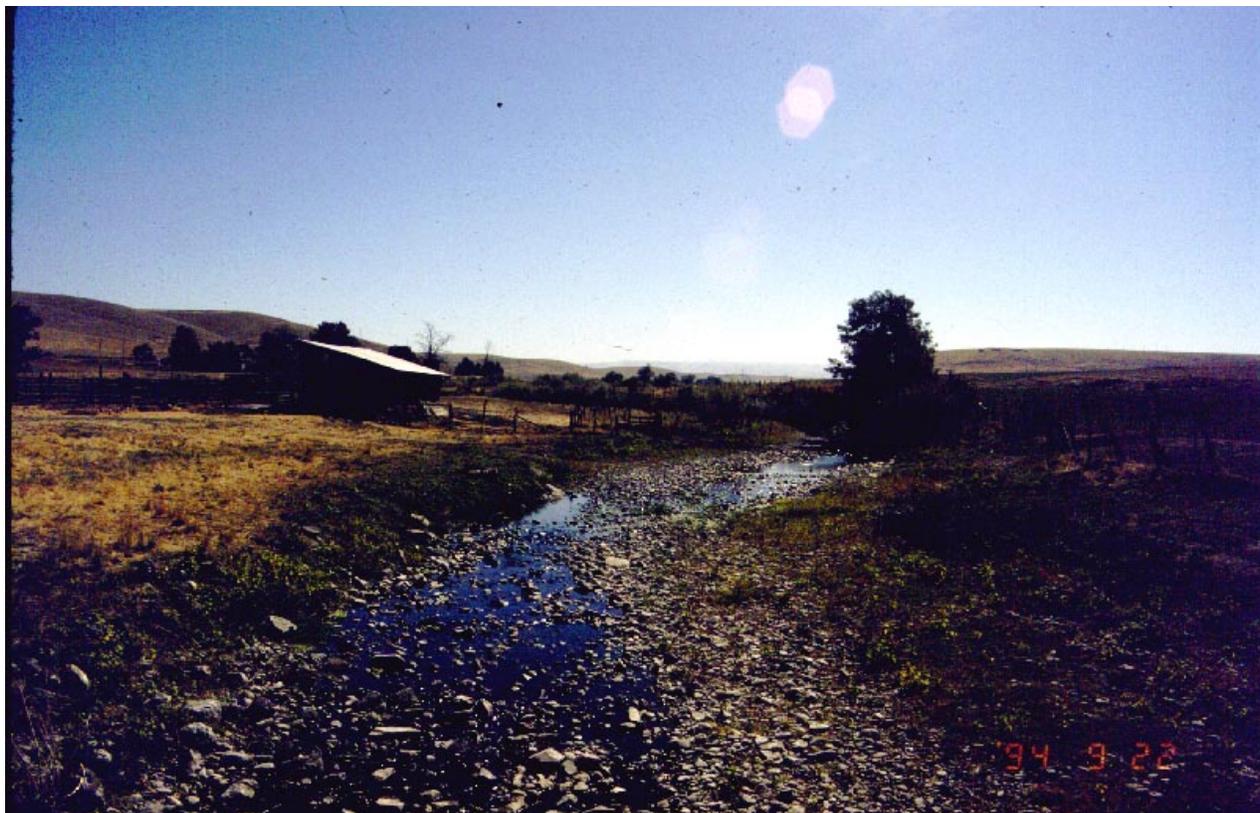
Photo 1:	Straughan property, 1994. Following 5 years of passive treatment.
-----------------	---

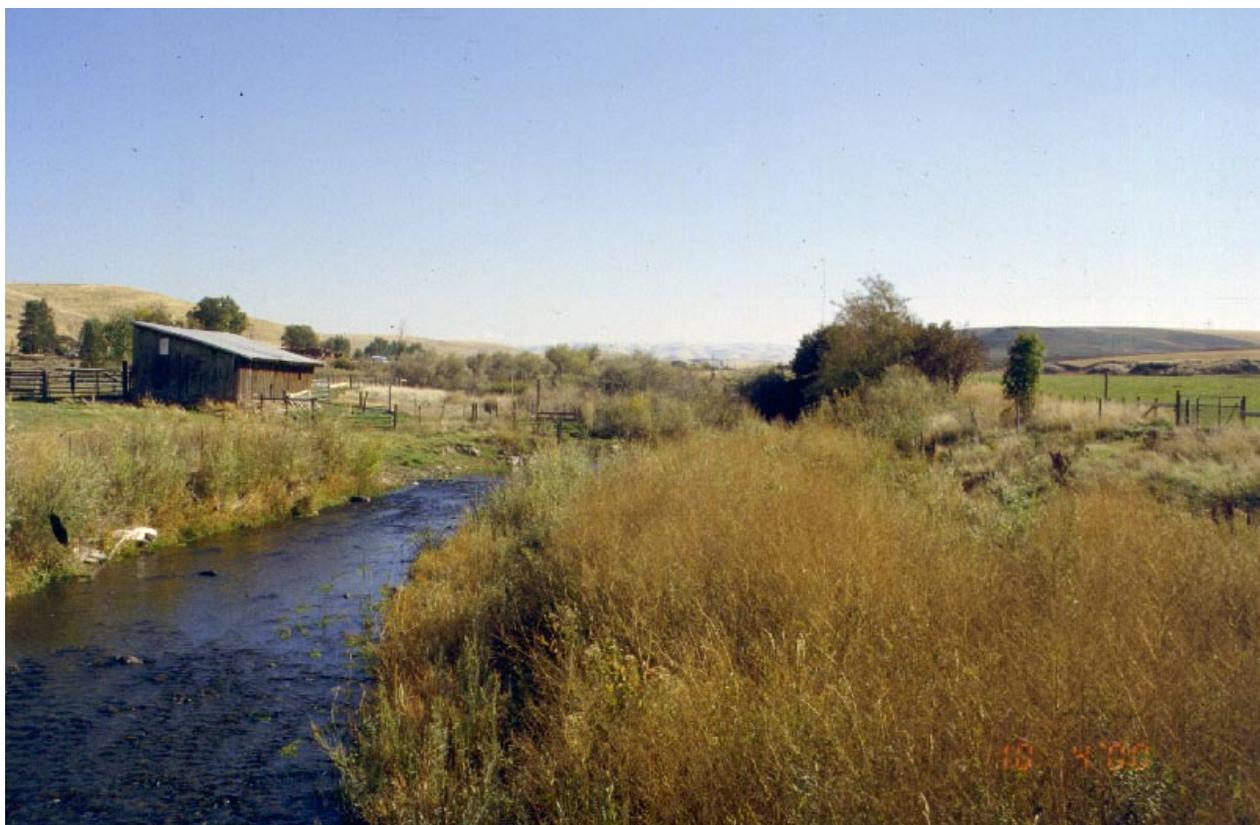
Photo 2:	Straughan property, 2000. Following 11 years of passive treatment.
-----------------	--

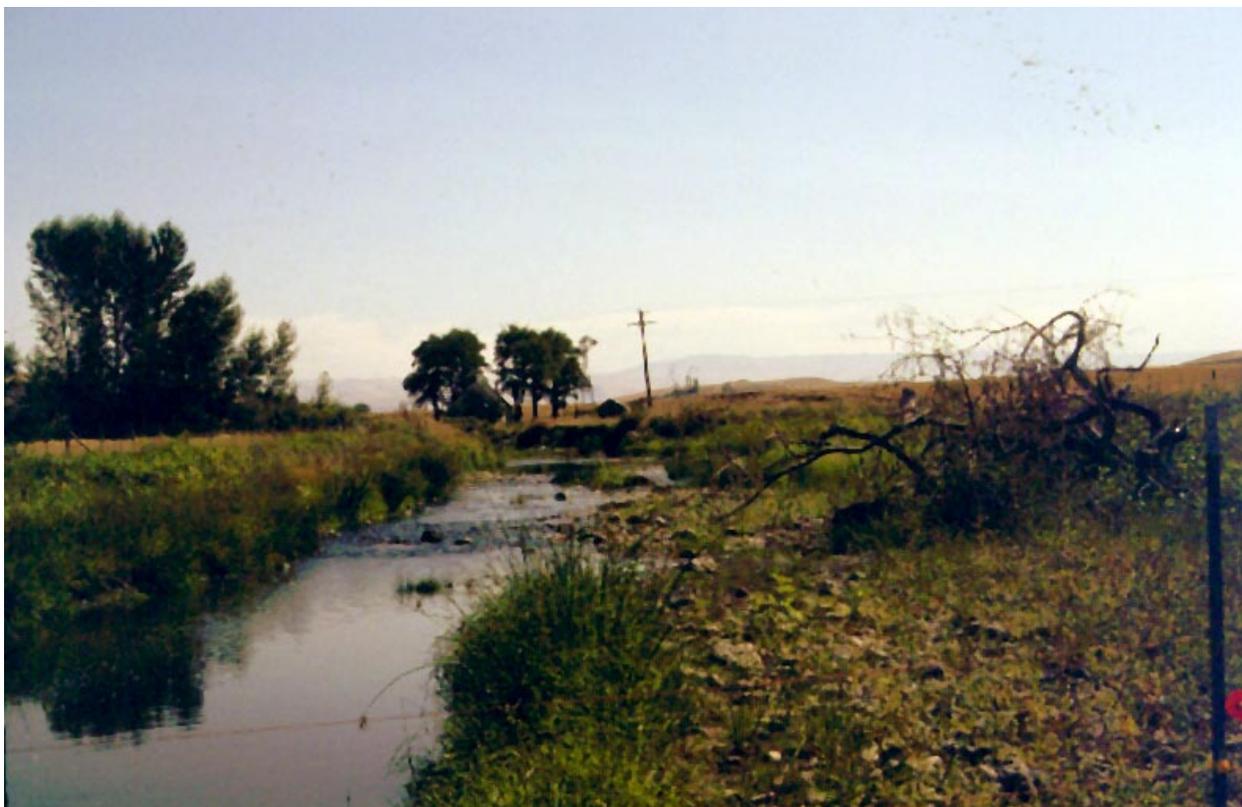
Photo 3:	McDaniel property, 1991. Pre-treatment photo.
-----------------	---

Also implemented in 1989, work on the McDaniel property involved active and passive Habitat Improvement treatments, including livestock exclusion fencing and the installation of rock structures (jetties and toe-rock) to protect and stabilize banks. The 1990 flood caused damage to fences and instream structures and maintenance work was required in 1991. Riparian conditions within the 20.3 acre lease area, have improved significantly since the implementation of Habitat Improvement projects (Photos 3 and 4).

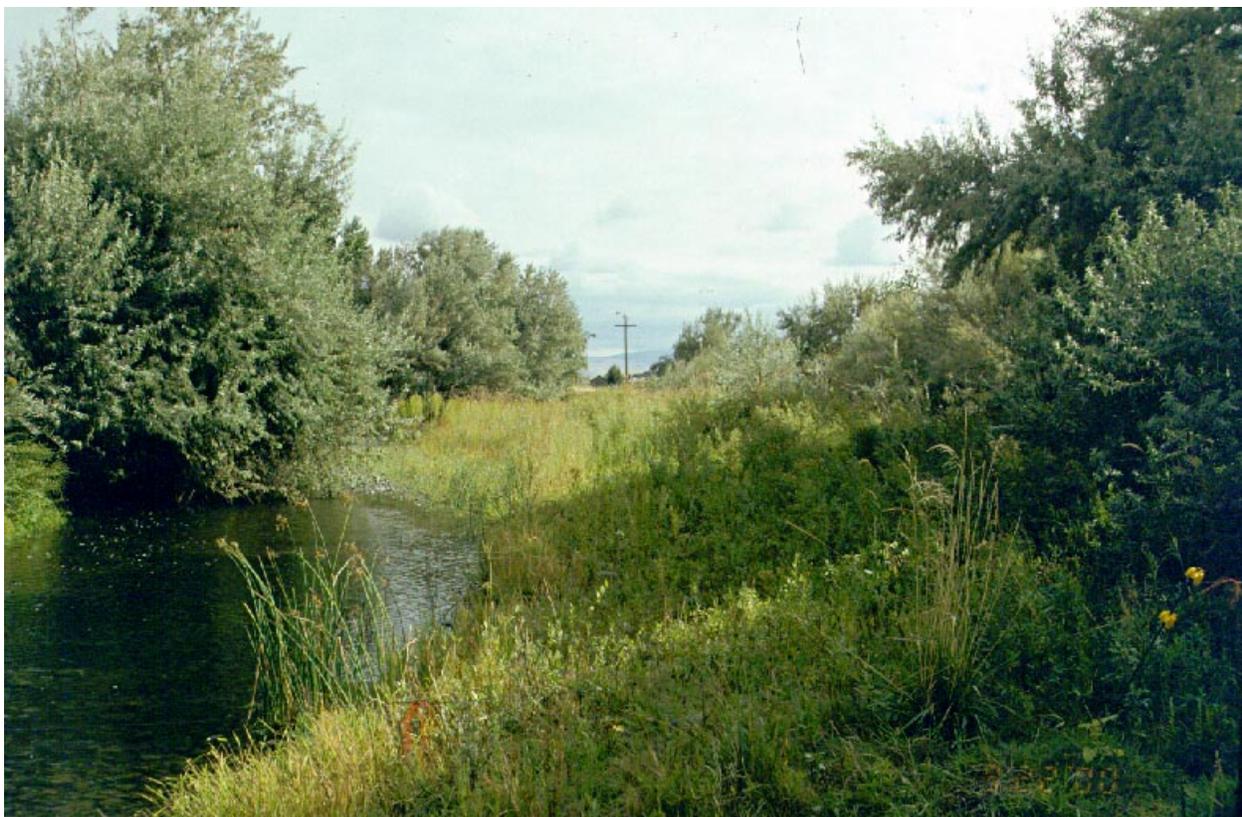
Photo 4:	McDaniel property, 2000. Riparian recovery following livestock exclusion fencing.
-----------------	---

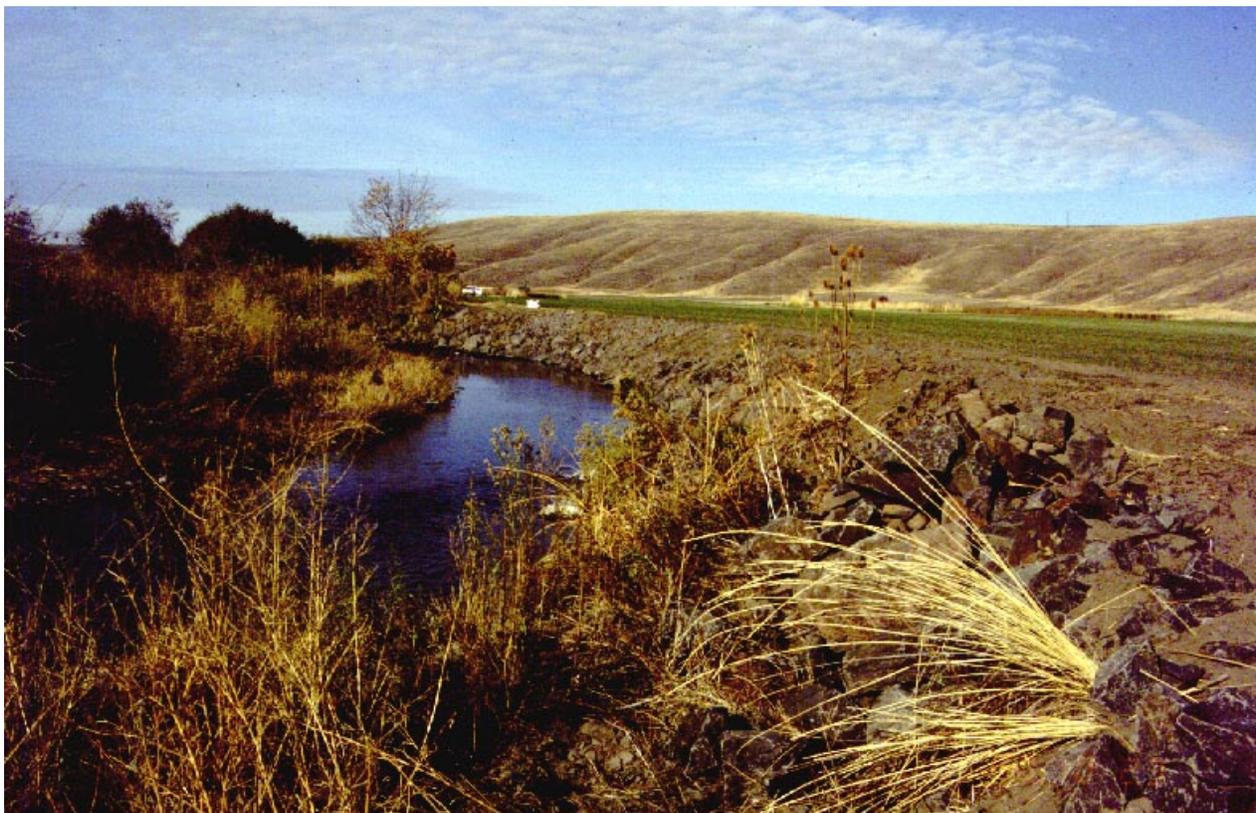
Photo 5:	Rhinhart property, 1990. Following implementation of bank stabilization treatment.
-----------------	--

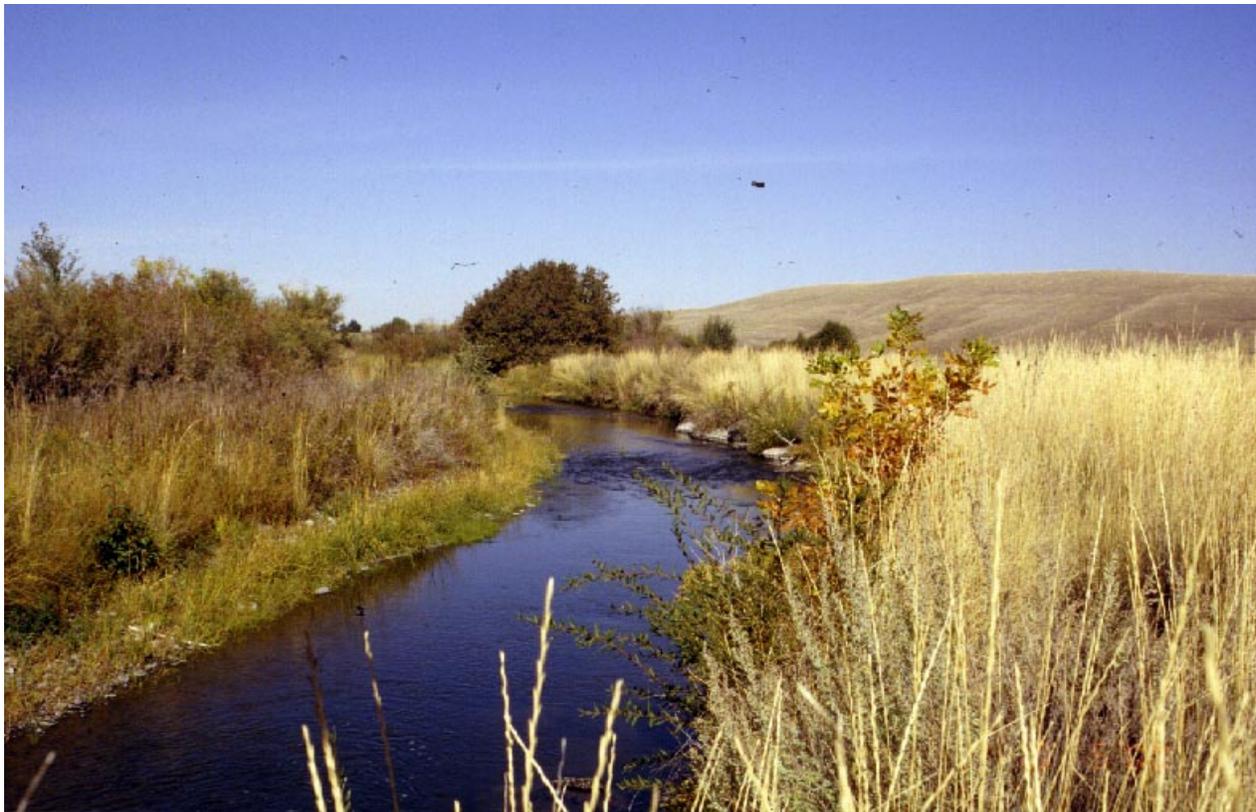
Photo 6:	Rhinhart property, 2000. Following 10 years of recovery at bank stabilization treatment site.
-----------------	---

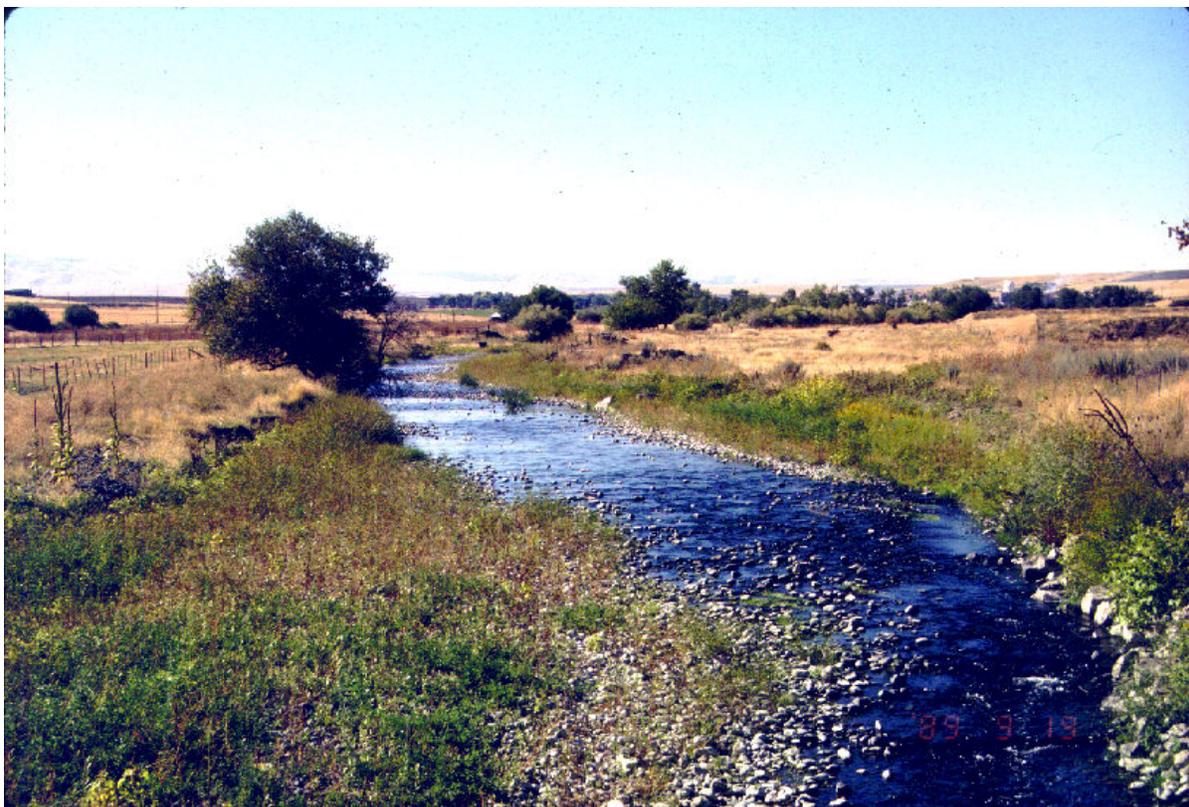
Photo 7:	Hemphill property, 1989. Pre-treatment photo.
-----------------	---

Habitat Improvement work on the Hemphill property was limited to passive treatments, namely the installation of 0.38 miles of livestock exclusion fence in 1998. Riparian habitat conditions within the 10.0 acre project area, showed significant improvement during the period of the lease agreement (Photos 7 and 8). This favorable, and relatively rapid response, was likely attributable to intact stream channel/floodplain connectivity within the treated reach. Flood events prompted major fence maintenance in 1991.

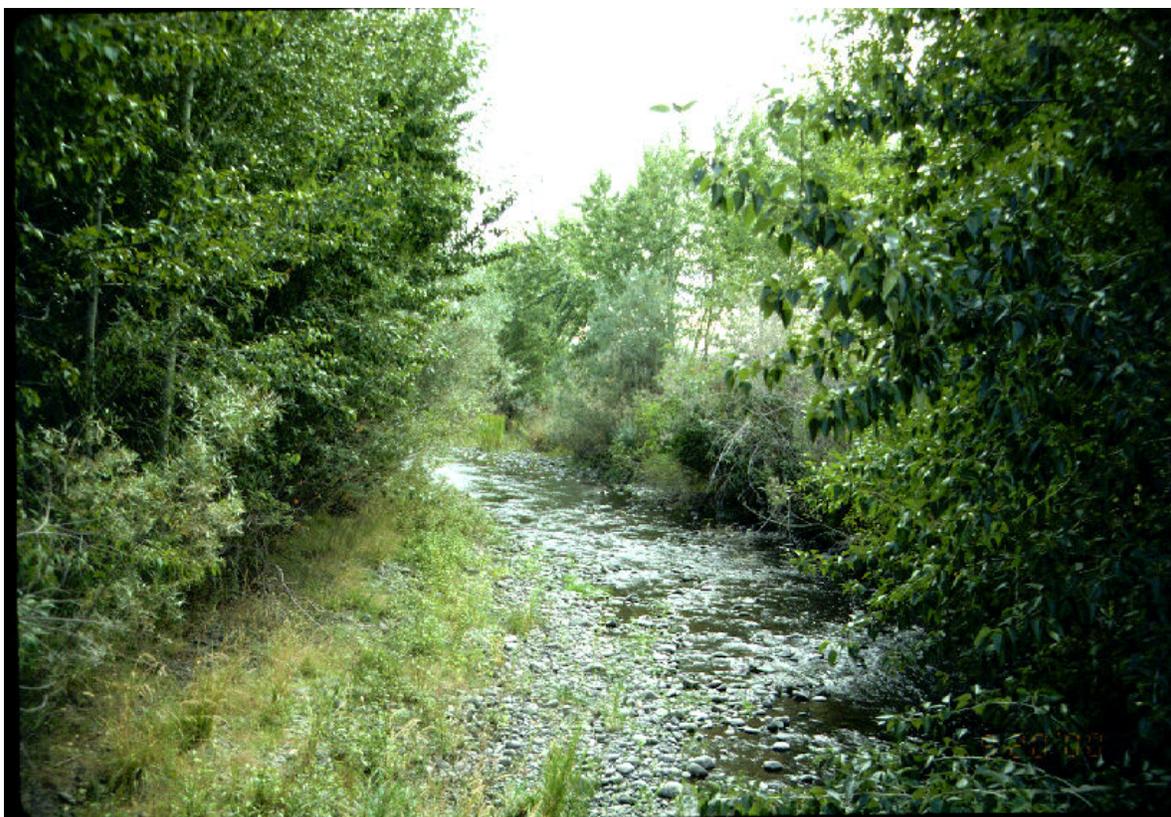
Photo 8:	Hemphill property, 2000. Riparian recovery following livestock exclusion fencing.
-----------------	---

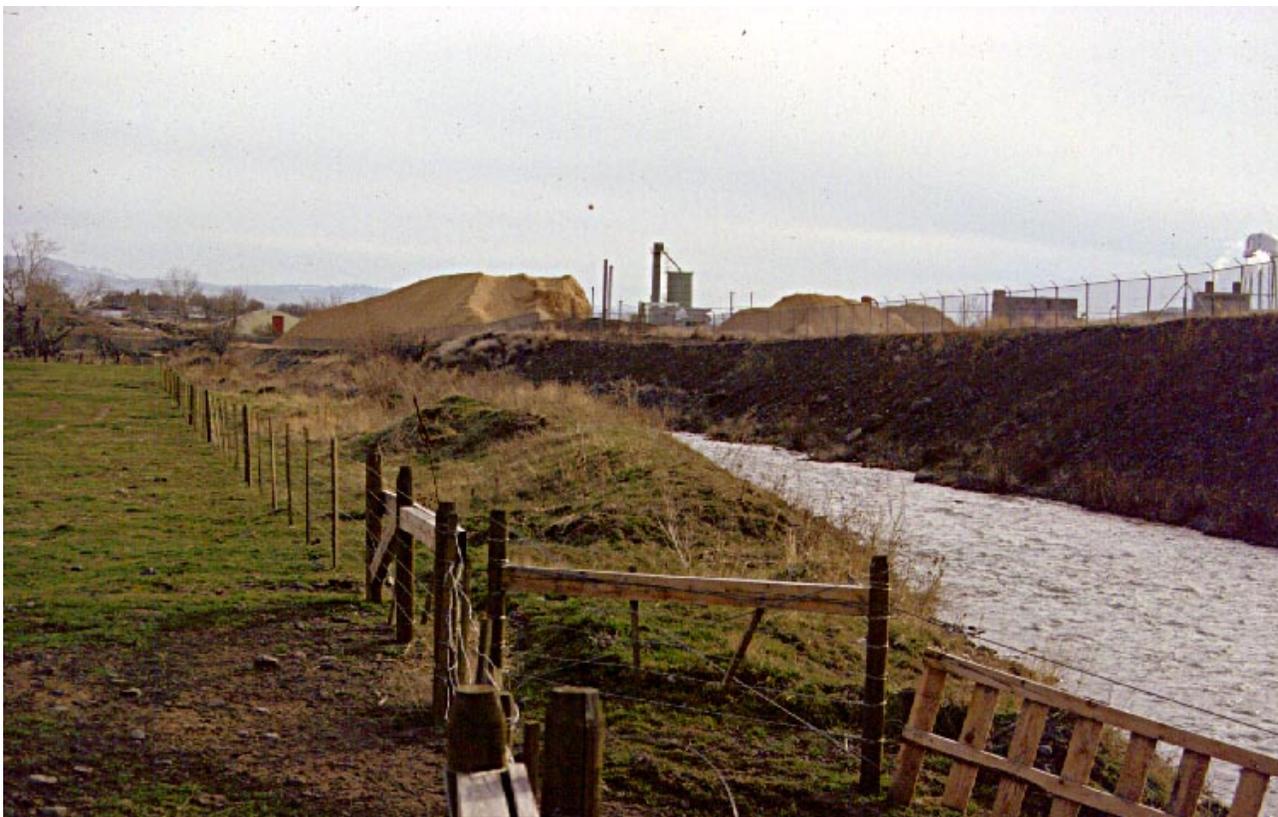
Photo 9: Weinke property, 1990. One year following fence installation.

Habitat Improvements on the Weinke property consisted primarily of livestock exclusion fencing, installed along the property's 0.44 mile section of stream (Photos 9 and 10). In addition, bank stabilization treatments were implemented along a section of channel that encompasses the lower portion of the Weinke property and the upper portion of the adjacent Gambill property. Instream and fence maintenance was required in 1991, following the 1990 flood. The Habitat Biologist has been in contact with Mr. Weinke and is currently trying to develop a new lease agreement to extend protection of project investments on the property.

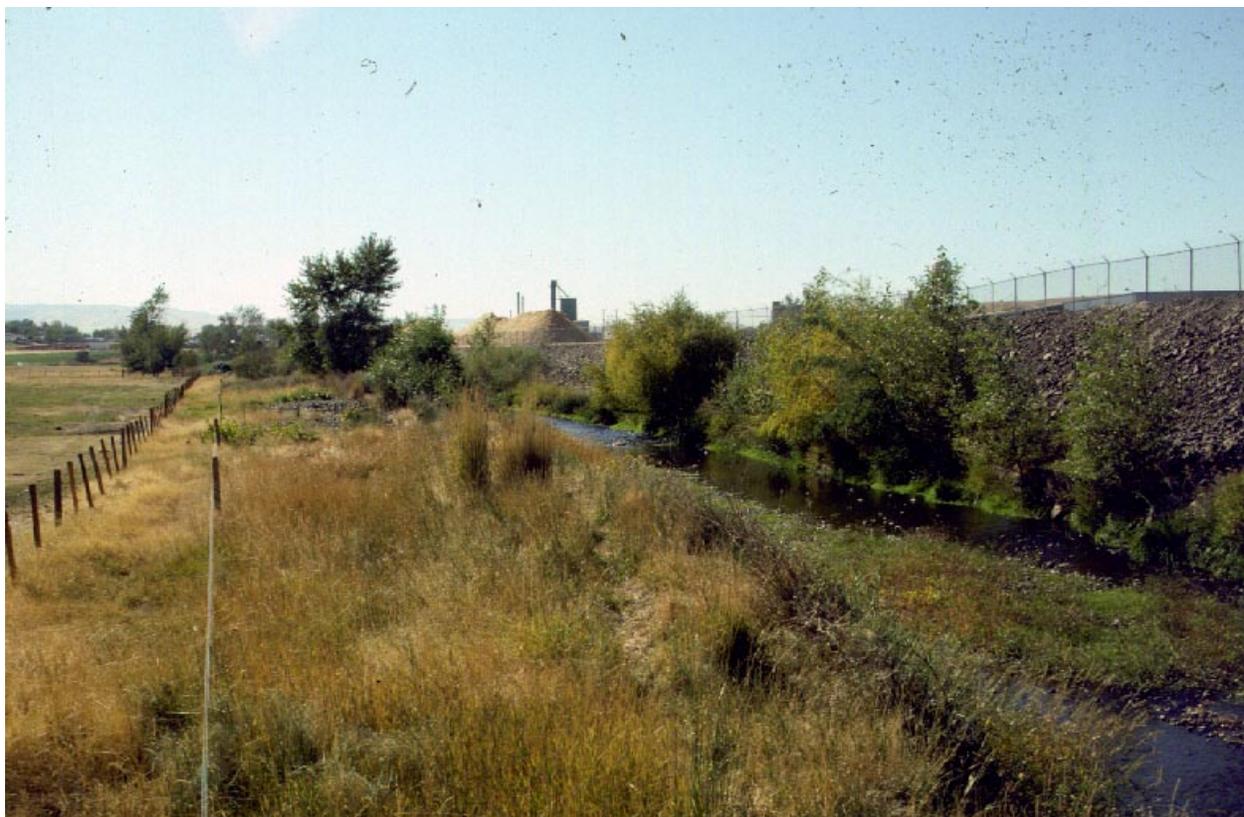
Photo 10: Weinke property, 1999. Following 8 years of riparian recovery within fenced area.

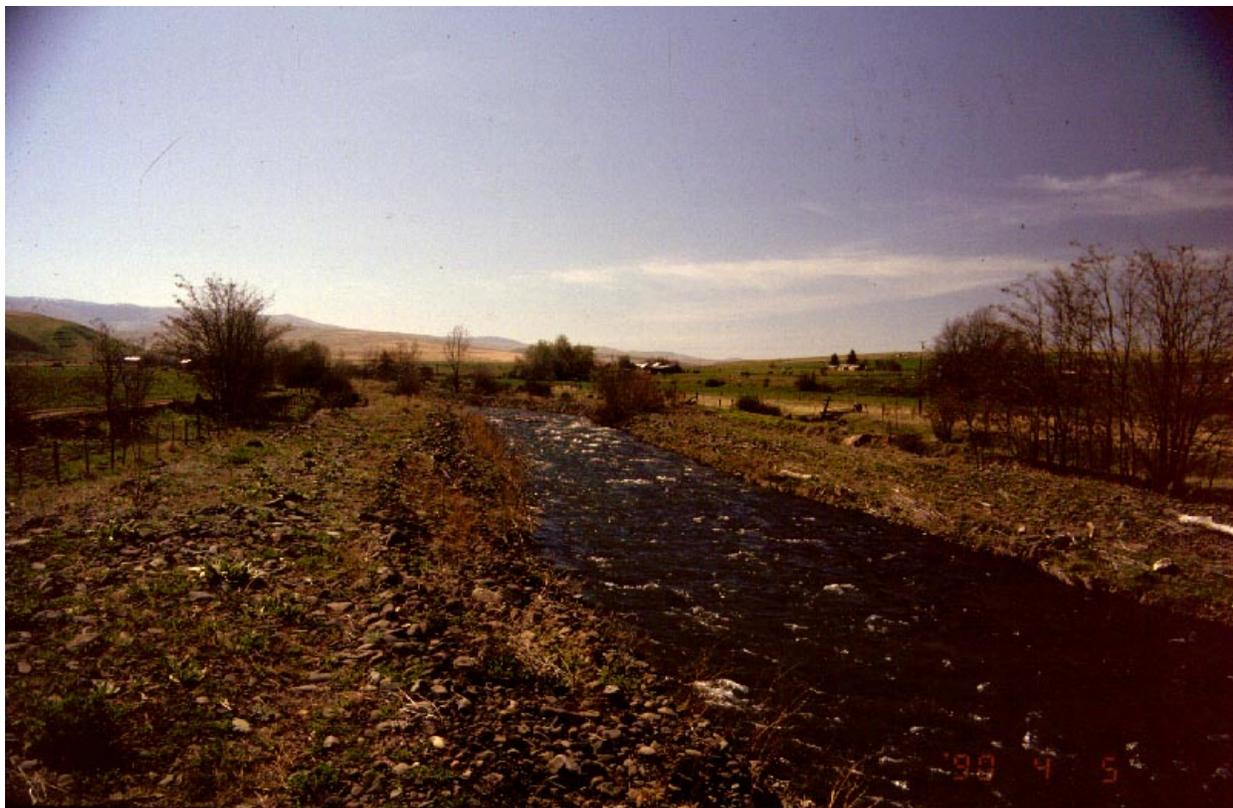
Photo 11: Magic Mile (Cumiskey property), 1990. Pre-treatment photo.

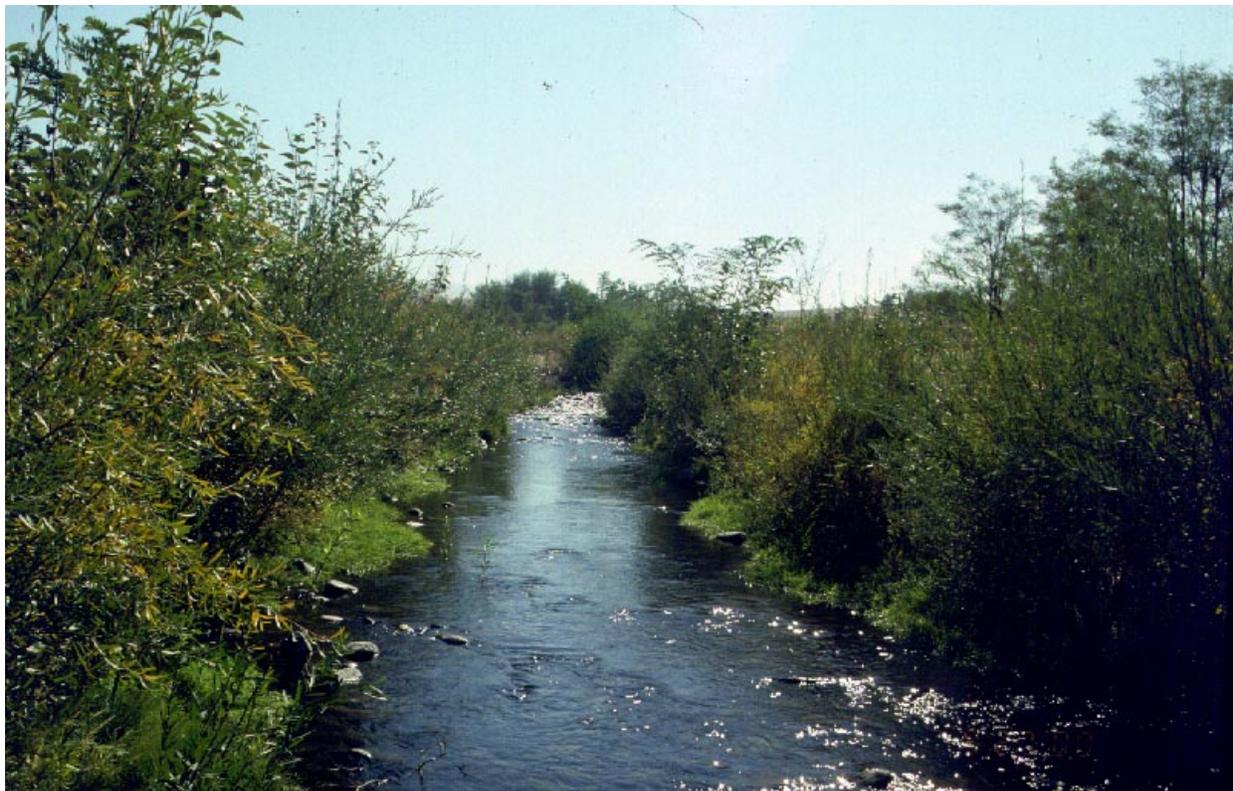
Photo 12: Magic Mile (Cumiskey property), 2000. Riparian recovery following livestock exclusion fencing.

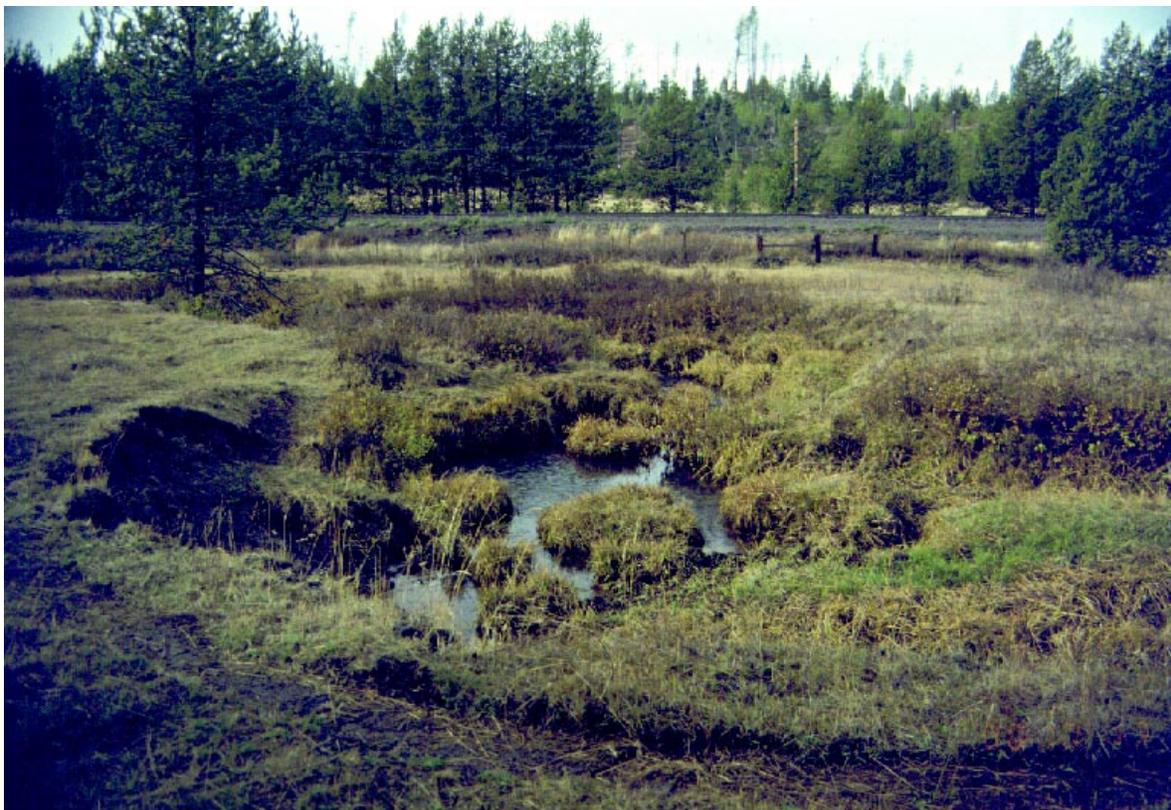
Photo 13:	LP (Boise Cascade) property, 1990. Pre-treatment photo.
------------------	---

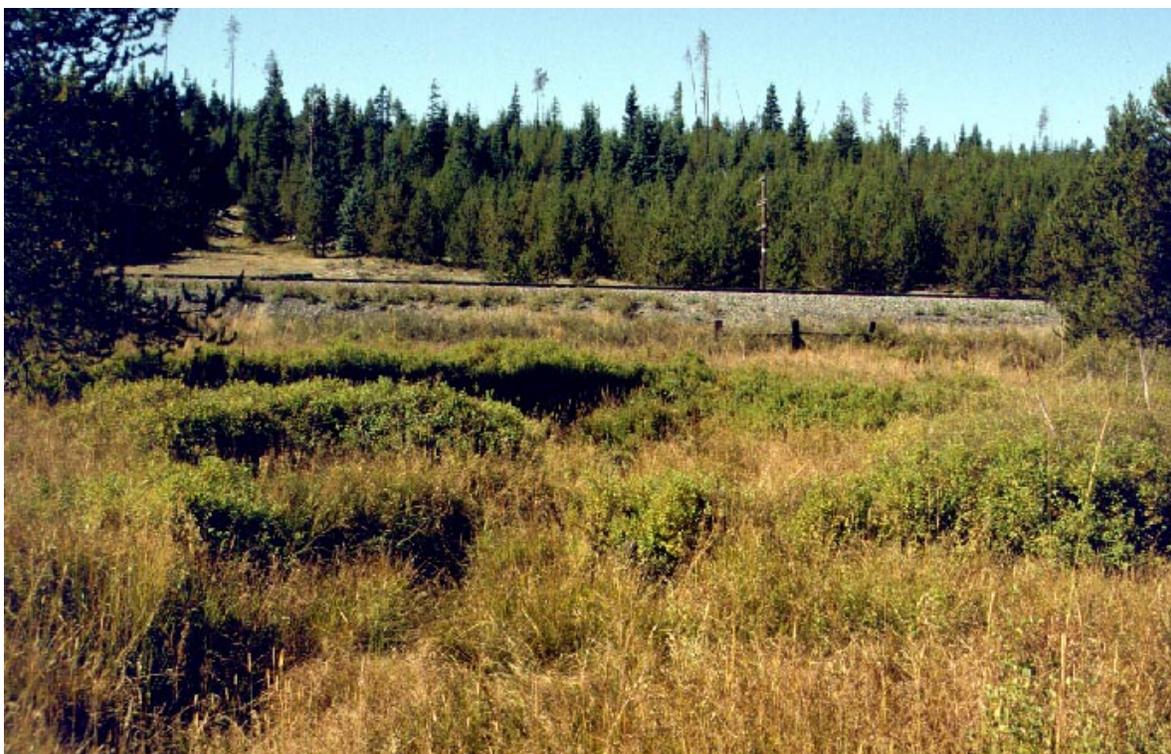
Photo 14:	LP (Boise Cascade) property, 1999. Riparian recovery, promoting channel stability following livestock exclusion fencing.
------------------	--

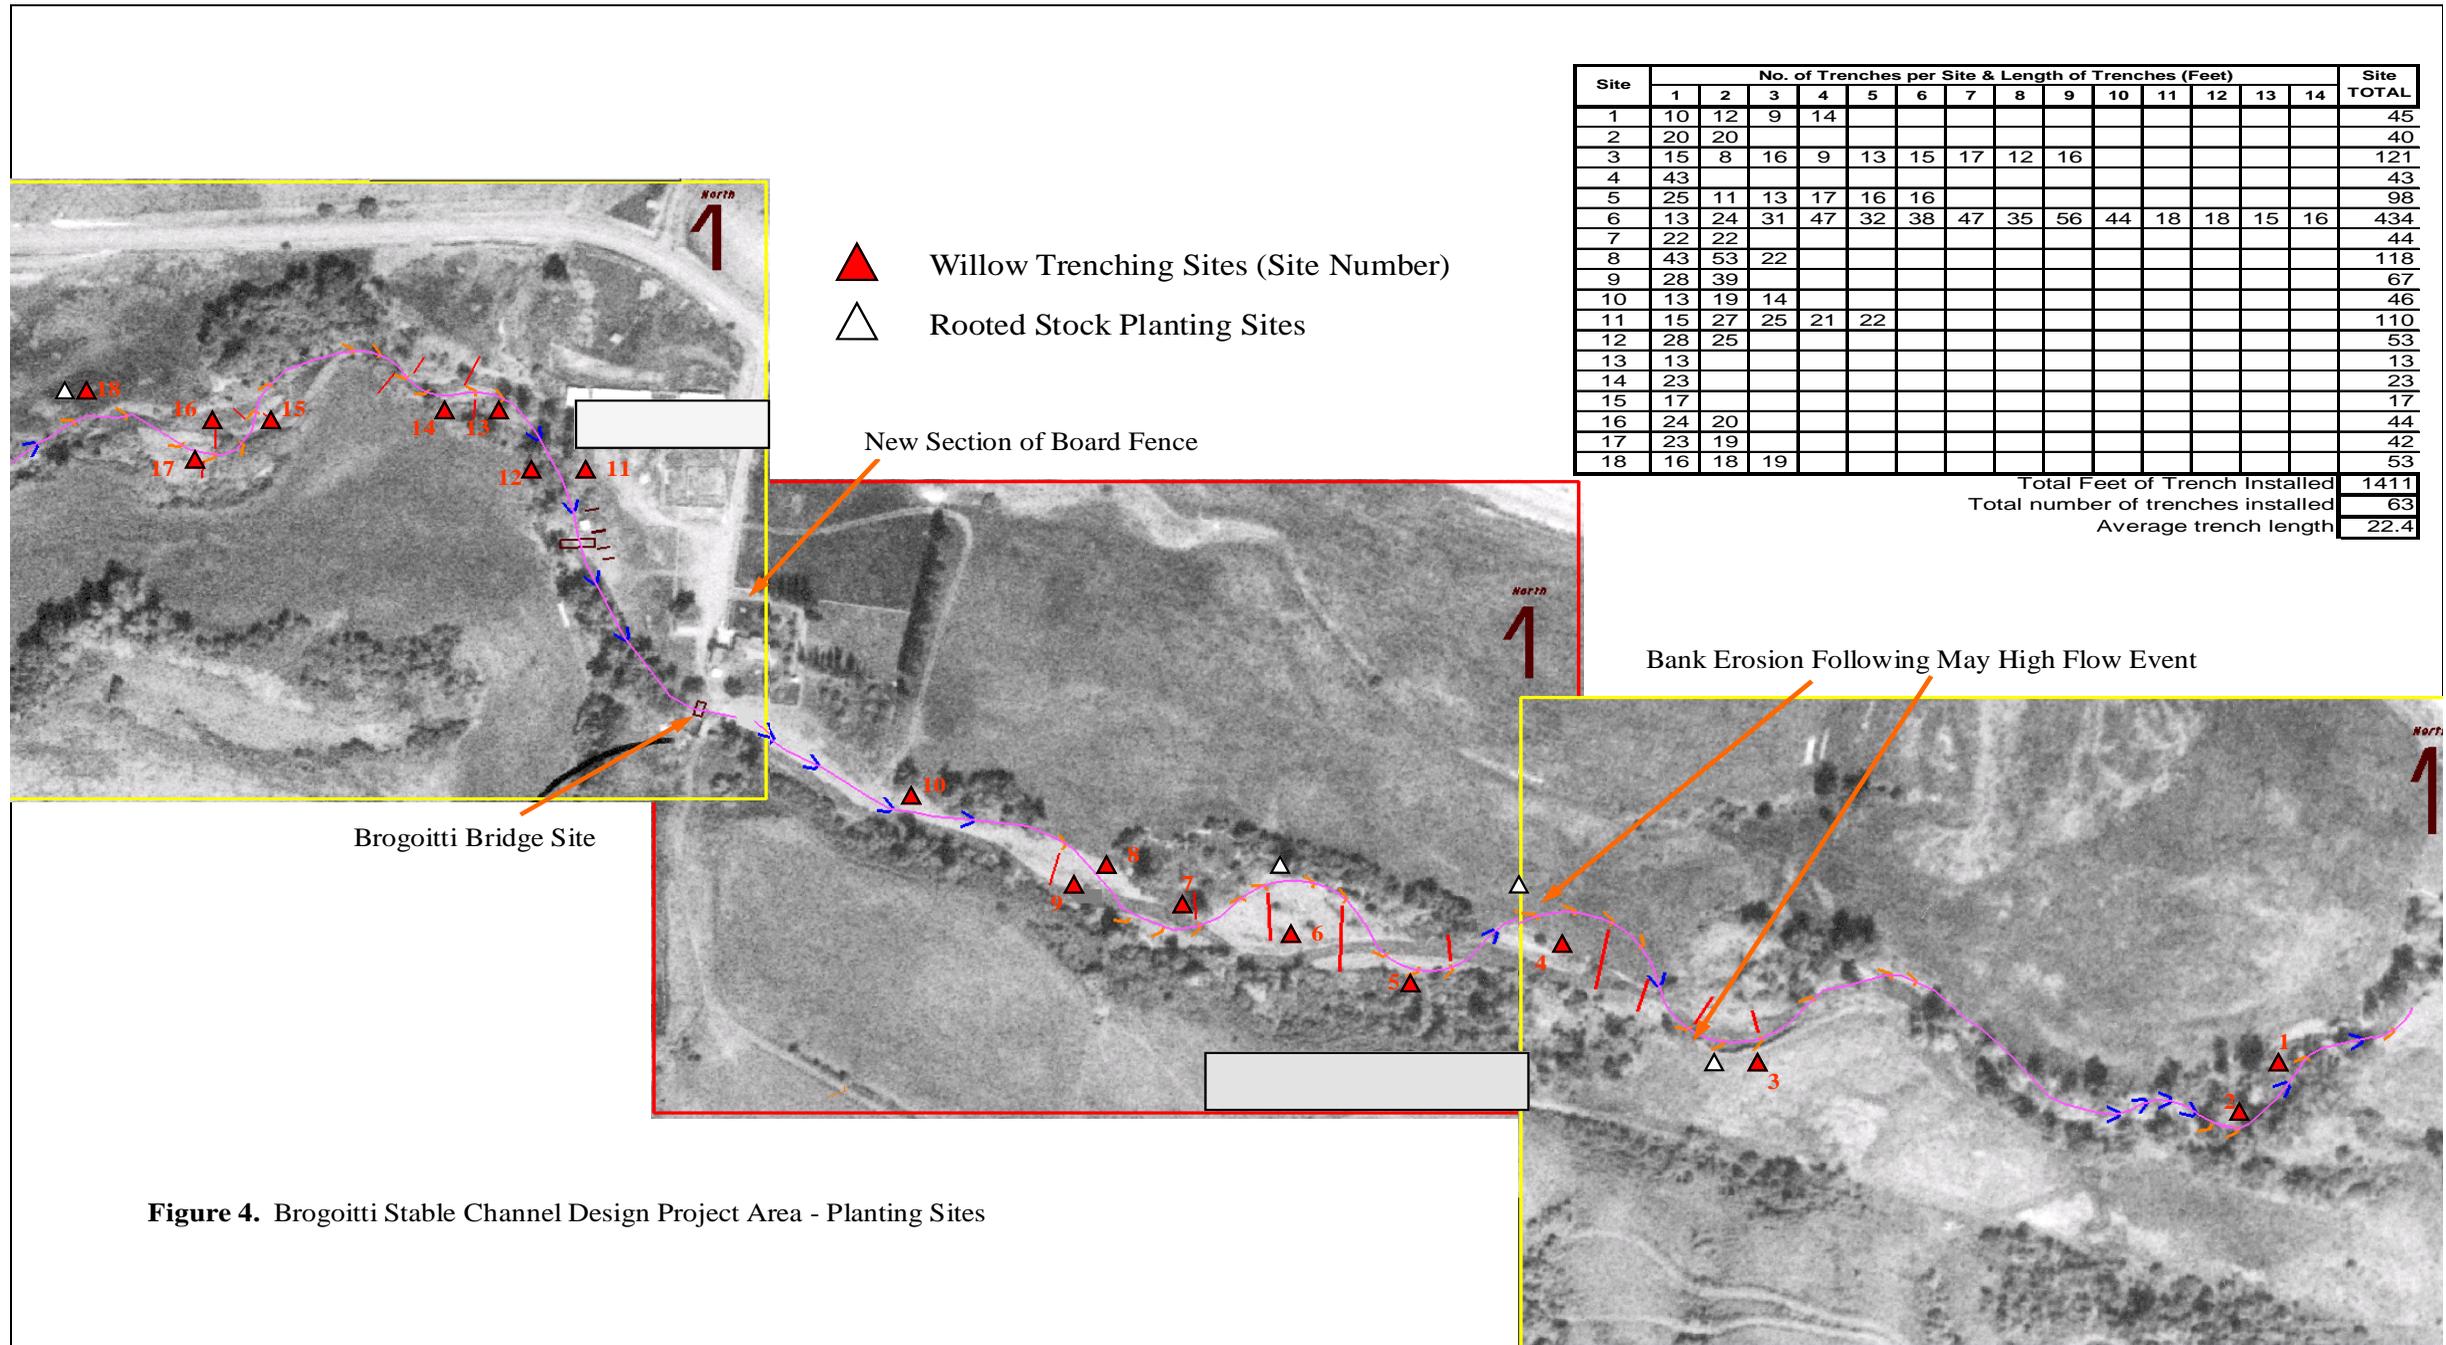
Figure 4. Brogoitti Stable Channel Design Project Area - Planting Sites

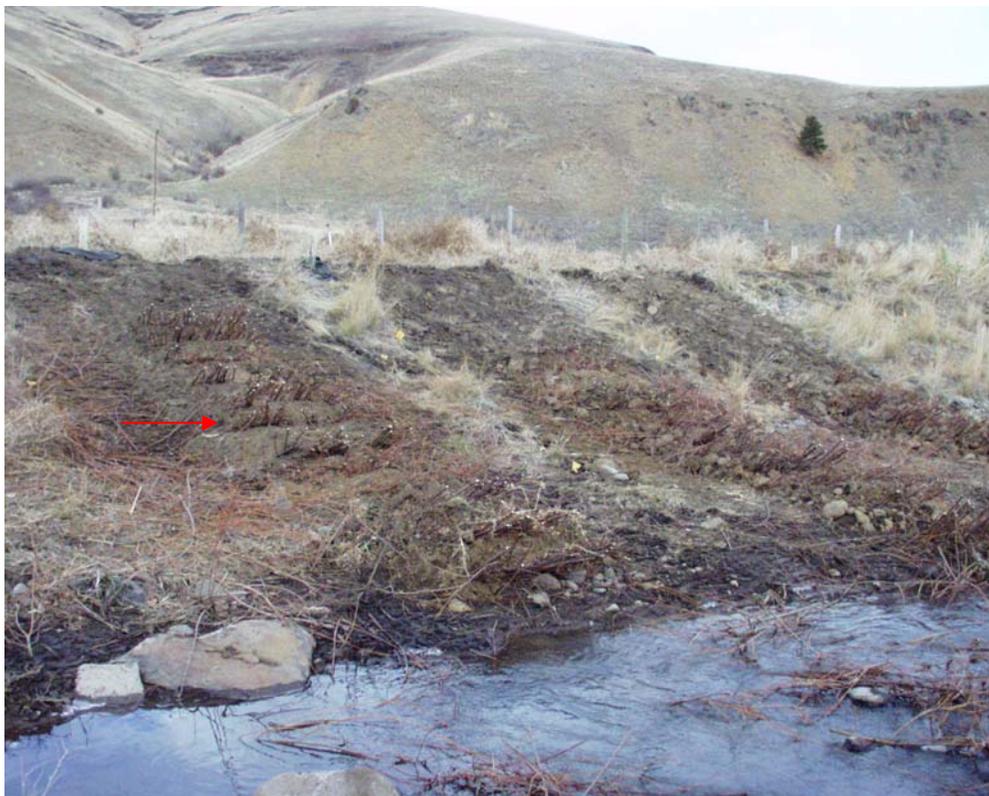
Photo 15:	Cross-stream (north) view. Three willow trenches installed along East Birch Creek. Rows of individual willow stems visible.
------------------	---

Trenches were installed to increase vegetative cover within flood prone areas. Willow trenches will also help to focus high velocity flows in the stream channel at above bankfull flow stages, thereby maintaining sediment transport capabilities and reducing the potential for excessive, localized aggradation. Similar trenches installed in 2002 have also helped promote fine sediment deposition,

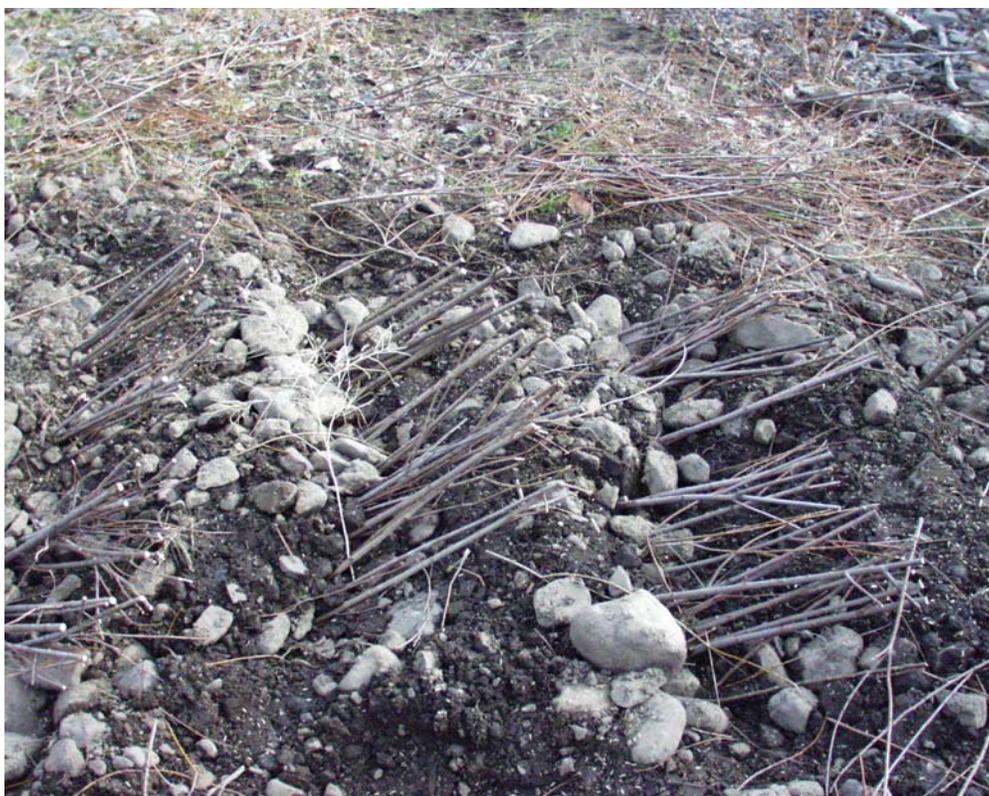
Photo 16:	View of willow cuttings (rows) installed in a trench along East Birch Creek. Installed at a 45 degree angle and trimmed.
------------------	--

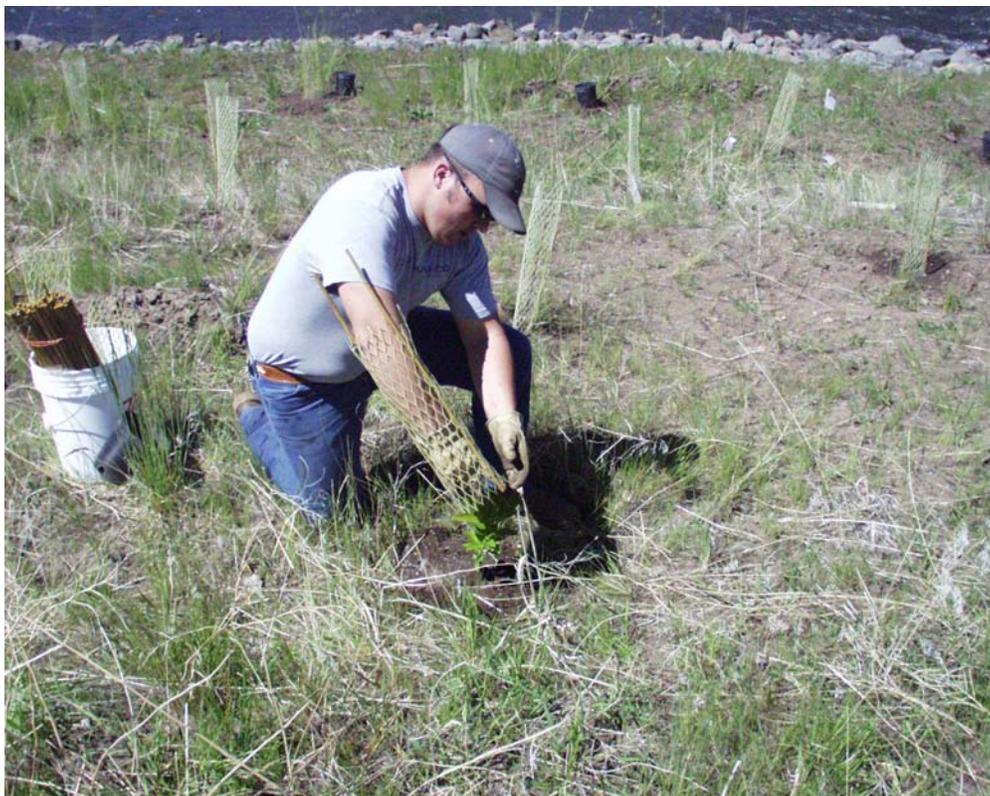
Photo 17:	Installation of plastic mesh browse cones to protect rooted stock plantings along East Birch Creek
------------------	--

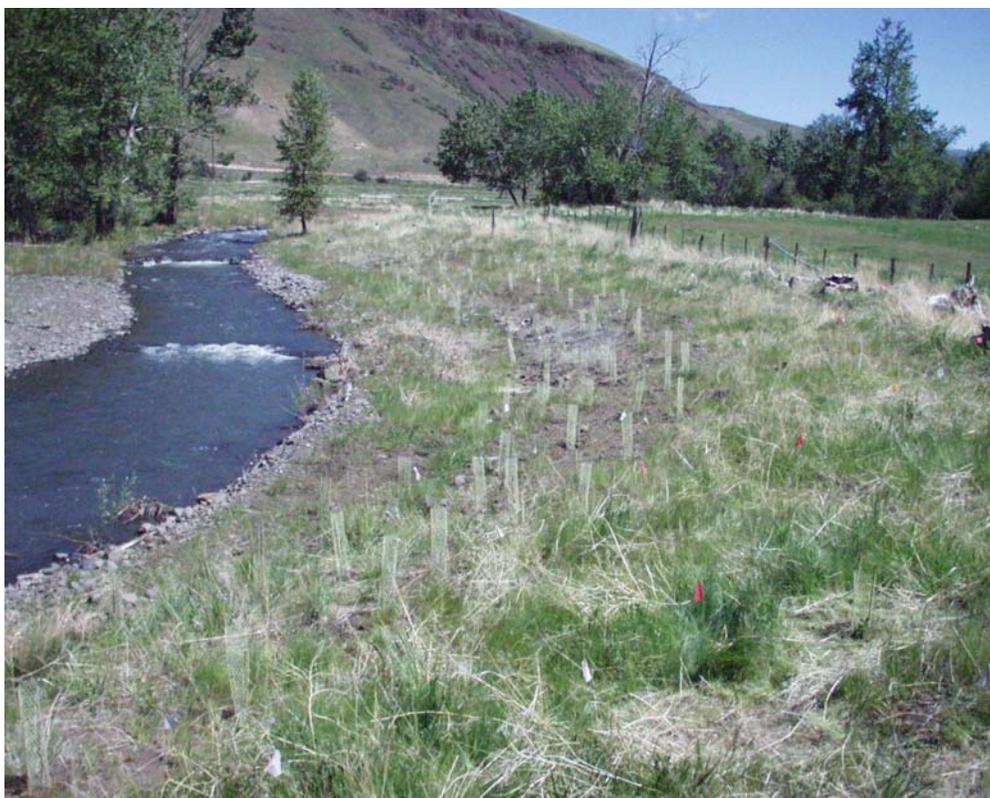
Photo 18:	View of rooted stock plantings along East Birch Creek, Brogoitti Property.
------------------	--

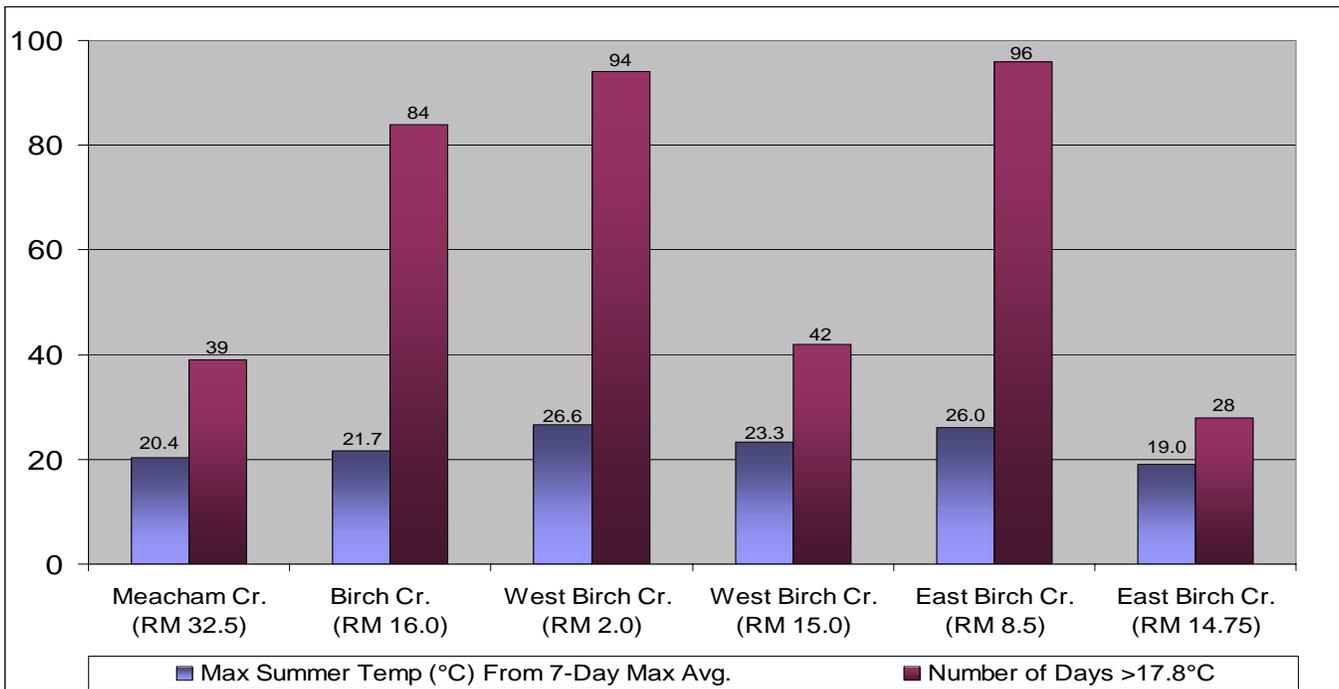
Figure 5. Summary of Maximum Summer Temperature, and Number of Days in Excess of the 17.8°C DEQ Standard, by site.

Temperatures at the Weinke Dam and Highway 395 sites may have been influenced by thermograph placement: units are attached to concrete structures which may act as heat sinks. The Houser site may have been influenced by extremely low flow at the site, although the raw data graph did not indicate dewatering of the unit. 2004 data were not compared to previous years' figures to determine if values for these sites represent normal conditions, nor were the compared to ambient air temperatures. Following deployment of thermographs for the 2004 season, the Habitat Biologist researched DEQ temperature standard protocols for temperature monitoring. The document describes methods for site selection, thermograph calibration, quality control, data verification and data analysis (DEQ 2004). Although the Program has not closely followed these standards in the past (including the 2004 season), the DEQ standards will be adopted as a guideline for temperature monitoring activities, beginning in 2005. Adopting the DEQ standards should improve the quality of data collected by and for the Program, as well as allow the Program to share standardized data with other agencies and entities conducting temperature monitoring within the Umatilla Subbasin using similar standards. Standardized data will provide a better tool for the Monitoring and Evaluation of Habitat Improvement projects.
