Umatilla River Subbasin Fish Habitat Improvement Program

Annual Report 2004 - 2005

2004 ANNUAL REPORT Project Completion/Summary Report January through December 2004

BPA Project No. 1987-100-02
Contract No.: 00005101

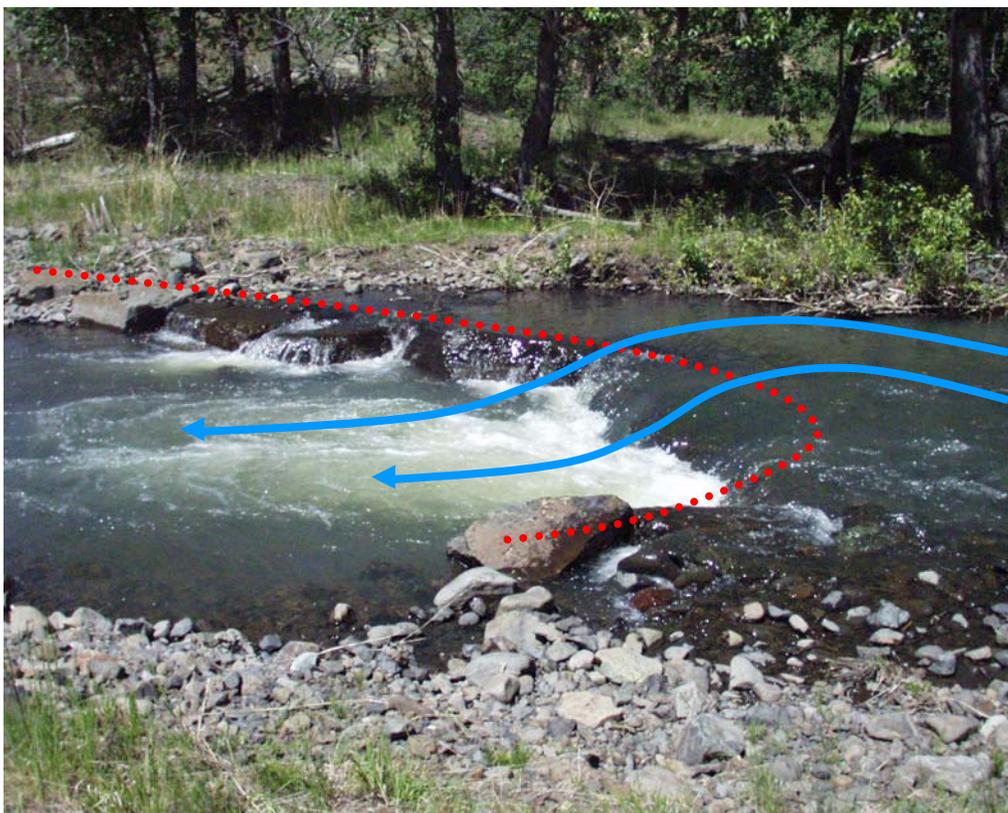
Cross stream view of typical “J-Hook Vane” installed on the Brogoitti property (East Birch Creek), using Rosgen design principals and techniques.

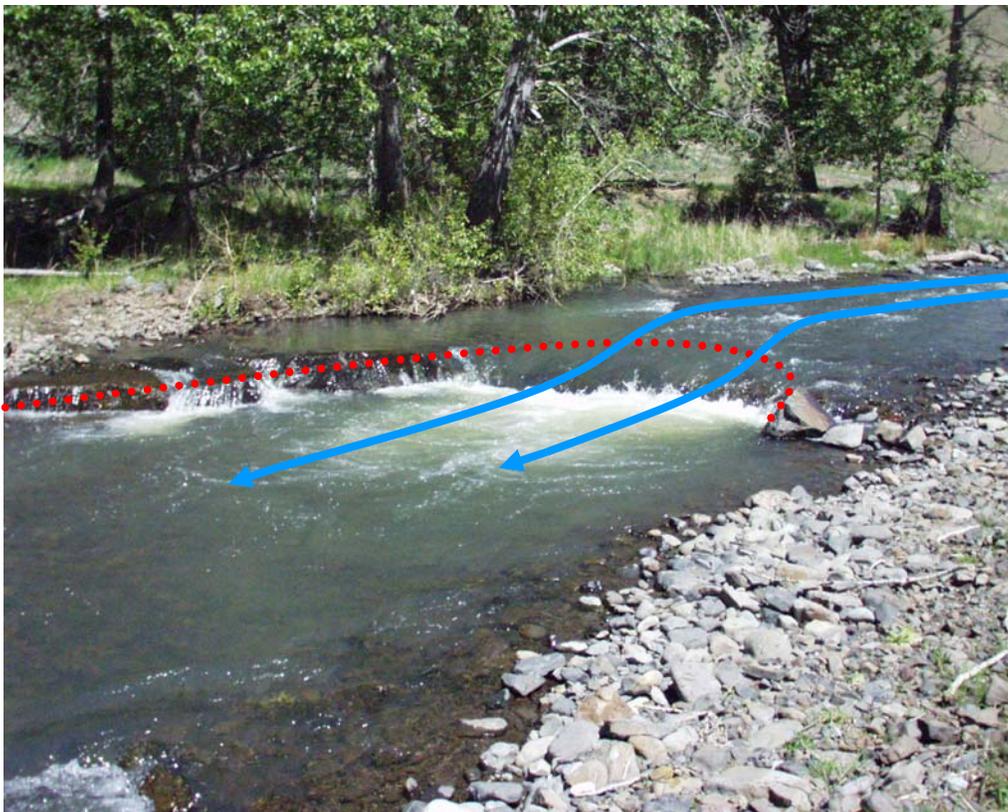
Upstream view of typical “J-Hook Vane” installed on the Brogoitti property (East Birch Creek), using Rosgen design principals and techniques.

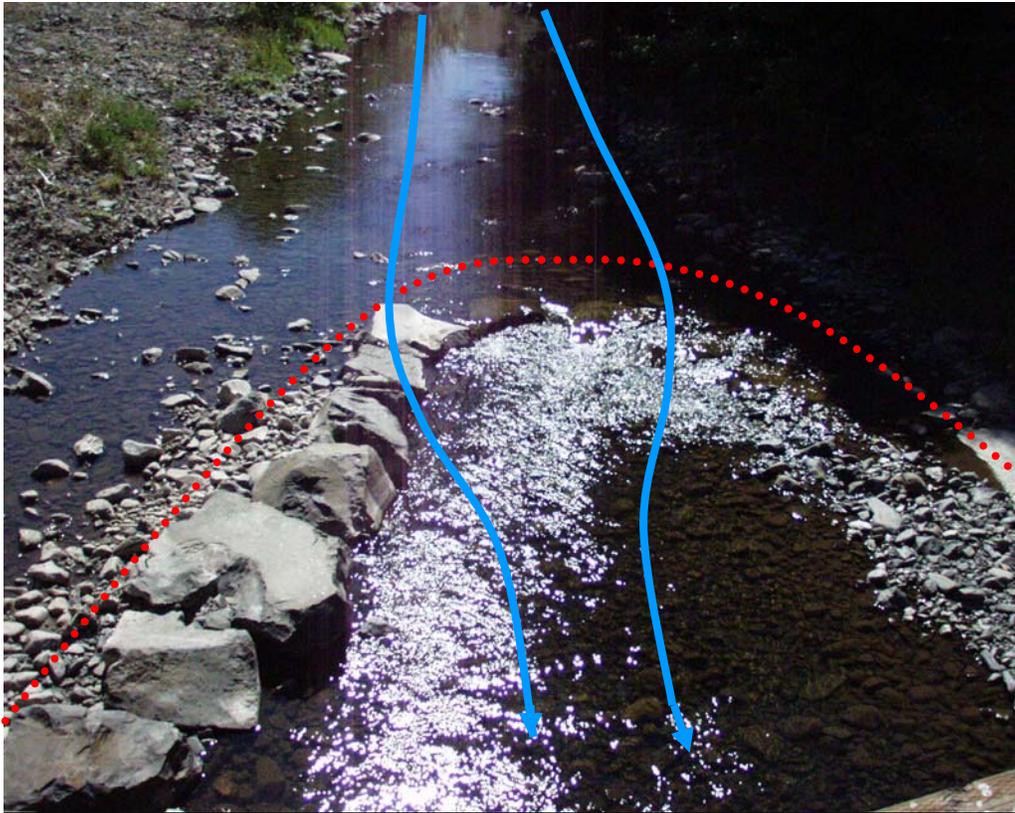
Upstream view of typical “Cross Vane” installed on the Brogoitti property (East Birch Creek), using Rosgen design principals and techniques.

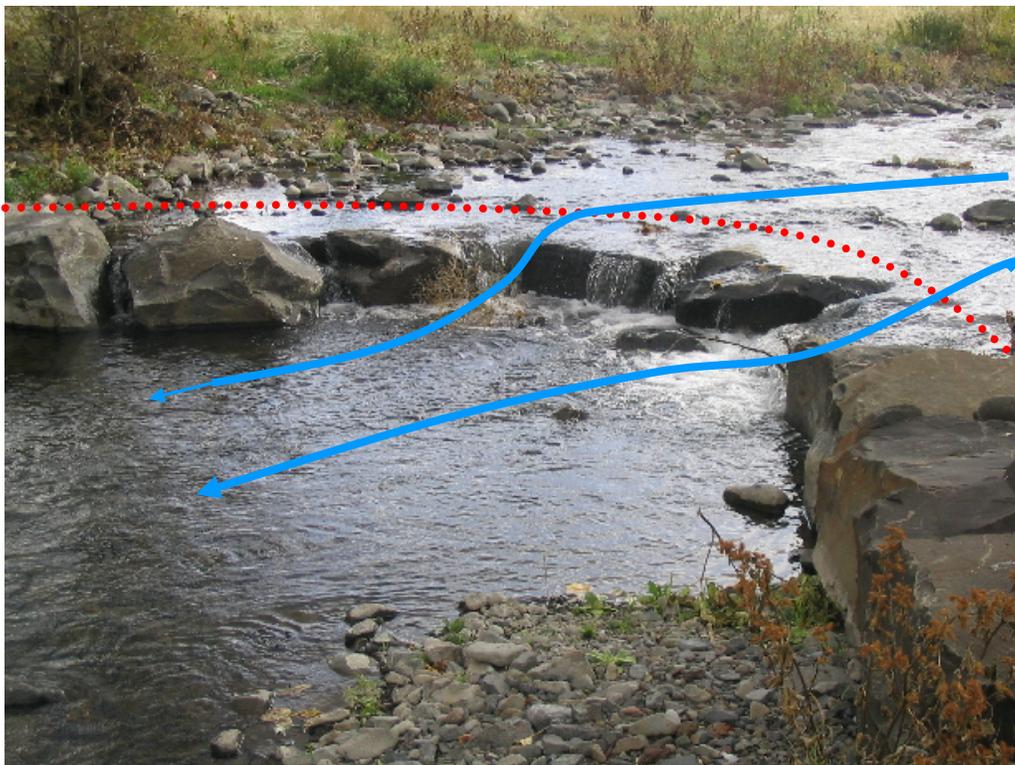
Upstream view of typical “Cross Vane” installed on the Brogoitti property (East Birch Creek), using Rosgen design principals and techniques.

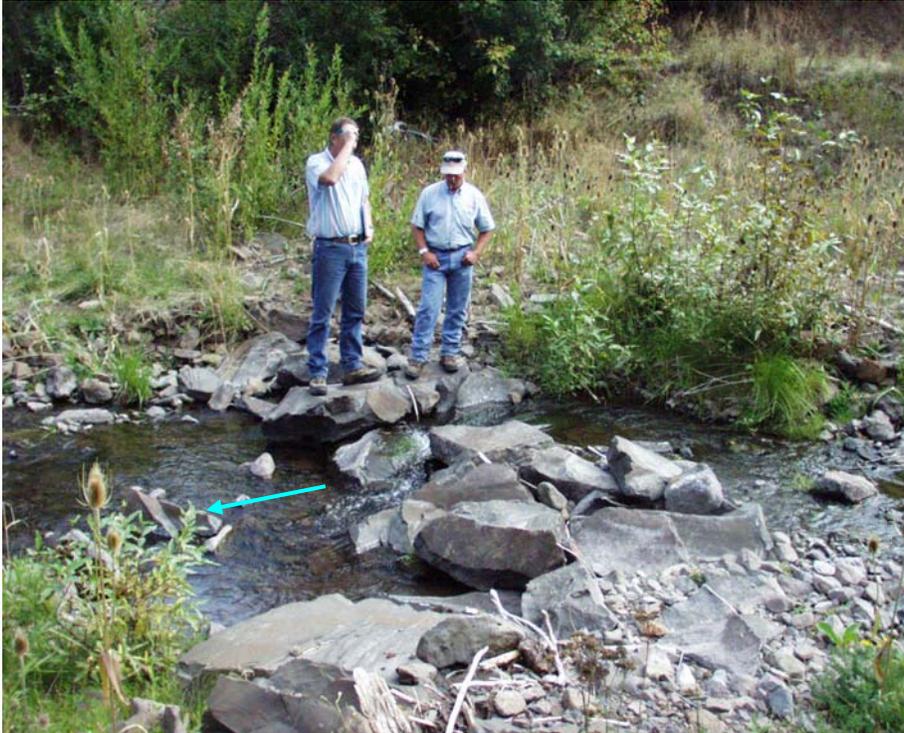
Site #:	1	Date/Time:	September 1, 2004 - 10:55
Description:	Cross-stream view (RB). Suspected fish passage impediment. At low flow, no passage concerns noted, no action taken at this site.

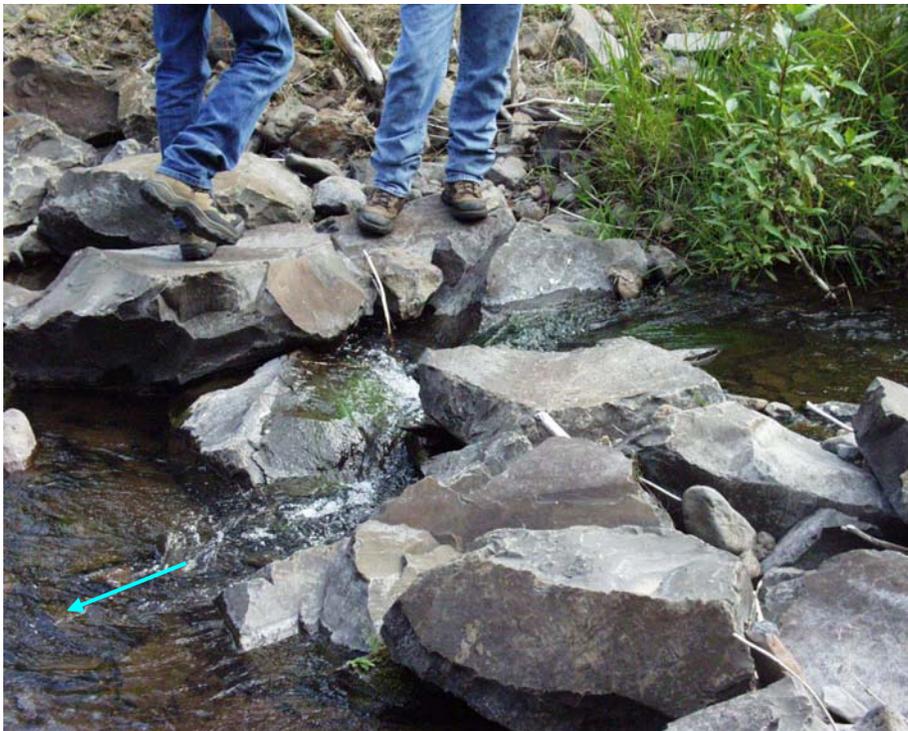
Site #:	1	Date/Time:	September 1, 2004 - 10:55
Description:	Cross-stream view (RB). At low flow, no passage concerns noted. Dropped from the work plan, no action taken at this site.

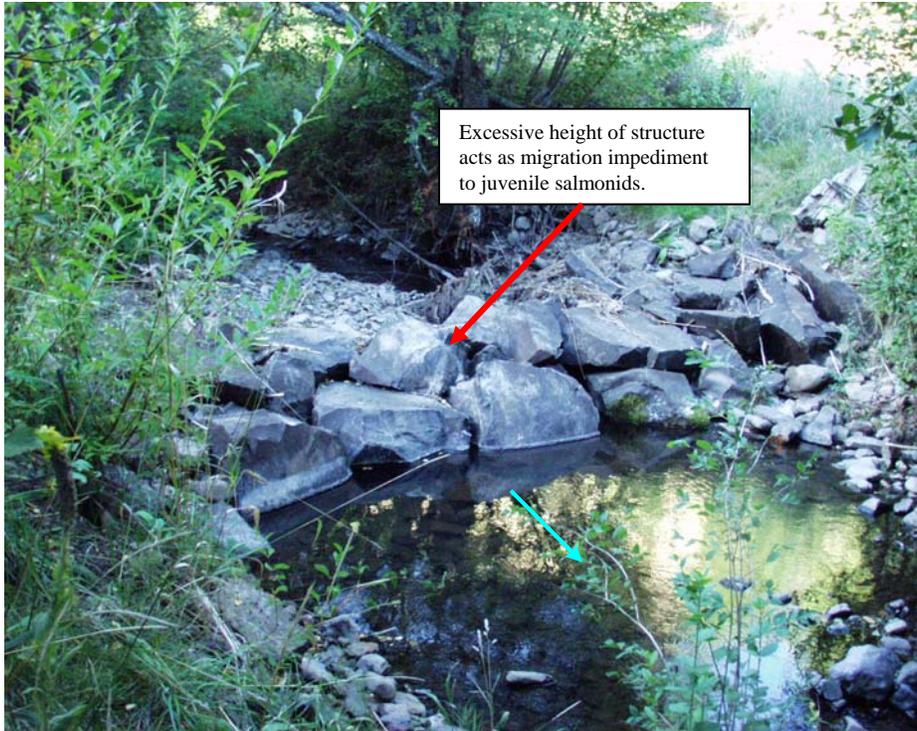
Site #:	2	Date/Time:	September 8, 2004 - 08:10
Description:	Upstream view. Prior to maintenance.

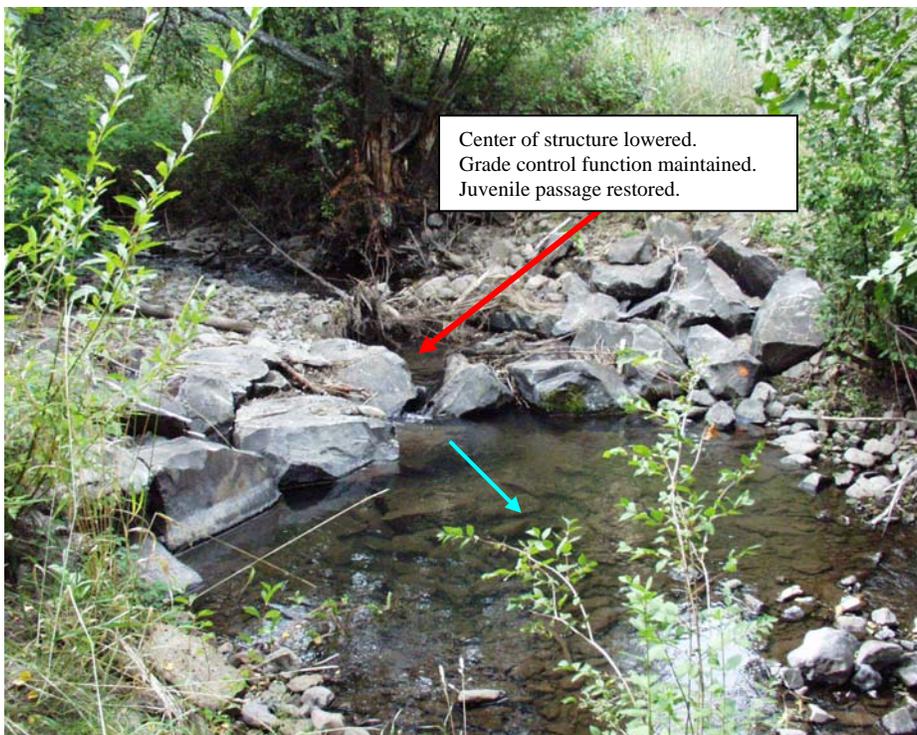
Site #:	2	Date/Time:	September 9, 2004 - 11:00
Description:	Upstream view. Post-maintenance.

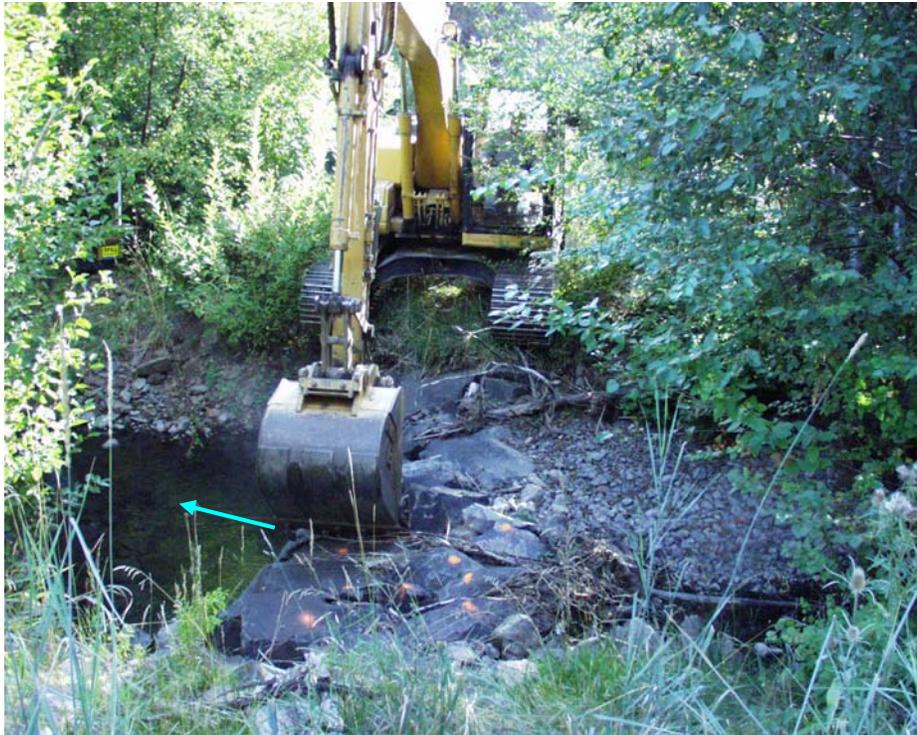
Site #:	2	Date/Time:	September 8, 2004 - 08:40
Description:	Cross-stream view (RB). Beginning of maintenance work. Stones slated for removal/manipulation marked with orange paint.

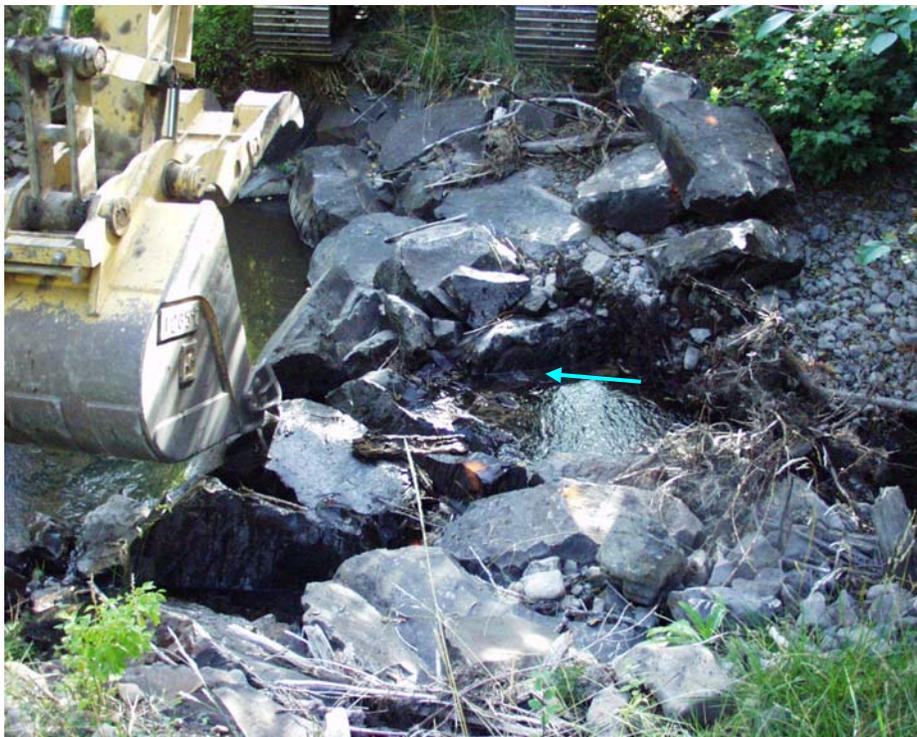
Site #:	2	Date/Time:	September 8, 2004 - 08:45
Description:	Cross-stream view (RB). Maintenance work in progress.

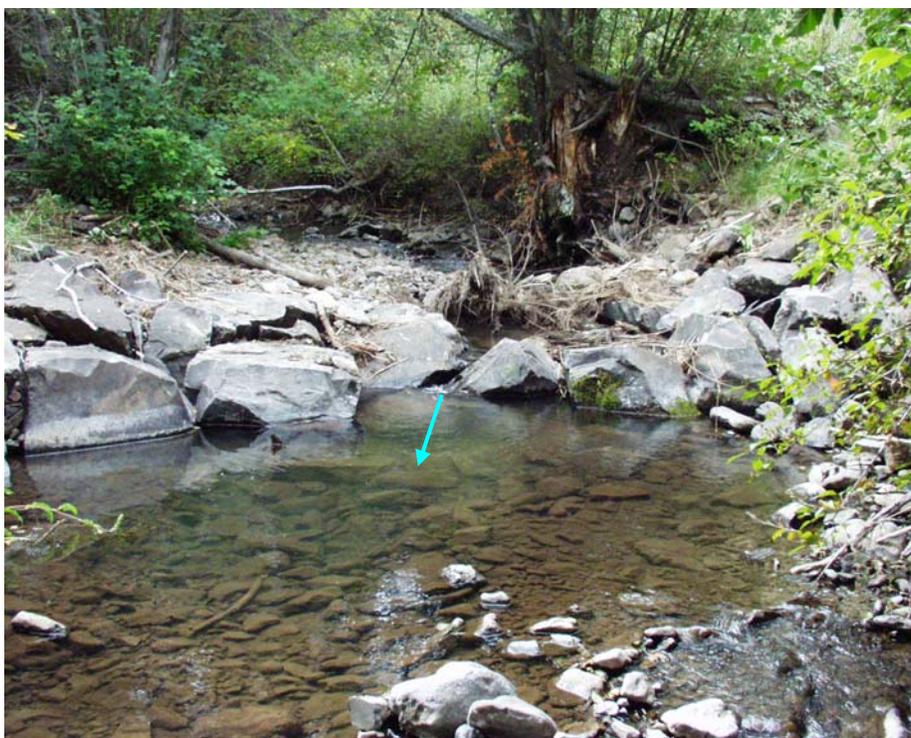
Site #:	2	Date/Time:	September 9, 2004 - 11:00
Description:	Upstream view. Post-maintenance.

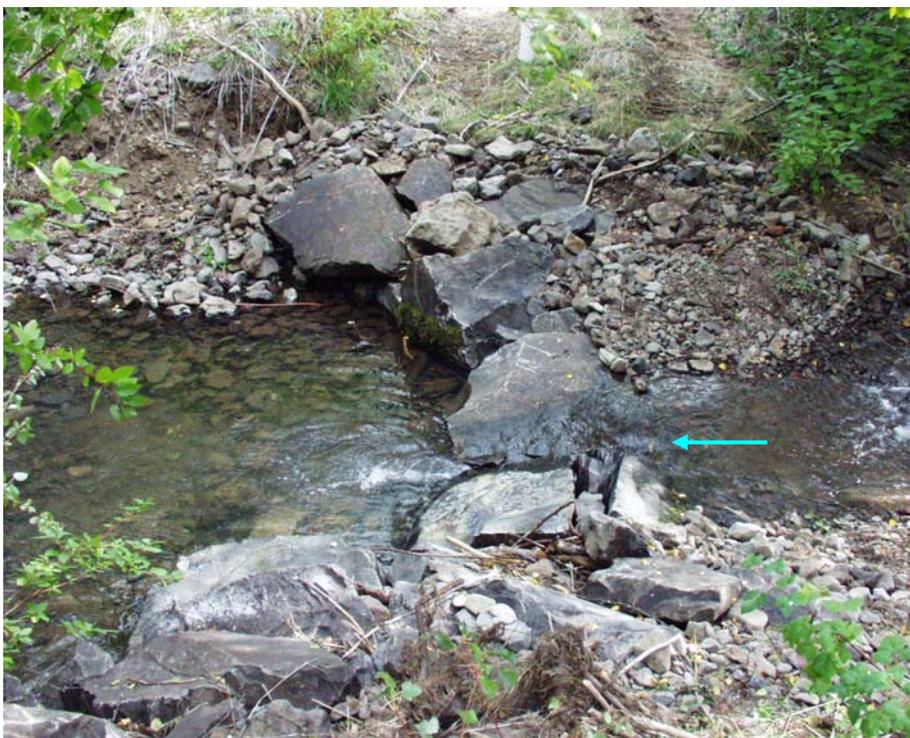
Site #:	3	Date/Time:	September 9, 2004 - 10:50
Description:	Cross-stream view (RB). Post maintenance.

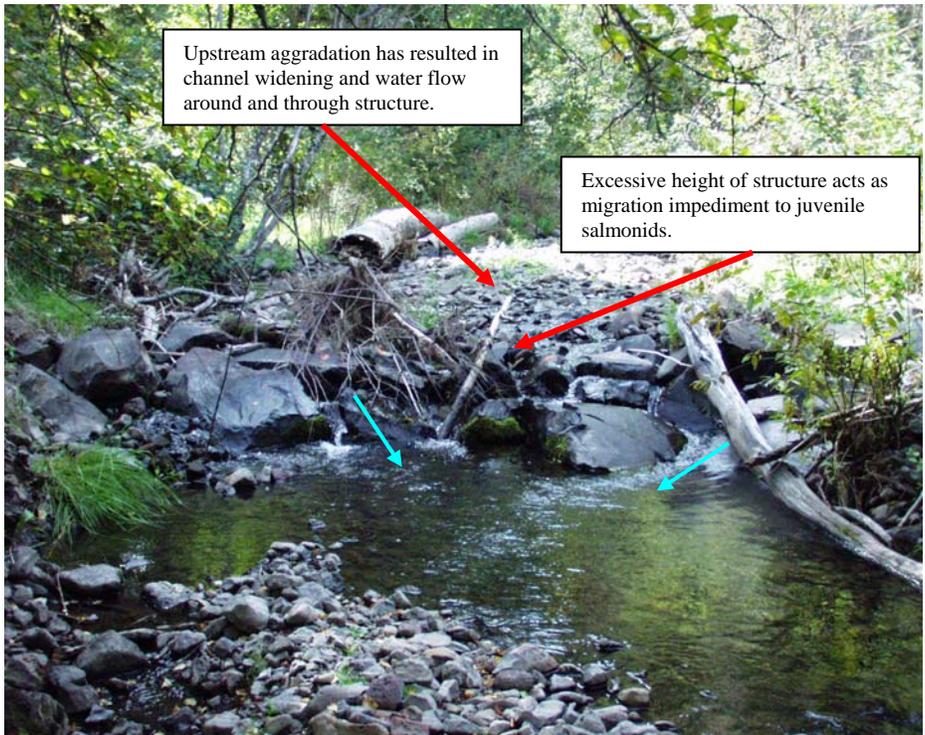
Site #:	4	Date/Time:	September 8, 2004 - 11:00
Description:	Upstream view. Prior to maintenance.

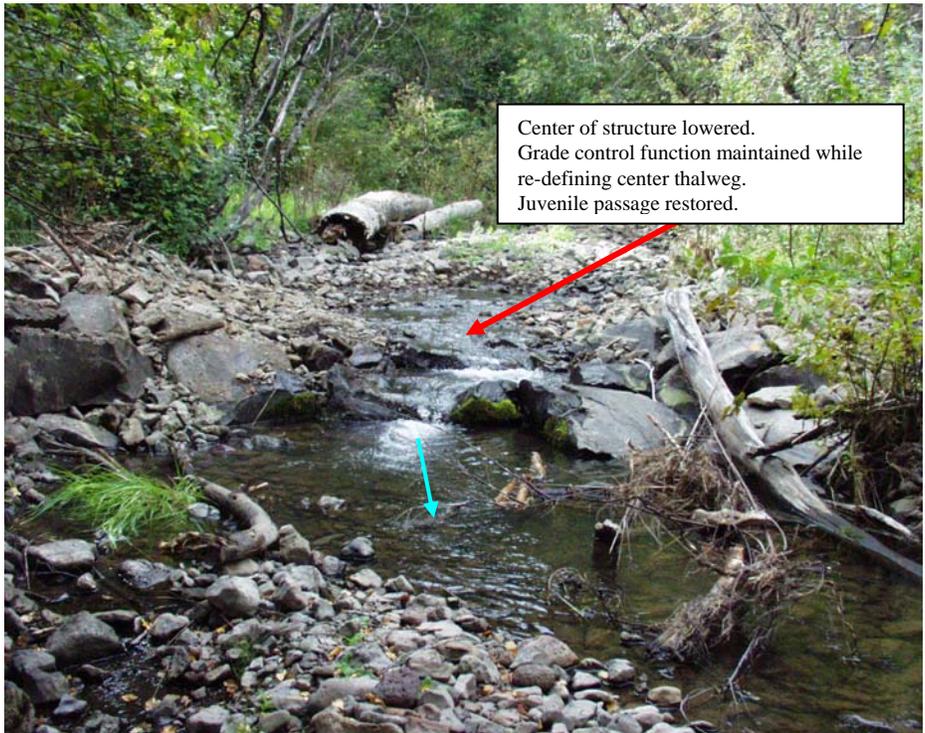
Site #:	4	Date/Time:	September 9, 2004 - 10:50
Description:	Upstream view. Post-maintenance.

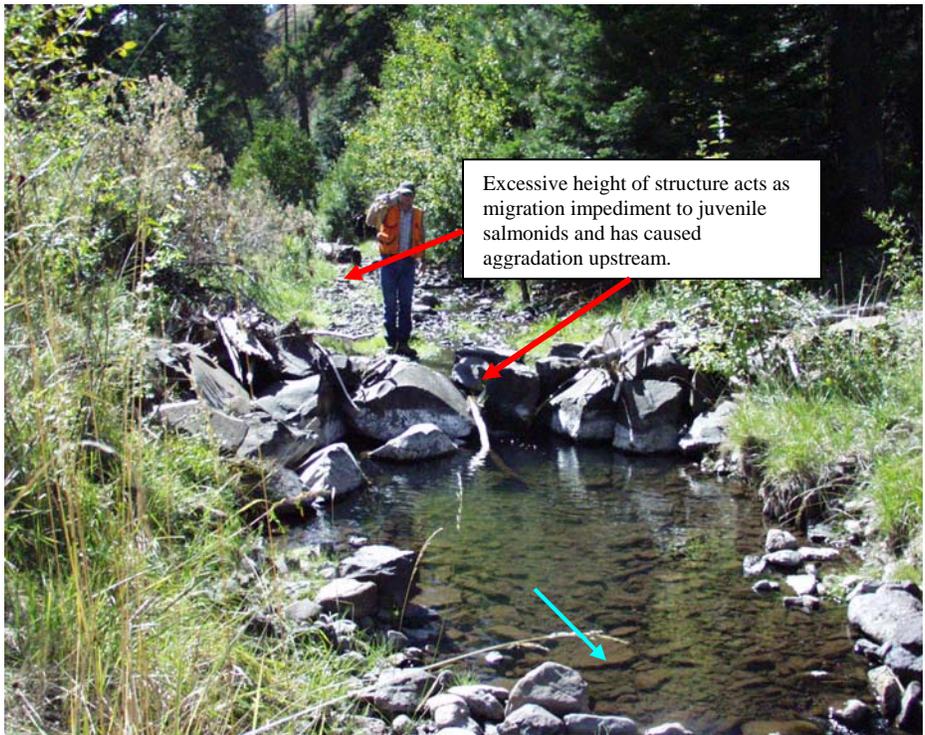
Site #:	5	Date/Time:	September 8, 2004 - 11:42
Description:	Upstream view. Prior to maintenance.

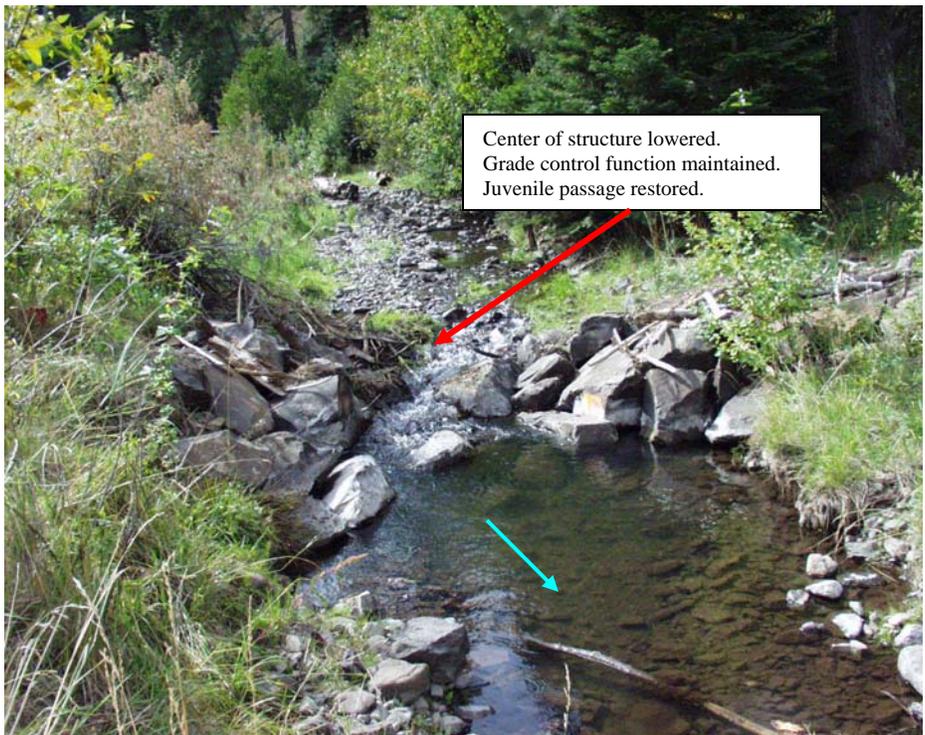
Site #:	5	Date/Time:	September 1, 2004 - 12:40
Description:	Upstream view. Post-maintenance.

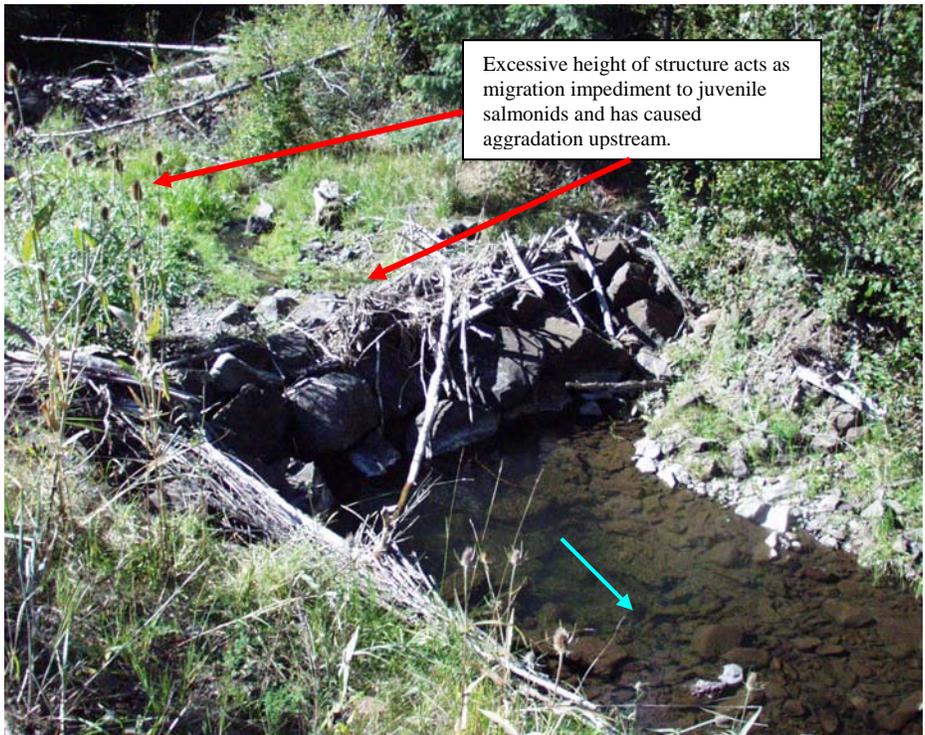
Site #:	6	Date/Time:	September 1, 2004 - 10:15
Description:	Upstream view. Prior to maintenance.

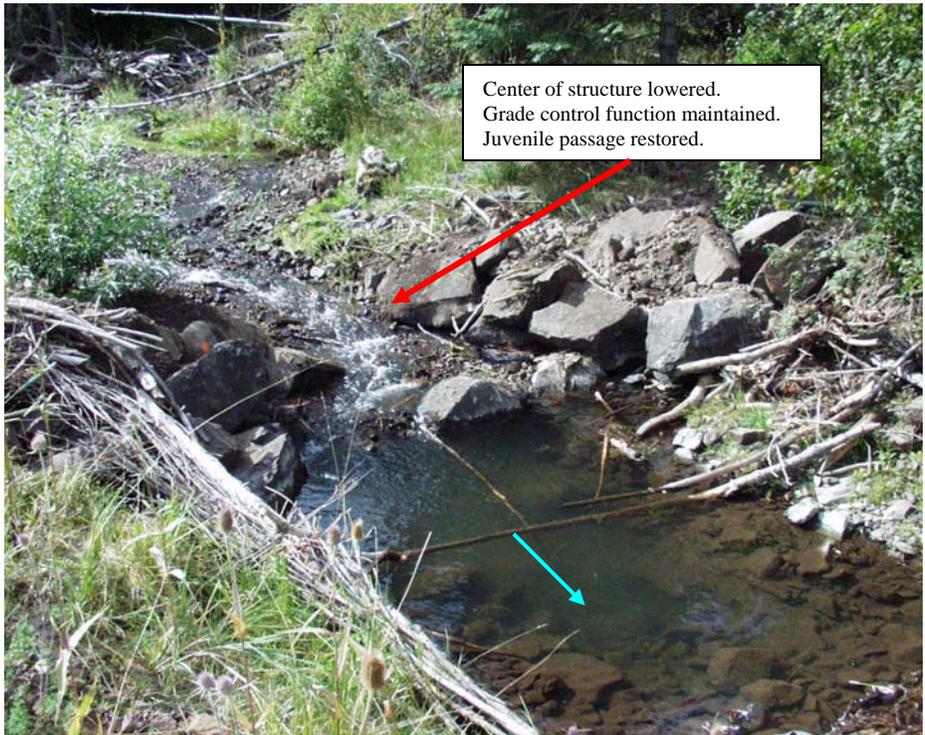
Site #:	6	Date/Time:	September 9, 2004 - 10:40
Description:	Upstream view. Post-maintenance.

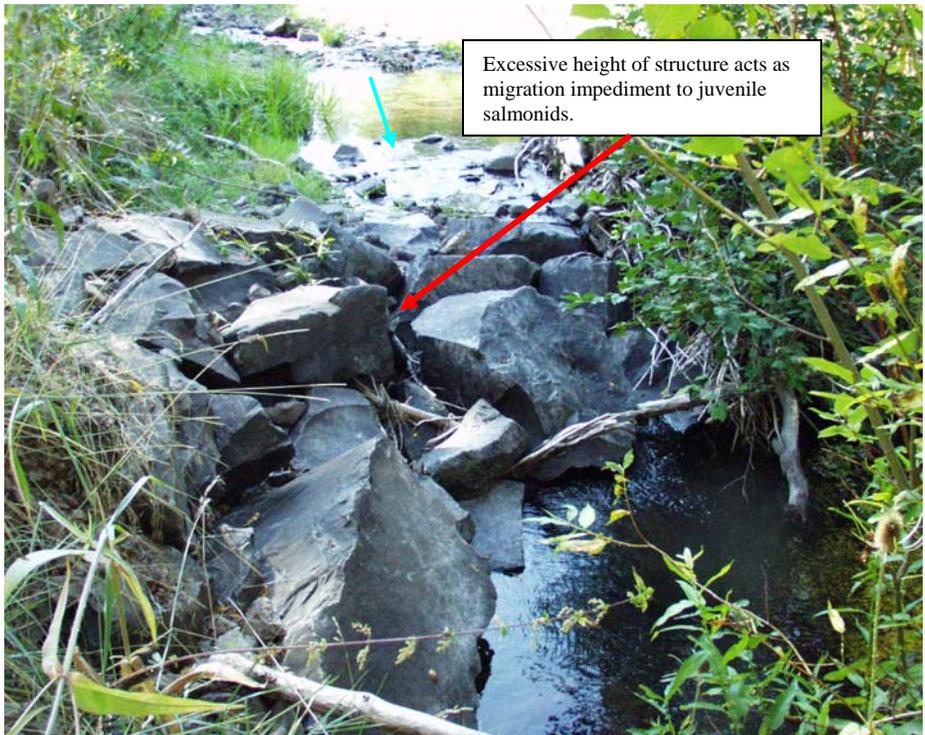
Site #:	7	Date/Time:	September 1, 2004 - 10:10
Description:	Upstream view. Prior to maintenance.

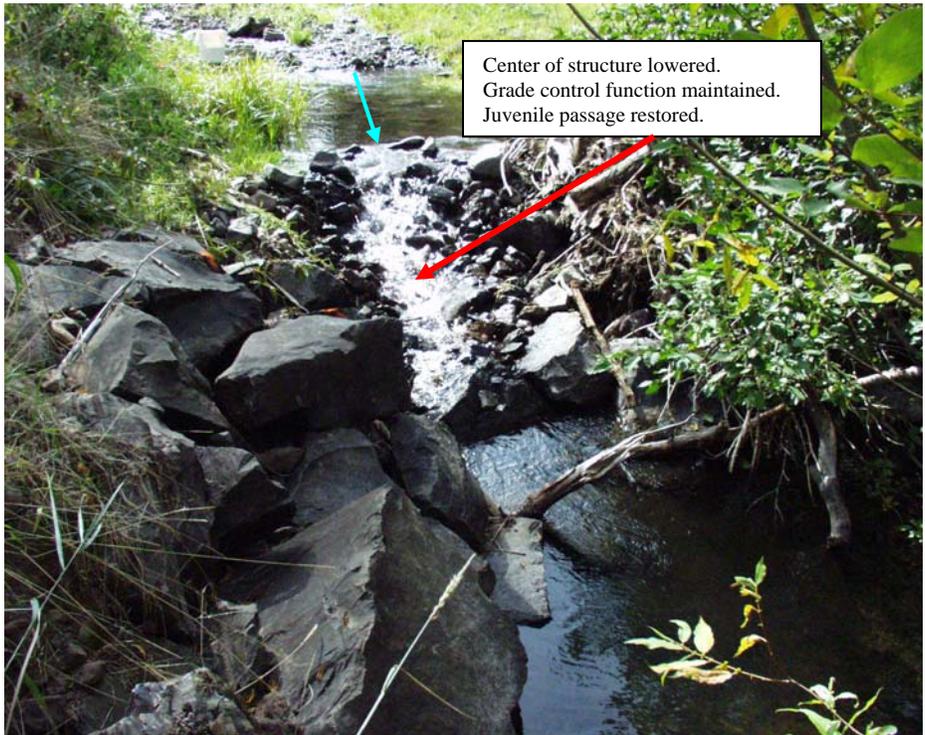
Site #:	7	Date/Time:	September 9, 2004 - 10:30
Description:	Upstream view. Post-maintenance.

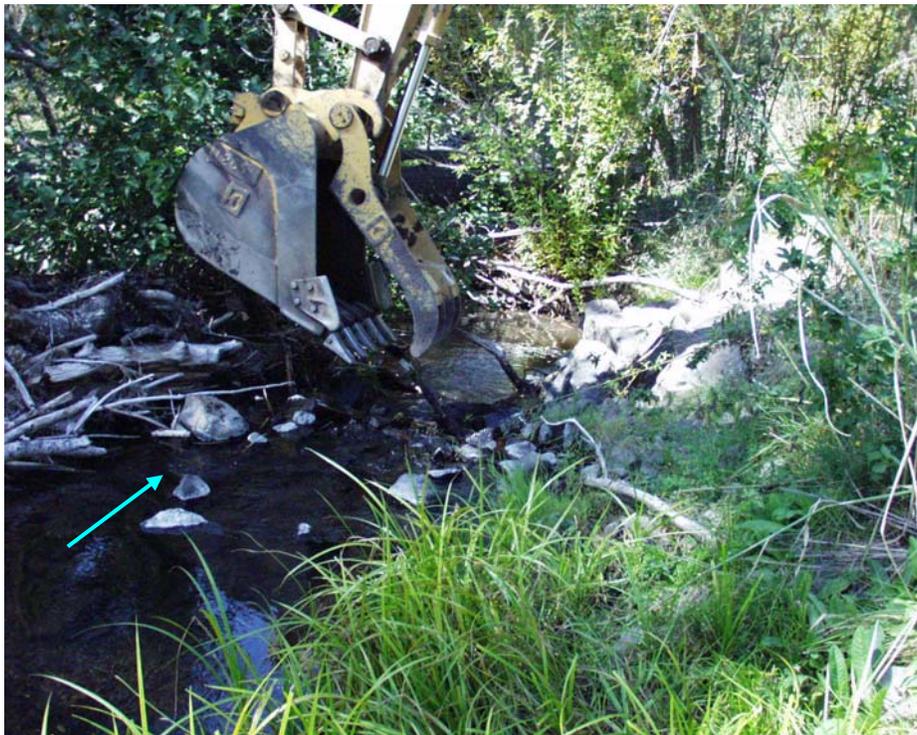
Site #:	7	Date/Time:	September 8, 2004 - 14:20
Description:	Downstream view. Maintenance work in progress.

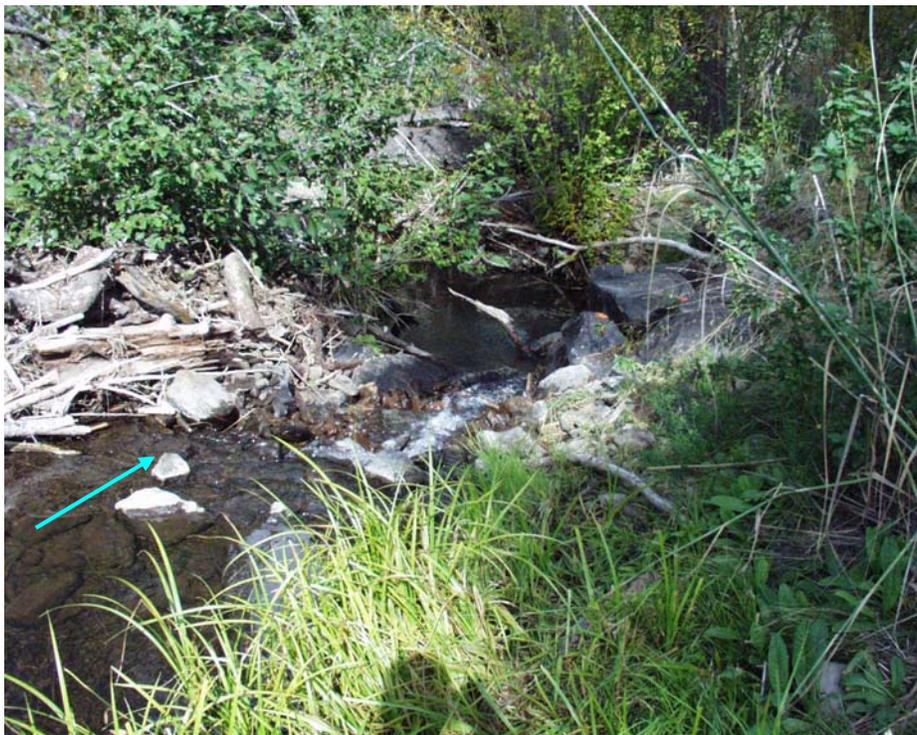
Site #:	7	Date/Time:	September 9, 2004 - 10:30
Description:	Downstream view. Post-maintenance.

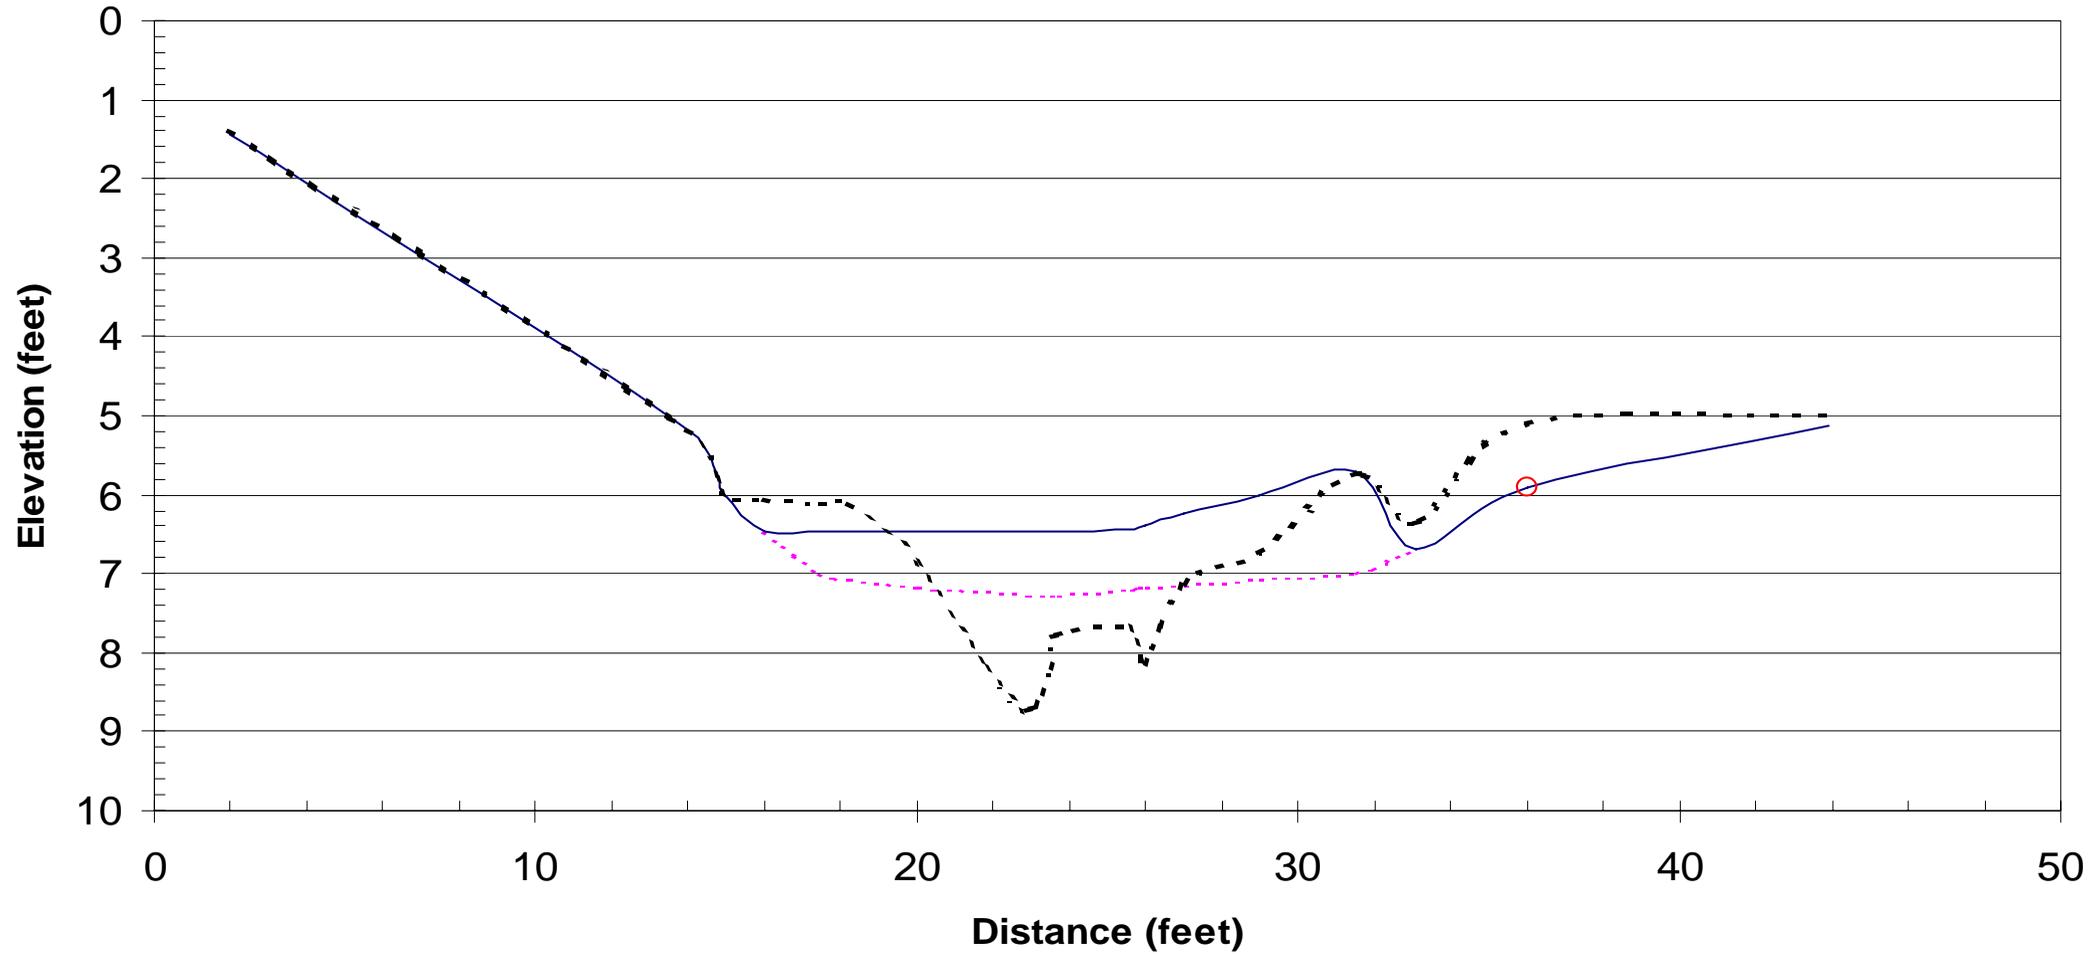
Westgate Creek - Site 6 (Channel Cross Section - Upstream View)

— Apr 23/04 ····· Proposed - - - - Sept 27/04 As-Built ○ Normal High Water

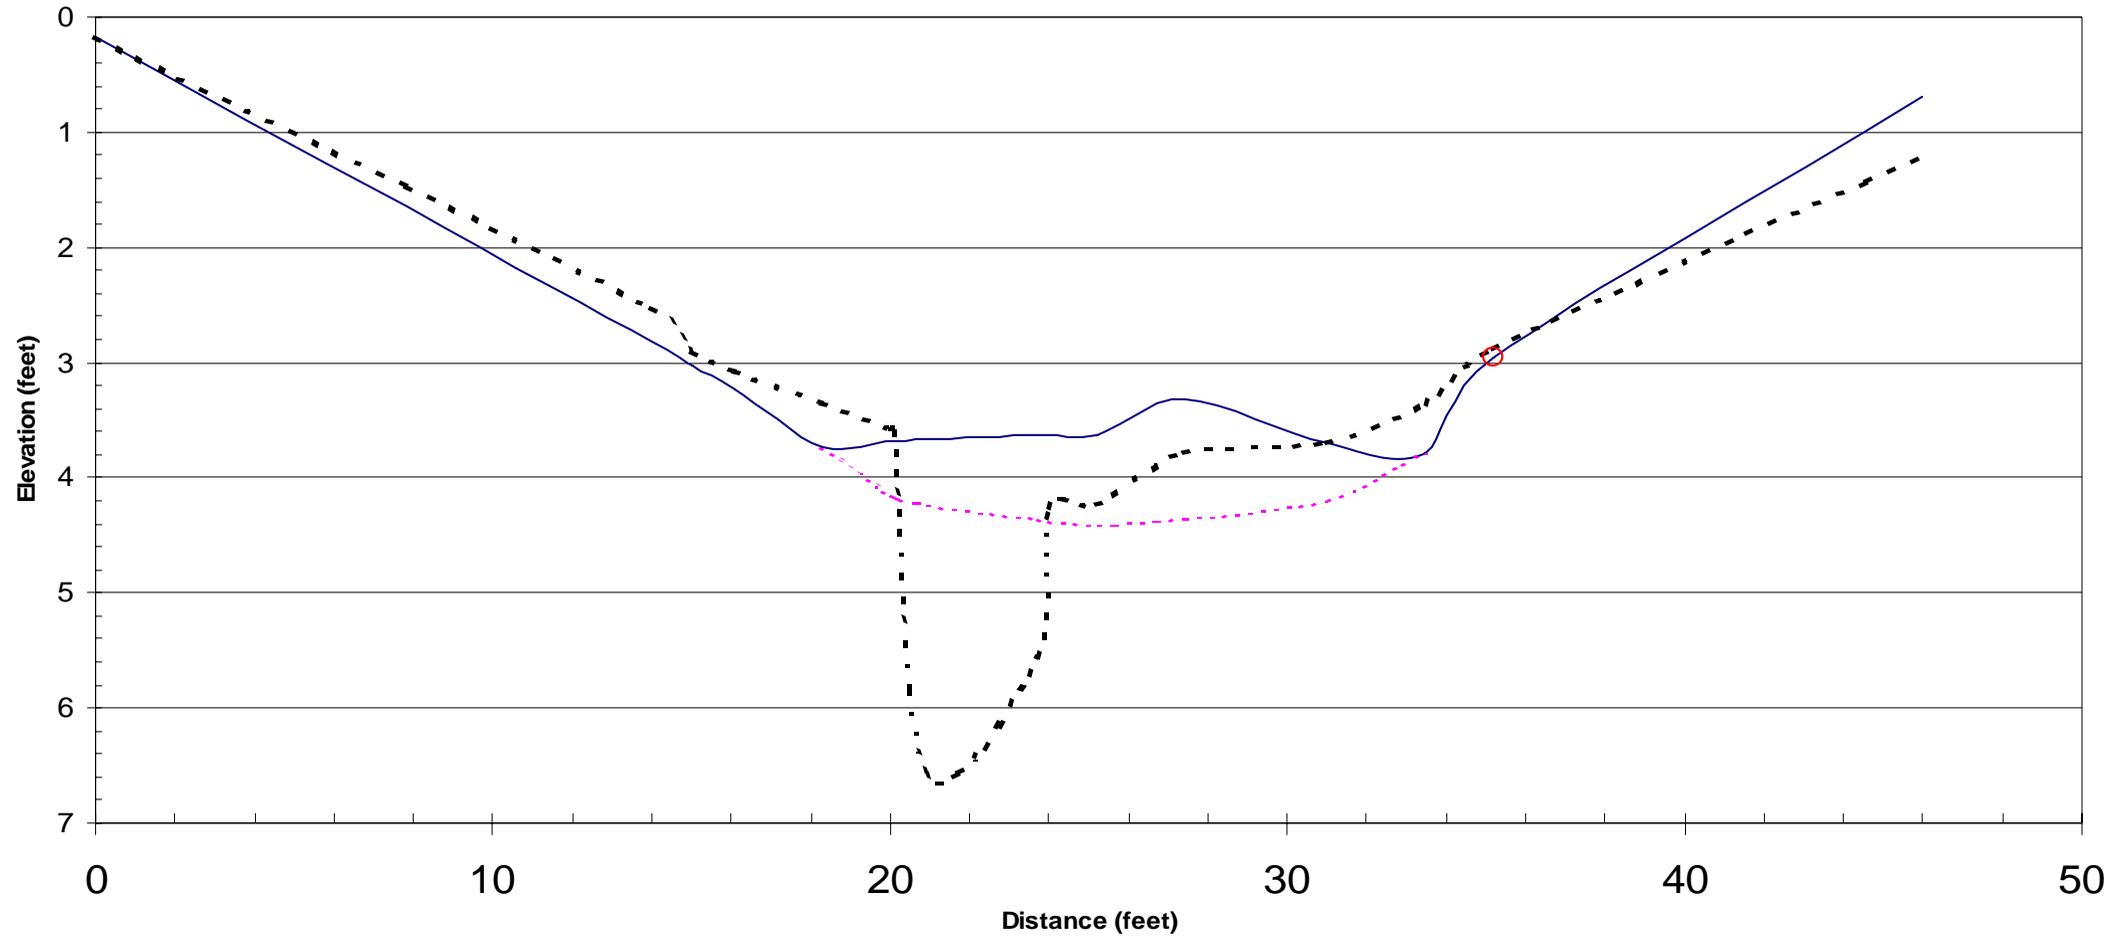
Westgate Site 6 - Monitoring Long Profile

— Apr 23/04 ····· Poposed - - - - Sep 27/04 As-Built ○ Normal High Water
