# EUV inspection of reticle defect repair sites

SPIE Microlithography  
San Jose, CA, United States  
February 27, 2007 through March 1, 2007

# EUV Inspection of Defect-Repair Sites & *Status of the actinic inspection tool*

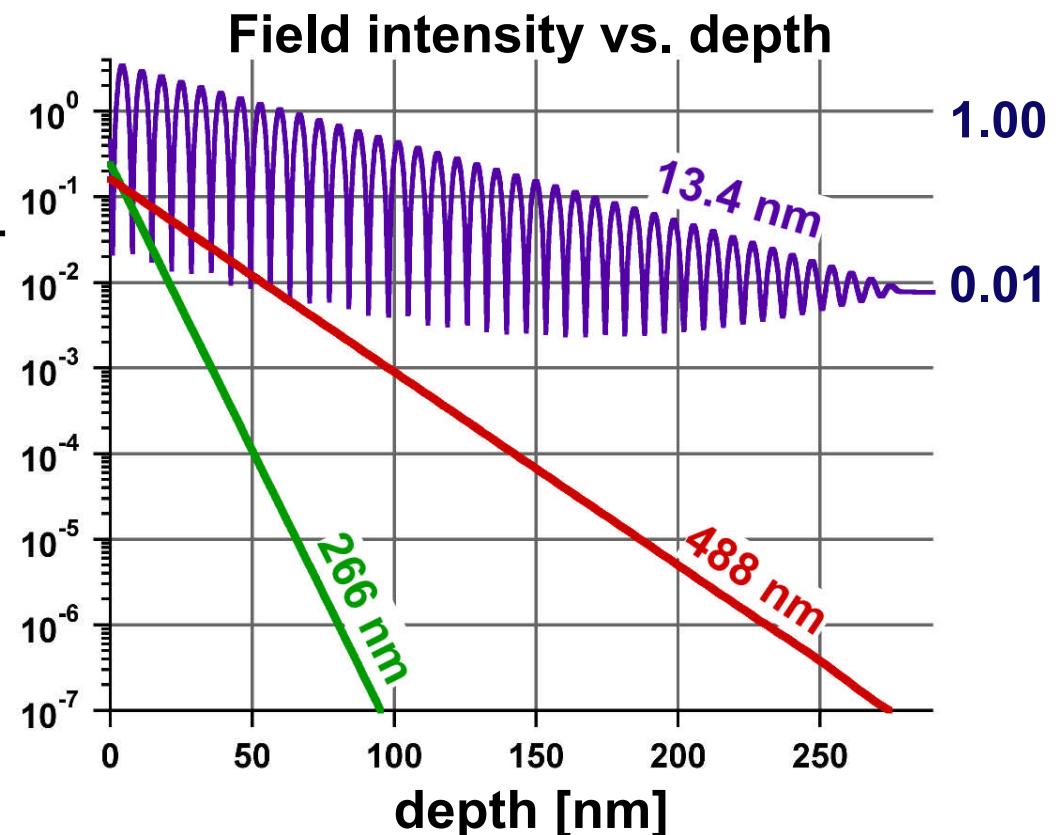
# Different wavelengths see different ML structures

- EUV light penetrates deeply into the resonant ML structure
- 488-nm and 266-nm light barely reaches below the surface

Field Penetration for three  $\lambda$ s

$\lambda$	“1%” depth	bi-layers
13.4 nm	215 nm	31
488 nm	53.6 nm	8
266 nm	20.6 nm	3

**At-wavelength testing**  
probes the actual  
multilayer response.

EUV light penetrates deeply into the resonant structure.

UV inspection probes the surface only: *depth* = 20–50 nm (3–8 bi-layers)

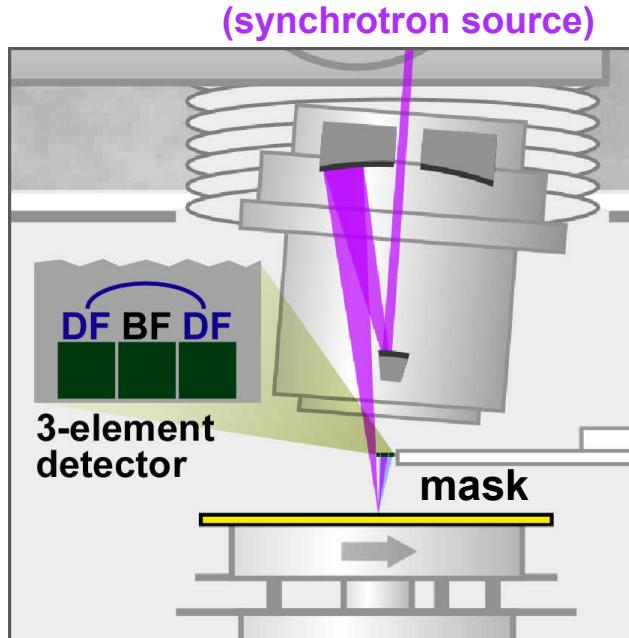
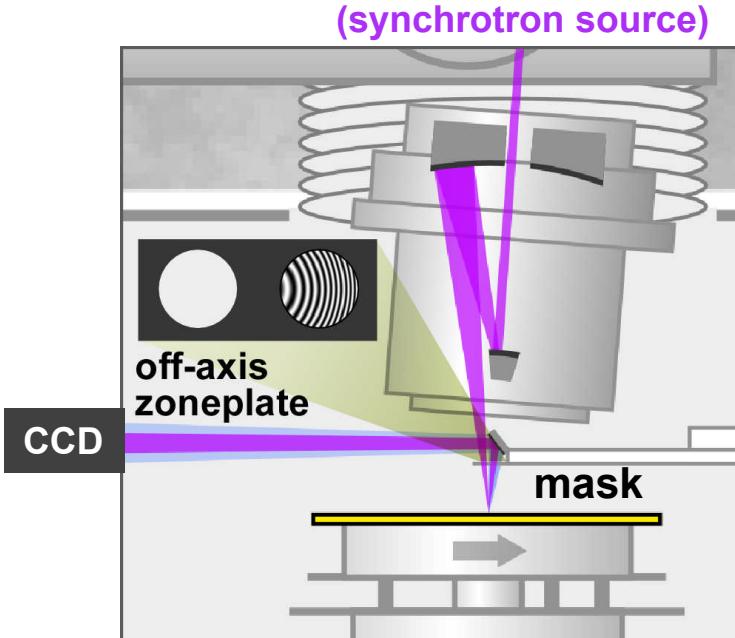
# The SEMATECH Berkeley Actinic Mask Inspection Tool

**Worldwide**, this is the only EUV mask inspection tool offering **imaging and scanning** in **dark-field and bright-field modes**.

**Scanning** reveals open-field defects, measures subtle mirror reflectivity changes not seen without EUV light.

**Imaging** uses a zoneplate lens to measure the aerial image directly, testing defect printability models without printing.

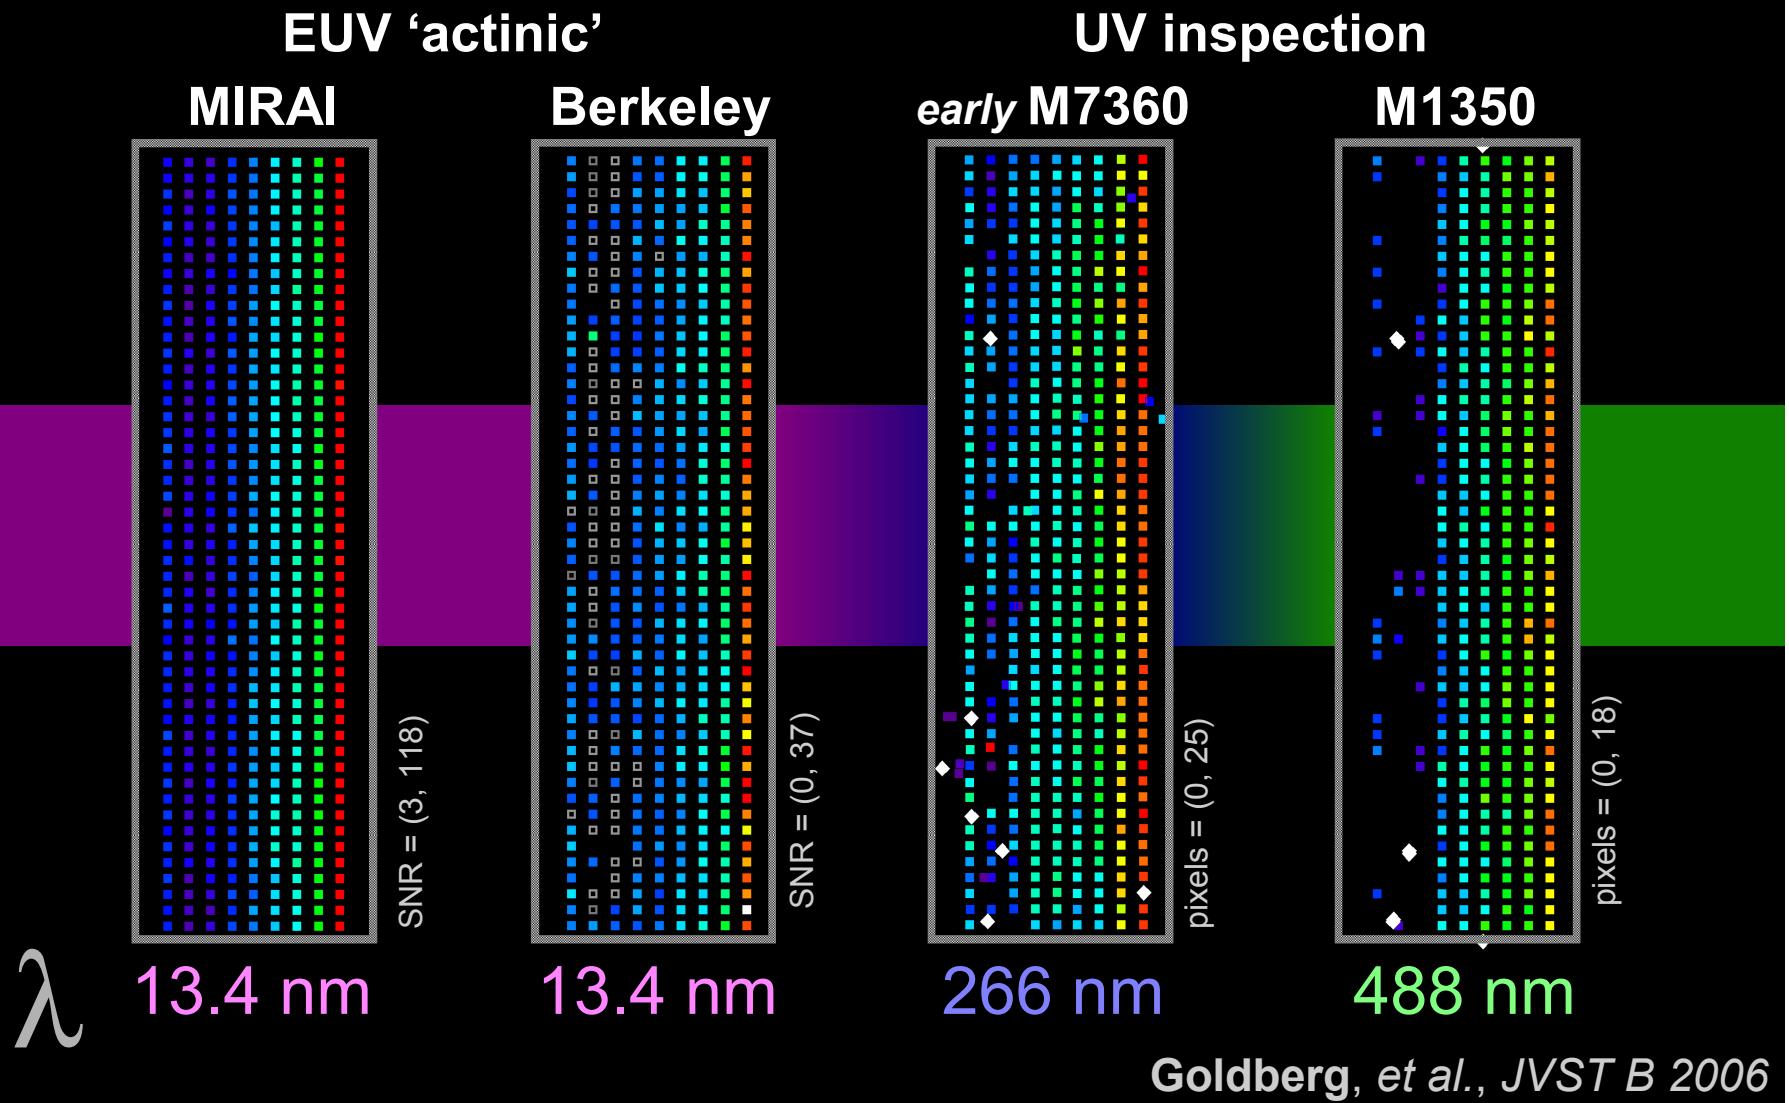
# Earlier comparison of 4 inspection tools. . .

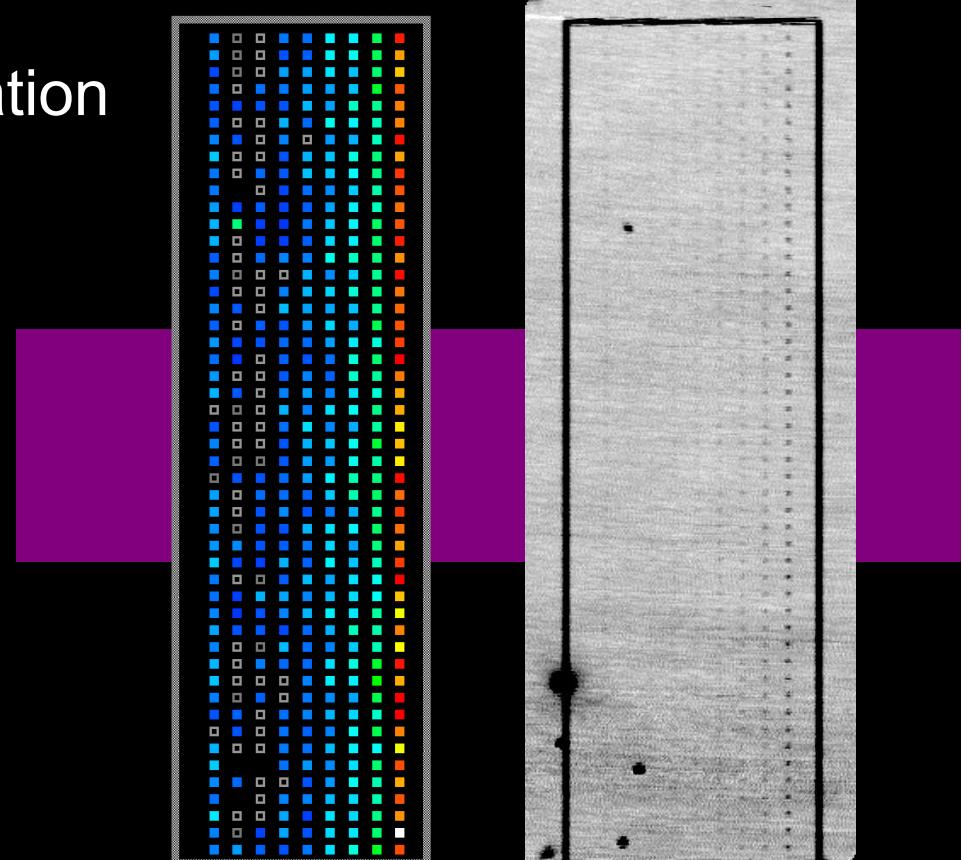
# Bright-field revealed defects that do not scatter

Phase defects **scatter** well  
→ *buried bumps and pits*

Surface particles and contamination  
**absorb light** and scatter poorly,  
→ especially  $\mu\text{m}$ -scale defects

Actinic **DF only** could miss  
critical defects

**BF only** doesn't have enough  
sensitivity

EUV  
dark-field  
**scattering**

EUV  
bright-field  
**reflectivity**

Actinic inspection with **DF-only** or **BF-only** can miss critical defects!

- **DF has higher sensitivity** to small defects (due to flare, SNR, etc.)
- However, **DF may not see  $\mu$ m-scale absorptive** surface regions.

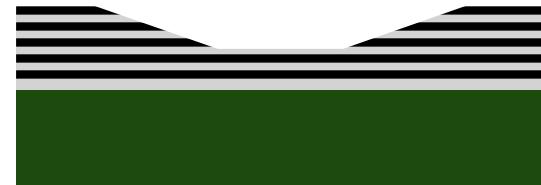
## Group I A,B,C,D,E

Sites were etched as ditches (pits) with shallow sidewall angles in the range of  $2^\circ$ – $4^\circ$ .

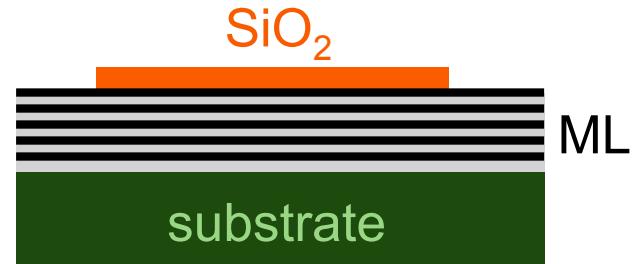
## Group II F,G,H,I,J

$\text{SiO}_2$  was deposited in different thicknesses: 1.5–12 nm

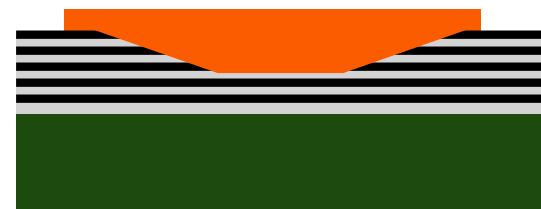
## Group III K,L,M,N

Defects etched into the top layer to different depths. The area was covered with a  $\sim$ 5 nm  $\text{SiO}_2$  protection layer

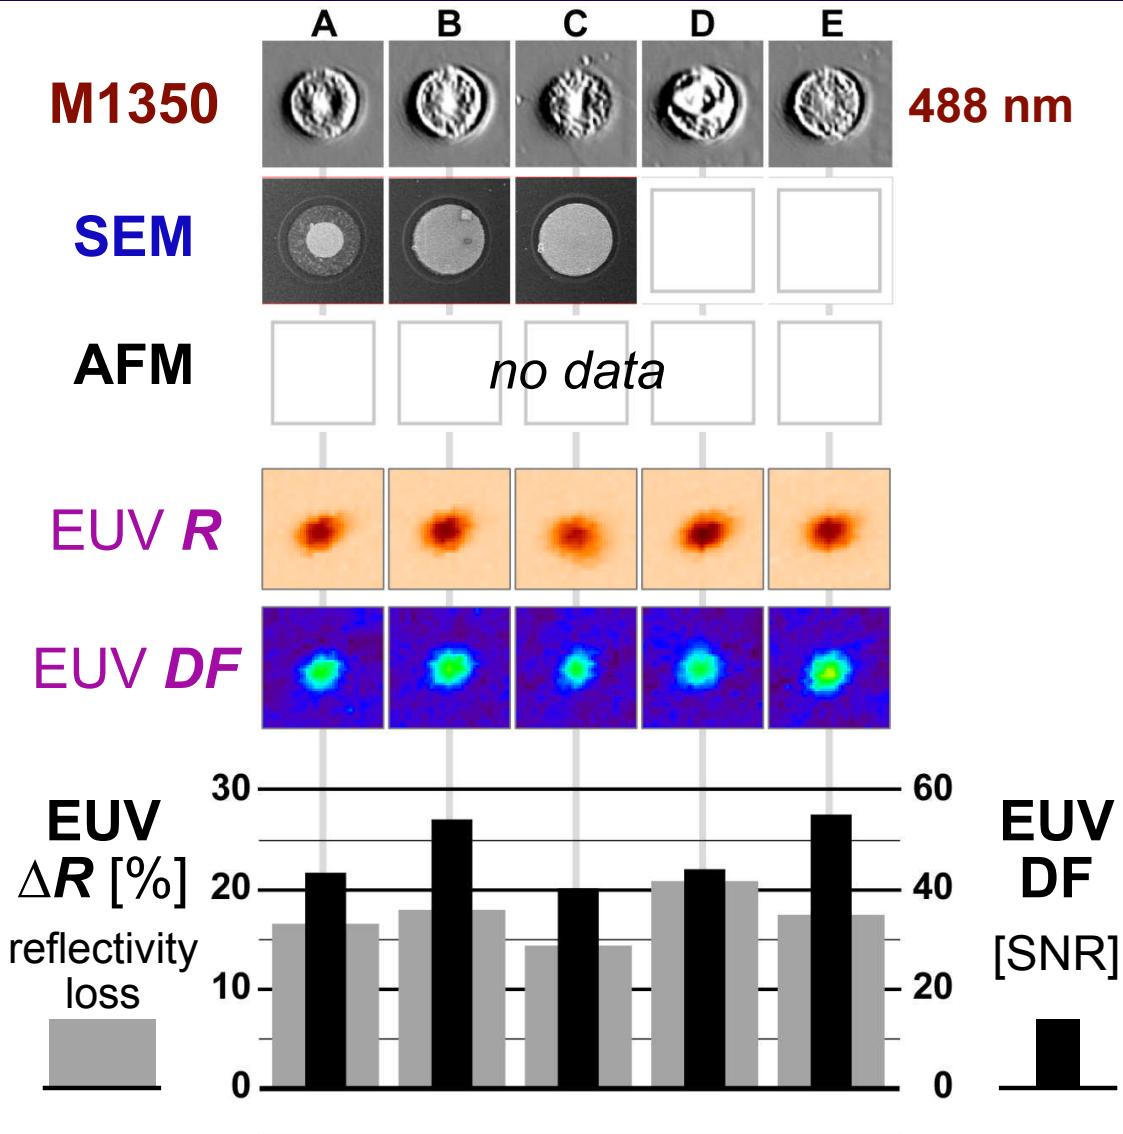
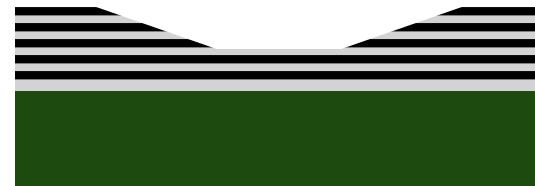
# Measurements of Group I: shallow ditches

**M1350:**

→ High contrast

**EUV:**

→ Strong reflectivity loss  
→ **Strong scattering**

**sites dramatically  
re-direct the beam**

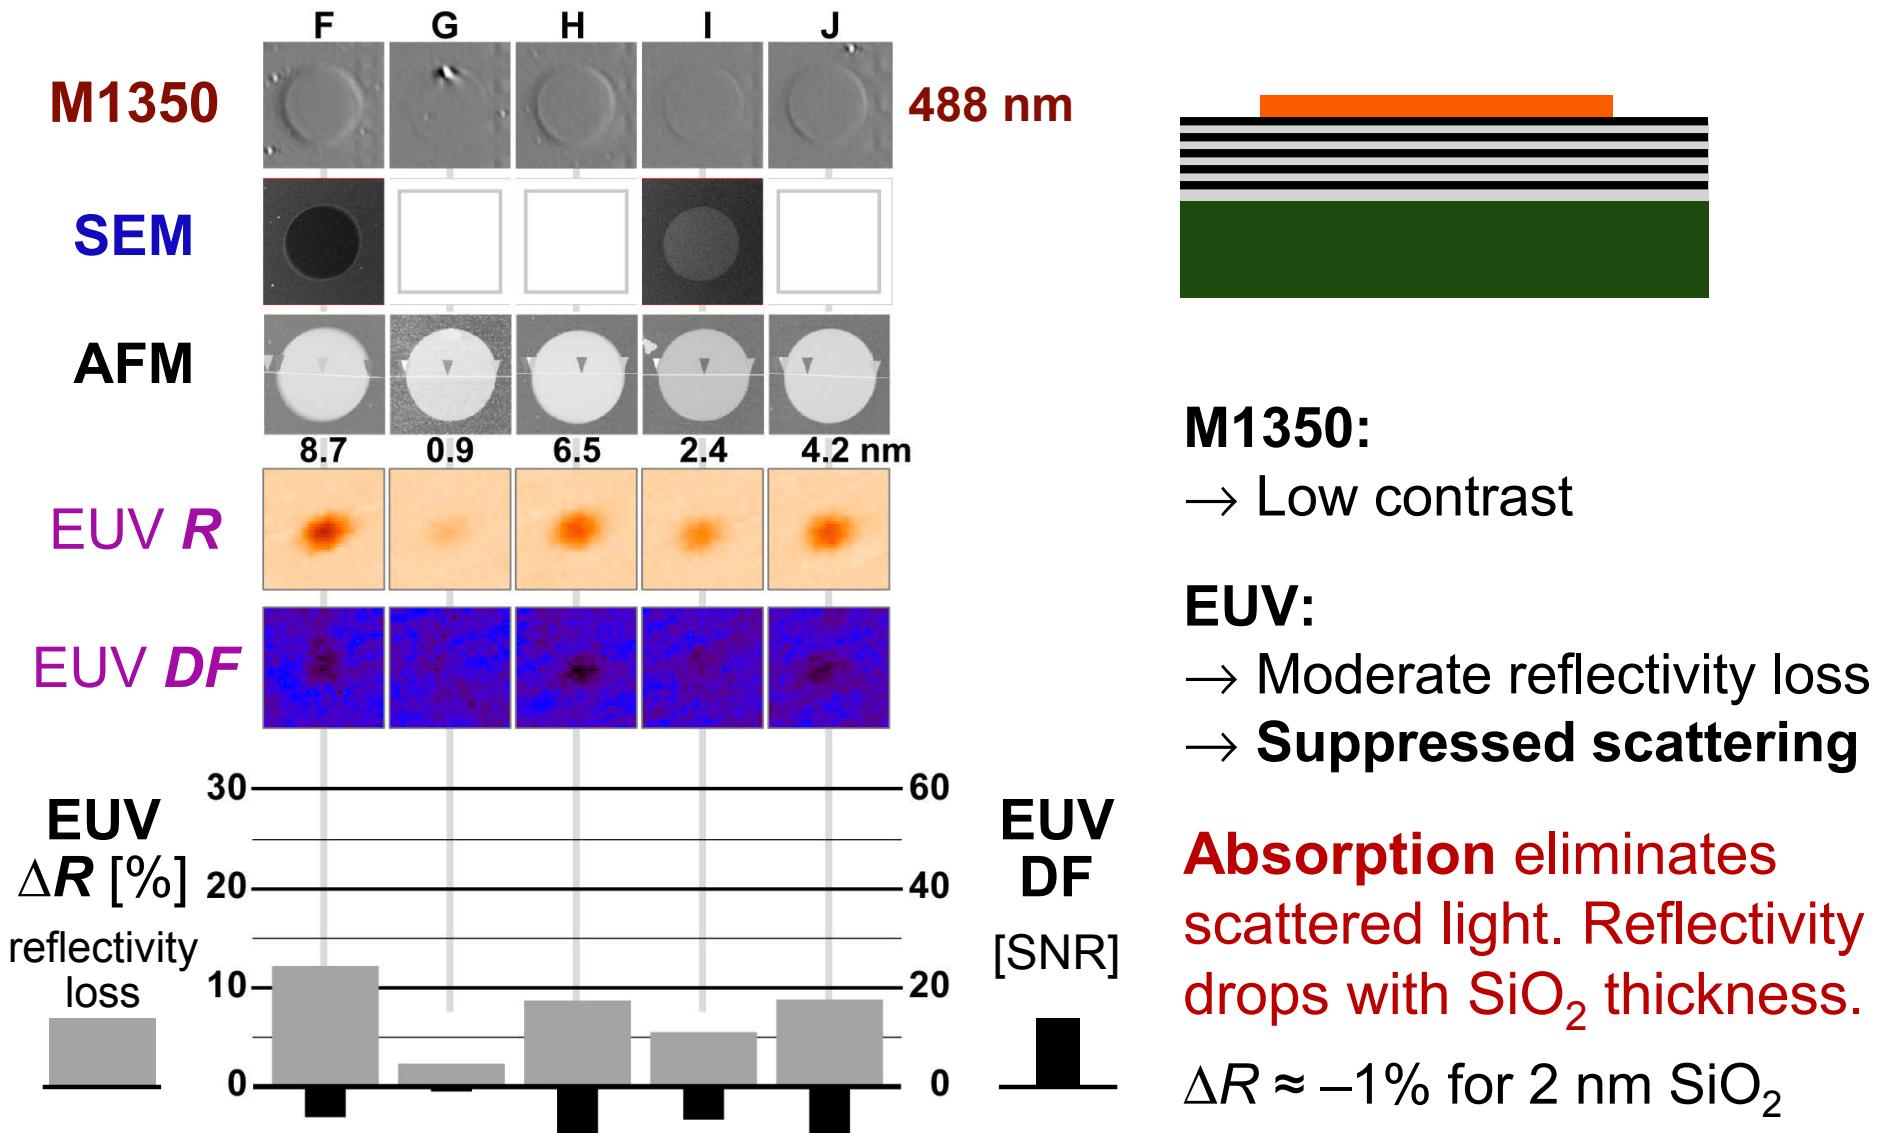
# Measurements of Group II: $SiO_2$ deposition

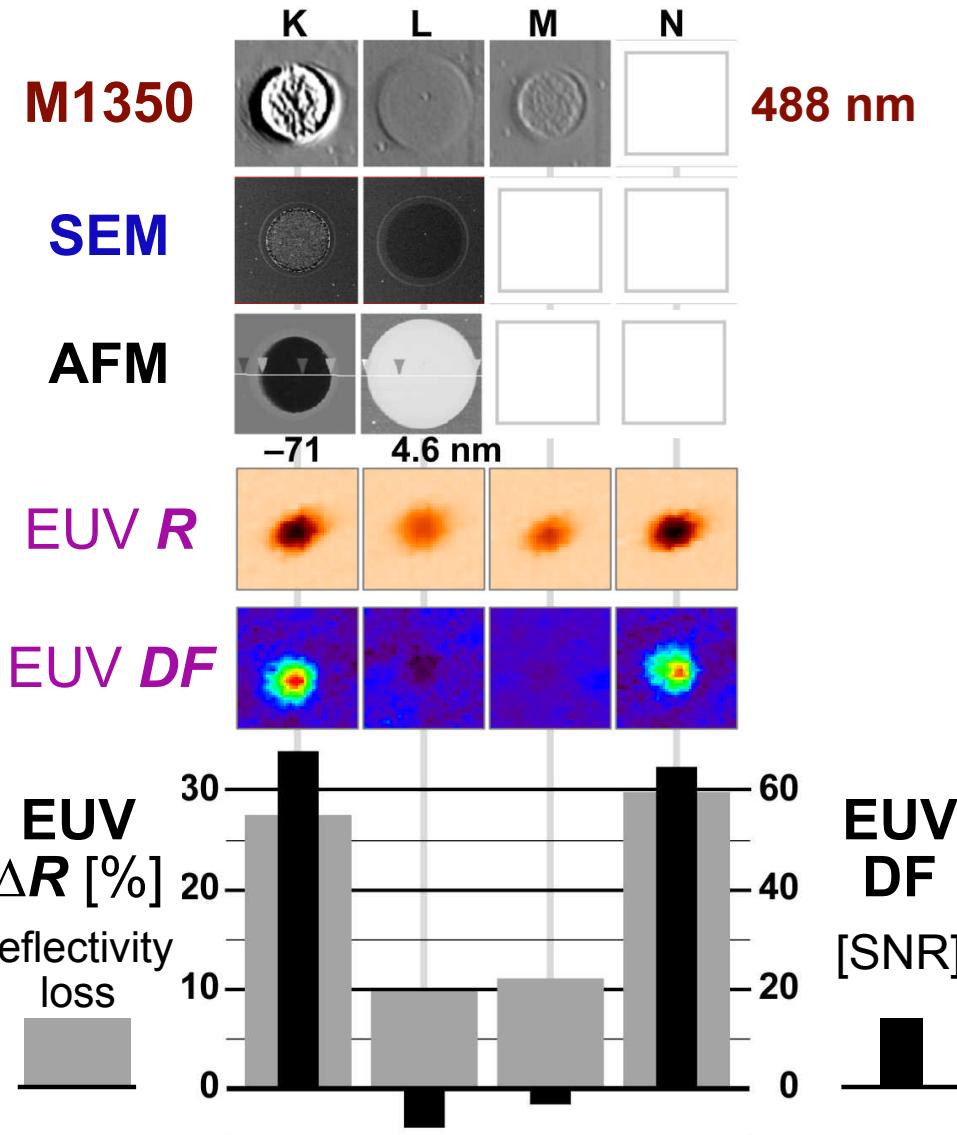
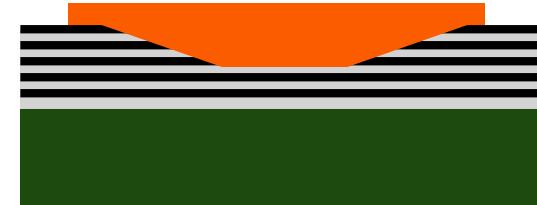
# Measurements of Group III: $SiO_2$ ditch protection

**M1350:**  
→ Mixed results

**EUV:**  
→ Mixed results

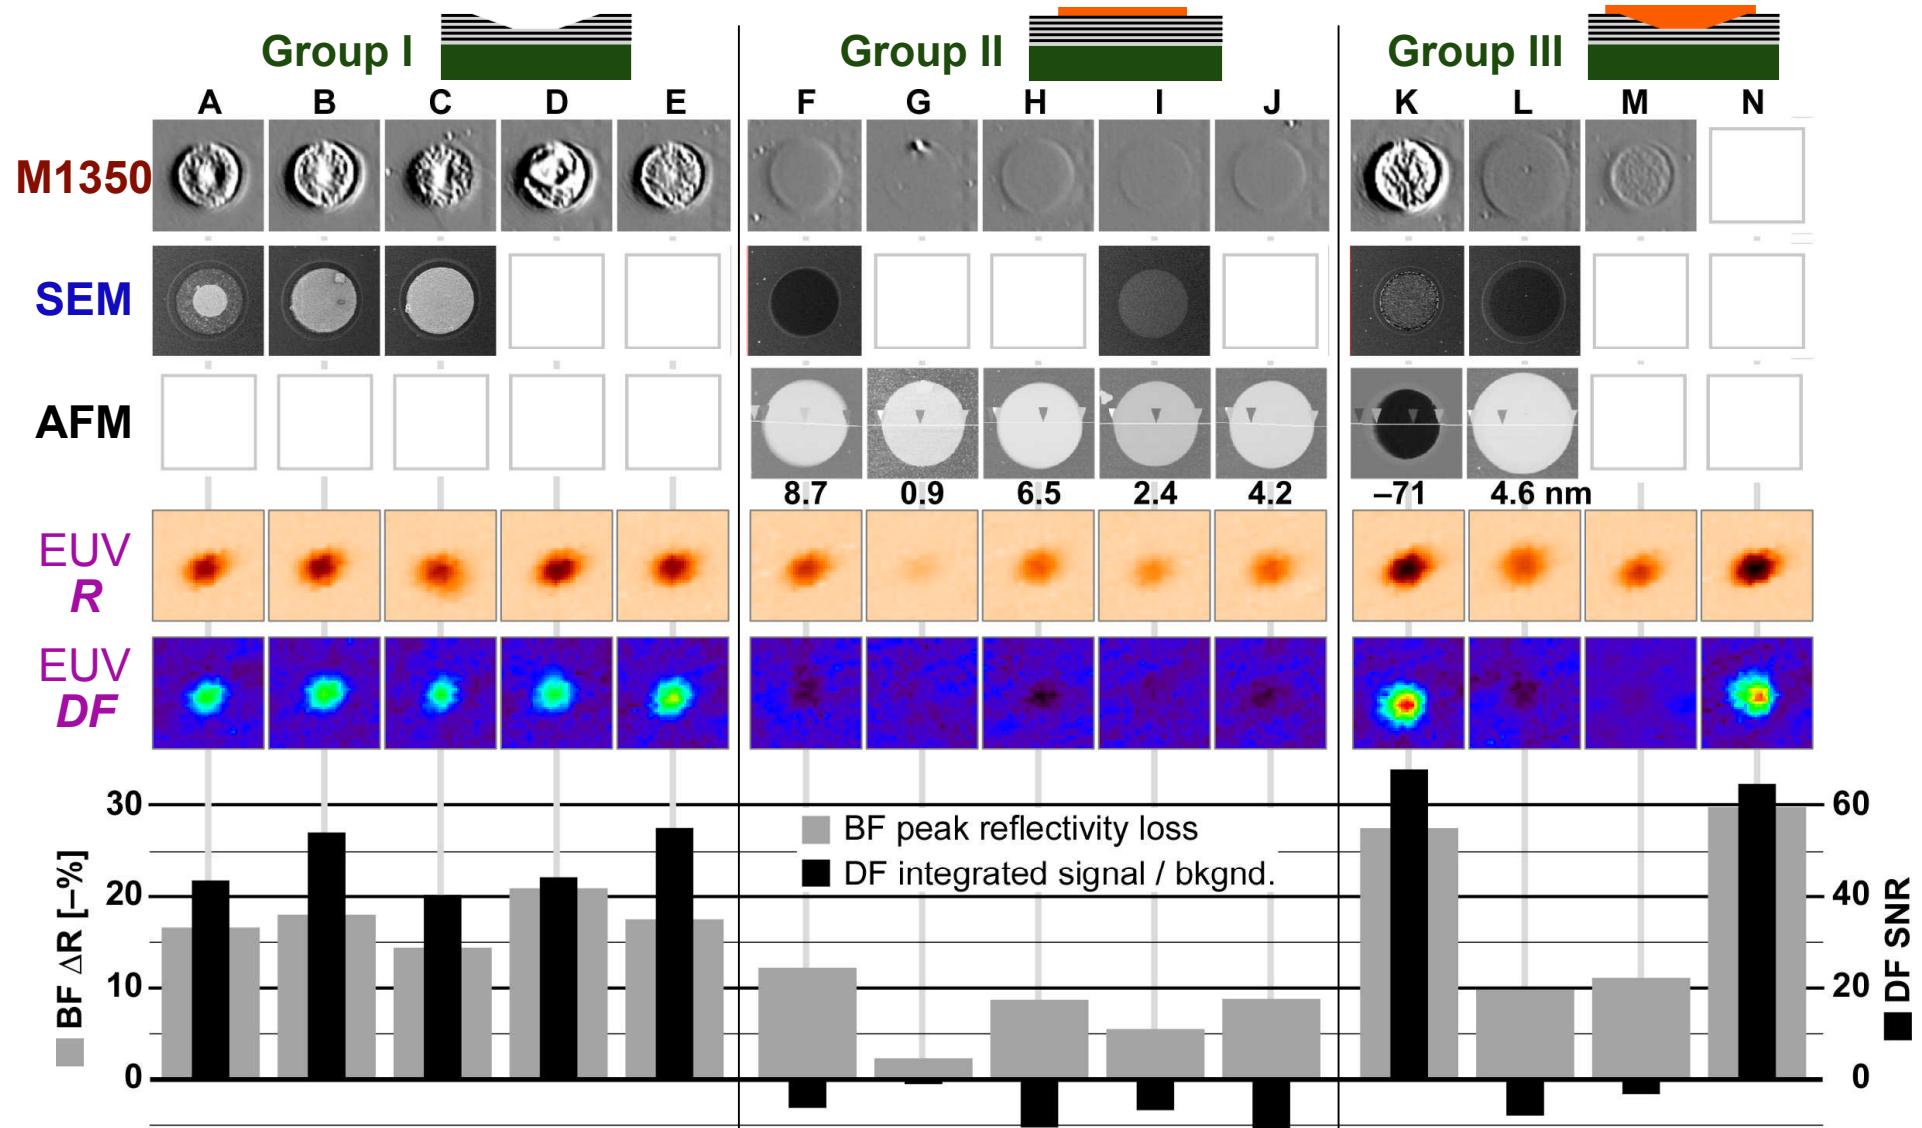
# Some sites scatter strongly, others absorb light

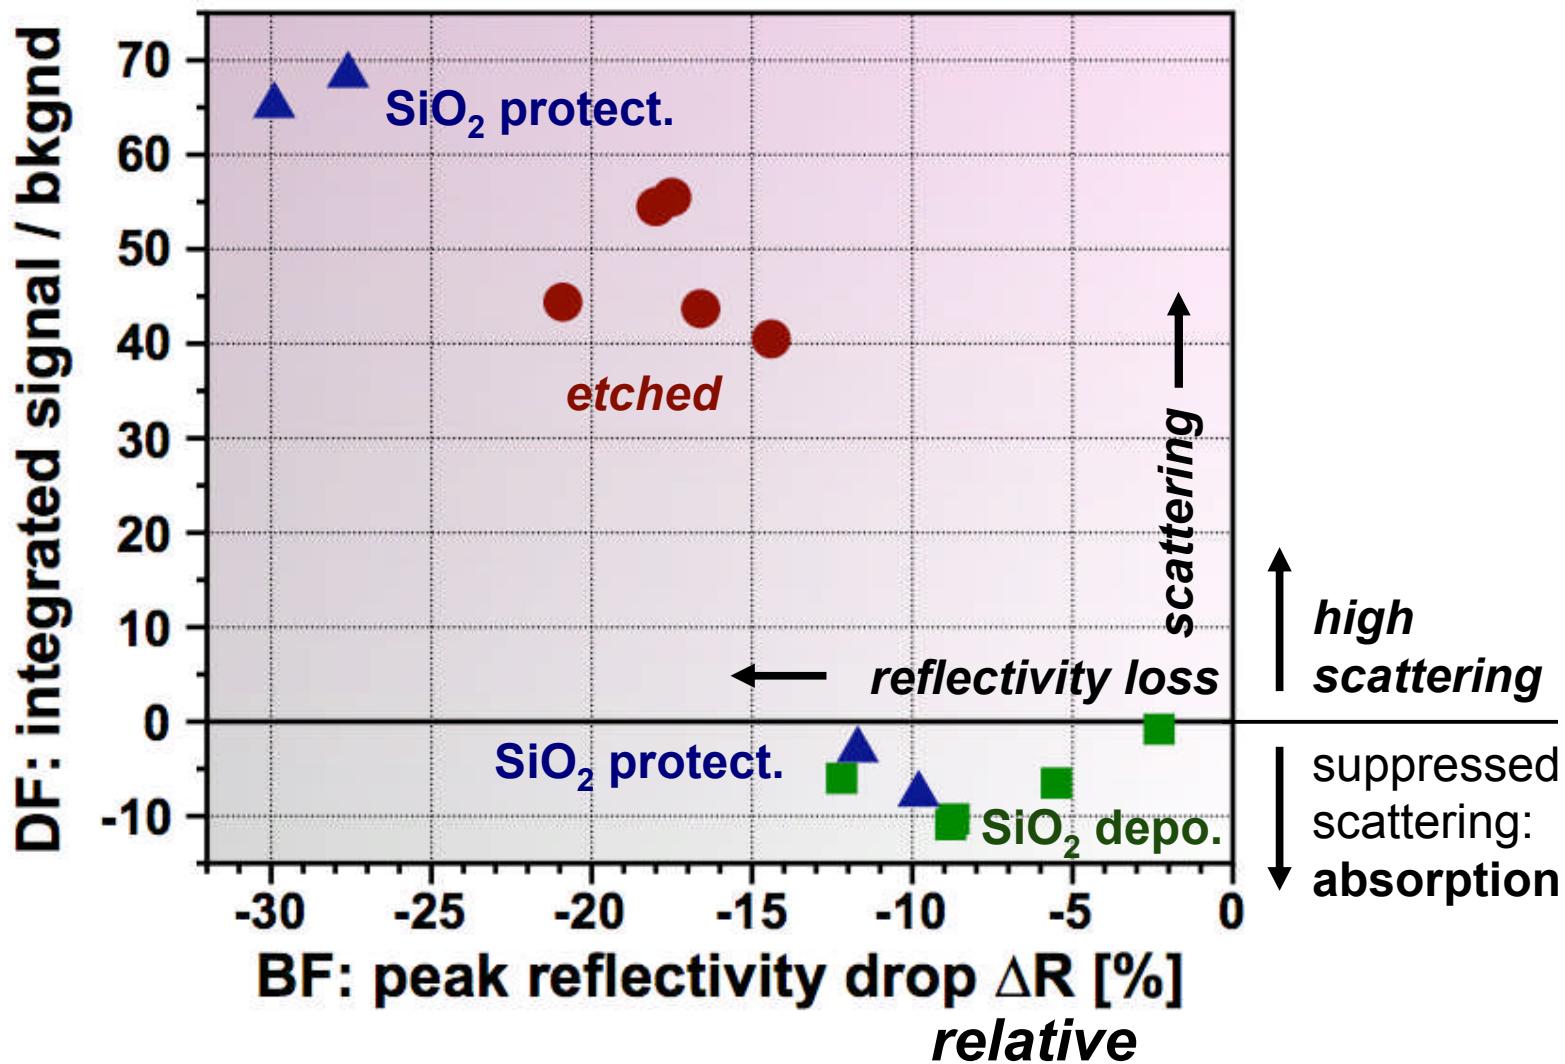
# Actinic BF and DF correlation has no single trend

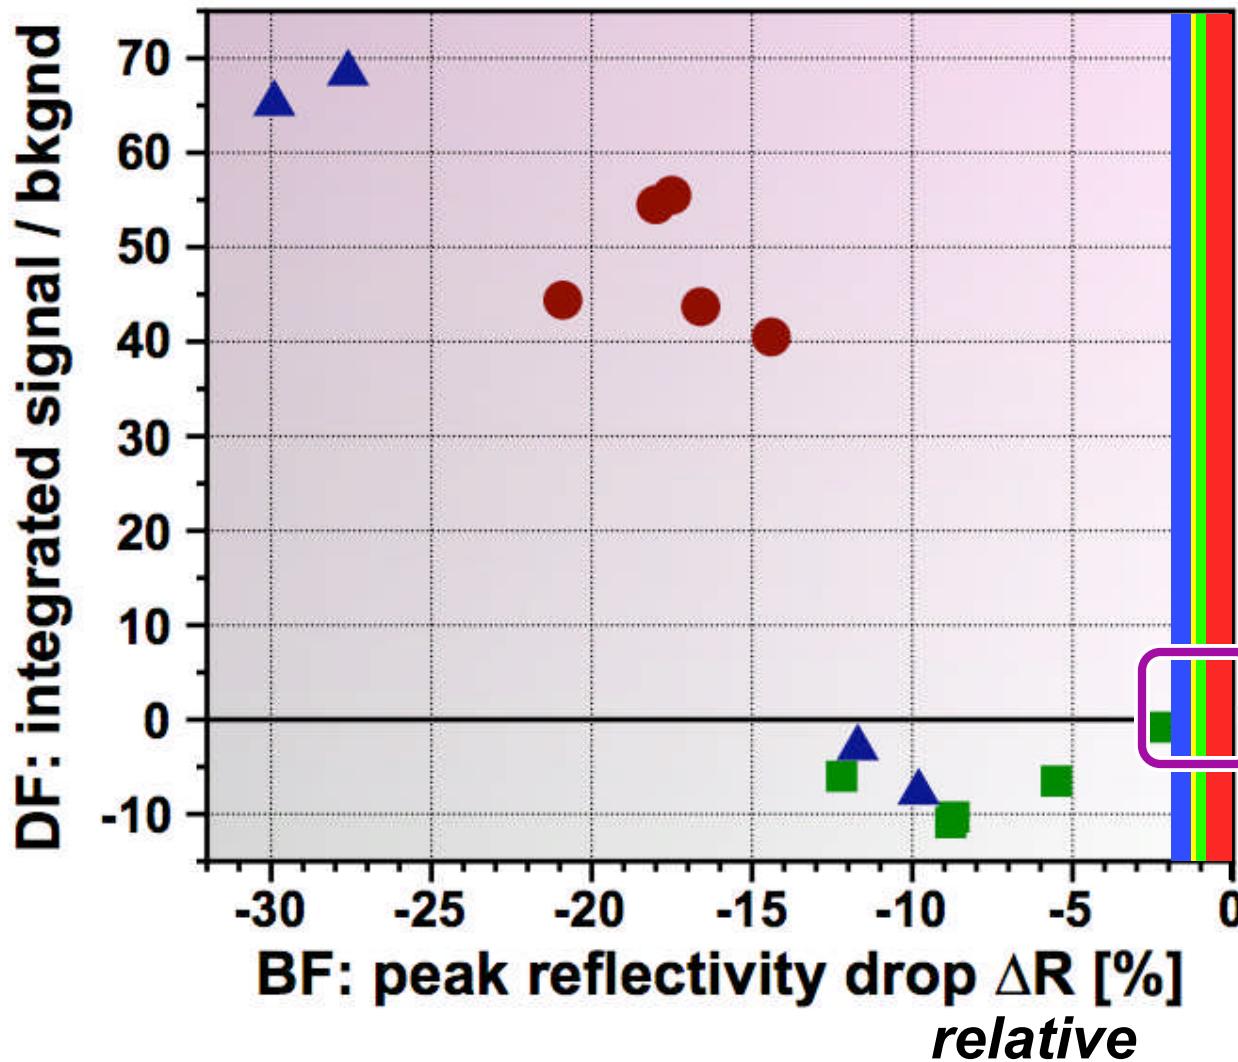
# These sites are well beyond the SEMI P-38-1103 reflection uniformity standard

## Allowed $\Delta R$ (abs)

- Class A:  $\leq 0.5\%$
- Class B:  $\leq 0.7\%$
- Class C:  $\leq 0.8\%$
- Class D:  $\leq 1.2\%$

Perhaps the correlation here matters little since we are **so far beyond the allowed  $\Delta R$**

Perhaps we should only consider *this region*

The SEMI P-38 standard may not adequately address reflectivity changes on the  $\mu$ m-to-mm length scale.

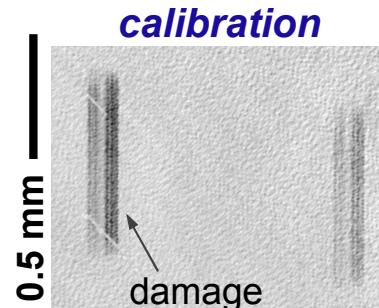
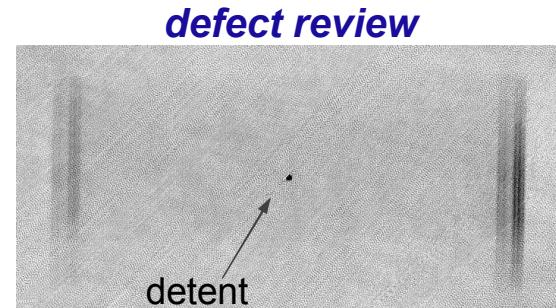
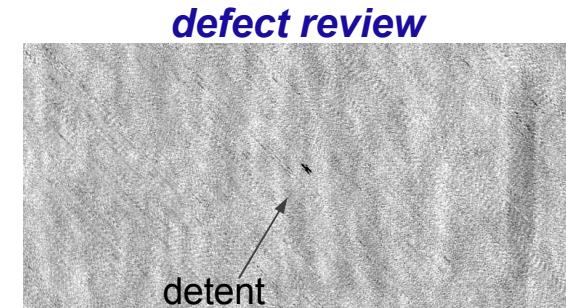
**Actinic BF scans** of Lasertec inspection regions **intentionally damaged** with different operating modes and power levels.

**5 @ full power**  
 $\Delta R_{max} = -5.4\%$

**20 @ full power**  
 $\Delta R_{max} = -2.1\%$

**1 @ lower power**  
 $\Delta R_{max} = -0.8\%$

- A mask was prepared to **assess the damage threshold** of the Lasertec M7360, during qualification.
- **Actinic BF** saw narrow damage ( $\Delta R_{rel} \leq -6\%$ ) at high power.
  - Some of the regions are **undetectable** in the Lasertec tool itself.
- Damaged areas may be **too small** for normal reflectometry.

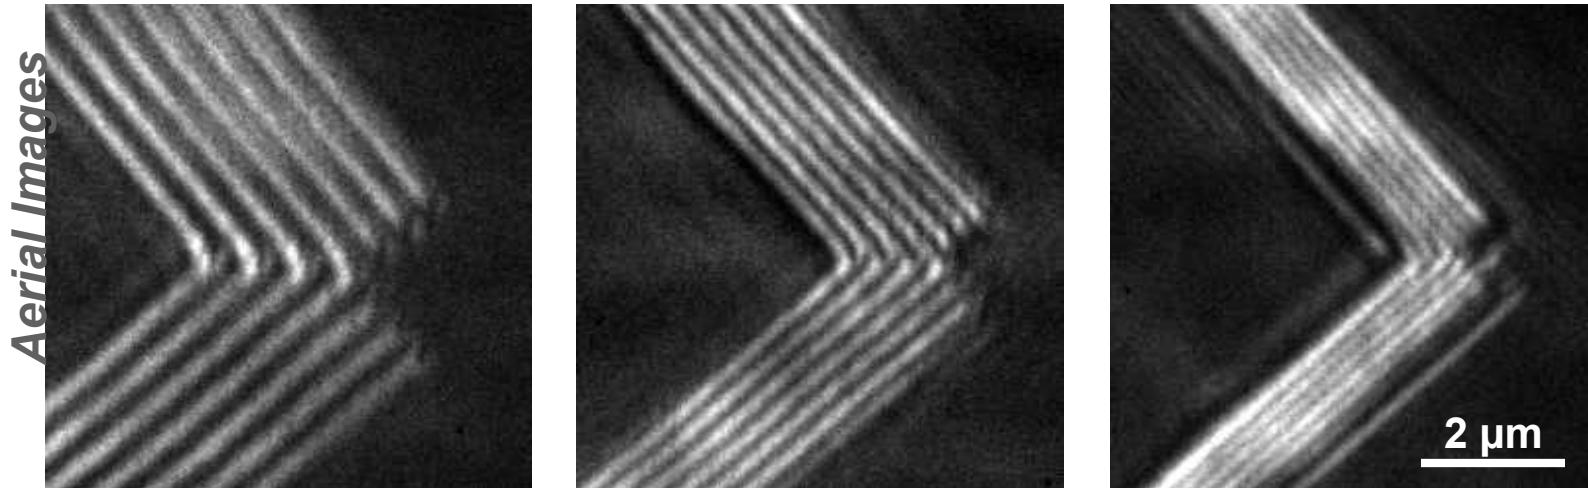
# Early tests resolved elbow images down to 100-nm (mask), 25-nm (4x wafer equivalent)

- **System Resolution** is currently designed to match a 4 $\times$ , 0.25-NA stepper.
- **Illumination:** 6° incidence. Partial coherence:  $\sigma_x > 1.0$ ,  $\sigma_y = 0.7$

half-pitch: 250 nm  
62.5 nm

150 nm  
37.5 nm

100 nm (mask)  
25 nm (4x wafer equiv.)

Imaging is performed  
with **EUV light, directly**

- There is **no scintillator, no conversion** to visible light, and **no microscope** objective.
- Consequently the measurements are **linear**.

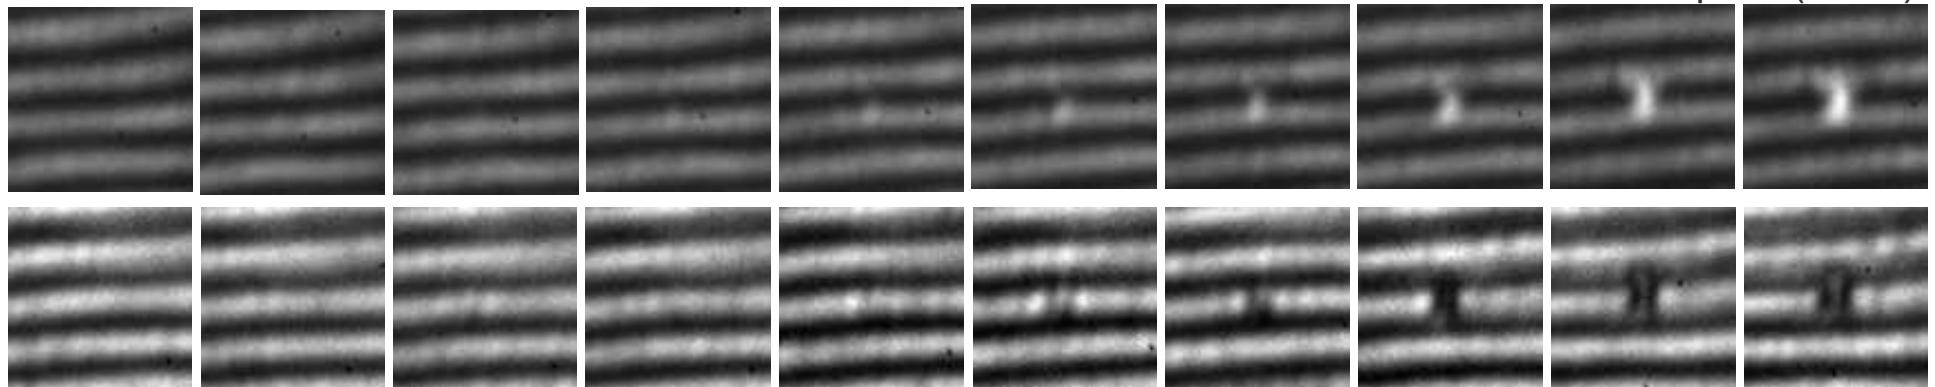
## Size series: bright and dark defects

300 nm half-pitch (mask)  
75 nm half-pitch (wafer)

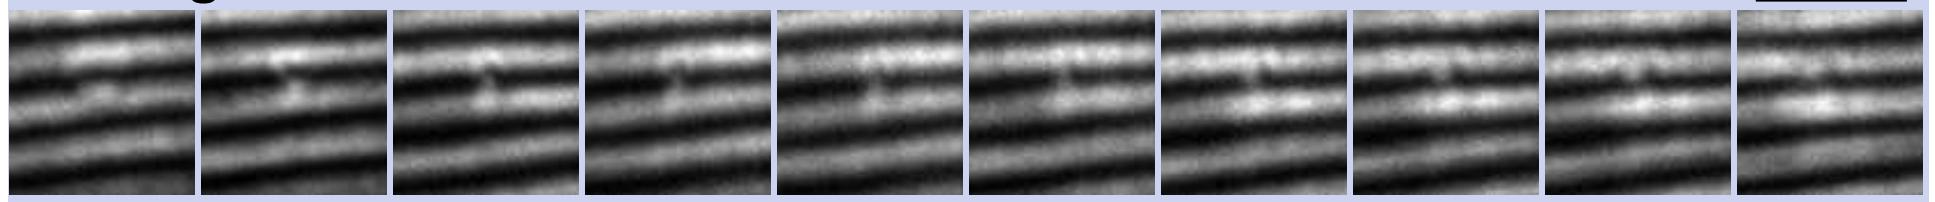
## Through-focus series

2  $\mu$ m

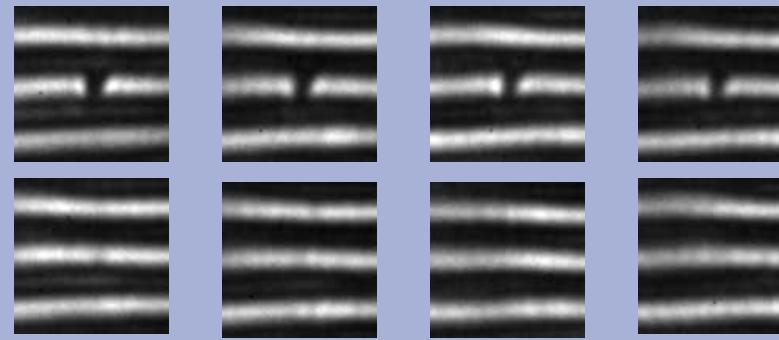
## Defect repair studies

2  $\mu$ m

half-pitch: 450 nm (mask)  
112.5 nm (wafer)

Complete series  
with  $\geq 17$  images  
were collected in  
**30-40 minutes.**
