Diagnostic Evaluation of Detrimental Phenomena in High-Power Lithium-Ion Batteries

A pouch-type lithium-ion cell, with graphite anode and $\text{LiNi}_{0.8}\text{Co}_{0.15}\text{Al}_{0.05}\text{O}_2$ cathode, was cycled at C/2 over 100% depth of discharge (DOD) at ambient temperature. The $\text{LiNi}_{0.8}\text{Co}_{0.15}\text{Al}_{0.05}\text{O}_2$ composite cathode was primarily responsible for the significant impedance rise and capacity fade observed in that cell. The processes that led to this impedance rise were assessed by investigating the cathode surface electronic conductance, surface structure, composition, and state of charge at the microscopic level with the use of local probe techniques. Raman microscopy mapping of the cathode surface provided evidence that the state of charge of individual $\text{LiNi}_{0.8}\text{Co}_{0.15}\text{Al}_{0.05}\text{O}_2$ particles was non-uniform despite the deep discharge at the end of cell testing. Current-sensing atomic force microscopy imaging revealed that the cathode surface electronic conductance diminished significantly in the tested cells. Loss of contact of active material particles with the carbon matrix and thin film formatio

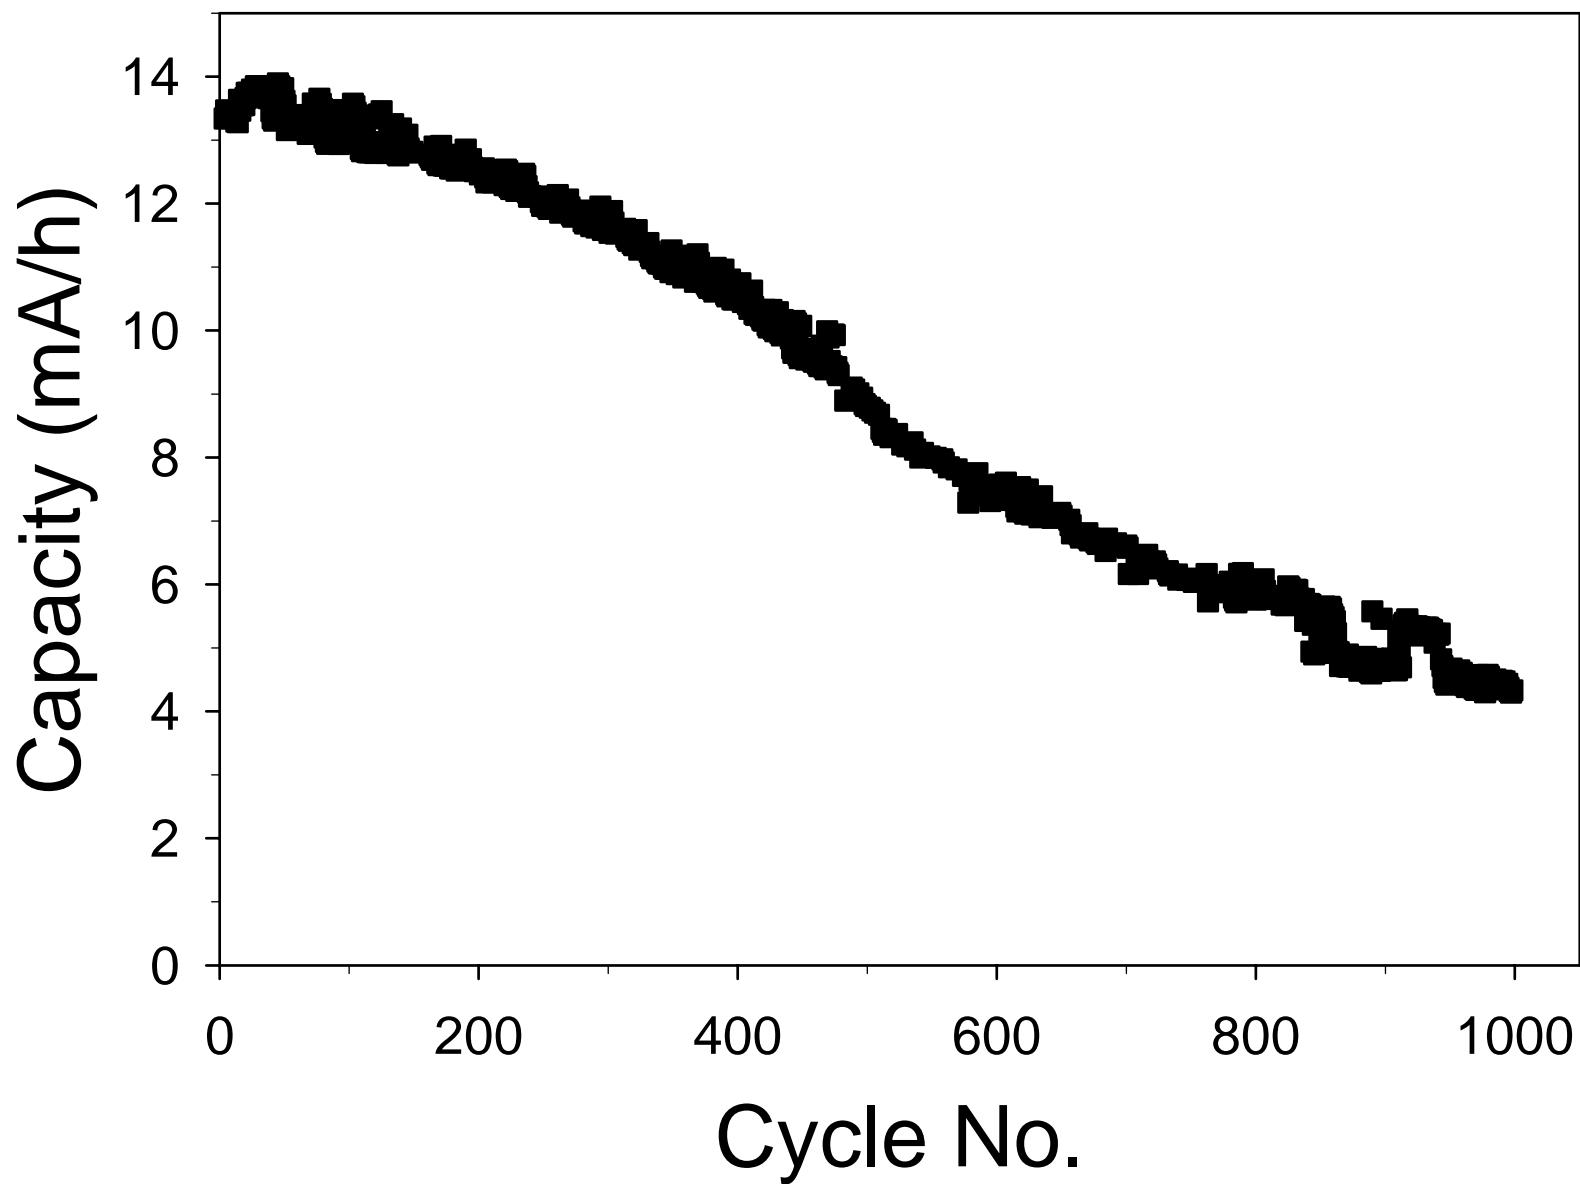
Figure1. C/2 discharge capacity of a $\text{LiNi}_{0.8}\text{Co}_{0.15}\text{Al}_{0.05}\text{O}_2$ /1.2 M LiPF_6 , EC/EMC/Mag-10 pouch cell under a 100% DOD cycling regimen.

The C/2 discharge capacity vs. cycle history for the cell tested in this study is shown in Figure 1. The cycle coulombic efficiency averaged 99.93%, which led to a 70% capacity fade during C/2 cycling after 1000 cycles [5]. Low-rate capacity measurements at C/25 showed only 40% capacity fade, which indicates that impedance changes in the cell are responsible for a significant fraction of the observed capacity fade at C/2. Post-test electrochemical diagnostic studies of the electrodes revealed that the C/25 capacity of the anode, after being harvested from the cycled cell, showed essentially identical capacity to the fresh anode in a half-cell measurement. On the other hand, the tested LiNi_{0.8}Co_{0.15}Al_{0.05}O₂ cathode displayed an irreversible C/25 capacity loss of about 27% with reference to the fresh cathode. The loss of cycleable Li, most likely due to solvent reduction on the anode, was found to be partially responsible for the observed cell capacity loss. However, it appears that the cathode degradation is the most important contributor to the cell failure mechanism during the long-term cycling. X-ray diffraction spectra of the cycled cathode (not shown here) indicate that the active material is still intact, i.e., no new

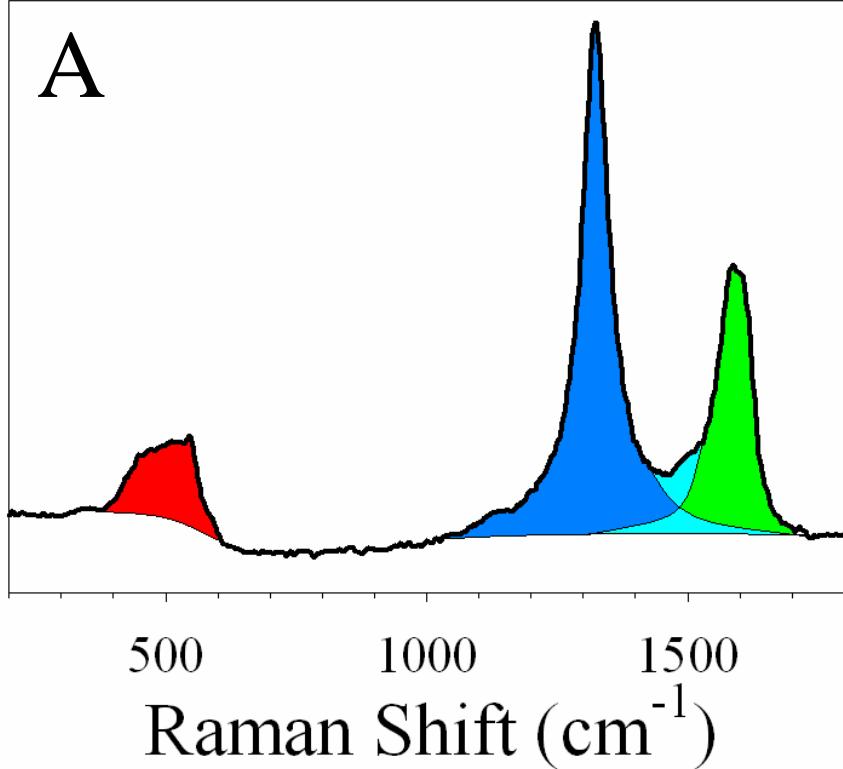
Figure 2. (A) A typical Raman spectrum of the composite $\text{LiNi}_{0.8}\text{Co}_{0.15}\text{Al}_{0.05}\text{O}_2$ electrode, (B) $52 \times 75 \mu\text{m}$ Raman microscope image of the composite $\text{LiNi}_{0.8}\text{Co}_{0.15}\text{Al}_{0.05}\text{O}_2$ cathode from the cycled cell. The image was collected at $0.7 \mu\text{m}$ resolution. The intensities of red, blue, and green colors correspond to the integrated band intensities of $\text{LiNi}_{0.8}\text{Co}_{0.15}\text{Al}_{0.05}\text{O}_2$, and D, G carbon bands of each spectrum, respectively, (C) optical image of the mapped area.

Figure 2A shows a typical *ex situ* Raman microscopy spectrum of the composite $\text{LiNi}_{0.8}\text{Co}_{0.15}\text{Al}_{0.05}\text{O}_2$ cathode. It consists of two groups of bands: a broad maximum centered at $\sim 510 \text{ cm}^{-1}$, characteristic for $\text{LiNi}_{0.8}\text{Co}_{0.15}\text{Al}_{0.05}\text{O}_2$ oxide, and two peaks at ~ 1350 and $\sim 1600 \text{ cm}^{-1}$. The band at 510 cm^{-1} consists of two Raman-active vibrations characteristic for $\text{LiNi}_{0.8}\text{Co}_{0.15}\text{Al}_{0.05}\text{O}_2$ oxide, which crystallizes in the rhombohedral layered structure of $\alpha\text{-NaFeO}_2$ (R3m). The (G) band at 1600 cm^{-1} corresponds to the E_{2g} active mode of graphite [22]. The (D) band at $\sim 1350 \text{ cm}^{-1}$ is assigned to the A_{1g} mode and is associated with the breakage of symmetry that occurs at the edges of graphite sheets. The carbon G and D bands represent graphite and carbon black conducting additives, which are the carbonaceous components of the composite cathode. A semi-quantitative surface analysis of the cathode surface composition was carried out by Raman mapping of a $52 \times 75 \mu\text{m}$ section of the cathode surface at $0.7 \mu\text{m}$ resolution (Figure 2B). The optical image of the mapped area is shown in Figure 2C. The $1.2 \mu\text{m}$ diameter laser beam was able to probe and map individual $\text{LiNi}_{0.8}\text{Co}_{0.15}\text{Al}_{0.05}\text{O}_2$ agglomerates, which were about one order of magnitude larger than the laser beam and consisted of smaller sub-micron primary crystallites. Thousands of Raman spectra were deconvoluted, analyzed, and displayed as color-coded points on the composition image map in which the saturations of red, blue, and green colors are proportional to the integrated areas under the respective Raman bands of $\text{LiNi}_{0.8}\text{Co}_{0.15}\text{Al}_{0.05}\text{O}_2$, acetylene black, and graphite, respectively. The resultant color for each location corresponds to the local surface concentration ratio of the components of the

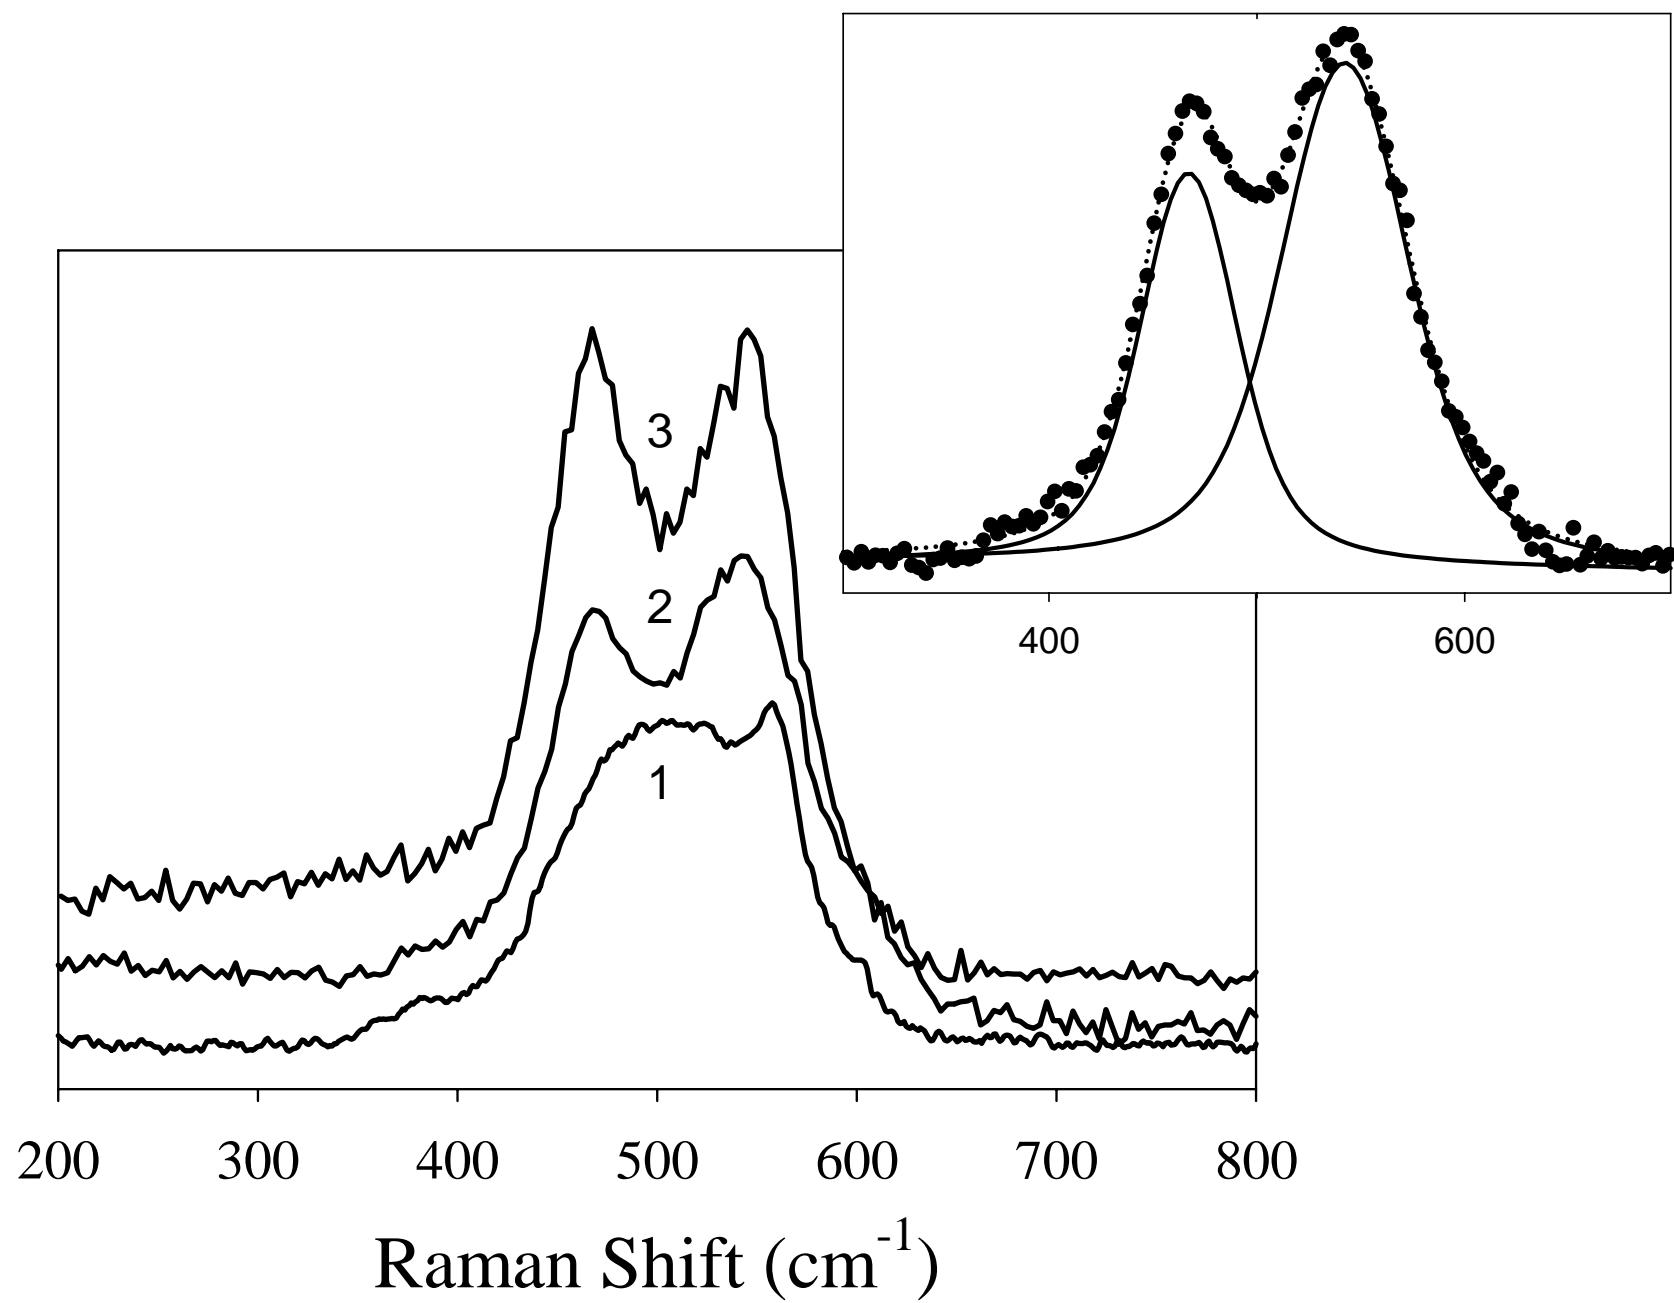
Figure 3. Raman microscope spectra of three individual $\text{LiNi}_{0.8}\text{Co}_{0.15}\text{Al}_{0.05}\text{O}_2$ particles in the tested cathode. The insert shows an example of deconvoluted $\text{Li}_{1-x}\text{Ni}_{0.8}\text{Co}_{0.15}\text{Al}_{0.05}\text{O}_2$ spectrum.

Interestingly, the spectra of the $\text{LiNi}_{0.8}\text{Co}_{0.15}\text{Al}_{0.05}\text{O}_2$ particles in the tested cathode vary significantly as a function of location on the cathode surface. Figure 3 shows Raman signatures of three separate oxide particles that were selected and investigated by Raman microscopy (see Figure 2B). The spectra shown in Fig. 3 display features characteristic for fully discharged (1), partially charged (2), and fully charged (3) $\text{Li}_{1-x}\text{Ni}_{0.8}\text{Co}_{0.15}\text{Al}_{0.05}\text{O}_2$ material. The spectra of all three particles are dominated by two bands at 475 and 553 cm^{-1} , characteristic for $\text{Li}_{1-x}\text{Ni}_{0.8}\text{Co}_{0.15}\text{Al}_{0.05}\text{O}_2$ oxide and associated with vibrations characteristic of the NiO_2 lattice. An example of a deconvoluted $\text{Li}_{1-x}\text{Ni}_{0.8}\text{Co}_{0.15}\text{Al}_{0.05}\text{O}_2$ spectrum is shown in the Fig. 3 insert. The symmetry of these vibrations in $\text{Li}_{1-x}\text{Ni}_{0.8}\text{Co}_{0.15}\text{Al}_{0.05}\text{O}_2$ is somewhat distorted by the presence of electronic and coordination structures originating from weak Li-O bonds. The bands tend to broaden and the 475/553 band ratio varies significantly with increasing lithium content in the lattice. Such a change of the band profiles in the vibrational spectra is usually attributed to a change of the a and c parameters of the $\text{Li}_{1-x}\text{Ni}_{0.8}\text{Co}_{0.15}\text{Al}_{0.05}\text{O}_2$ crystal lattice with a different lithium content. The level of lithiation can be monitored by observing and quantifying changes of 475/553 peak parameters, i.e., peak widths and peak intensity ratio. Therefore, we can conclude that the cathode surface SOC is highly non-uniform and varies between individual grains of active material from fully discharged through partially charged to fully charged, even though the cell was fully discharged at the end of cell testing.

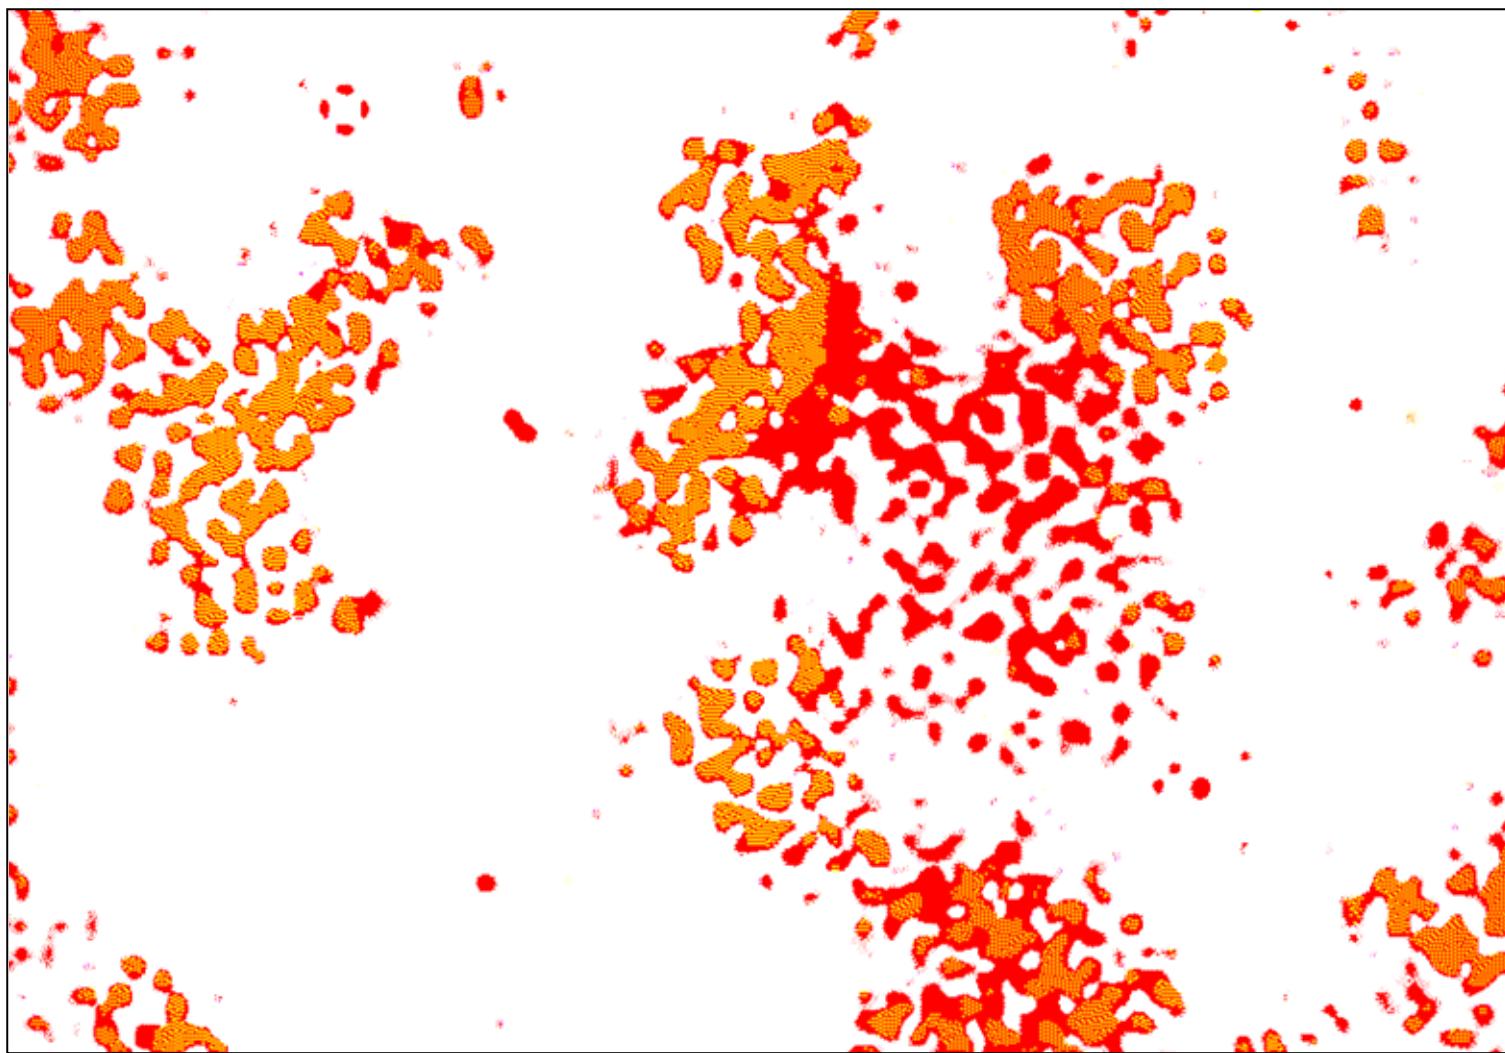
Figure 4. Color-coded pattern of fully discharged (orange) and partially or fully charged (red) $\text{Li}_{1-x}\text{Ni}_{0.8}\text{Co}_{0.15}\text{Al}_{0.05}\text{O}_2$. The SOC map was derived from the Raman microscopy image of the composite $\text{LiNi}_{0.8}\text{Co}_{0.15}\text{Al}_{0.05}\text{O}_2$ cathode that is shown in Fig. 2B.

To quantify the amount of charged active material still present at the surface of the composite cathode, the Raman spectra that constitute the color-coded map shown in Fig. 2B were deconvoluted. Each individual spectrum was examined and deconvoluted to determine the SOC of the active material at each location. Figure 4 shows a color-coded pattern of fully discharged (orange) and partially or fully charged (red) $\text{Li}_{1-x}\text{Ni}_{0.8}\text{Co}_{0.15}\text{Al}_{0.05}\text{O}_2$. The white areas correspond to locations where spectral characteristics and SOC of the $\text{Li}_{1-x}\text{Ni}_{0.8}\text{Co}_{0.15}\text{Al}_{0.05}\text{O}_2$ could not be probed because the oxide was covered by a thick layer of carbon additives. The micro-Raman surface SOC map of the cathode from the cycled cell clearly indicates that lithium content in the exposed bare oxide grains varies substantially at different locations. Interestingly, primary oxide particles within the same agglomerate remain at different SOC. These observations suggest that kinetic barriers at the micro-scale exist within the composite cathode and were likely contributors to non-uniform current density and charge distribution in the tested cathode.

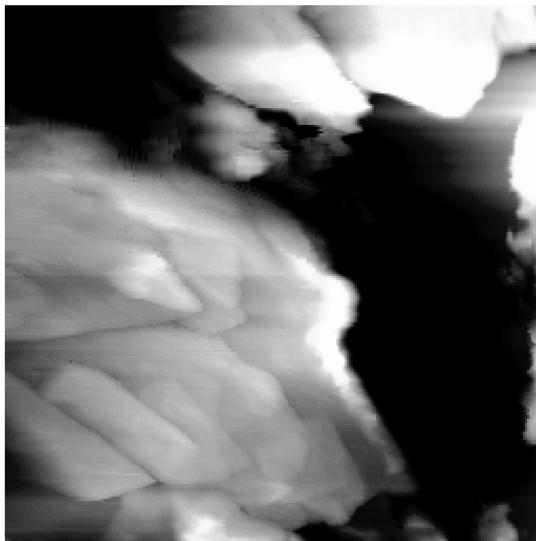
A

Figure 5. CSAFM images of surface conductance (right-hand panel) and topography (left-hand panel) of a $5 \times 5 \mu\text{m}$ region of the composite $\text{LiNi}_{0.8}\text{Co}_{0.15}\text{Al}_{0.05}\text{O}_2$ cathode surface at 1.0 V tip-sample voltage difference: (A) fresh cell; (B) cathode from the cycled cell.

Figure 5 shows CSAFM images of surface conductance (right-hand panel) and topography (left-hand panel) of a representative $5 \times 5 \mu\text{m}$ region of the composite $\text{LiNi}_{0.8}\text{Co}_{0.15}\text{Al}_{0.05}\text{O}_2$ cathode surface at 1.0 V tip-sample voltage difference from (A) a fresh cell, and (B) the cathode from the cycled cell. The surface morphology images of both cathodes reveal no significant changes in the cathode surface topography in tested cells. The surface conductance image of the cathode from a fresh cell exhibits areas of mostly high electronic conductance (black areas) and only a few insulating regions (white areas).

Highly conductive graphite and acetylene black additives constitute are primarily responsible for the excellent electronic properties observed at the cathode surface. The insulating areas on the cathode surface are most likely associated with the presence of non-conductive PVDF binder, SEI layers, and deep cavities between particles of the electrode components. The conductance image of the cathode from the tested cell shows a substantial increase of surface resistance. Large areas of the cathode surface became insulating except for a few locations, which still display very good (black areas) or fair (gray) electronic conductivity. This result is similar to our earlier studies of the $\text{LiNi}_{0.8}\text{Co}_{0.2}\text{O}_2$ and $\text{LiNi}_{0.8}\text{Co}_{0.15}\text{Al}_{0.05}\text{O}_2$ cathodes [4, 12], which showed a complete lack of conductivity of the cathode surface, consistent with either loss of contact of particles at the electrode surface with the rest of the electrode, or the presence of a nonconductive film of polycarbonates and/or LiF , Li_xPF_y , $\text{Li}_x\text{PF}_y\text{O}_z$ -type compounds [23].
