LM-07K022
April 18, 2007

Nickel Alloy Primary Water Bulk Surface and SCC Corrosion Film Analytical Characterization and SCC Mechanistic Implications

David Morton, Nathan Lewis, Michael Hanson, Steve Rice and Paul Sanders

Lockheed Martin Corporation
Schenectady, NY 12301-1072

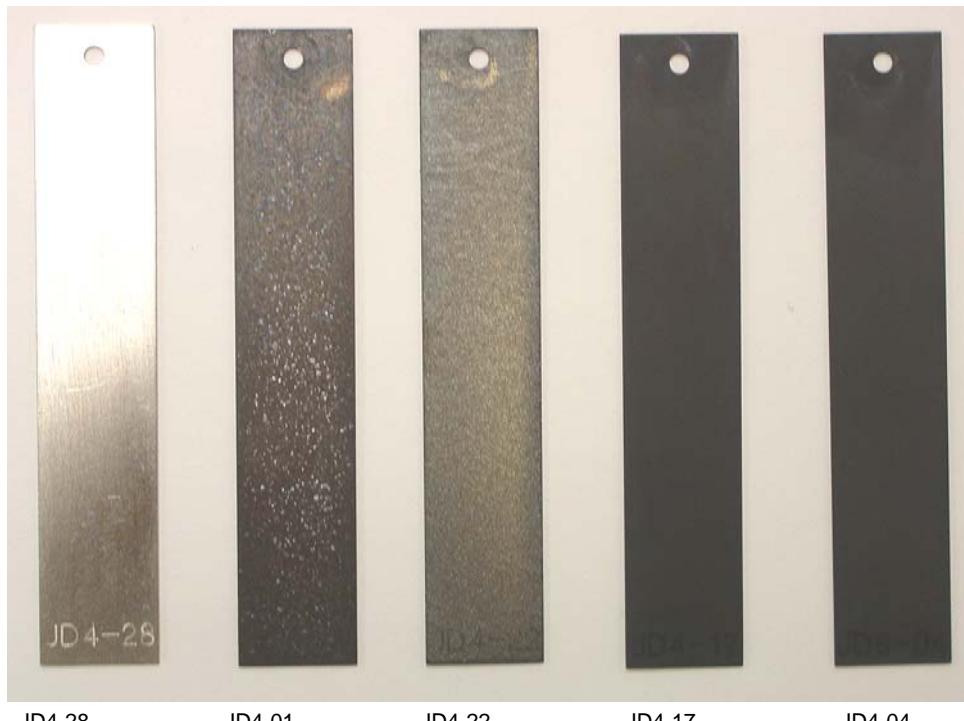
Figure 1: Comparison of Optical Heat Tints on Alloy 600 Specimens with Different Surface Treatments. Darker oxides generally indicate thicker corrosion films.

Representative optical photographs of the test specimens are provided in Figures 1 and 2. These low magnification photographs capture the post-test oxide film heat tint coloration. Generally, darker heat tints imply thicker corrosion films. Figure 1 compares specimens with different surface conditions (SA, ECP, as-machined and cold rolled). Figure 2 compares as-machined (AM) specimens tested at different temperatures and different exposure times. As shown in these figures, all specimens developed a heat tint. A dark gray heat tint formed on as-machined and cold worked specimens exposed to 640°F primary water for 4000/5000 hours. In comparison gold/brown heat tints formed on as-machined specimens exposed for a similar duration at 550°F and for 500 hours at 640°F, Figure 2. This data qualitatively indicates that increased exposure times and increased temperatures give rise to thicker corrosion films. The heat tints of the Alloy X-750 AH specimens look analogous to their counterpart Alloy 600 specimens.

A speckled brown/gray heat tint was observed on the SA Alloy 600 specimen exposed at 640°F for 4000 hours and a speckled gold/brown heat tint was observed on the ECP Alloy 600 specimen

exposed at 640°F for 5000 hours. These results indicate that the SA and ECP surface treatments reduce the rate of corrosion. The speckled appearance occurs because the Alloy 600 grain structure is visible in the ECP and SA specimens and oxidation was not extensive enough to entirely obscure the grain structure. Cold worked-ECP specimen oxide films were analogous to non-cold worked

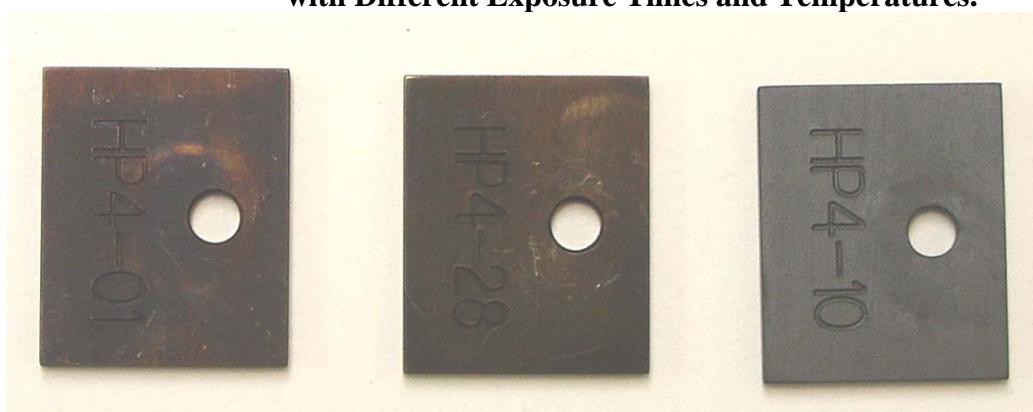
Figure 2: Comparison of Optical Heat Tints on As-Machined (AM) Alloy 600 Specimens with Different Exposure Times and Temperatures.

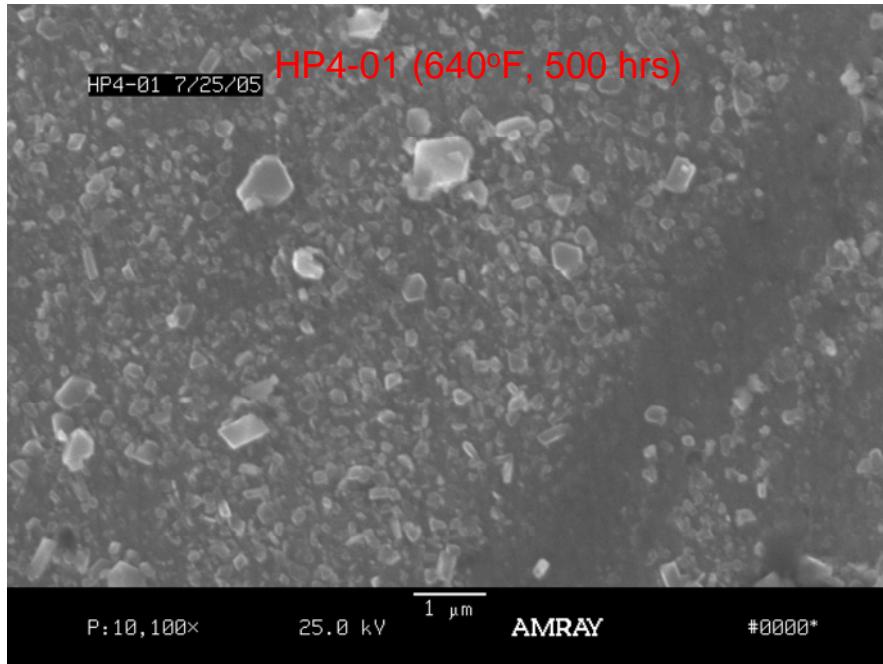
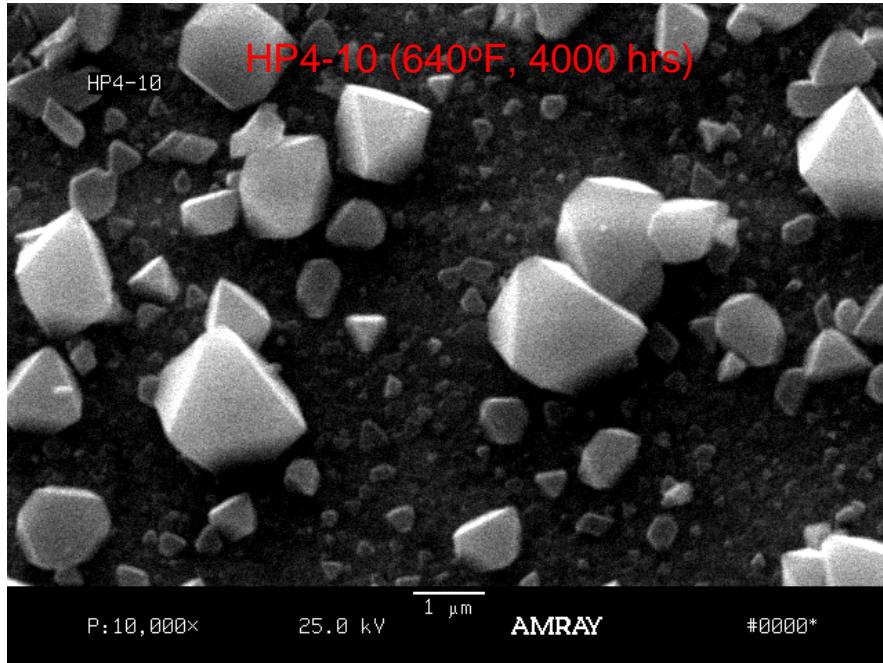
Figure 3: SEM Images Comparing As-Machined Alloy 600 Specimens Exposed to 640°F Hydrogenated Water for 500 and 4000 hours.

a) 500 hour exposure

b) 4000 hour exposure

Figures 3-7 provide representative scanning electron microscope (SEM) photographs characterizing the extent of outer layer oxide buildup as a function of surface condition, exposure time and exposure temperature. Figure 3 compares two as-machined specimens exposed at 640°F for 500 and 4000 hours. As illustrated in Figure 3, well formed polyhedral crystals formed under both exposure periods. There was no preferential orientation relationship observed between the oxide crystals and the underlying substrate. As discussed below X-ray diffraction and energy dispersive spectroscopy (EDS) analyses confirmed that these large crystals are a nickel rich ferrite with trace amounts of chromium. The smaller crystals tended to be more chromium rich.

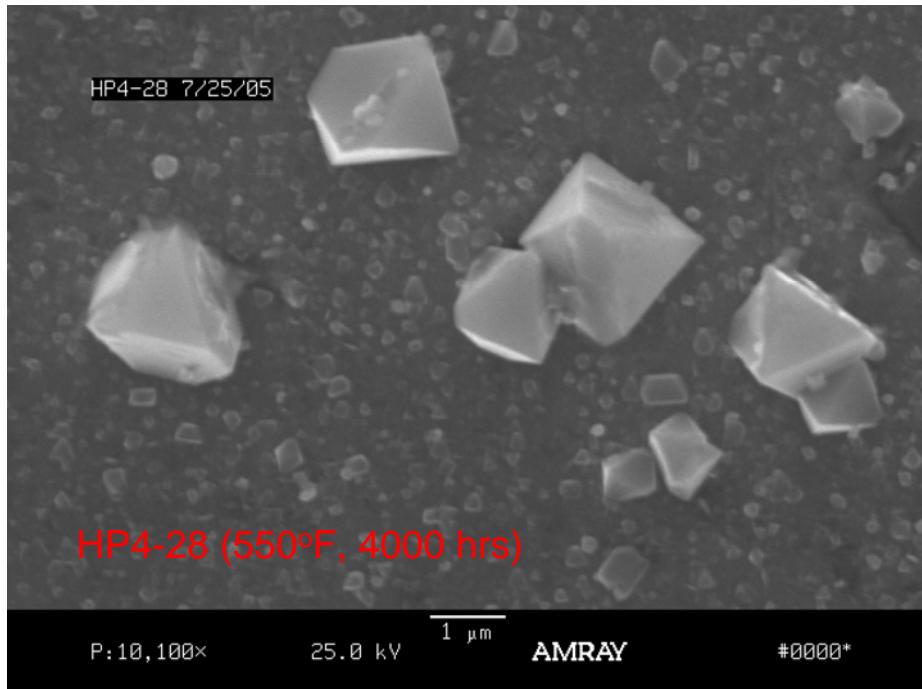
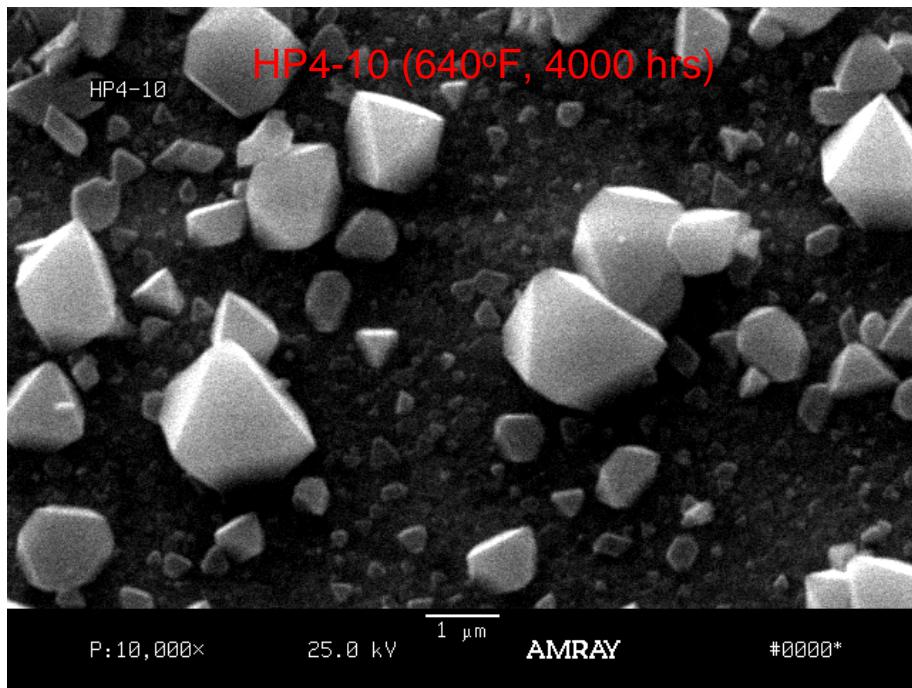
Figure 4: SEM Images Comparing As-Machined Alloy 600 Specimen Exposed to 550°F and 640°F Hydrogenated Water for 4000 hours.

a) 550°F for 4000 hours

b) 640°F for 4000 hours

Figure 4 compares sister as-machined Alloy 600 specimens tested at 550 and 640°F for 4000 hours. The effect of temperature on the outer oxide crystal morphology and size distribution is less pronounced than the effect of exposure time noted in Figure 3. The most apparent difference between the 550 and 640°F outer layers was a slightly greater number density of large crystals at elevated temperature.

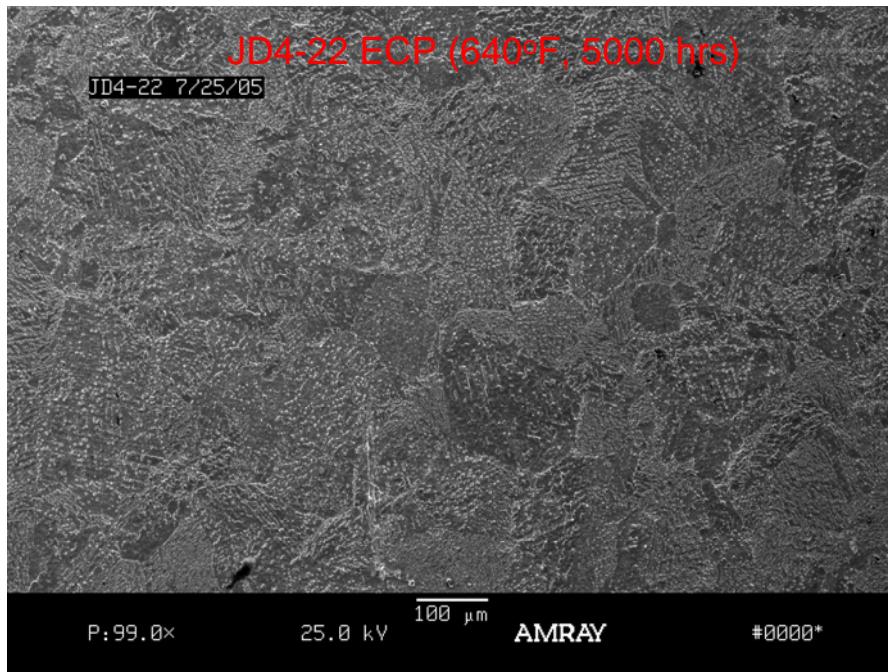
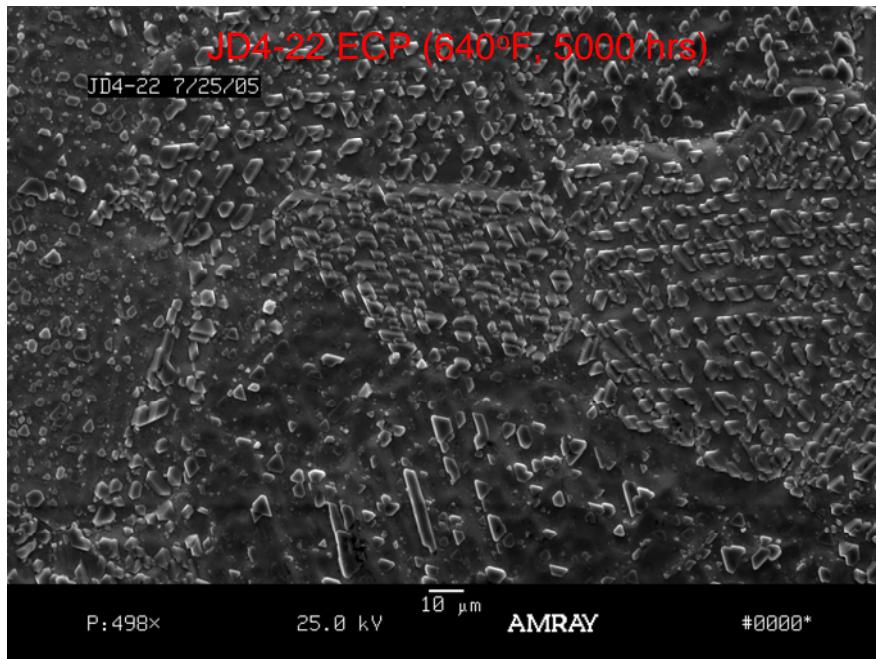
Figure 5: SEM Images of an Electrochemically Polished Alloy 600 Specimen Exposed to 640°F Hydrogenated Water for 5000 hours.

a) Low magnification image showing the underlying grain structure

b) Higher magnification image indicates that the outer layer ferrite crystals exhibit preferred growth orientations related to the grain in the underlying substrate

Figures 5 and 6 provide SEM inspection results for an ECP specimen tested at 640°F for 5000 hours and Figure 7 provide results for a SA specimen tested at 640°F for 4000 hours. The outer layer crystal morphology of the SA and ECP specimens was similar. In both cases the underlying surface grain structure was apparent. Additionally, each SA and ECP specimen grain gave rise to a particular outer layer crystal orientation. Recall, as-machined specimens showed a random orientation of outer layer oxide crystals. This observed grain dependent crystal orientation indicates that the crystal nucleation occurs at the metal surface (i.e., heterogeneous nucleation).

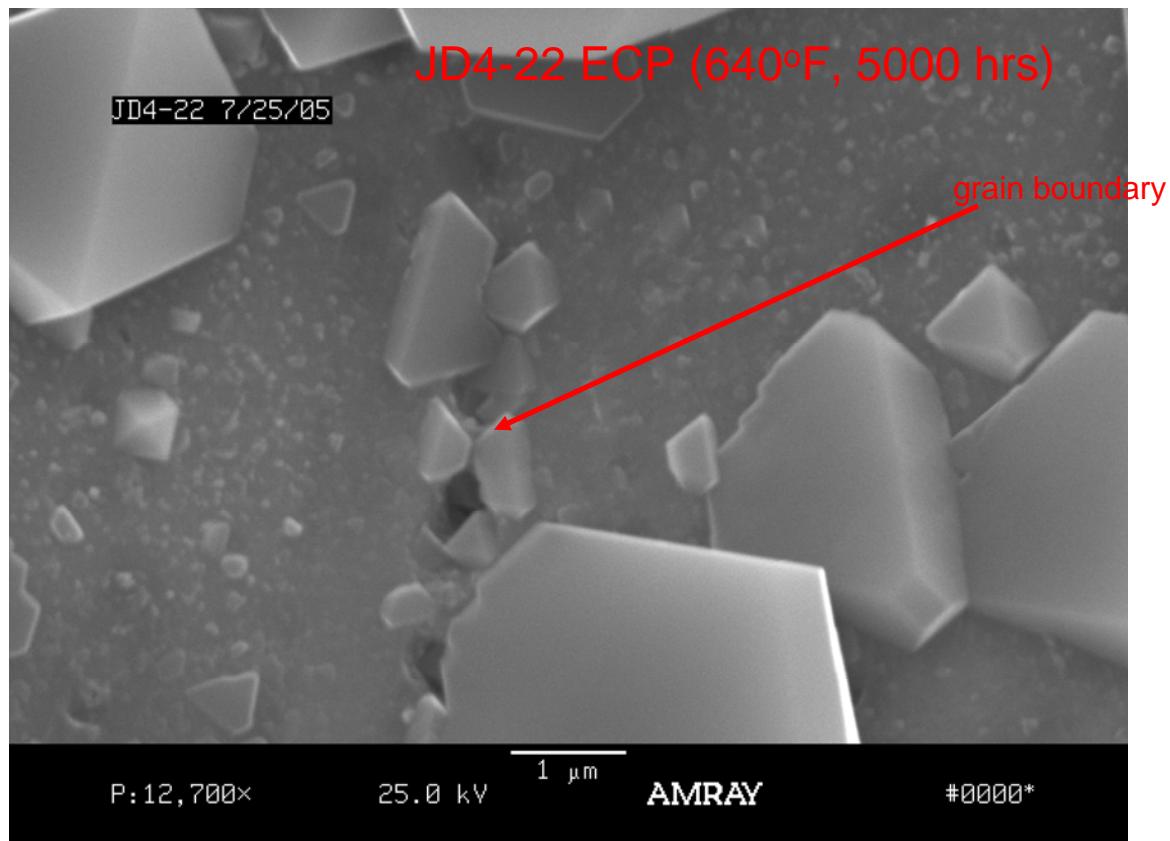
Figure 6: High Magnification SEM Image of an Electrochemically Polished Alloy 600 Specimen Exposed to 640°F Hydrogenated Water for 5000 hours. Image shows increased oxide crystal growth at a grain boundary.

Figure 6 provides a high magnification view of an Alloy 600 ECP specimen grain boundary. This photograph indicates that grain boundaries were etched by the ECP process and that preferential growth of oxide crystals occurs at grain boundaries. These results are consistent with prior results [4] which observed preferential grain boundary oxide growth in ECP specimens. This accelerated growth is likely due to greater outward cation (e.g., Fe^{+2}) transport along grain boundaries compared with bulk transport rates.

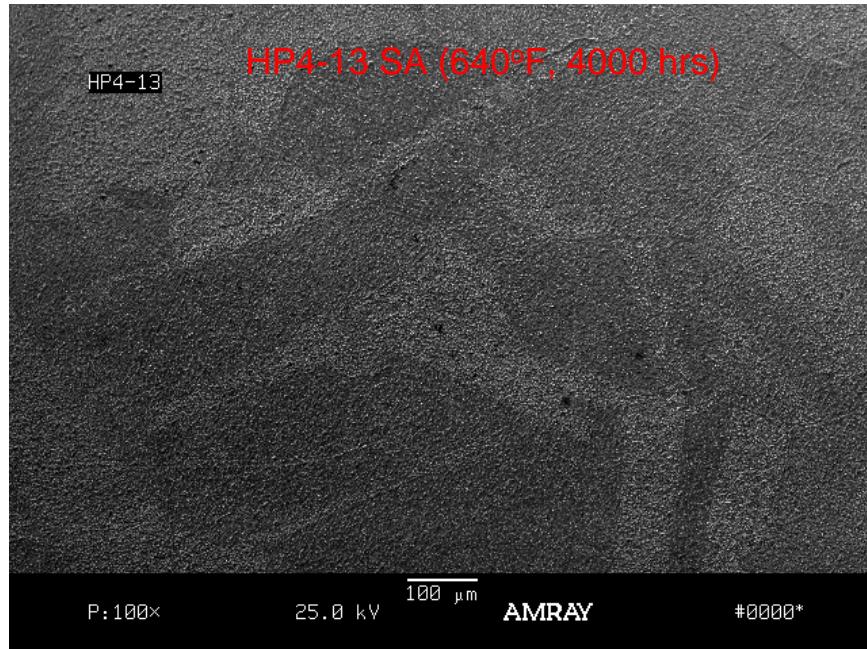
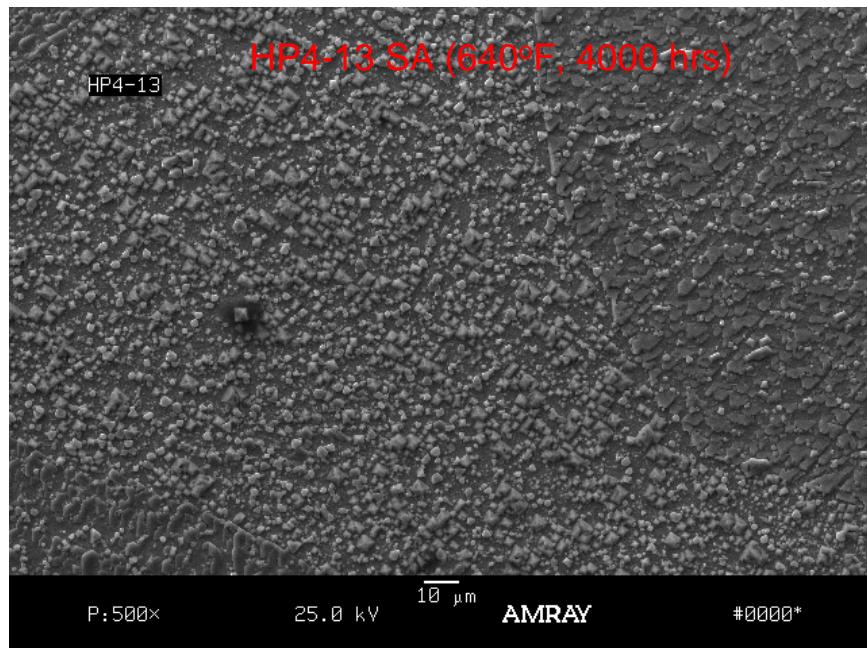
Figure 7: SEM Image of a Solution Annealed Alloy 600 Specimen Exposed to 640°F Hydrogenated Water for 4000 hours.

a) Low magnification image showing the underlying grain structure

b) Higher magnification indicates that each grain nucleated a particular outer layer ferrite crystal oxide orientation

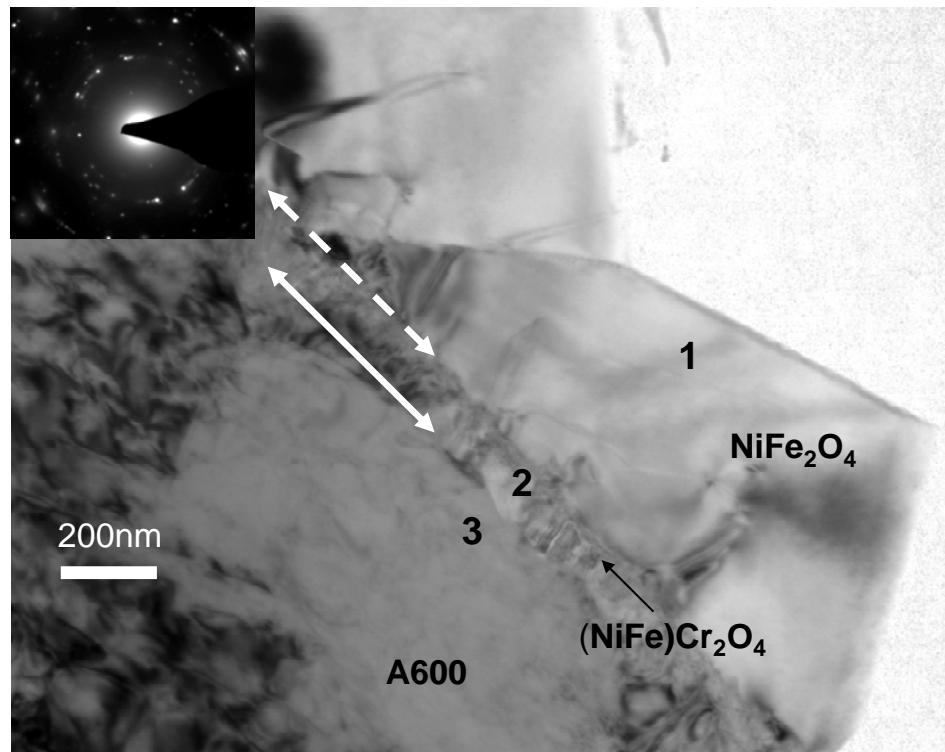
Figure 8: Low Magnification AEM Image of an Electrochemically Polished Specimen Exposed to 640°F Hydrogenated Water for 5000 hours.

A representative low magnification AEM image of the oxide layers that formed on an electrochemically polished Alloy 600 specimen exposed to 640°F primary water for 5000 hours is presented in Figure 8. The inner chromium rich oxide layer completely covered the Alloy 600 substrate and had a relative uniform thickness of $\sim 0.1 \mu\text{m}$.

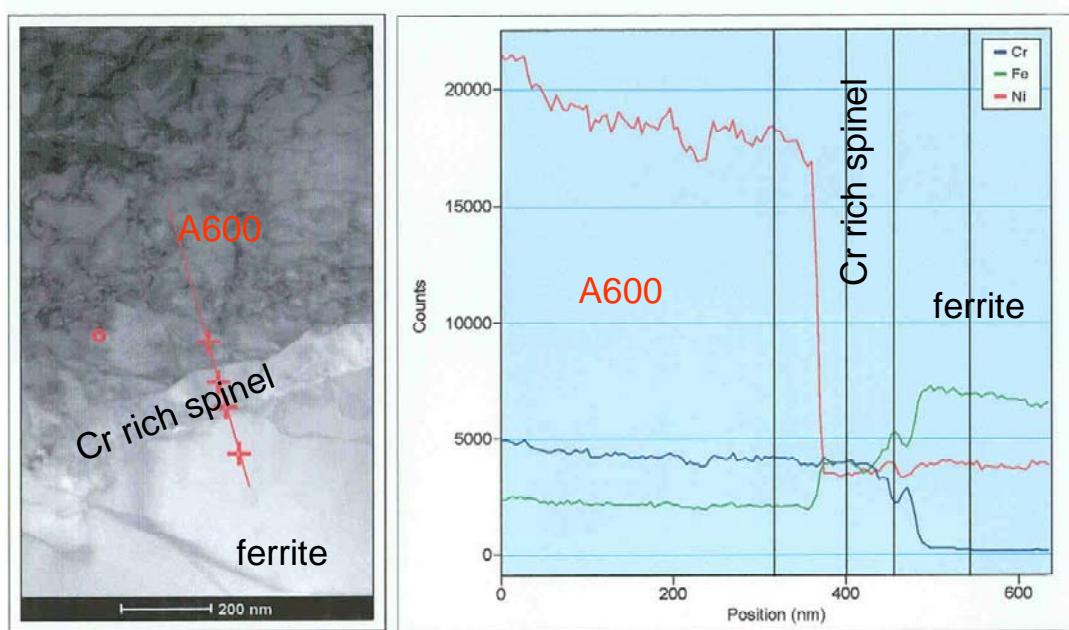
Figure 9: AEM Line Scan of an Electrochemically Polished Specimen Exposed to 640°F Hydrogenated Water for 5000 hours.

AEM electron diffraction analysis and grazing incidence X-ray diffraction confirmed that the large outer layer crystals were a nickel rich ferrite and the inner layer was a chromium rich spinel. The actual lattice size was between NiCr_2O_4 and NiFe_2O_4 . Energy dispersive spectroscopy analysis of

the inner and outer layer oxide films suggests inner and outer non-stoichiometric oxide layers compositions of $\text{Ni}(\text{Cr}_{0.5}\text{Fe}_{0.5})_2\text{O}_4$ and $(\text{Ni}_{0.9}\text{Fe}_{0.1})\text{Fe}_2\text{O}_4$, respectively.

These results are consistent with results from a prior 680°F (360°C) study [4], except that a thin Cr-rich layer (assumed to be Cr_2O_3) was observed beneath the chromium rich spinel. Nickel enrichment was also observed at the metal/oxide interface in the Reference [4] study. The presence of Cr_2O_3 and the dealloyed region beneath the chromia is suggestive of a selective oxidation process (i.e., chromium is oxidizing more readily than the other alloy constituents). Extensive efforts were employed in this study to identify the possible presence of Cr_2O_3 and nickel enrichment at the metal oxide interface. However, neither Cr_2O_3 nor nickel enrichment was observed at the oxide metal interface, of electrochemically polished and solution annealed specimens. Figure 9, for example, provide representative AEM line scan data: 1) confirming the duplex spinel layer oxide structure and 2) showing no evidence of an additional Cr_2O_3 layer or associated nickel metal enrichment at the metal/oxide interface.

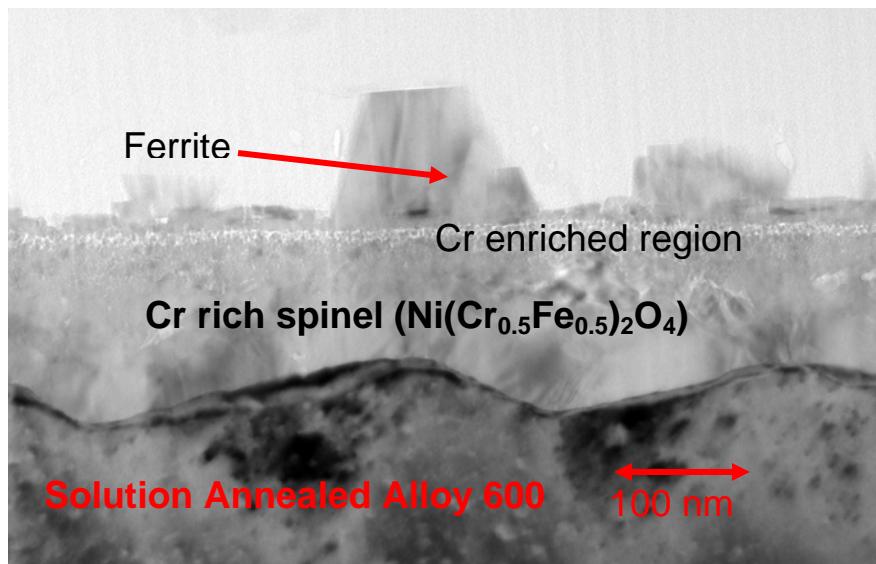
Figure 10: Low Magnification AEM Image of a Solution Annealed Specimen Exposed to 640°F Hydrogenated Water for 4000 hours.

The composition and structure of oxide films which formed on solution annealed specimens were analogous to those that formed on the electrochemically polished specimens. Figure 10 provides a representative AEM image which shows the duplex layer spinel oxide structure on a solution annealed specimen. AEM line scan results, Figure 11, indicate that no Cr_2O_3 or nickel metal enrichment is seen at the metal/oxide interface. The only difference noted between SA and ECP specimen oxide films was that chromium enrichment was noted between the ferrite and chromite spinel layers in the SA specimens. The chromium enrichment at this location is unusual in films grown in hydrogenated water. This region is suspected to have originated during the specimen solution annealing heat treatment. This region is believed to delineate the original (pretest) outermost test specimen surface.

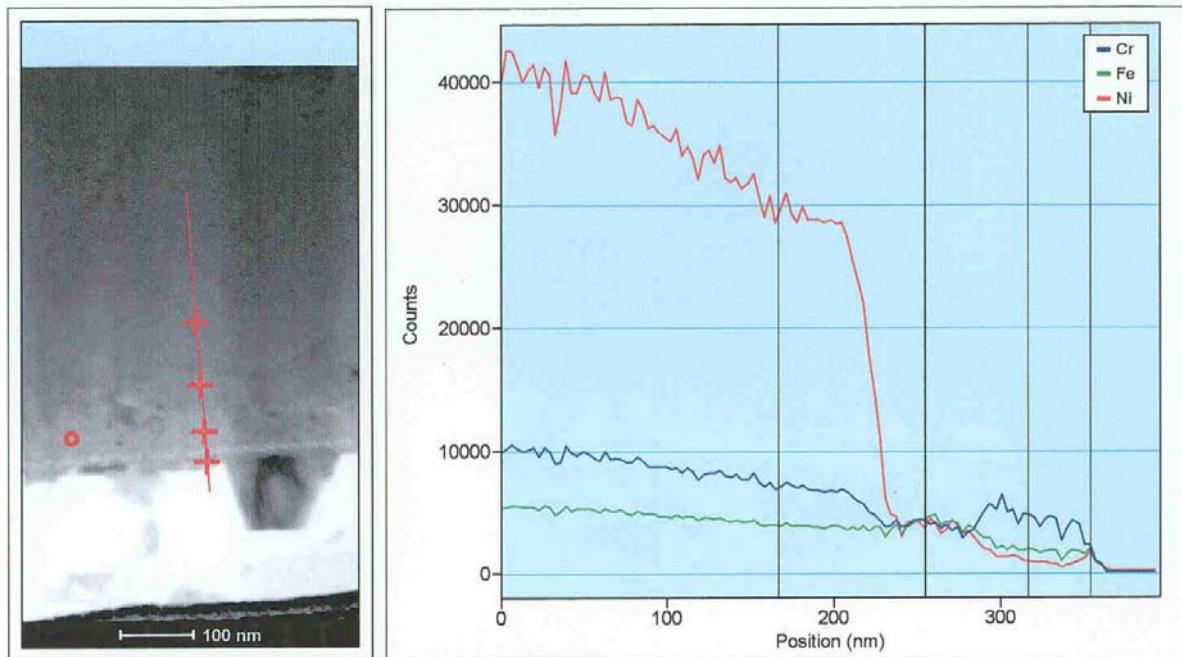
Figure 11: AEM Line Scan of a Solution Annealed Specimen Exposed to 640°F Hydrogenated Water for 4000 hours (Scan was in a region between outer layer ferrite crystals).

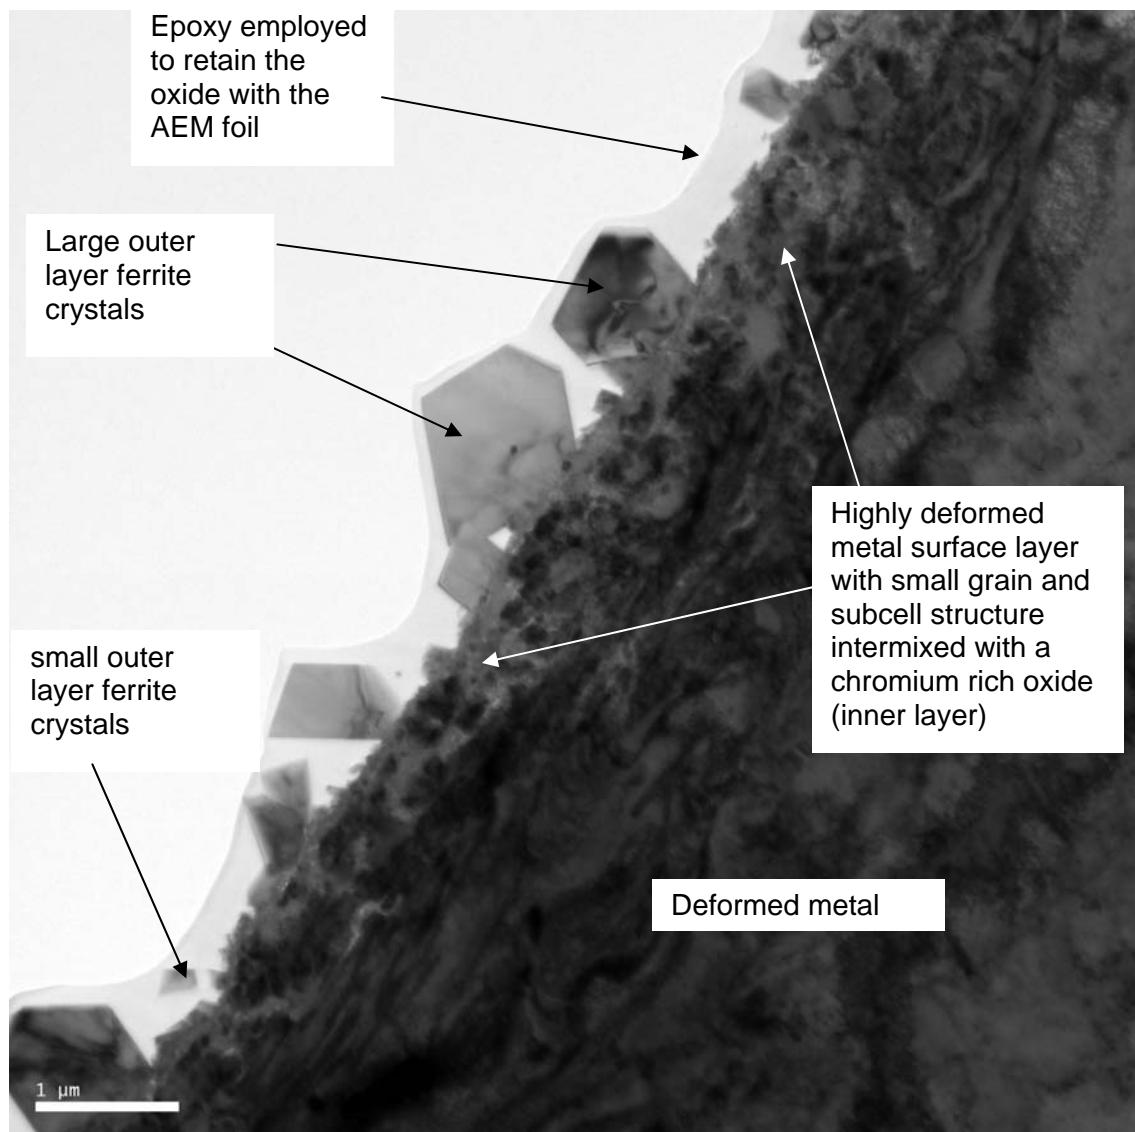
Figure 12: Low Magnification AEM Image of an As-Machined Specimen Exposed to 640°F Hydrogenated Water for 5000 hours.

Analogous to the SA and ECP specimens, large ferrite crystals are the outermost oxide layer on as-machined specimens, Figure 12. Unlike SA and ECP specimen ferrite crystals, as-machined specimen ferrites were not preferentially orientated with the underlying substrate and were not very adherent. (The large crystals were easily rubbed off).

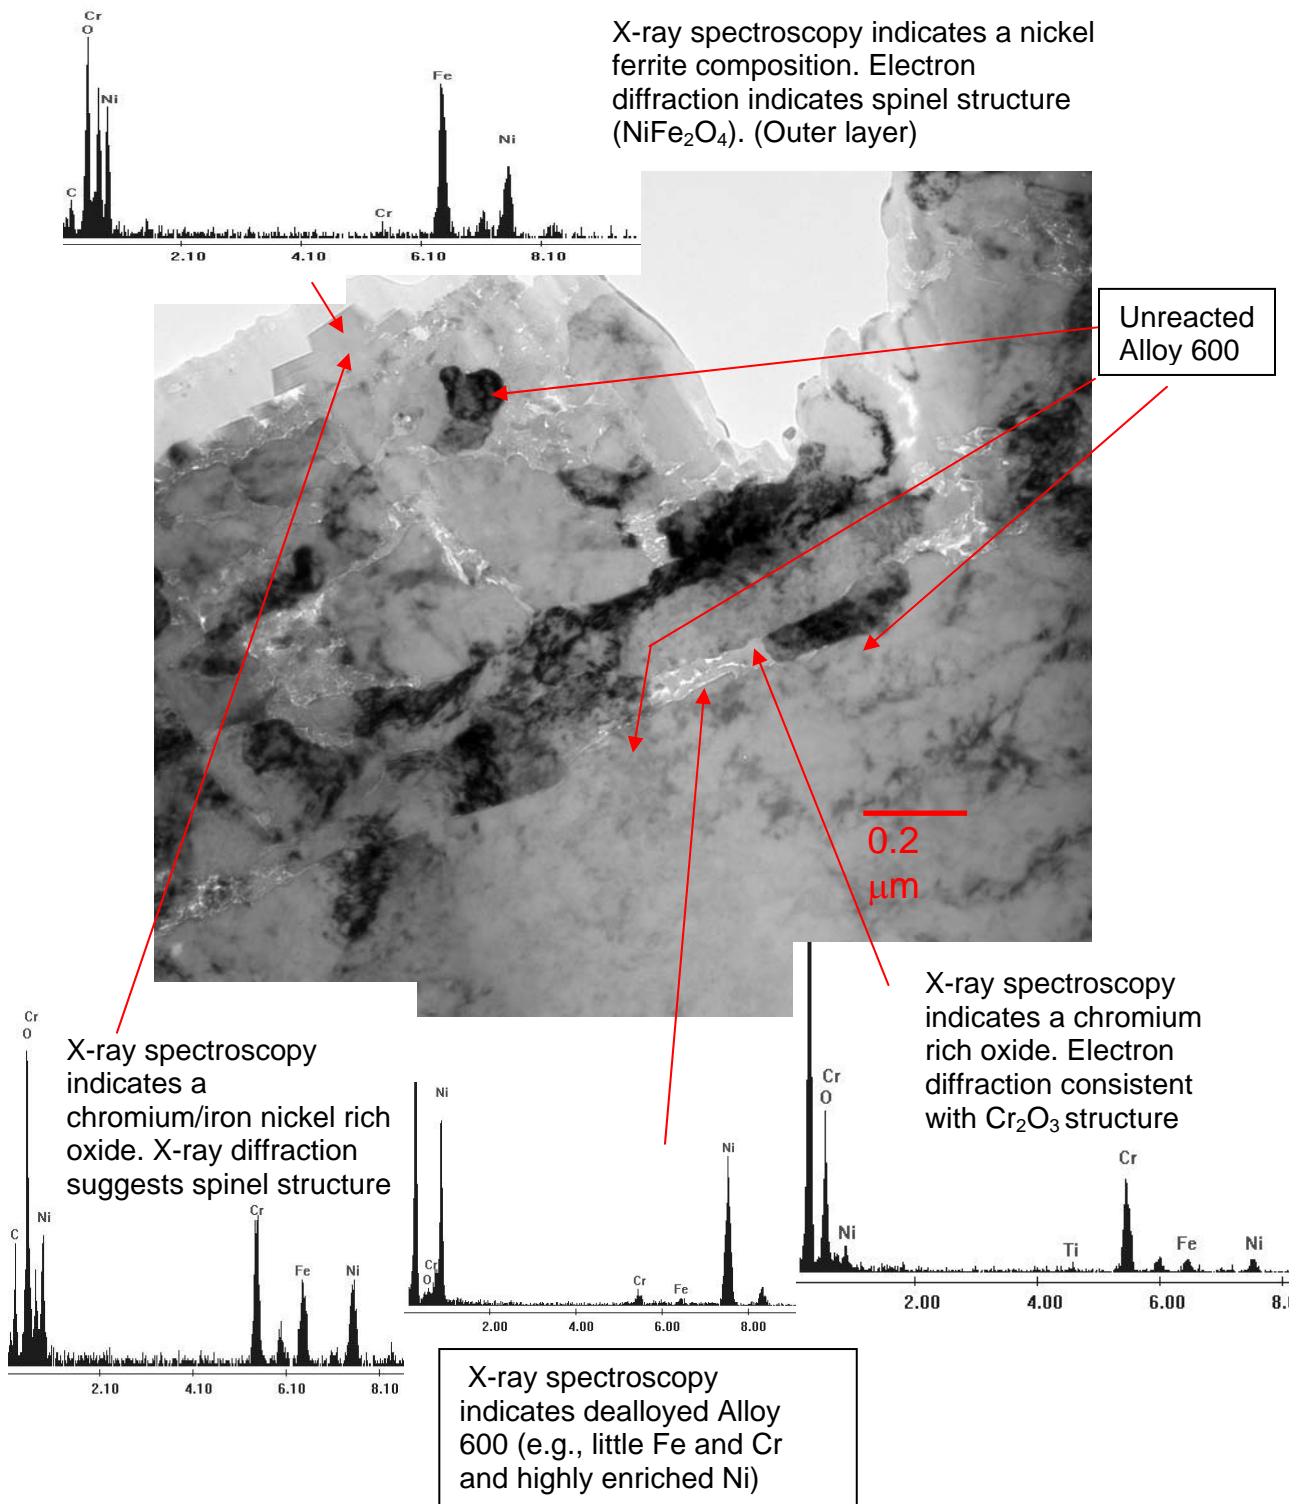
Figure 13: AEM Photograph of an As-Machined Specimen Exposed to 640°F Hydrogenated Water for 5000 hours.

Figure 13 shows an AEM image with corresponding X-ray spectra from the highly deformed surface layer. The X-ray spectra show the large variation in elemental constituents within this layer that include small grains of unreacted Alloy 600, dealloyed Alloy 600 (highly Ni enriched metal), spinels (Ni ferrite and Ni chromite) and Cr_2O_3 . These results suggest the preferential oxidation of chromium in select regions. That is, the fine grain chromium rich oxide formed by dealloying the adjacent Alloy 600. These observations are somewhat consistent with the Reference [4] observations of a thin layer of Cr_2O_3 at the metal/oxide interface with nickel enrichment beneath the oxide. The presence of a uniform layer of Cr_2O_3 at the metal/oxide interface with nickel enrichment beneath the oxide is indicative of a selective oxidation process. *However, in this study a uniform layer of chromia (Cr_2O_3) was not present indicating that the oxidation occurred by non-selective oxidation.*

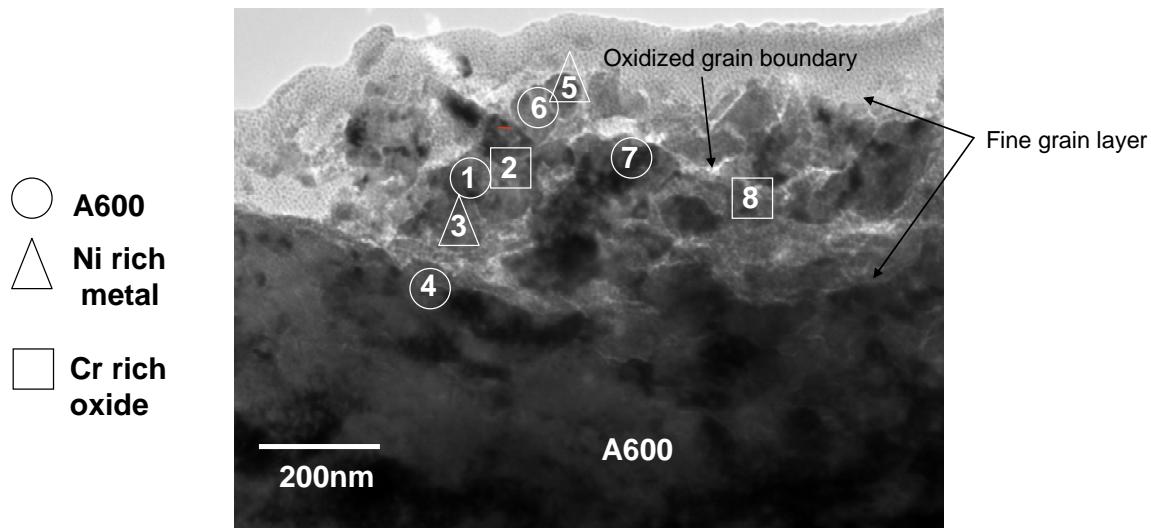
Figure 14: AEM Image of the Fine Grain Chromium Rich Inner Oxide Layer that Formed on an As-Machined Specimen Exposed to 550°F Hydrogenated Water for 5000 hours.

The composition and structure of the inner oxide layer of the as-machined specimens was dramatically different from what was observed on the SA and ECP specimens. A uniform chromium rich spinel oxide layer was not observed. In contrast, the inner oxide layer consisted of a layer intermixed with oxidized, unoxidized and dealloyed material. Unlike the SA and ECP specimens which had a deformation free outer surface, the as-machined specimens had a highly deformed surface layer of 0.5 to 0.75 μm thickness with a very fine grain structure including deformation subcells. As shown in the AEM images (Figures 12-14), the deformed metal surface layer was not uniformly oxidized. Specifically, some small grain and subcell regions were oxidized and other adjacent small grain and subcell regions were not. The major phase of oxidized material was indexed by X-ray diffraction as a non-stoichiometric nickel chromite in both the 550 and 640°F test specimens. A minor phase of Cr_2O_3 was noted in the 640°F specimens and a minor chromium rich oxide phase (possibly a non-stoichiometric form of $\text{CrO}(\text{OH})$) was observed in the 550°F specimens. In general, oxide was observed throughout the entire depth of the deformation layer. The presence of isolated Cr_2O_3 pockets in the as-machined specimens but not in the SA and ECP specimens is consistent with gaseous oxidization results which indicated that chromia nucleates more readily within machined surfaces compared to ECP surfaces due to faster diffusion of Cr along the many metal subcell and small grain boundaries within the deformed surface layer [8].

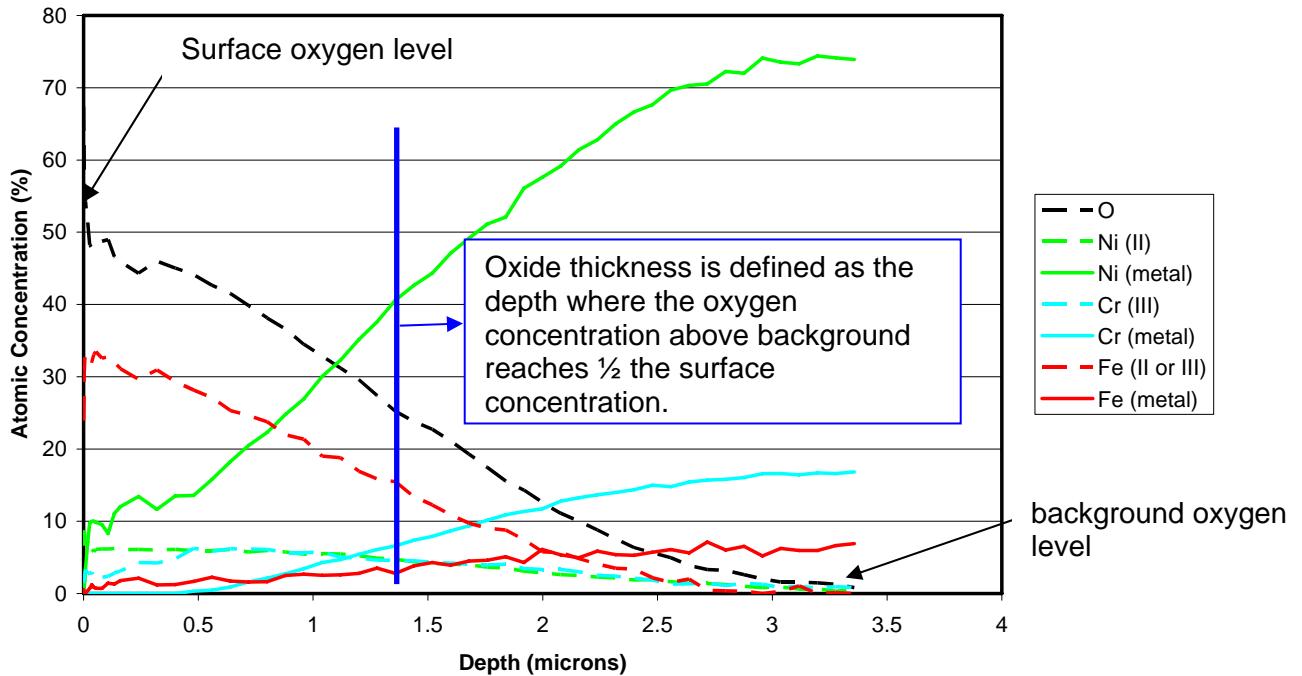
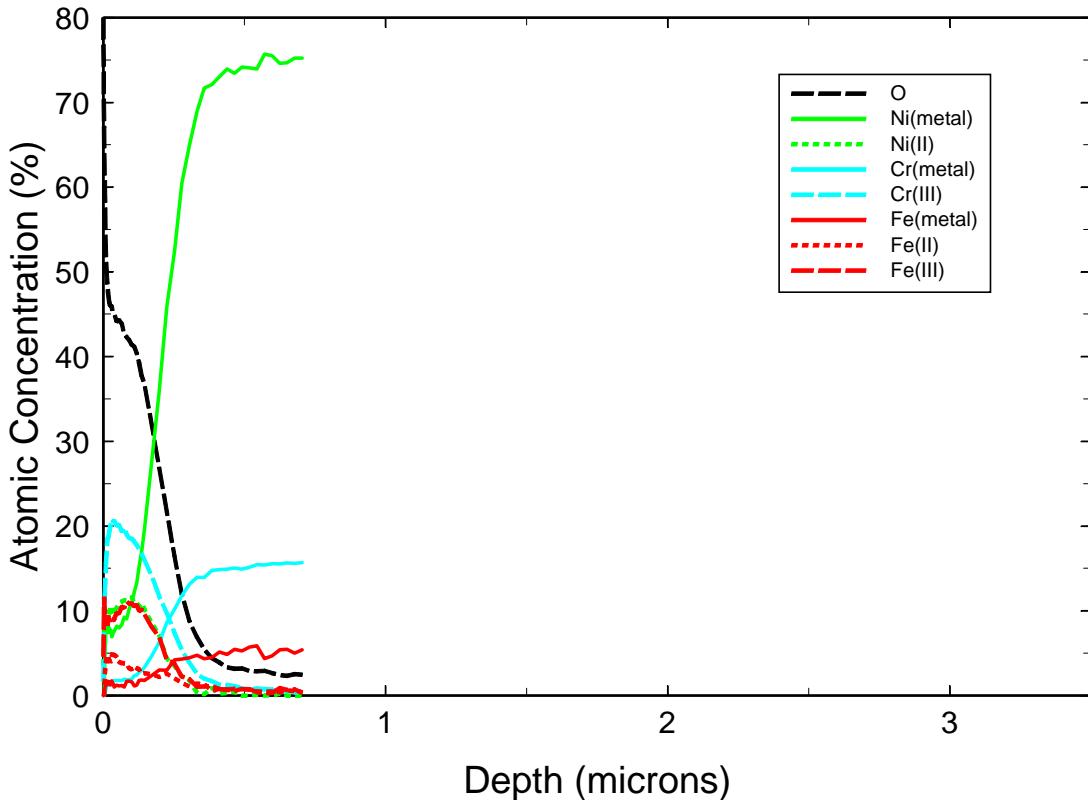
Figure 15: ESCA Oxide Depth Profile of an As-Machined Specimen Exposed to 640°F Hydrogenated Water for 5000 hours.

a) depth profile with the ferrite outer layer present

b) depth profile with the ferrite outer layer removed

Representative Electron Spectroscopy for Chemical Analysis (ESCA) inspection results of as-machined specimens exposed to primary water for 5000 hours at 640 and 550°F are presented in Figures 15 and 16, respectively. Each ESCA depth profile provides the composition and oxidation state of key elemental species as a function of depth from the outermost surface. For each as-machined specimen, two ESCA inspections were performed: one with the outer ferrite layer present (Figures 15a and 16a) and one with the outer ferrite layer removed² (Figures 15b and 16b). Comparisons between the ESCA results with and without the outer oxide layer revealed that the outer ferrite rich layer was much thicker than the inner layer. As summarized in Table 4, the outer layer oxide thickness was roughly 5 times thicker than the inner layer oxide thickness.

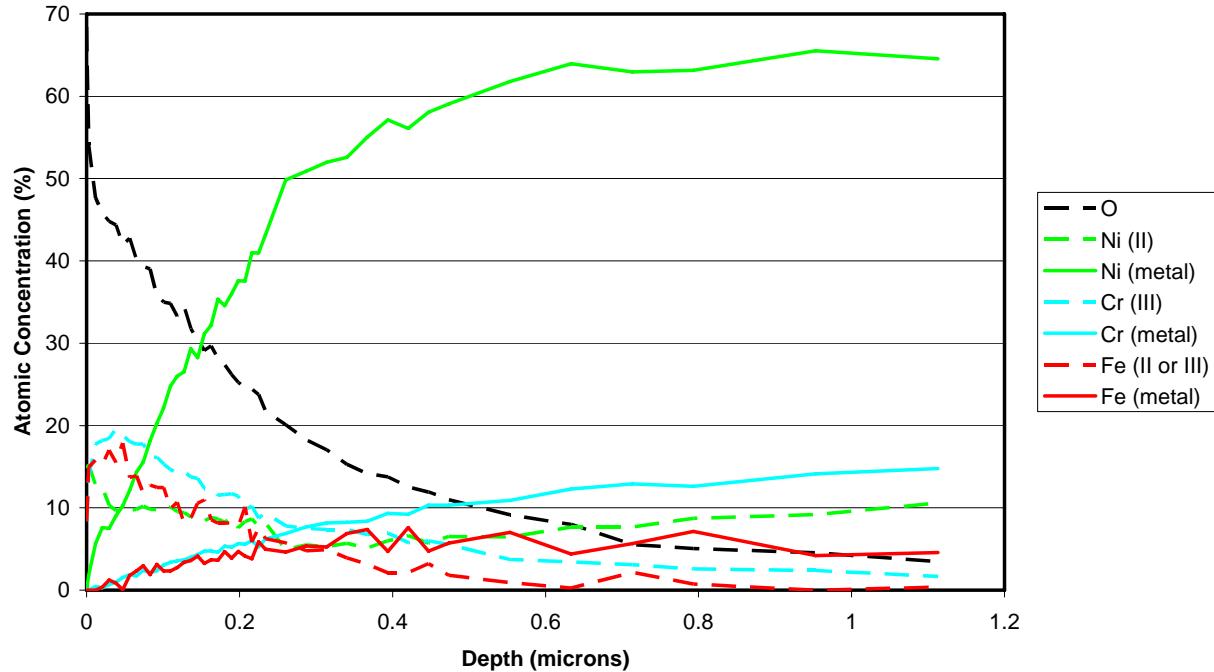
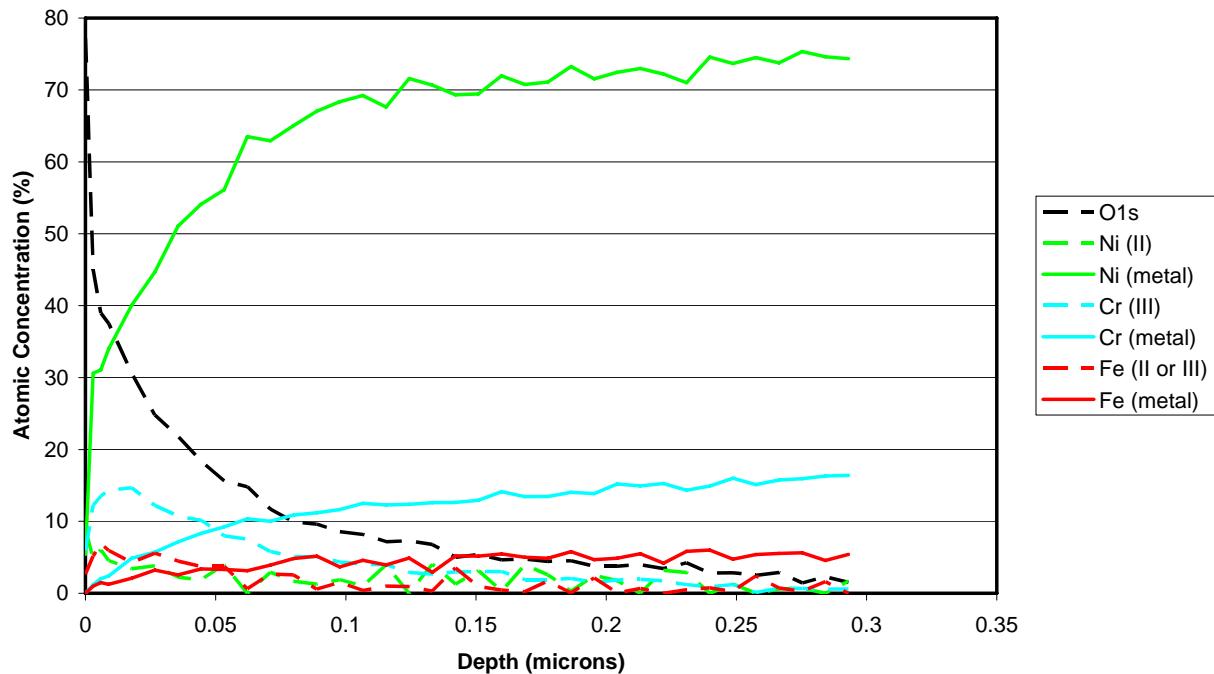
Figure 16: ESCA Oxide Depth Profile of an As-Machined Specimen Exposed to 550°F Hydrogenated Water for 5000 hours.

a) depth profile with the ferrite outer layer present

b) depth profile with the ferrite outer layer removed

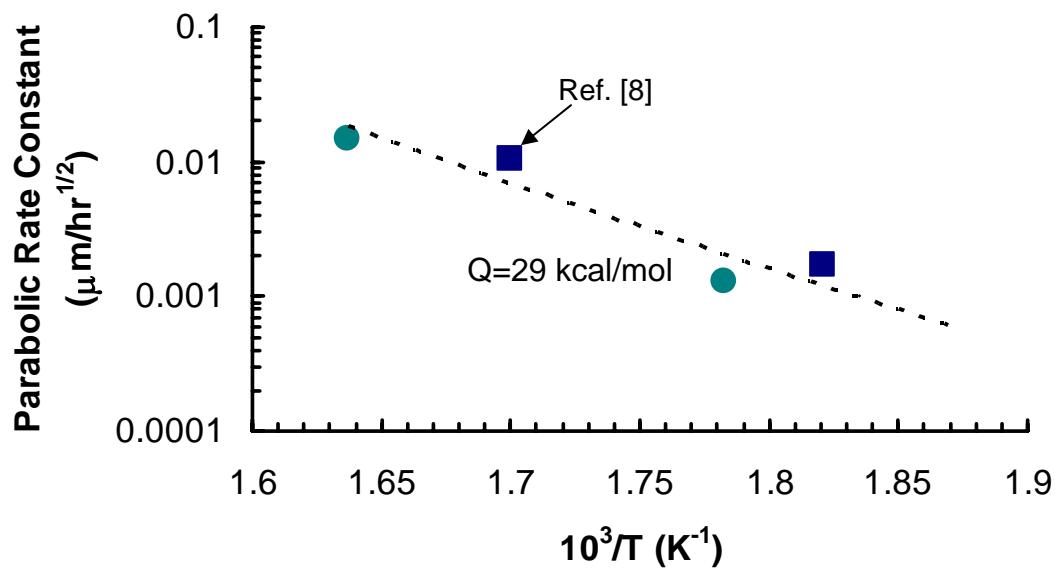
Figure 17: Comparison between Alloy 600 Parabolic Corrosion Rate Constants Measured in This Study and Reference [8].

The plan going into this study was: 1) to generate oxide thickness parabolic rate constants at each test temperature from gravimetric analyses of oxide descale data and ESCA evaluations of as-machined specimens and 2) to compare these constants to determine the Arrhenius temperature dependency of Alloy 600 corrosion. As-machined specimen descale data, however, did not accurately characterize the material oxidation. Unfortunately, because of the non-uniform (intermixed oxidized and non-oxidized material) inner layer microstructure, the descale process removed both non-oxidized and oxidized material. Since this bias prevented the use of the descale data, corrosion kinetics were evaluated primarily through the ESCA test data.

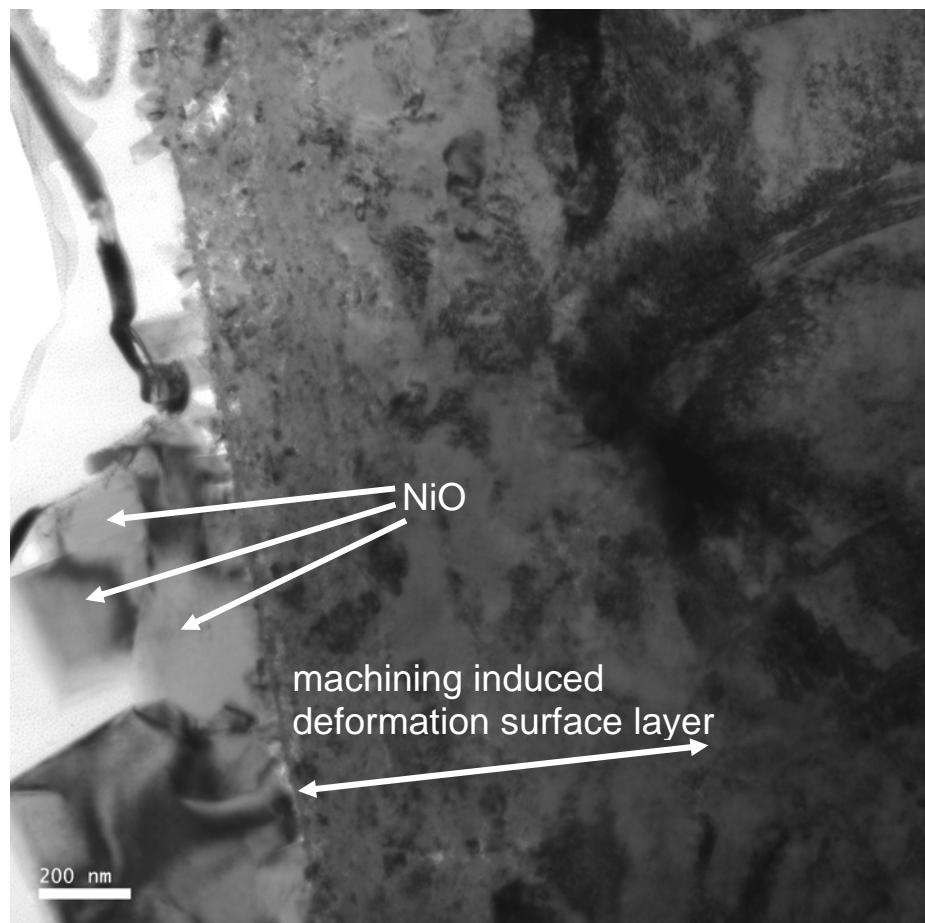
Figure 18: AEM Cross-Sectional Image Showing the Corrosion Product Oxides which Form on an Alloy 600 SCC Initiation Tensile Specimen Exposed to 680°F (360°C) High Purity Water with 30 cc/kg Dissolved Hydrogen for 1879 hours.

AEM inspection of the corrosion films that form on Alloy 600 tensile SCC initiation specimens [6] revealed an oxide composition and morphology similar to that of the as-machined corrosion coupons. Specifically, a machining induced deformation surface layer of 0.5 to 1 μm was observed, Figure 18. Analogous with the as-machined corrosion coupons this deformation layer gave rise to an inner chromium oxide layer that was intermixed with oxidized material and non-oxidized material, Figure 19. The only significant difference that was observed between as-machined corrosion coupons and the tensile specimen oxide films was that in addition to outer layer spinel crystals, NiO was also observed in the outer layer, Figure 18. This difference was expected since the corrosion coupon study was performed well into the nickel metal regime whereas SCC initiation tests were performed at a hydrogen level corresponding to the Ni/NiO phase transition to maximize the SCC susceptibility [2].
