LM-07K022
April 18, 2007

Nickel Alloy Primary Water Bulk Surface and SCC Corrosion Film Analytical Characterization and SCC Mechanistic Implications

David Morton, Nathan Lewis, Michael Hanson, Steve Rice and Paul Sanders

Lockheed Martin Corporation
Schenectady, NY 12301-1072

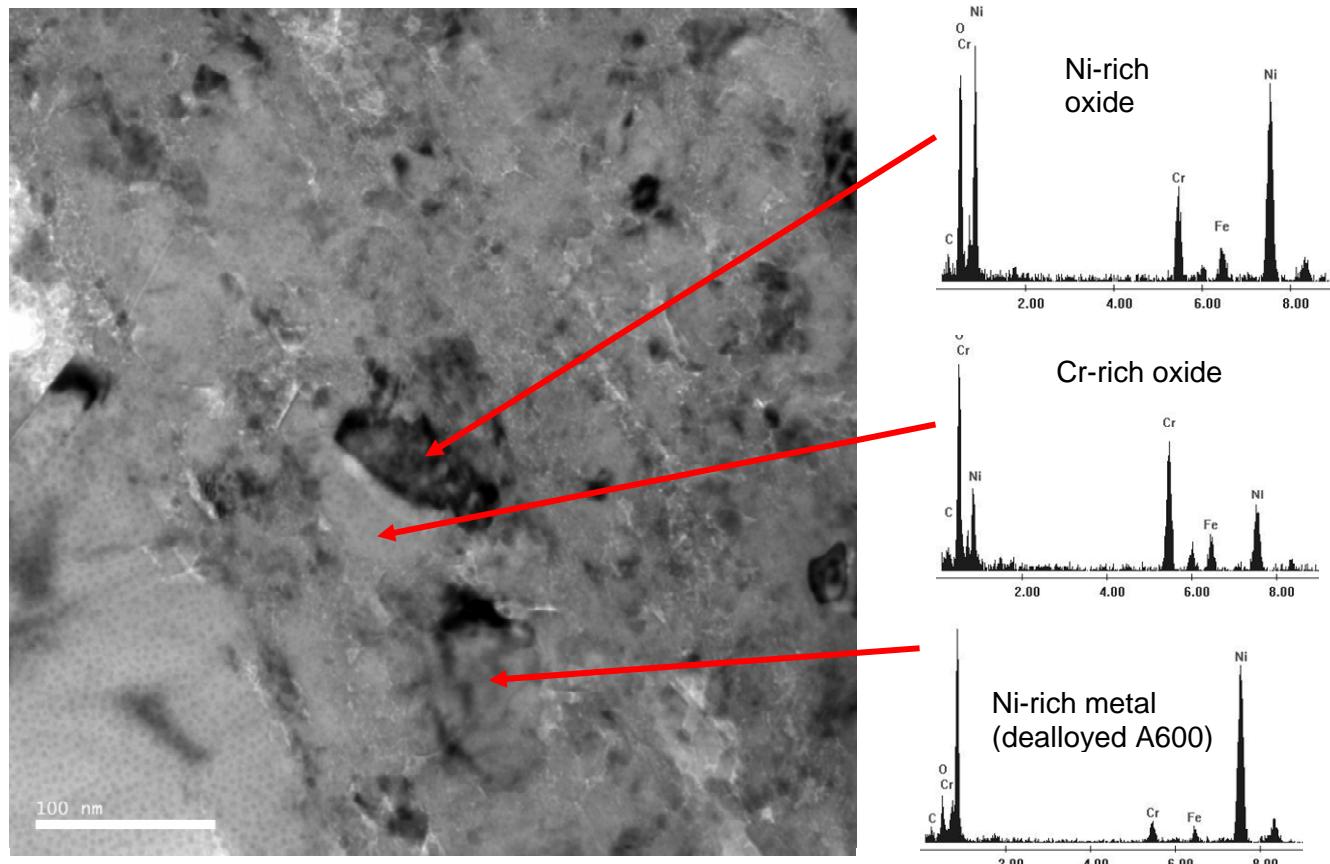
Figure 19: AEM Image of the Corrosion Product Oxides which Form in the Inner Oxide Layer (heavily deformed layer) of an Alloy 600 SCC Initiation Tensile Specimen Exposed to 680°F (360°C) High Purity Water with 30 cc/kg Dissolved Hydrogen for 1879 Hours: Results show the inner layer is intermixed with oxidized, dealloyed and unoxidized material.

AEM inspection of the corrosion films that form on Alloy 600 tensile SCC initiation specimens [6] revealed an oxide composition and morphology similar to that of the as-machined corrosion coupons. Specifically, a machining induced deformation surface layer of 0.5 to 1 μm was observed, Figure 18. Analogous with the as-machined corrosion coupons this deformation layer gave rise to an inner chromium oxide layer that was intermixed with oxidized material and non-oxidized material, Figure 19. The only significant difference that was observed between as-machined corrosion coupons and the tensile specimen oxide films was that in addition to outer layer spinel crystals, NiO was also observed in the outer layer, Figure 18. This difference was expected since the corrosion coupon study was performed well into the nickel metal regime whereas SCC initiation tests were performed at a hydrogen level corresponding to the Ni/NiO phase transition to maximize the SCC susceptibility [2].

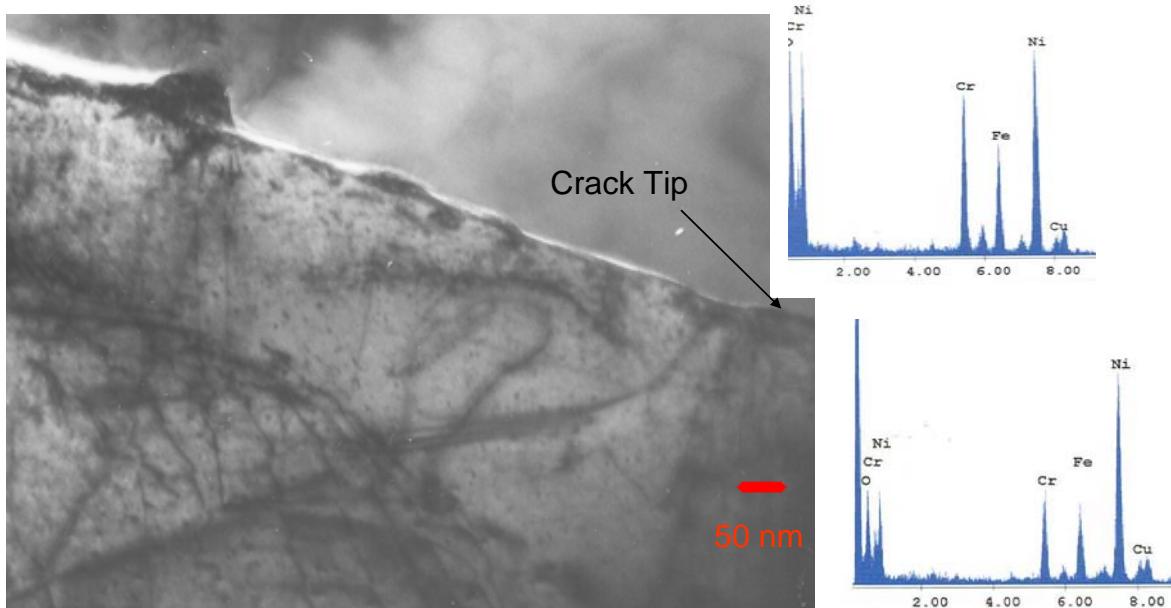
Figure 20. AEM Bright Field Image Showing an Intergranular SCC Crack Tip. Note the sharpness of the crack-tip. X-ray spectra from the oxide within the crack shows the variation in elemental constituents near the SCC crack tip. (high purity hydrogenated water, 640°F -338°C-).

Hydrogenated water exposed Alloy 600 SCC growth rate specimens exhibit sharp crack tips with crack tip radii of \sim 2-3 nm [7,10,11] and with little general corrosion (Figure 20). Crack paths are intergranular with no evidence of cracking along slip planes or off the grain boundary and proceeded around Cr_7C_3 carbides. A thin layer (\sim 20 nm) of Cr-rich oxide is observed along the carbide/matrix interface and no oxidation of carbides ahead of the crack tips is noted.

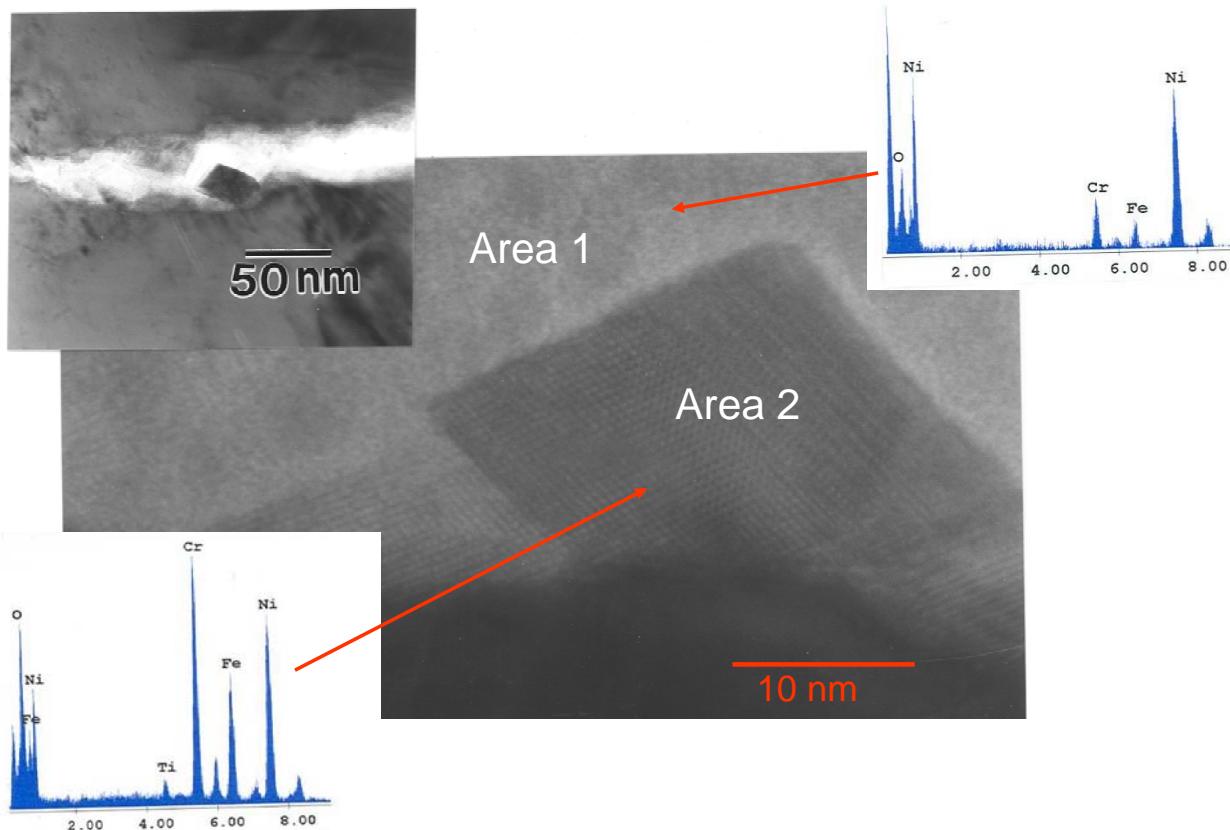
Figure 21. AEM High Magnification Image Near an SCC Crack Tip Region Showing Very Fine Grain Oxide Area 1 and Larger Oxide Crystal Area 2. X-ray spectrum 1 and 2 from area 1 and 2 show Ni rich oxide with elemental ratios similar to the base metal and larger oxide with roughly equal Fe, Cr and Ni (120 cc/kg hydrogenated water, 640°F -338°C-).

In contrast to the duplex oxide layers that are observed on bulk surfaces (e.g., corrosion coupons), Alloy 600 SCC crack tip and crack wake oxides consist of single layered oxides. NiO structure and spinel structure oxides are observed [7,11]. It is important to note that both iron and chromium are observed in the NiO structure oxide. Chromium rich spinels (e.g., NiCr_2O_4) are also observed, with the Cr rich spinel being the most common spinel phase. The high resolution AEM image in Figure 21 shows a Cr-rich, spinel structure oxide embedded in the NiO structure oxide near the crack tip in a specimen tested at 120 cc/kg hydrogen. Spinel oxides were more readily observed when specimens were tested within the nickel metal regime. NiO structure oxides are observed at all hydrogen levels.

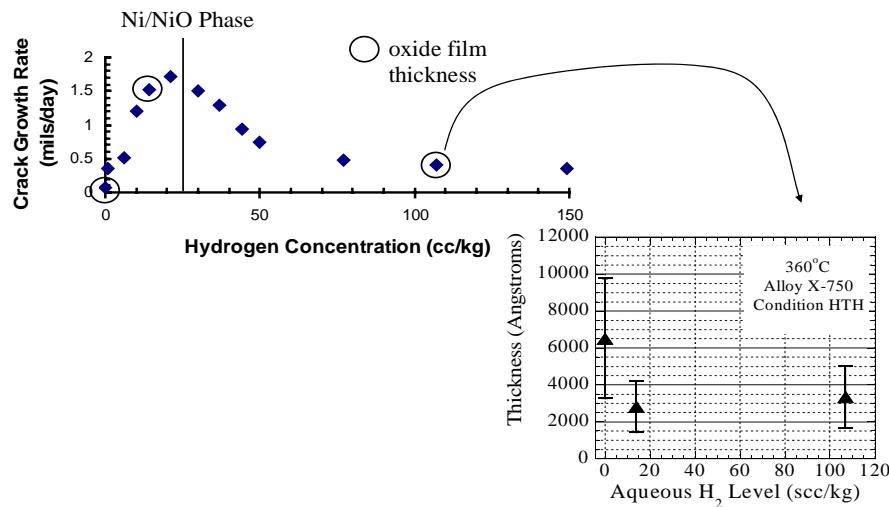
Figure 22: Comparison between the SCC and Corrosion Coolant Hydrogen Dependencies of Alloy X-750 in the HTH Condition at 680°F. Note a different functionality is observed suggesting that corrosion is not the rate controlling step in SCC, [12]. (ESCA corrosion film thickness measurements were performed on the external surface of the three noted compact tension crack growth rate specimens).

A comparison between the Table 5 corrosion data at 550°F and 640°F indicates that the thermal activation (Q) of Alloy 600 corrosion is approximately 30 kcal/mol. The similarity between the thermal activation energy of SCC, 33 kcal/mol [3], and the thermal activation of corrosion measured in this study suggests that 1) corrosion could be the rate controlling step in primary water SCC or 2) that corrosion and SCC have a common rate controlling subprocess. *Prior work [12, 13] suggests that hypothesis 2 (corrosion and SCC have a common rate controlling subprocess) is more likely.* Hypothesis 1 is unlikely since testing [12,13] has identified that nickel alloy primary water corrosion and SCC often show different key parameter dependencies. Specifically, Reference [12] showed a difference between the SCC and corrosion coolant hydrogen dependency of Alloy X-750, Figure 22. Reference [13] test results, additionally, showed a significant difference in the corrosion performance between specimens solution annealed before and after machining but no difference in the SCC initiation performance, Figure 23.

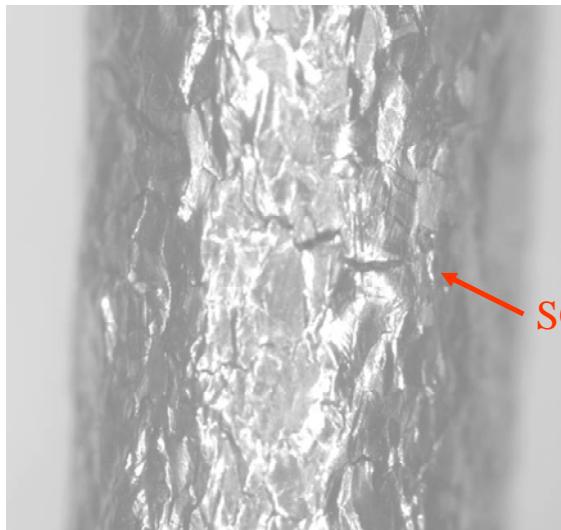
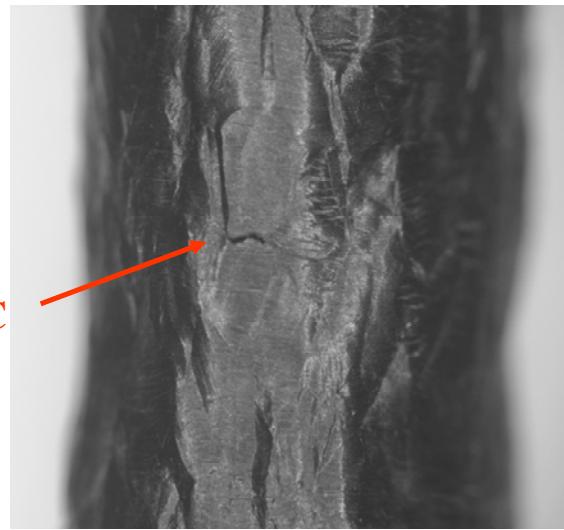
Figure 23: Comparison Between the Corrosion and SCC Performance of SA Specimens Heat Treated Before and After Machining: No difference in SCC initiation but significant corrosion differences [13].

Tensile specimen machined then solution annealed at 2100°F for 20 minutes in vacuum with Ar quench

Material solution annealed at 2100°F for 20 minutes in vacuum with water quench then tensile specimen machined
