# Kalispel Resident Fish Project

Annual Report 2004 - 2005

DOE/BP-00004574-3

PROJECT NUMBER 1995-00-100

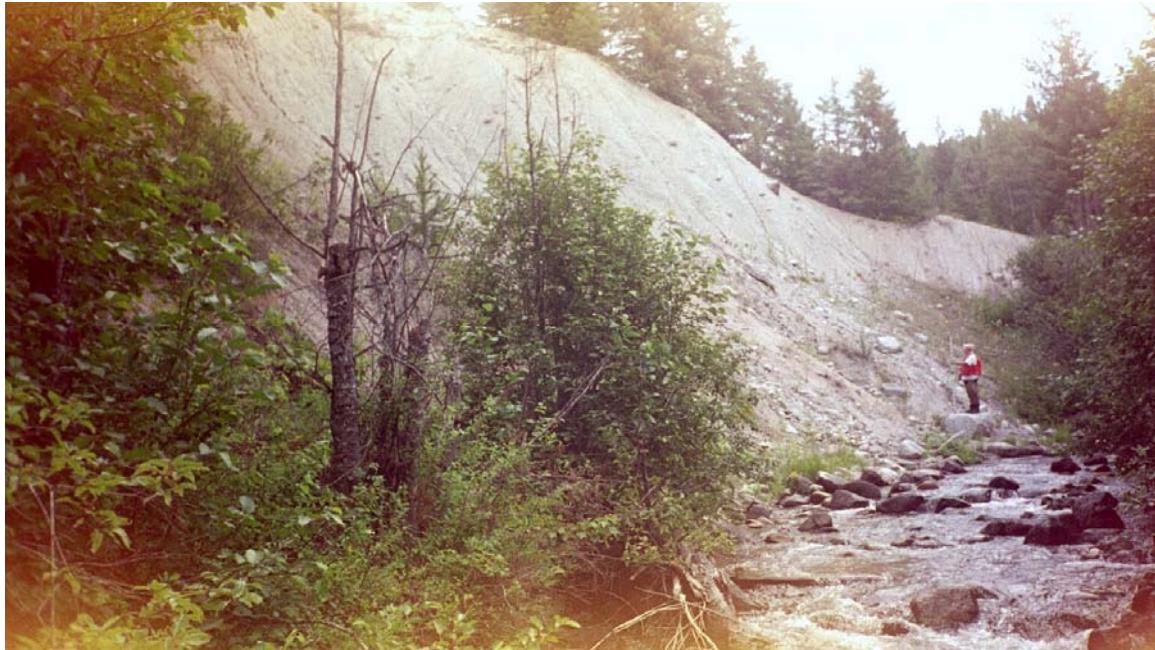
Figure 8. Large bank failure in East Branch LeClerc Creek reach 2.

Reach 2 was 1440 m in length and classified as a Rosgen A2 channel type. This reach contained a large bank failure just below the mouth of Fourth of July Creek (Figure 8). Boulder was the dominant substrate in the reach, and contributed to a high instream cover rating (3.9). Westslope cutthroat (0.3 fish/100 m<sup>2</sup>), rainbow (1.0 fish/100 m<sup>2</sup>), brook (0.5 fish/100 m<sup>2</sup>), and brown trout (.86 fish/100 m<sup>2</sup>) were all observed in the snorkel station.

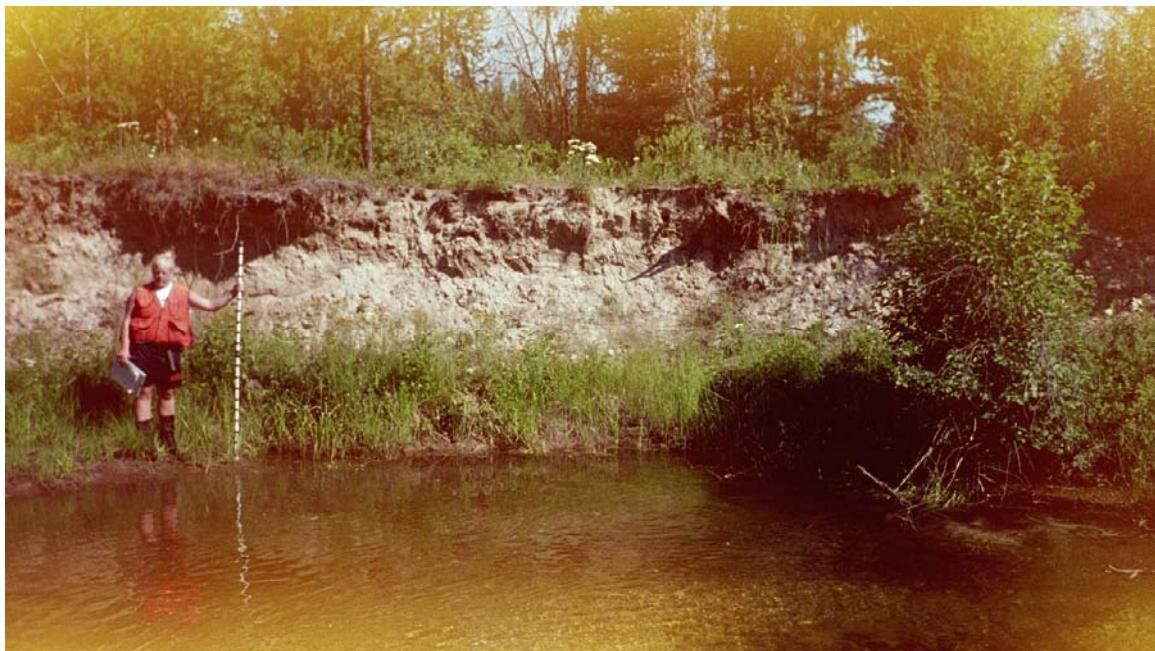
Figure 9. Unstable bank in East Branch LeClerc Creek reach 8.

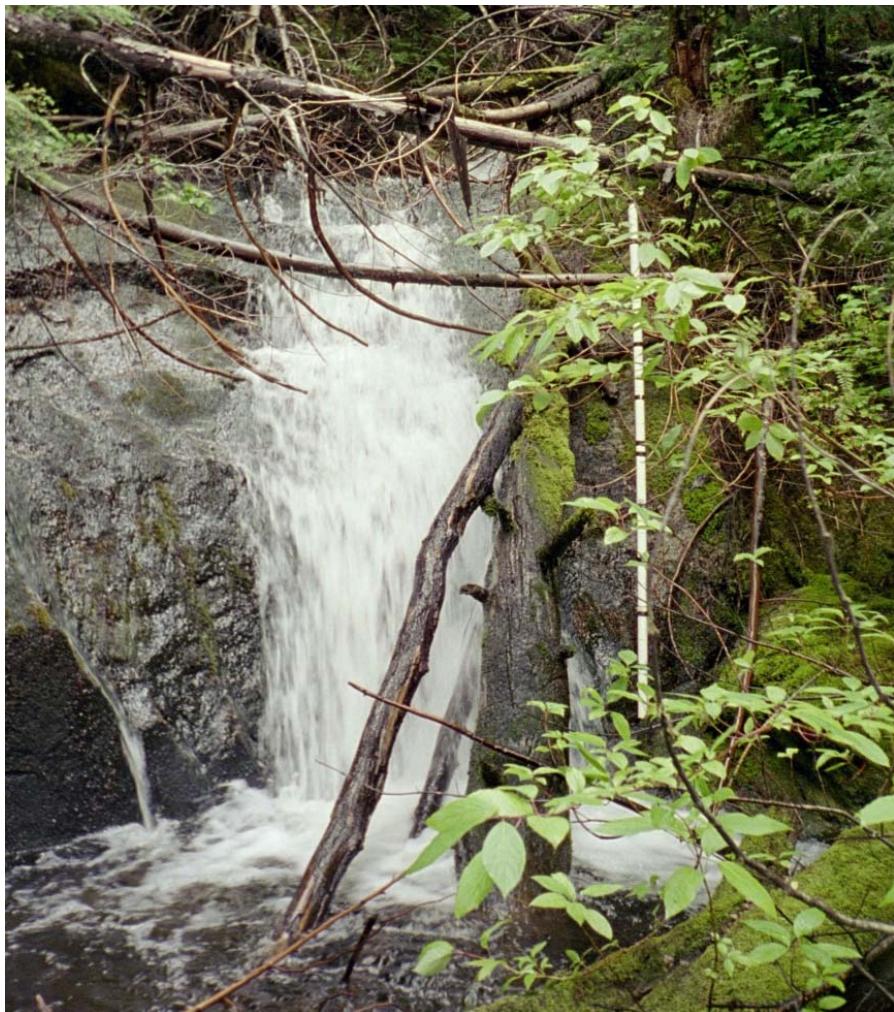
Figure 10. Fish passage barrier in East Branch LeClerc reach 14.

Reach 14 was 900 m in length and classified as a Rosgen A5 channel type. It contained the most pool type habitat (22%) of any reaches surveyed. The dominant substrate was sand. The overall embeddness was 76%. A fish passage barrier was observed in the reach (Figure 10). The barrier was 3.5 m high and no brook trout were observed above it. Bank stability improved from the previous 6 reaches and was up to 95%. Cutthroat trout were the only species observed at a density of 4.5 fish/100 m<sup>2</sup>, the highest of the survey. Reach 14 was the last reach that fish data was collected.

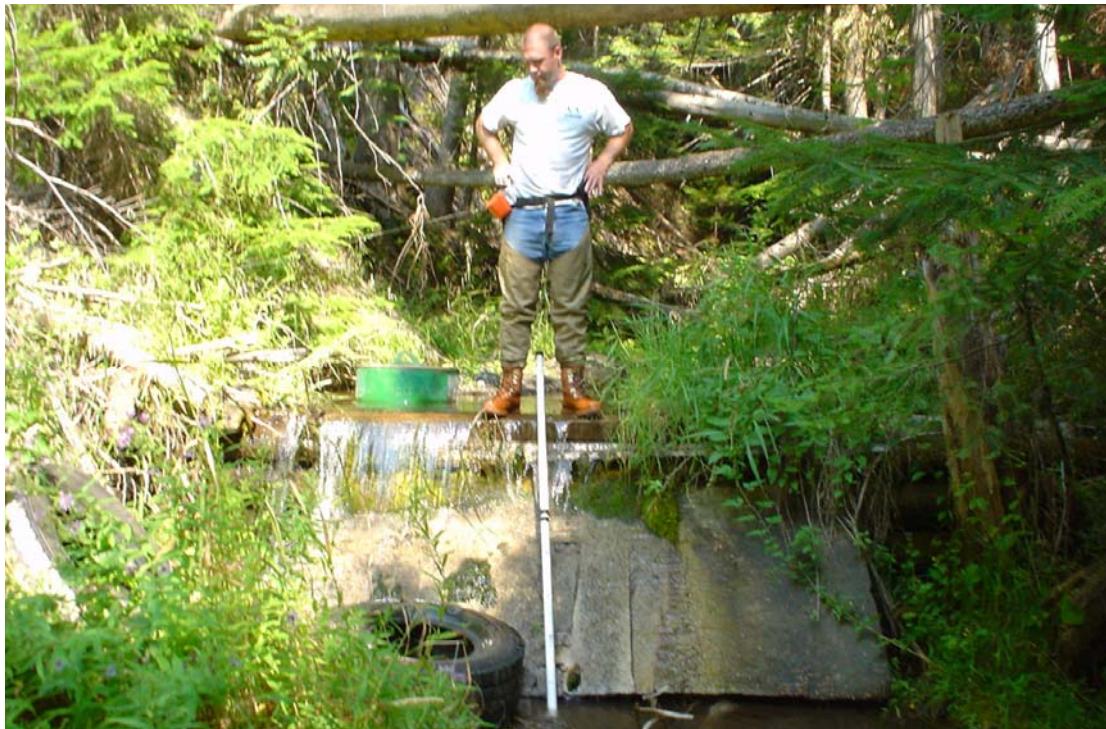
Figure 21. Man-made barrier in reach 1 of Lost Creek.

Reach 1 was 1,140 m in length and classified as a Rosgen A4 channel type (Table 20). Reach 1 contained good canopy shading of the channel. The reach was highly embedded (82%) and contained no spawning gravels (Table 21). The reach was primarily made up of riffle type habitat (81%) with only 17% of the habitat composed of pools (Table 22). A 1.5 m man-made barrier was observed in the lower end of the reach. The barrier was approximately 1.5 m in height (Figure 21).

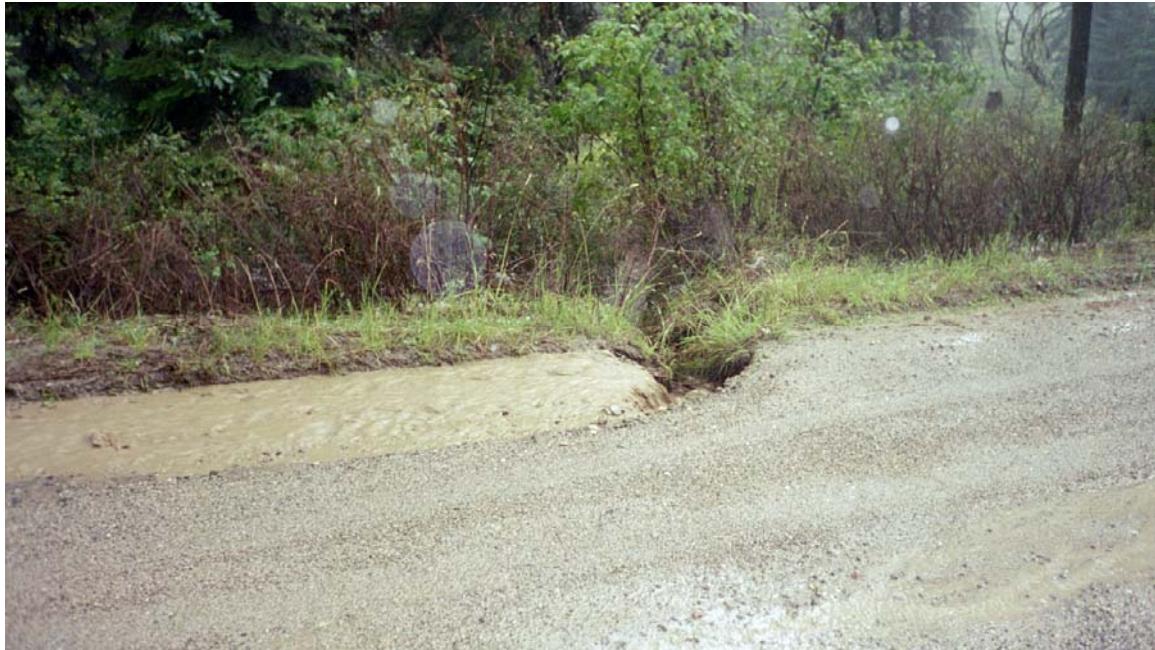
Figure 22. Forest Service Road 1934 contributing fine sediment to the stream channel.

Various land-use and management activities can affect native salmonid habitats. This has lead to altered and degraded riparian areas, which have adversely impacted streams throughout the west. These riparian alterations have contributed to widespread declines of inland native fishes, which often favor exotic species (Griffith 1988). Generally, the land-use activities that have the greatest impact on stream habitat are timber harvest, mining, roads, and grazing. Anderson (1988), citing a 1986 report of the Montana State Water Quality Bureau, suggested that the single greatest threat to watersheds and aquatic life is timber harvest and associated road building within forests. Increased delivery of sediments, especially fine sediments, is usually associated with timber harvesting and road construction (Eaglin and Hubert 1993; Frissell and Liss 1986; Havis and others 1993). Roads often contribute more sediment to streams than any other land management activity (Meehan 1991), but most land management activities, such as mining, timber harvest, grazing, and recreation are dependent on roads. Within the East Branch LeClerc, Diamond Fork and Lost creek watersheds, logging, grazing, and roads have all contributed to the degradation of aquatic and riparian habitat. Roads, both abandoned and in-service, run adjacent to East Branch LeClerc Creek and Lost Creek throughout much of the watersheds. In many locations, these roads are point sediment sources during precipitation events (Figure 22). Ideally, roads would be excluded from riparian zones because they are often a major source of soil erosion. In some cases as much as 90% of instream sediments have come from roads (Anderson et al. 1976).

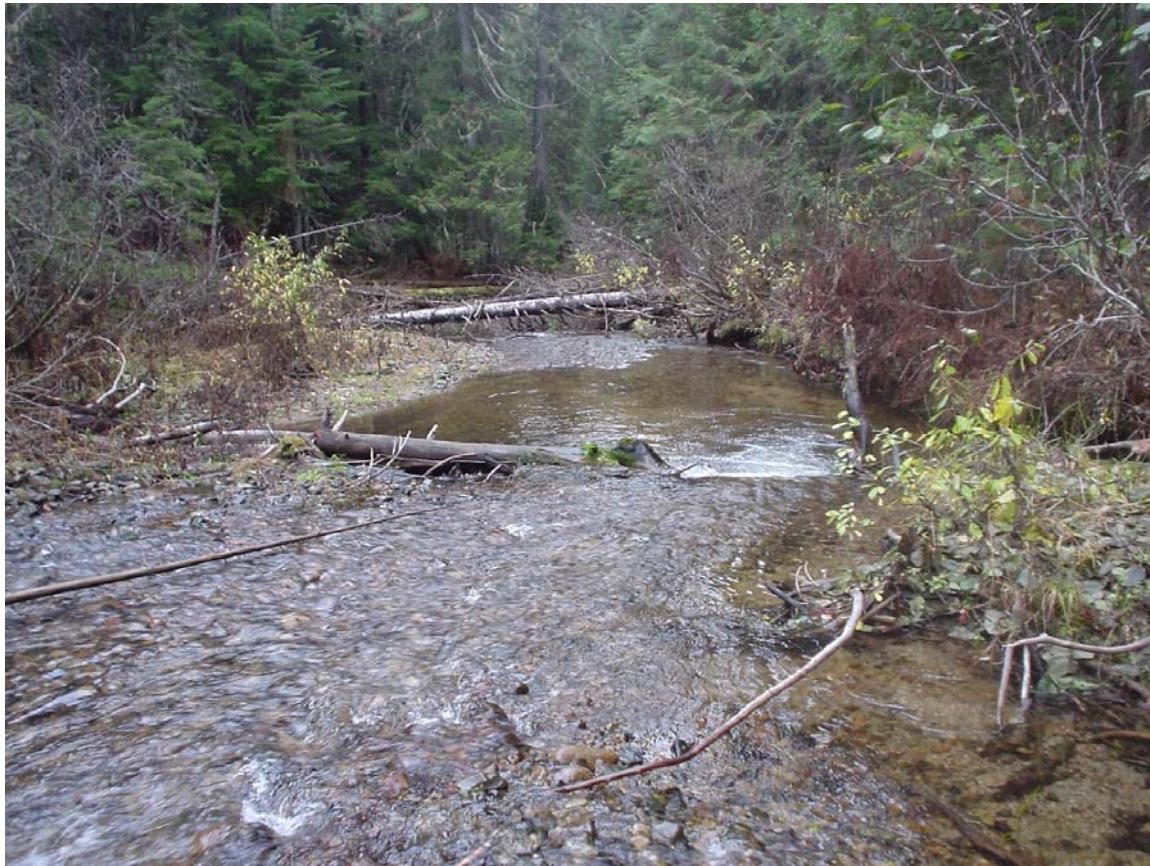
Figure 44. A pool formed by LWD that spans the channel of SFG.

Impacts from past land management activities appear to have simplified the stream channel in EBL. LWD played a major role in pool formation in SFG; 62% of the pools were formed by LWD pieces that spanned the entire channel width (Figure 44). LWD was sparse in EBL and likely resulted in a relatively low pool frequency. None of the LWD pieces observed in EBL spanned the entire channel. LWD in both channels appeared to be relatively stable; the bases of the LWD were buried in well vegetated banks and the wood appeared to have been in the channel for a relatively long time. LWD sizes were similar in both channels; mean LWD diameter in EBL was 26 in (SD = 4.9) and mean diameter was 23.6 in (SD = 6.2) in SFG. Based on the size of LWD pieces, apparent stability, and a lack of large accumulations (jams), large wood likely recruits to the channel from nearby riparian areas and mobility is minimal. Numerous large (>30" diameter), old stumps were observed along the channel in the EBL

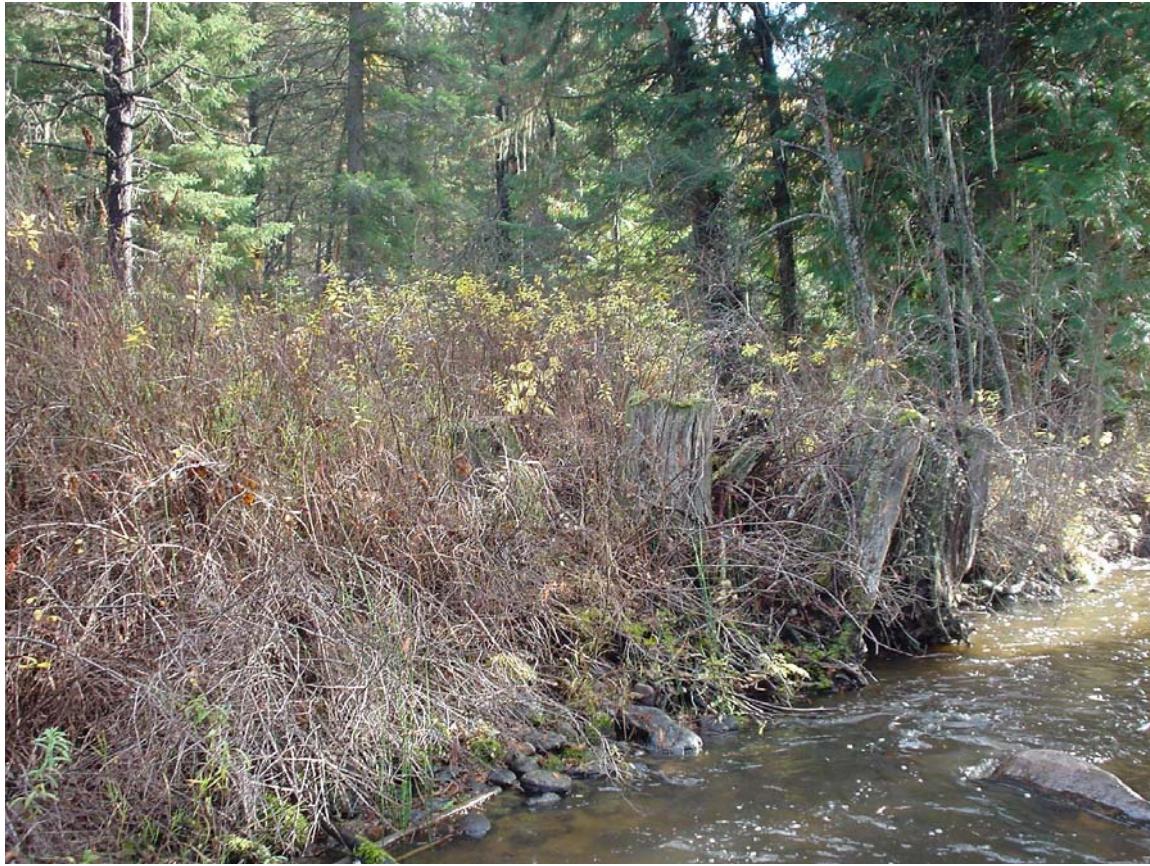
Figure 45. Old stumps observed along the banks of the EBL reach.

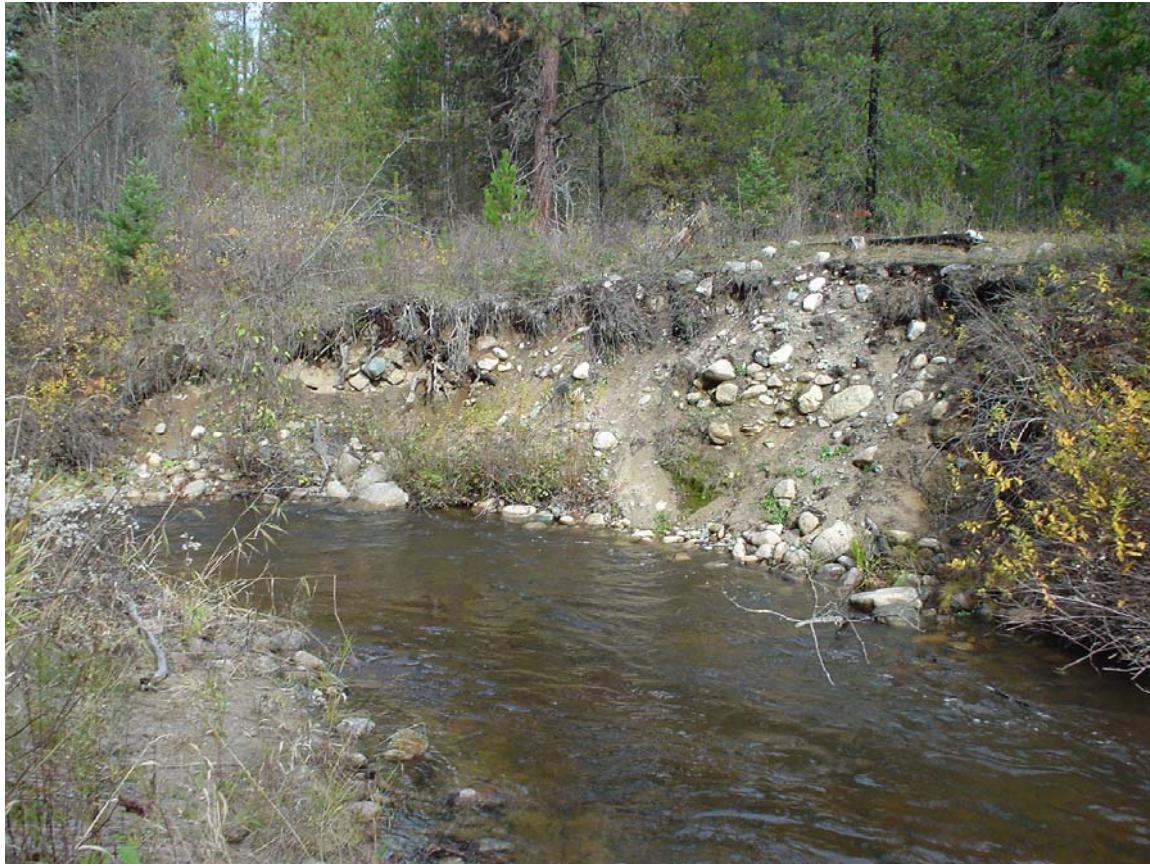
Figure 46. Unstable bank in the EBL reach (2004 photograph).
