SANDIA REPORT

SAND2003-3819
Unlimited Release
Printed November 2003

Suppression of Electron Emission from Metal Electrodes LDRD 28771 Final Report

David J. Johnson, William E. Fowler, Harry C. Ives, Mark E. Savage, and
William A. Stygar

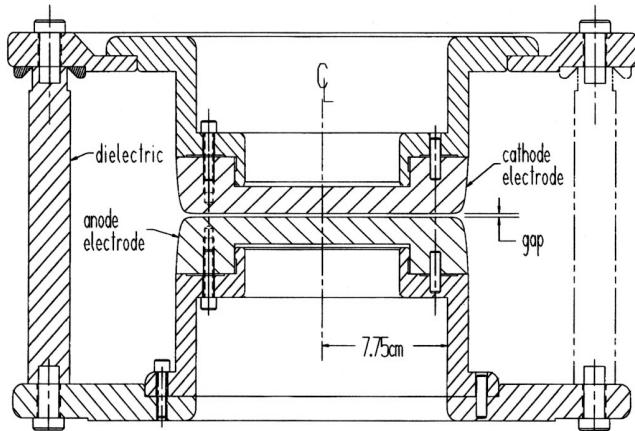
Figure 1. A cross-sectional view of the electrode support apparatus showing the 17-cm-diameter stainless steel electrodes.

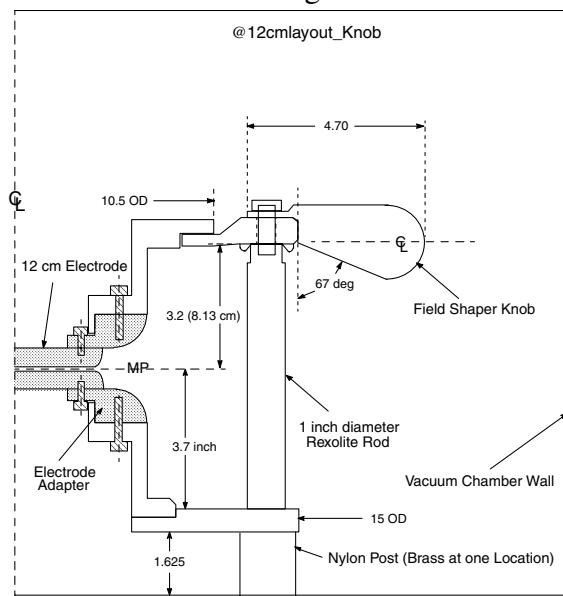
Figure 2. A layout of the high voltage test support assembly with adapters for 8, 12, and 15-cm-diameter electrodes as located in the vacuum chamber. The dimensions are indicated in inches.

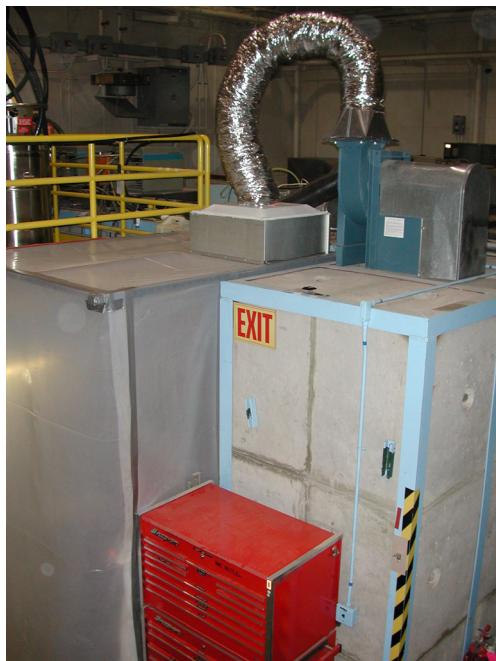
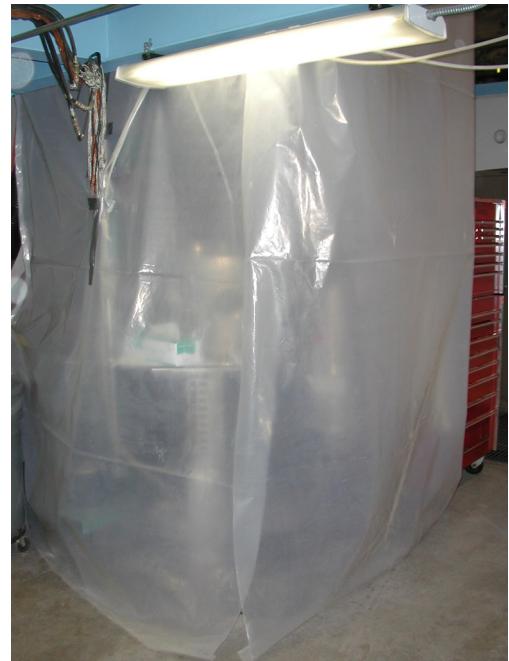
Figure 6. Photographs of the high voltage test stand and filtered air systems. (top) The interior of the test stand vacuum chamber showing the electrode support hardware, ring up coil, and vacuum feed thru's. (center) The vacuum chamber, (lower left) Top view of filtered air tent showing the HEPA filter and blower fan. (lower right) Side view of the filtered air tent showing the point of entry.

The electrical diagnostics are illustrated in Fig. 5. The current measured at the post was the combination of currents in the AK-gap and the dielectric support rods. The post Rogowski's and dB/dt loop had 1.5 to 7 ns L/R times that were numerically corrected. The monitor signals were integrated with 1 ns response time passive RC integrators with $\tau = 1\ \mu s$ that was numerically droop corrected. The diode dV/dt monitor was recorded directly and used to determine the displacement current in the diode. The gauge of the voltage monitor was corrected for changes in distance to the cathode flange which changed with AK-gap. This current was of similar amplitude to the measured current because of the $\sim 80\ pF$ AK-gap capacitance. The discharge current was determined from the difference between the AK-gap Rogowski current and the displacement current. The diode voltage measurements were determined accurate to $\pm 2\%$ by calibrations against a resistive voltage monitor. The voltage on the TG-125 pulser was set to a precision 0.1 kV with a digital meter and determined accurate to $\pm 0.5\%$ by comparisons to electrostatic voltmeters. The current monitors were calibrated to an accuracy of $\pm 5\%$ on short circuit shots against the Ion Physic current monitor. Photographs of the vacuum chamber, electrode-support assembly with ring-up coil, clean air tent, and blower fan and HEPA filter are shown in Fig. 5.

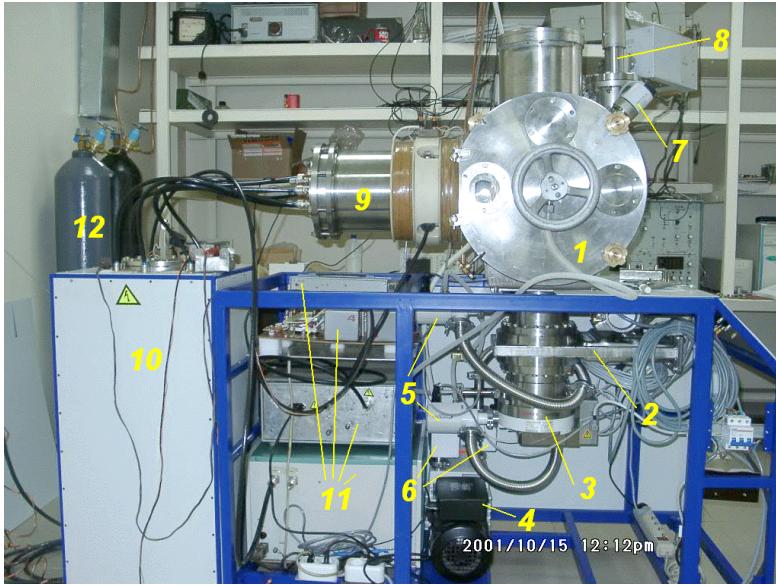
Figure 7. View of the Russian IHCE electron beam treatment installation. 1 – vacuum chamber; 2 – HV gate valve; 3 – turbo drag pump, 4 – rotary pump; 5 – vacuum valves; 6 – oil mist filter and condensate separator; 7 – compact full range vacuum auge; 8 – mass-spectrometer for residual gas analysis; 9 - e-gun; 10 – high voltage pulse generator; 11 – power supplies and control units of e-gun, 12 – pure argon bottle.

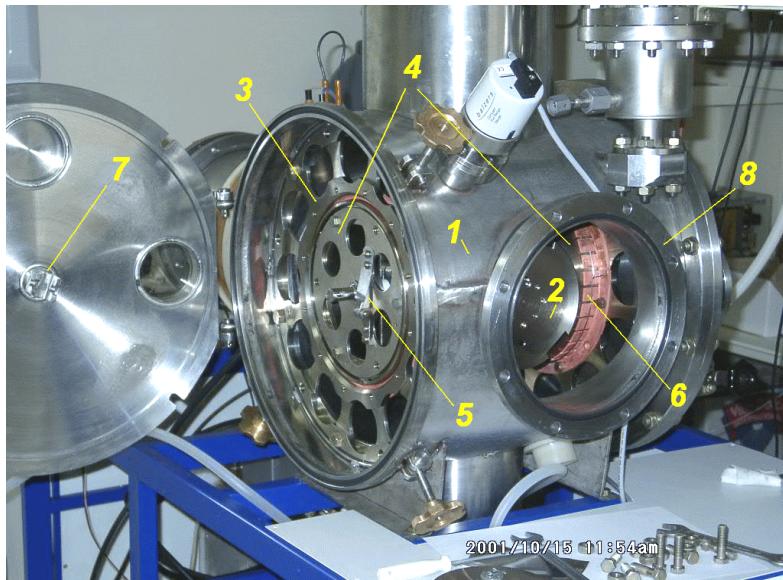
Figure 8. Russian mechanism of positioning electrodes under the treatment. 1 – vacuum chamber, 2 – specimen holder, 3 – stator, 4 – rotor, 5 – ratchet mechanism, 6 – current tap, 7 – drive shaft, 8 – specimen loading port.

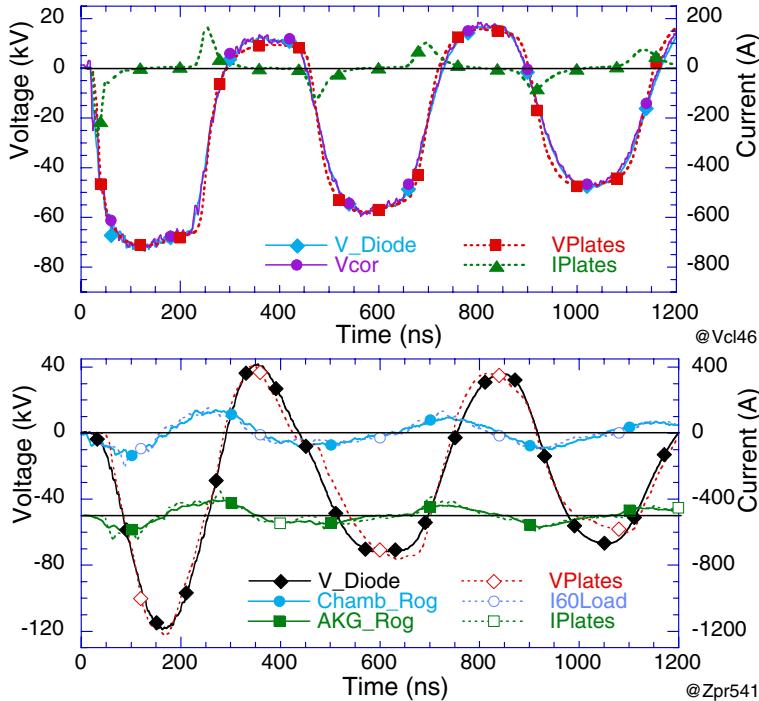
Figure 9. The diode voltage and current from the pulser circuit without (upper) and with (lower) ring-up coil. Data were acquired with 40 kV charge on the pulser and 3.8 mm AK-gap without crowbar circuit. Dotted curves were calculated with the SCREAMER circuit analysis program.

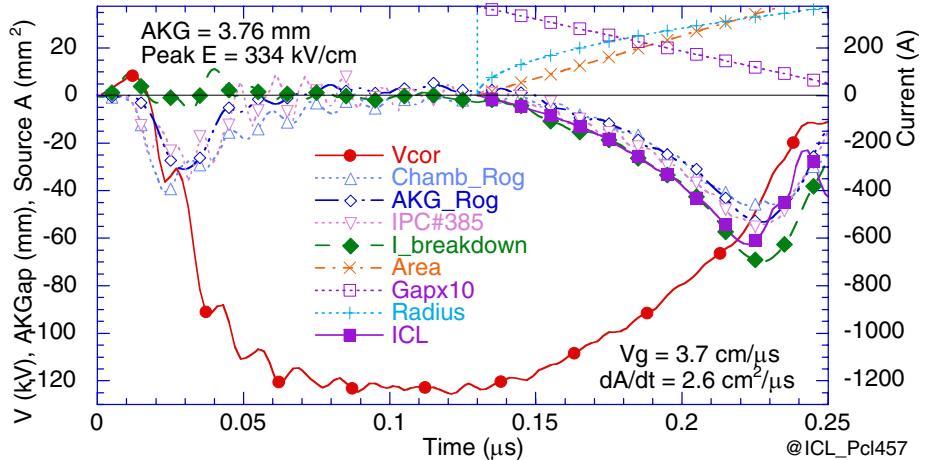
Figure 10. Electrical data for flat pulse shot Pcl457 with solvent cleaned 304L electrodes. The size of the gap and area for the ICL fit are plotted with square and \times symbols. The crowbar circuit did not fire, as was often the case with breakdowns at early or middle times.

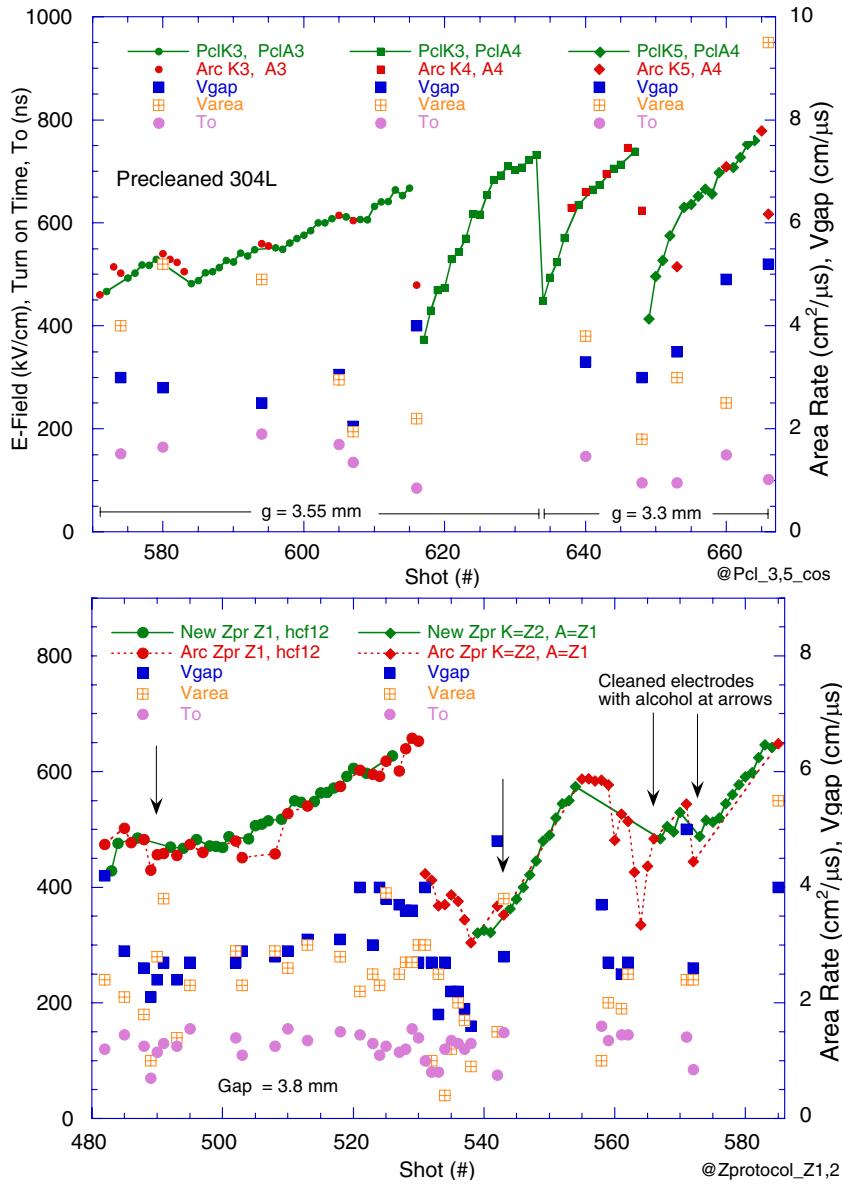
Figure 13. Breakdown E-field thresholds together with plasma area expansion and closure rates for shots with solvent precleaned (upper) and Z-protocol (lower) treated electrodes using the $1-\cos(\omega t)$ voltage pulse. See Fig. 10 for details.

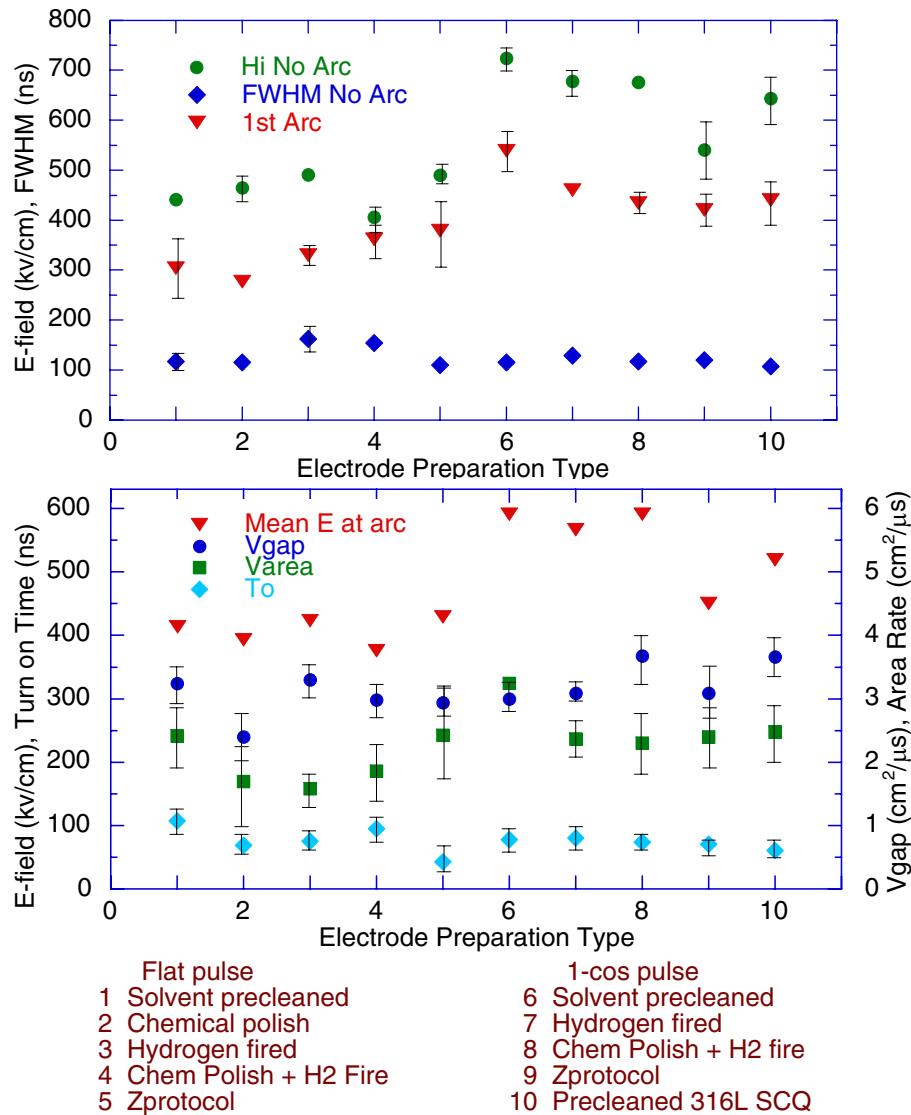
Figure 14.
Summary of the data from various surface preparations on 304L, except for #10 on 316L stainless steel. See text for details.
(upper) Average E-fields for 1st breakdowns and without breakdowns. The error bars are \pm the standard deviation divided by #shots^{1/2} for 3 or 4 shots. Errors smaller than 10% are not shown.
(lower) The average ICP fit data. The error bars are \pm the standard deviation for 7 to 49 shots. The To begins at 20 and 80 ns for the flat and 1-cos pulses, respectively.

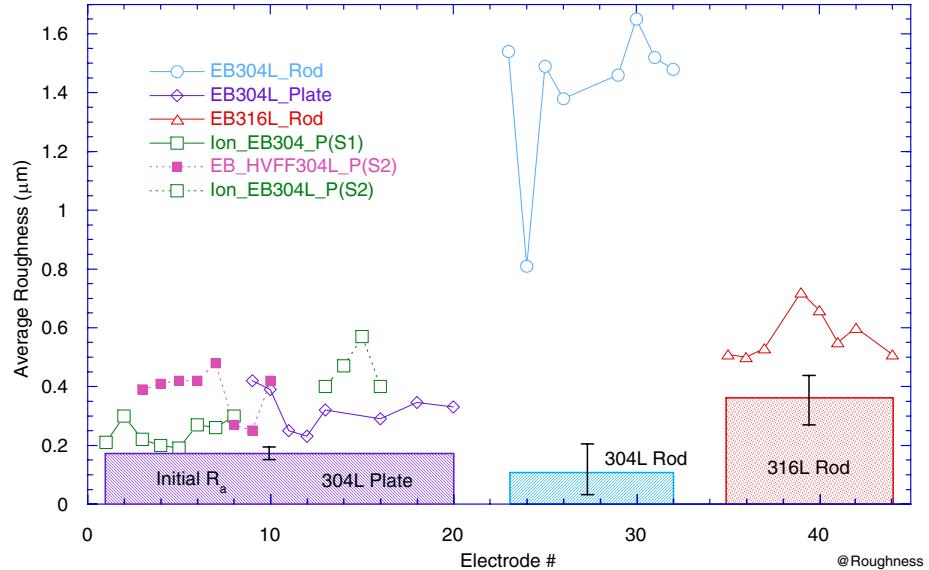
Figure 15. The average surface roughness, R_a , of the 8 cm electrodes returned from IHCE tested at SNL. The 304L plate electrode from the second order are labeled with dotted curves. The mean R_a 's for untreated electrodes are indicated as boxes with cross hatches. The error bars on the boxes indicate the range of the measured R_a .

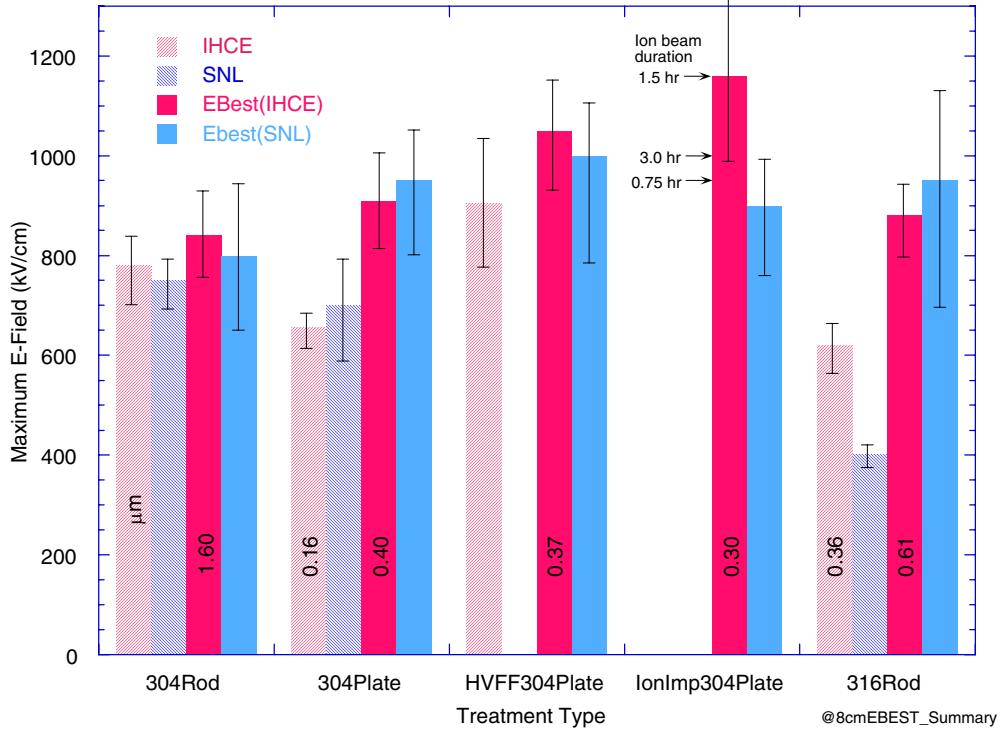
Figure 16. A summary of the test results before and after E-beam treatment of stainless steel electrodes. The SNL ion implantation results are the average of 0.75, 1.5 and 3 hr ion treatments with no consistent better results at 1.5 hr.

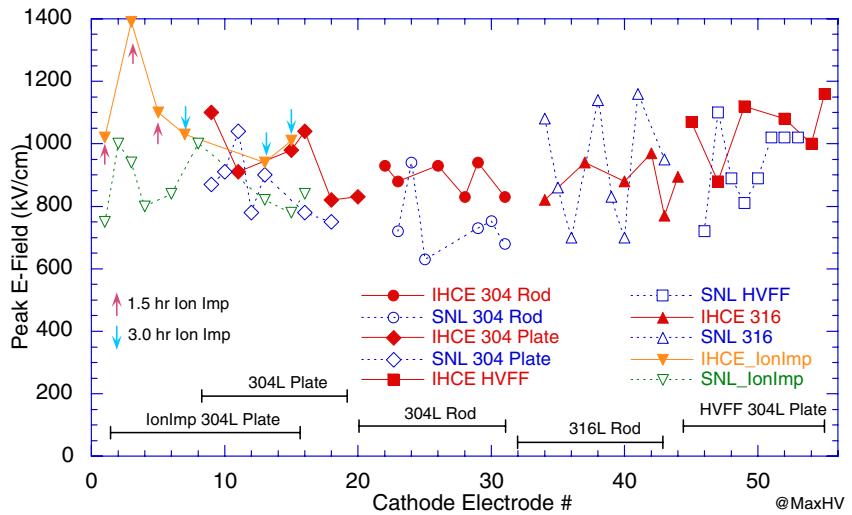
Figure 17. The highest E-field reached by IHCE and SNL versus cathode number.

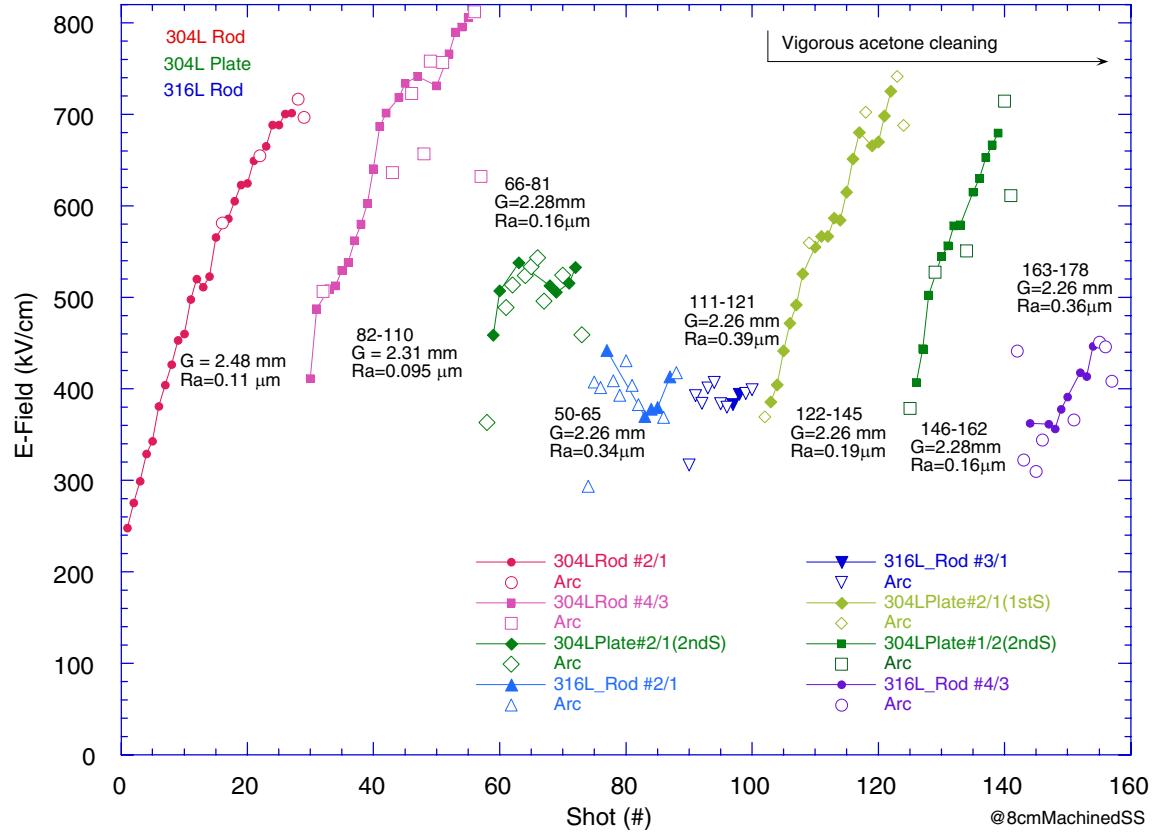
Figure 18. The HV-test results for various machined stainless steel electrodes. The shots that held the voltage pulse without arcs are indicated as closed symbols. Many of the arcs with very little voltage drop below the mean value were minor conditioning arcs that caused no visible damage to the electrodes. The numbers near the data are the shot numbers, AKG spacing, and average roughness, Ra. The electrode numbers are indicated after the electrode description in the legend, with the number of the cathode/anode.

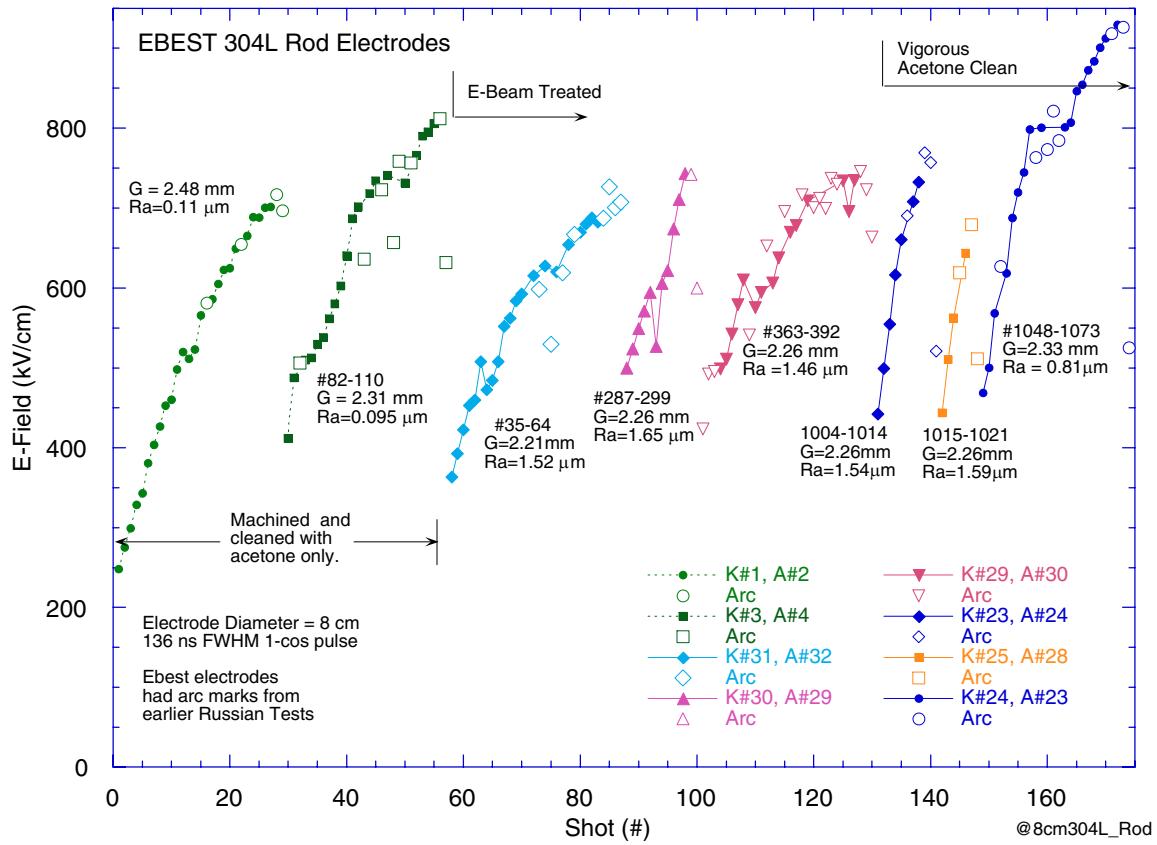
Figure 19. The HV-test results for machined (dotted) and EBEST (continuous) 304L rod stock stainless steel electrodes. Photographs of 304L rod electrodes before (lower left) and after EBEST treatment (lower right). The EBEST photograph is from electrode 1/31. The typical crater density of this type electrode was $10/\text{mm}^2$.

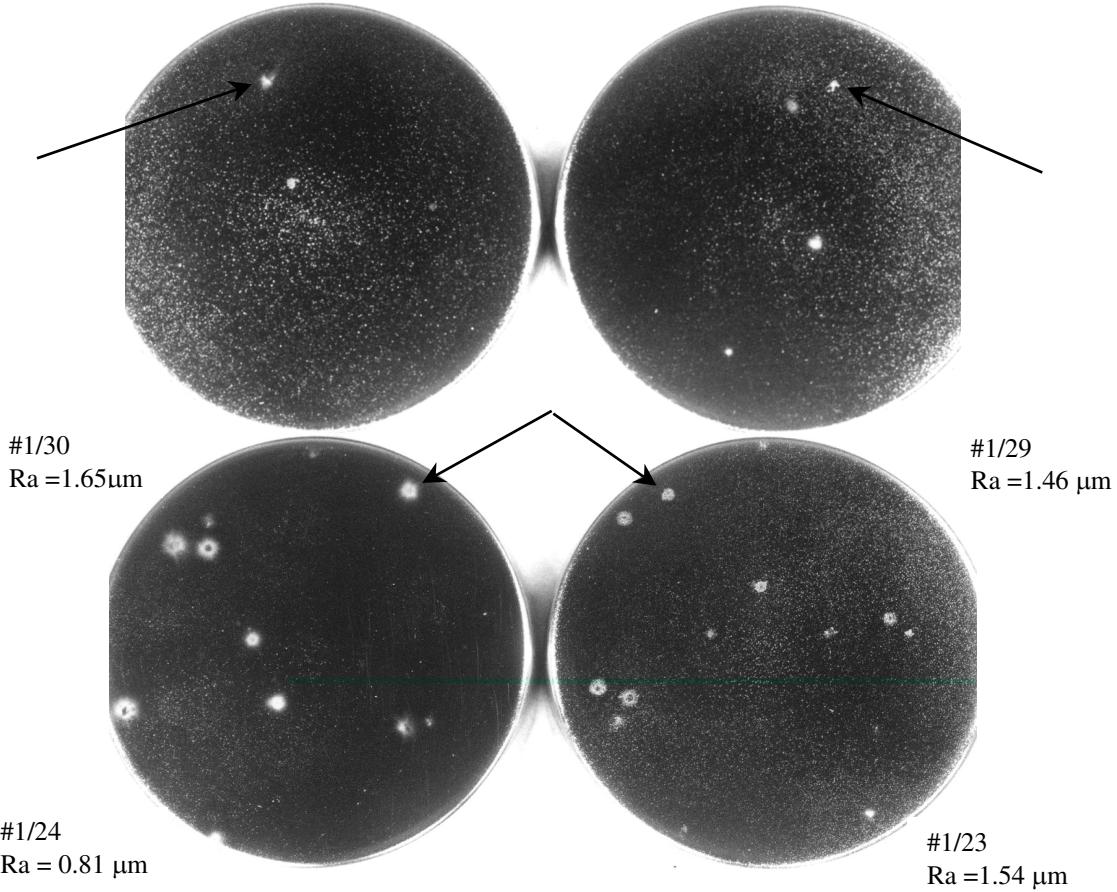
Figure 20. Photographs of EBEST 304L rod electrodes. (upper) Cathode #1/30 (left) and anode #1/29 (right) after shot 299 for magenta data series in Fig. 14. (lower) Cathode #1/24 (left) and anode #1/23 (right) after shot 1074 from blue data series in Fig. 14. The arrows point to damage spots from the only new arc marks that were visible after the test series.

Photographs of 304L rod electrodes #1/30, 1/29, 1/24, and 1/23 are shown in Fig. 20. The photos show the speckled surfaces typical of the EBEST 304L rod electrodes. Apparently the many inclusions in 304L rod are able to more easily produce the craters via propagation of gas released from the inclusions along grain boundaries during EBEST. It is thought that the grain boundaries are preferentially stretched along the axis of the rod when the rod stock is drawn. For this reason we also chose to test 304L plate stock because the grain boundaries are elongated parallel rather than perpendicular to the surface in this case. Cathode #1/24 has a factor of two lower roughness than the other EBEST 304L rod electrodes and perhaps for this reason held 20% higher voltage even though it has a large number of arc marks from previous tests. The new arc mark attributed to shot 1073 occurred in a very smooth region of the cathode.

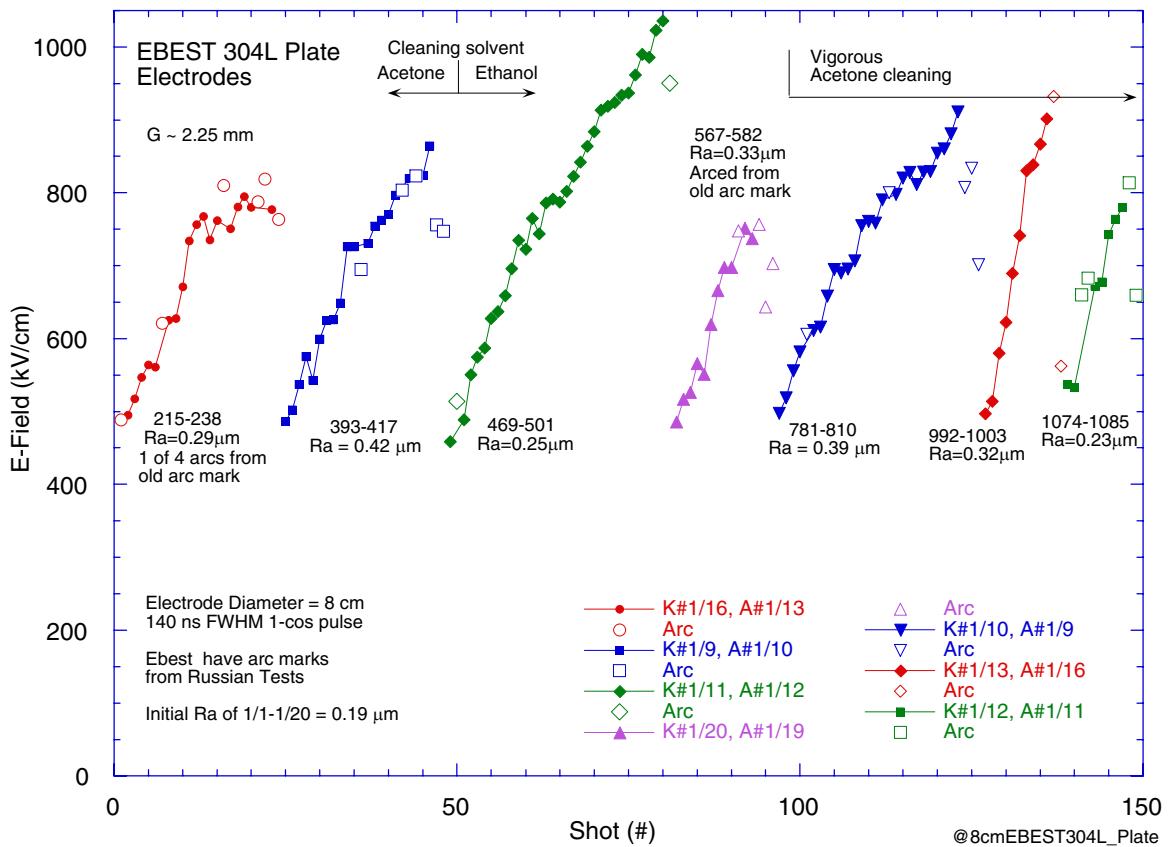
Figure 21. The HV-test results for EBEST 304L plate stock stainless steel electrodes. Microscope photographs of 304L plate electrode before (lower left) and after EBEST (right). The EBEST electrode was #1/12 with $R_a = 0.23 \mu\text{m}$. The typical crater density of this type electrode was $1/\text{mm}^2$.

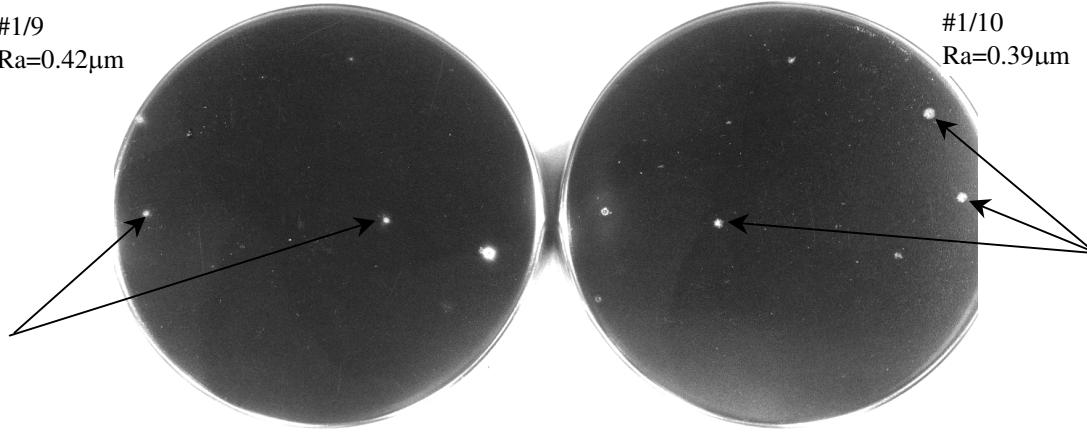
Figure 23. A photograph of EBEST 304L plate cathode #1/9 (left) and anode #1/10(right) after shot 417. This was the last shot of first blue curve data series in Fig. 19. The arrows point to damage spots from the only new arc marks that were visible.

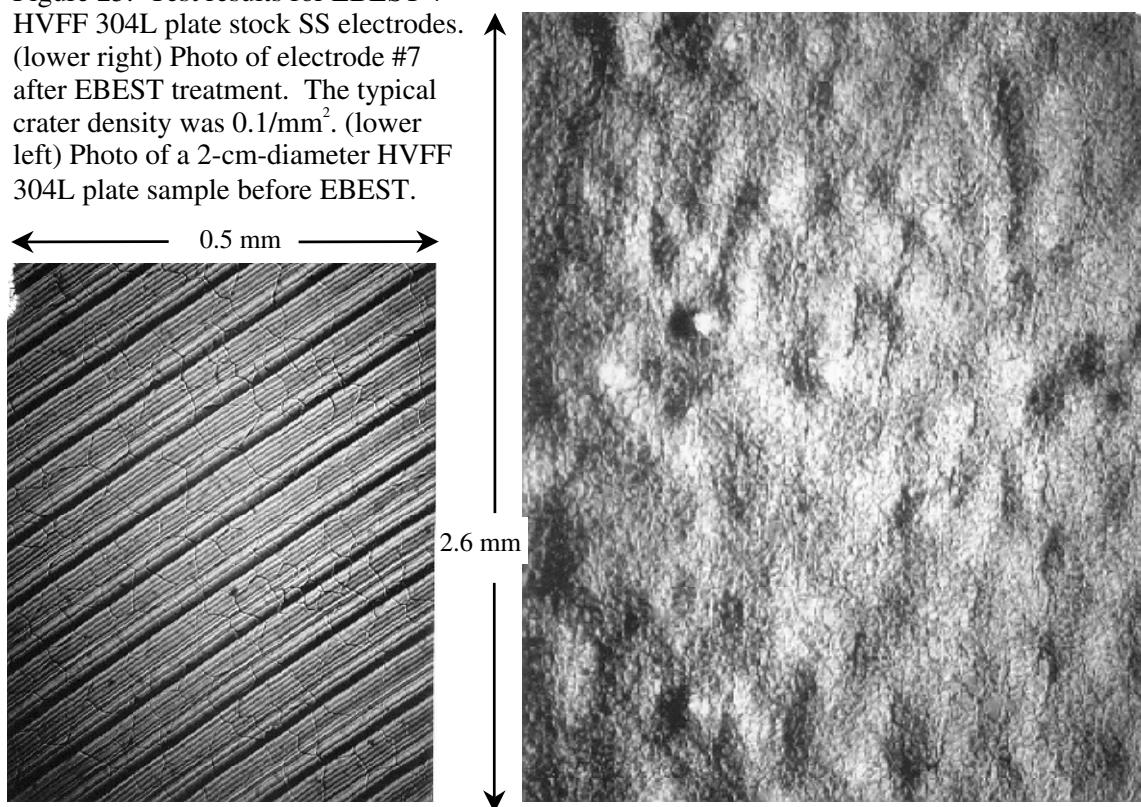
The photograph of the HVFF 304L plate sample sample in the lower left image in Fig. 25 shows the grain boundaries that are exposed during hydrogen firing. This sample was machined from the same 304L plate material lot as the EBEST electrodes. The HVFF process involves 6 steps. The steps applied to the vacuum furnace are: 1.) load the electrodes and evacuate to 10^{-6} Torr, 2.) back fill with argon to 3 psi while raising the temperature to 800 °C, 3.) displace argon with hydrogen with 5 purges over 1 hr, 4) heat to 1000 °C for 30 min. (to burn off hydrocarbons), 5.) displace hydrogen with argon with 5 purges over 1.33 hr while dropping temperature to 800 °C, and 6.) evacuate to 10^{-6} Torr and cool to 40 °C over 8 hrs. The result of HVFF is to lower the carbon and raise the oxygen content near the stainless steel surface. The results of AES analysis preformed at SNL on a similar 304L plate sample are shown in Fig. 26 along with comparison data for 304L and 316L rod. We assume the initial 304L plate had a similar concentration to the 304L rod based on the experience of Diane Pebbles, Org. 1822, who acquired the data. The 304L plate data were acquired 30 minutes and 30 days after HVFF to get information on the effect of the shipment delay time to IHCE. The actual electrodes were treated ~ 60 days after HVFF but this additional time should not effect the increased penetration of the oxygen in the surface layer. The data acquired at 30 days show some increase in carbon in the front surface < 1 nm but that the concentration from 1 to 10 nm is still much below the initial level. The lower carbon concentration after HVFF indicates a reduction in hydrocarbon inclusions at the grain boundaries. This reduction results in almost no craters after EBEST as shown by the EBEST surface photograph in Fig. 25.

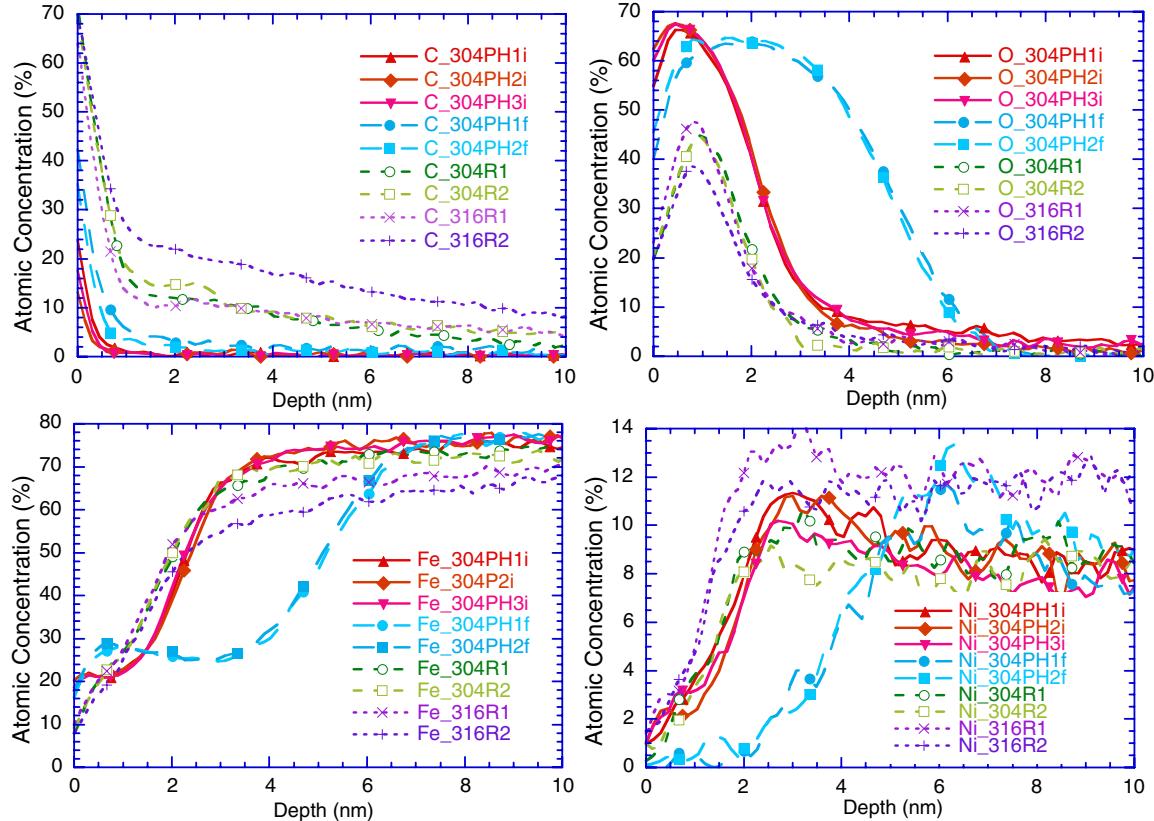
Figure 26. Auger electron spectroscopy atomic concentration results for 304L plate and rod and 316L rod stainless steel. The letters and numbers of the labels in the legends designate, element, SS type, stock (P=plate,R=rod), process (H=HVFF, blank=none), sample number, and time delay for 304L plate (i = 30 min, f = 30 days). The bulk carbon and sulfur concentration specifications for 304L and 316L stainless steel are < 0.03%.

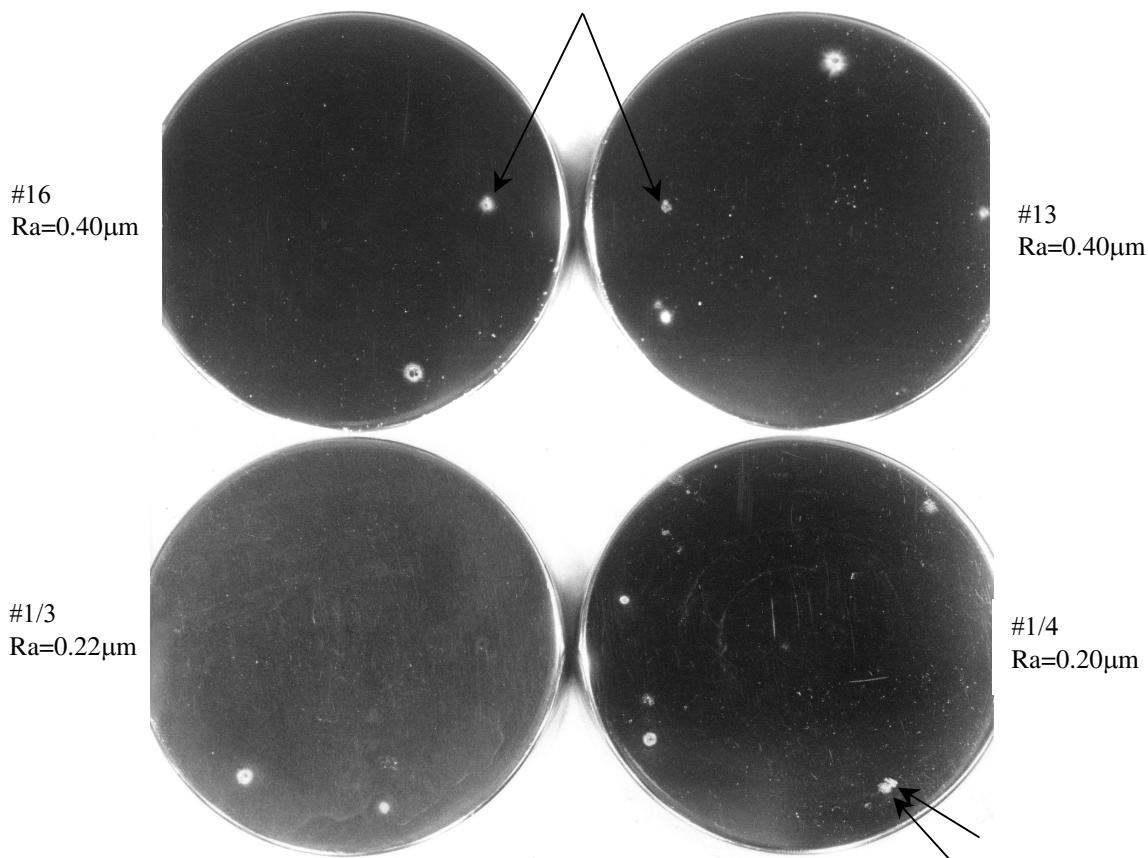
Figure 27. (top) A photograph of Ti implantation + EBEST 304L plate cathode #16 (left) and anode #13 (right) after shot 108. This was the first data series in Fig. 27 with red data points. (bottom) A photograph of Ti implantation + EBEST 304L plate cathode #1/3 (left) and anode #1/4 (right) after shot 134. This was the second data series in Fig. 27 with green data points. The arrows point to damage spots from the new arc marks.

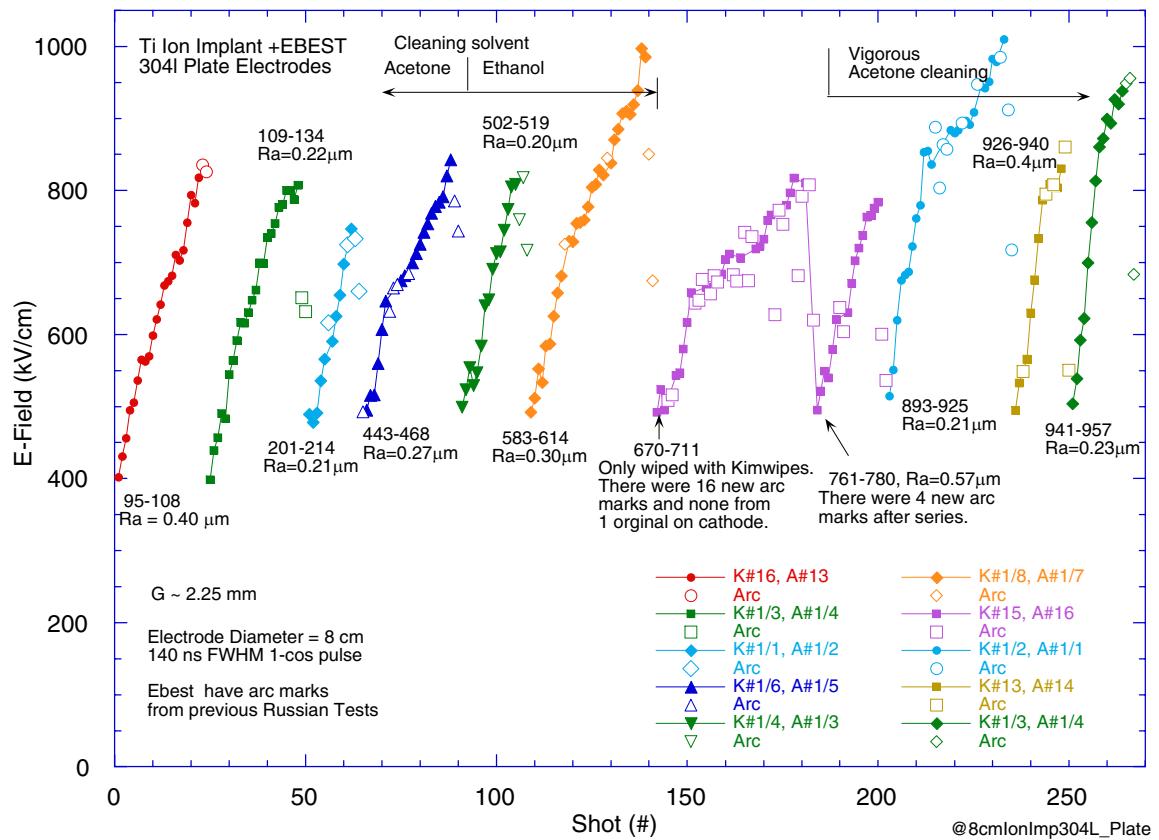
Figure 28. The HV-test results for Ti ion implantation + EBEST 304L plate stock stainless steel electrodes. Photographs of 304L plate electrodes before (lower left) and after implantation + EBEST treatment (lower right). The photograph is from electrode #1/6. The typical crater density of this type electrode was $0.5/\text{mm}^2$.

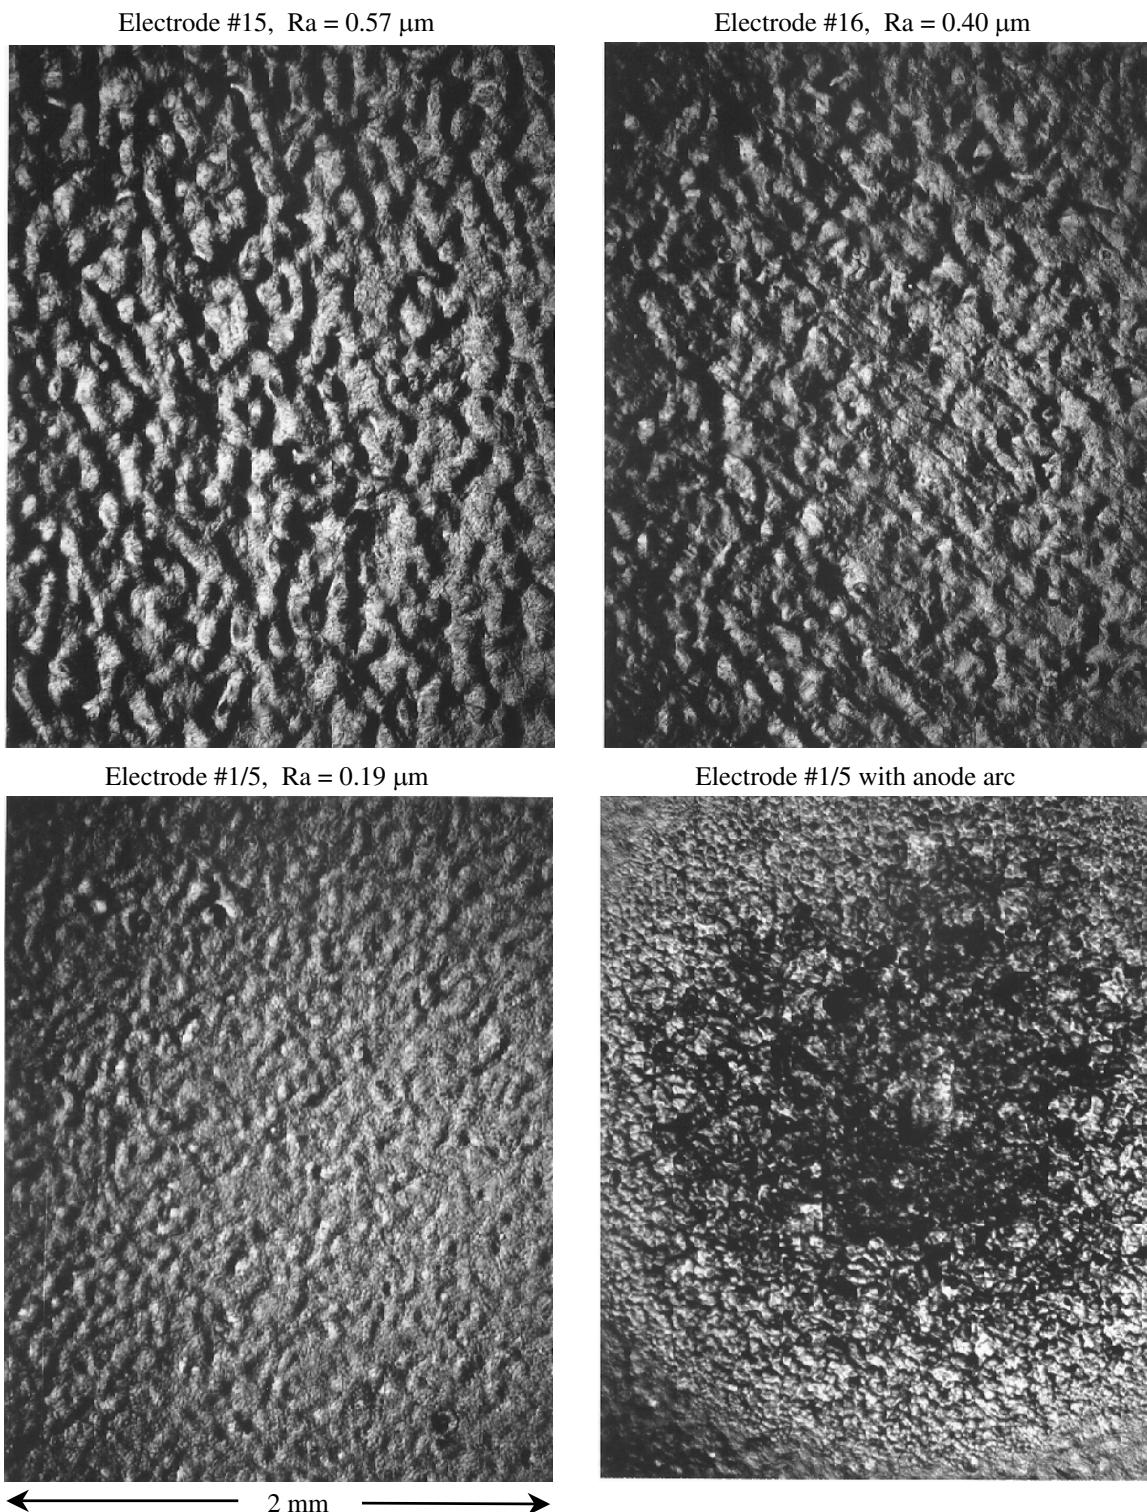
Figure 29. Microscope photos of 3 Ti implantation electrodes with the full range of R_a observed.

Photographs of the surfaces of three ion implantation electrodes are shown in Fig. 29 along with one photo of a medium size anode arc. The photos show the variation of surface roughness that is indicated in Fig. 15. The lower right photo is an example of an anode arc that would probably not cause a HV breakdown on later tests.

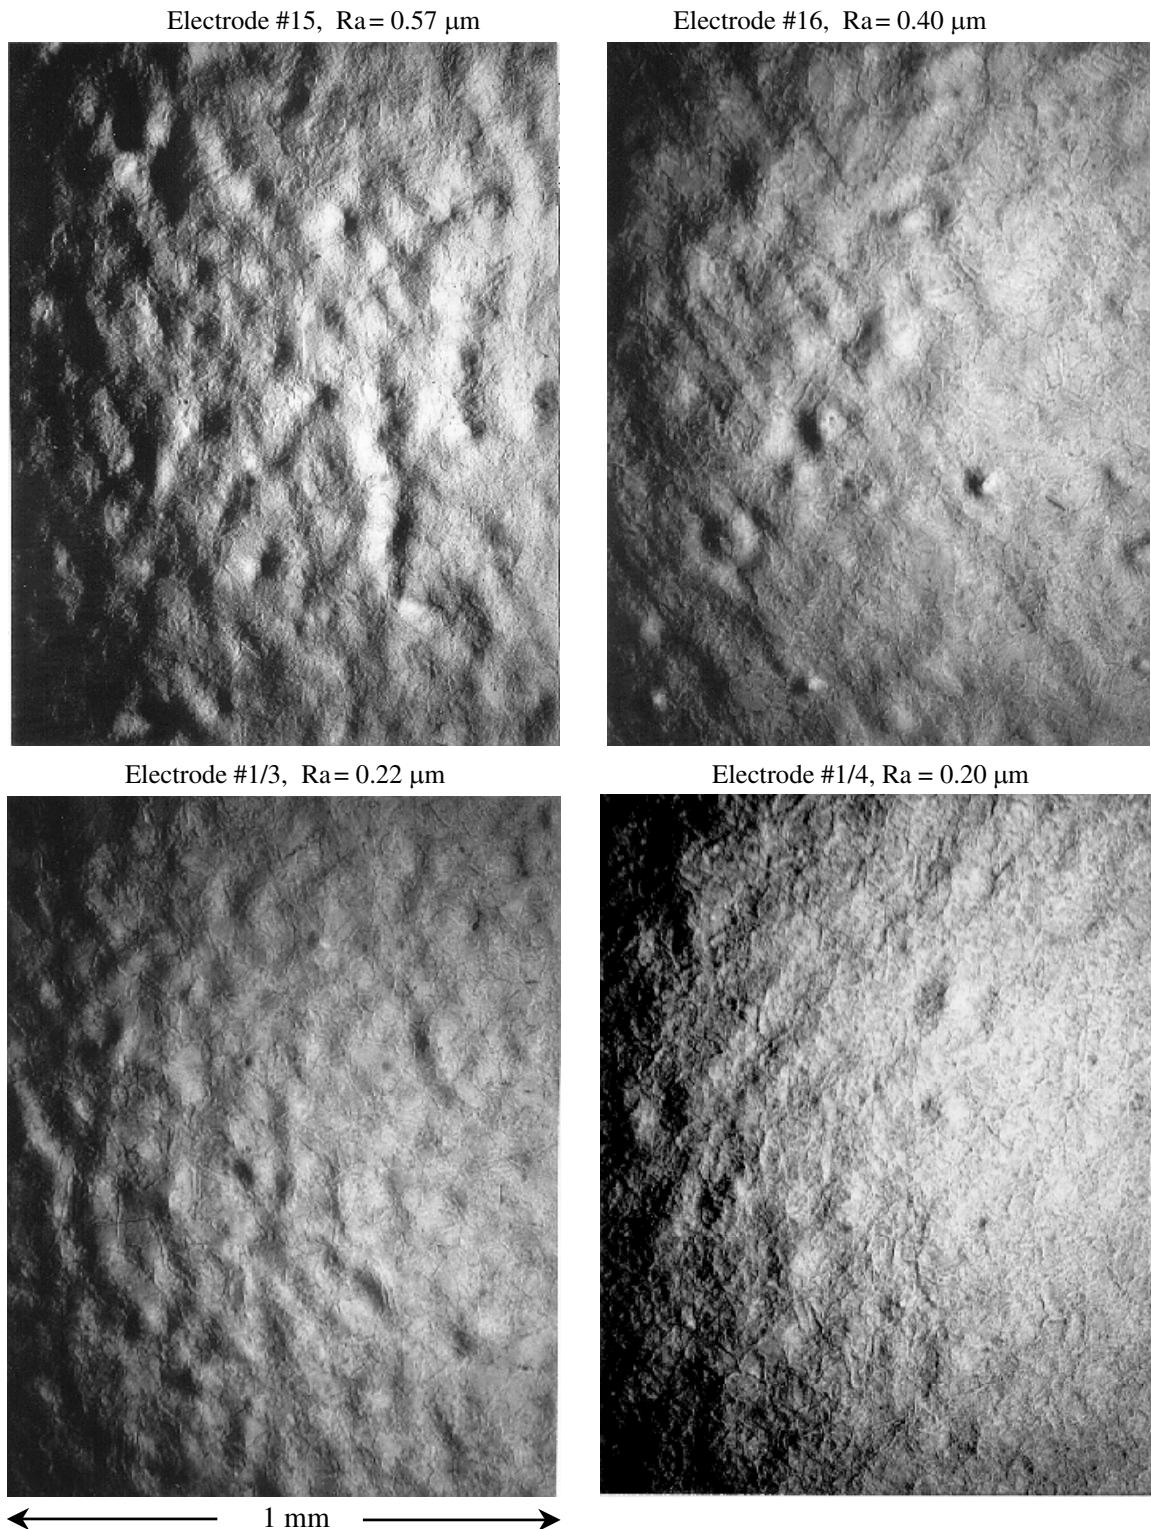
Figure 30. (upper) Photographs of second shipment ion implantation + EBEST 304L plate electrodes. (lower) Photographs of first shipment ion implantation electrodes.

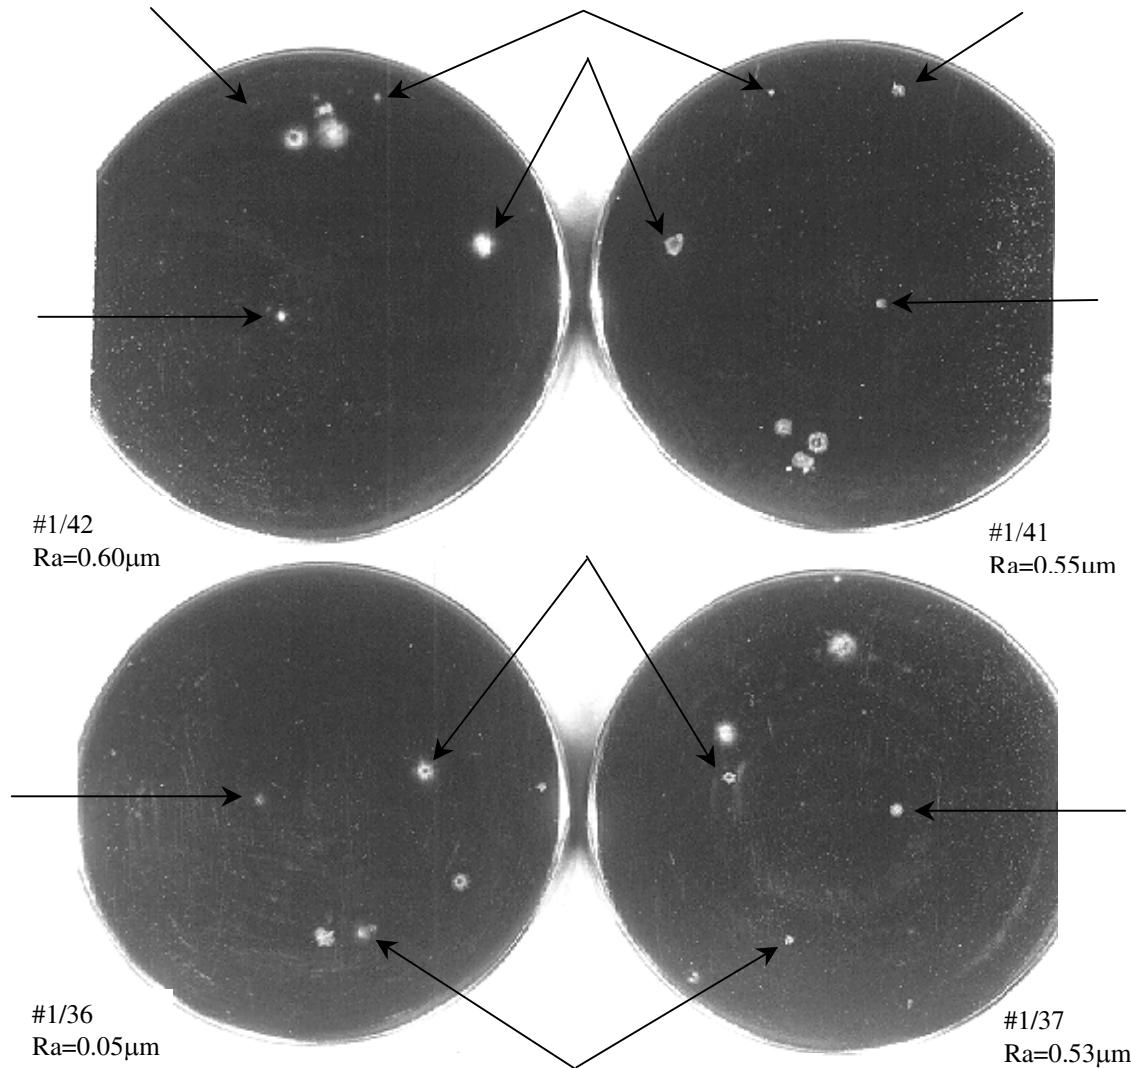
Figure 31. (top) A photo of EBEST 316L rod cathode #1/42 (left) and anode #1/41 (right) after shot 347. This was the 2nd data series in Fig. 31 with blue data points. (bottom) A photograph of EBEST 304L plate cathode #1/36 (left) and anode #1/37 (right) after shot 861. These were from the eighth data series in Fig. 31 with green data points. These electrodes have more scratches than other EBEST 316L electrodes. The arrows point to damage spots from the new arc marks.
