SANDIA REPORT

SAND2003-3819
Unlimited Release
Printed November 2003

Suppression of Electron Emission from Metal Electrodes LDRD 28771 Final Report

David J. Johnson, William E. Fowler, Harry C. Ives, Mark E. Savage, and
William A. Stygar

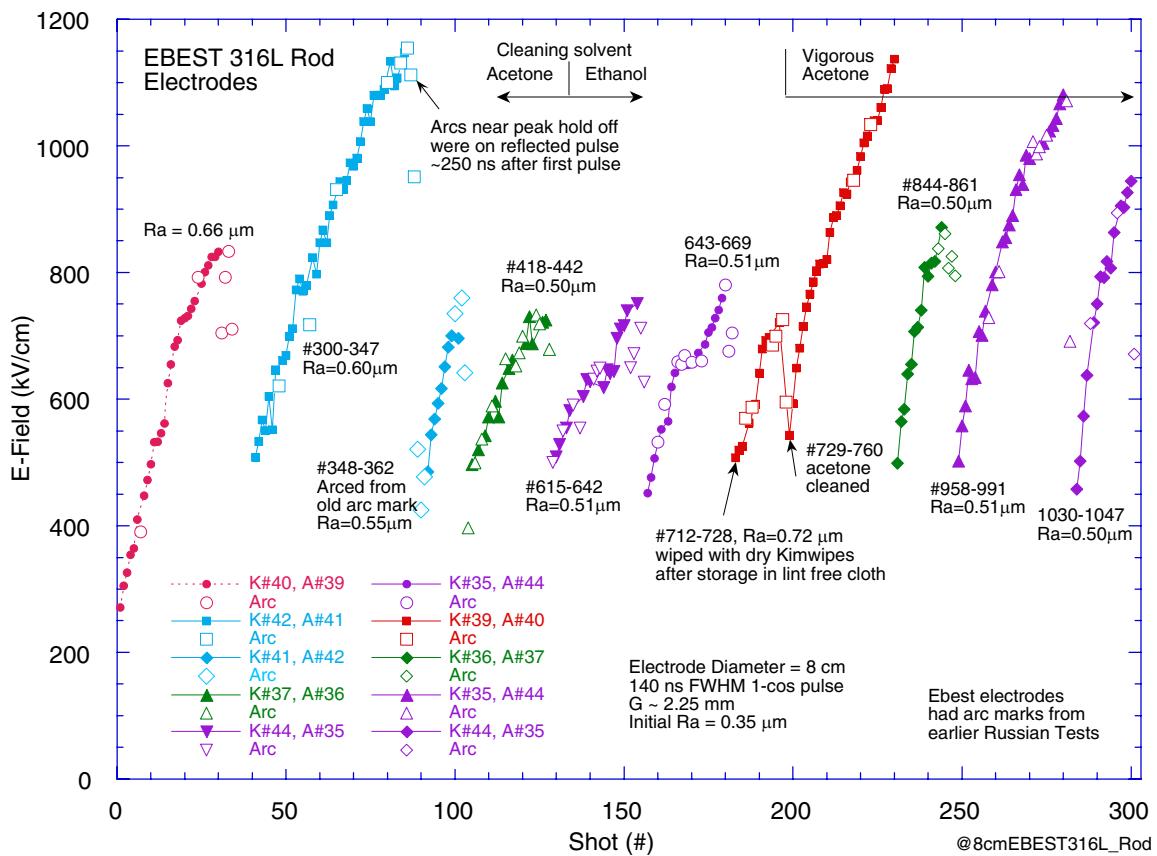
Figure 32. Test results for EBEST 316L plate stock stainless steel electrodes. Photos of 316L plate electrodes before (lower left) and after EBEST (lower right). The photo from EBEST electrode #1/39 shows a typical crater density of $5/\text{mm}^2$ even though the roughness measurement was the highest for the EBEST 316L electrodes, with $R_a = 0.76 \mu\text{m}$.

It is surprising that the EBEST 316L electrodes show so much variation in HV hold-off. There was a variation in R_a but it did not correlate with hold-off. Electrode #1/39 had the highest R_a but the highest HV hold-off. There also was no correlation of hold-off to the crater density. Most areas on all the 316L electrodes had ~ 5 craters/mm². The photos in Fig. 33 show the typical appearance of EBEST 316L rod at different magnifications. The photos show how the EBEST smoothed the surface, exposed grain boundaries, and produced craters. Many of the craters show only a smooth dimple in the anode surface.

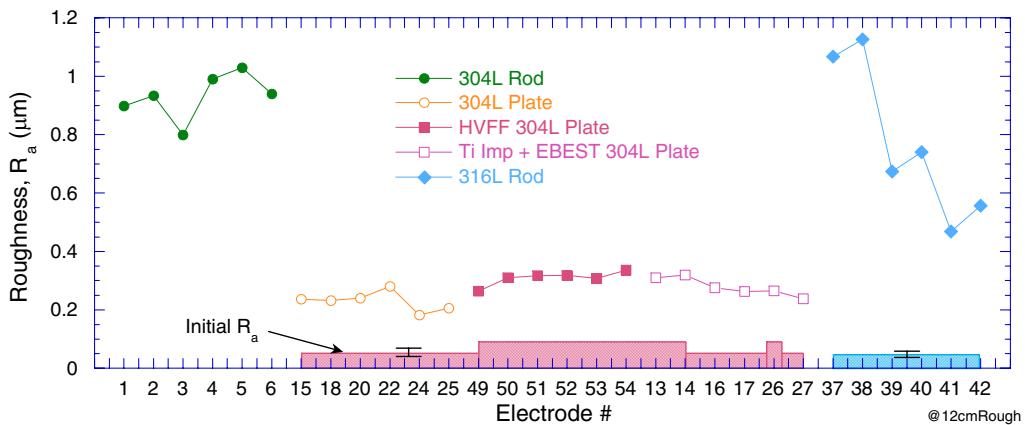
Figure 34. The average surface roughness, R_a , of the 12 cm electrodes measured before and after EBEST. The initial surface R_a of the HVFF and 3 Ti Imp electrodes came from the second order and are estimated from the higher R_a of #13 and #14 because the only electrode retained was polished before the roughness gauge was available.

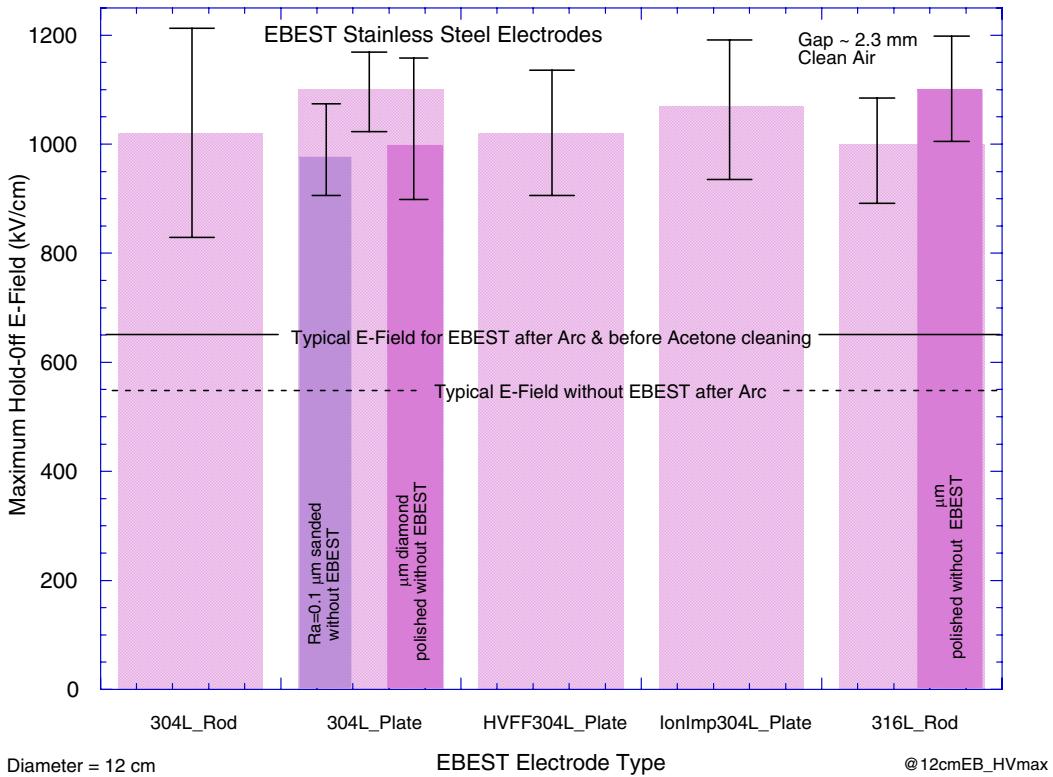
Figure 35. A summary of the HV hold-off results for tests of 12-cm EBEST electrodes. The range of the maximum hold-offs are shown by the error bars. The dark purple bar shows data for electrons wet sanded to $R_a = 0.1 \mu\text{m}$ with 2000 grit carborundum paper. The dark purple bars are data for electrodes that were diamond polished to give $R_a = 0.05 \mu\text{m}$.

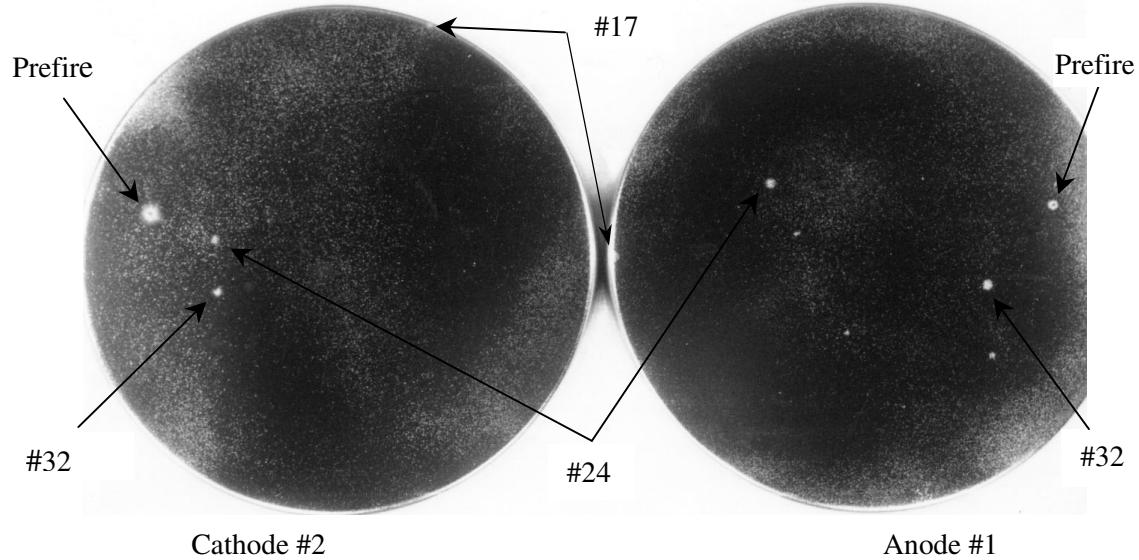
Figure 36. A photograph of EBEST 304L rod electrodes #1 and 2 taken after shot 32. Shot numbers label the identified arc marks. There are 3 unidentified arc marks on the anode that occurred on prefires associated with shot #32.

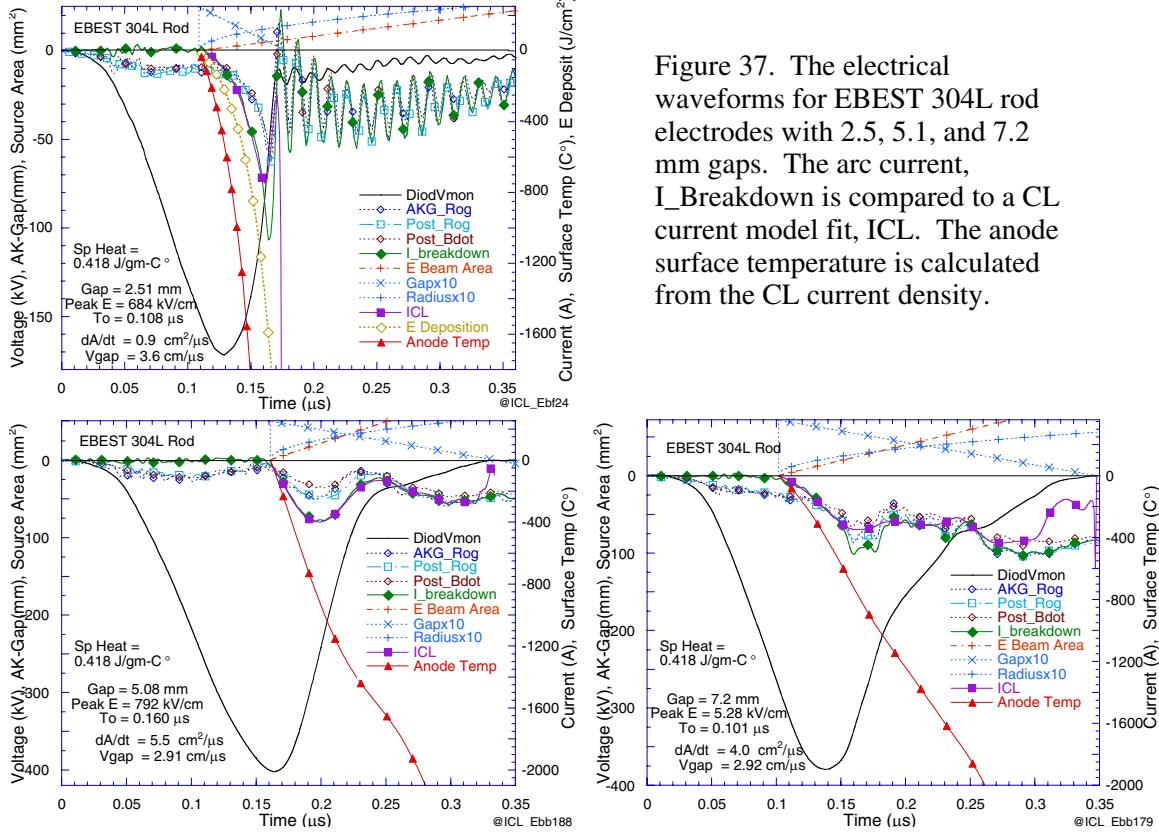
Figure 37. The electrical waveforms for EBEST 304L rod electrodes with 2.5, 5.1, and 7.2 mm gaps. The arc current, $I_{\text{Breakdown}}$ is compared to a CL current model fit, ICL . The anode surface temperature is calculated from the CL current density.

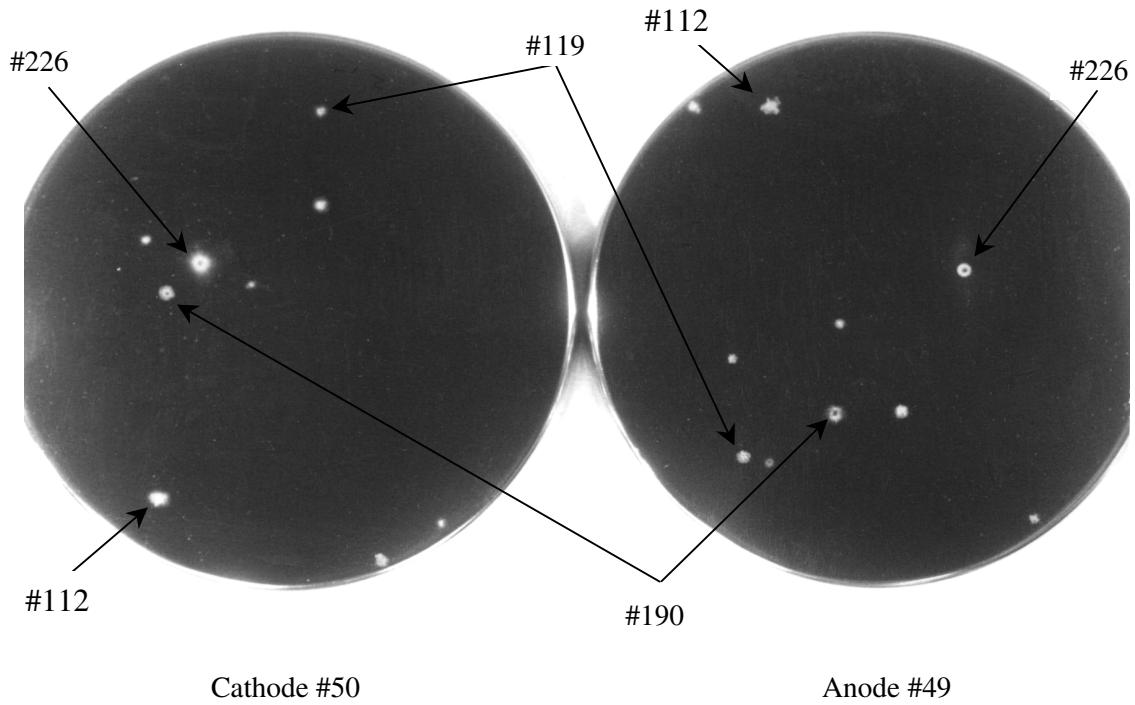
Figure 38. Photograph of 12-cm-diameter EBEST + HVFF electrodes taken after shot 226 in the upper plot of Fig. 41. The location of the last arcs from the 2nd, 3rd, 4th, and 5th shot series are labeled. The cathode was rotated 67.5° between each of these shot series.

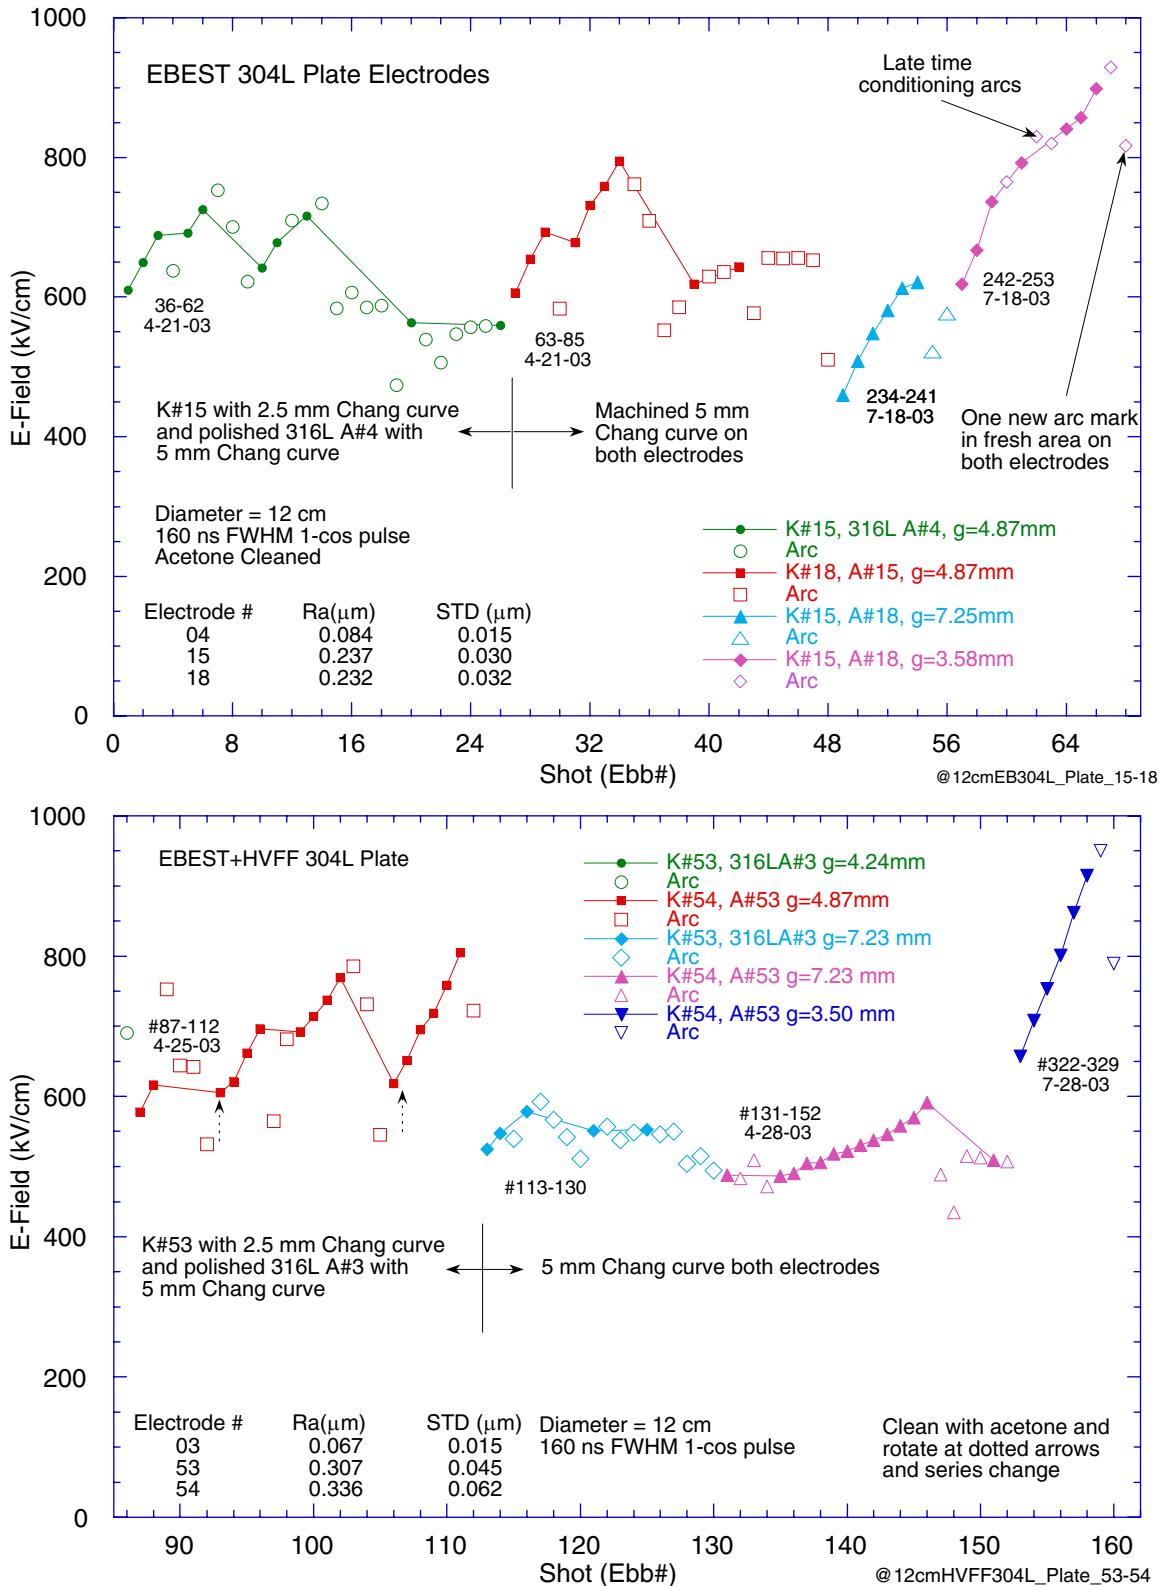
Figure 45. High voltage breakdown data for 12 cm EBEST (machined and HVFF) 304L plate stock electrodes with large gaps. The initial tests used cathodes with 2.5 mm Chang curves and 316L anodes with 5 mm Chang curves.

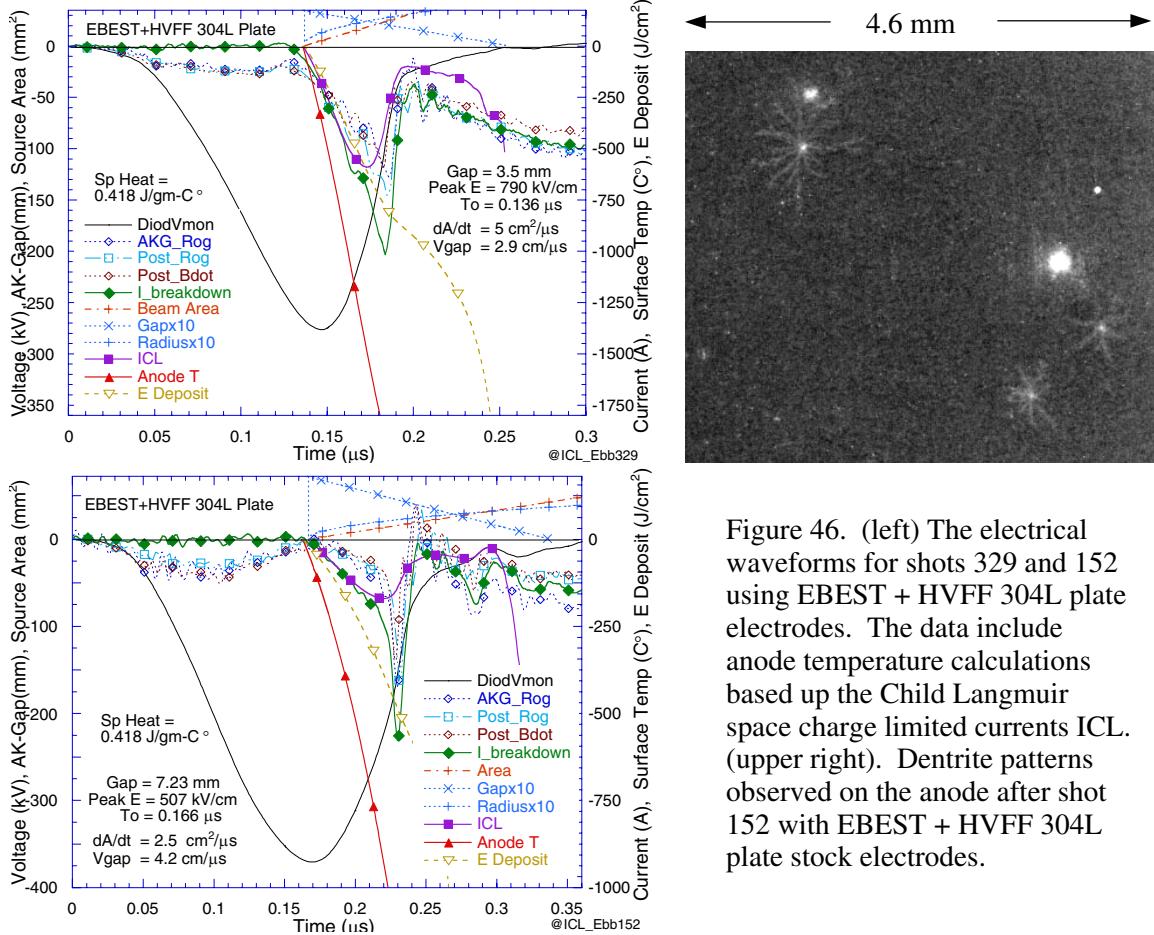
Figure 46. (left) The electrical waveforms for shots 329 and 152 using EBEST + HVFF 304L plate electrodes. The data include anode temperature calculations based up the Child Langmuir space charge limited currents ICL. (upper right). Dentrite patterns observed on the anode after shot 152 with EBEST + HVFF 304L plate stock electrodes.

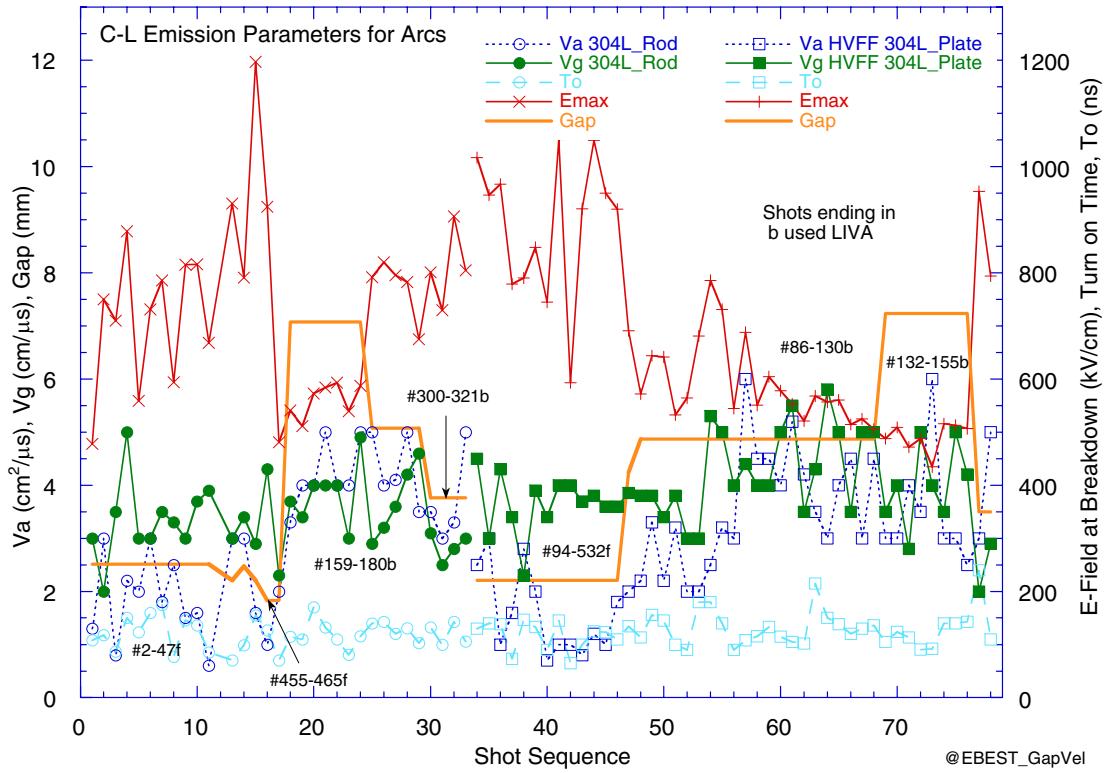
Figure 49. The CL model fit parameters of the breakdown shots for EBEST 304L rod and HVFF 304L plate stock electrodes listed in the previous plots of the individual breakdown data.

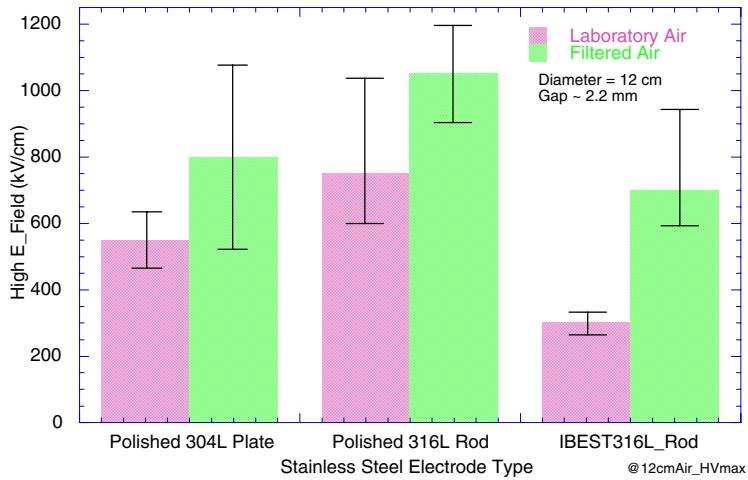
Figure 54. A summary of the hold off data for polished 304L plate and 316L rod cleaned in laboratory and filtered air. Some comparison data obtained with a 5 J/cm^2 , 50 ns, 800 keV, nitrogen beam treatment is shown as IBEST.

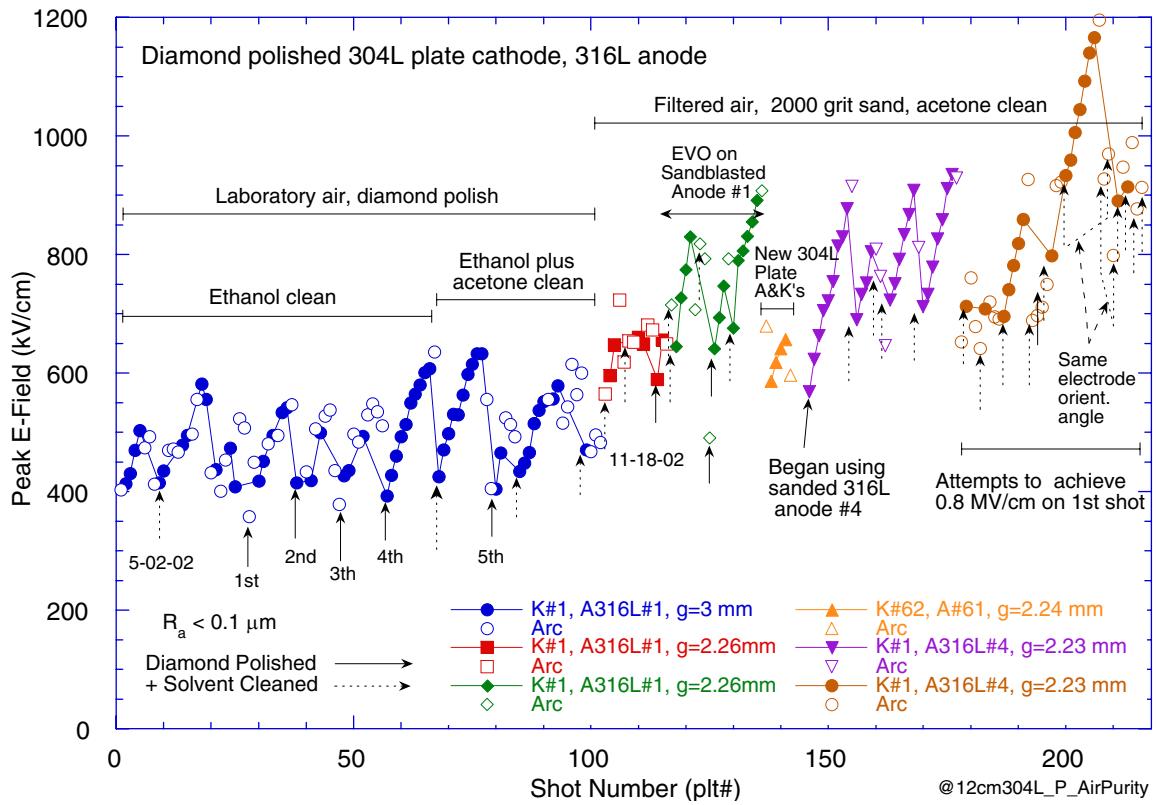
Figure 55. The electrical breakdown data for polished 304L plate cathodes acquired with various cleaning procedures.

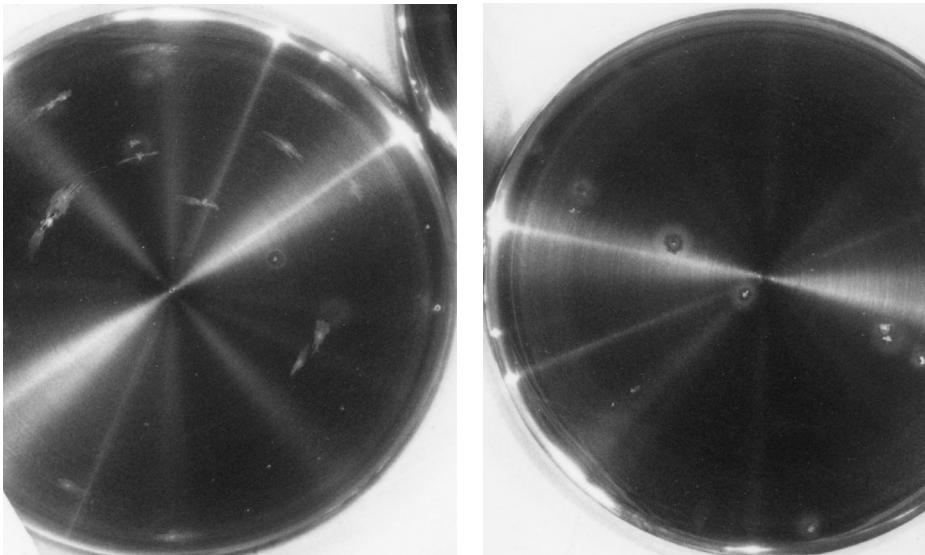
Figure 60.
The arc marks on 316L anodes #3 (left) and #4 (right) that occurred during the preliminary shot series shown in Fig. 45.

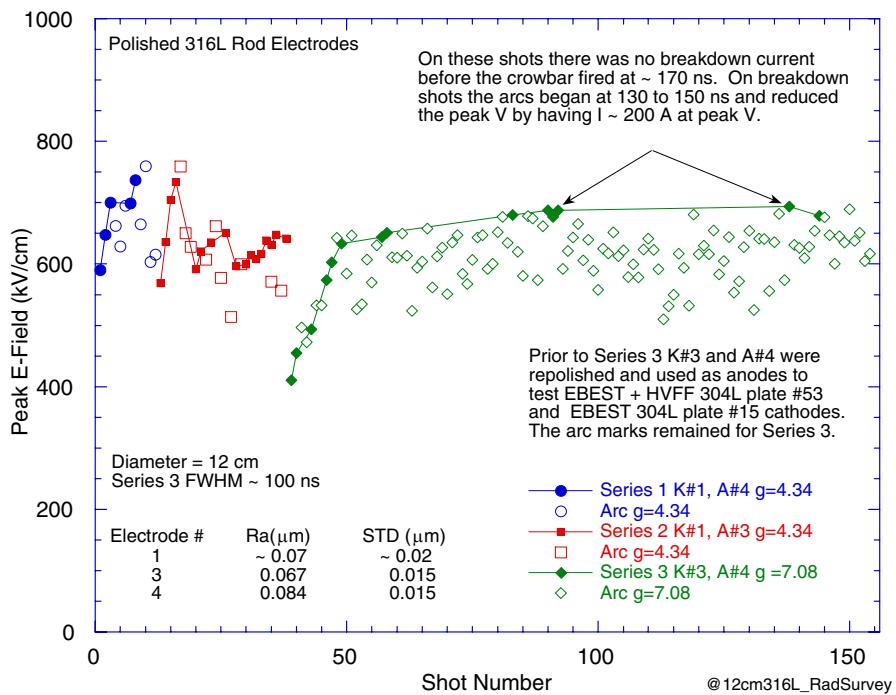
Figure 61.
 (upper) Electrical breakdown data for polished 316L rod stock stainless steel electrodes. Shots for the radiation survey, Series 3, are shown in green.
 (lower) The 316L electrodes after the radiation survey. The arrow points to an area on the cathode with many small pit marks from the arcs.

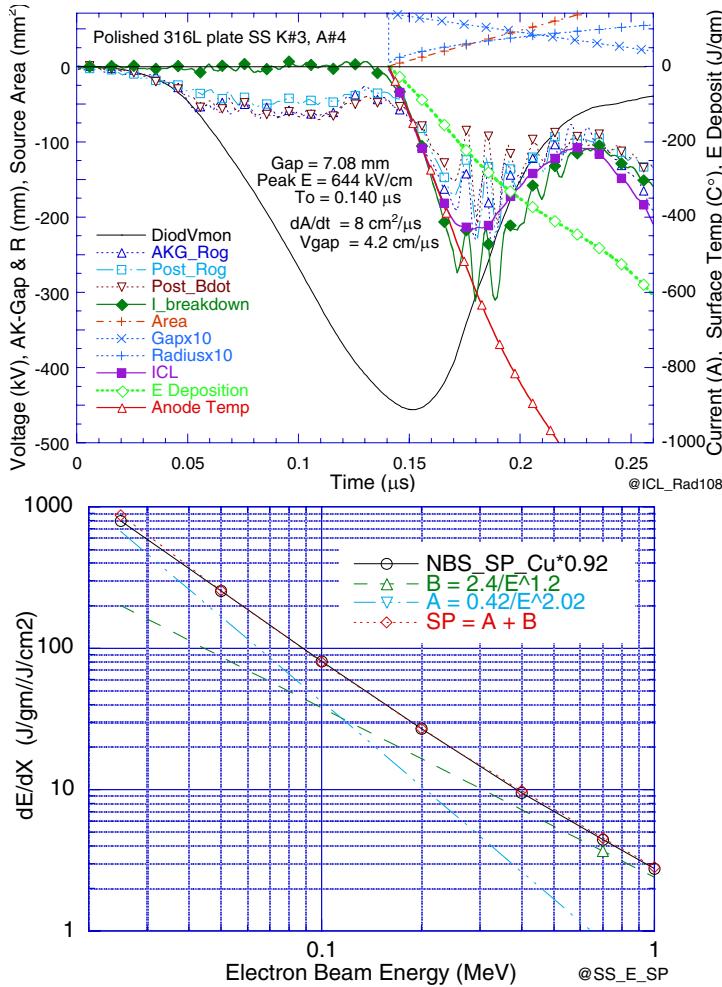
Figure 62. (upper) Electrical breakdown data for shot 108 with polished 316L rod stock stainless steel electrodes acquired at the end of the 125 shot radiation survey series. (lower left) The electron beam surface stopping power extrapolated from the copper data in the Spencer Monograph [46]. The analog expressions for A and B were used in the Kaleidagraph graphics program to calculate the temperature.

The electrical waveforms for shot 108 taken near the end of the radiation survey test are shown in Fig. 62. The current does not show the jump late in time current that was observed for many of the EBEST electrode shots. Although some of the shots in the first half of the series showed the jump those in the second half did not. This could be due to conditioning of the cathode, which delayed turn on and resulted in insufficient time to heat the anode. There might have been a small increase of V_{gap} with higher E-field but the spread in data such as shown in Fig. 59 make it difficult to be sure. The V_{area} values for the highest voltage shots in the radiation survey series were $\sim 7 \text{ cm}^2/\mu\text{s}$. This is nearly twice the typical values for EBEST tests and may indicate the presence of more than one arc.

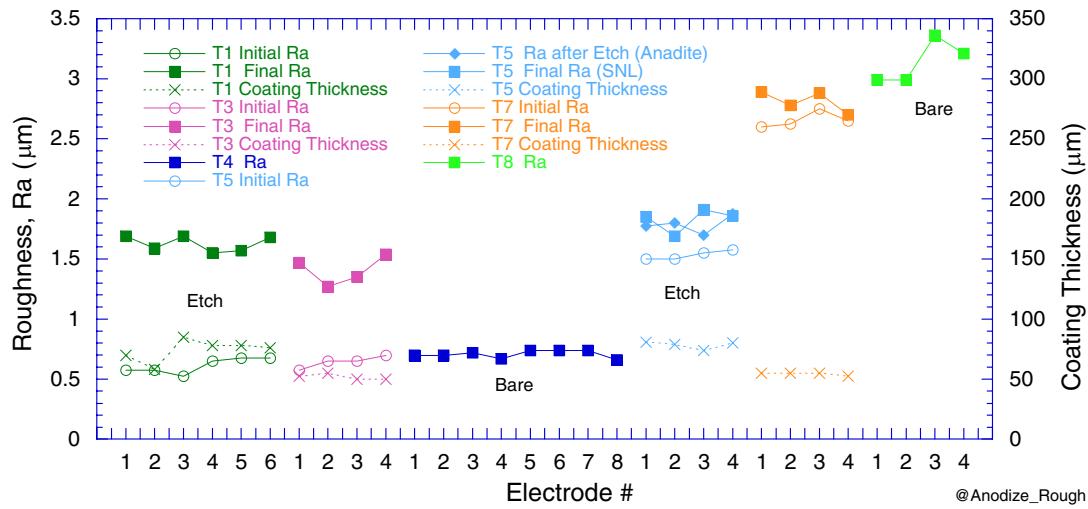
Figure 63. The surface roughness and anodized coating thickness of the electrodes tested.

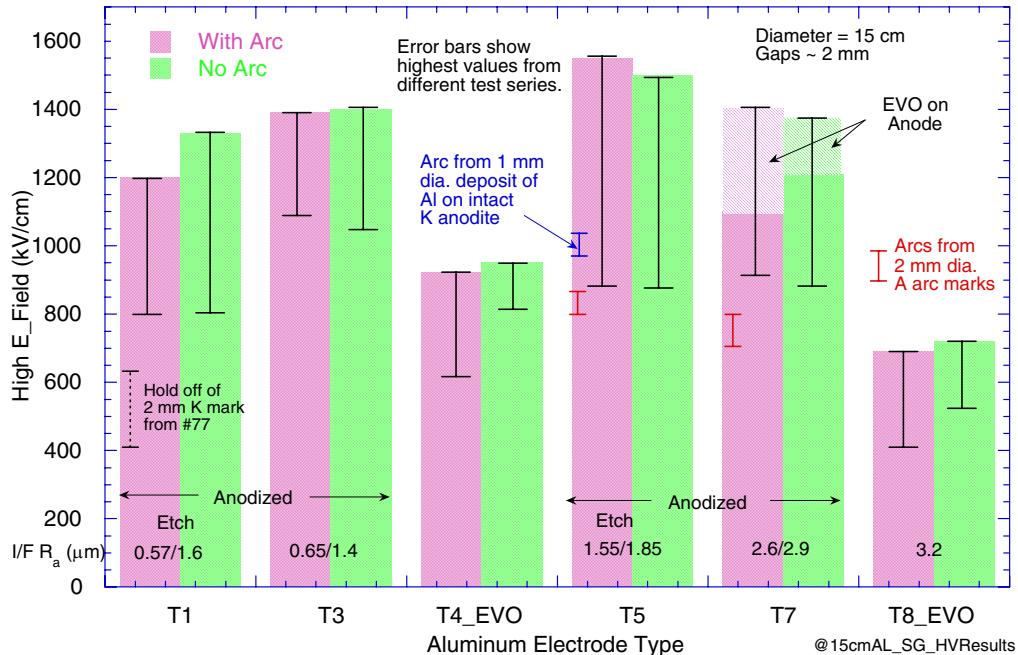
Figure 64. A summary of the test results for anodized and bare aluminum with small gaps.

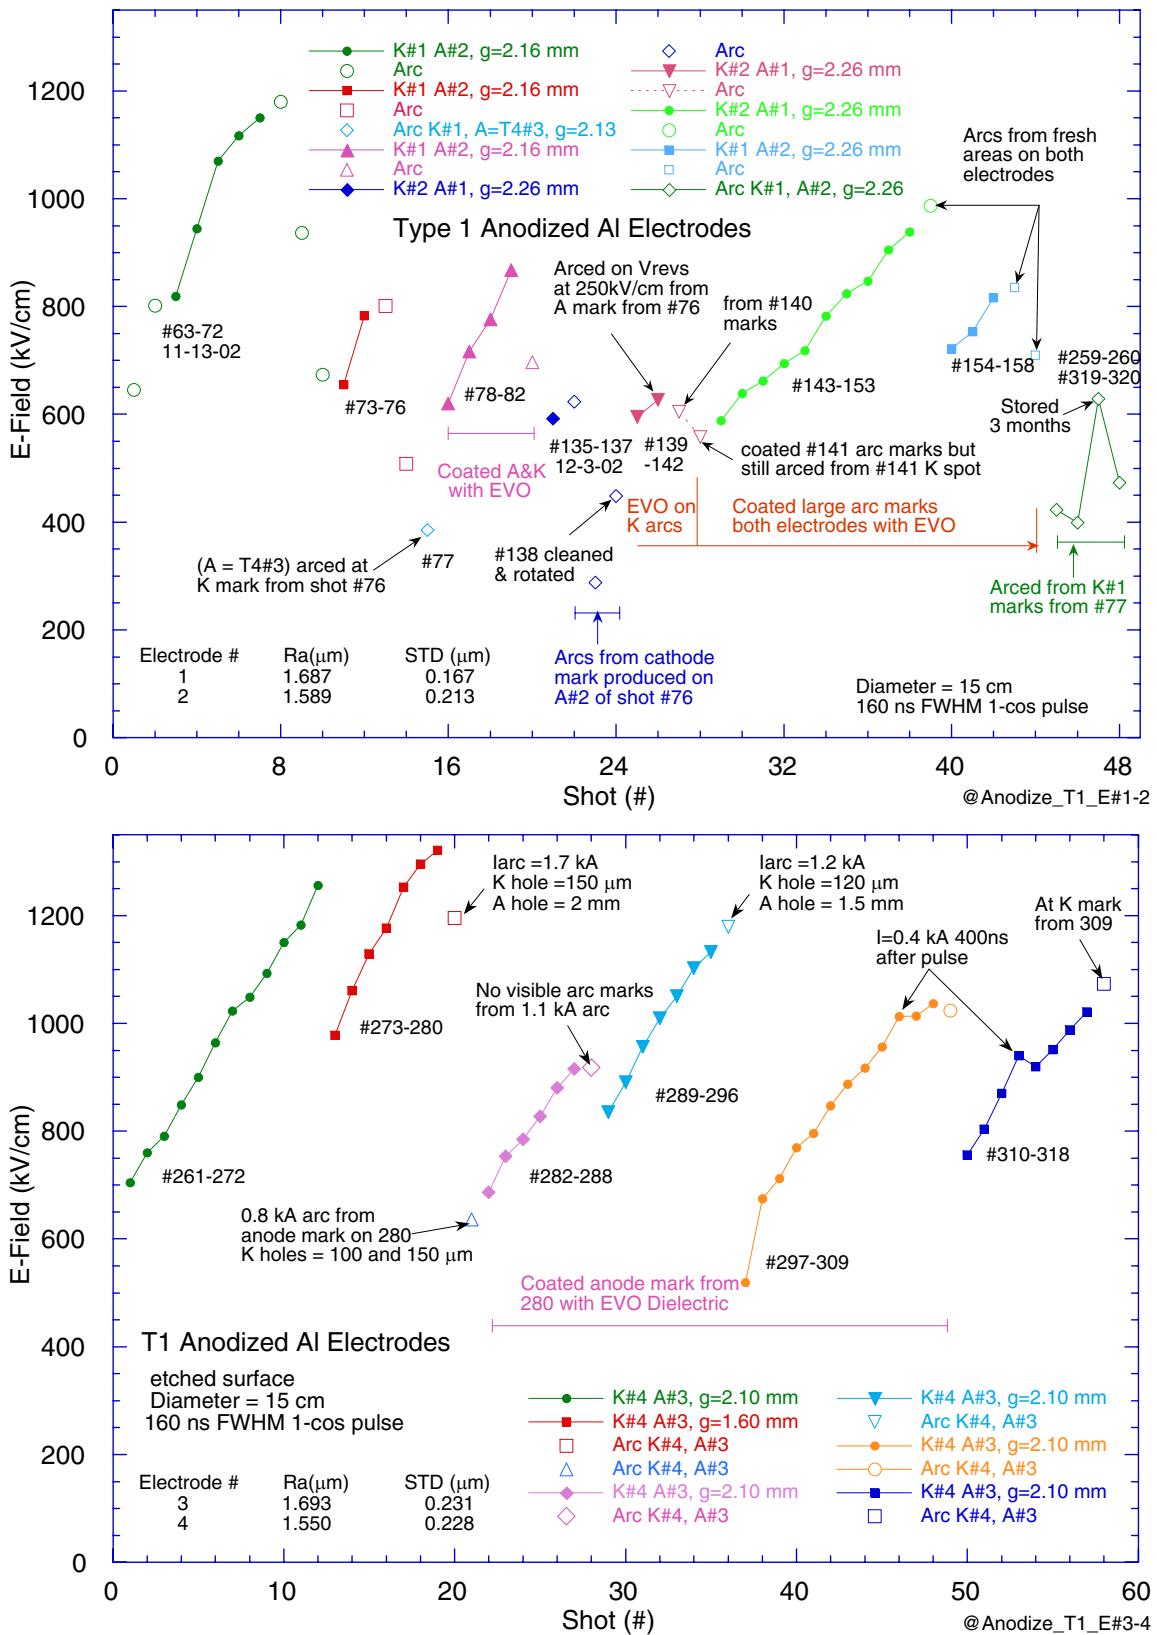
Figure 65. Breakdown data for T1 anodized aluminum anodes #1 to #4 acquired with small gaps.

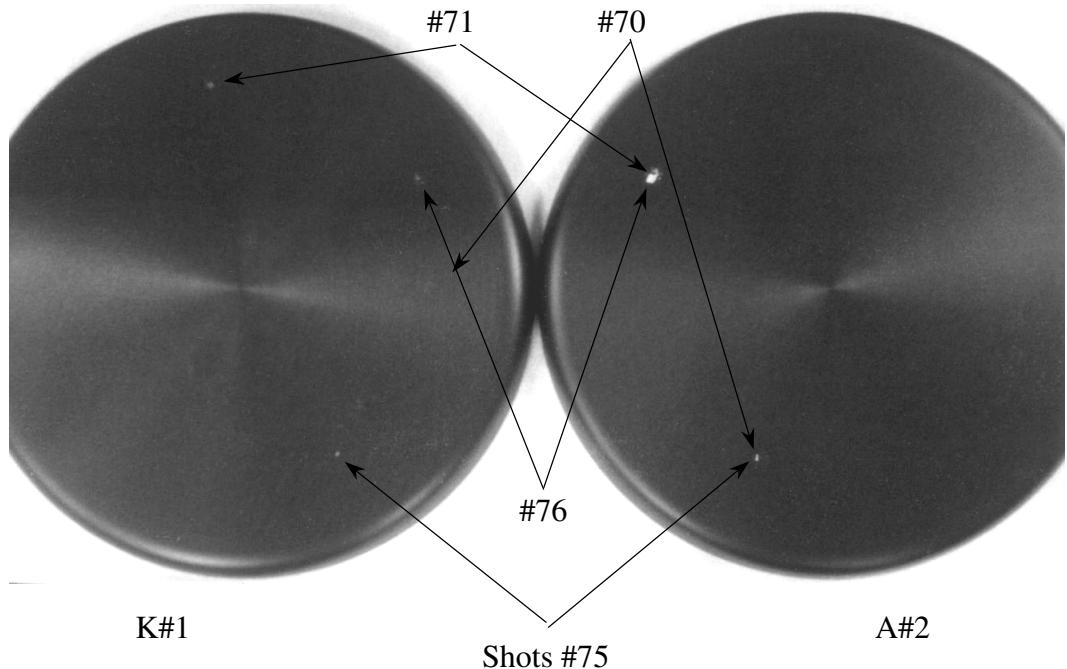
Figure 66. The damage patterns on anodized aluminum electrodes 1 and 2 after shot 76. The cathode, K#1 was rotated 67.5° counter clockwise in photo after shot 72.

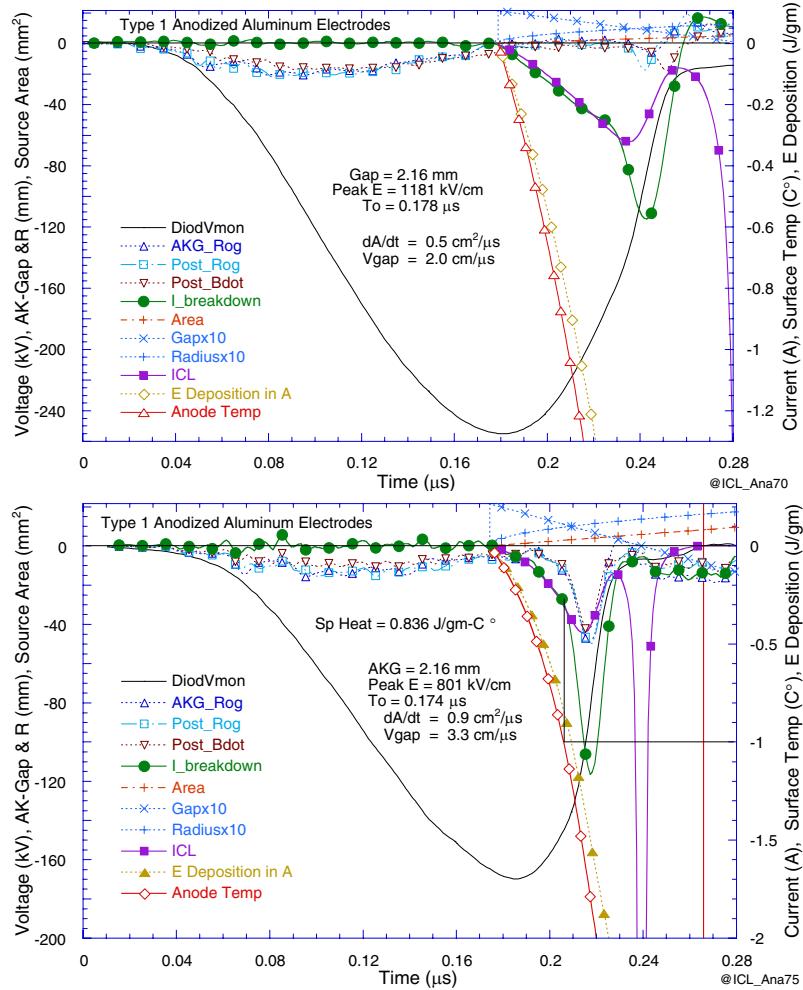
Figure 67. Electrical data from T1 anodized aluminum shots 70, 75. The purple curves are calculated Child-Langmuir space-charge limited currents for a linear area growth and gap closure rates. The anode temperatures calculated from the CL current density. The surface stopping power for normal incidence electron on aluminum oxide was used in the calculation.

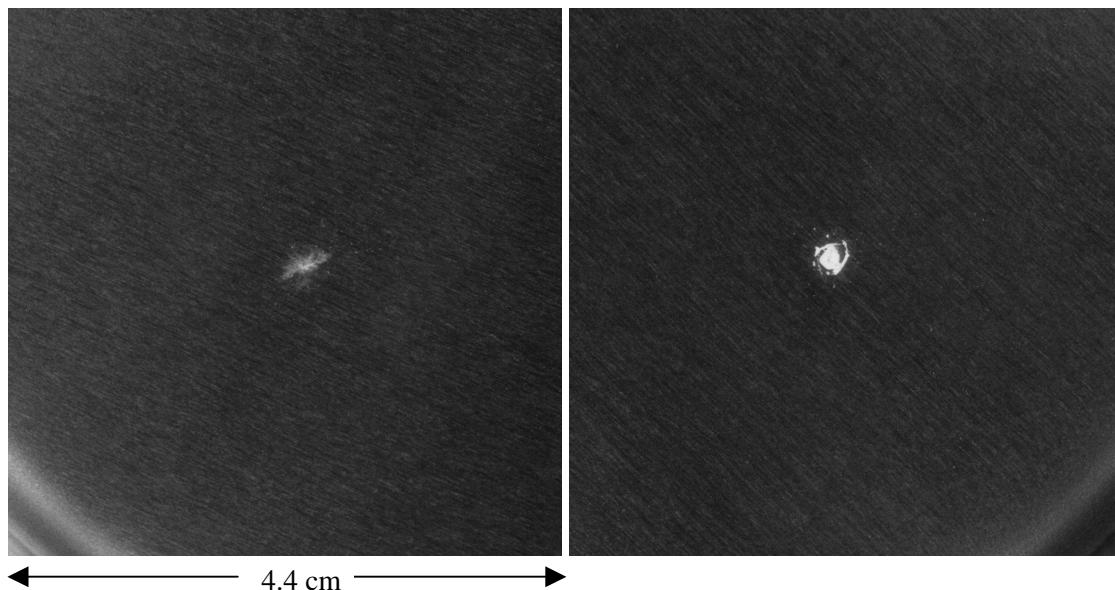
Figure 68. The damage from the arc that occurred on T1 electrodes shot 280 is located at the center of each photo. Cathode #4 is on left and anode #3 is on the right.

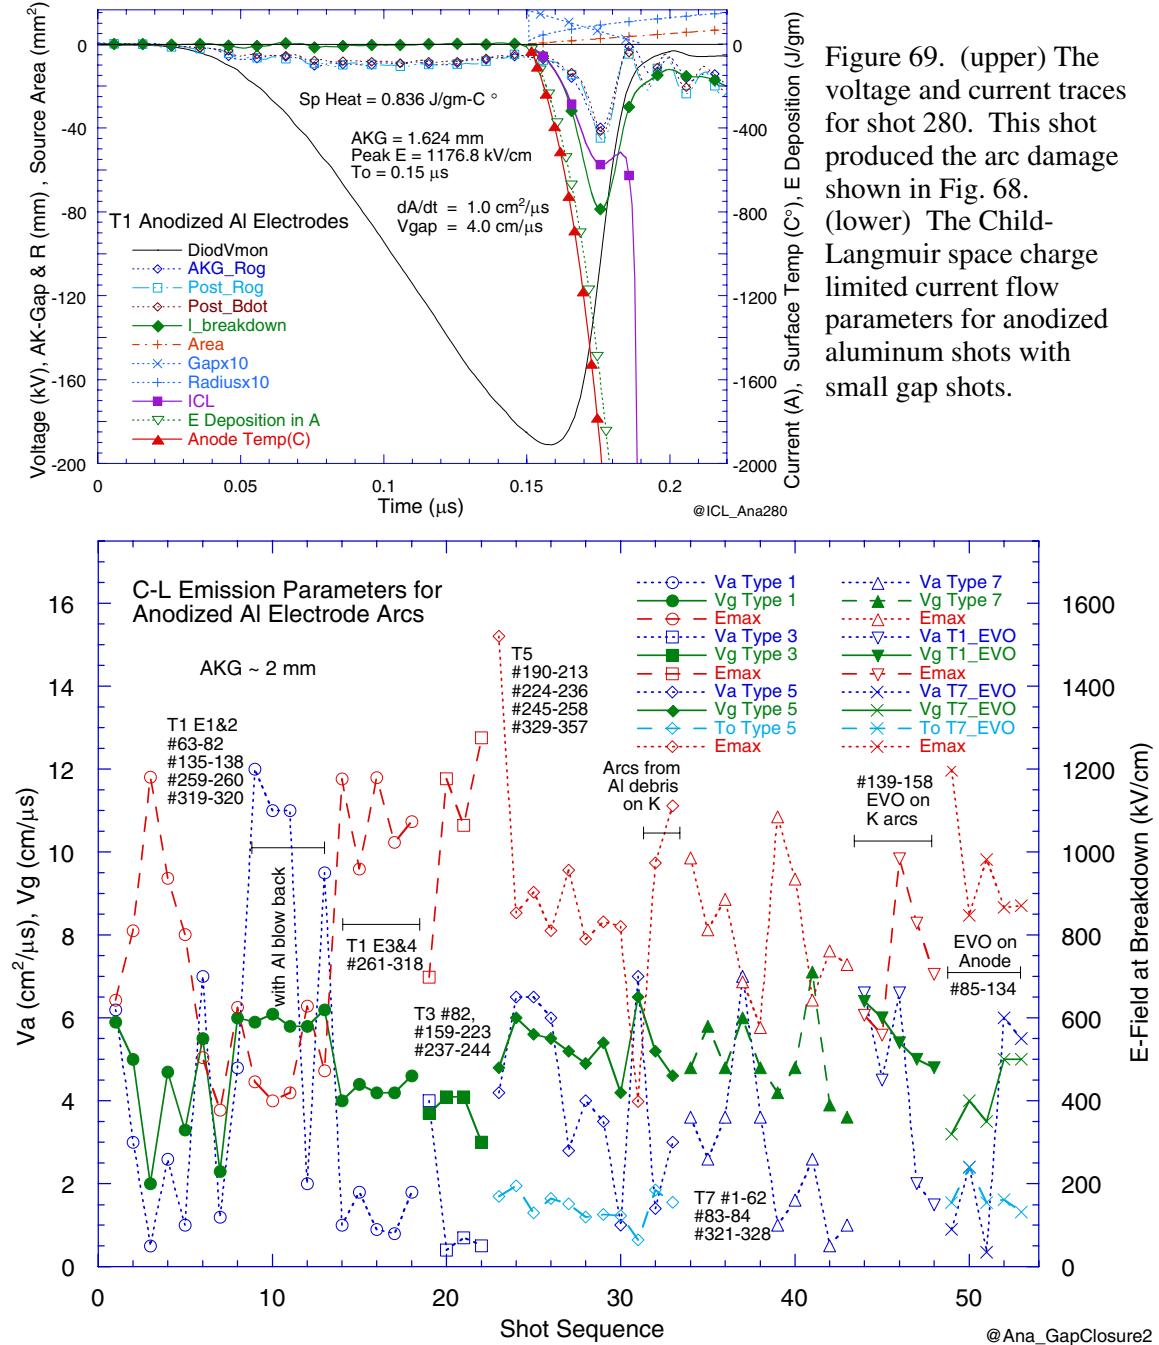
Figure 69. (upper) The voltage and current traces for shot 280. This shot produced the arc damage shown in Fig. 68. (lower) The Child-Langmuir space charge limited current flow parameters for anodized aluminum shots with small gap shots.

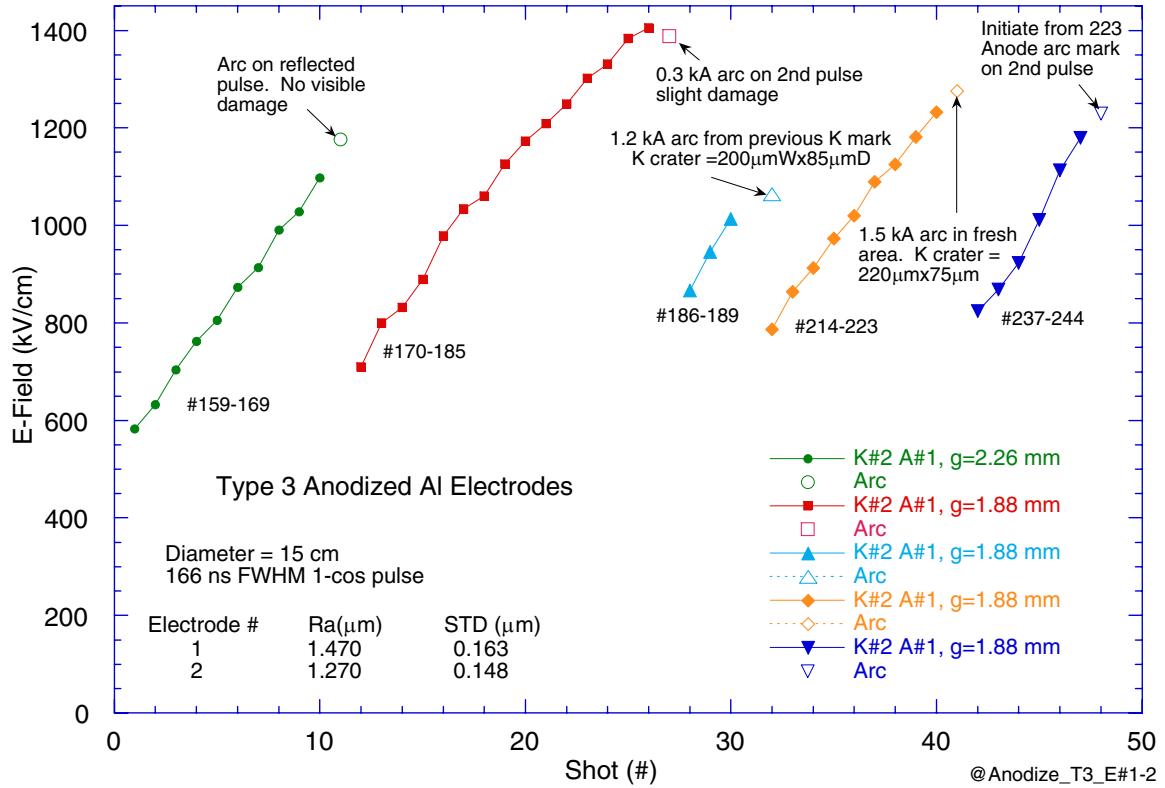
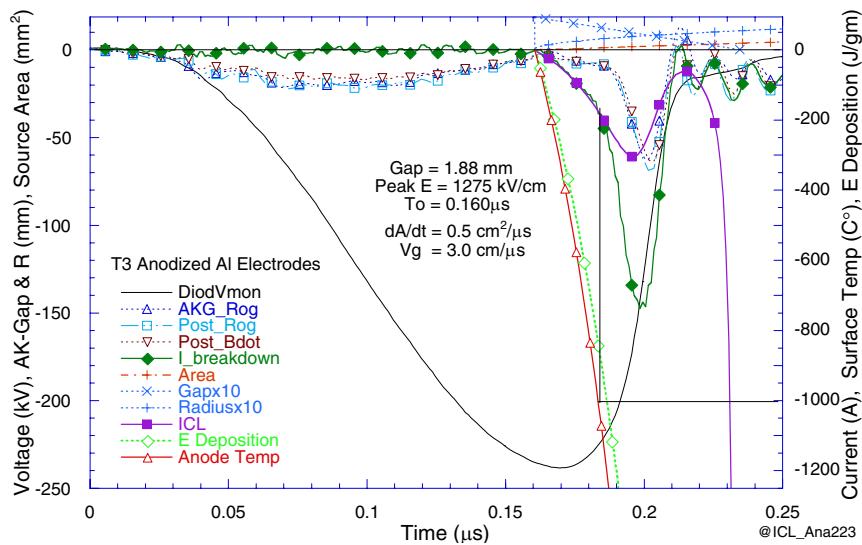
Figure 70.
(upper) Breakdown data for T3 anodized aluminum electrodes K#2 and A#1 acquired with small gaps.
(lower) Electrical data from T3 shot 223. See Fig. 67 for a description of the waveforms and calculations.

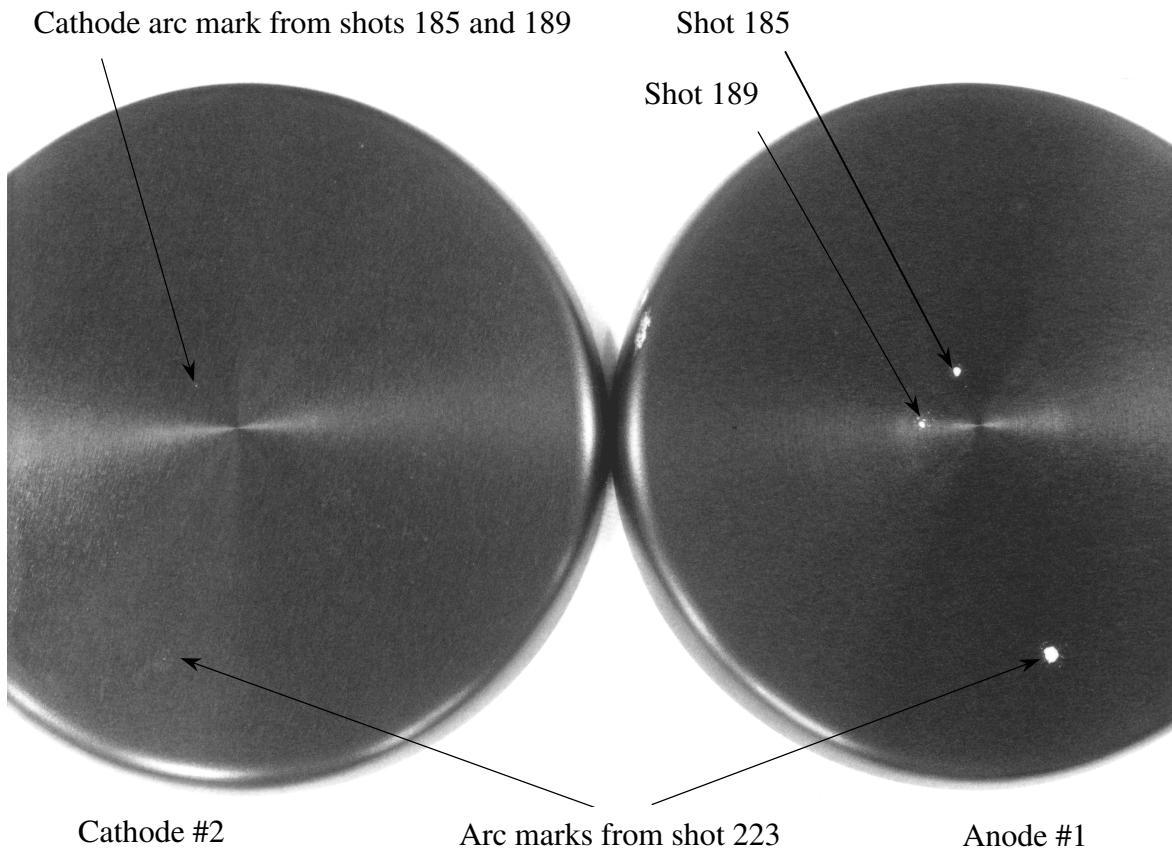
Figure 71. The appearance of T3 electrodes after shot 223, which was the last shot of series 4 shown in Fig. 70.
