SANDIA REPORT

SAND2003-3819
Unlimited Release
Printed November 2003

Suppression of Electron Emission from Metal Electrodes LDRD 28771 Final Report

David J. Johnson, William E. Fowler, Harry C. Ives, Mark E. Savage, and
William A. Stygar

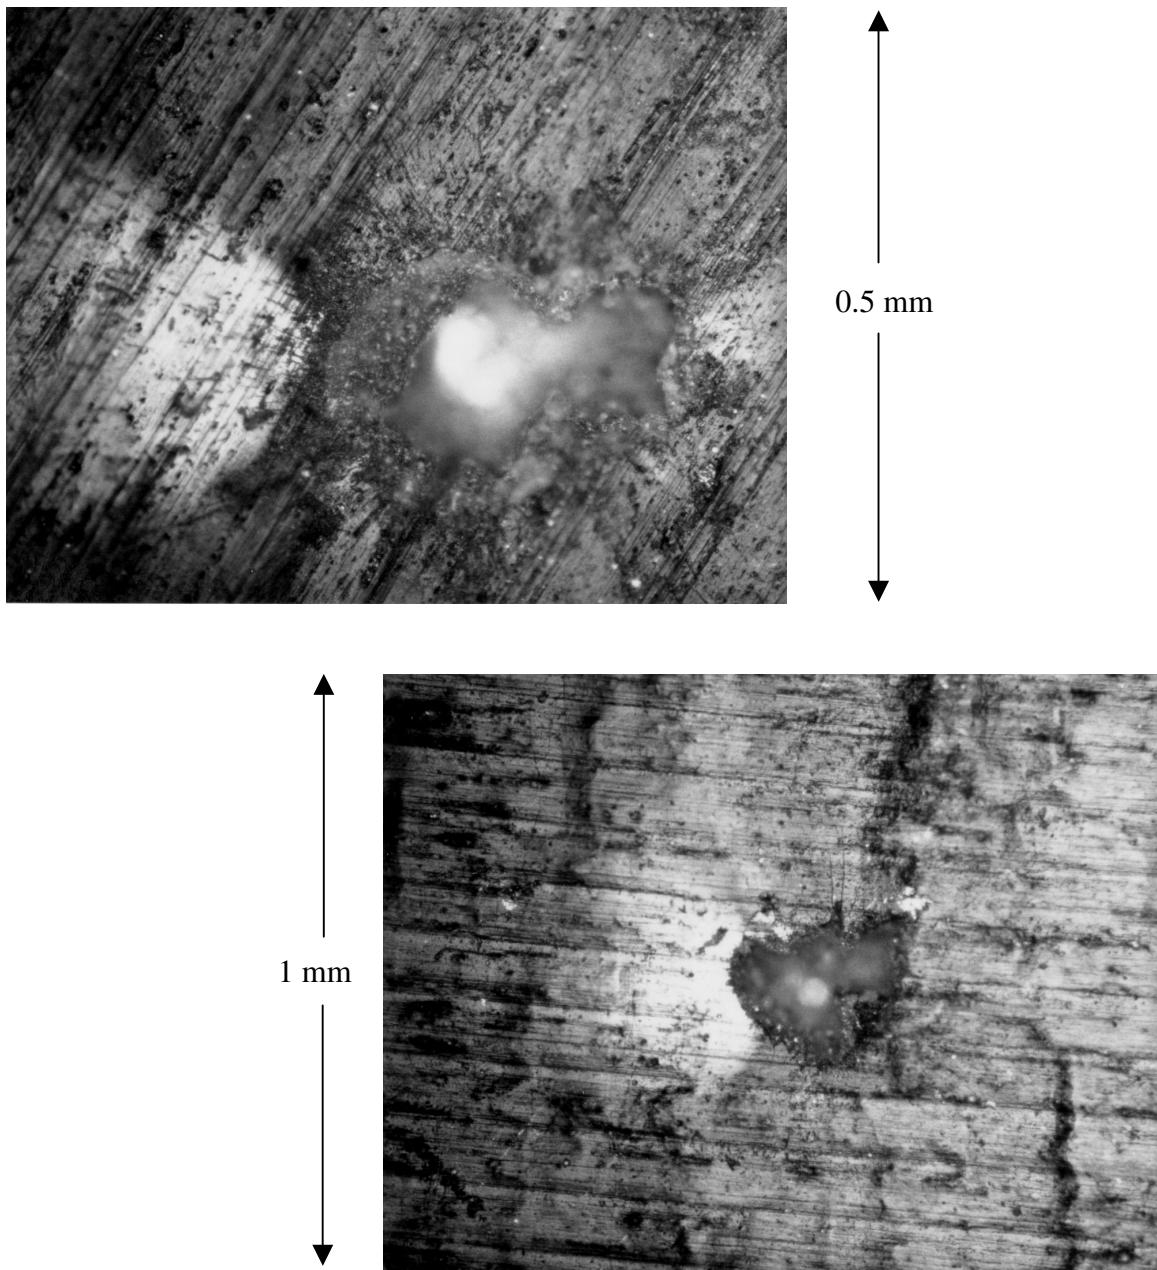
Figure 72. (top) Cathode arc mark from shot 189. This mark is $\sim 85 \mu\text{m}$ deep.
(bottom) Cathode arc mark from shot 223. This mark is $\sim 75 \mu\text{m}$ deep.

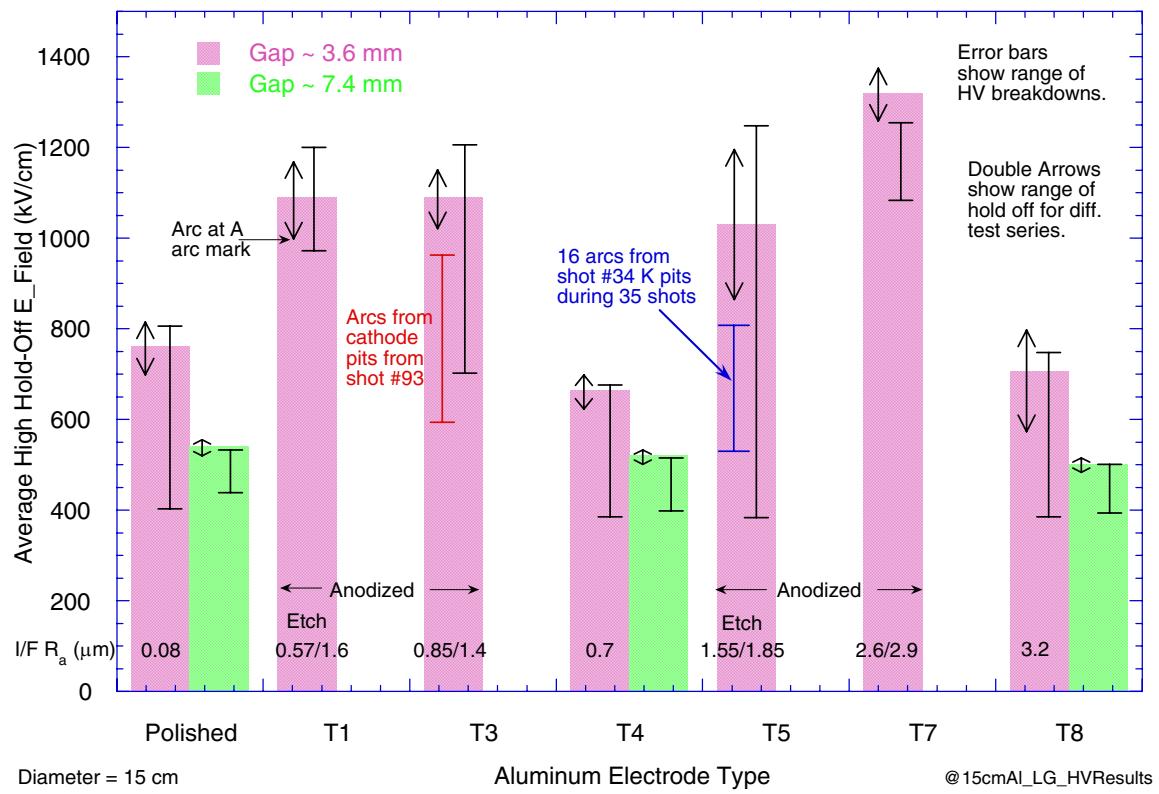
Figure 73. A summary of the test results for anodized and bare aluminum with large gaps.

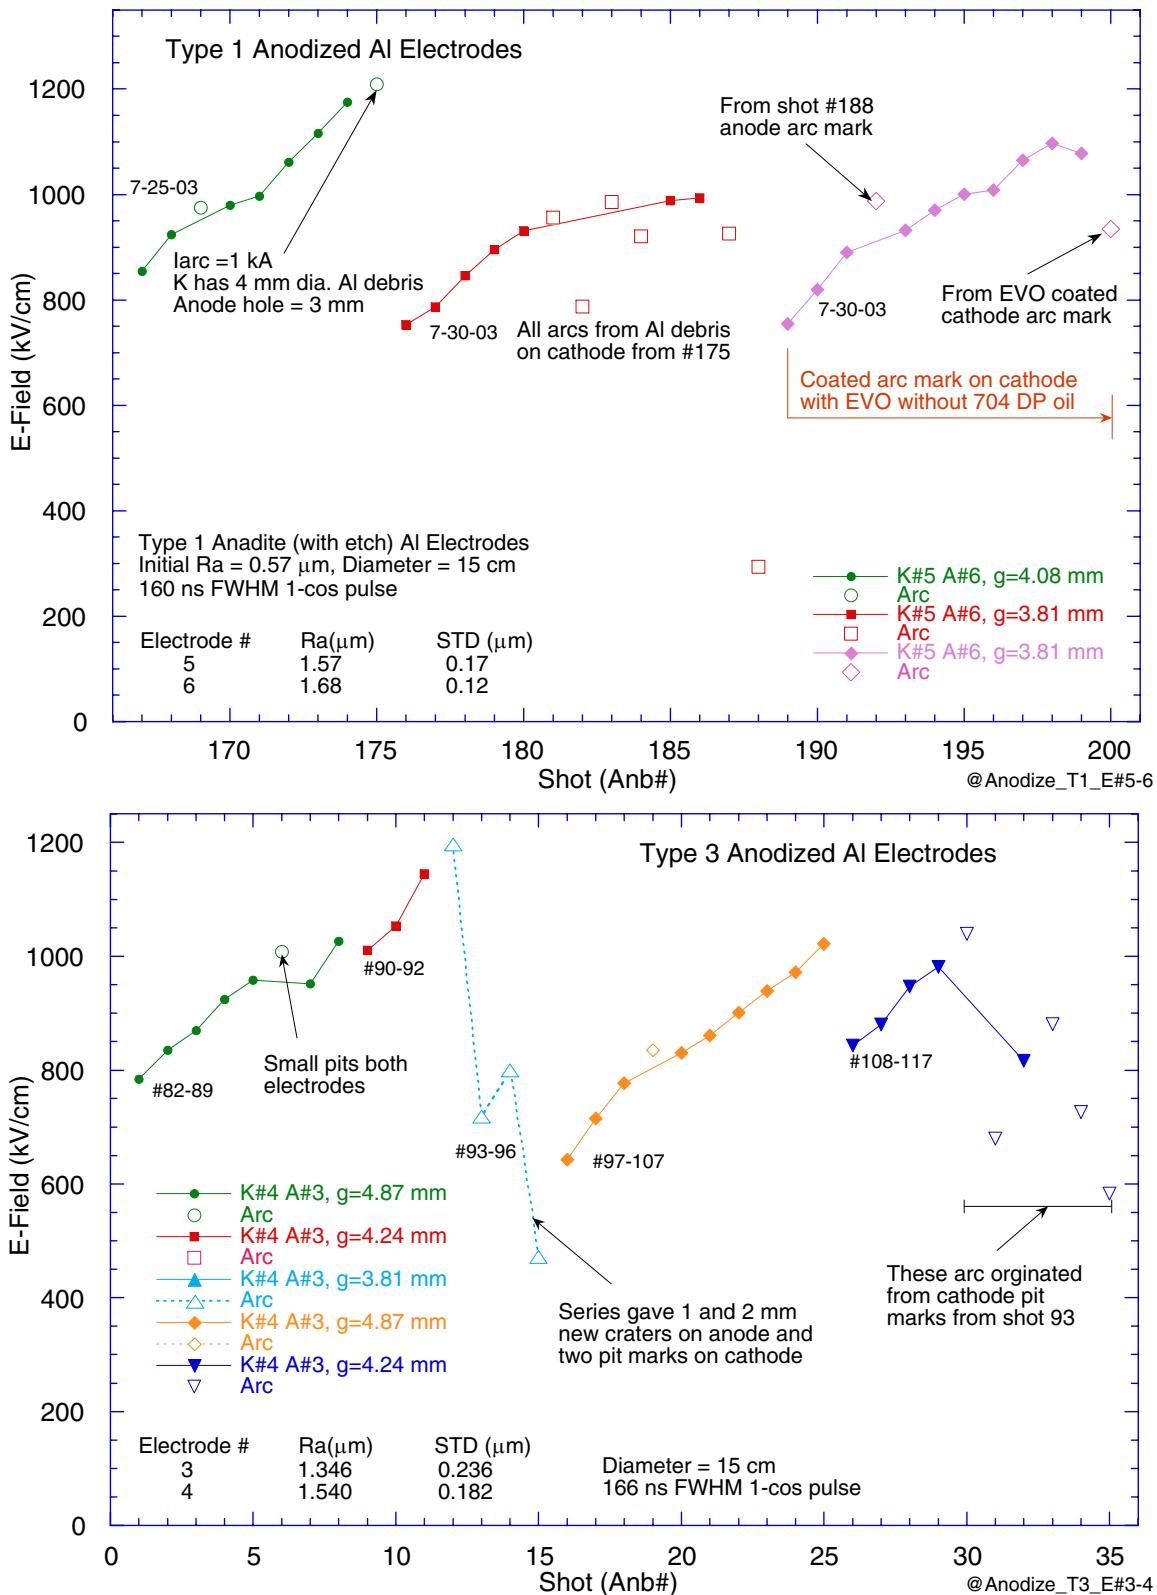
Figure 74. Breakdown data for T1 and T3 anodized aluminum electrodes acquired with large gaps.

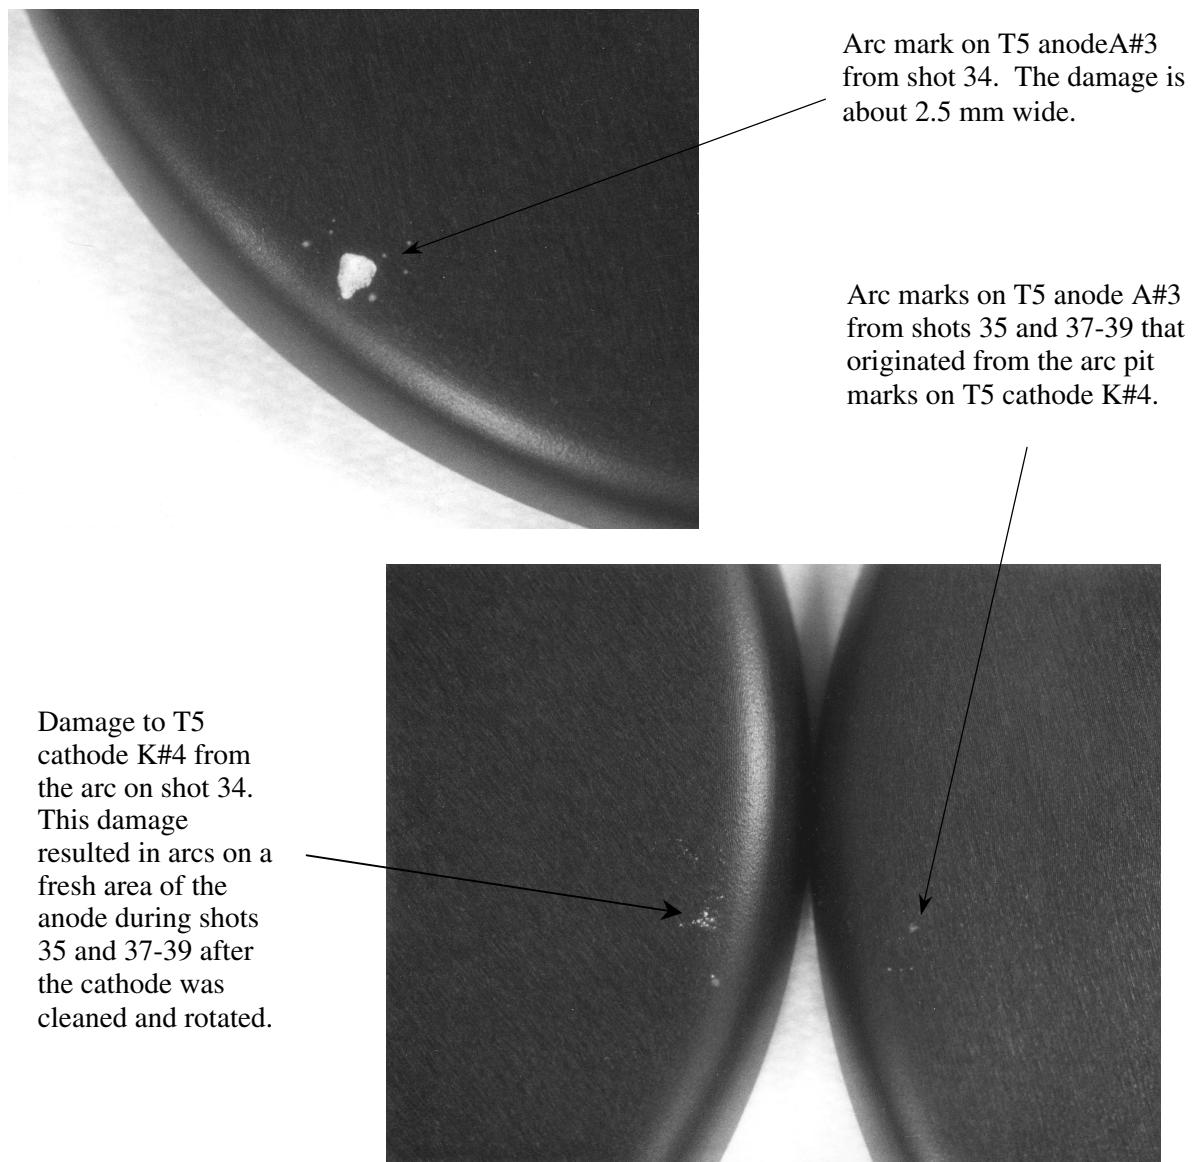
Figure 76. Damage patterns on T5 electrodes #3 and 4 that occurred during the 3rd large gap shot series with these electrodes. The damage most likely occurred on shots Anb34.

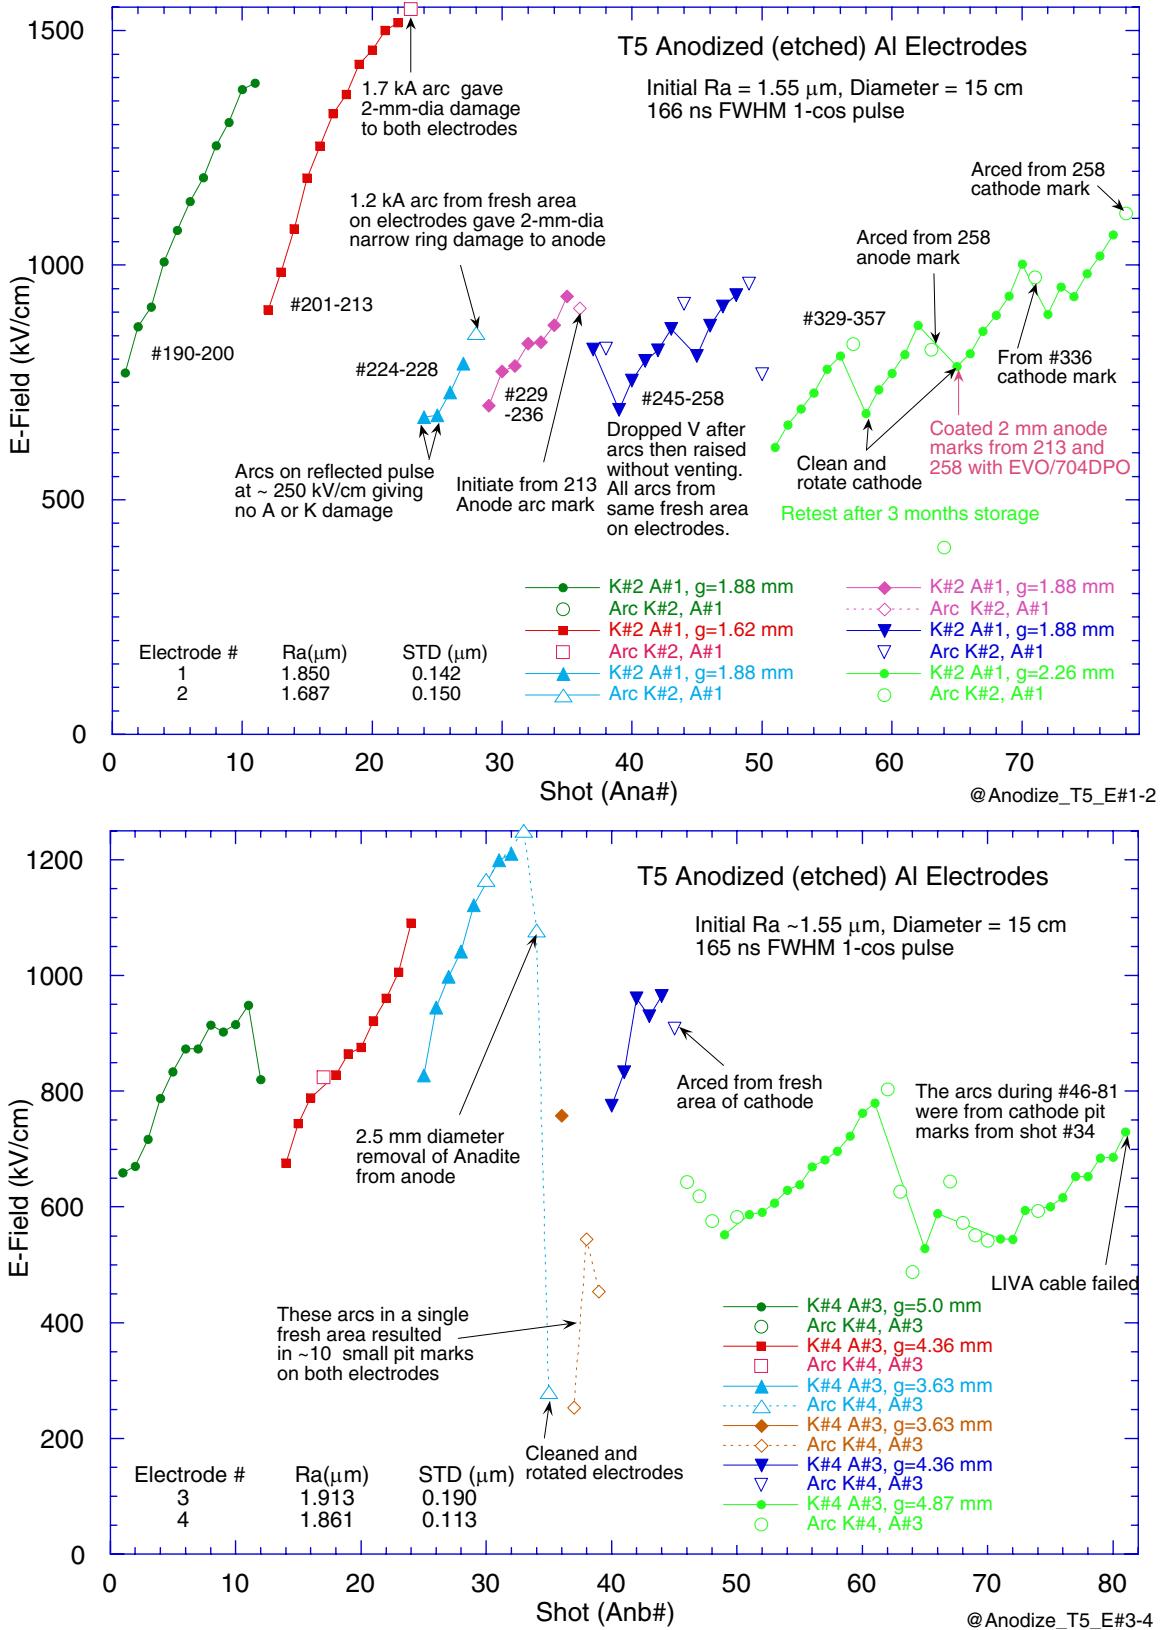
Figure 77. Breakdown data T5 anodized etched Al electrodes tested with small and large gaps.

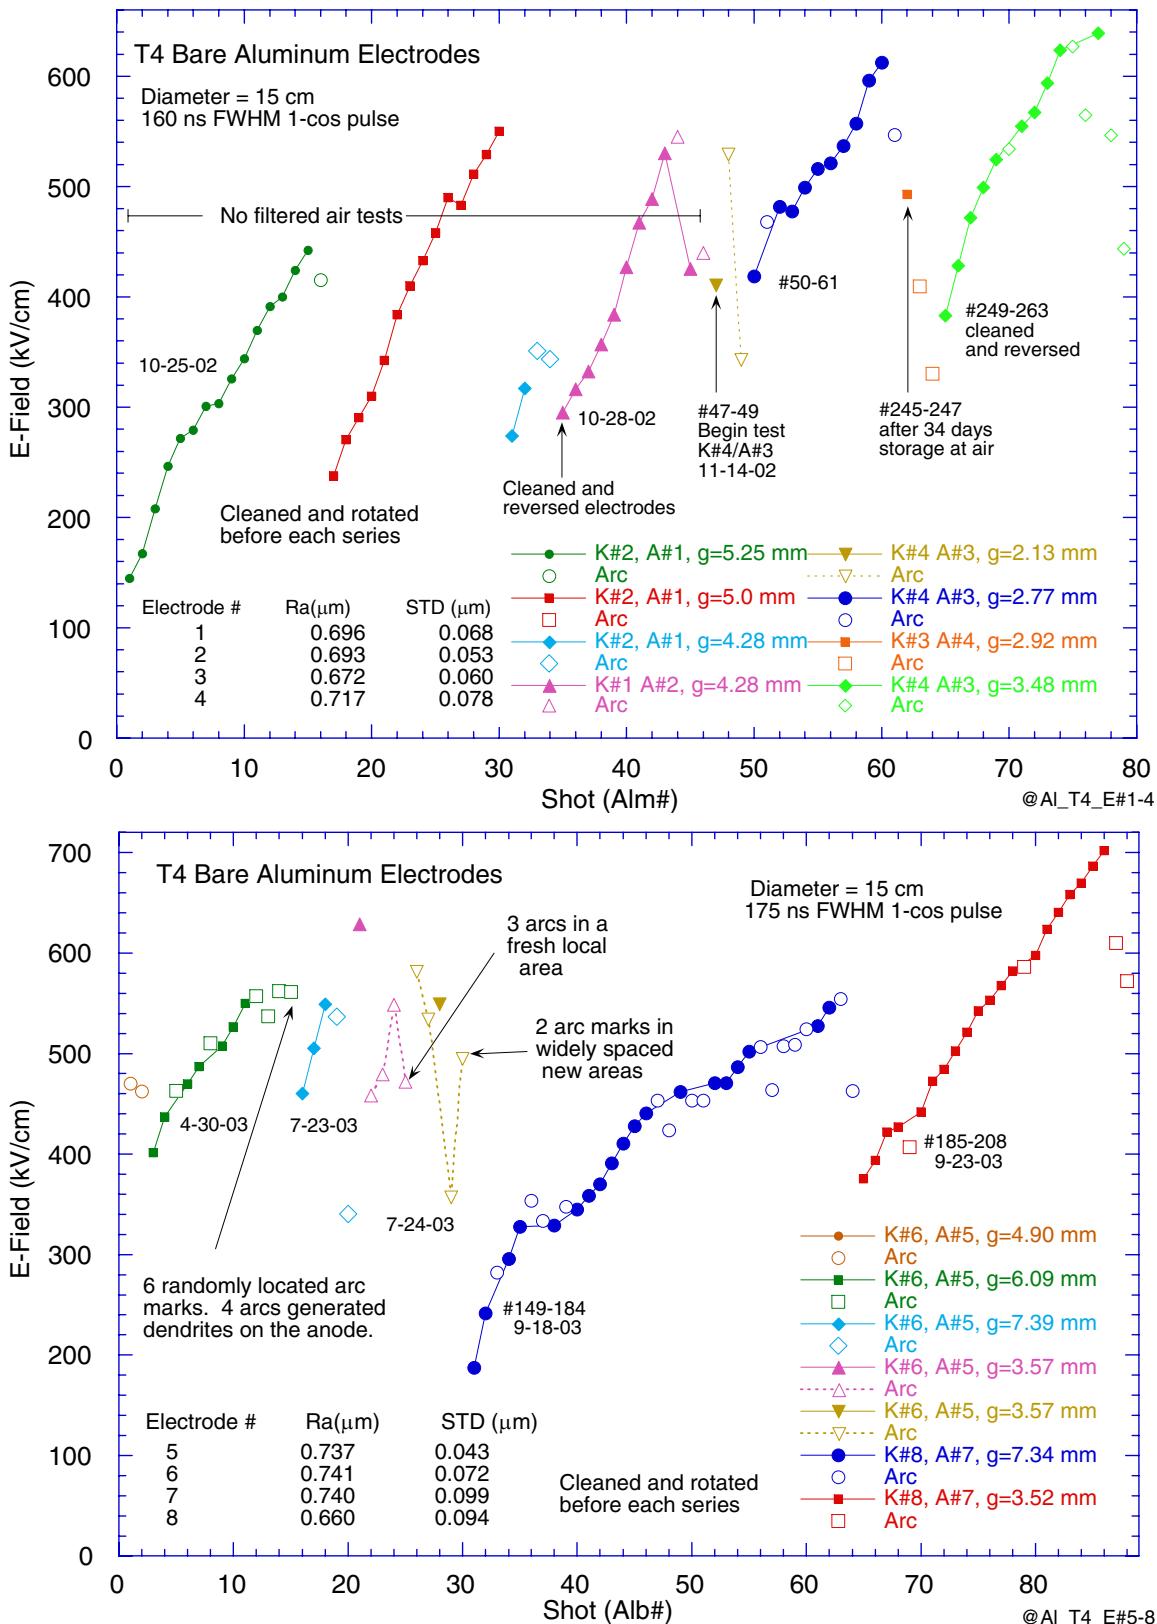
Figure 79. Breakdown data for T4 bare aluminum electrodes #1 to #8.
